WILD TROUT TRUST

**River Irt**

Bertol Angling Club

01/10/2020

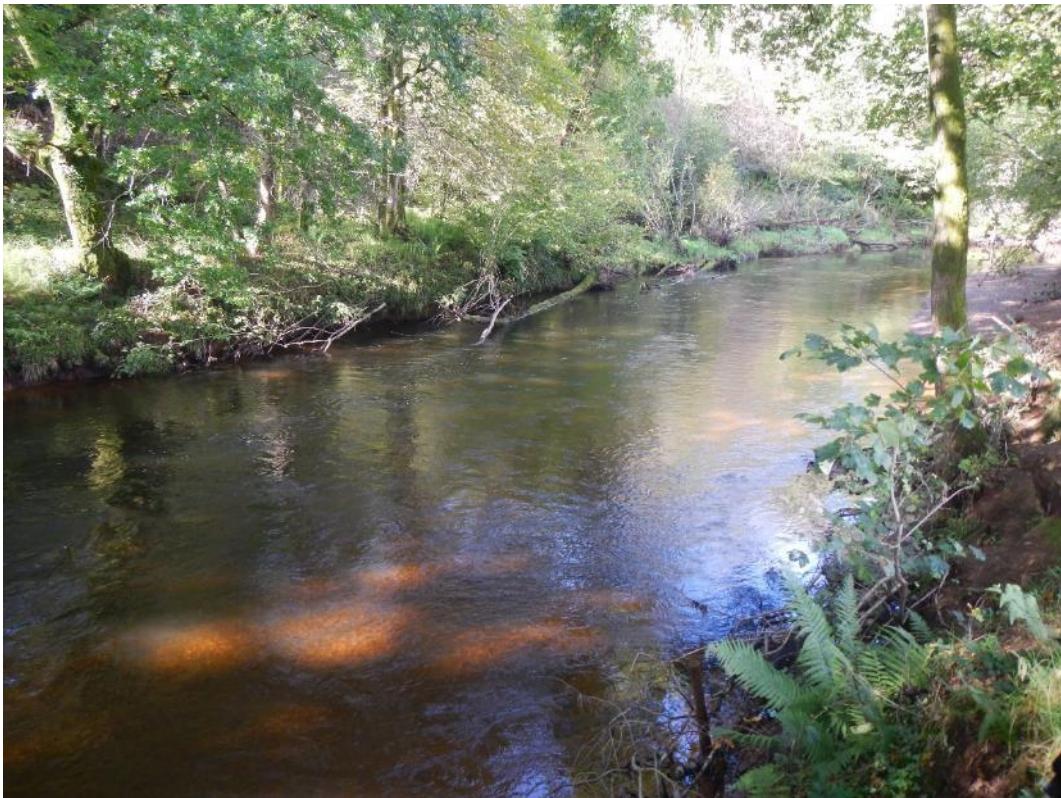
Figure 24. The line of trees along the bank create a somewhat over-shaded avenue; however, when considered over the broader reach this short section is not an issue. Some very limited coppicing could be beneficial to let the odd patch of light in, and may be worthwhile if the material could be used for in-channel structure, but short shaded sections do provide their own benefit in terms of water temperature regulation, so even no action here could be justified. Note the highly beneficial woody material along the far, right bank. The relatively stable channel section downstream could really benefit from the introduction of additional substantial pieces of woody material if agreement could be gained from the landowner. Even in this upstream section, excess fine sediment was observed within the substrate, signifying that the land use/erosion issues are not just localised, but also likely to be occurring further upstream.
