WILD TROUT TRUST

River Team
(lower catchment)

March 2021

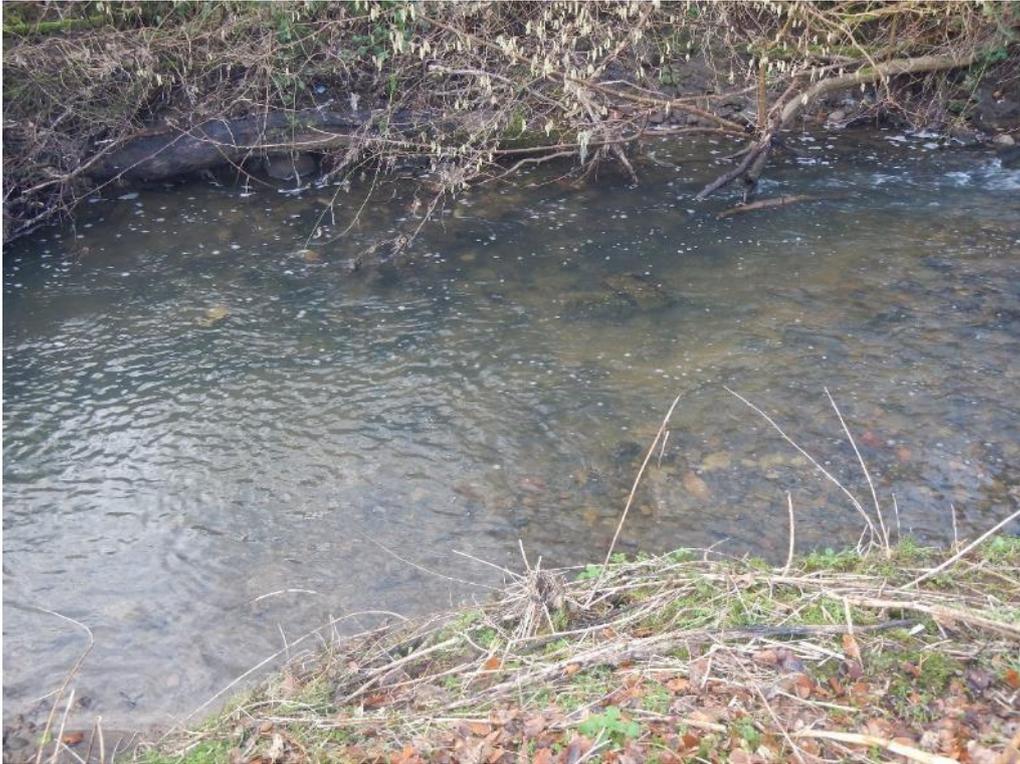
BB74. In-channel habitat in this area would be of a relatively high quality, barring the elevated fine sediment load. Low and trailing branches provide valuable cover.

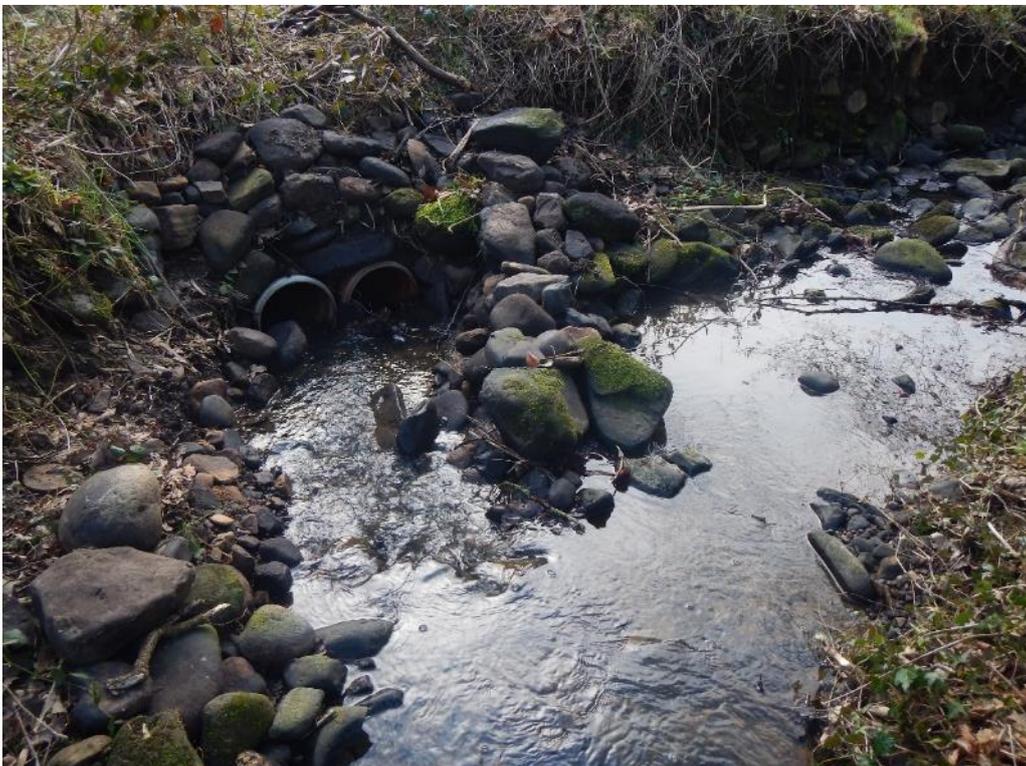
BB98. A significant proportion of the Red Burn has been diverted through an old pond, greatly decreasing the accessibility of Red Burn as a potential spawning tributary (NZ 22309 54843 - NZ 22325 54787). This probably illegal diversion should be stopped.

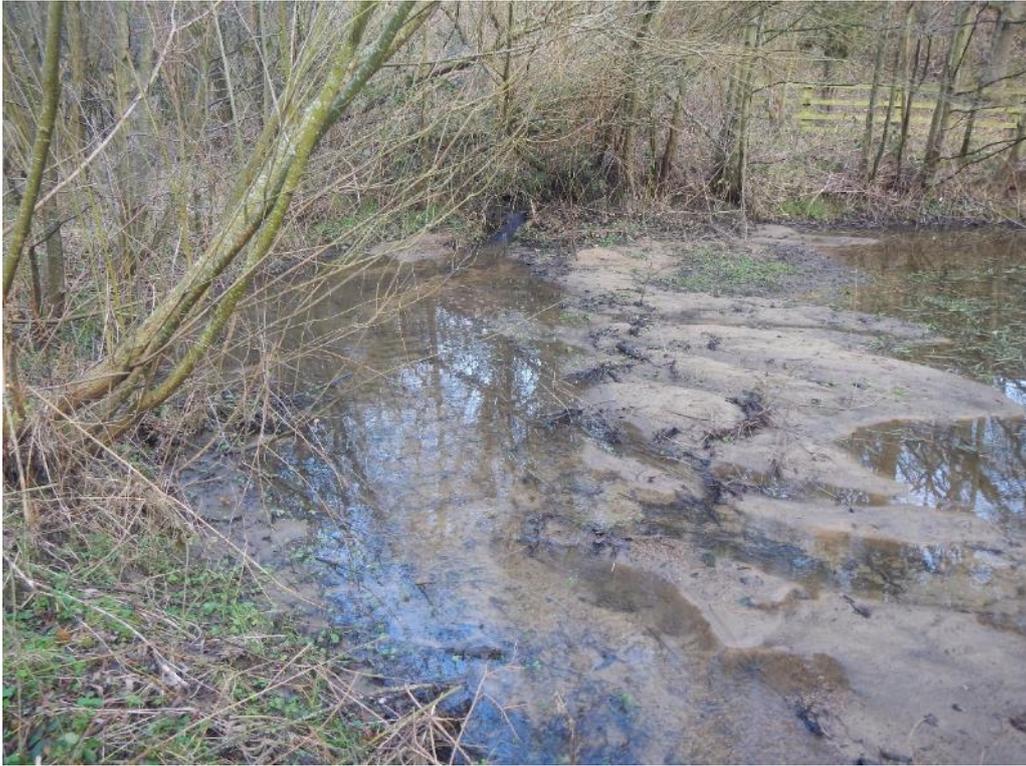
BB102. The pond is clearly acting as a silt trap for large volumes of fine sediment. The source of that fine sediment should be identified and addressed (see previous River Team report for possible causes). The increased flow through the pond will also remobilise this material in high flows, elevating fine sediment output to the Beamish Burn – another reason to cease the flow-through.

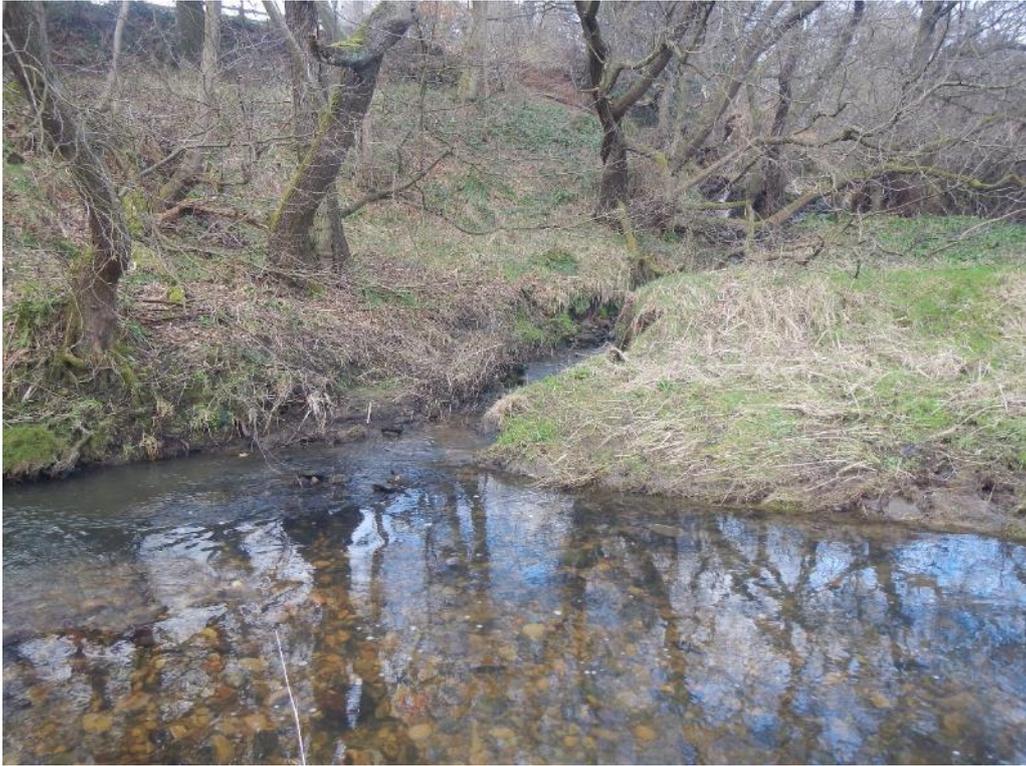
BB107. The downstream end of Letch Burn (tributary) is poorly accessible, owing to steep cascades (NZ 22322 54705).

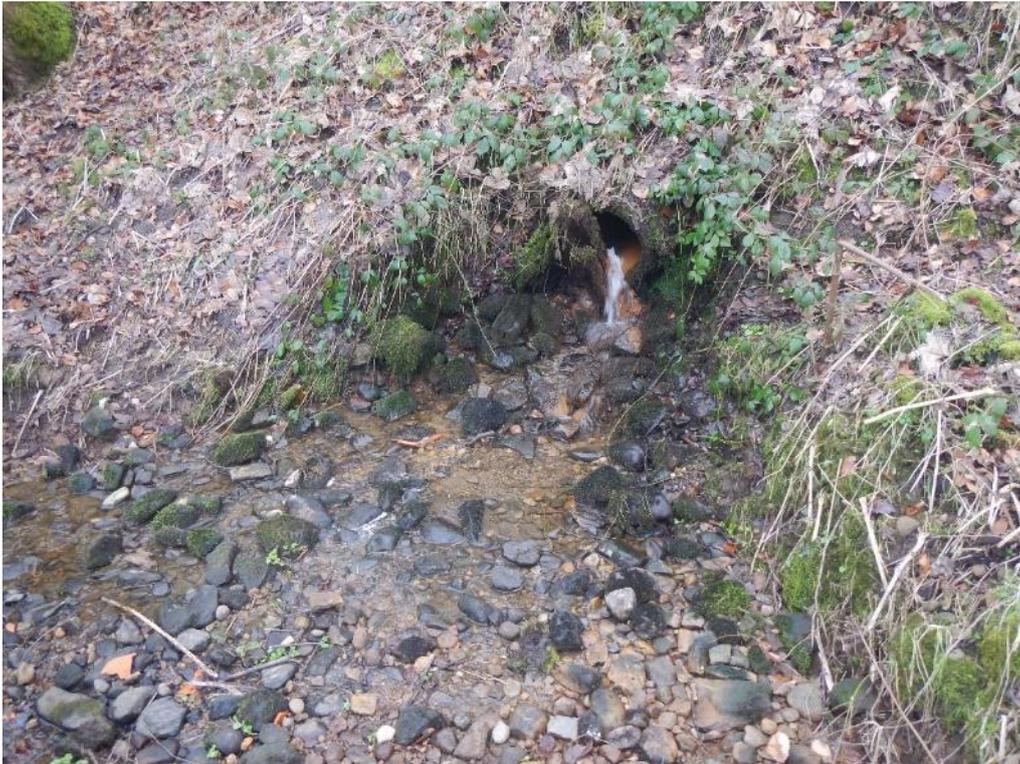
BB119. A pipe discharge at NZ 22538 54498 appears to be relatively clean water with slightly elevated iron content.

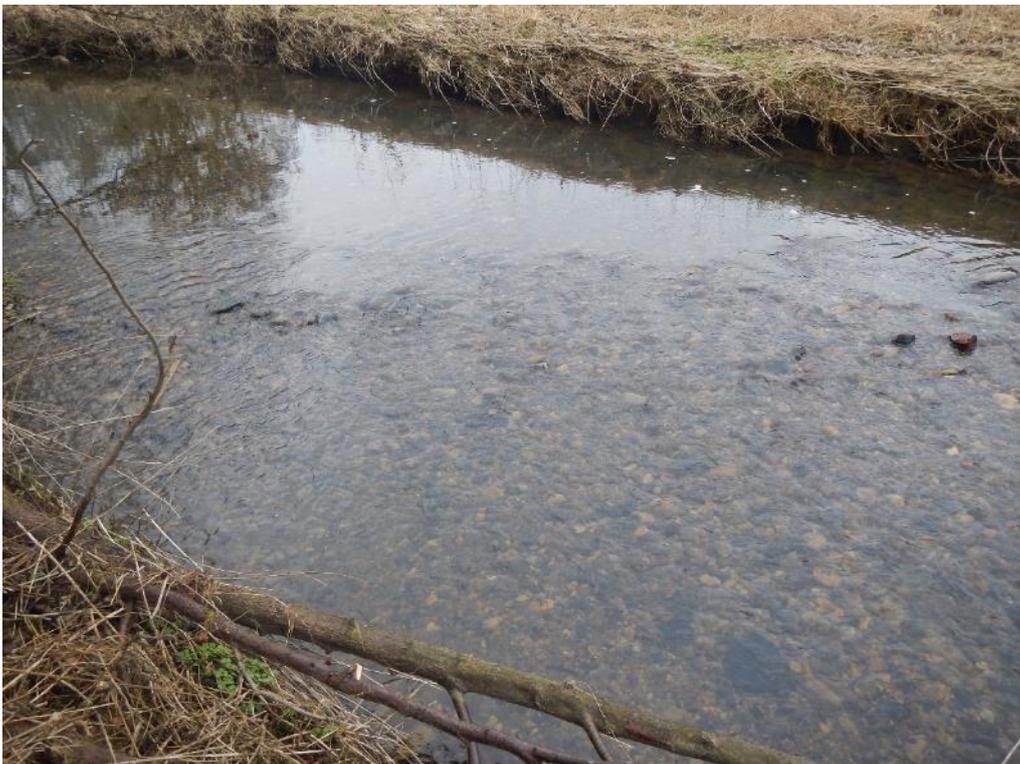
UB1. The high *potential* of substrate for salmonid spawning continues through a slightly lower gradient area, but the fine sediment loading reduces its value.

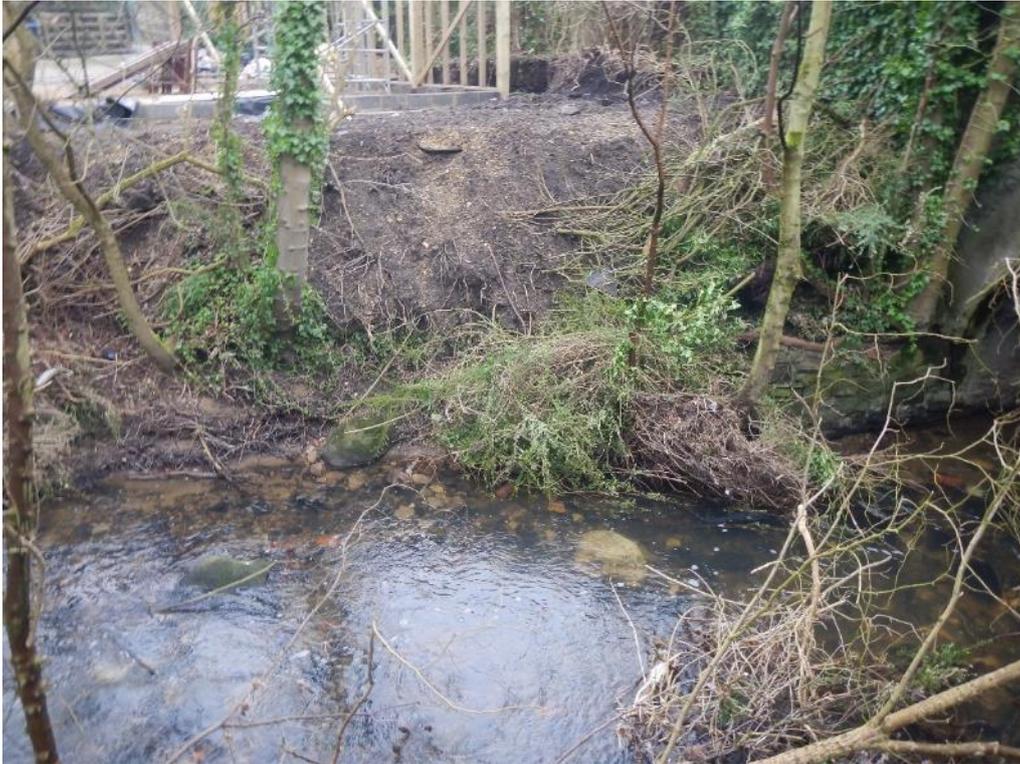
UB10. Almost level with the pipe, but on the opposite bank, inappropriate garden waste disposal and loss of material into the burn (NZ 22748 54215).

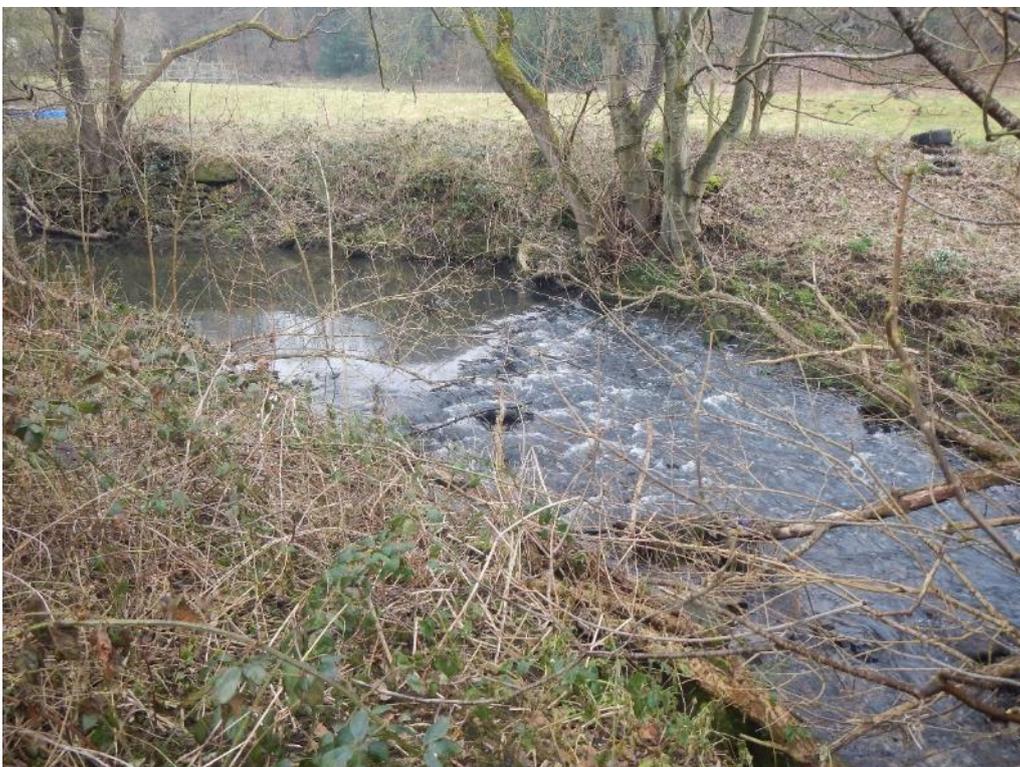
UB12. A small weir / bed check structure impounds the burn upstream slightly but is relatively passable (NZ 22763 54186).

<p style="text-align: center;">UB12</p>	<p style="text-align: center;">3</p>	<p style="text-align: center;">NZ 22763 54186</p>	<p>Ideally this would be removed, but it may provide stability to the bridge footings upstream and contribute to the current swim-through conditions, so removal is not a priority.</p>
<p>Disintegrating ford</p>

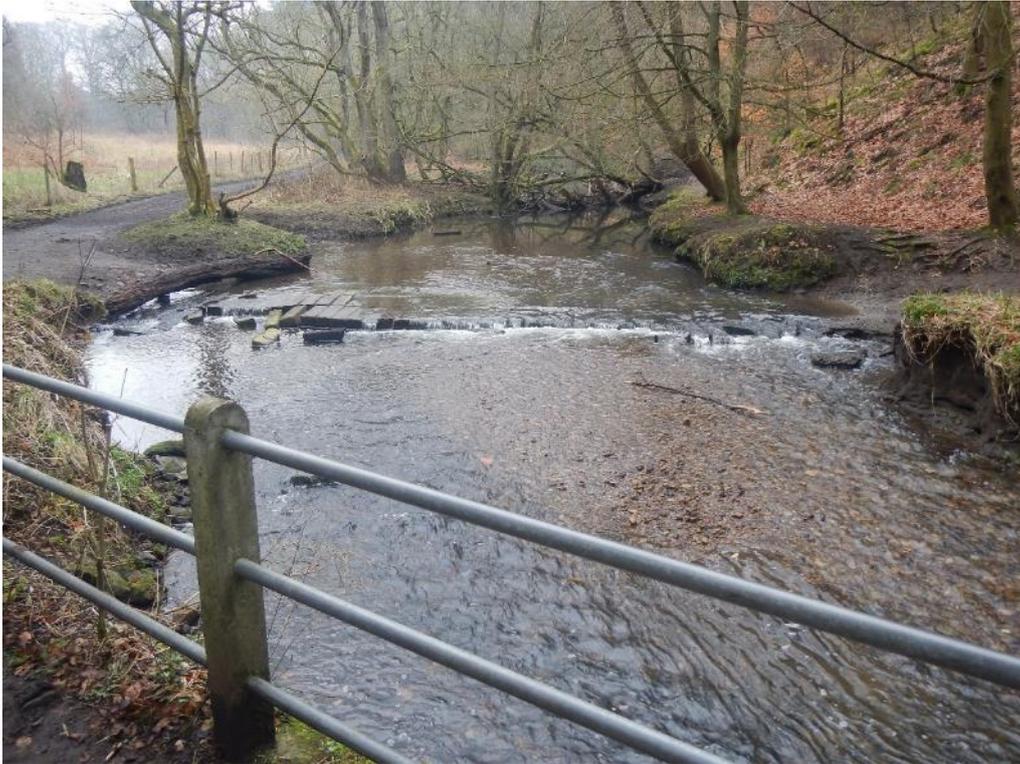
UB19. A disintegrating ford poses a small obstruction and should ideally be allowed to wash out fully to reinstate a more natural dimensions to the overwide channel (NZ 22582 54071). If the ford is reinstated, it should be set below bed level, to create support, over which a natural bed can form - without a step.

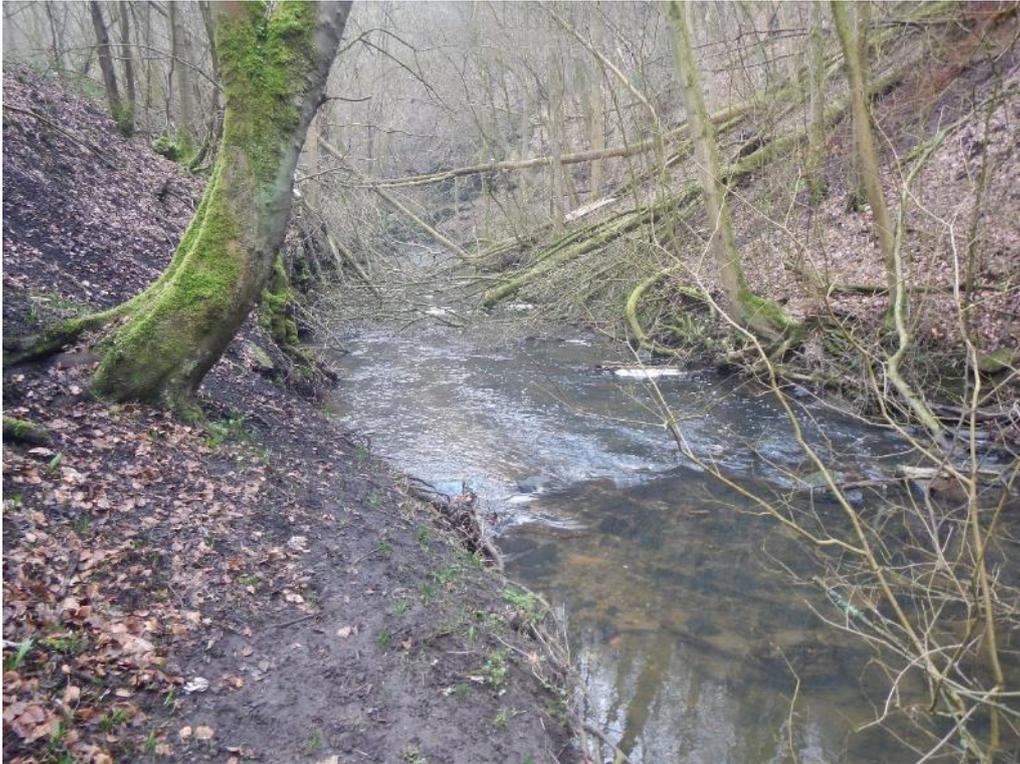
UB32. Semi-natural (allowing that much of the surrounding land appears to have been modified by past mining) treefall into the burn through the gorge section downstream is beneficial and should be allowed to remain in situ. Note the fine sediment accumulation on the bed (foreground).

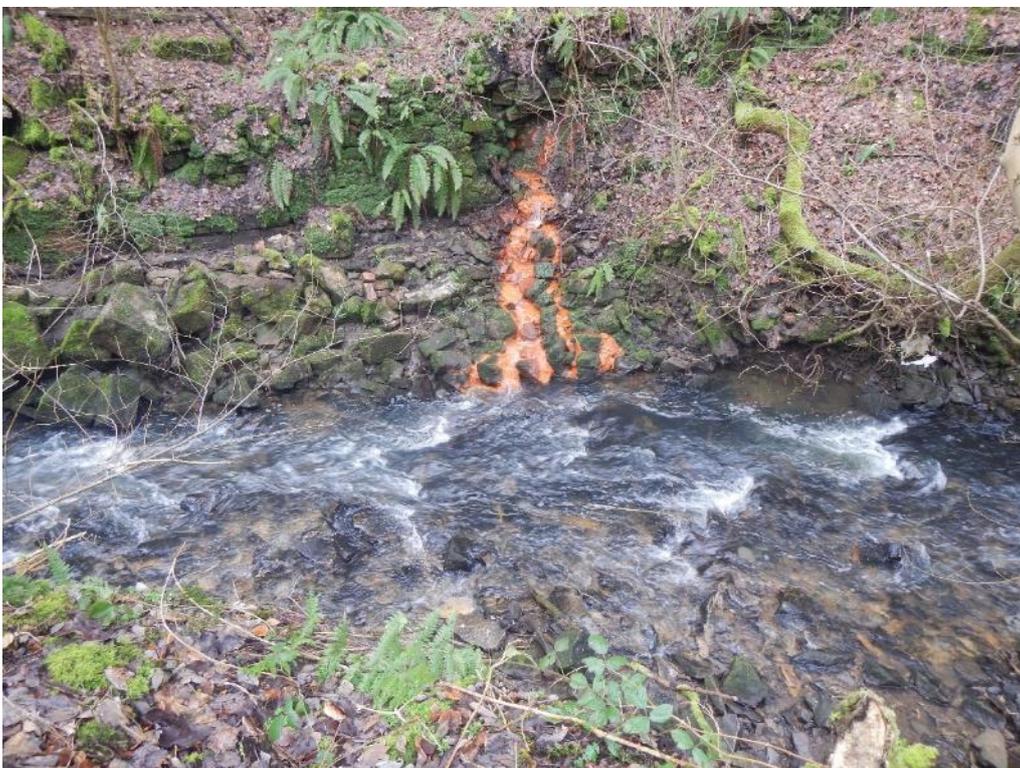
UB25. Elevated iron discharge. Such discharges can cause problems for aquatic life, but with reasonable dilution, as is occurring, the impact is likely to be minimal.

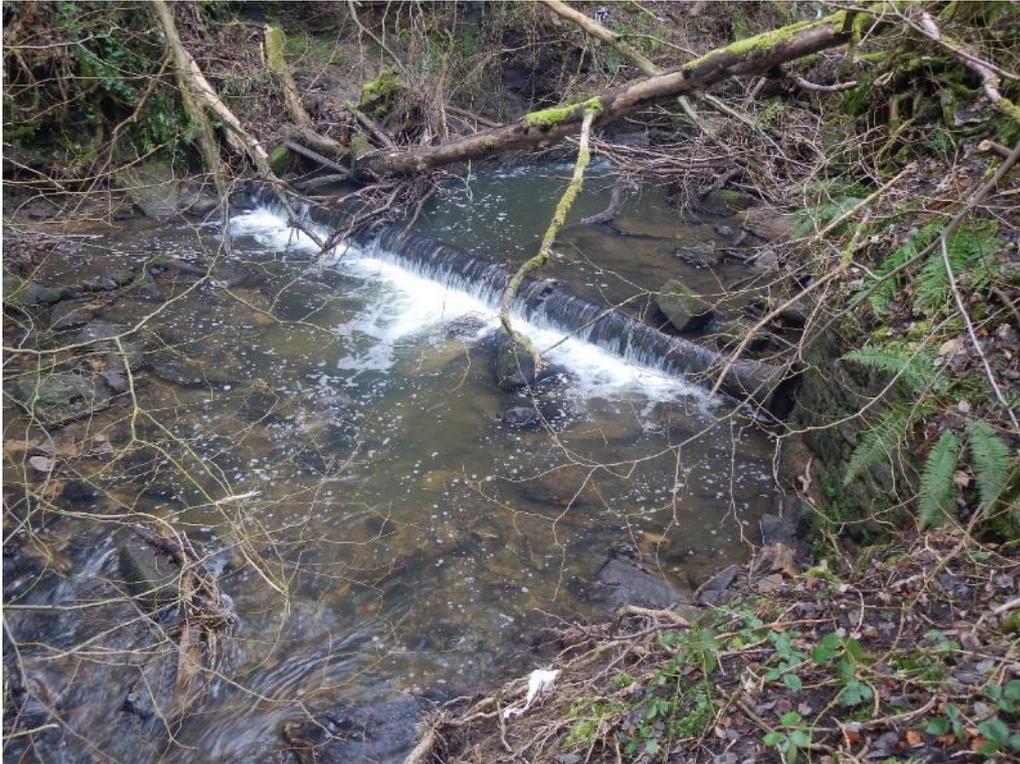
UB28. A strange pipe / weir (seemingly unattached at either end) creates an unnecessary obstruction and should be removed (NZ 22524 53895).

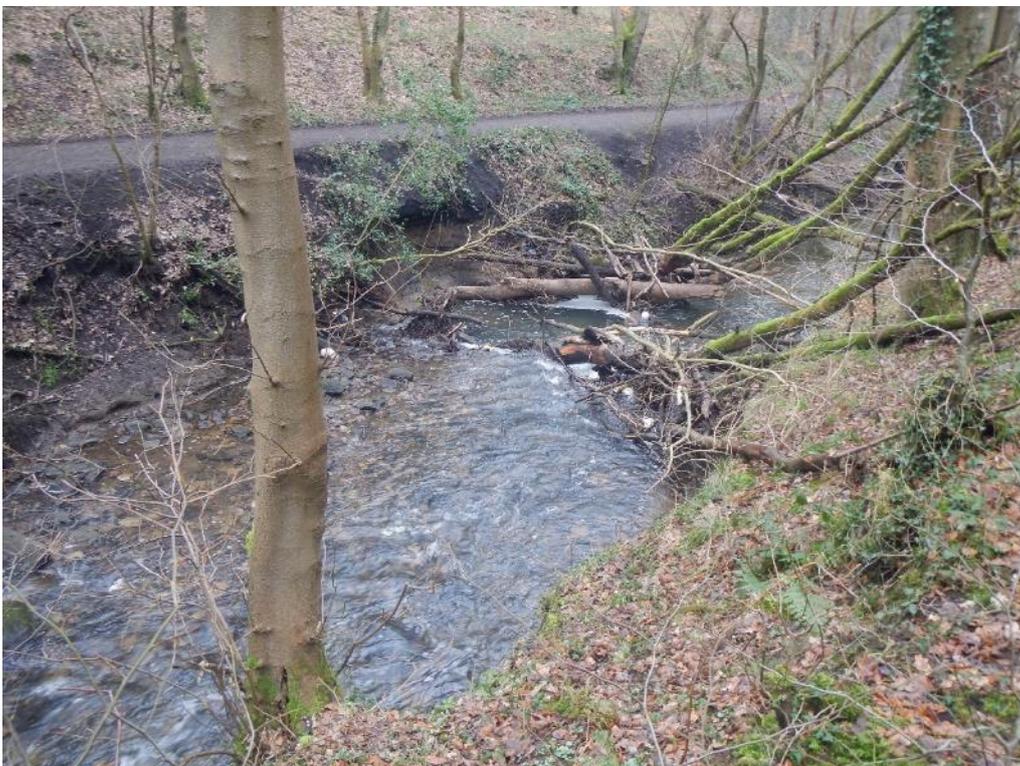
UB32. More bank erosion (NZ 22723 53884). The underlying cause is the straightened, steepened channel and lack of vegetation to bind the soils. Although the woody material is contributing to the erosion locally, the roughness it provides will also slow flow through the section, reducing the overall energy and likelihood of further bed incision, so its retention would be beneficial.

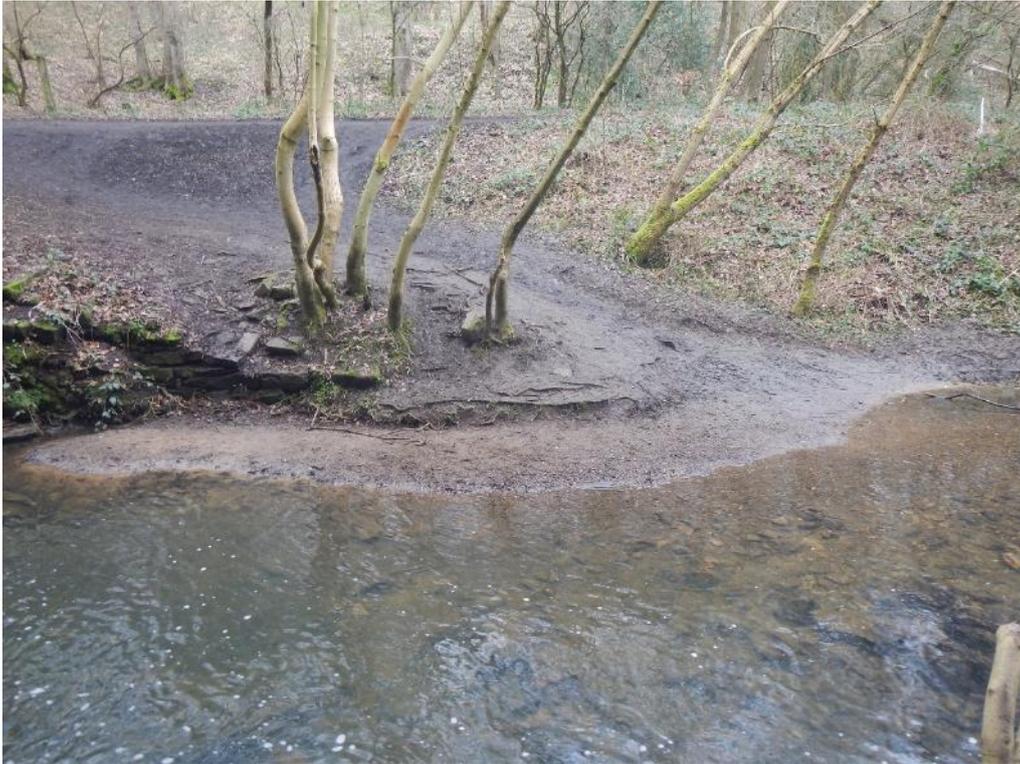
UB34. Another access/fording point creates familiar issues (NZ 22814 53855).

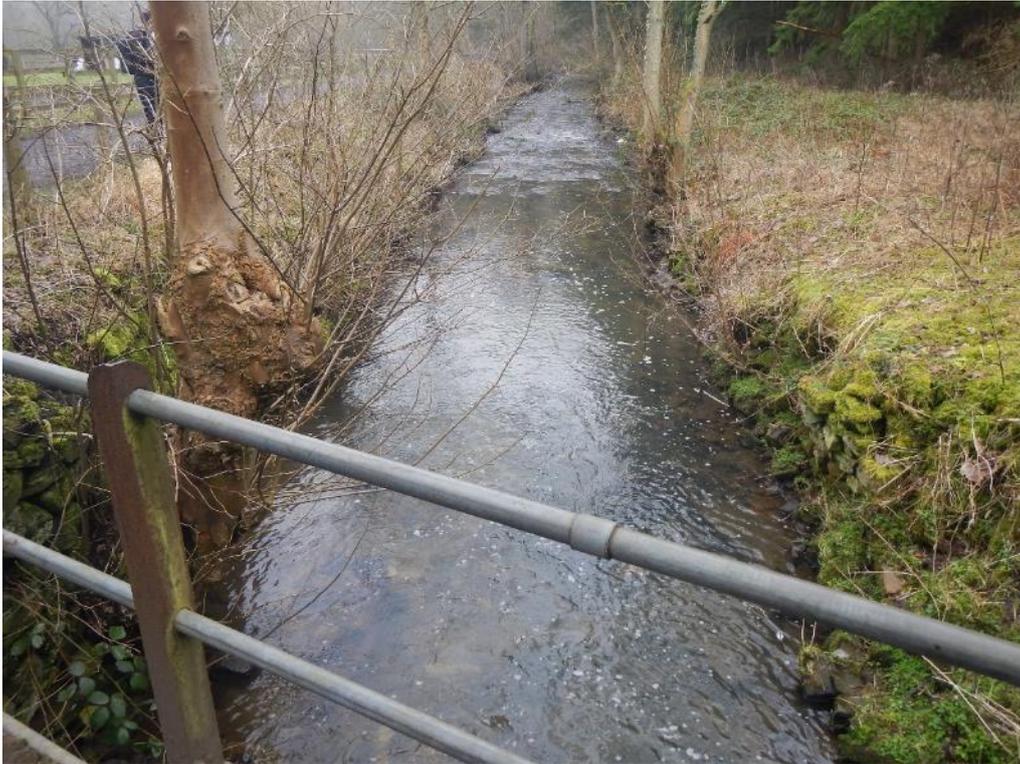
UB39. Channel straightening has clearly been undertaken throughout much of the next section downstream, pushing the burn to the RB side of the valley bottom, with paleo-channels evident in the adjacent fields (NZ 22987 53841 - NZ 23497 54220).

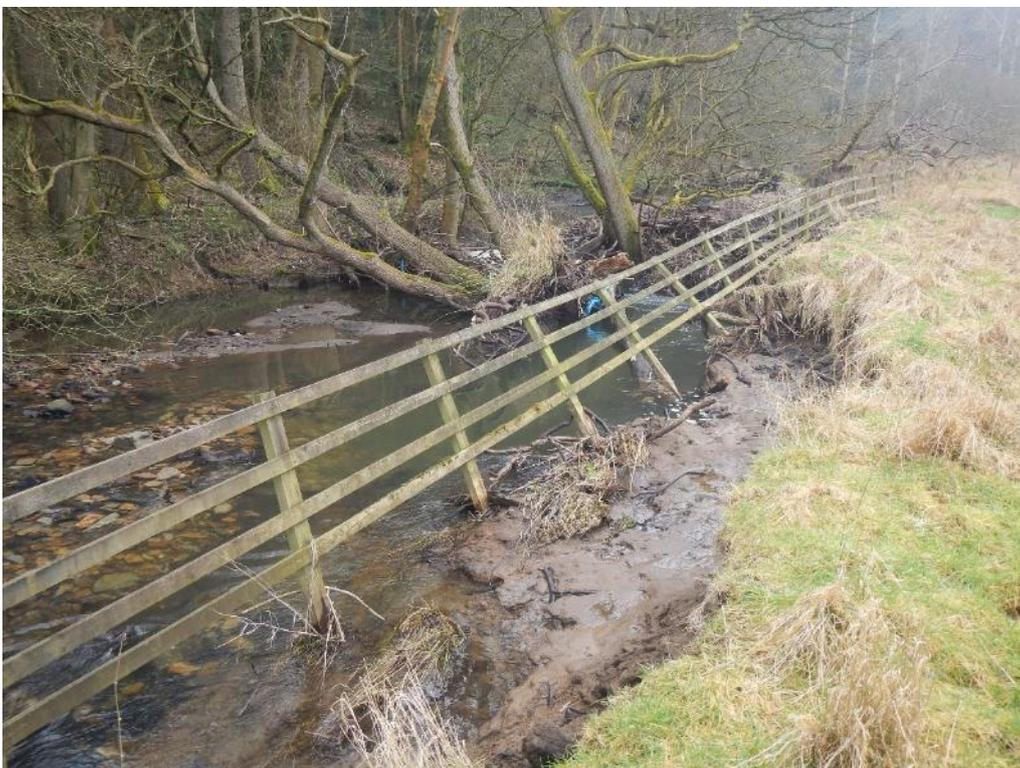
UB51. In response to the historical straightening, the burn is now starting to win back some sinuosity through lateral erosion (assisted by valuable inputs of large woody material). This should be facilitated wherever possible.

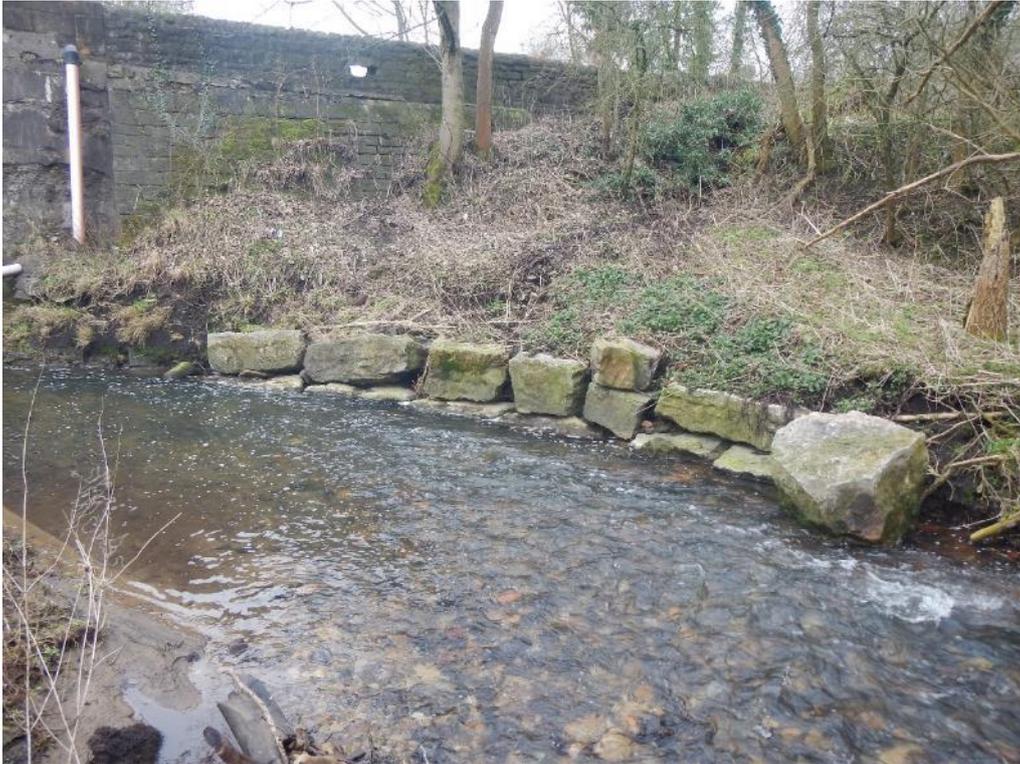
UB52. Poorly installed rock armouring of the bank upstream of the bridge is failing. It would have been preferable to use green engineering techniques and planting to naturally stabilise the banks. The bridge is clear-span and poses no issues.

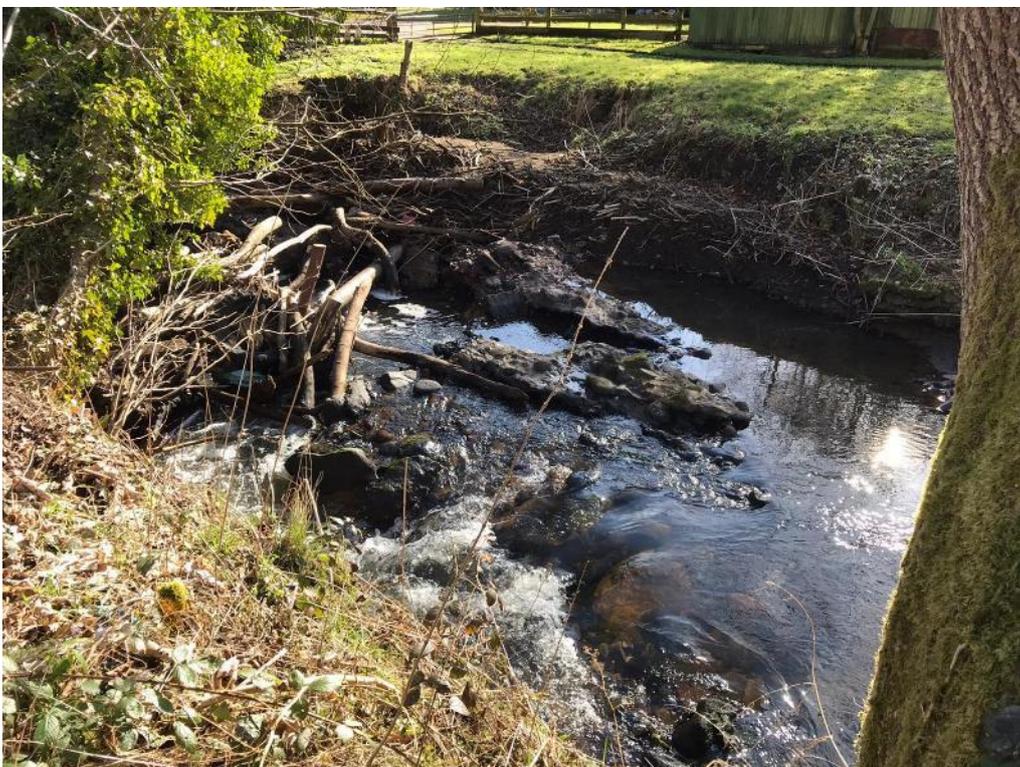
UB53. Armouring around an old pipe crossing (identified in previous EA surveys as creating a weir/obstruction) now poses less of an issue (NZ 23510 54250). However, the artificial structure should be removed from the watercourse if it is now redundant.

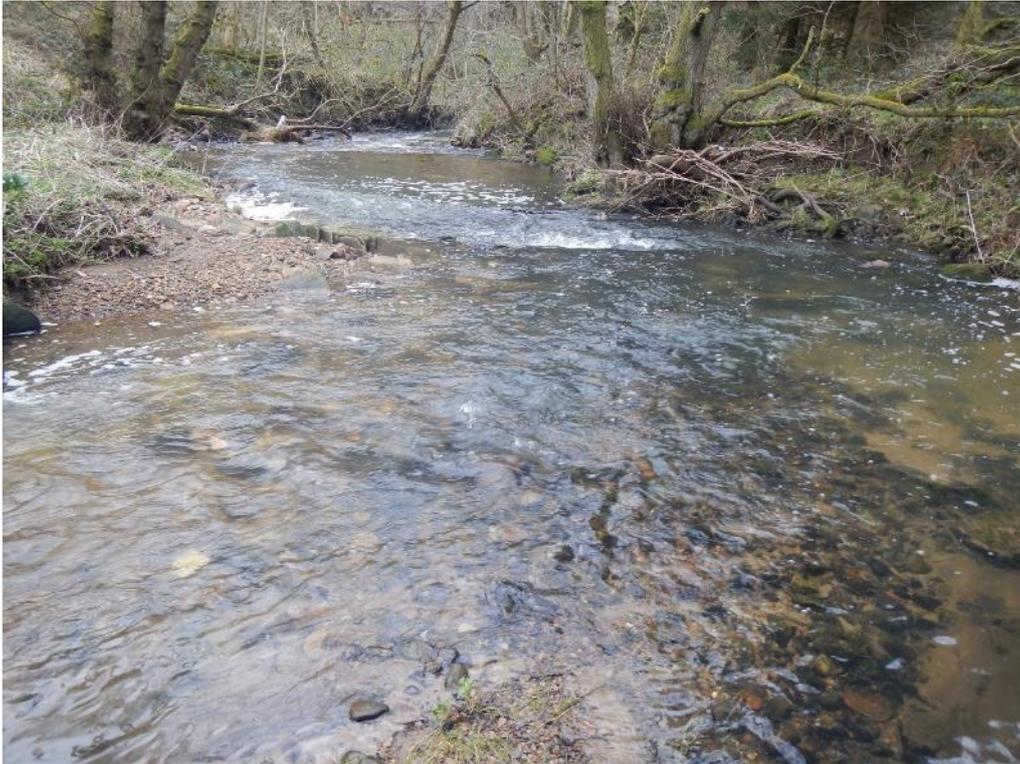
Te4. Basic habitat quality remains high, with valuable woody input. However, with reduced stream energy, the fine sediment issues become increasingly apparent, blocking the interstices of the coarser natural bed material, even in high velocity areas.

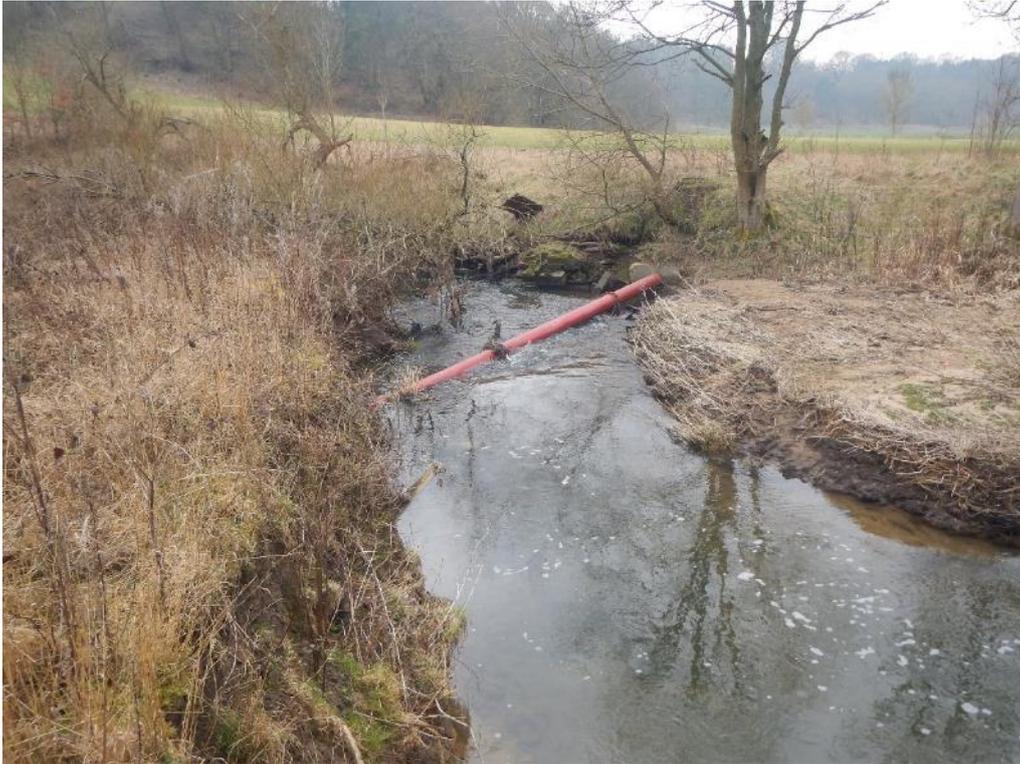
Te21. A pipe crossing creates a potential hazard if it is damaged but was having a minimal impact upon the river (NZ 24264 54787).

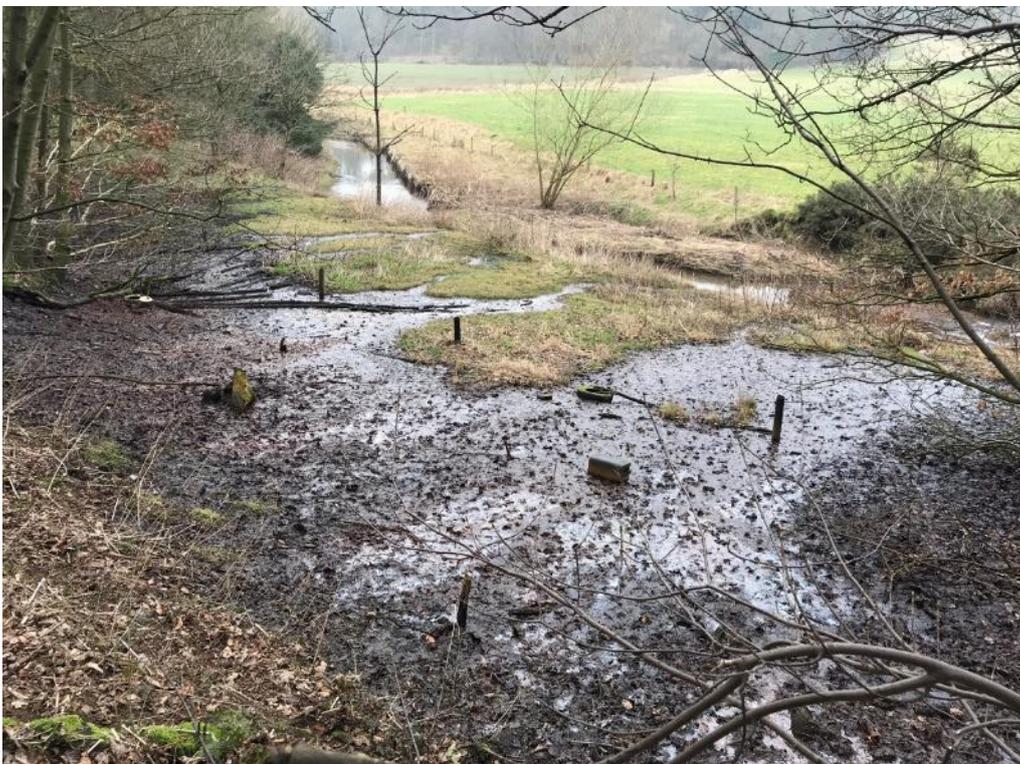
Te33. Leachate from the historical High Urpeth landfill is entering the watercourse and should be addressed (NZ 24532 54759). Japanese knotweed was also observed here, but not noticed in the many kilometres of suitable areas upstream during the 'River Team walkover'. All knotweed should be treated with herbicide by a licenced operative to eradicate it before it spreads and caused further issues, including increased bank erosion.

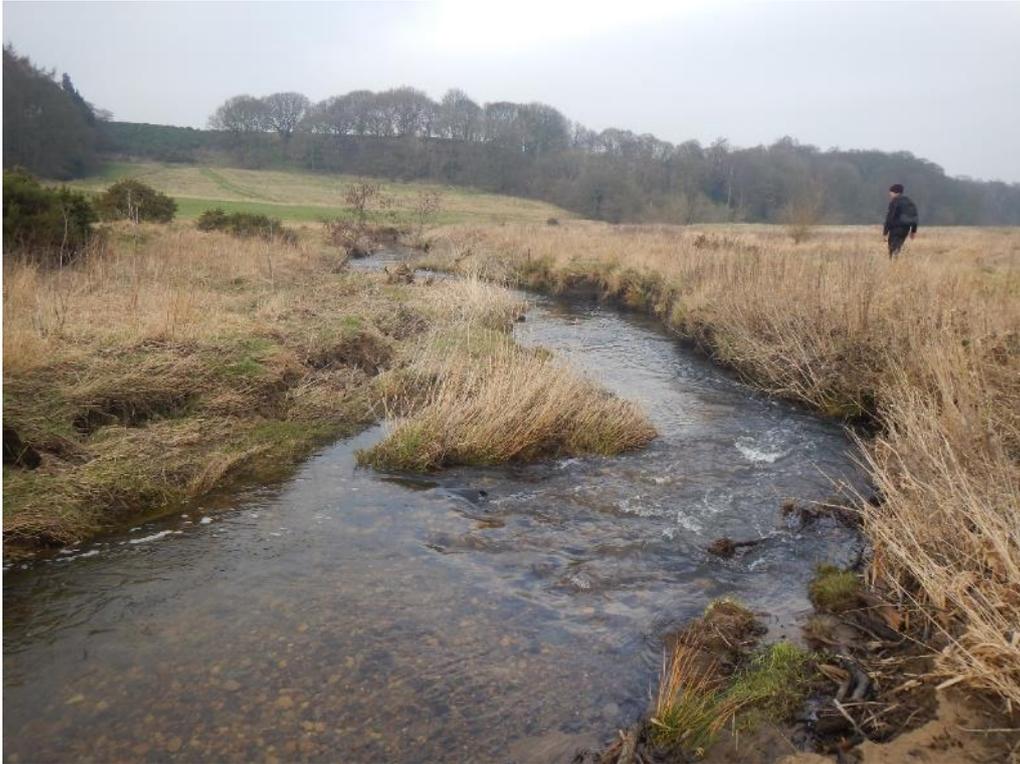
Te36. Although still realigned from its natural course, the river downstream is continuing to recover morphologically, where it crosses the floodplain. However, once it reaches the LB side it remains there, following a relatively straight course.

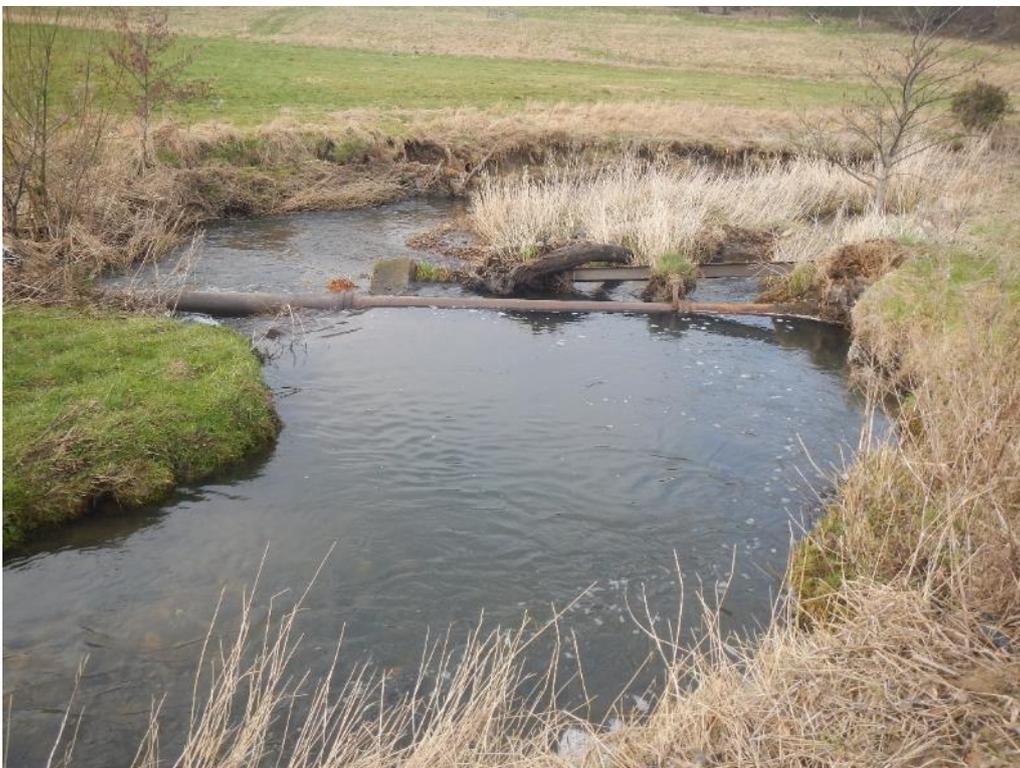
TE37. A further crossing of what is suspected to be the same pipe observed upstream (NZ 24545 55004). While these crossings are far from ideal, the relatively open, connected flood plain probably reduces the chances of major debris build-ups and the associated risk to the pipe.

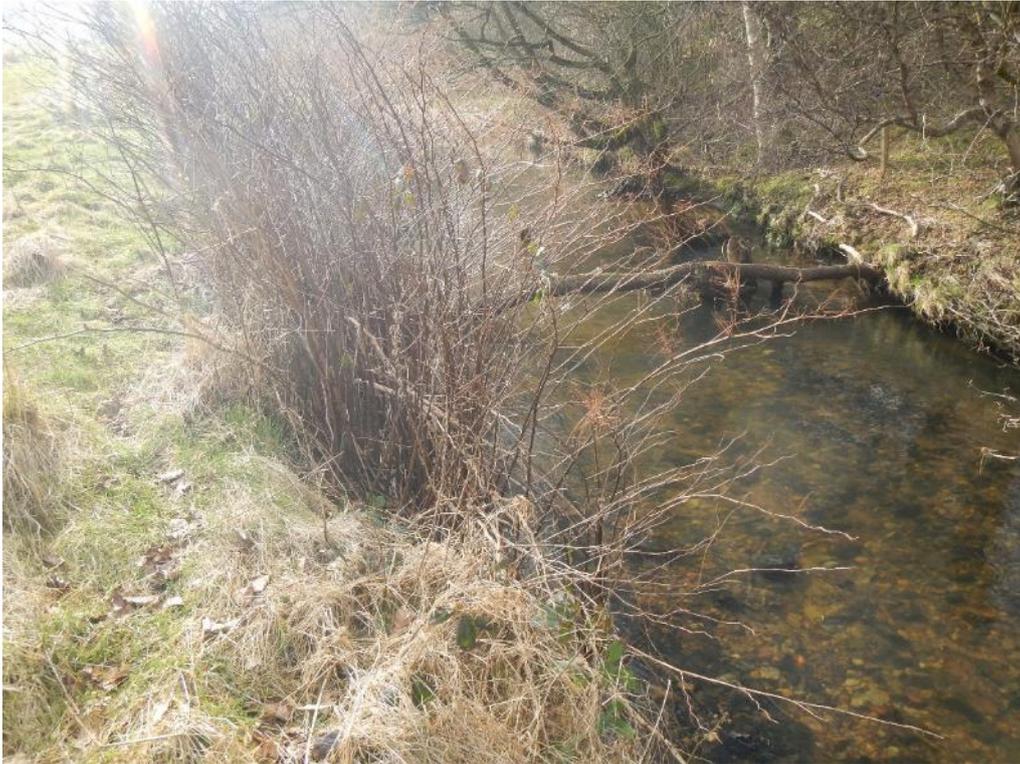
Te42. More Japanese knotweed (NZ 24676 55189). As for upstream, all stands should be treated before they become a major issue. Note the straight channel that is consequently more uniform in depth than would naturally occur.

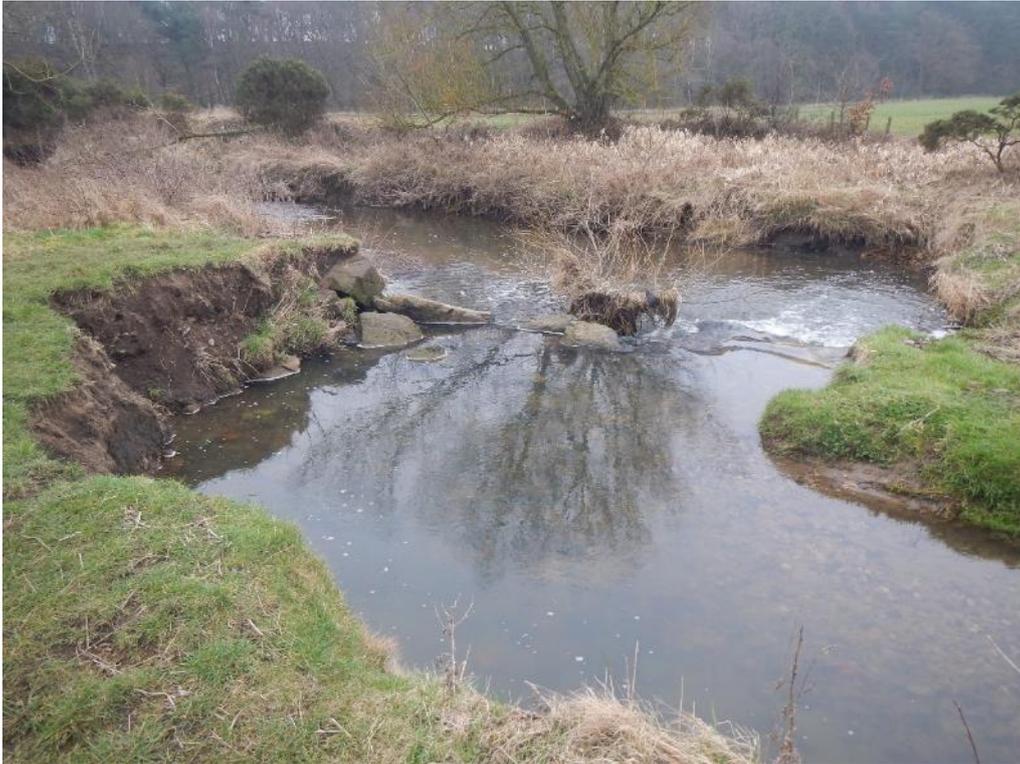
Te61. Downstream of the agricultural land, the river has been allowed more freedom to recover from past straightening/realignment and habitat improves greatly. A weir (or possibly failed bank protection) creates an obstruction but left alone this should be scoured out over time, alleviating the issue.

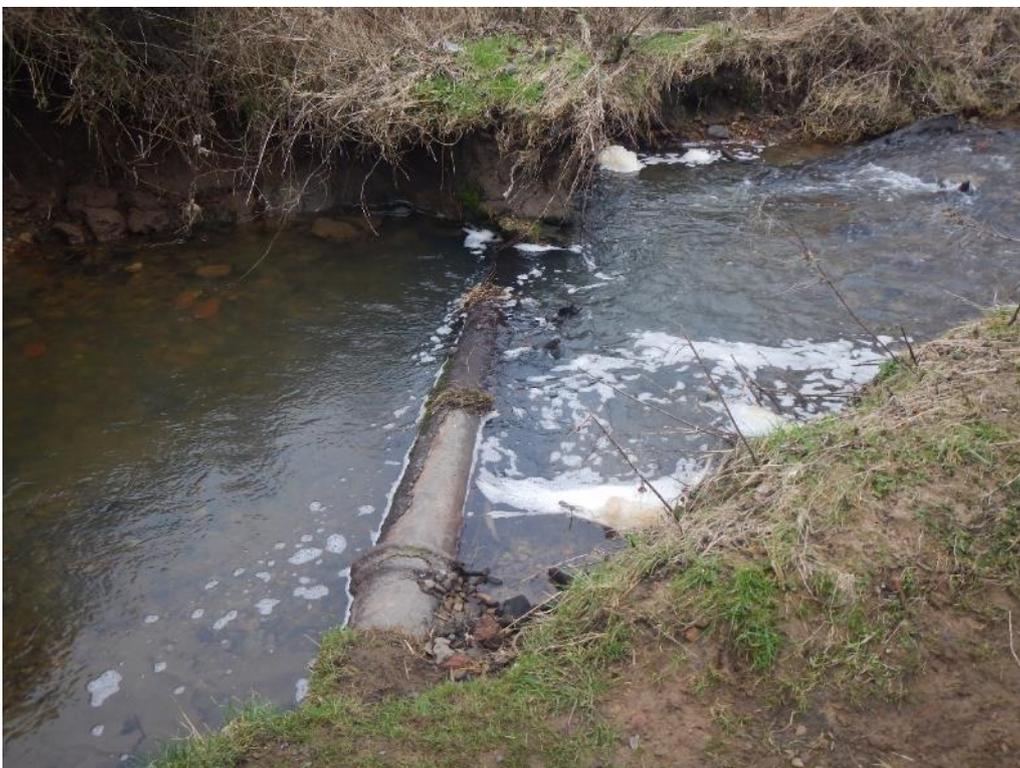
Te62. The water pipe crosses the river again (NZ 25042 55687). As before, creating issues more for the maintenance of the pipe than for habitat quality (providing it remains free from debris).

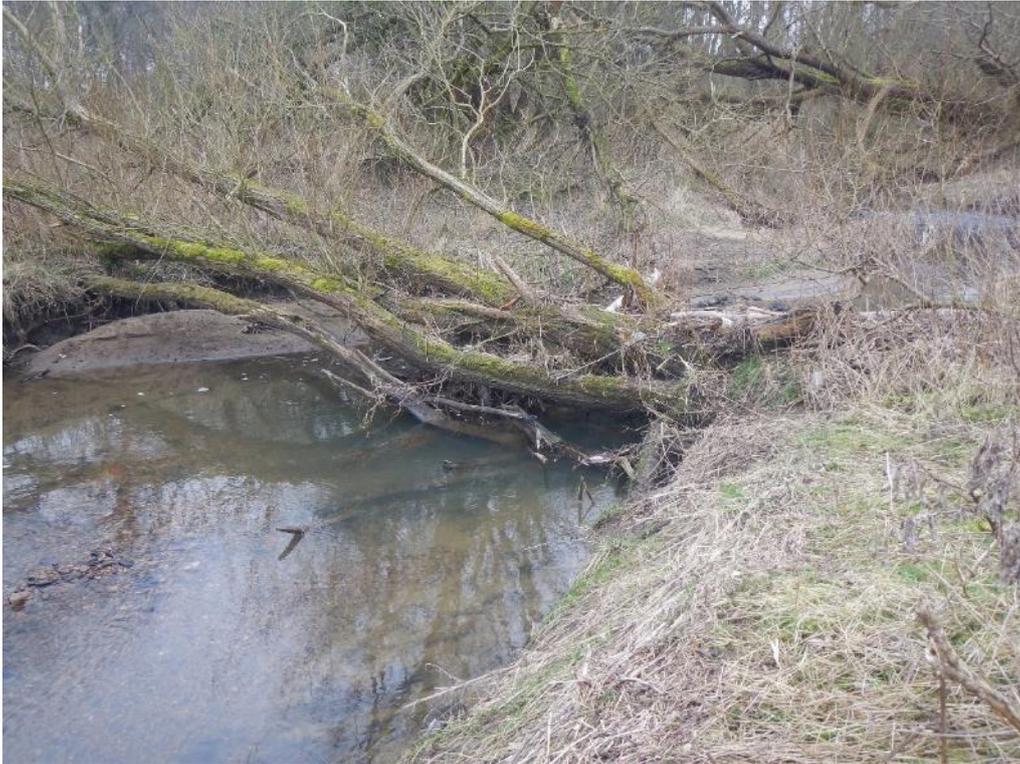
Te69. Although it is generally best to leave naturally occurring woody material well alone, a fallen willow in the pool downstream could be realigned to aid conveyance down the river and reduce pressure at the gabion breach a short distance upstream (**Te68**).
