WILD TROUT TRUST

River Team
(lower catchment)

March 2021

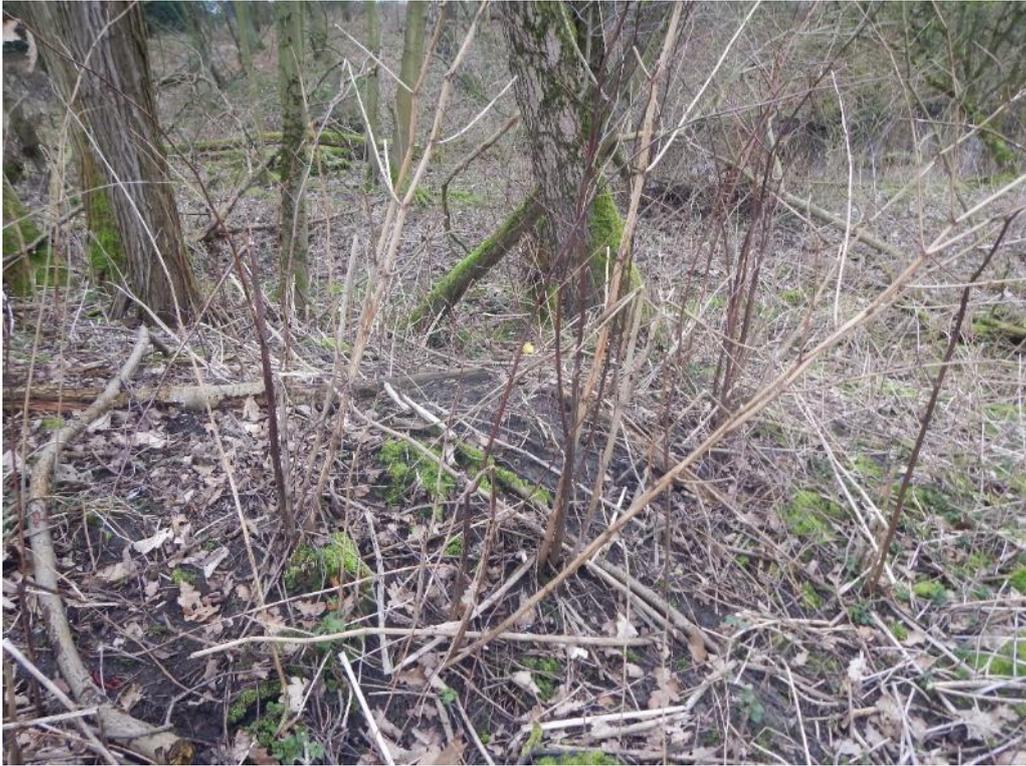
Te83. Further stands of Japanese knotweed were observed on a track in the riverside wood (NZ 24931 55537).

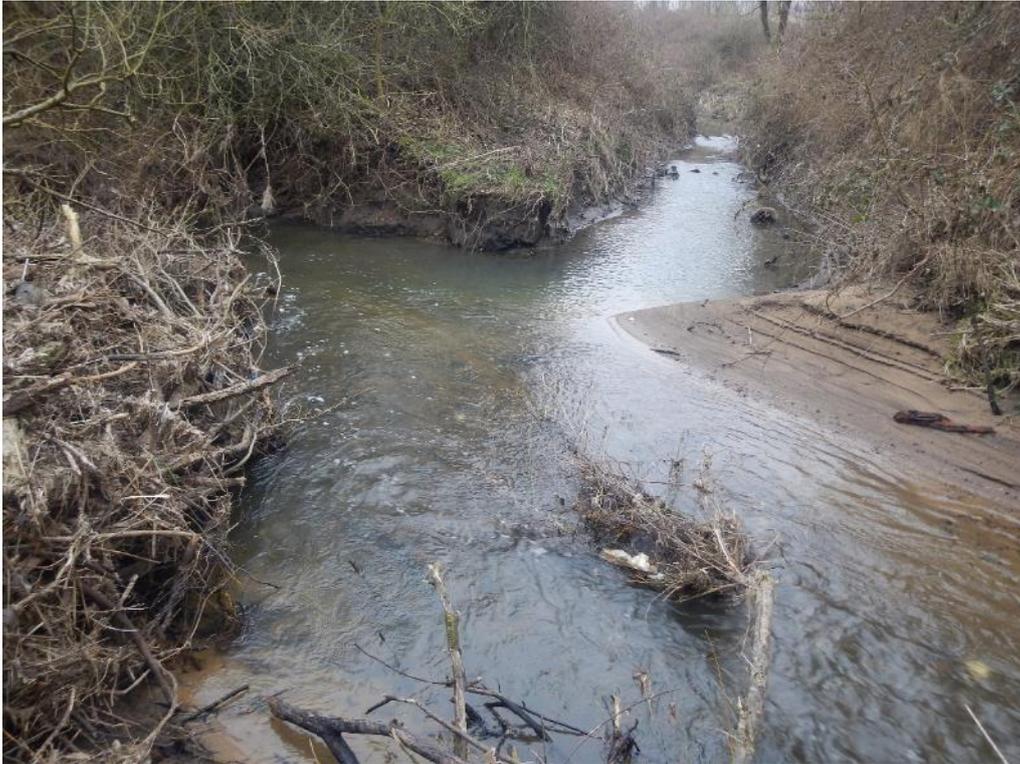
Te112. At its confluence with the Team (left of shot), Rowletch Burn (right of shot) is clearly much higher turbidity (NZ 26119 56442). Large accumulations of sand and silt highlight the scale of the sediment issues on the River Team catchment, with the majority derived from upstream of Rowletch Burn.

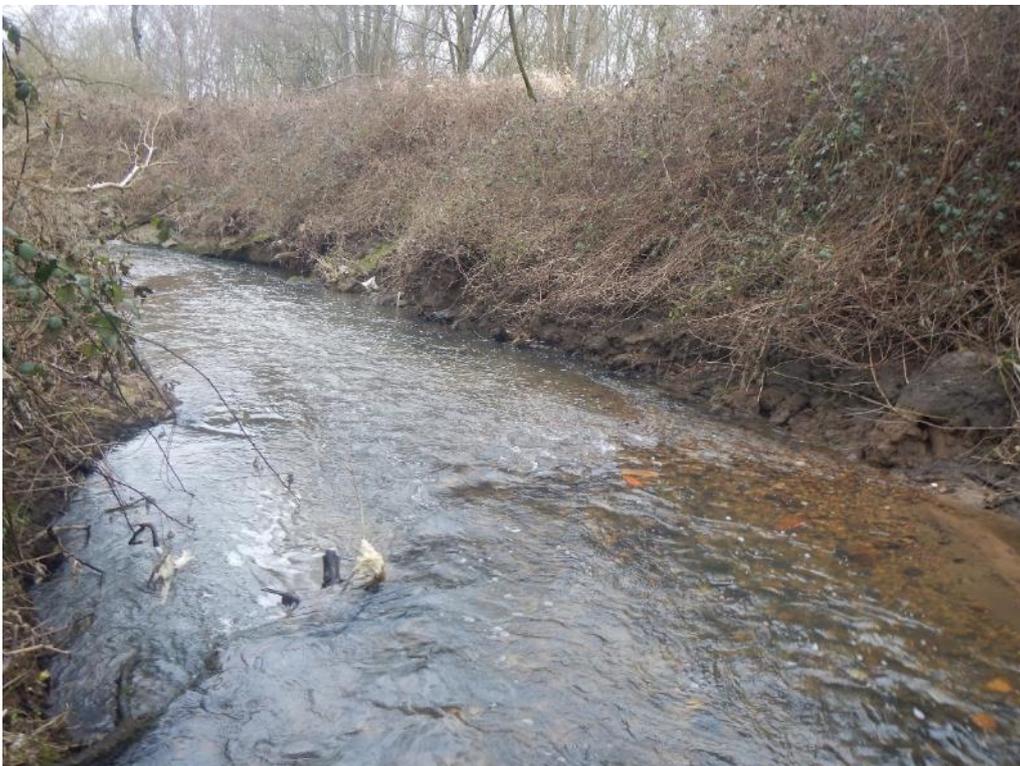
Te114. The unstable nature of the banks along this section of straightened and incised channel contributes further fine sediment as the river adjusts to win back sinuosity.

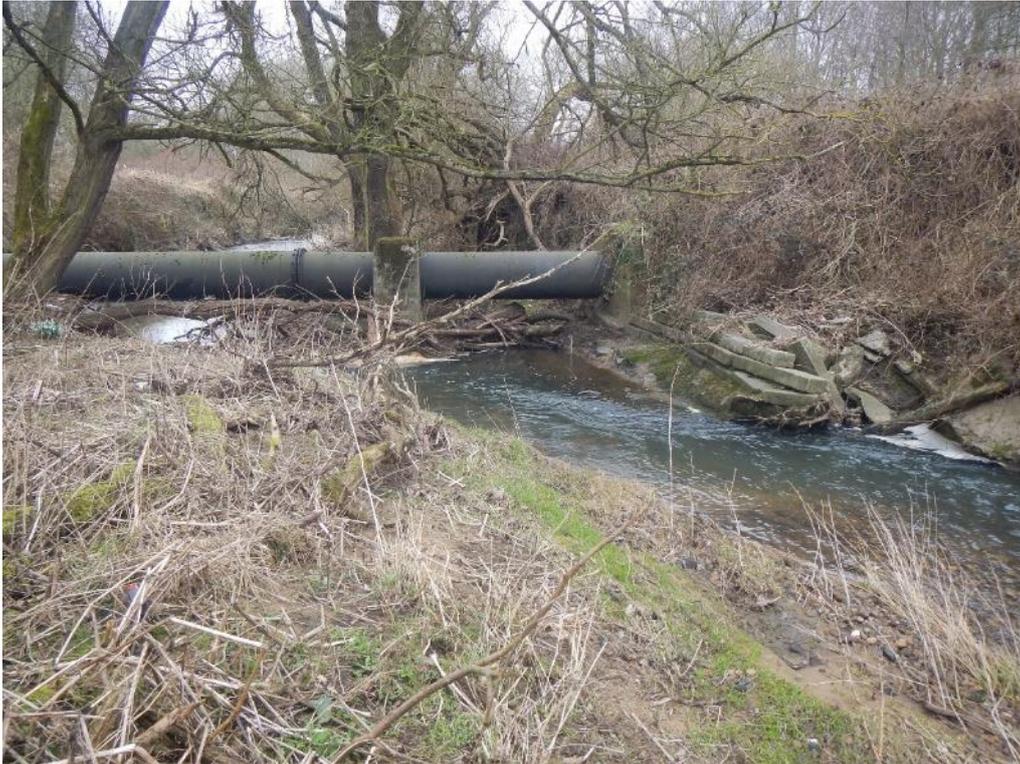
Te115. Another large pipe crossing poses minimal issue to the river, barring the erosion resulting from failing hard bank revetment. Several natural debris dams were also present in this area, most were providing cover and developing beneficial morphological features.

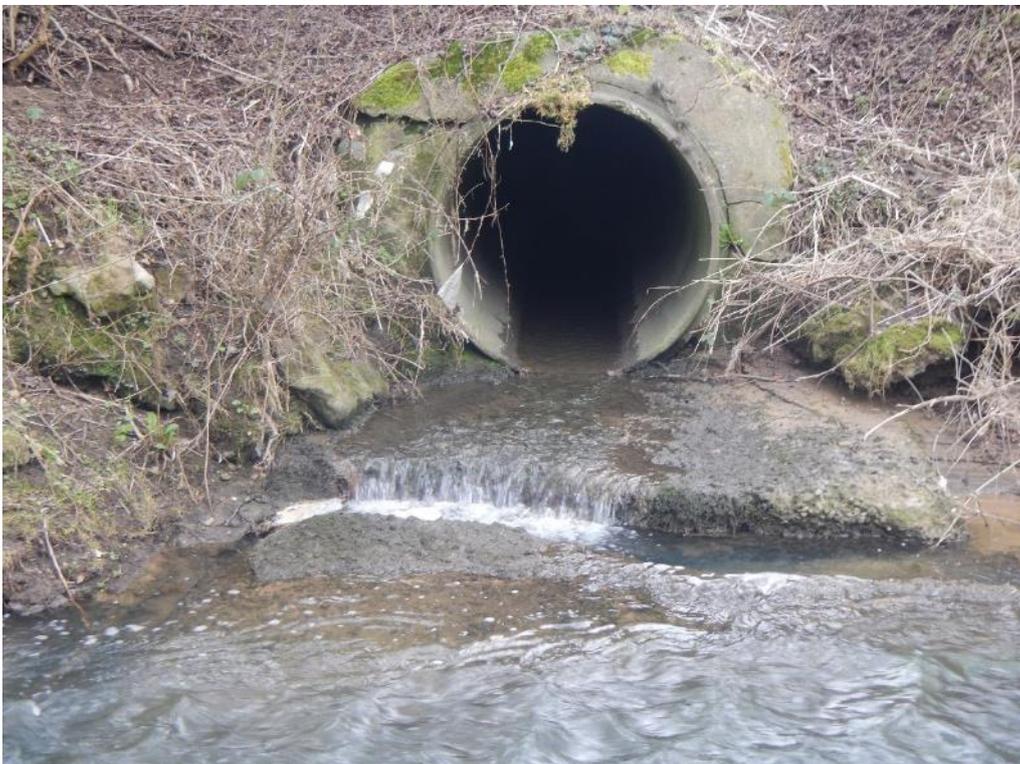
Te117. Leyburnhold Gill joins from the RB via a pipe culvert (NZ 26118 56575). Access to the culvert is poor, but the watercourse is small and straightened for the majority of its length upstream through an industrial and housing area, so its inaccessibility is unlikely to be a major loss without channel restoration upstream.

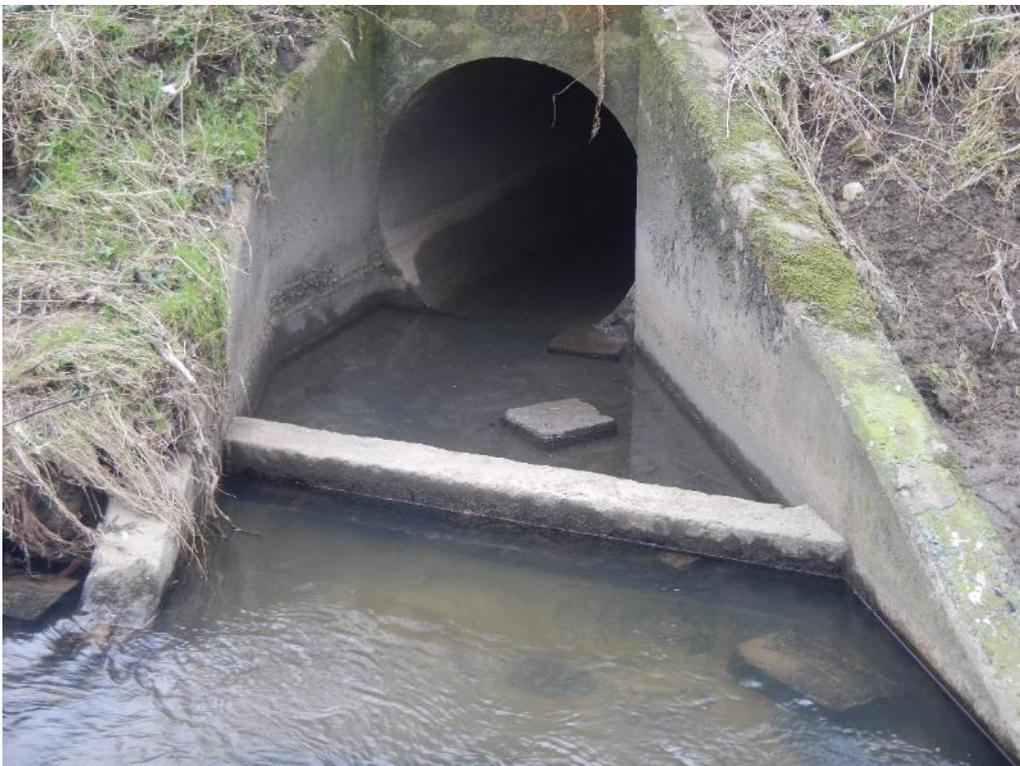
Te121. Observed from the far bank, a large capacity culvert on the LB was not discharging at the time of the walkover. A greyish biofilm / sewage fungus on the bed suggests it may discharge poor quality water at certain times - likely associated with the STW (NZ 25998 56723).

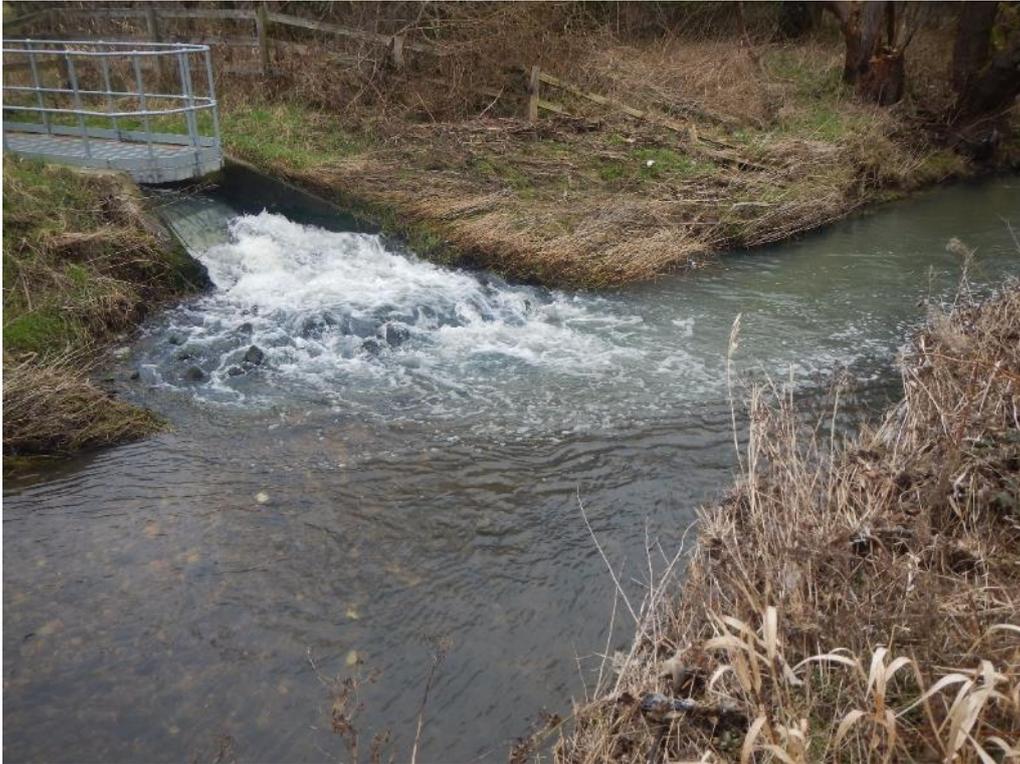
Te128. The upstream of the two main STW discharges was creating significant discolouration of the river and had a notable odour (NZ 25970 56794). It also contributes a large volume of water to the lower Team, so has the potential for a major impact.

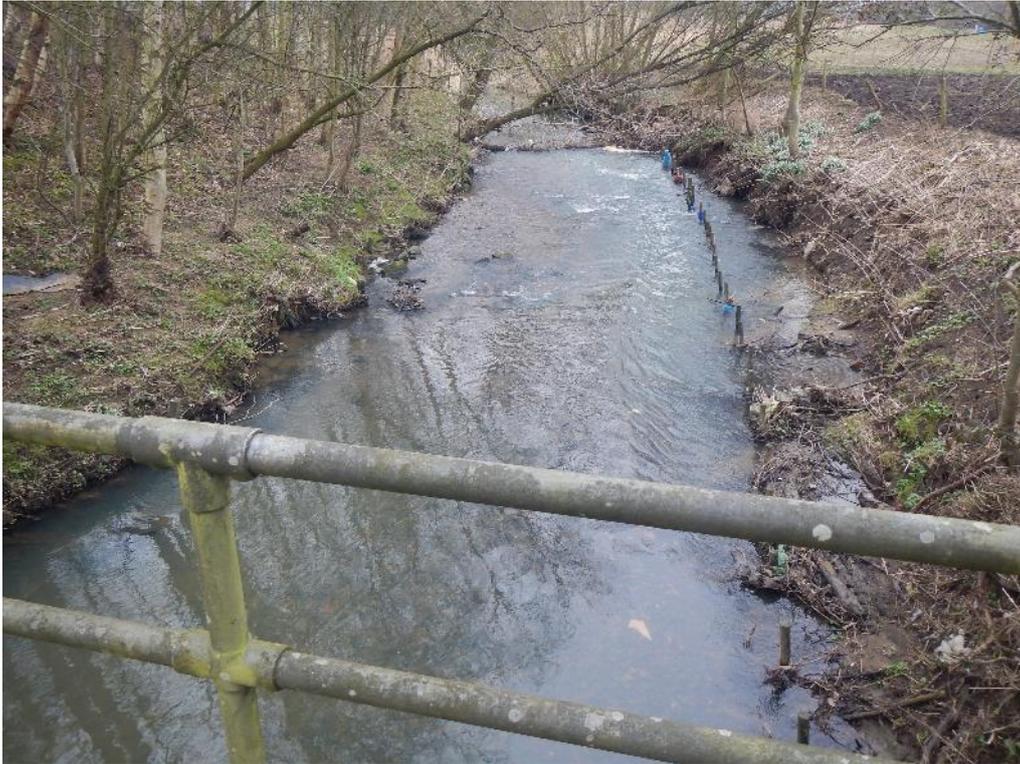
Te153. Looking downstream from the bridge to Moor Mill Farm (NZ 25649 57262). Horses are currently excluded from the watercourse, but the old fence is now barely functional. Previous bank protection is beginning to fail (right of shot)

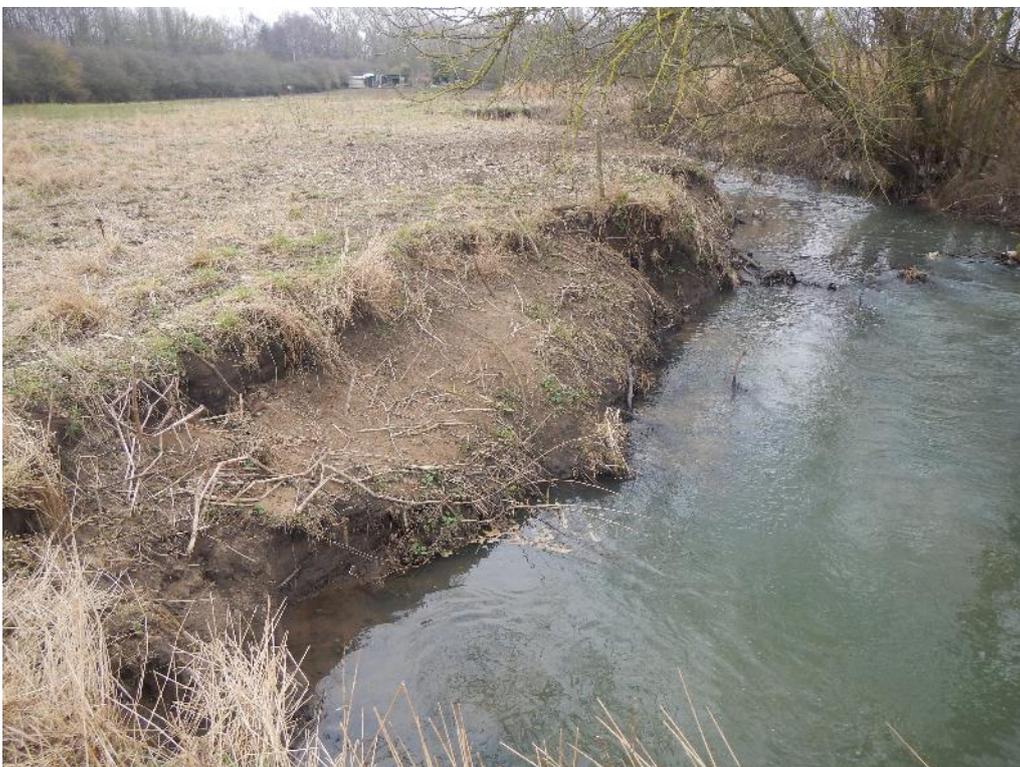
Te154. Further downstream, the fencing ceases and livestock have access to the RB (NZ 25608 57292 - NZ 25431 57547). Fortunately, the grazing pressure in this area appears to be relatively low. Fencing could facilitate tree regeneration or tree planting, which would be beneficial to habitat quality and bank stability.

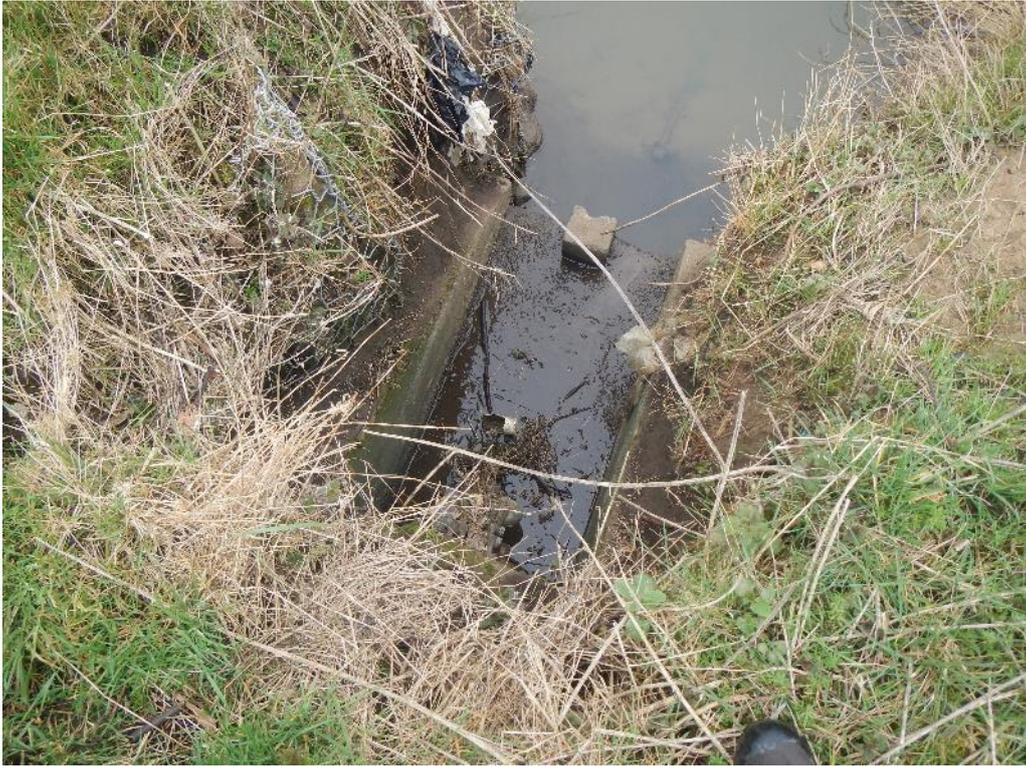
Te169. A small outfall was observed at, which appears to discharge slightly elevated levels of fine sediment – possibly road drainage (NZ 25173 57788).

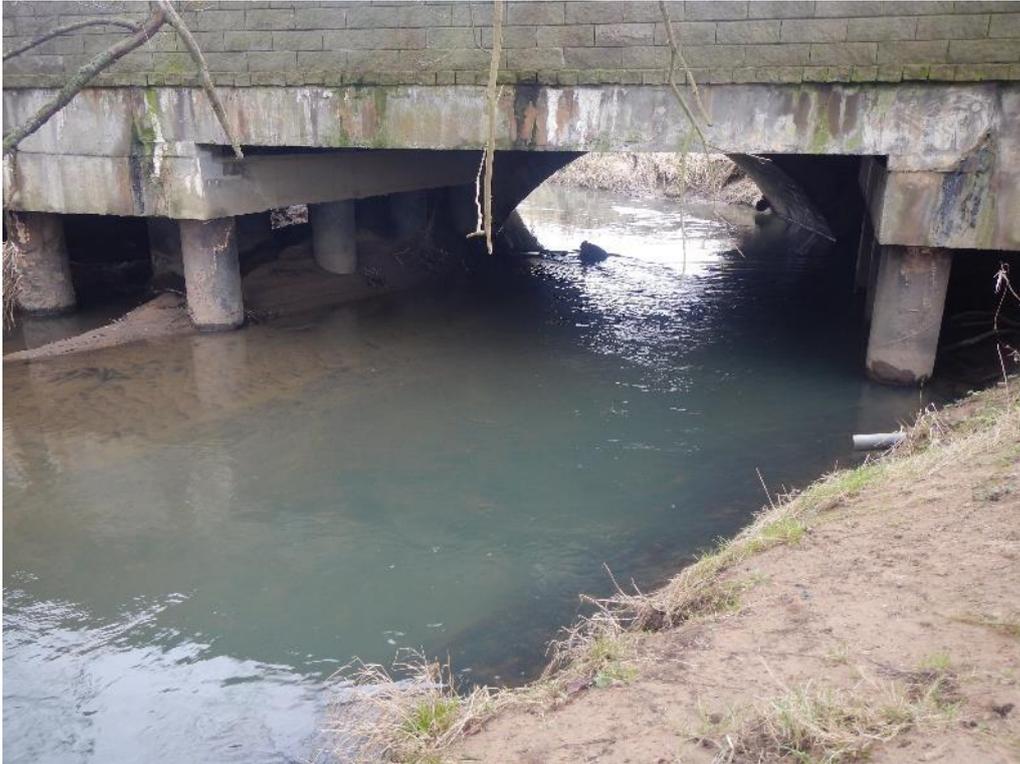
Te178. Hagg Ln Road Bridge appears to have been extended downstream, requiring in-channel pillars that have increased sediment deposition, but river flow appears sufficient to maintain a free-flowing central channel (NZ 25108 57889). Note just how much fine sediment is in the system by this point.

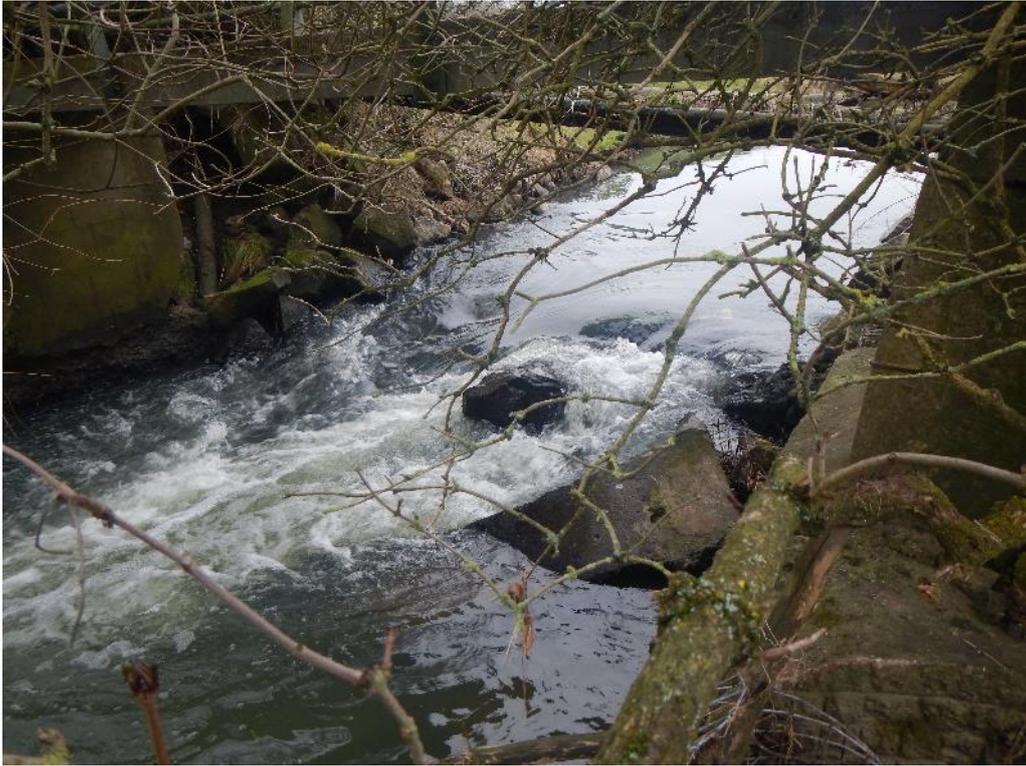
Te189. The footings of the dilapidated footpath bridge create an obstruction to fish movement through elevated flow velocities (NZ 25040 58245). This should be replaced with a more appropriate, larger, clear-span structure when the crossing is next maintained.

<p style="text-align: center;">Te189</p>	2	NZ 25040 58245	Replace with larger, completely clear span structure.
Further increased grazing pressure in the final two fields upstream of Lamesley Roundabout.

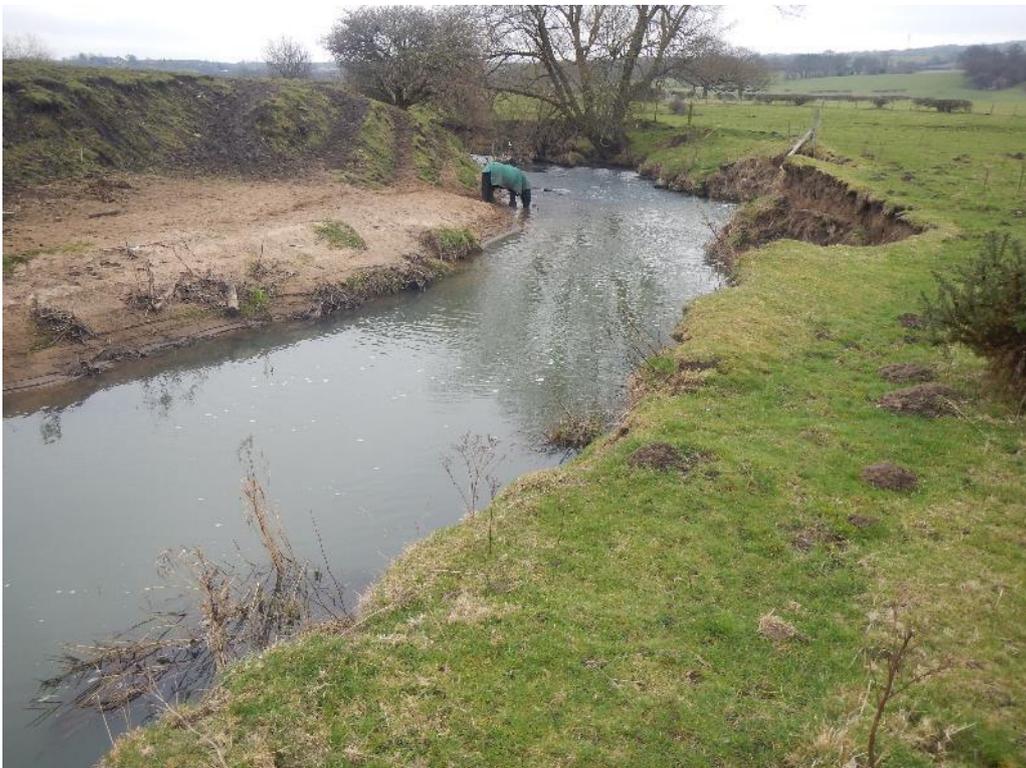
Te197. The impact of grazing increases further in the final field on each bank side upstream of Lamesley Roundabout (NZ 24899 58355 & NZ 24937 58349).

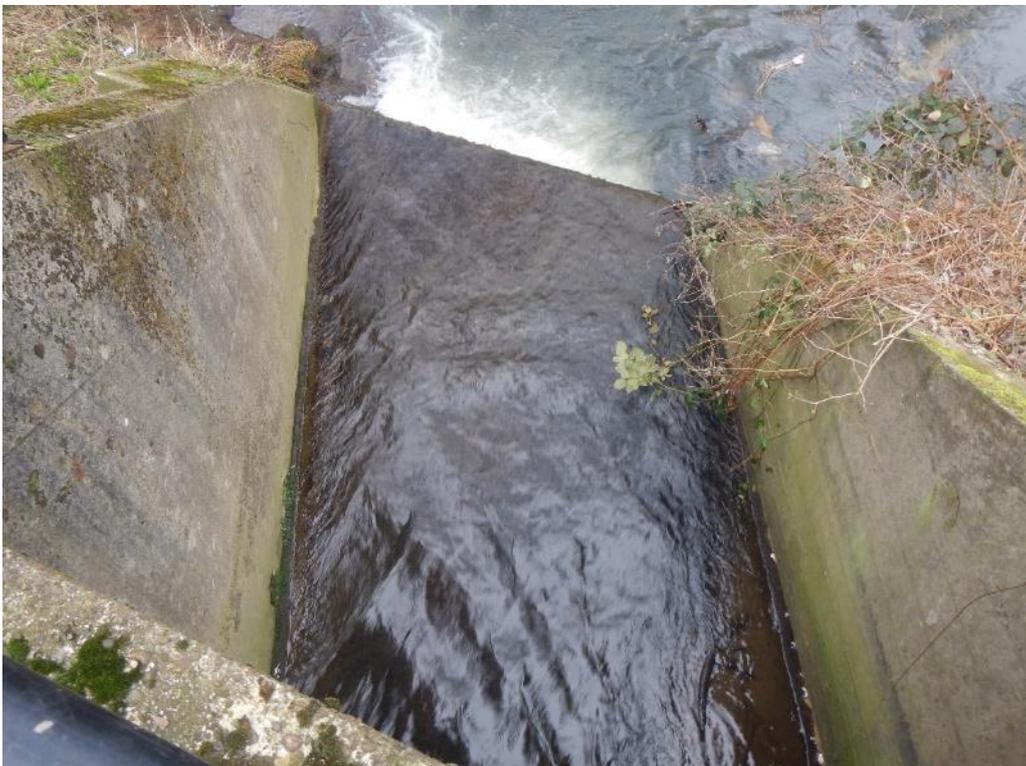
Te215. Black Burn joins via a culvert (NZ 24603 59967), limiting its potential, although poorly accessible from the main river it is possible that there are areas of higher quality habitat upstream. The water appeared to be of a reasonable quality.

<p style="text-align: center;">Te215</p>	<p style="text-align: center;">2/3</p>	<p style="text-align: center;">NZ 24603 59967</p>	<p>Further investigation of the habitat potential and accessibility of the burn upstream.</p>
<p>Elevated levels of fine sediment from a culver</p>

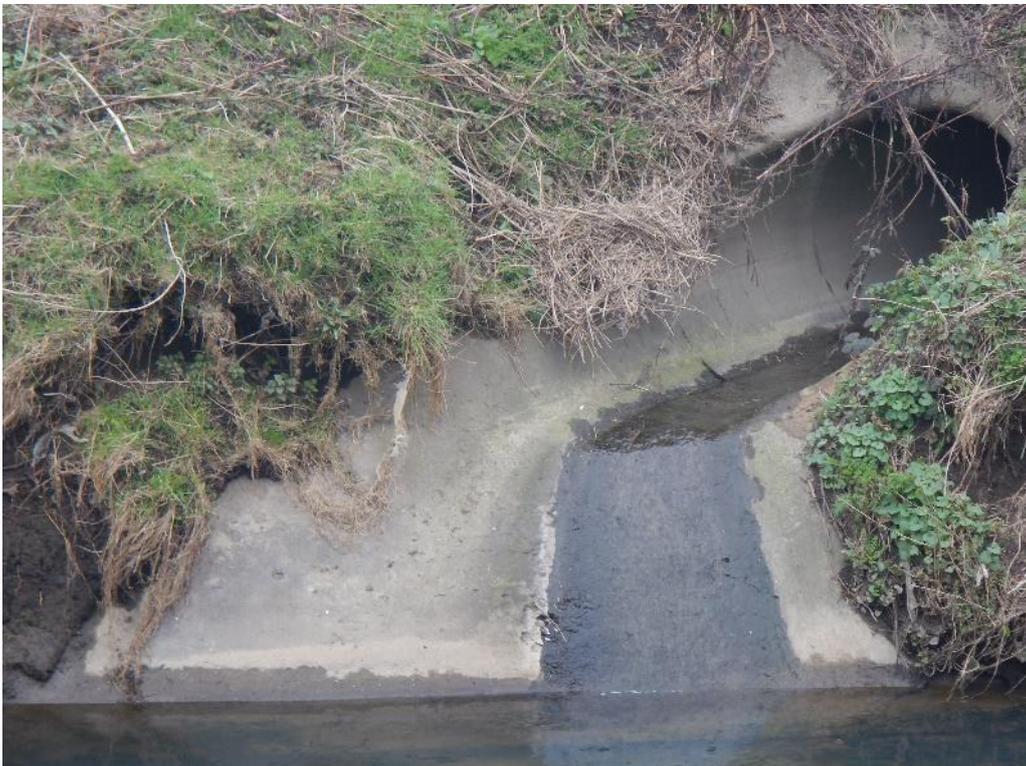
Te226. What appeared to be a surface water outfall with associated fine grey sediment input (NZ 24510 60459).

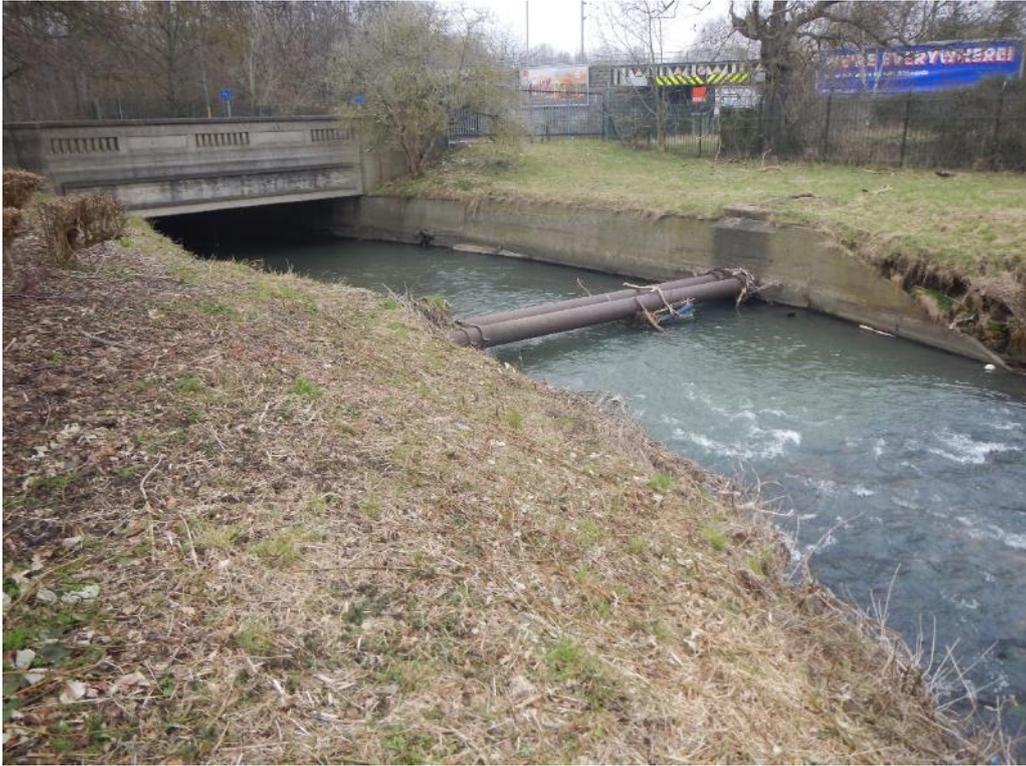
Te429. An inappropriately placed pipe crossing creates a potential hazard if it breaks and almost certainly reduces peak flow conveyance through a high flood risk area. NZ 24135 61356

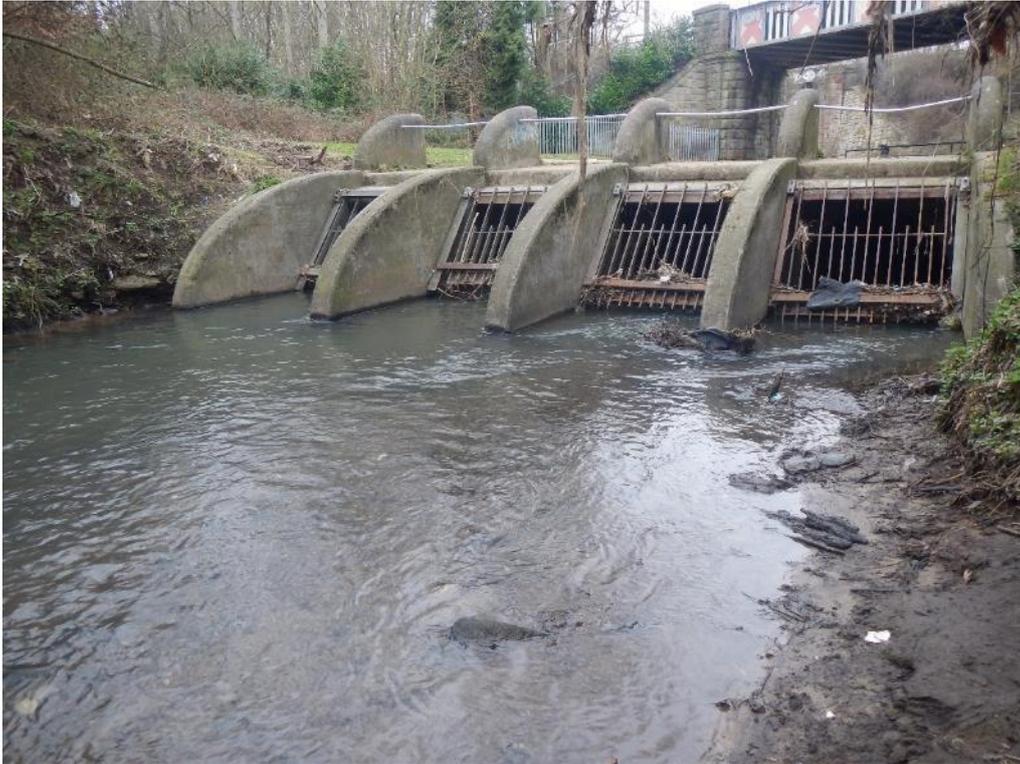
Te258. The River then disappears into another section of culvert (NZ 24011 61418). Any potential to skylight the watercourse/break it out of the culvert would provide improvements to habitat, fish passage, safety and the aesthetics of the area.

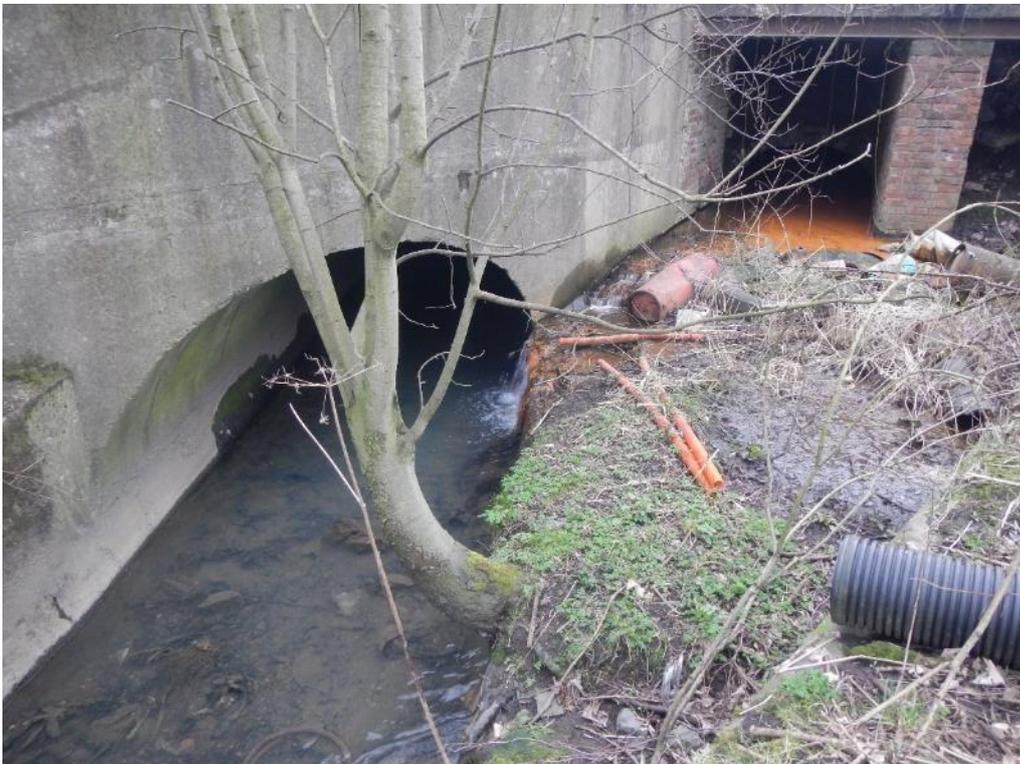
RoB1. Rowletch Burn was walked from NZ 26842 55047, where it emerges from a culvert. Significant seepage of iron-laden water was observed from the LB. Rubbish appears to be escaping from the adjacent compound.

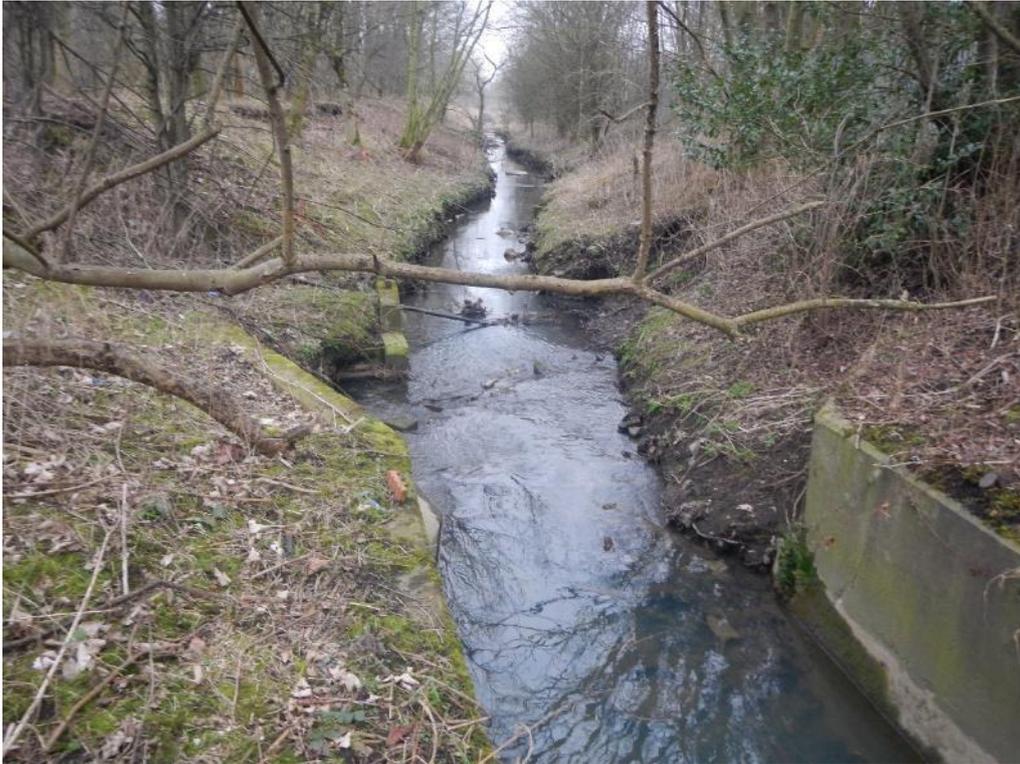
RoB2. The channel downstream is particularly straightened and artificial.

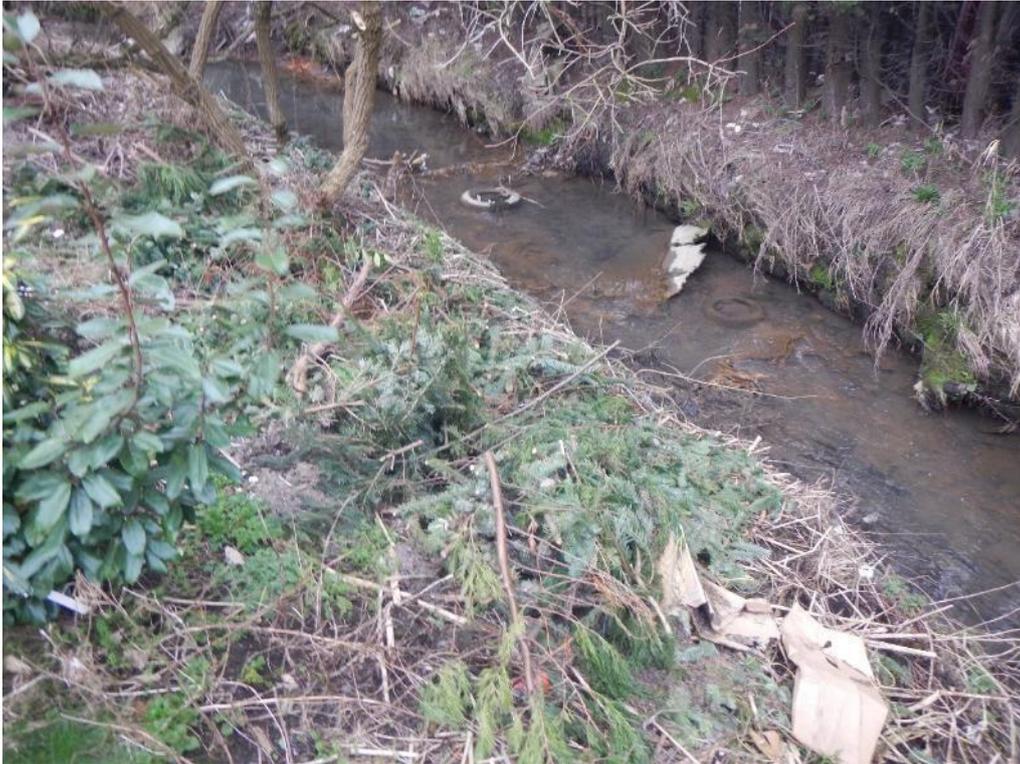
RoB29. In the section downstream of Station Ln, adjacent to the road/industrial site, large quantities of both waste/litter and garden waste are being dumped on the bank (NZ 26503 55620).

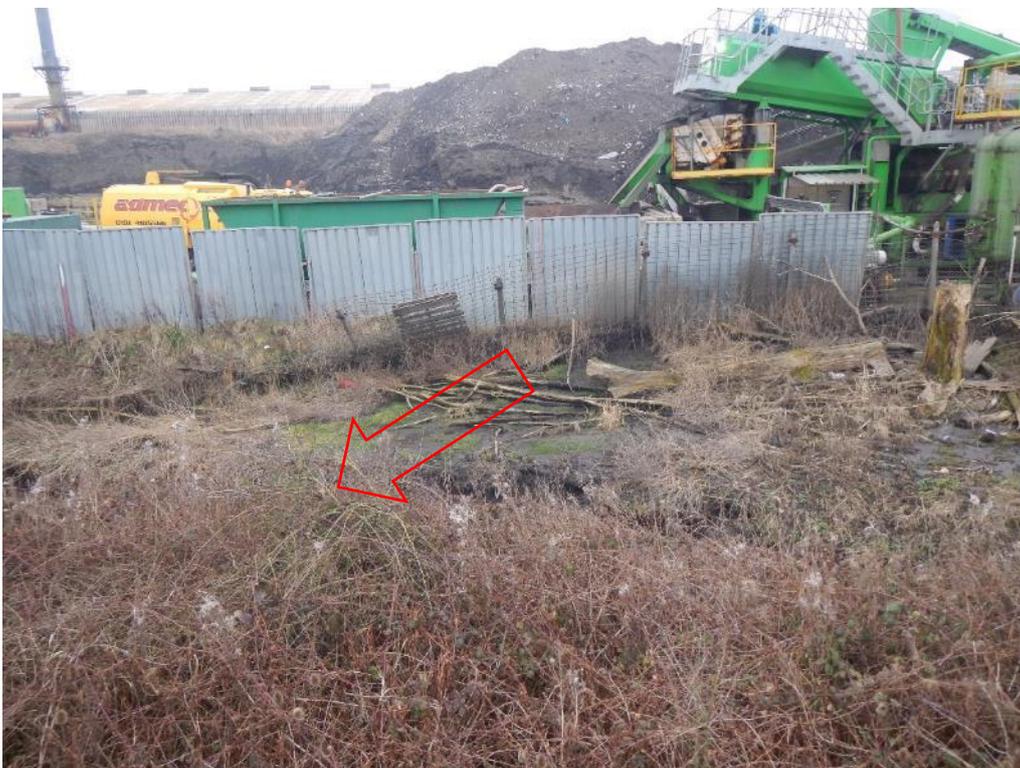
RoB37. Clears signs of material washing out of the site compound into the burn (NZ 26413 55811).

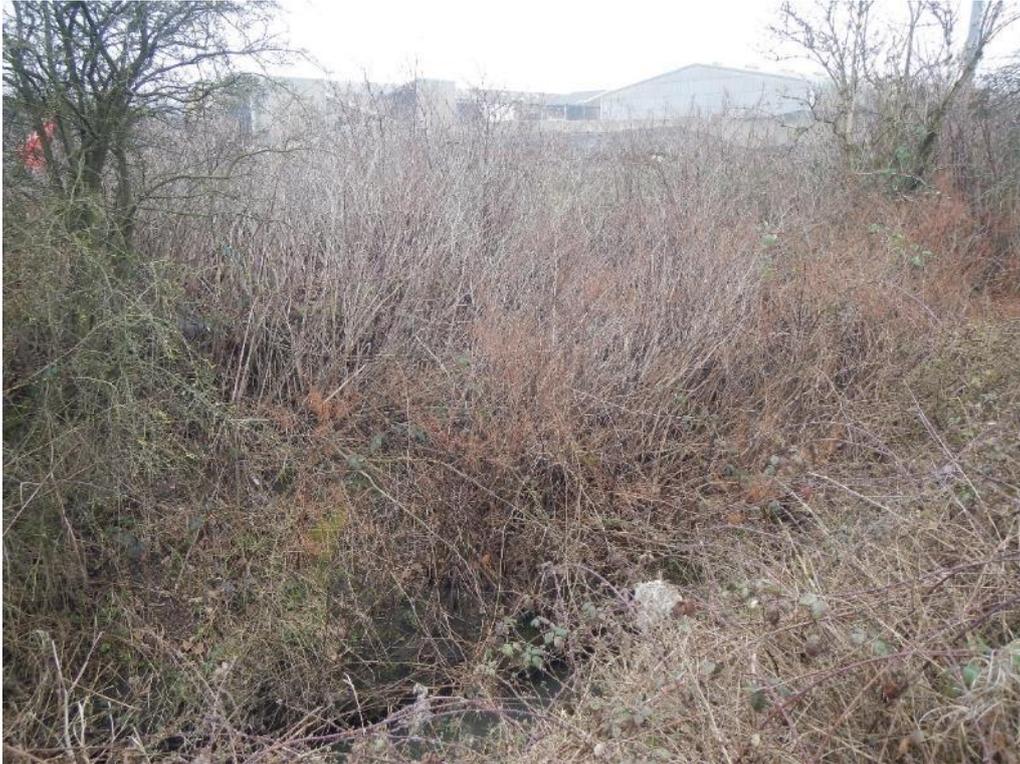
RoB40. Japanese knotweed may have escaped from the site as it was not observed further upstream (NZ 26360 55964).

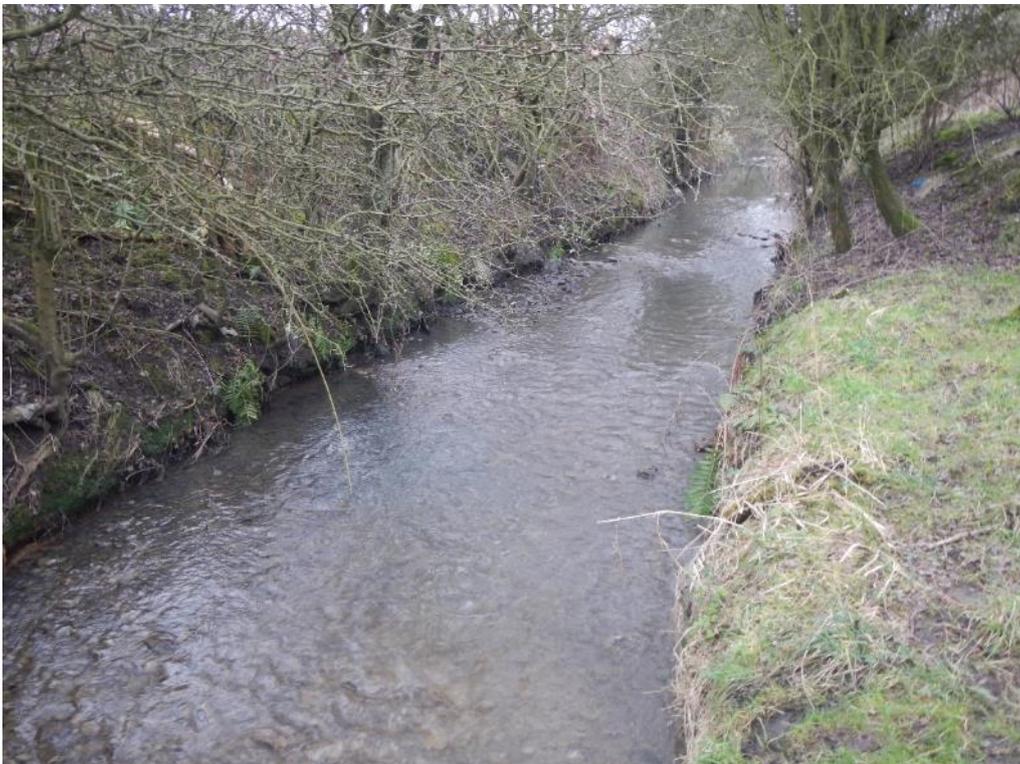
RoB41. A slight increase in gradient improves flow diversity but the uniform width and a lack of structure contribute to a uniform bed profile. Marginal deposition is beginning to occur, but in-channel structure would really kick-start improvements in channel morphology.

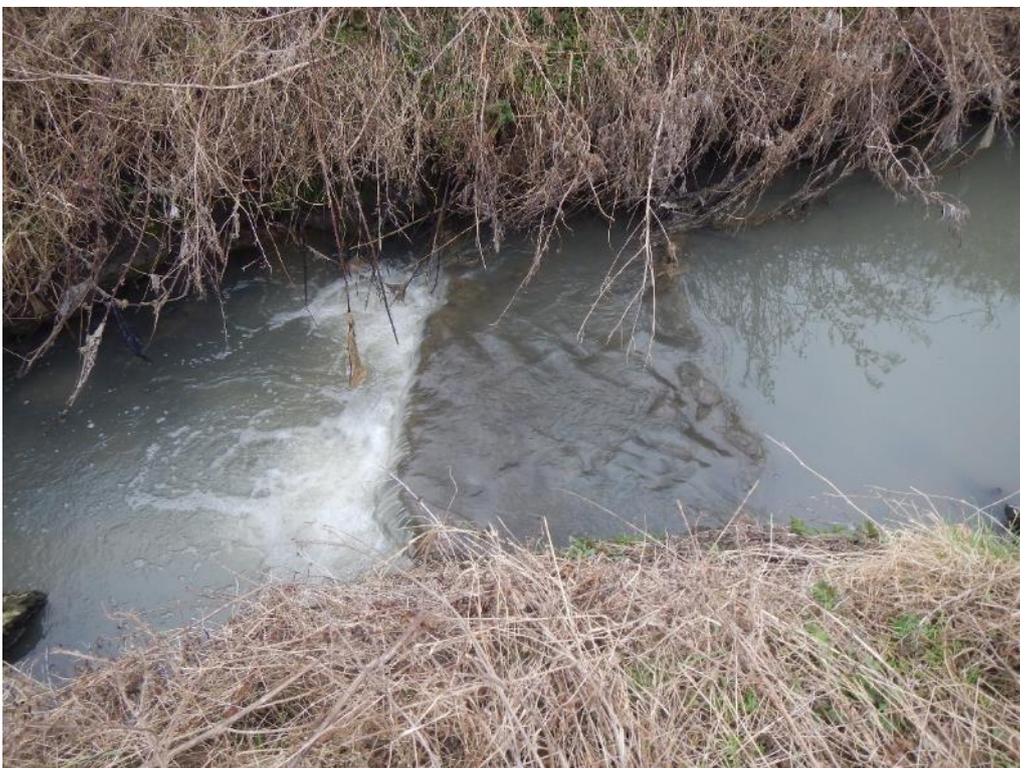
Rob46. A small concrete weir would pose an obstruction to fish, but the burn is unlikely to support any in its current state (NZ 26295 56119).

<p>Rob46</p>	<p>2/3</p>	<p>NZ 26295 56119</p>	<p>This weir would be a higher priority for removal if other improvements could help the burn to support fish.</p>
<p>Track crossing to Union Brickworks Clay Pit creates more fine sediment input and obstruction.</p>

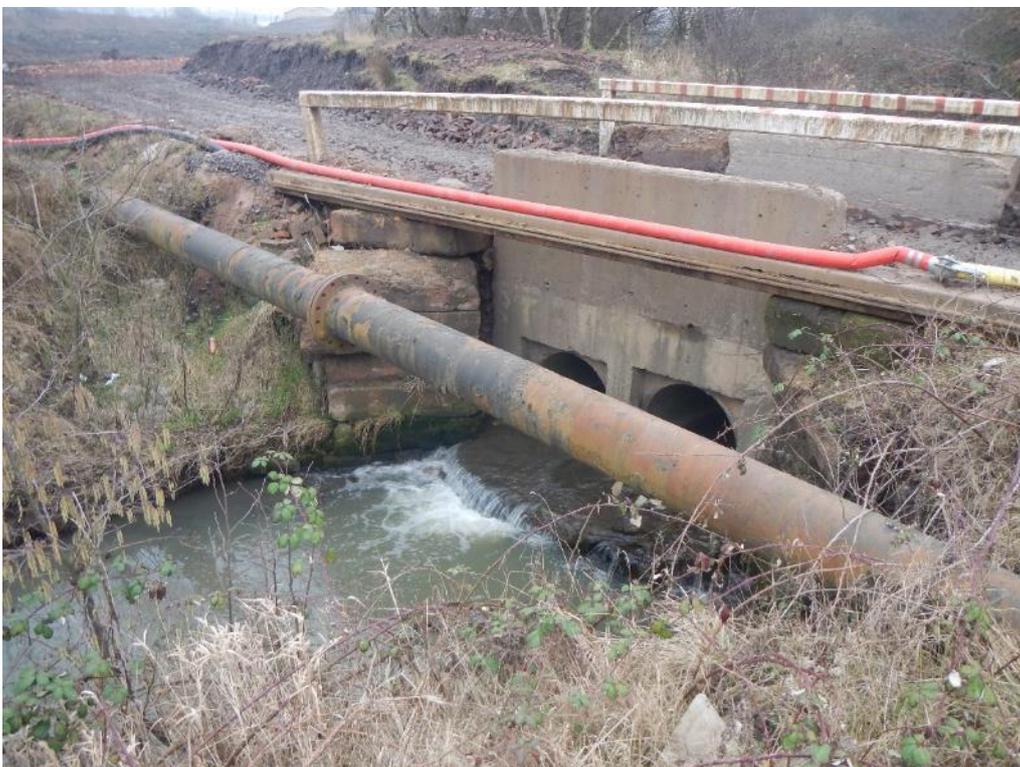
RoB51. The track crossing to the disused Union Brickworks Clay Pit (now decommissioned) creates another fine sediment input to the burn, particularly after heavy rain (NZ 26286 56152). The raised footings and twin pipes of the bridge also create an obstruction.

<p>RoB51</p>	<p>1/2</p>	<p>NZ 26286 56152</p>	<ol style="list-style-type: none"> 1. Seek better maintenance of the track (free from mud) and install cross-drains to discharge to soak-away. 2. An easement would be beneficial if the burn can be brought up to a standard that supports fish life.

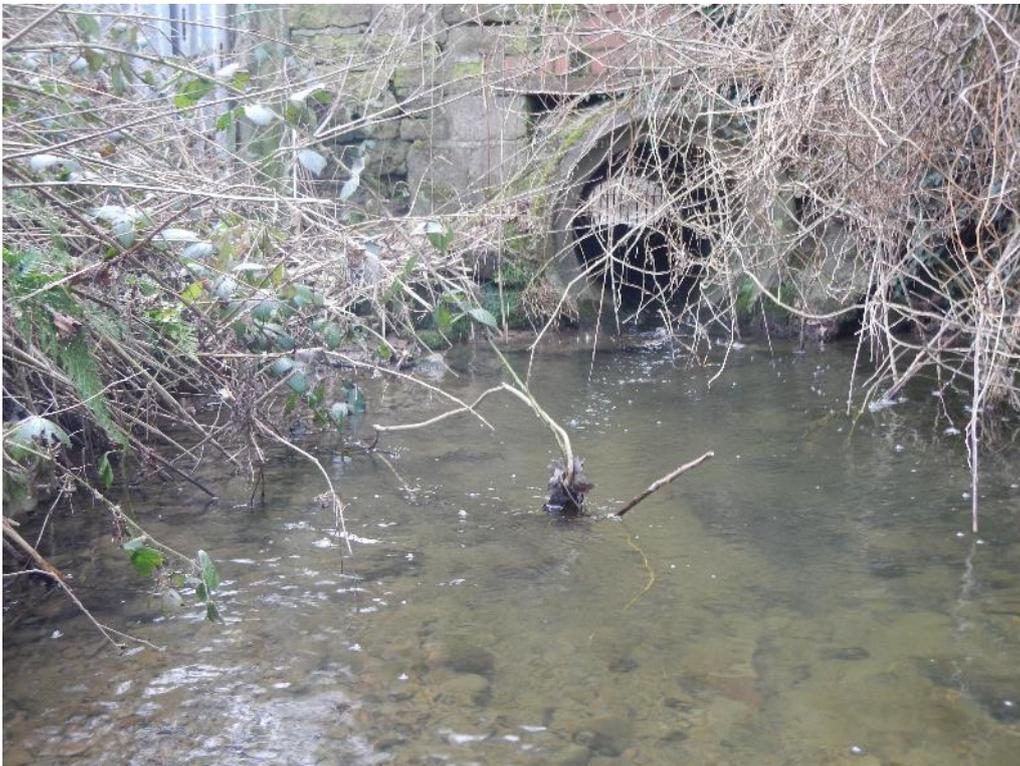
SB1. A perched culvert with a blocked grid at the upstream limit of the Strandy Burn section walked (NZ 24475 57682).

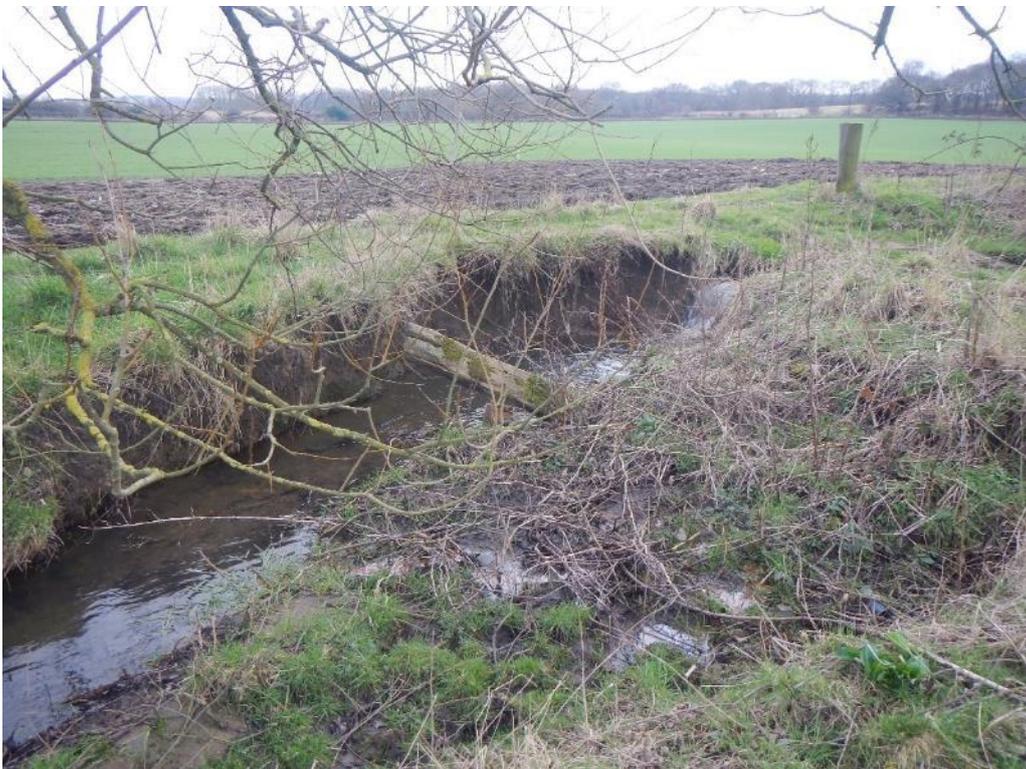
SB10. Numerous culverts appear to have been removed from the burn, which may account for strange steps in the bed that reduce the burn's accessibility (NZ 24607 57869).
