WILD TROUT TRUST

River Team
(lower catchment)

March 2021

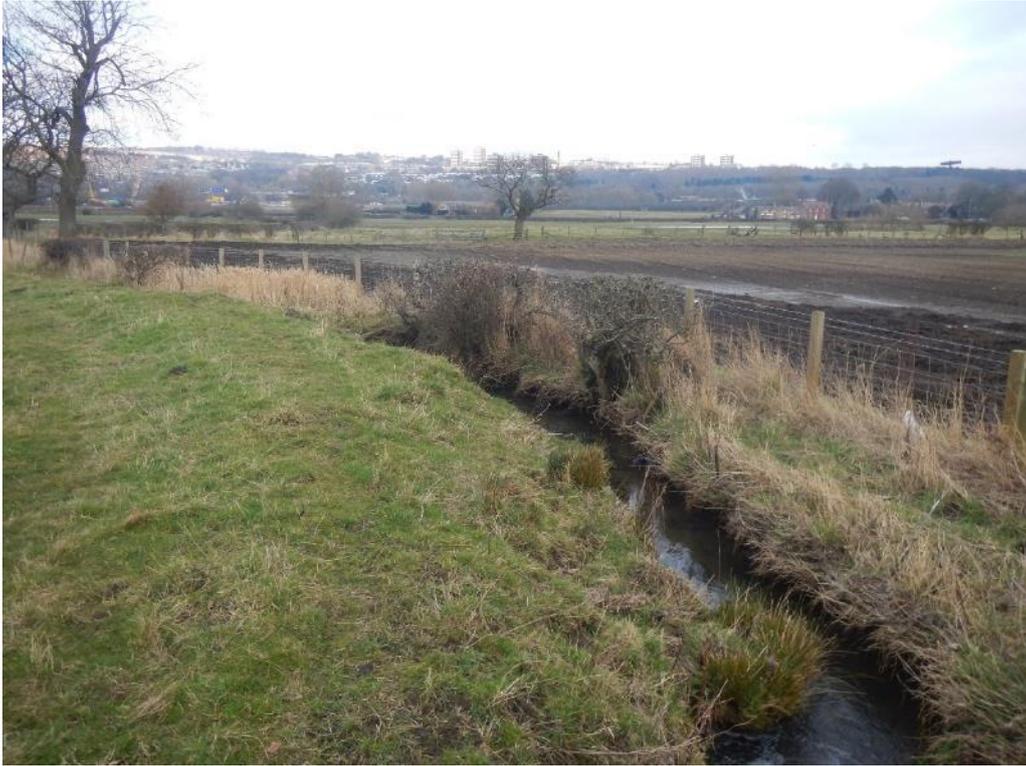
SB16. Suspected signs of the burn's pre-straightening paleochannels in the adjacent field. Note how they are still wet, being the natural low point in the floodplain. These channels could be restored to naturally improve land drainage (NZ 24704 57922). Buffer fencing would also be beneficial on one or both banks from here, downstream to the River team.

<p style="text-align: center;">SB16</p>	2	Throughout the section of Strandy Burn walked.	<ol style="list-style-type: none"> 1. Potential for channel restoration to improve habitat quality and land drainage throughout. 2. Buffer fencing from here to the River Team.

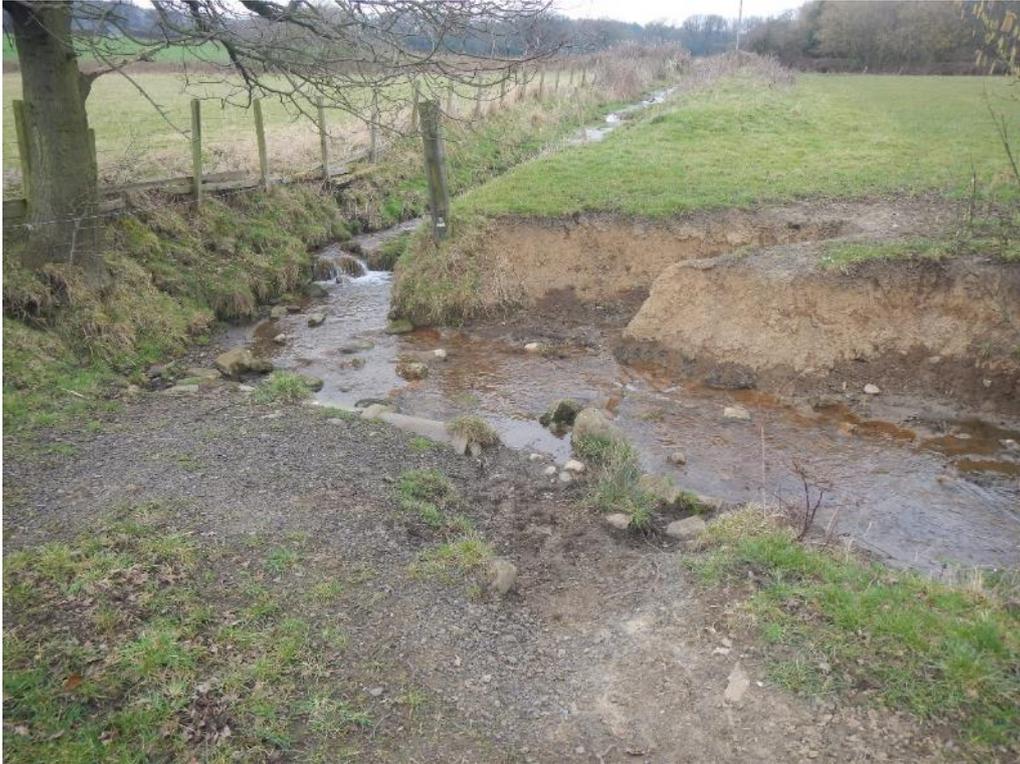
SB25. Livestock access and significant poaching/erosion at the furthest point upstream that was inspected (NZ 24217 57926). Note that although being the unnamed tributary of Strandy Burn, this watercourse supplied the majority flow.
