## WILD TROUT TRUST

**Follow up Advisory Visit / Project Proposal:**

**R. Ure, Tanfield Angling Club ([GB104027069461](mailto:GB104027069461))**

**Prof J Grey ([jgrey@wildtrout.org](mailto:jgrey@wildtrout.org)); April 2026**

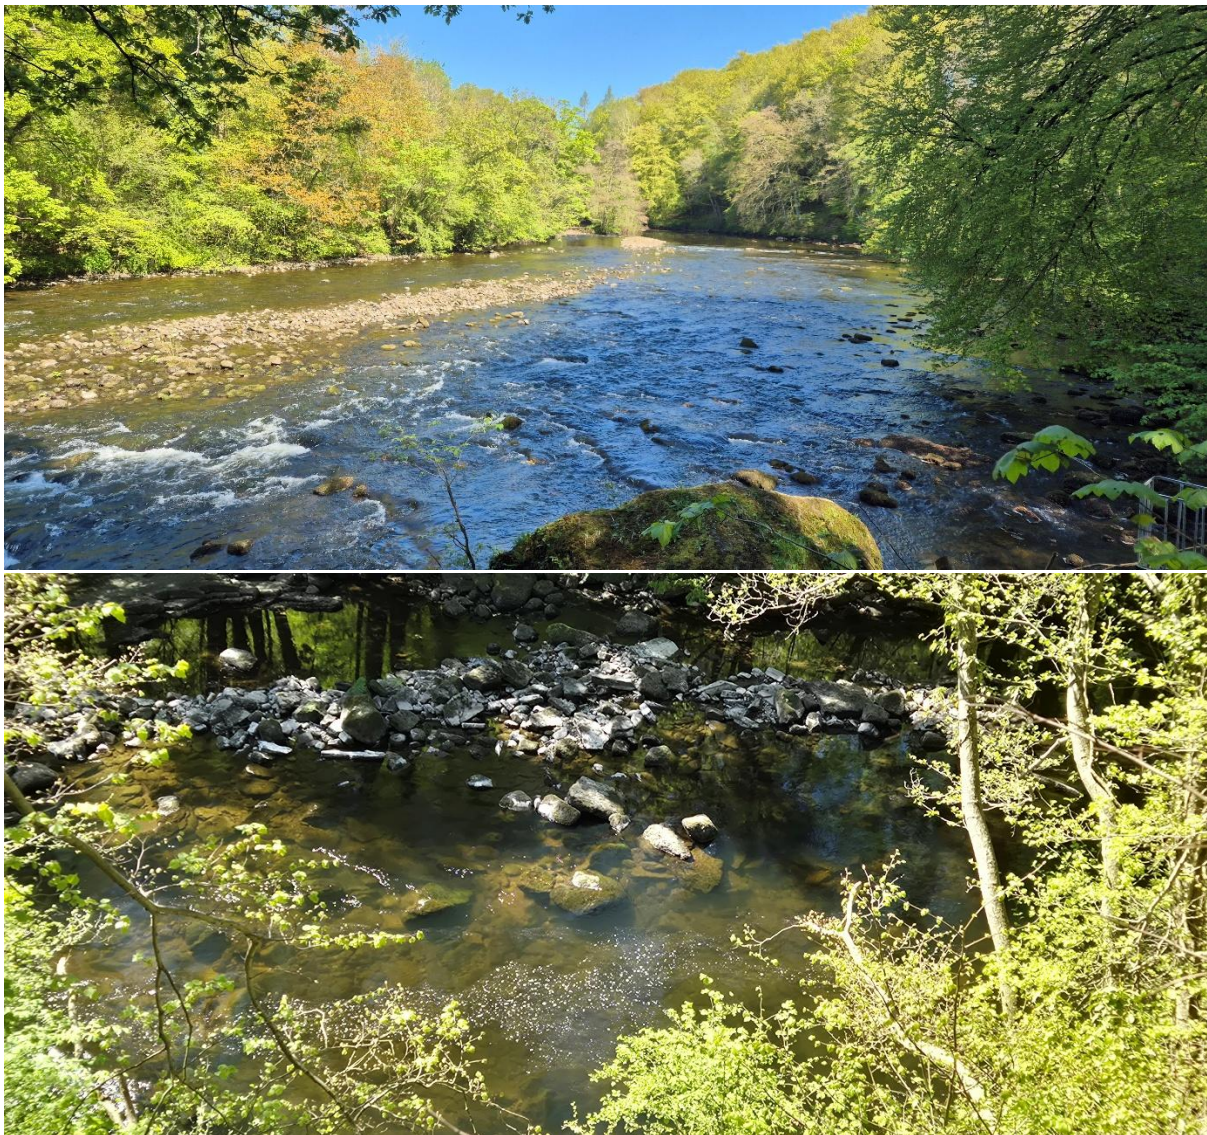
**Fig 1. Good examples of physically diverse morphology where the channel interacted with bedrock and the banks were unmodified: top – broad shallower riffles; and bottom – narrow, deeper glide between large boulders in the tightest pinch point of the valley. Fantastic diversity in the riparian deciduous woodland to both banks.**

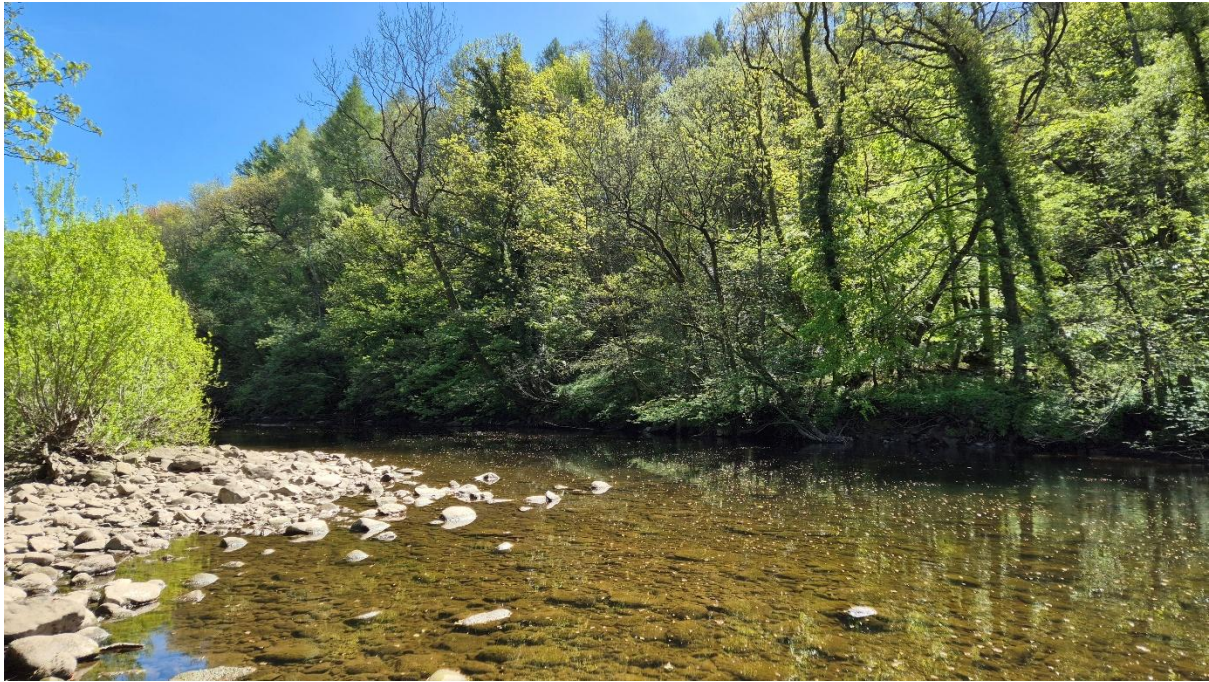
**Fig 2. Looking d/s, a deposition bar to the LB on the inside of the bend with increasing depth to the RB and fantastic low cover and shade provided by the riparian trees. Willow was managing to establish on the deposition bar (no livestock access) and will continue to stabilise the structure, as well as providing some canopy height diversity.**

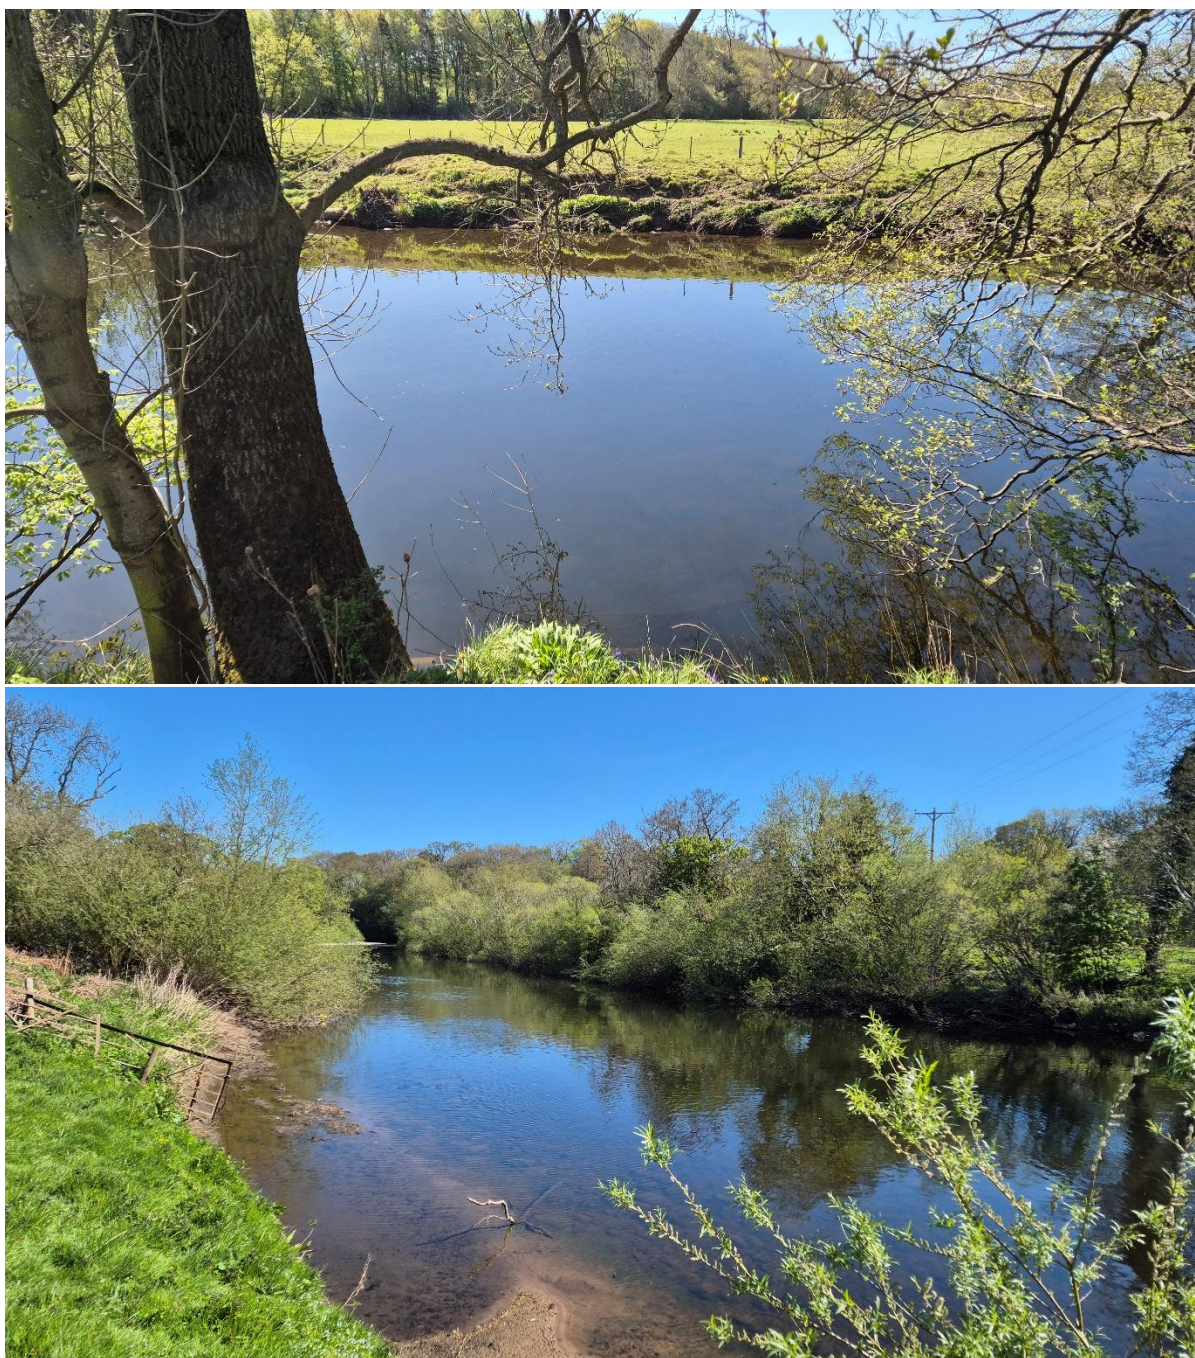
Forcing the channel into an unnatural position within the floodplain has also altered its gradient with consequent impacts on the geomorphology. Hence, there are long, relatively deep and sluggish canalised sections where the gradient has been removed or the bed lowered, interspersed with long fast shallow riffles to compensate (Figs 3&4).

**Fig 3. Examples of deep, impounded, sluggish canalised sections (relatively devoid of features) where the gradient had been reduced through artificial realignment. Note the fine sediment deposition to the LB in the lee of a small willow.**

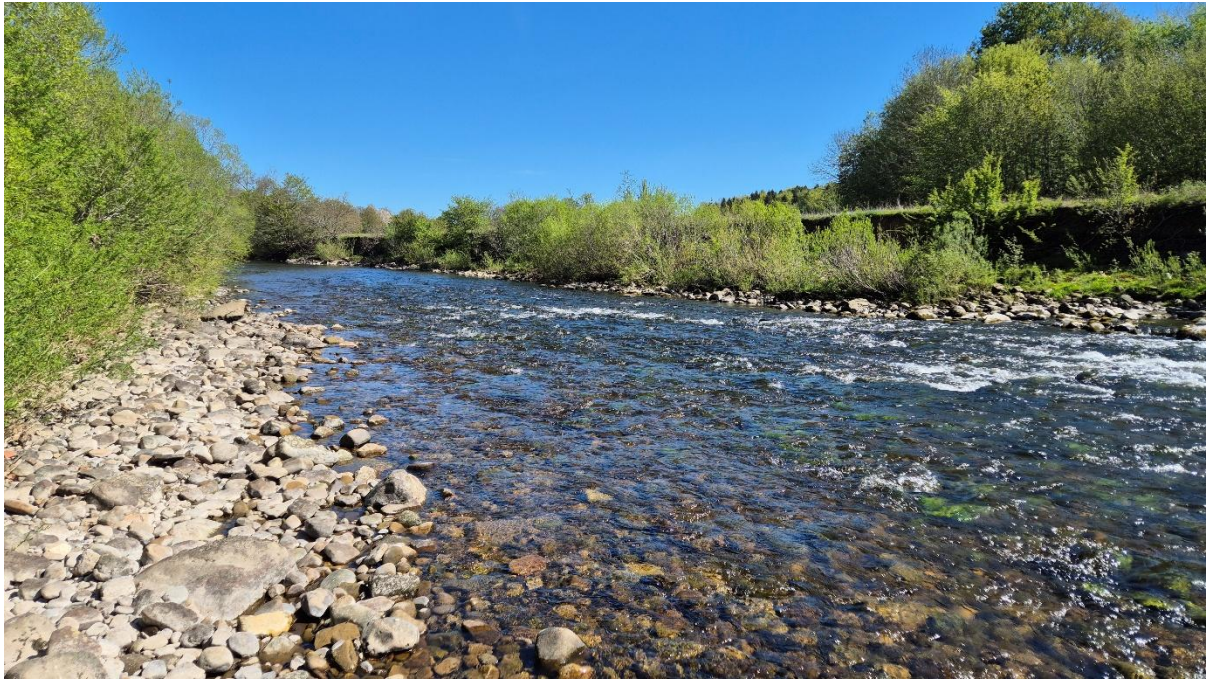
**Fig 4. In contrast to Fig 3, fast shallow continuous riffles between canalised sections compensating for modifications to the gradient.**

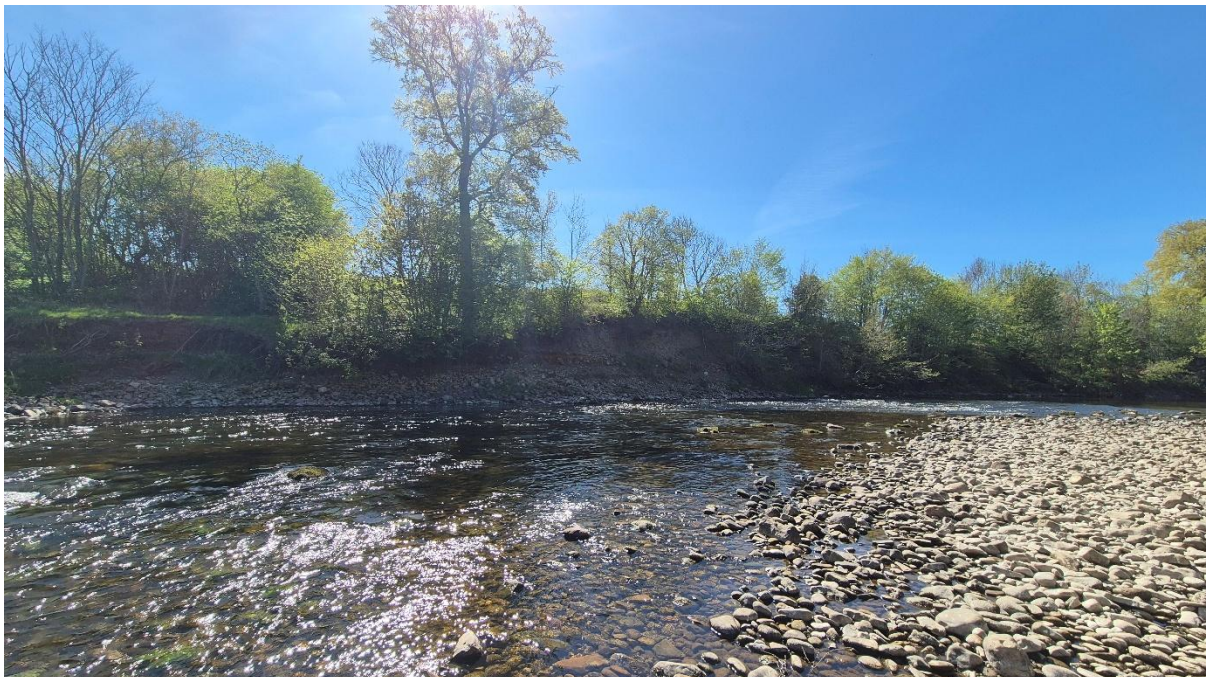
A consequence of this artificial incision has been to disconnect the river from its floodplain, preventing spate energy from dissipating and hence causing net loss of finer substrate fractions like gravels d/s. All the actions like embankment to prevent re-meandering of the channel, also inhibit channel recovery and effectively prevent the natural resupply of alluvial gravel laid down historically, except in a few locations; eg Fig 5.

**Fig 5. One of the few sites of active erosion observed, this was a vital supply of finer substrate fractions like cobble and gravel, having been laid down historically by the river and currently being re-accessed.**

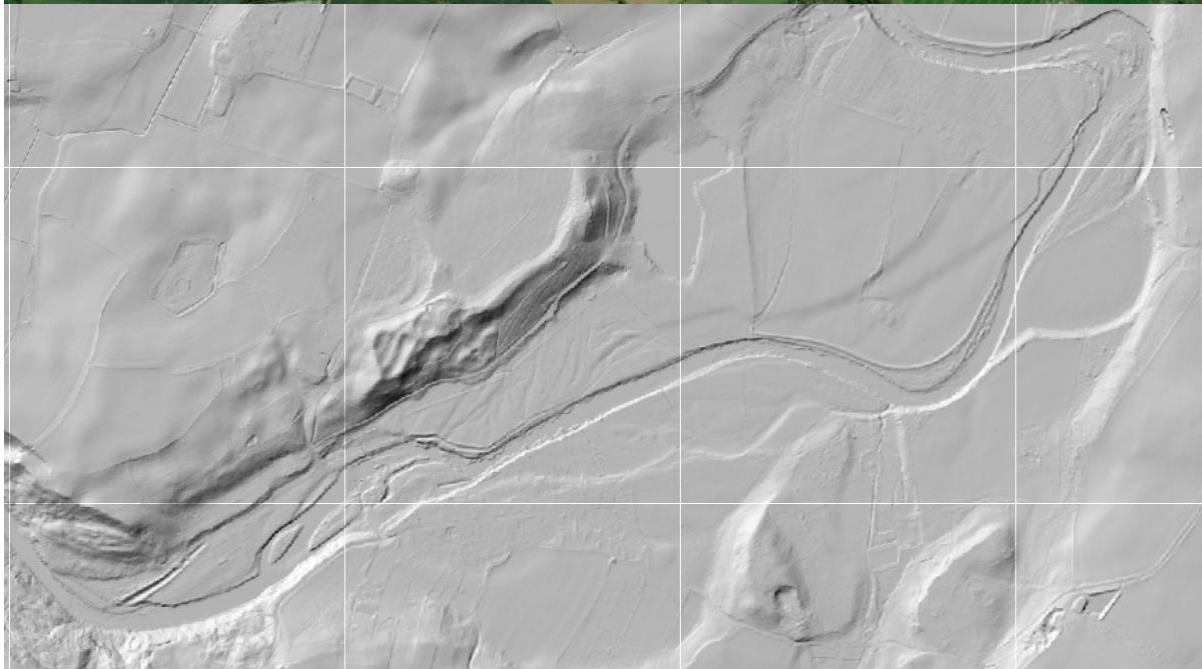
Elements of these modifications can be seen in Figs 6 & 7 using LiDAR-derived terrain mapping and historical mapping, respectively, especially the channel straightening, incision and embankments. The extant channel is in stark contrast to the more meandering paleochannels evident across the entire floodplain in Fig 6.

**Fig 6. Digital terrain model derived from LiDAR data of the Ure flowing from bottom left to top right with the shadow intensity especially to the LB (northern) emphasising how incised the straightened extant channel has become. Paleochannels, ghosts of the channel's position over time, are evident meandering across the full width of the floodplain.**

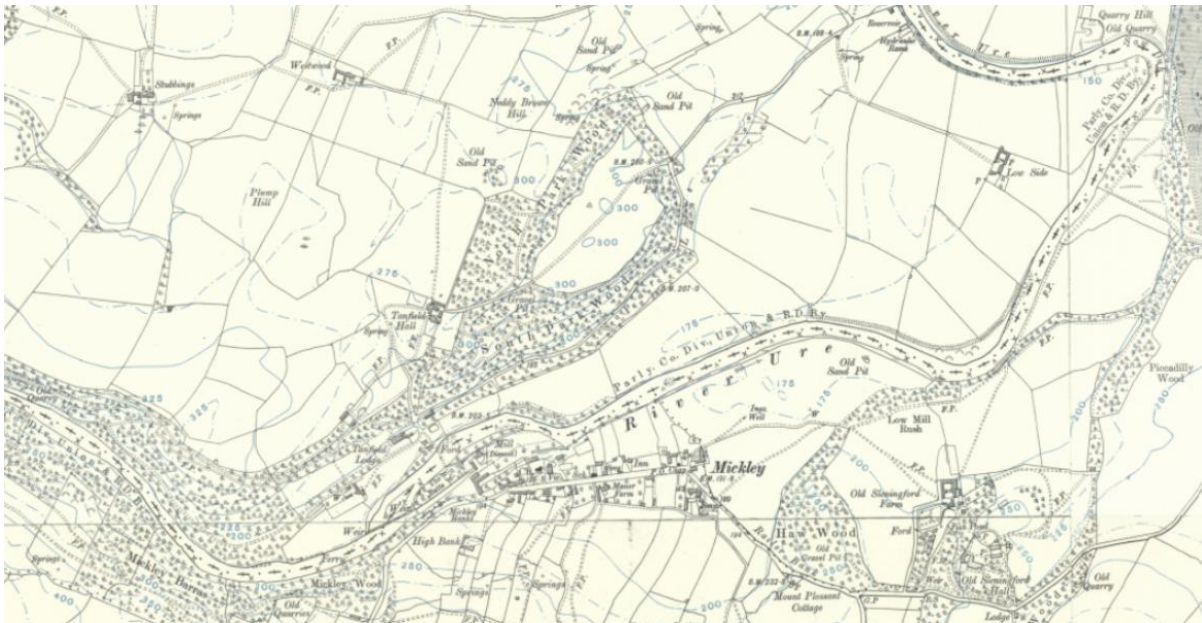
**Fig 7. An excerpt from The Ordnance Survey six-inch map series from 1888-1915 (<https://maps.nls.uk/>) of the same reach in Fig 6 highlights that the modifications had already been instigated ~150y ago and there has been virtually no change since.**

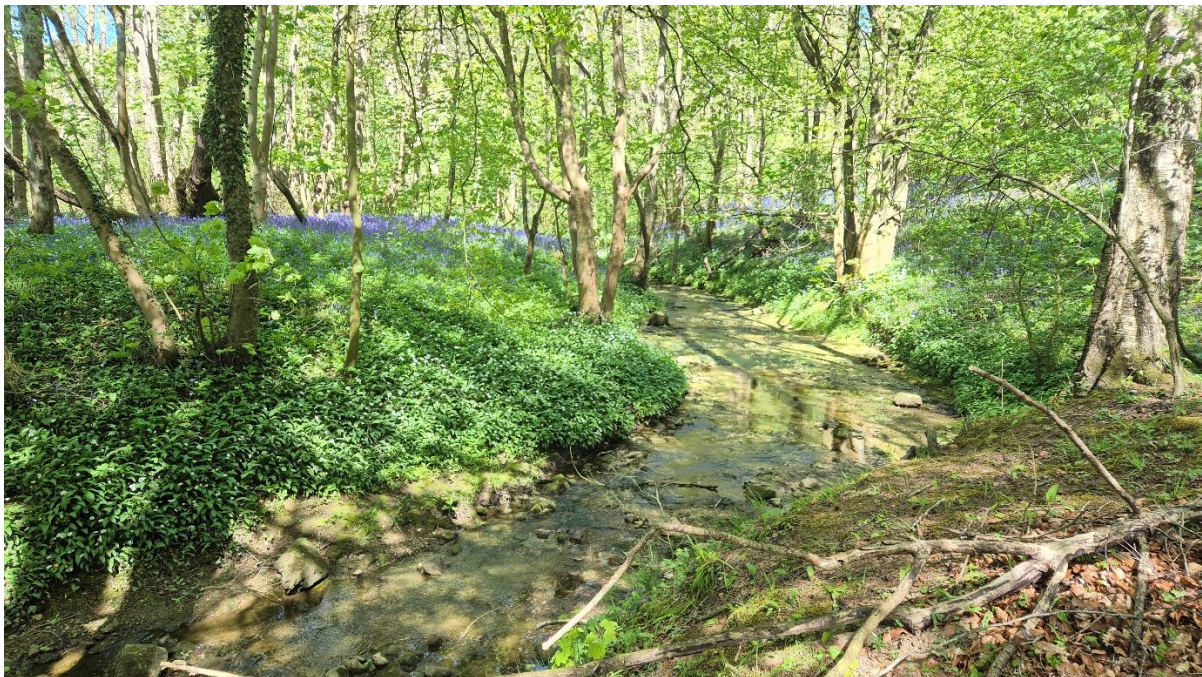
**Fig 8. The lowest reach of Black Robin Beck prior to the confluence with the Ure, comprised a flattish bedrock seam that extended ~50% across the width of the mainstem. As such, it presented naturally challenging access to the tributary because water depth was reduced to a thin skim of fluming flow.**

The challenge for fish accessing the beck was the bedrock seam at the confluence resulting in a shallow skim of water and hence impassable during low summer flow (Fig 8). It is not clear whether the natural state of the bed should be bedrock here. Human modification of the channel may

have removed its ability to retain smaller size-fractions of substrate. To counter this, introduction of large woody structure into the channel, lodged by standing trees on the adjacent banks, may improve retention of finer substrates on top of the bedrock and diversify the depth profile. The aim would be to make the habitat within the beck as structurally complex as possible, and hence potentially much more temporally dynamic as the beck pushes around, over and under that structure. This should improve the spawning and fry habitat whilst reducing the risk of predation and washout during spate flow. Given the ample width of buffer on both banks, it should not impact unduly upon either landowner.

- Spawning habitat on Black Robin Beck (3.1). Proposal for WTT to apply for EA Fishery Improvement Programme funding or similar to enable some large woody structure works within the lower reaches of the beck and work with volunteers to install. WTT can liaise with the neighbouring estate if TAC liaises with their landlords, and if agreed in principle, draw-up a more detailed plan. It is understood that TAC still stocks which could potentially negate any benefit of improving spawning habitat; see <https://www.wildtrout.org/content/trout-stocking>.

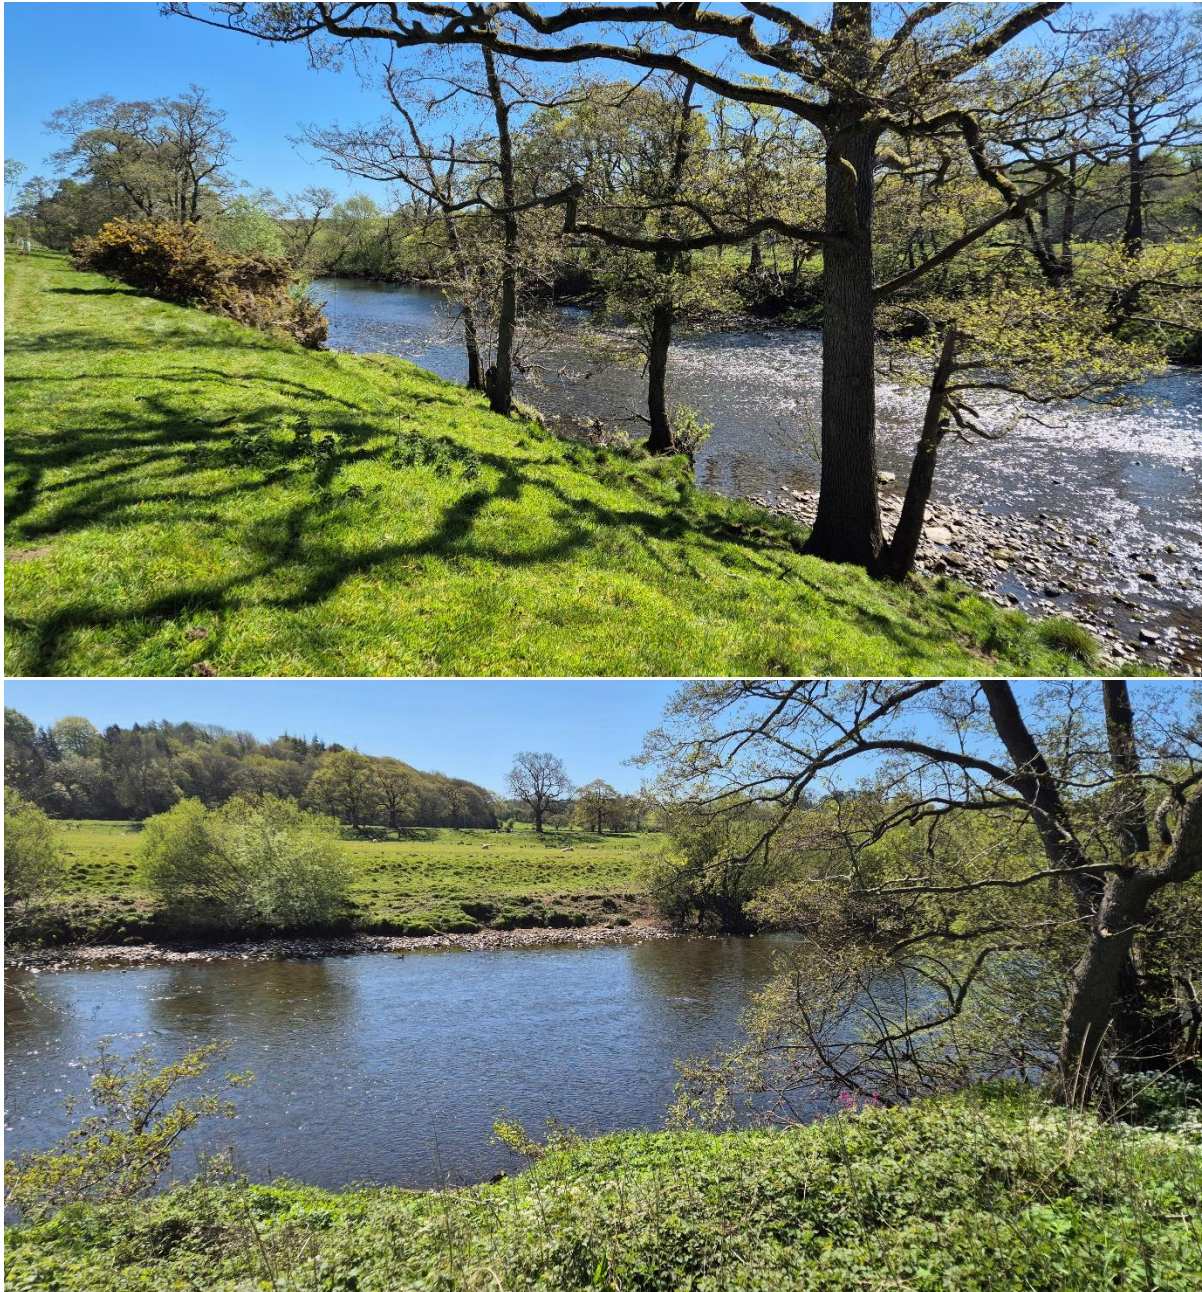
Generally, tree cover and herb understorey were good along the banks but there were some short sections where unfettered livestock access was preventing any natural regeneration of trees and causing accelerated lateral migration of the banks (Fig 9). Superficially, those sections may appear tree-lined, but those that were there were all mature with no clear succession options, and a mature one-tree-deep fringe is not very resilient.

**Fig 9.** Wherever livestock had unfettered access, there was no natural regeneration of trees and hence no potential succession. Deposition bars remained unconsolidated, there was little in the way of marginal herb understorey, and the bank toe was often vertical (see far bank) because of livestock causing lateral erosion.

Sheep and cattle trampling, poaching, grazing and repeated scratching / licking at the exposed soil for micronutrients destabilises the banks and increases erosion by the river under relatively minor lifts in flow. Classic signs of this are a vertical bank toe, often with bare soil, and exposed cobble and boulder in between with little respite from those actions to allow plants to colonise and help stabilise. It leads to an over-exposed margin, with very little shade because of the lack of herb vegetation, leaving the stone prone to excessive heating from the sun. The ideal would be a shaggy marginal herb fringe providing low, cool cover, especially important for weaker swimming trout and grayling fry.

Capital costs for flood-spec livestock fencing to protect riverbanks are reasonably simple to find, and there may be revenue payments available as well, depending upon the width (min 6-12m) of buffer afforded and type of land management scheme. Access arrangements can be incorporated for anglers, as well as alternative drinking supply (eg pasture or solar pumps) if there are no other reliable sources such as springs, seeps, or mains.

A ~500m stretch on the LB from SE 25637 77179 to SE 26087 77364 and the equivalent length on the RB would benefit from such a buffer. Another reach that would benefit: SE 26657 77588 to SE 26768 77755.

- Riparian buffer strip and livestock exclusion fencing requires buy-in from landowner / tenants. TAC to explore potential for reaches as outlined in 3.2.

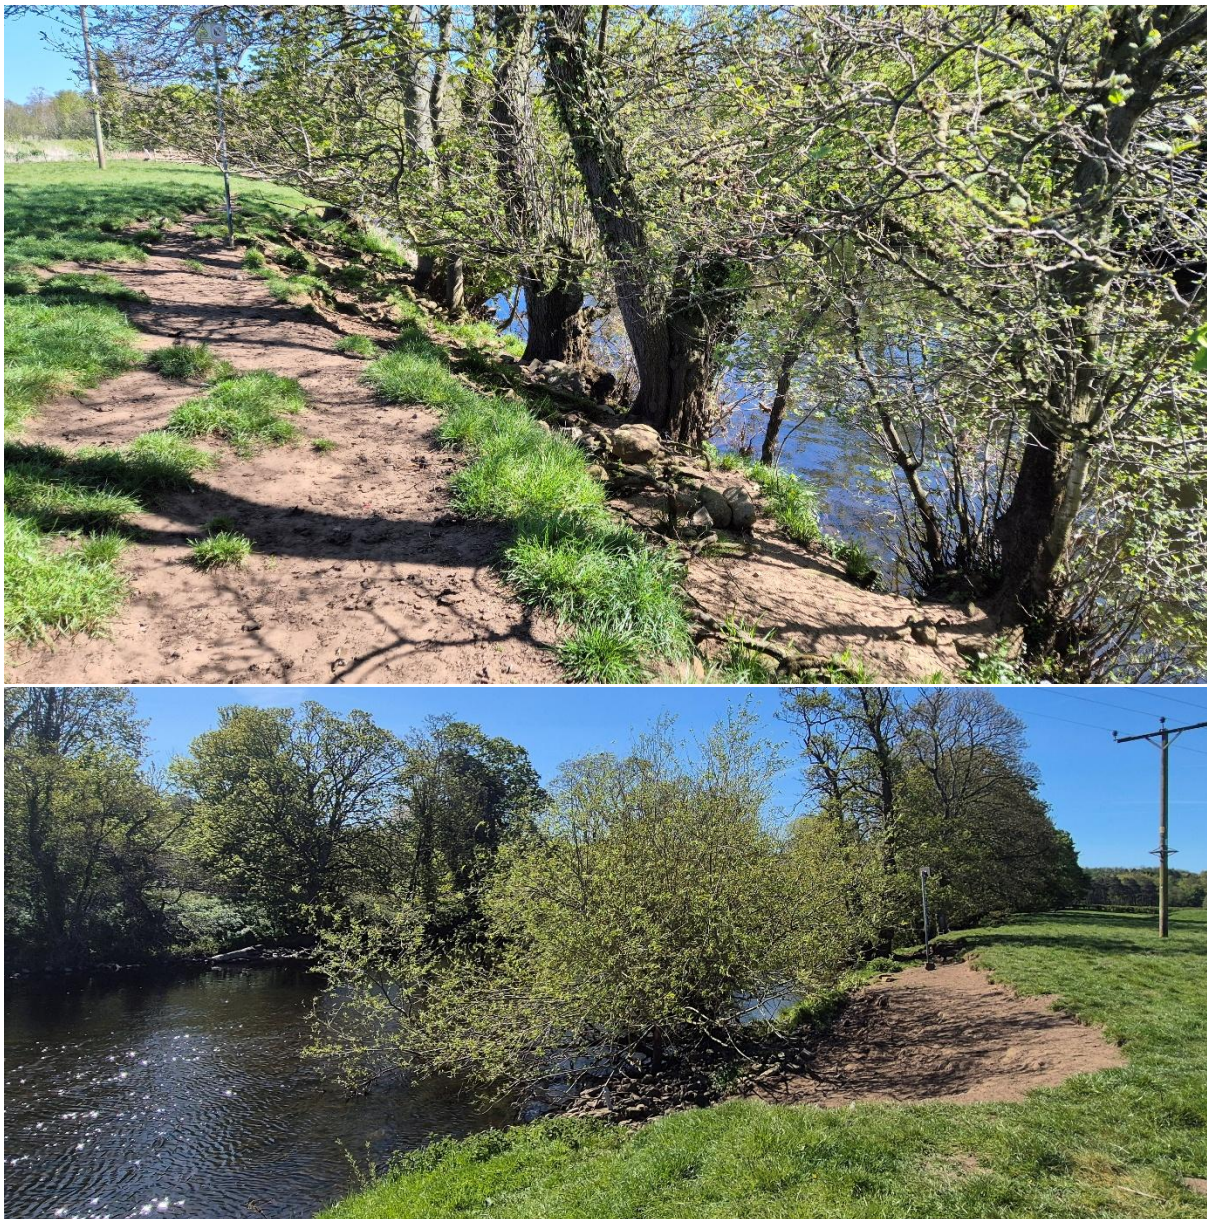
**Fig 10. Bare soil and exposed roots caused by stock activity seeking shade or browse, increasing the risk of the trees succumbing to disease and failure.**

On steeper banks with mature trees, livestock often causes issues when seeking shade or trying to access browse, by trampling the soil and exposing and damaging root systems which could ultimately cause the demise of the tree and loss of a substantial chunk of bank in the process; see Fig 10.

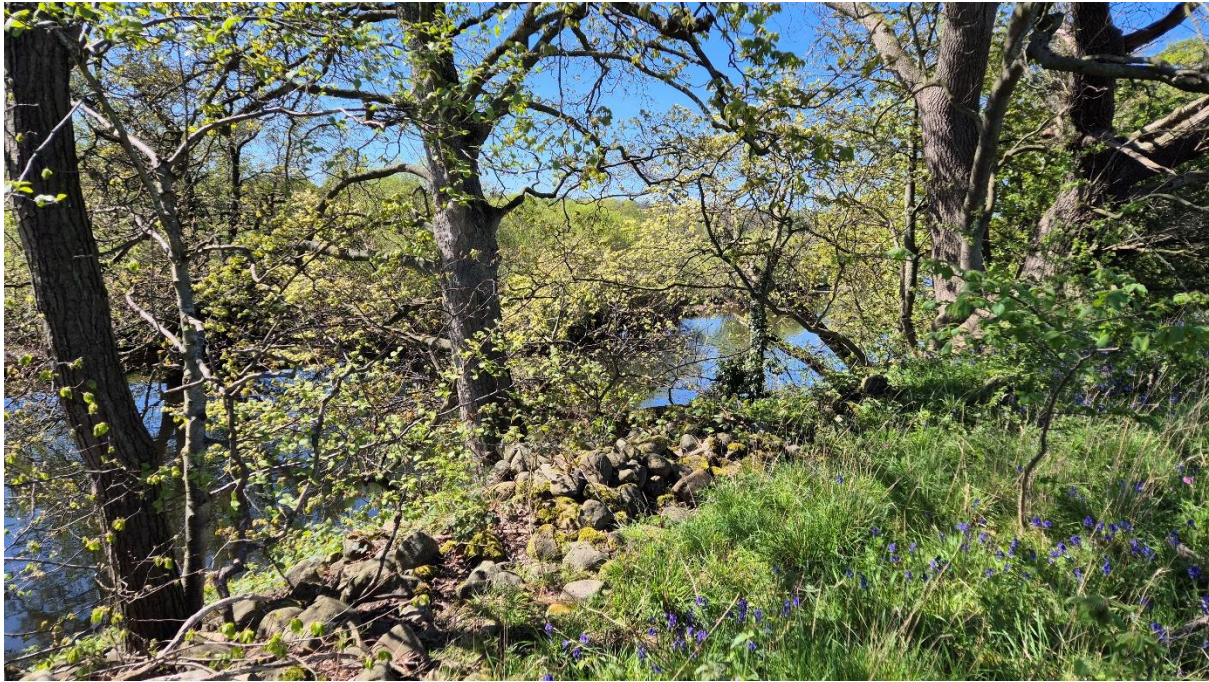
Some livestock erosion scars around the bankside of more mature trees had been filled with stone (Fig 11). It was unclear whether this was material taken from the riverbed elsewhere or if it was stone winnowed from the arable fields adjacent. Either way, such unconsolidated material is unlikely to provide any further bank stabilisation. It is more likely to accentuate the destabilisation of the bank in the longer term, by preventing any natural understorey or tree succession from establishing. In the absence of full channel restoration, such stone would be better cast within one of the sluggish canalised reaches to be redistributed by the river under spate flow, and the section of bank protected from livestock with buffer fencing.

**Fig 11. Cobble and boulder 'infill' of bank edges, hindering a naturally diverse herb and tree flora from developing, the roots of which would create true resilience to future spate flow events.**

- Stone return to the river (3.3) would work best as noted in conjunction with buffer strip creation.
- Several specific trees were identified during the walkover which would be suitable to hinge / lodge; eg leaning at a suitable angle in a d/s direction, of a suitable size / species, with multistems present to provide anchorage / lodging / protection on the u/s side, and in more depositional areas.

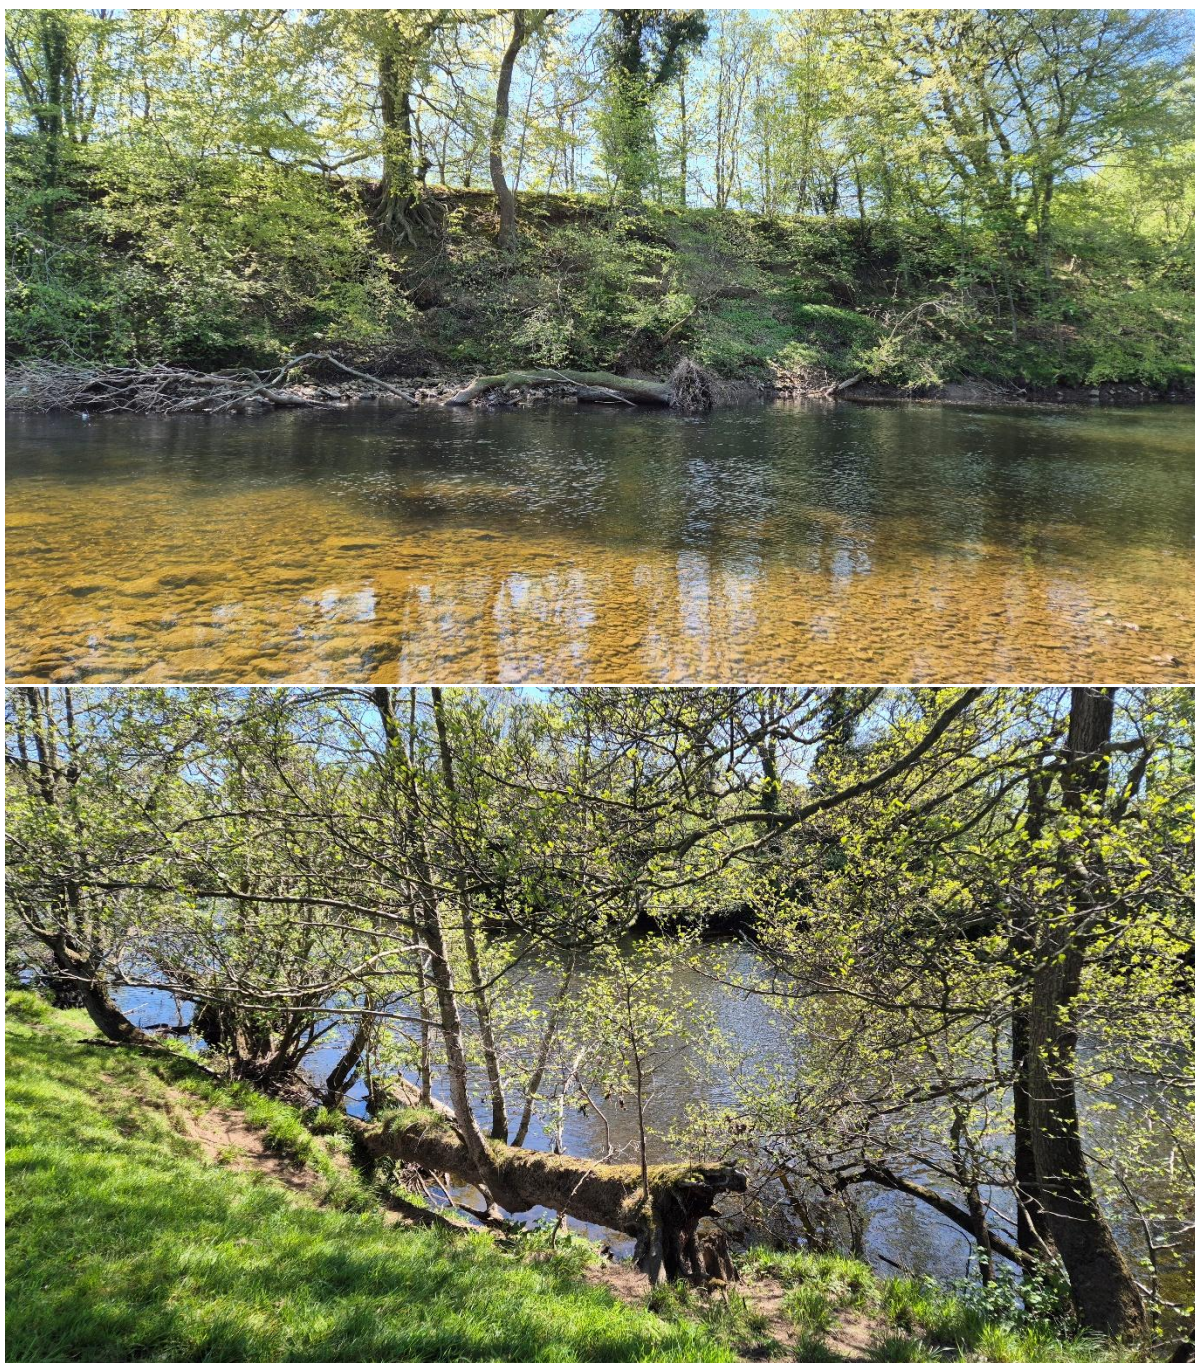
Several large naturally fallen trees were observed during the visit at various locations and appeared to have been *in situ* for one or two winters at least, causing physical diversity within the margins and creating habitat (Fig 12). Natural tree fall is instrumental in channel geomorphology, but it is one of the key parameters that humans have been exceedingly fastidious in removing because of perceived flood risk and a tendency to tidiness.

**Fig 12. Two examples of naturally fallen woody structure creating good habitat.**

Several tree trunks had been felled and tethered to replicate similar, and more could be done, either via hinging of pliant species such as crack willow, or lodging using opposing forces between other living stems, to reduce the amount of unnatural material used. These should be focussed in more depositional areas to reduce the stress on the structure under spate flow and reduce risk of it moving; see appendix.

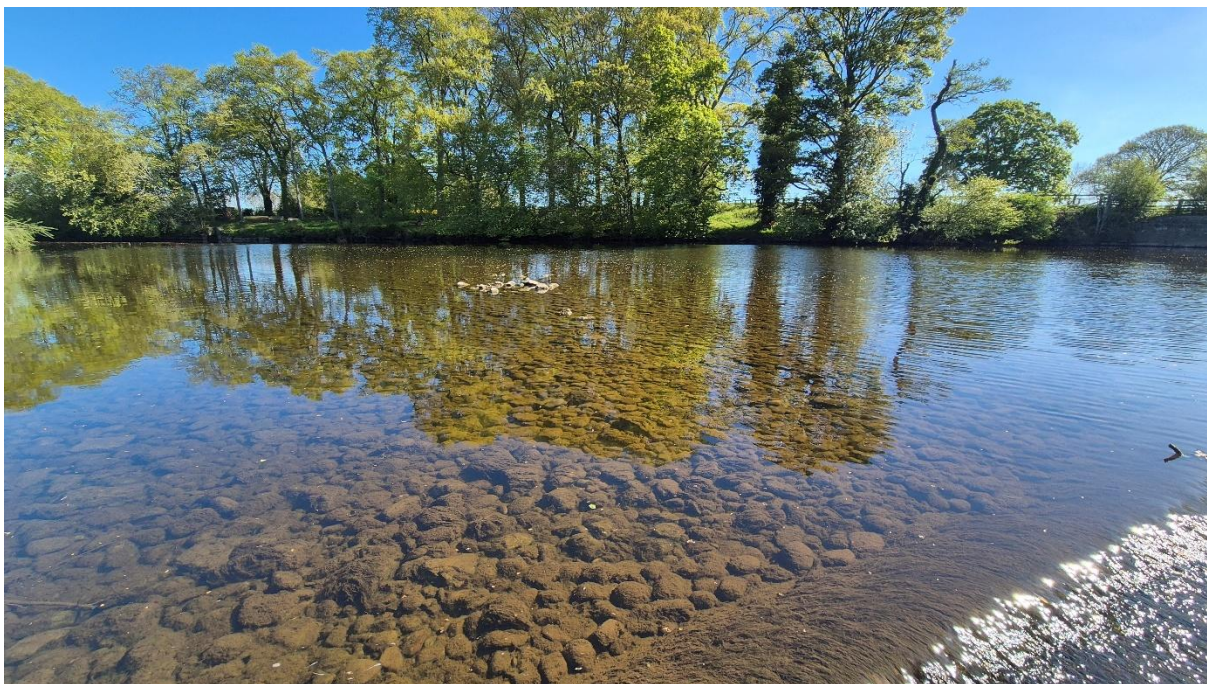
Tanfield Mill weir also serves an offtake for a private hydropower scheme and presented a considerable issue for fish passage and sediment transport (Fig 13). The weir was ~65m wide, impounding the river for 550m, and was in poor condition with several points of failure noted (Fig 14). The aggradation of sediment u/s had reduced the depth markedly, and being overly-wide already, would be prone to warming. The reach d/s of the weir was dominated by bedrock seams but would probably not be if the thousands of tonnes of sediment trapped upstream of the weir could be remobilised and allowed to move through the system naturally.

**Fig 13. SE 27553 78738: u/s of the 65m wide weir at Tanfield Mill, sediment had become aggraded (trapped) creating shallow featureless water prone to warming.**

From an environmental and fishery perspective, removal would be the gold standard allowing unhindered fish movement in both directions and reinstating natural transport of sediment. Installation of a fish pass would be a very poor option, potentially very expensive, carrying the burden of future maintenance liability, especially given the clearly unsound nature of the aging structure.

- Free-flowing, connected rivers, unimpeded by weirs are more resilient wild fisheries, so TAC should be supportive of any measures to improve fish passage via the EA or Great Yorkshire Rivers partnership (<https://www.greatyorkshirerivers.org/>)

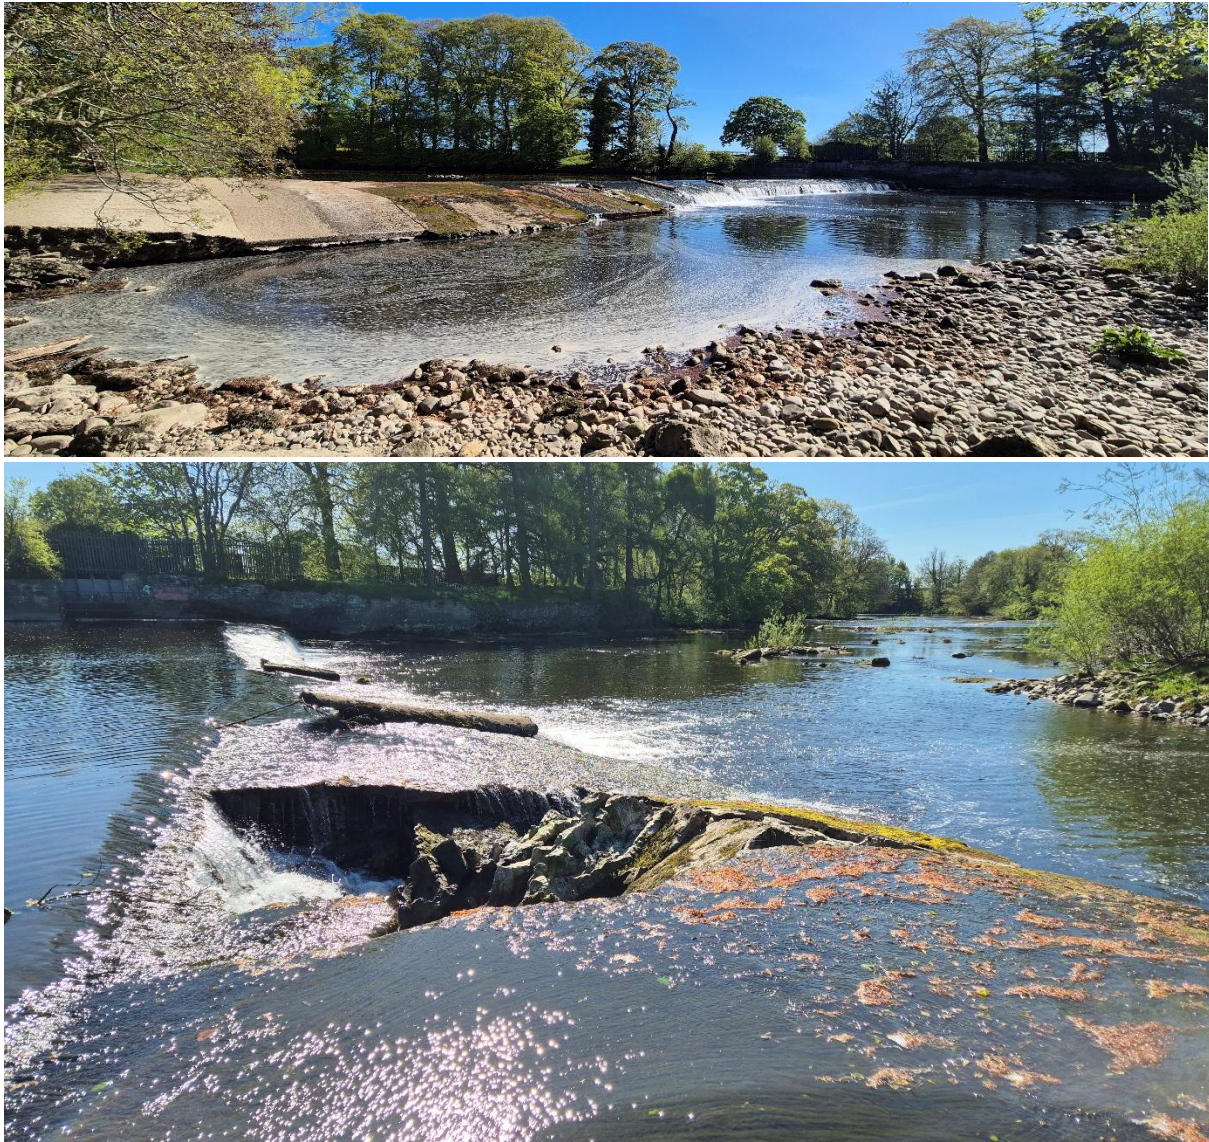
**Fig 14. SE 27553 78738: Tanfield Mill weir was in a very poor state of repair, and could fail at one of several weak points under spate flow in the near future, with unknown consequences. It is a major barrier to fish passage.**
