Skitter Beck Walkover Survey

September 2015

1.0 Introduction

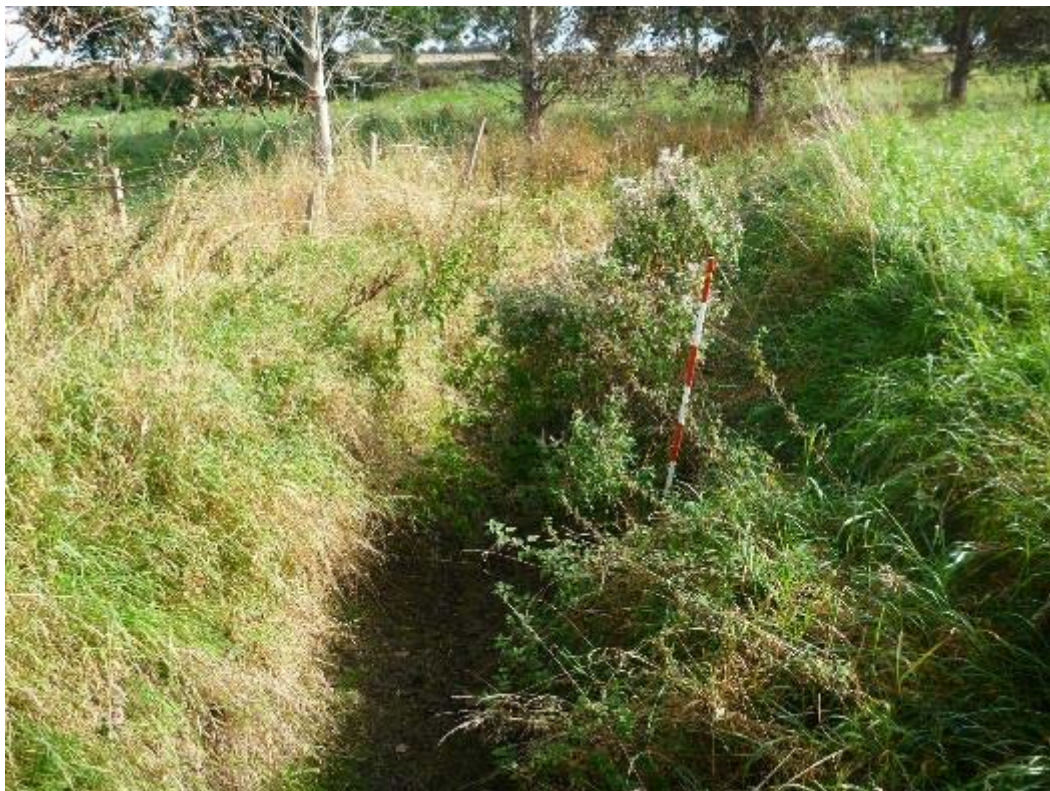
This section (marked on the map as the New Beck Drain) was walked in a downstream direction from the footbridge at TA1634711002. The channel was dry (Photos 1, 2) from this point to the confluence of a ditch on the RHB at TA1531911878, where some standing water was ponded (Photo 4). From this point downstream, the channel was largely dry or intermittently contained standing water, up to the Brocklesby Road bridge at TA1461112726, where a low flow estimated to be less than 0.5 litres/second could be observed over a small (approximately 0.15m) step weir (Photos 5, 6). A low, wet area of ground containing reedmace (*Typha latifolia*) and regenerating willows is present on the LHB immediately upstream of the bridge, which may indicate a source of water (a spring or surface drainage) feeding the Beck. Sticklebacks (*Gasterosteus aculeatus*) were observed in the standing water pools and the flowing section, and a kingfisher (*Alcedo atthis*) was seen near the road bridge.

Photo 1 Dry channel at footbridge (TA1634711002). Ranging pole increments are 0.2m.

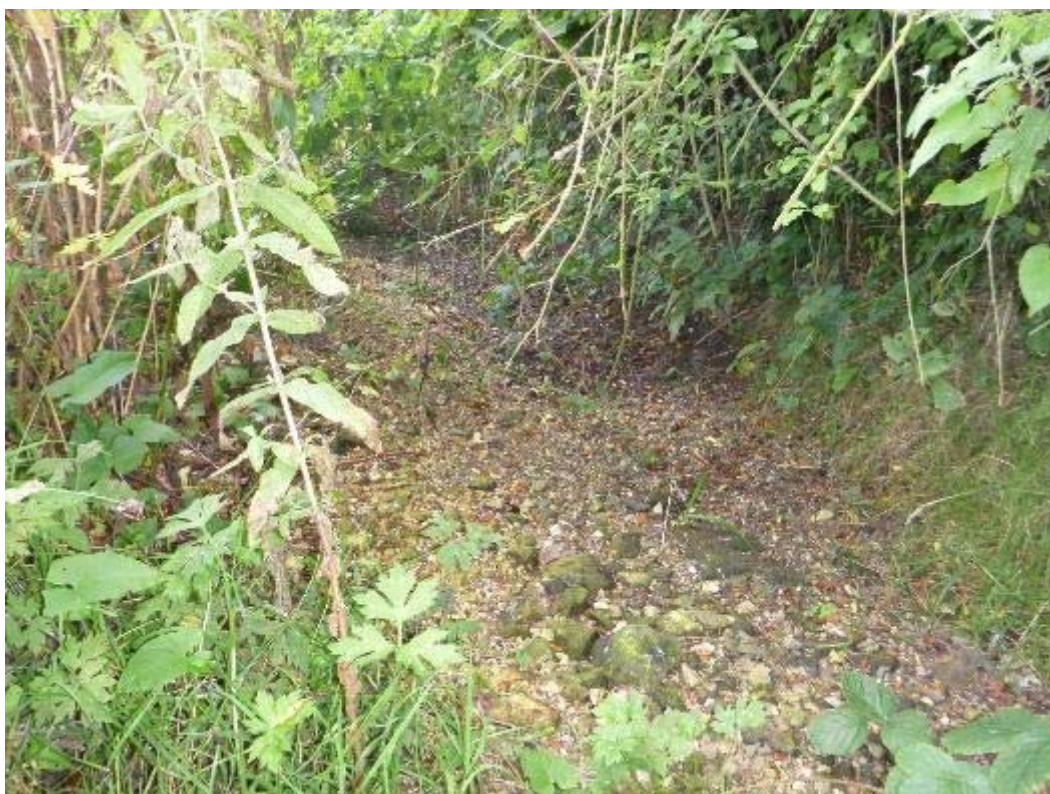
Photo 2 The bed of the dry section is predominantly gravel (TA1550811517).

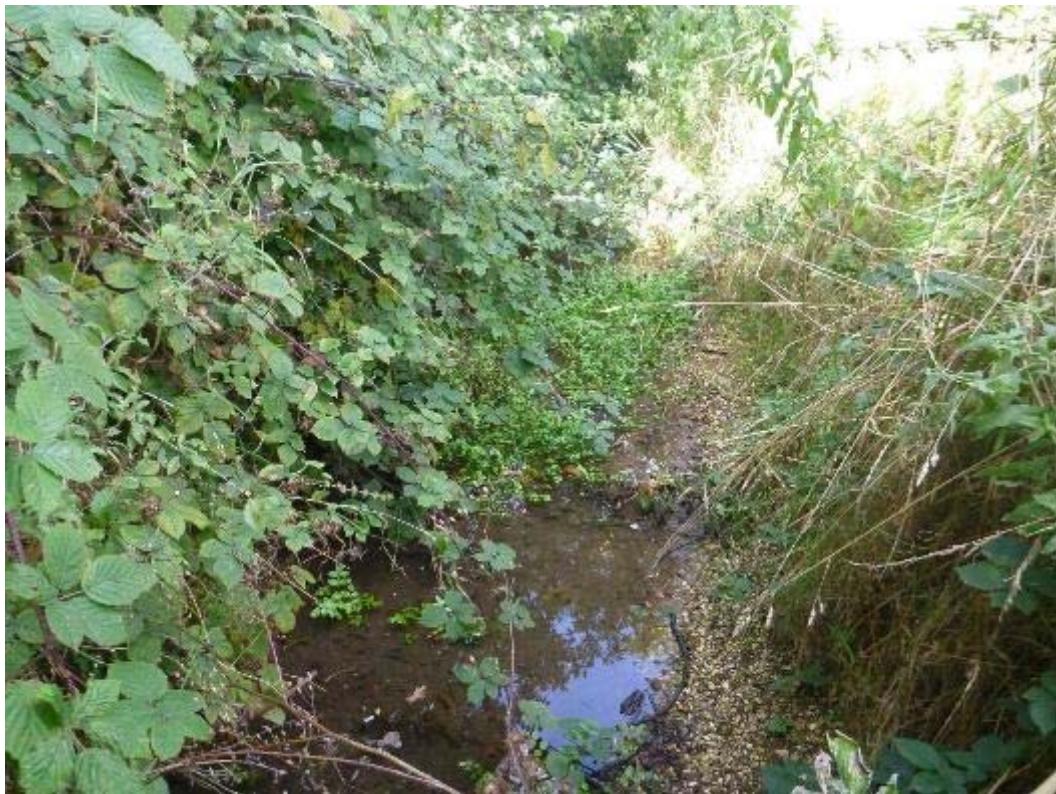
Largely dry with intermittent standing water (Photo 4) up to a low (approximately 15cm head drop) step weir (Photos 5, 6) where a flow estimate of <0.5 litres/second could be observed. Sticklebacks (*Gasterosteus aculeatus*) were observed in the standing water pools and the flowing section, and a kingfisher (*Alcedo atthis*) was seen near the road bridge.

Photo 4 Ponded water close to confluence with a field drain (TA1531511881).

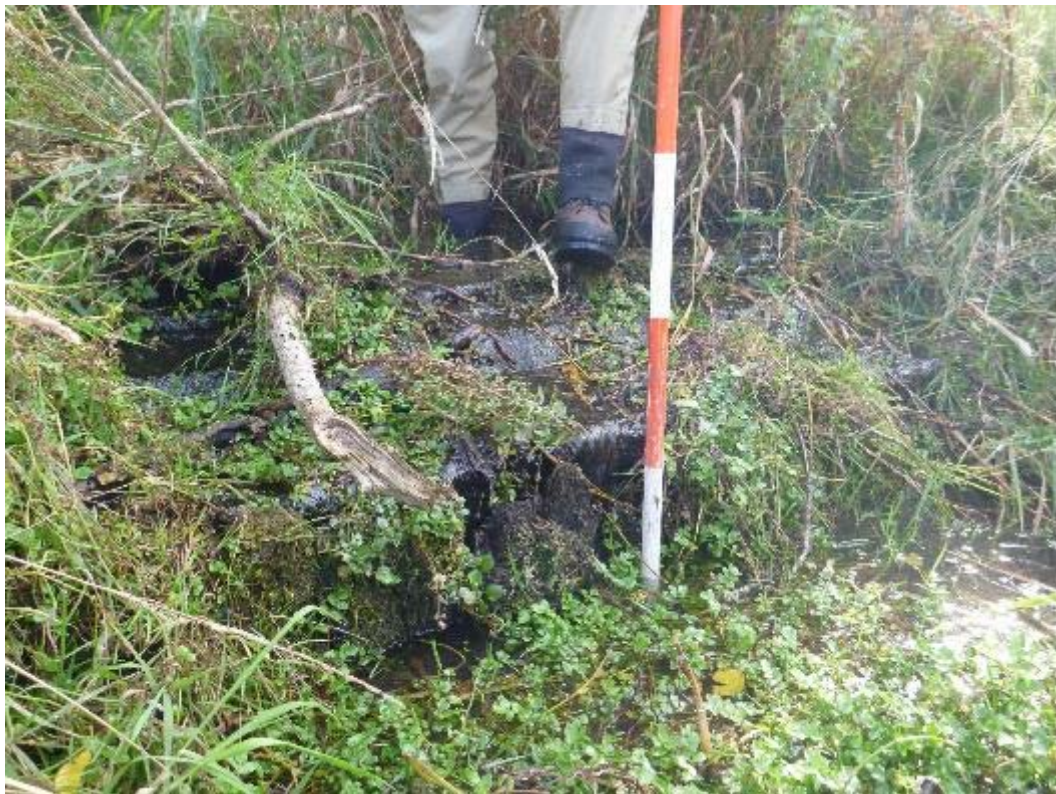
Photo 6 Step weir upstream of Brocklesby Road bridge (TA1461112726). Head difference approximately 0.15m.

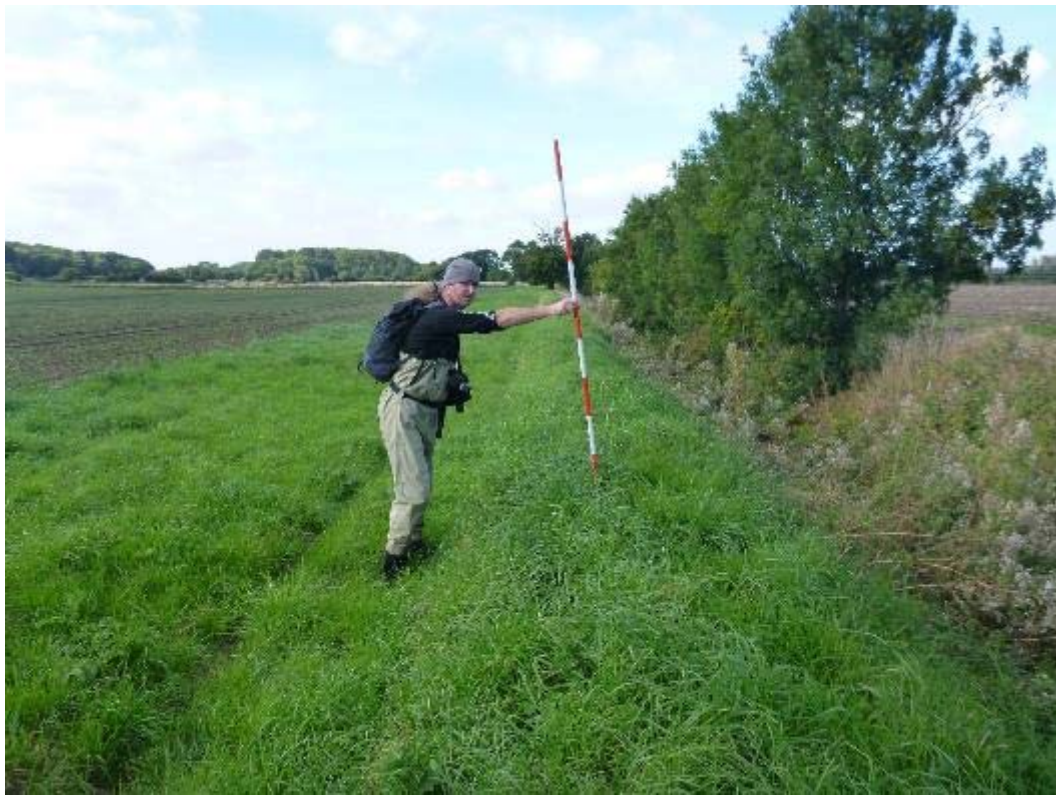
Photo 7 Raised bund of former dredging spoil on one bank – typical throughout the course of the Beck. (TA1450512798).

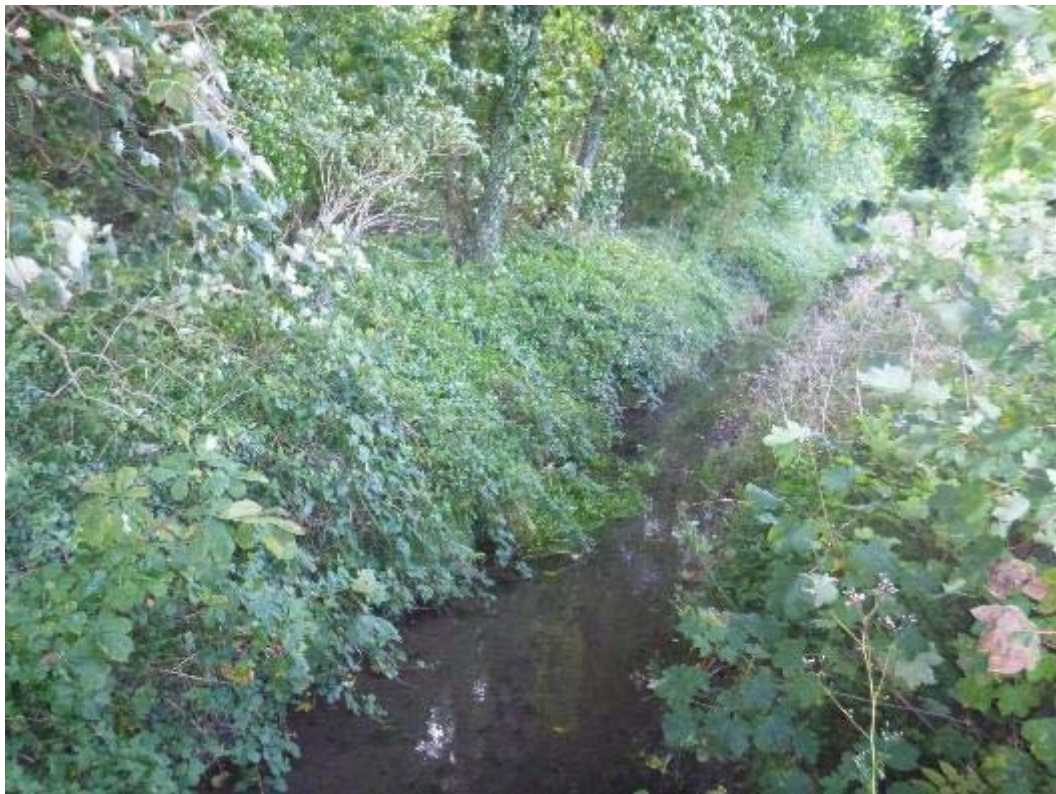
Photo 8 Less aquatic vegetation in more shaded areas in Alder Wood (TA1363513360).

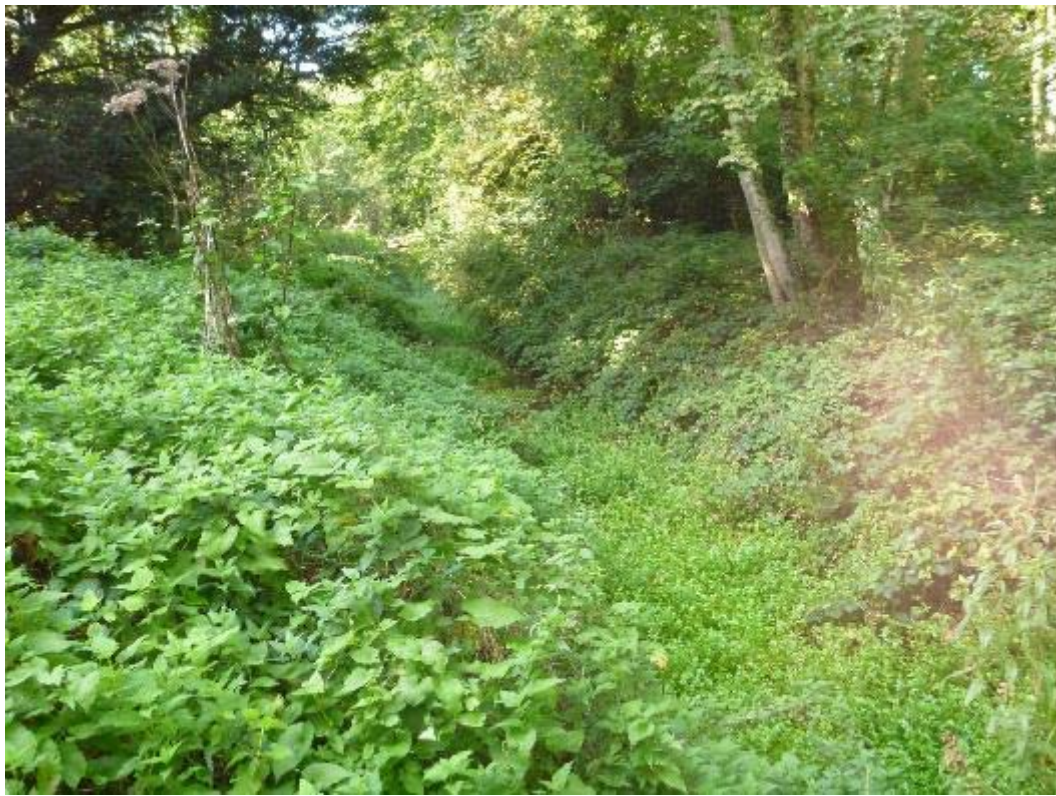
Photo 9 More aquatic vegetation in less shaded areas within Alder Wood (TA1332513565).

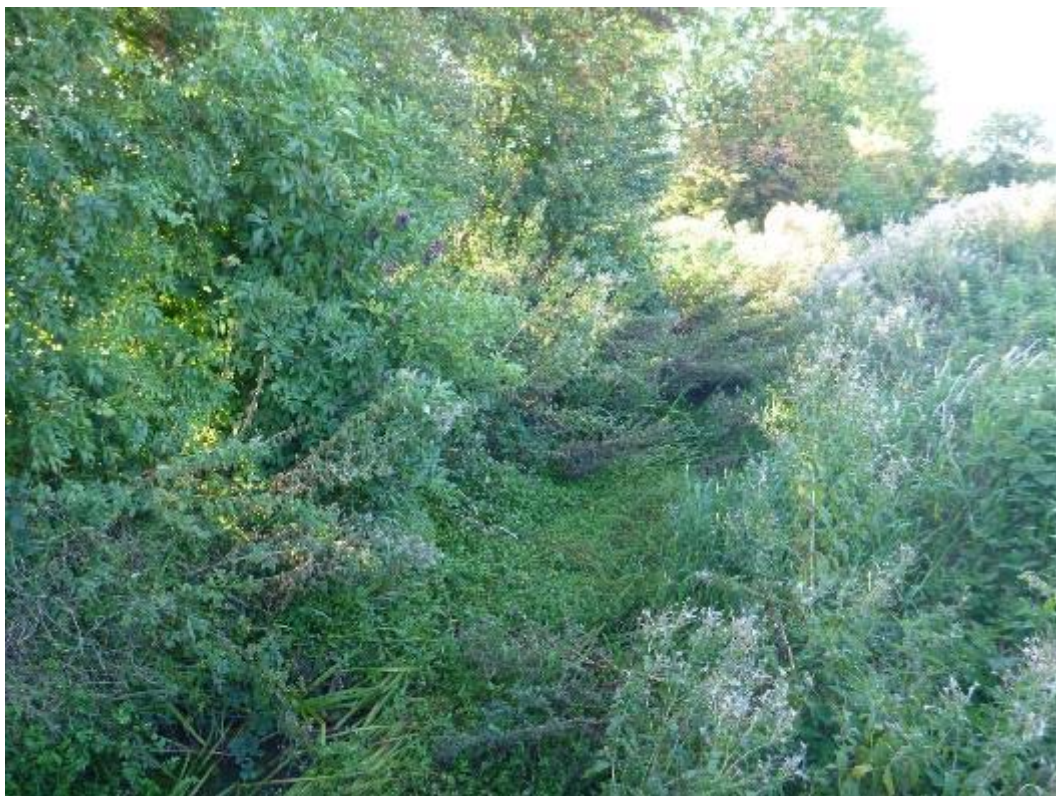
Downstream of the railway crossing (TA1305013919) to the A180 culvert (TA1258614401) the channel is open and overgrown with both in-stream and bankside vegetation (Photo 10).

Photo 10 Overgrown section downstream of Alder Carr Wood and railway line (TA1279614121)

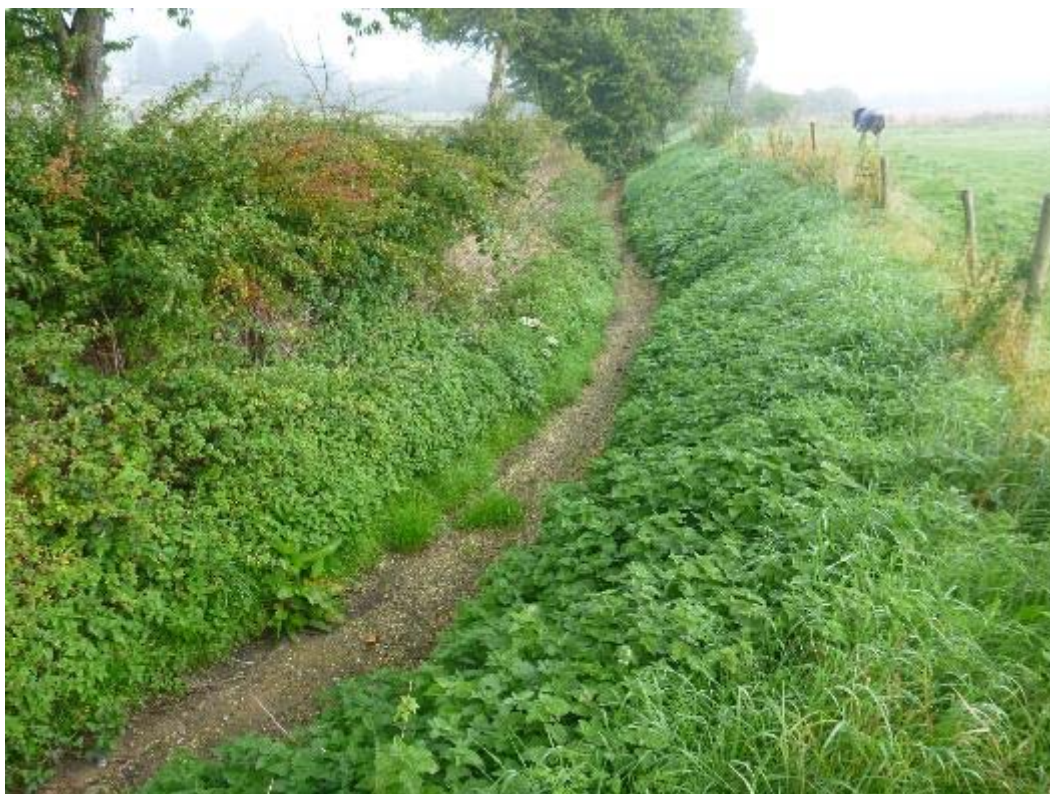
Photo 13 Dry channel downstream of Kirmington (TA1097111246)

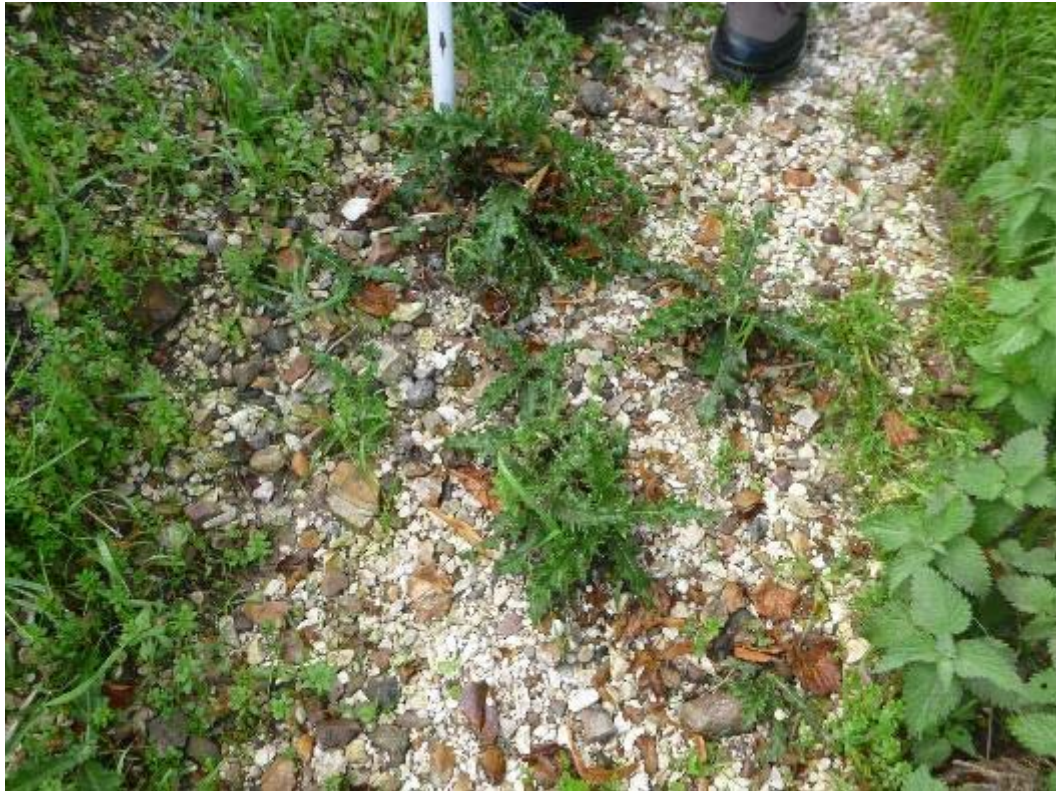
The pattern of vegetation in the channel at the toe of the banks indicates the recent flow history in this reach. Where the channel is dry, recent colonisation of thistles in the centre of the channel and sparse grass growth at the immediate toe of the bank indicate that water was flowing here to a depth of 10 – 15 cm earlier this year. More established grass growth above this level indicates the likely base flow level, when water is flowing (Photos 14, 15). Further investigation of the relationship between groundwater level, rainfall and abstraction is required prior to considering any habitat improvements within this reach.

Photo 14 Thistles growing in bed of the beck give an indication of the length of time it has been dry – probably several weeks.

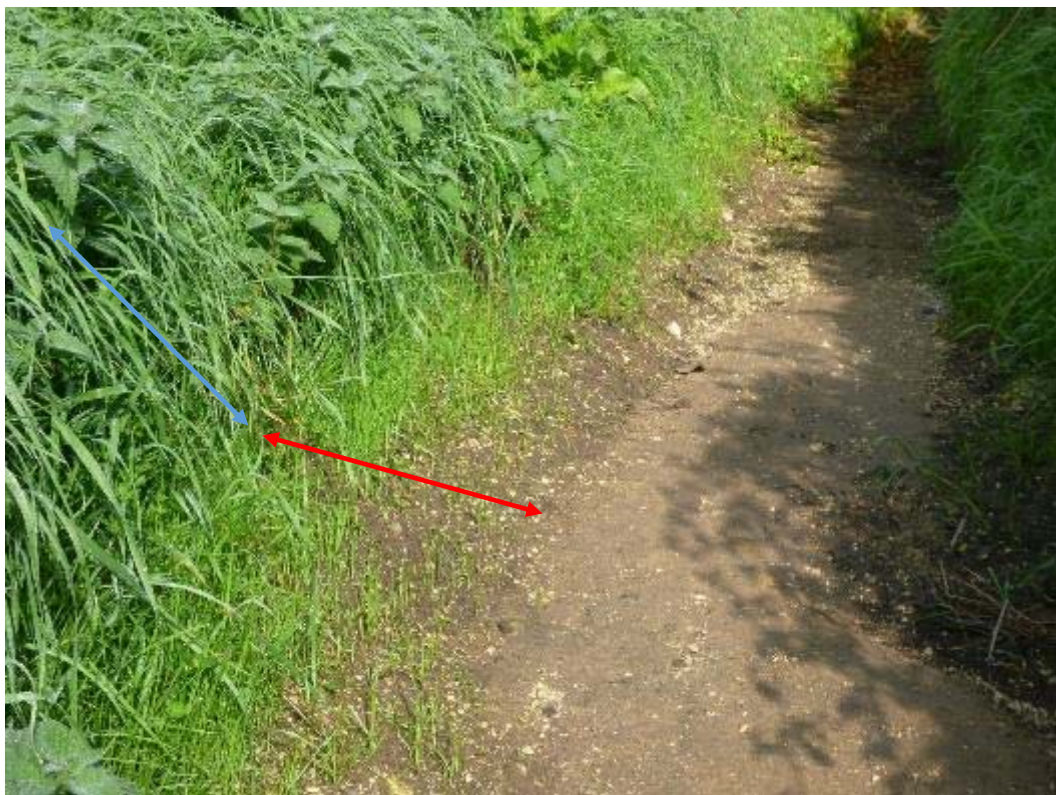
Photo 15 The pattern of vegetation establishment in the margins indicates growth in the current year since drying (red arrow) and more established growth indicating a probable winter base flow level (blue arrow).

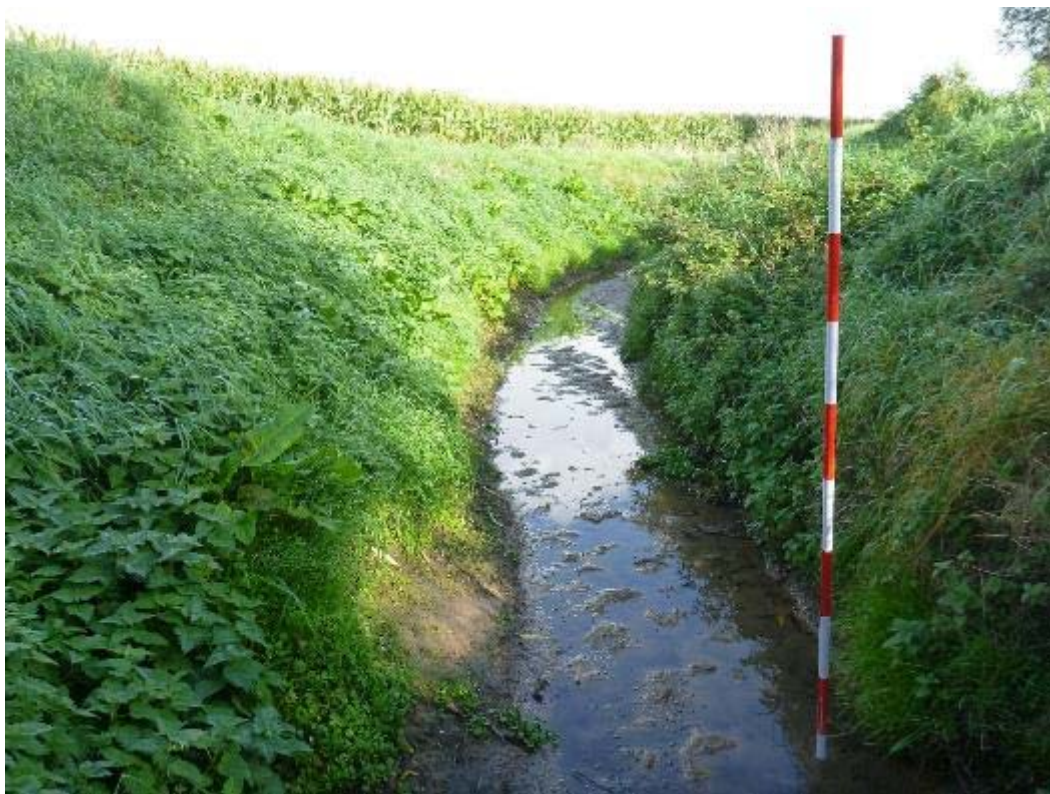
downstream of this point (Photo 16) until TA1112911696, where treated effluent from the sewage works off Habrough Lane enters (Photo 17). From this point downstream water was present in the channel, apart from at the downstream end of the reach (see below). However, the flow was extremely small throughout this reach and appeared to be entirely derived from the sewage works discharge at the time of the survey. It is not known whether the WFD target failures for physico-chemical parameters (ammonia and phosphate) are related to this effluent discharge and the lack of dilution in the receiving watercourse, but it would be worth checking.

Photo 16 Standing water (TA1106911570s).

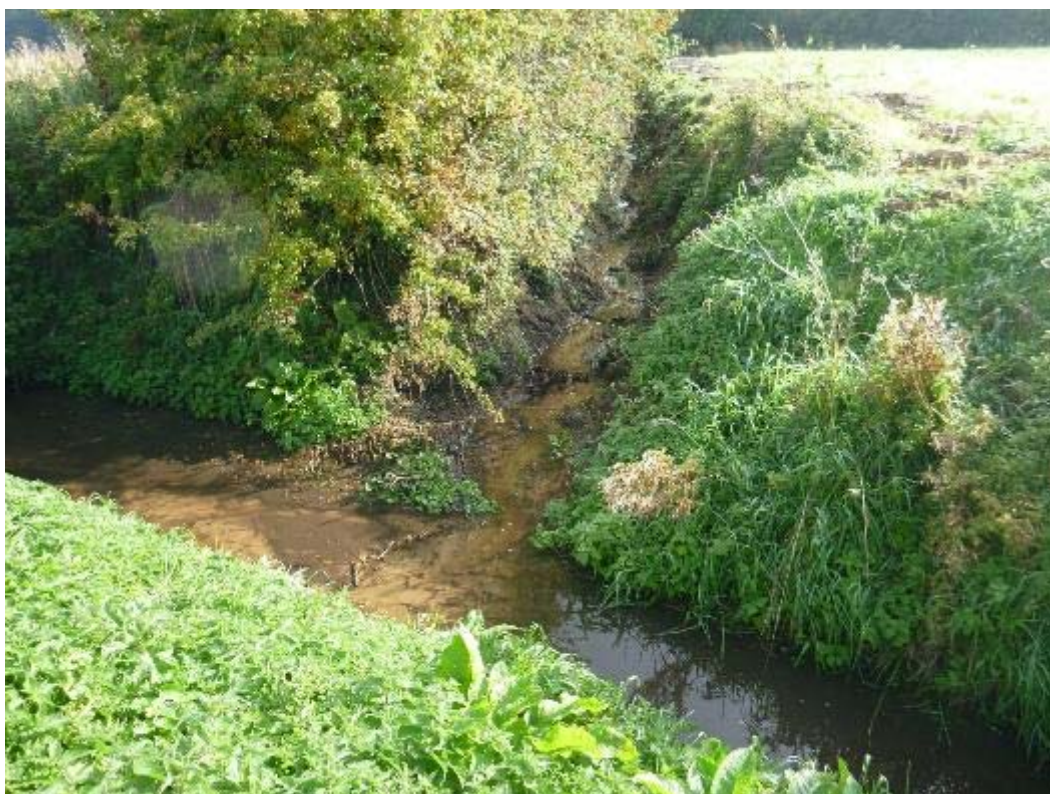
Photo 17 Effluent from Habrough Lane sewage treatment works entering the brook. Fine sediment accumulation is due to recent clearing out of the drain and proximity upstream of a culvert (out of shot, left of picture)(TA1112911696).

Advice: It is not known whether the WFD target failures for physico-chemical parameters (ammonia and phosphate) are related to the STW effluent discharge and the lack of dilution in the receiving watercourse. This should be checked.

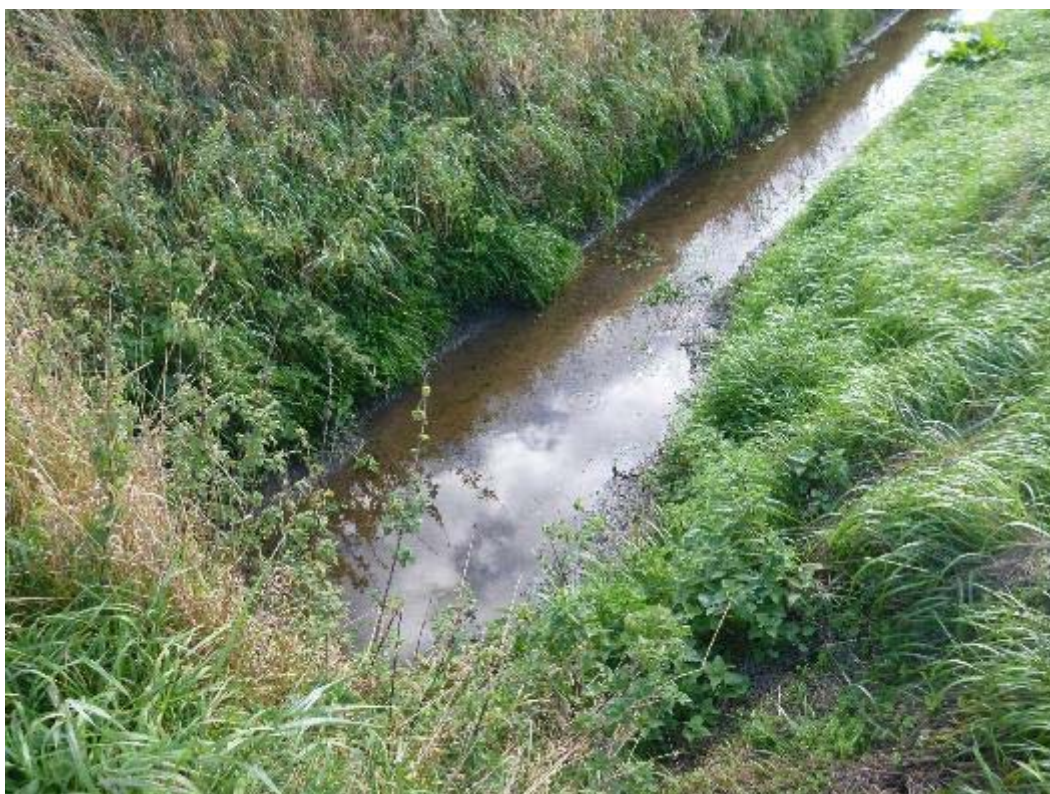
A number of culverts are present along this reach which are recorded on the map; most are farm track crossings or railway culverts. There is a pattern of water ponding and fine sediment accumulation upstream of the culverts and bed scour (occurring at higher flows) downstream (Photos 21, 22).

Photo 21 Fine sediment accumulated in impoundment upstream of a culvert (TA1124712427)

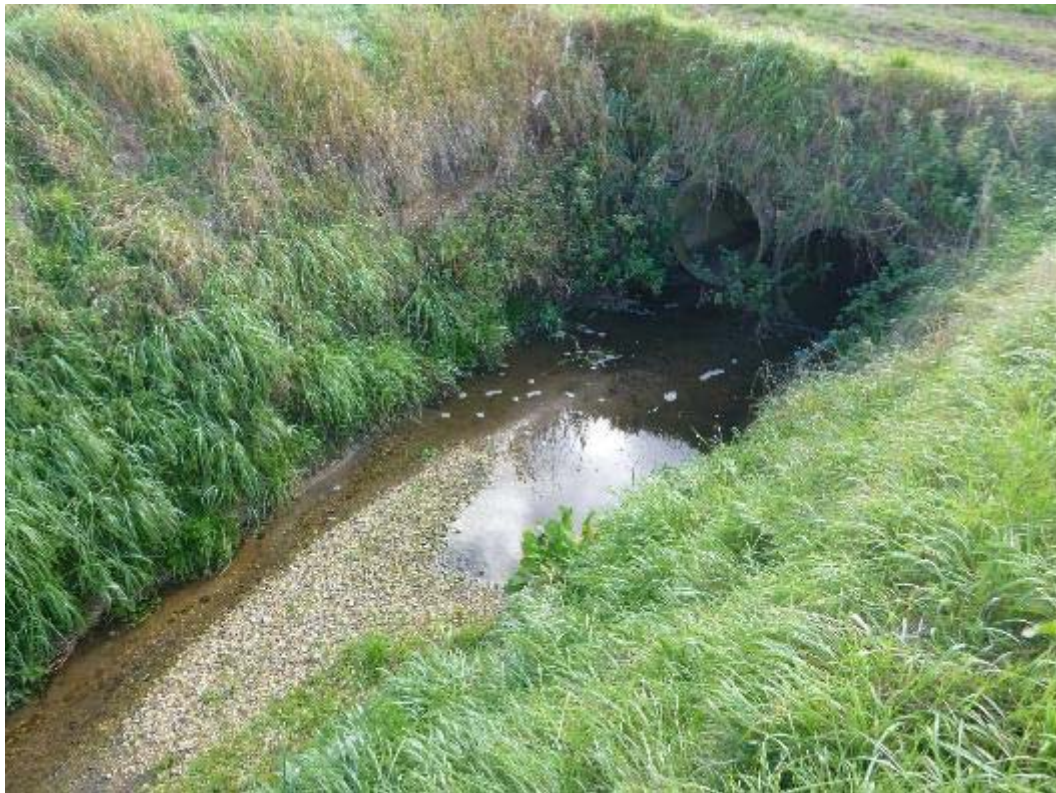
Photo 22 Bed scour downstream of a culvert (TA1124712427).

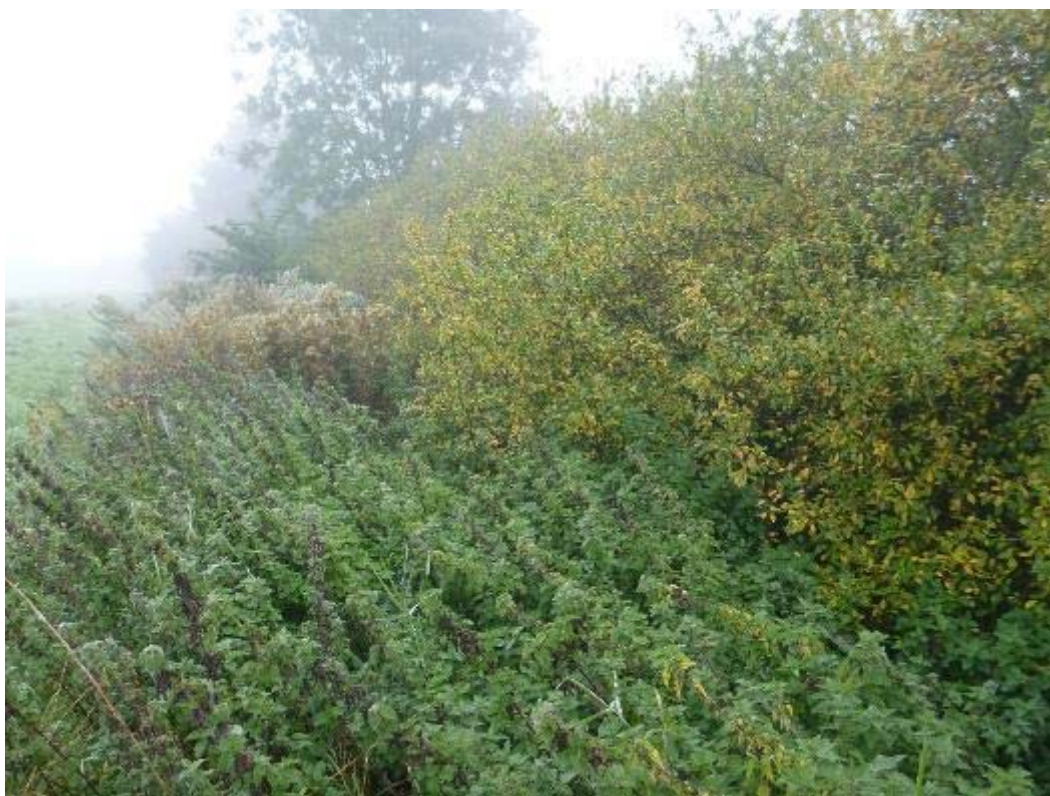
In common with the previous section, the channel is engineered and maintained for land drainage, being straight, steep-sided and lacking any variation in depth (Photos 18 – 20, 23). Bed substrate is largely gravel, with fine sediment accumulations upstream of culverts as noted above. Aquatic vegetation is sparse and the banks are open throughout this reach from Kirmington to the culvert at Brocklesby Junction (TA1193413453), probably reflecting the channel maintenance regime here. Between Brocklesby Road and the railway crossing (TA1228913762) the channel is heavily shaded by hawthorn, blackthorn, elder and brambles (Photo 24).

Photo 24 Densely shaded channel near Brocklesby Junction (TA1225113684).

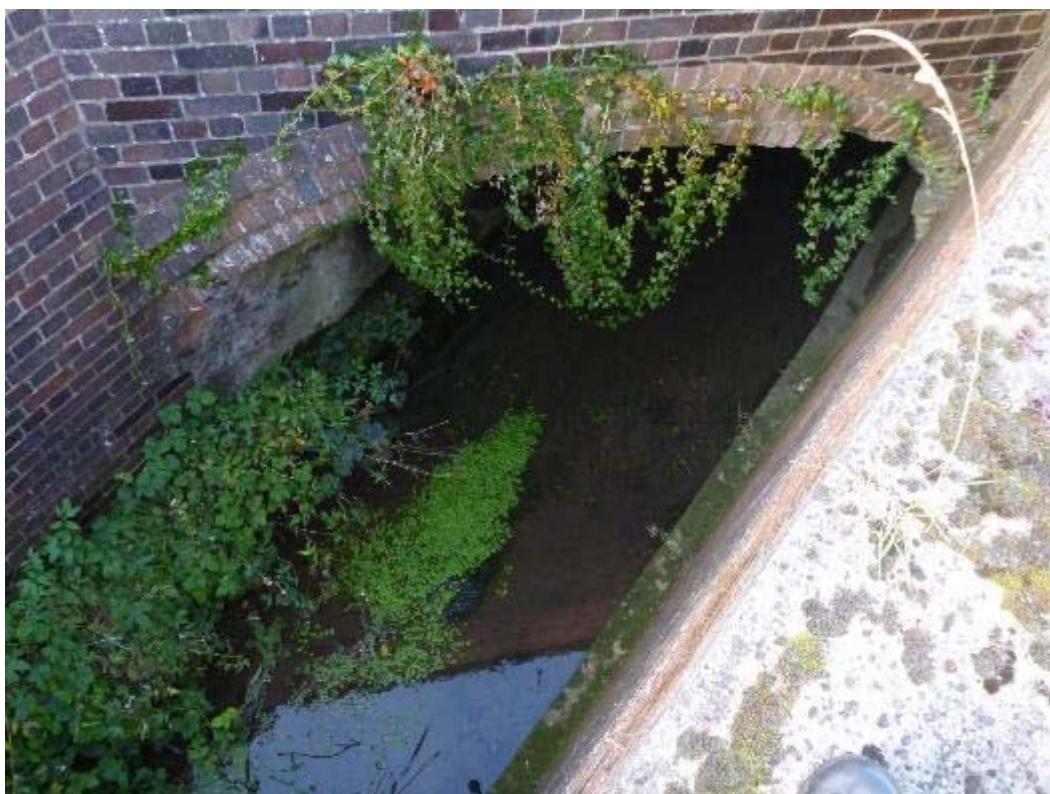
Water is ponded above the railway culvert and downstream it flows over the concrete lip of the culvert (approximately 0.3m high) forming a small scour pool (Photos 25, 26). Immediately downstream the flow is extremely shallow over a hard gravel bed through a woodland area (Photo 27); this opens out causing the channel and banks to become increasingly vegetated

Photo 25 Water ponded upstream of the railway culvert (TA1229113769).

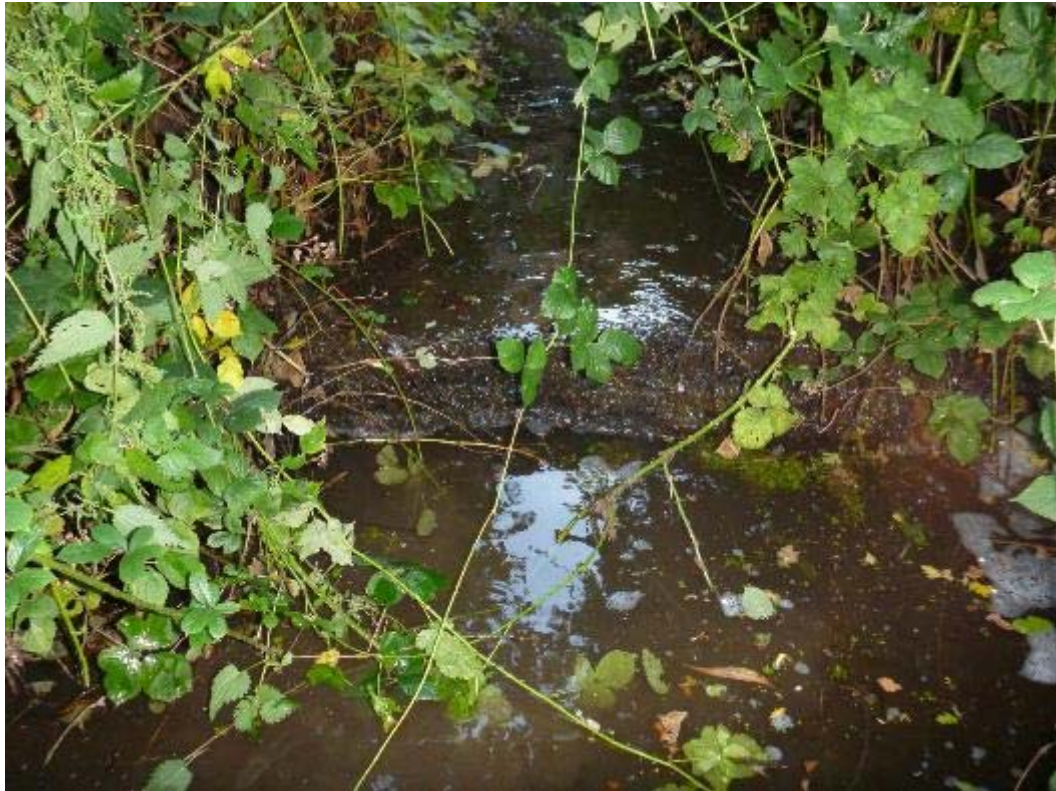
Photo 26 Step weir immediately downstream of railway culvert (TA1229113769).

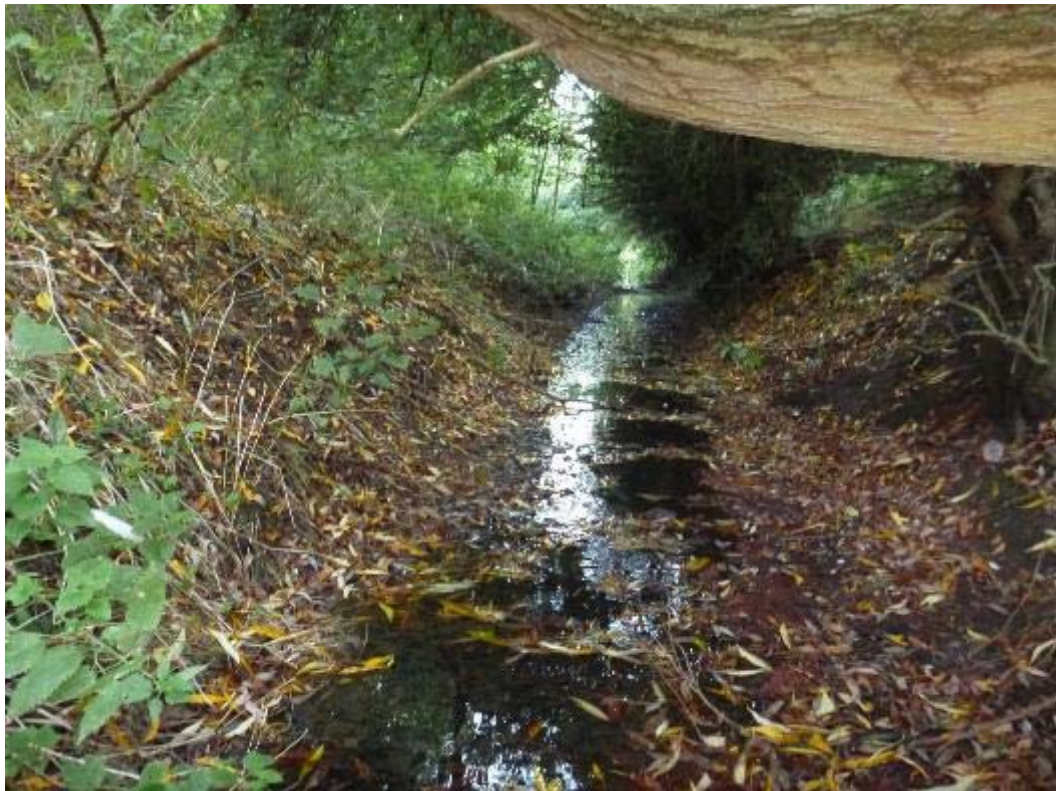
Photo 27 Very shallow flow over hard gravel bed (TA1233113853).

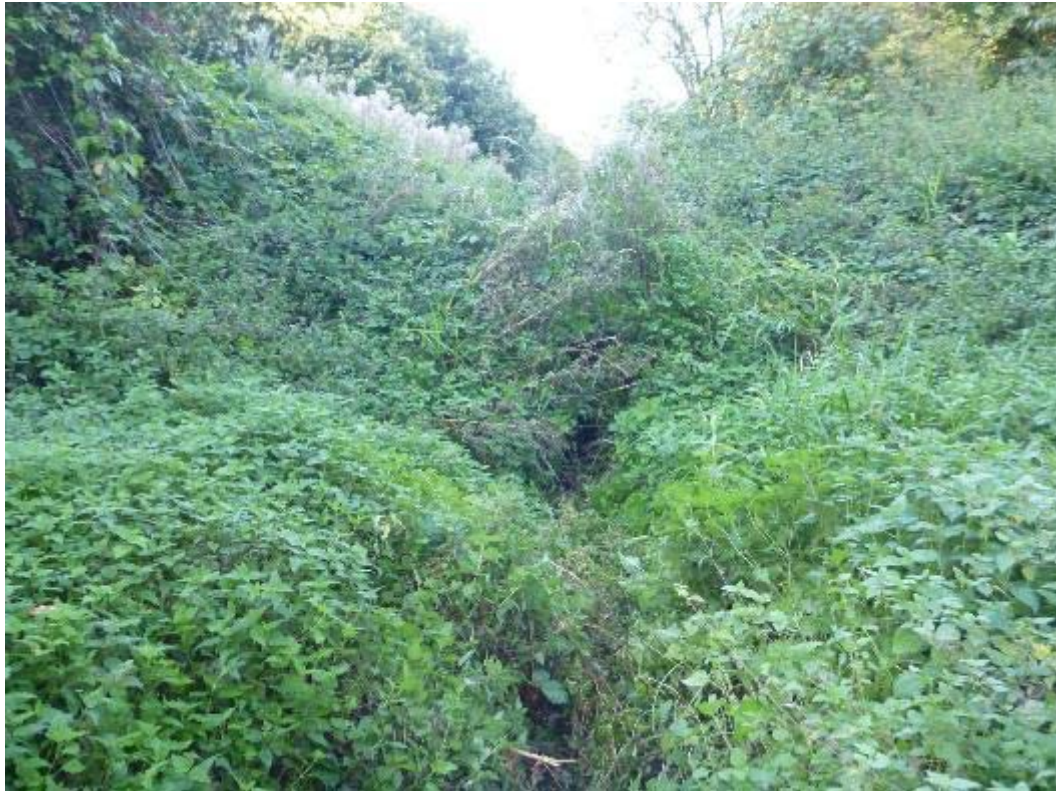
until it was impenetrable during this survey (Photo 28). A short distance downstream, where the channel emerges from the wood, it is dry again (Photo 29) and remains so until the A180 culvert where water from the Keelby arm backs up a short distance.

Photo 28 Channel and banks choked with vegetation in clearing in woods (TA1236213916).

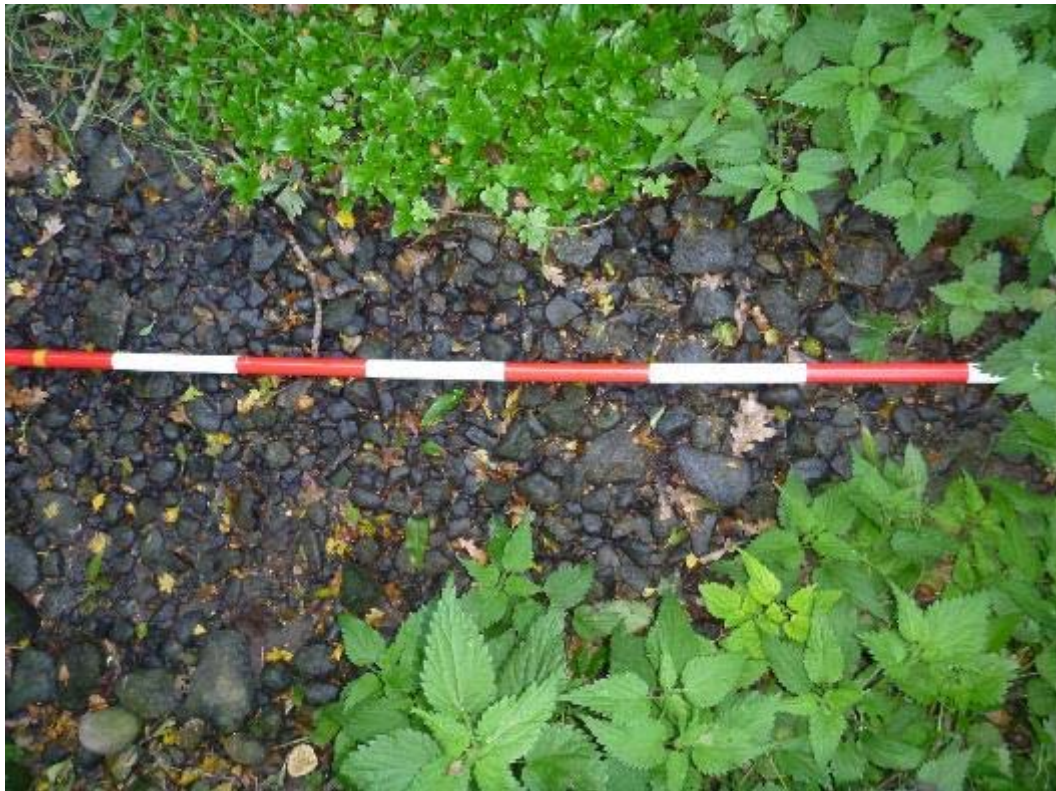
Photo 29 Dry river bed (TA1249614201).

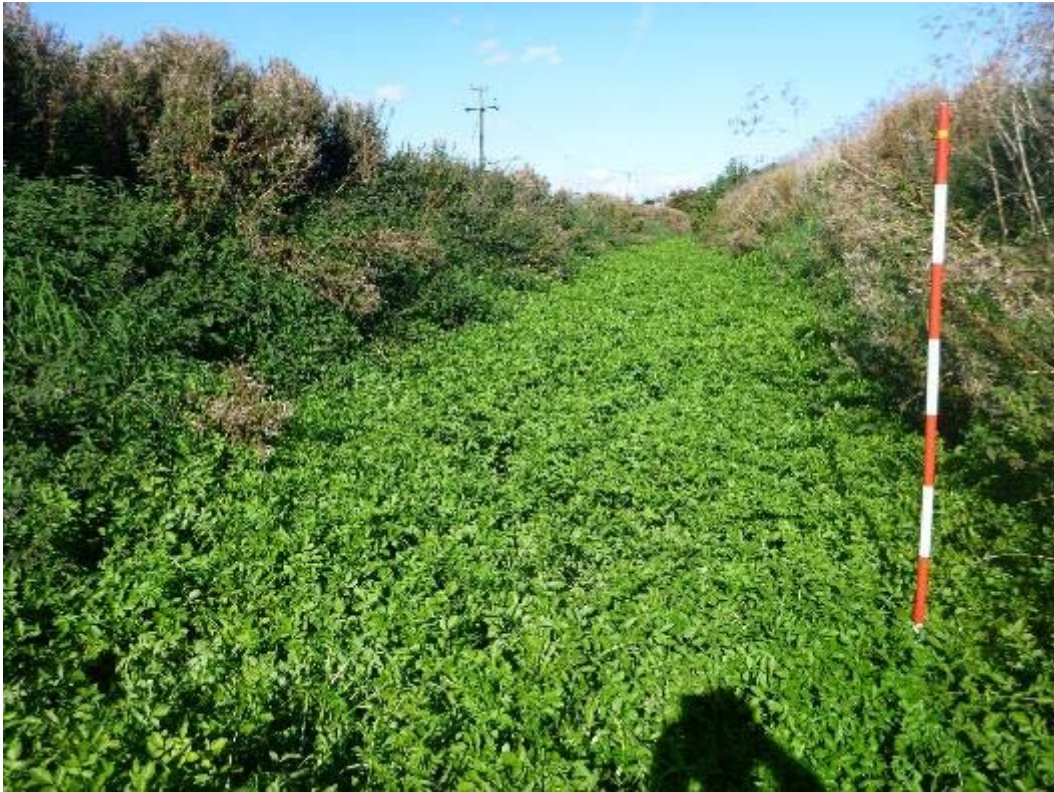
This section between the railway line and Ulceby Skitter is a wider, open channel which was choked with *Apium* at the time of the visit. The river bed is hard gravel and small areas of clear water are present, with starwort (*Callitriche* sp.) and water-crowfoot (*Ranunculus* sp.). Just upstream of the road bridge is a step weir approximately 0.15m high which impounds water upstream and where fine sediment has accumulated (Photos 30 -33).

Photo 30 Upstream of Ulceby Skitter, channel choked with fools' water cress (TA1244814740).

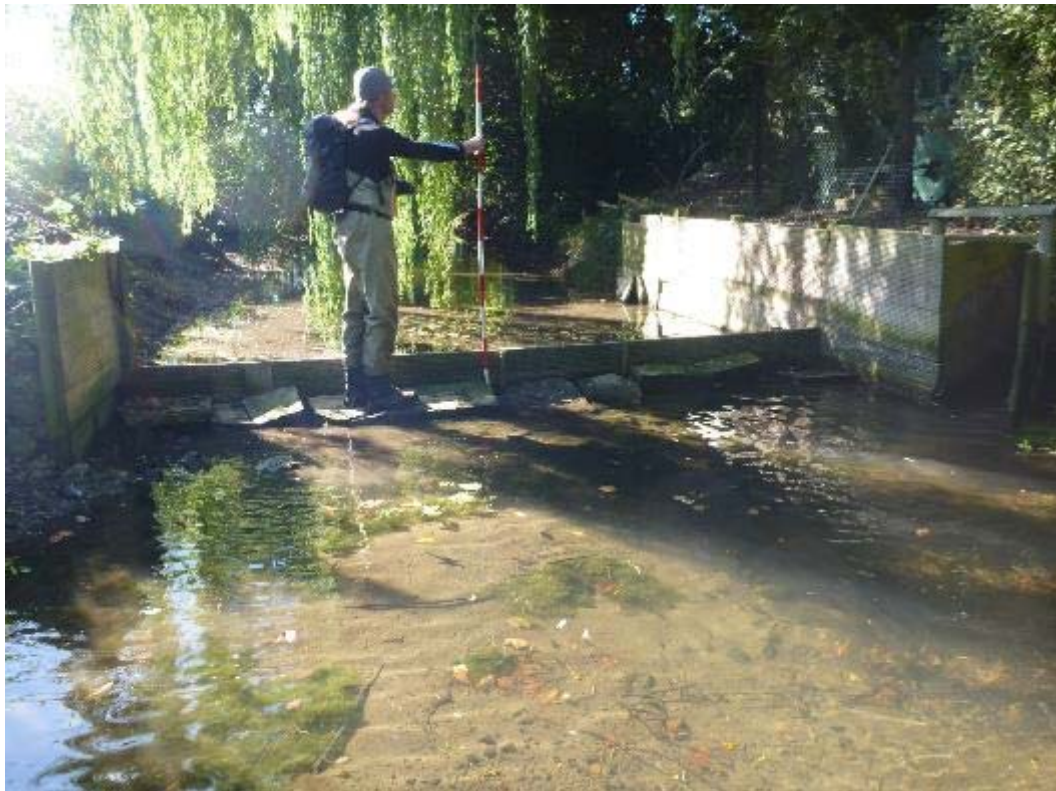
At TA1240615129 the Beck a weir (approximately 0.35m high) has been constructed from decking boards which diverts the flow into a short, narrow channel on the LHB which contains a waterwheel. This appears to be an ornamental feature, probably constructed by the occupier of the house on the LHB. There is a deeper area scoured below the outlet from the narrow channel indicating that the structure is effective at diverting flows via this route when the Beck is running higher (Photo 37).

Photo 37 Decking board weir, river diversion and waterwheel (TA1240315126).

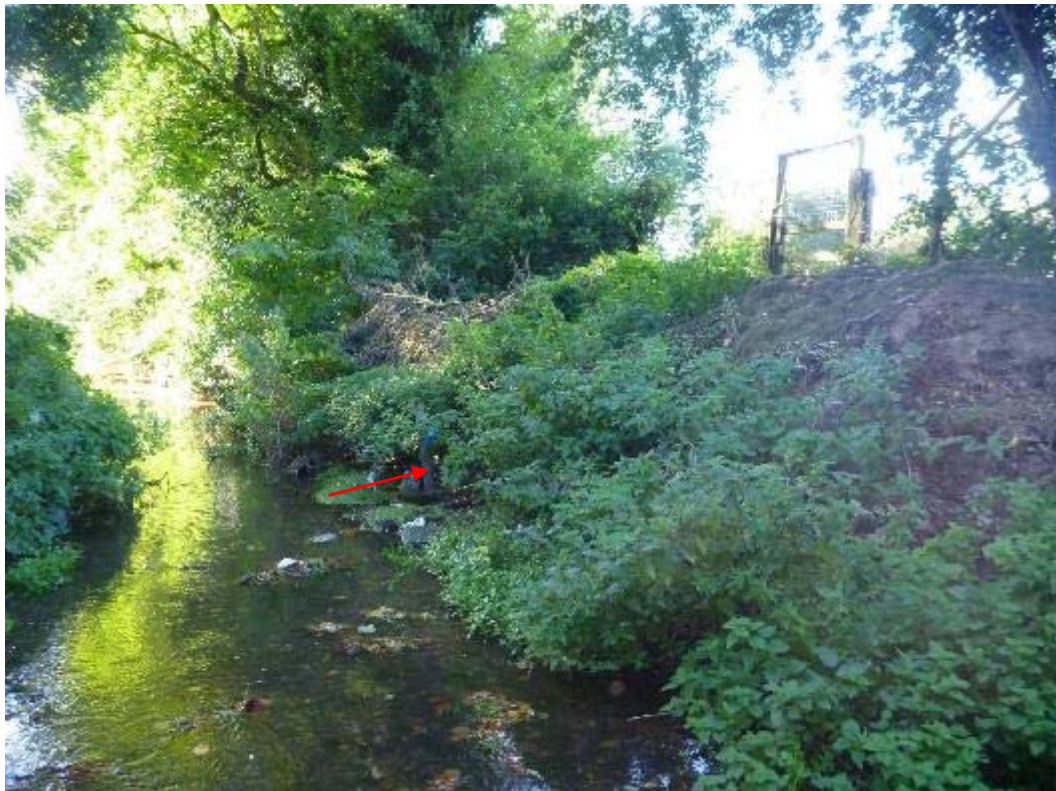
A short distance downstream, adjacent to the garden of the last house on the LHB before the railway culvert, a small electric submersible pump was taking water from the Beck into the garden via a 1-inch pipe. In the same location, a number of plastic bags of dog faeces had been thrown into the Beck and a pile of garden/grass clippings was slumping into the watercourse (Photo 39).

Photo 39 Immediately upstream of railway culvert at TA1241815165. Electric pump abstracting water from the Beck (arrow), bags of dog faeces and garden waste.
