Skitter Beck Walkover Survey

September 2015

1.0 Introduction

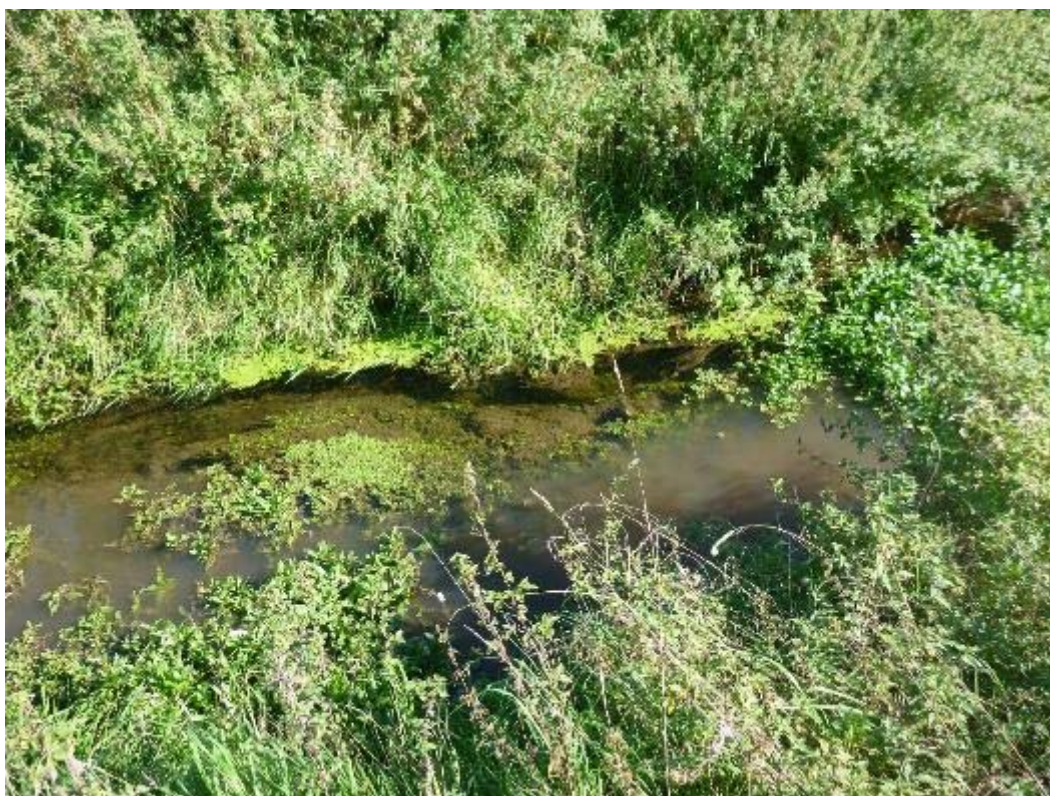
Photo 46 Discolouration caused by fine sediment in water joining from a field drain. Note starwort and water crowfoot in water relatively free from fools' water cress (TA1192416980).

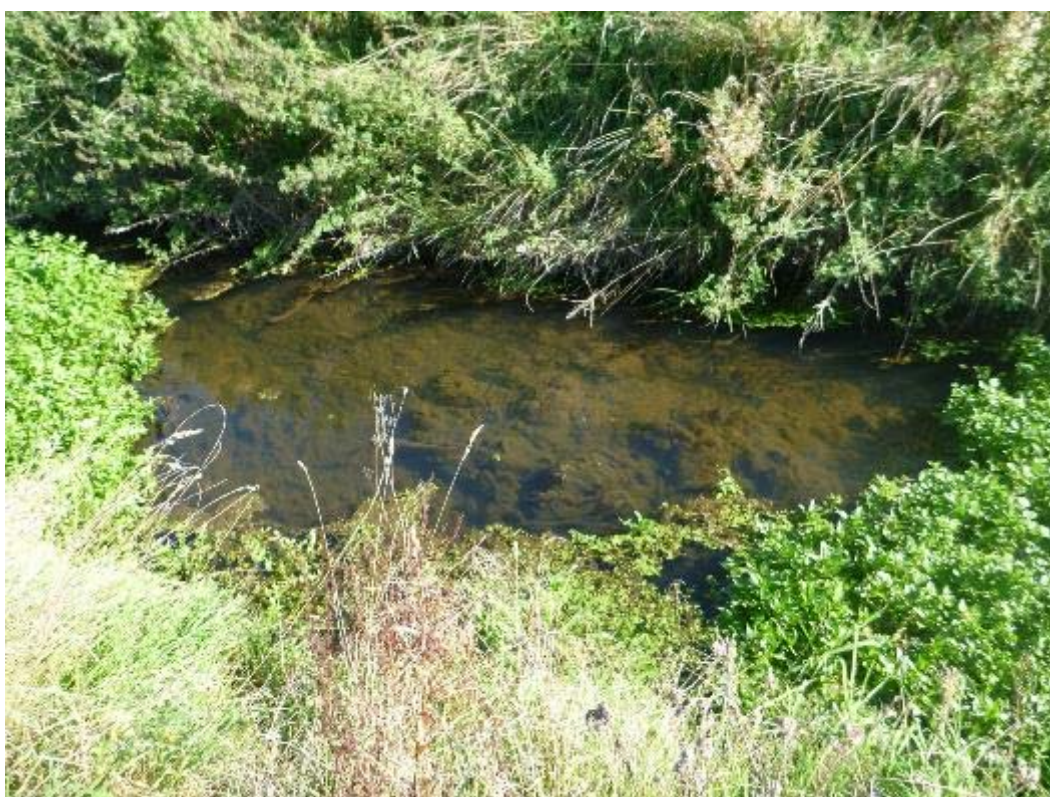
Photo 47 Filamentous algae on the bed in clear spots between fools' water cress (TA1189817133)

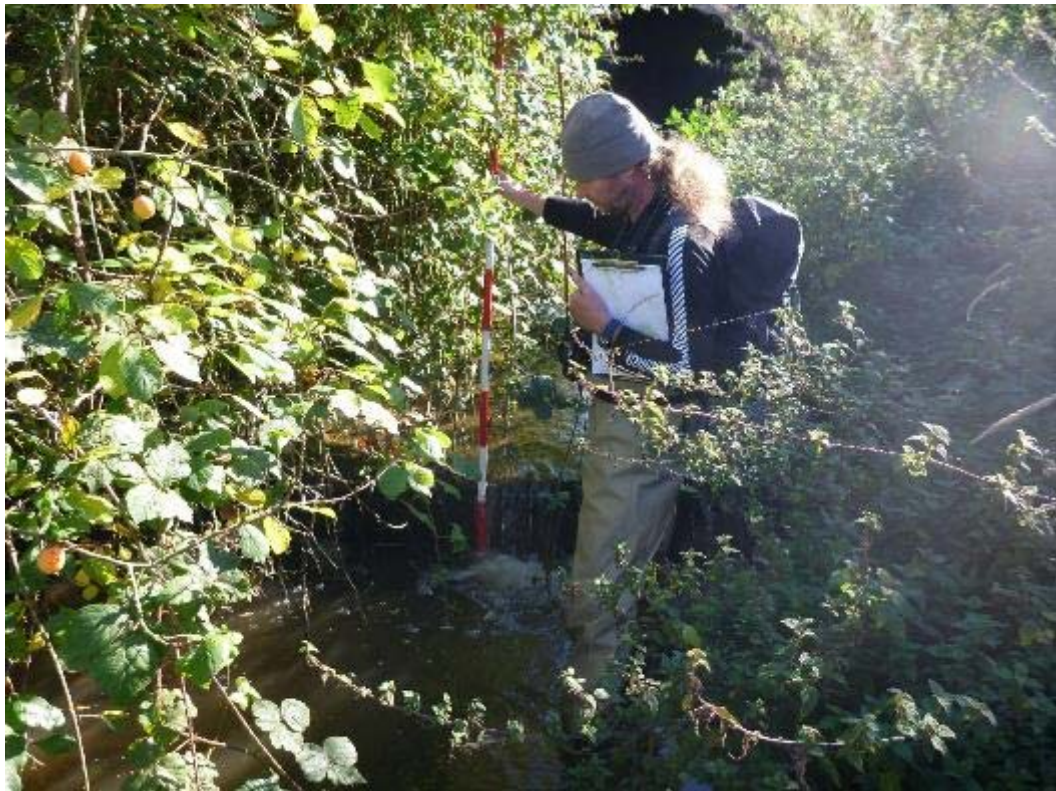
The Crook Mill Road culvert is a flat-bottomed, corrugated metal tunnel, downstream of which is a concrete sill with a step weir at the downstream end; the head difference is approximately 0.3m across the weir (Photo 49). Downstream is a small scour pool and a short section of slightly faster-flowing water before the Beck resumes its typical uniform shape and slow flow.

The Crook Mill Road culvert is a flat-bottomed, corrugated metal tunnel, downstream of which is a concrete sill with a step weir with a c0.3m head drop (Photo 49). Downstream of the weir is a small scour pool and a short section of slightly faster-flowing water before the Beck resumes its typical uniform shape and slow flow. The bed also changes from hard gravel to much finer sediment with a lower abundance of pioneer chalk stream plants despite a general absence of shade.

Photo 49 Step weir downstream of Crook Mill road culvert (TA1218417902)

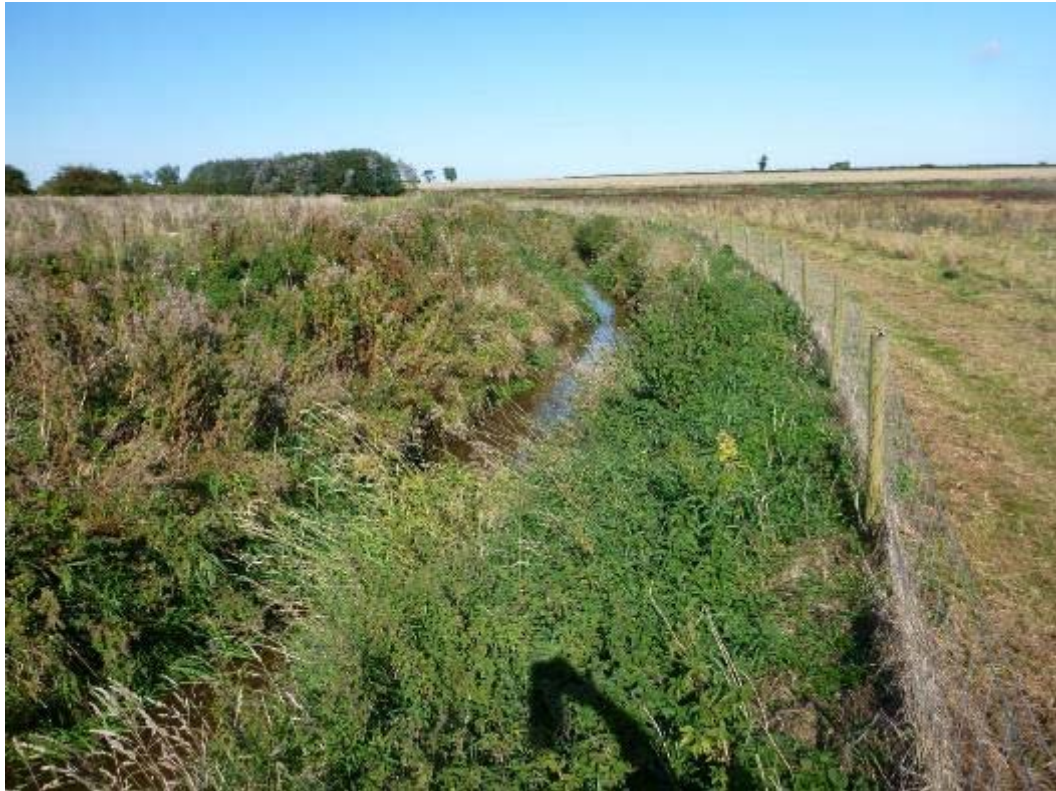
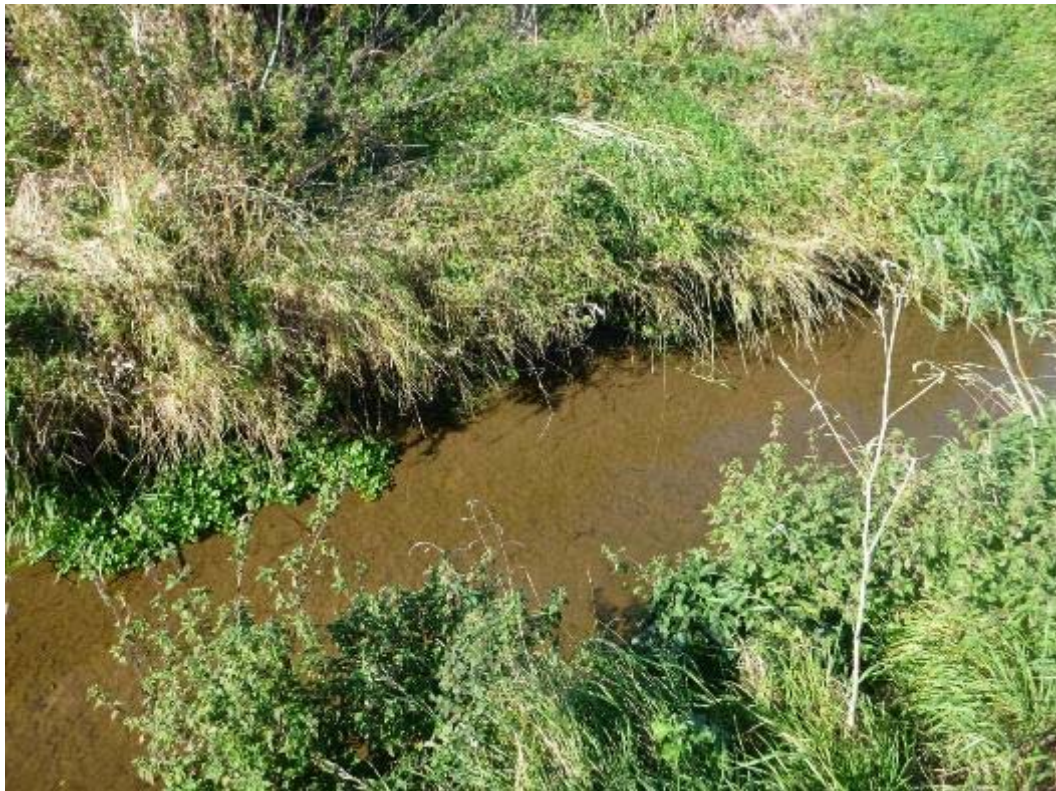
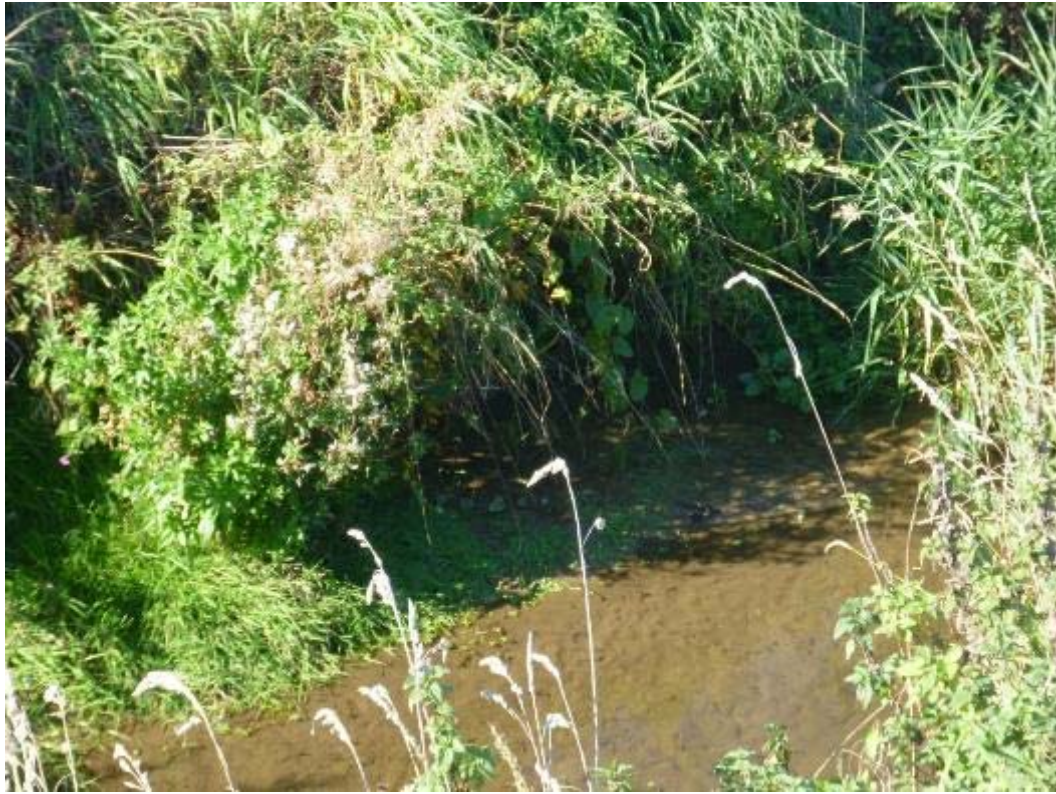
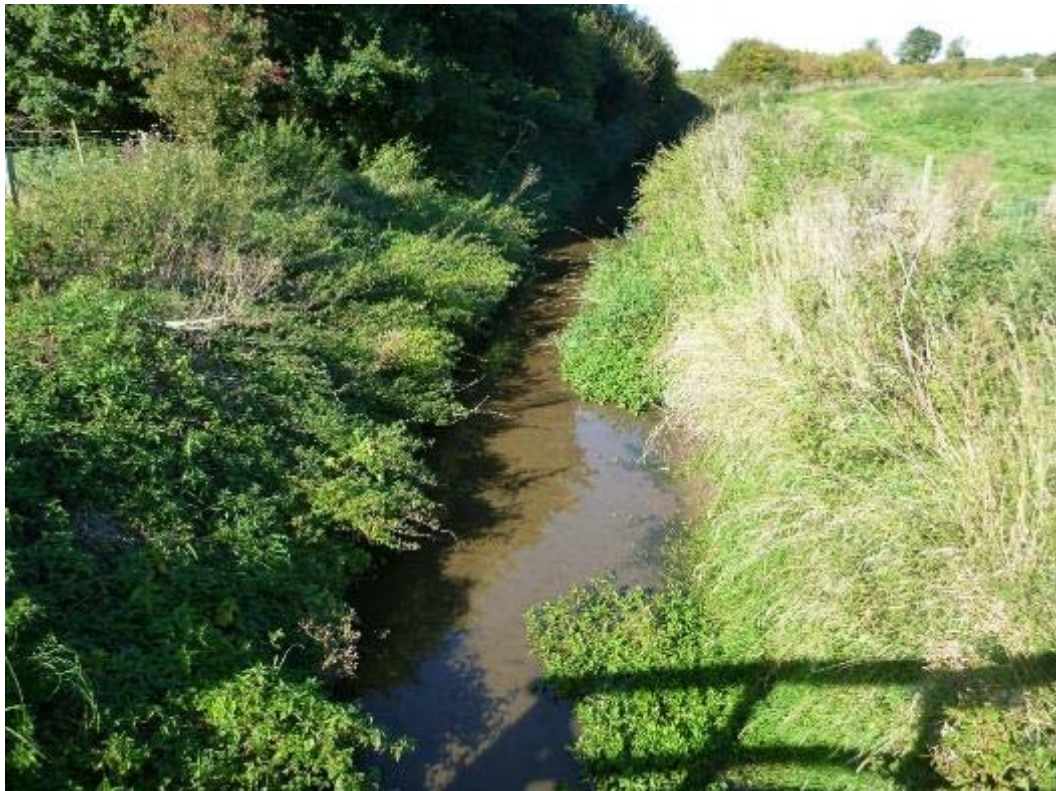
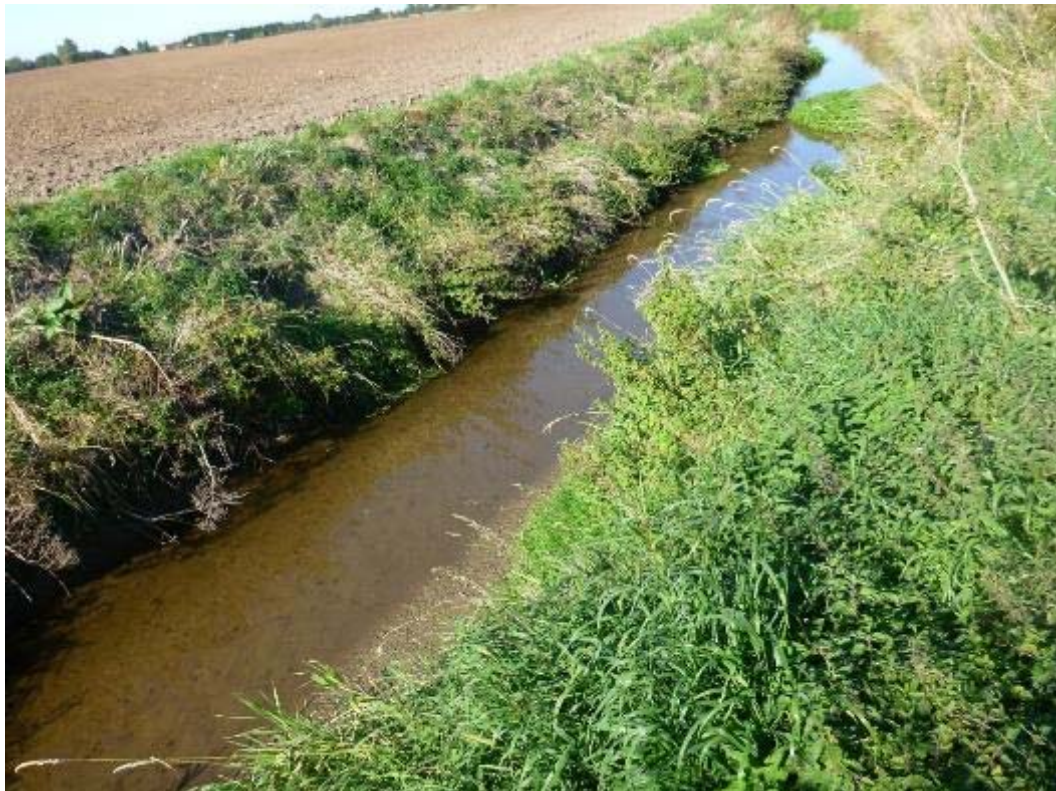
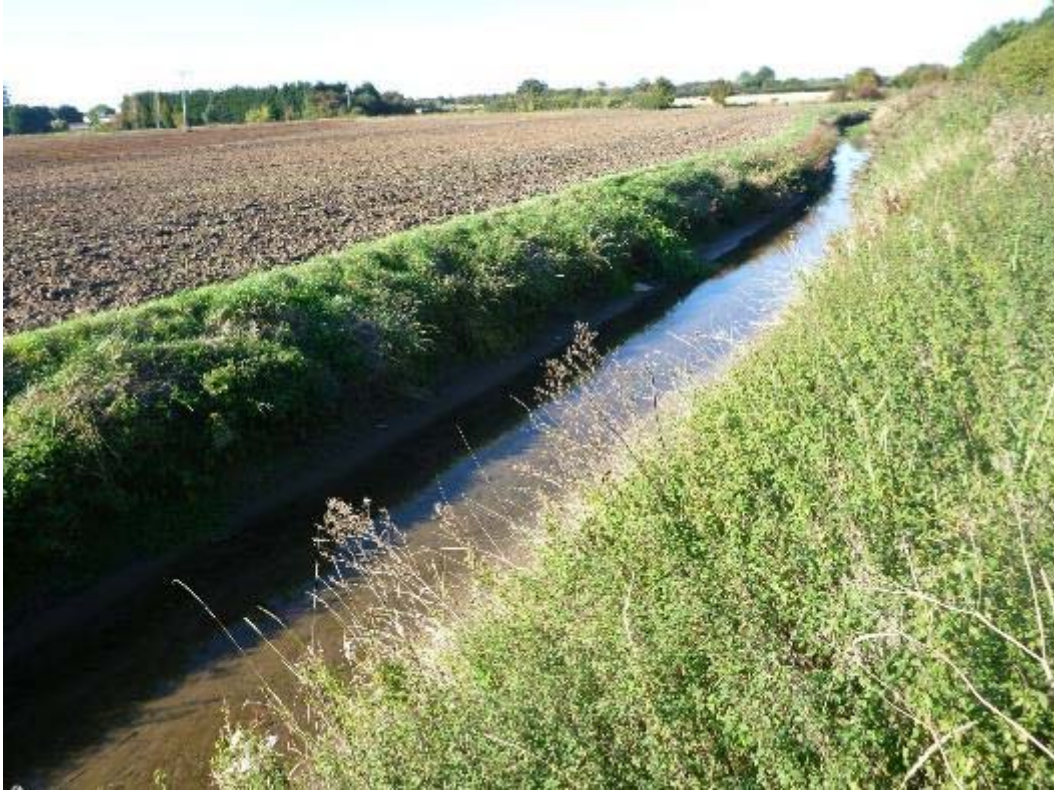
With progress downstream it also becomes obvious that water level varies on a regular basis; indicated by a marginal zone of un-vegetated mud and silt (Photos 50 -56). It is likely that these effects are caused by the backing-up and release of water within the lower reaches of the Beck caused by the closing and opening of the tidal gate at West Halton Skitter.

Advice The effects on the Beck caused by the operation of the tidal gate greatly limit the potential effectiveness of in-stream habitat improvement techniques, so it is not recommended that these are undertaken on downstream of Crook Mill Road.

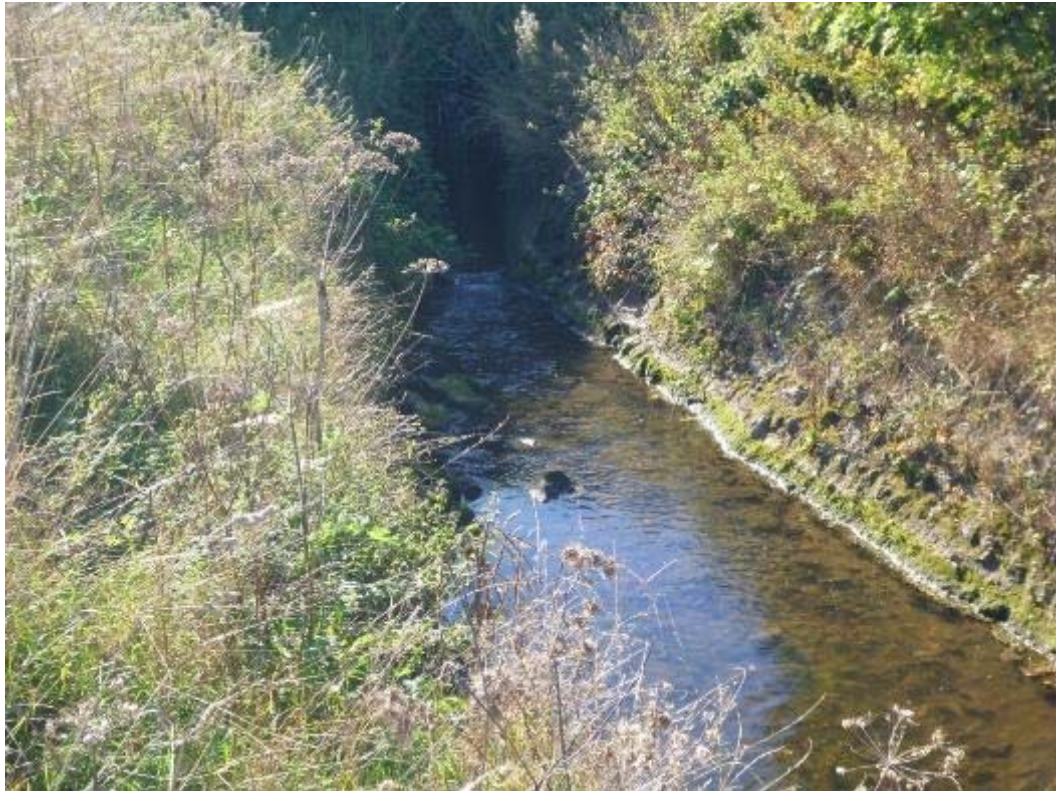
The visible effects of the "tide-locking" caused by the closure of the tidal gate start at the wood at TA 12075 18324 and these effects become more pronounced downstream of College Bridge (TA 11969 19338) where there is a small step weir downstream of the culvert (Photo 54).

Photo 54 Small step weir downstream of College Road bridge culvert (TA1197719339)

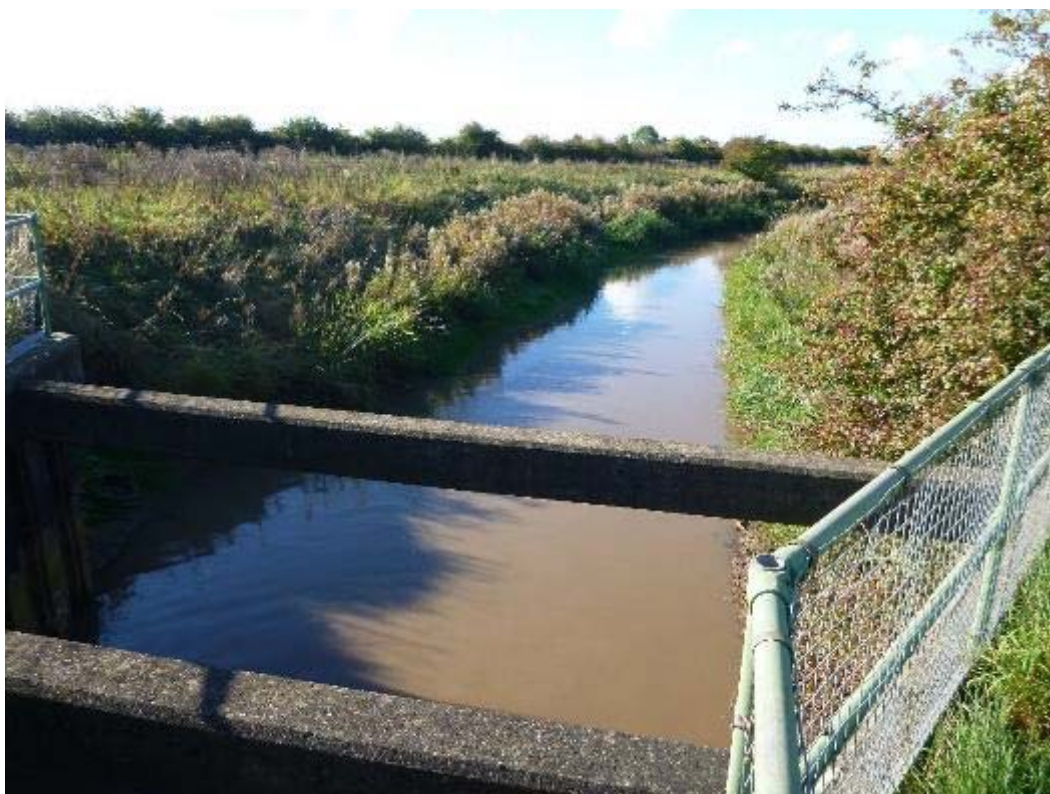
On the day of the survey of the lower reaches of the Beck, the outfall to the Humber estuary (TA1439822885) was visited at about 10.00 hrs (shortly after a high tide of over 7m) and about 16.00 hrs (shortly after low tide). The outfall structure comprises side-hung, forward pointing gates which open and close according to differential water pressure (gravity operated). At high tide the gates are closed and sea water level was approximately 3 m higher than water levels in the Beck at 10.00hrs. Water in the Beck was backed-up and not flowing at this time. At low tide, the gates were open and the Beck was flowing out into the Humber estuary (Photos 57 – 63).

Photo 62 River side of Skitter Beck outfall, tide in and gates closed, water backing-up in the Beck, 10.00hrs 30/09/2015 (TA1439822885).

The effects upon the Beck caused by the opening and closing of the tide gates greatly limit the effectiveness of in-stream habitat improvement techniques, so it is not recommended that these are undertaken on reaches downstream of Crook Mill Road.

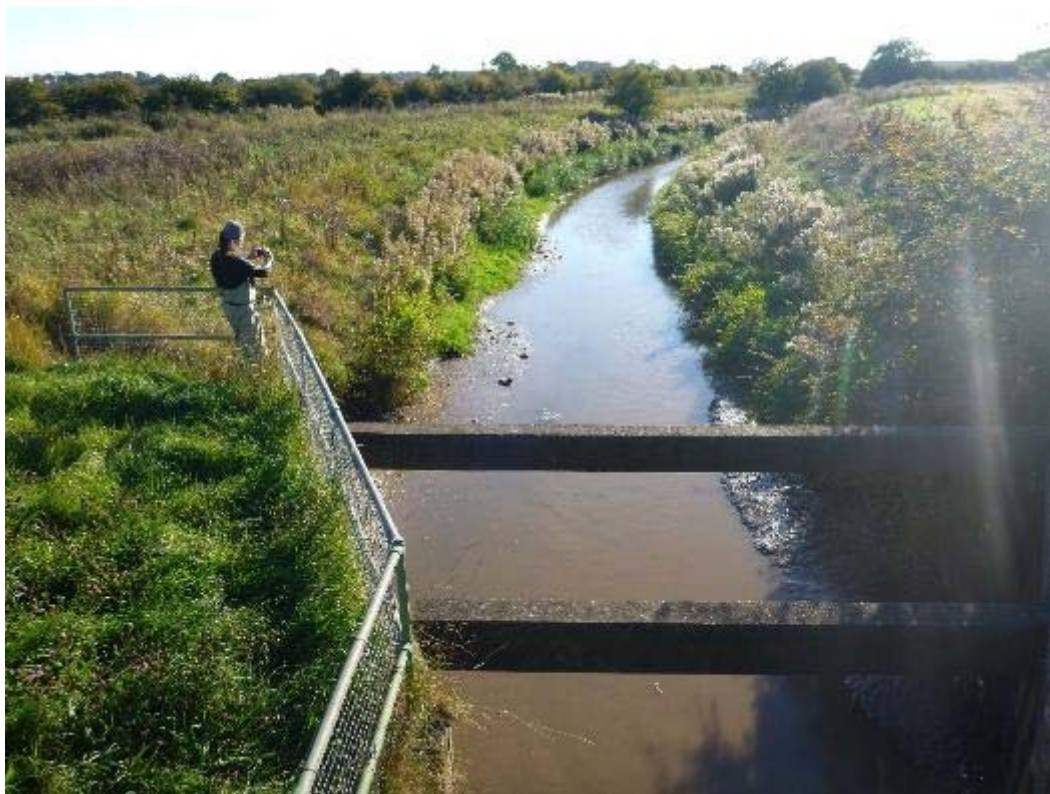
Photo 63 River side of Skitter Beck outfall, tide out and gates open, water flowing into estuary, 16.15hrs 30/09/2015 (TA1439822885).

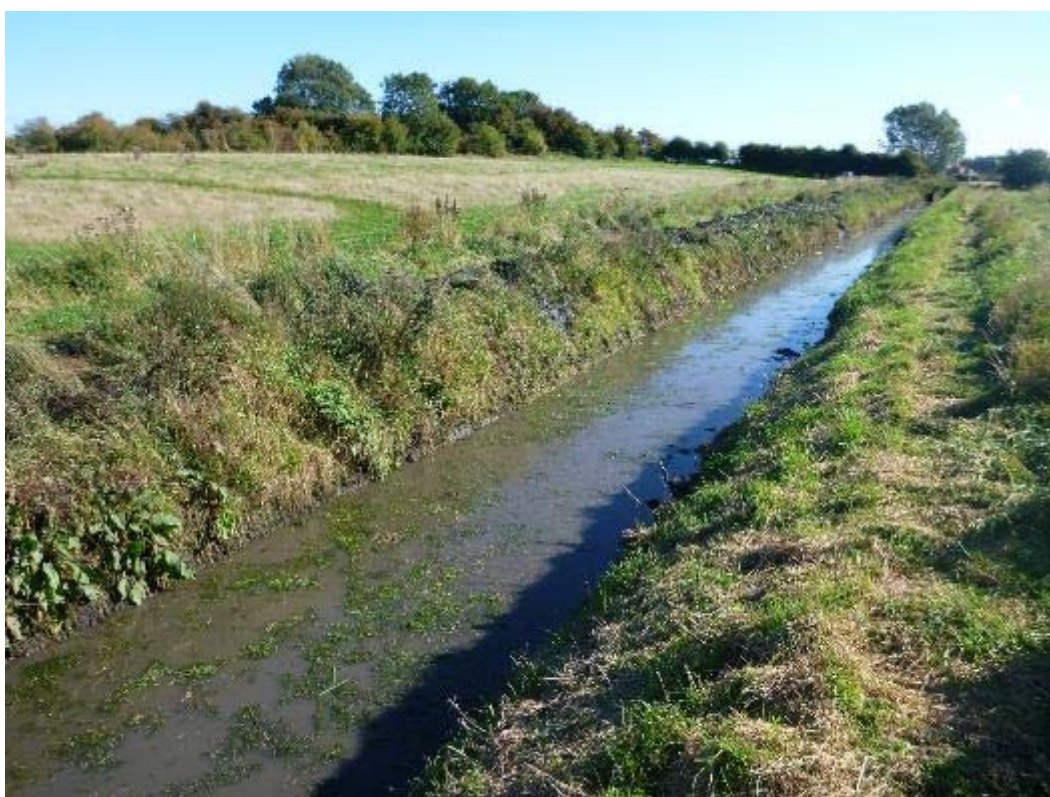
Downstream of Crook Mill Road, a drain runs roughly parallel to the Beck on the RHB, rising near the road and joining the Beck opposite Thornton Abbey, alongside a lake (TA1212518345). This drain was being slubbed out at the time of the survey and this indicates the type of routine maintenance that may also take place on the Beck itself (Photo 64). This illustrates a crucial point – that if any habitat improvements are to be carried out, the landowners and/or land managers must accept the proposals and be prepared to change routine management practices.

Photo 64 Recent dredging of drain running parallel to Skitter Beck (TA1212518345).
