Advisory Visit / Walkover Survey

River Tean Staffordshire

February 2016

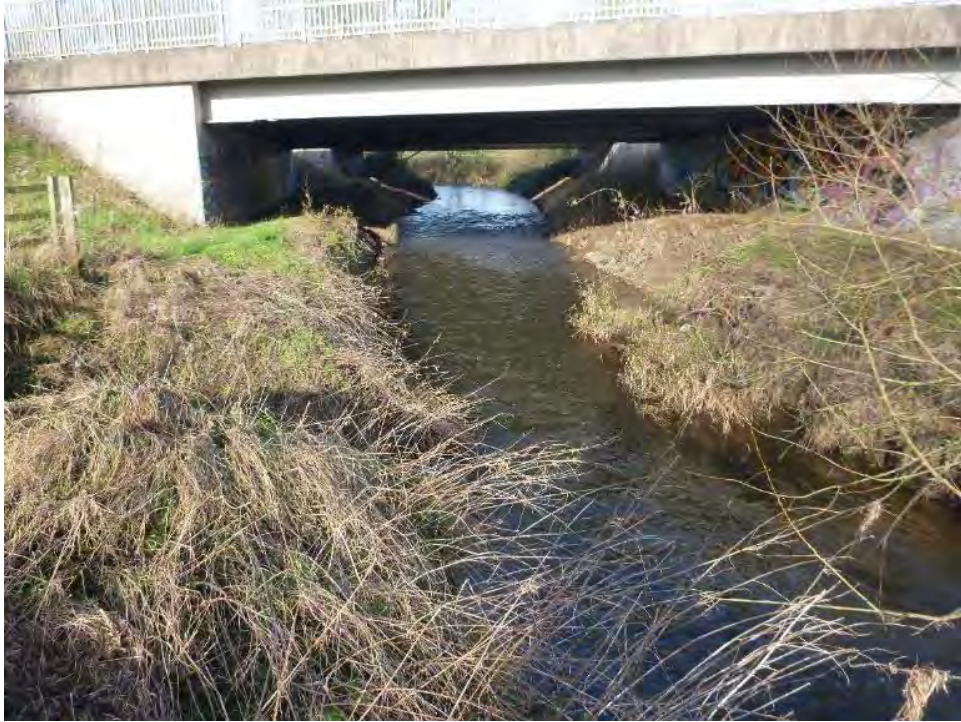
At the Dove confluence, the Tean is crossed by two bridges carrying the carriageways of the A50 trunk road. There is a steep, shallow riffle under the bridges with decreasing particle size from cobble to gravel with progress upstream (Photo 1). Immediately upstream of the confluence, the RB is reinforced with gabion baskets overplanted with young alder trees, probably where the river course was altered during the A50 construction.

Photo 1 Beneath the A50 bridges.

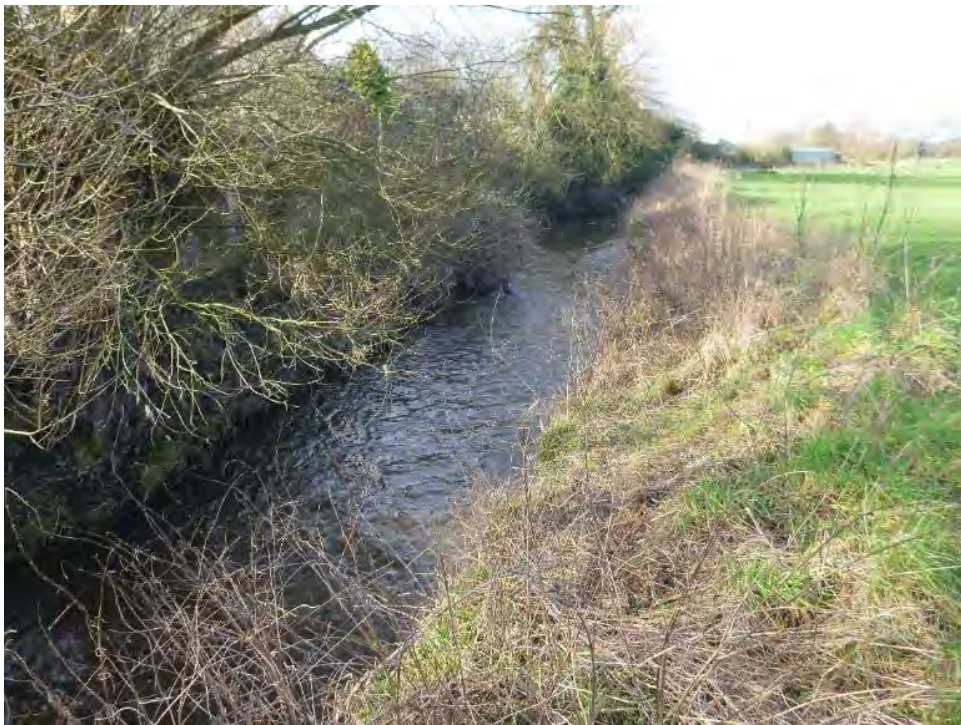
Alongside Noah's Ark Farm, the channel is straightened and has a trapezoidal cross-section (Photo 2). There is a blockstone toe to the bank which probably dates to channel engineering works in the mid to late C20th; this has collapsed in many areas leading to accelerated rates of bank erosion. In common with the rest of the river, many of these eroding areas have been reinforced with waste concrete/rubble tipped down the bank.

Photo 2 Downstream of Noah's Ark Farm – straight, incised, fast-flowing channel.

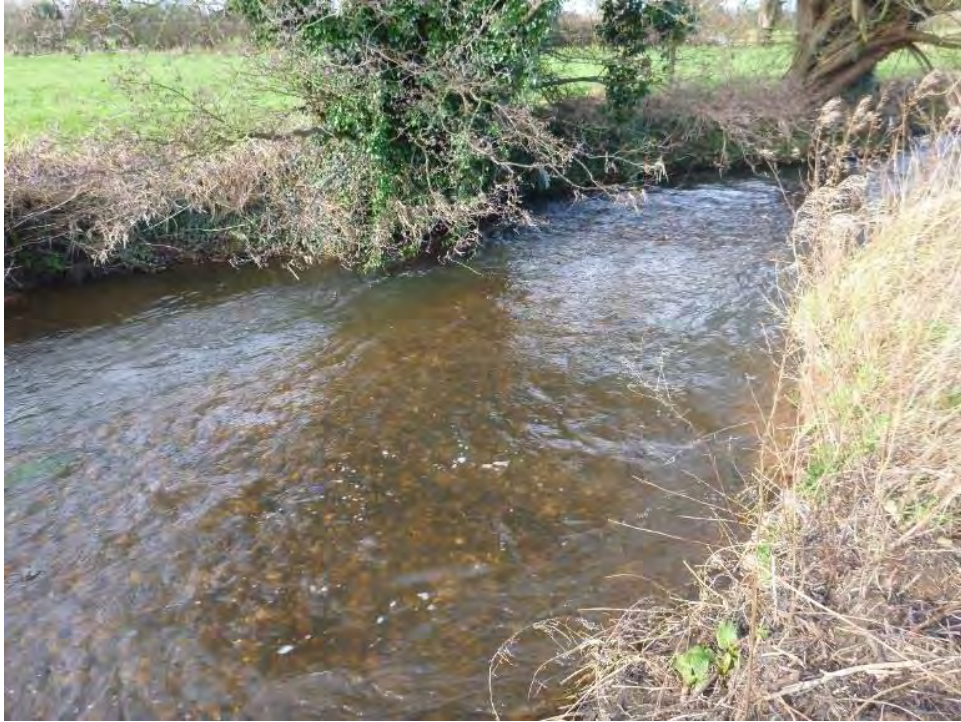
Upstream of Noah's Ark Farm, there is a meander in the river and some more natural river features are present, including a lateral scour pool and point bar (Photo 3).

Photo 3 Rare example of natural river features in Section 1 – a lateral scour pool and gravel point bar.

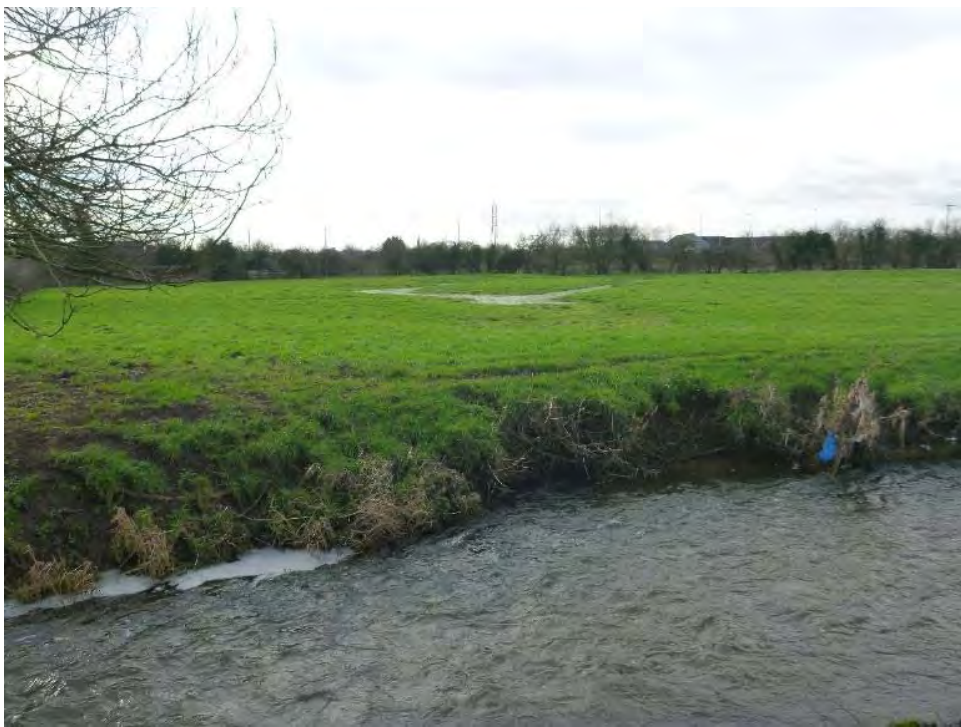
Upstream of the field boundary at SK 10159 34601 the river channel is straight, wide (5m at water level, 8.5m bankfull), open (treeless) and a uniformly shallow (mid-calf depth) riffle-glide habitat. The bed is gravel and water crowfoot (*Ranunculus* sp.) is abundant. Paleo-channels from a former river course are evident in the field on the right bank (Photos 4 – 5).

Photo 4 Possible paleo-channel in the field on the RB upstream of Noah's Ark farm.

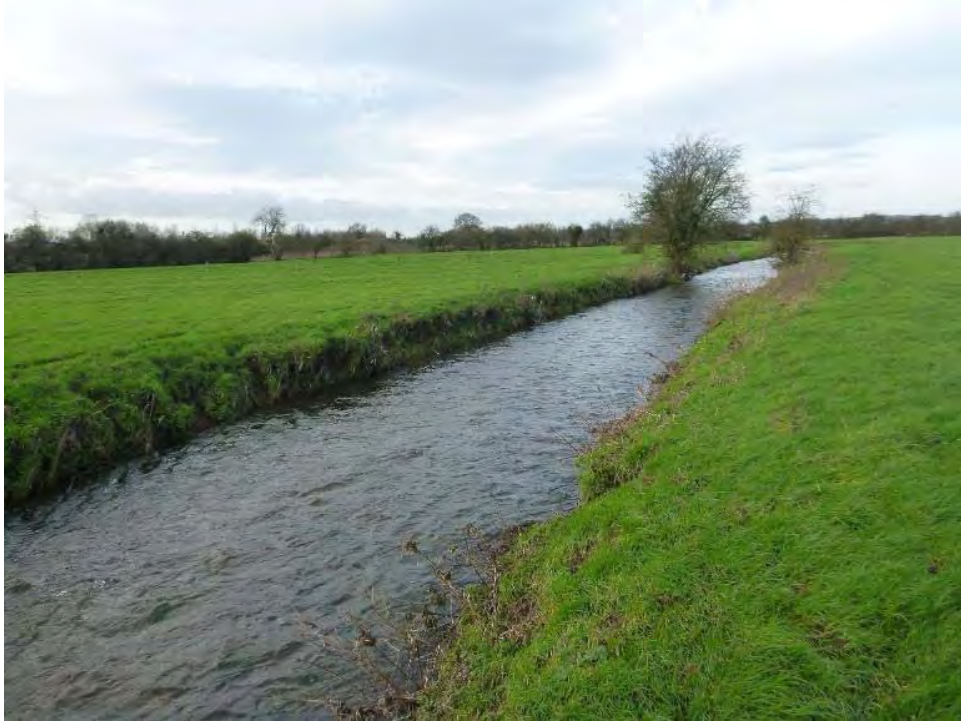
Photo 5 Uniform, wide, shallow channel.

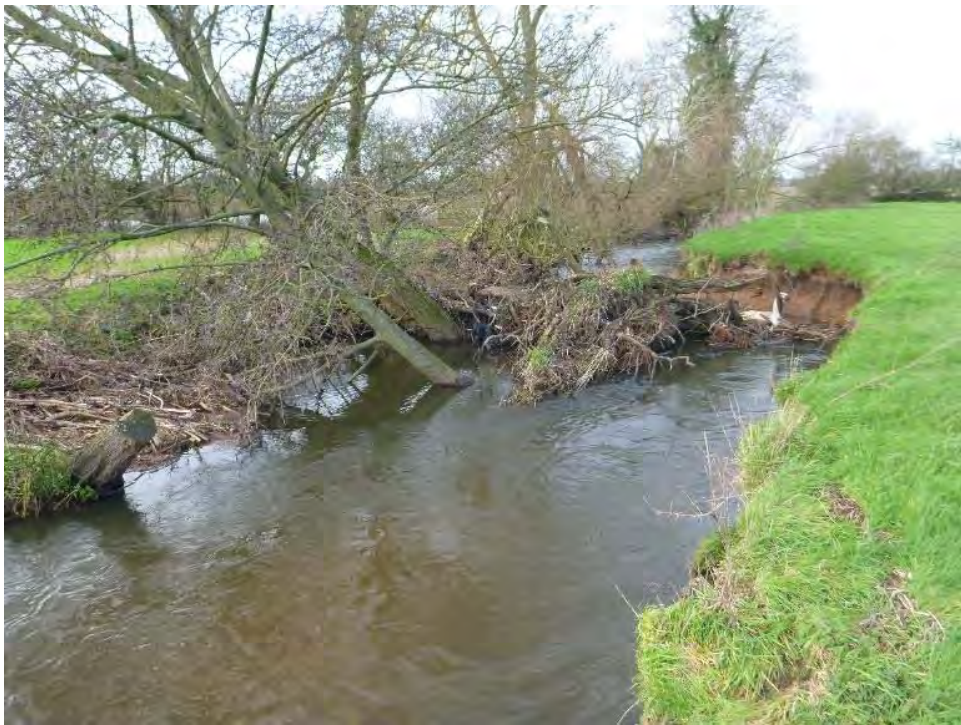
A farm bridge and tractor ford are present at SK 10043 34688, upstream of which is a deeper glide (slightly impounded by the bridge invert) and a large woody debris (LWD) dam where a crack willow and alder have fallen away from the LB. The river is eroding behind the root plate, introducing some sinuosity to the channel (Photo 6).

Photo 6 Woody debris from collapsed trees, creating some sinuosity and depth variation in an otherwise very uniform channel.

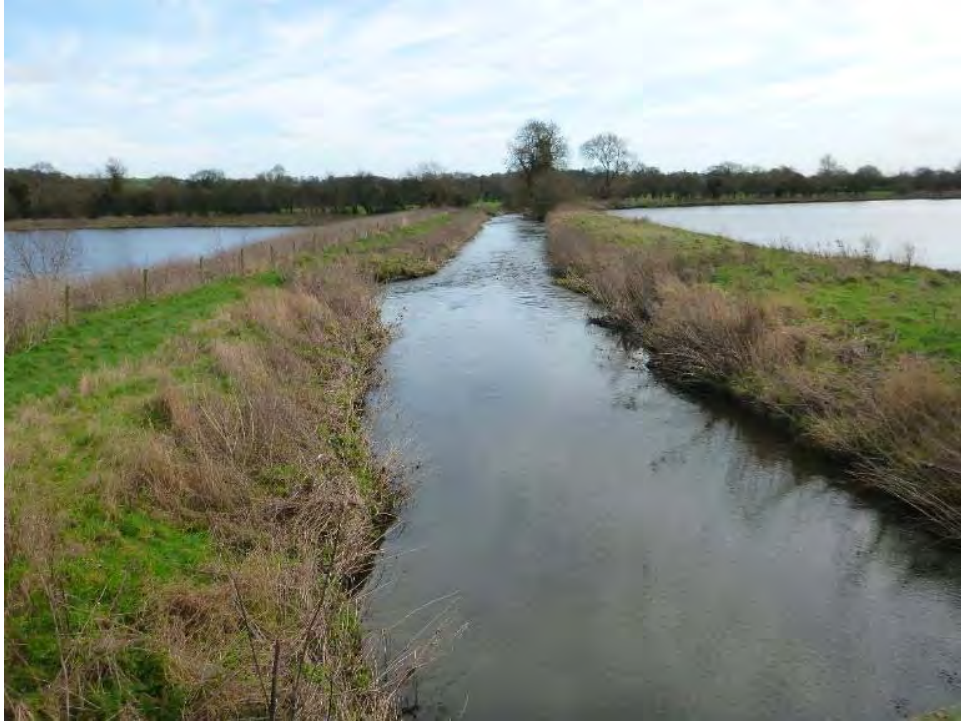
Uttoxeter gravel quarry is located beyond the next field boundary (SK 099203 4723). The straight, wide, shallow nature of the river resumes here upstream to the quarry plant bridge at (SK0976234748). The river is bordered by flooded gravel pits, with a 10-m wide strip of land on the RB and a circa 25 – 30m strip on the LB. The water level in the pit on the RB appears to be approximately the same as that in the river, whereas the water level in the pit on the LB appears substantially lower (Photo 7).

Photo 7 View downstream from quarry plant bridge.

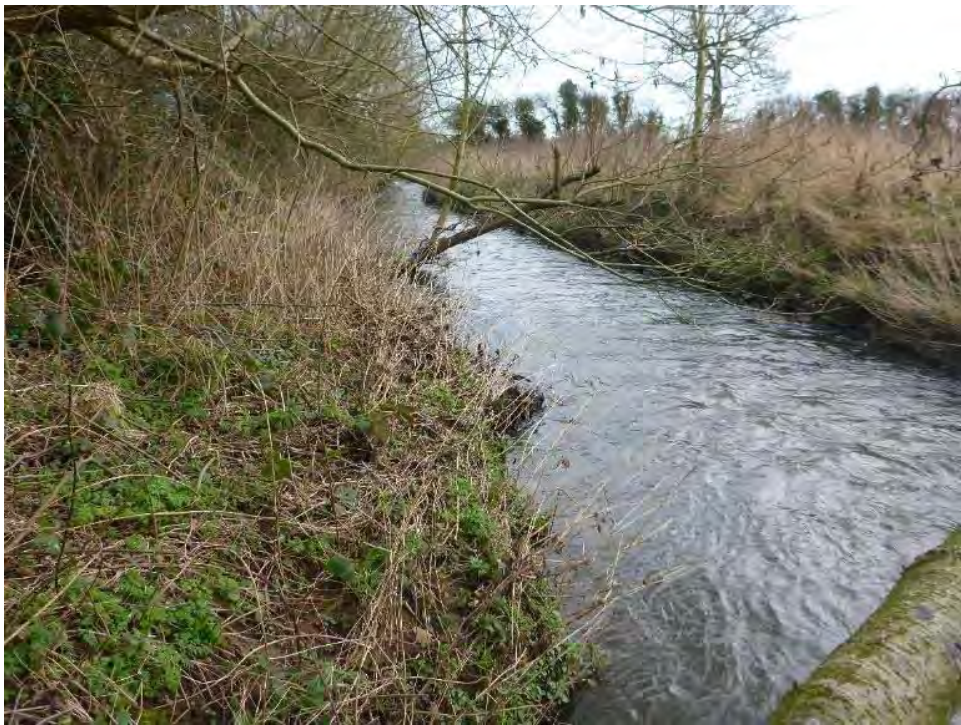
Photo 8 River channel upstream of quarry plant bridge (downstream view)

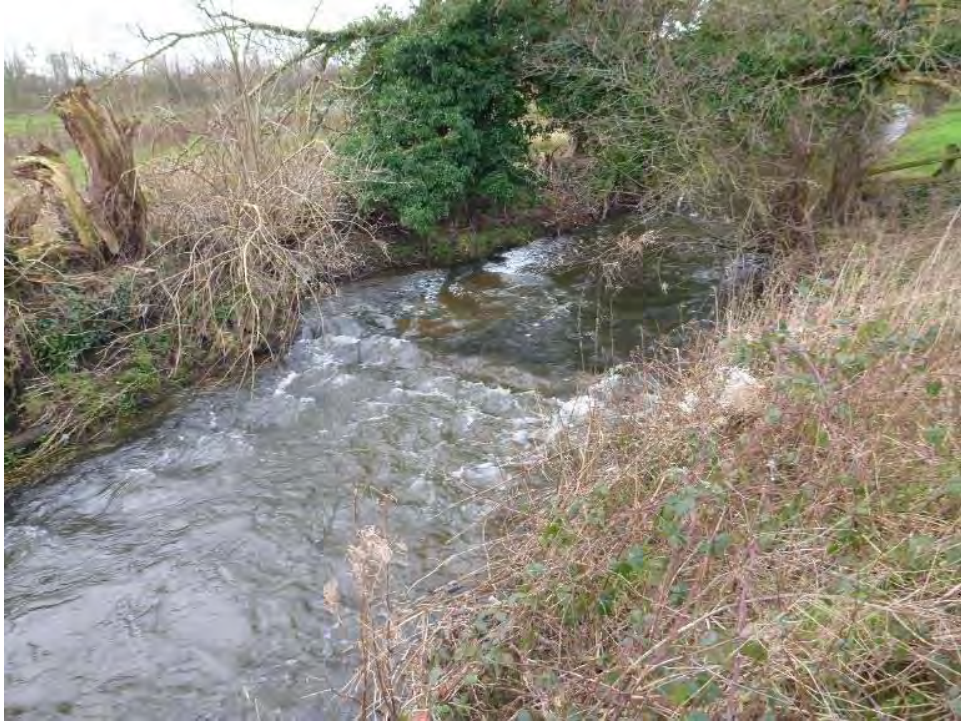
At the boundary of Leasows Farm garden (SK0947434793) there is a short section of river bed with a concrete base and side walls, possibly a former weir. It does not form an obstacle to fish migration or have an upstream impounding effect (Photo 9). The channel remains artificially straight throughout this area and almost to the upstream end of this section.

Photo 9 Concrete bed structure downstream of Leasows Farm

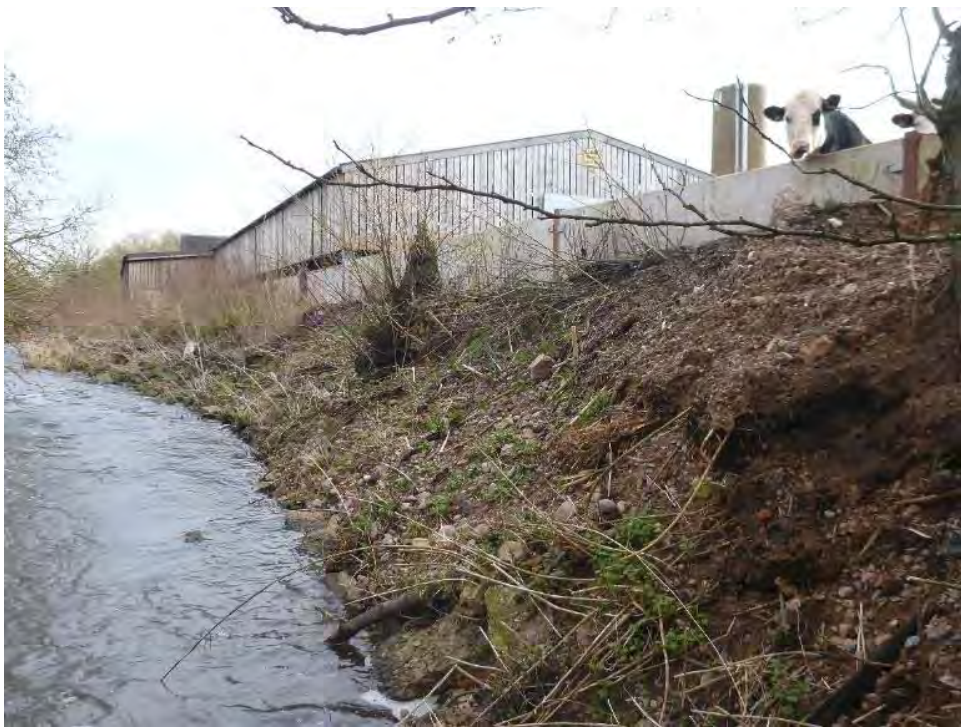
Photo 10 Cottonmill Farm (downstream view).

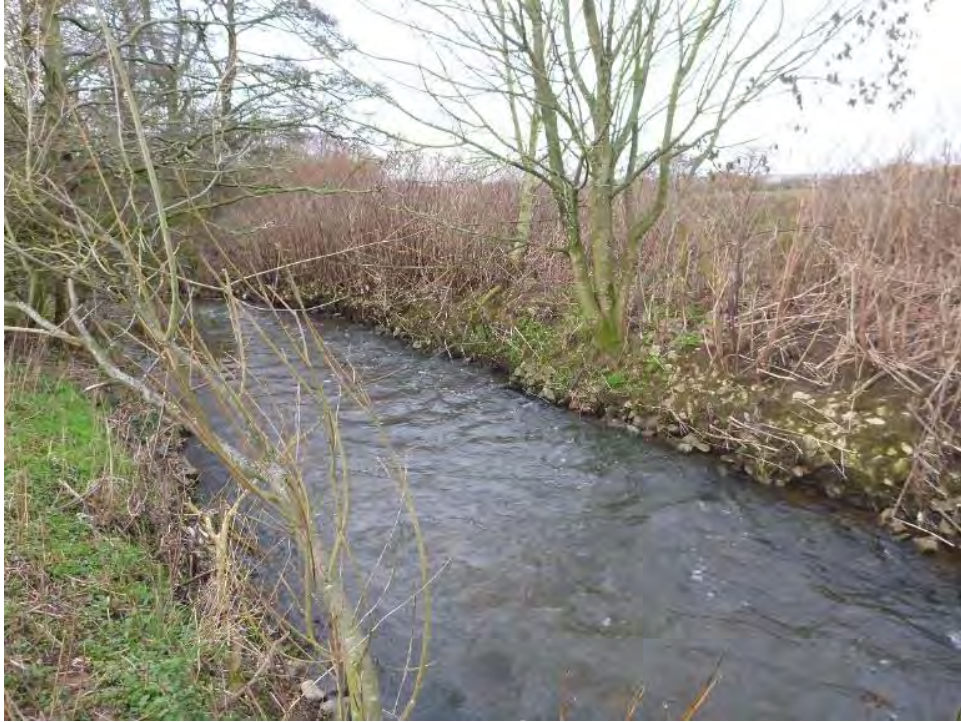
Photo 11 Extensive stone revetment of the banks upstream of Cottonmill Farm. Japanese knotweed present on far bank (LB).

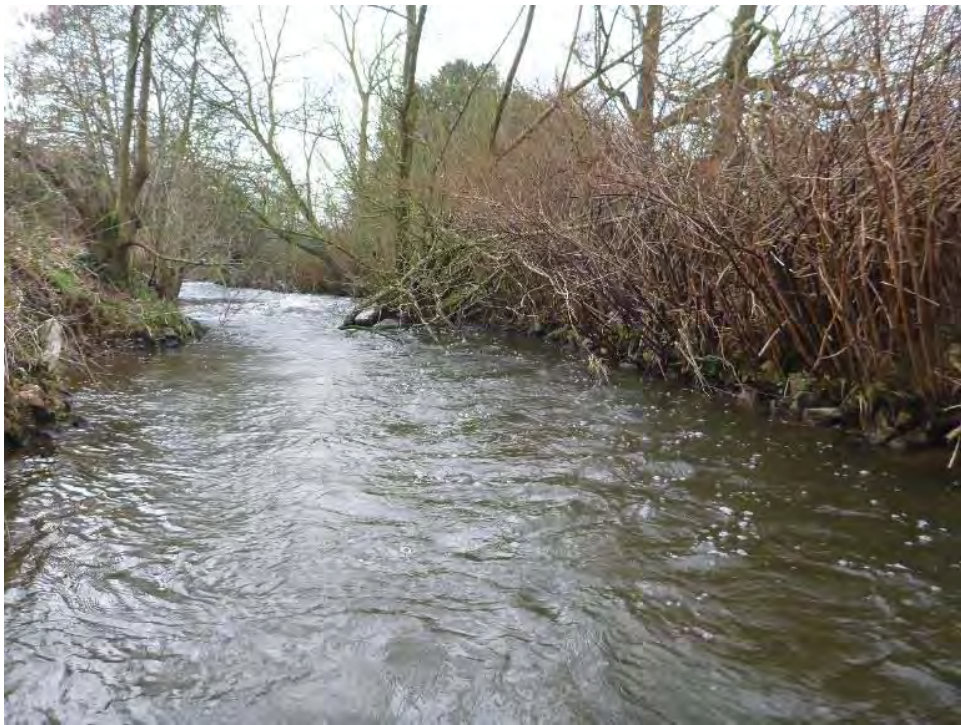
Photo 12 Steep bed level change approaching site of former Uttoxeter Mill. Note Japanese knotweed on LB (right of picture).

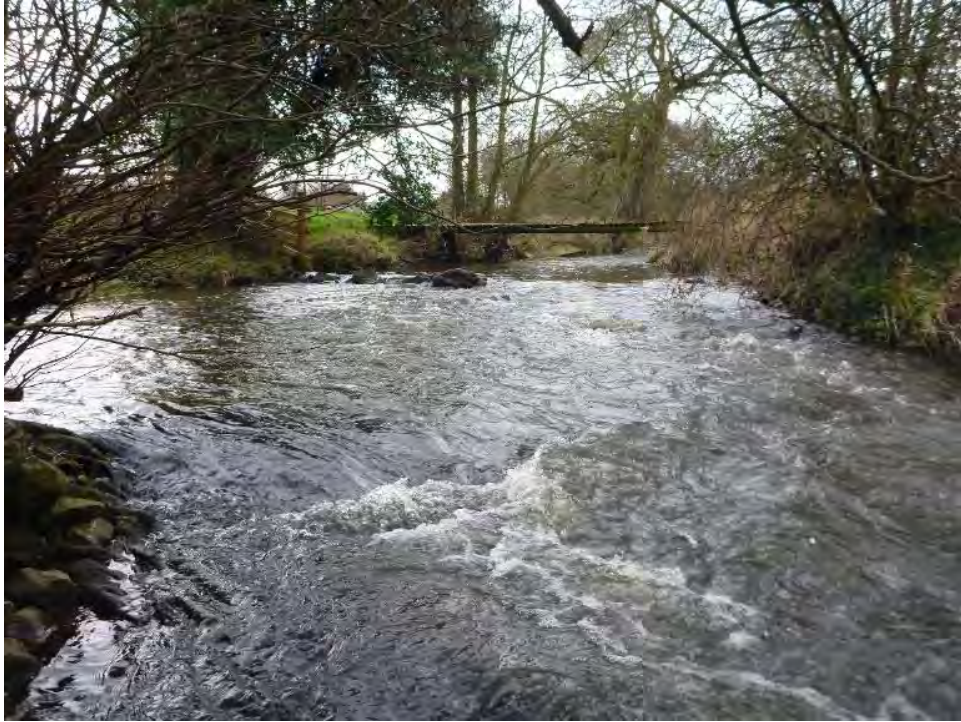
Photo 13 One of a series of relatively steep changes in bed level around the former site of Uttoxeter Mill. None represent obstacles to fish passage.

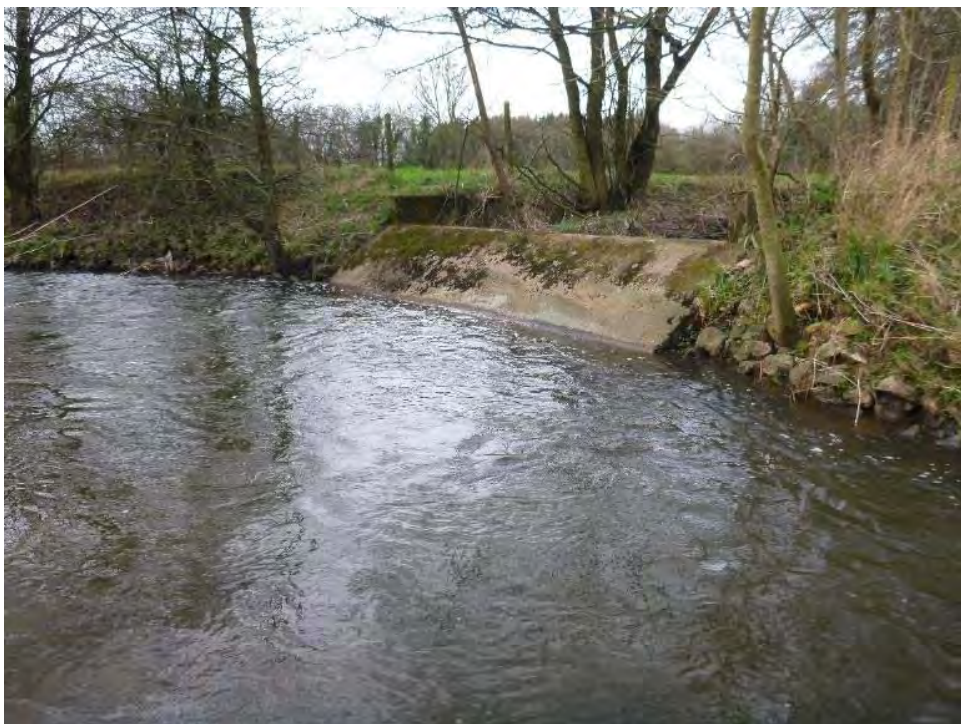
Photo 14 Redundant concrete overflow from river at former Uttoxeter Mill site.

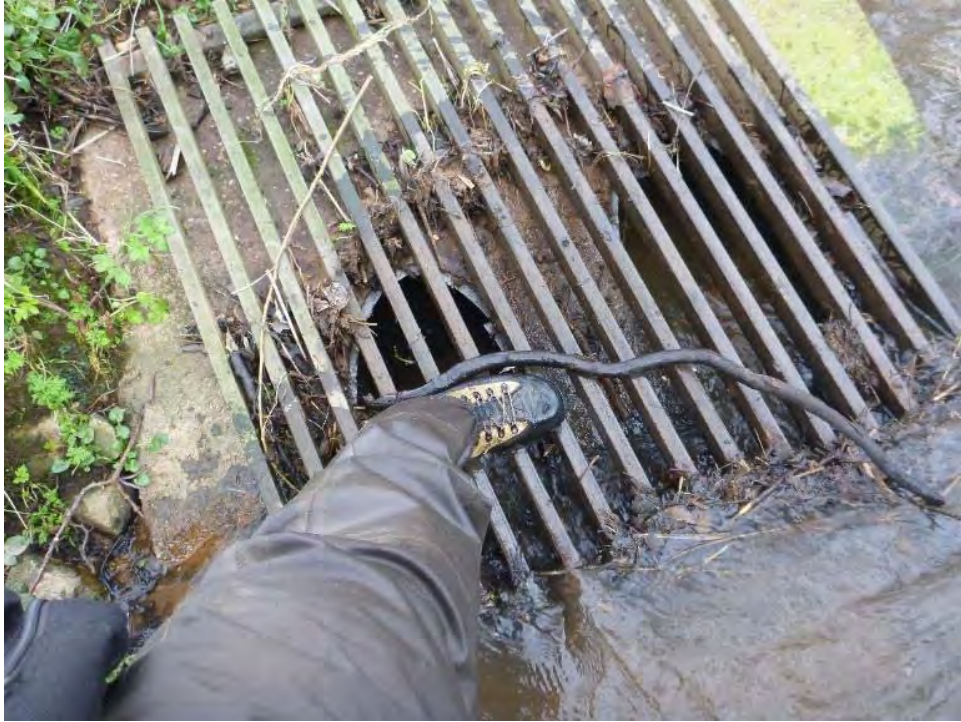
Photo 15 Twin 300-mm pipes taking water off the river, downstream of old railway bridge (SK0868134868).

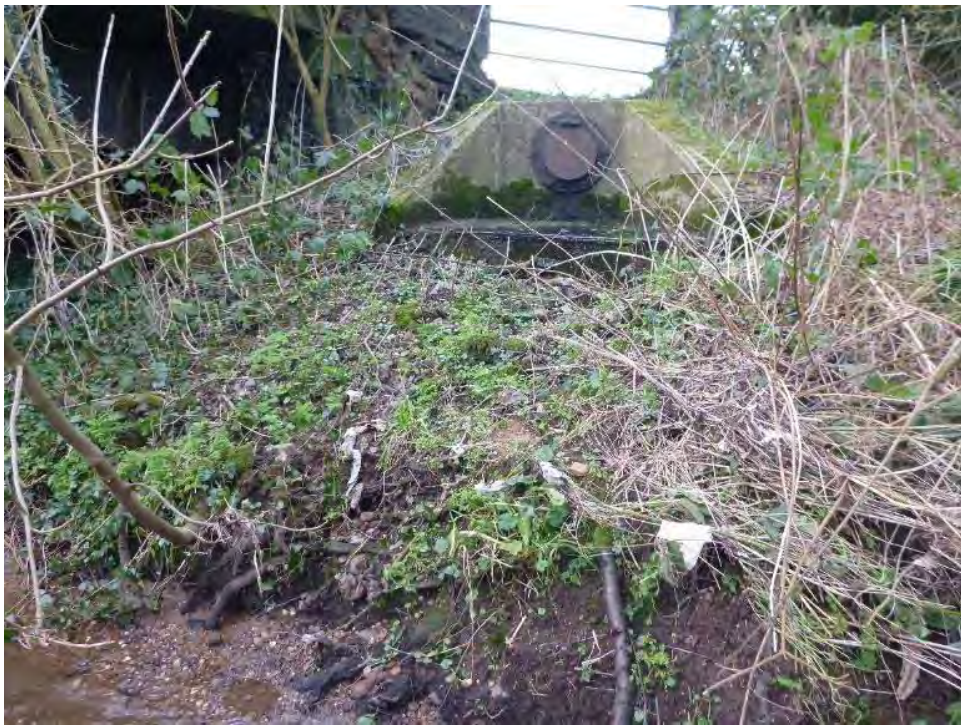
Photo 16 Combined sewer- storm water overflow (?) with sewage rags below.

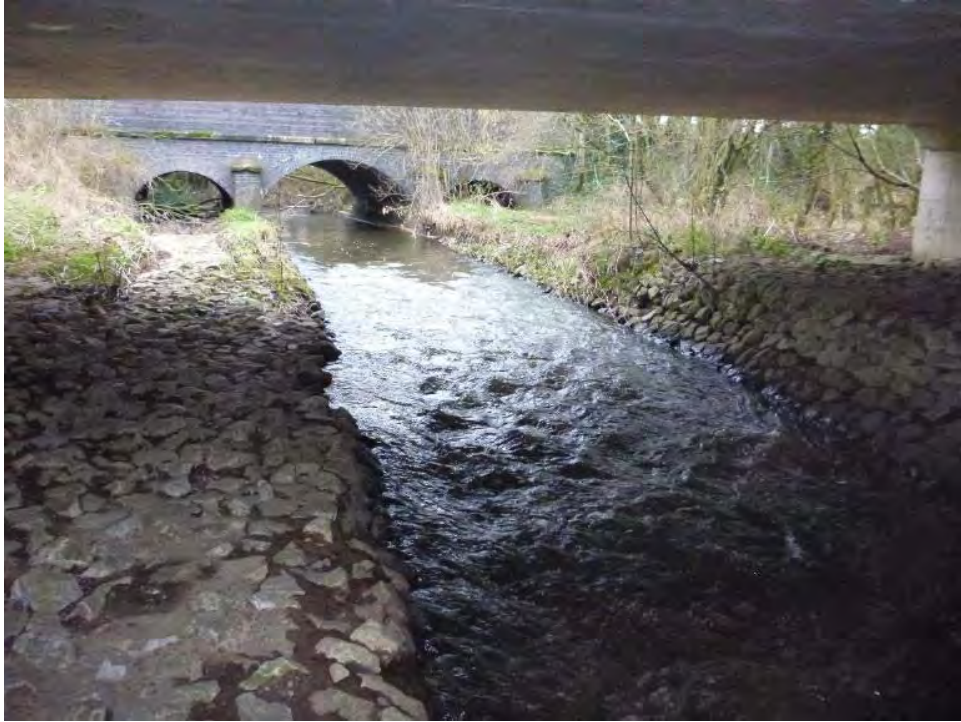
Photo 17 Culvert beneath A518 Ashbourne Road, with old road bridge in background.

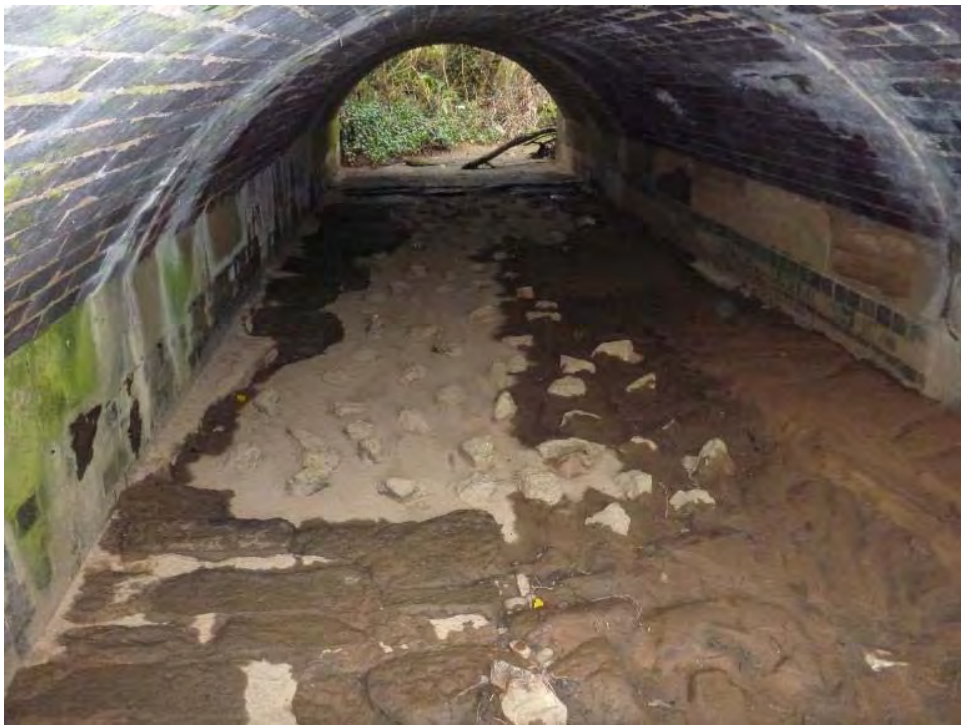
Photo 18 RB side arch of old road bridge.

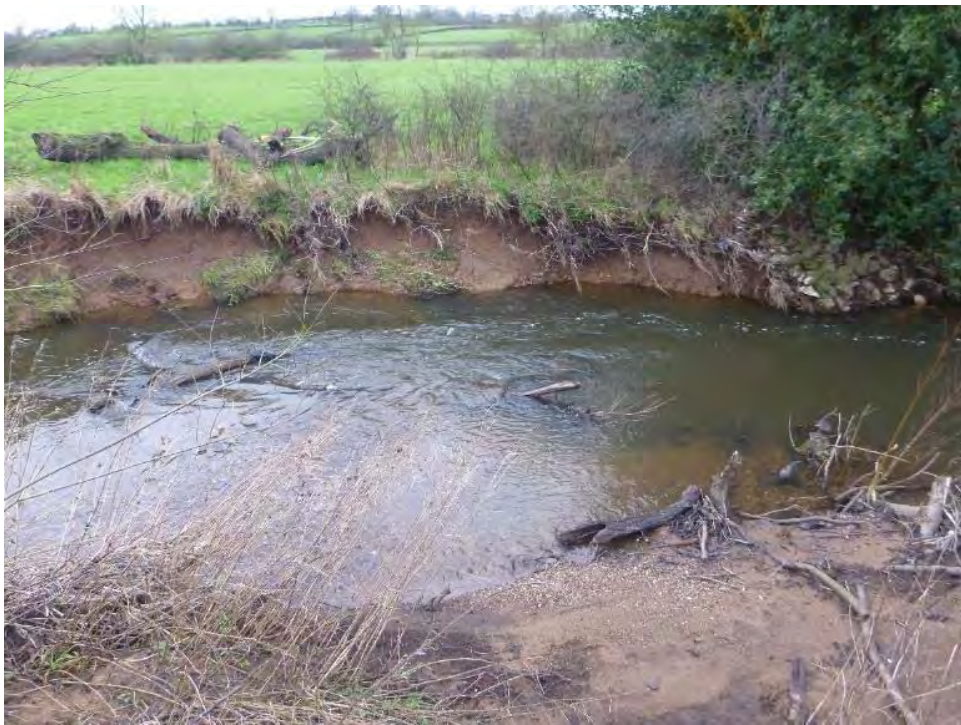
Photo 20 Site of LWD removal, note the bank erosion behind the stone toe (right, far bank).

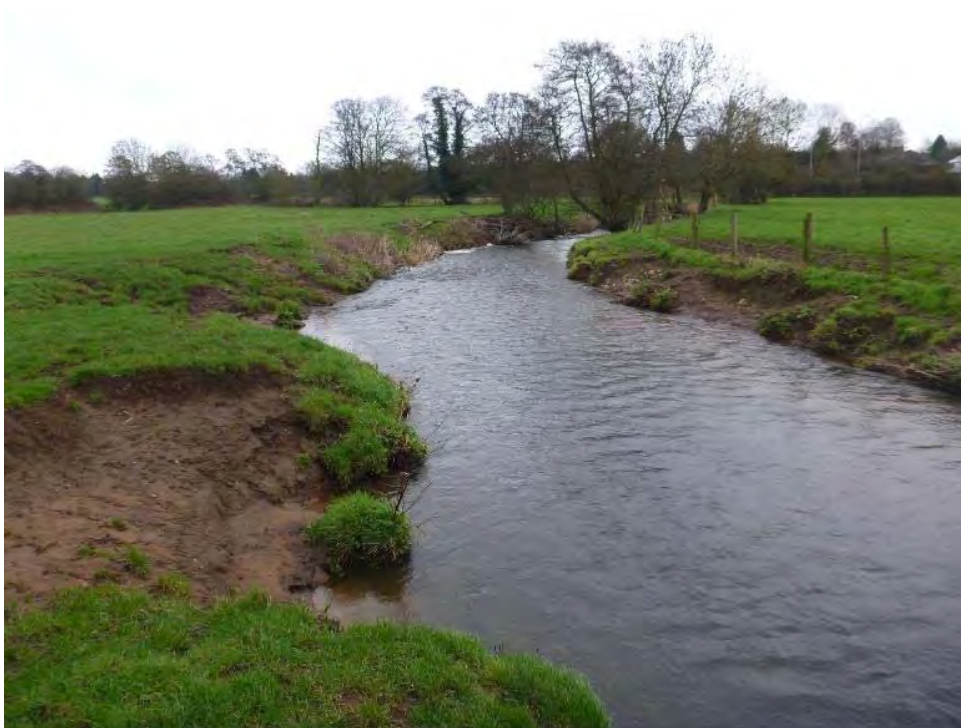
There is moderate tree cover throughout, mainly mature alders, a number of which are being lost to *Phytophthora* disease and reducing bank stability; this is particularly noticeable on the downstream section (downstream of SK0770634997), e.g. Photo 22.

Photo 22 Open sections where tree loss has occurred and grazing prevents regeneration.

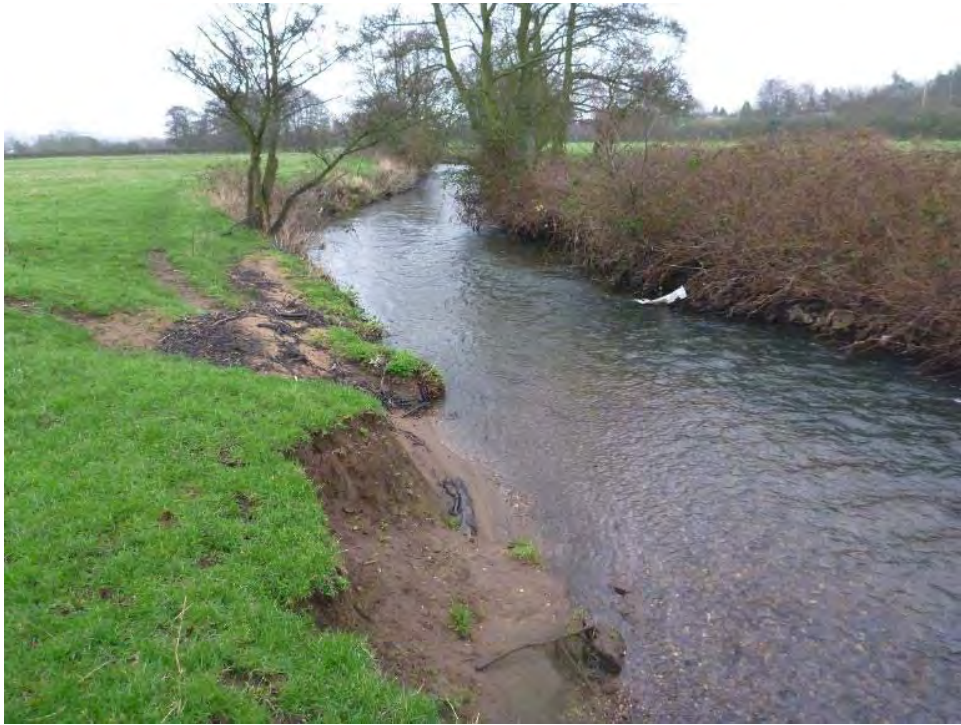
The channel remains incised and a blockstone toe is present throughout most of the section, indicating past channel engineering (bed lowering). In some areas, the stone toe has blown out and bank erosion is occurring at accelerated rates, especially where trees are absent and where woody debris accumulations have promoted bank scour. There is some LWD present, but also evidence of recent removal (e.g. SK0838134800, Photo 20), probably prompted by the above-noted tree loss, stone toe blowout and increased bank erosion rates. Tree succession is not occurring because of grazing, which is a cause of concern for future bank stability and channel shading. Selective coppicing, stock fencing and tree planting would benefit this part of the river (Photos 22 – 25).

Photo 25 Lack of trees and bank stability in grazed areas.

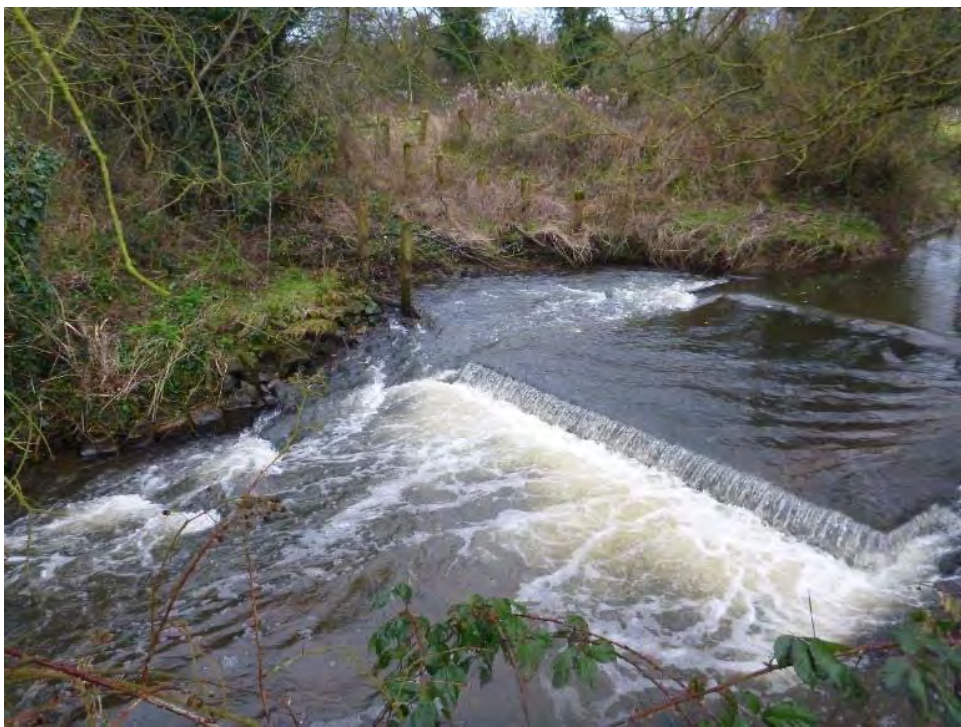
populations of grayling and trout, along with occasional chub and dace. A small weir is present at SK 07719 34865, which consists of a low concrete apron (Photo 26). The river has eroded around the RB side of the concrete creating a cascade which would provide passage for more active swimming fish species (trout); a similar route appears to be available against the LB at higher flows. The structure may however be a physical or behavioural barrier to less capable swimmers such as grayling.

Photo 26 Weir at SK 07719 34865.

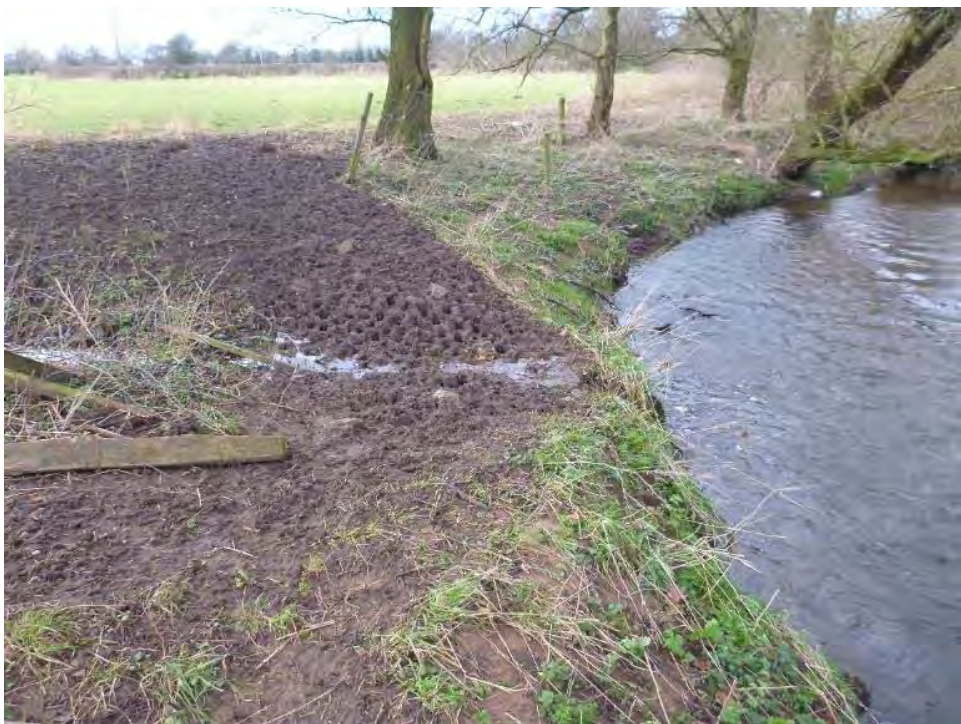
Photo 30 Bank poaching where field access is close to the river – a source of fine sediment input.

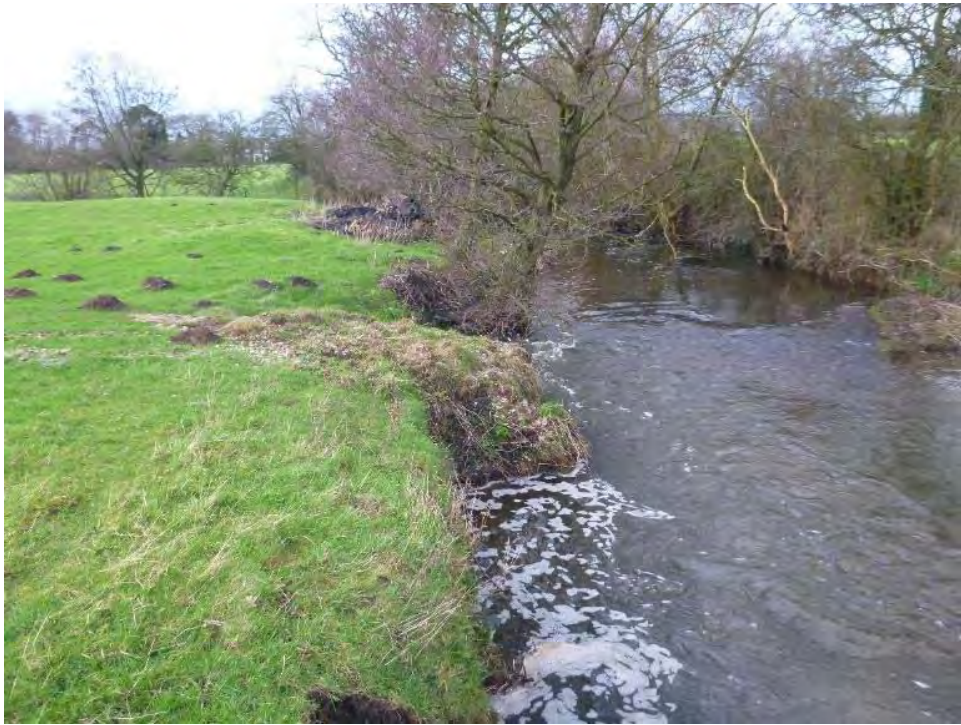
Photo 31 A site of LWD removal and bank erosion back-filling.

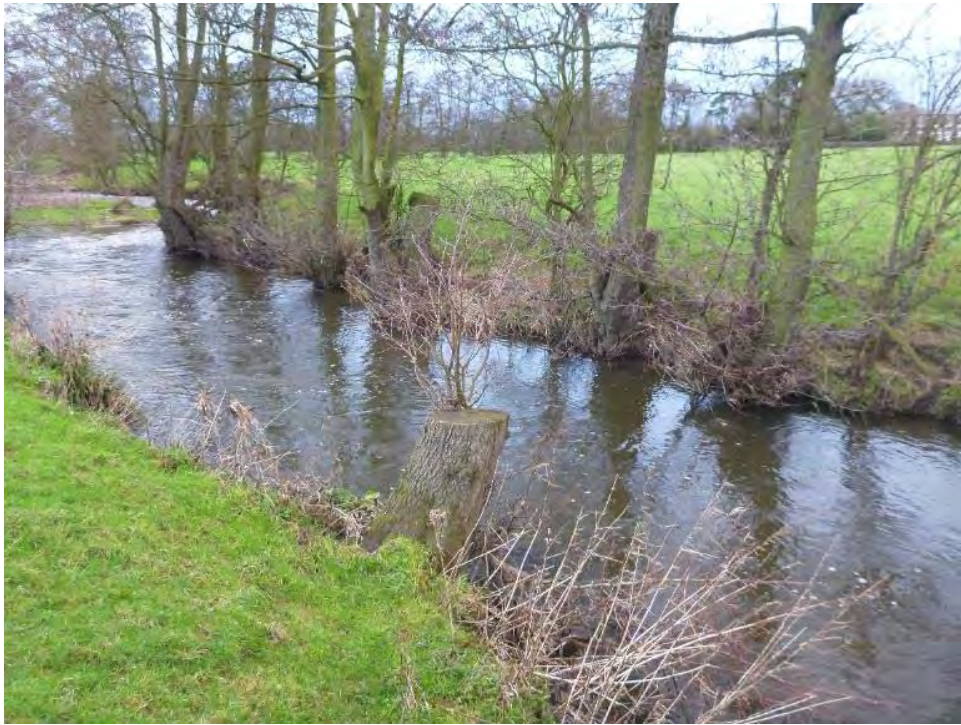
Photo 33 Coppicing of trees downstream of road bridge SK0704235723.

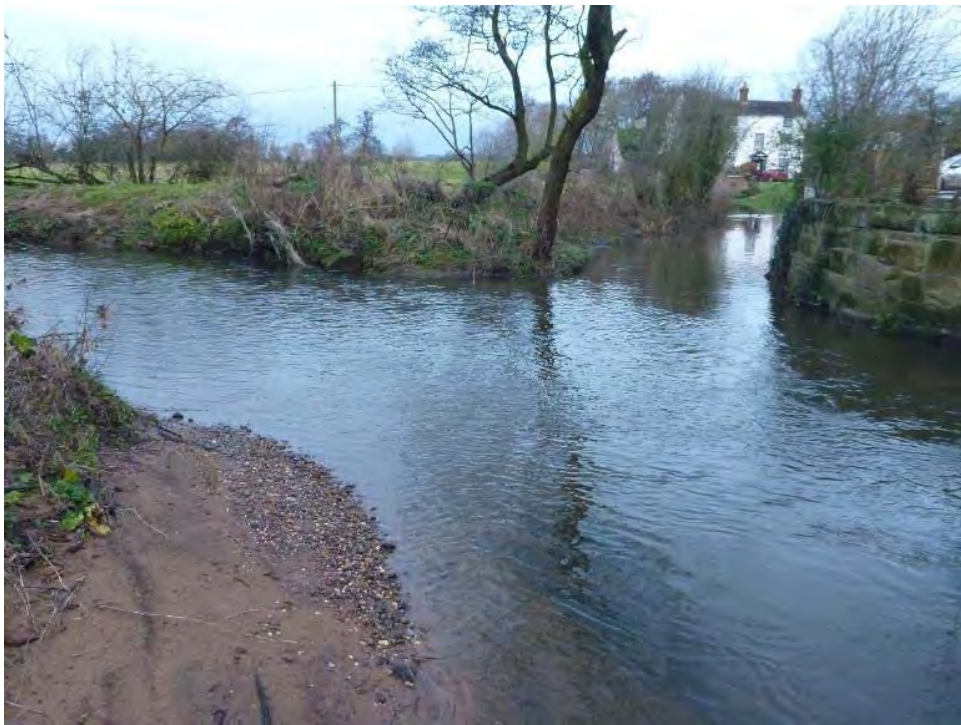
Upstream of the road bridge, there is an old mill leat joining the river on the LB (SK0701835749, Photo 31). The water in this leat is static and inspection of its upstream end alongside the weir at SK 06761 35807 reveals it is blocked off, the entire river flow following the channel alongside the road (Photos 32-33). The weir itself is an obstacle to fish passage, being a stepped structure with a head loss of approximately 1 metre and a closed penstock sluice against the LB. The weir appears to be redundant, so in theory could be removed subject to permissions and due diligence with regard to bed re-grading.

Photo 34 Redundant mill leat at Springfields / Mill Farm

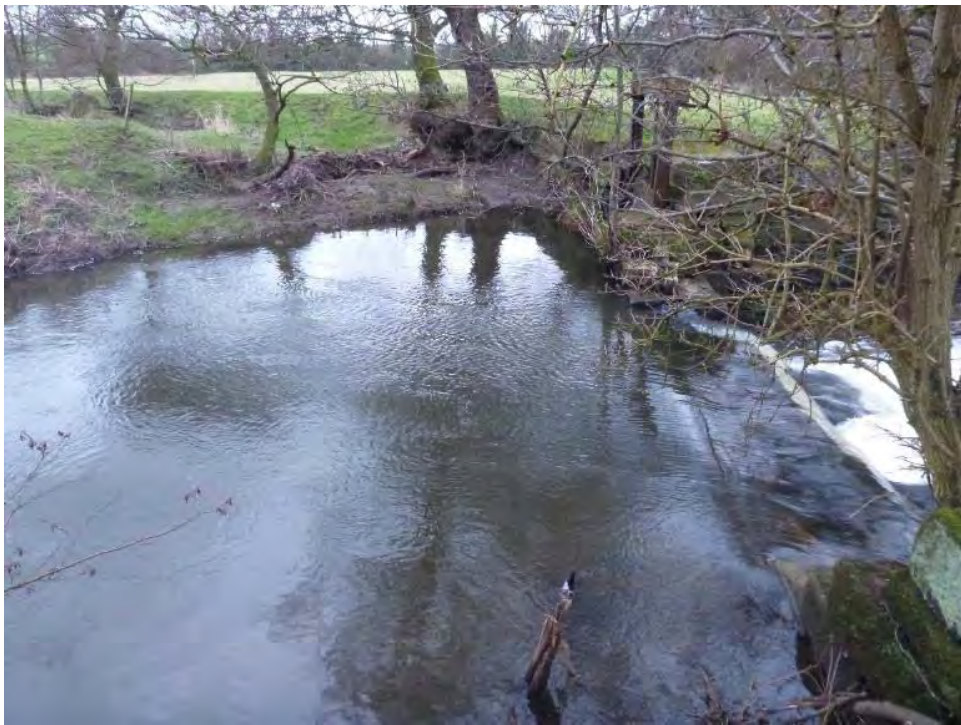
Photo 36 Upstream of above weir, showing blocked-off mill leat.

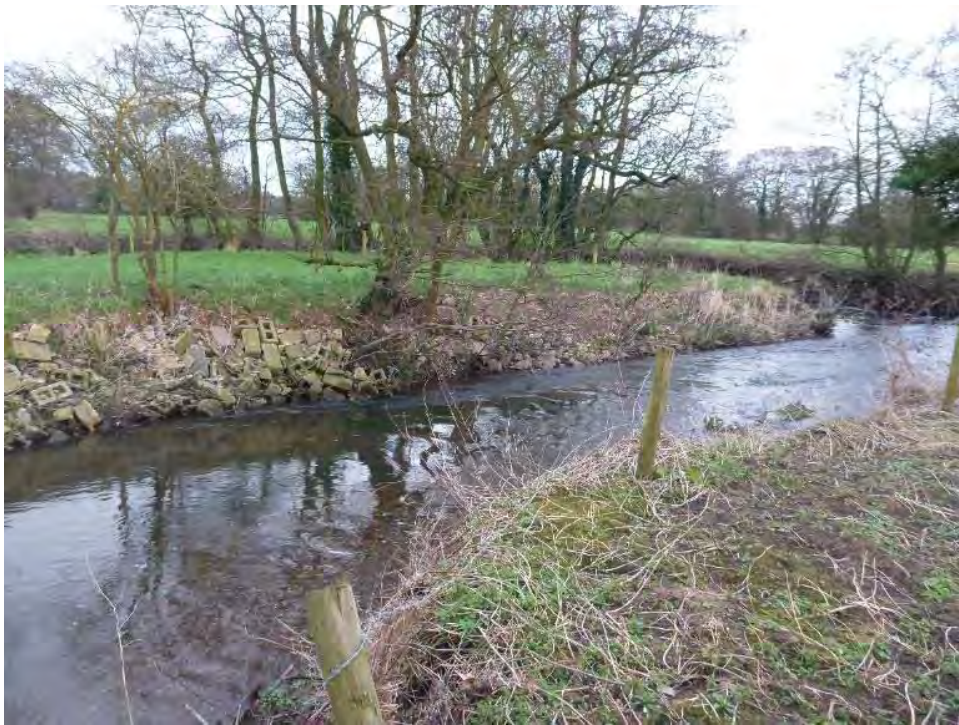
The LB here is extensively reinforced with waste concrete and rubble, which is visually unattractive and is leading to the loss of depth (and hence adult fish habitat) on lateral scour pools. This is because material introduced on the outside of a meander slumps to a stable angle of repose, creating a shallower slope rather than a vertical or undercut bank. This limits the depth of the pool and reduces its value as habitat for larger fish. A better solution would be fencing off a buffer strip and allowing trees and their roots to provide natural bank stability.

Photo 41 Rubble bank reinforcement is extensive along the LB of the lower part of section 3.

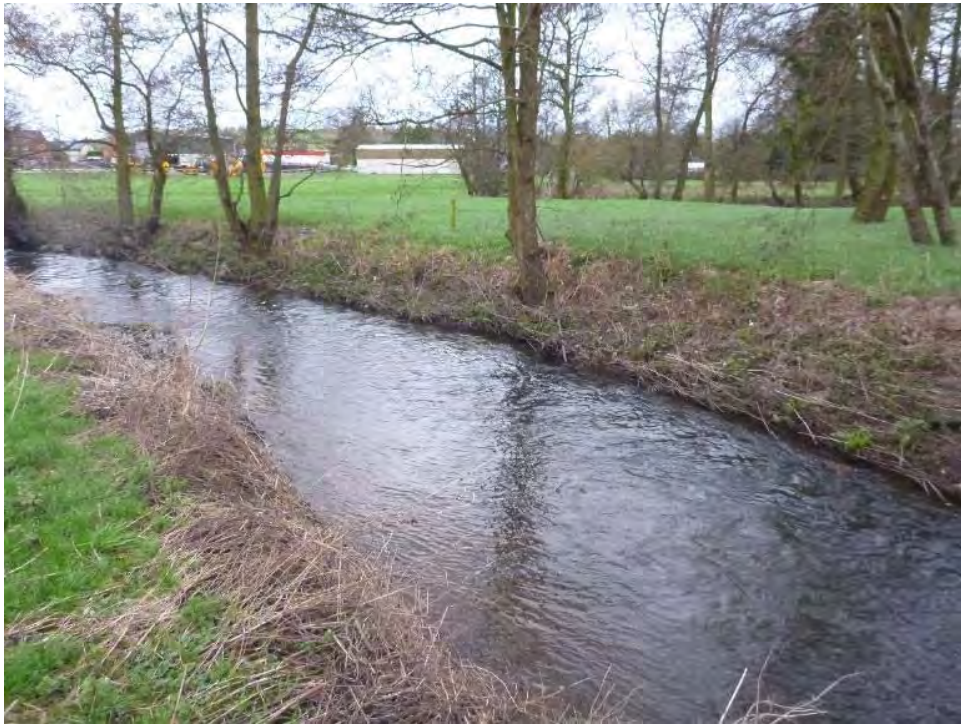
Photo 42 Past reinforcement has stabilised banks but leads to a lack of habitat variety.

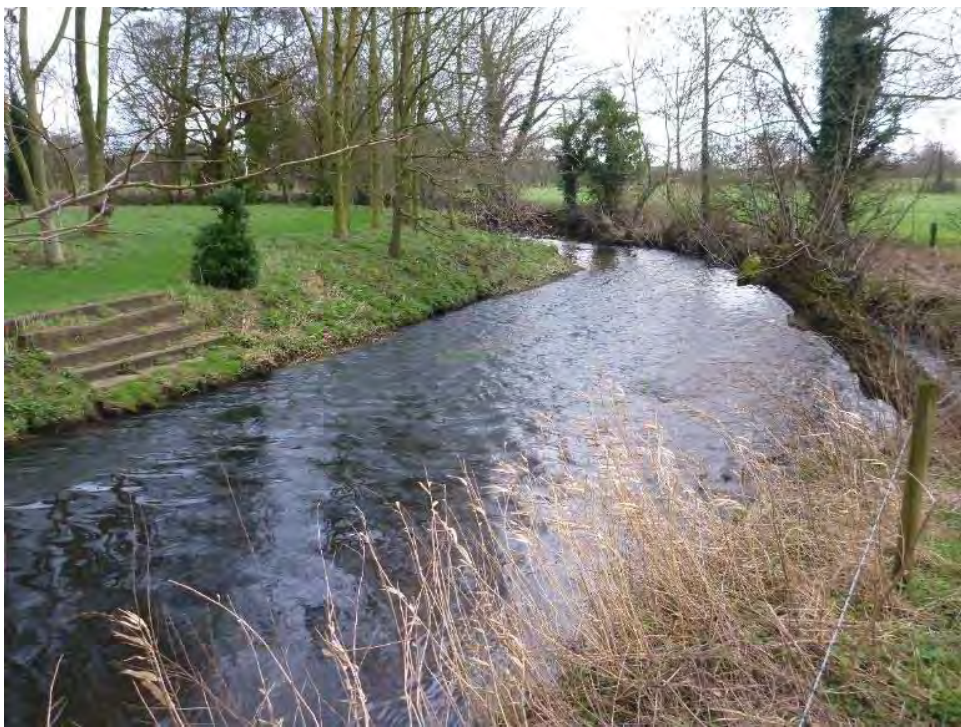
Photo 43 More manicured banks on the LB provide poorer habitat. A fringe of shaggy vegetation should be retained.
