Advisory Visit / Walkover Survey

River Tean Staffordshire

February 2016

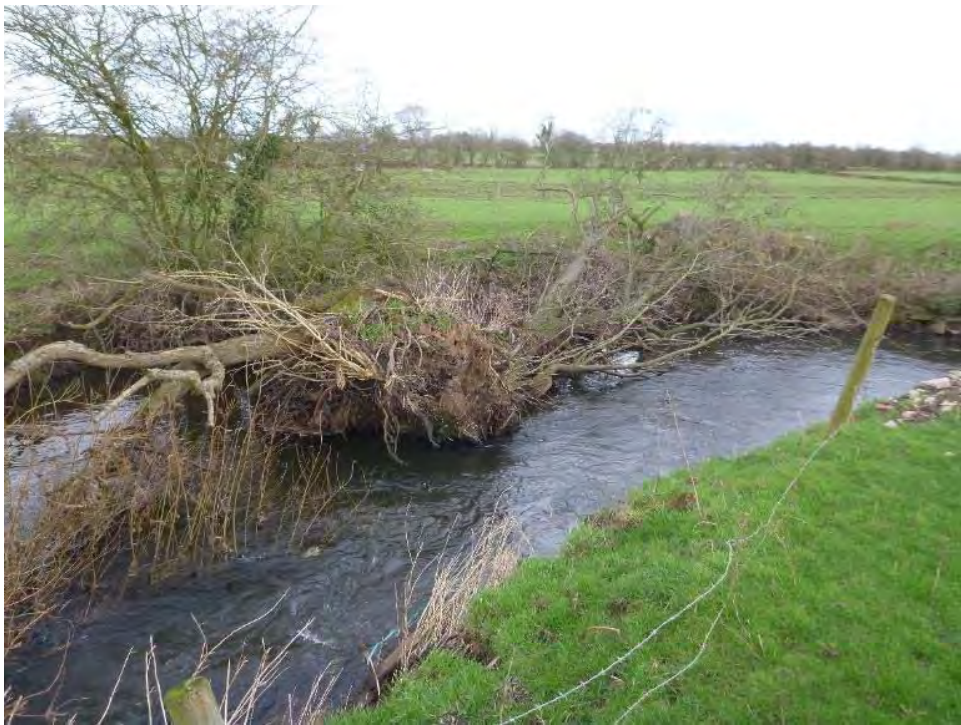
and a number are being lost to the river and not replaced. Unrestricted grazing is preventing tree regeneration in this area.

Photo 47 More open areas on the upstream part of the section – trees are being lost and not replaced.

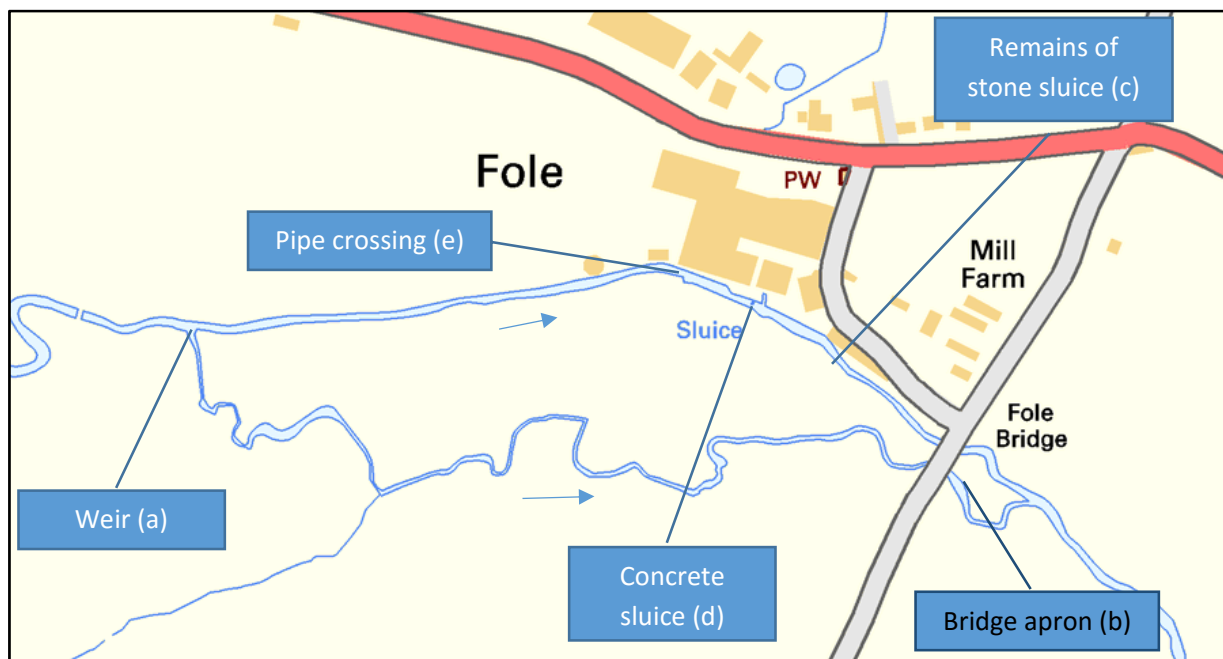
Figure 1 Flow split and structures at Fole

The downstream half of this section consists of two channels (Figure 1), splitting at a weir at SK0395937238 (Figure 1 - a) and re-joining downstream of Fole Bridge.

The southern (RH) channel appears to be the original river course, having a meandering plan-form. There are two obstacles to fish migration on the southern channel: a small (circa 300mm) drop off its road bridge culvert apron (SK0452337126, Figure 1 - b) which may impede fish passage at

- A redundant, stone-built sluice is present alongside the mill site at SK0443537219 (Figure 1–c). There are no gates or vertical drops present, but a swift flow of water through a narrow stone channel. This is probably passable by trout but may deter less capable swimming species.

- A concrete weir with an undershot penstock sluice is present alongside the former Fole dairy site at SK0437237259 (Figure 1–d). The penstock has an aperture of approximately 1.5 m and appears to be permanently open; at moderate river levels it appears not to be an obstacle to fish migration. At higher flows the velocity of water through the sluice aperture may prevent fish movement. A large scour pool is present downstream and the Broadgatehall Brook joins the Tean here, via a culvert under the former dairy site and a steep, shallow, concrete apron which is an obstacle to fish migration between the river and brook.

- A pipe crosses the river at SK0432337279, a short distance above the concrete weir. The pipe forms a low weir with a head loss of approximately 0.5m (Figure 1-e, Photo).

The weir at the channel split (Figure 1-a) formerly had sluice gates, but now the relative flow down each channel is determined by the fixed crest height of the weir. The weir is in a poor state of repair and the landowner has introduced concrete blocks to maintain the crest height and flow split. Bank erosion on the southern channel is a concern for the landowner and many areas on the outside of bends have been reinforced with rubble.

- Establishing a more natural river channel around Fole Mill, for example by utilising the course of the existing southern channel and creating new connections at the upstream and downstream ends. Potential benefits include designing a channel according to geomorphological principles to reduce the tendency for bank erosion, improve in-stream habitat, remove barriers to fish migration and reduce flood risk.
- Fencing and tree regeneration to reduce erosion rates.
- Re-meandering the river alongside Checkley STW where it is currently artificially straight.

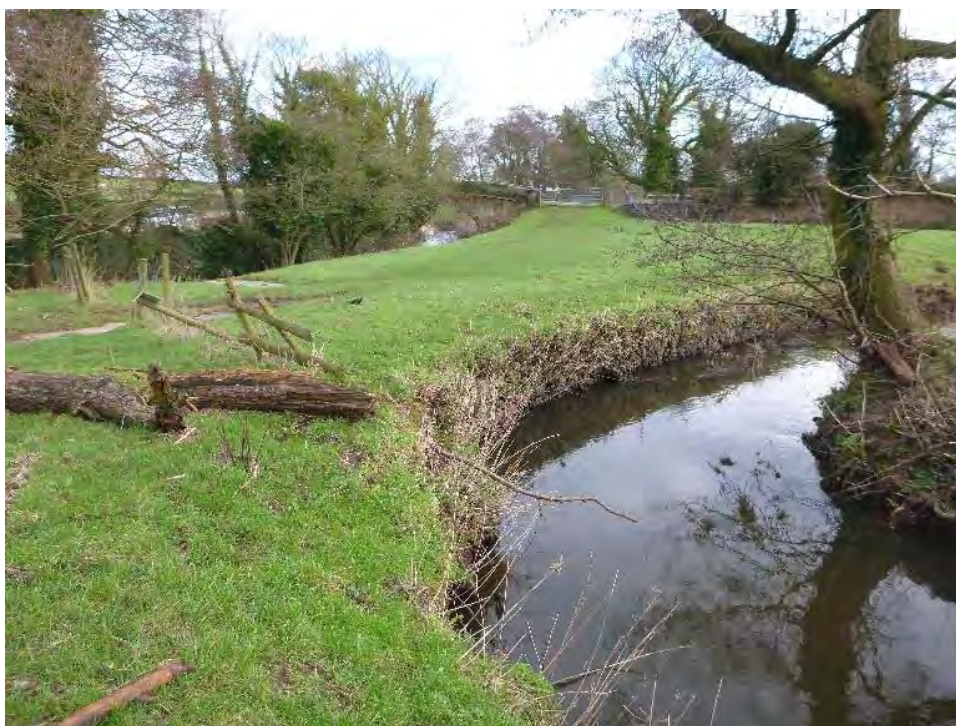
Photo 53 Flood spillway from southern into northern channel, with recent gabion bank reinforcement of LB of southern channel (foreground). Downstream view towards road bridge.

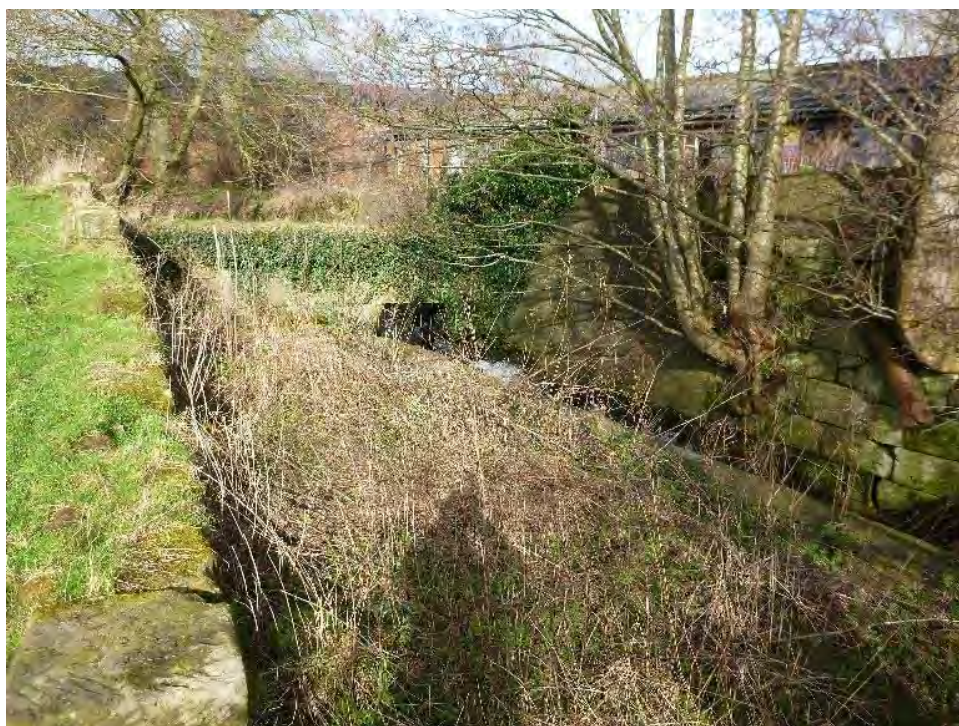
Photo 55 As above.

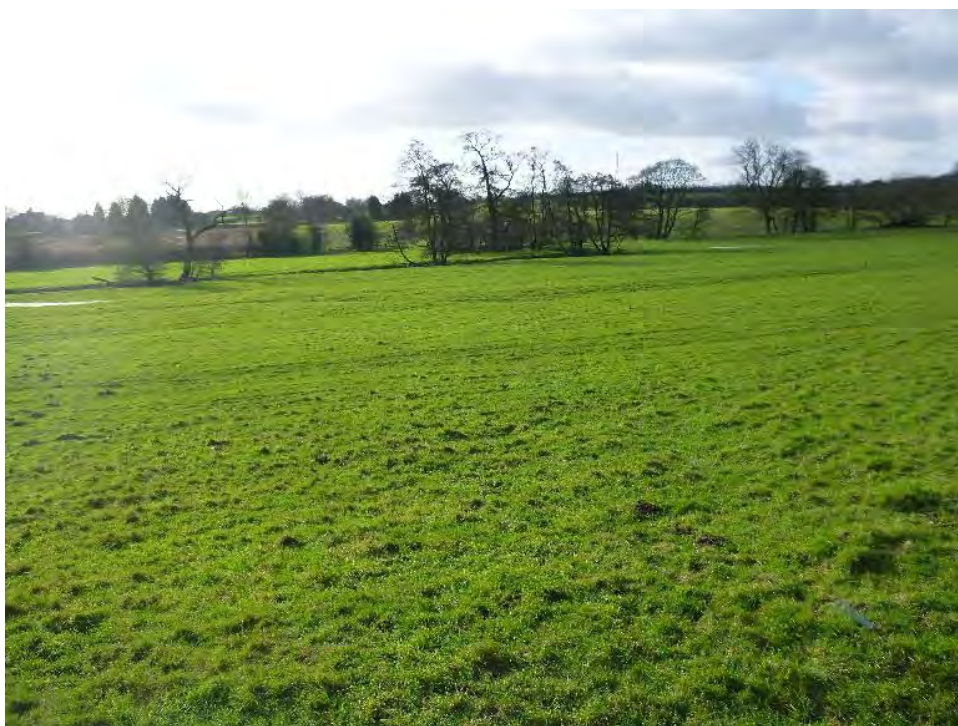
Photo 57 Lower lying ground looking towards southern channel from bank of northern channel (behind camera), at location of sluice C (Figure 1).

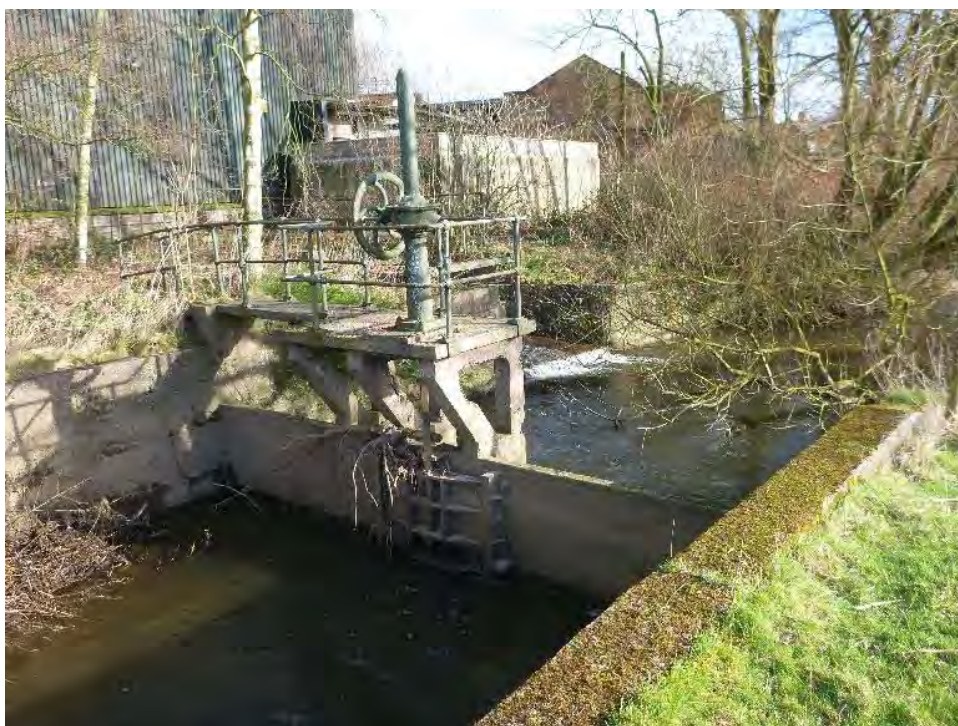
Photo 59 Weir and penstock sluice, just upstream of Broadgatehall Brook confluence.

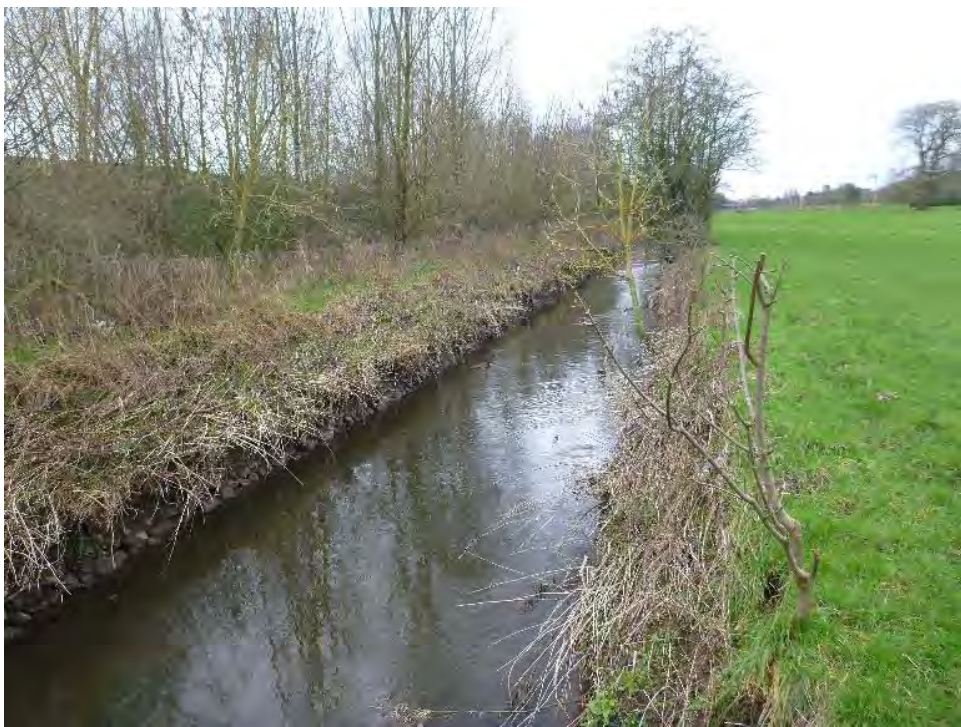
Photo 67 Alongside Checkley STW – straight channel, possible opportunity for re-meandering in field on LB (right of picture).

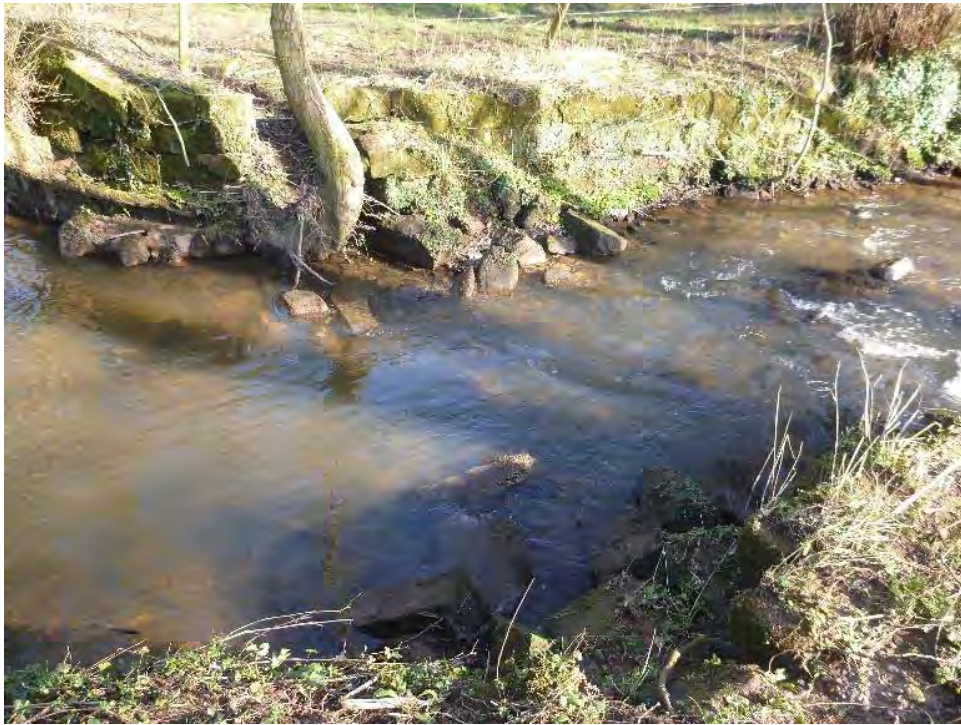
Photo 70 Former weir at Hey Bridge, Lower Tean.

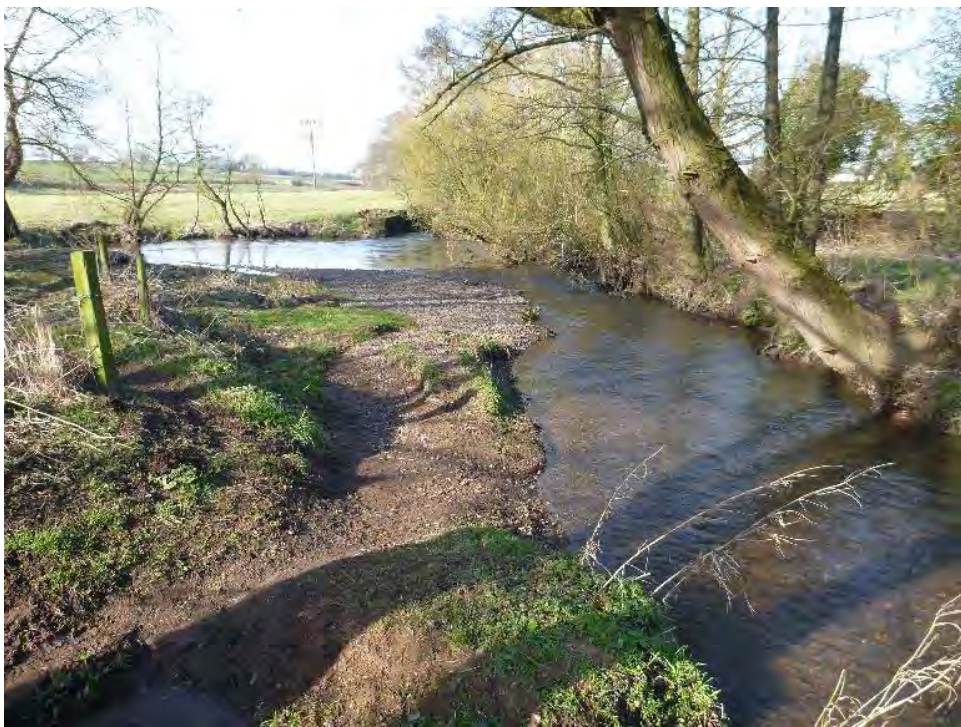
At the end of Mill Lane, Lower Tean (SK0140938544), there is a footbridge upstream of which is a former sluice structure and mill pool. The side walls of the stone-built structure remain, but there is no obstacle to fish passage. Upstream of this point, the channel is straight until just upstream of a bridge at Hall Green Farm (SK0127538718), where the meandering channel resumes. The straight channel suggests historic channel realignment and the lower-lying land to the west of the existing channel may have been the previous river course; this remains a route for flood water judging by debris on fences perpendicular to the valley. A former channel joins the river on the RB just upstream of the Mill Lane footbridge, which may be the downstream end of a previous river channel.

Photo 73 Upstream view from Mill Lane footbridge, Lower Tean, with sluice and weirpool in background.

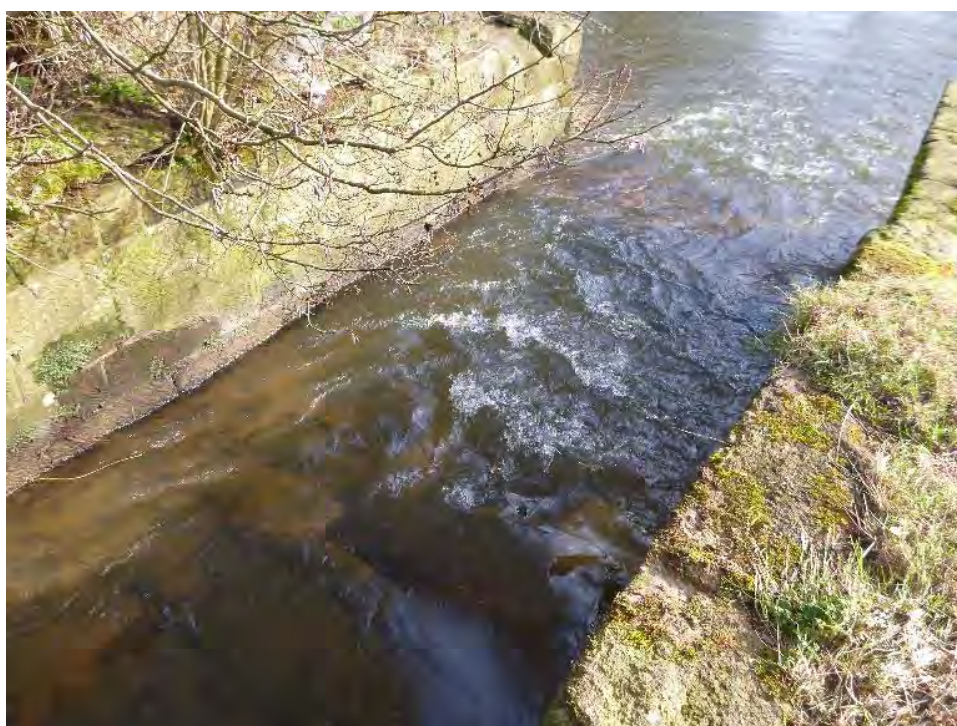
Photo 75 Mill Lane sluice (downstream end)

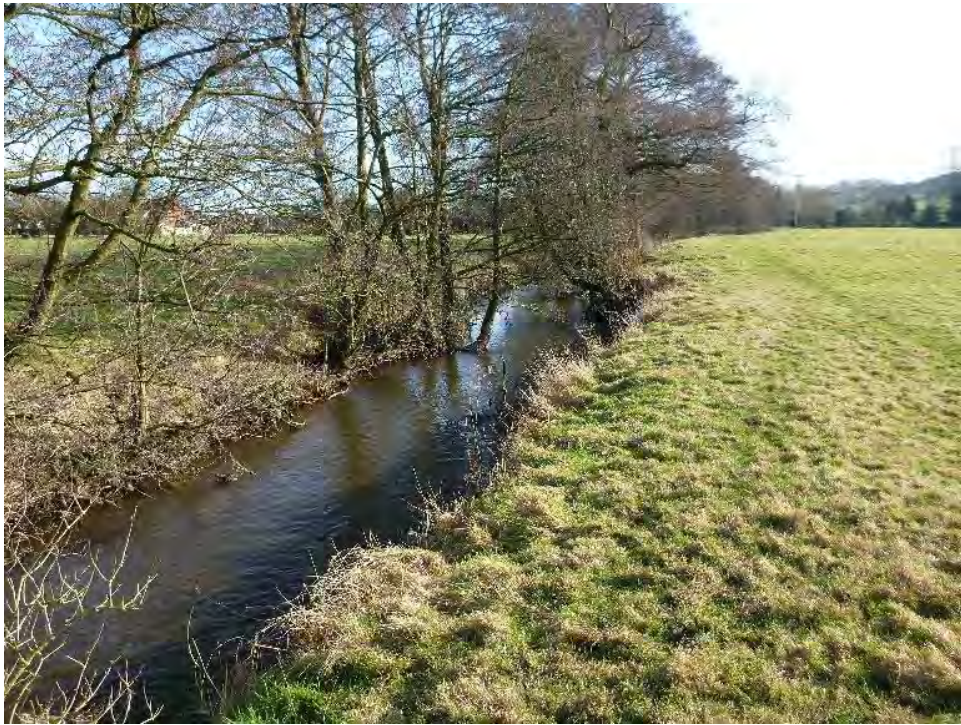
Photo 78 Straight channel downstream of Hall Green Farm.

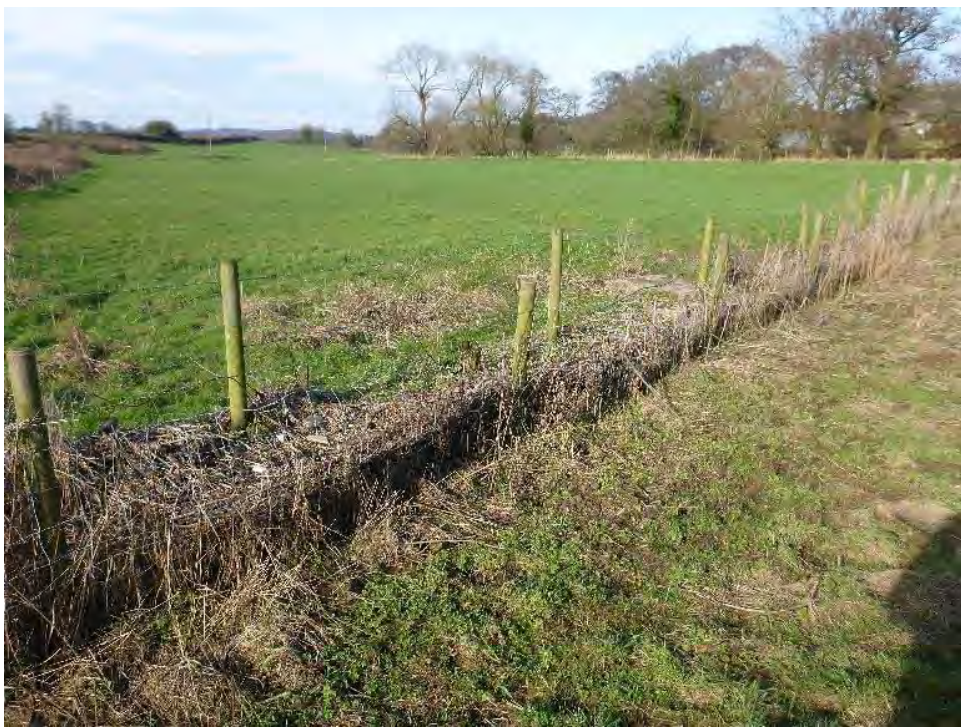
Photo 79 Lower lying ground to the west of the channel (tree-line, background, right) near Hall Green Farm, with flood debris on the fence.
