WILD TROUT TRUST

River Tove, Greens Norton, Towcester

Great Ouse (Upper) Catchment

2024

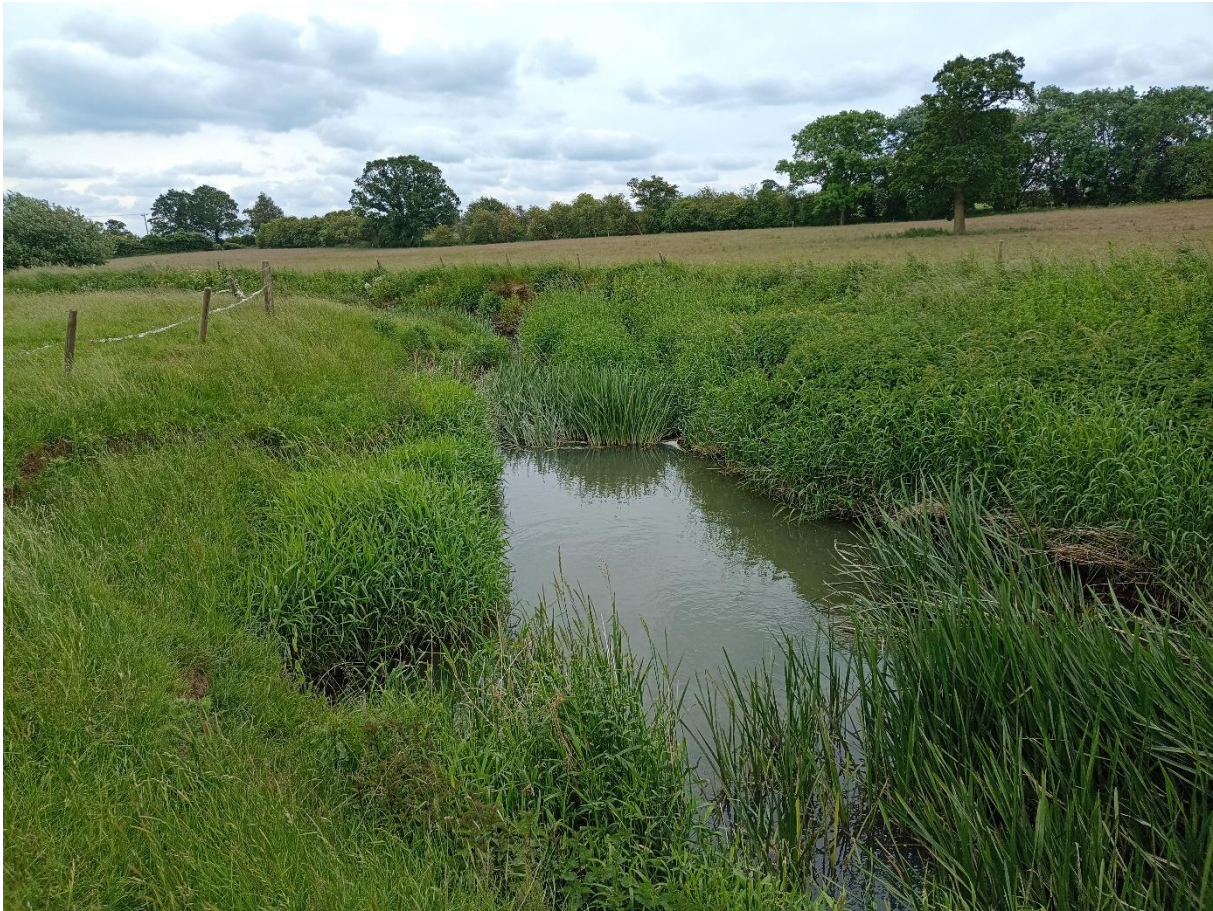
Figure 2. The Tove just downstream of the confluence with the Blakesley Brook, showing the incised nature of the channel due to historical land drainage works.

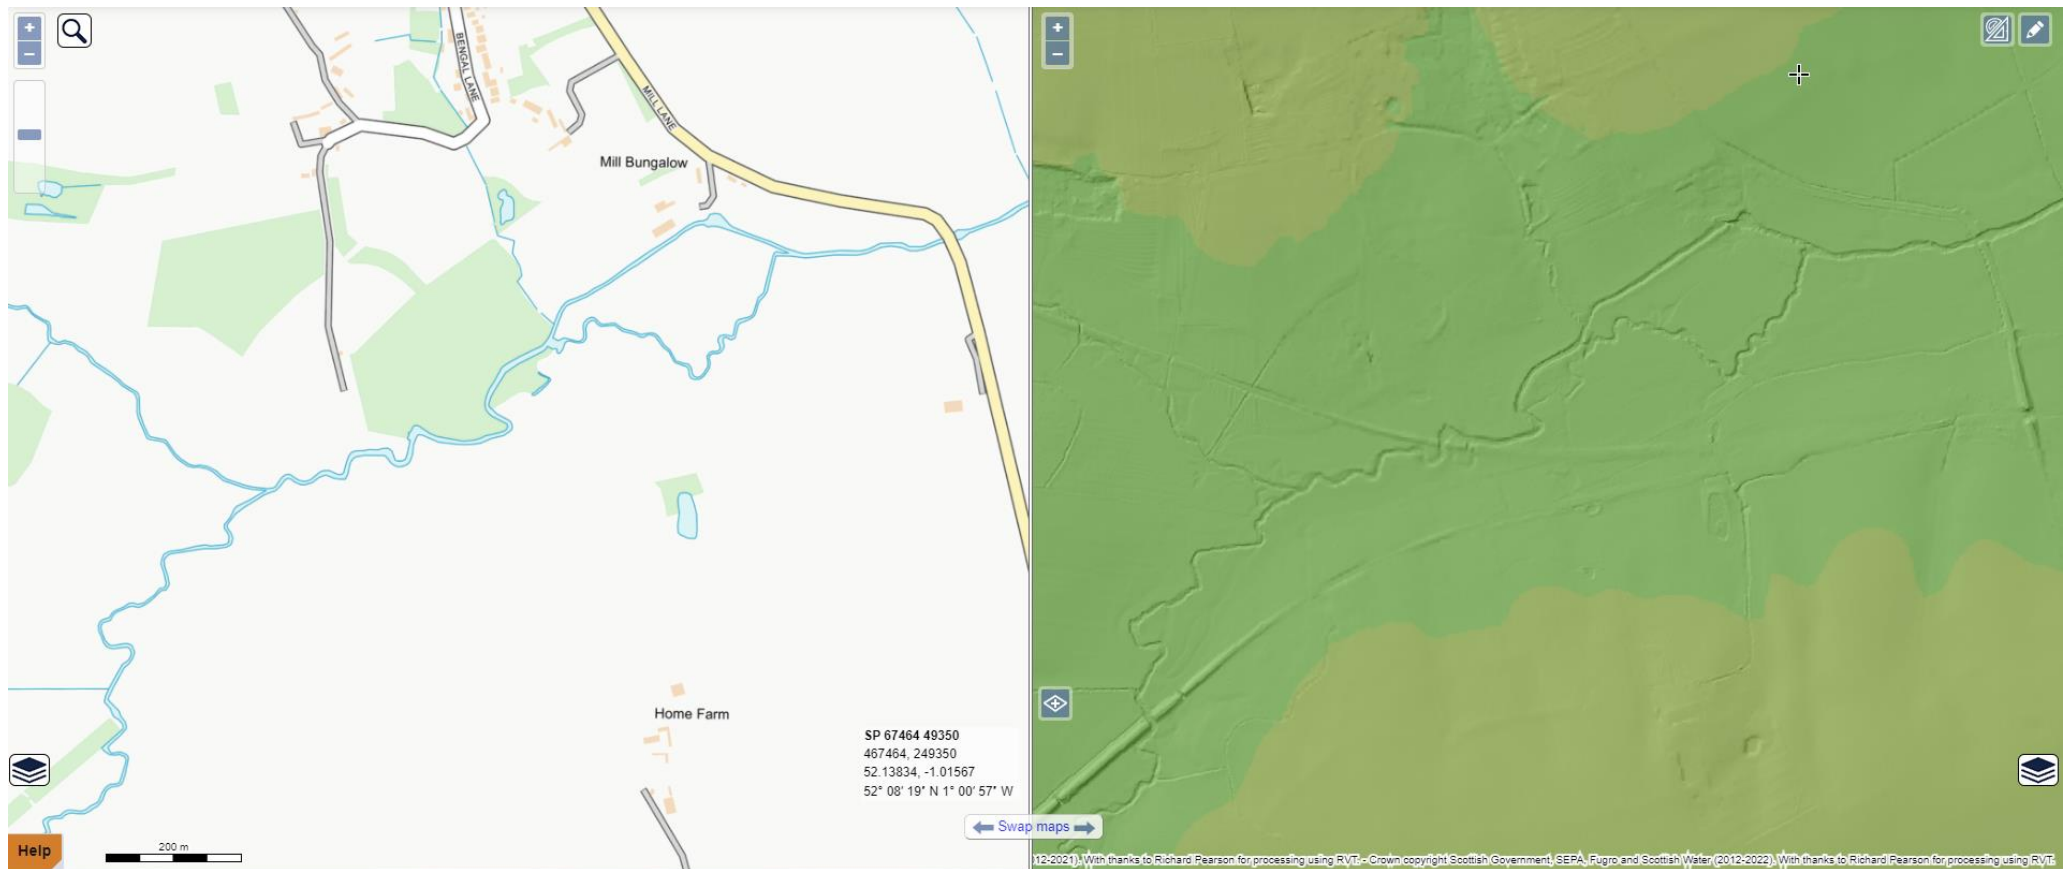
The maps in [Figure 3](#) - [Figure 6](#) give some perspective on the changes that have occurred. The LiDAR map in [Figure 4](#) shows the extent to which the Blakesley Brook has been straightened, the remains of numerous cut-off meanders visible as paleochannels adjacent to the current course. This occurred prior to the Victorian era OS map ([Figure 6](#)).

Figure 3 OS Opendata map (left) and LiDAR land level map (right) showing clear evidence of channel modification and the remains of railway embankments – see below for detail. <https://maps.nls.uk/geo/explore/side-by-side>

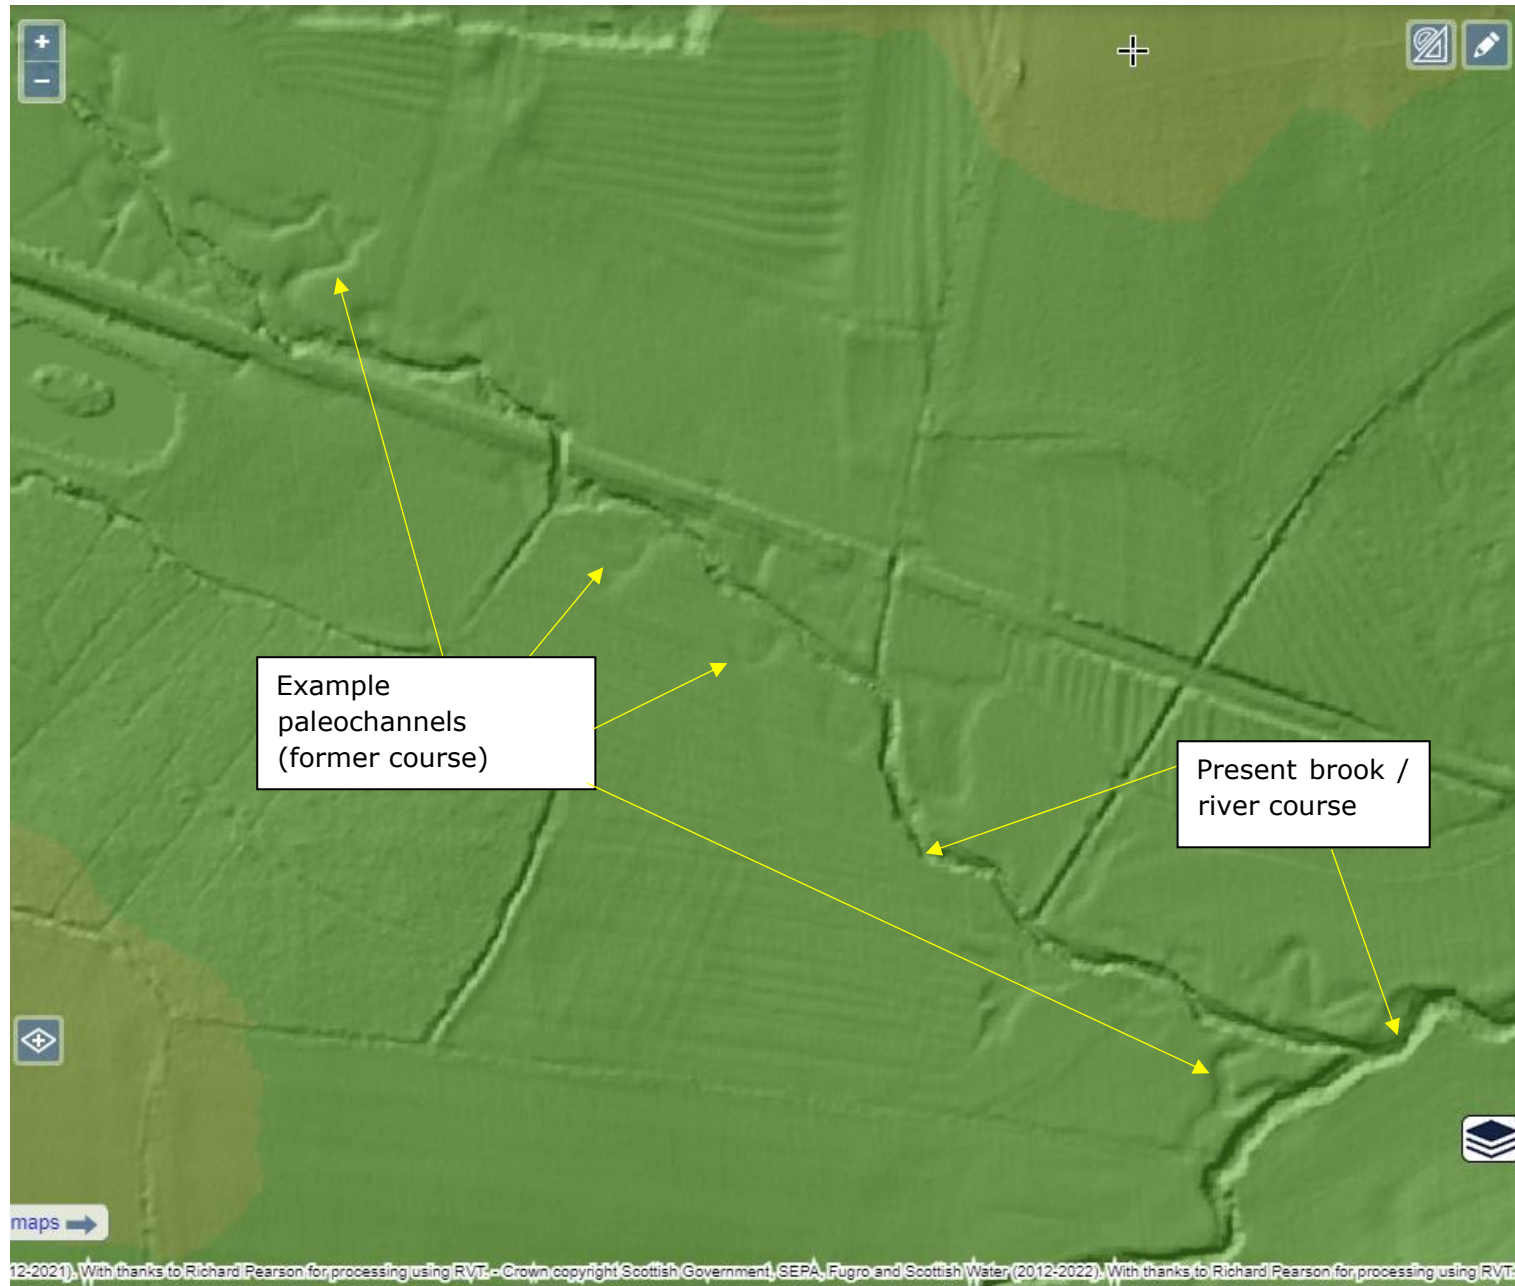
Figure 4 LiDAR map, detail of the Blakesley Brook at the confluence with the Tove, showing extensive paleochannels where meanders have been cut off by straightening (and likely deepening) of the river channel for land drainage.

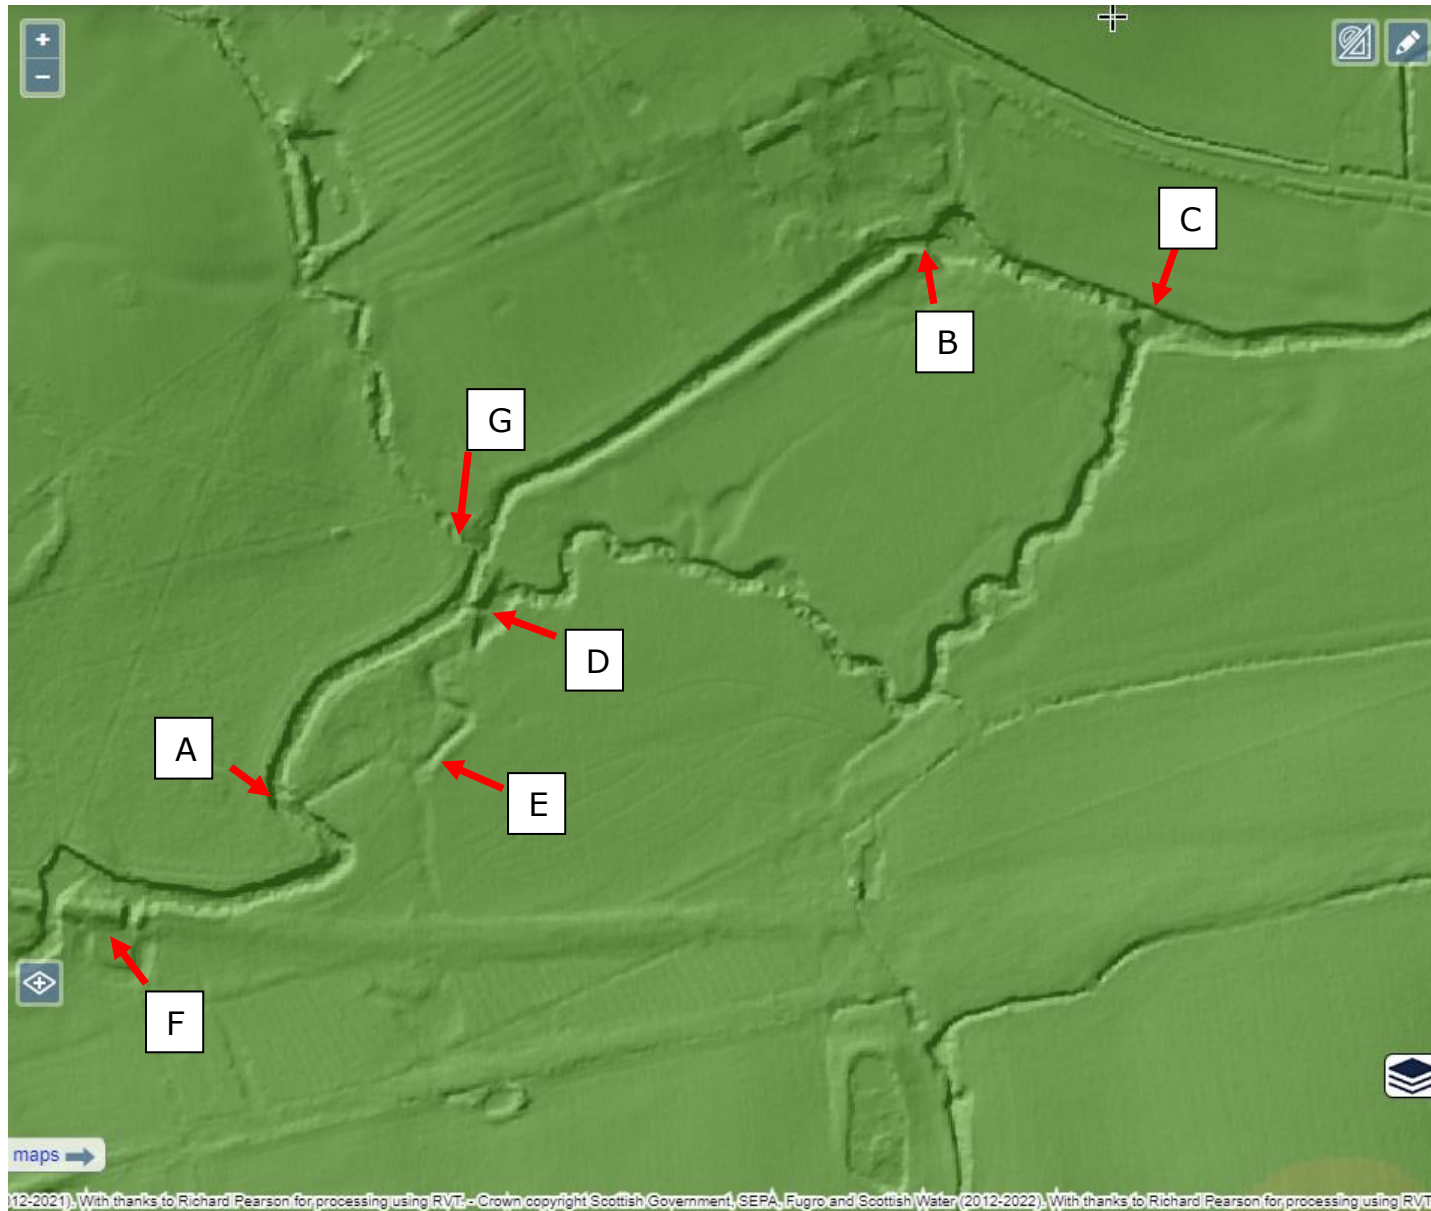
Approximately 250m downstream of the Blakesley Brook confluence, the Tove is crossed by a former railway embankment/bridge, then enters a high-level artificial cut (mill leat) leading to the site of a former corn mill (52.136191, -1.0175952), where an impounding weir remains ([Figure 11](#)). Partway along the mill leat, a proportion of the river flow overflows to a low-level channel (probably original river course) through a culvert pipe at 52.134752, -1.0204142 ([Figure 8](#)). Between them, the mill leat weir and overflow culvert create a barrier to fish, essentially preventing upstream movement. The two channels merge at 52.135991, -1.0152322 into an artificially widened, deepened and straightened channel leading to the road bridge at Mill Lane (52.136162, -1.0116836).

Figure 5 LiDAR map, detail of the Tove showing the mill leat (A – C, with impounding weir at B); overspill from leat into low-level channel - likely original river course (D); paleochannel of former river course (E); channel realignment likely due to railway construction (F); unnamed tributary stream (G).

Part way along the mill leat, a tributary stream enters from the left (north) bank, which drains from Bengal Lane just west of Greens Norton Hall (Point G, [Figure 5](#)). A storm sewer overflow discharges to this stream, the outlet from which has been relocated to avoid discharge to the pond in the hall grounds (landowner, pers. comm.). In 2023, this sewer storm overflow spilled 5 times for a total of 1.75 hours (permit number: AWCNF10017; <https://theriverstrust.org/sewage-map>).

Additionally, Greens Norton sewage treatment works, permit number: AW1NF1004 (52.134509 , -1.0251671) discharges to the Tove within this reach from the left (north) bank close to point F ([Figure 5](#)). The Rivers Trust sewage map reports: *In 2023, this sewer storm overflow spilled 87 times for a total of 1,599.38 hours, discharging into the River Tove.* 2023 was a particularly wet year which may account for the large number and long duration of spills, but the discharge of untreated sewage is a concern and may limit the potential for trout and other aquatic wildlife within this reach.

- Restoring the full flow of the river to the low-level, natural channel (between A and C, [Figure 5](#)) via the paleochannel (E); this would

improve in-stream habitat and restore fish passage.

- Bed-raising the above channel to encourage spilling onto the floodplain at lower return periods (smaller flood events).
- Retention of all / part of the mill leat as a flood spillway / source of flow pathways onto re-wetted floodplain / outlet for flow from north bank tributary.
- Further works beyond the boundaries of Figure 15, e.g. re-meandering / bed-raising / floodplain lowering of the Tove and Blakesley Brook upstream of the railway embankment.

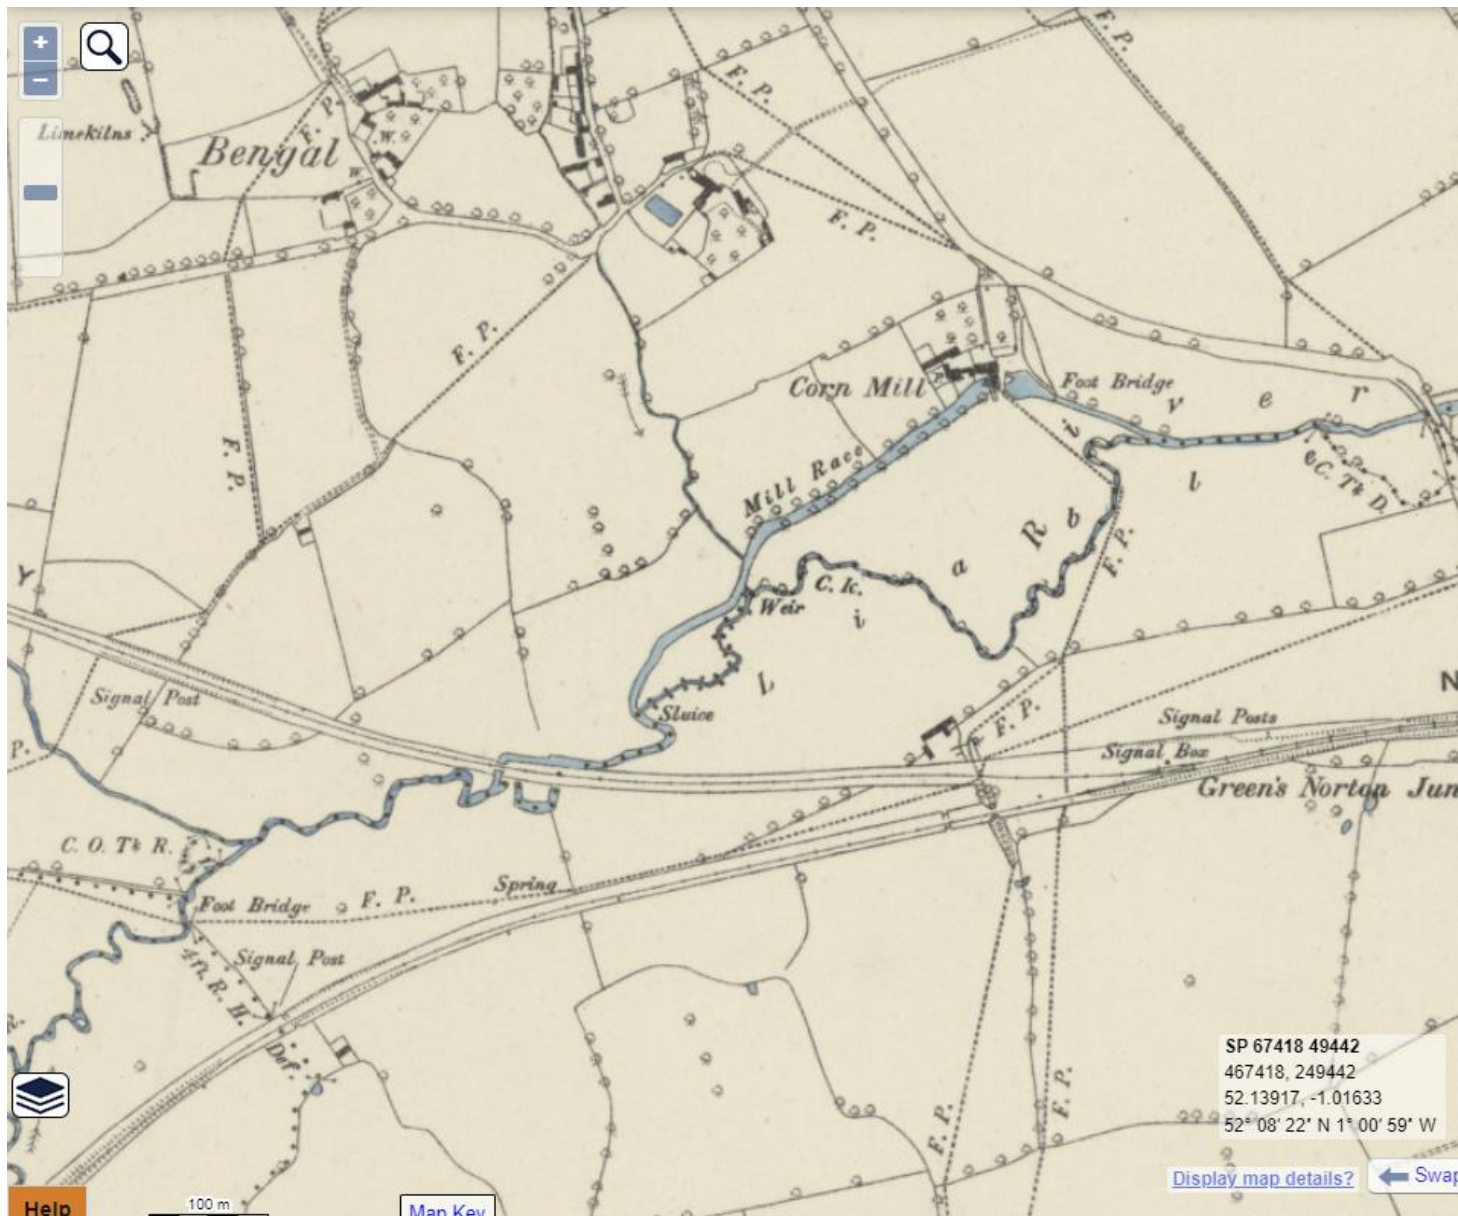
Figure 6 OS Six-inch series map (1840s – 1880s). Note parish boundary (dotted line) which often follow the original course of rivers/streams, even after the channel has been realigned.

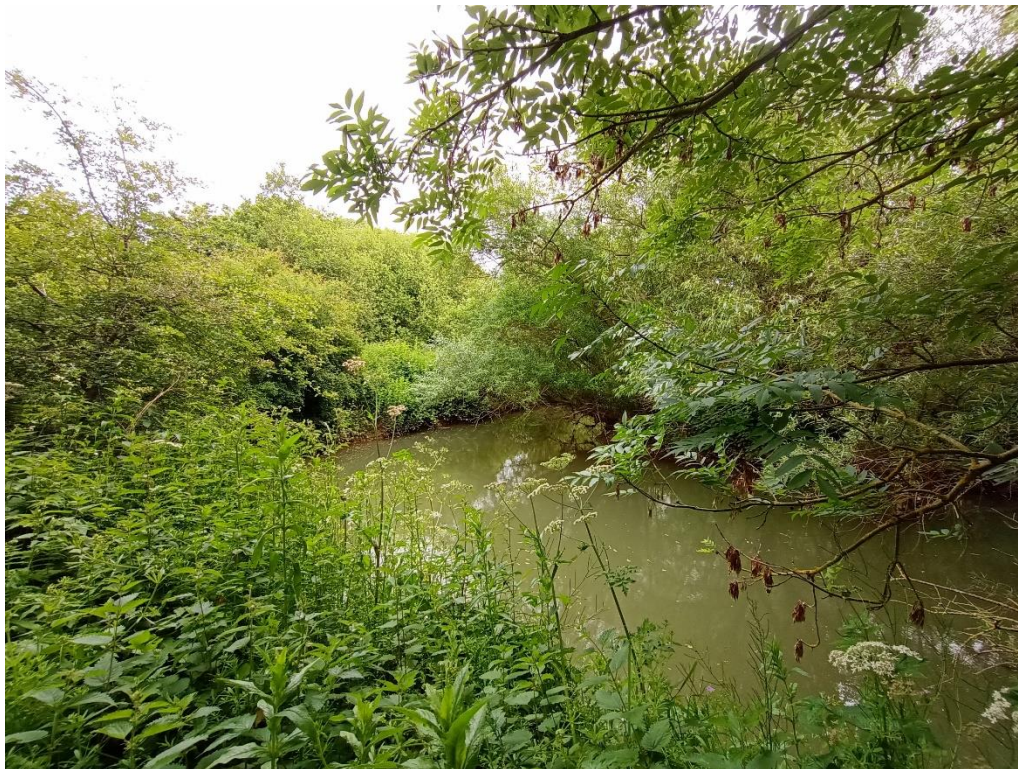
Figure 7 (52.133607, -1.0233754) Downstream of railway embankment, close to point F (from Figure 5).

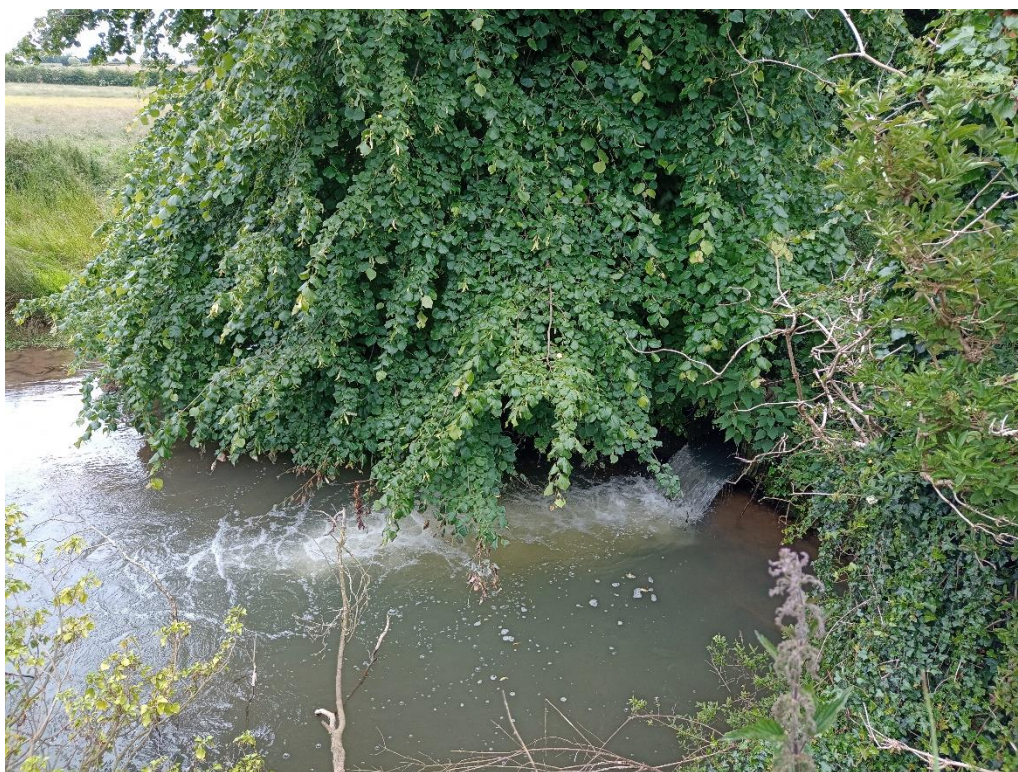
Figure 8 (52.134752, -1.0204142) Overspill from mill leat to river channel (point D, Figure 5)

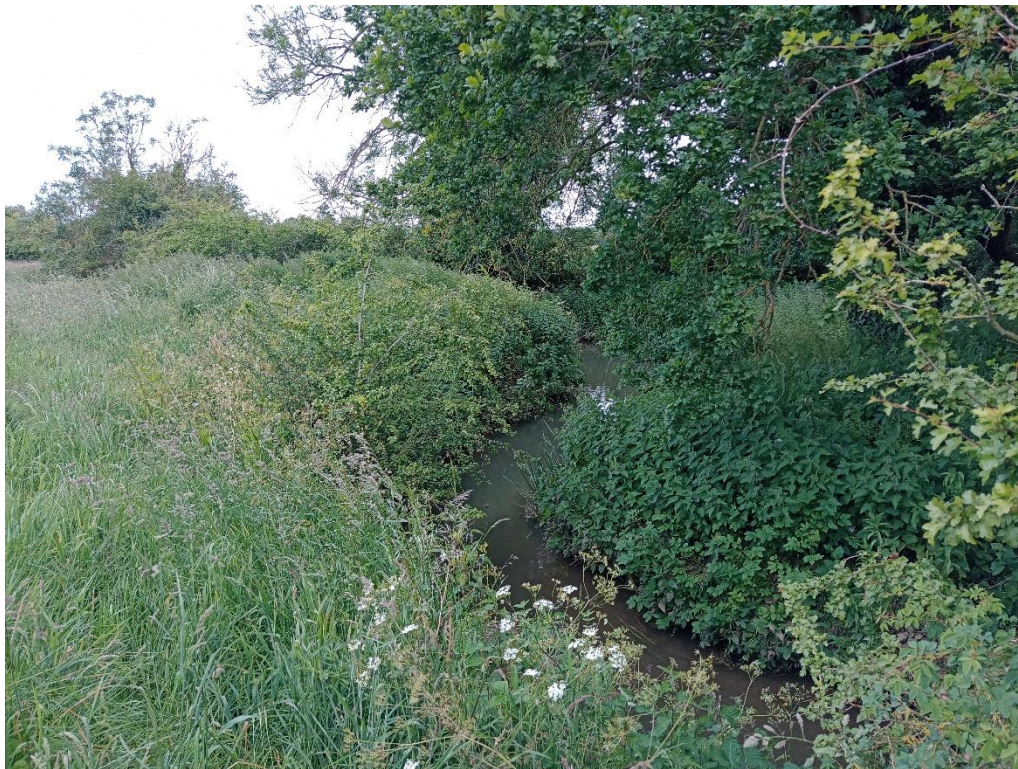
Figure 9 River channel between points D and C, Figure 5.

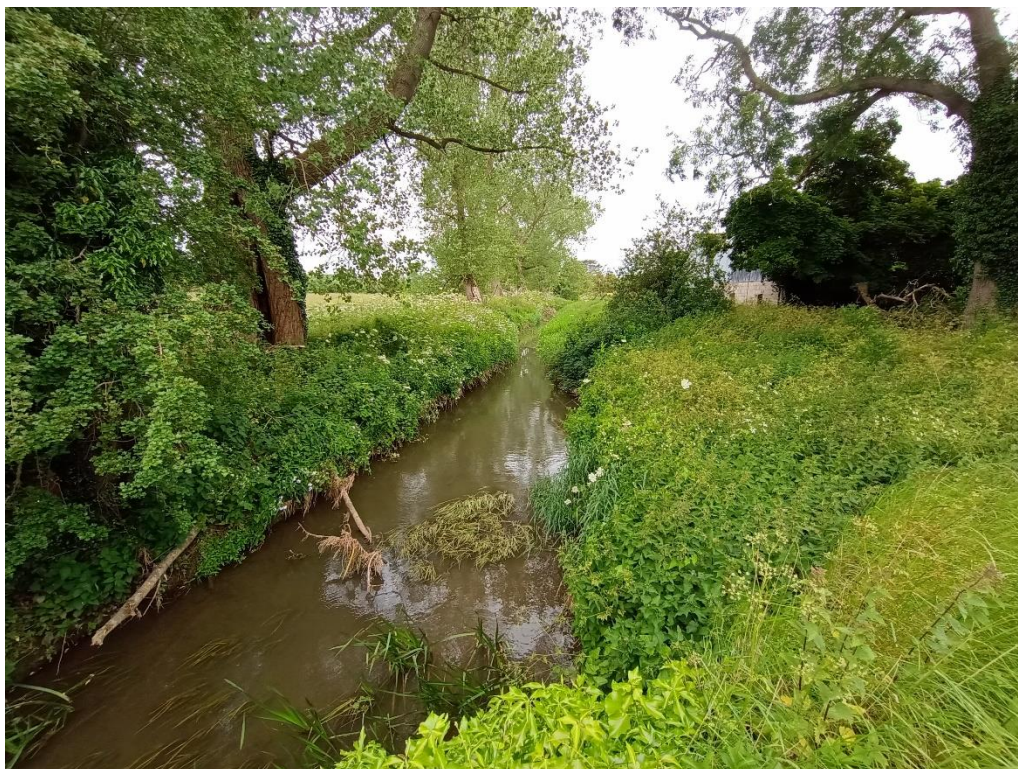
Figure 10 (52.136191, -1.0175952) Mill leat, upstream view from weir / former mill site.

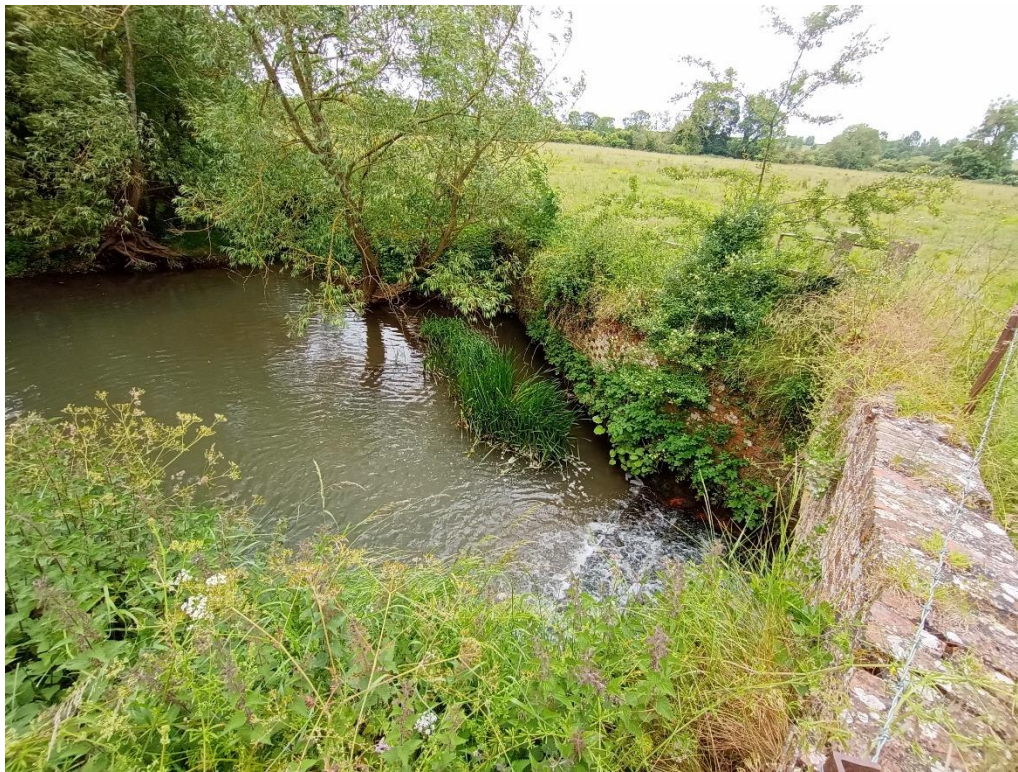
Figure 11 (52.136191, -1.0175952) Impounding weir on the mill leat at former mill site.

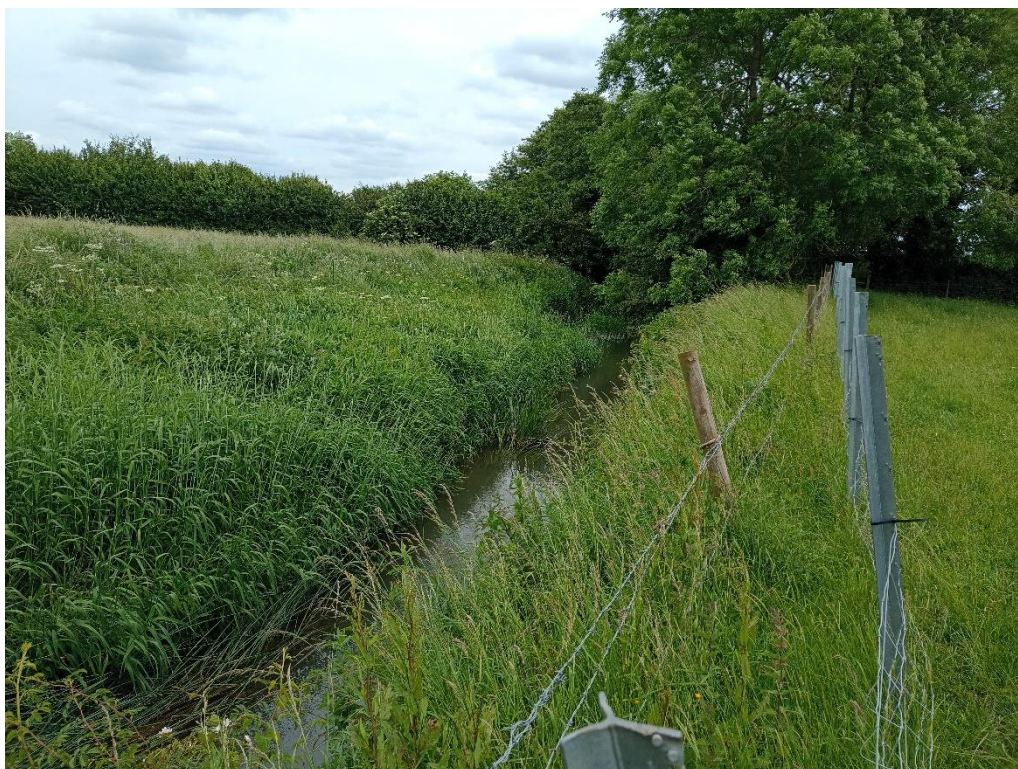
Figure 12 (52.136070, -1.0129470) River Tove upstream of Mill Lane road bridge.

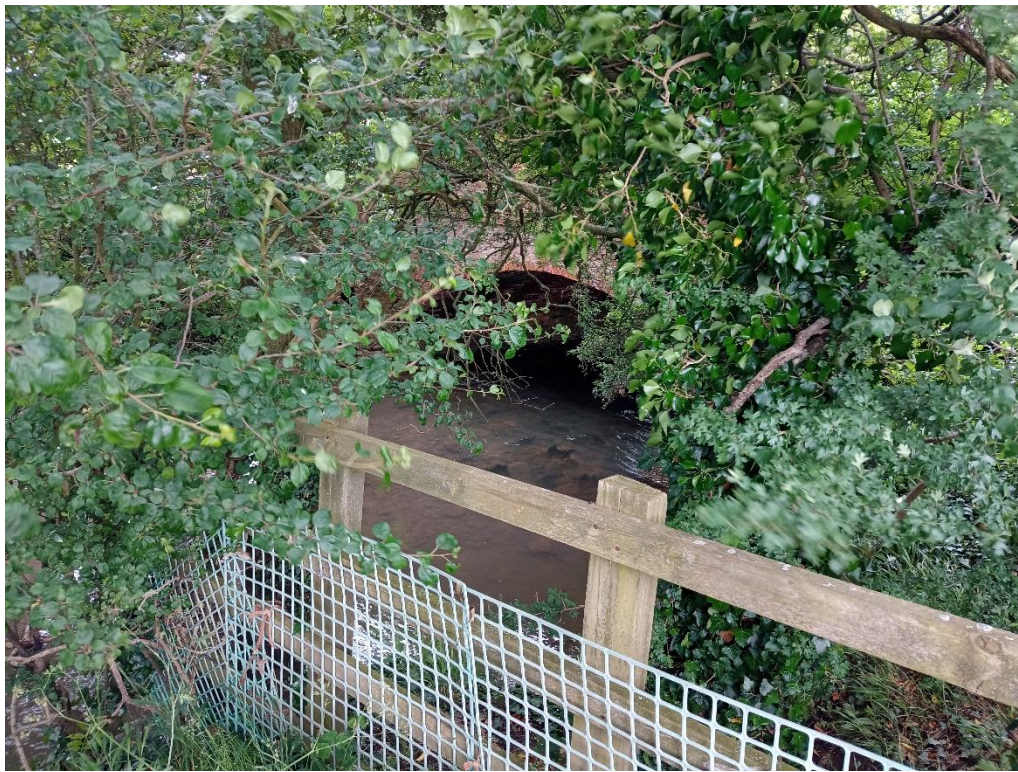
Figure 13 (52.136162, -1.0116836) Mill Lane road bridge.

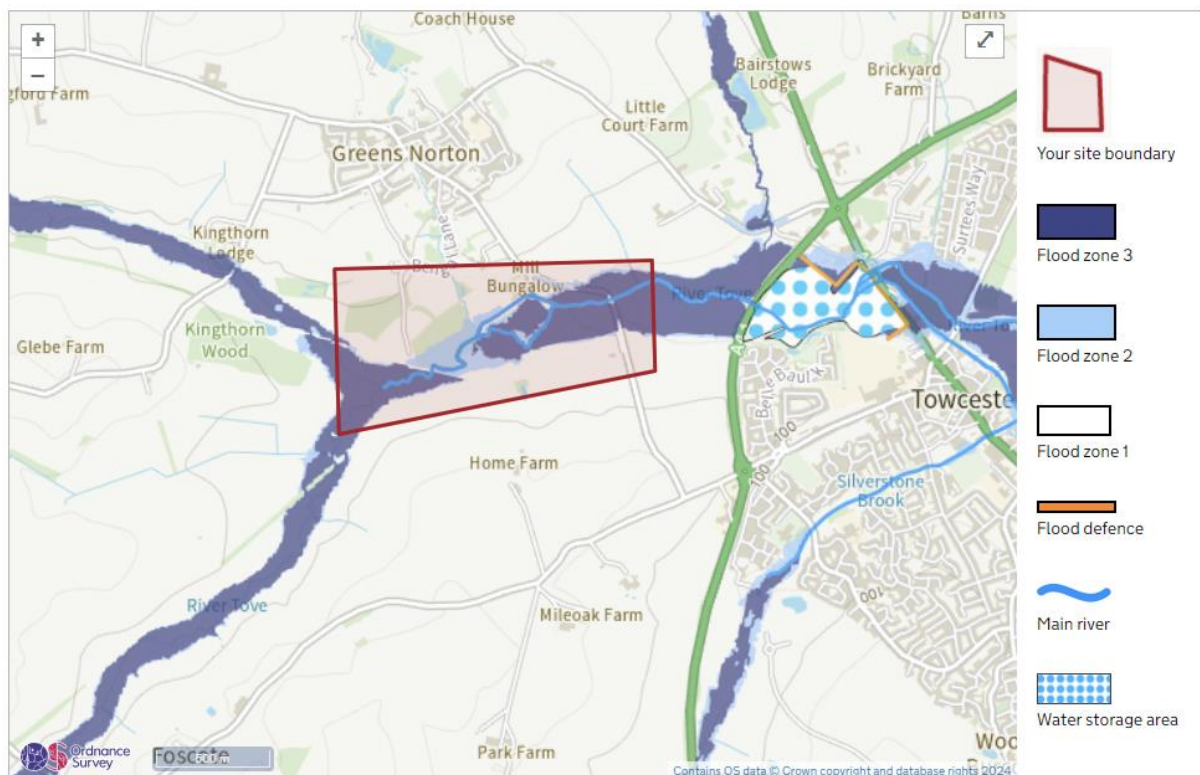
There is potential here for a river restoration project that could deliver multiple benefits, including habitat / biodiversity improvements and possible flood risk benefits to downstream areas. It appears from the flood map ([Figure 14](#)) that the railway embankment throttles back some flood flow. Also, there is a flood water storage area close to Towcester, so there is likely to be an existing flood model that could be used to develop ideas.

Figure 14 From <https://flood-map-for-planning.service.gov.uk/location>. Note the apparent throttle effect of the railway embankment on flood flows (flood zone 2 area within the site boundary). Also, an existing flood water storage area exists downstream of the A43.
