WILD TROUT TRUST

Tullaghobegly River

(Donegal)

June 2022

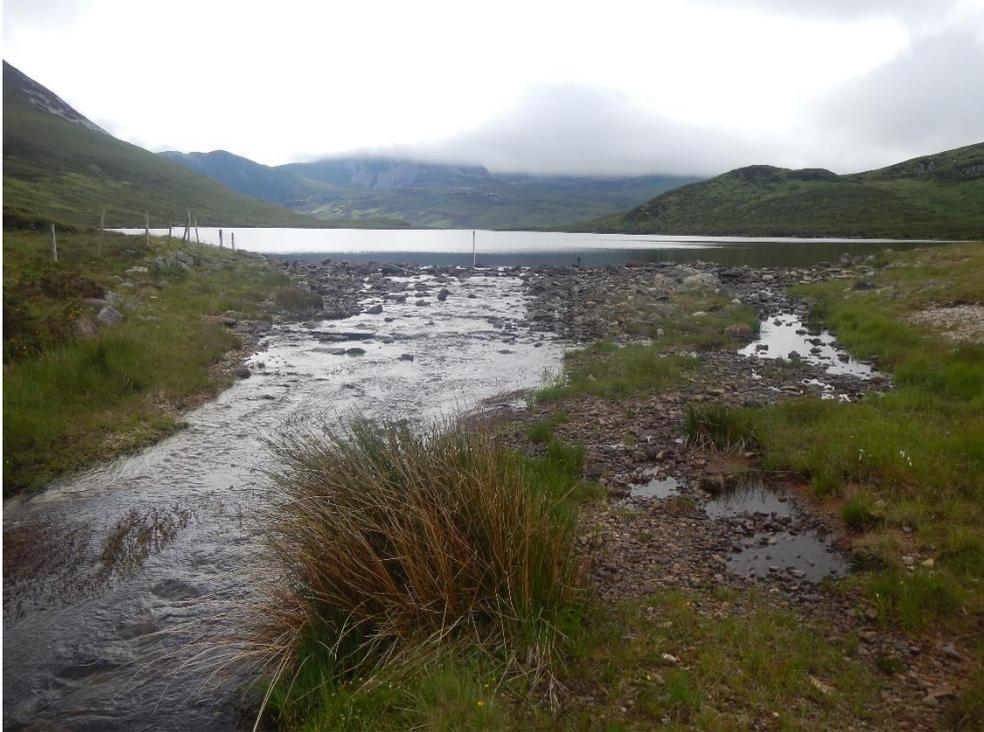
Figure 1 (55.073055, -8.095563). The first section of river was walked from Lough Altan, where the outflow appeared to have been raised with a boulder impoundment. The substrate upstream in the lough and immediately downstream was smaller diameter gravel, suitable substrate for salmonid spawning. Gravel was relatively abundant in the first <80 metres d/s of Lough Altan, where the gradient was low; however, the gravel supply is only likely to be occurring in very high flow.

Observation	Recommendation	Priority 1-3	Coordinates (Lat/Long)
Figure 1. Raised bed at outflow to Lough Altan	<p>Ideally, the raised rock overspill from the lough should be removed to:</p> <ul style="list-style-type: none"> • Reinststate a natural outflow and regular gravel supply to the river • Facilitate outlet spawning • Restore habitat at the mouths of inlet streams where they enter the lough 	1	55.073055, -8.095563
Figure 3. Drying of the outflow to Lough Altan and creation of a complete barrier.	<ul style="list-style-type: none"> • A hands off flow (HOF) should be applied to the Tullaghobegly River (Lough Altan), as is best practice for all watercourses, whereby a natural, continual flow from the lough is always maintained to the river (along with fish passage) • Undertake exhaustive salmon pearl mussel surveys within the depleted reach d/s of Lough Altan to ascertain whether they are present and, therefore, whether the abstraction is creating a potential impact upon those species within some of the best habitat on the river 	1	55.073055, -8.095563

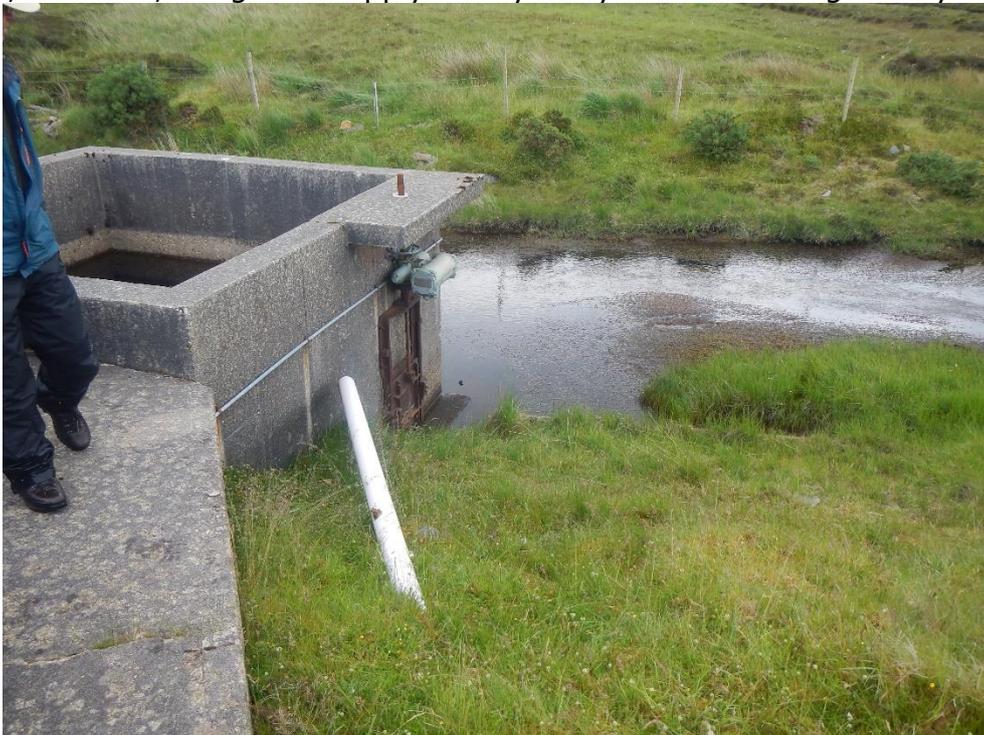
Figure 2. What appeared to be abstraction infrastructure was observed at the lough and several points down the river. It was not clear what aspects were still operational, but it is understood that the Mowi Ireland fish farm abstracts from the Lough, significantly depleting flow for the first ~1.5km of river d/s of the lough to the fish farm discharge. On the day of the visit, the fish farm discharge appeared to be greater in volume than the river on the day of the WTT visit (see Figure 16).

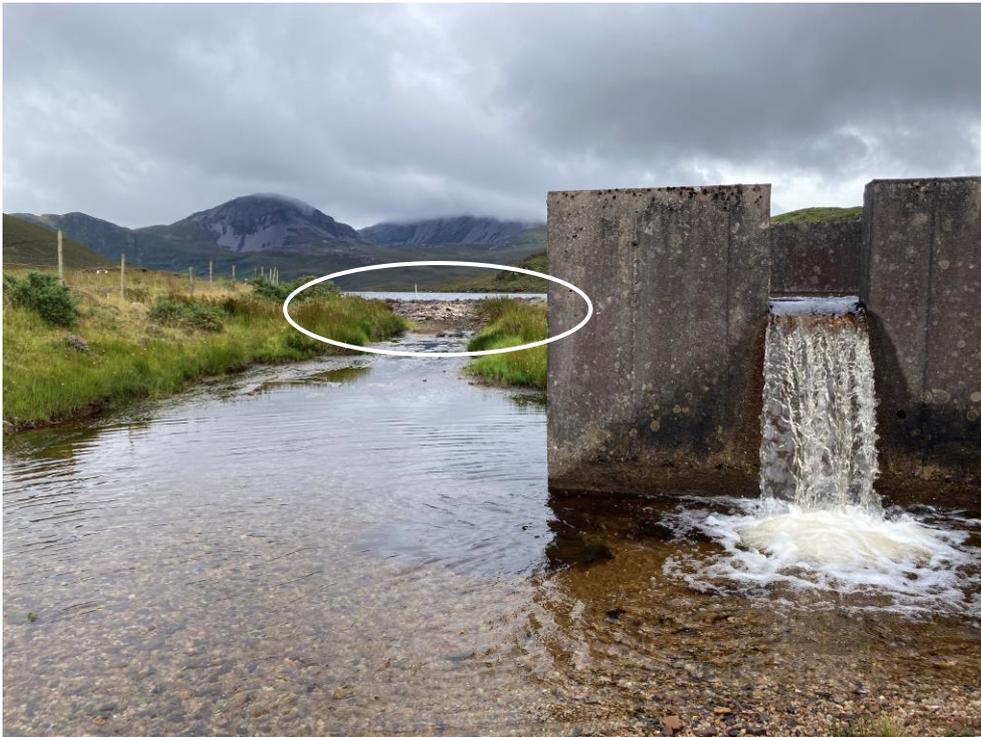
Figure 3. Following the WTT site visit, a photograph supplied by Cloughaneely AA (taken 18/08/2022), showed no flow passing over the boulder impoundment at the outflow of the lough (white ellipse), with the first section of the channel completely dry (and degraded for >50m of the first 80m of highest quality habitat d/s of the lough), and also creating a complete barrier to fish. At that time, what appeared to be a compensation discharge was occurring from the concrete infrastructure, but still left the impassable section and dry riverbed u/s.

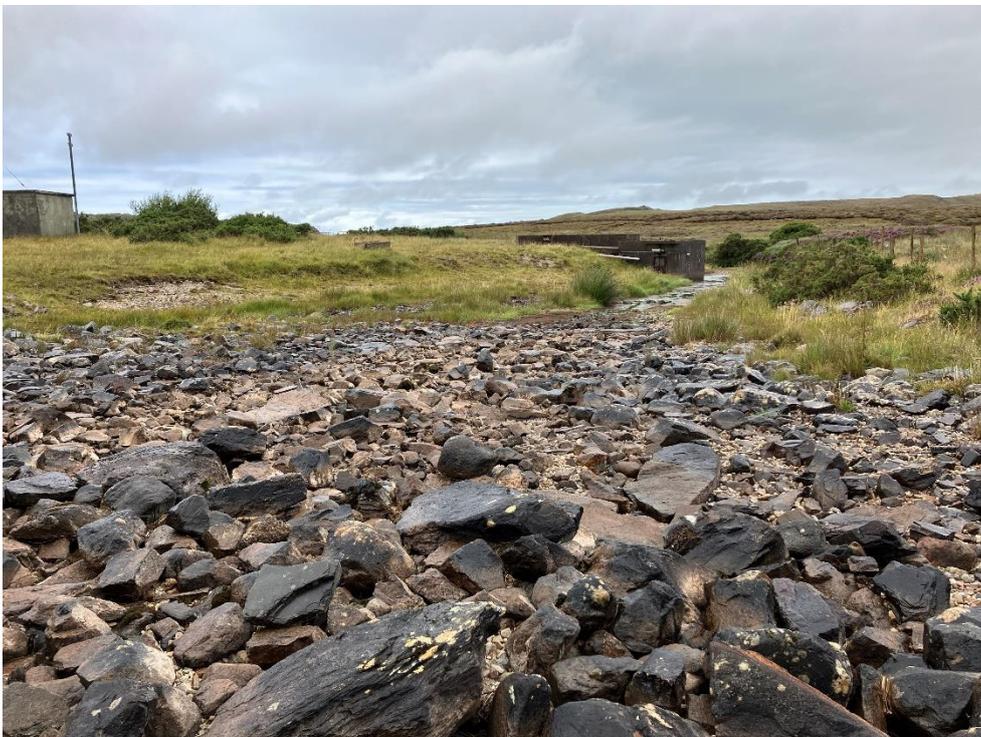
Figure 4. Looking down the completely dry channel d/s of the lough (18/08/2022). The raised cobble/boulder impoundment that facilitates this abstraction will have also raised the level of the lough, drowning habitat at the mouth of the inlet streams and potentially impacting upon salmonid spawning areas. Any outlet spawning populations would also be affected, with juveniles inhibited (most of the time) and sometimes prevented (as on 18/08/2022) from re-entering the lough.

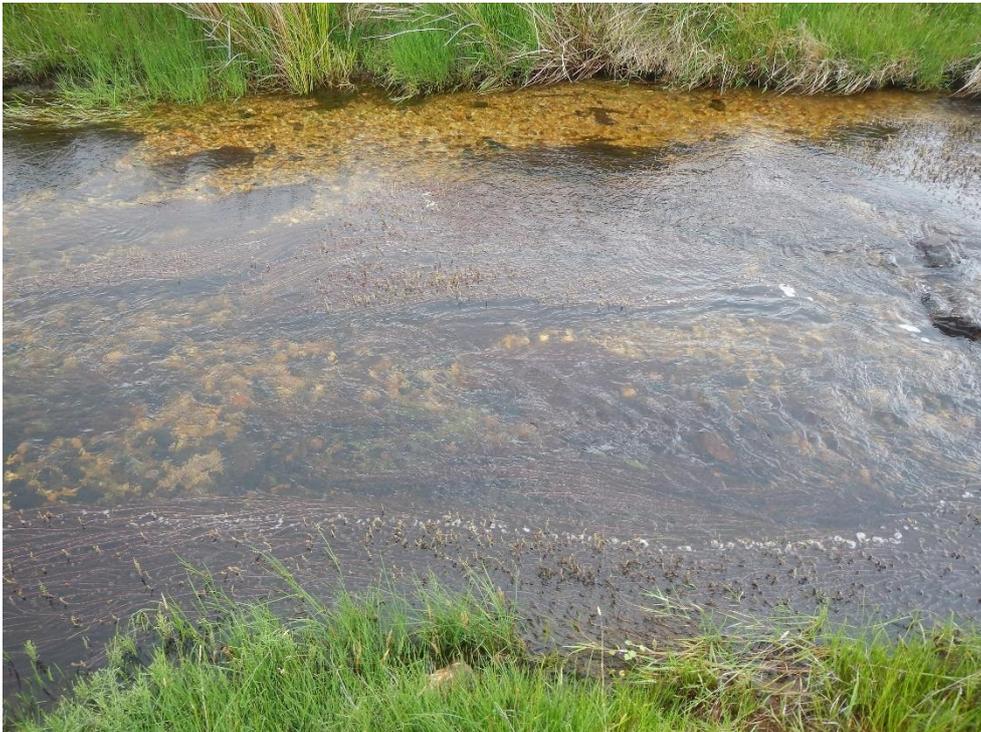
Figure 5. On the day of the WTT survey (with flow in the upper 50m of channel), where gravels were present, the river provided high quality habitat for salmonid spawning, invertebrates and potentially pearl mussels. Beds of aquatic macrophytes further enhanced habitat for juvenile salmonids and invertebrates. A large proportion of this higher quality habitat is lost when abstraction occurs at low flows (as on 18/08/2022).

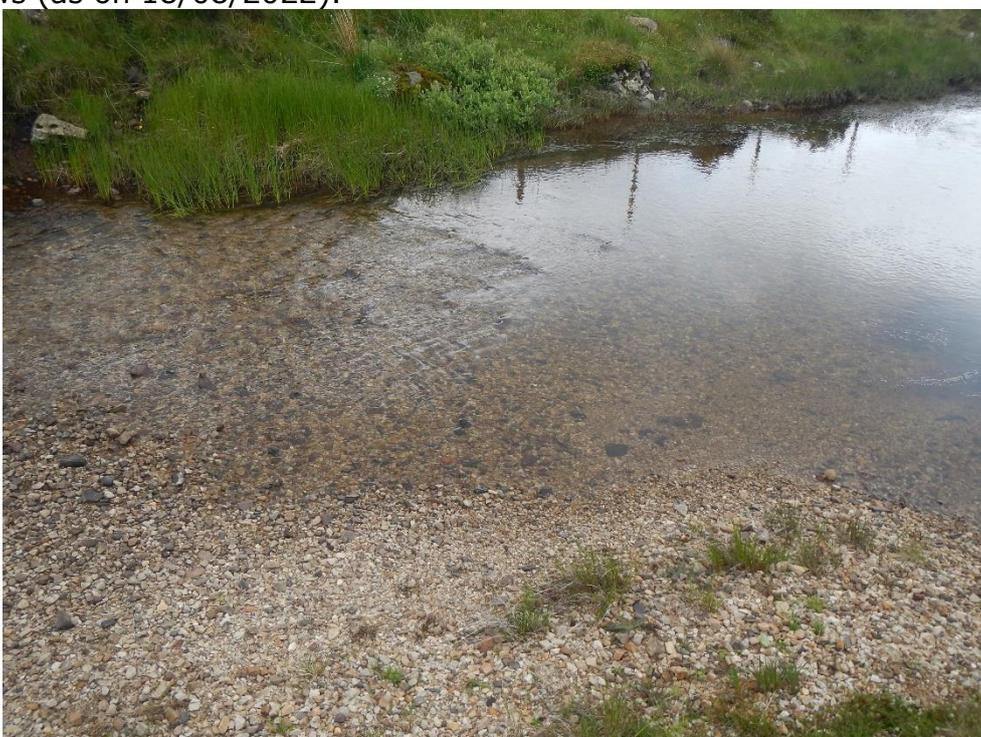
Figure 6. With flow, the initial ~80m section of the river d/s of Lough Altan provided the highest quality habitat observed on the catchment, with a near absence of fine sediment or algae, owing to the effect of the lough u/s. This could be an important area for salmonid spawning and pearl mussels. Records of mussels here are limited, possibly in part due to intermittent fish access past the two major natural obstructions d/s, the lough outflow impoundment, artificially reduced flow through abstraction and drying of the upper section, but that doesn't preclude the potential natural importance of the area to both fish and mussels.

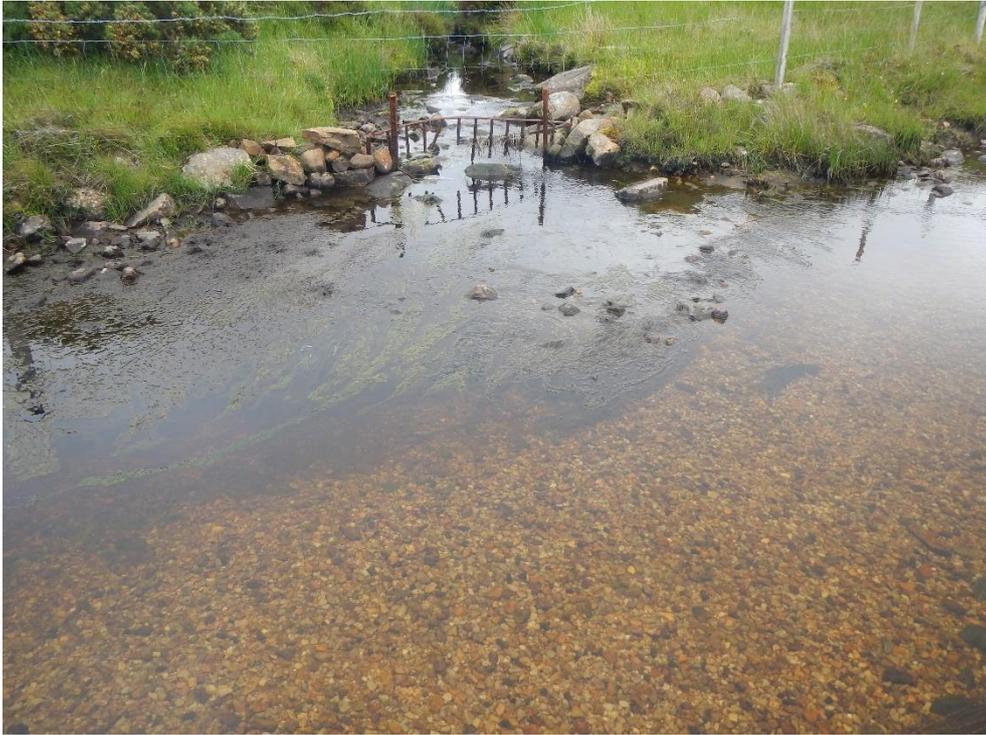
Figure 7 (55.073513, -8.095903). A RB tributary appeared to supply elevated nutrients, with strings of algae hanging from the aquatic vegetation. There are no properties or infrastructure on the tributary, so the only likely impact is peat degradation from draining or grazing/sheep scarring. Inspection of aerial photography (Google Maps) appears to show deep scarring of the watercourse. Livestock exclusion, revegetation and planting would be beneficial.

Observation	Recommendation	Priority 1-3	Coordinates (Lat/Long)
Figure 7. Small RB tributary supplying elevated levels of nutrients	Owing to the potential value of the main river habitat here, it would be worth investigating options to fence, revegetate and plant trees along the tributary	1/2	55.073513, -8.095903
Figure 9. Herbicide use along watercourse	<ul style="list-style-type: none"> • Maintain an unsprayed buffer along the watercourse. • Install a buffer fence 	2	55.075018, -8.097695
Figure 10. Channel straightening	Channel restoration to reinstate the meander	1	55.075538, -8.098513
Figure 13. Emergent vegetation choking the outflow from Procklis Lough	Occasional inspection of the outflow to ensure it remains easily passable	2	55.078658, -8.099872
Figure 17. Highly polluting discharge from the Mowi Ireland salmon farm	<ul style="list-style-type: none"> • Seek further inspection and testing of the discharge • If the discharge is within its operating conditions, seek revision of those conditions to protect the water quality and habitat of the river (along with the dependent species) • Seek further, more effective treatment of the effluent from the Mowi fish farm 	1	55.082712, -8.098777

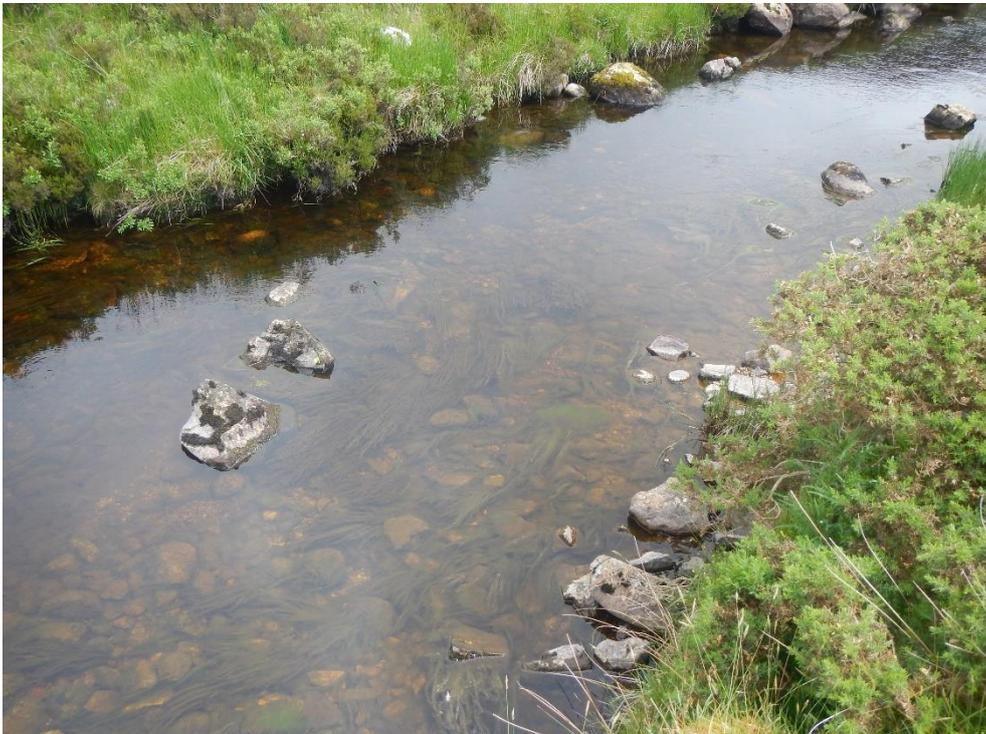
Figure 8. Downstream of the tributary, the substrate was very different in appearance, with a significant coating of algae. Also note the change from a predominantly gravel bed to cobble and boulder. From this point d/s, the gradient increases for several hundred metres, where gravel greatly reduced. This was partially owing to the higher gradient, but also reduced/intermittent supply.

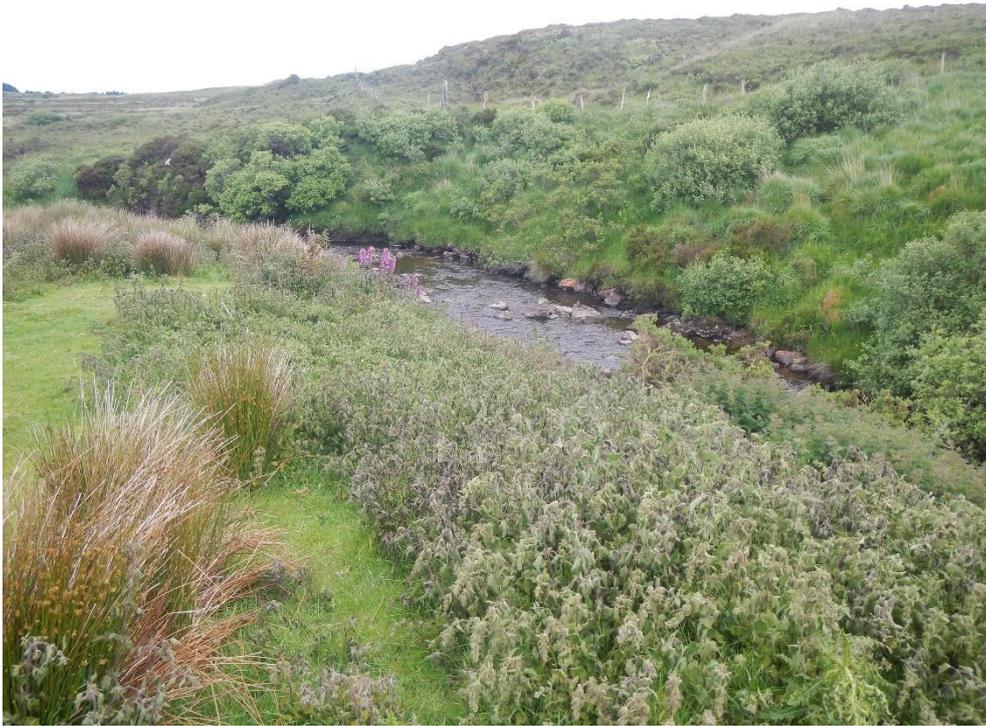
Figure 9 (55.075018, -8.097695). Herbicide appeared to have been sprayed on nettles alongside the water course. This should be undertaken very carefully and only by licensed operatives as it has the potential also to kill aquatic macrophytes within the water course. It would be far better to install fencing and leave an untreated buffer along the water course.

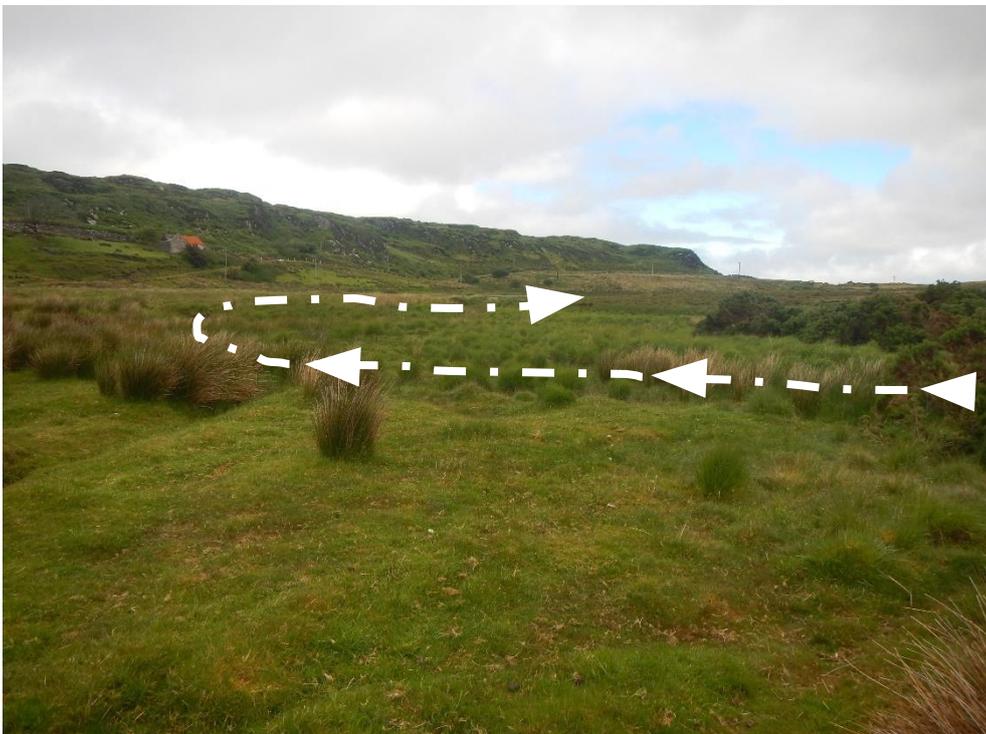
Figure 10 (55.075538, -8.098513). A section of the river had clearly been straightened, with a paleochannel evident in the adjacent field (dashed white line), removing the sinuosity of a valuable right-hand meander. Straightening shortens the water course, thereby increasing the gradient and reducing the potential to retain smaller gravel substrate in that area, which could otherwise provide additional spawning habitat. Reinstating this meander would improve the capacity of the area to support salmonids and pearl mussels.

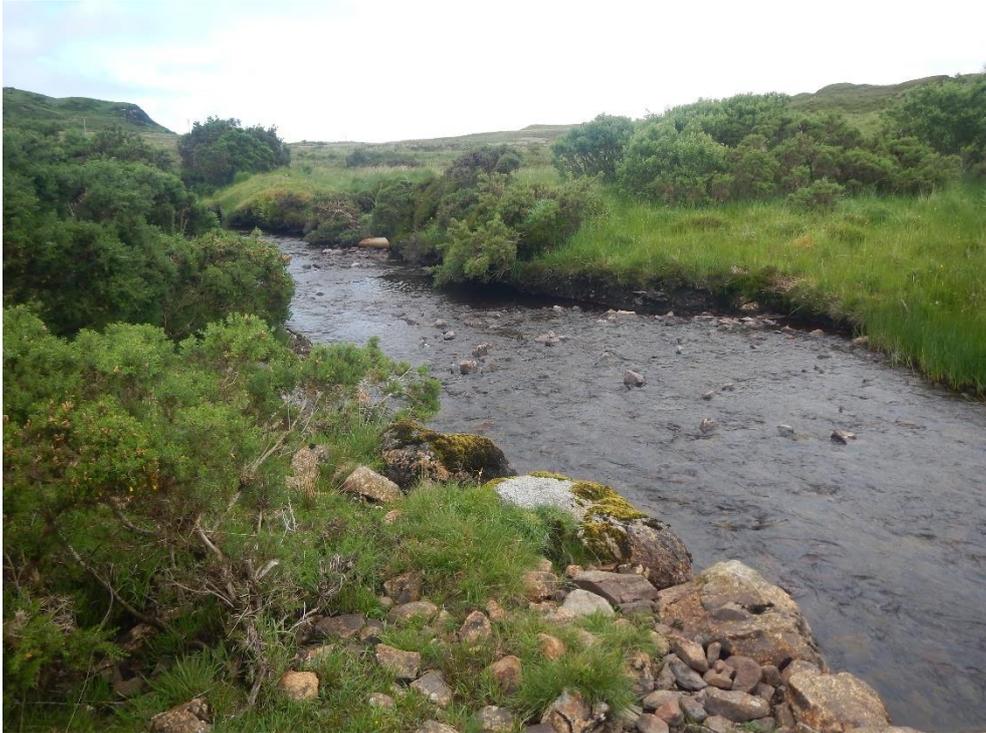
Figure 11. The detrimental impact of the straightening was evident in the steepened channel d/s, where bed incision was clearly occurring, with a lack of deeper pools, undercutting of the banks and a coarse cobble substrate.

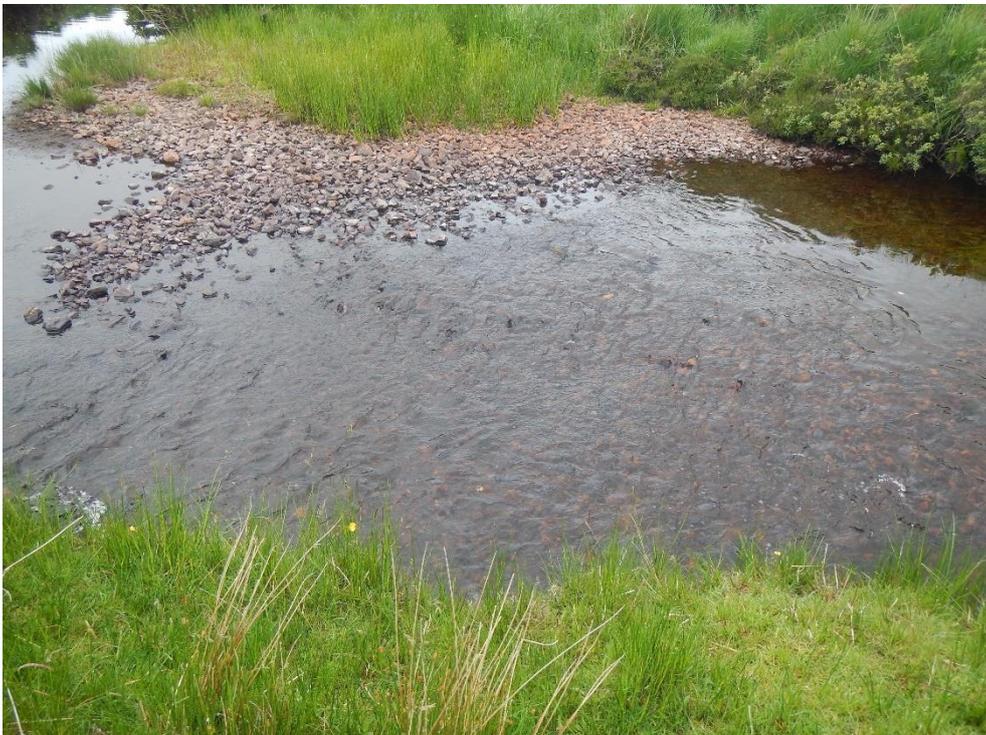
Figure 12. Downstream of the cut-off meander, where more bends remained, retention of gravel substrate suitable for salmonid spawning (and potentially pearl mussels) was again occurring. Even if access to this area is only possible for migratory salmonids in certain years, it could still preform a vital function in the long-term abundance of those populations, with high-quality habitat greatly benefiting the offspring of any fish that do gain access.

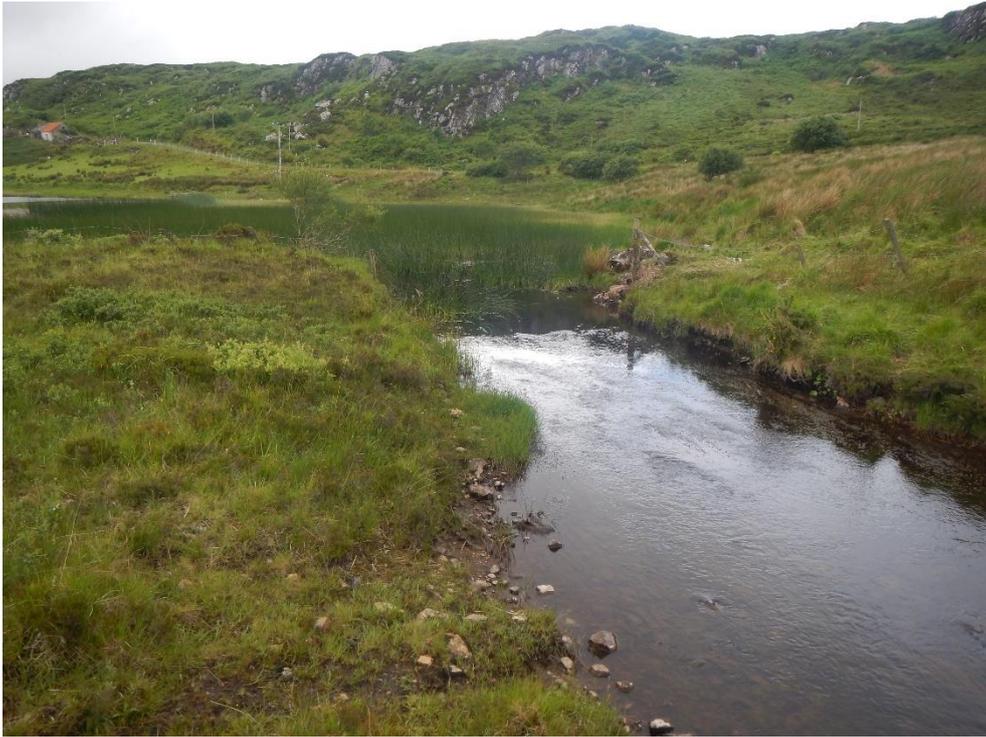
Figure 13 (55.078658, -8.099872). Extensive emergent vegetation growth at the outlet of Procklis Lough (a small, online lough) was almost certainly exacerbated by reduced flow down the channel, owing to the abstraction u/s, and potentially dredging/incision of the river channel d/s to drain the lough and surrounding land (see also Figure 14). This vegetation encroachment should be monitored as a series of low flow years could lead to further blockage, although it is to be hoped that high winter flows would ultimately maintain a free channel most winters.

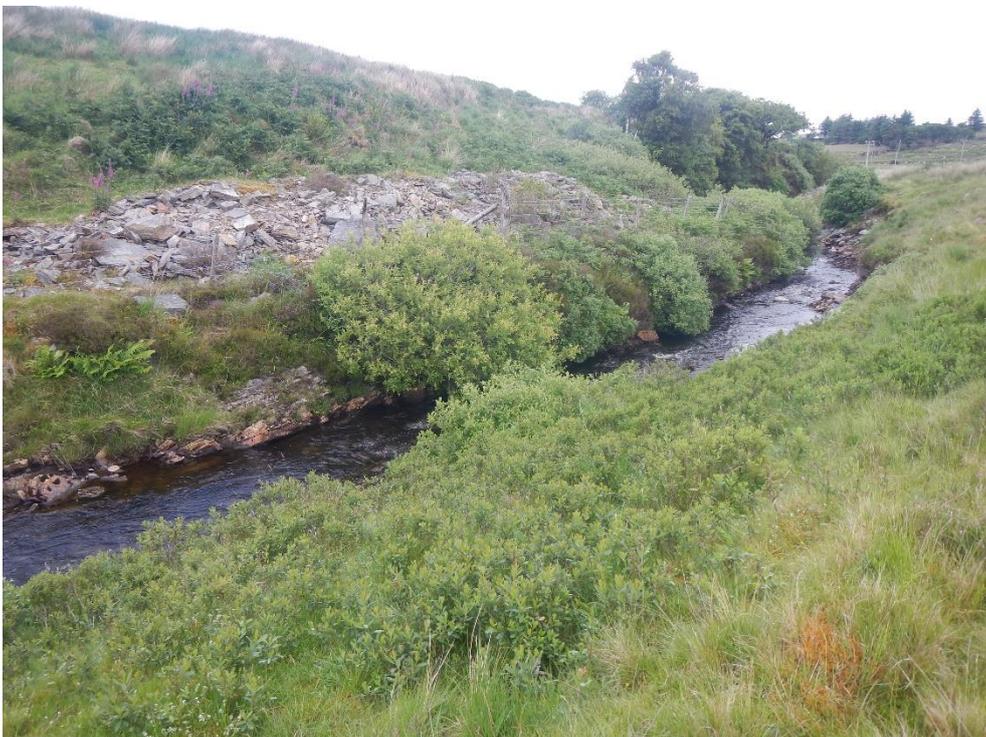
Figure 14. Downstream of the lough, the river channel appeared to have been incised down into the bedrock, potentially to drain the area around the lough and reduce its size.

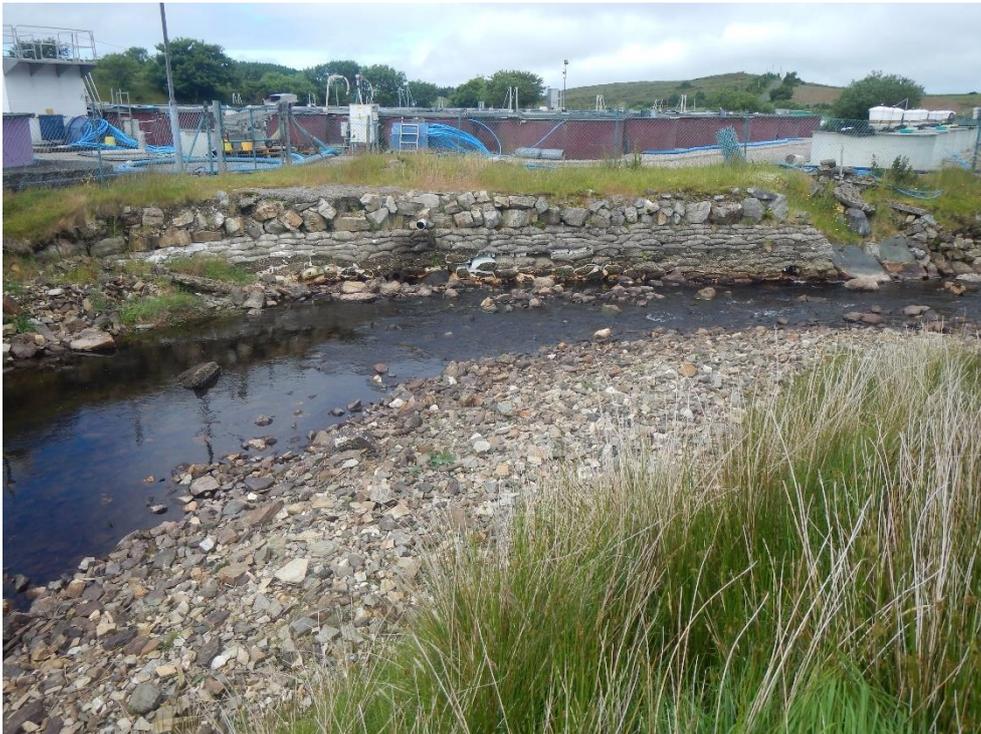
Figure 15. Inappropriate bank protection had been undertaken alongside the Mowi Ireland fish hatchery. It would be far better to have maintained a naturally vegetated and stable bank of appropriate size. The lack of diverse vegetation suggests that the bank is grazed. As that bank appeared inaccessible at either end, this may suggest livestock are crossing the river in very low flow, which could indicate further impact of the abstraction upon flows within the depleted reach.

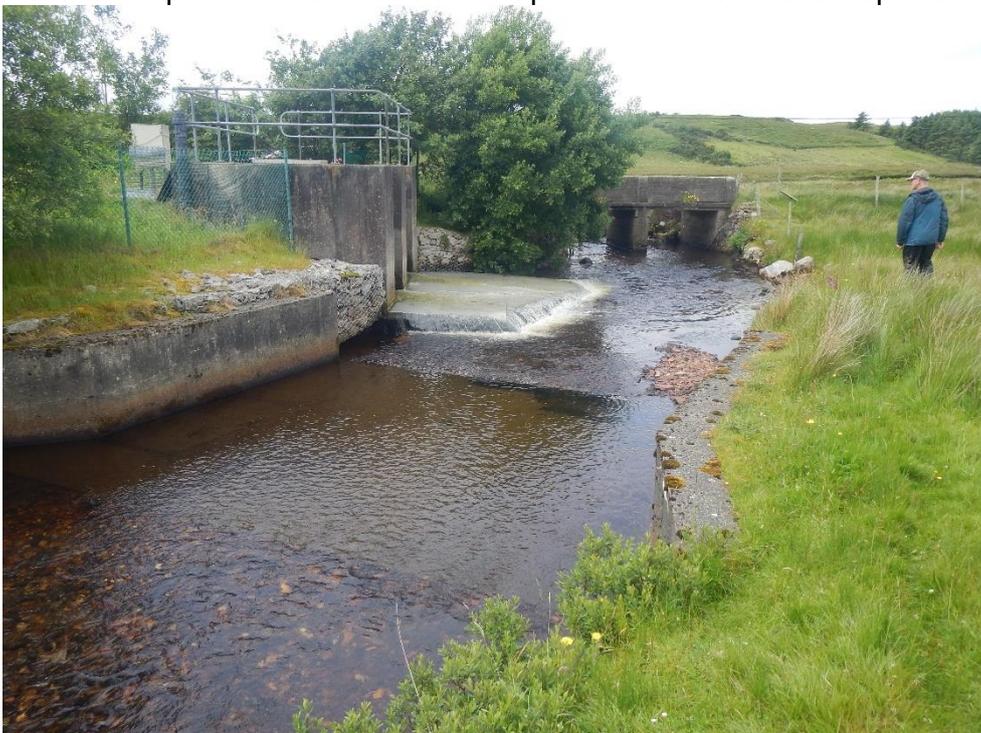
Figure 16. The Mowi hatchery discharge appeared to be greater than the flow of the river at the time of inspection. In most scenarios, a Q95 hands-off flow (no abstraction allowed below the flow volume that is exceeded 95% of the time) is the standard protection afforded to watercourses, but seemingly not in this case, demonstrating one of the many environmental issues with the industry. Whatever the abstraction regime and accepting that the site is licensed for its abstraction and discharge, that water should naturally be in the river, improving habitat quality and abundance and assisting fish passage through the now depleted river reach.

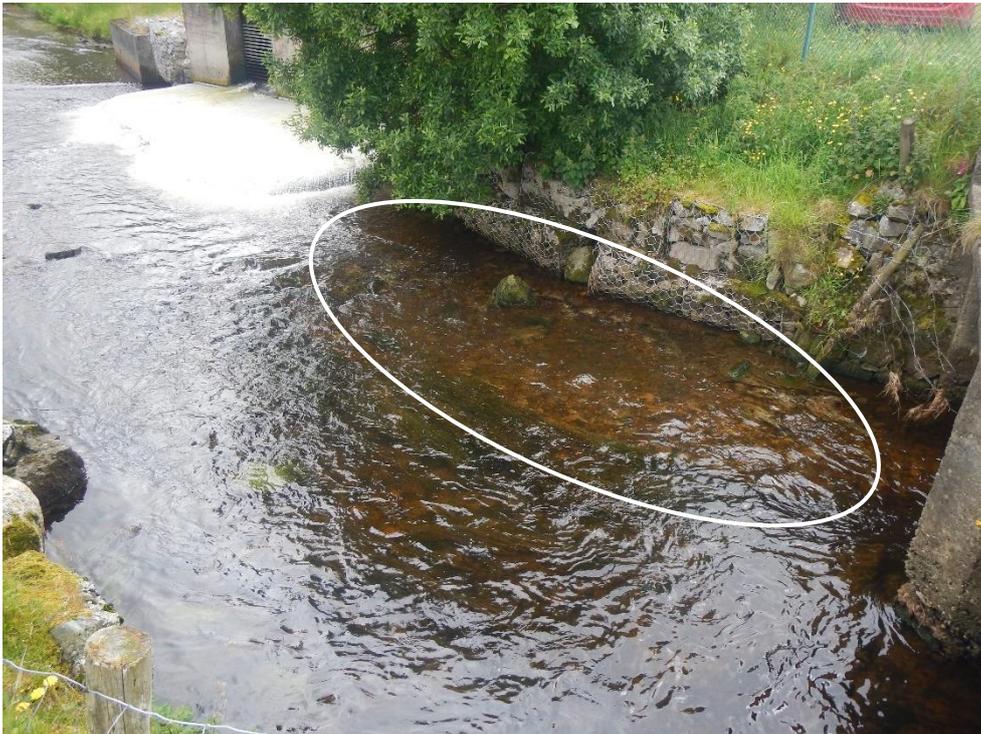
Figure 17 (55.082712, -8.098777). Immediately d/s of the discharge, the detrimental impact of the incredibly poor quality, high-nutrient water discharge was evident, with sewage fungus growing on the riverbed (white circle).

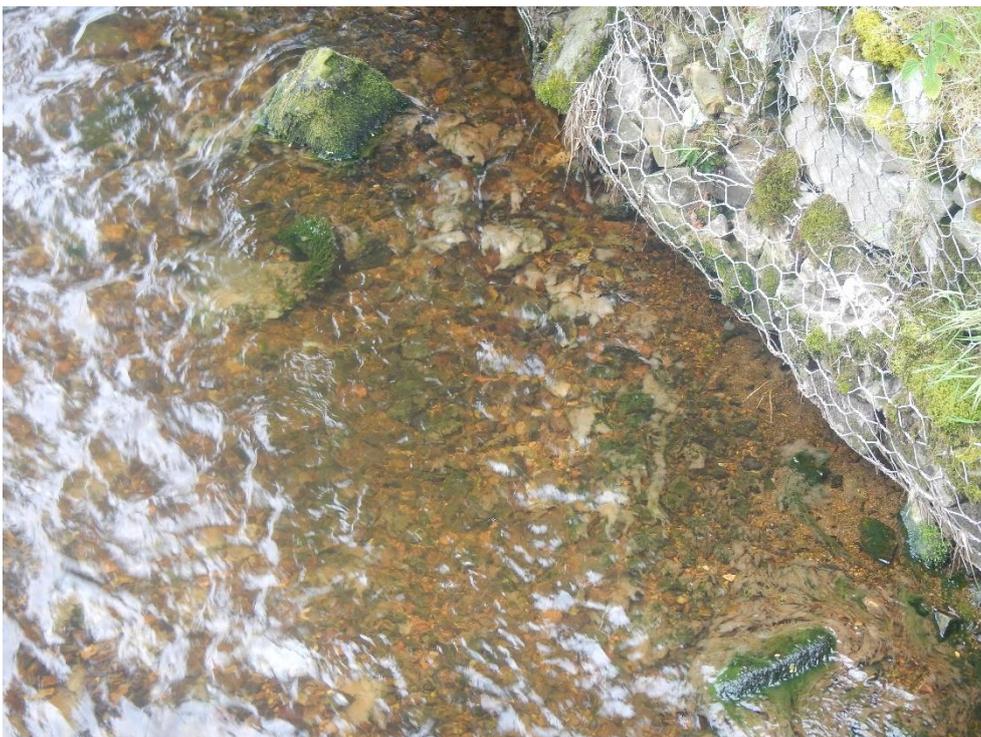
Figure 18. A close-up of sewage fungus coating the substrate immediately d/s of the discharge point; this was the case for a significant length along the LB side of the river. In the most recent EPA assessment, the Tullaghobegly River suffered a decline in Biological Quality Rating (Q Value) from 4 (WFD Moderate in 2018) to 3 (WFD Status Poor in 2021) at the upper site, downstream of the MOWI fish farm. The lower site in Falcarragh remained at good quality (Q Value 4), presumably being sufficiently far d/s, with sufficient dilution and natural biological remediation occurring within the river. This does not detract from the issues of an extended reach of degraded river d/s of the fish farm.

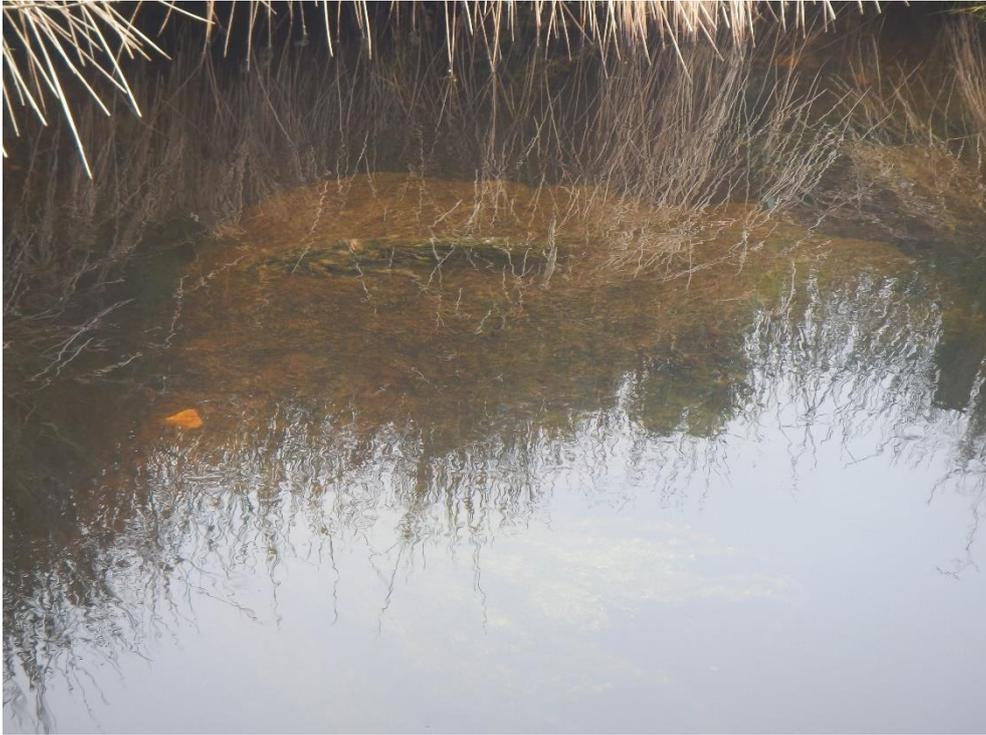
Figure 19 (55.082587, -8.099862). The impact of sewage fungus could be seen for at least 80m d/s, coating areas of the bed, trailing vegetation and aquatic macrophytes. The impact of elevated algal growth on the substrate, aquatic and marginal vegetation extended for a significant distance.

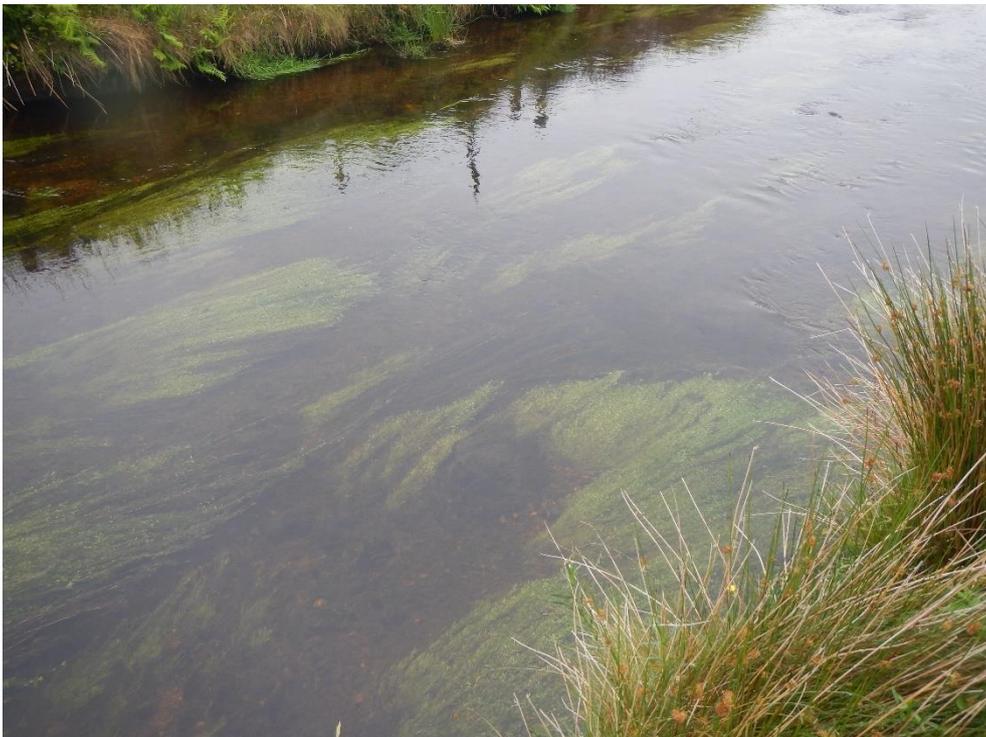
Figure 20. The abundance and composition of the aquatic macrophyte communities changed d/s of the discharge, with starwort *Callitriche* sp. observed for the first time in great abundance, and an increase in the growth of pondweed of the *Potamogeton* genus (in addition to the sewage fungus and algae). The river changed in character through this reach too, becoming lower gradient and slower flowing, further assisting the colonisation of aquatic macrophytes, which dominated the channel and bound the substrate in many areas. This results in little potential for salmonid spawning. A significant increase in the fine sediment component of the riverbed was also observed through this area.

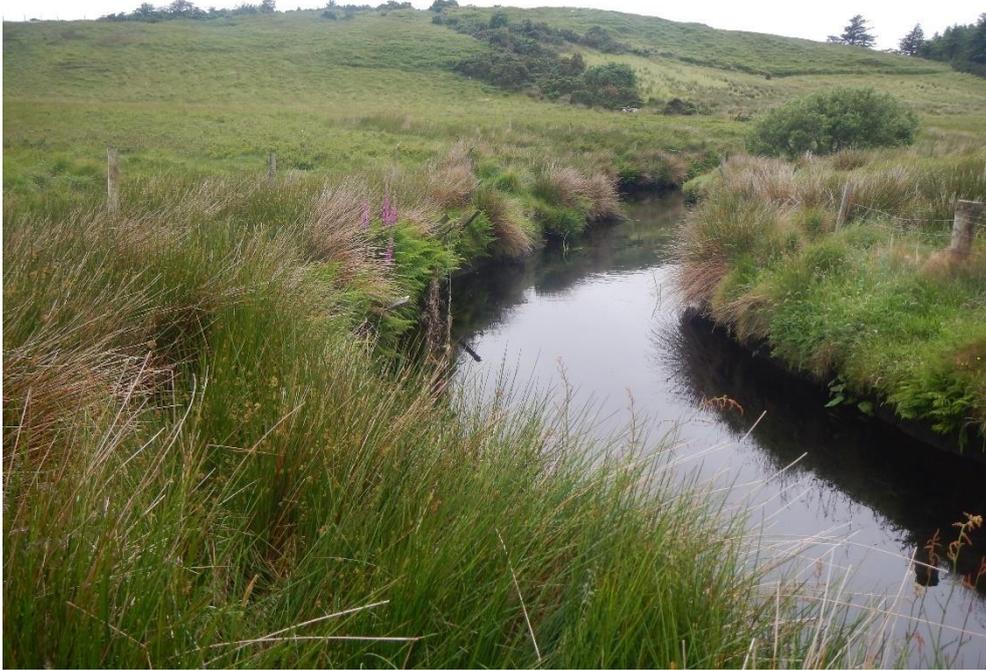
Figure 21 (55.083693, -8.101017). Bends and longer pool areas were present through this reach which provide some cover from water depth and overhanging vegetation along undercut banks, but the area generally lacked trees and shade. Tree planting would be beneficial throughout this area to provide shade, cover and food for invertebrates through leaf litter.

Figure 21. Lack of trees/cover	<ul style="list-style-type: none"> • Undertake planting with native broadleaf species • Undertake strategic planting with willow whips/cuttings to provide cover features 	2	55.083693, -8.101017

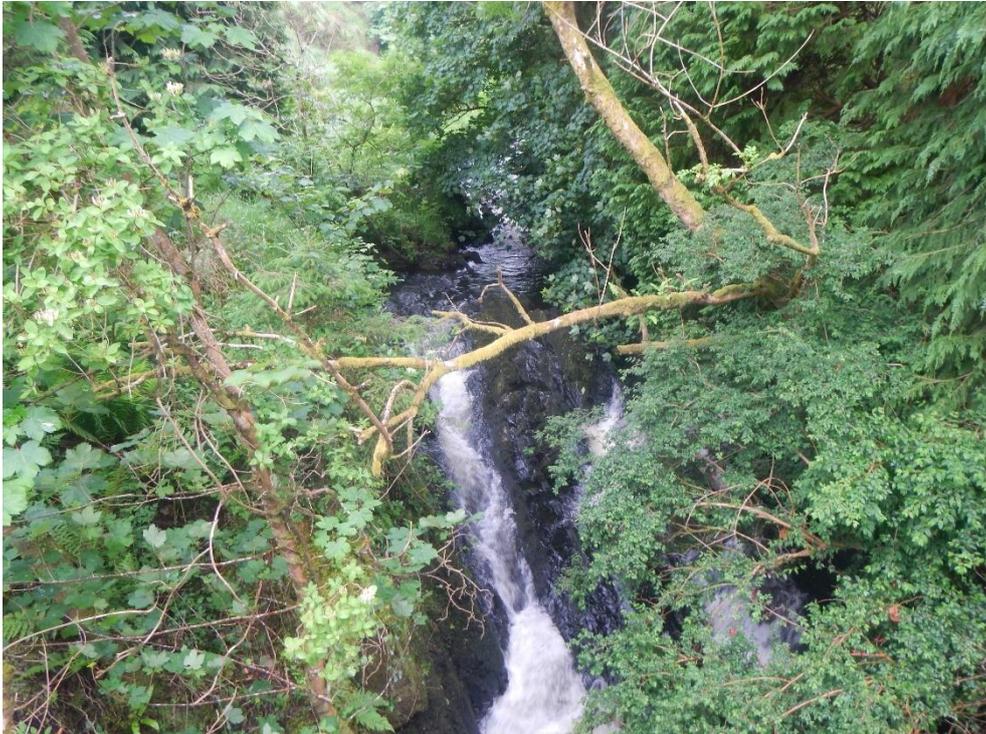
Figure 22 (55.088308, -8.100267). Asnomedan Falls, a poorly passable bedrock outcrop, restricted fish access u/s, but trout and salmon are known to be naturally present u/s, indicating that it is passable in certain flows. Homing of escapee hatchery salmon above this point represents a potential issue for what is likely to be a small spawning population of fish u/s of the falls in most years.

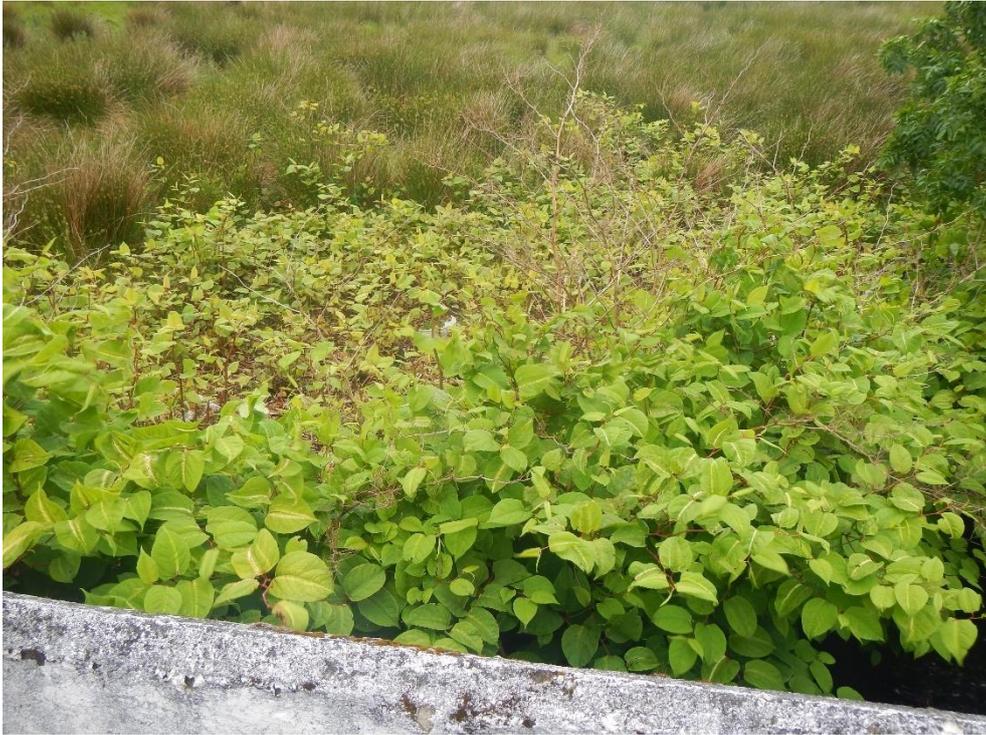
Figure 23 (55.089522, -8.100158). A spot-check at the bridge ~100m d/s of the bridge revealed a well-established stand of Japanese knotweed; the first observed on the walkover. This highly invasive, non-native species should be eradicated with herbicide by a licensed operative before it spreads. The importance of tackling this issue quickly is heightened by the location, high up in the catchment, where it has the potential to spread for many miles d/s.

Observation	Recommendation	Priority 1-3	Coordinates (Lat/Long)
Figure 23. Japanese knotweed	Treatment with herbicide by licensed operative	1	55.089522, -8.100158
Figure 25. Lack of trees	<ul style="list-style-type: none"> • Undertake planting with native broadleaf species • Undertake strategic planting with willow whips/cuttings to provide cover features 	3	55.104593, -8.095445
Figure 26. Over-maintained riverbanks	<ul style="list-style-type: none"> • Allow an uncut buffer along the watercourse • Where necessary, maintain a small access track set well back from the river <p>This is a high priority as it is so easy to achieve, for significant benefit</p>	1	55.104597, -8.095462
Figure 28. Lack of trees	<ul style="list-style-type: none"> • Undertake planting with native broadleaf species • Undertake strategic planting with willow whips/cuttings to provide cover features 	2	55.105052, -8.097192
Figure 31. Browsing of planted saplings	Install tree guards	2	55.10646, -8.098735

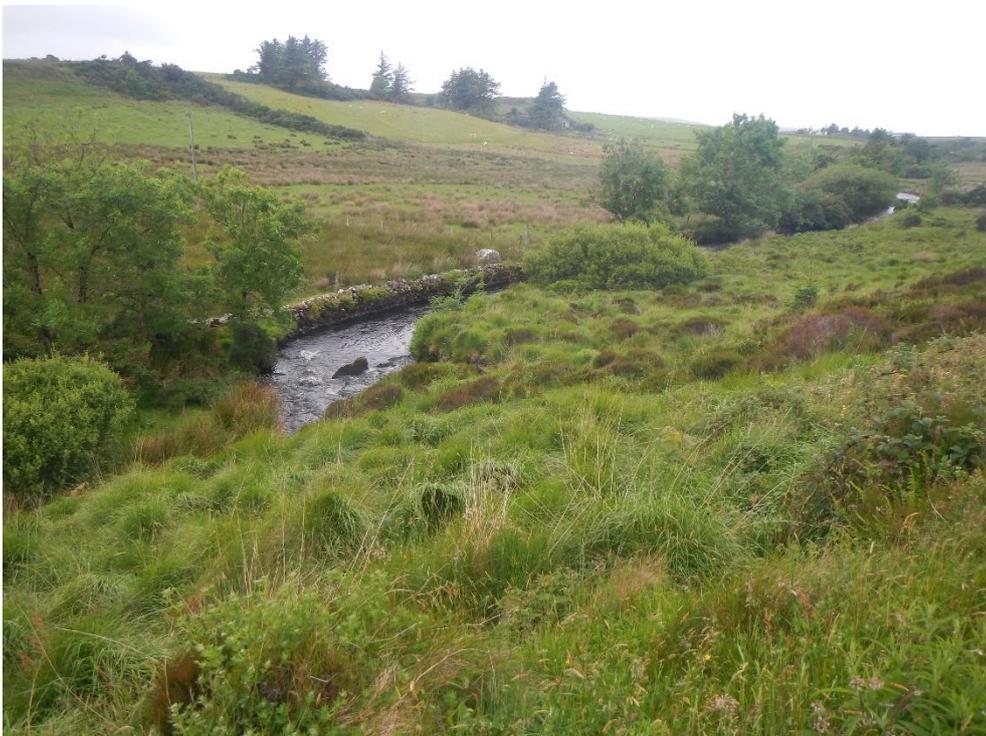
Figure 24. In many areas, the channel d/s of the bridge had been revetted to maintain it within an unnaturally straight channel. This greatly reduces the riverine habitat quality of those areas, increasing the gradient locally and preventing the development and maintenance of pool features, also increasing conveyance which can increase the energy of the river and reduces the potential to retain smaller gravel substrate.

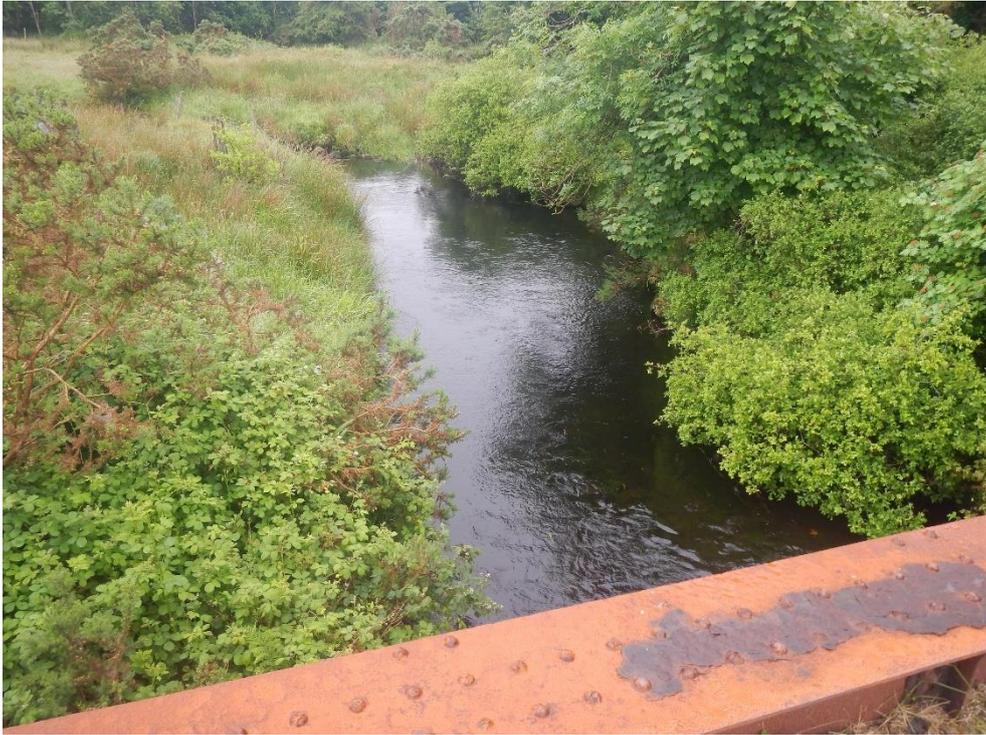
Figure 25 (55.104593, -8.095445). A spot check was undertaken at the old railway crossing, where habitat u/s appeared to be good quality with well vegetated banks and occasional overhanging trees. Increasing the number of bankside trees through the reach u/s would be beneficial.

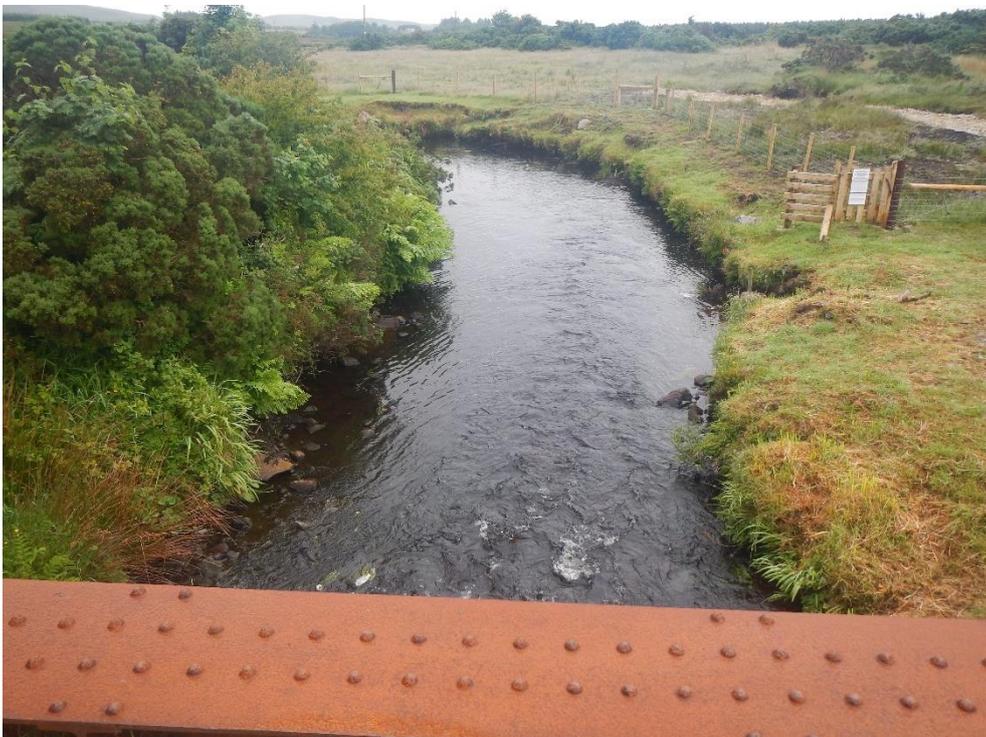
Figure 26 (55.104597, -8.095462). D/s, the RB was more manicured, with a corresponding reduction in habitat quality and a loss of overhanging and trailing vegetation. This reduced habitat quality for invertebrates and juvenile fish within the river margin.
