WILD TROUT TRUST

Tullaghobegly River

(Donegal)

June 2022

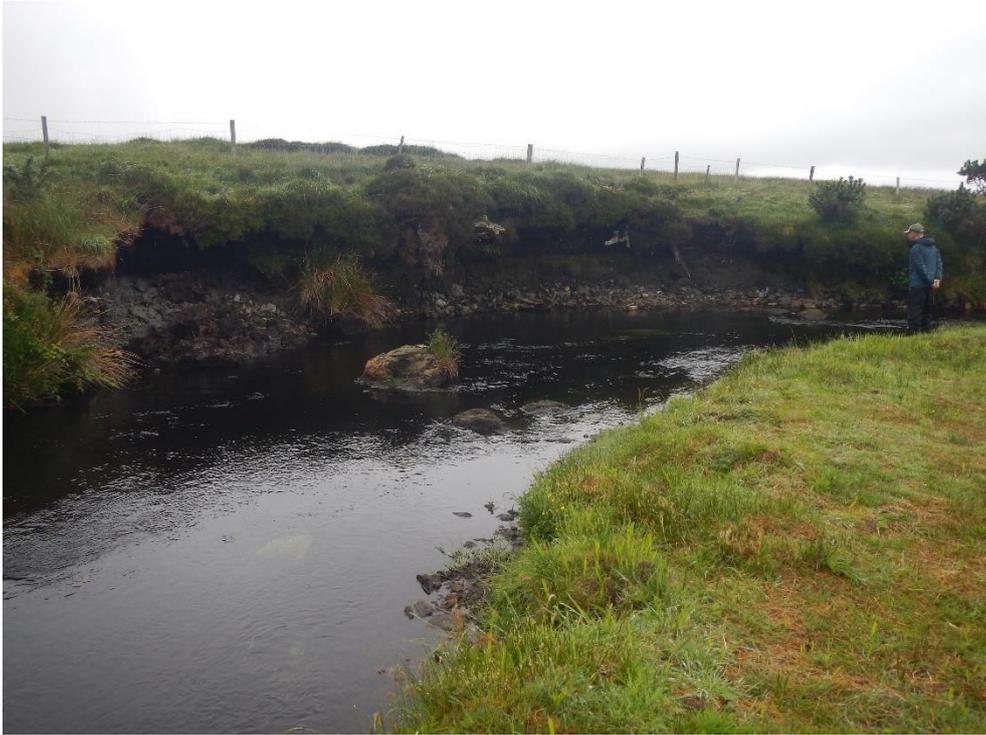
Figure 27. Erosion of a high section of LB may appear detrimental, but further inspection revealed a rich seam of cobble and coarse gravel within the back toe. As an isolated occurrence (as opposed to long sections degraded by livestock), short sections of relatively natural erosion are beneficial in maintaining varied river habitat and substrate composition.

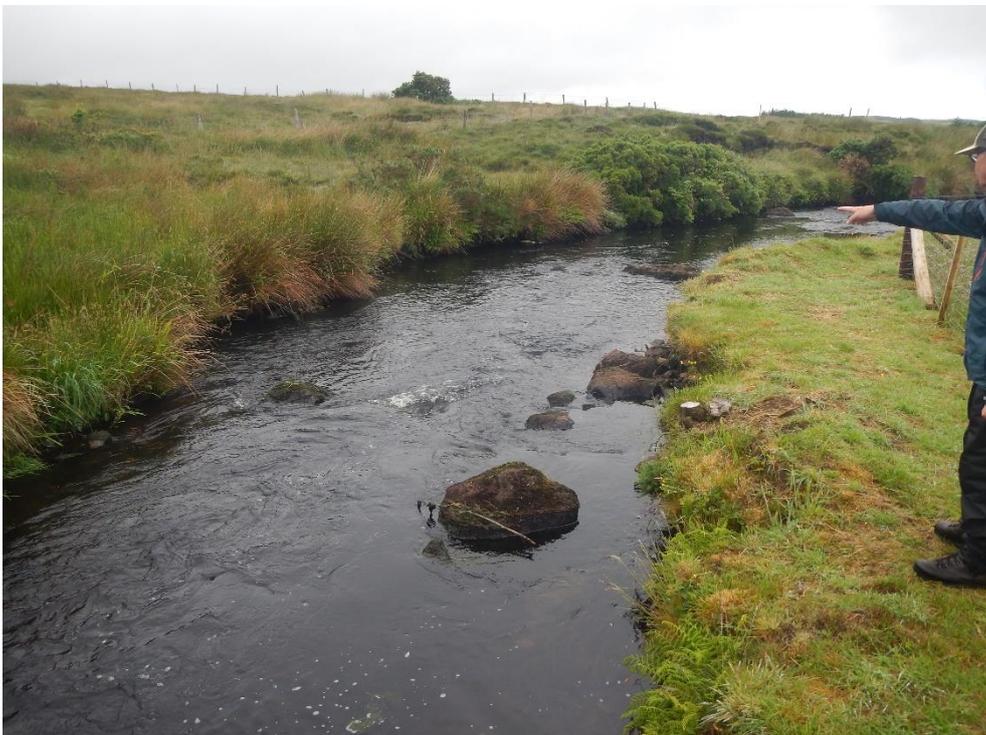
Figure 28 (55.105052, -8.097192). In general, there was a lack of bankside trees in this reach, something that could be easily addressed as the grazing pressure did not appear to be intense enough to prevent sapling growth on the LB, and the RB was recently buffer fenced. At strategic locations, live willow whips/cuttings could also be pushed into the bank toe to provide more low and overhanging cover. This would be highly beneficial on the outside bend of non-fishing banks.

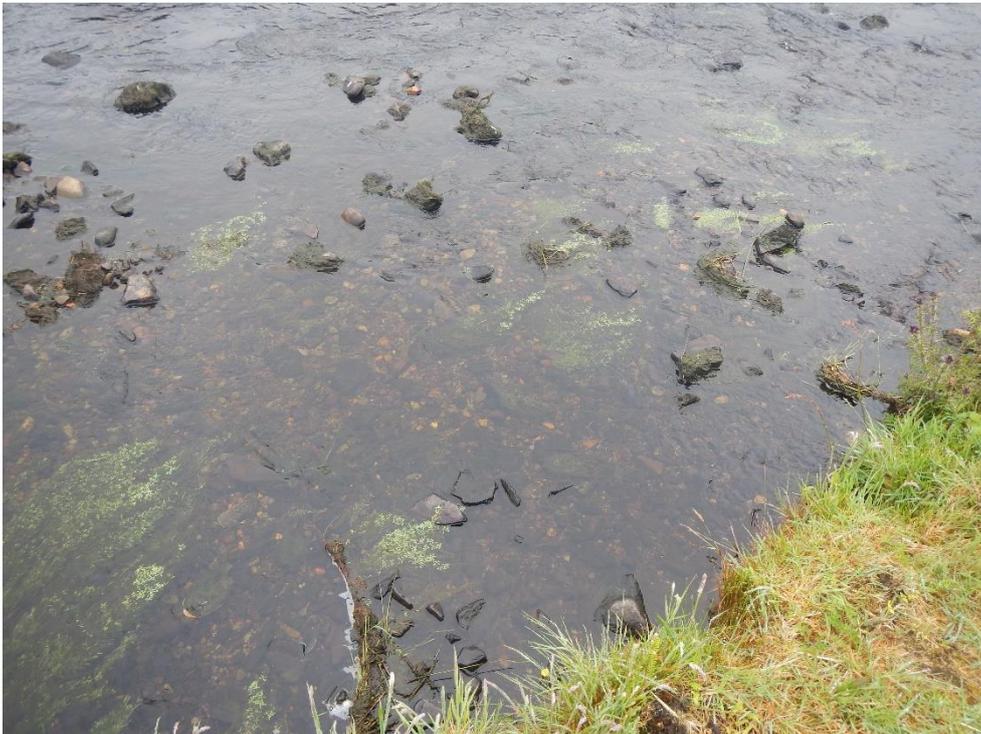
Figure 29. In shallower areas, the growth of *Callitriche* sp. and/or algae was extensive, demonstrating a continued impact from enrichment u/s.

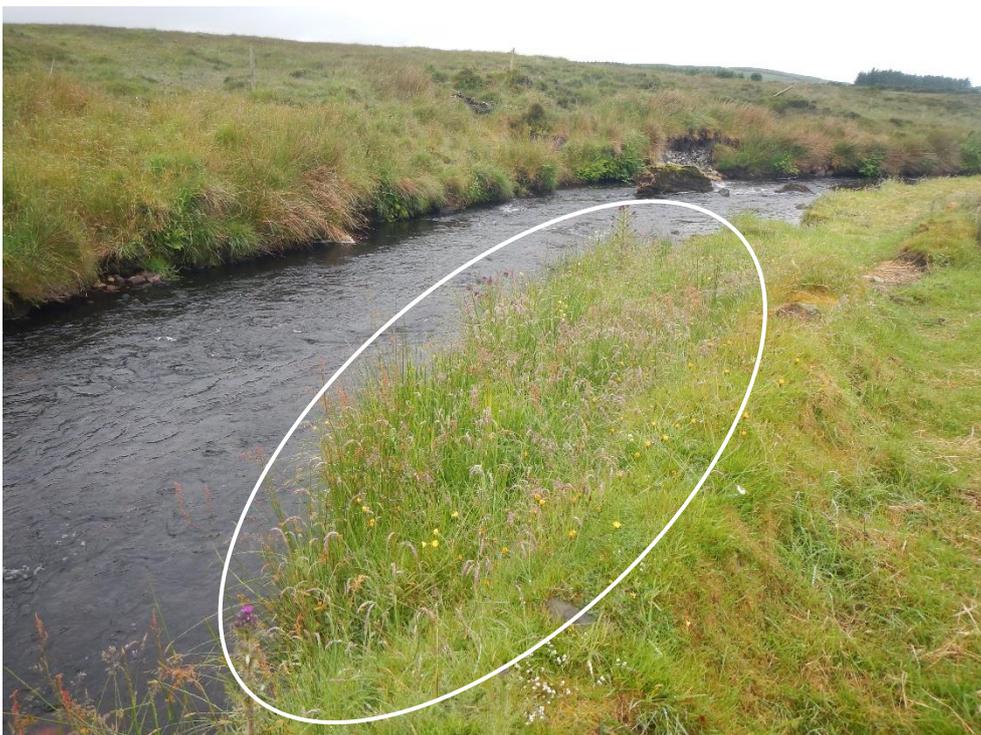
Figure 30. At one section of RB, the vegetation had been allowed to develop along the watercourse without being mown (white ellipse) and much higher quality riparian habitat was provided. This serves as a demonstration of how the bank should be better managed in other areas, maintaining only a narrow access path, set back from the river. In some areas, it may not even be necessary to maintain a track. A hands-off approach will pay dividends when managing the river and banks, undertaking only the minimum maintenance that is required for angler access and leaving in-channel trees and branches for cover (where they exist).

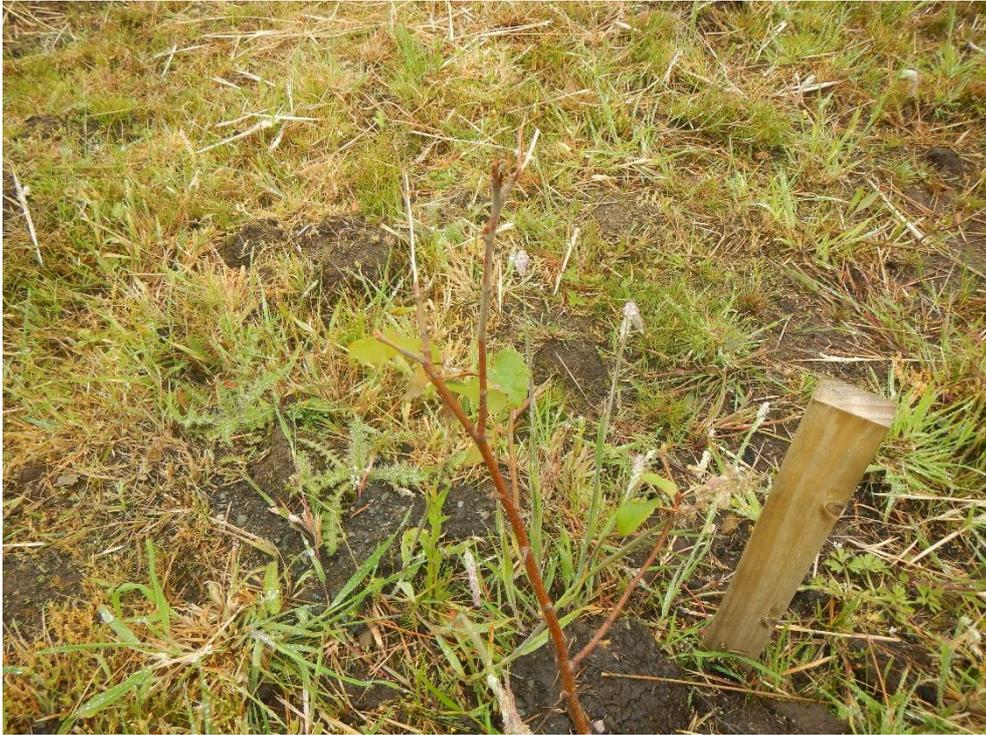
Figure 31 (55.10646, -8.098735). Beneficial tree planting work had been undertaken in several areas; however, being unguarded, some were already suffering from browsing pressure, presumably from deer. It may be beneficial to add tree guards in areas where browsing is observed to be an issue.

Observation	Recommendation	Priority 1-3	Coordinates (Lat/Long)
Figure 23. Japanese knotweed	Treatment with herbicide by licensed operative	1	55.089522, -8.100158
Figure 25. Lack of trees	<ul style="list-style-type: none"> • Undertake planting with native broadleaf species • Undertake strategic planting with willow whips/cuttings to provide cover features 	3	55.104593, -8.095445
Figure 26. Over-maintained riverbanks	<ul style="list-style-type: none"> • Allow an uncut buffer along the watercourse • Where necessary, maintain a small access track set well back from the river <p>This is a high priority as it is so easy to achieve, for significant benefit</p>	1	55.104597, -8.095462
Figure 28. Lack of trees	<ul style="list-style-type: none"> • Undertake planting with native broadleaf species • Undertake strategic planting with willow whips/cuttings to provide cover features 	2	55.105052, -8.097192
Figure 31. Browsing of planted saplings	Install tree guards	2	55.10646, -8.098735

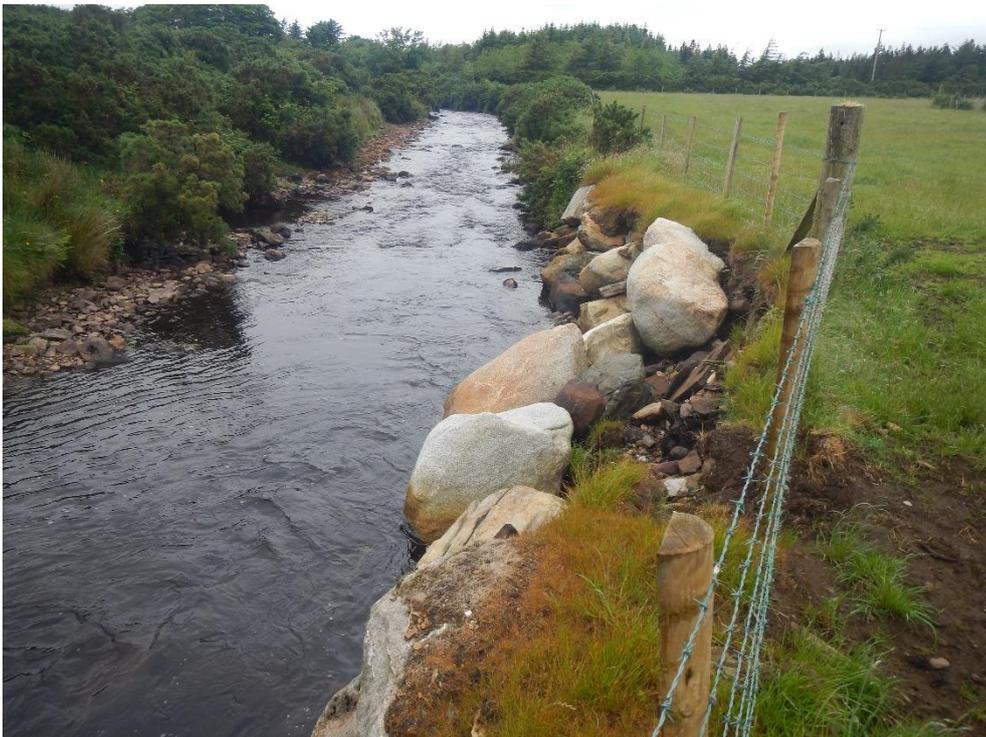
Figure 32 (55.107812, -8.099552). At several sections of RB, boulders had been used in a failed attempt to prevent erosion. Unfortunately, placing large boulders along a riverbank is more likely to increase erosion long term, as was already evident. Ideally, the riverbank would just be fenced further back to allow a better vegetated bank to stabilise, without the use of boulders. If necessary, brush bank protection could be used to protect the bank, but it is rarely required on fenced, well-vegetated bank. Dredging of the channel/pool downstream has probably exacerbated the erosion issue here too, by lowering the riverbed (Figure 34).

Figure 32 & Figure 33. Boulder revetment of the bank and dredging d/s	<ul style="list-style-type: none"> • Avoid the use of large, hard structures as bank protection • Maintain a wide, well-vegetated buffer along the watercourse • Install brash bank protection if absolutely necessary • Cease dredging of the channel 	1	55.107812, -8.099552

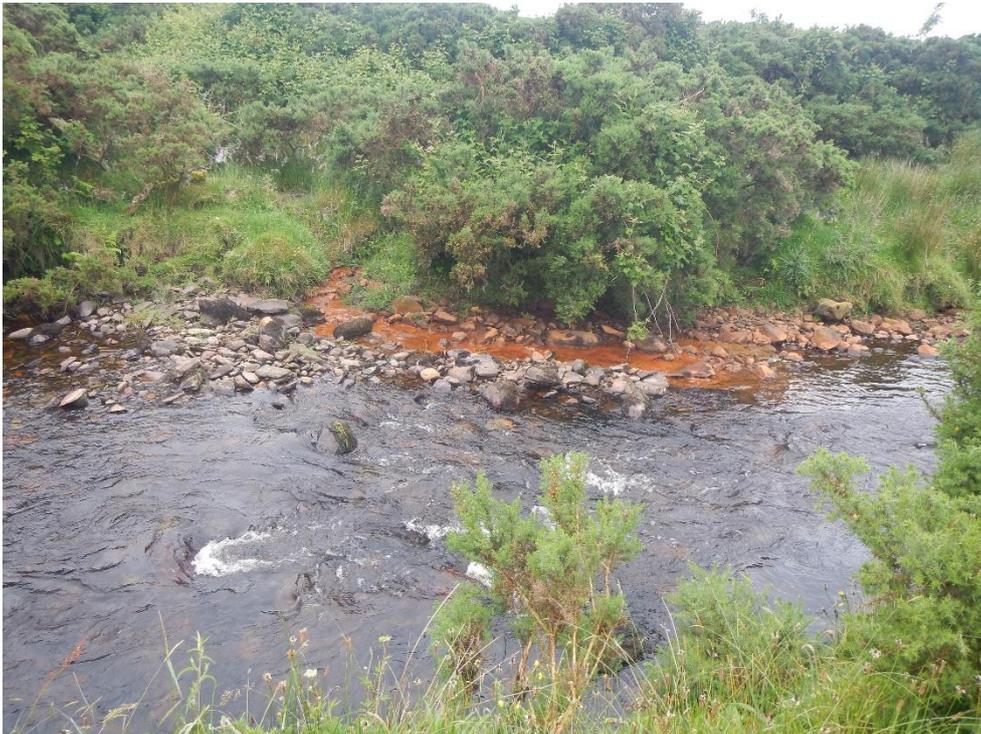
Figure 33. Drainage from an area of the LB land was supplying elevated levels of iron. While this may look alarming, as a limited occurrence like this, the ecological impact is likely to be minimal as the oxidised, ochre coloured iron precipitate is fairly inert. Note that the dilution within the river is such that the issue is only observable for a few metres; this will also be the case for any impact upon water quality.

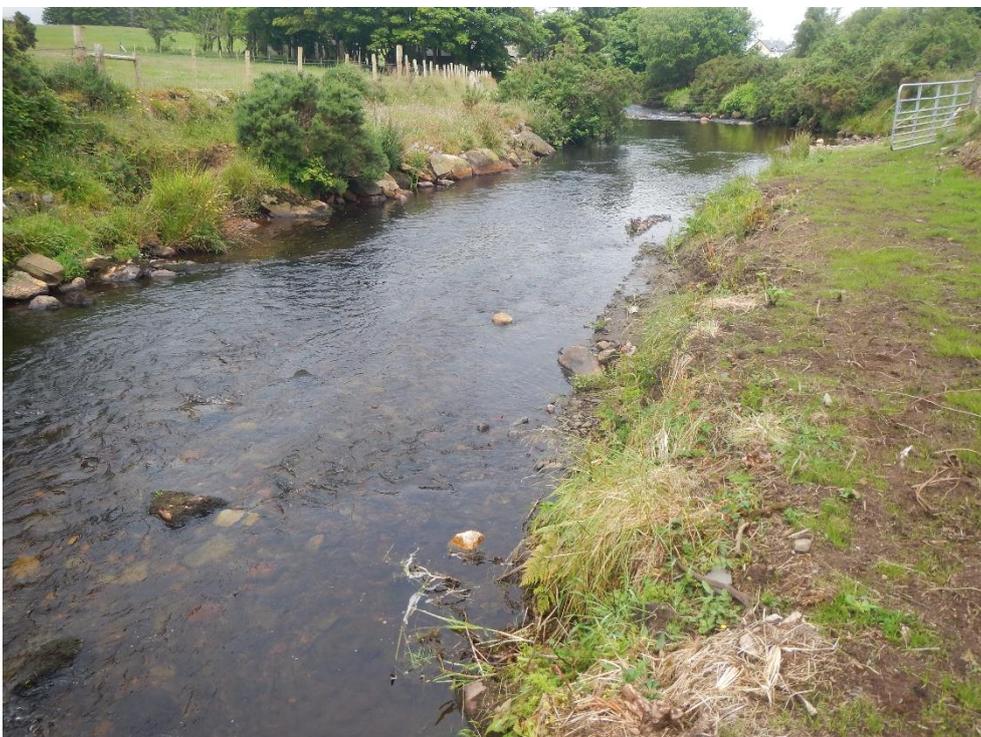
Figure 34 (55.108552, -8.10066). Recent dredging work had been undertaken to a pool and adjacent bank presumably in an attempt to create more fish-holding water. However, the dimensions of a river channel are always dictated by the flow it receives. Deepening or widening will just increase the amount of sediment deposited there until the channel dimensions reduce back to a state of equilibrium, where the flow received can maintain the proportions through scour at high flow.

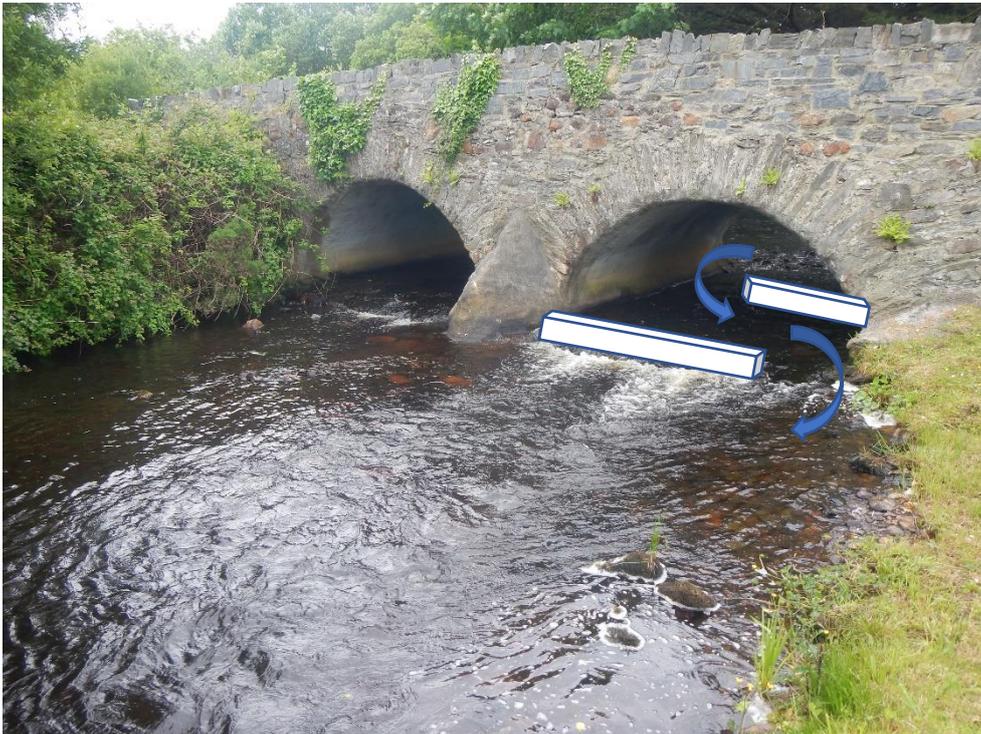
Figure 35 (55.121302, -8.106115). A spot-check was undertaken at Big Bridge, where the footings create a small obstruction to fish movement. They should be passable with a bit of extra water, but may form a behavioural barrier, particularly for salmon, with sea trout more likely to pass small obstructions in lower flows. Partial-width baffles (white blocks in Figure 33) could be installed in of one of the bridge spans, maintaining a bed-depth notch of at least 40cm width at alternating sides, to dissipate flow energy, increase water depth and improve passability. While this is a relatively low priority, it could improve low-flow passability and assist fish to move u/s.

Observation	Recommendation	Priority 1-3	Coordinates (Lat/Long)
Figure 35. Small obstruction at Big Bridge footings	<ul style="list-style-type: none"> • Install partial-width baffles on alternating sides of one or other bridge span 	2	55.121302, -8.106115
Figure 36. Boulders inhibiting flow around the outside bend	<ul style="list-style-type: none"> • Carefully remove all except one or two, well-spaced boulders • The removed boulders could be distributed well away from each other within the channel. Advice should be sought on the placing, to avoid creation of erosion issues or inhibition of natural geomorphological processes 	2	55.121378, -8.105792
Figure 37. Over-maintained riverbanks	<ul style="list-style-type: none"> • Allow an uncut buffer along the watercourse • Where necessary, maintain a small access track set well back from the river • Plant willows in LB <p>This is a high priority as it is so easy to achieve, for significant benefit</p>	1	55.121687, -8.10623

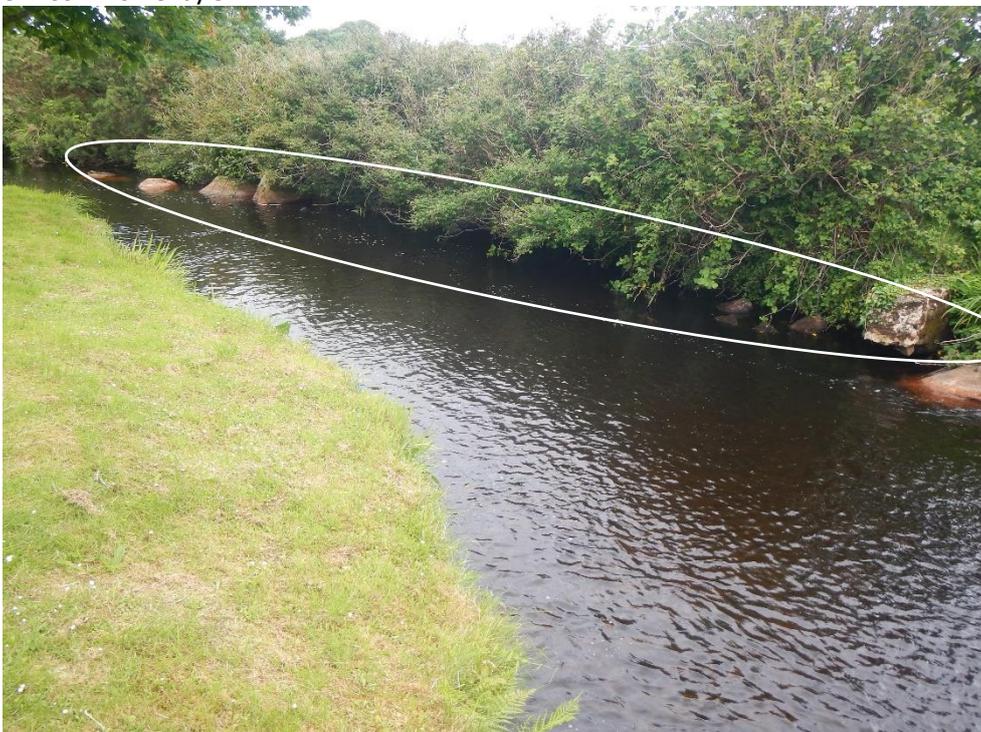
Figure 36 (55.121378, -8.105792). D/s of the bridge, a good pool was degraded by a line of boulders alongside outside bend (white ellipse), limiting access to overhanging cover, where fish would choose to lie. One or two individual, well-spaced boulders could provide lies, but these multiple structures simply prevent flow passing around the outside bend and valuable overhead cover.

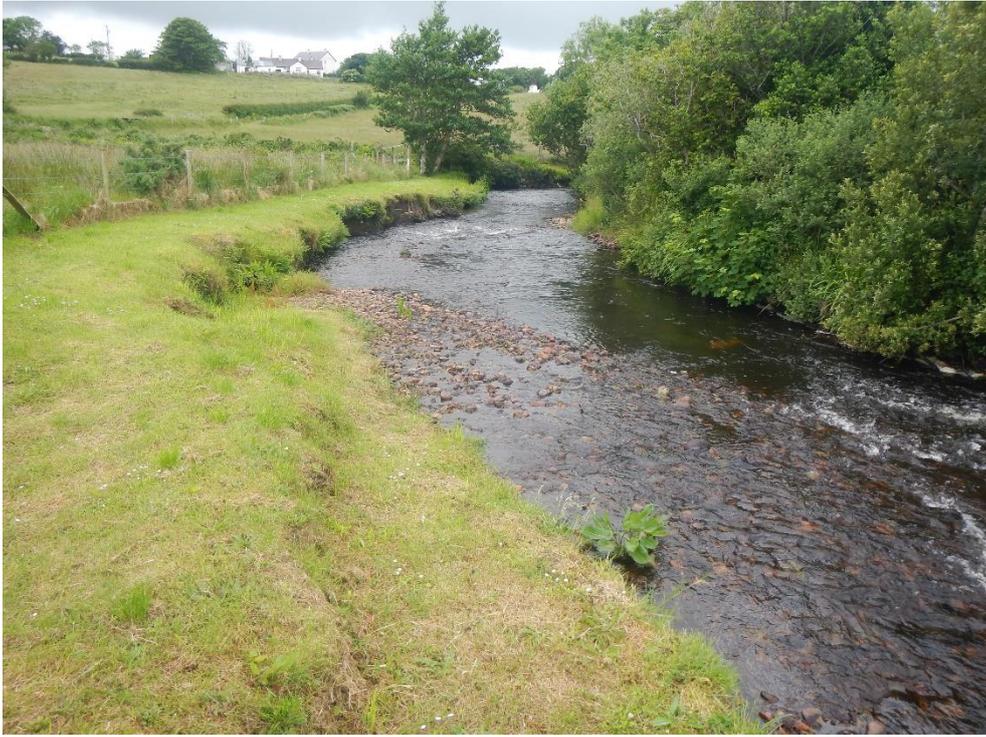
Figure 37 (55.121687, -8.10623). As with other areas, the strimming observed was counterproductive to the preservation of high-quality riparian habitat and it would be far better to leave bankside area uncut. Overhanging willows on the far RB provide some good cover alongside juvenile habitat. It would be beneficial to transplant some cuttings across onto the opposite LB to provide more cover and bank stability there.

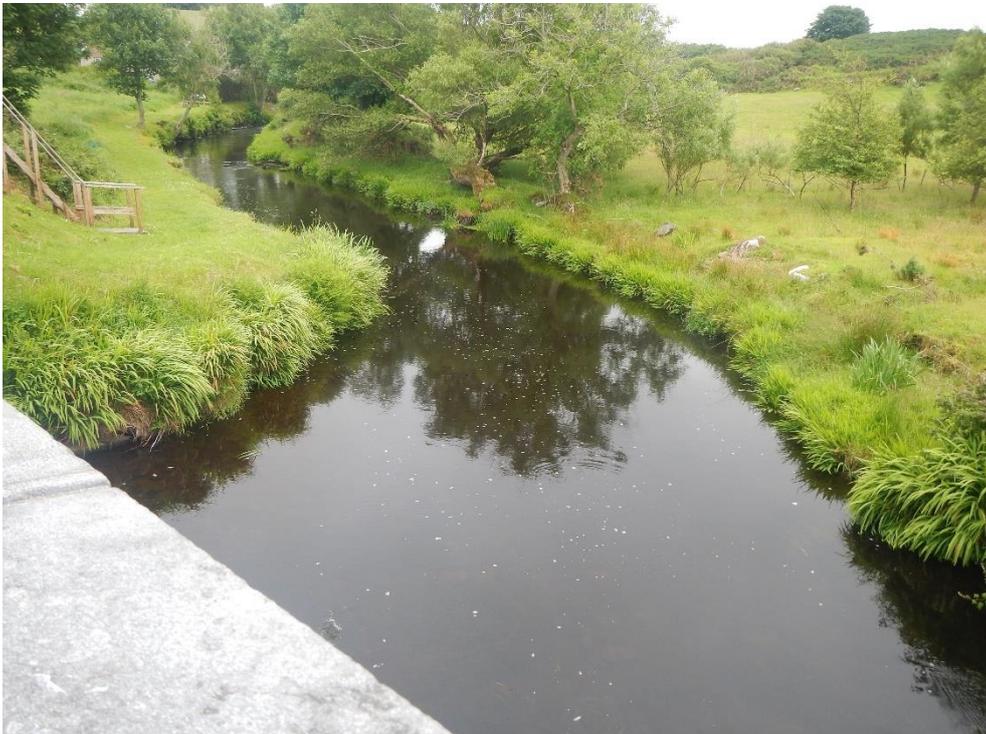
Figure 38 (55.135412, -8.117067). The final area visited was between the N56 road bridge and the tidal limit. U/s of the bridge, the bank maintenance should be reduced. Habitat along the LB (right of shot) could be greatly improved by establishing several feature trees to provide shade and cover and hold more fish.

Figure 38. Over-maintained riverbanks	<ul style="list-style-type: none"> • Allow an uncut buffer along the watercourse • Where necessary, maintain a small access track set well back from the river • Plant willows in LB <p>This is a high priority as it is so easy to achieve, for significant benefit</p>	1	55.135412, -8.117067

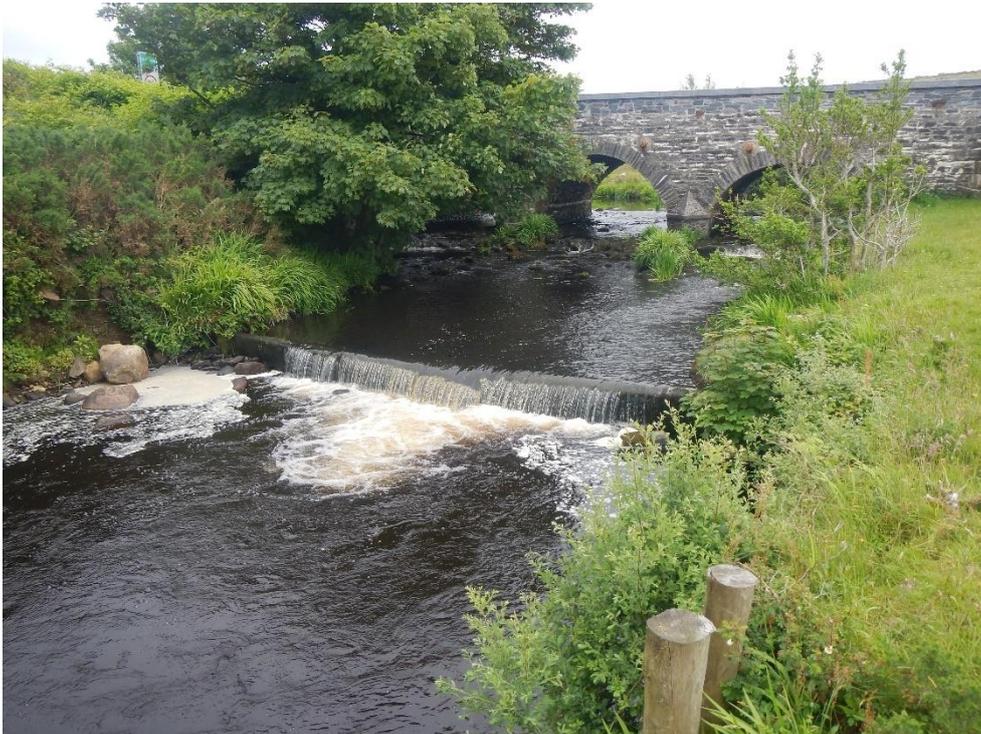
Figure 39 (55.13565, -8.117325). The N56 bridge footings provide a slightly more problematic obstruction but access had been somewhat eased by the installation of a small weir/pre-barrage d/s. This would be a more traditional method to ease fish passage, however, the weir itself also creates an obstruction that - although passable - is likely to be a behavioural barrier in extremes of temperature and certain flows. It is better than nothing, but the ideal solution would be a more natural ramp of cobble and boulders grading out the step from the bridge footings to the riverbed d/s. It may be that this is the case within the impounded pool u/s and the weir could be removed, but this was not possible to ascertain without further inspection.

Observation	Recommendation	Priority 1-3	Coordinates (Lat/Long)
Figure 39. Weir/pre-barrage to bridge footings	Further investigation as to whether the bridge footings already form a gradual rock ramp or would create a significantly perched step without the weir. If they would form a gradually graded feature, the weir could be removed.	2	55.13565, -8.117325

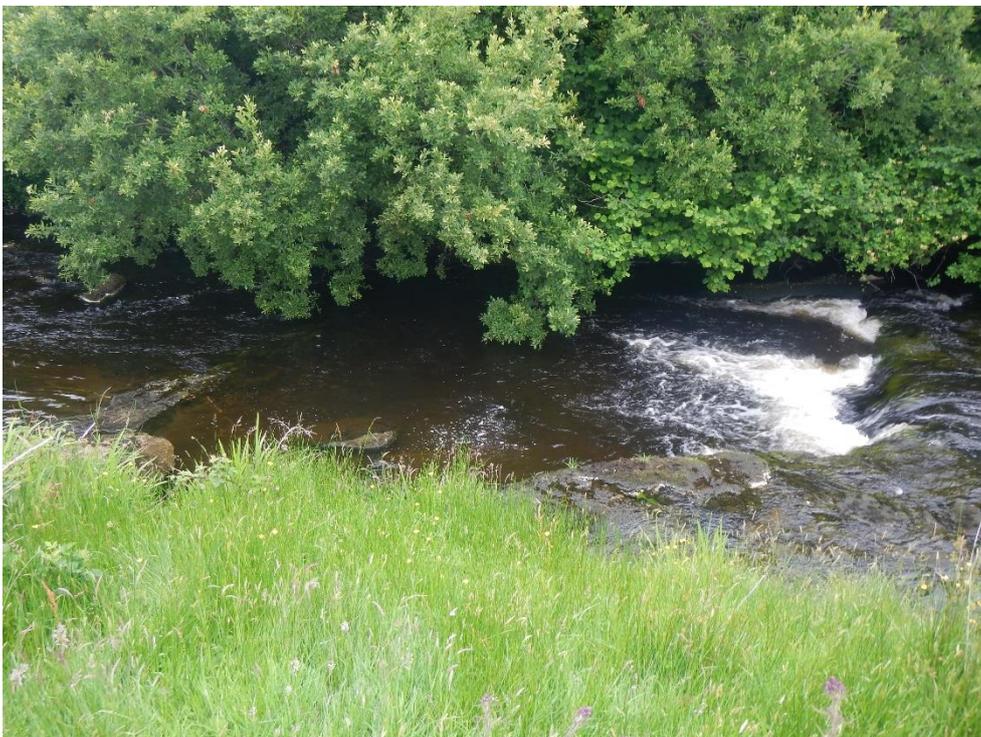
Figure 40. Habitat within the lower section was generally good, greatly enhanced by overhanging boughs and vegetation along the far, RB.

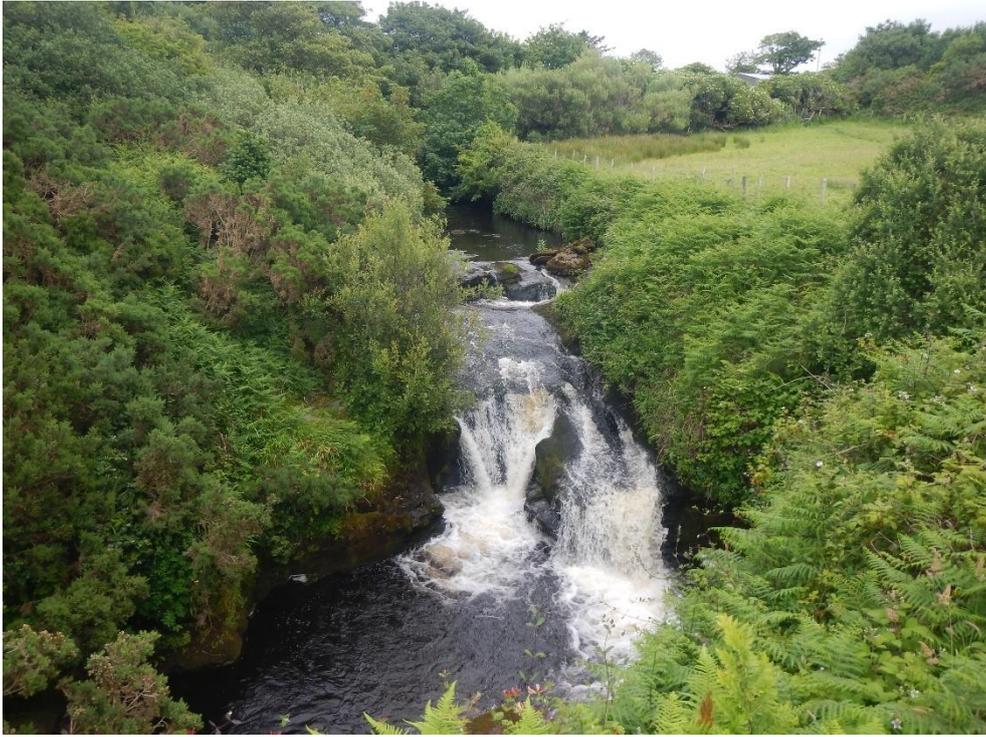
Figure 41 (55.136085, -8.120538). Just u/s from the tidal limit, major bedrock outcrops create a series of falls, the largest only being passable in higher flows and certainly a major barrier to salmon and sea trout in most flows. However, it is a natural feature and as such, requires no action. Reasonable numbers (>100 each year) of salmon and sea trout are reportedly caught u/s of here (C. Gallagher, pers. comm., 21st June 2022).

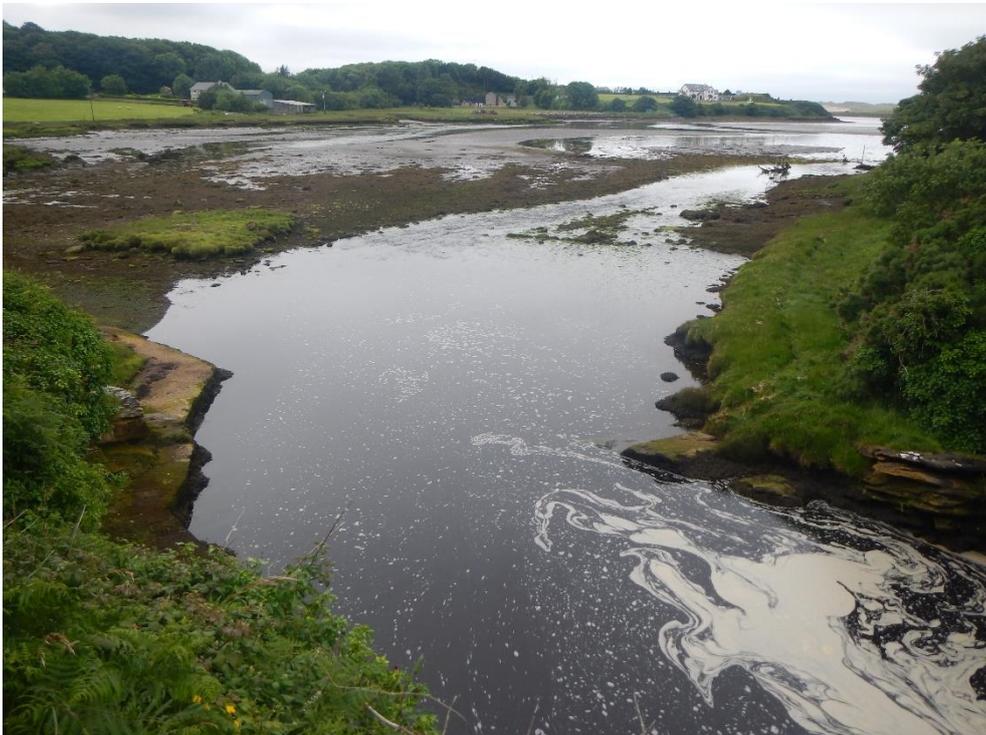
Figure 42 (55.136085, -8.121203). A large bedrock pool d/s of the falls marked the upper extent of the tide and provided a valuable resting area for fish entering the estuary and lower river, whether they manage to run the river or not, the latter being a real potential issue in low flow years and almost certainly contributing to annual fluctuations in salmon and sea trout runs and catches u/s.
