**Advisory Visit**

**River Ivel, Radwell, Herts**

**March 2021**

**Rob Mungovan**

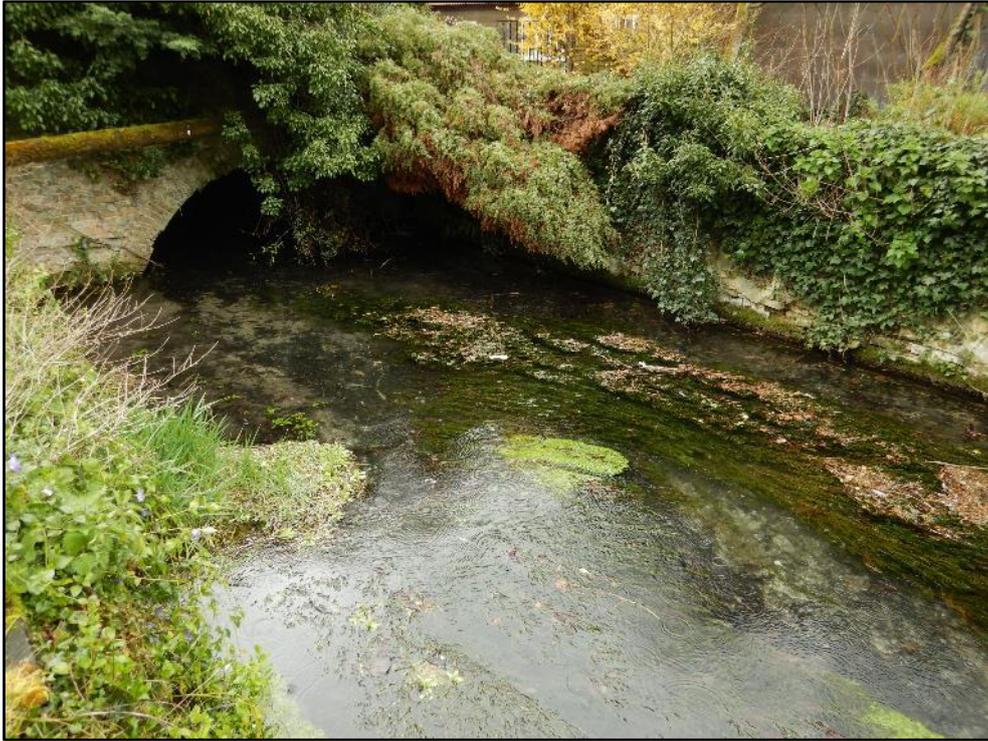
The mill presents a total barrier to the migration of fish, both upstream and downstream, with a drop estimated to be in excess of 1.2m (the actual mill sluice was not seen).

Pic 1 – The channel emerging from the mill.

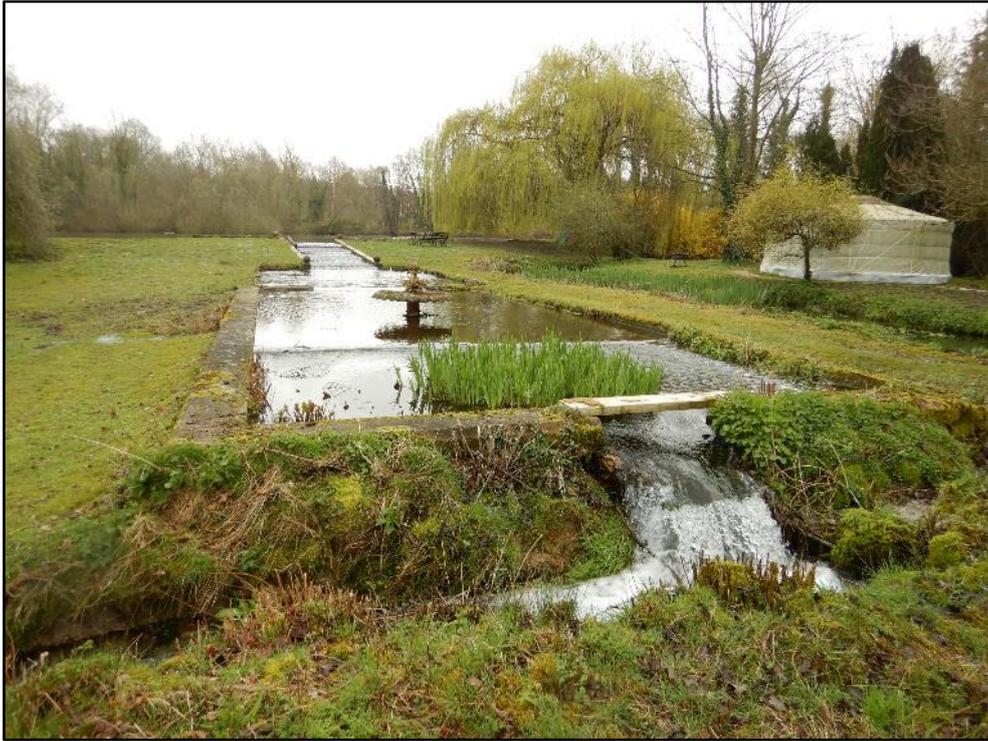
A second channel originates from the mill pond. It too is completely impassable to fish, with the relicts of ornamental ponds and swimming pools now visible (pic 2). Once away from the significantly modified river associated with the mill pond, the river took on a more natural appearance. However, it is clear that the river has been significantly changed over many centuries for the purpose of milling, land drainage and for pleasure gardens. Fortunately, the river has been left with a clean gravel bed, which provides potential spawning opportunities for brown trout (if present) and other gravel spawning fish species. Spawning trout require loose gravel with a good flow-through of oxygenated water. Juvenile trout need shallow water with plenty of diverse structure for protection against predators and wash-out from high flows. Any weak link in habitat quality or quantity will restrict the population from reaching its full potential. Unfortunately, no trout nor their redds (spawning depressions) were observed during the visit.

Pic 2 – The legacy of ponds and swimming pools which prevent fish from migrating upstream into the mill pond.

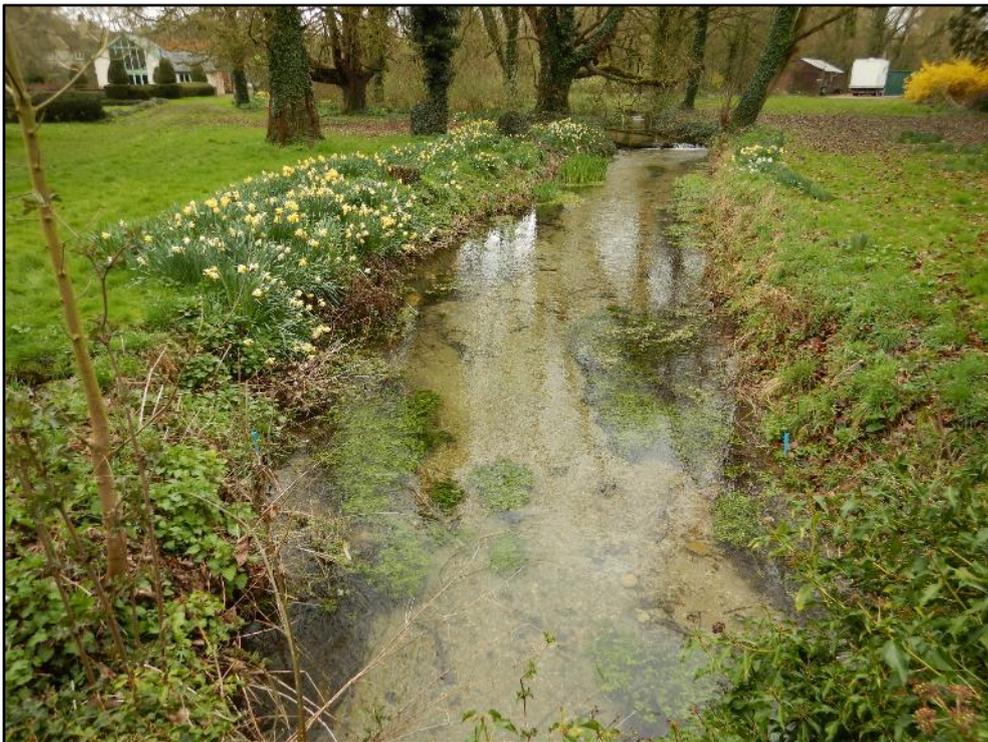
The river contains occasional plants of lesser water parsnip and starwort (pic3) both of which are typical chalk river plants and provide important cover for aquatic invertebrates and fish.

Pic 3 – The river below the mill pond is a small and attractive chalkstream with the main aquatic plant being lesser water parsnip.

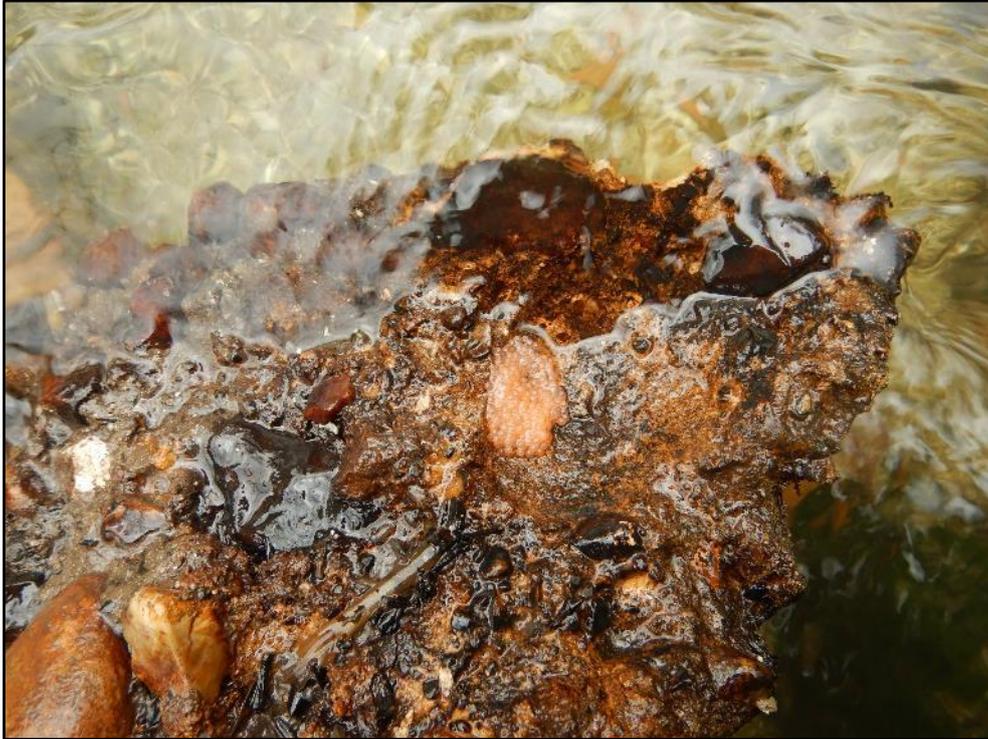
Stone turning revealed the eggs of bullhead fish and aquatic invertebrates including the nymphs of the *Baetis* genus of mayflies and caddisfly larvae (pics 4 &5). This is indicative of good water quality and represents important food for fish.

Pic 4 – Bullhead fish eggs.

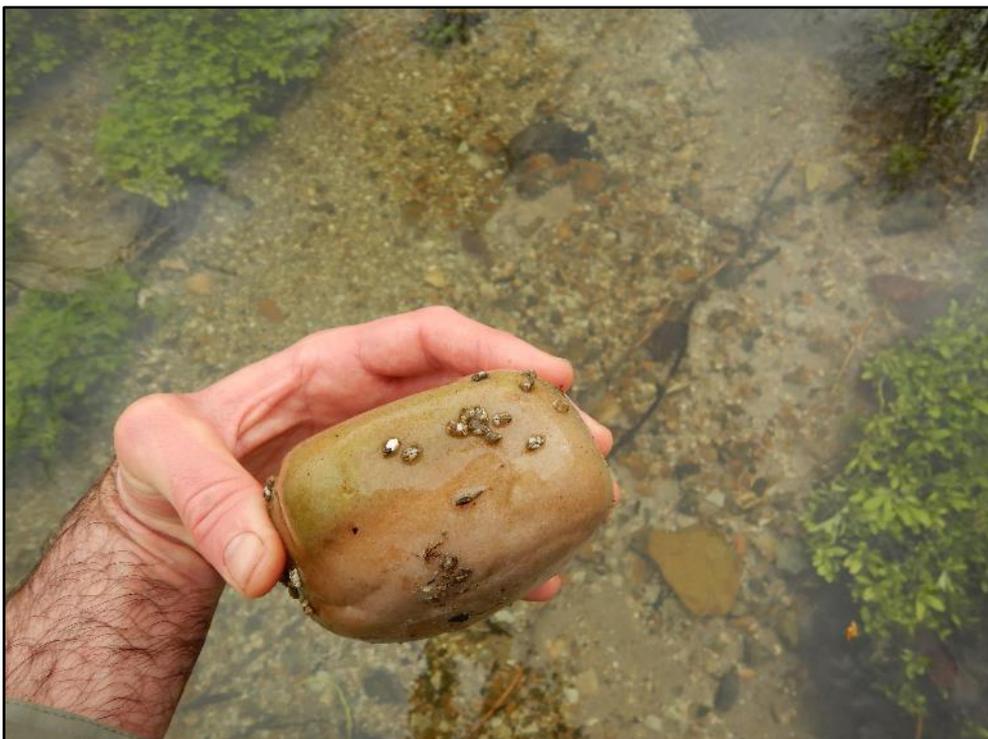
Pic 5 – Small mayfly nymphs (*Baetis* genus) and caddisfly larvae (most probably of the *Agapetus* genus).

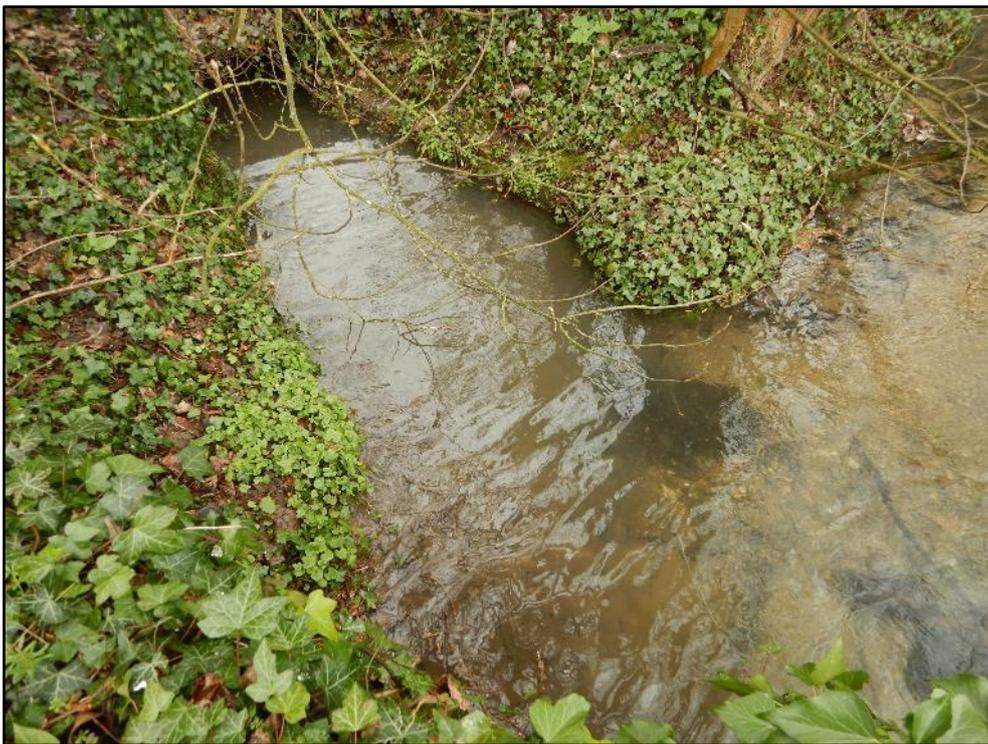
One point source of silt entering the river was seen (pic 6). It conveys road drainage to the river. It was considered relatively minor but did have the capacity to discolour the river for many metres downstream. It has the potential to deliver unseen pollutants and as such presents a threat. Regular checks could be made to this point to ascertain if the water quality is acceptable. A means of assessing the impact of discharge would be through the application of the Riverfly Partnership's *Anglers' Riverfly Monitoring Initiative* (ARMI). By monitoring groups of invertebrates and taking an estimate of their abundance over a period of time, trends or even declines in invertebrate numbers may be observed. More information about ARMI can be found at [www.riverflies.org/](http://www.riverflies.org/)

Pic 6 – Road drainage entering the river.

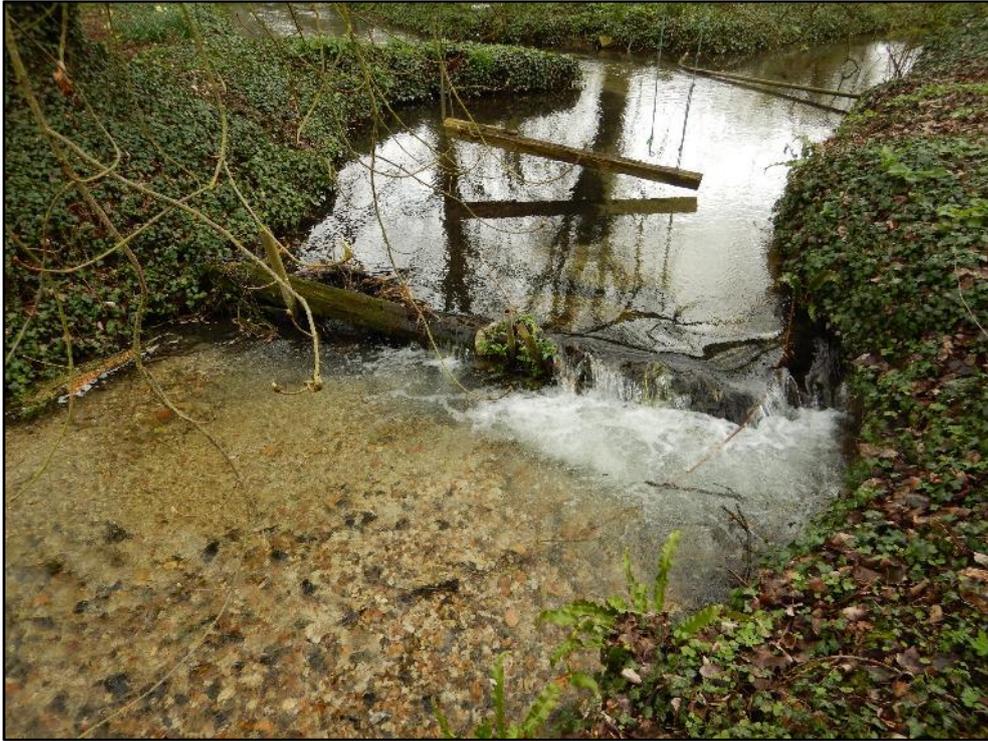
Pic 7 – The weir results in small area of intense bed scour, the pool is unsuitable for fish to rest in.

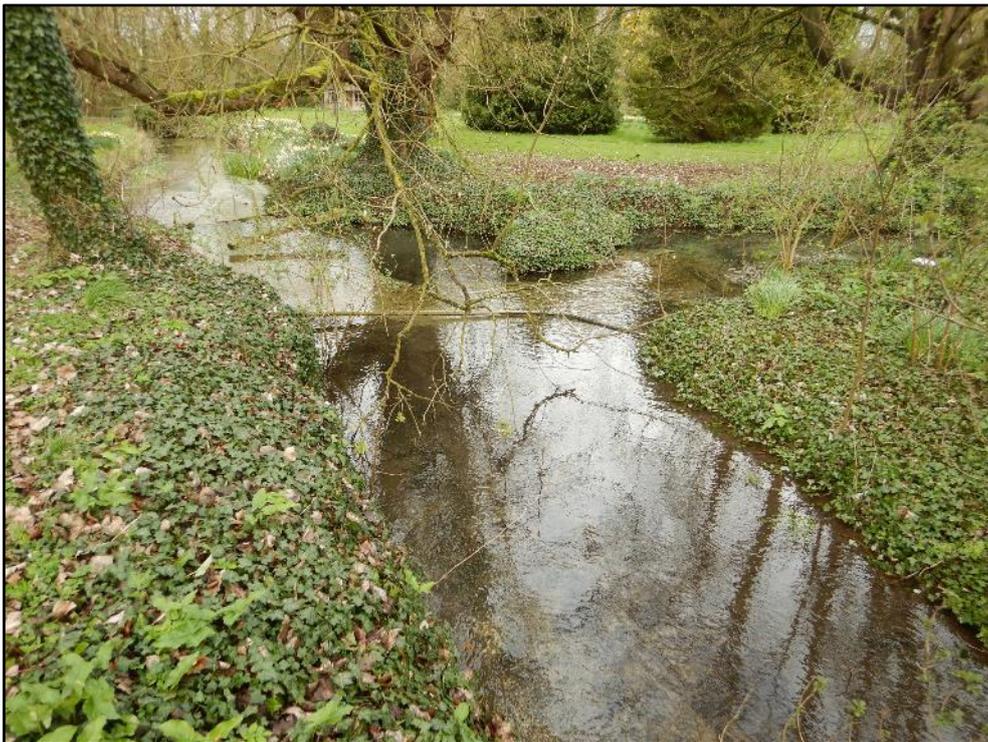
Pic 8 – Above the weir the river is impounded, with fine silt smothering the bed degrading the river habitat.

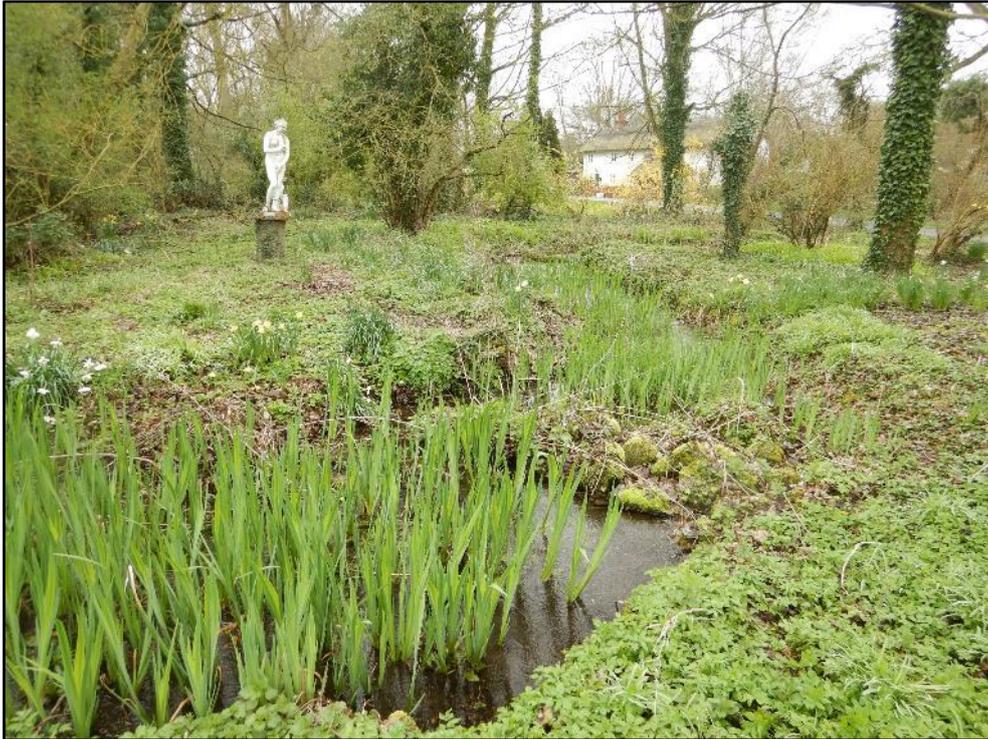
Throughout the grounds of the Mill House are many, largely defunct, channels and semi-filled ponds (pic 9). Many of the channels convey a small flow. These small flows represent leak points from the main river. With a significantly reduced flow from what the Ivel once had, it may now be beneficial to close-off some of the “leak” pathways and focus the limited flow to channels where it is most beneficial.

Pic 9 – A former fish rearing pond which still conveys a small flow from the river.

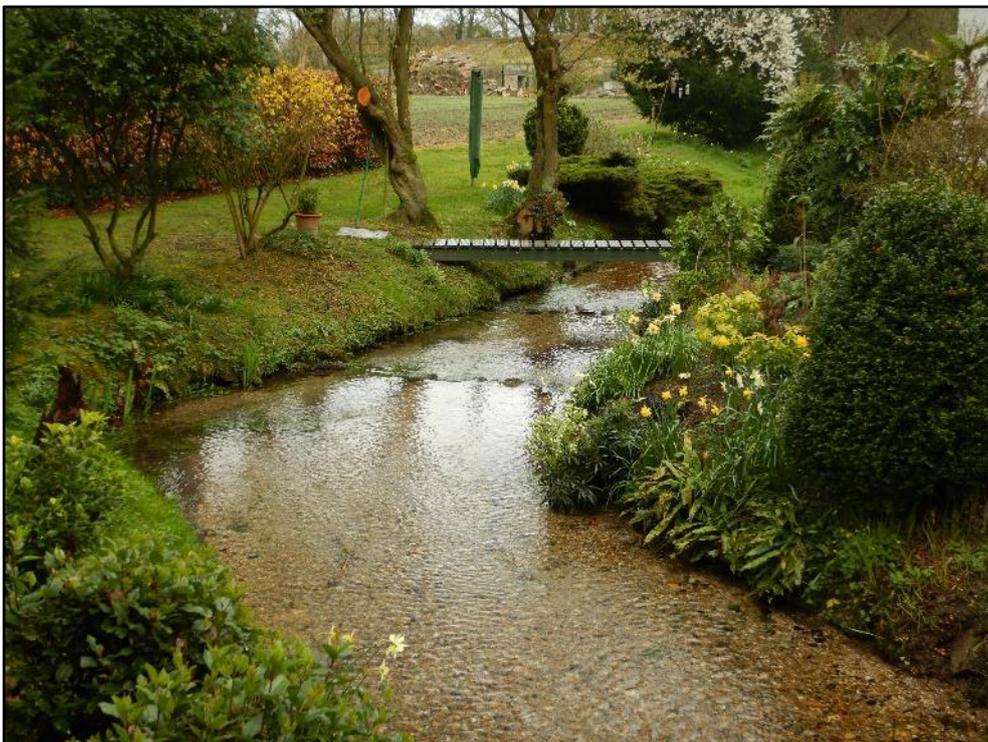
The third channel is referred to as “the leat”. It by-passes the mill and the mill pond, and in theory would enable fish to migrate upstream. However, that is unlikely to happen due to the habitat being too shallow and devoid of marginal cover (pic 10). There are several low structures that also present challenges for migrating fish (pic 11).

Pic 10 – The leat has been incorporated into the grounds of a garden. The channel is too tidy and shallow to offer fish habitat.

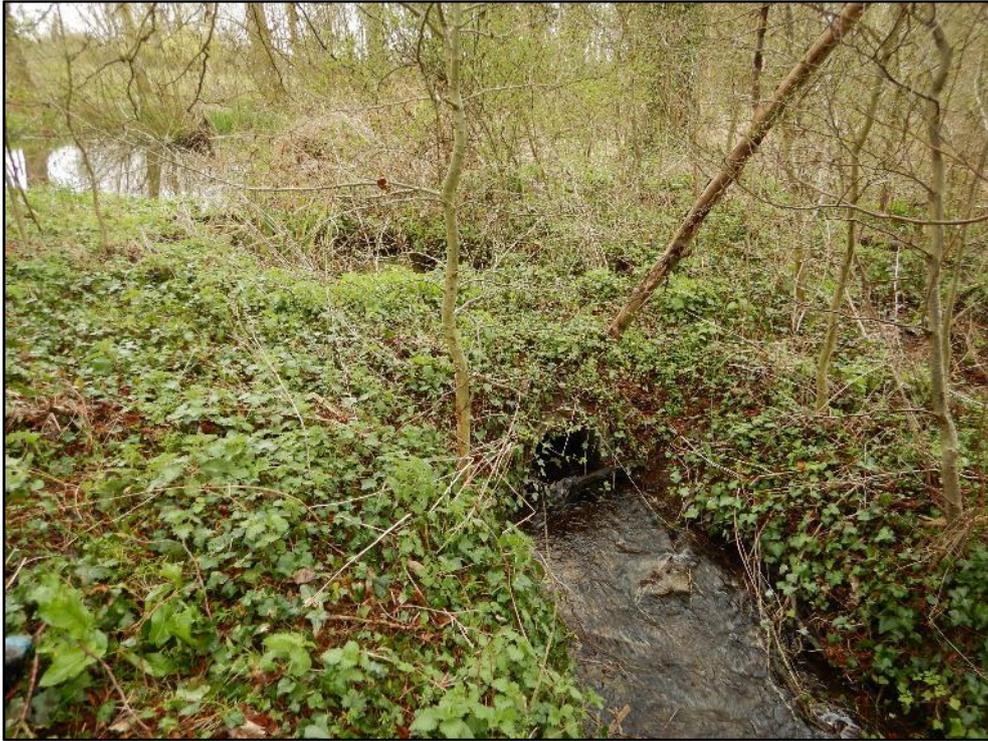
Pic 11 – The point of connection of the leat to the river above the mill pond. In-channel structures promoting high velocity flows prevent upstream fish migration.

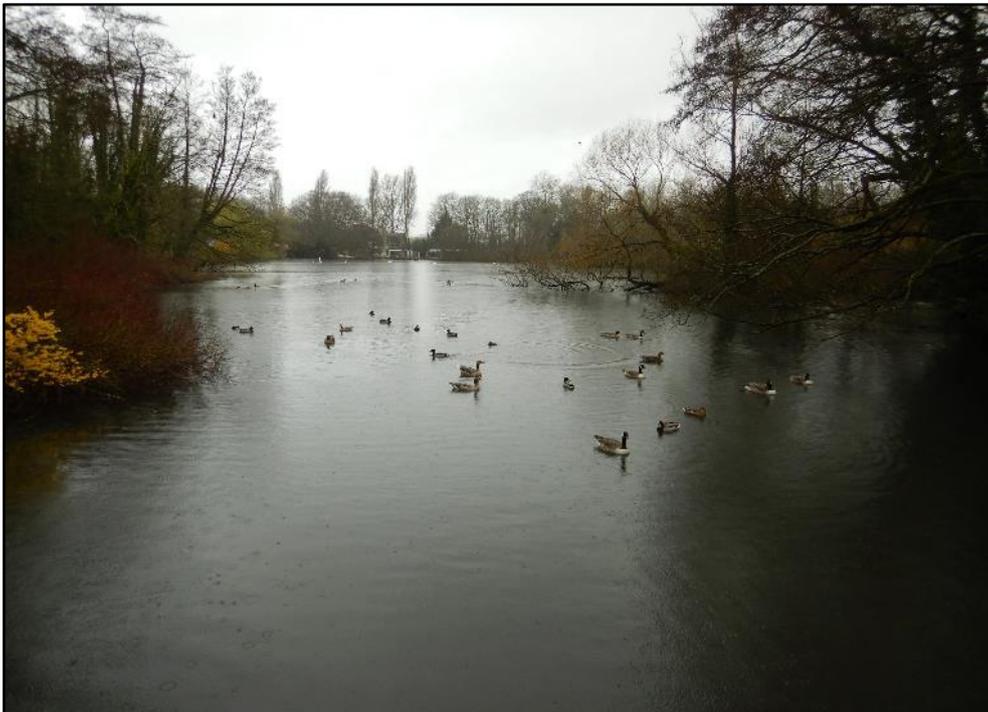
The mill pond forms an amenity feature of significant importance to the village (pic 12). The mill sluice is no longer operated and as such the pond is effectively a large settling pond for sediment entering from the river above, as well as taking road run-off. Silt depths were not assessed during the visit, but it is suspected that the pond contains a very high volume of silt which will adversely affect water quality. One would expect the mill pond to offer a deep-water refuge for a range of fish, including brown trout, yet few fish are thought to inhabit it.

Pic 12 – The Radwell mill pond with the mill just visible in the distance.

The mill pond is held at a fixed level that is believed to be higher than it once was. The pond impounds a long section of river. Lowering the head of water retained would allow more of the river upstream to naturalise. A similar conversation should be had with the Stotfold Mill Preservation Trust downstream, with a view to brokering an operation agreement.

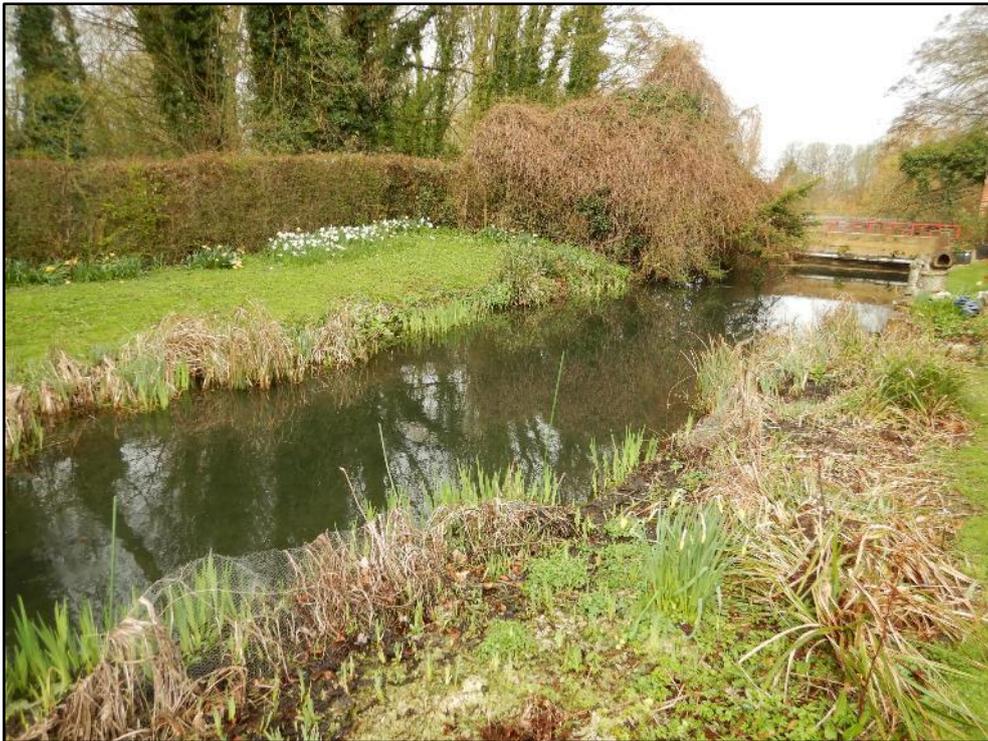
The river immediately upstream of the mill pond is impounded and the bed is smothered in dark organic silt (pic 13). The base of the road bridge touches the water indicating that when built water levels were lower. The bridge now acts a boom and captures floating matter which, in addition to being unsightly, can lead to the complete smothering of the water surface by algae and duckweed in summer, resulting in total shading of the river for many metres upstream. It was at this location that a large shoal (100+) of roach or rudd were observed. They presumably inhabit the lake but may have moved up into flowing water to spawn, or to seek better water quality if the lake is starting to suffer from eutrophication and/or sedimentation (a common problem when no flushing occurs, and trees/birds are present and increase organic loading).

Pic 13 – The mill pond impounds the river. The road bridge is to the right of the picture.

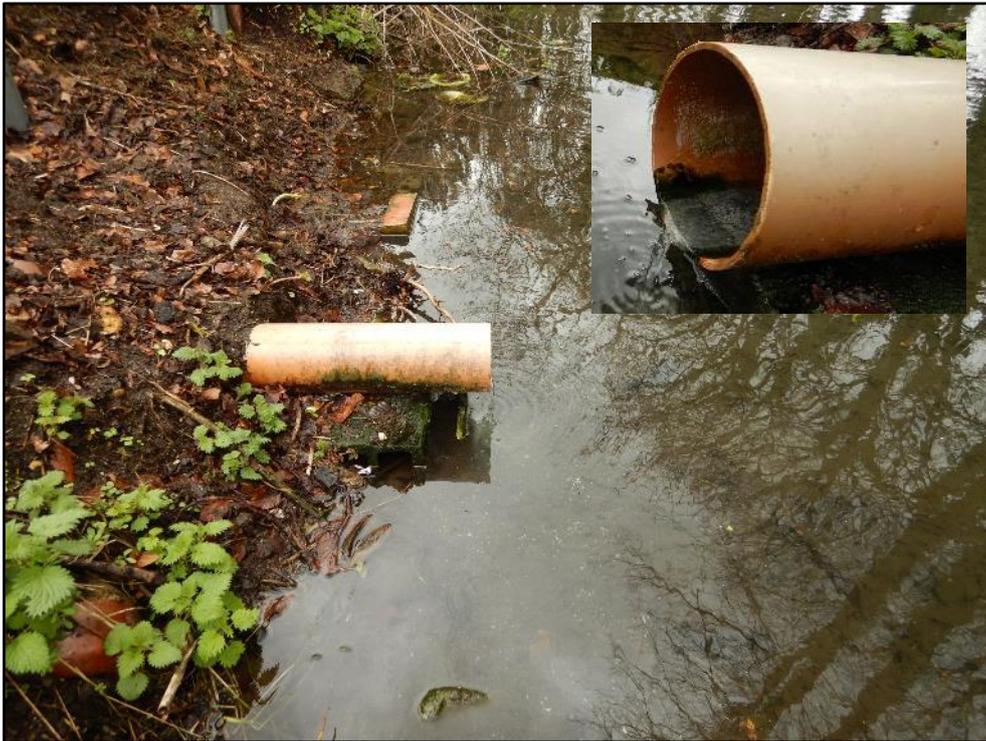
~30m above the road bridge, a pipe discharges a consented private effluent outfall to the river (pic 14). Sewage fungus is associated with the discharge (see inset pic). The source is at Radwell House and has been drawn to the attention of the EA for further inspection.

Pic 14 – A consented private outfall which has sewage fungus associated with it.

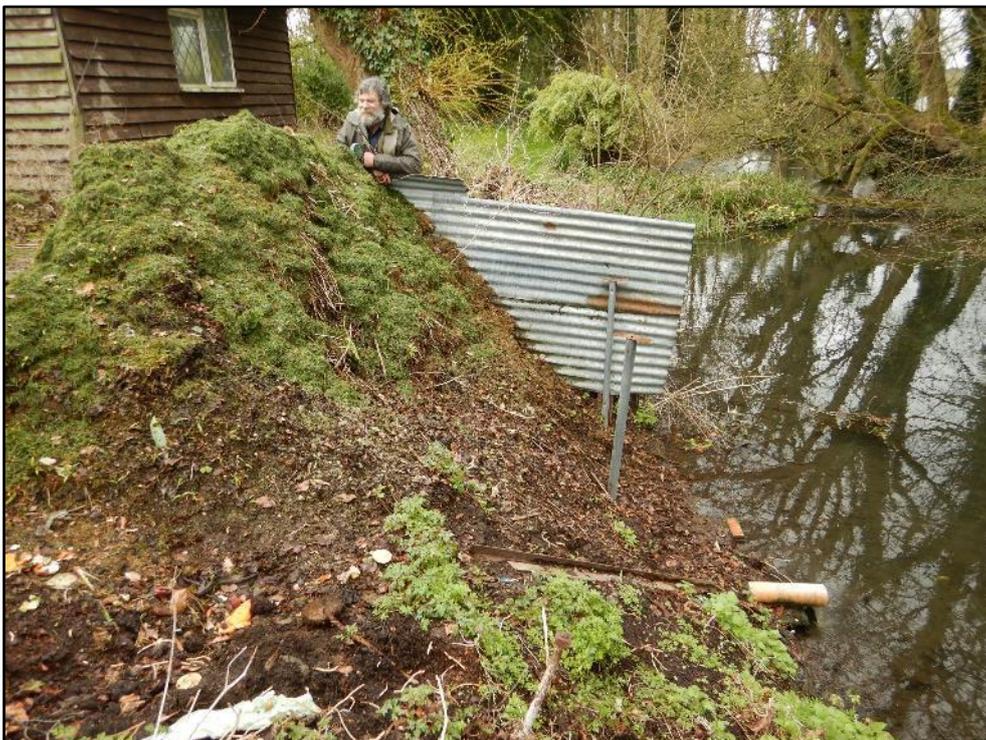
Also situated at the river's edge at this point is a compost heap with organic matter tumbling into the river (pic 15). Grass cuttings are a known source of nitrogen, and pose a significant risk to dissolved oxygen concentrations via leachate. Following onsite discussion, the landowner confirmed that the compost heap would be moved away from the river.

Pic 15 – Compost heaps should not be located on the riverbank.

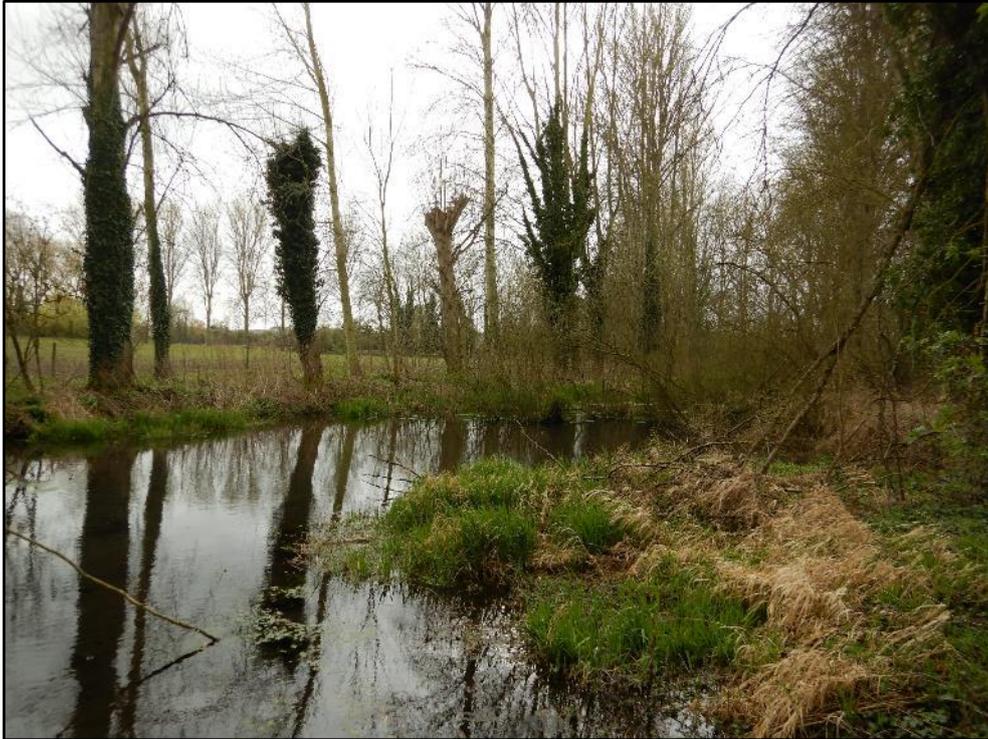
The impounding effect of the mill pond continues upstream for at least 150m, with black silt and leaves smothering the bed (pic 16). Where the tree canopy casts less shade, an array of marginal plants are present

Pic 16 – The river is impounded above the mill pond for at least 150m.

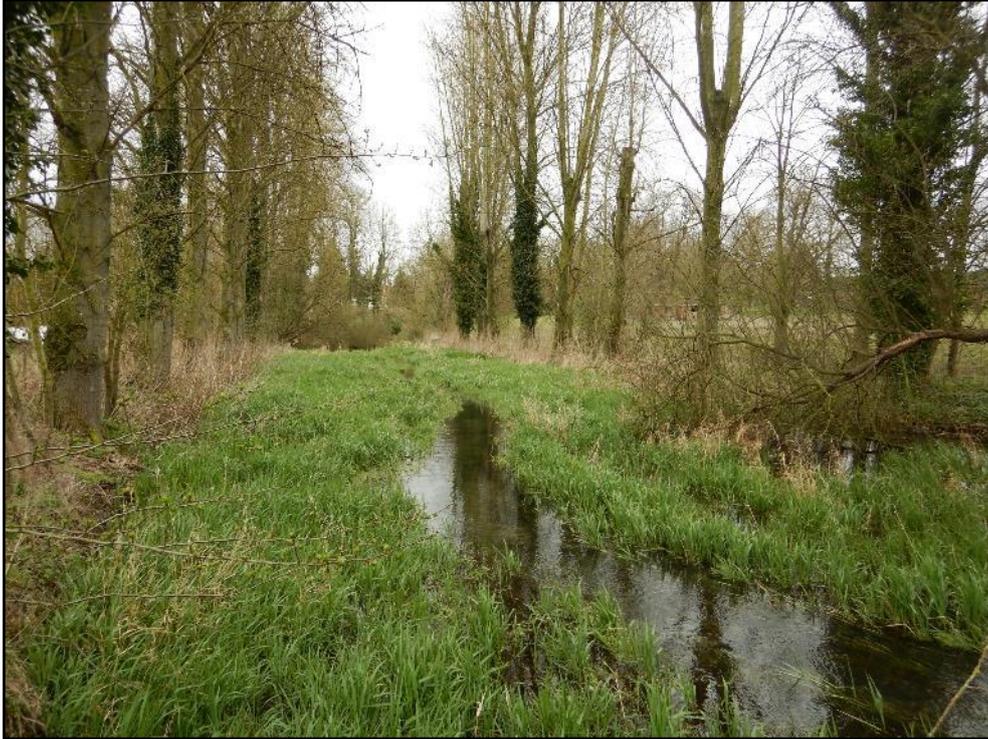
The over-wide channel is a result of historical landscaping to create a broadwater which were fashionable in the mid-18<sup>th</sup> century. This illustrates how the river's natural form has been radically changed. Those changes now result in ecological strain on the river, which is not in its natural course. With the river having been realigned it is prone bed seepage in dry periods. Seepage from the river reduces flow available to transport sediment, resulting in silt smothering the bed. The problem of siltation is further compounded by the mill pond. Careful thought is needed between RevIvel and key landowners as to whether any of the past changes to the river system are still needed. Can the river be restored to a more natural form? The most obvious starting point is the mill impoundment, can it be lowered at all?

Pic 17 – The river is now creating its own sinuous channel as it flows through the former broadwater.

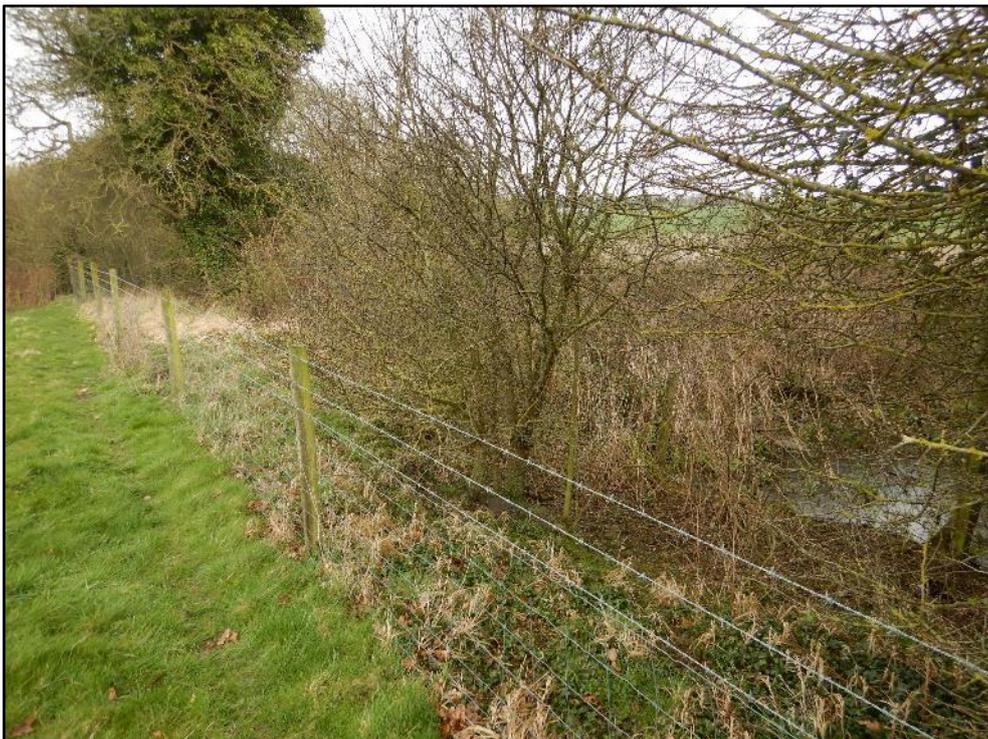
At Radwell Common the river is much narrower ( $\sim 3\text{m}$ ) but is hidden behind a fence and hedge (pic 18). Where the canopy is broken marginal plants are present (pic 19) and the river winds its way through with occasional patches of chalky gravel. Consideration should be given to making some openings in the reach to reduce the excessive shading.

Pic 18 – The river is partially hidden at Radwell Common.

The river is very shaded in parts of Radwell Common and consideration should be given to opening parts of the canopy.

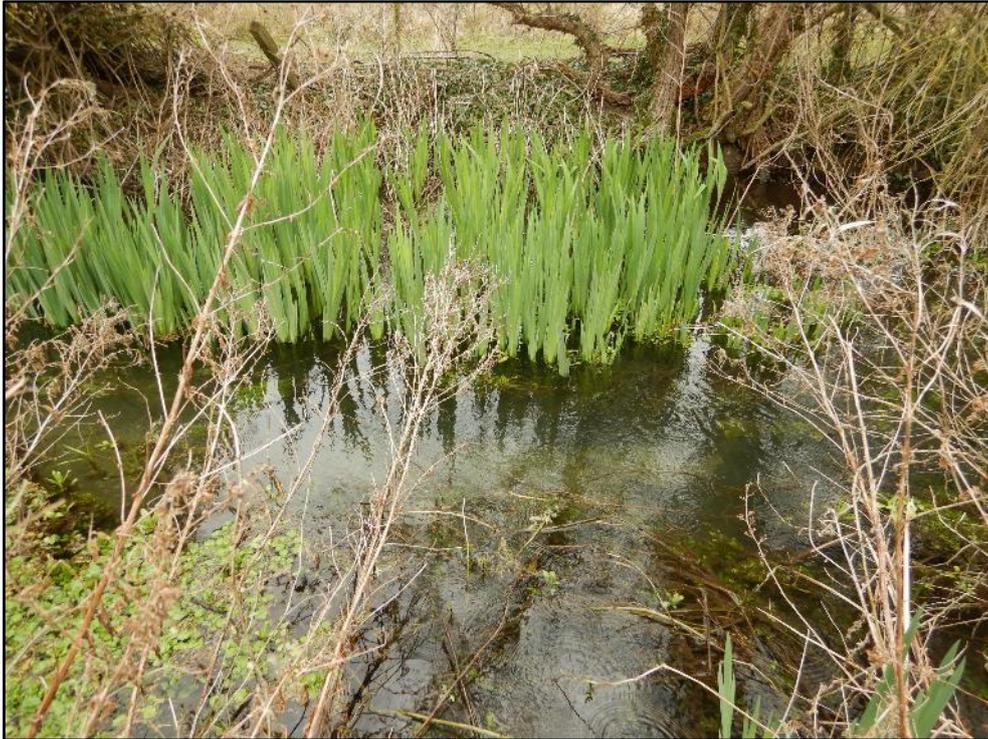
Pic 19 – Where the river is open there is an attractive array of plants.

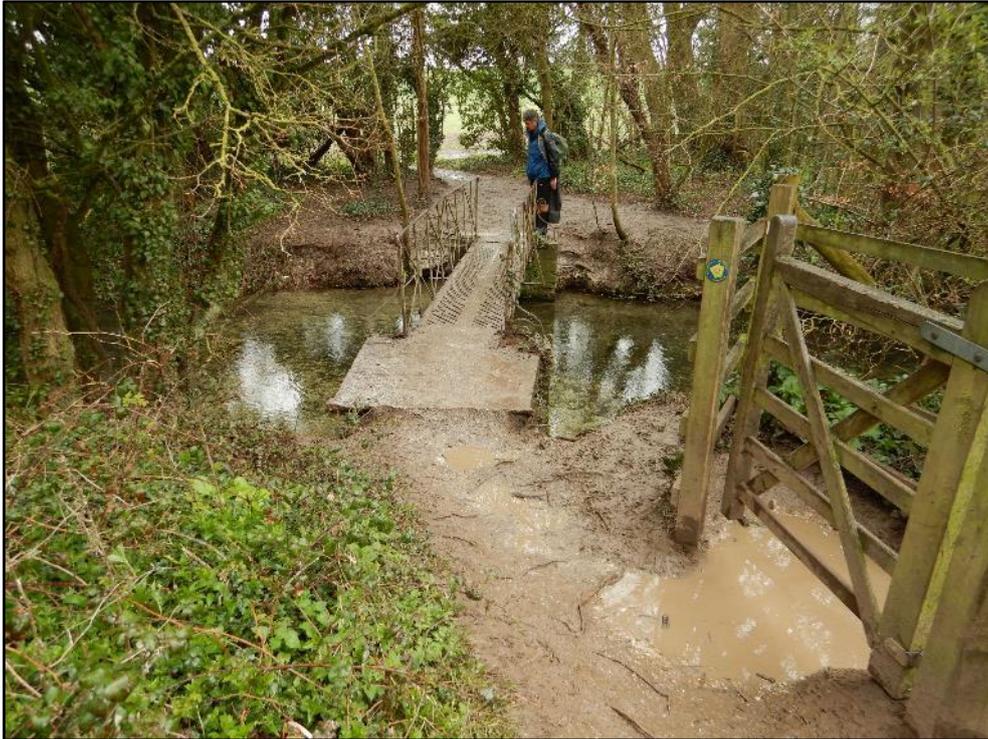
At the Iron Bridge the impact of bank erosion by heavy footfall and dogs, is apparent (pic 20). Consequently, bank vegetation is suppressed with few water plants, and silt smoothes the riverbed. It is hard to stop bank erosion by dogs at popular locations. Log revetments backfilled with granular material (MOT type 1 or crushed concrete, topped with gravel) could improve bank stability. Any measures put in place must not introduce a hazard to river users.

Pic 20 – A well-used footpath combined with bank erosion results in high input of sediment to the river at the Iron Bridge.

At the Iron Bridge the impact of bank erosion by dogs, and the large volume of degrading silt entering the river is apparent. Measures could be implemented to reduce the silt input. Dialogue would be needed with Hertfordshire County Council due to the public right of way being affected.

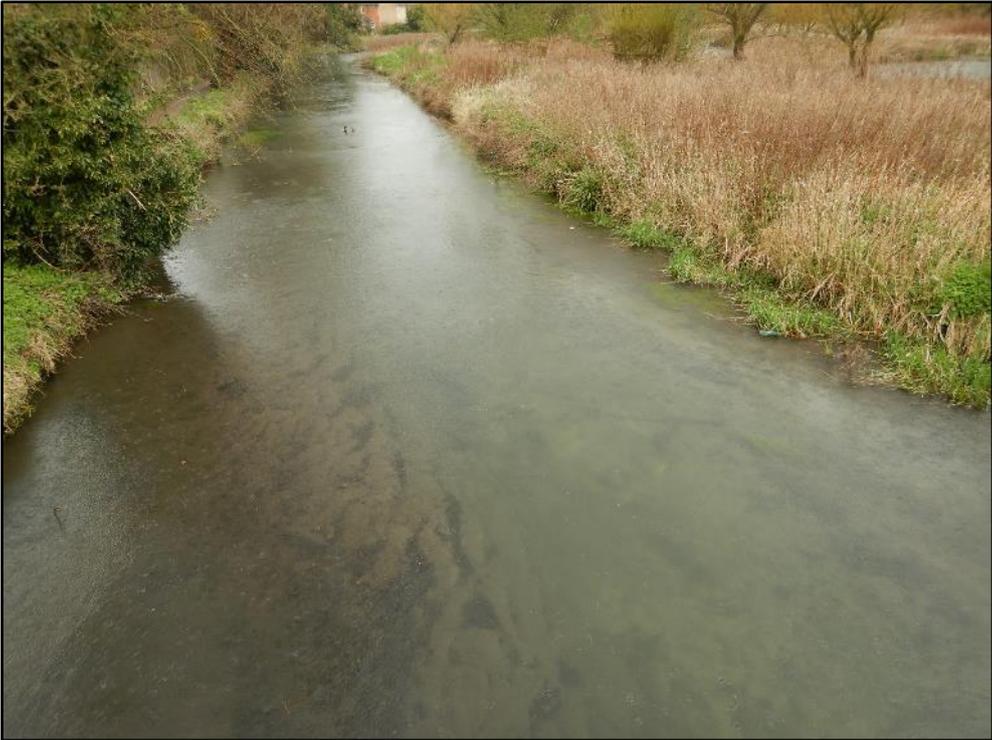
The river downstream of the New Bridge is barren of aquatic plants and in-channel features (pic 21). It is over-wide and subject to the impounding effect of Stotfold Mill. The mill is an operational mill and is preserved by Stotfold Mill Preservation Trust. Dialogue should be initiated with the mill to see if during non-working periods the head of water could be reduced to lower the upstream impoundment, that would aid sediment transport and enable some establishment of natural riverine processes. There may also be opportunities to explore fish passage through, or around, Stotfold Mill to allow fish to migrate upstream to below Radwell Mill.

Pic 21 – The river downstream of New Bridge is severely denuded of habitat and the bed is smothered by silt.

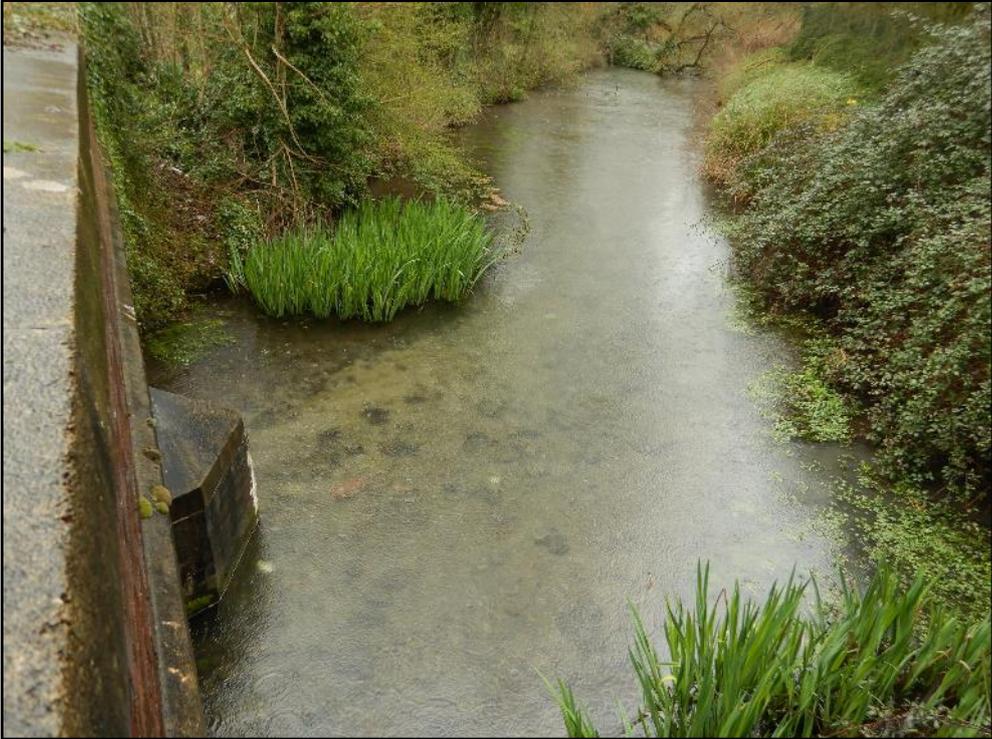
Immediately above New Bridge the river is less impounded, and sand dominates the bed substrate (pic 22) in place of deep organic silt. However, habitat is still poor, with limited marginal cover provided by yellow flag iris and trailing brambles. The river flows through an area of woodland but of most interest was the river's meandering course (pic 23). Whilst much of the river upstream of Radwell Mill has been realigned, this short reach is considered to be the river's true course. Consequently, the river at this location has much potential for restoration.

Pic 22 – Above New Bridge the river suffers less impoundment from Stotfold Mill.

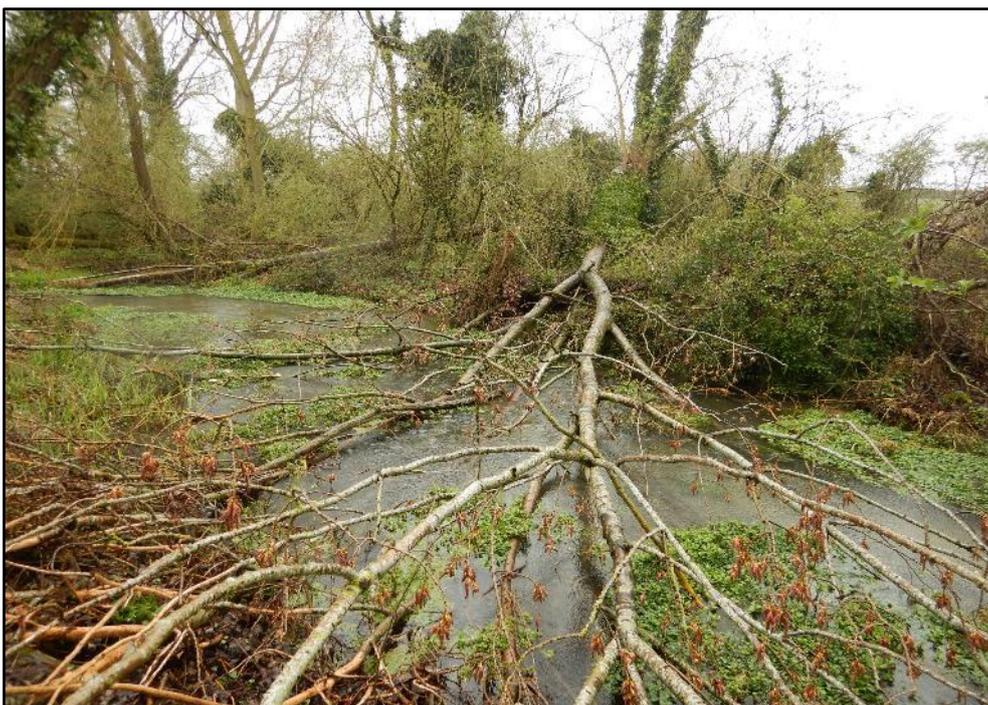
In places trees have fallen into the channel (pic 24), this is not a problem and should be seen as an opportunity to create flow diversity, initiate bed scour (as debris builds against branches pushing flow down against the bed), and to provide important overhead cover.

Pic 24 – A fallen tree creates complex flow pathways and gives important overhead cover.

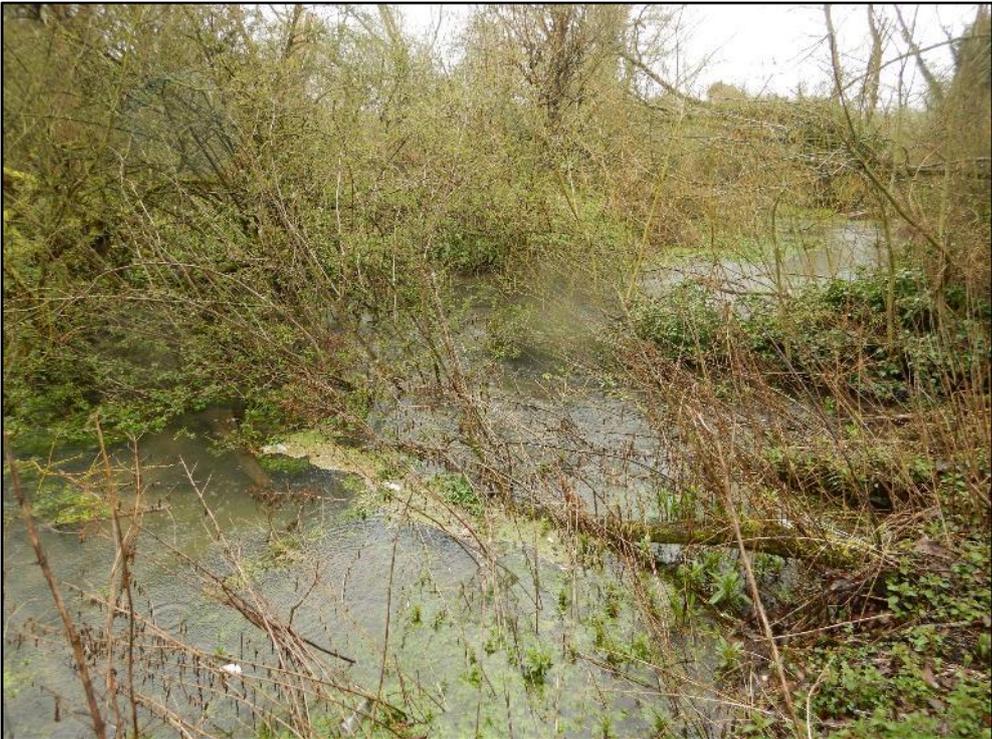
In other situations, the presence of fallen branches may require some adjustment (pic 25) to prevent impoundment and siltation upstream. In this case branches can be pulled back towards the bank to provide natural flow deflection and marginal cover. Similarly, the occasional branch across the river provides flow diversity and cover for fish (pic 26) without creating an impoundment. Each piece of fallen LWM should be assessed on a case-by-case basis, with the default position for it to be retained in situ.

Pic 25 – Fallen willows should be hinge-cut to lie against the margins in this relatively small river before they root in the channel.

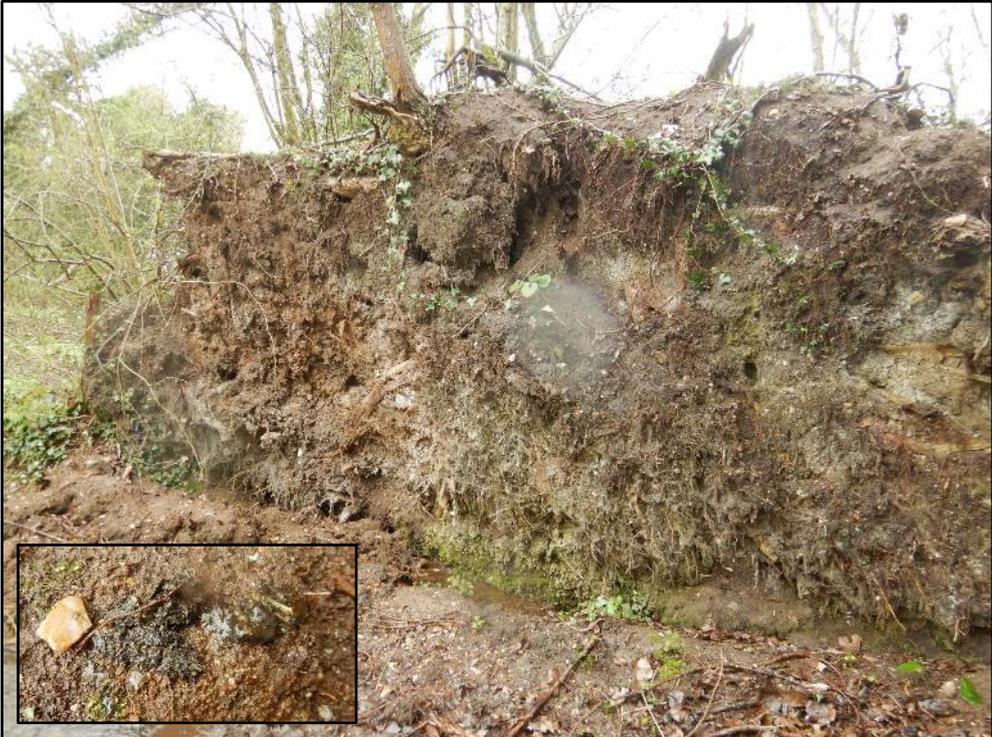
A point of interest, poplar trees have blown over resulting in up-turned root-plates (pic 27). They mimic eroding riverbanks, and in lowland England they provide important nest sites for kingfishers. Any riverside path should try to avoid them for fear of disturbing nesting kingfishers. At the base of the tree was a fresh otter spraint (inset pic).

Pic 27 – Kingfisher will dig burrows into the exposed root-plates of trees.

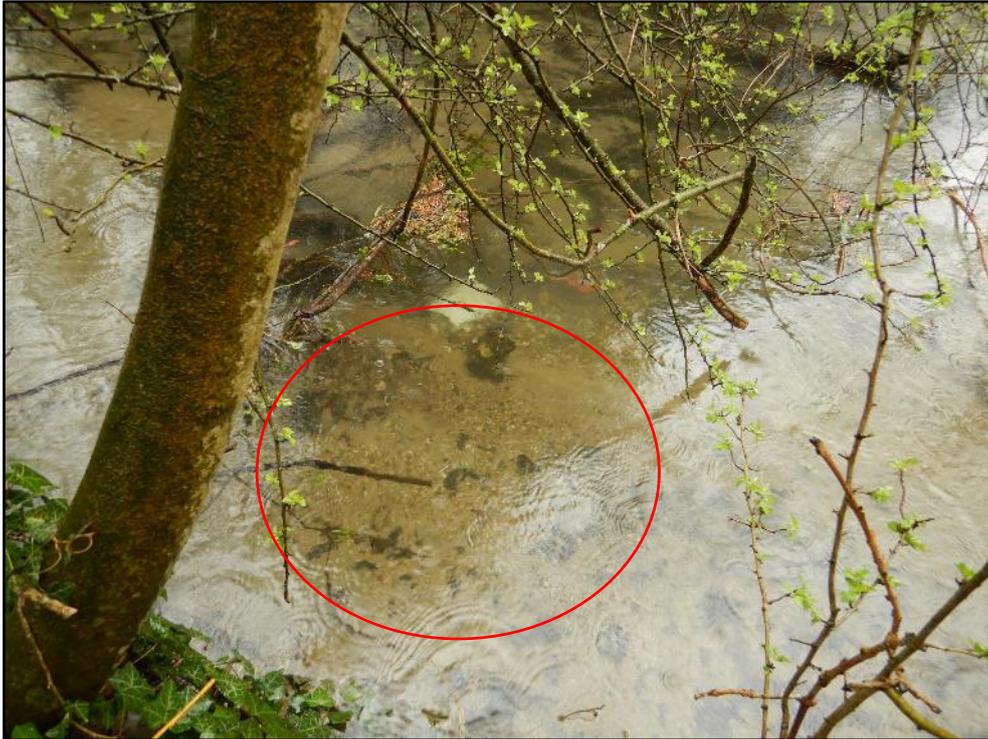
Exposed gravel is present where the flow has scoured silt from the riverbed (pic 28). This reach has much potential for enhancement through positive management of the existing fallen trees and from sensitive vegetation management. It was stated by the mill owner that the Bedfordshire and Ivel Internal Drainage Board (IDB) maintains this reach. It appears that they may have backed-off from this area but nevertheless, it would be advantageous for the RevIvel to establish dialogue with the IDB to ensure that both parties are aware of management priorities and work together for the good of the river.

Pic 28 – Gravel is exposed where flow scours sand and silt from the bed.
