WILD TROUT TRUST

Advisory Visit

R Wharfe, Bradford Waltonians, October 2021

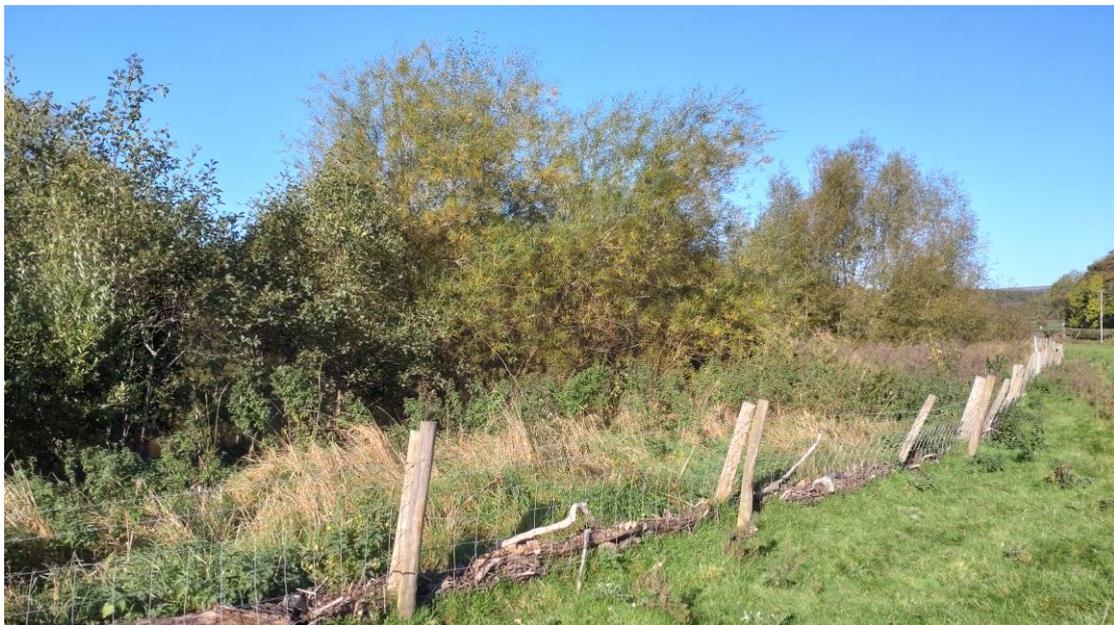
Fig 1. The state of the sheep-netting fence-line that has protected the river bank and riparian zone for ~20y. The difference between grazed and non-grazed vegetation is stark.

The fence of sheep-netting was falling into disrepair and clearly had been patched in places. It is important to maintain the integrity of fencing as even a seemingly inconsequential hole will be exploited by sheep, the grass always being greener...! Much of the Wharfe further u/s in the Dales is devoid of any such protection and the short sward of constantly grazed grass harbours little biodiversity, often eroding badly because of the lack of root matrix.

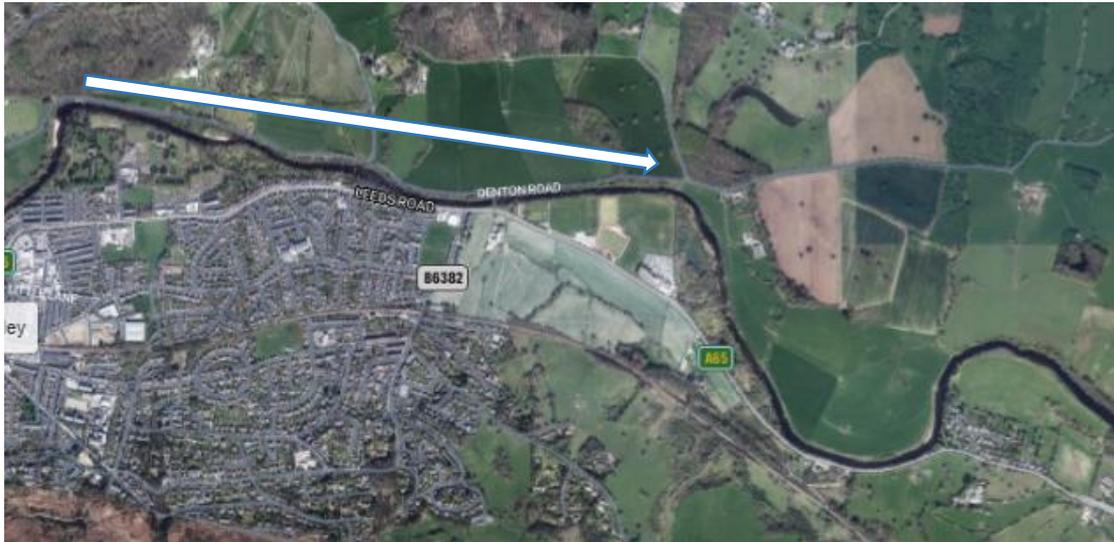
Fig 2. The white arrow highlights how the Wharfe has been tightly constrained between the town and Denton Rd on a straightened course for 2.25km before being shunted around the 'U-bend' at Crook.

A straighter channel is shorter and steeper than would naturally occur, delivering water from A to B quicker and, hence increasing erosive power. The erosion of the LB is merely symptomatic of the river trying to return to the lowest point within the floodplain which is remarkably broad at Crook Farm. Indeed, scrutiny of satellite imagery and even a good look at the fields around Crook Farm revealed several shallow depressions or paleochannels, the ghostly former paths of the river still etched in the landscape.

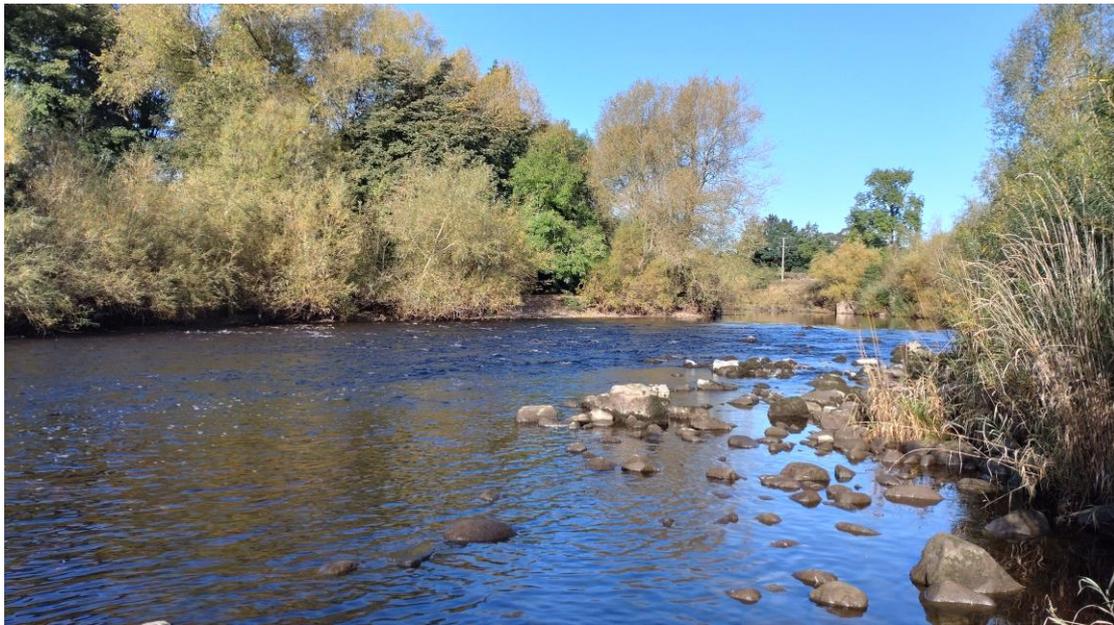
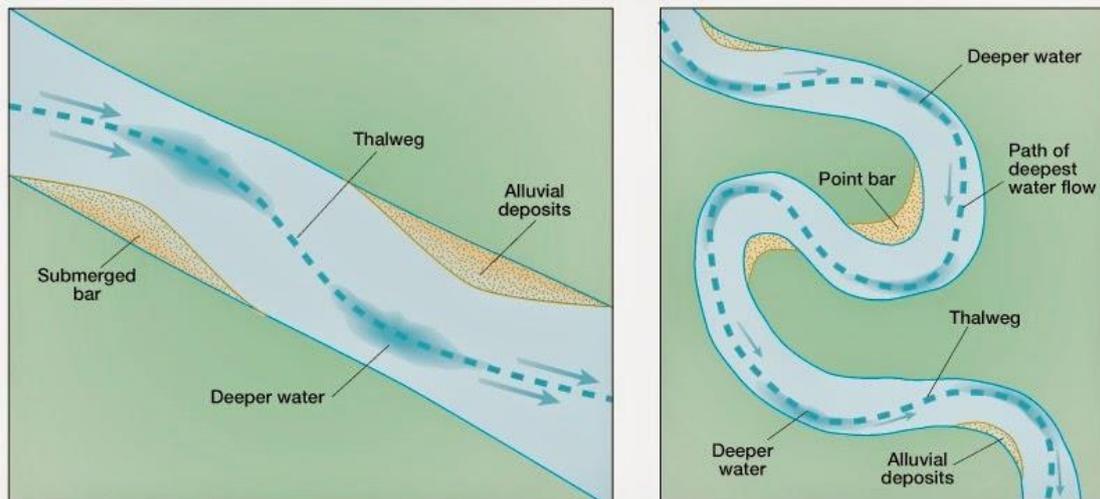
At SE 14516 47938, the thalweg (line of fastest flow; see Fig 3) kicks off from the LB to the RB and deposition bars have formed, pinching the flow and creating a faster, shallow riffle. Over time, marginal plants have colonised the bar and it has stabilised (Fig 3).

Fig 3. At SE 14516 47938, the thalweg crossed from LB (outside of bend) to RB, resulting in deposition bar formation. Note: even in a straightened channel, a river will start to adopt a sinuous course, and if unconstrained will develop into a meandering planform over time.

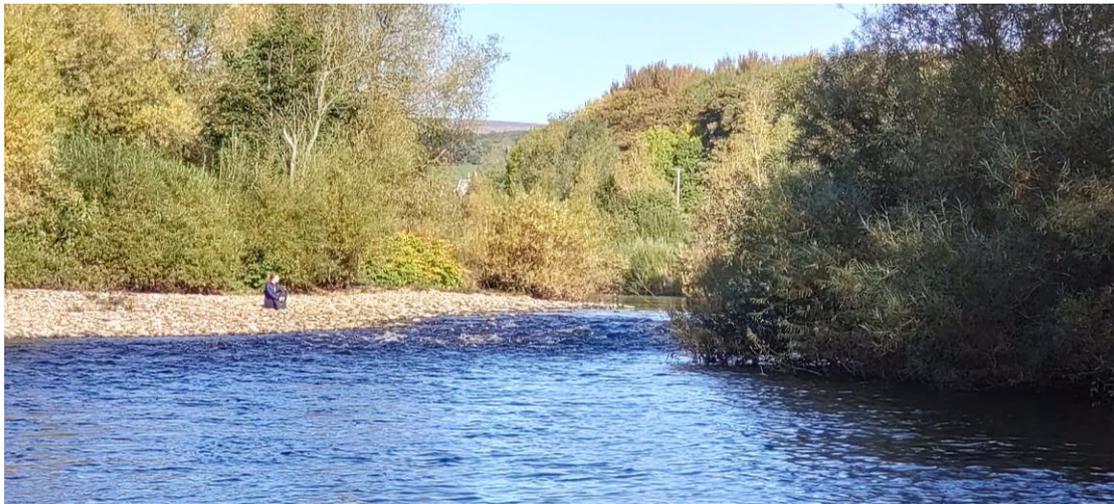
Fig 4. Another pinch between a large deposition bar to the RB and a dense, low spreading willow which provided fantastic cover (and shade).

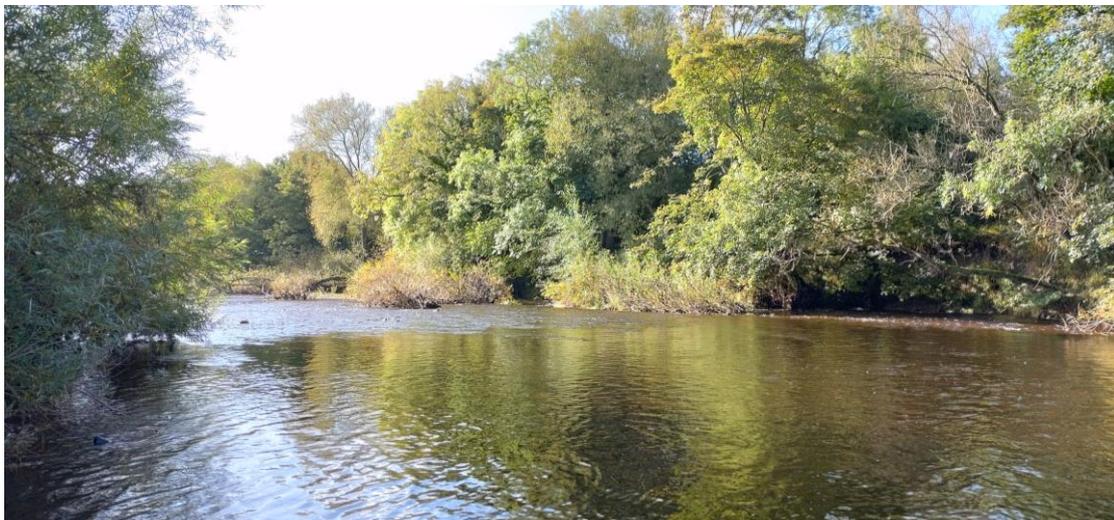
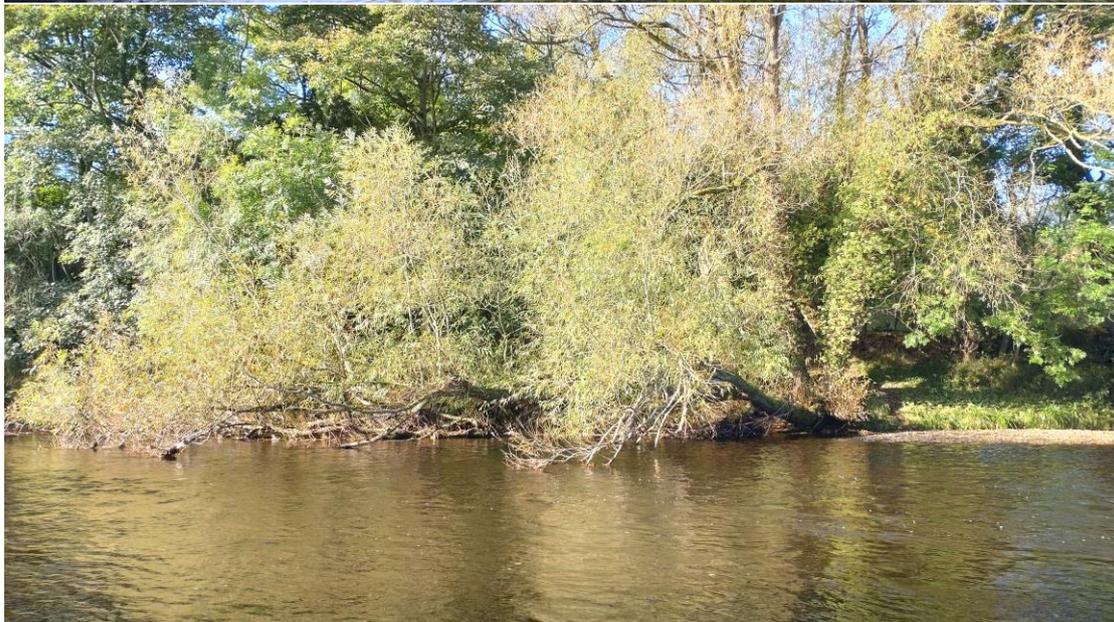
Fig 5. Upper: colonisation of a point bar by willow has led to the creation of a secluded and shady backwater close to the RB. Lower: fabulous examples of leaning crack willow from the RB. The presence of several living limbs over the water will provide more resilience to future spate flow. The outside edge of such willows provides good feeding lines for trout adjacent to ample cover.

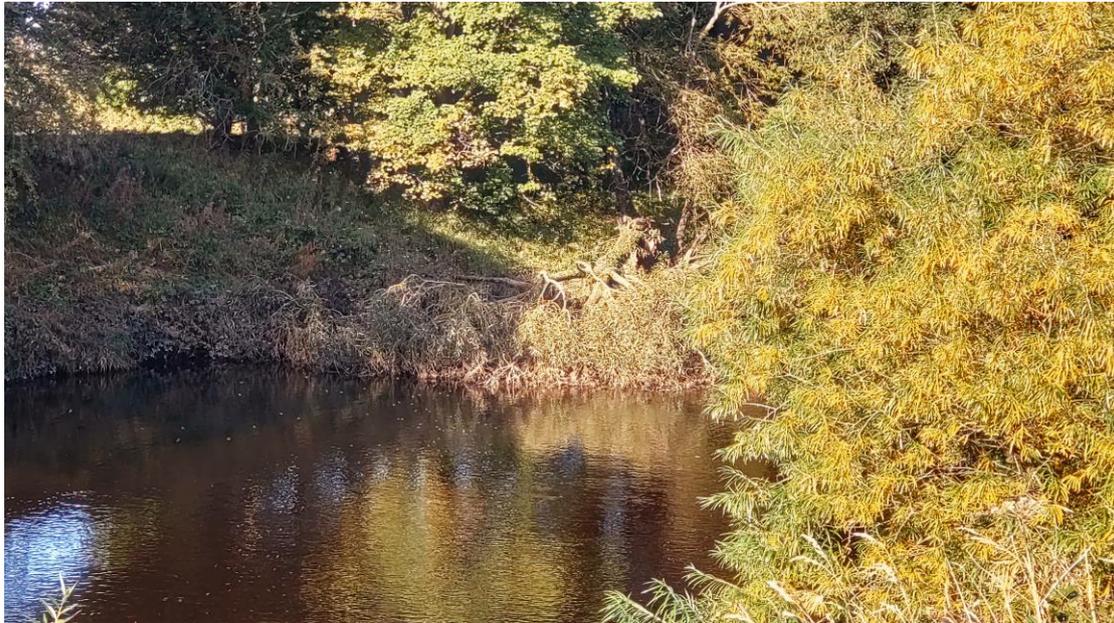
Fig 6. The crown of a detached limb from a crack willow had created a considerable amount of cover in the RB margin on a slower section of the river which was otherwise devoid. There are methods available to retain such material *in situ*.

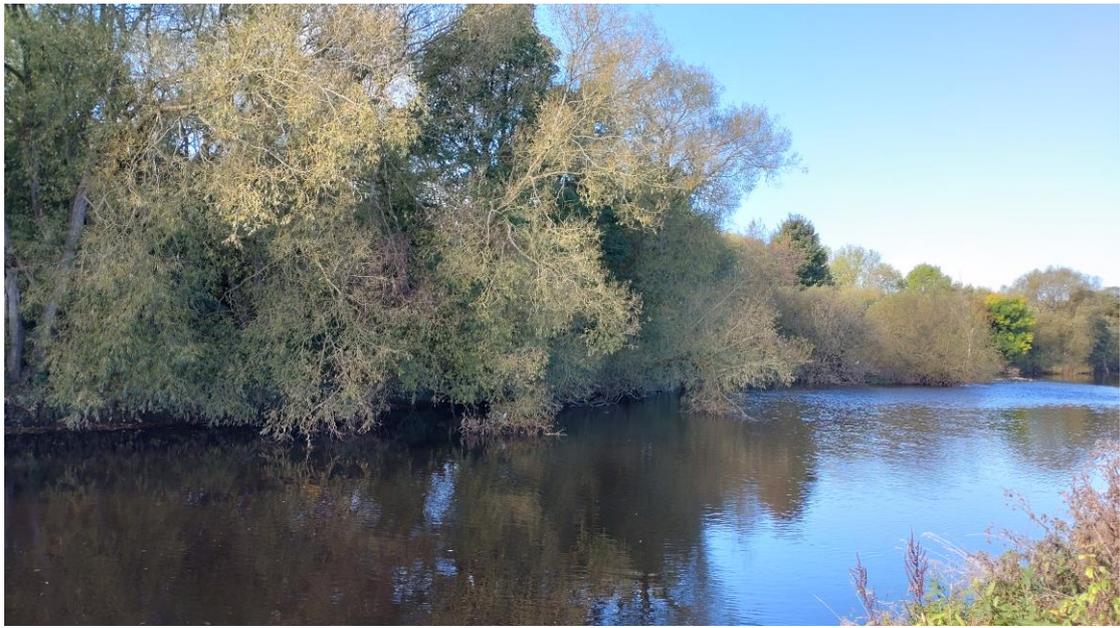
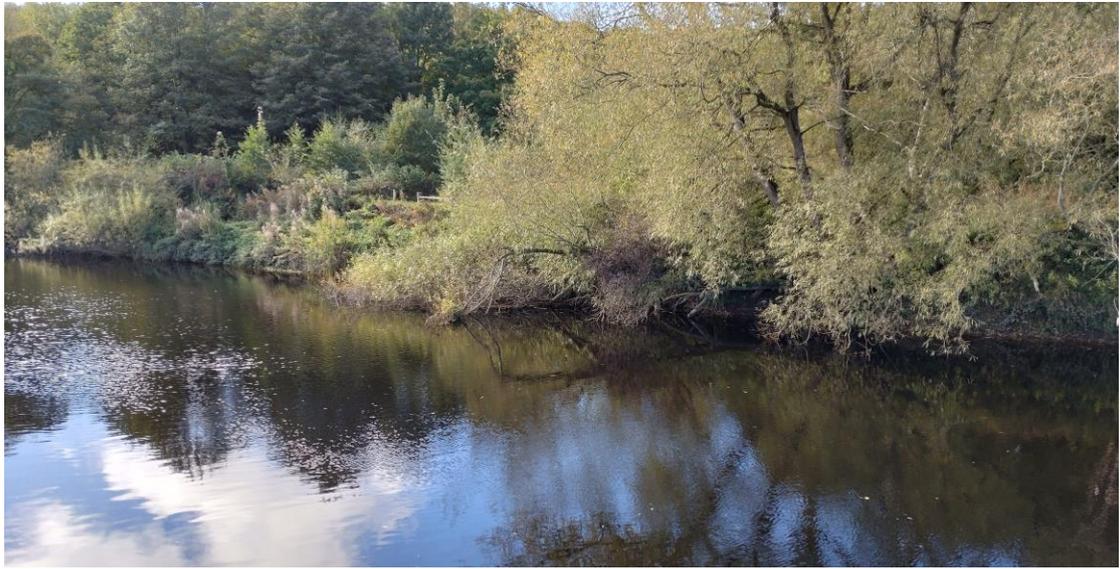
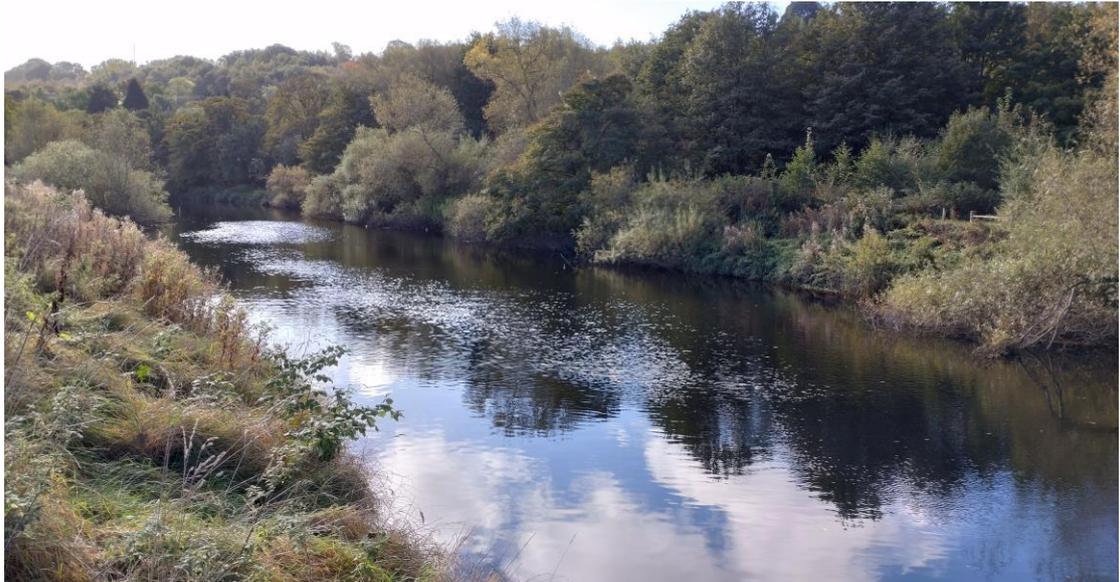
Towards the 'bottom of the U-bend', the flow was notably sluggish and the channel relatively deep and featureless. The channel had been pushed against the side of the valley for such a distance that it was effectively perched above where it should have been on the floodplain, and the water impounded as a result. There was a stand of mature crack willow on the remaining RB with club fishing rights, several of which had limbs that were leaning toward the river (Fig 7). These could be encouraged to 'hinge' into the channel and provide further diversity and cover (as in Fig 6). The LB was relatively devoid of mature trees that could be managed for environmental gain for the remainder of the club water.

Fig 7. Impounded and relatively featureless water but scope for improvement via judicious management of a few of the crack willows on the RB (upper & mid). The lower image exemplifies the canalised reach and lack of mature trees on the LB aside from shrubby goat willow. Even some of these smaller goat willows can be hinged at a d/s angle to increase cover.

Any activity like this requires careful planning and consent from landowner and the relevant authority (in this case, the Environment Agency for works on main river) but can be achieved relatively easily and cheaply. The idea is to work with the processes of the river, rather than against them, so identifying areas that will not take the brunt of spate flow and are already marginally depositional in character would be ideal. Suitable sites and trees for the above techniques were identified in Figs 7 & 10.

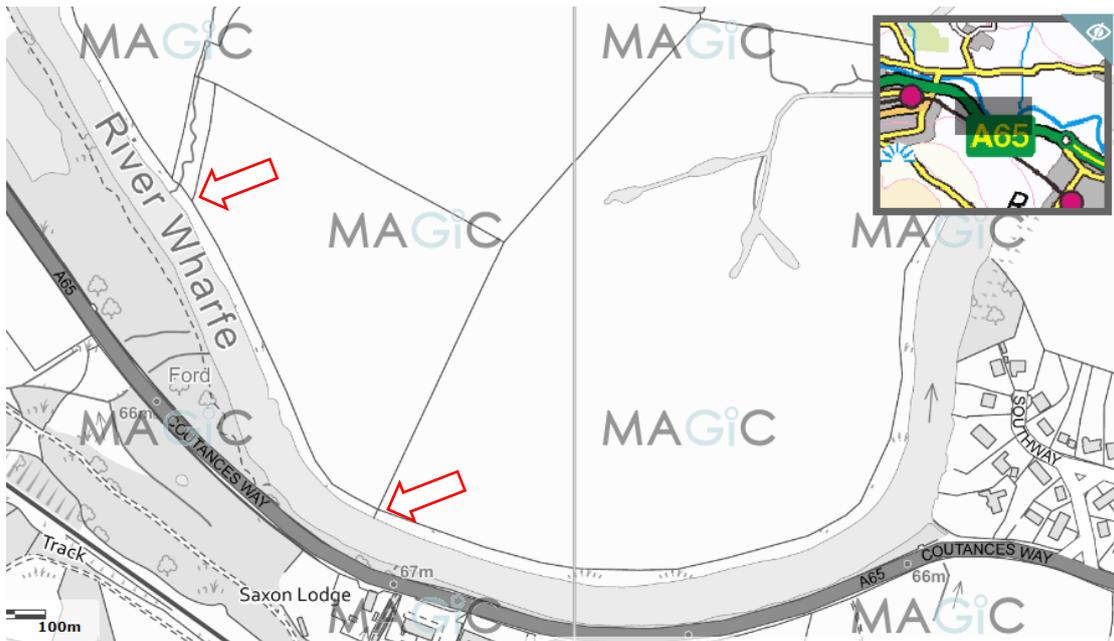
Map 2. Extract from [MAGiC](#) of the field boundaries at Crook Farm and the contentious points identified on the fence-line (red arrows).

- At SE 14684 47554, where a small beck joined the Wharfe from Low Park Plantation, the fence to the north of the beck was intact but had collapsed on the south side. Cattle had accessed the confluence and there was considerable poaching. Without reinstatement of that fencing, livestock would have complete access to the formerly protected bank u/s & d/s. NB – this beck, although tiny could represent spawning opportunities for trout – see Recommendations.
- At SE 14836 47293, the fence on the western (u/s) side of the field boundary was intact sheep-netting, whereas on the eastern (d/s) side, it had been replaced by a single strand of breast-high barb. The difference in vegetation structure on the non-grazed (u/s) *versus* grazed section was marked, as was the reoccurrence of erosion scarring where sheep had access (Fig 8).

Reinstatement of the fencing and upgrading the single strand to multi-strand flood-spec would be required to prevent further deterioration. Hurdles or stock access gates could be installed for access for extremely short periods of mob-grazing if required. However, there is always a risk on steep sloping banks that grazing and trampling will rapidly result in bank instability and further loss of land.

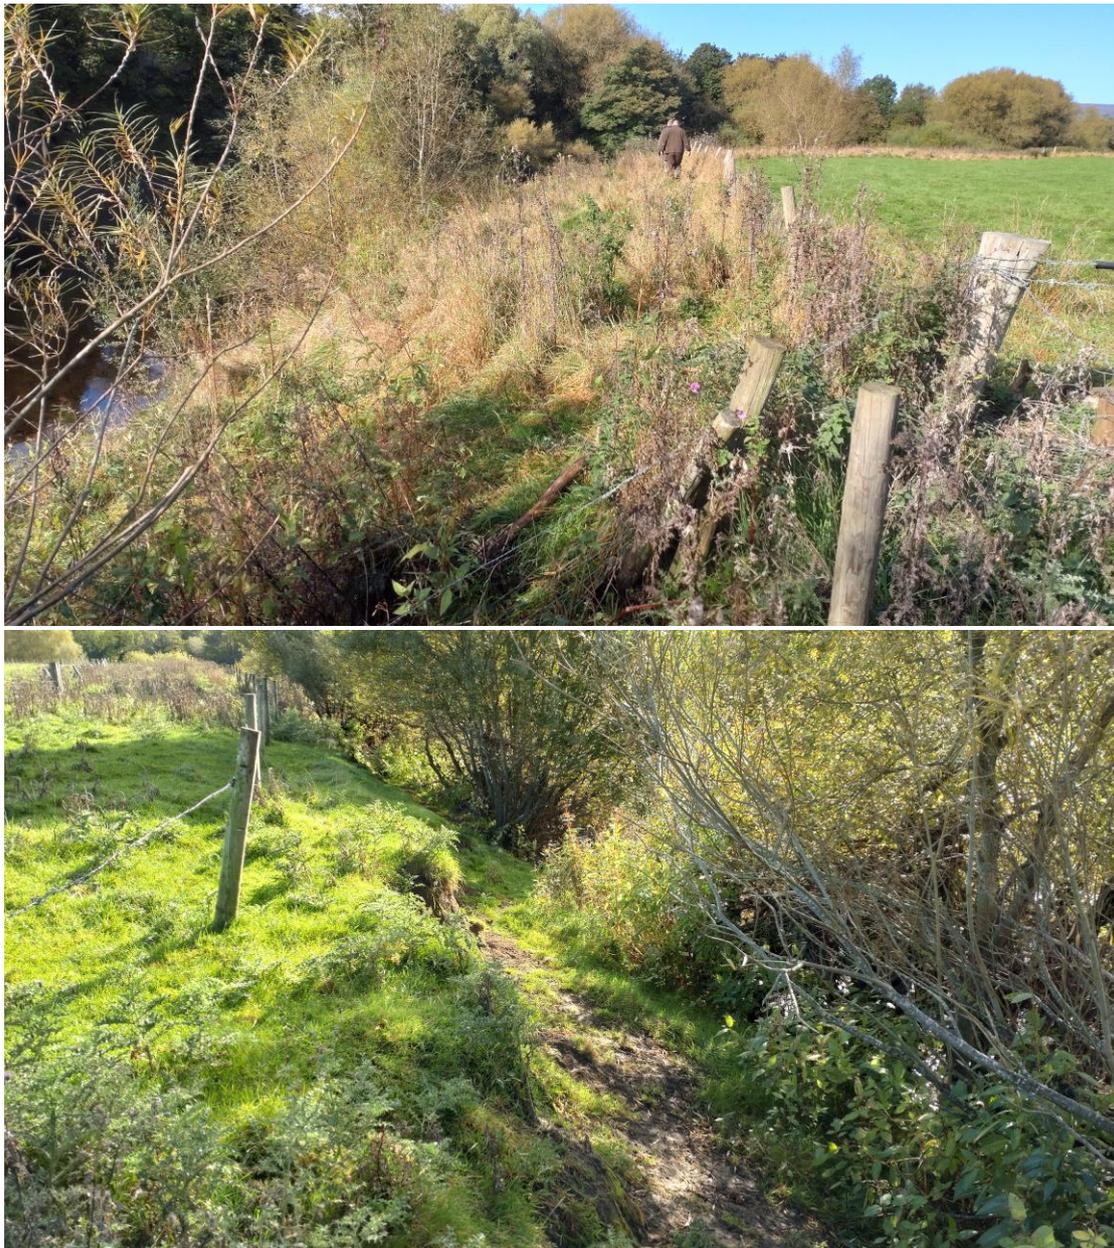
Fig 8. At SE 14836 47293 looking u/s (upper) and d/s (lower) at non-grazed and grazed banks, respectively. It was immediately clear that sheep trampling the bank to browse on the willow were causing erosion scars of bare earth which would be less resilient to further erosion under spate flow and lead to further loss of land.

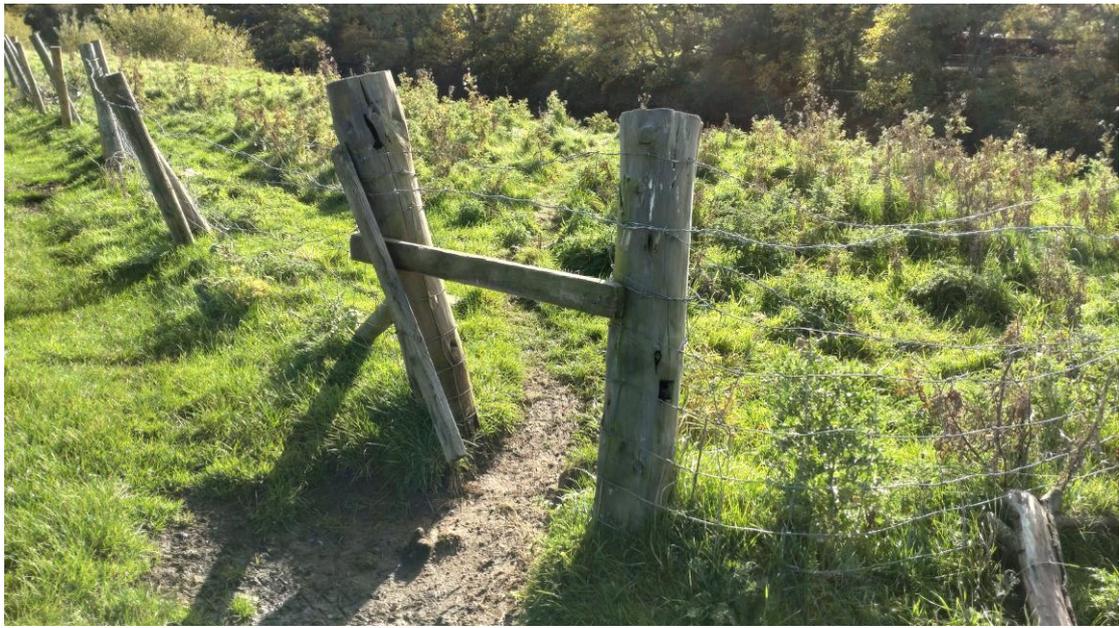
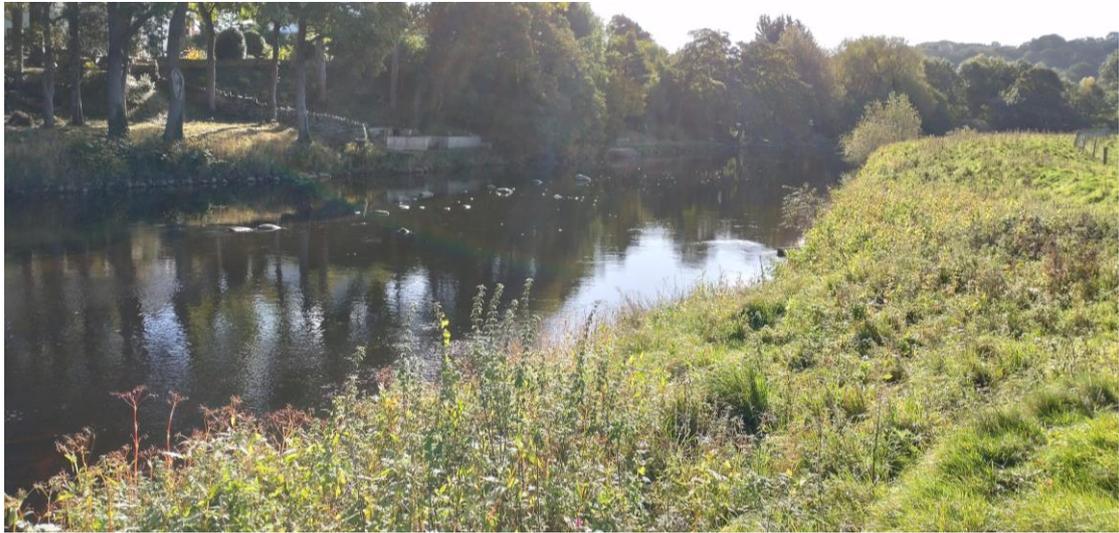
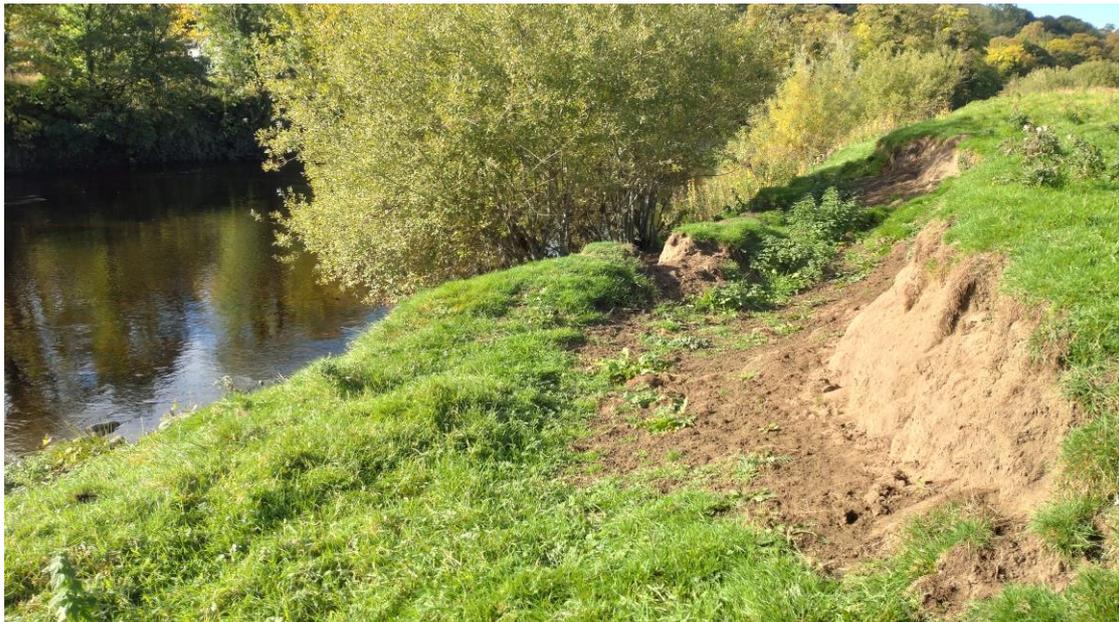
Further d/s in the same large field, there were occasional changes in the format of the fencing but for the remainder of club water, while cattle were excluded, sheep had unfettered access to the waterline (Fig 9). As a consequence, the vegetation was reduced to a short-sward and all the ecosystem benefits of the native herbage to wildlife (diversity / feeding / pollination), flood risk (hydraulic roughness, slowing the flow), and landowner (preventing erosion and loss of land) were lost.

Fig 9. Various images of the LB where sheep had access – loss of native herb-rich vegetation and increased susceptibility to erosion.

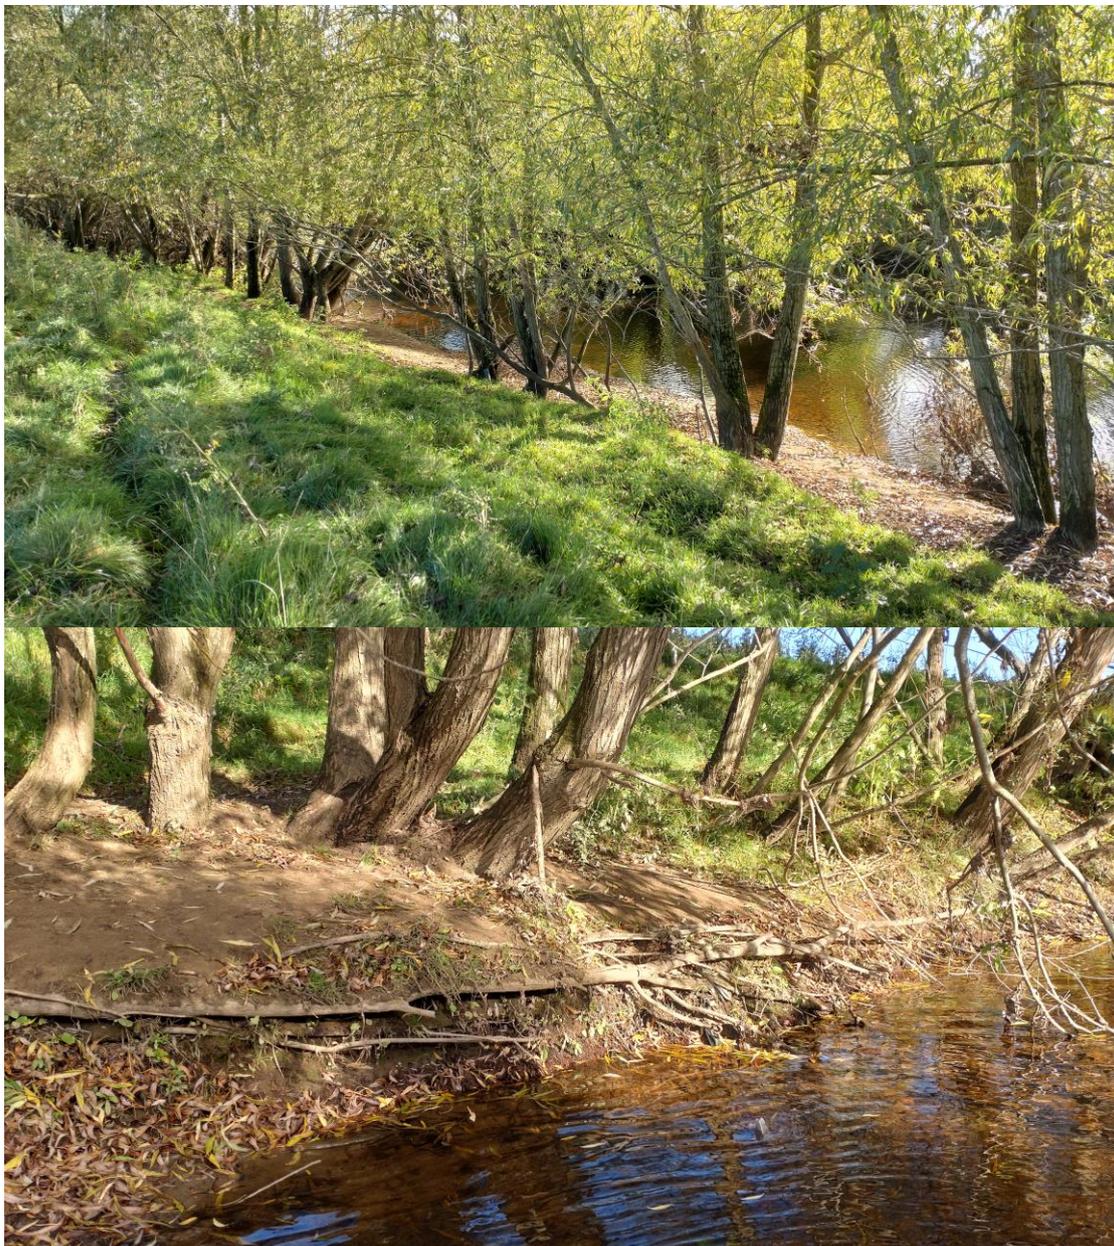
At the bottom of the 'U-bend' (SE 15103 47242), there was a short, linear stand of willow which had been planted as part of the original bank protection scheme (Fig 10). While these had established and prevented further retreat of the bank line, there were tell-tale signs of erosion arising beneath them because sheep were trampling the bank to browse. Further deterioration of the bank and exposure of the roots, ultimately leading to the collapse of the trees is inevitable with continued stock access. The multi-stemmed nature of these trees suggested that they had been coppiced in the past. One or two trunks could be hinged in a d/s direction to bolster the banks, prevent sheep access along the waterline, and provide low cover over the water, plus encouraging new low growth. The latter would not occur unless sheep were excluded.

Fig 10. Upper - a clear browse-line evident in the branching, and lower - bare poached earth beneath the willow stand; evidence of the detrimental impacts of livestock access.

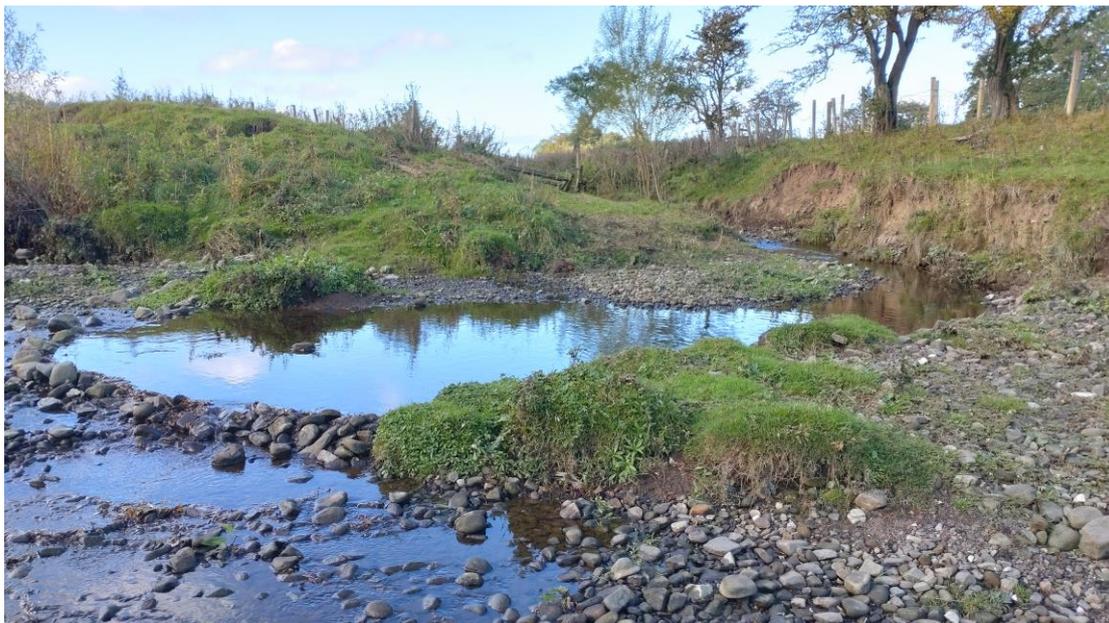
Fig 11. At SE 15340 47616, the confluence of Hundwith Beck on the LB would normally have been accessible bar the temporary damming of flow by local kids. However, livestock from the adjacent field d/s had breached the old fence and there was evidence of poaching and grazing.

Access from the Wharfe would normally be unhindered (see Fig 11) but rather exposed compared to the cover around the smaller beck u/s at SE 14684 47554. Hence, the initial obstacle to fish passage was not physical but behavioural – risk of predation may limit passage attempts to the hours of darkness. To improve the habitat would simply require the reinstatement of the fence-line (visible top right of Fig 11) and allow natural regeneration to succeed.

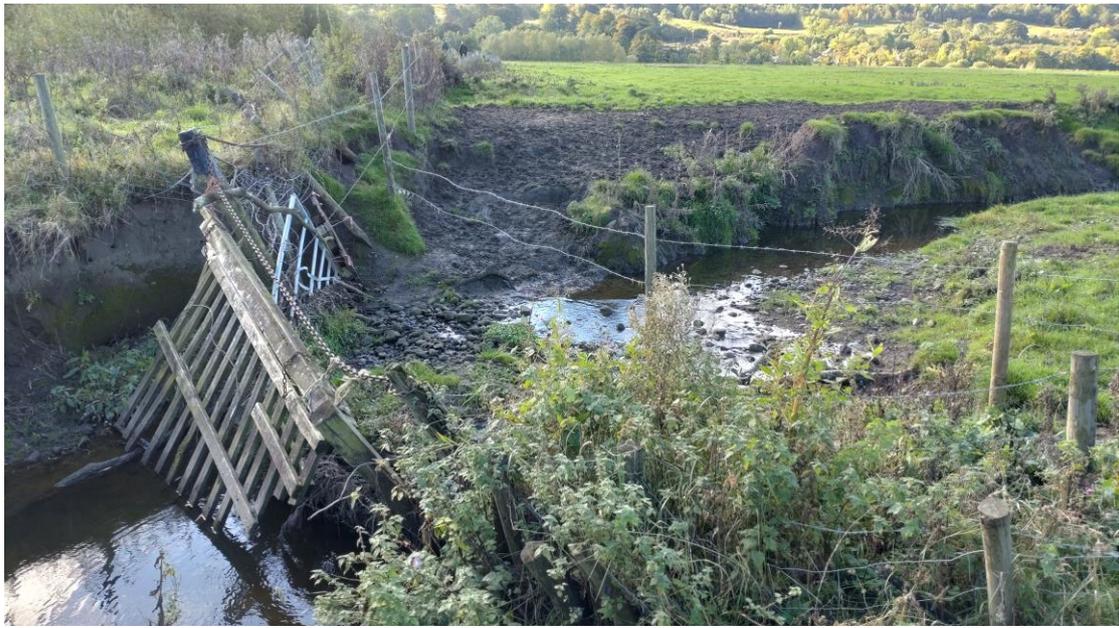
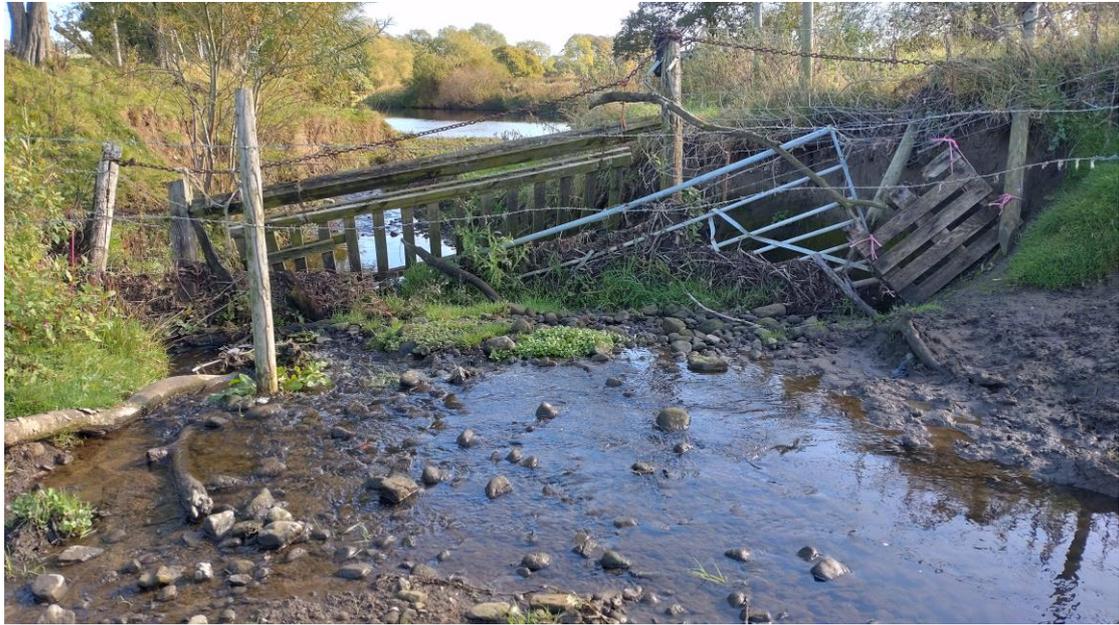
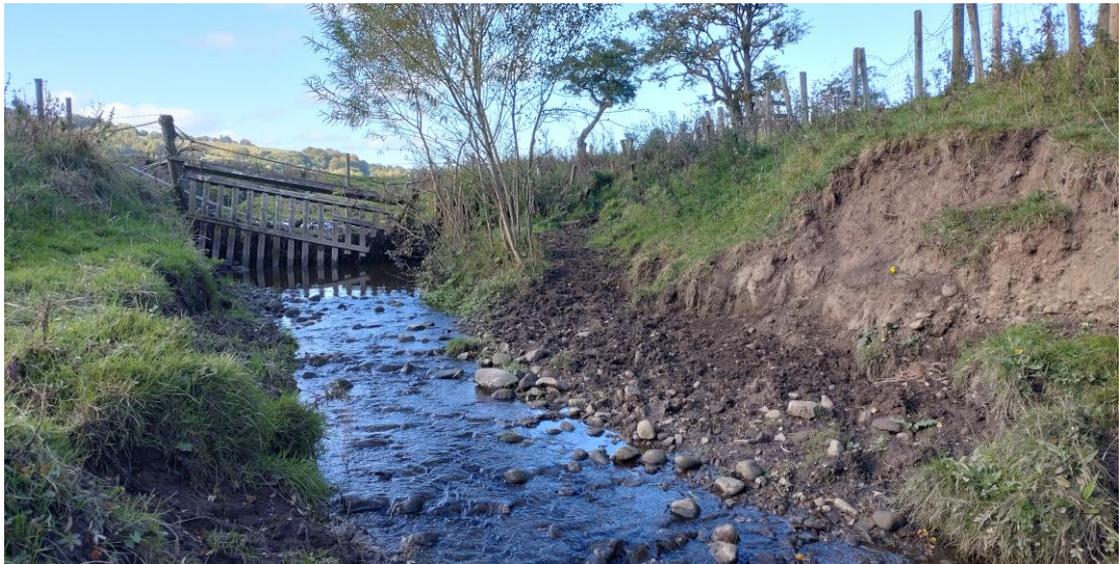
However, within 40m of the confluence, a series of 'Heath Robinson' water-gates that had sequentially failed and been repaired had created a physical barrier that was impassable to fish (Fig 12). So much material and sediment had since accumulated against the collapsed gates that there was a vertical headloss of ~0.5m. The downstream side was becoming incised, effectively starved of gravel and cobble from u/s.

Fig 12. A series of ineffective water-gates had blocked and caused an impassable barrier to fish passage. Note the poaching and fine sediment ingress both above and below the blockage.

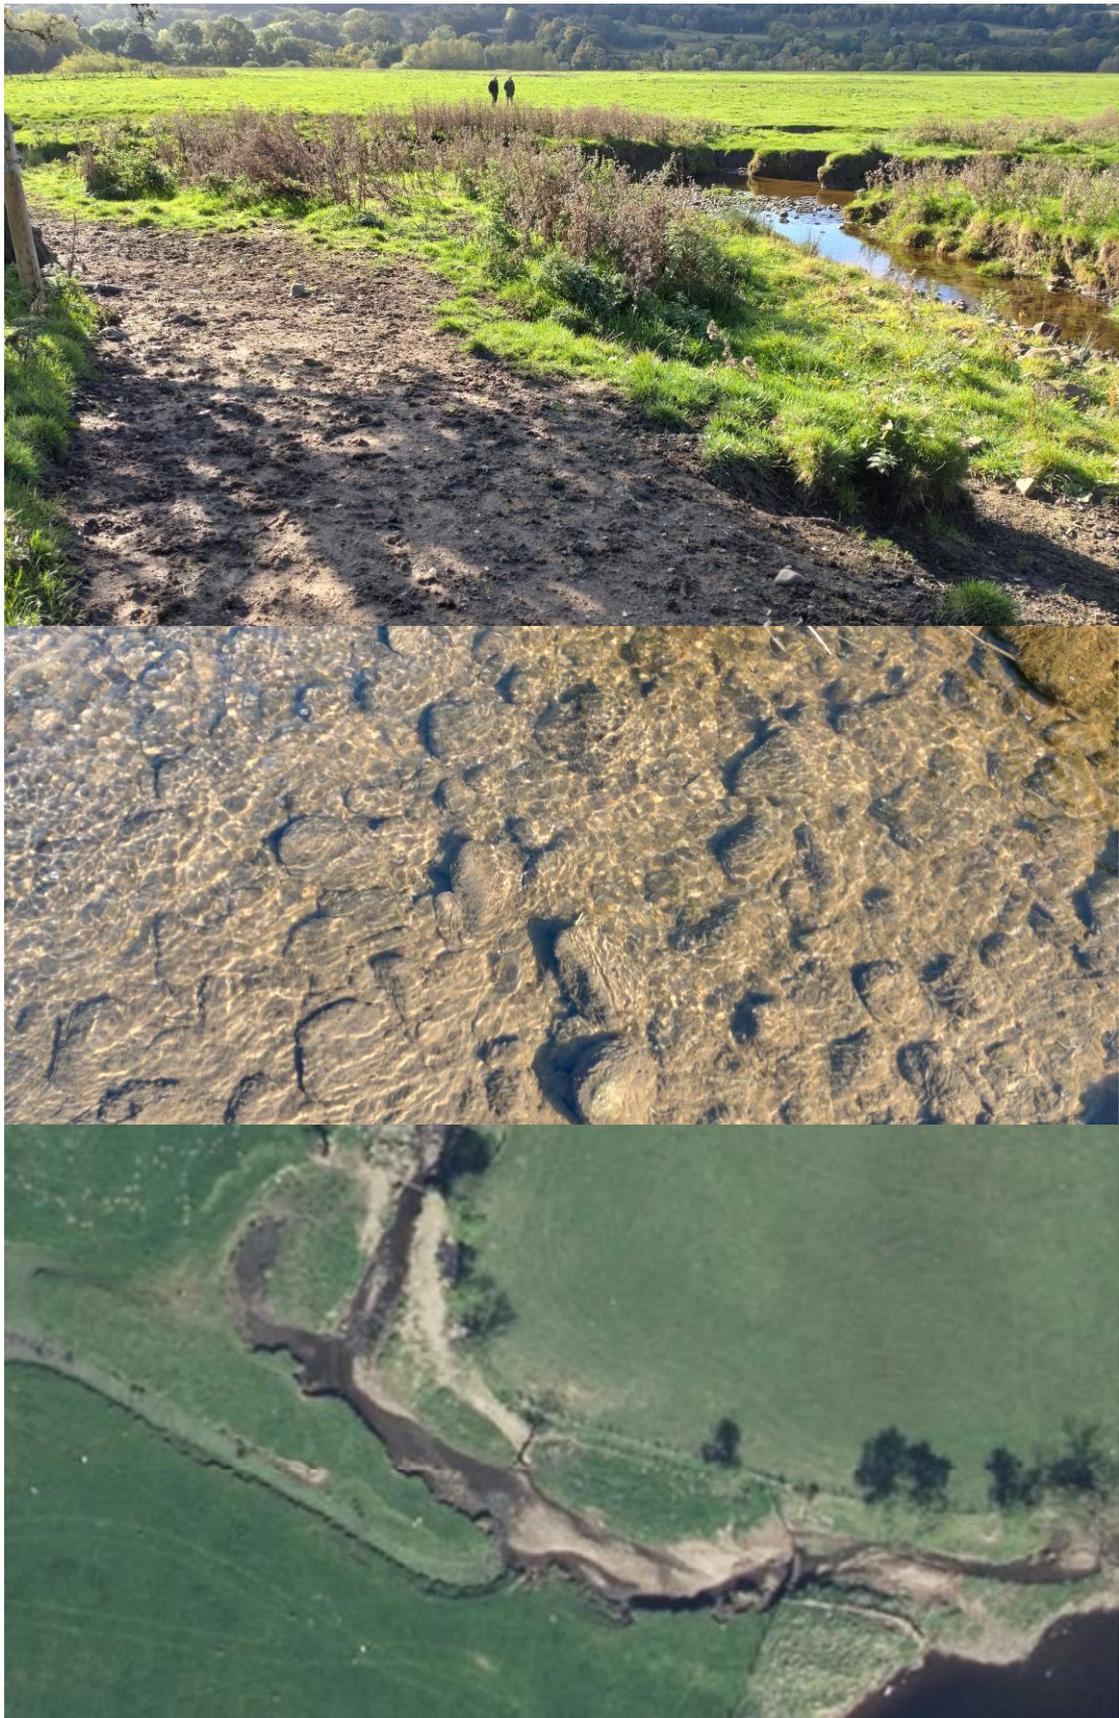
Fig 13. Excessive poaching and fine sediment ingress to Hundwith Beck. The bed was smothered with silt and satellite imagery confirmed this was a long-term issue.

Hundwith Beck only flowed through the corner of the field for ~85m but it was clearly the focal drinking point for both sheep and cattle. The banks were heavily poached, and the substrate smothered in fine

silt (Fig 13). Satellite imagery suggested this was a persistent problem. The extent of degradation was a clear breach of the Farming Rules for Water (2018) and should be addressed by excluding livestock from the channel and providing an alternative drinking supply (eg mains supply, pasture pumps, solar etc). A poorer alternative would be limiting access to a specific part of the beck and formalising a drinking bay with hard standing on the approach. The latter is not without issues; it will require ongoing maintenance and still creates a focal point of activity and nutrient (excretion) input.

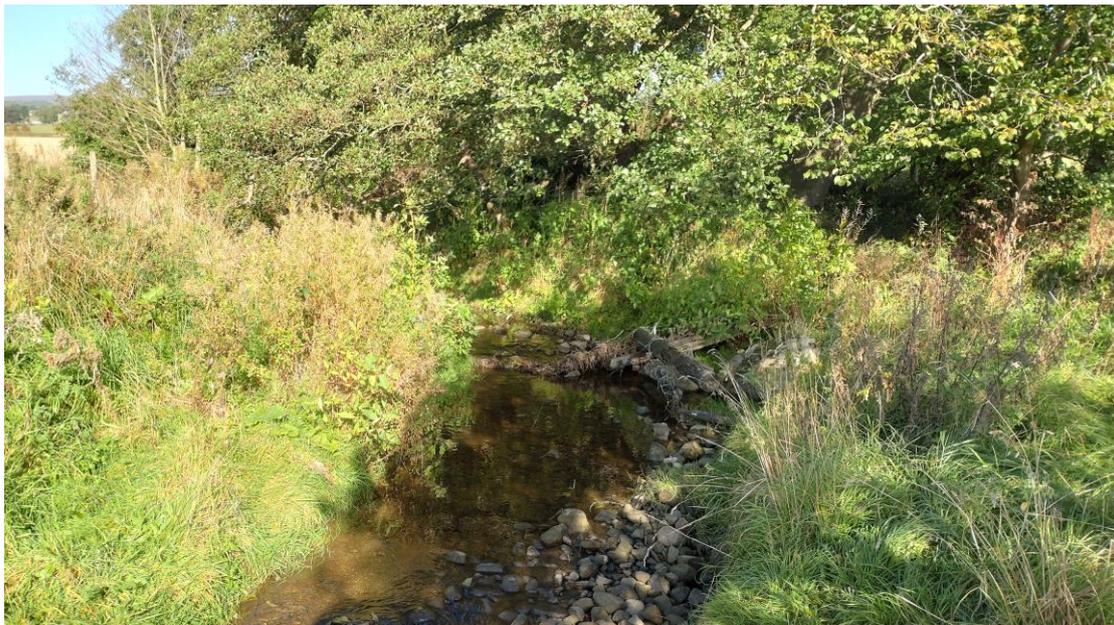
The remainder of Hundwith Beck was not observed beyond the field boundary (Fig 14) but appeared to be better protected with fencing and a reasonably mature, native, mixed-deciduous woodland strip. Electric-fishing data from near to Low Park Rd ~800m u/s suggest trout use the Beck there but densities were low and should be higher. Removing the physical and behavioural barriers near the mouth of the Beck will help considerably.

Fig 14. U/s of the drinking area, Hundwith Beck appeared better protected.
