WILD TROUT TRUST

Advisory Visit Report

River Stour

Whichford Mill

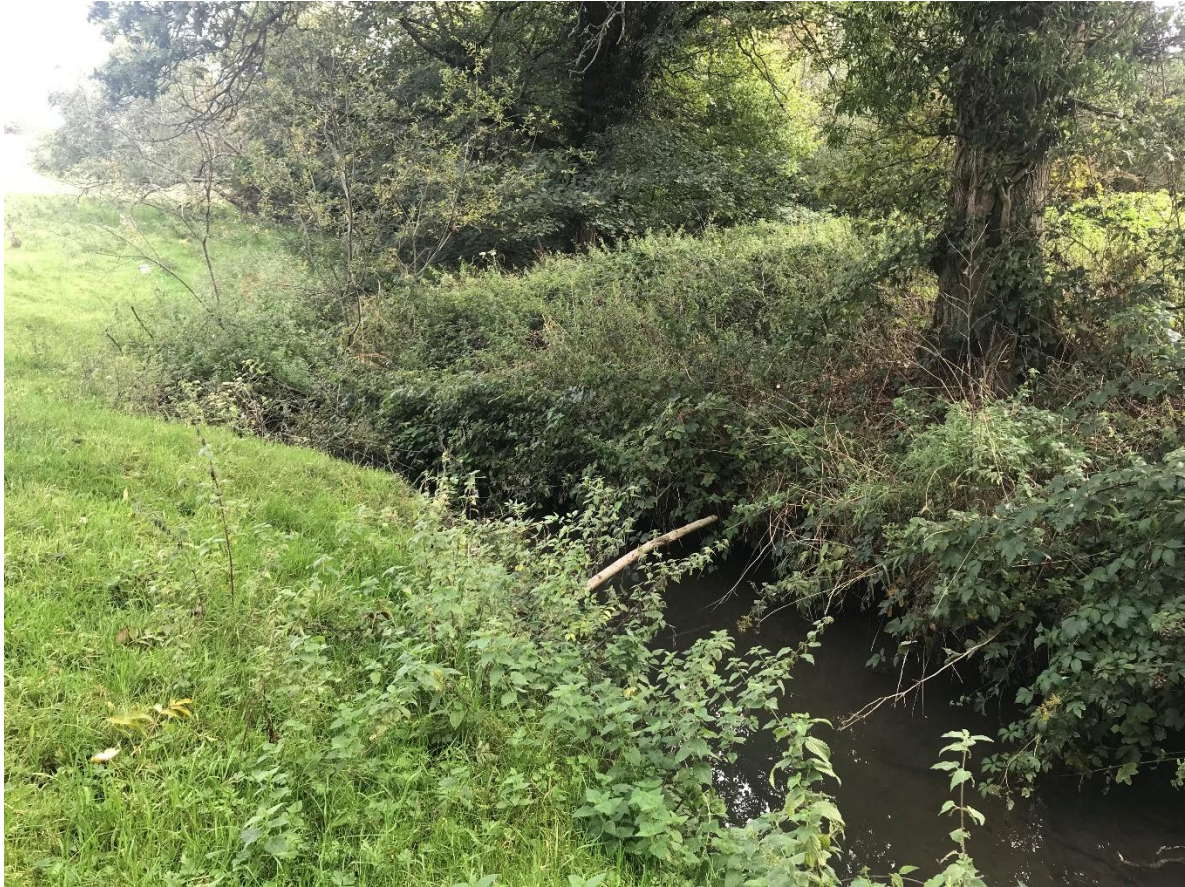
Starting at the upstream end, it soon becomes apparent the Stour has been modified at some point in history, dredged and over-deepened (Photo 1). This is likely due to agricultural practice in the latter half of the 20th century, where modifying rivers to get water to run as fast as possible down the catchment was encouraged for land drainage. Unfortunately, this physically removes any of the natural and varied habitat the river would ordinarily form, which good quality communities of river wildlife are dependent on.

Photo 1 (52.025990 , -1.5390821) The channel around the upstream extent of the upper section; although the channel meanders, it has been over deepened, and the channel incised following drainage work.

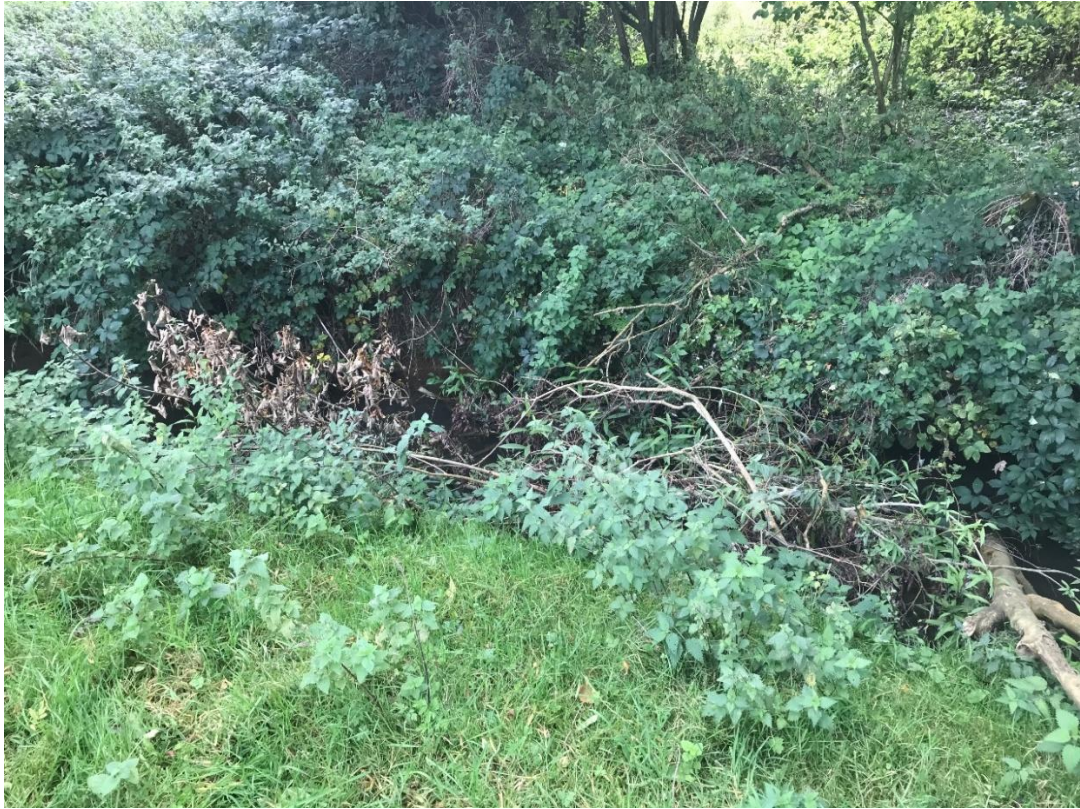
Photo 2 (52.025889 , -1.5393557) Several large pieces of wood were lodged in the channel from the surrounding woodland at the top of the reach...

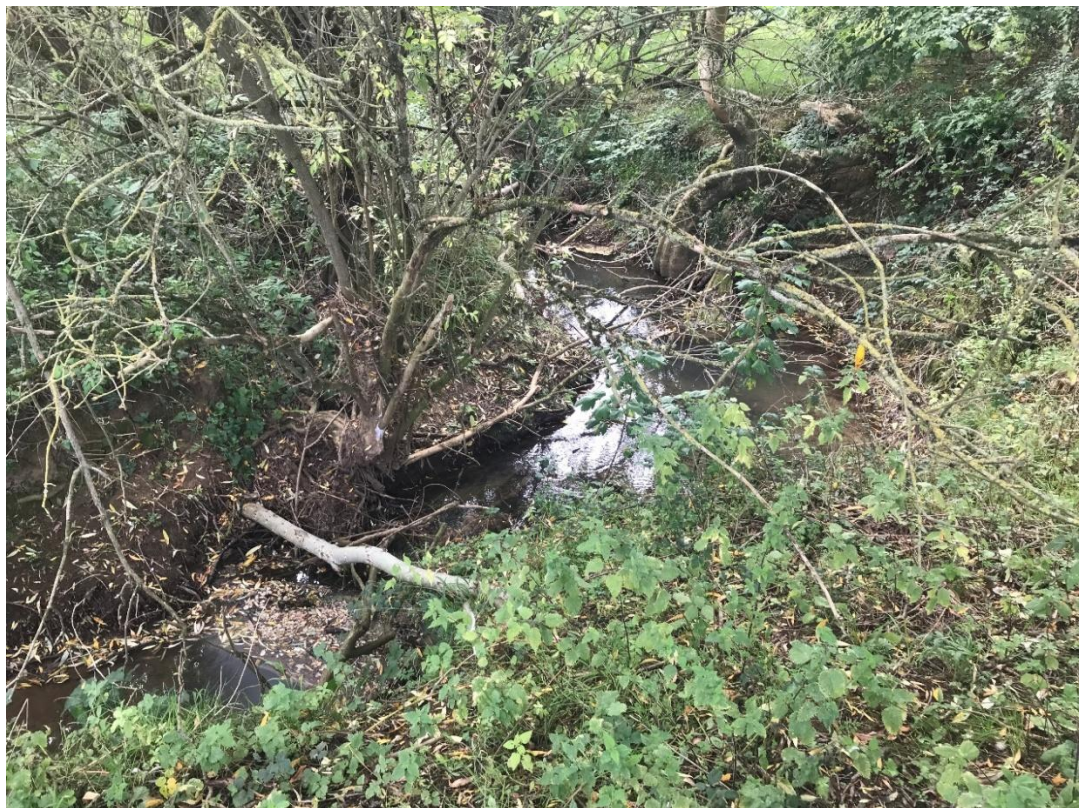
Photo 3 This continued into the first significant bend. One option for the whole of this reach upstream of the mill would be to utilise the material available in the adjacent wood to build some very large 'leaky dam' structures as a natural flood management measure. These would help slow the flow down during floods, back

the water up and force it out onto the floodplain to help temporarily store it. Increased rates of flow will scour underneath structure to help diversify the riverbed and physical habitat available for aquatic wildlife.

- Consider utilising the upper reach for a natural flood management project, increasing connectivity between the channel and the narrow floodplain, especially by using very large woody material to form 'leaky dams' which also creates habitat for river wildlife.
- Investigate potential for regrading banks in key locations and where could the spoil go to (Figure 4). Appropriate licences will be required for this (seek advice). Alternatively, look for opportunities to raise the bed of the river to restore natural connectedness between stream levels and the floodplain below the Mill. A good explanation of this technique is available in this Advisory Visit report: [West-Glen-2022.pdf](#)

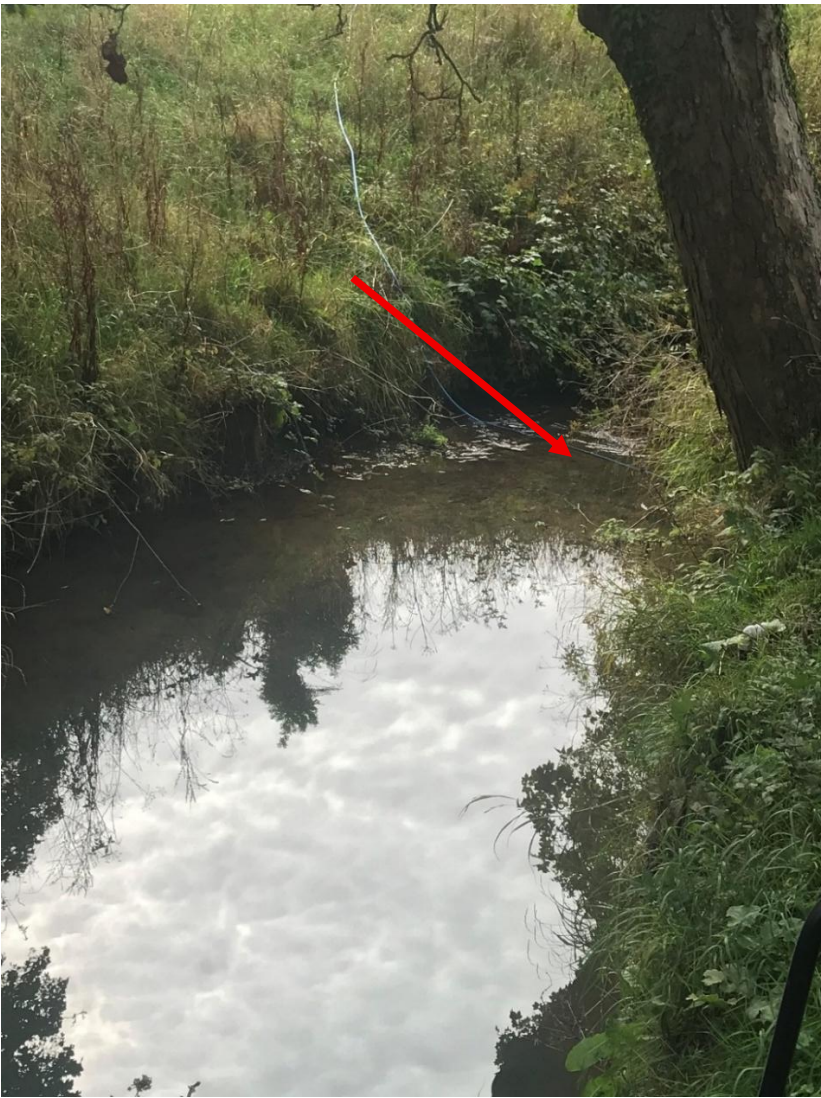
Photo 4 The bottom of the end of the dipping pool as it lifts into a shallower, faster flowing riffle around the bend, to the right of this photo (red arrow).

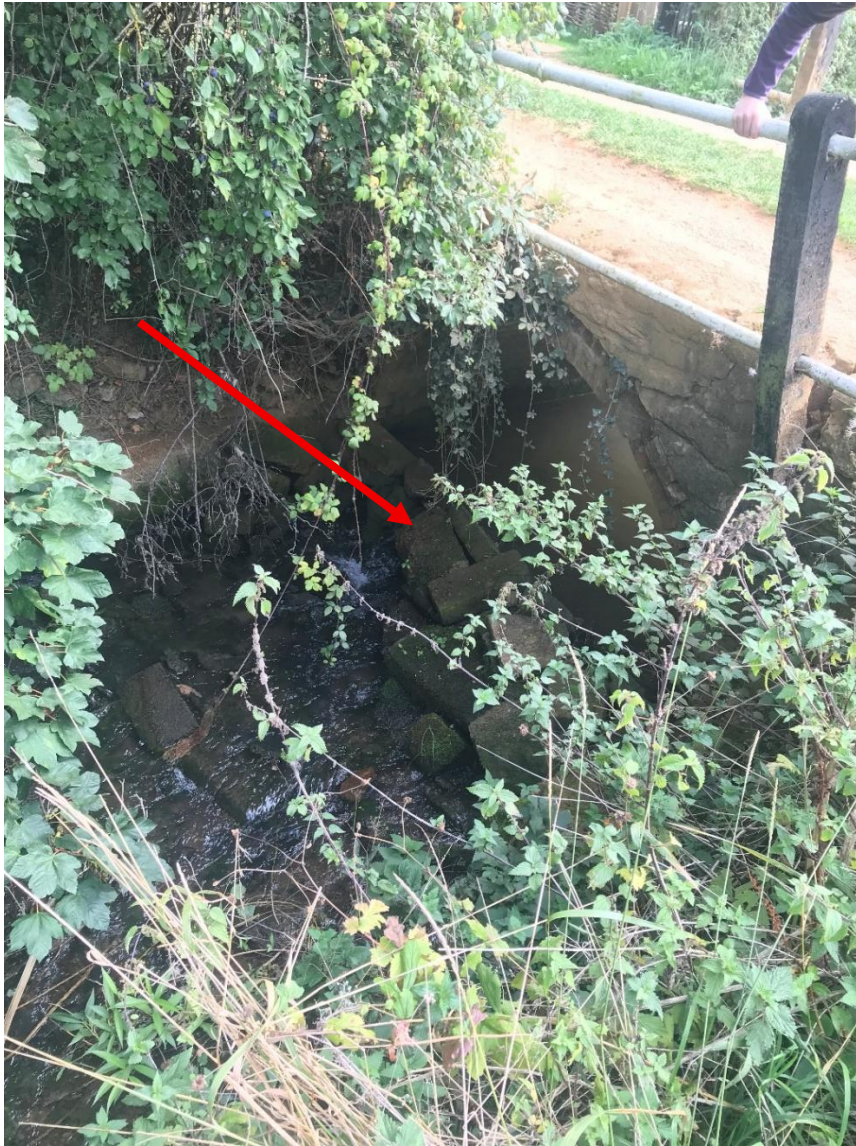
Photo 5 (52.025915 , -1.5400128) Concrete blocks have been placed across the downstream end of the access bridge arch, to hold water back (red arrow). This will be severing access for fish up and downstream and negatively altering the habitat upstream by un-naturally impounding water. If removed, the riverbed level is likely to move in the meander upstream as it re-adjusts, back up to the dipping pool. Once the riverbed 'settles' following removal of the structure, water levels can be manipulated if required for a dipping area, perhaps by using very large woody material structures, to create beneficial habitat at the same time.

- Remove the concrete blocks from under the access bridge to Whichford Mill. Review the response of the river upstream of this, install large woody material to maintain dipping pool levels and generate a riffle downstream in the bend, benefiting both visitors to the Mill and wildlife.

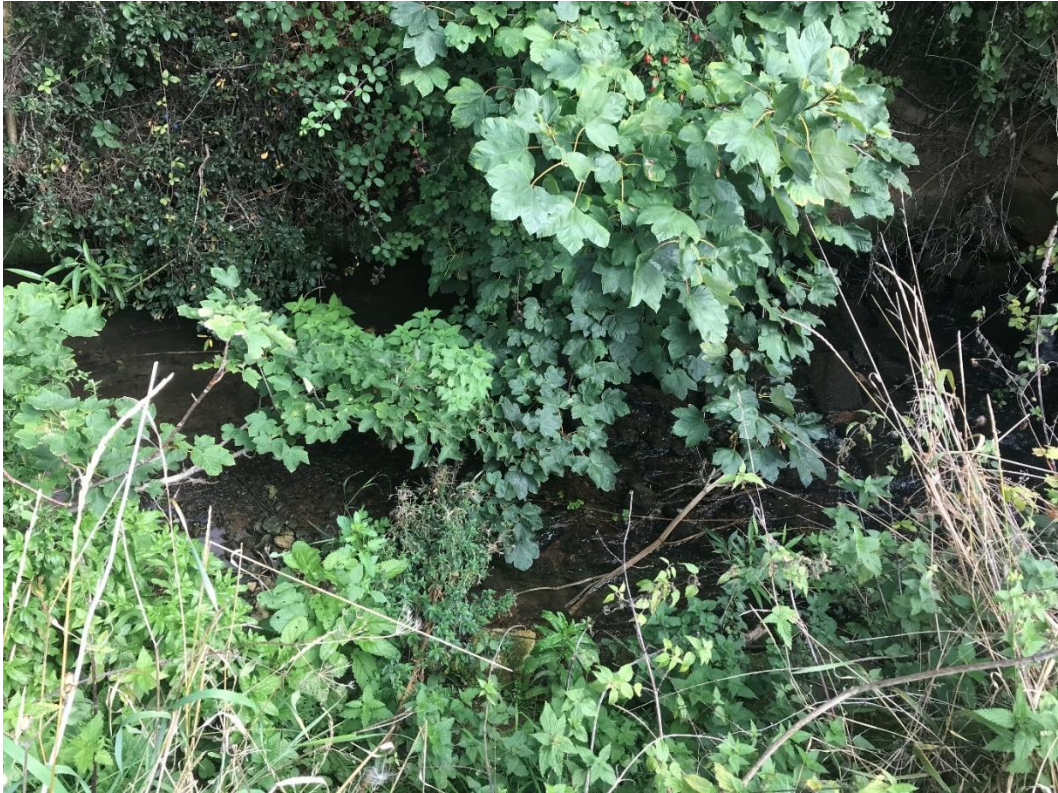
Photo 6 Downstream of the bridge. Note the higher velocity flow and resulting clean patch of gravel.

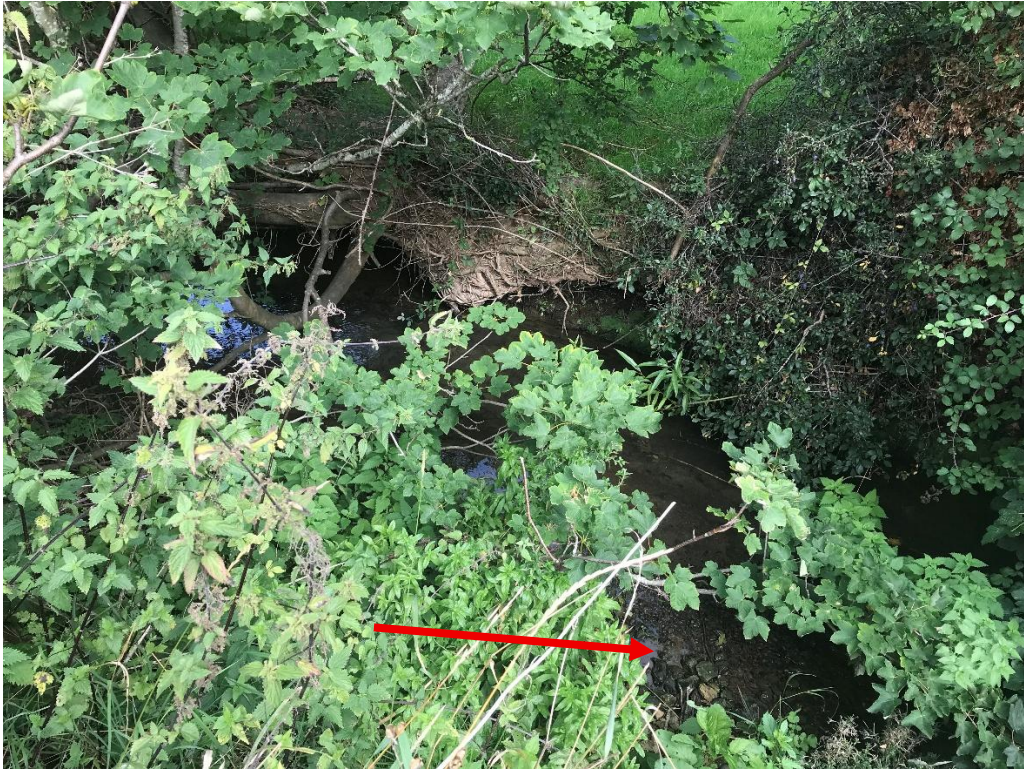
Photo 7 (52.025998 , -1.5401791) Undercut banks, roots trailing in the water and boughs leaning over (and eventually into!) the watercourse are all highly beneficial habitat features providing opportunities for invertebrates and fish. There is a minor example of a meander trying to form here (as per Figure 1), with gravel deposition on the inside of the bend and erosion into the bank on the outside of the bend (red arrow highlights the gravel deposition).

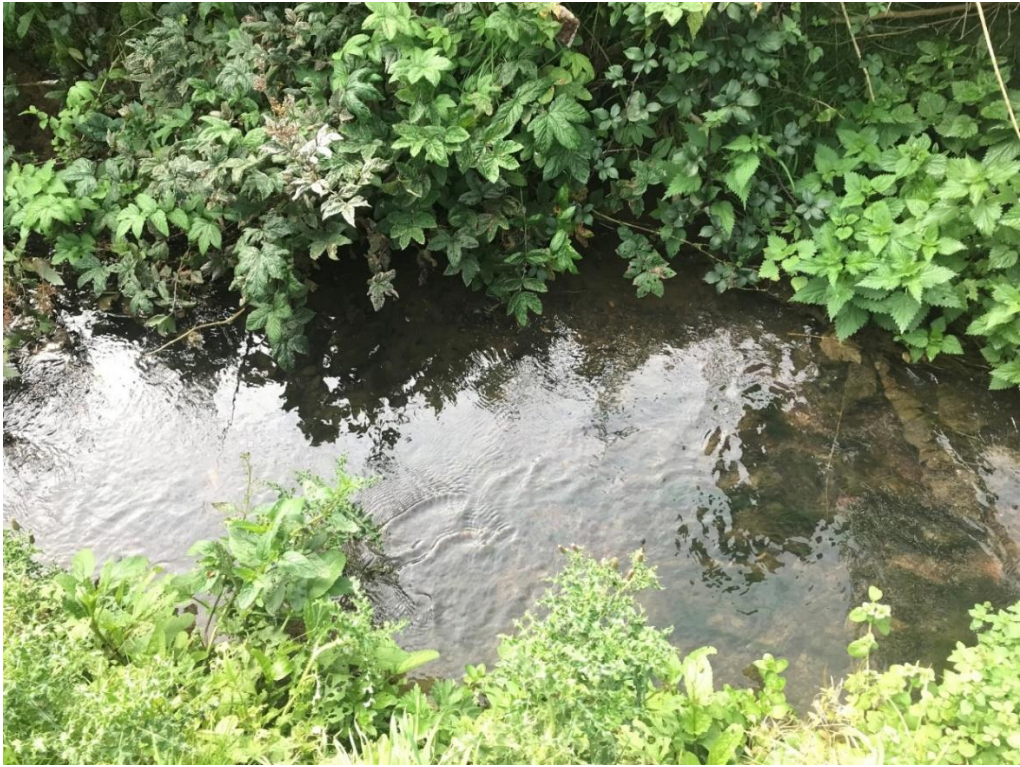
Photo 8 Another example of better-quality stream habitat trying to form. The over-hanging and trailing vegetation flanking this shallow glide and flowing over

a gravel bottom provides plenty of opportunities for aquatic biodiversity here. Some filamentous algae, potentially an indicator of elevated levels of nitrate and phosphate in the water, is present. The volume of growth isn't smothering the gravel currently - but has potential to – something to keep an eye on.

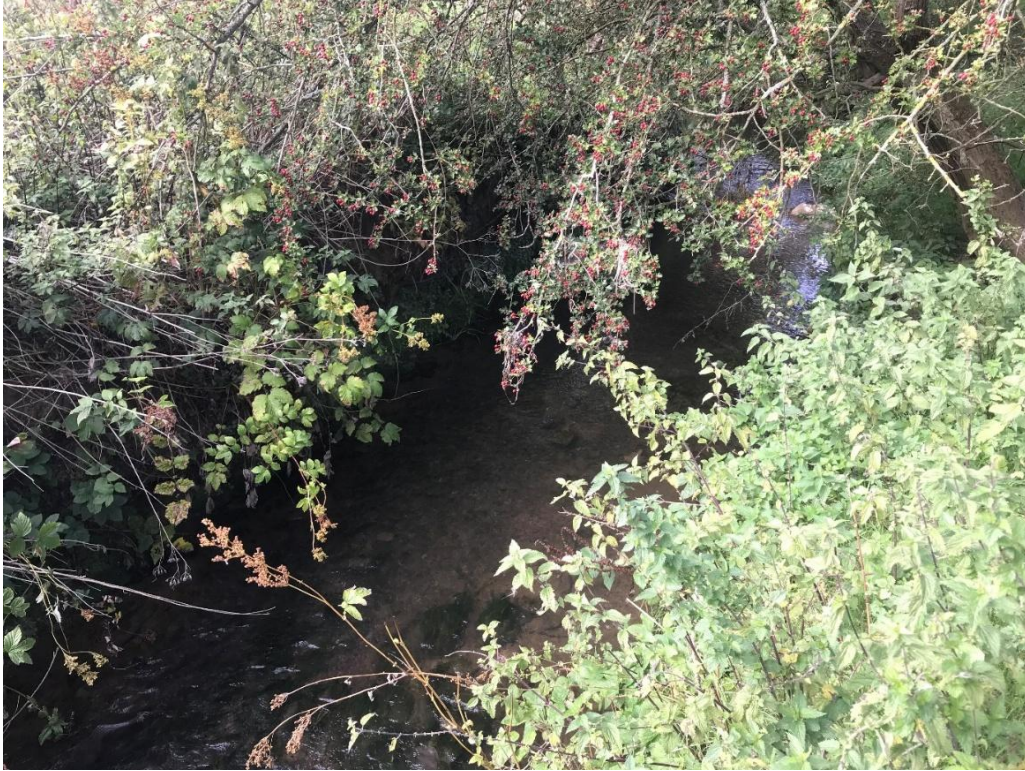
Photo 9 (52.026062 , -1.5404420) The thick overhanging vegetation, coupled with the increase in depth and steady pace of flow, makes this an attractive spot for many fish species that could be present. Slower growing native shrubs and trees, such as the hawthorn on the RHB, provides the very beneficial overhead cover for stream wildlife. Faster growing willow is good in places, but can dominate, and create too much shade to the watercourse – as seen in Photo 15.

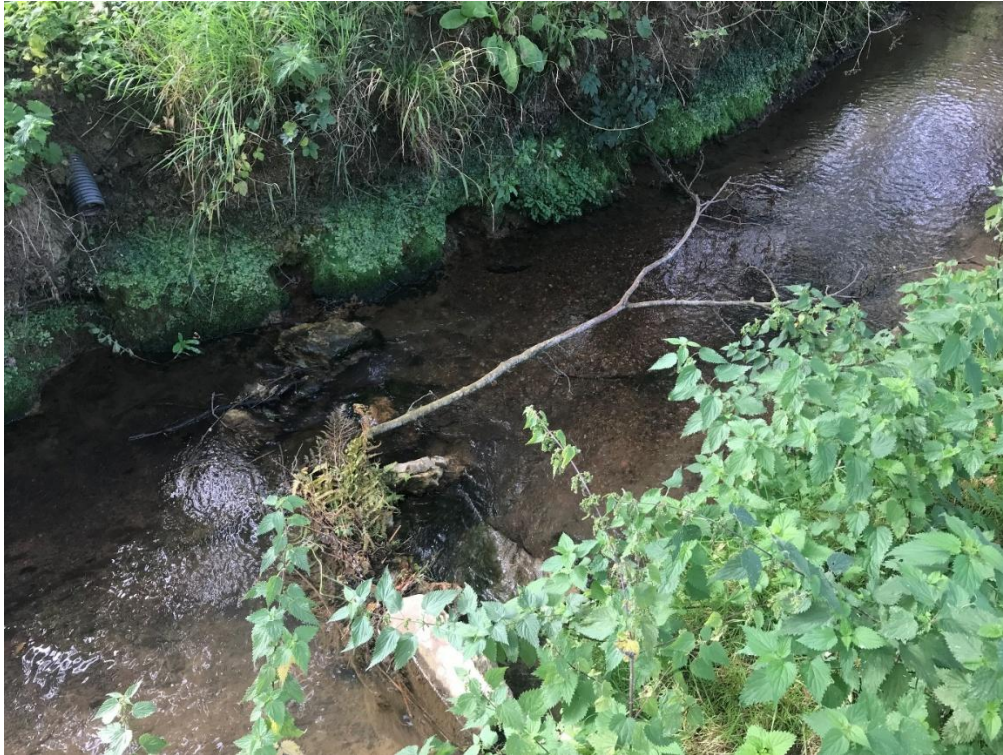
Photo 10 (52.026087 , -1.5405788) A concrete bed-check has been introduced at some point. The river has responded positively to this pinching of the channel where it has broken through, ensuring flow is energised and beneficial areas of flow diversity are generated. However, it would be beneficial to remove this and replace the artificial concrete with natural large woody material, and use locally sourced larger rocks for the riffle feature in the middle of the channel (ensuring fish passage is maintained). The height of the bank has left the section immediately downstream barren of habitat features such as trailing vegetation or woody material. There are opportunities to introduce some woody material here to mitigate this.

- Downstream of the mill, remove concrete bed checks and kicker boards, develop a plan to replace with large woody material features (Figure 5) to diversify flow patterns and encourage river processes of erosion and deposition. These will also help move and clean gravels, too.

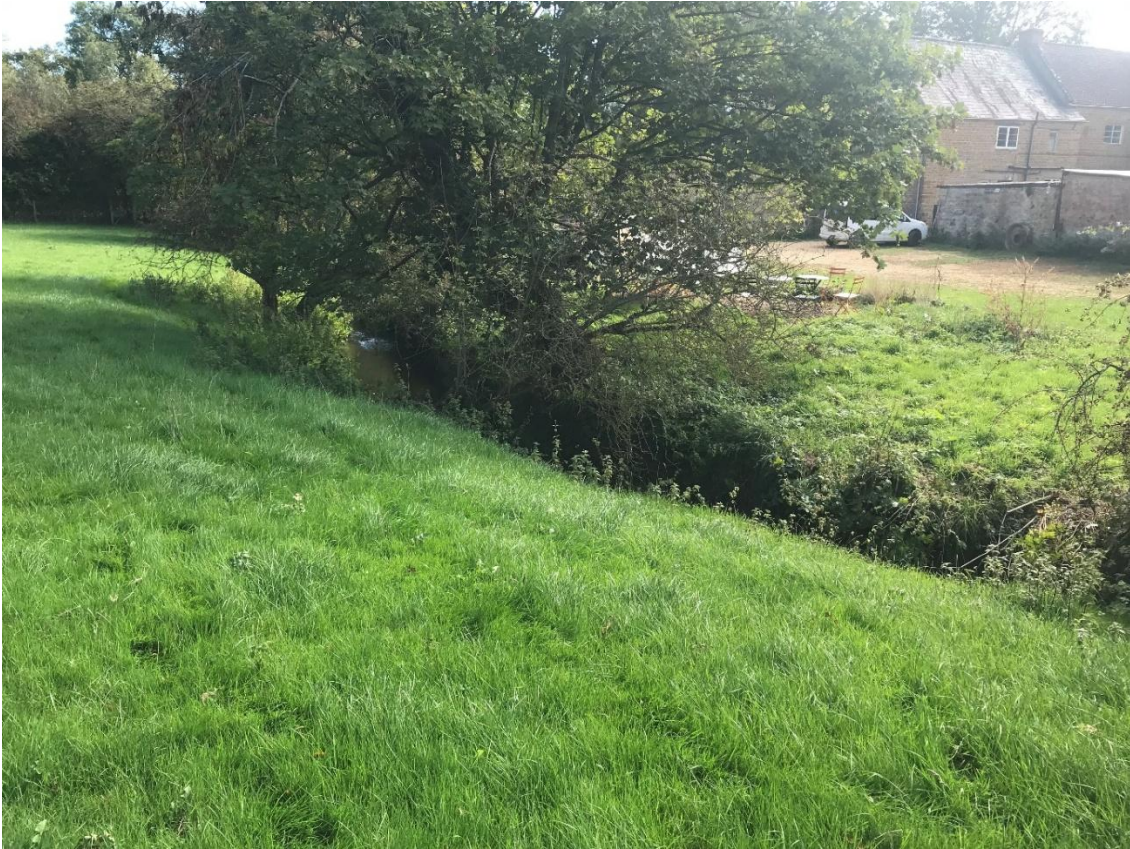
Photo 11 Highlighting the level of channel incision in the reach downstream of the mill. Regrading (pulling back) the bank, even if just on the inside of where meanders are trying to form, would be beneficial and kick start additional river process. A large volume of material will be generated from this activity that will need to be removed from the floodplain.

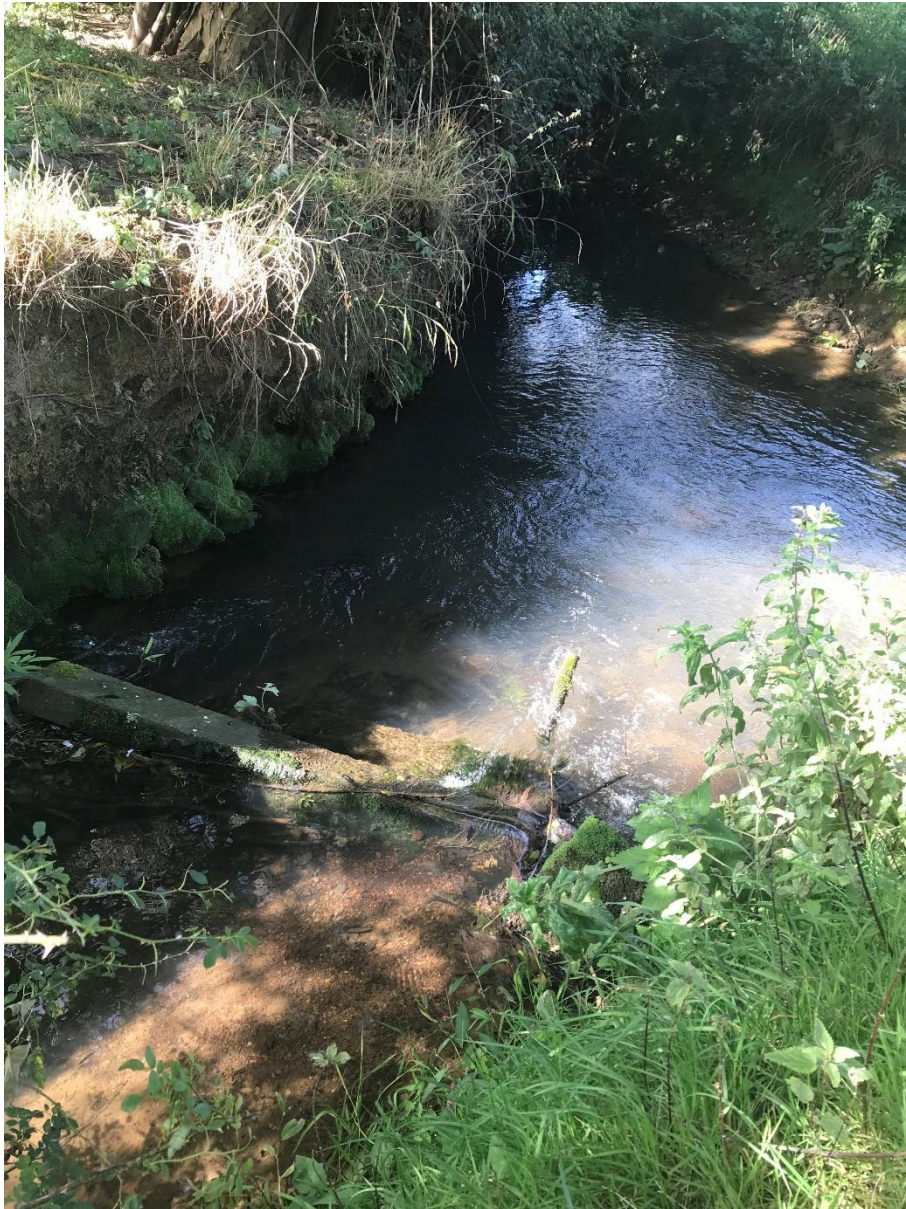
Photo 12 (52.026072 , -1.5411286) Another concrete bed check. This one is more severe with potential to impact fish migration and alter habitat upstream by artificially holding bed material back and encouraging deposition of silt. This should be removed and opportunities reviewed for introducing large woody deflectors, if appropriate. The pool habitat immediately downstream of this feature is providing additional channel variation, however the face of the RHB is bare, limiting the habitat value here. Pinning some large and brashy material here (or hinging a tree over into this location if there is one suitably adjacent) will moderate rates of bank erosion and provide some excellent habitats for fish and invertebrates.

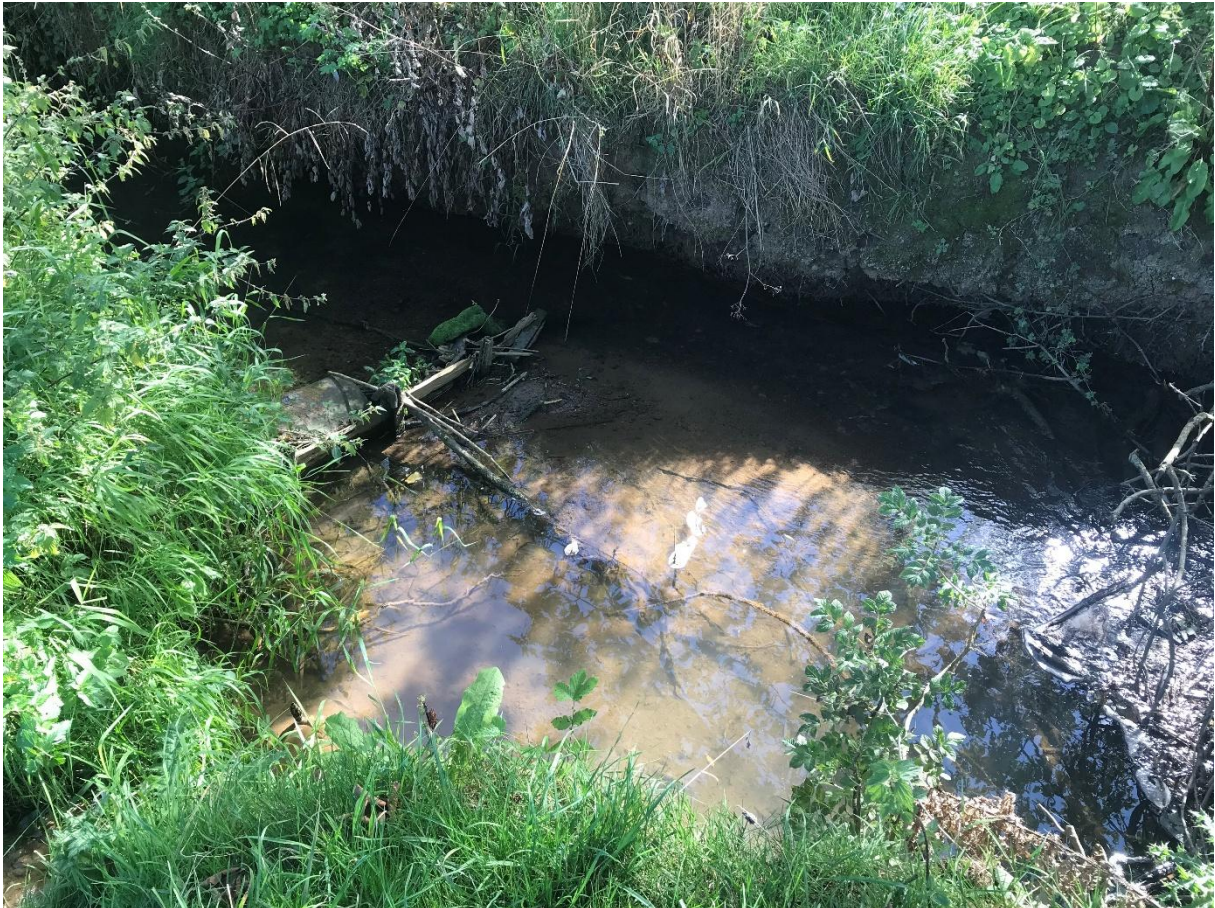
Photo 13 (52.026107 , -1.5412547) A board has been pinned across the channel, for reasons that weren't apparent. The way it has been installed, perpendicular to the channel, is impounding flows upstream and causing fine sediment to deposit across the riverbed downstream. Removing this and replacing it with some large woody material to pinch the channel (perhaps even in a series of woody features), will energise flows and create areas of faster and slower velocity will let habitat develop naturally and opportunities for a diverse ecosystem.

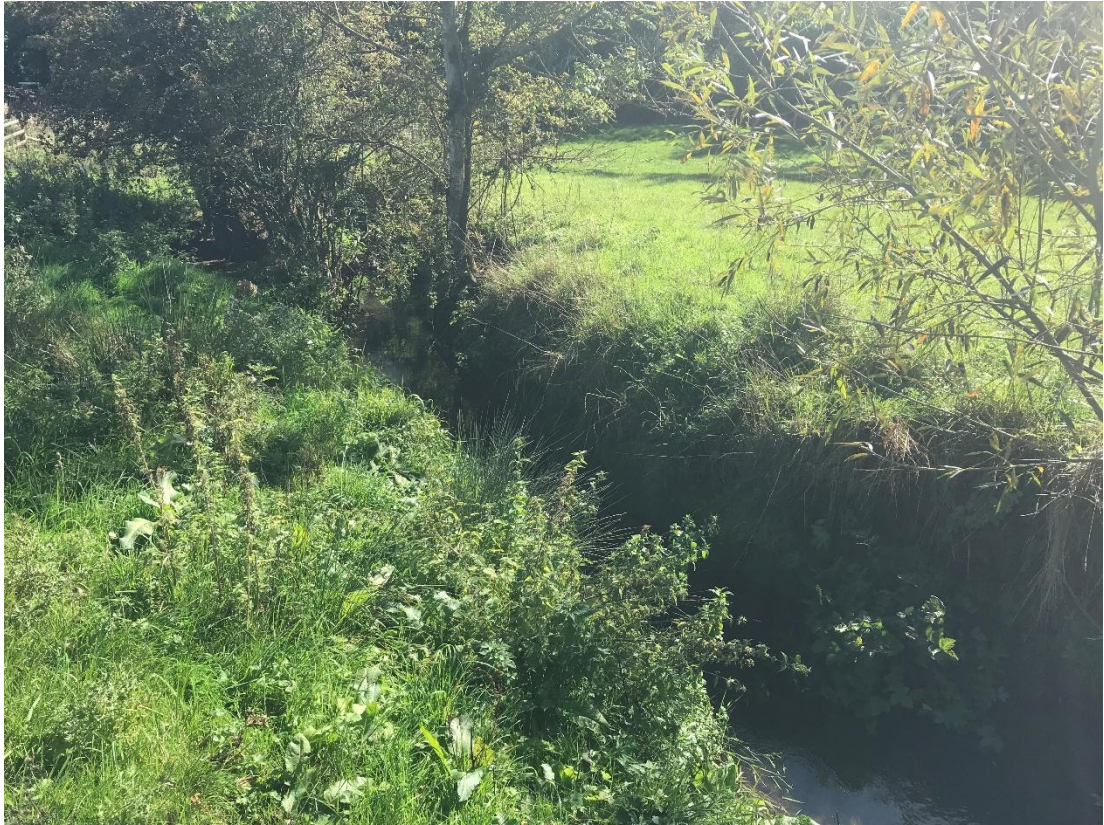
Photo 14 (52.026010 , -1.5422820) Highlighting the level of channel incision and the floodplain area as the valley floor opens out.

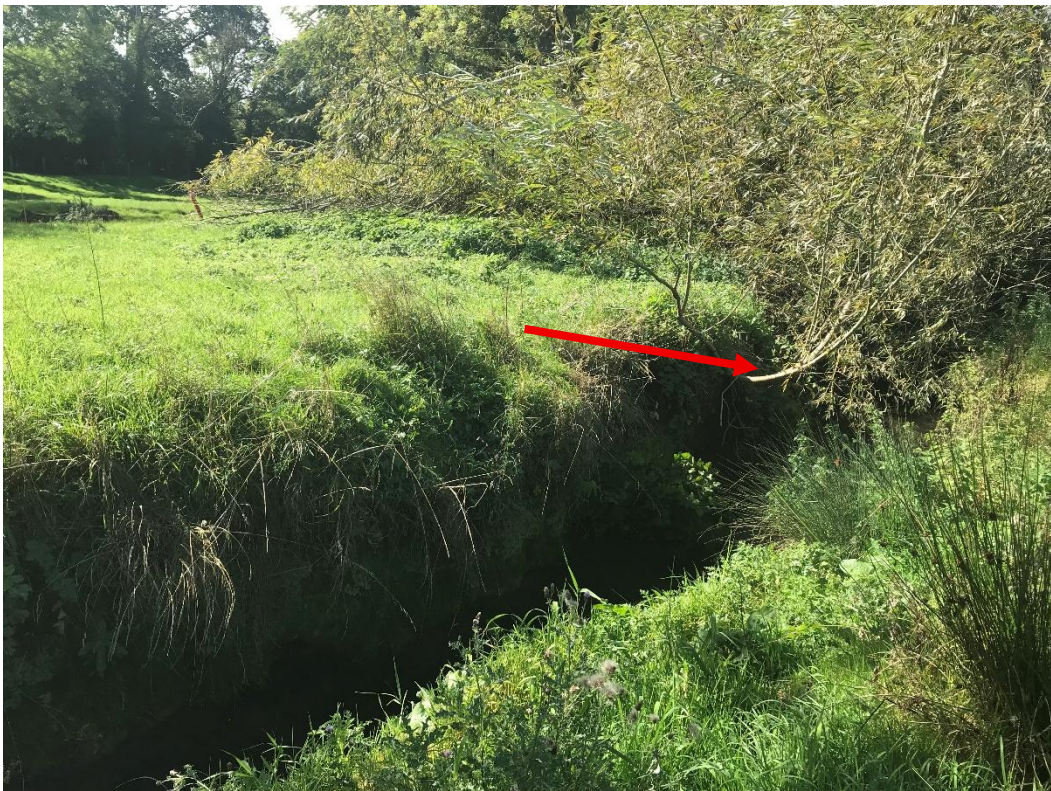
Photo 15 A classic issue for tributaries of the Warwickshire Avon that have been over deepened. Willow (generally crack willow) takes over, dominating the channel (red arrow). The degraded channel is then subjected to heavy shading

within a dark tunnel of tree growth, supressing any other vegetation, and leaving a barren habitat that supports very little aquatic biodiversity.

- Create a vegetation management plan. Look at willow and hazel locations and plan how to cut some back on incremental cycles to maintain flows through the channel and some light to the channel where things are particularly over-grown. Plan where materials can be used, procuring both larger bits of wood and brash for use in river habitat work (Figure 8).

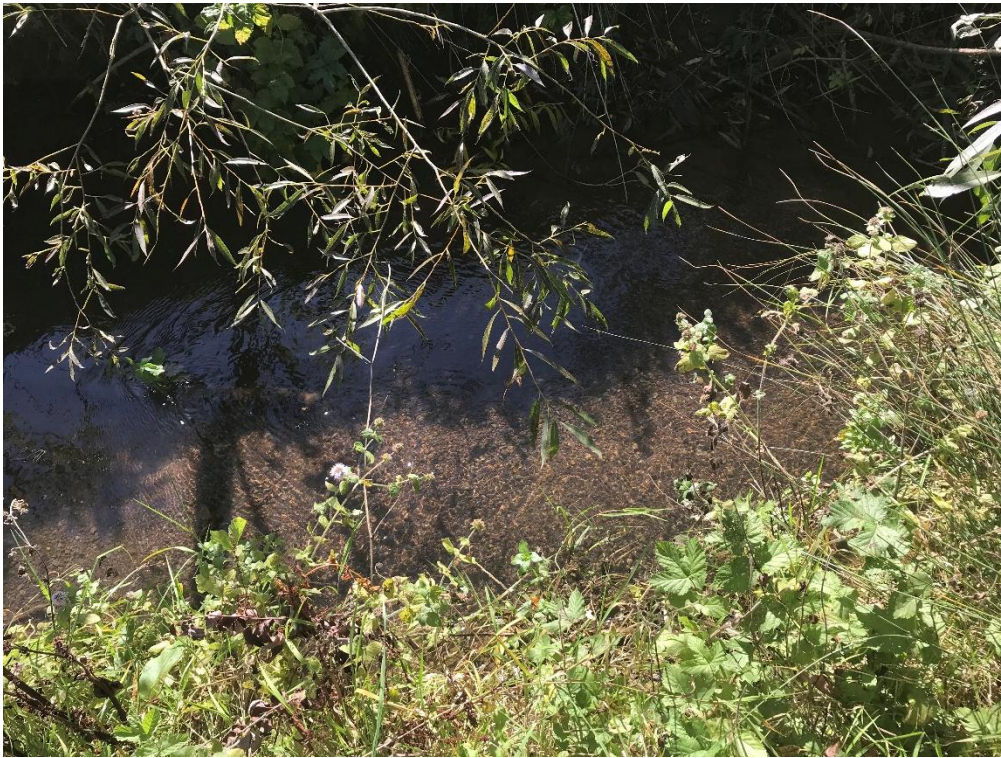
Photo 16 Gravel deposits seen throughout the reach downstream of the Mill. This is very positive and indicative of channel recovery following dredging.

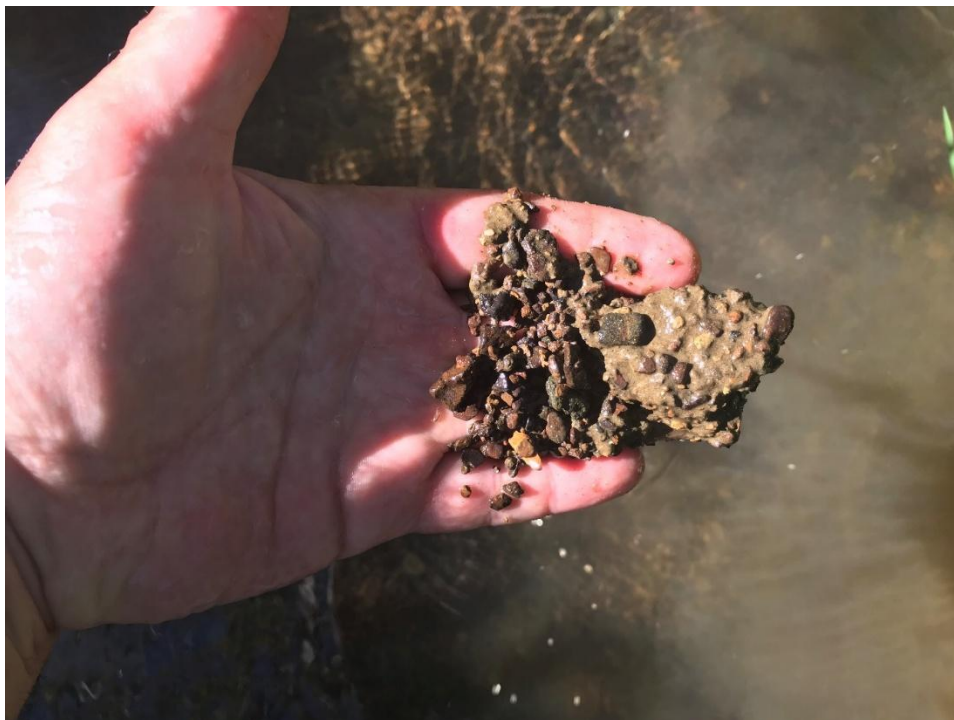
Photo 17 However, a high volume of fine sediment was found within the gravel deposits, limiting their value and potential for use by gravel dependent species that form diverse aquatic ecosystems.

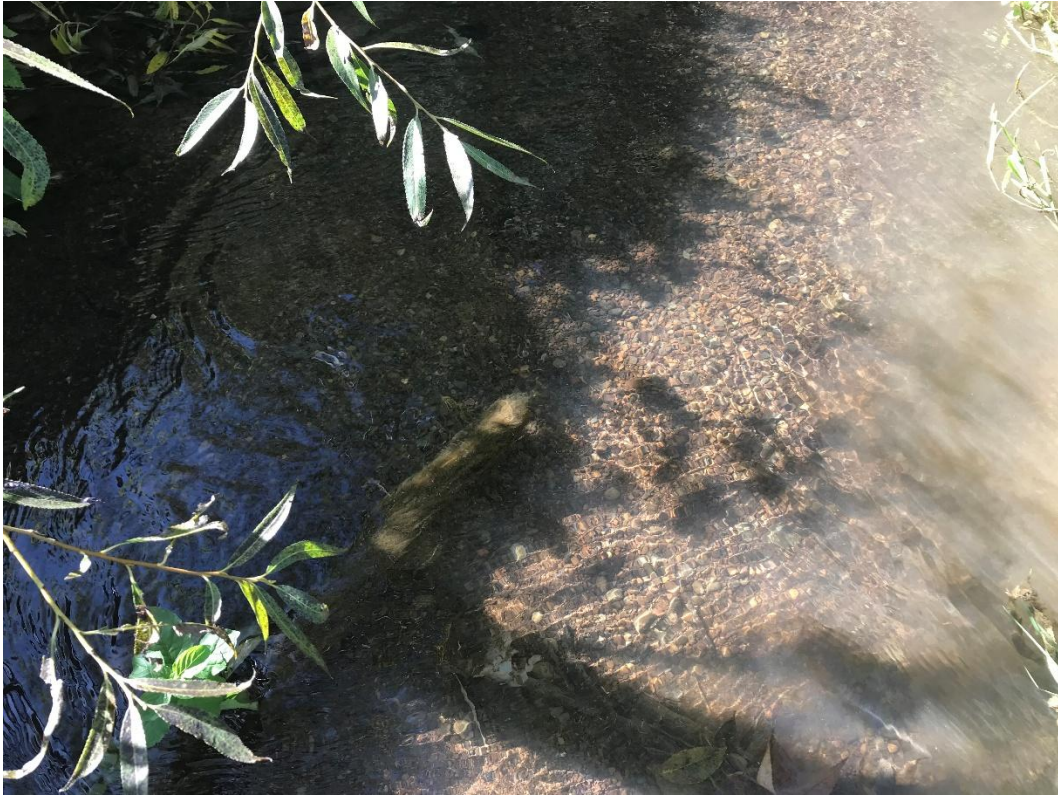
Photo 18 The piece of wood encroaching into the channel over a bed of gravel creates a very positive feature. It will pinch flows in the channel, increasing velocities (especially during floods) that will then clean gravels of fine silt or sort gravels by size as they deposit, allowing for various aquatic species to select areas by their needs. Although, this piece of wood is not particularly large, so limits the magnitude of influence it has on the gravel. Introducing more or larger pieces of woody material will amplify the effects of cleaning and sorting.

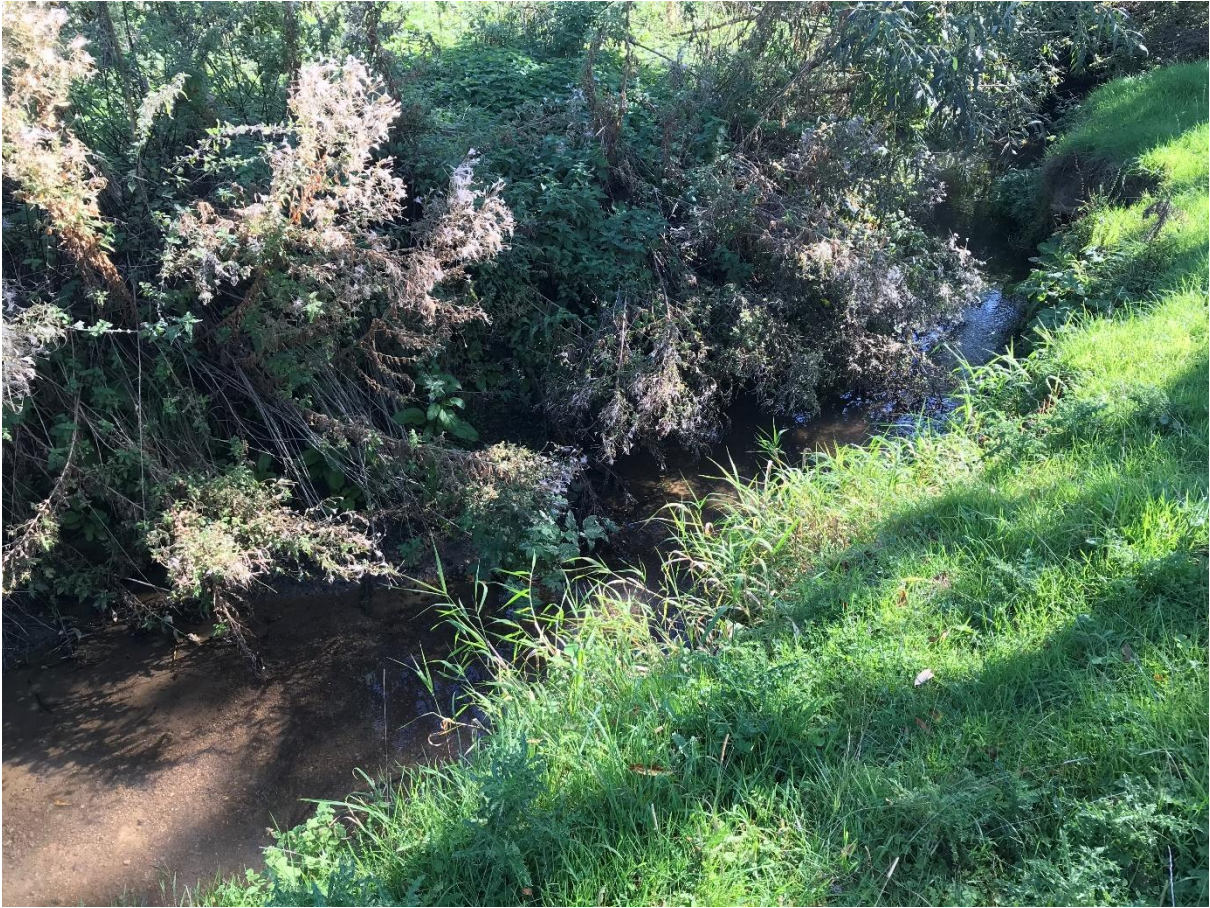
Photo 19 (52.025947 , -1.5425448) The willow growth along the LHB is providing excellent overhead 'cover' and a degree of marginal habitat structure along the channel edge. Given the fast-growing nature of willow, this material could be hinged over (pleached) and pinned along the toe of the bank. This will provide excellent habitat structure for fish and invertebrates, plus refuge from increased rates of flow when water levels rise. The increased light levels will allow the willow to regenerate and other plant species to come through, improving biodiversity.

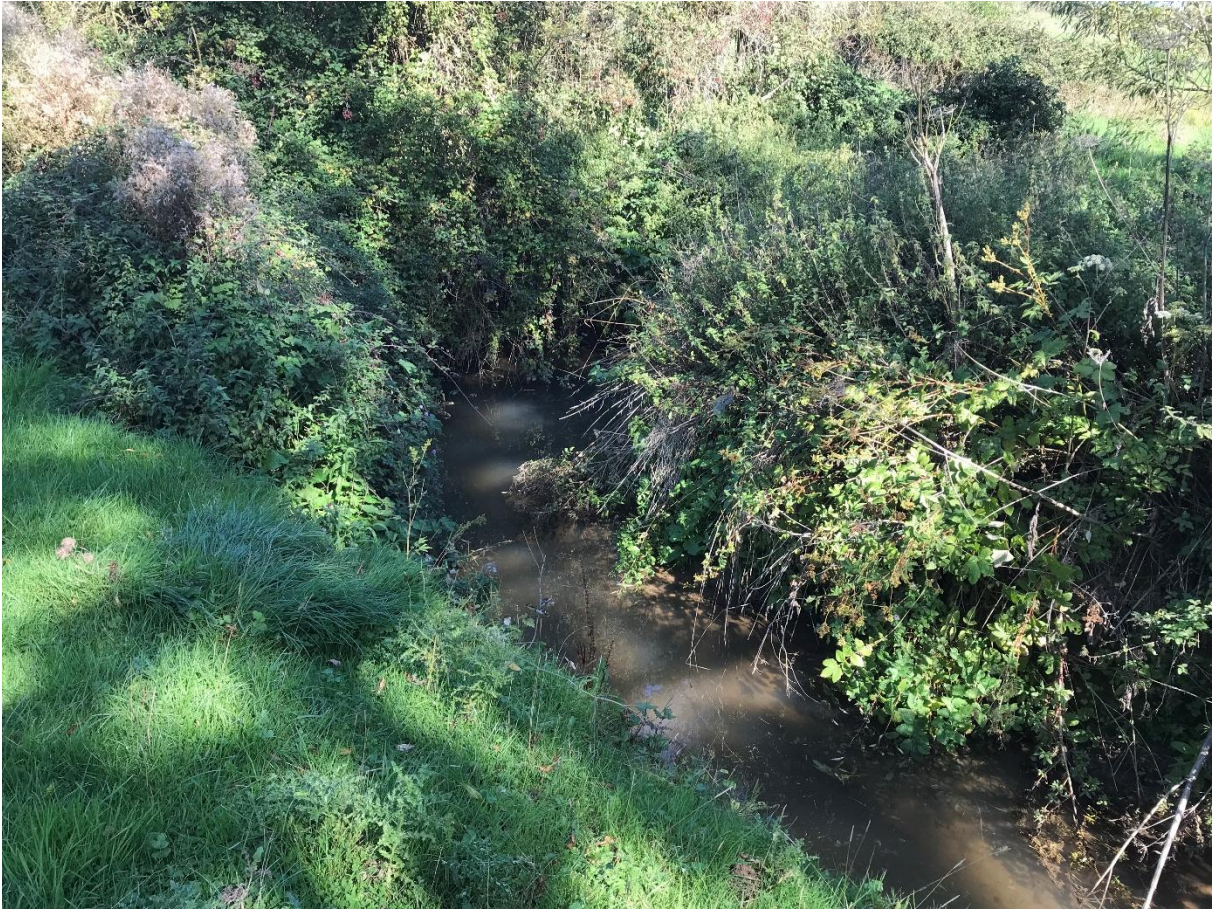
Photo 20 Further downstream, brambles and shrubs have grown thickly over the channel, leaving habitat featureless and over shaded. The density of growth could also lead to blockages upstream as woody material and leaf matter gets trapped against the tangle of over-hanging vegetation. In naturally functioning rivers that haven't been modified, this is not a problem as the river will self-regulate a response to benefit the ecosystem. Here the blockage will simply hold water back, reduce/eliminate pace of flow and degrade any stream habitat available upstream. It could also solidify build-up and lead to disconnecting the watercourse for fish passage up and downstream, as seen with the blocks under the bridge in Photo 5. Some management of the competitive and rank vegetation to reduce the shading and blockages, and reallocation of any woody material for use in and along the channel, will improve the opportunities for biodiversity here.

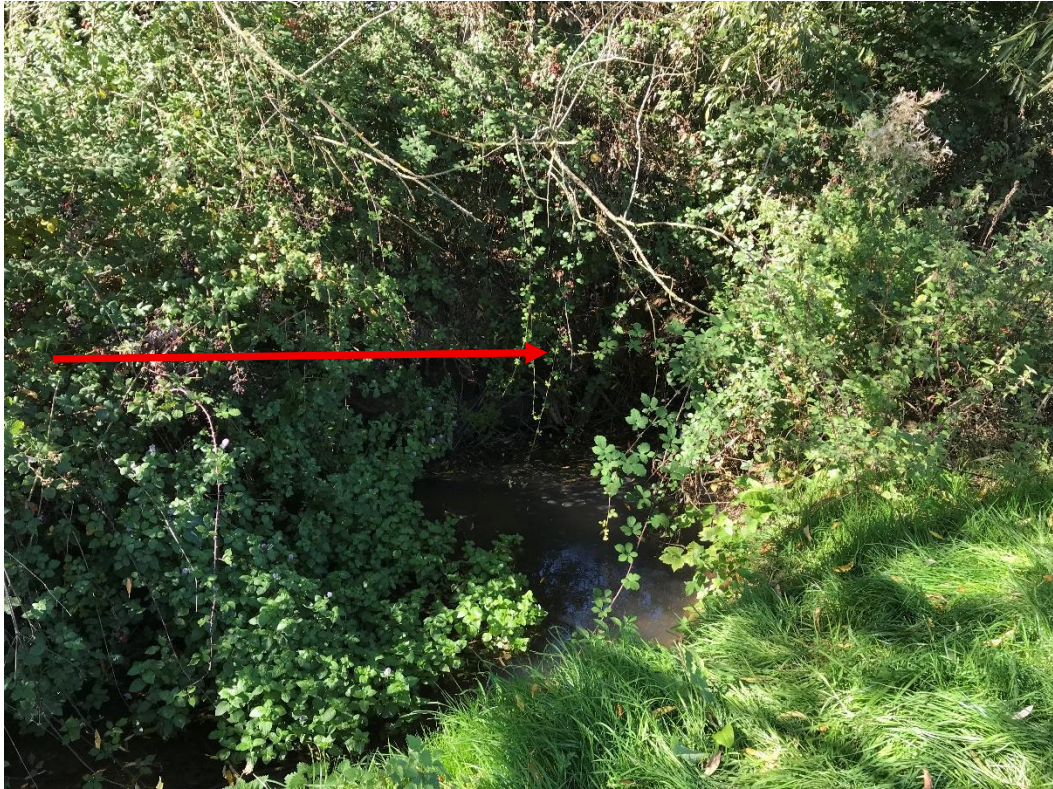
Photo 21 (52.025930 , -1.5427809) An example of what can happen when some light is allowed to reach the channel; a patch of water mint proliferates and will be providing additional habitat structure for aquatic species (and foraging for insect pollinators). Note the bramble creating a 'mat' of vegetation overshading and blocking the channel downstream, likely to accumulate a blockage (red arrow).

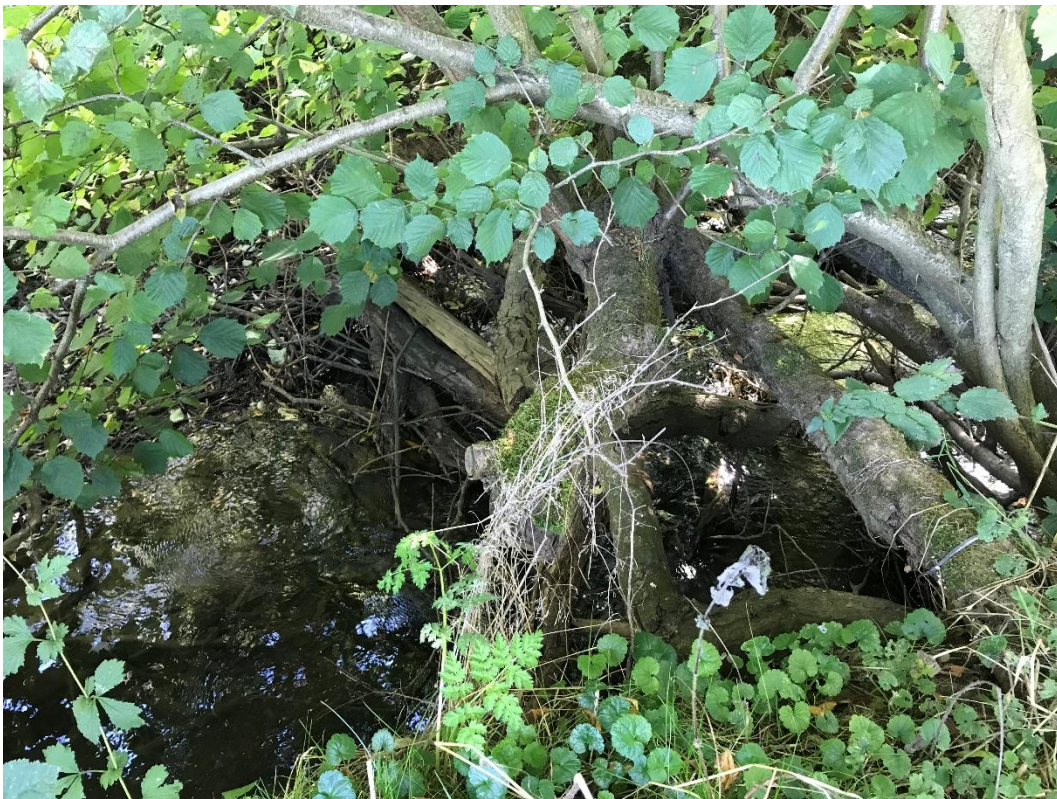
Photo 22 The large woody material covering the channel here provides excellent complex habitat structure. The spaces between the large boughs provide a

relatively unimpeded flow pathway at lower flows and helps self-maintain an open gap here, while fine leaf and branch material has accumulated to one side, providing resources for a range of invertebrates. The larger boughs being lodged above the low flow channel will come in to play as river levels rise, to slow flows for ecosystem and flood water management benefits.
