WILD TROUT TRUST

Advisory Visit Report

River Stour

Whichford Mill

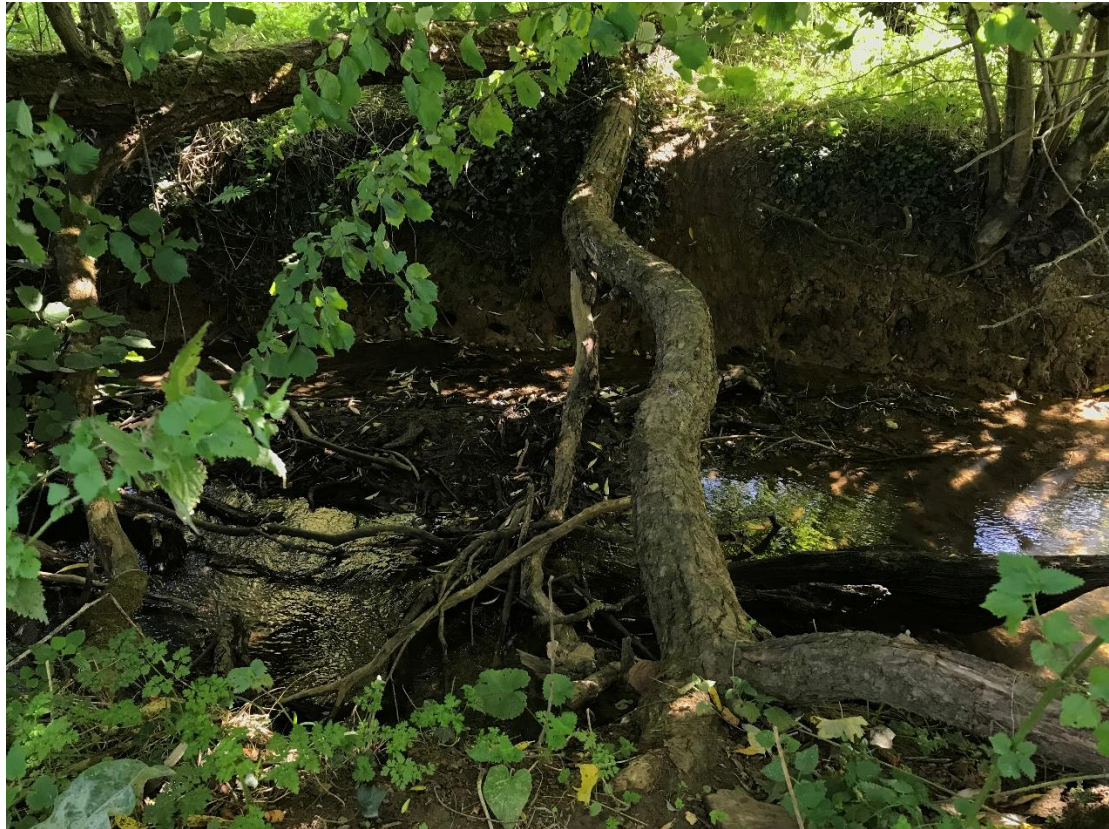
Photo 23 (52.025559 , -1.5432583) Near the downstream limit of the section visited on the day. The channel here is a little over shaded, but the growth of slower growing, high-canopied hazel coppice is an excellent form of bankside growth for shading the river and keeping it cool from intense sunshine and heat in the summer months. The large bough and branches covering the channel here are creating a very beneficial habitat for fish and invertebrates and will help slow rates of flow down when river levels rise, so providing refugia for stream species, too. It would be worth reviewing these sections to see if further enhancements can be made by introducing woody material along marginal areas to push low flows around and help maintain fine silt transport through this section. Coppicing some of the hazel on a cycle across several years may produce useable materials for this work and gently increase light levels to the channel as coppice stands mature.

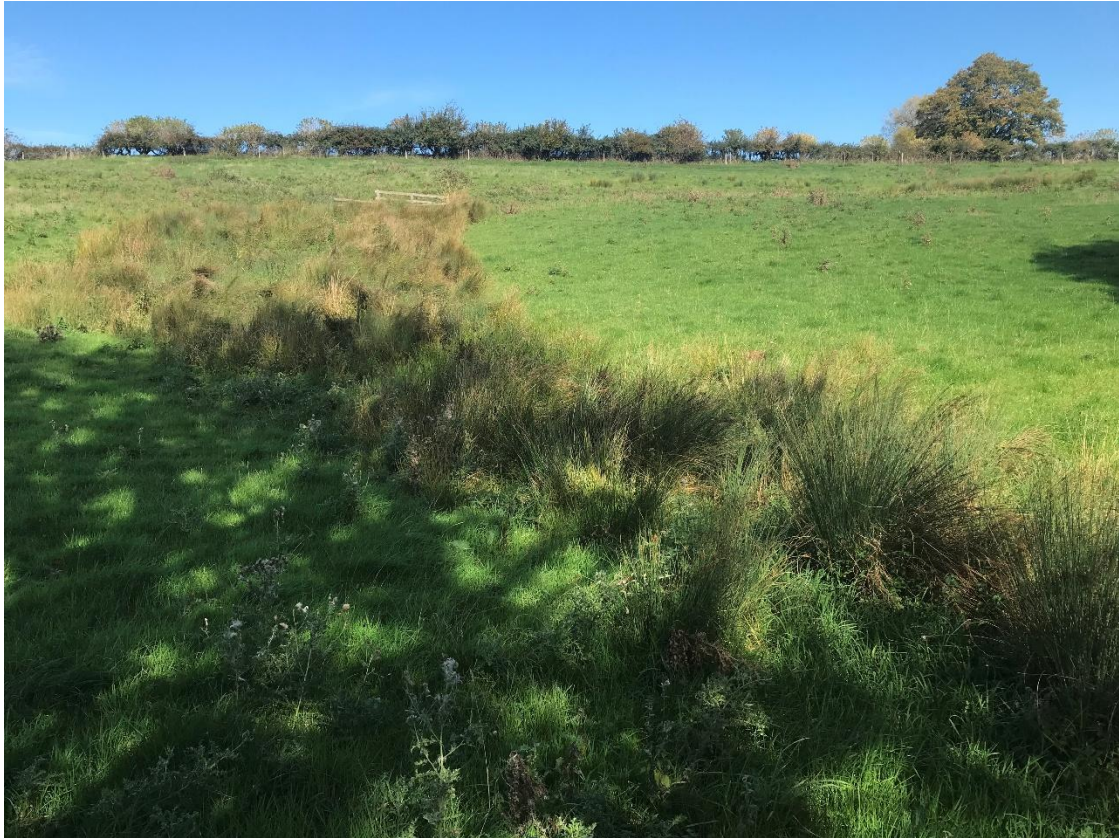
Photo 24 Opportunities to benefit the watercourse and its wildlife exist when looking into the surrounding landscape, too. Three large ditches run off the slope in the field opposite Whichford Mill, around 52.026272 , -1.5421318. Natural flood management interventions to slow the flows coming out of these springs, once the landscape becomes saturated, will help contribute to moderating the extremes of high and low flows in the river channel. If land drains exist, it may be possible to smash these out, back away from the river to allow the valley floor to wet up and hold water, rather than it flowing straight into the river from the drains.
