WILD TROUT TRUST

A walkover habitat assessment

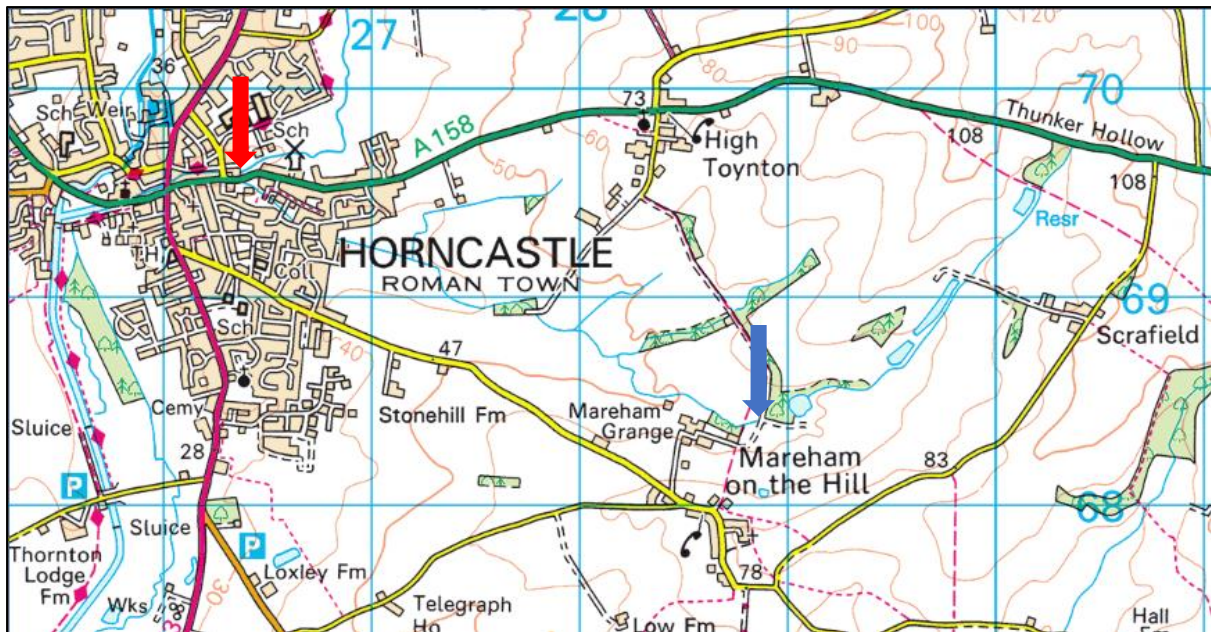
Map 1 – The location of the Thunker Beck through Mareham on the Hill to the River Waring. Red arrow is downstream limit, blue arrow is upper limit of visit. © Ordnance Survey.

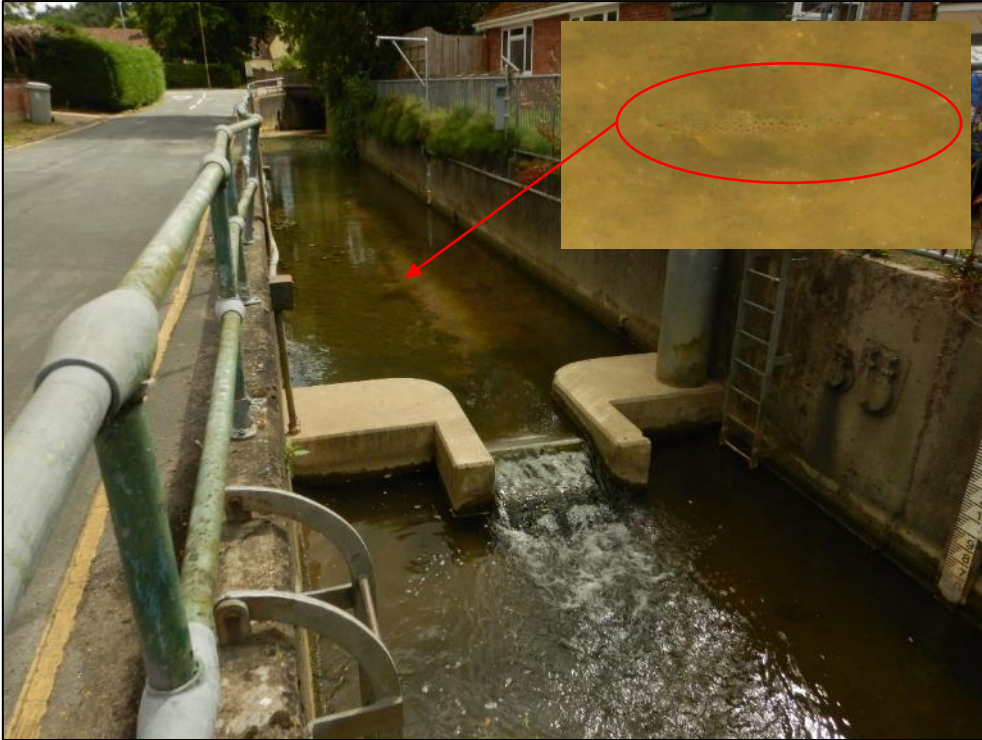
Pic 1 – The EA’s River Waring gauging station presents a drop of $\sim 0.2\text{m}$ over a smooth concrete flume $\sim 0.7\text{m}$ wide. The structure is considered passable to adult trout (at the time of visit), but dace would probably not pass due to the turbulent water and high velocity. The large number (30+) of dace upstream of the structure probably migrated in the spring when river flow was higher, and the structure was drowned out. The fish may now be trapped in a reach of river with very poor habitat (///trading.aunts.however). Inset picture shows a brown trout. Trout habitat is poor.

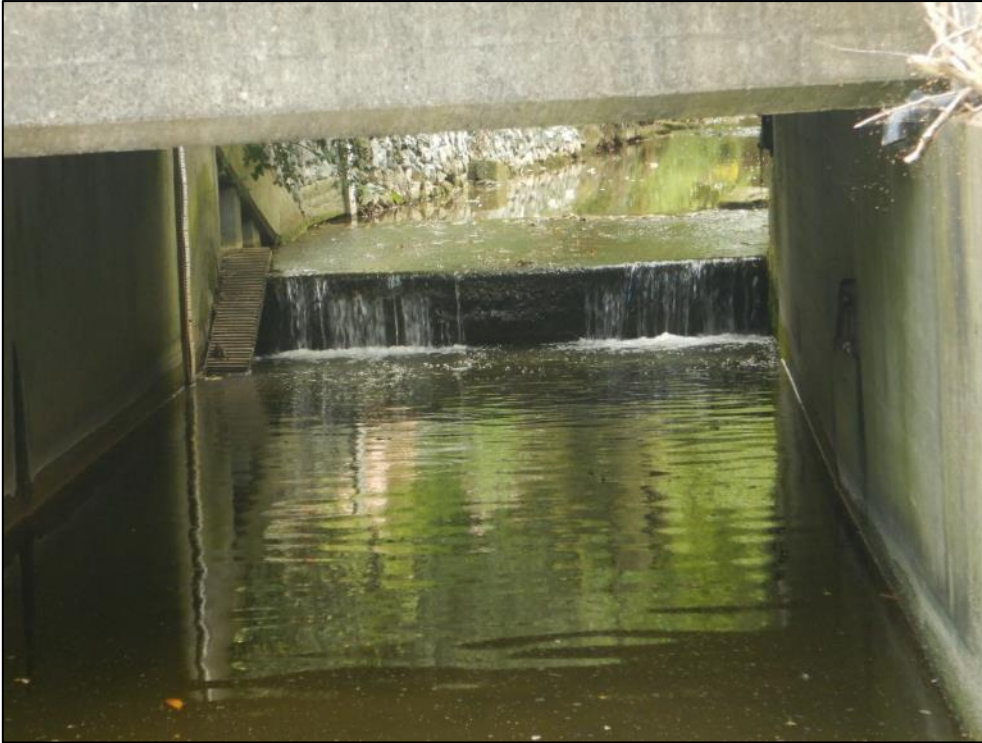
Pic 3 – The 2nd weir observed on the Waring with a drop $\sim 0.5\text{m}$ over $\sim 4\text{m}$ width. With no notch to focus the flow, the water is spread thinly (in places with none) across the weir with minimal depth downstream, making it impossible for fish to traverse in low to medium flow ([///submerged.blaring.digs](http://submerged.blaring.digs)). This structure is a significant barrier to fish migration. Trout habitat is very poor.

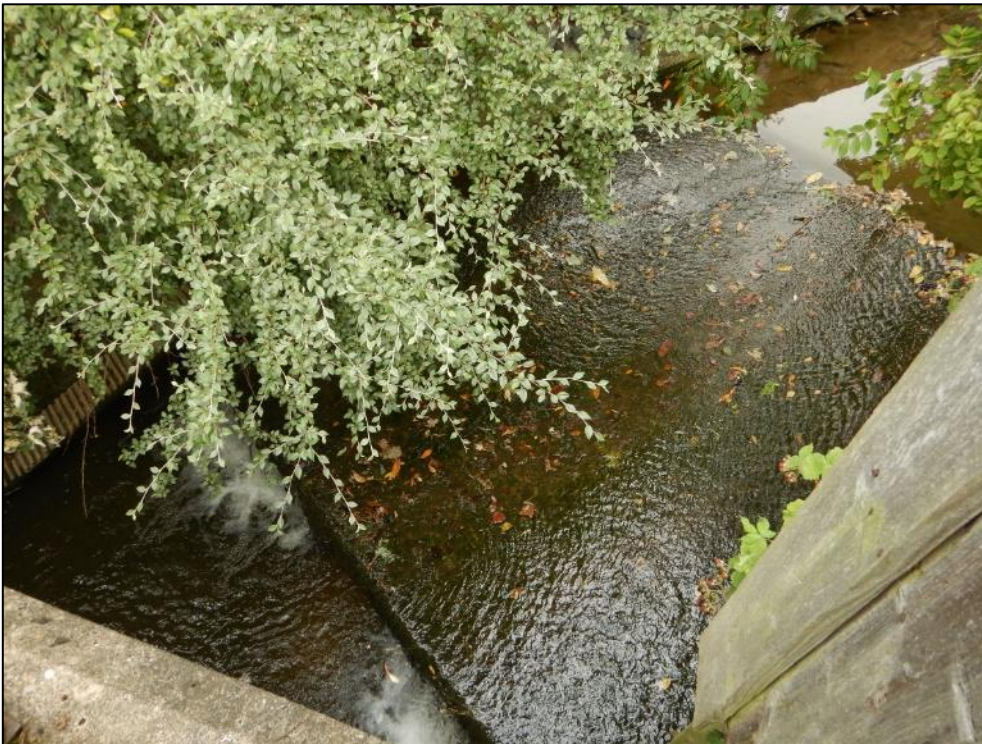
Pic 4 – The same structure as shown in pic 3 but viewed from above. A concrete spillway $\sim 4\text{m}$ length makes it even harder for fish to traverse. In low water the depth is too low, and in higher flows the water velocity over the spillway may force fish back ([///submerged.blaring.digs](http://submerged.blaring.digs)). This structure is a significant barrier to fish migration. Trout habitat is poor.

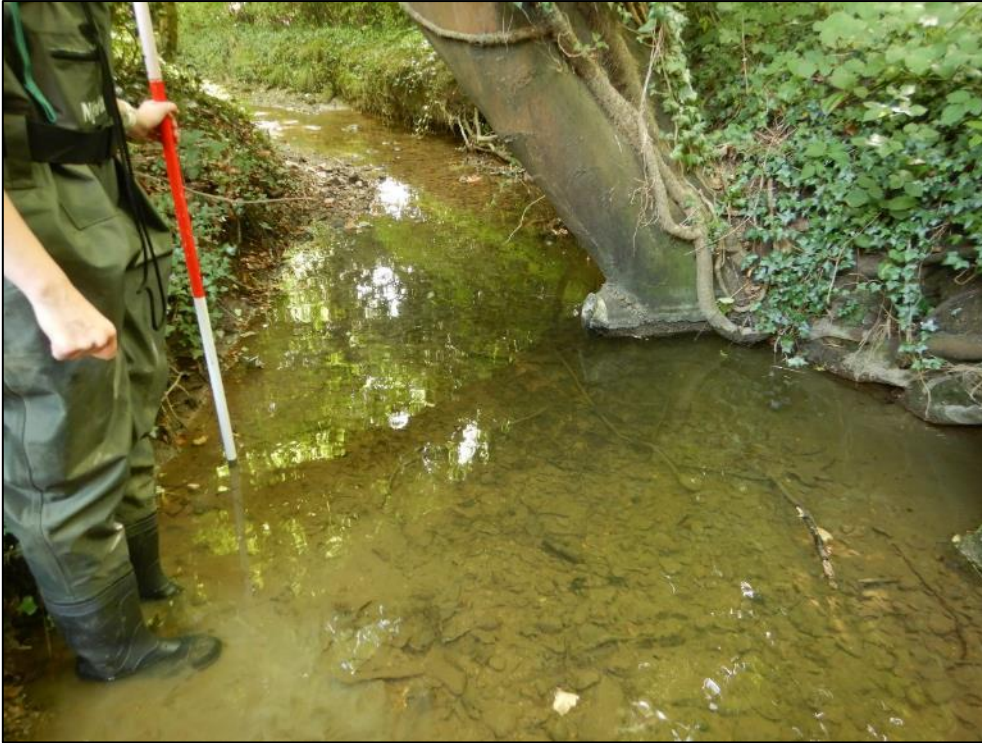
Pic 9 – A trout was seen taking cover at the base of the ash tree. The shallow pool and tree roots clearly provide cover for trout in the lower part of the Thunker (///mocking.attention.boasted). Signal crayfish found. Trout habitat is good.

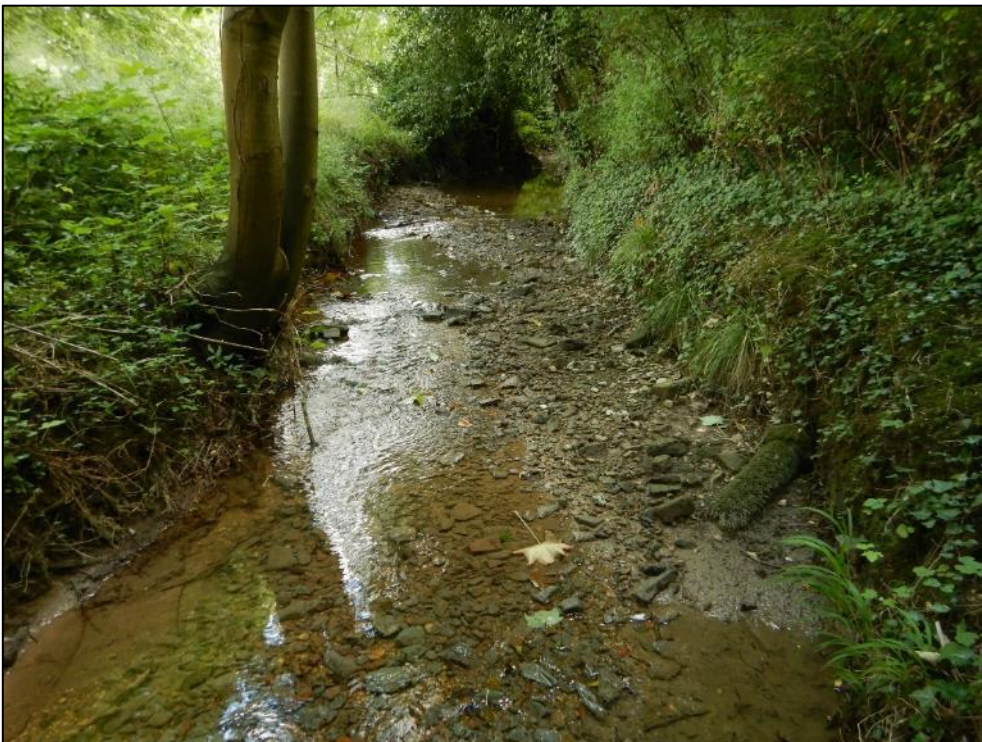
Pic 10 – The Thunker is ~2m wide with an emerging pool and riffle sequence formed from gravel and limestone pieces. The shallow depth naturally inhibits the passage of fish in low flows but once flow increases fish are free to move. Trout habitat is poor due to shallow depth.

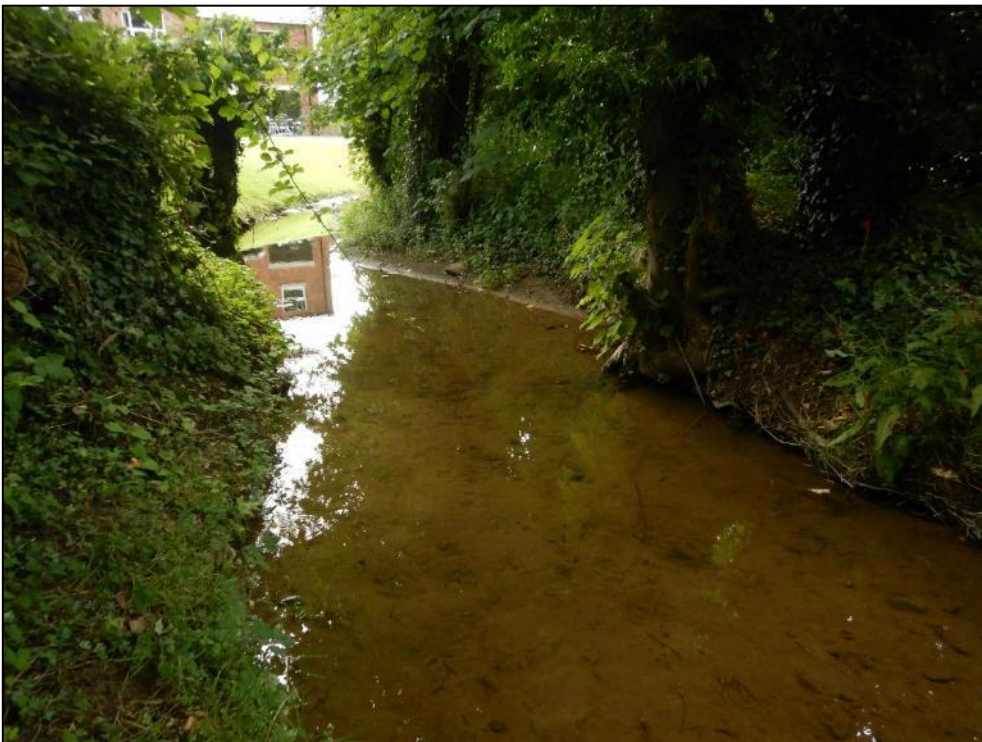
Pic 14 – A silted pool near private gardens was not fully accessed. If the pool was clear of silt, it would present fish holding habitat, no fish were observed. An appropriately located flow deflector could encourage cleansing of the pool (///lodge.forced.workroom). Adequate trout habitat where water depth above silt allows (but tidy gardens may limit fish-holding habitat).

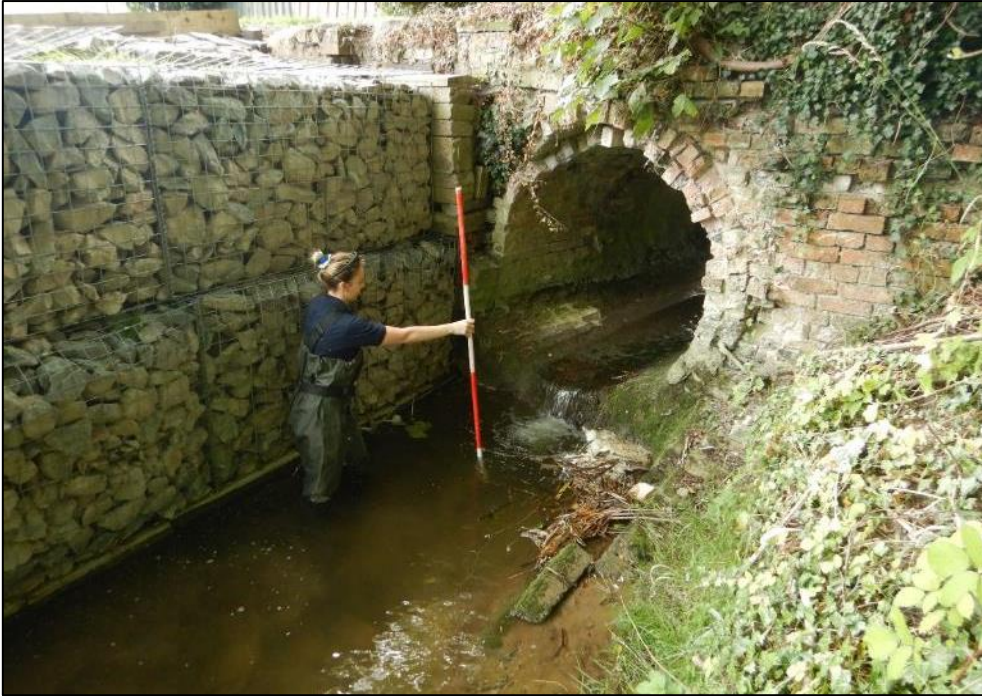
Pic 15 – A round brick culvert presents a significant barrier (with a shallow depth, smooth bed and no resting points) to the upstream movement of all fish species. The head drop from the culvert is $\sim 0.2\text{m}$ and may be drowned out before water velocities become prohibitive to the swimming abilities of fish. The pool beneath ($\sim 0.5\text{m}$) presents a resting opportunity for fish about to traverse the culvert (which is $>5\text{m}$ length). The recent construction of gabion walling degrades the habitat and suggests a high energy environment when flow is elevated (///stared.slang.suggested). Adequate trout habitat afforded by depth of pool.

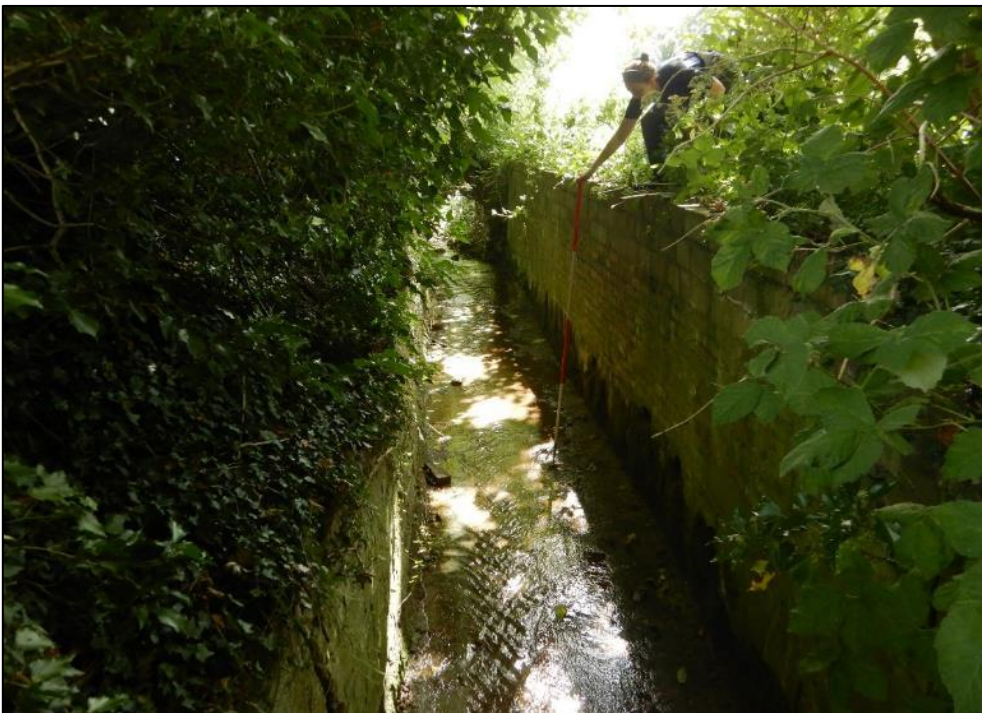
Pic 16 – Immediately upstream of the brick culvert (pic 15) the channel is constrained by concrete walling and a concrete bed with the width narrowing to $\sim 1.5\text{m}$. This reach very inhospitable to fish, and as water velocity increases it will be harder for fish to move through (///nourished.diplomats.agreeing). Poor trout habitat.

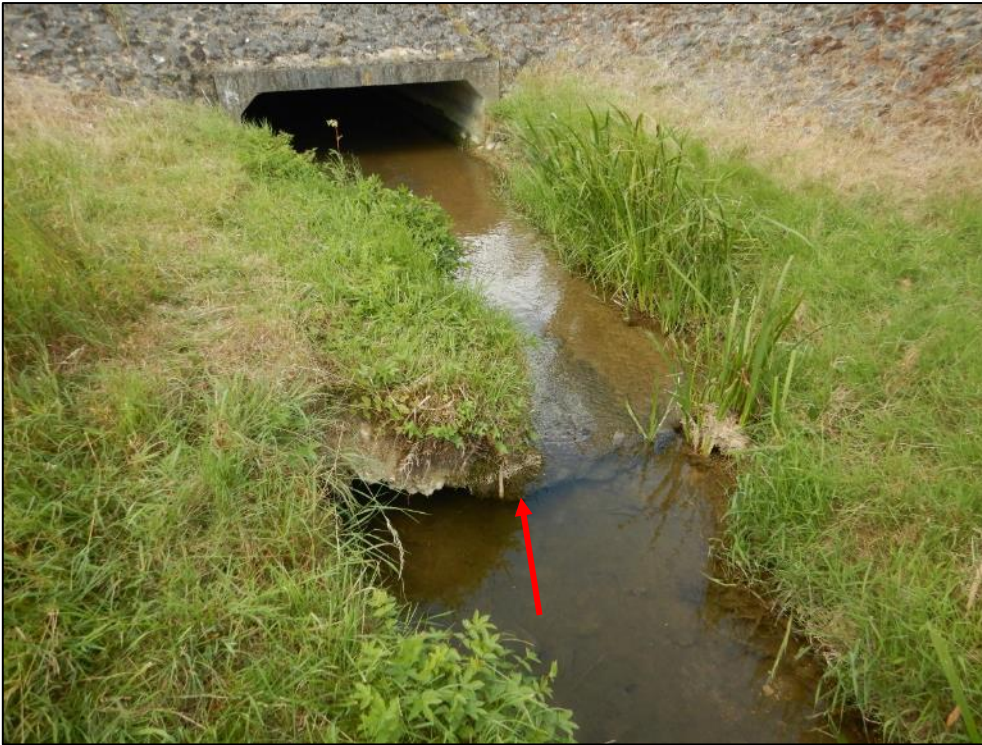
Pic 27 – An adult trout (>0.25m) took shelter beneath the dislodged concrete foundations (red arrow) of the Banovallum Gardens bridge (///freedom.laminated.public). Trout habitat is adequate.

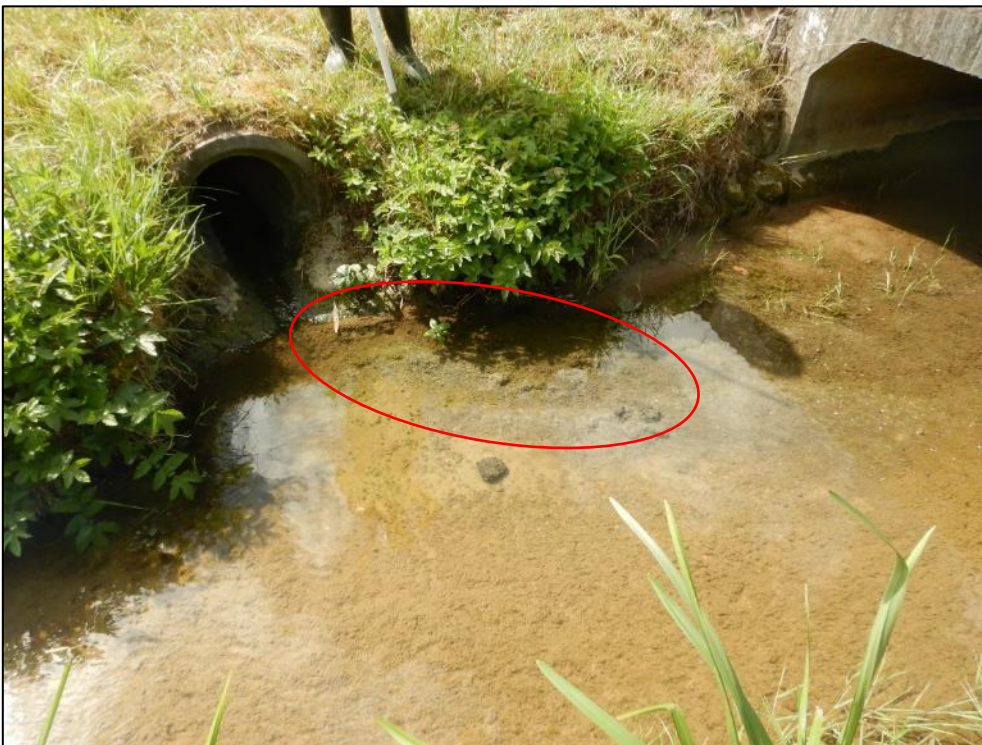
Pic 28 – Nutrient enrichment was detected from a surface water discharge. Signs of sewage fungus were apparent (red oval), whilst not causing a problem at the time of visit this enrichment (probably due to a mis-connected washing machine) may become lethal during extreme low-flow periods in combination with hot temperatures (///freedom.laminated.public). Trout habitat is poor.

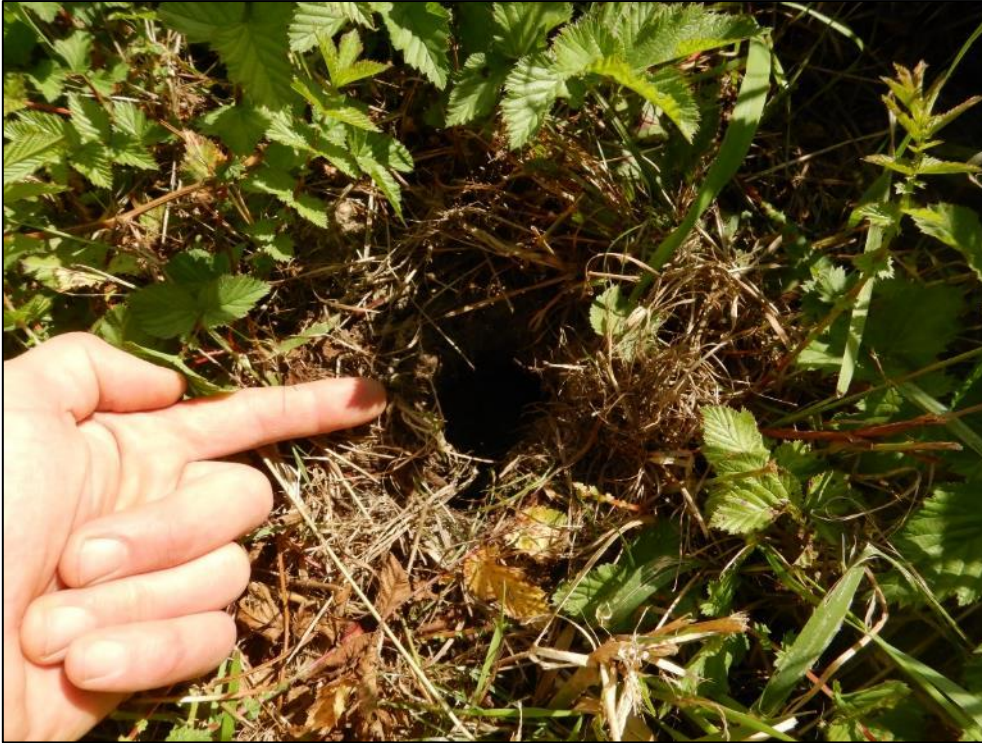
Pic 29 – The first obvious water vole burrow noted. Water voles were present at Mareham on the Hill in May 2024 (///shaves.immediate.smoking).

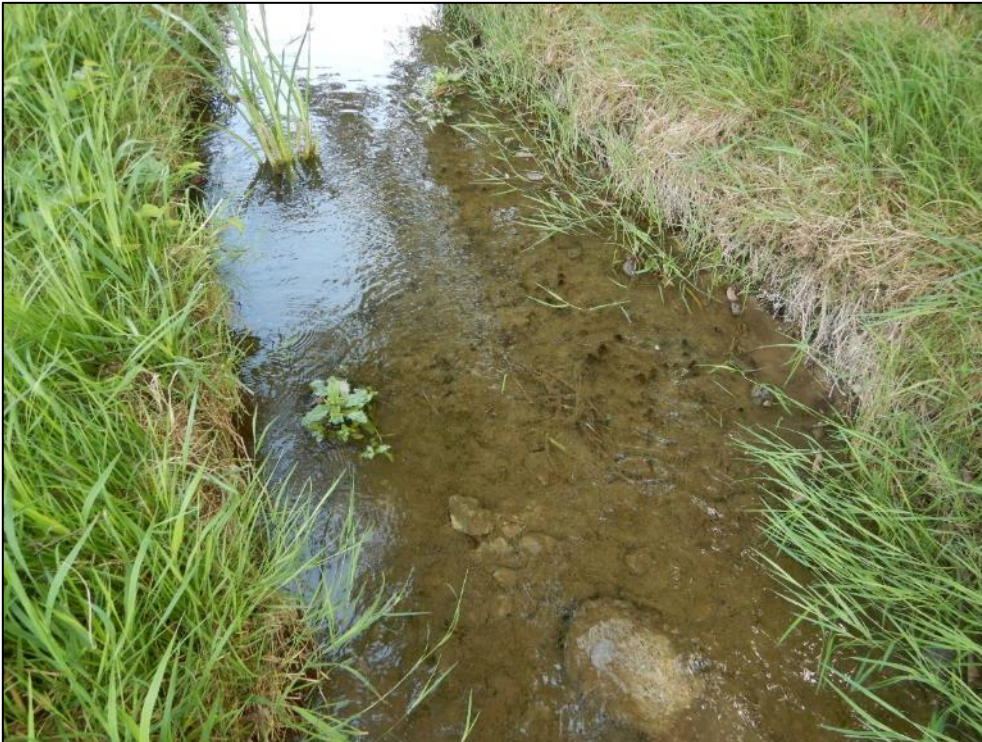
Pic 30 – Siltation and algae noted on bed, possible deterioration in water quality may influence trout distribution. Concerningly one dead bullhead seen, together with live signal crayfish and *Gammarus* (///bunkers.nanny.animals). Poor trout habitat.

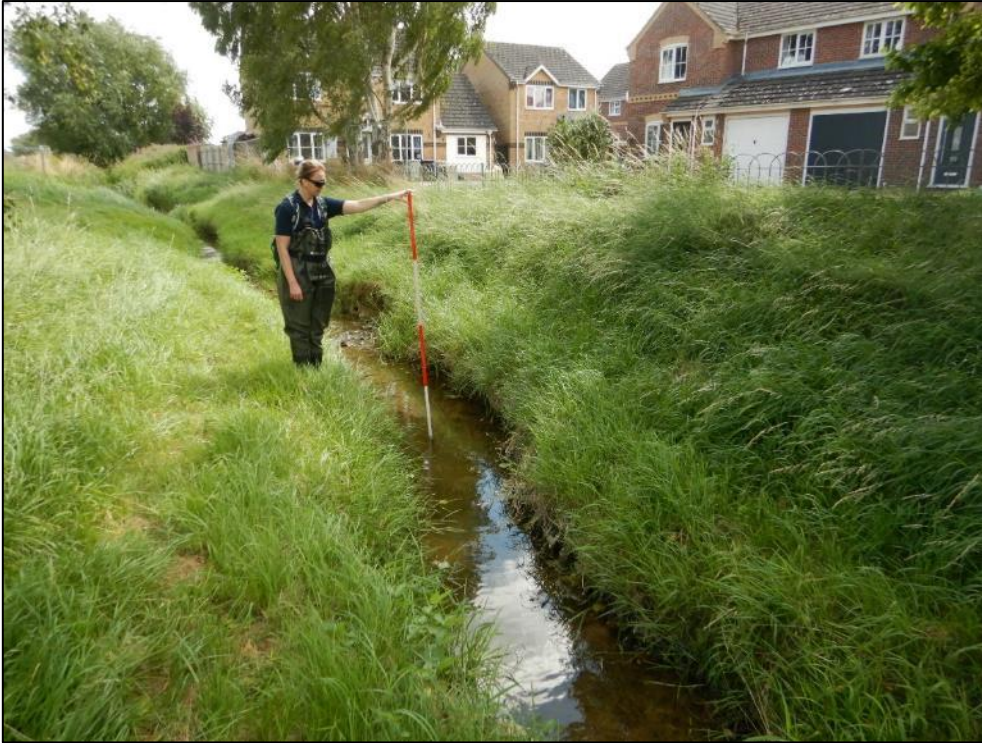
Pic 31 – 4x YoY trout seen with a larger trout (~0.2m) using small pool with depth (~0.2m). Alder roots retain the pool's form and provide cover (///lonely.nappy.coconuts). Good trout habitat (in miniature) but limited in extent.

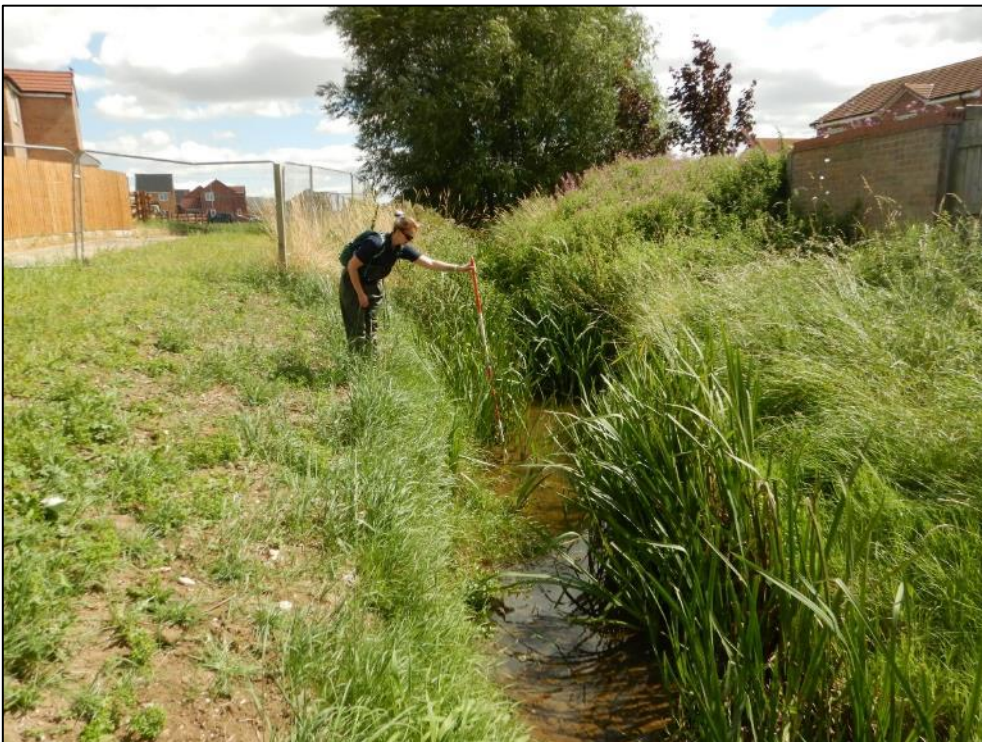
Pic 32 – The channel has been over-deepened at this location and consequently is dominated by bur reed due to an abundance of soft sediment. YoY trout seen as well as a large signal crayfish (///scrap.kidney.defected). Adequate trout habitat.

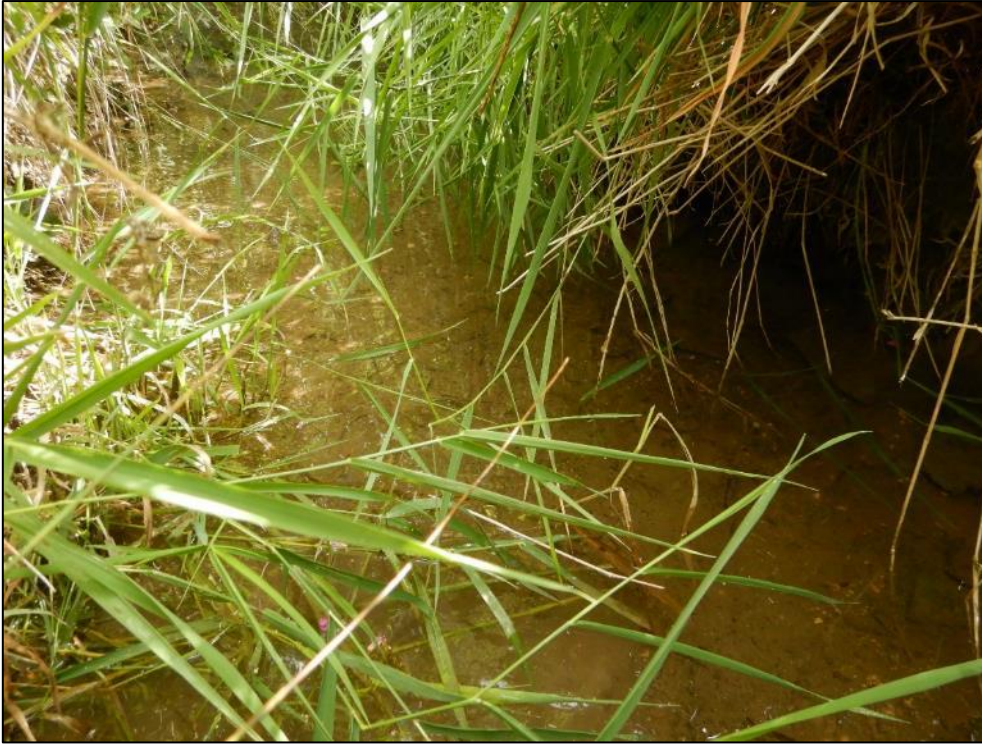
Pic 33 – The first juvenile minnow seen in shallow ($\sim 0.15\text{m}$) depth with a width $\sim 1\text{m}$. Water vole food pile observed. Gravel dominates the bed once again ([///twit.courts.bashed](http://twit.courts.bashed)). Adequate trout habitat.

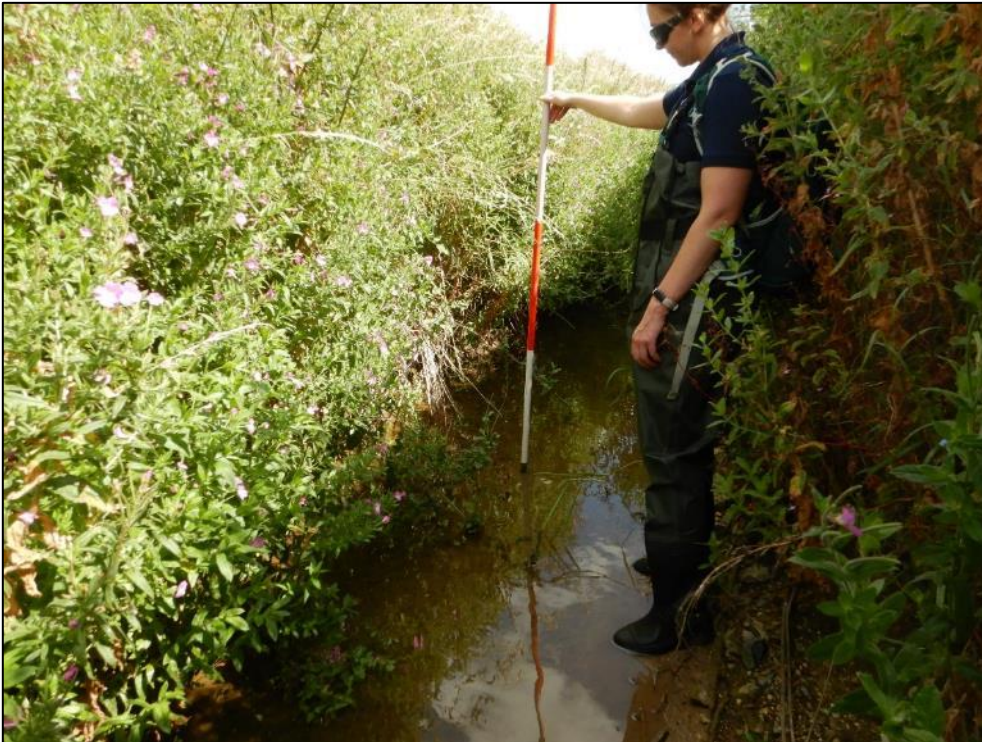
Pic 34 – Depth $\sim 0.1\text{m}$ could possibly harbour YoY trout but channel disturbance by surveyors would have prevented them being seen. Juvenile minnows observed as well as water vole food piles. Bed scour has created depth by removing gravel to expose chalk ([///damp.doctors.redouble](http://damp.doctors.redouble)). Adequate trout habitat.

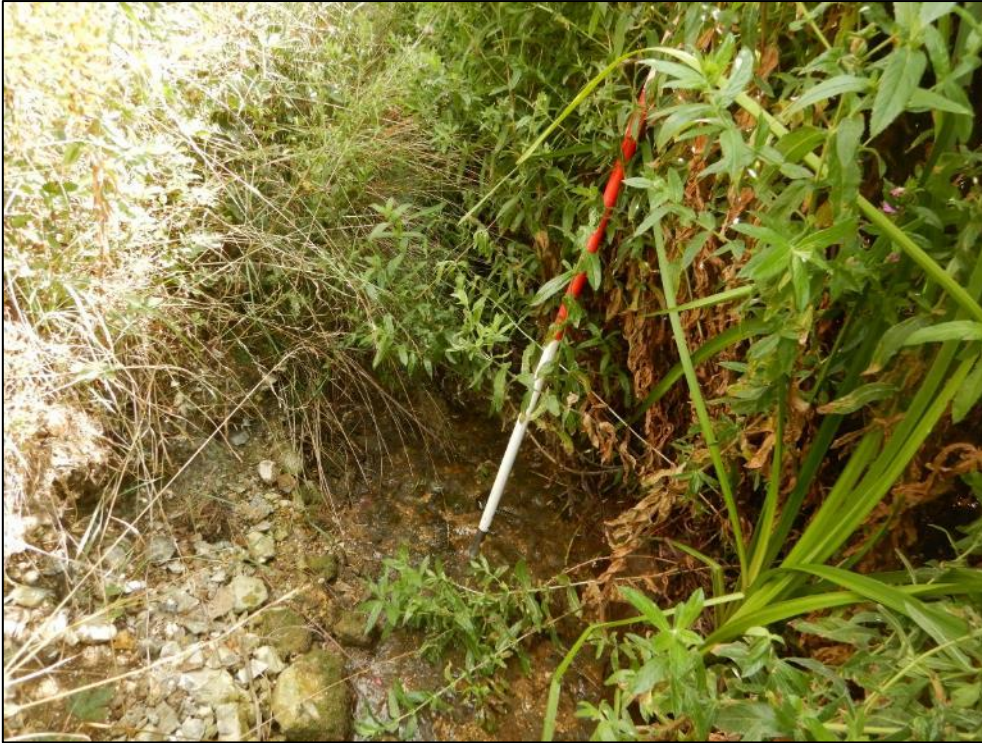
Pic 35 – Gravel bed (with tufa deposits) could provide trout spawning habitat. Stickleback seen in deeper water. Very shallow depth could prevent adult fish movement in low flows. Tall marginal vegetation engulfing channel helps to shade it (///rods.threaded.easy). No trout habitat due to shallow depth.

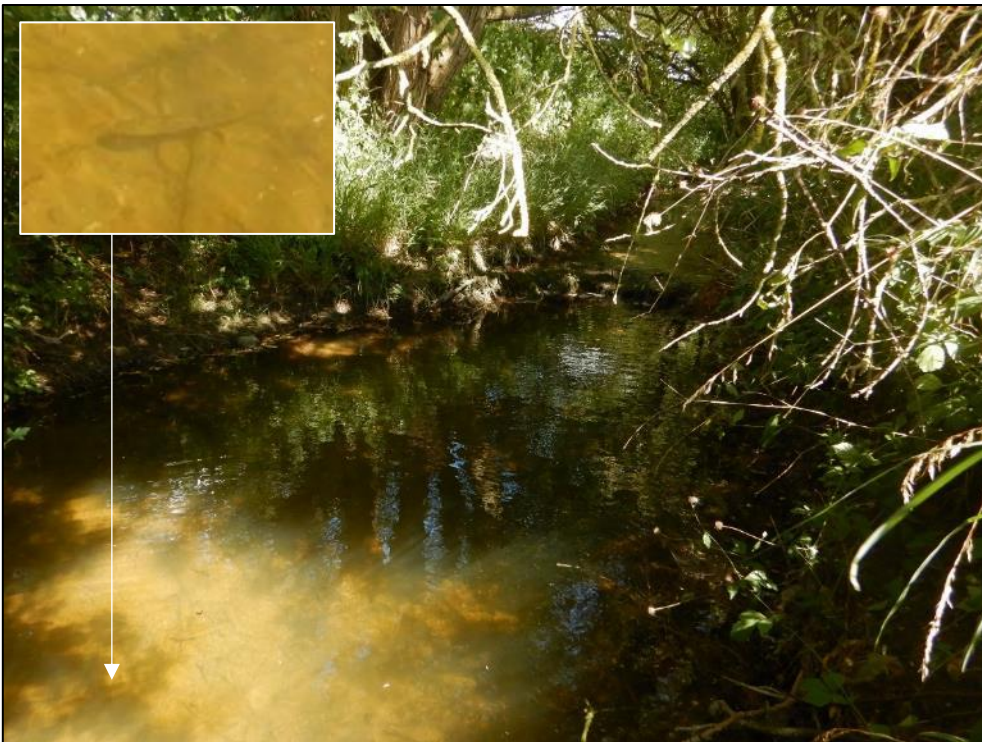
Pic 38 – 3x adult trout (~0.25m) observed in deeper pool (>0.5m) with trees holding bank firm allowing scour to be focussed in central channel (///midwinter.poem.fatherly). Good trout habitat.

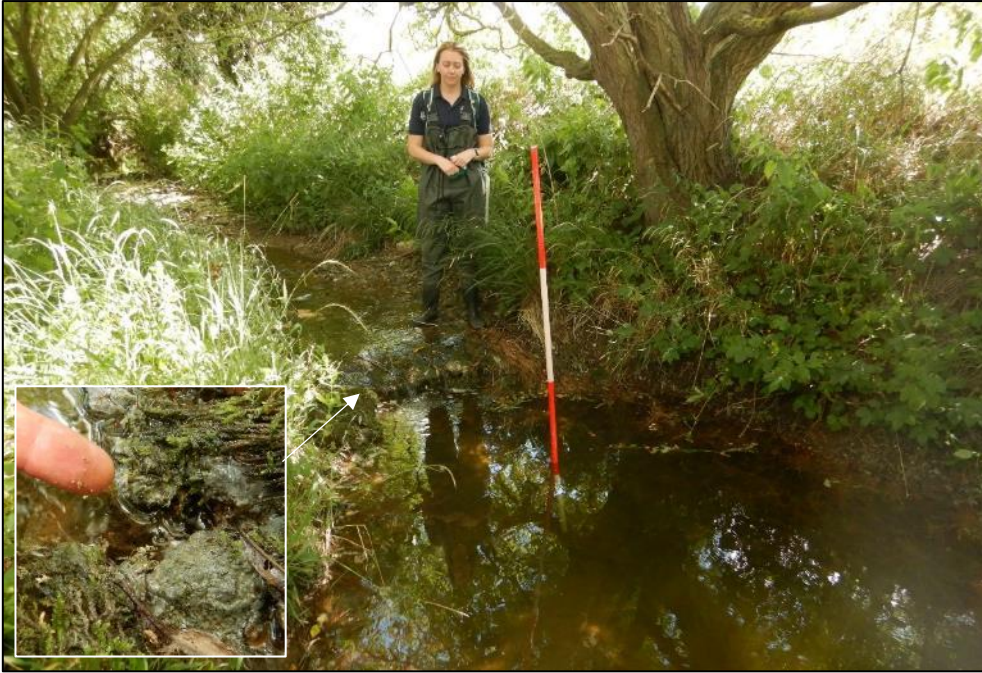
Pic 39 – An excellent natural pool creates a riverine form in stark contrast to the ditch-like watercourse downstream. The Thunker exhibits channel stability, with a tufa dam presenting a natural step appearance (inset picture shows tufa encrusting willow roots and moss). Whilst the tufa dam is a natural barrier to fish movement in low flows the depth (~0.6m) and width of the pool (~2.5m) provides excellent sanctuary for fish. Many YoY trout were observed together with 3x adult trout. A small rise in flow would enable trout to overcome the ~0.2m head drop. Bullhead were found upstream of the tufa dam (///tinned.flattens.regrading). Good trout habitat.

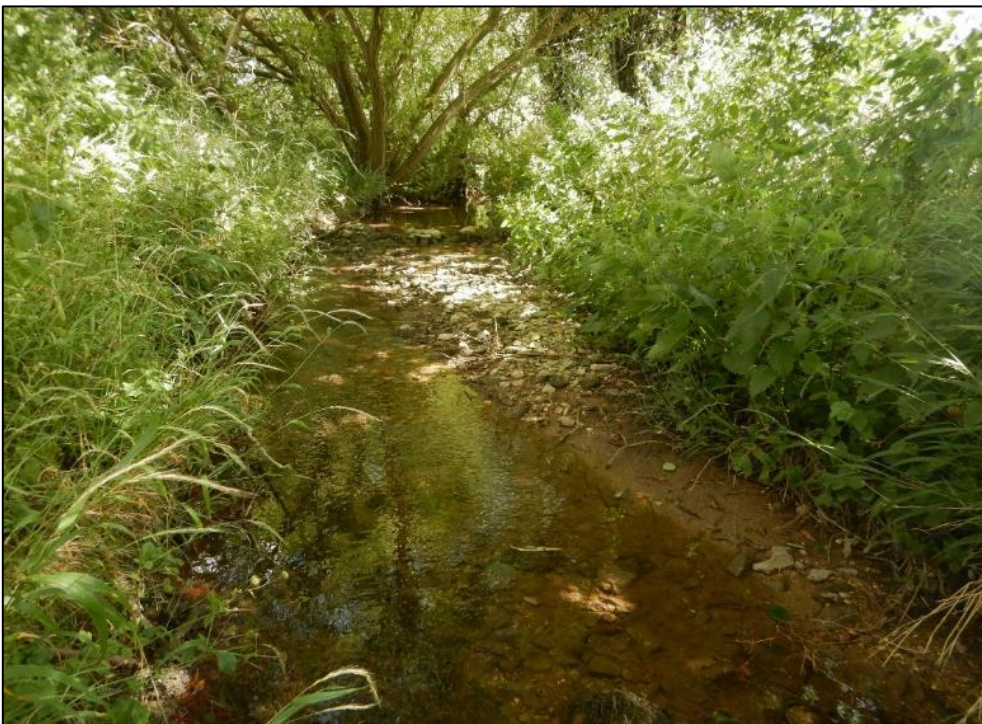
Pic 40 – Upstream of the tufa dam the channel continues to show habitat stability with graded gravel bars providing important habitat diversity, potential trout spawning habitat and adaptation to flow variation (low flows are focussed on one side of the channel) (///cobble.misfits.should). Good trout habitat.

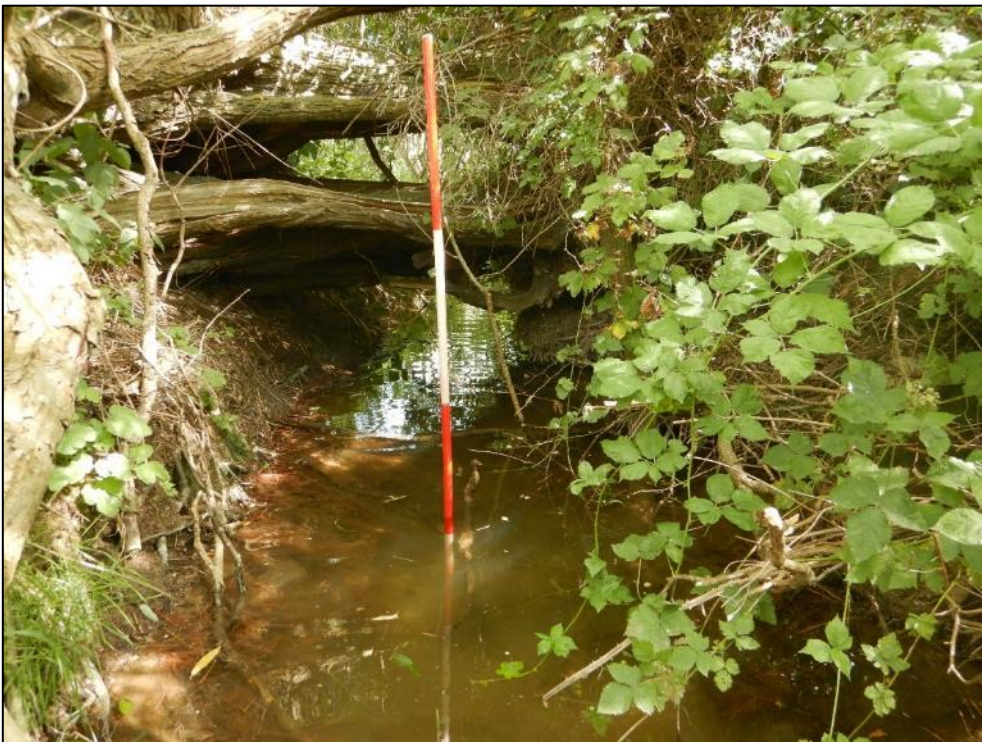
Pic 42 – 2x YoY trout seen in pool created where fallen willow pushes high flows against bed. Depth $\sim 0.6\text{m}$, channel width $\sim 1.5\text{m}$. This fallen, but stable, willow represents an excellent example of Natural Flood Management (NFM) which in addition to slowing the downstream movement of water will cause water to spill-out to the floodplain, lessening flood peaks to the downstream community and making the Thunker a less challenging environment for fish ([///roughness.connects.chop](#)). Good trout habitat.

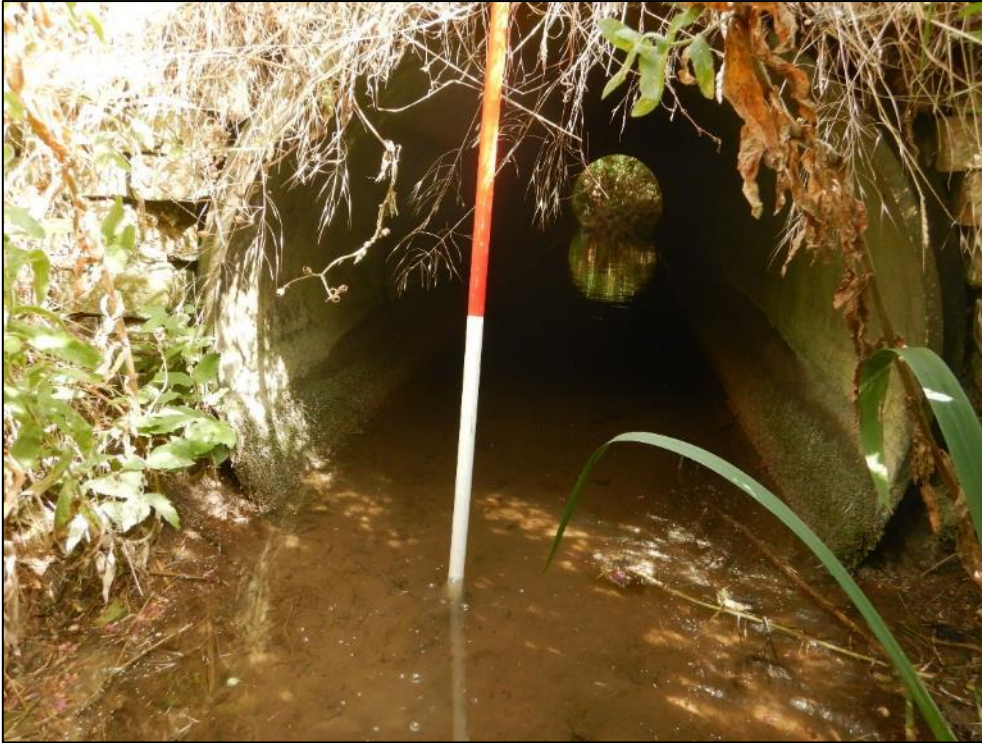
Pic 43 – Farm access culvert set below existing bed level presents no barrier to fish movements. Water vole feeding signs observed on flag iris (///loaded.strongman.turntable). Poor trout habitat.

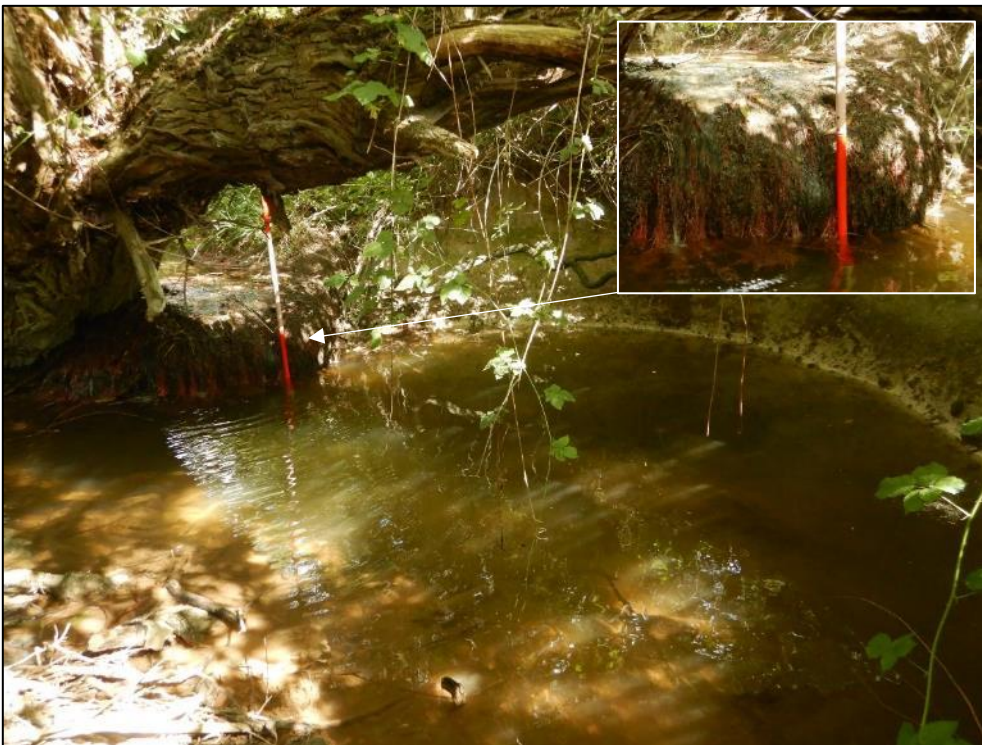
Pic 44 – Another plunge pool (~0.7m depth, ~3m width) from tufa forming over willow roots (indicating channel stability) focussing flow to the side of the pool and promoting scour. The restriction posed by the willow tree in combination with the drop presents further NFM, benefitting downstream communities and biodiversity. No fish were observed (///corded.reckoned.topic). Good trout habitat.

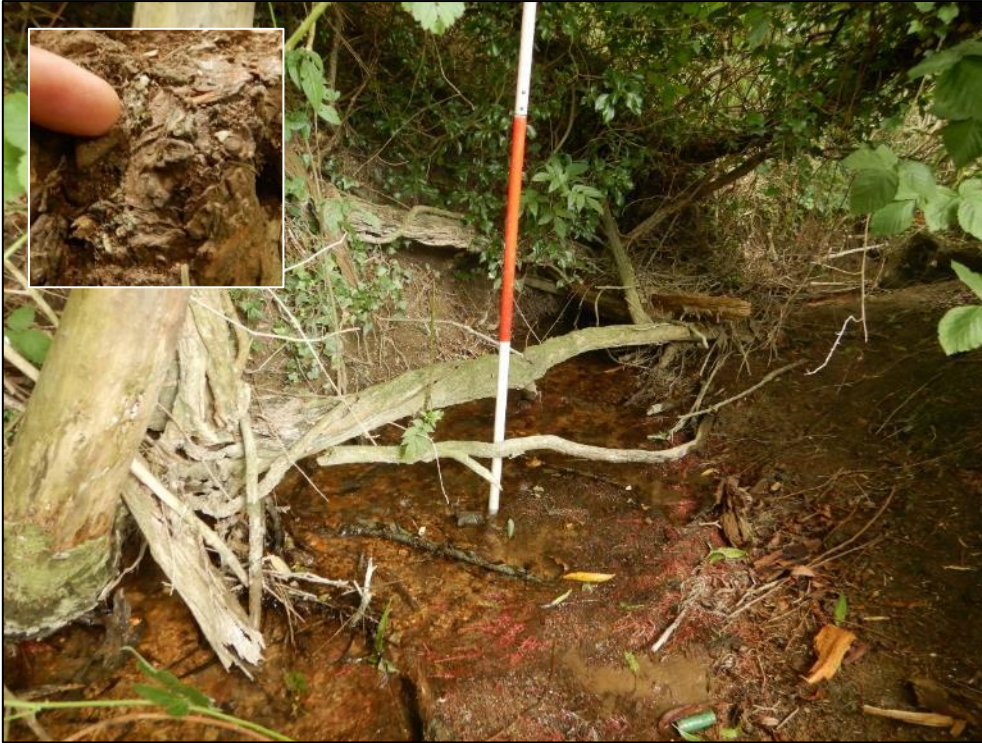
Pic 45 – The base flow appears much reduced from this point upstream. The shallow depth would hinder fish movements but in higher flow they would be free to move. An old otter spraint was found amongst the tree roots (inset picture) (///trickster.training.indoor). Poor trout habitat due to limited depth.

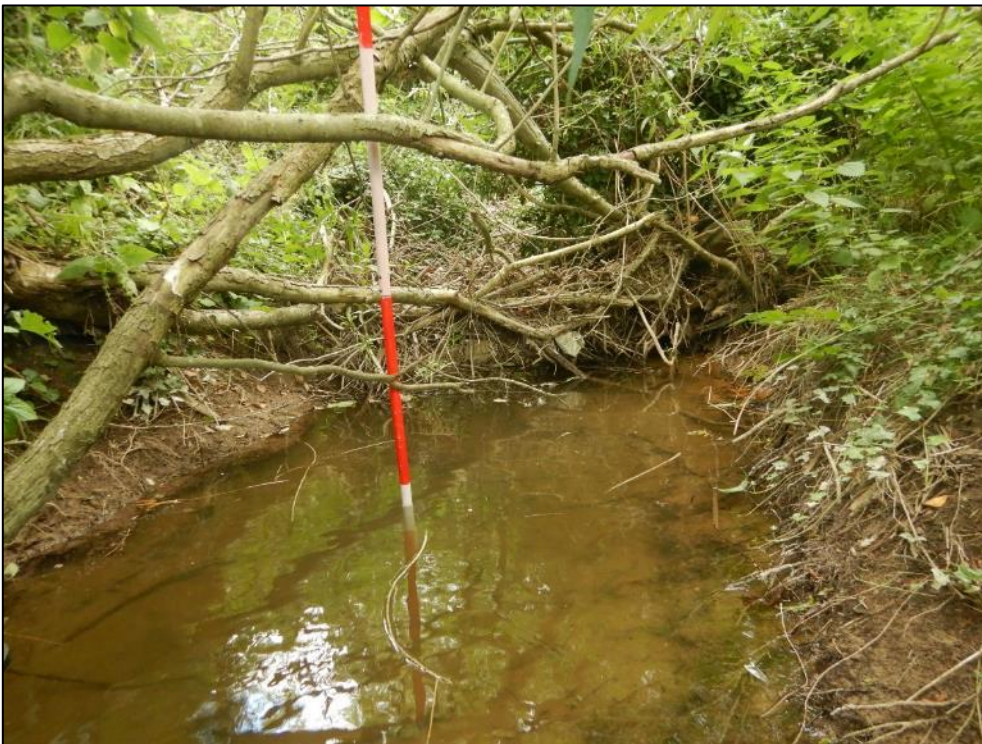
Pic 46 – Log jam provides excellent NFM, and subsequent downstream ‘pool’ shows less evidence of scour as the log jam has defused the flow as opposed to funnelling it. No fish observed (///ends.bloomers.ecologist). Good trout habitat.

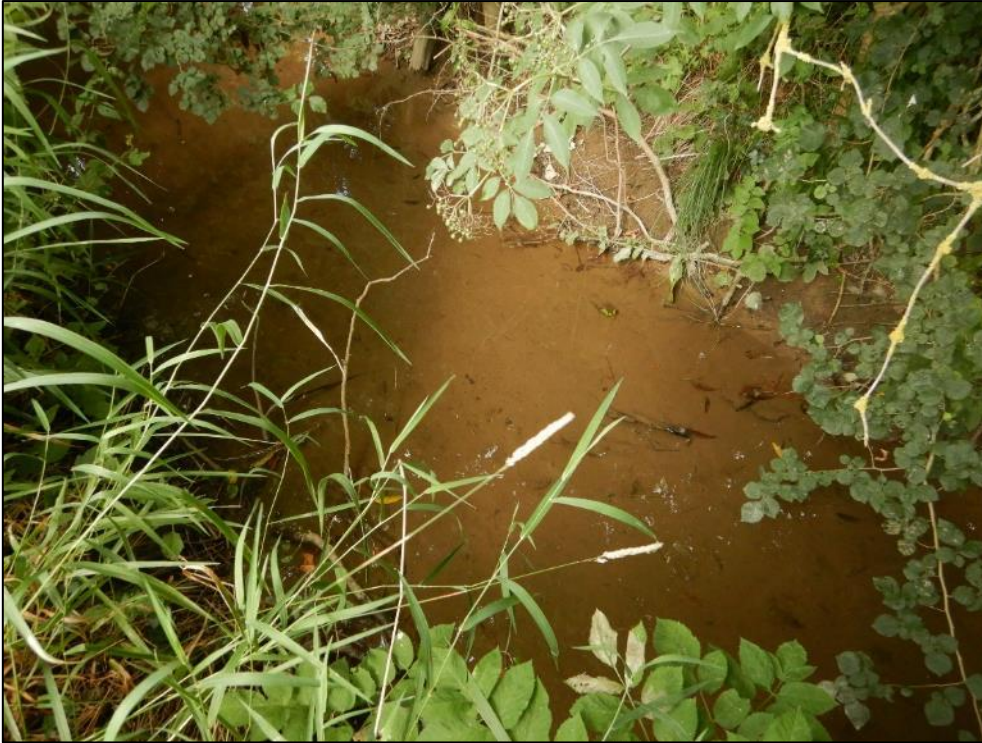
Pic 47 – Evidence of the impoundment (or water retention) provided by the log jam (pic 46) is apparent by the silted channel. Juvenile stickleback were observed (///shaves.recap.formal). Poor trout habitat.

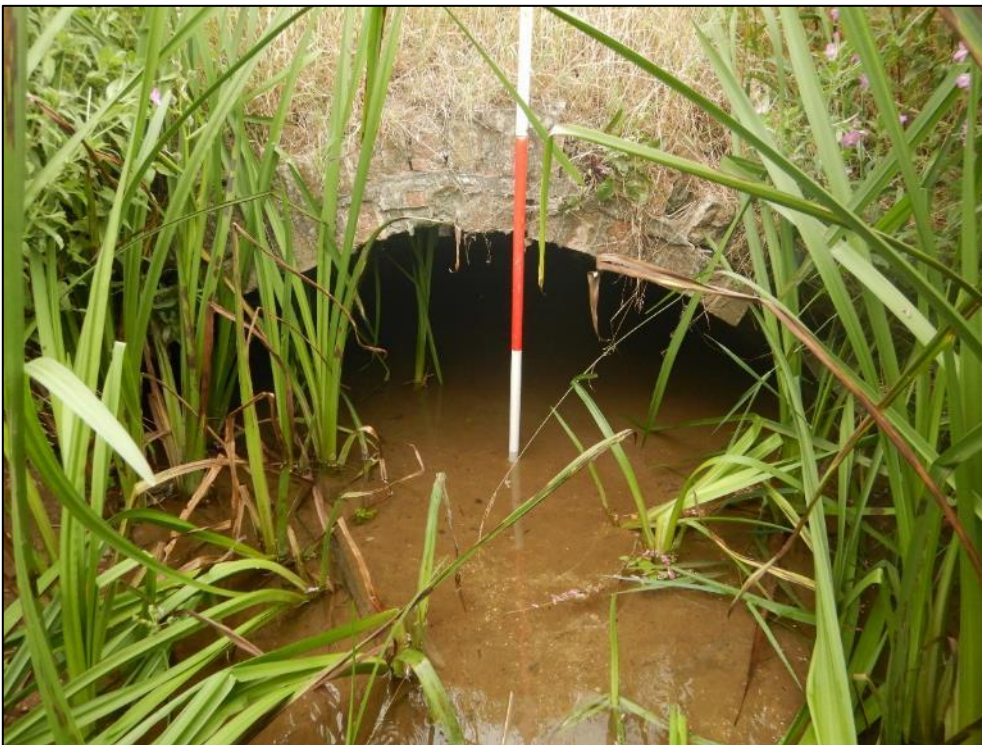
Pic 48 – Brick arch bridge is passable but is significantly silted due to downstream impoundment. ~0.05m of open water above 0.2m of silt. Juvenile stickleback seen (///exams.haircuts.elect). Poor trout habitat.
