WILD TROUT TRUST

A walkover habitat assessment

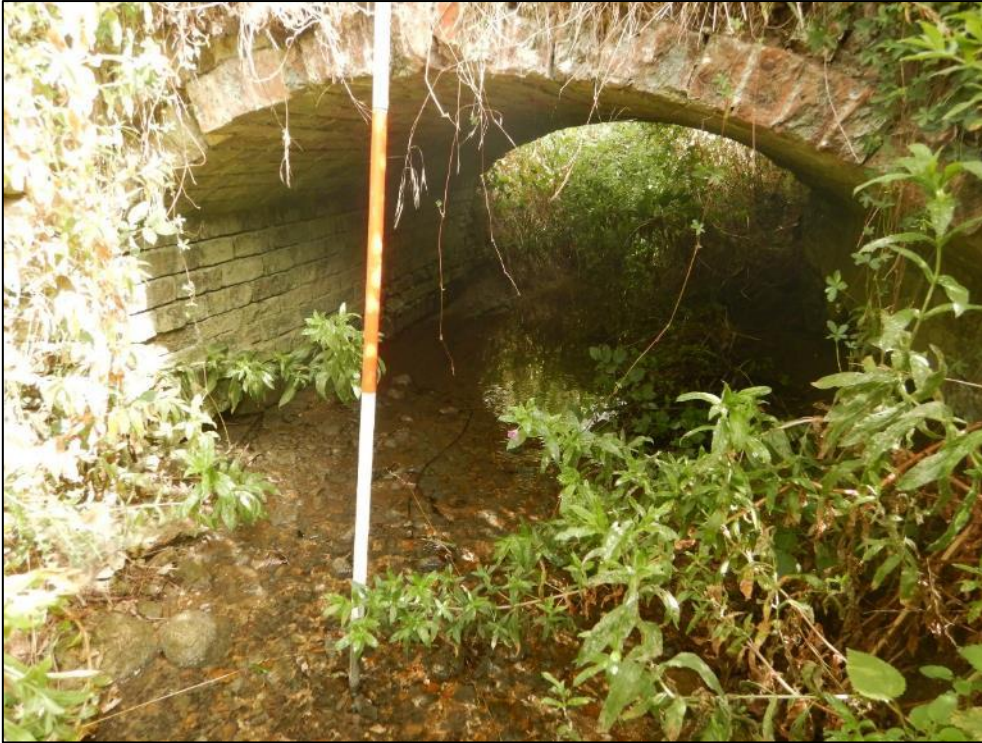
Pic 49 – Brick arch bridge is passable with clean gravel beneath. No bullhead found beneath stones, no otter spraint found (///exams.haircuts.elect). Good trout habitat.

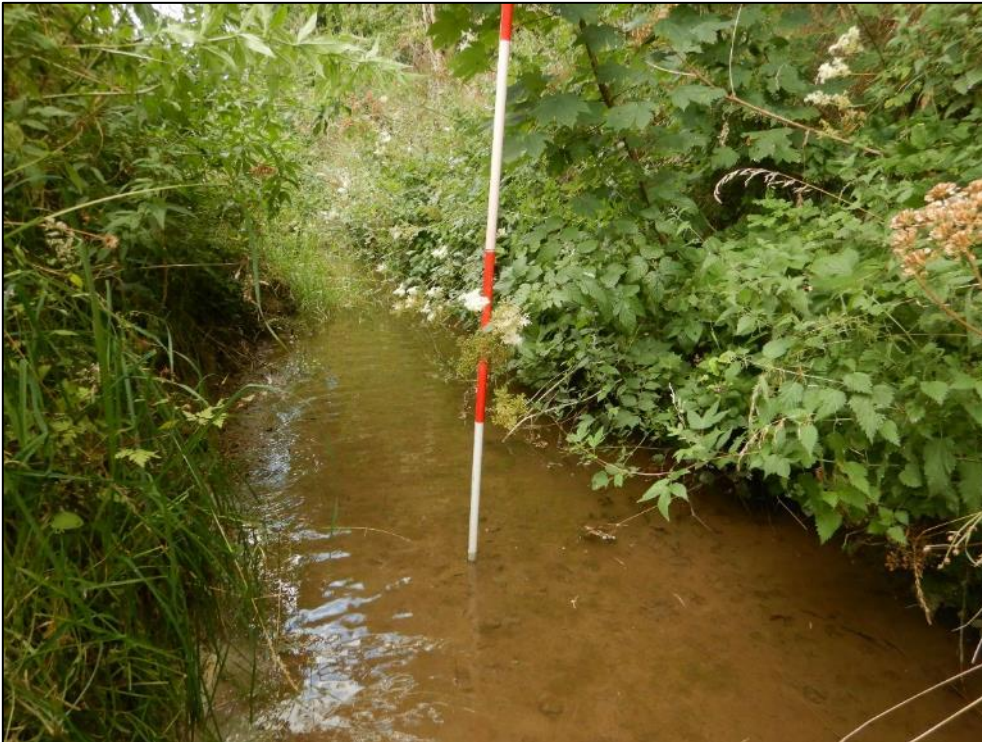
Pic 50 – ~3m deep incised channel with silt smothering bed leaving ~0.1m depth of open water. Many juvenile stickleback seen plus 1 signal crayfish (///zooms.tadpole.purified). Poor trout habitat.
