WILD TROUT TRUST

Advisory Visit Report

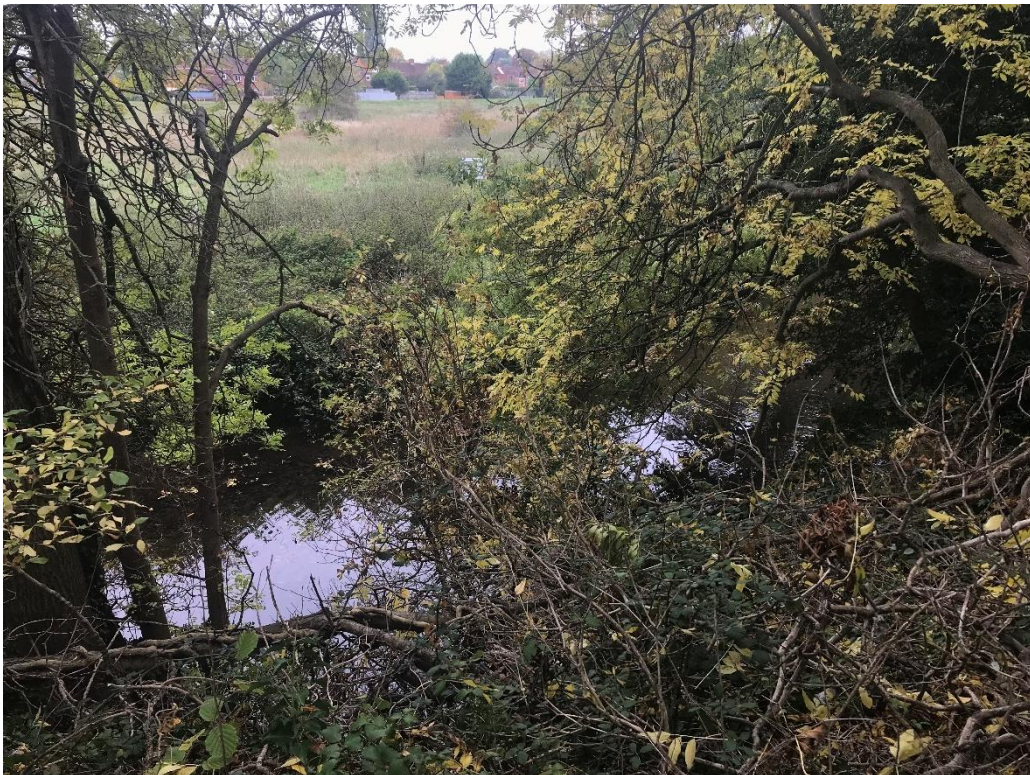
Photo 4 The river channel, sunk well below the surrounding landscape, following historic modifications. A lack of channel habitat features result, and flood waters will be contained between the high banks, unable to dissipate to the floodplain.

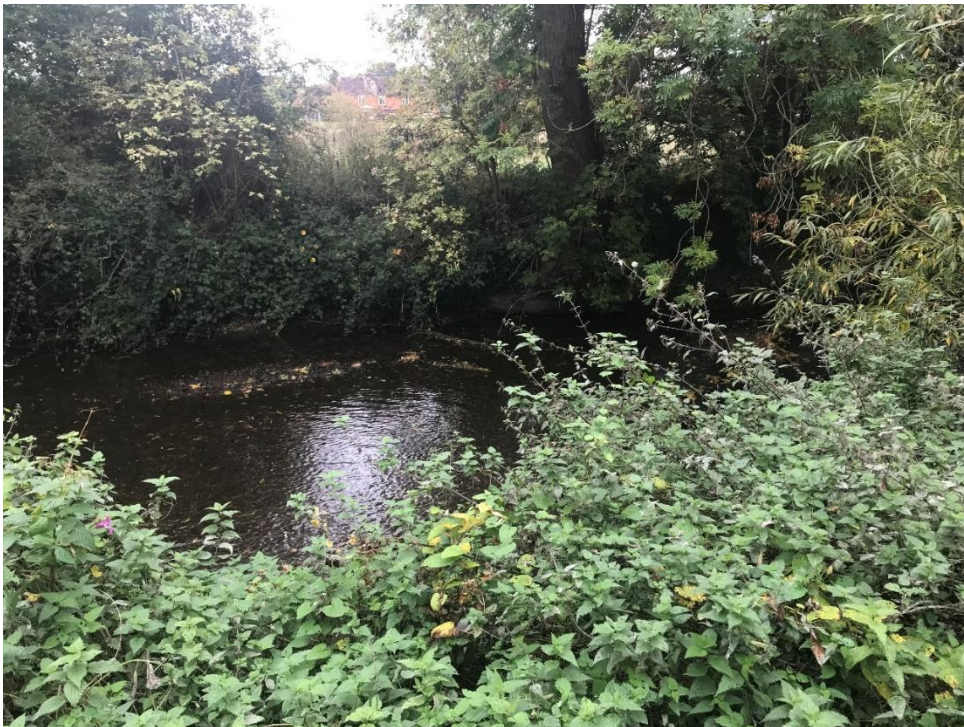
Photo 6 Another example of the modified channel. River habitat is poor, with unaturally high banks (52.218644 , -1.8692894). It could be possible to install woody structure along the margins of the channel through these sections, to provide better habitat for invertebrate and fish life at low flows. Greater resilience to flood water conditions could also be achieved by creating refuge habitat through channel 'roughness' which dissipates the energy of flood water around the boundaries of the channel.

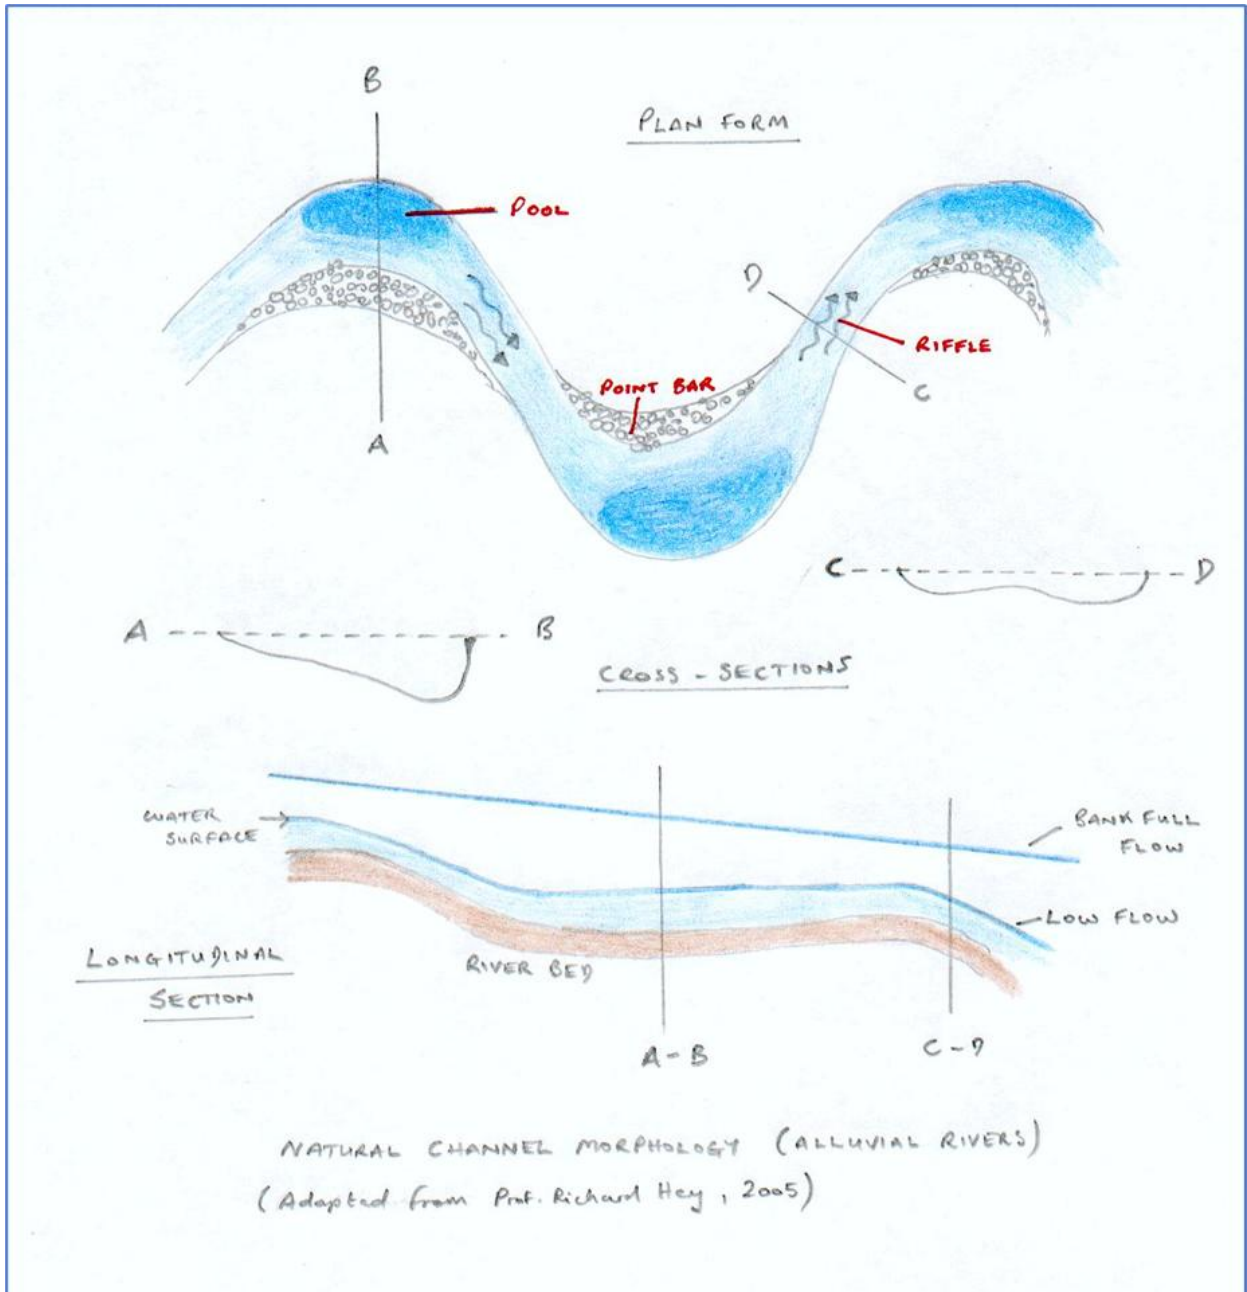
Figure 1. An infographic showing the natural dynamics of a river as it meanders, erodes and deposits material, changing in shape, gradient, depth and flow speeds.

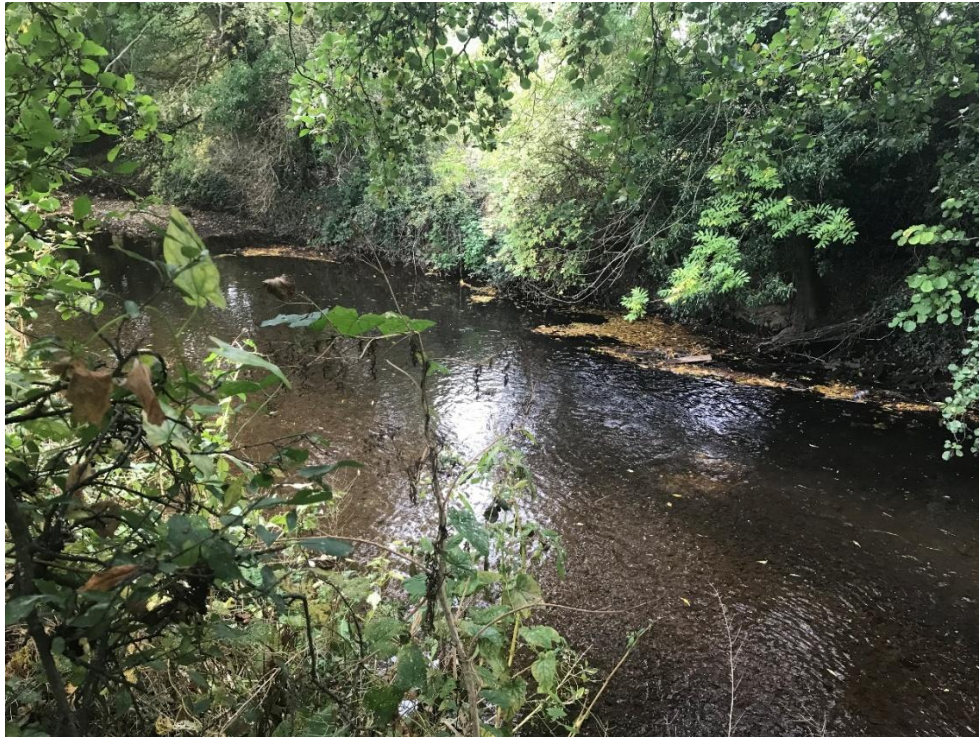
Photo 8 At the tail of the riffle, the response feature we would expect in a dynamic, gravel supplied river system; the water has eroded the bed of the river into the far RHB to create deeper, slower water in a deep glide and pool sequence (slow flow, greater than knee deep). Different aquatic species or life stages will find home here in this diversity of habitat. The submerged, trailing tree roots against the far RH bank provides some of the most desirable habit for adult trout and chub, along with multiple invertebrate species that will graze or attach on the tangle of root fibres. The shallower water adjacent the near LH bank will be populated by many insects such as shrimp, mayfly and caddis fly, plus minnow, chub, dace, roach and barbel fry. A happy place for kingfishers!

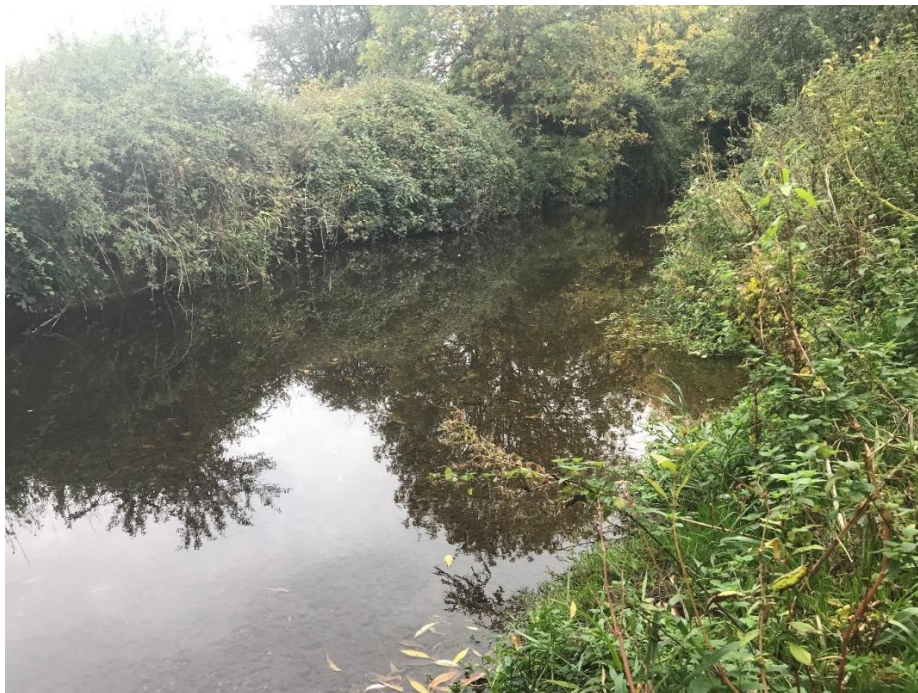
Photo 9 Pool habitats can be beneficial, as long as it is in the mix with other habitat types up and downstream, such as riffles and glides, to form part of a wider mosaic. The habitat is reasonable here, with bramble overhanging the water on the far side to provide valuable cover for fish and protect the artificially high and steep banks during winter floods. The encroachment of trailing vegetation on the near LH bank is equally valuable for providing cover to aquatic species. Rich, rank riparian shrub and plant growth is providing extremely good riverside habitat for a huge array of invertebrates and birds, too.

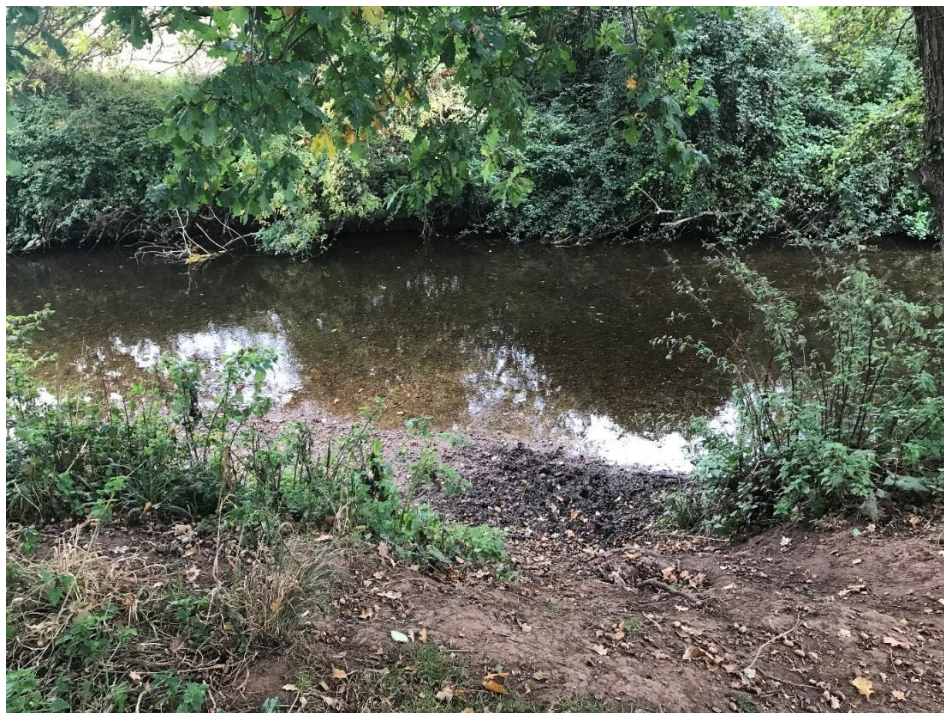
Photo 10 One example of several areas of bare ground created by desire paths. Consider directing access away from specific problematic spots like this to more suitable locations, allowing vegetation to re-establish that naturally protects the bank. This could be achieved through creation of woven fences or installation of

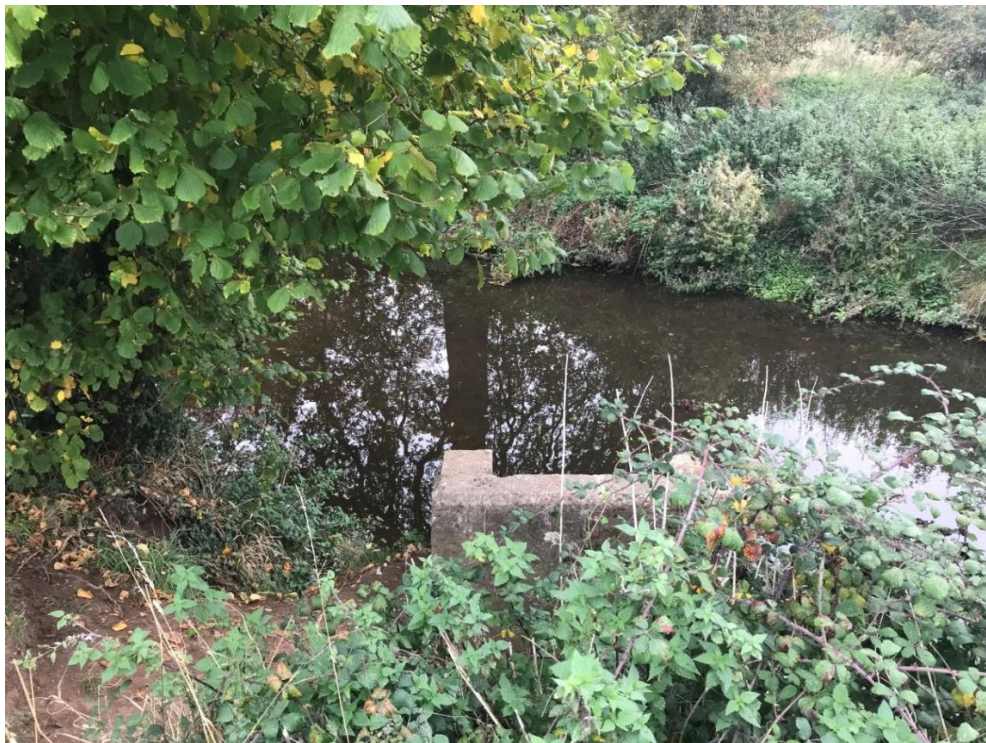
Photo 11 Concrete structure containing the outfall pipe (52.219485 , -1.8716143).

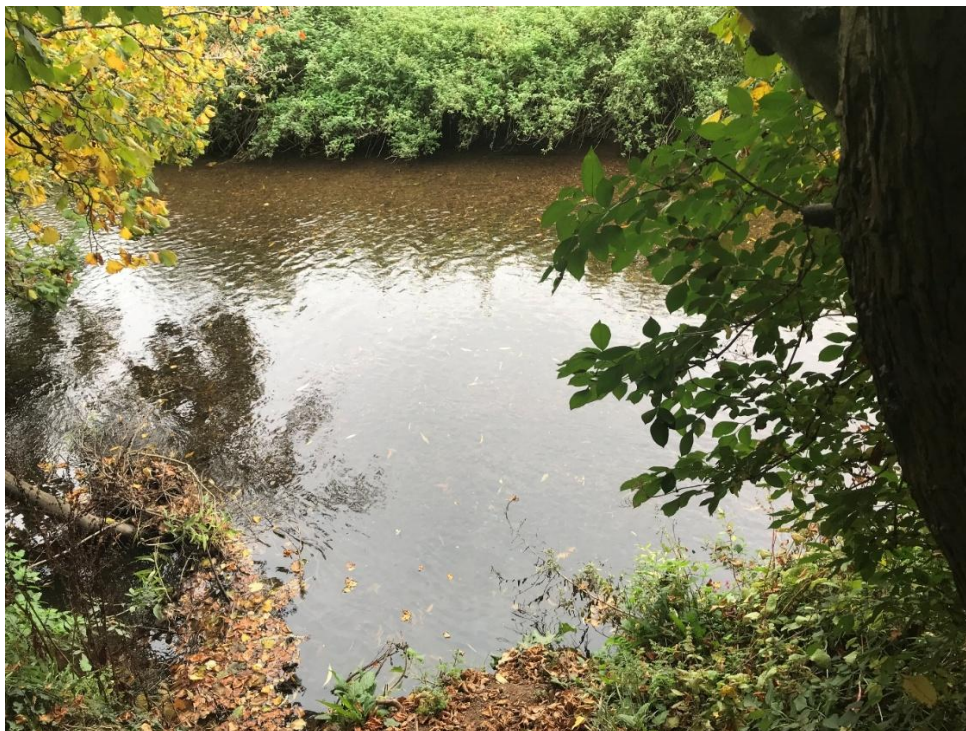
Photo 13 The section of watercourse adjacent to the overflow pipe was again modified with limited habitat features. Pinning large woody material or installing root plates from alternating bank sides would help narrow the low flow channel. This will create flow diversity at lower river levels and provide physical structure for aquatic wildlife, also scouring the bed and aiding further river habitat development during floods.

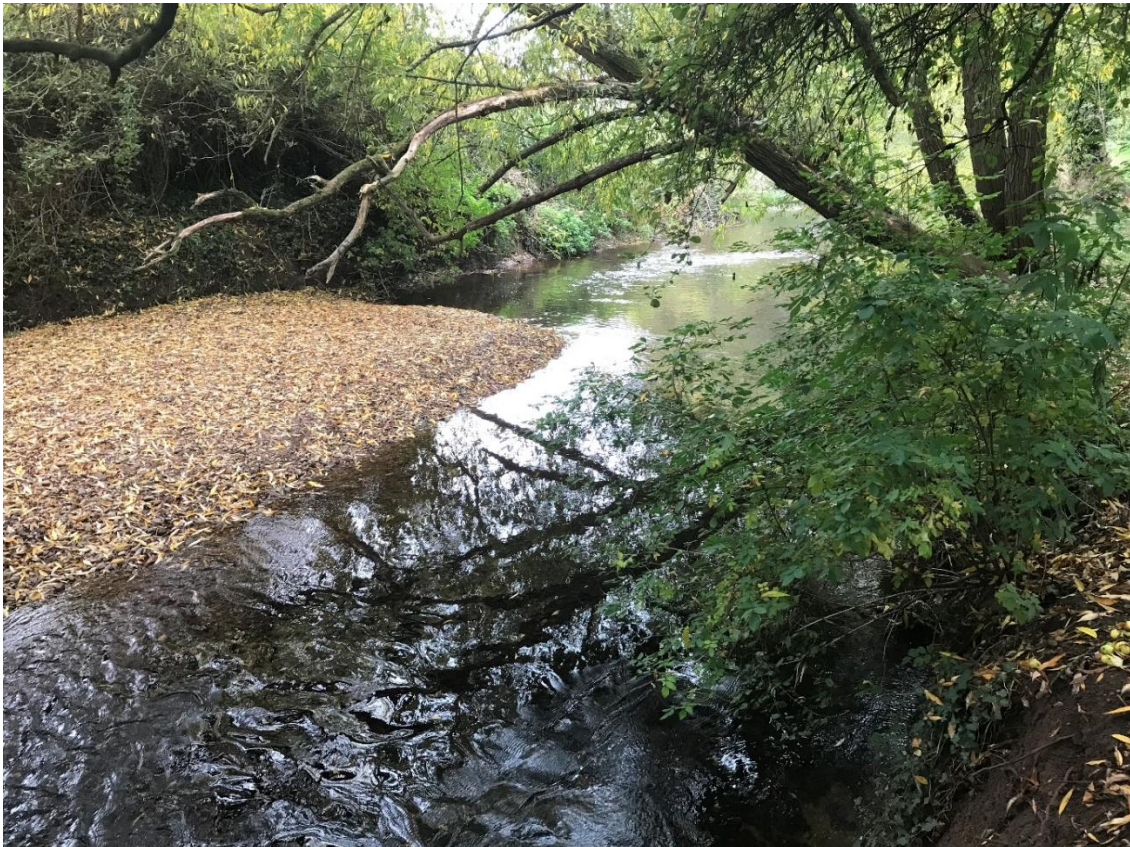
Photo 14 An excellent side bar of gravel forming, as a natural process of the river depositing gravel eroded from the catchment floodplains. This is starting to force a meander (wiggle), with the inside of this formed by the gently sloping bar which allows rising river levels to gently dissipate over during floods. The opposite effect on the LH bank is erosion, nicely regulated by mature bankside vegetation on what will eventually be the outside of the bend, providing deeper water for a variety of aquatic species. The pinching of the channel by the bar reinvigorates flow, energising it for some distance downstream of this picture.

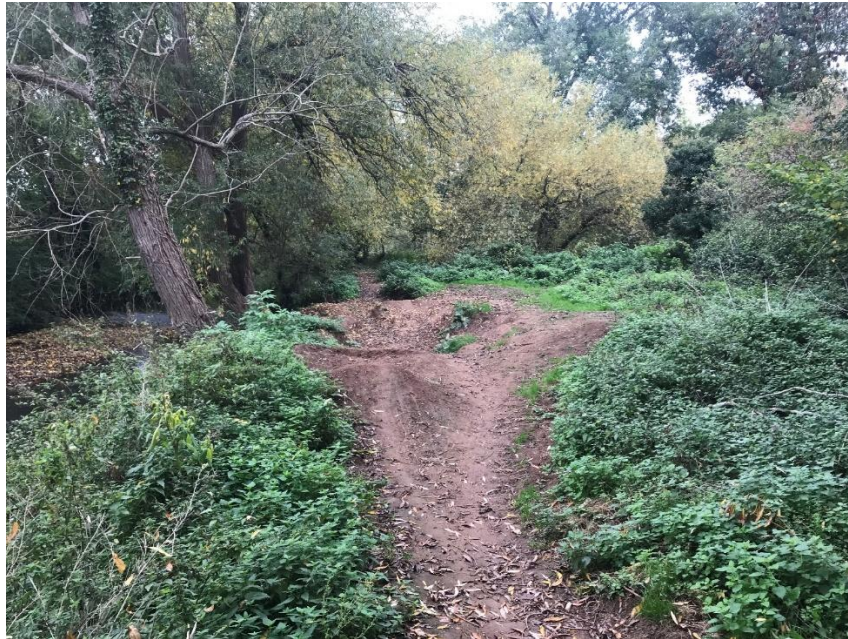
Photo 15 The area between the footpath and the river is much wider now, potentially allowing a very good quality habitat corridor to develop. However, this location at 52.220189 , -1.8728127 has also become attractive as a makeshift bike track. The damage to the woodland and the riverbank here may lead to some significant issues with mass failure of the bank during floods, potentially creating large areas of erosion which will affect the river's ability to form quality habitat dynamics (in an overwide channel) and provide large inputs of fine sediment to the watercourse.

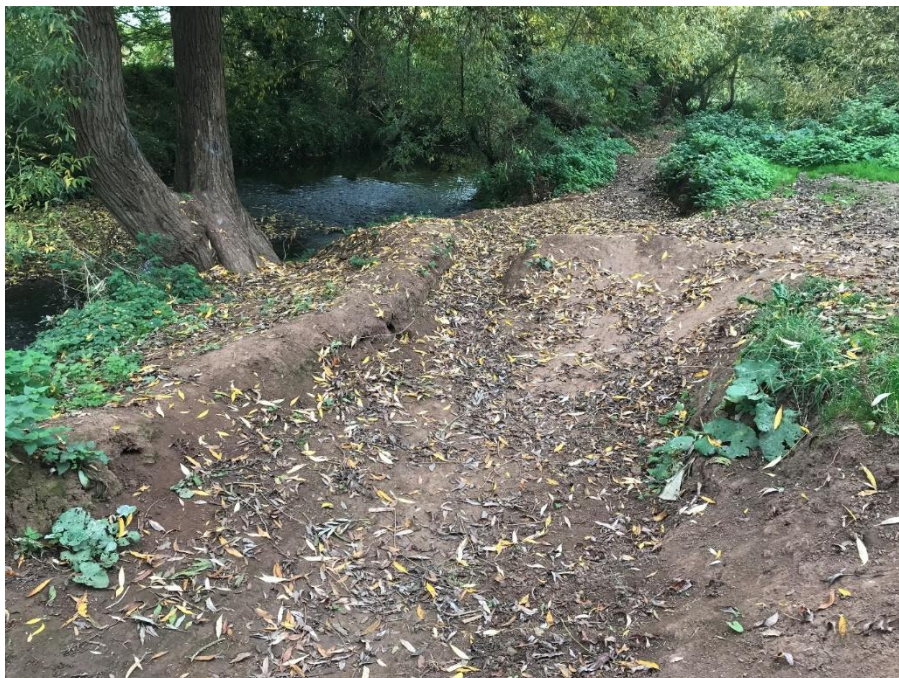
Photo 16 The magnitude of the biking damage can be seen here. Winter floods are likely to have a significant impact on this area due to a lack of woodland vegetation that should be protecting the banks and volume of bank material already lost.

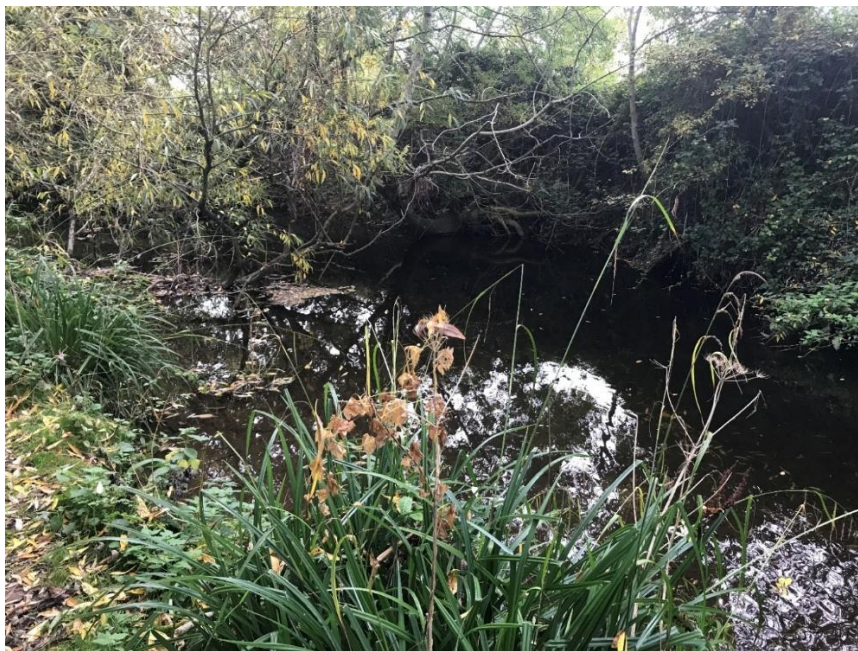
Photo 17 'Shaggy' riparian habitat interacting with the pool here provides excellent habitat for adult fish, particularly.

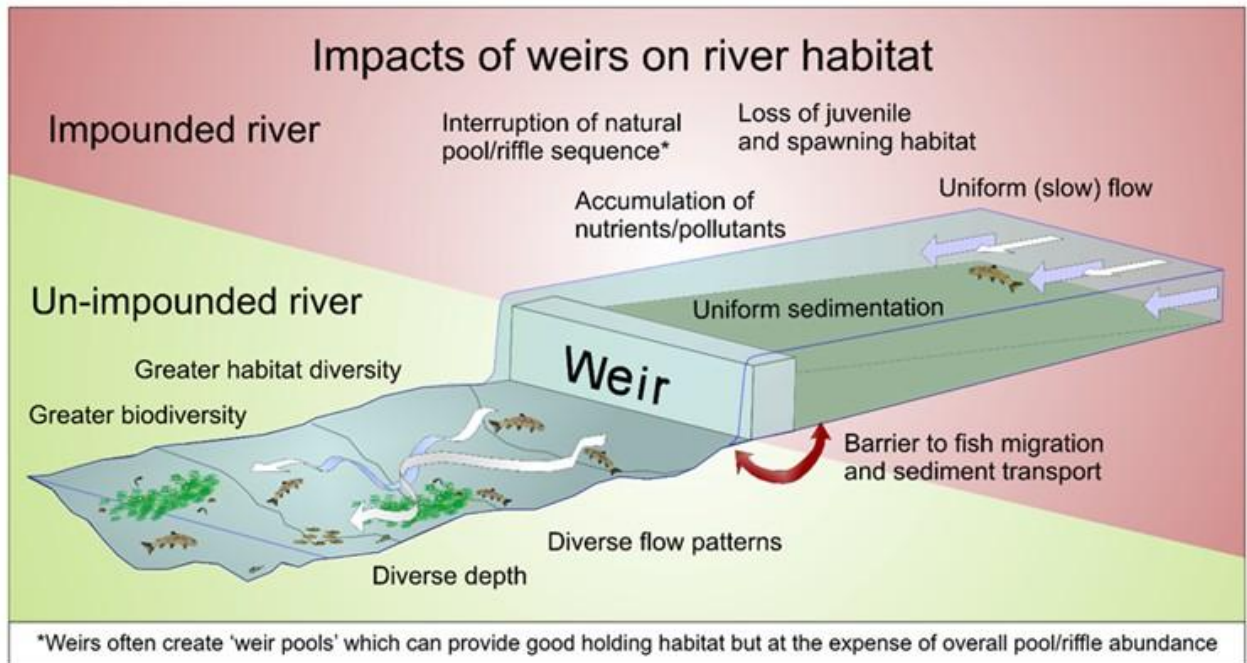
Figure 4 A diagram highlighting the impact weirs will have on river ecosystems.
