River Yeo, Cheddar, Somerset

Wild Trout Trust report on a walkover survey carried out on 17 October 2020

Written by Theo Pike: tpike@wildtrout.org

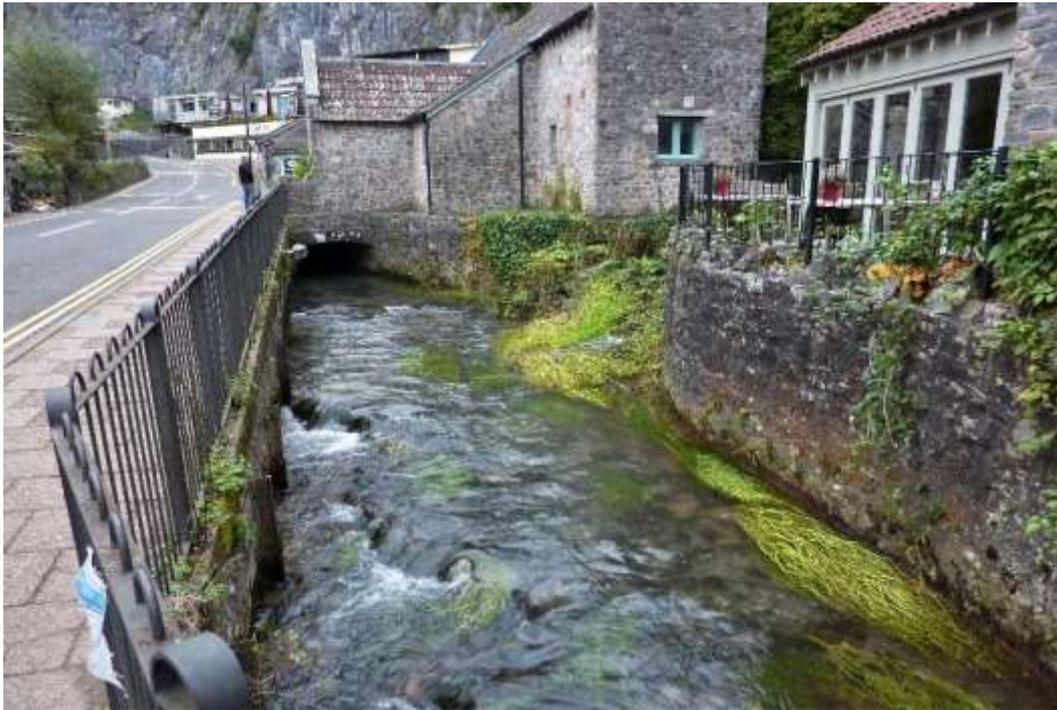
Figure 3: The River Yeo between Gough's Cave and the Upper Pond in Cheddar

The Cheddar Yeo emerges from Gough's Cave and flows briefly above ground in a torrential rocky and gravelly channel before diving under the road through three box culverts, into the large online impoundment of Upper Pond.

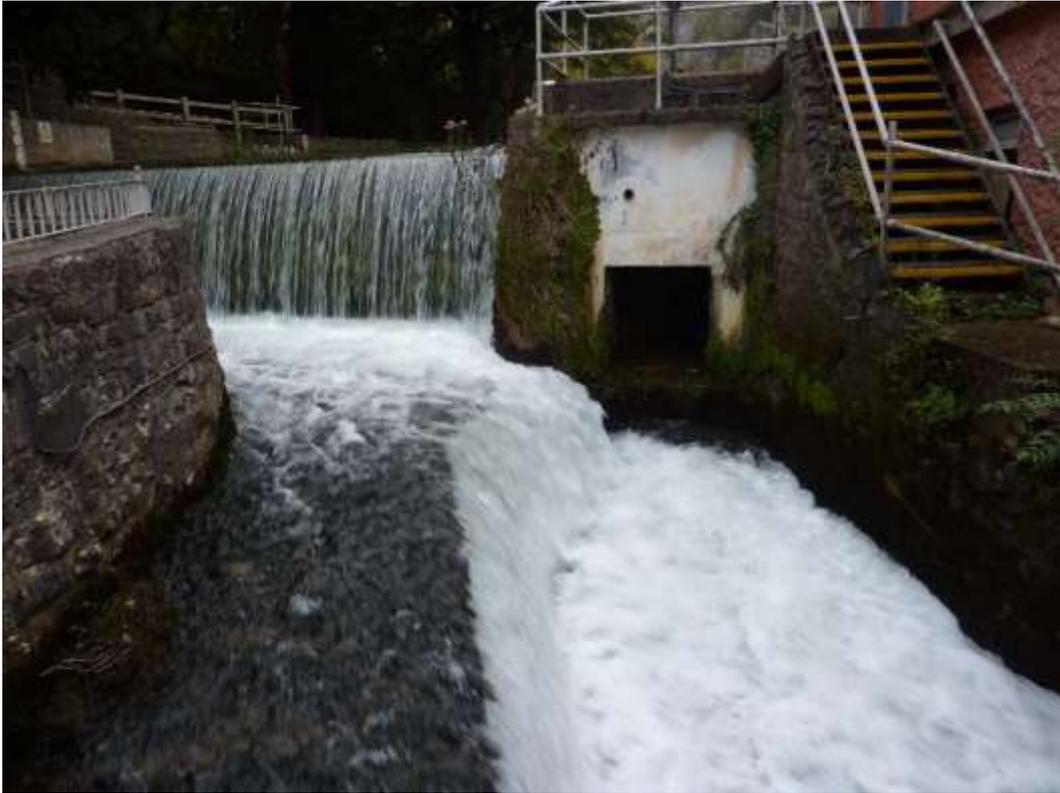
Figure 4: The gauging weir and cascade at Cox's Mill

Such technology would still allow essential flow measurement to take place, without the weir's contribution to solar thermal heading and other destructive impacts on river function (as described in *Appendix 3: Weirs and their impacts*). In turn, this would also allow this stretch of the River Yeo to be renaturalised, including restoring fish passage for a full range of species.

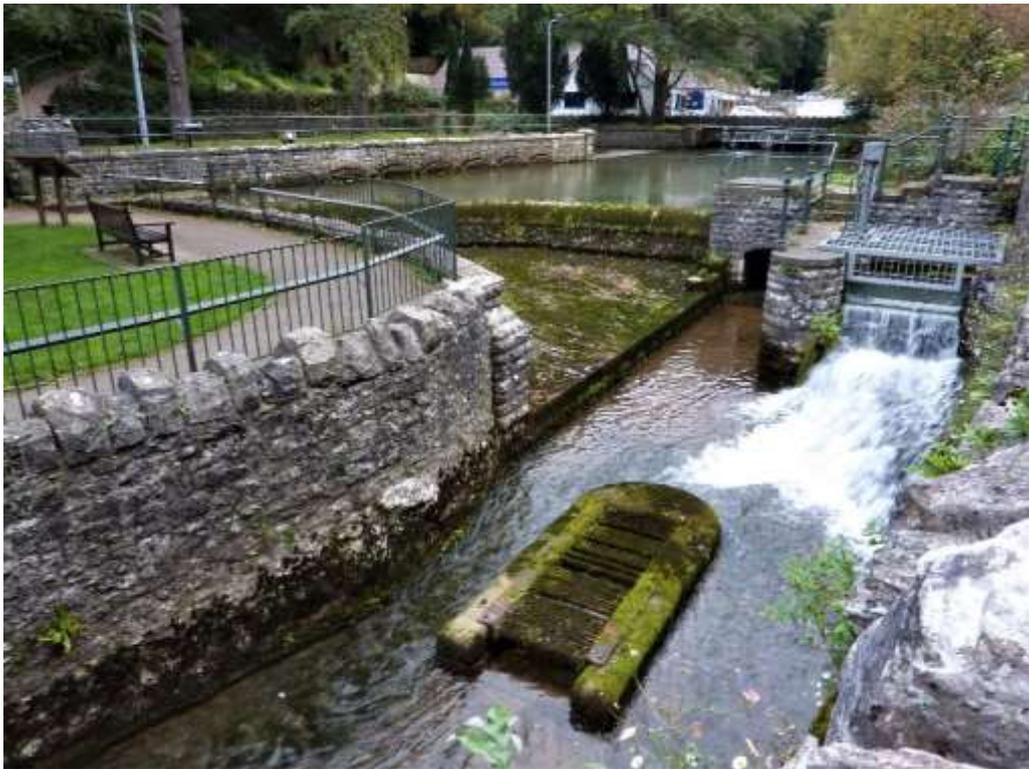
Figure 5: The Middle Pond, with hands-off flows discharging into the river from structures at its downstream end

Immediately downstream of these structures, the channel is artificially straight and fast, but gravelly, and may be worth investigating further as fish spawning habitat. Adding Large Woody Material (LWM) flow deflectors in this area could help to add some much-needed sinuosity, and restart natural processes of scour and deposition. Associated marginal planting of wetland plants like iris could add additional diversity and low-level cover for adult and juvenile trout alike. By increasing channel roughness, these improvements could also help to 'slow the flow' into areas further downstream.

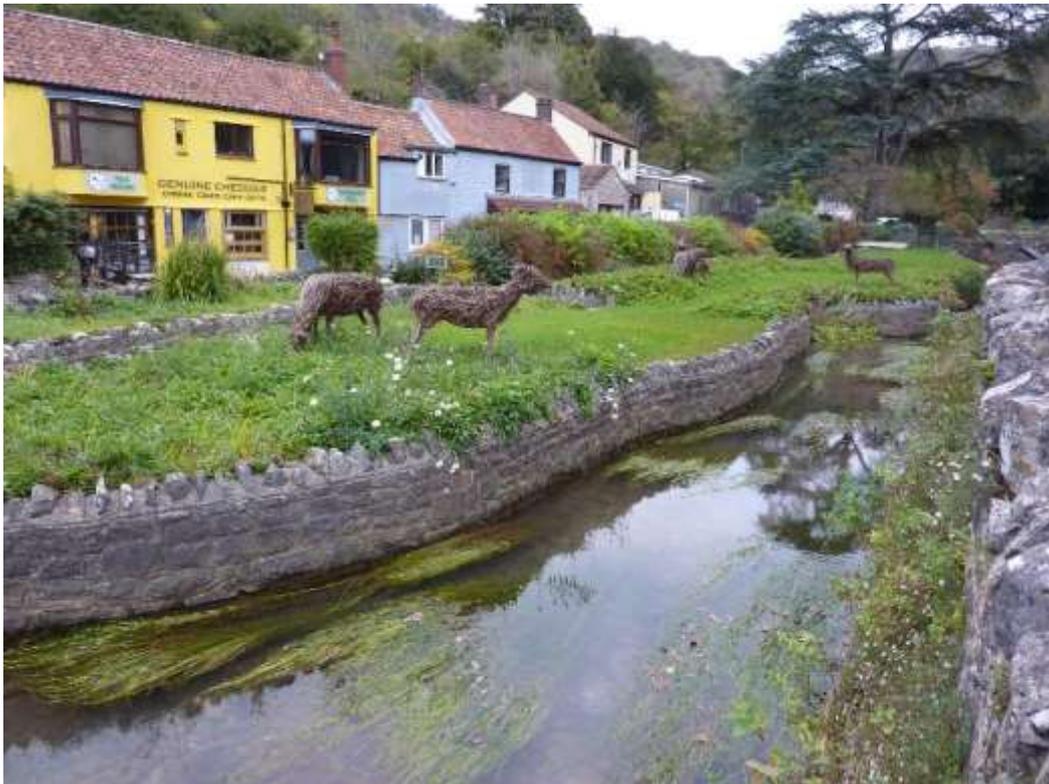
Figure 6: Braided but vertical, hard-sided channels at the Island Beds

Although sediment supply from upstream must be very limited, deposits of gravel and cobbles are still present on the bed of the river, and several adult trout were observed, for the first time in this walkover (for public awareness, it was also good to see trout pictured on the adjacent information board!)

Thick stands of water crowfoot help to mitigate the armoured channel sides and lack of marginal vegetation, but adding LWM and associated marginal planting in low level berms or pool and riffle sequences (perhaps created by redistributing existing substrate within the channel as part of the weir removal works suggested below) would help to add valuable habitat complexity, and improve trout spawning and survival. Such soft, graduated habitat near the water level will also benefit water birds and many species of insects.

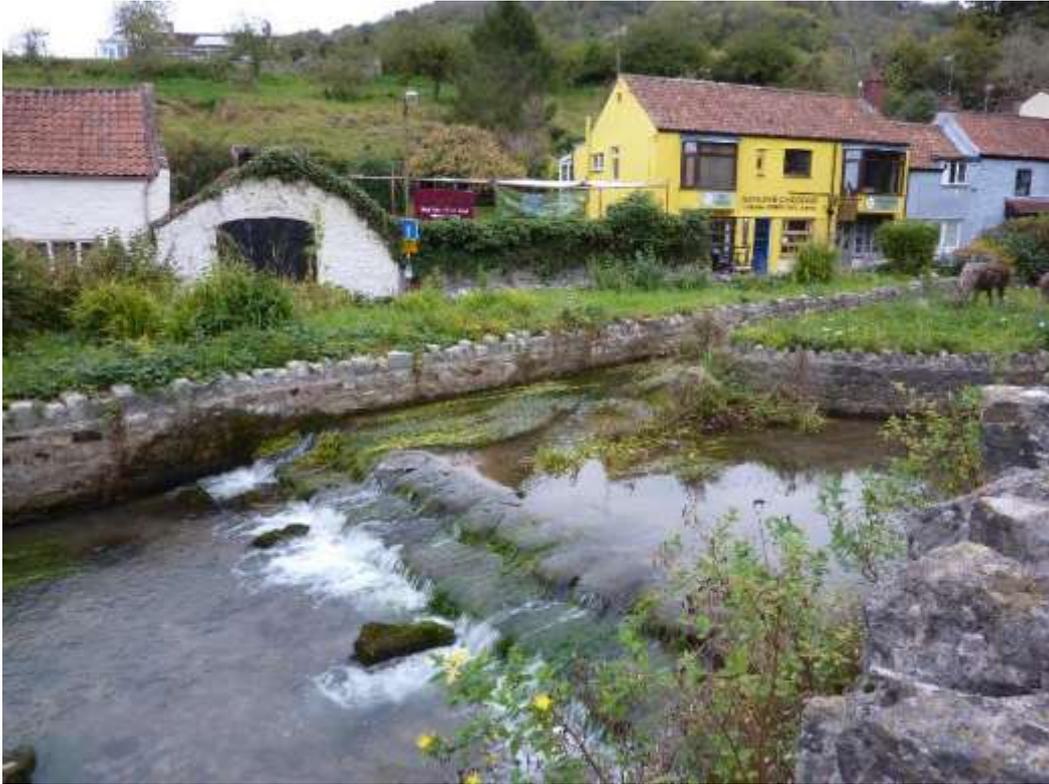
Figure 7: A weir impounding the Cheddar Yeo though the Island Beds reach

In this case, as in so many other instances, the best option would be to remove the weir completely, allowing this whole stretch of river to be restored to more natural sinuosity within its existing planform. It is likely that the weir has been constructed from individual boulders of local limestone, so these could be retained and redistributed, with addition LWM, as habitat features – all helping to restart the natural processes of scour and deposition which have been suppressed by the presence of the weir. Removing this weir could also help to reduce flood risk in this area.

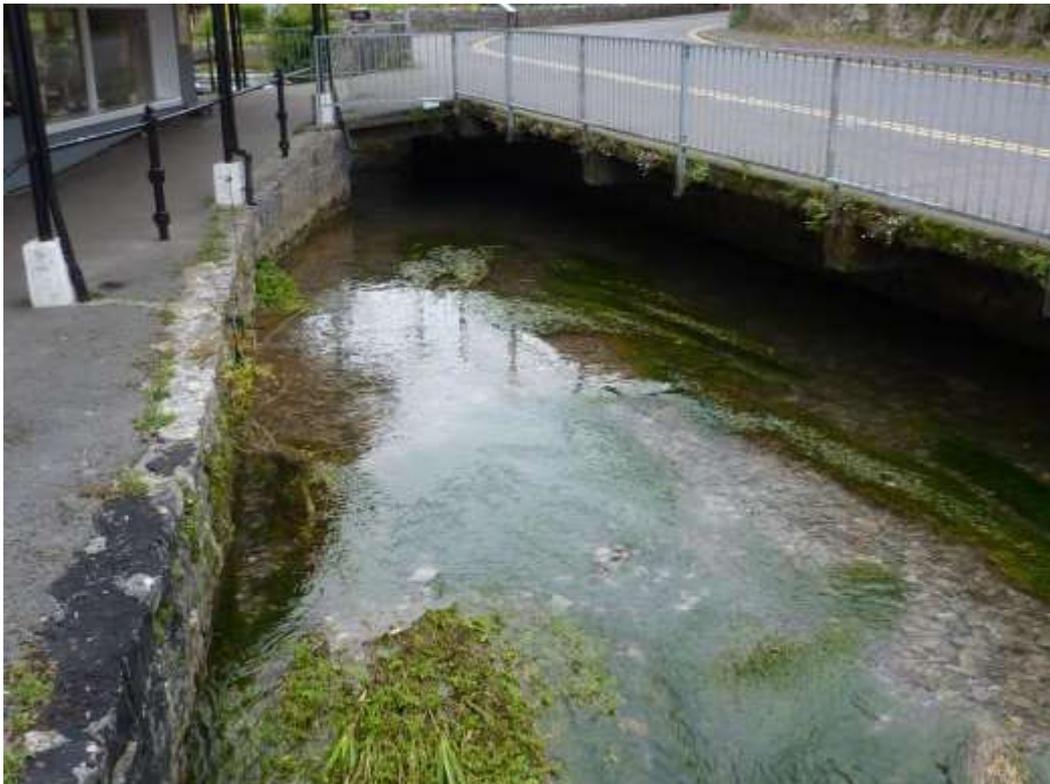
Figure 8: Surprisingly good habitat under a partial box culvert, which could be further enhanced by creating a soft vegetated toe along the RB

A short distance further downstream, as shown in Figure 8 above, the river is pinched into a partially covered box culvert. This constriction of the channel seems to have forced the river to scour downwards, and several more trout were observed in this deep pool with overhead cover and trailing beds of water crowfoot.

With landowner permission, easy access to the river at this point could also make it a suitable location for riverfly monitoring by members of the local community.

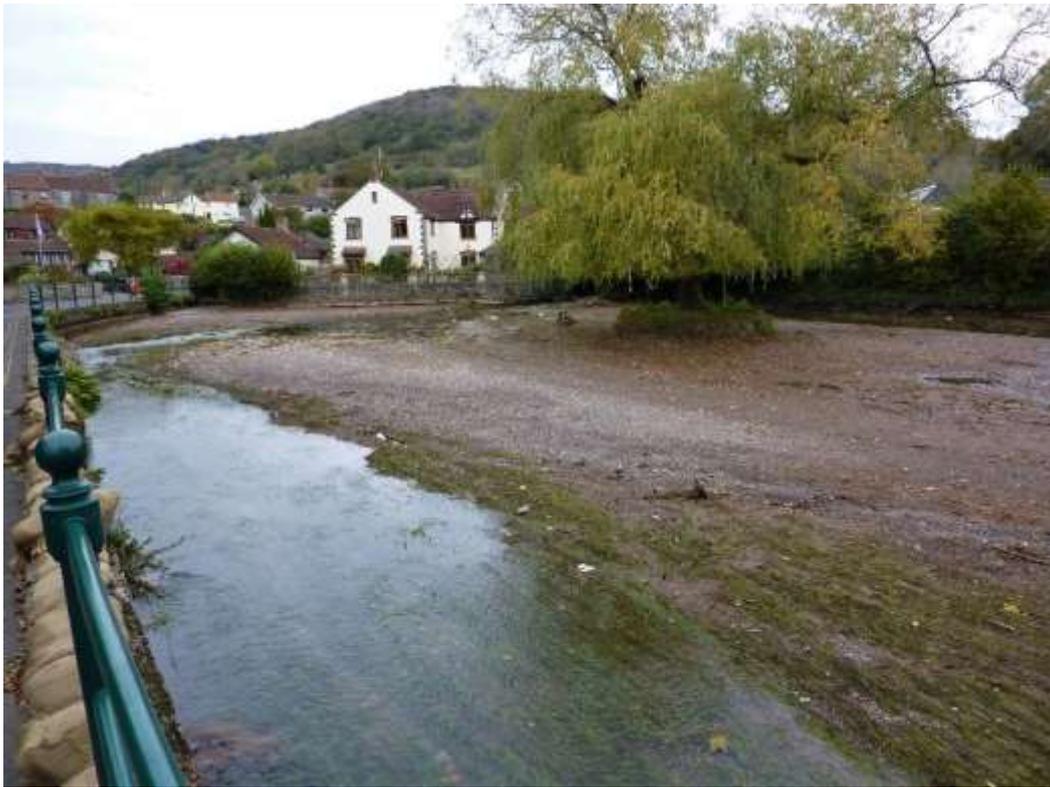
Figure 9: The drained-down former mill pond for Cheddar Flour Mills, suggesting the potential to restore the river and renaturalise this area for flood alleviation

Alongside these improvements, it would be worth investigating replace all of the impermeable care park surfaces in this area with permeable paving, promoting infiltration of rainfall and reducing flood risk by preventing flashy runoff into the river.

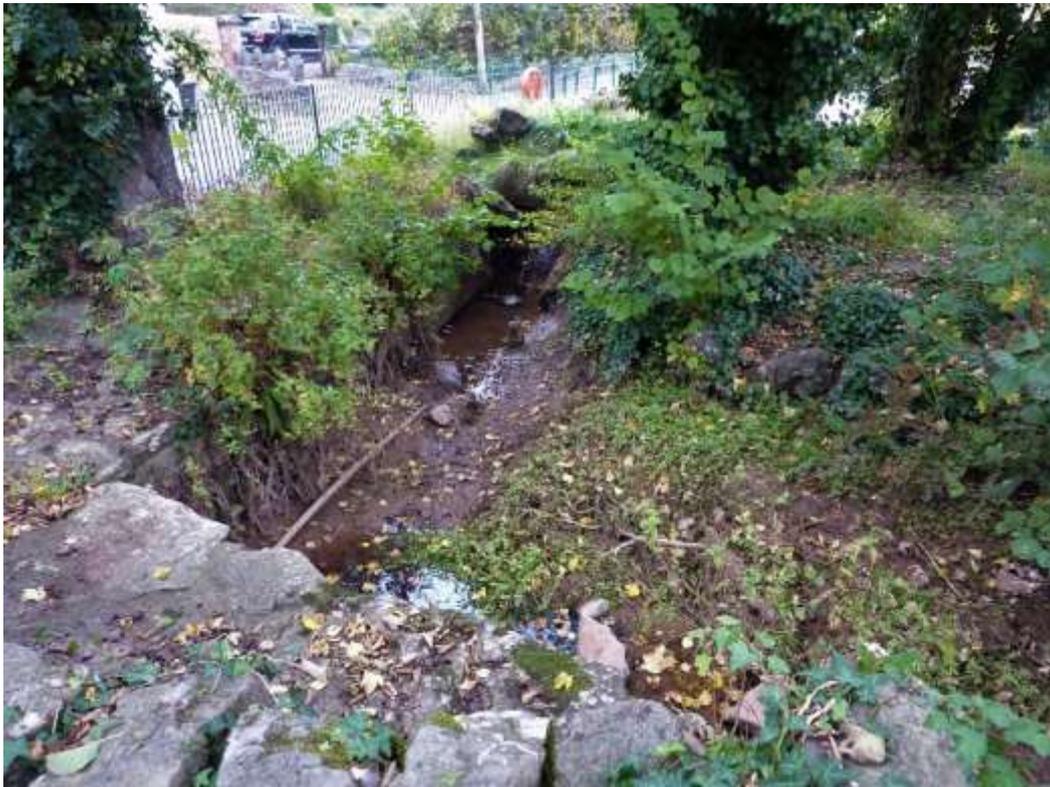
Figure 10: Part of the possible fish pass channel (dry at the time of this survey) downstream of the mill pond

However, a separate, adjacent ornamental rocky channel (shown in Figure 10 above - dry at the time of the walkover due to the mill pond having been drawn down) has some of the appearance of a nature-like fish pass, and it would be interesting to study this possibility further. The top of the channel is currently obstructed by a metal grille with narrow set bars, perhaps designed as a weed rack or trash grid. This would need to be removed or modified in order to let the channel function properly as a fish pass, and flows into the channel would need to be adjusted to create a suitable attraction flow to help fish to locate it.

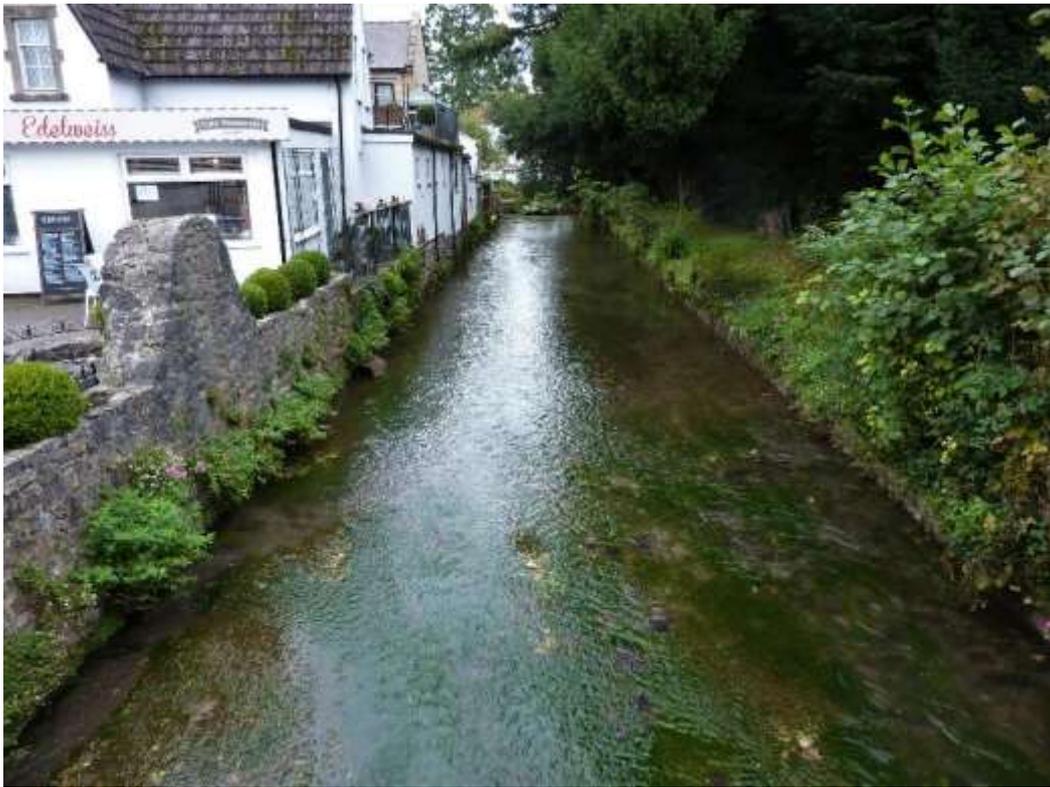
Figure 11: The head race for the former tannery: very straight, with hard vertical sides, but showing abundant growths of water crowfoot

In this whole area, as well as further downstream, it would be beneficial to engage with local residents and encourage river-friendly gardening practices - including replacing hard, vertical banks with sloping edges fringed with 1 – 2 metres of softly trailing waterside plants, to increase biodiversity and habitat for birds, fish and insects.

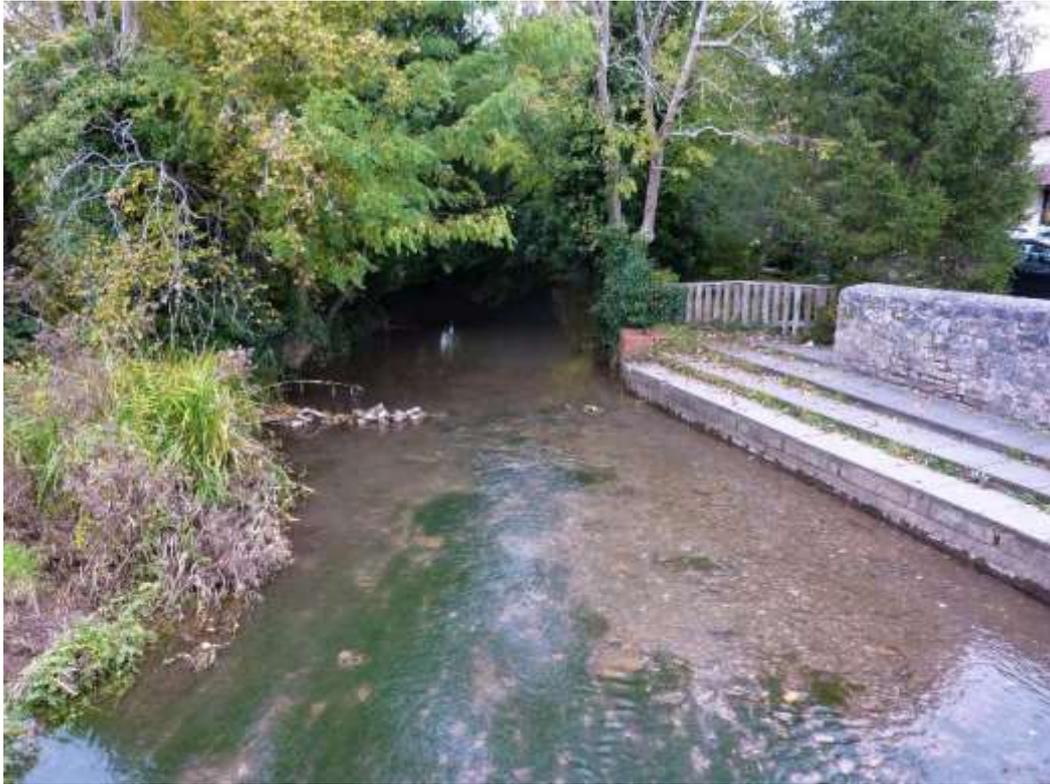
Figure 12: The river upstream of the Redcliffe Street bridge

Downstream of the bridge, the river is briefly split into two channels on either side of a small ornamental island: adding flow deflectors in this area is also recommended. The river then becomes impounded by weirs associated with the former Middle and Lower Paper Mills.

With landowner permission, easy access to the river at the Redcliffe Street bridge could make it a suitable location for riverfly monitoring by members of the local community. It would also be useful to monitor this area because of the presence of a CSO discharging intermittently into the river at 46054 53295 (approx.). In 2019 this CSO spilled 25 times for a total of 37 hours: regular kick-sampling above and below the outfall would produce better understanding of the impact of this intermittent pollution on the river environment.

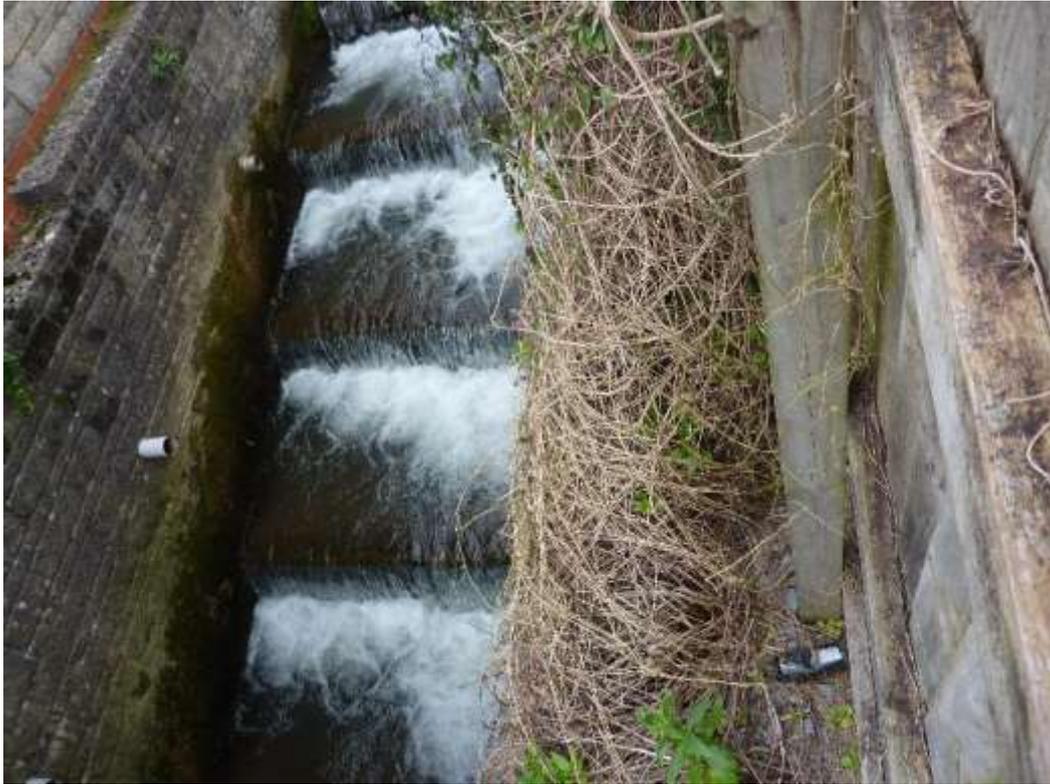
Figure 13: The stepped weir structure seen from Felsberg Way

As discussed above in relation to the redundant Cheddar Flour Mills mill pond, it would be worth studying the potential of both restoring a natural river channel and providing high flow flood storage in the present Felsberg Way impoundment area, at the same time as restoring fish passage for a full range of species.

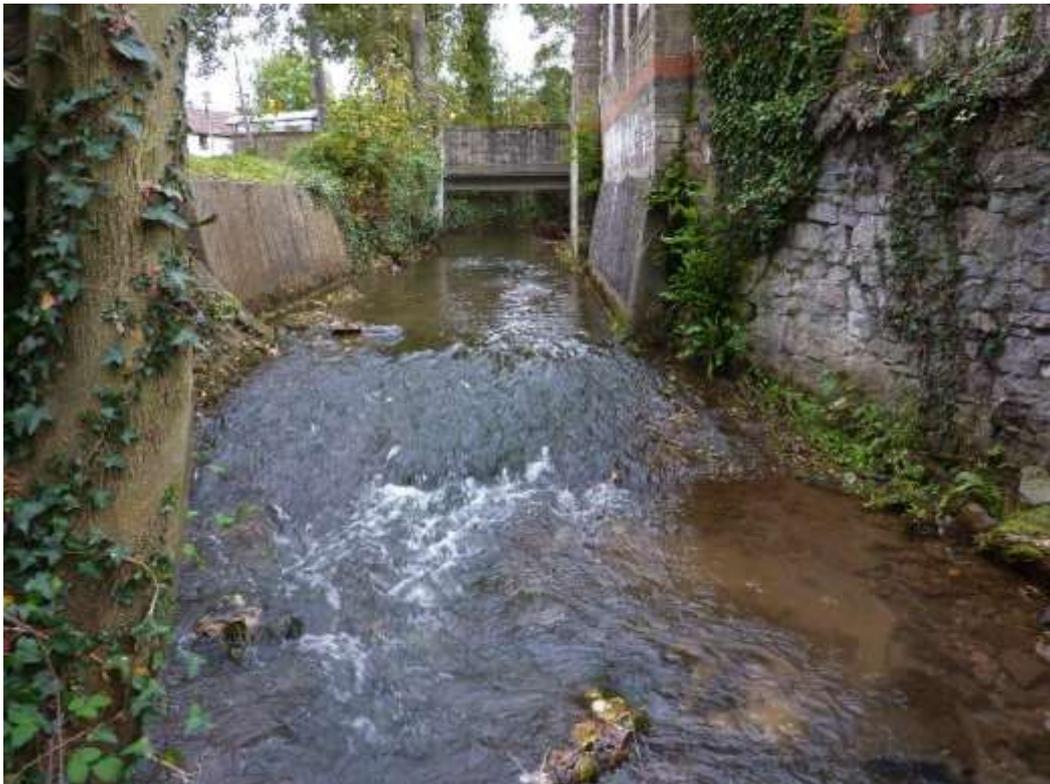
Figure 14: A small concrete weir impounding a short section of the western channel adjacent to Sainsbury's supermarket and car park

A further small weir, 50 metres downstream, has already been notched, and trout were seen in one or two of the pools. Improvements in this area could include adding LWM to the channel to improve habitat complexity for fish at all life stages

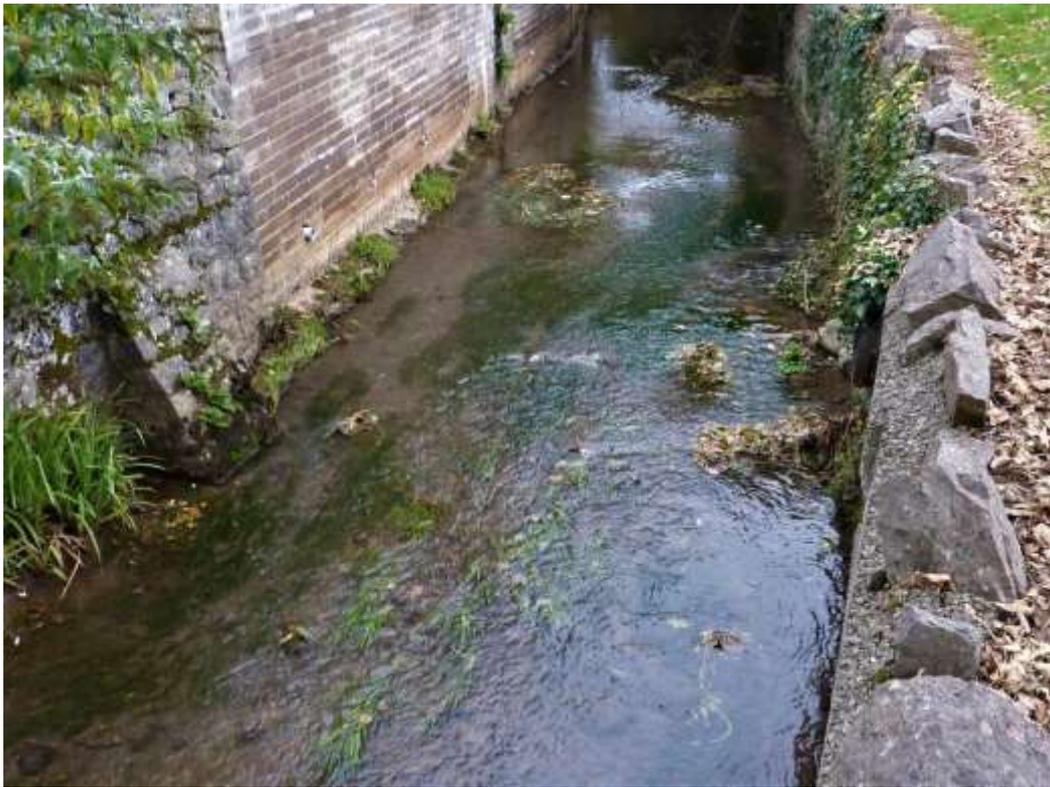
Figure 15: A shallow stretch of channel between high walls adjacent to Fairlands Way

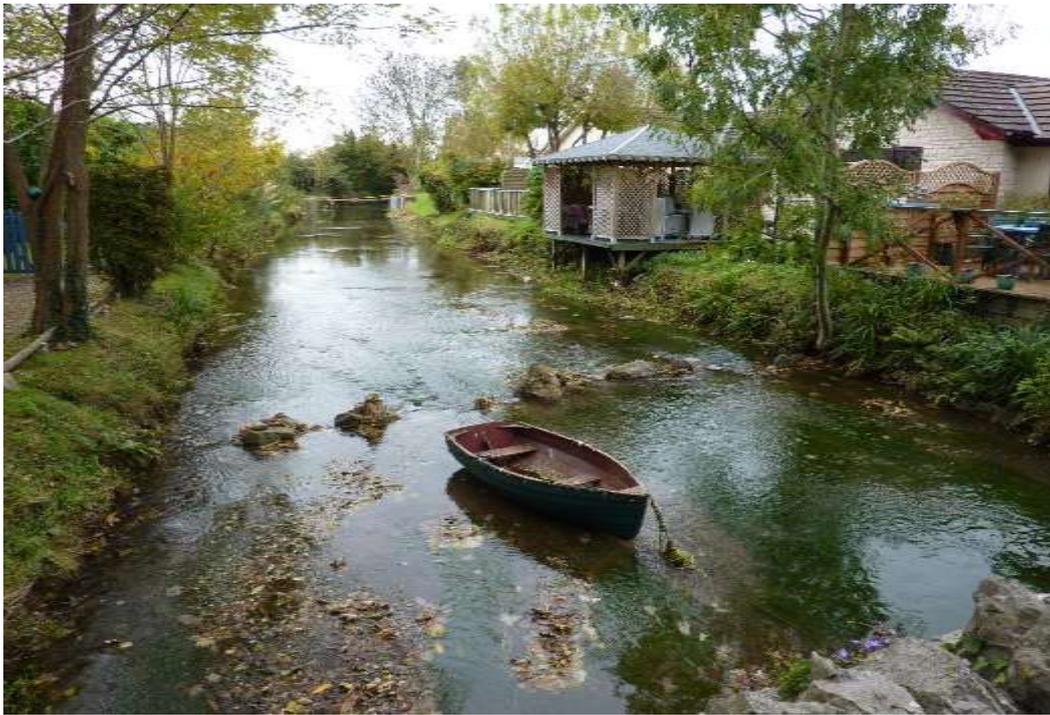
Figure 16: Looking downstream from the bridge at Cheddar Bridge Touring Park

At Cheddar Bridge Touring Park, the river is wide and unshaded, with gravel, boulders, and healthy stands of water crowfoot. However, the channel has almost certainly been straightened at some point, and it would be beneficial to address this lack of sinuosity, perhaps with alternating marginal berms which could be planted with attractive native species such as flag iris and purple loosestrife. In addition to restoring natural processes of scour and deposition, this would also help to increase the aesthetic value of this stretch of river for guests of the Touring Park.

This is currently the site of the EA's fish surveys. Since it is situated just downstream of Wessex Water's Frog Lane pumping station, where a CSO is currently unmonitored for duration of spillages, it would be worth engaging with the proprietors of the Touring Park to explore the possibility of riverfly monitoring or other citizen science projects to understand the impact of the CSO in this area.

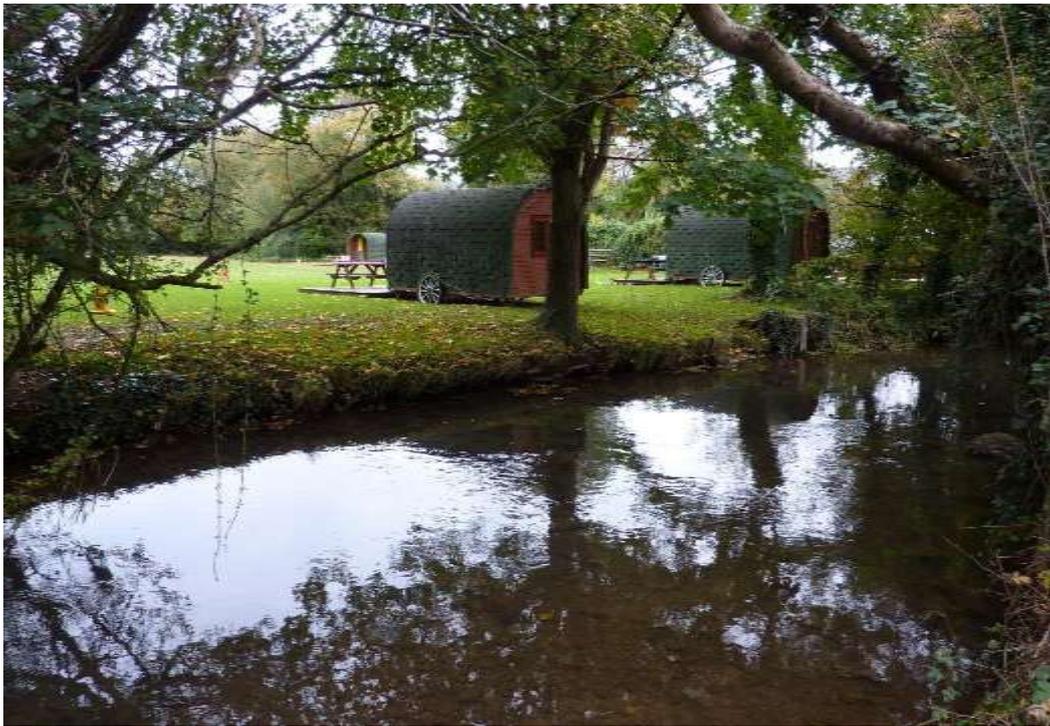
Figure 17: The very dark, overshaded channel at the downstream end of the Cheddar Bridge Touring Park

With better light penetration from the southerly LB, a more relaxed mowing regime could be implemented on the RB, allowing a beneficial 'shaggy' fringe of vegetation to develop: far better habitat for insects, birds and fish, and more attractive for guests of the Touring Park, as discussed above.

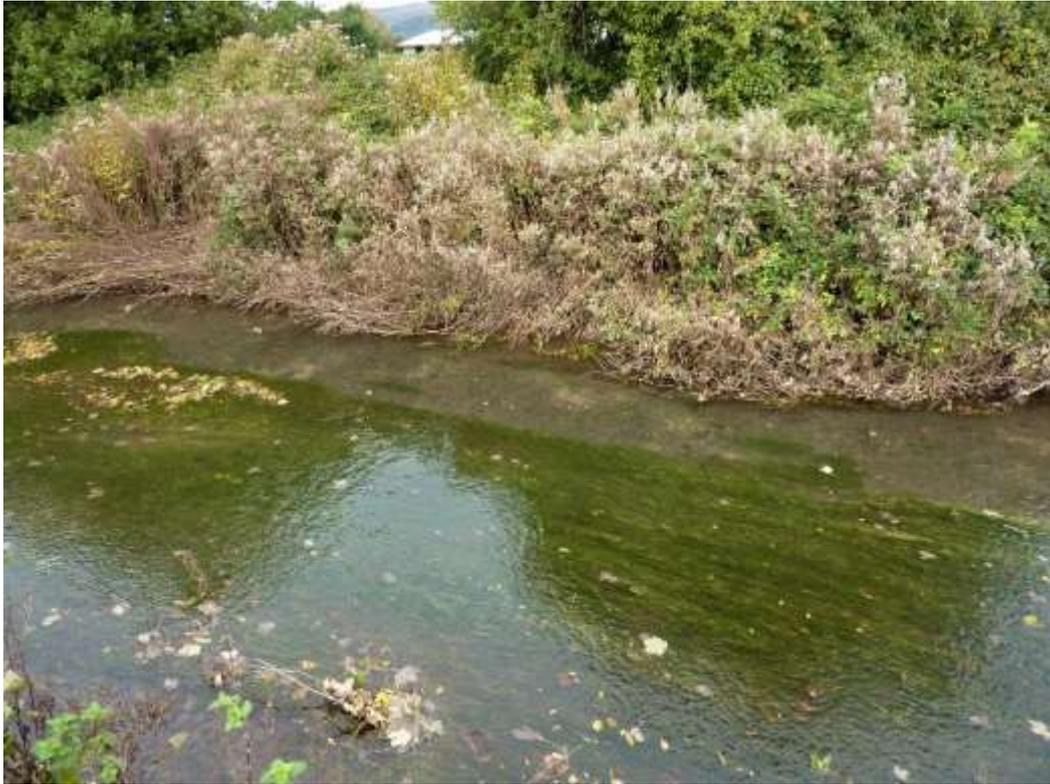
Figure 18: Well-scoured gravel channels between stands of water crowfoot and soft, trailing marginal fringes

It is recommended that any future management of this area should be undertaken with a very light touch: in particular, the shaggy riparian fringes should be left untidied for the benefit of many species of insects, birds, animals and fish. Future diversity of this stretch could be further enhanced by the introduction of LWM, perhaps by planting small trees such as goat willow, with the aim of 'hinging' them into the margins in due course as additional habitat features.

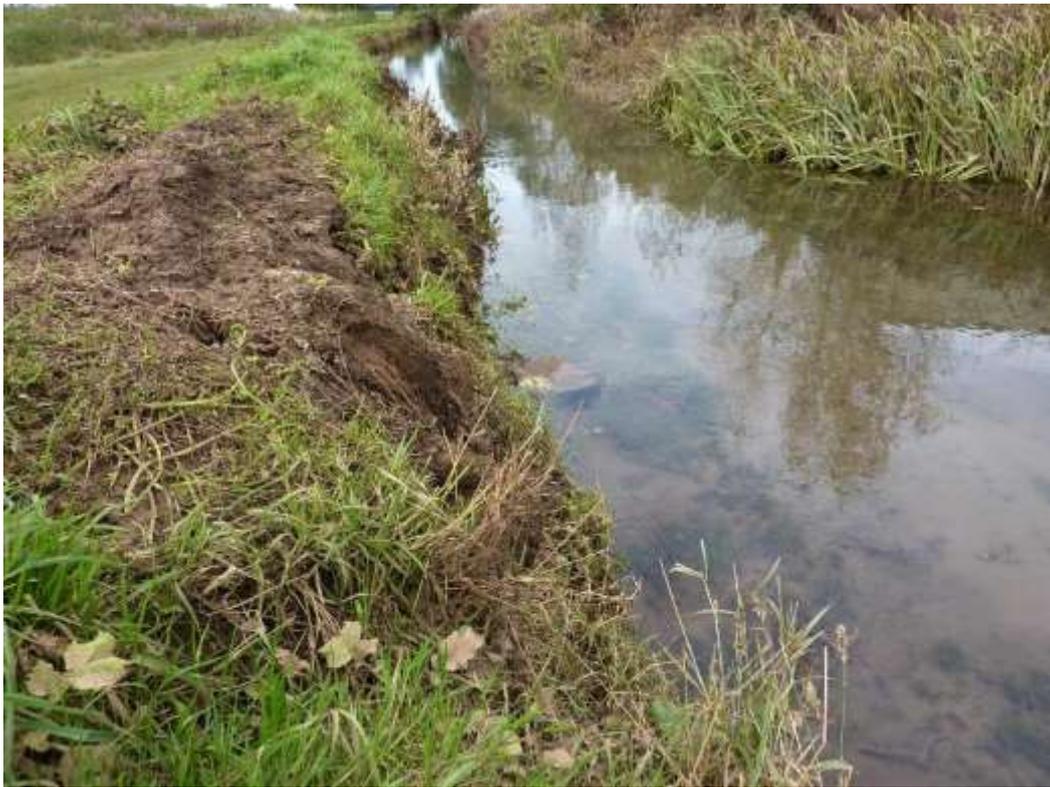
Figure 19: Recent evidence of unnecessary marginal 'tidying', with vegetation and substrate scraped out onto the bank

Unless a clear local flood risk case exists for managing this stretch of channel for maximum conveyance, it is suggested that a less aggressive management regime would be ecologically beneficial, and could help to 'slow the flow' of flood water to more vulnerable areas further downstream. Indeed, it might even be possible to create a flood retention SuDS or wetland area on the LB at ST 45579 52755 (approx.)

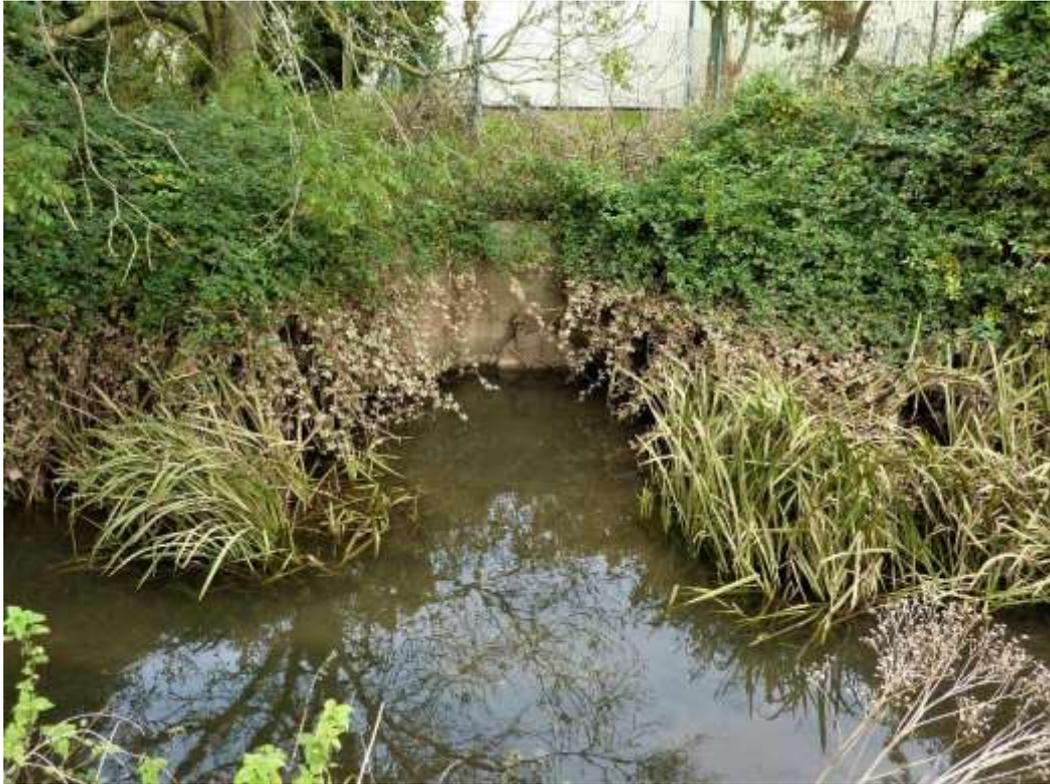
Figure 20: A surface water outfall from the Cheddar Business Park, which flows into a short stretch of channel with much more complex habitat than the dredged areas up- and downstream

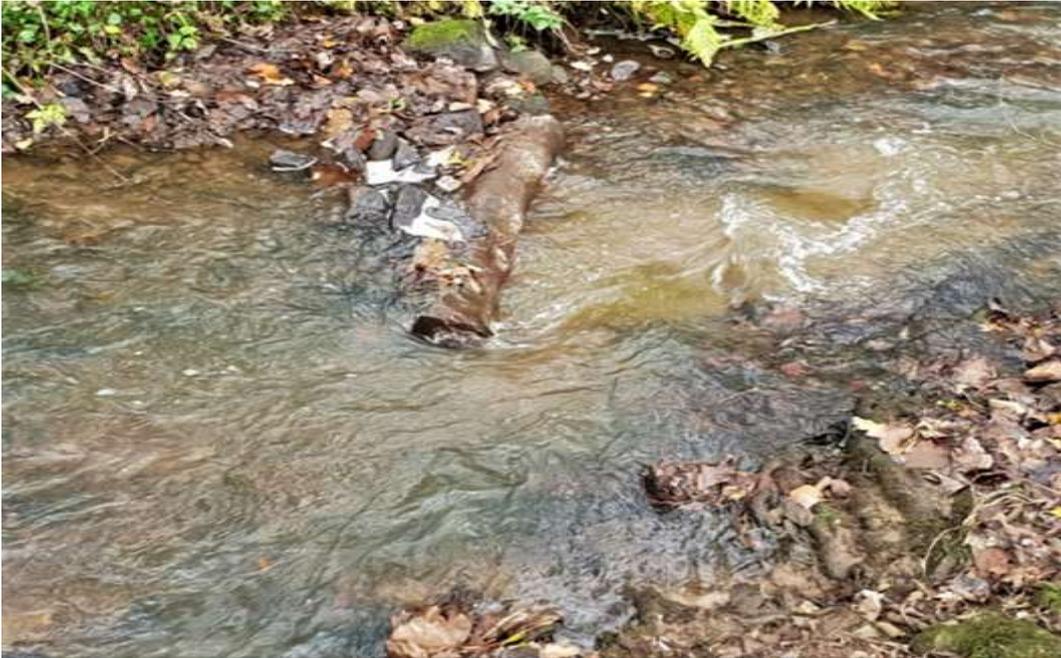
Figure 21: A flow deflector log pinned at an angle, using rebar stakes, partially across the stream (split chestnut stakes can also be used). In order to create scour in the centre of the channel, the log is angled upstream. At lower flows, the stream width is reduced, keeping the gravels clean and helping to move mobile sediment downstream. Higher flows can run over the top with little impediment.

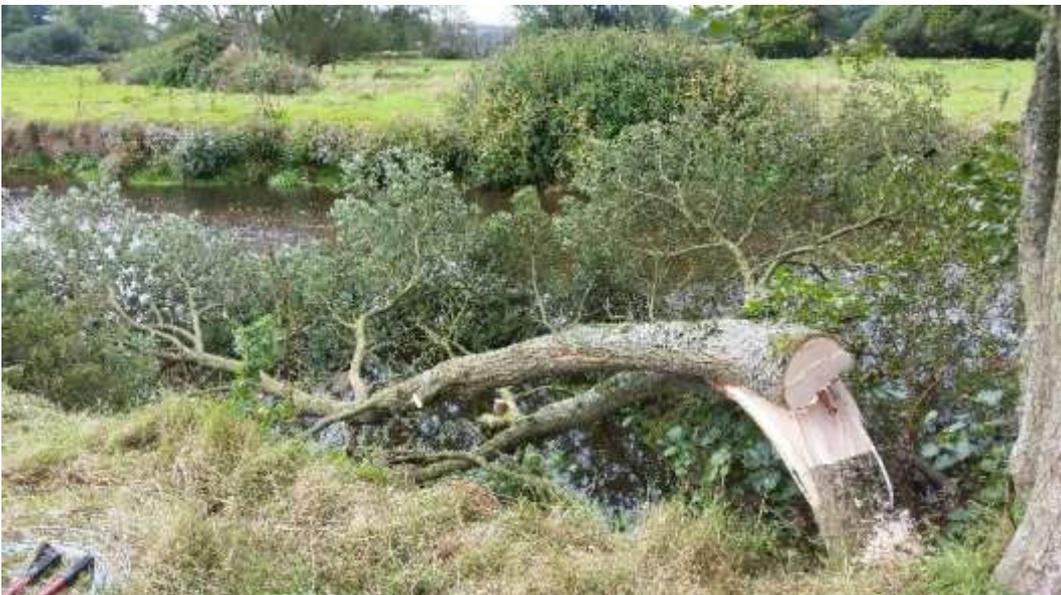
Figure 22: To reduce overshadowing and increase habitat, bankside trees can be hinged into the edge of a river so that they can continue to grow (depending on species) and provide low-level cover for fish, insects and birds. For extra security, the branches can be staked, or the trunk can be cabled back to the stump.

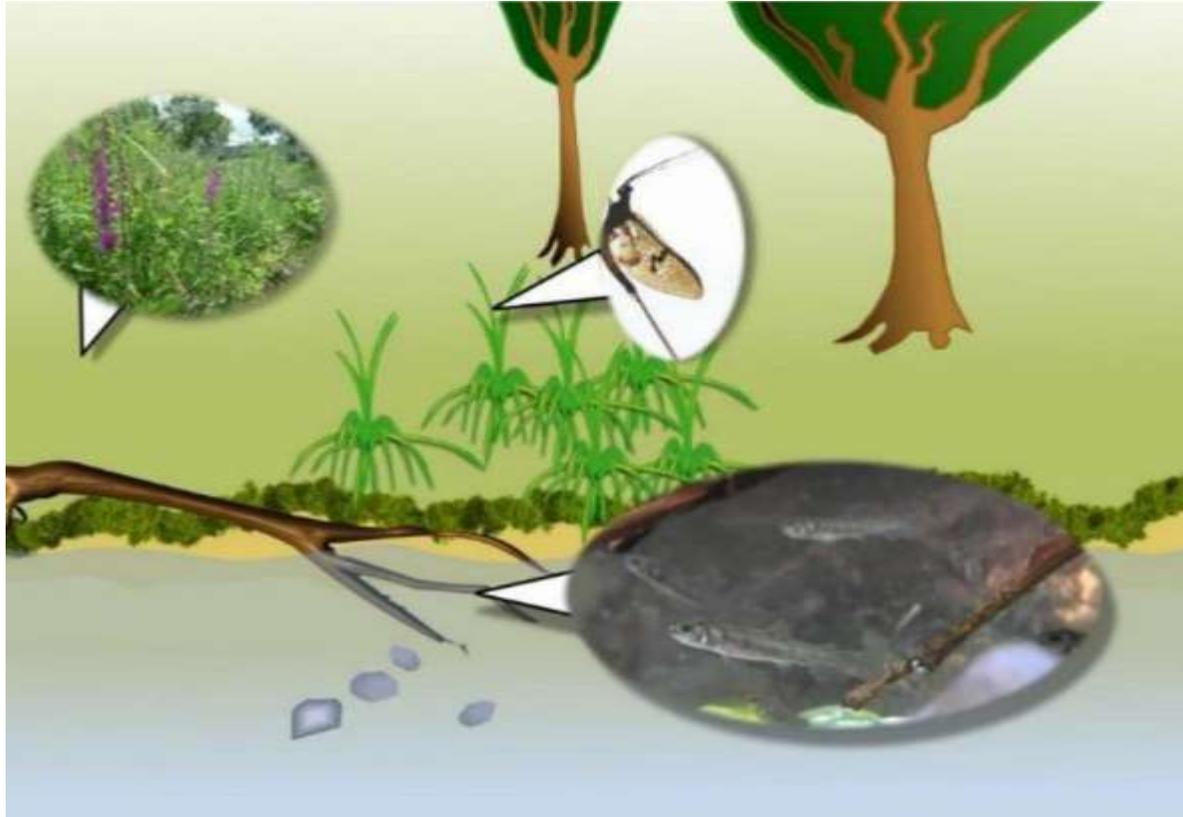
Figure 26: Larger cobbles and submerged 'brashy' cover and/or exposed fronds of tree roots provide vital cover from predation and spate flows for tiny juvenile fish in shallower water (<30cm deep). Trailing, overhanging vegetation also provides a similar function, and has many benefits for invertebrate populations (some of which will provide a ready food supply for the juvenile fish).

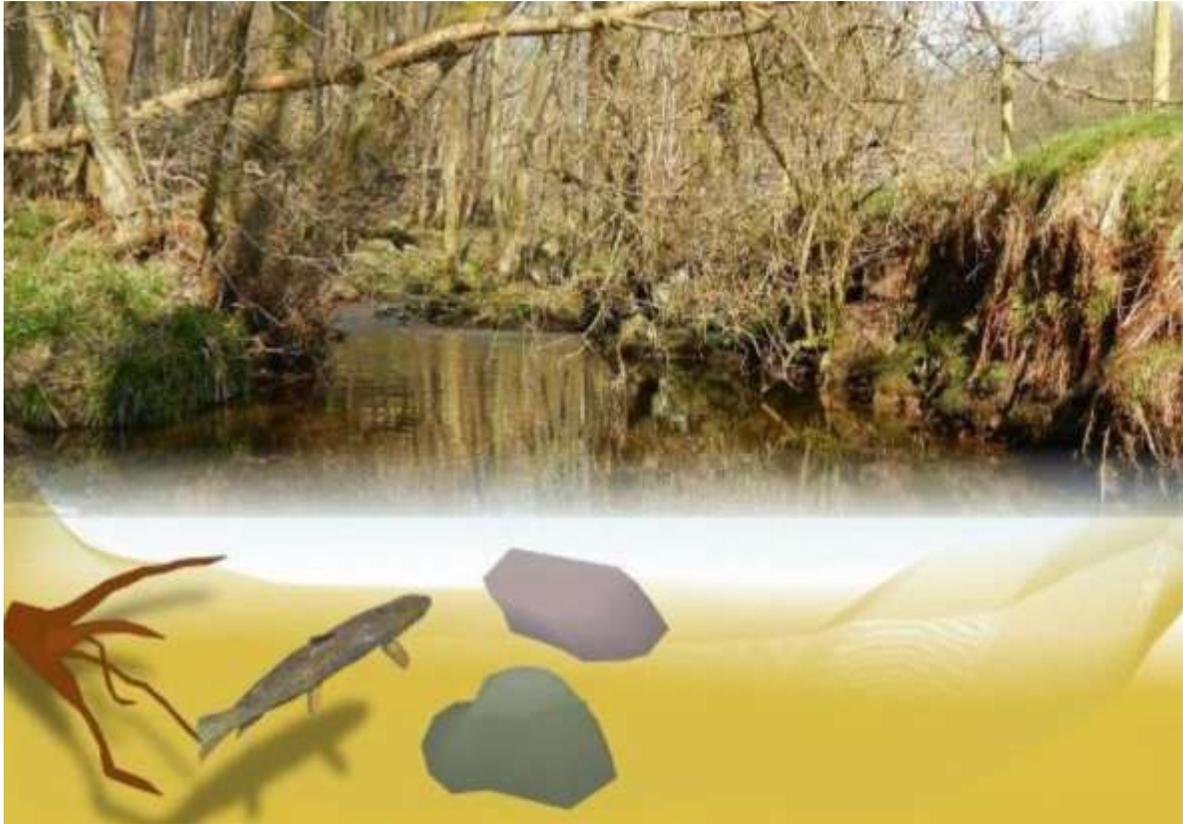
Figure 27: The availability of deeper water bolt holes (>30cm), low overhanging cover and/or larger submerged structures such as boulders, fallen trees, large root-wads etc. close to a good food supply (e.g. below a riffle in this case) are all strong components of adult trout habitat requirements.

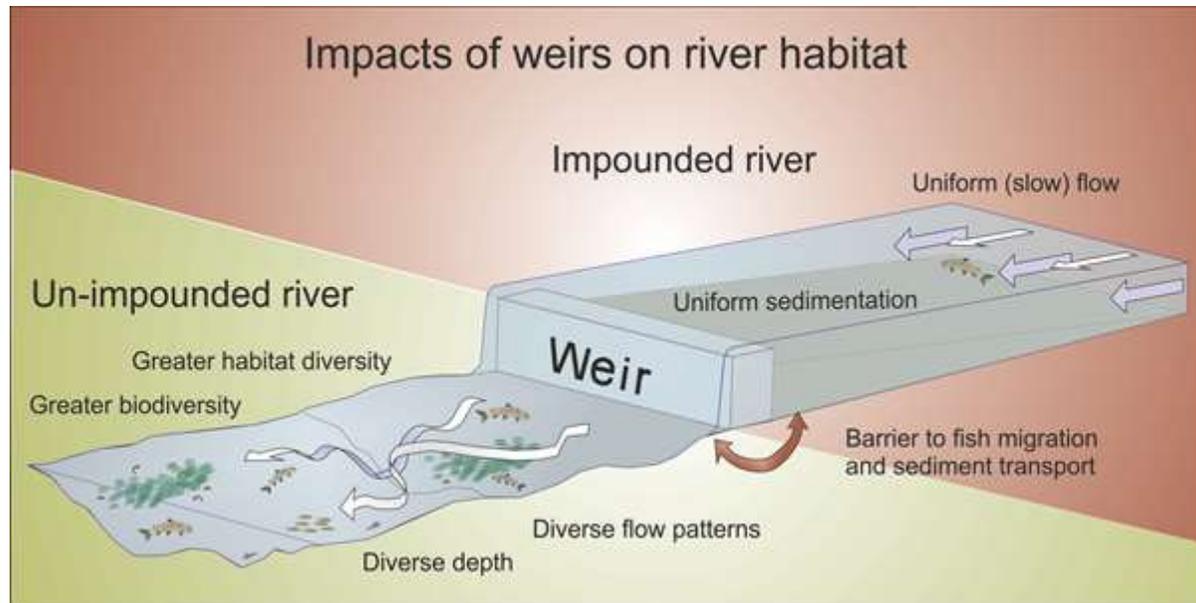
Figure 28: An illustration showing the impacts of weirs on habitat quality

Weirs tend to create extended stretches of slowly-moving water, where sediment carried in suspension drops out of the water column uniformly across the stream bed, and habitat quality and diversity are severely degraded (*Figure 28*). Such conditions can sometimes temporarily provide sufficient deep water habitat for small numbers of adult trout and other species (until the deep water inevitably fills with sediment) but are generally unsuitable for many beneficial invertebrates, and gravel spawning fish, fry and juveniles.

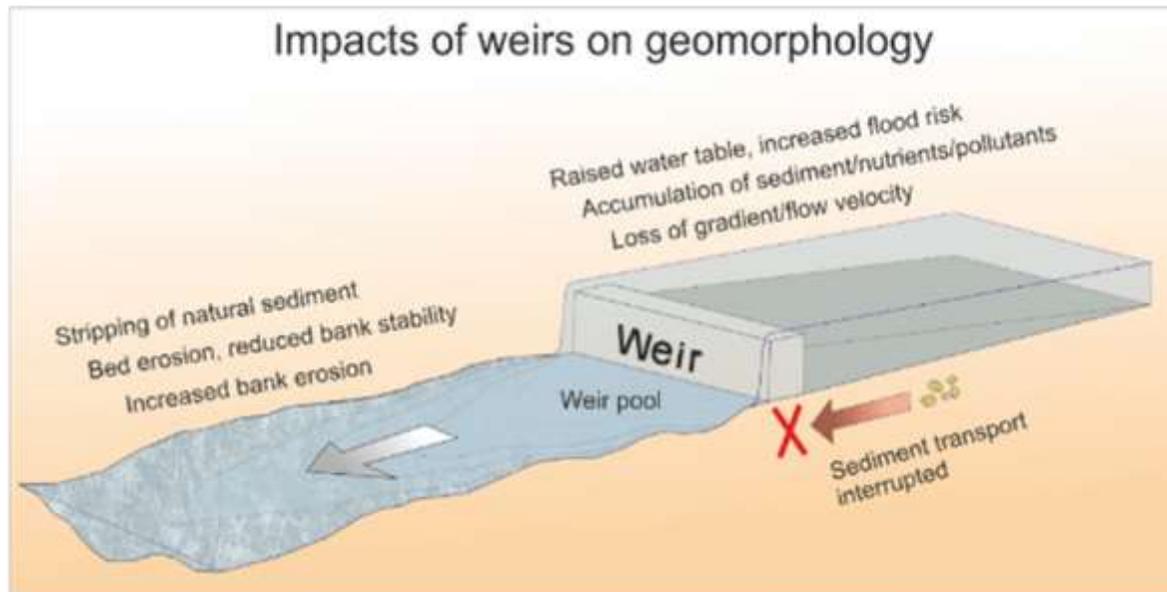
Figure 29: An illustration showing the impacts of weirs on river geomorphology

Weirs of all sizes are often significant obstacles – or even complete barriers – to fish passage, preventing many species from moving up and down rivers freely to fulfil the different stages of their life cycles. Weirs also interrupt the natural transport of river sediment (Figure 29). This can cause the river downstream to become depleted of coarse sediment, and increase rates of bed and bank erosion as a result of the interrupted supply of suitable gravel and cobbles from upstream.
