# WILD TROUT TRUST

**Avon Water – Bridge Farm, Sway, Hampshire**

**Advisory Visit May 2023**

**By A. Thomas, [athomas@wildtrout.org](mailto:athomas@wildtrout.org)**

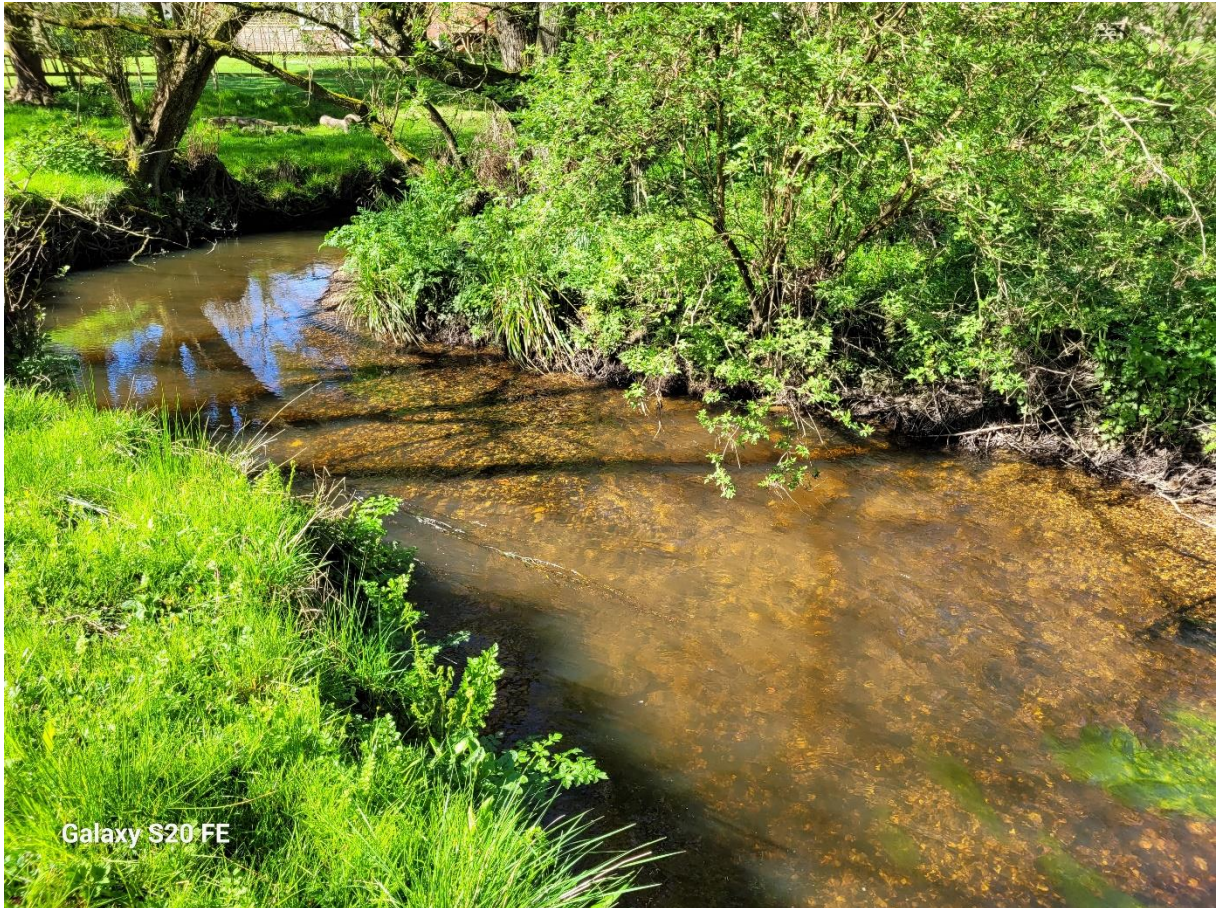
Photo 1. Numerous, meander bends supporting deeper pools and valuable shallow pool-tails and gravel-bottomed riffles provide the full range of habitat required for all trout life-stages.

This section of the Avon Water appears to be largely natural and unmodified. As a result, habitat quality for trout is very good. The river has a naturally meandering planform and supports a varied sequence of pools, glides and broken riffles. This diverse habitat provides good holding pools for large adult trout, as well as spawning opportunities on gravel-rich pool tails (photo 1). Suitable habitat for supporting fry in shallow, well-covered margins (photo 2) and parr on rough, broken riffles (photo 3) was also well represented.

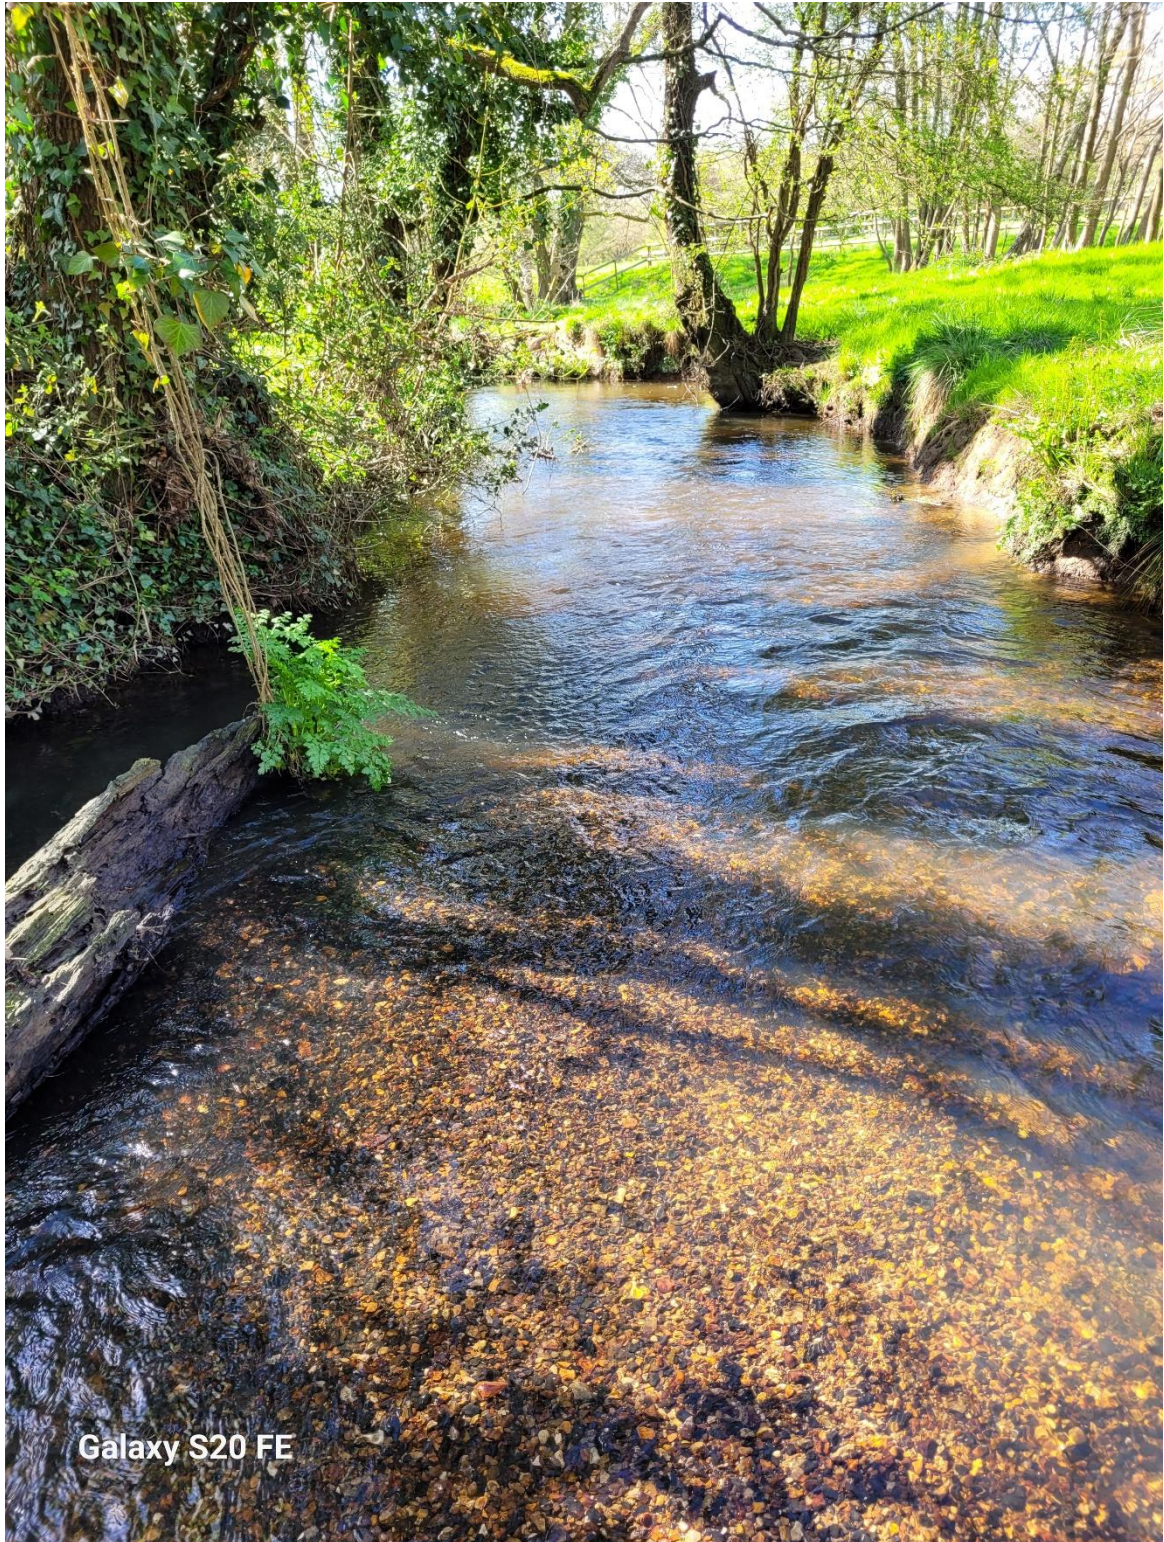
Photo 3. Shallow broken riffle habitat provides excellent opportunities for parr to hold safely in water too shallow for large predatory adult trout. The presence of the naturally fallen large wood material provides an excellent “cover log” and adds value to this important habitat.

The Forest streams are not noted for luxurious beds of aquatic plants, however, beds of starwort *Callitriche stagnalis* were evident in locations where direct sunlight was penetrating to the riverbed (photo 3). This plant is more usually associated with gently flowing chalkstreams and spring-fed ponds, rather than slightly acidic, spate streams. Its presence might suggest the availability of a slightly more neutral water chemistry and nutrients. That said, the gravel bed was bright and clean, with no evidence of the excessive filamentous algal growth that is so common on most of our nutrient enriched lowland rivers. Marginal emergent plants were largely absent, other than the odd clump of sedge *Carex spp* and reed sweet grass *Glyceria maxima*.

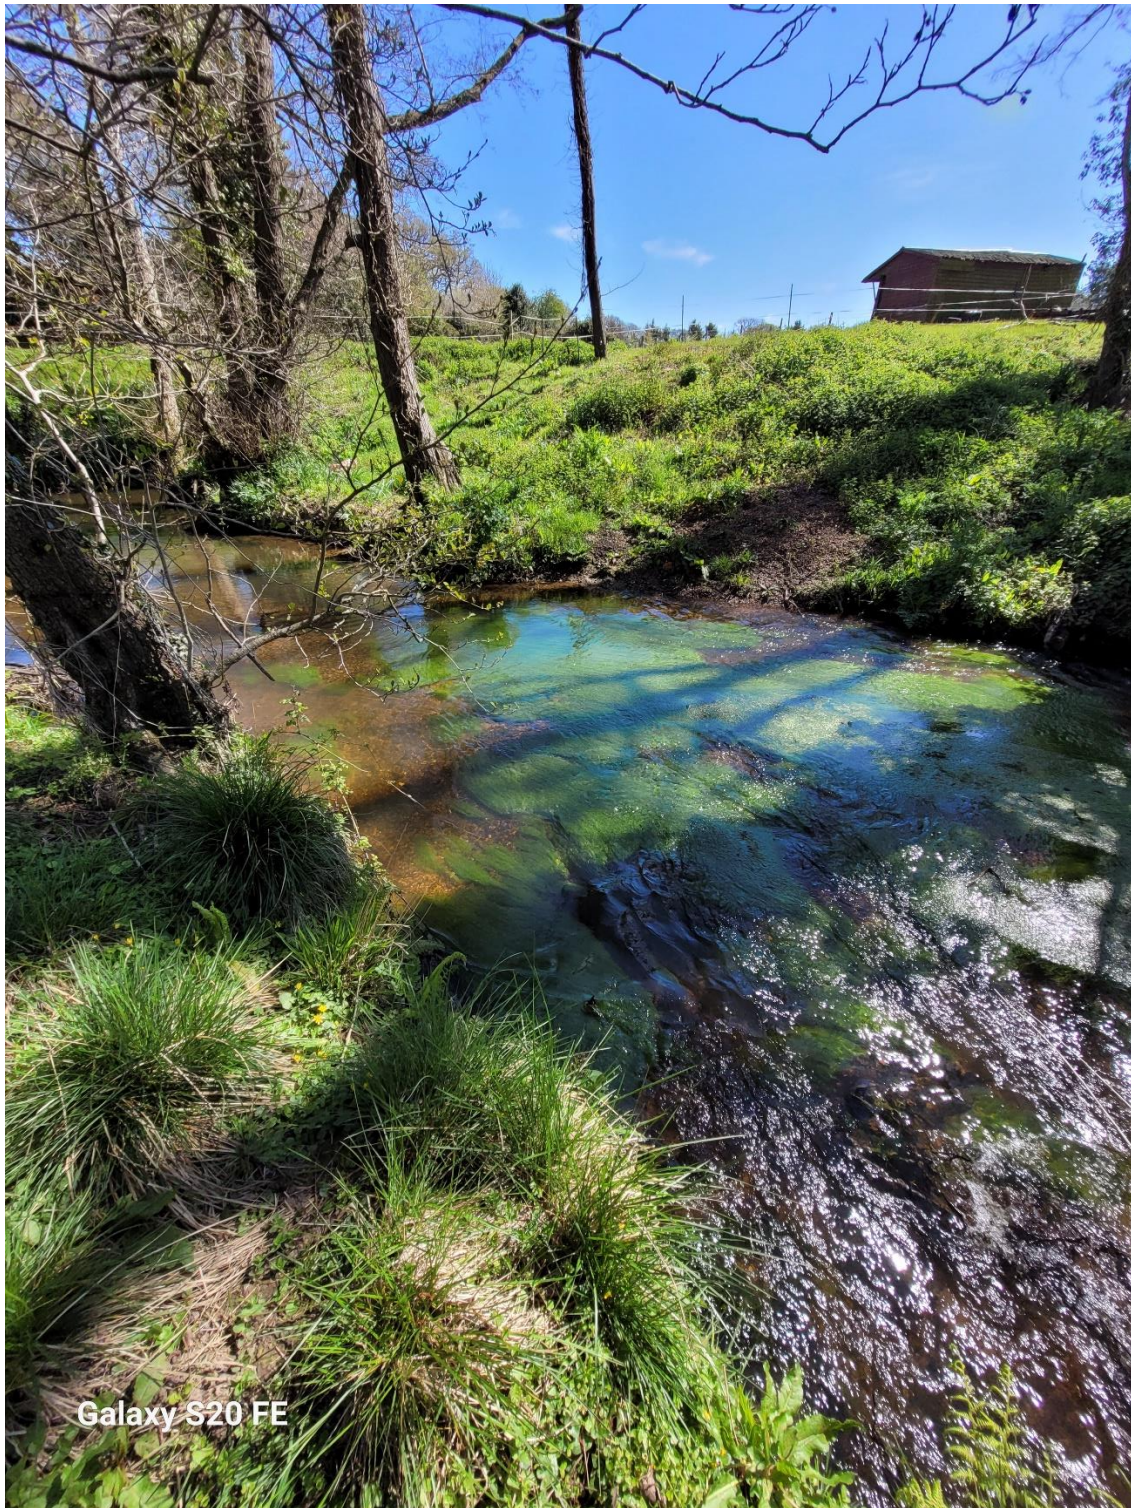
Photo 4. A significant bed of submerged starwort, where a gap in the tree canopy enables sufficient light to hit the riverbed at a suitably shallow section.

Where there were beds of starwort (photo 4), these provide opportunities for specialist invertebrates, as well collecting fine sediment and funnelling elevated flow velocities to maintain clean gravel runs. Submerged weed beds in these areas also provide valuable niche habitats for fish of various life stages, dependant on local depth and flow velocities.

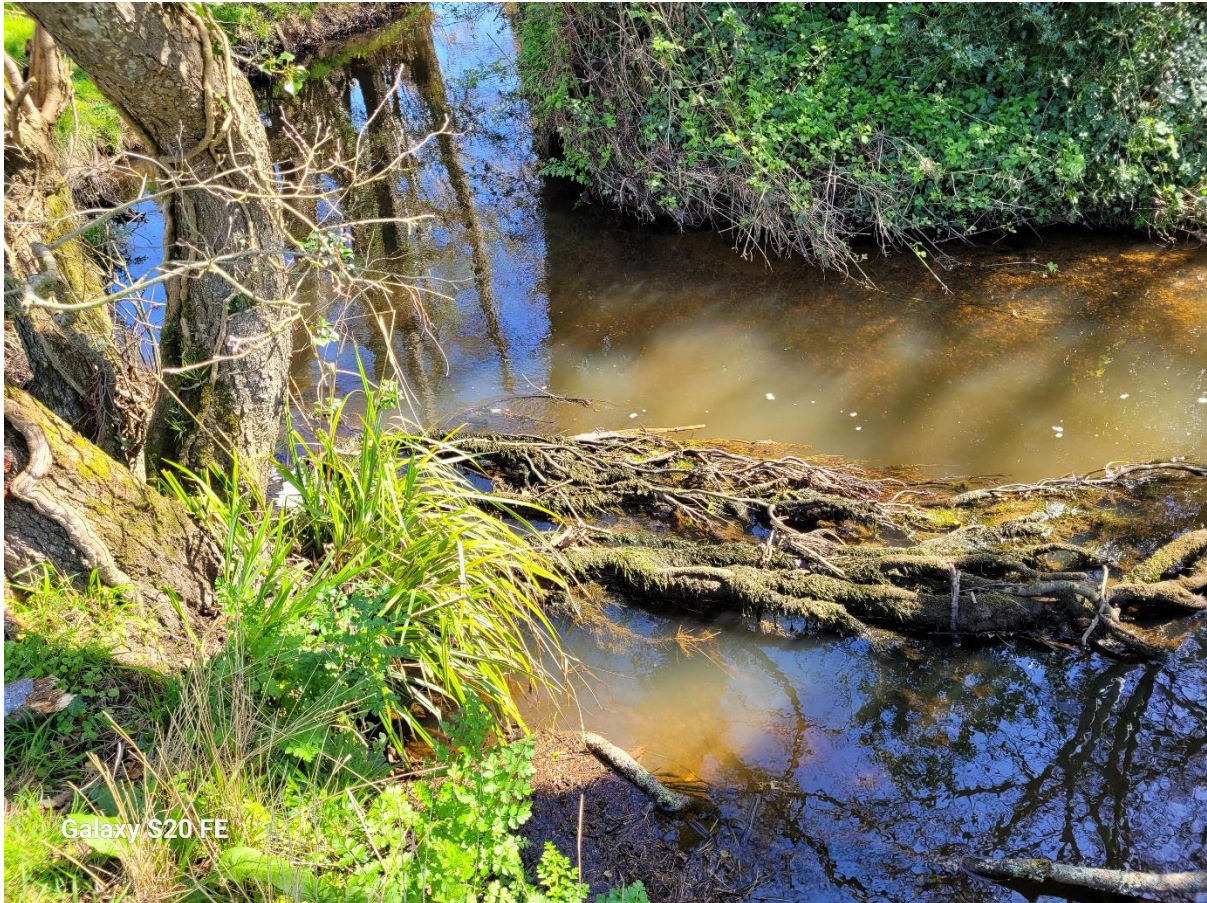
Photo 5. Complex root system from a bank-top alder provides a potentially safe holding area for an adult trout.

Some of the Alders were mature singles, but there were also clumps of previously coppiced stools. All river margin trees provide good bank protection, tying in vulnerable bank soils but also provide excellent submerged cover for fish (photo 5).

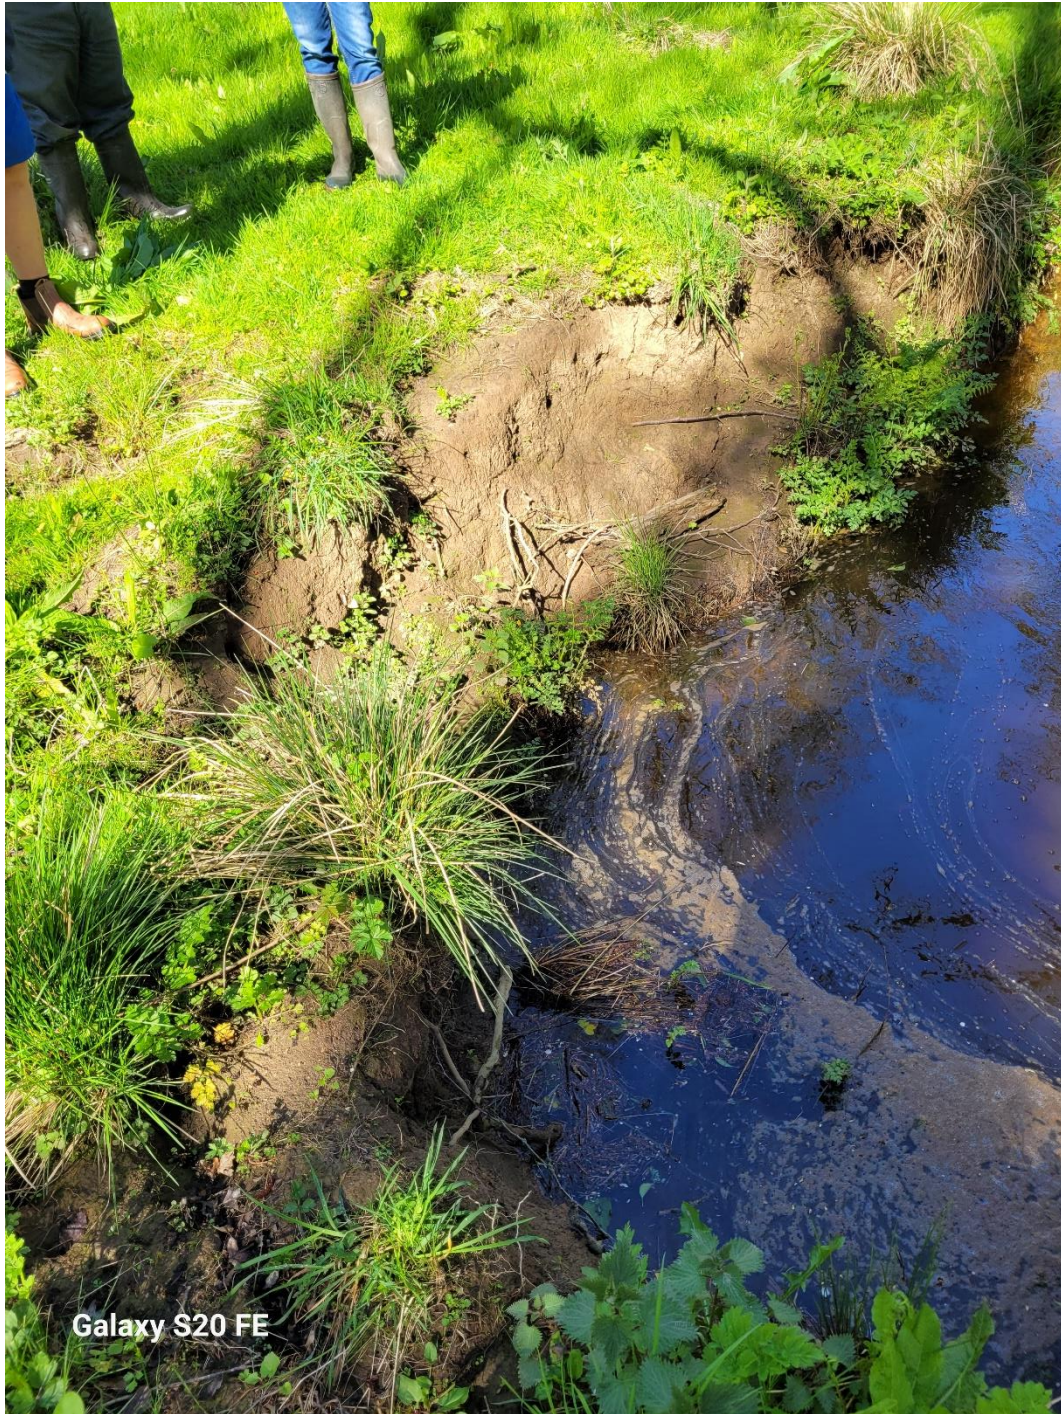
In a few areas there was evidence of slight bank erosion (photo 6), sometimes caused by back eddying adjacent to steep banks, with little or no root systems available to help bind in the soils at the toe of the bank. The river has a very active morphology, and some bank erosion is inevitable and completely natural. Indeed, some bed and bank erosion is essential to maintain fresh gravel supplies, vital for maintaining the ecology of the river.

Photo 6. Bank slumping caused by a large back eddy, nibbling the toe of an undefended margin. Note the fine, friable soils here, with no complex root systems tying in the soil. When banks slump like this, often a new toe to the bank forms from the sods that slide into the margins. Provided there is enough light, these then provide a platform for pioneering emergent plants to root. A good option here is to heel in sods of sedge won from other locations to help accelerate a naturally recovery.

Erosion pressures were not considered to be significant, however, there were some very tight meander bends, where there is the possibility of over topping and if these areas correspond to sections with limited tree/root growth then they might be vulnerable to cutting through in a big flood event. An additional risk occurs where the bank tops are heavily infested with non-native Himalayan balsam *Impatiens glandulifera*. The vigorous summer growth of this plant tends to outcompete native plants that might otherwise help bind top-soils together. Tackling the areas where this plant exists by hand-pulling, or strimming below the first leaf node, prior to the plant seeding, is highly recommended. In addition, planting up any headland promontories with additional trees is recommended to help build resilience and reduce risks associated with possible bank failure in the future.

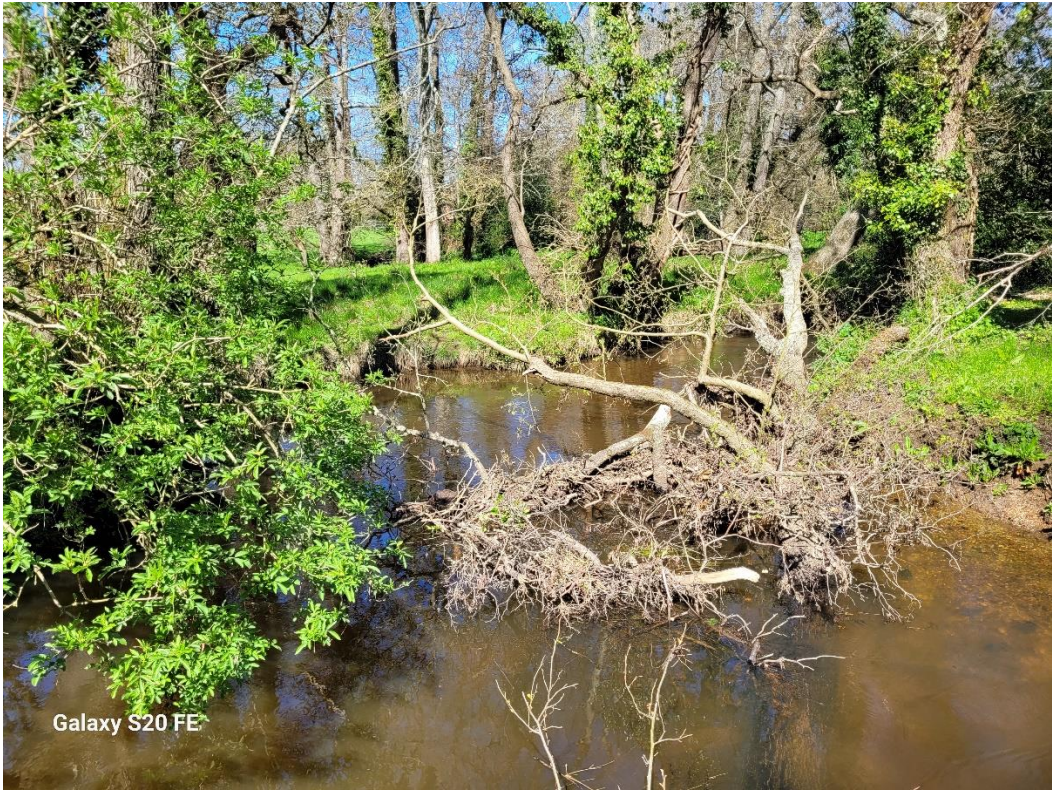
There were numerous examples of naturally fallen woody material (photo 7) within the river channel. This ranged from large woody tree-trunk sections and branches to coarse woody brush. This woody material is extremely valuable and performs several key functions that underpin the stream's ecology.

Larger woody trunk and branch sections often promote local bed scour and help to drive the processes that sort and settle river sediments, ranging from coarse gravel to fine silt. In addition, it provides habitat as cover logs for fish and supports a myriad of grazing invertebrates that process the wood, along with the finer material and leaf litter it helps retain. In relatively nutrient poor systems, this woody material provides the building blocks for the entire river's food web.

Photo 7. Large and coarse woody material accumulating within the channel. Both forms of woody material are extremely valuable and whenever possible should be left in situ. If a large debris dam forms, then it might be necessary to ease out a gap to ensure that fish migration is still feasible.

Very occasionally, woody material can accumulate and form into a debris dam, spanning the full width of the channel. Usually, water continues to flow under the debris, promoting bed scour and valuable habitat. However, occasionally they can become occluded by fine brush and leaf litter and if water fails to flow beneath, then upstream levels can rise and flow velocities reduce, resulting in sediments accumulating in the reach immediately above the dam. If dams are left in place, they can eventually cause a differential step to form in the riverbed, resulting in difficulties for fish on both upstream spawning migrations but also for downstream sea trout smolt dispersal. In such cases it is recommended to intervene and ease out some material to ensure there is always flow below any natural woody blockage. If any intervention is required, it is always recommended to do the minimum, so that fallen woody material is retained within the channel; a good rule of thumb is simply to move any offending wood into a position where it isn't significantly backing up the river.

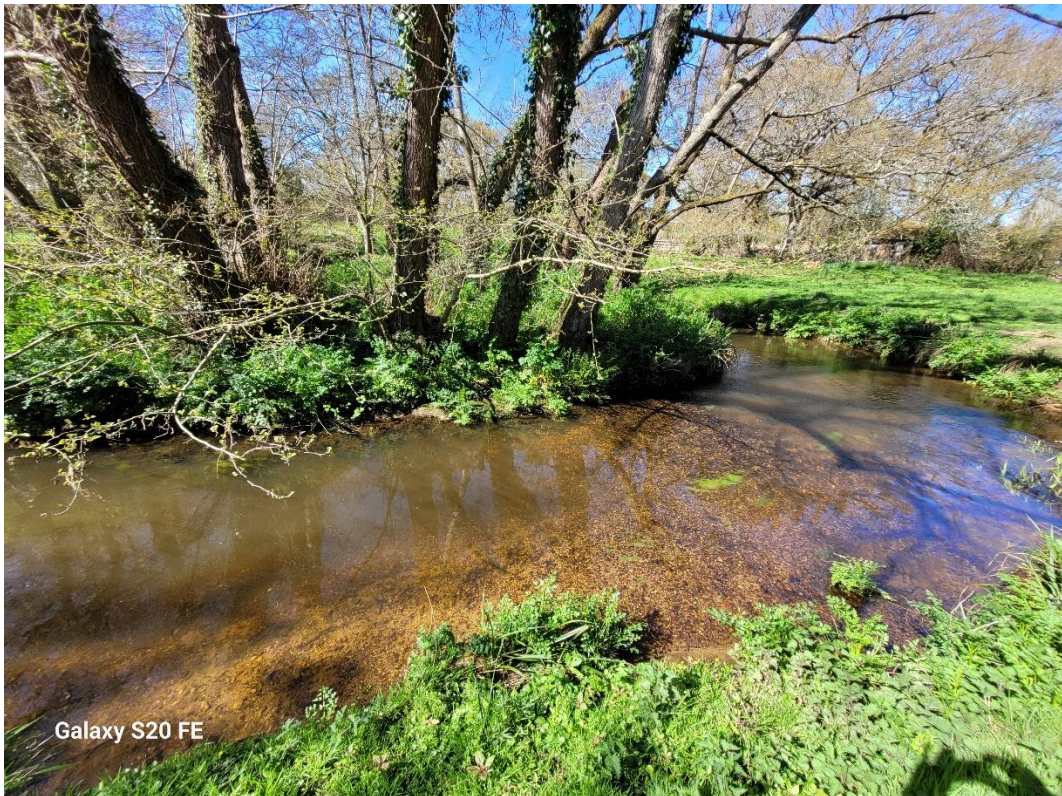
This reach of the Avon Water is obviously an important area for seatrout spawning. The owner has witnessed and filmed large sea trout spawning and there was evidence of old trout redds, still clearly visible in May (Photo 8).

Photo 8. A classic pool and tail with the remains of a large seatrout redd
