## Advisory Visit River Calder, Chantry Bridge

Advisory Visit by Paul Gaskell (pgaskell@wildtrout.org)

12/07/2021

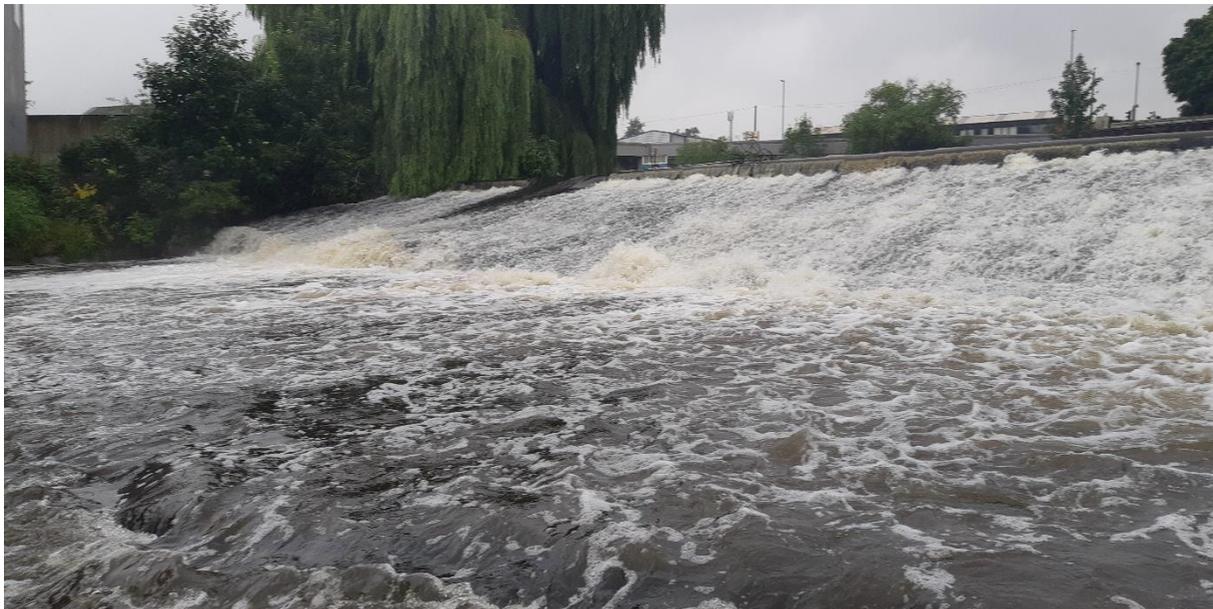
The reach was assessed, sequentially, in a downstream progression from an upstream limit below a large weir at SE3372620105 (Fig.1)

Figure 1: Approximately a third of the total width of the weir marking the upstream boundary of the visited reach.

In the context of this report, it is important to highlight that the weir in Figure 1 (along with others on the Calder system) is one of the most significant impacts on the ecology of the river. The undoubted cultural significance of the Hepworth Gallery, constructed directly below the weir, came at a reported cost of £35 million. While the challenges of notching down to bed level (or complete/majority removal) are significant – the

Despite the likely costs involved – and changes to the local landscape – it would be wrong to ignore the huge potential biodiversity benefits of considering various weir-removal options.

- Seek involvement and collaboration with local group(s) tackling the impacts of weirs in the Calder system (e.g. Calder and Colne Rivers Trust) – and use the rationale outlined in this report to urge greater consideration of weir removal options (including “partial” and “complete” options) ahead of fish pass installation which leads to the retention of impounded reaches.

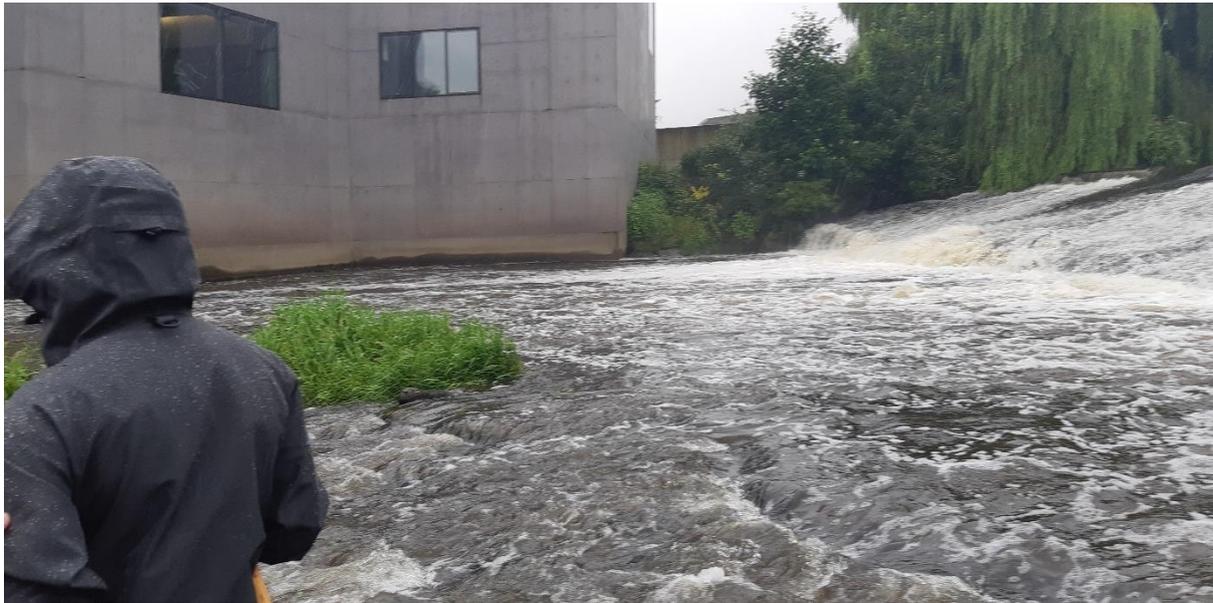
This structure is, in common with many comparable weirs, part of complex associated infrastructure, including historic (14<sup>th</sup> century) and modern road bridges. With that said, the Hepworth Gallery, built in 2011 has its footings and outer walls in the water of the river, directly downstream of the weir (Fig. 2).

Figure 2: The Hepworth Gallery (left and centre of frame) directly downstream of the weir.

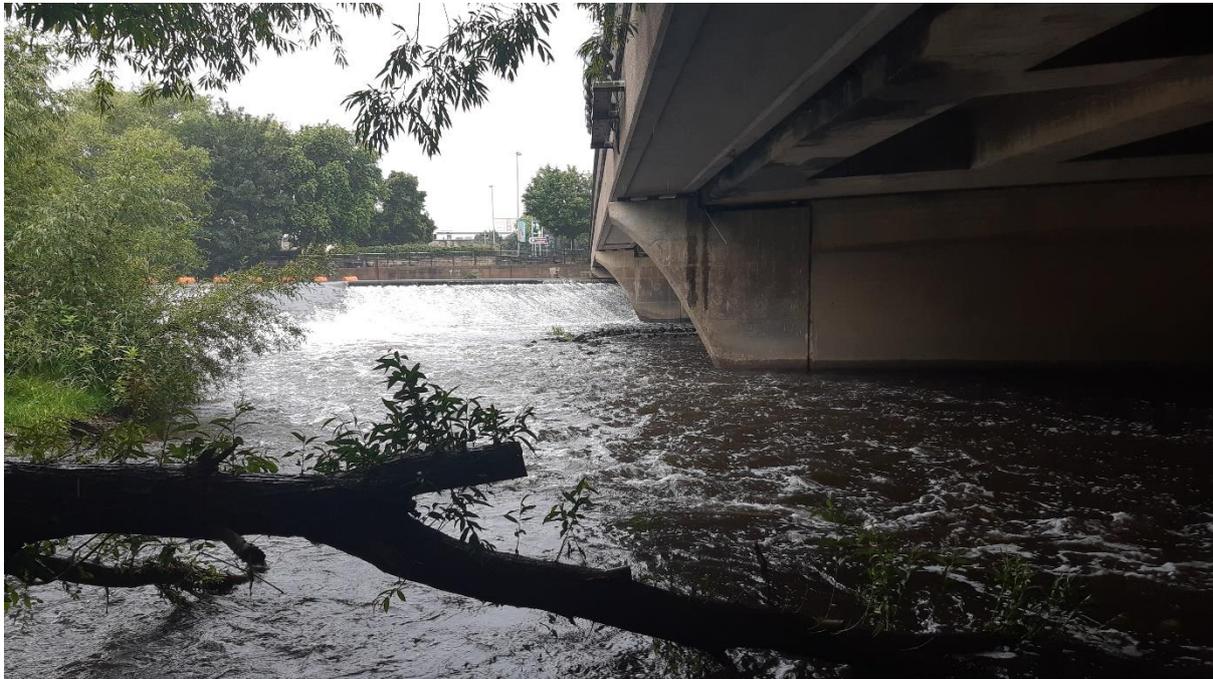
More complex (and more biodiverse) habitat was readily evident downstream of the weir – in the absence of an impounding effect (e.g. Figs.7-9).

Figure 7: Greater flow energy below the weir can redistribute bed materials – enabling colonisation by flora and fauna to further increase structural diversity.

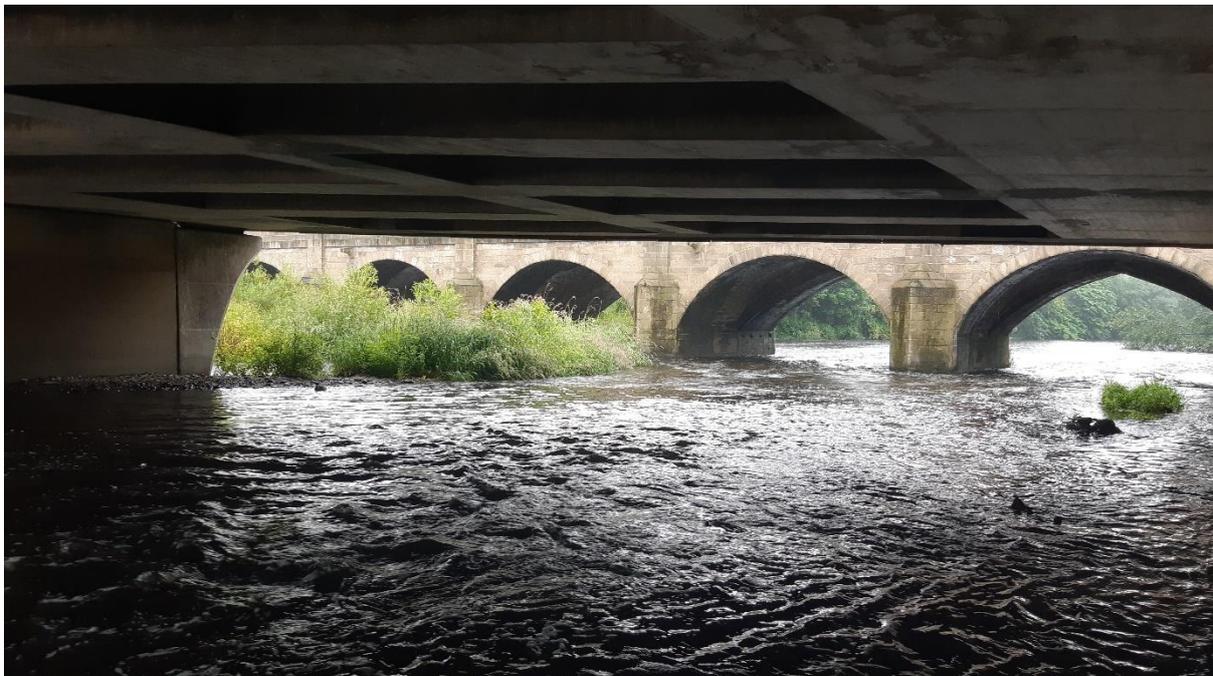
Figure 8: Even with the presence of old and new bridges, the natural gradient and stream-bed promotes much more biodiverse communities than the impounded reach upstream.

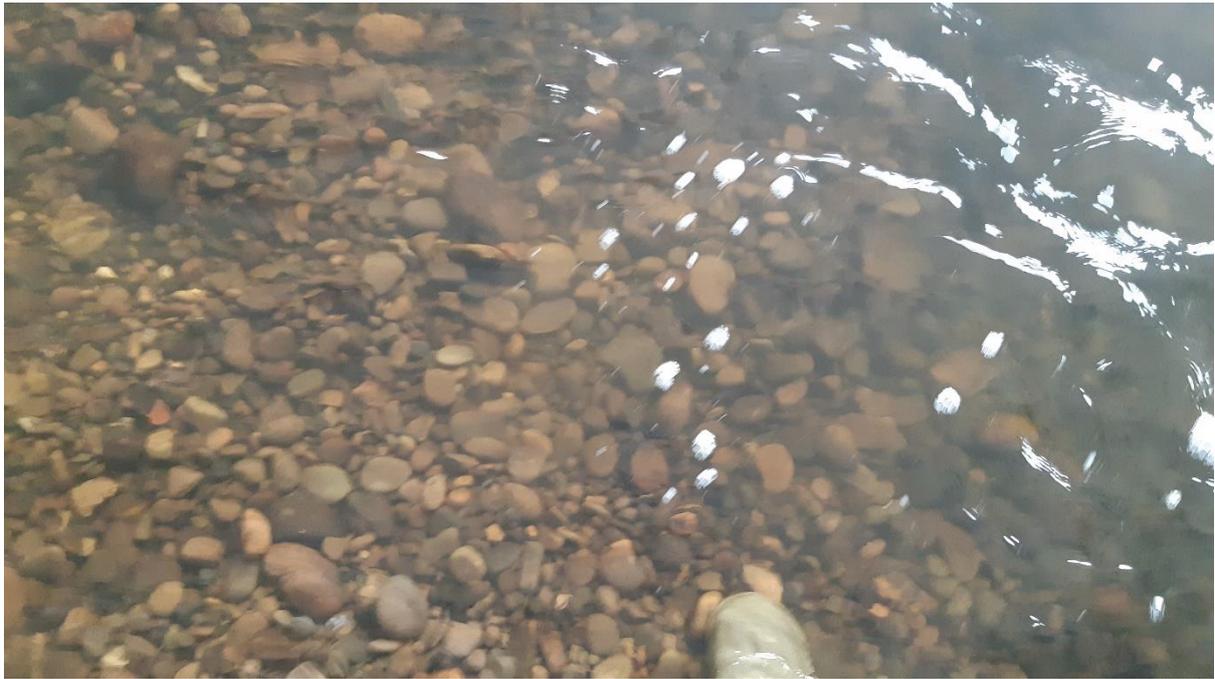
Figure 9: Although supply is interrupted by the weir, gravels of the particle-sizes suitable for trout and salmon spawning were present.

Gravels (Fig.9), low “brush” cover (Fig.10) and deeper scour-pool habitat (Fig.11) were all noted to be present within the visited reach. Consequently, opportunities exist for wild trout to complete full lifecycles – pending water quality that is good enough over a sufficient duration.

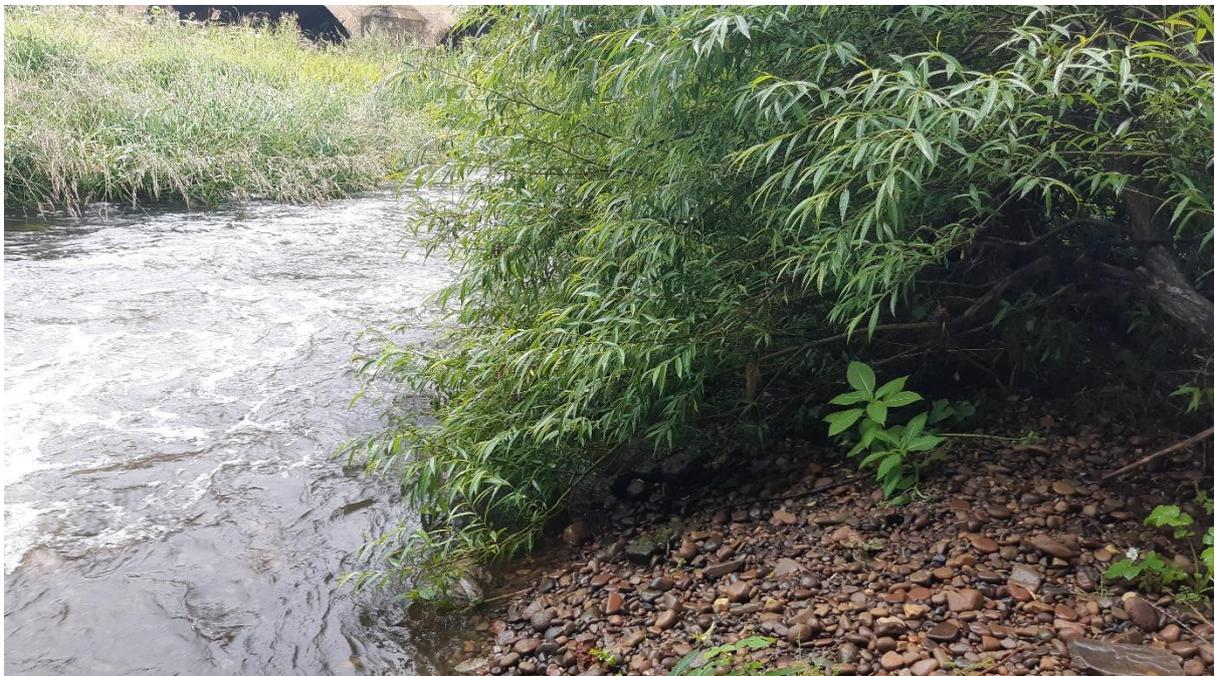
Figure 10: Vegetation colonising gravel and cobble deposits (enabled by the lack of impoundment) has created good juvenile (and adult) trout habitat.

- Replace the active construction of habitat features with a policy of retaining native vegetation colonising gravel bars and retaining fallen large woody material

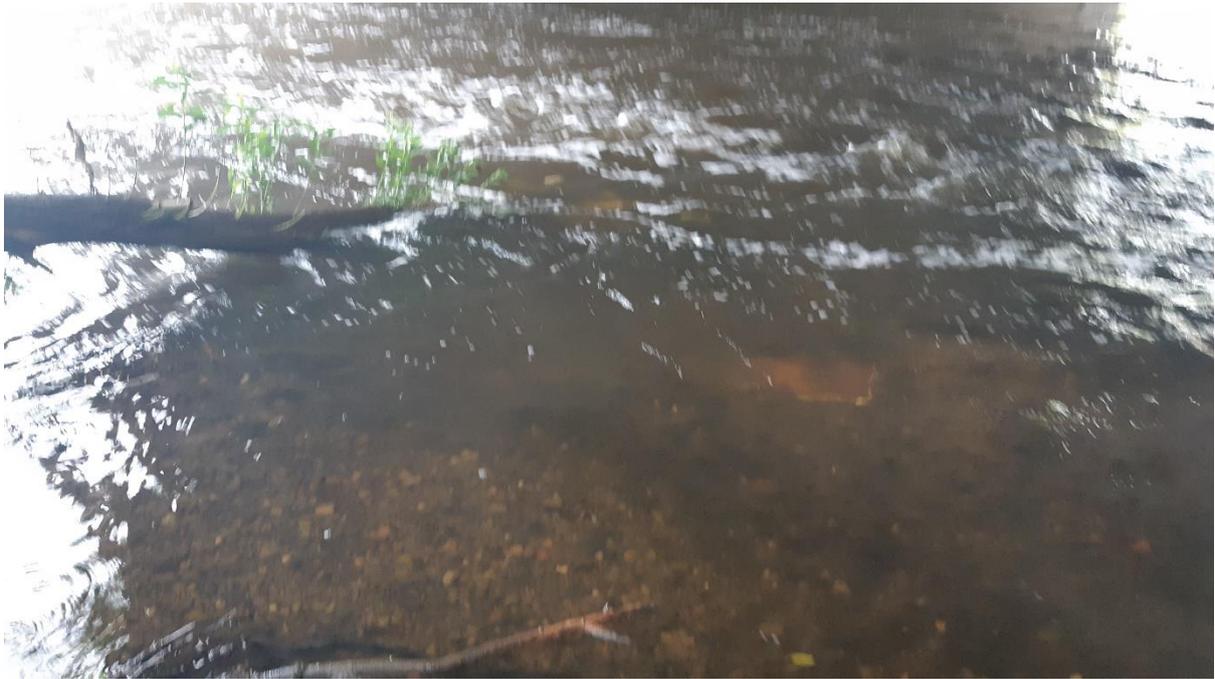
Figure 11: Localised bed scour associated with stable woody material.

As well as “sorting” or grading-out gravels that are both silt-free and of a size suitable for spawning, large woody material further diversifies the depth and current-speed (Fig. 11). The cover and deeper water are key resources for adult, flow-loving fish. Additionally, localised scouring action helps to prevent clogging of the spaces between each gravel particle. As a result there should be a better flow of oxygenated water through those gravel deposits – a vital factor for good egg survival in gravel-spawning species (such as trout and barbel).

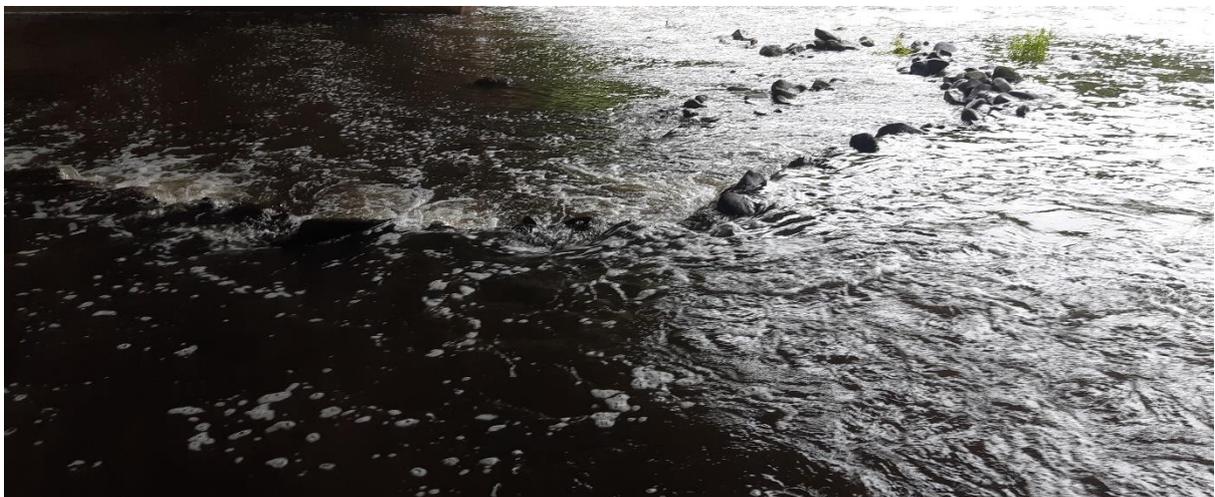
This concept of localised scour driving the bed down to create depth is to be much preferred to the idea of holding water back for the same purpose. Consequently, the building of low depth-retaining weirs using cobble and boulder material from the riverbed (e.g. Fig.12) should be avoided, in favour of facilitating or preserving bed-scour.

Figure 12: Low cobble/boulder weir - while not creating a significant impoundment - is best to allow to degrade during subsequent spate events.

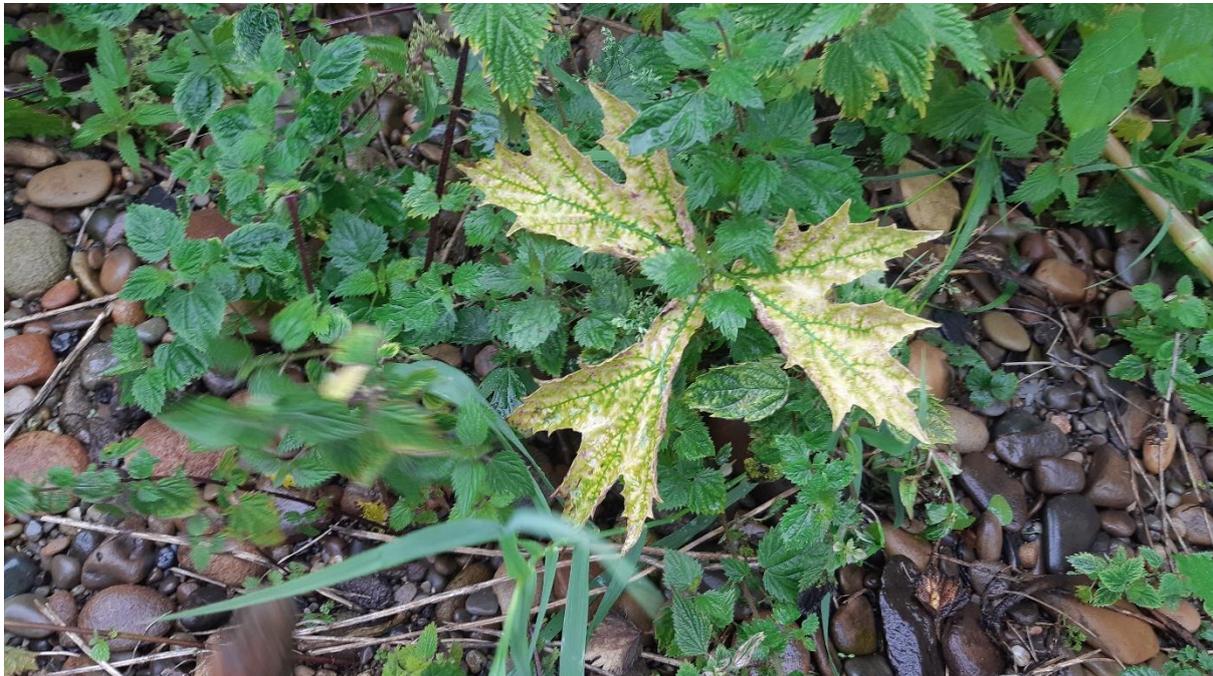
There was also evidence of control undertaken by external parties (either local council or Environment Agency staff) of the invasive and dangerous giant hogweed (Fig. 13).

Figure 13: Giant hogweed plant showing signs of chemical treatment.

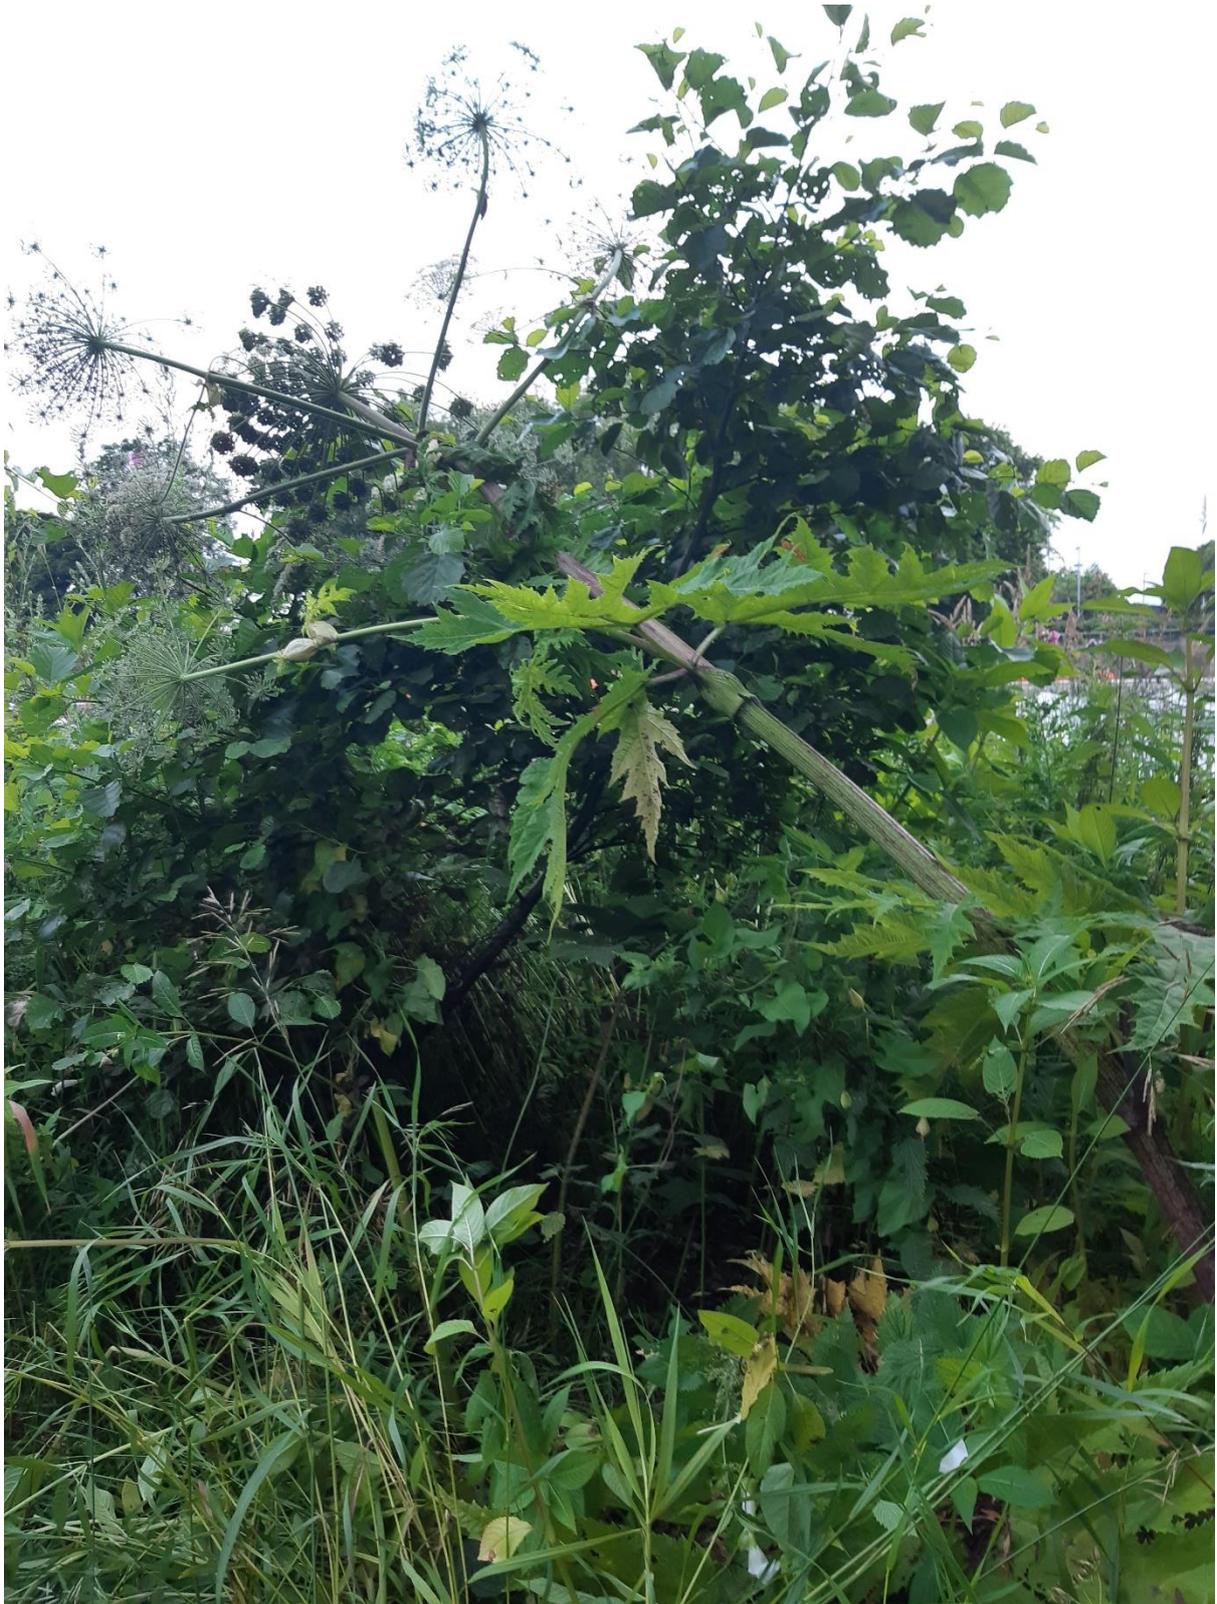
However, the vegetated gravel bars towards the RB had several maturing giant hogweed plants that had not been treated (Fig. 14).

Figure 14: One of multiple untreated hogweed plants on site.

The photo-toxic (sunlight-activated) sap which causes chemical skin burns makes this plant extremely difficult for volunteer groups to deal with. Particularly dedicated group members may wish to go through the formal training and accreditation (including use of all the appropriate personal protective equipment) needed to tackle giant hogweed. However, this comes with full warning of both the legal and health and safety implications

attached to that course of action. Campaigning to have the existing control efforts extended would be extremely worthwhile – particularly in the context of areas where this plant has got out of control. The sheer dominance and density this huge plant can achieve, coupled with the toxic sap, make it a significant priority to tackle while the problem is still relatively manageable.

- Explore options for control of giant hogweed and Japanese knotweed (to complement the excellent ongoing Himalayan balsam control) including:
  - Local authority and rivers trust control programme(s)

- Consider seeking funding to train a number of group volunteers in stem injection for Japanese knotweed
  - Consider seeking funding to employ a specialist contractor to undertake giant hogweed control

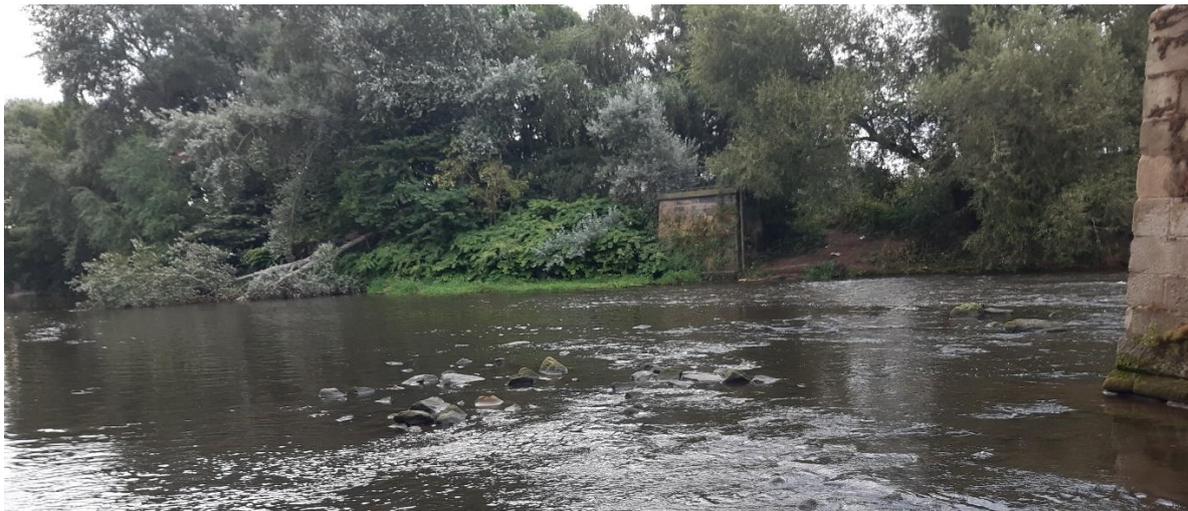
Although lacking the chemical burn risk associated with giant hogweed, the large stands of Japanese knotweed noted on site (e.g. Fig. 15) also require specialist control to avoid inadvertent spreading of propagules (fragments from which whole new plants can grow).

Figure 15: Japanese knotweed stand on the RB – upstream of a large, fallen poplar tree.

Also visible (left of frame, background) in Figure 15 is a large, fallen poplar which, due to its size and entanglement with standing trees on the bank, is stably-anchored. This is providing excellent cover habitat within deep water. It will also be contributing increased structural variety in the cross-section of the riverbed by encouraging localised scour and deposition during spate flows.

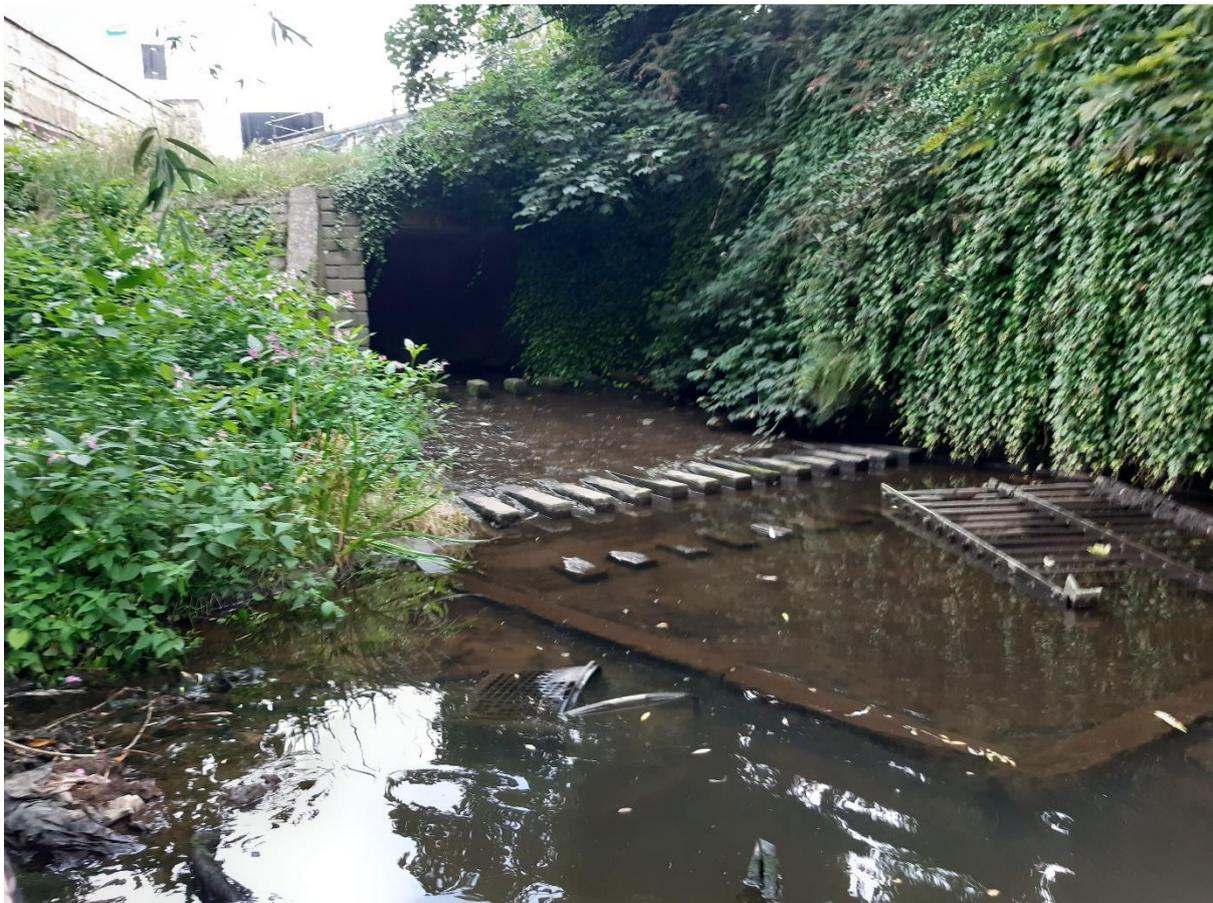
The acceptance of retaining stable, fallen woody material and the colonisation of gravel bars is a very important step in maximising the biodiversity within urban rivers. Similarly, in concert with habitat quality, monitoring and understanding water quality is likewise crucial. The presence of a large outfall on the LB (Fig. 16) is an obvious spot to maintain vigilance and report cloudy and/or foul-smelling discharges that occur outside periods of heavy rainfall. Establishing and maintaining monitoring of aquatic invertebrates is also an excellent way to detect pollution incidents that may occur when direct observation is not possible. Since aquatic invertebrates are exposed to whatever is in the water 24-hours a day, they provide ever-present detection. Therefore, even short-lived pollution incidents that would otherwise not be possible to either witness

or obtain chemical samples for can be reflected in the loss of characteristic groups of invertebrates.

Figure 16: Outfall discharging to the river on the LB towards the lower end of the visited reach

- Establish invertebrate monitoring (for instance as part of the Anglers Riverfly Monitoring Initiative: <https://www.riverflies.org/ARMI> ) upstream and downstream of the outfall pictured in Fig. 16.
