WILD TROUT TRUST

River Chelt

Guardians of the River Chelt

2025

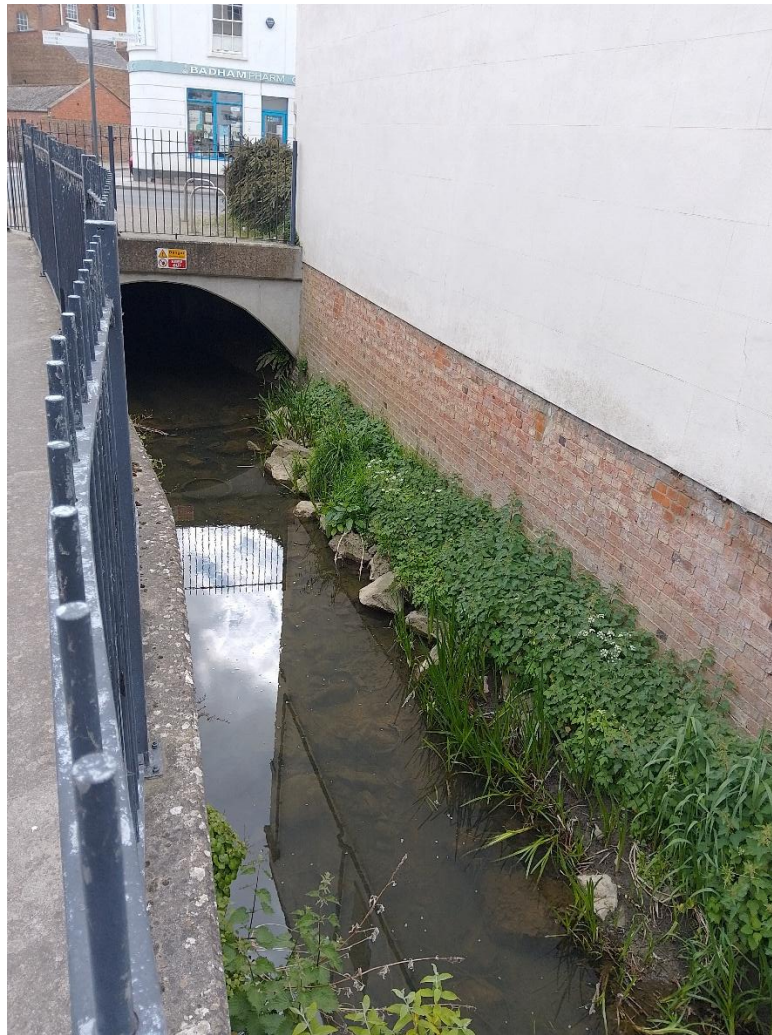
At the start of the reach inspected, the Chelt emerges from a significant length of culverting (c. 400m) where it has been incarcerated under urban development (Photo 1). This is the first example seen in the Chelt of serious fragmentation of river habitats and connectivity for fish populations. Culverts create a specific issue for fish, through engineered flows in smooth sided channels being too fast for swimming abilities when water levels rise, or levels too shallow for passage at times of low flow. Long culverts become very dark inside, demotivating some fish to pass through (especially those reliant on visual ability) due to wariness of potential predators. Passage issues can be remediated by changing flow conditions in the culvert, by introducing a rougher channel (larger bed material) or installing low baffles though the bed of the culvert to raise water levels at low flow and reduce high flow velocities (Figure 2 and Figure 3). Innovative solutions to light the interior of culverts have been previously used in river restoration projects, encouraging fish to pass through the feature. Any action to manage low flow in the culverts would need to go through appropriate regulatory channels and flood modelling to ensure no additional impact was made on flood water levels, beyond the existing influence of the culverts themselves. Overly straight channels hemmed in by smooth concrete, move flood water very quickly along the river channel. The restriction (or 'throttle') created by the culvert then backs water up as it can only convey a certain amount of water at a time. All fish species require free access to different parts of the catchment for feeding, reproduction and refuge through the year. Anything that inhibits this movement – a barrier like a culvert or weir – will impact fish ability to complete life cycle or numbers of fish present

Photo 1 The start of the survey section by the Bayshill Pub. The Chelt resurfaces after several hundred metres of being buried under the town. The river is heavily modified, constrained by high artificial banks in a straight channel. The larger rubble in the bed will offer some physical habitat for fish and aquatic invertebrates, the accumulation of sediment on the left bank is allowing some vegetation to take hold. The emergent and trailing leaves provide a small amount of natural habitat structure as well.

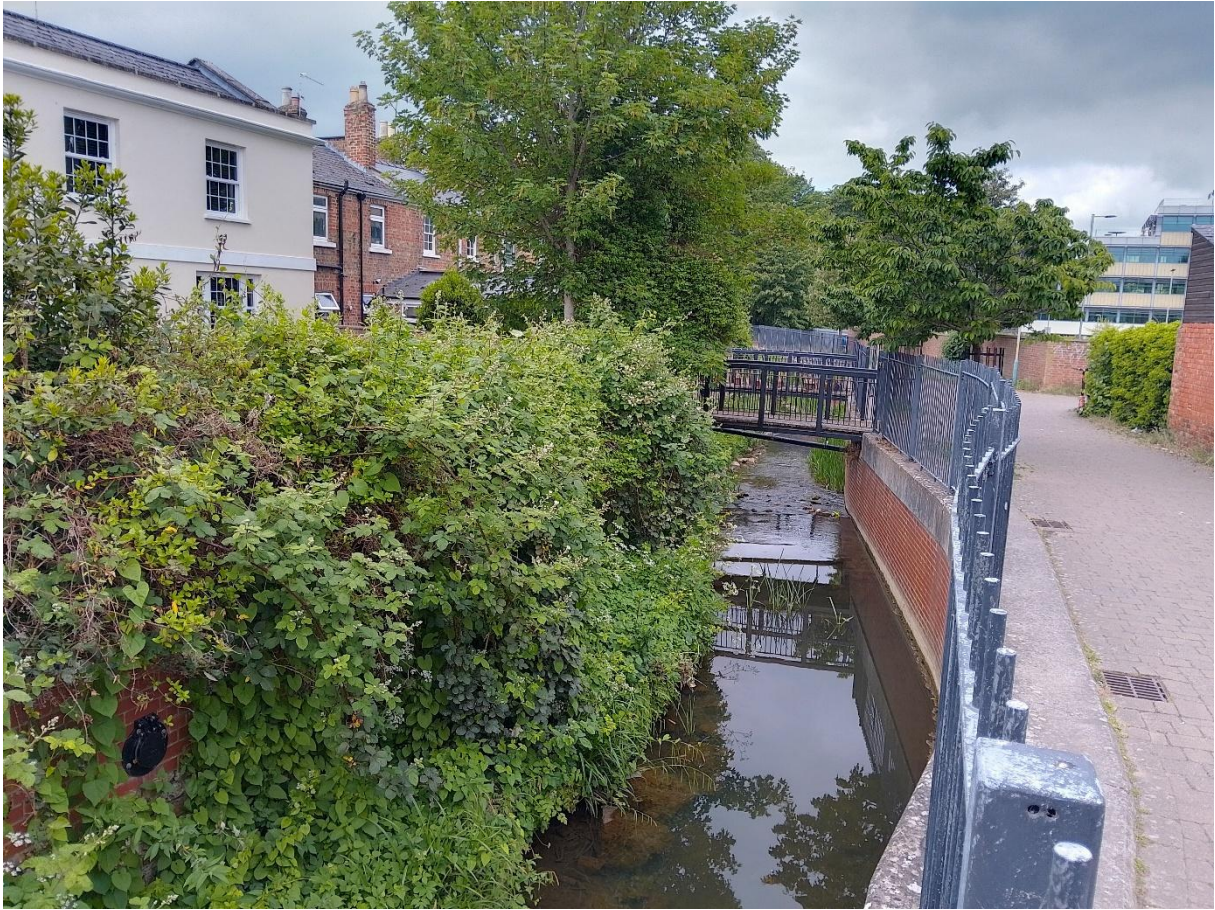
Photo 2 The deeply incised channel also has its movement limited by the high brick-built walkway on the RHB. Water velocities through this section are likely to be difficult as levels rise and flows speed up; the smooth brick wall provides little resistance to slow the water down. The summer vegetation on the LHB will provide some flood water refuge to aquatic wildlife, as the complex and 'shaggy' matt of branches and sticks provides resistance that saps the energy out of flow. This provides low flow pockets that fish swimming ability can cope with, so they don't get physically washed out in floods. Note the shallower faster water under the bridge where the river has deposited some material from the deeper water in the foreground, creating habitat change and flow diversity.

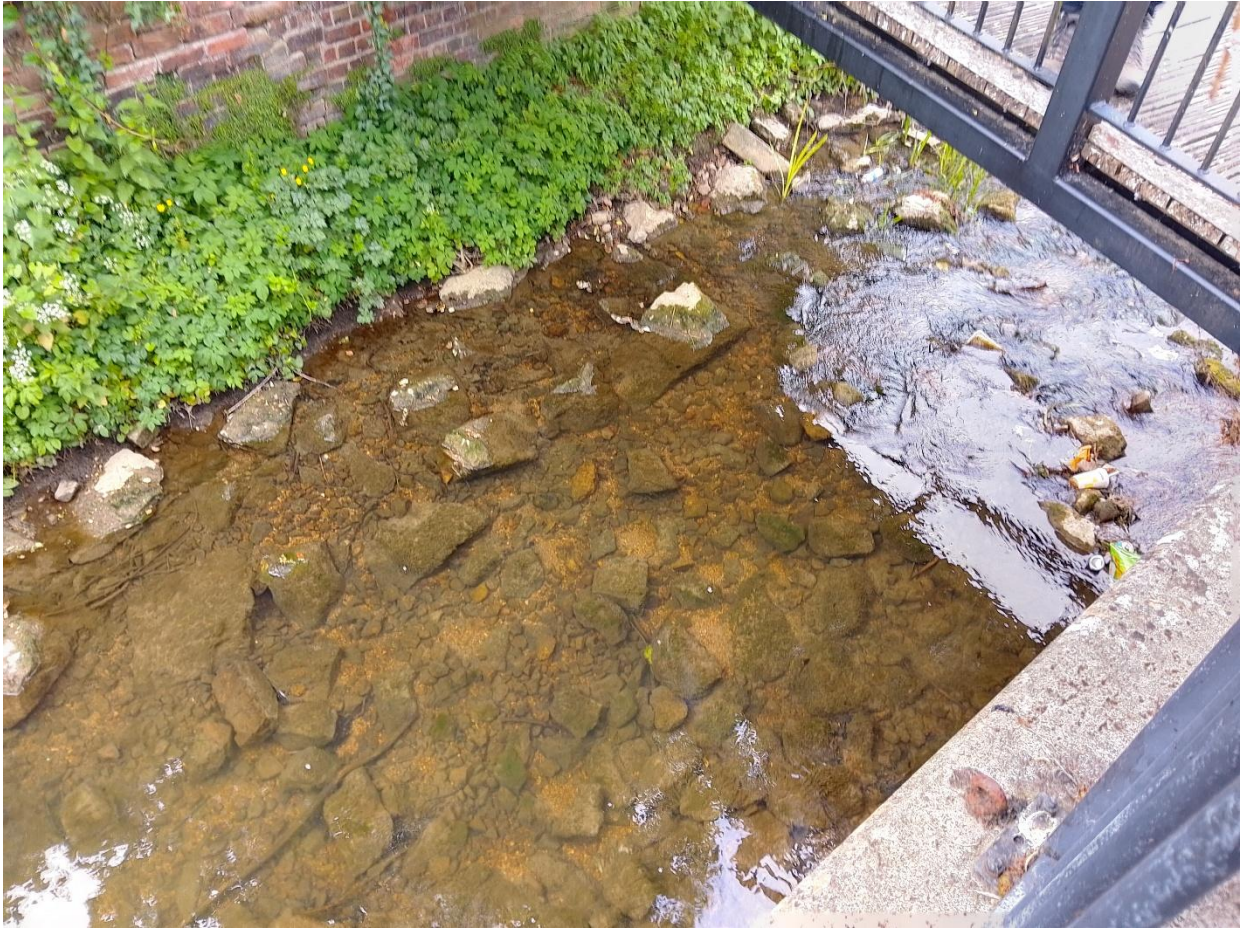
Heading a little further down the watercourse from the start point, the watercourse has deposited a riffle feature under a small footbridge (Photo 3). This was a good place to view what material, both man-made and natural, the Chelt was using to form these features, and how useable they might be as functional river habitat. As per the previous diagrams, a riffle can start a chain reaction in the watercourse as it energises flows, which then drives habitat dynamics immediately downstream. The attraction of diverse habitat features in proximity to each other for stream wildlife was proven, when two wild brown trout were spotted sitting on the uplift of water into the riffle.

Photo 3 A mixture of natural and man-made material blend to create some functional habitats here, allowing nature to keep a hold in this section of the Chelt. The large pieces of masonry stone and rip-rap from the bank provide a complex river bed profile. The gaps underneath this larger material create suitable locations for invertebrates, trout and bullhead to hide in. Two brown trout were seen here.

The riffle contained a range of bed materials in a wide range of sizes, from sand, pockets of gravel, some pebbles and then large pieces of masonry or rip-rap rocks that have been used at the bottom of the LHB to prevent erosion previously. This pattern of bed material was seen in places throughout the remainder of the Chelt being reviewed. This diversity of bed material, creating pockets of different depth and flow, will attract a range of aquatic species, if present. The large material provides a variety of gap sizes underneath and between it which will provide essential opportunities for trout and bullheads to seek refuge. Additionally, bullheads will lay their eggs under these larger pieces of stone. The mix of larger material, shallower water and flow diversity provides habitat for juvenile trout, too.

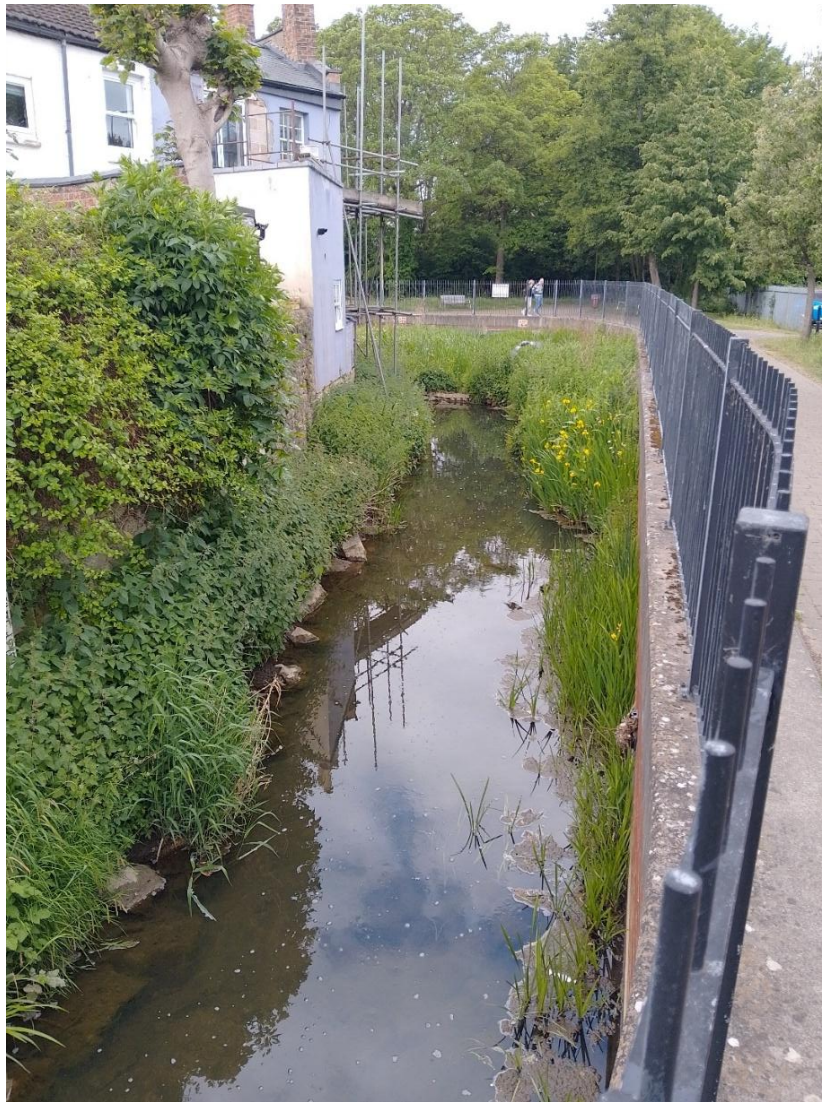
Moving to the bottom of this straight section of channel, the Chelt turns a left-hand bend, initiating a short section of more natural river response, despite being constrained on both banks (Photo 4 and Photo 5).

Photo 4 Emergent vegetation has pushed into the channel here, helping to self-narrow the pool as it approaches the bend. Not just fantastic cover for the fish present in this stretch, the vertical physical structure will be important to aquatic and wetland invertebrates such as damselfly (Zygoptera) and other species that use this to emerge from the water or crawl under it to lay eggs. A small number of mayfly (Ephemera danica) were hatching from this section of the Chelt on the day of the visit, suggesting reasonable water quality. Trout will thrive in this environment, with invertebrate food drifting down from the riffle above and additional refugia under the rip rap on the left-hand bank.

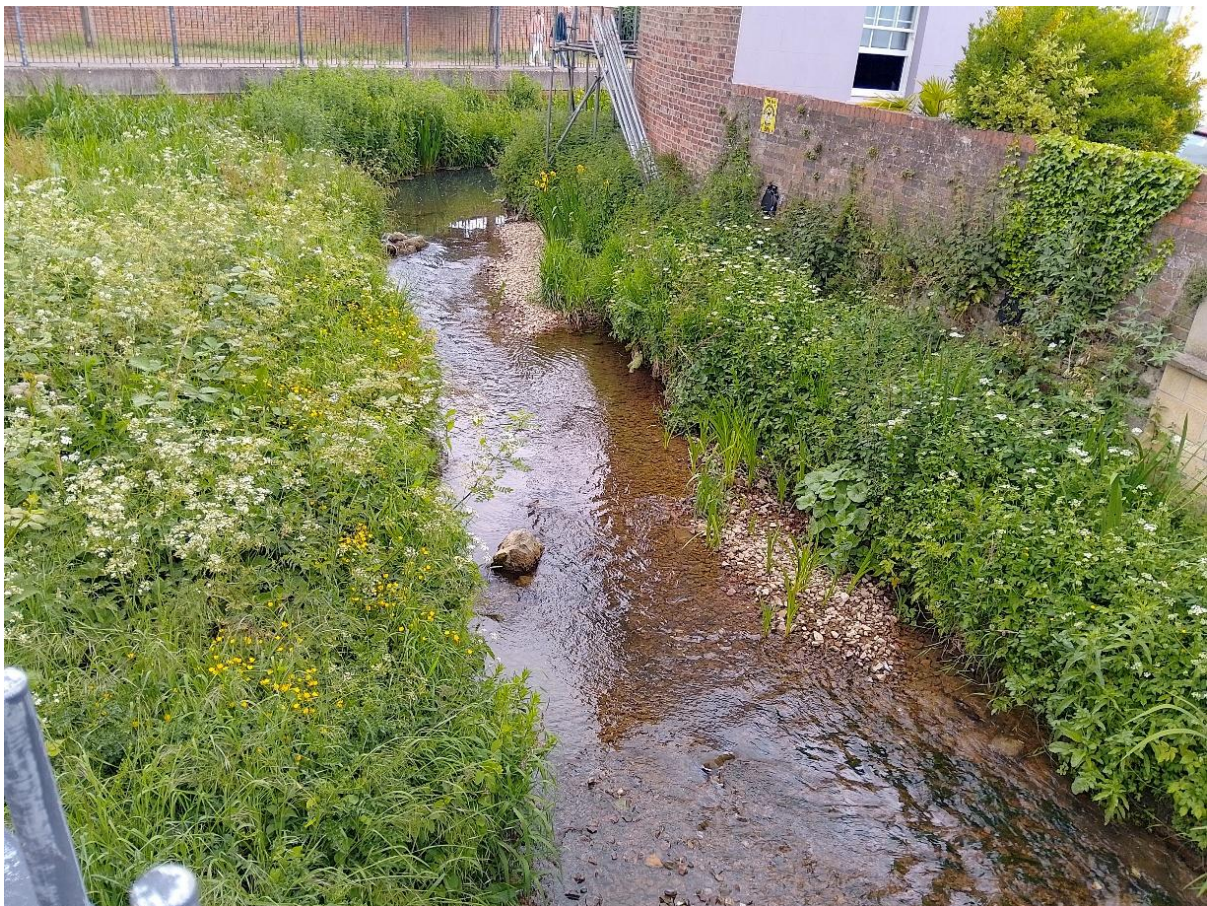
The habitat on the bend is a great example of what the Chelt could start producing, if it was in a less modified and impacted state (51.899535 , - 2.0815380). Rivers quickly start to recover when given the space to do so, with natural dynamics of flow and movement of bed material forming beneficial habitats. Here the bed level is appropriate to the height of the bank, which allows flood water to quickly spill out into the surrounding space, slows how quickly it moves downstream and moderates the flow energy within the channel, making floods less hostile to river wildlife. The deposition of good quality, natural gravels - as would be expected of a small Cotswold watercourse - has formed small side bars, short riffles and a glide; excellent flow and habitat diversity. Areas of slower flow allow this smaller material to deposit. The size of the substrate also provides opportunities for trout to spawn in winter. It would be well worth checking this area in December to look for where trout have dug nests in the gravel (called 'redds'). In a more natural setting, the expansive area of wetland plants on the RHB would be seen as an extremely beneficial buffer strip to surrounding land use, and good quality habitat. However, given this is growing across the front of an underground flood alleviation channel, it is not known if this habitat will be retained or removed for flood risk as seen at many other locations downstream.

Photo 5 Channel recovery, once the watercourse was given space to meander and deposit material naturally; habitat diversity and species respond positively to this.

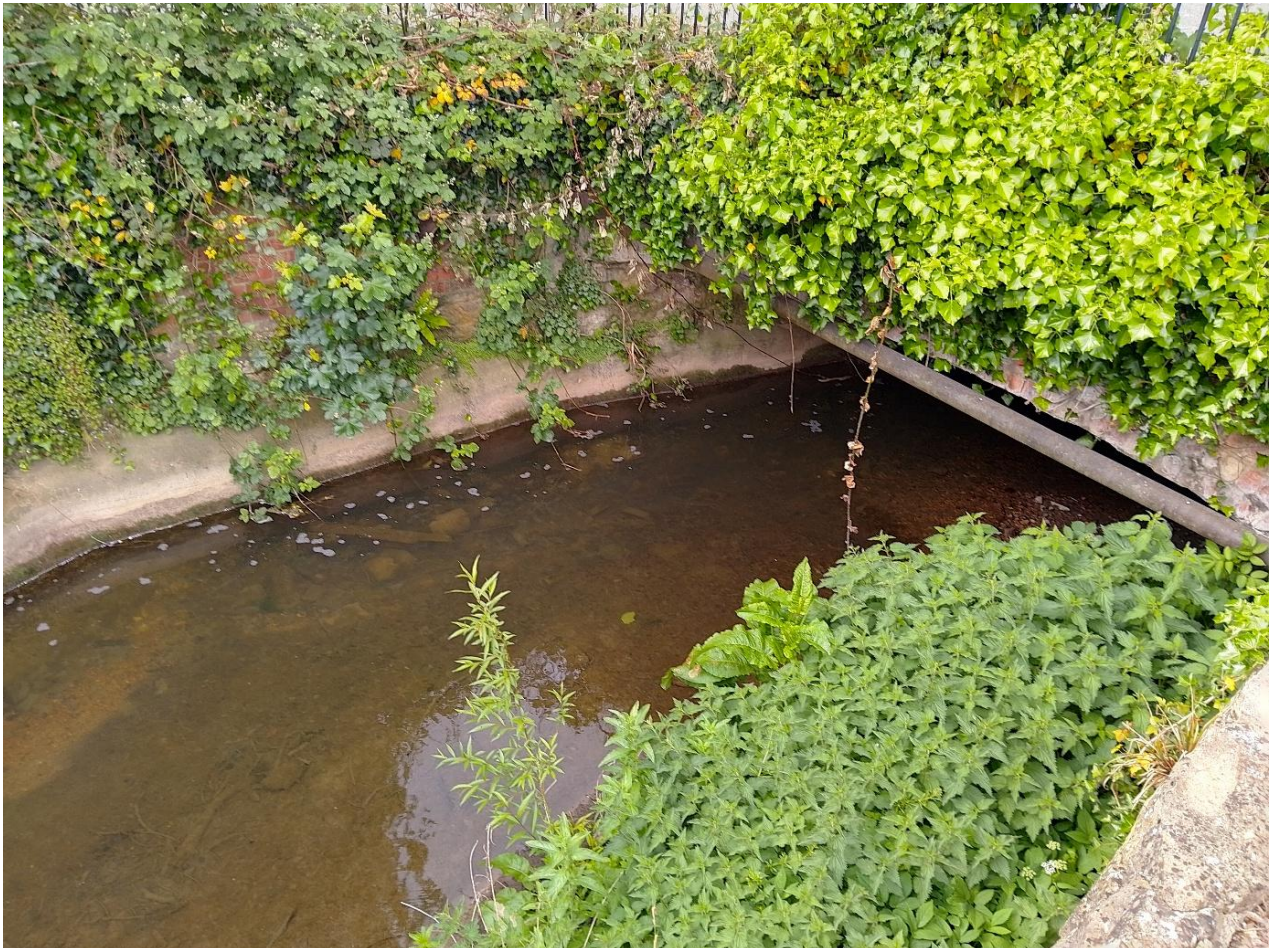
Immediately downstream of the recovering river channel, the Chelt is buried under the first culvert in the stretch (Photo 6). This will disrupt the natural processes of the river and damage formation of habitats immediately downstream. The low height of the culvert and footpath on top has potential to disrupt the lifecycle of certain river invertebrates, especially when making upstream flights as mating adults. At around 25 metres in length, this culvert could influence fish movements but has retained enough depth at low flows to allow fish to pass through relatively easily.

Photo 6 The culvert supporting the footpath onto Royal Wells Way (51.899522 , - 2.0816930).

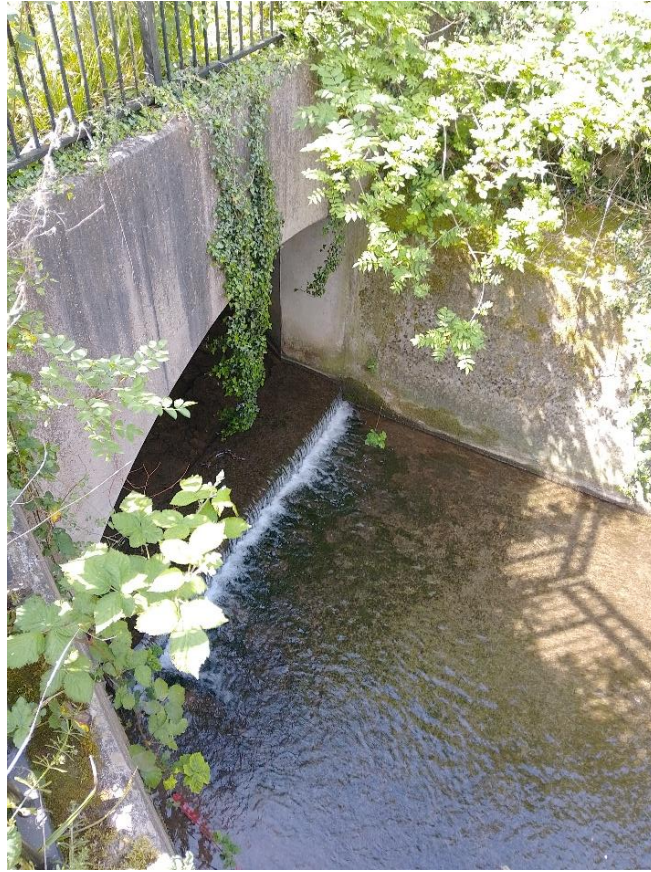
At the end of the parkland, the Chelt is put through another box culvert of around 12m length, which forms the footpath bridge out of the park to Waitrose carpark. This has the additional issue of a small step in the concrete bed at the downstream end creating a barrier to fish at low flows. The Chelt is then put through a fully lined concrete channel before it hits the start of the Waitrose car park culvert (Photo 9 and Photo 10). Obviously, this is a very degraded place for river wildlife, devoid of any natural habitat. The key issue for fish in engineered water conveyance channels (these are not rivers anymore) is the same as for culverts; too shallow at low flow and once levels pick up, flow velocity quickly becomes too fast, especially for smaller fish with poorer swimming ability. Easy wins to help alleviate this is to use low baffles on the concrete bed which raise water levels at low flows, and slow flows when velocities increase, to aid fish passage through these man-made features (Figure 4 and Figure 5).

Photo 9. The downstream end of the culvert with the footbridge over the top of it, a small step in concrete bed level creates further fish passage issues.

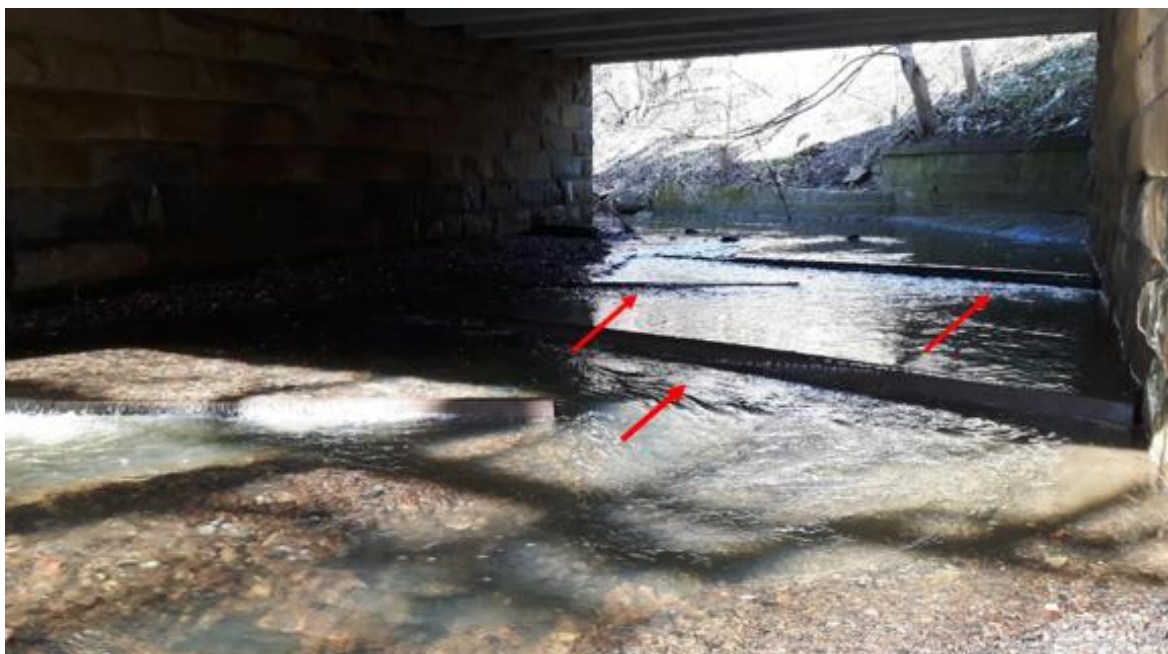
Figure 5 Alternatively, a series of low baffles can be installed in a culvert to create depth and flow conditions allowing fish to pass through at low flows (red arrows highlight the baffles)

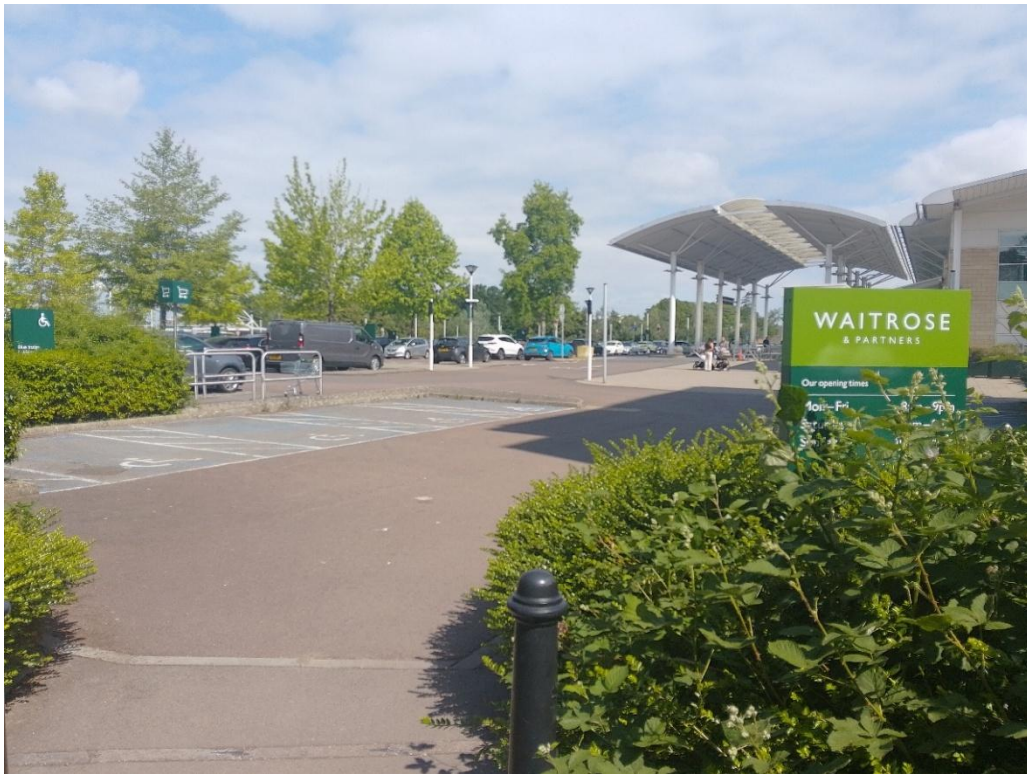
The Chelt is buried under Waitrose car park for 80m in a culvert (Photo 11), it then reappears, and the channel is split, with one side going over a large vertical weir and put through another 60m culvert (Photo 12). The second, left-hand channel (St James Walk Flats overflow channel) goes through a short additional culvert (Photo 13), reappears for 35m, is culverted under Honeybourne Way (Photo 14), then put over a high vertical weir. Whichever route fish try to take up or downstream, they are faced with an impassable vertical barrier or significant length of potentially impassable culvert (Photo 15 and Photo 16).

Photo 11 Car park over the River Chelt. The dark, underground channel will not be used by fish.

- One option for improving fish passage at Waitrose car park is cutting out discreet sections of carpark over the Chelt and replacing with solid grating to allow some light down to the channel. Locating these at up to eight car parking spots as per (Figure 8) may be a viable approach. Additional approaches to managing flow and water levels through the culvert should be considered with a fish passage specialist (e.g. feasibility of baffles, location and installation).

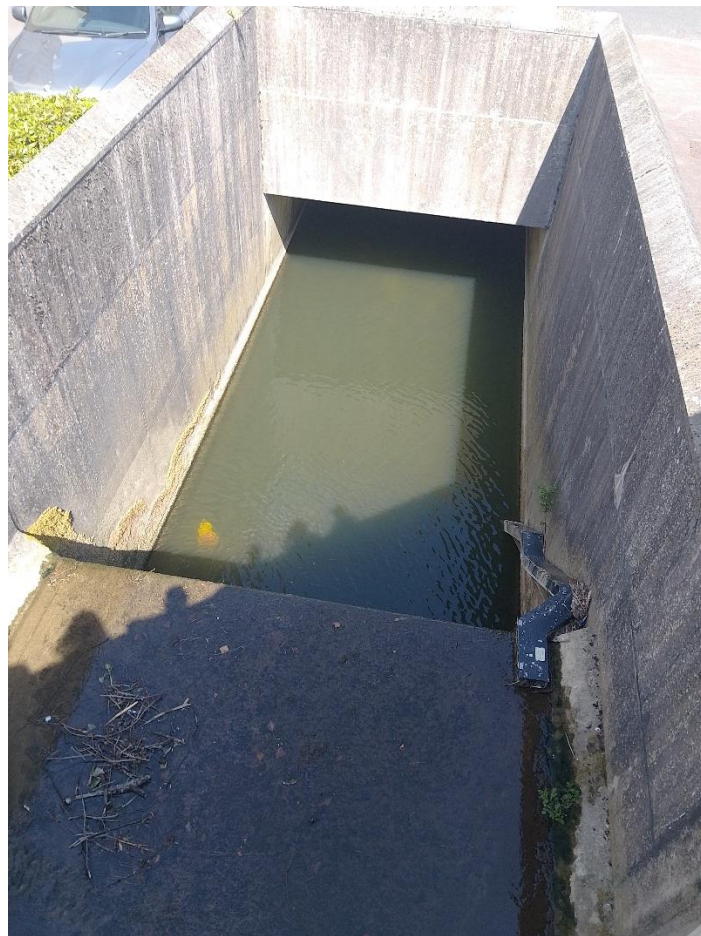
Photo 12 The large vertical drop and next culvert – right hand channel. An elver pass has been installed to the side of this.

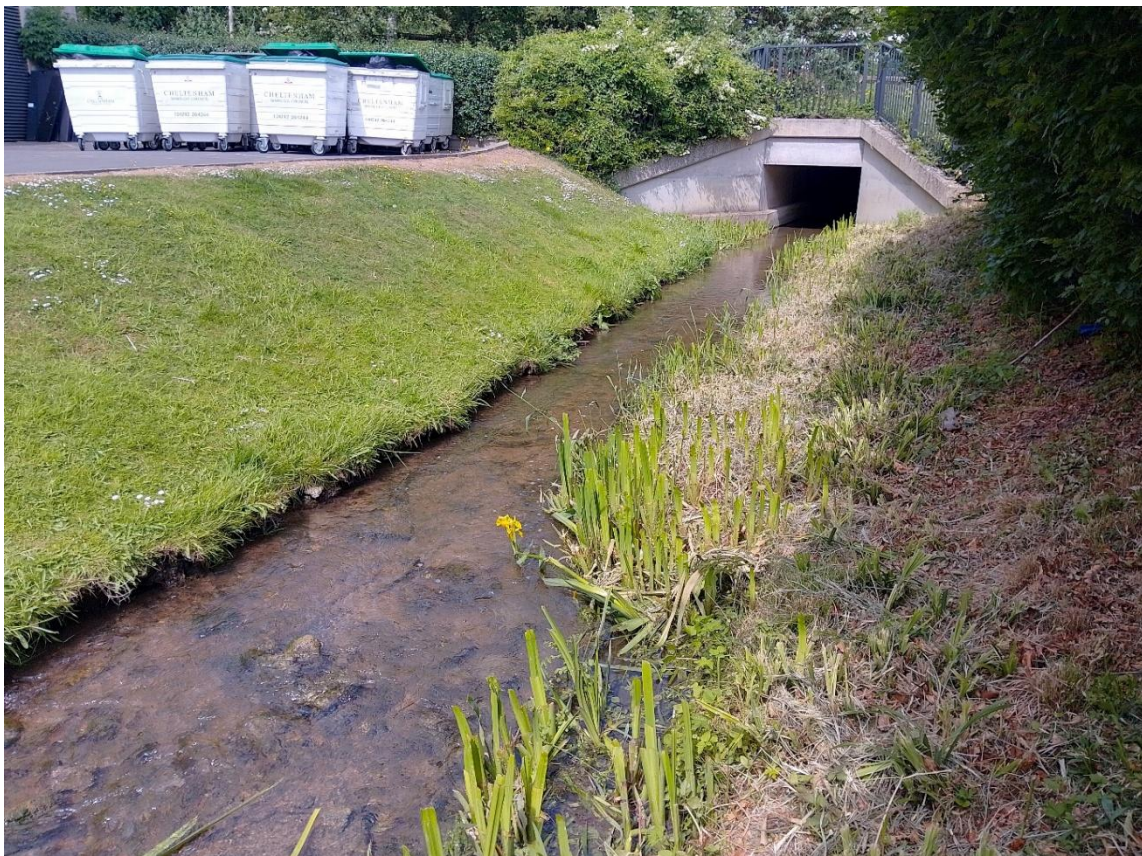
Photo 14 The short section of watercourse past St James Walk Flats, before it is culverted under Honeybourne Way. The emergent marginal vegetation should be

allowed to develop to provide a little habitat here; cutting it does little to reduce flood risk, compared to the adjacent hedge or huge throttle effect of the culvert entrance which are potentially far bigger issues!

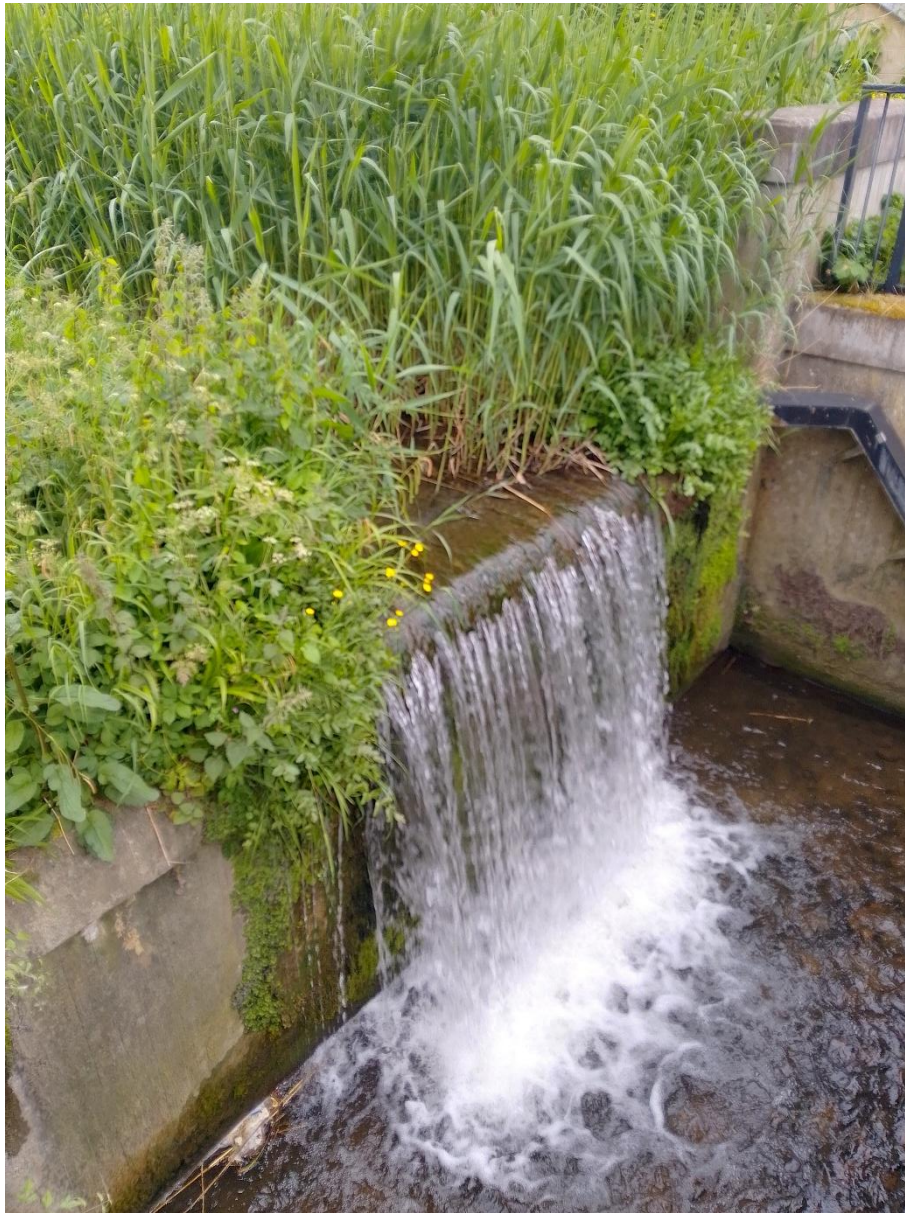
Photo 15 The vertical drop at the end of the St James Walk 'overflow' channel. Another elver pass has been installed on the far bank.

- The most feasible option for fish passage at the massive barriers around Waitrose car park would be to create a route through the overflow channel. This would involve adapting the weir at the downstream end (Figure 7), ensuring passage conditions in the culvert under Honeybourne Way, adapting the grill and offtake into the overflow channel just downstream of Waitrose and adapting the culvert under the car park, below.

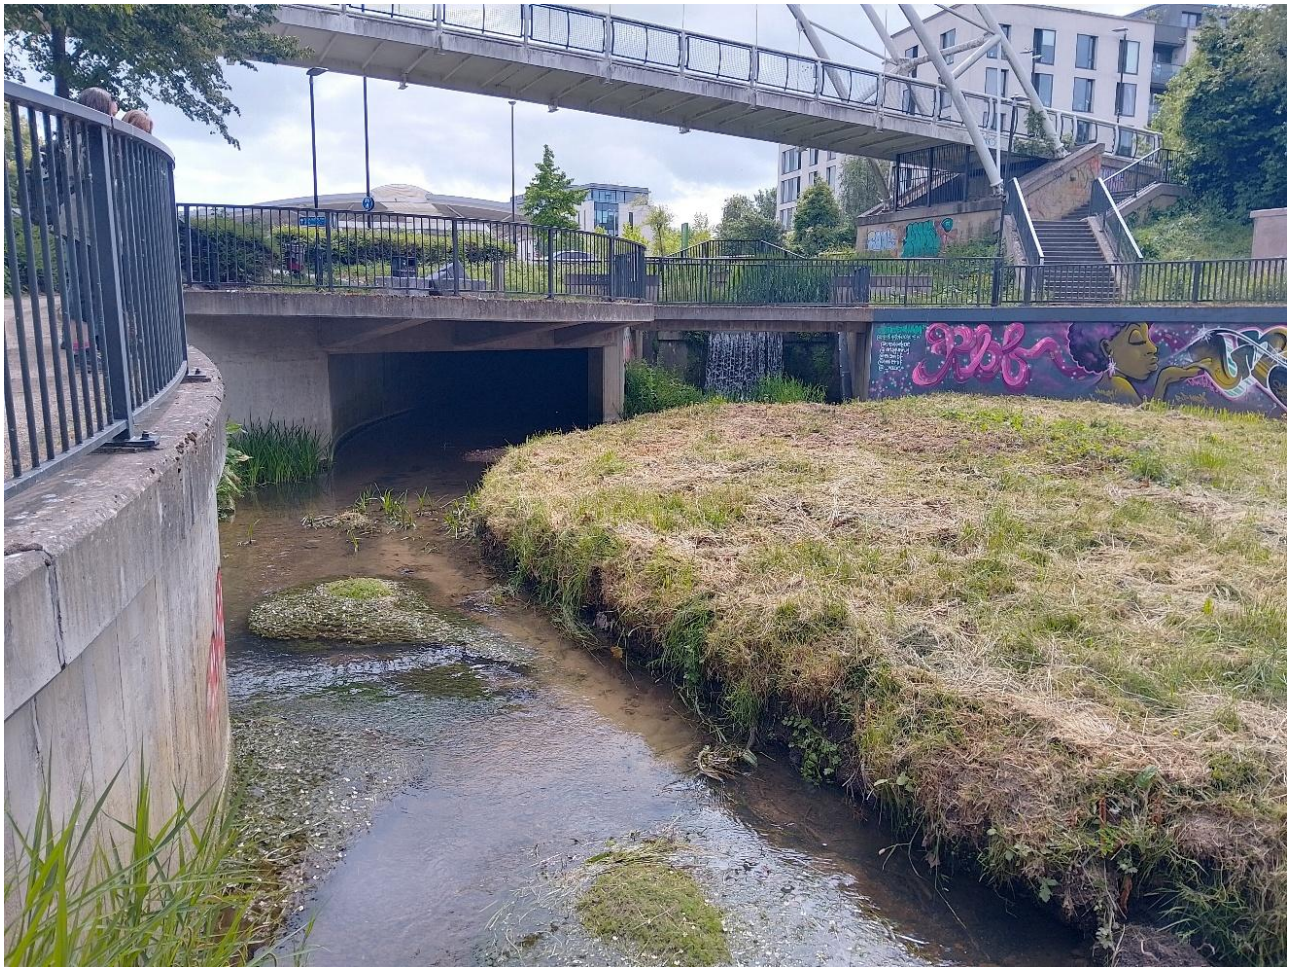
*Photo 16 Looking back upstream at the two connectivity issues fish face in this section of the Chelt – a massive culvert or a vertical weir. It is unsurprising eels are not well represented in fish surveys upstream, as they can't easily get there, despite the elver passes. Should pollution events occur, and fish populations are lost upstream, it will be very difficult for natural recolonisation to occur. The Chelt regains a little dignity here, escaping completely concrete lined channels. Despite the LHB being heavily trimmed, the slightly undercut bank and remnants of vegetation trailing in the water afford some refuge to fish and invertebrates. Submerged aquatic plant life starts to proliferate – water crowfoot (*Ranunculus* sp.). This is a very beneficial species and provides habitat for a great range of insect life, excellent cover for all fish species and constrains the channel to create positively energised flow diversity amongst its submerged clumps. This in turn drives a plethora of habitat niches for aquatic species to exploit. Lowering all of the grassed bank area would allow space for moving the channel away from the concrete retaining wall and provide a large area of additional flood water storage through a better-connected floodplain area.*

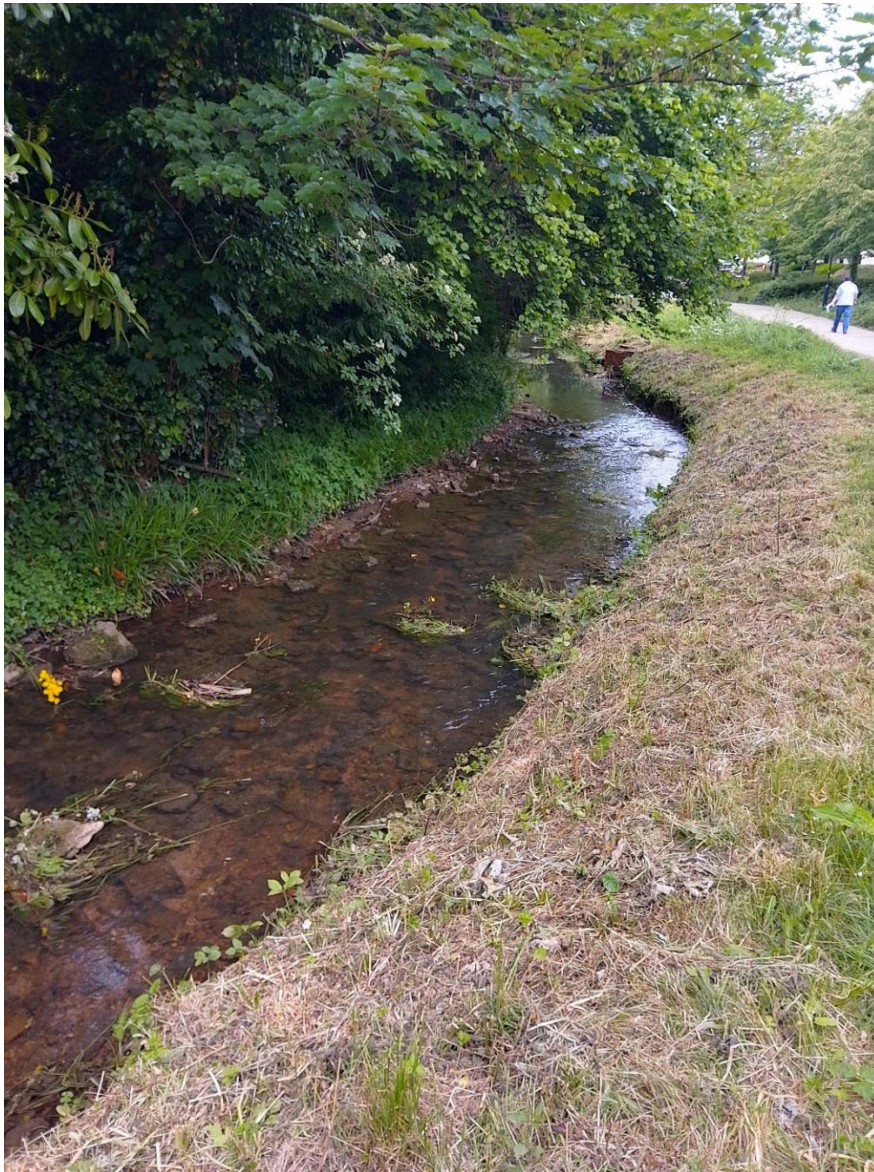
The remainder of the Chelt down to the Gloucester Road is straightened and modified. Although within a small 'green corridor', the Chelt now has housing adjacent to the left-hand bank, a footpath and key access road (Honeybourne Way) above the right-hand bank. The left-hand bank is wooded at the start of this reach, the grassland on the banks between the footpath and housing is heavily trimmed everywhere else, again in the interest of reducing flood risk (Photo 17).

Photo 17 The Chelt along Honeybourne Way (51.903077 , -2.0873508). Straight and within a classic flood engineered trapezoidal channel shape. Due to lack of natural sediment supply, the substrate is mostly man-made materials but will possibly function with the same effect as larger cobbles and boulders found naturally in streams. Trout, bullheads and all aquatic invertebrates will use the structure as key habitat in this section. Leaf litter from the adjacent trees will provide basal resources for shredding and grazing aquatic invertebrate groups.

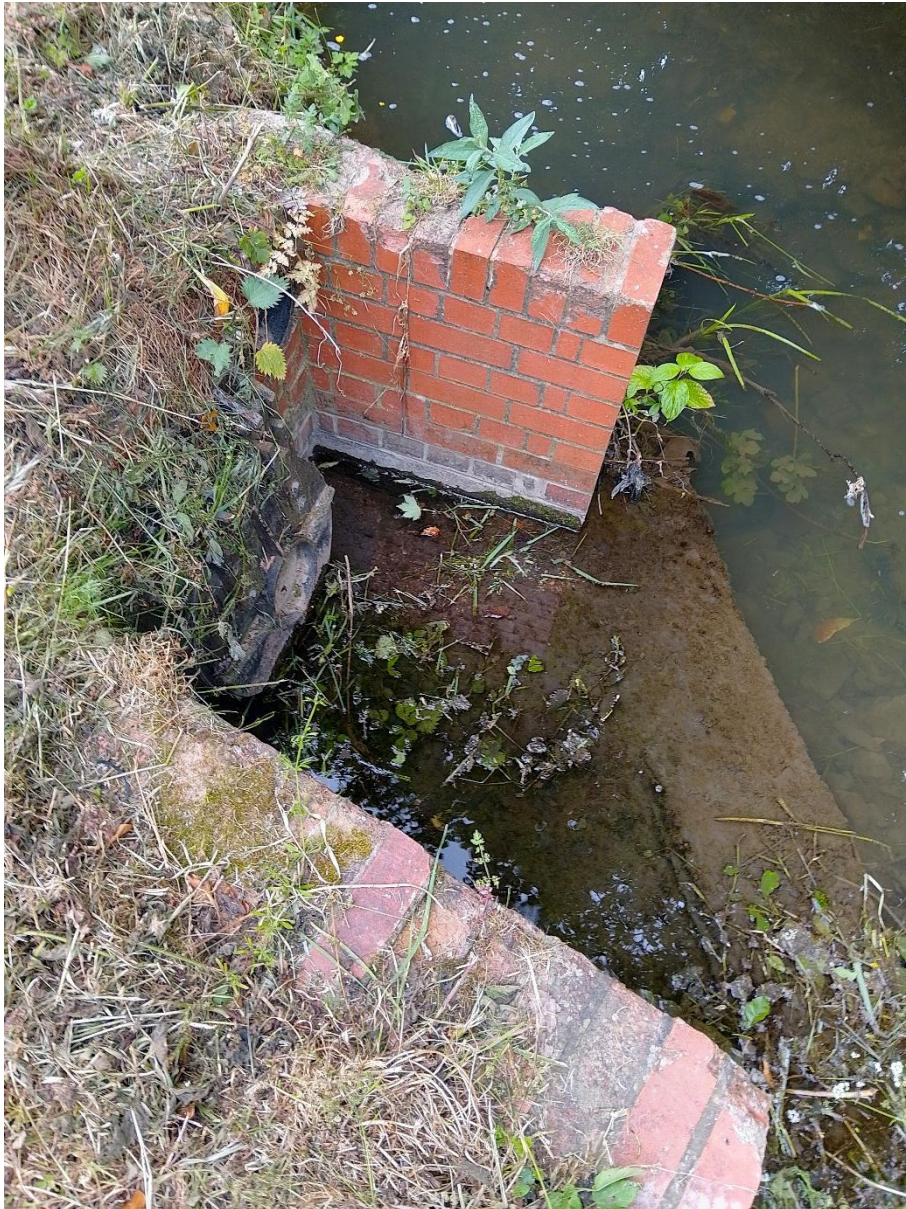
The substrate in the river channel along the first 100m or so is generally man-made rubble, with a small amount of natural material filling the gaps. The size of the rubble creates some flow diversity and structure the fish species present can utilise as functional habitat. This is too large for trout to spawn in, so uptake of habitat by juvenile fish may be limited. Water crowfoot, (*Ranunculus* sp.) is generally absent along the first section, most likely due to natural levels of shade from the bankside trees on the left-hand bank. Other features present were surface water drains with flap valves and erosion (Photo 18 and Photo 19).

Photo 18. One of two adjacent storm overflow drains (51.903289 , -2.0874793). What gets discharged to the watercourse from these drains is always a big concern. Obtaining a services map of pipework to review the likely inputs will help understand water quality impacts to the Chelt. GORC can also actively monitor upstream and downstream during periods the pipe is running. Concerns would be contents of road run off (microplastics and pollutants) and misconnections in residential properties (washing machine phosphate input). Mapping features like this and engaging the Council may provide opportunity to break these out (space provided) and run through an urban sustainable drainage system feature (SUDs – e.g. swales, retention pools etc) to allow the water to settle out fine sediment and contaminants a little before reaching the river. Examples such as the 'Outfall Safari' highlight where community groups have mapped issues before: <https://www.southeastriverstrust.org/projects/outfall-safaris>

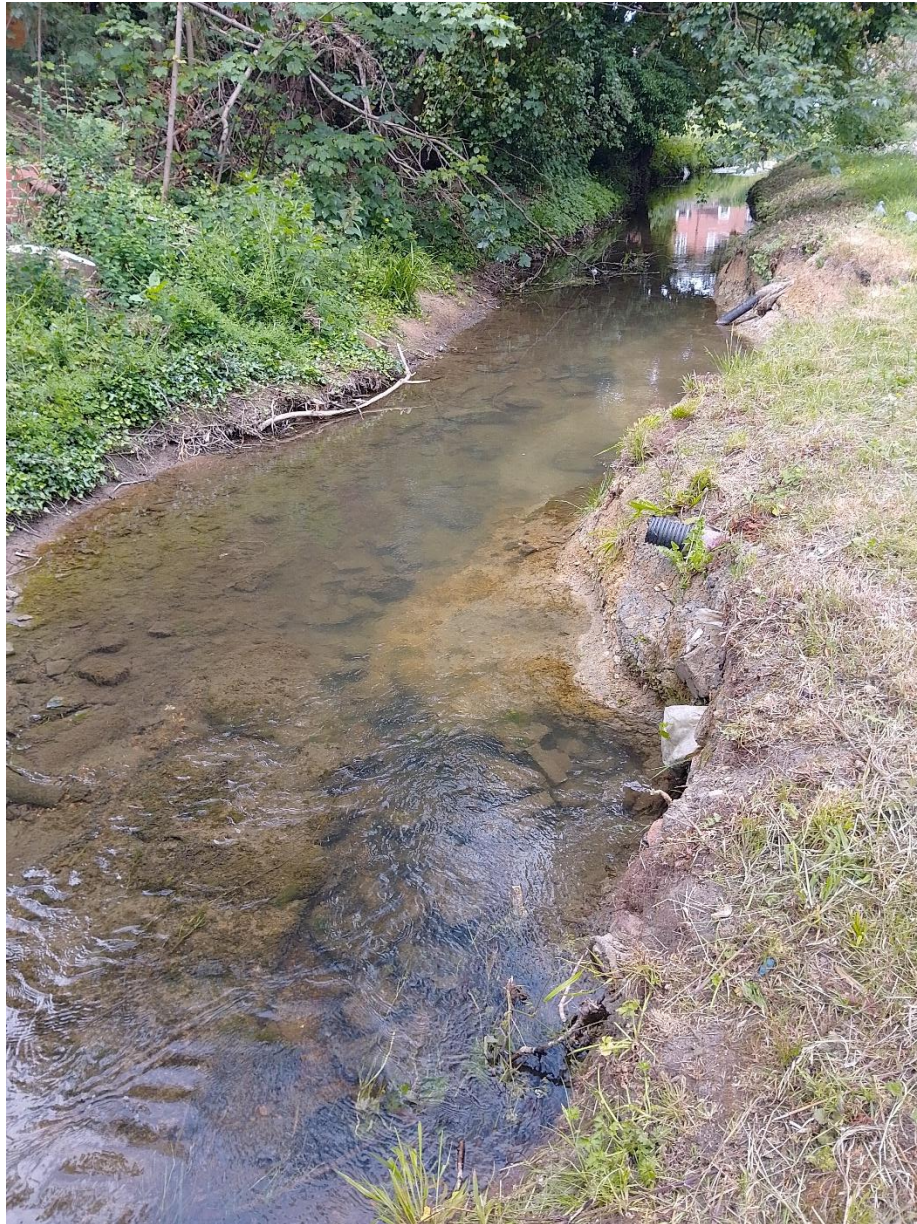
Photo 19 Points of bank erosion and unknown flexible pipes entering the river along the right-hand bank. Unvegetated and un-naturally high banks are very susceptible to erosion. Overly rapid (accelerated) rates of erosion create issues for stream ecology as fine particles of riverbank soil settle on the bed, smothering available habitat for fish and invertebrates. The reason for the pipes and what they are doing should be identified. If discharging to the watercourse, there may be implications for water quality (assuming they aren't for abstracting water).

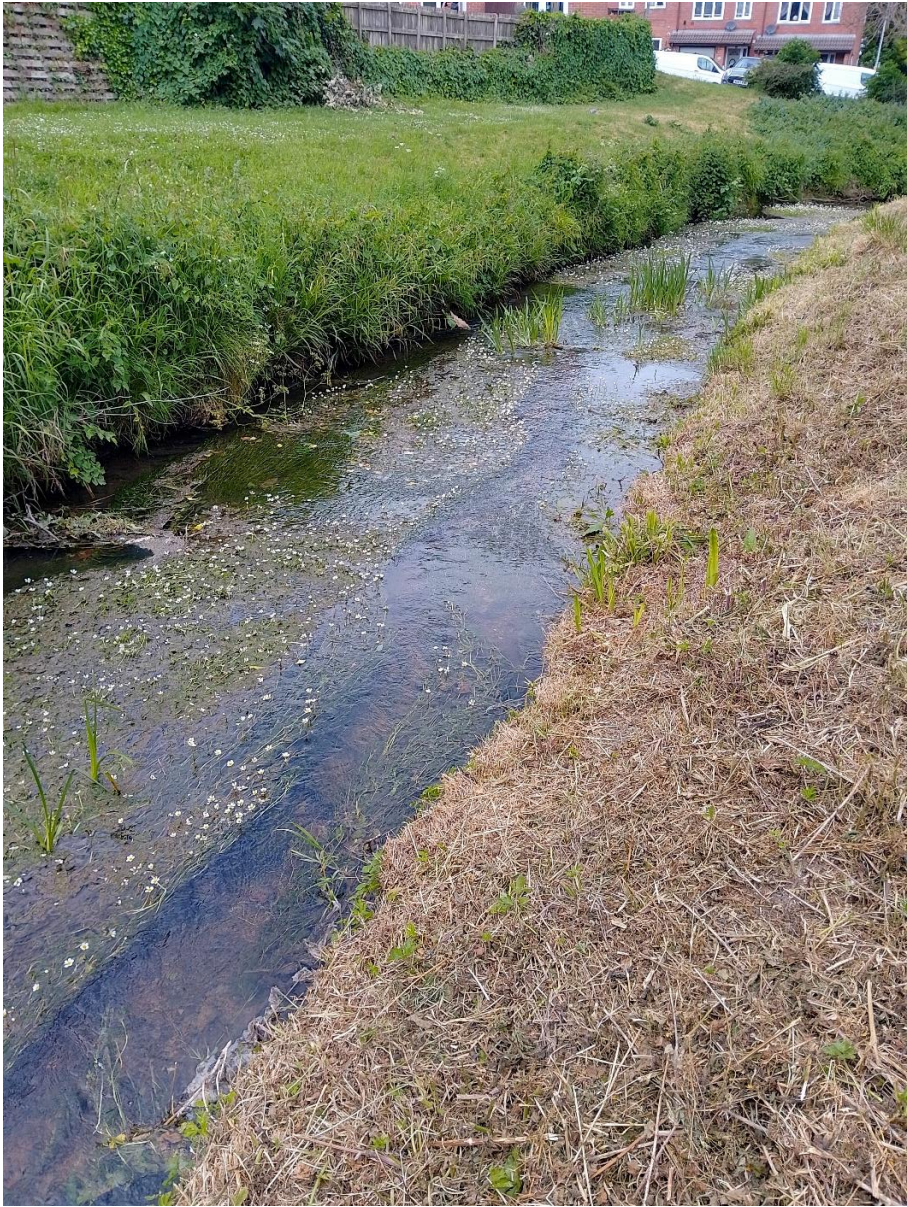
The final section of watercourse reviewed on the day had open grassy banks on both sides. The grass has been heavily strimmed, limiting habitat value. With less tree shade here, in-channel plant growth is now much more prolific, with some excellent *Ranunculus* growth mitigating the lack of habitat in the channel and margins of the high banks (Photo 20), although only during the summer. *Ranunculus* can exert a strong, beneficial influence on flows, by narrowing the channel to speed flow up between clumps of plant growth (and keep the riverbed clean of silt) and slowing flow down

Photo 20 The final section reviewed, running down to the Gloucester Road. Nice in channel plant growth is present in between the modified banks and channel.
