WILD TROUT TRUST

River Chelt

Guardians of the River Chelt

2025

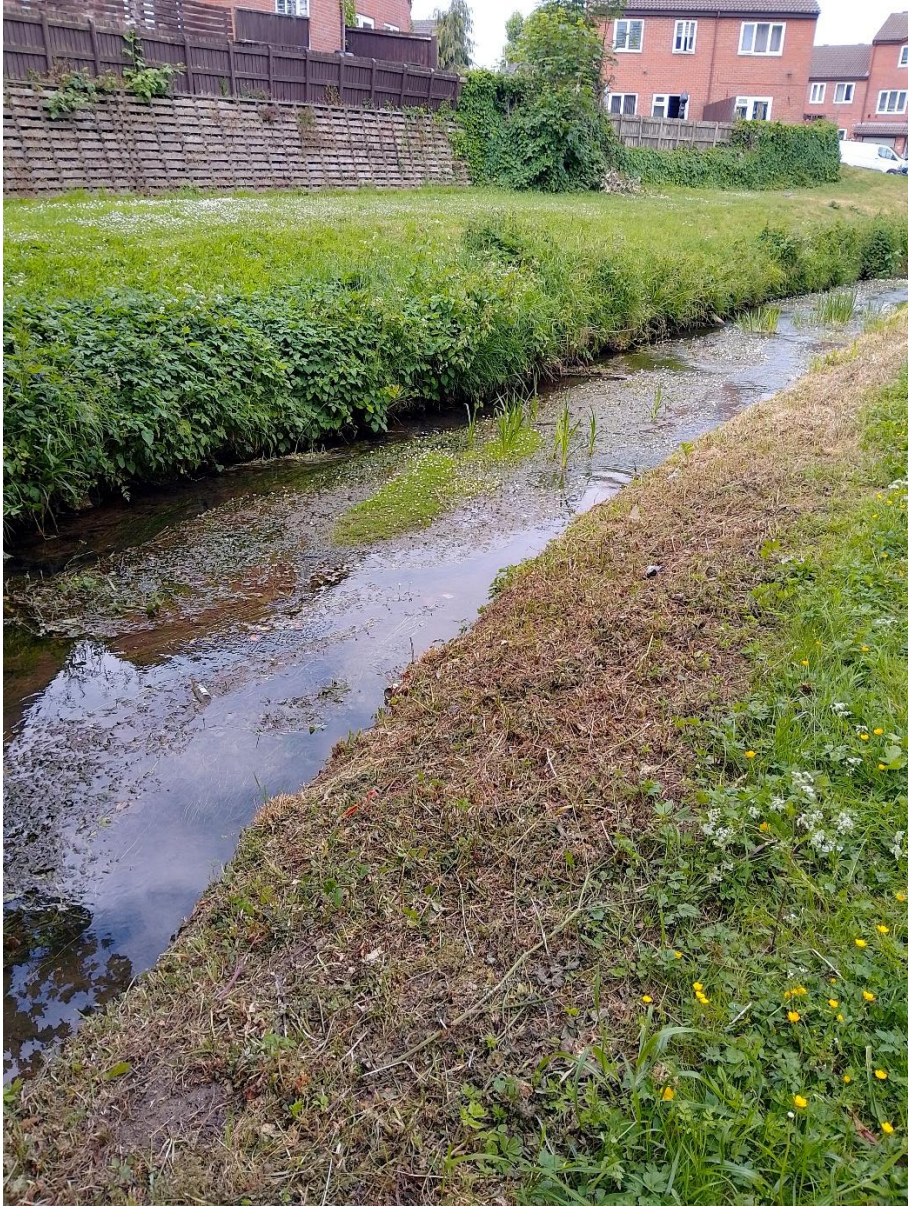
Once again, the channel of the Chelt has been artificially deepened and straightened, in between high banks, in the interest of water conveyance and flood risk management. In this situation, the bankside material is again taking up space that could be used for flood water capacity. Once the river level gets to the top of the bank, it can then only spread toward the surrounding infrastructure and homes. Regrading both the left and right bank and removing spoil, plus removing any throttles and impoundments to flow downstream, will provide much better flood resilience and capacity before it spreads to the surrounding area (or help avoid this). This will also help natural vegetation growth occur with water plants growing in the right places to help drive habitat quality.

Photo 21 Removing a large amount of the bankside material here would increase flood water storage capacity, while also giving an opportunity to lower bank heights, re-meander the watercourse and create bed level diversity and

subsequent variety in flow. It would also provide an opportunity to reinstate some natural and local material in the riverbed, especially gravel and pebble sized substrates for trout spawning. Giving the watercourse more space by regrading banks could offset allowing natural habitat features to evolve flood capacity wise. Leaving the water crowfoot and allowing a small marginal fringe of vegetation to develop will provide a huge boost to both aquatic wildlife and general insect life (especially pollinators) – equally important to local bird and bat food webs.

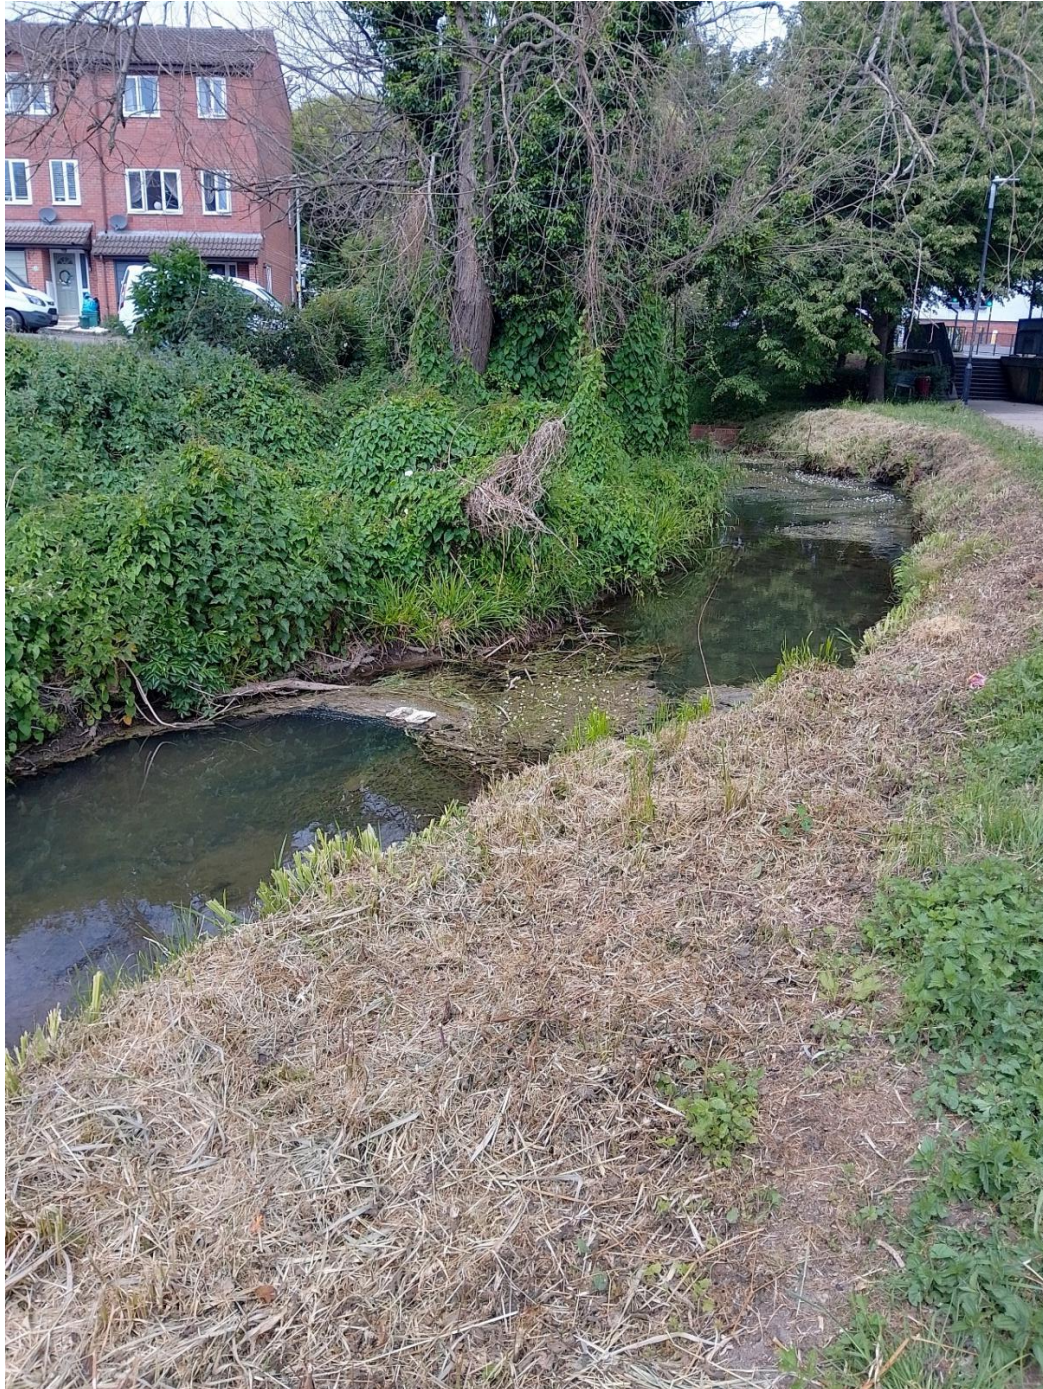
Photo 22 The end of the section of Chelt reviewed at Gloucester Road. The end of the channel that can be seen in the middle distance becomes quite constrained and a small brick wall interacts with the channel. This should be reviewed to avoid any influence on flood water being backed up by the constraint here.
