Advisory Visit Chinn Brook, Druids Heath

Advisory Visit by Paul Gaskell (pgaskell@wildtrout.org)

13/04/2022

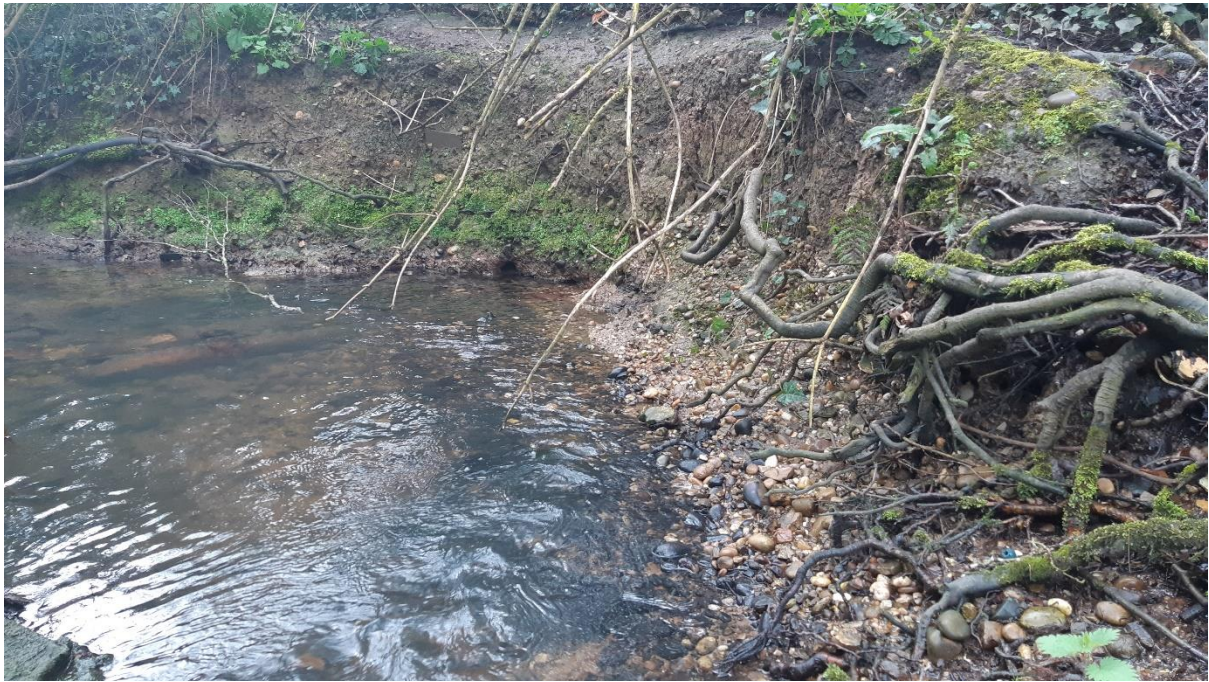
The reach was walked from downstream to upstream, with observations recorded sequentially. At the downstream limit of the reach, natural processes of erosion and deposition had created varied habitat features of high ecological value (Fig.1). Meanders – along with gravel-bed deposition and scour-pool formation – were promoted by the naturally-arising large woody material in the channel (Fig. 2).

Figure 1: Natural erosion providing valuable inputs of gravel. Note the reinforcing influence of tree roots which helps to keep erosion within manageable limits - while also promoting a meandering channel planform.

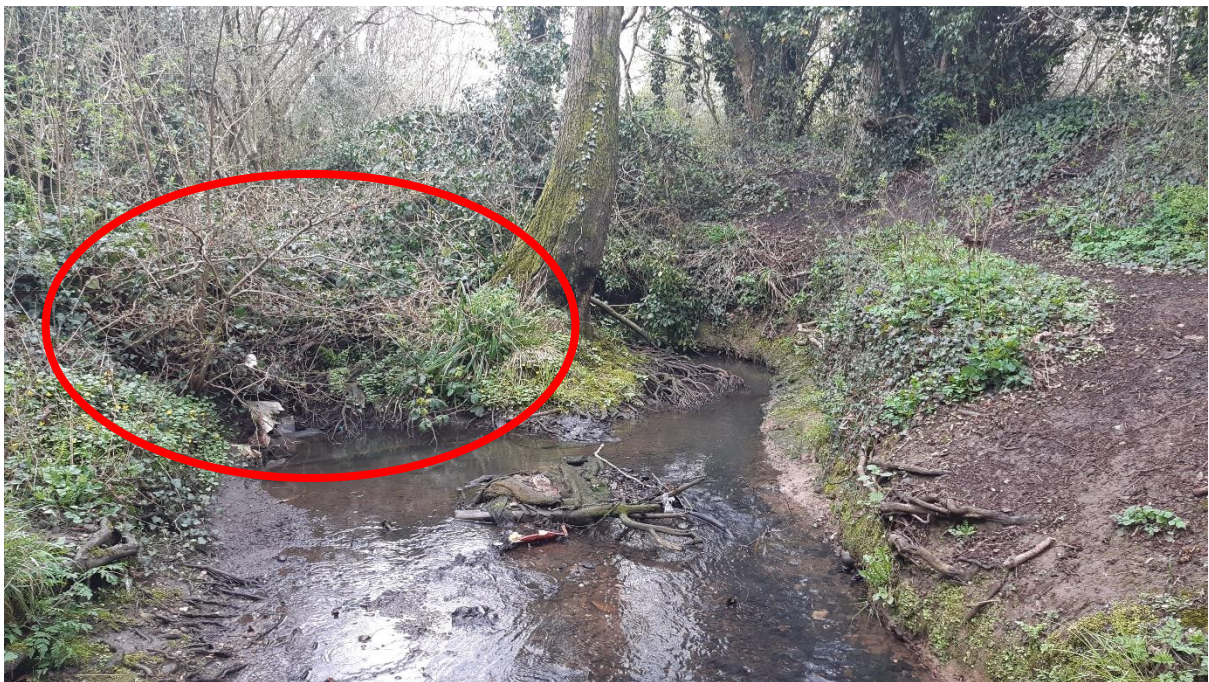
Figure 2: Natural and stable input of large woody material. The fallen tree (circled) is promoting additional structural diversity - while also helping to retain leaf litter (a vital food-source for a significant component of aquatic food-webs, particularly in rain-fed rivers).

- Undertake regular “balsam bashing” to hand-pull and compost Himalayan balsam on-site prior to plants setting seed
- Retain large woody material and naturally-arising debris-dams within the watercourse (over time these will encourage natural meandering and also help to retain essential leaf-litter to support aquatic and terrestrial foodwebs)

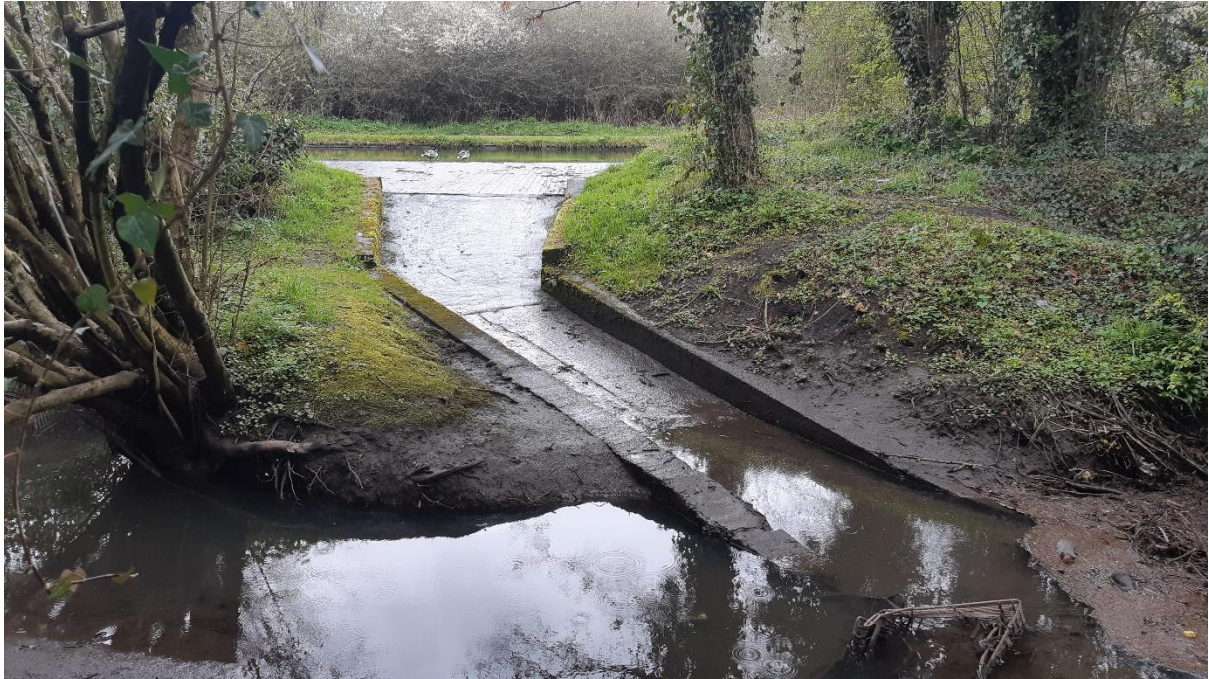
One potential source of nutrient enrichment (due to effects of boat-traffic, resuspension of nutrient-rich sediment and associated algal-growth) is the canal overspill at SP0735679242 (Fig. 3). However, while some larger olive nymphs were found in the Chinn Brook upstream of this overspill, it appears that there are other sources of elevated nutrients as well as the canal.

Figure 3: Canal overflow entering the Chinn Brook on the LB. The fallen tree shown in Fig.2 is a few metres downstream, outside the right hand side of the frame.

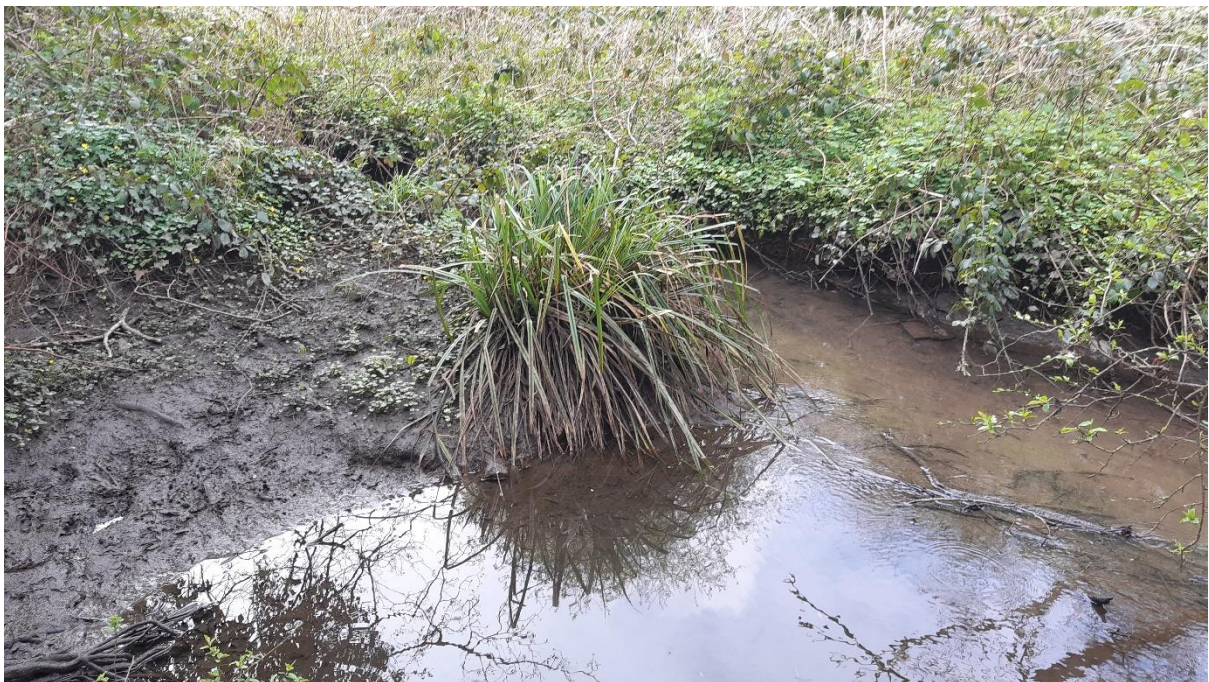
Upstream of the canal overflow, there is an offshoot to what was previously the natural channel – now heavily overgrown but also providing some good, wetted, habitat. The confluence between the original channel and the new, straightened channel is shown in Figure 4.

Figure 4: Confluence between old channel (lower left corner) and new channel (mid-to right of frame). Neither channel is fed by the canal overflow at this point.

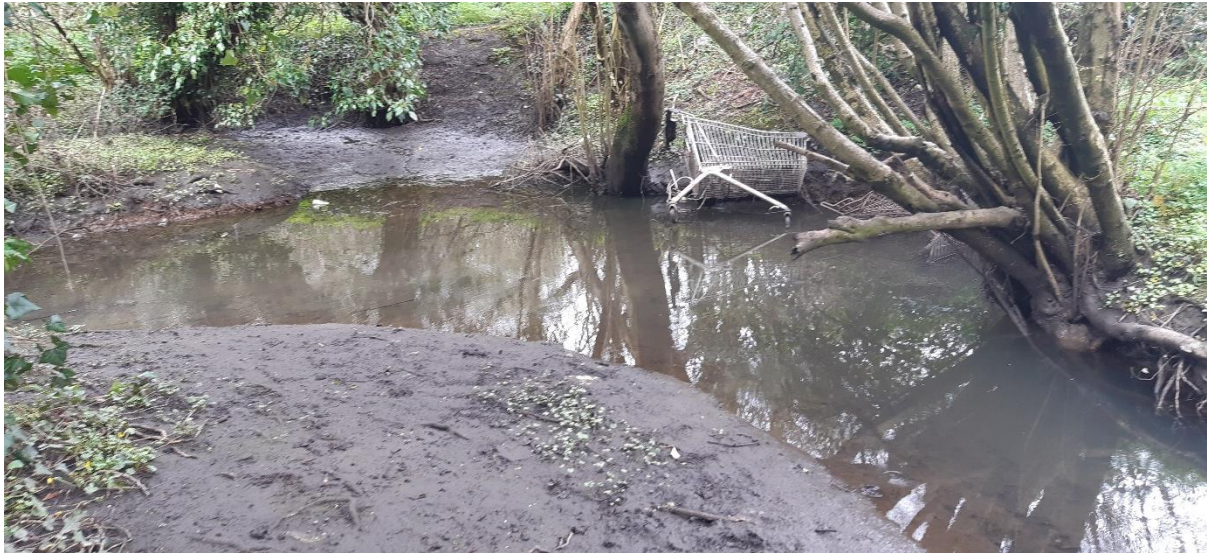
Discarded shopping trolleys and other litter was evident in this area (e.g. Fig. 5). Probably the most pragmatic approach to this is to remove the most

Figure 5: Discarded trolley in plain view of anyone walking along the brook. This item is worth removing as part of regular custodianship duties. Other items – such as extensively-colonised carpet off-cuts – are very difficult to spot and are also supporting a variety of flora and fauna. These are best left in place.

visible items – while leaving others that are being reclaimed by the fauna and flora of the brook. As long as the materials are relatively inert and visually difficult to notice, it may do more harm than good to rip out dumped items. However, very prominent items tend to act as “permission” to continue or accelerate the frequency of littering. For this reason, they are best removed.

- Undertake selective trash removal working parties to improve the visual amenity value of the brook
 - Leave or re-position dumped materials that have been extensively colonised by flora and/or fauna

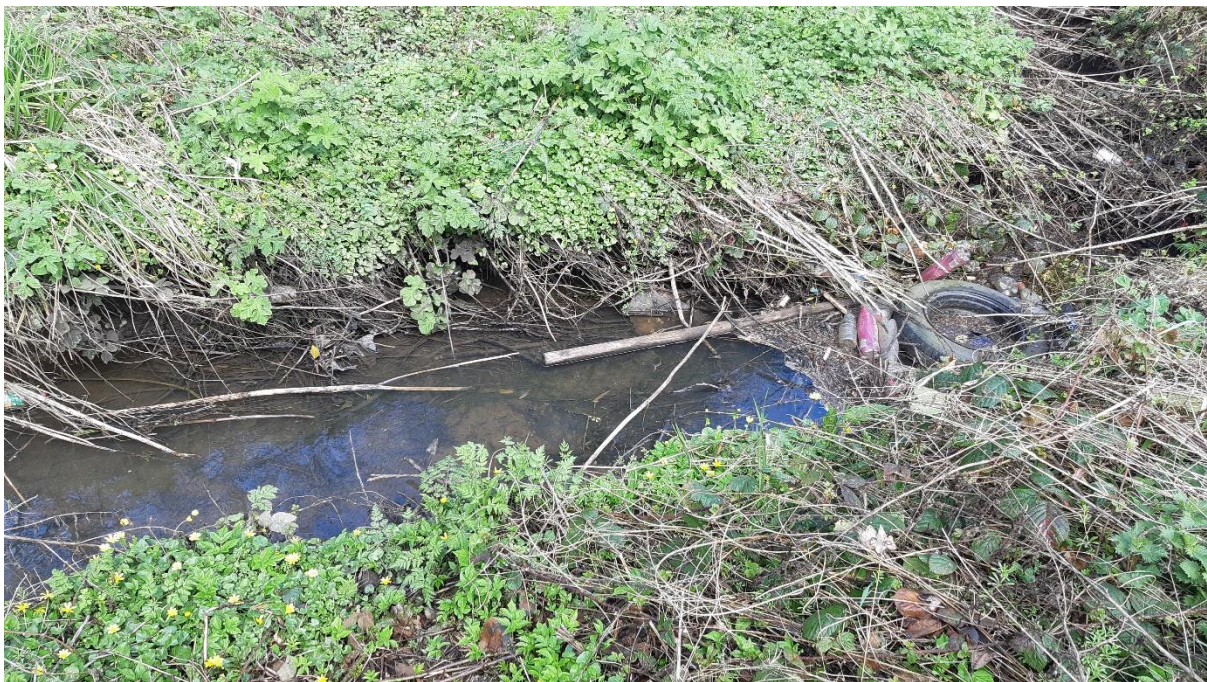
The main Brook channel upstream of this point is characterized by an artificially straightened planform, with a degree of incision below the adjacent floodplain (Figs. 6 and 7).

Figure 6: Straight, incised channel with vertical banks, uniform slow flow and trash trapped in debris dam.

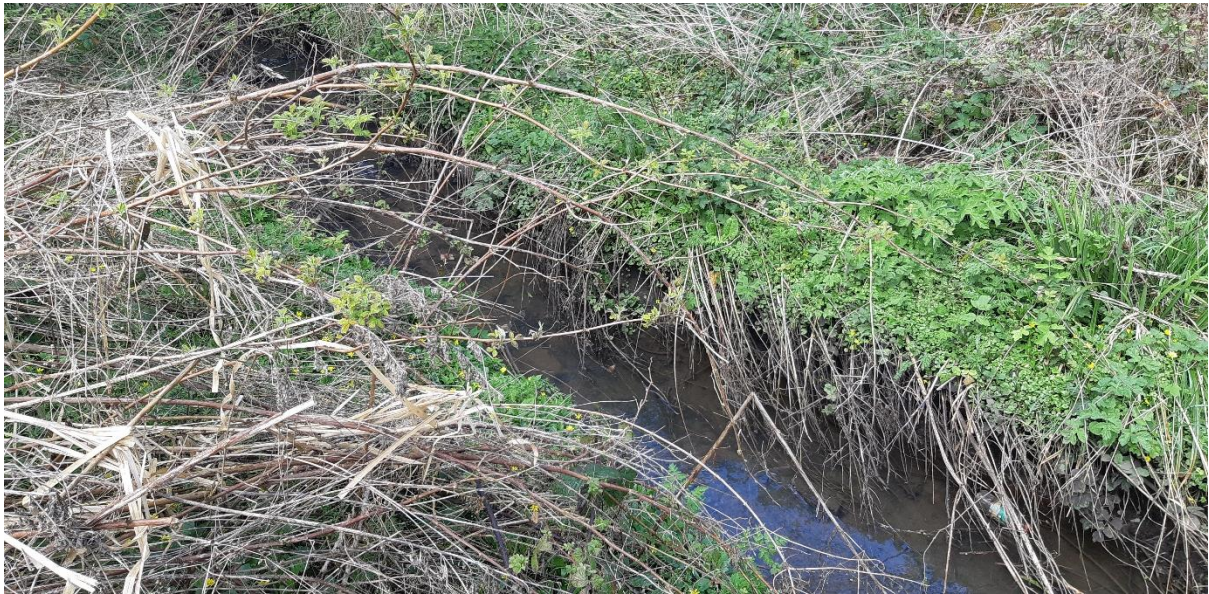
Figure 7: Incision below the flood-plain and steep, near-vertical banks on both sides of the channel. Note how it is far easier for vegetation to encroach and choke the channel than in natural sections.

This is a typical effect of straightening a channel. Whether simply a result of how it was dug – or whether the straightening initially made the channel steeper and caused it to erode downwards – the banks are now close to vertical. There is a marked “step” between the surrounding bank-top and the water’s surface under normal flow conditions. While trailing vegetation is providing some cover, the overall effect of slowing and straightening the brook has reduced habitat structural diversity. Biological diversity tends to map onto structural diversity due to a greater variety of opportunities for different species to exploit.

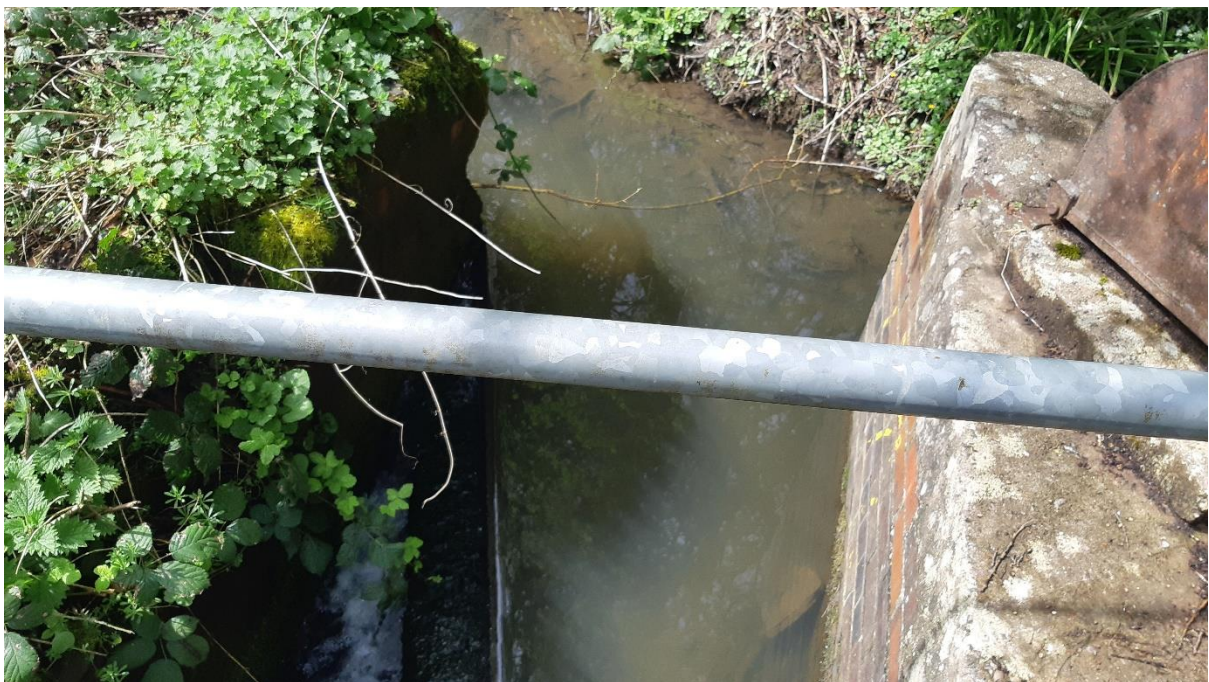
Figure 8: Facing upstream into the impounded reach above the weir.

Relative to the width of the brook, a very tall weir has been built at SP0729779204 (Figs.8 and 9). This creates a long reach of straightened, impounded flow upstream and creates a huge barrier for both upstream and downstream fish passage.

- Identify the reasoning behind the original straightening of the brook (and the party/parties responsible)
- Identify what the purpose of the weir is/was and whether bypassing is (or can be made) feasible
- Seek funding to support the connection of a nature-like, meandering channel to the obvious paleochannel (and transform the blocked-off, straightened channel into areas of wet woodland)

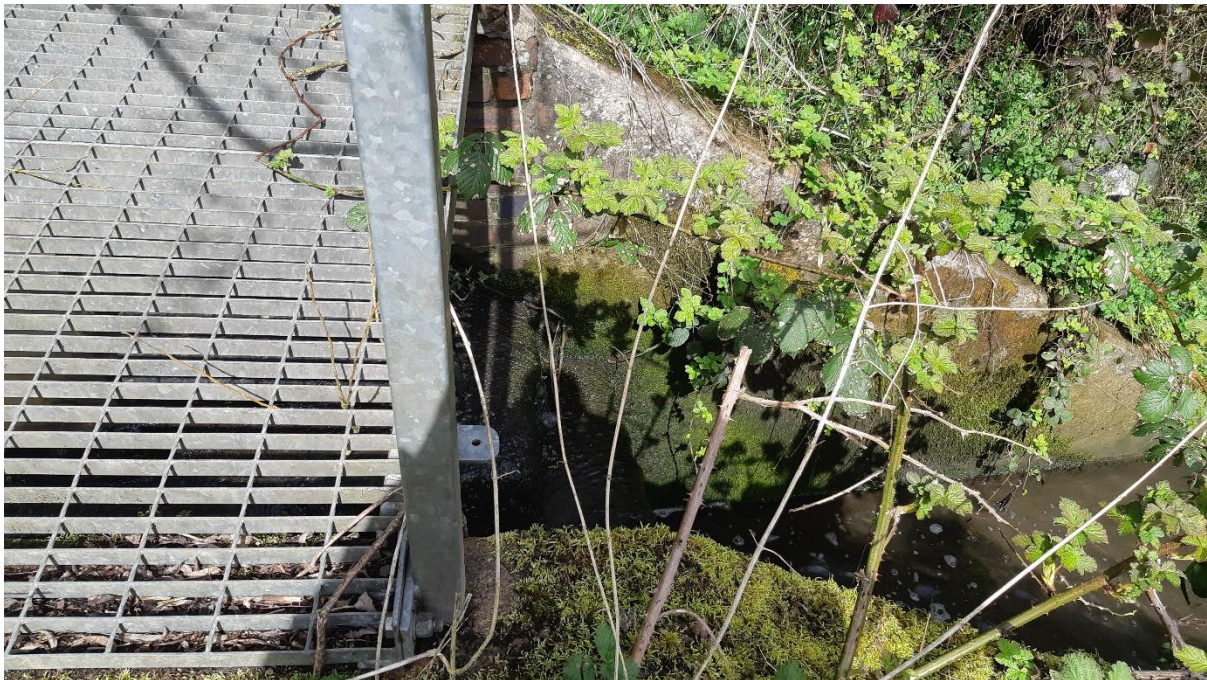
Figure 9: View from the side of the weir at SP0729779204

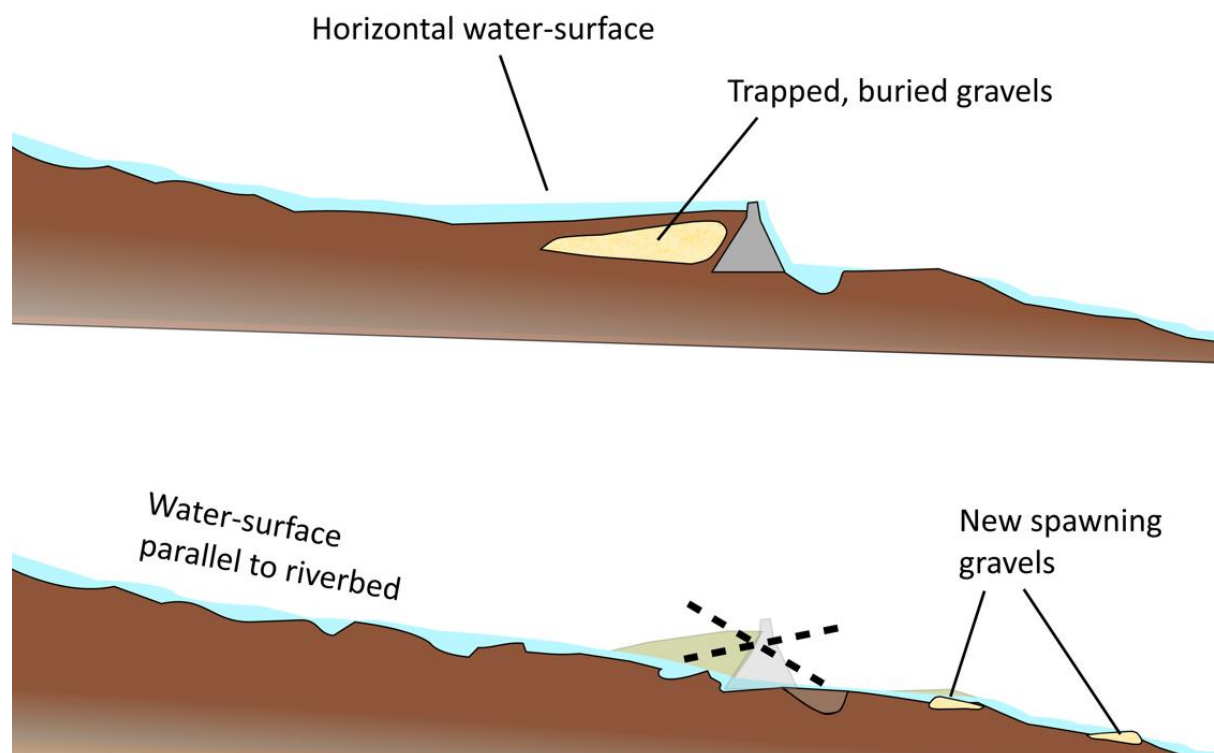
Figure 10: Impounded sections of river create unnatural "steps" in the longitudinal gradient. The interception of valuable substrate behind weirs interrupts its supply to downstream reaches. Under natural conditions the water surface should be parallel to that longitudinal slope – whereas large impoundments create a horizontal water surface with greatly reduced flow velocity.

While the basic barrier-effect of weirs is relatively widely appreciated, weirs also create a range of more subtle impacts. Figure 10 gives an indication of generalised impacts of weirs (or series of weirs) on the capacity of rivers to generate varied, high-quality habitat.

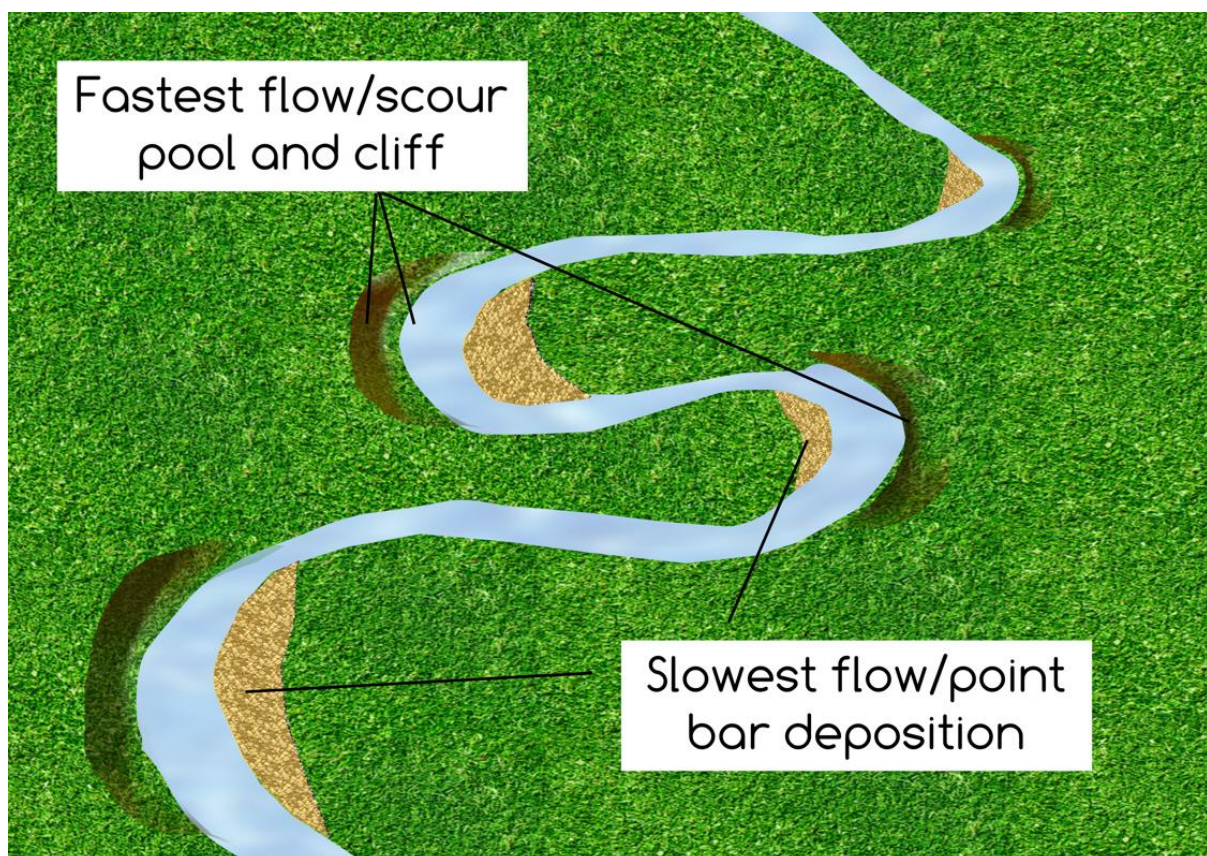
The value of a naturally meandering planform in terms of diversifying habitat structure is easier to appreciate with some explanatory diagrams (Figs. 11 & 12).

Figure 11: When meanders form naturally, the faster flow on the outside of the bend scours deeper pool habitat. The arising material is subsequently deposited downstream as point bars (and riffles) in the slower flows caused by friction between water and the riverbed.

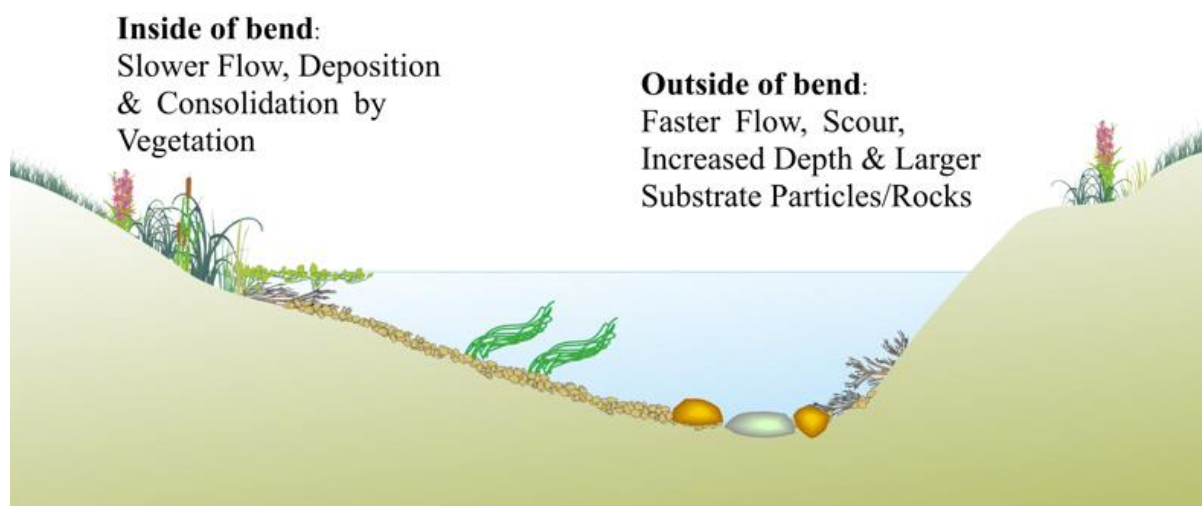
Figure 12: The benefits of natural river process can be seen in a typical cross-section through a bend. Each depth and velocity band over that cross-section will have its own characteristic flora and fauna. In contrast to pools formed by impounding water (which fill in with deposited material over time), sediment is continually scoured out of bend-pools.

Contrast the cross section shown in Fig. 12 with the trapezoidal cross-section shown in Fig. 13. Hopefully it is easier to see which has the greater diversity of micro-habitat niches to support more aquatic life (including fish populations which depend on the full food-web of a river). Natural cross-sections also have greater resilience to low-flow conditions by allowing flowing water to be focused into narrow channels. In over-capacity box-shaped channels, low flows often form separate ponds of stagnant water.

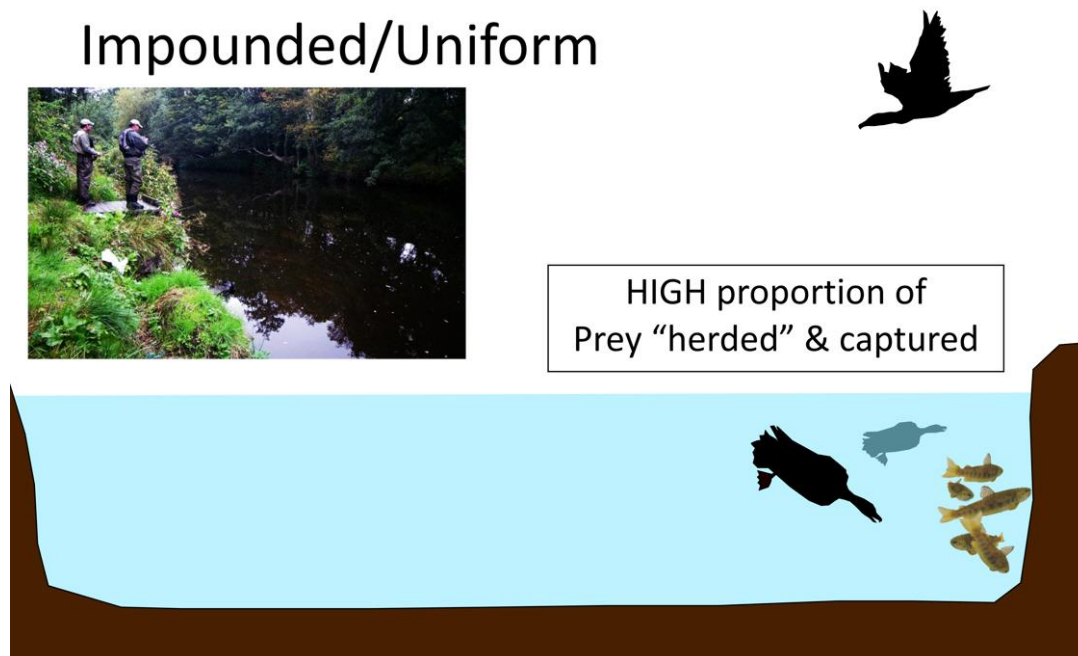
Figure 13: Trapezoidal, uniform cross-section. Simple habitat provides fewer niche opportunities and also disproportionately favours predator-efficiency.

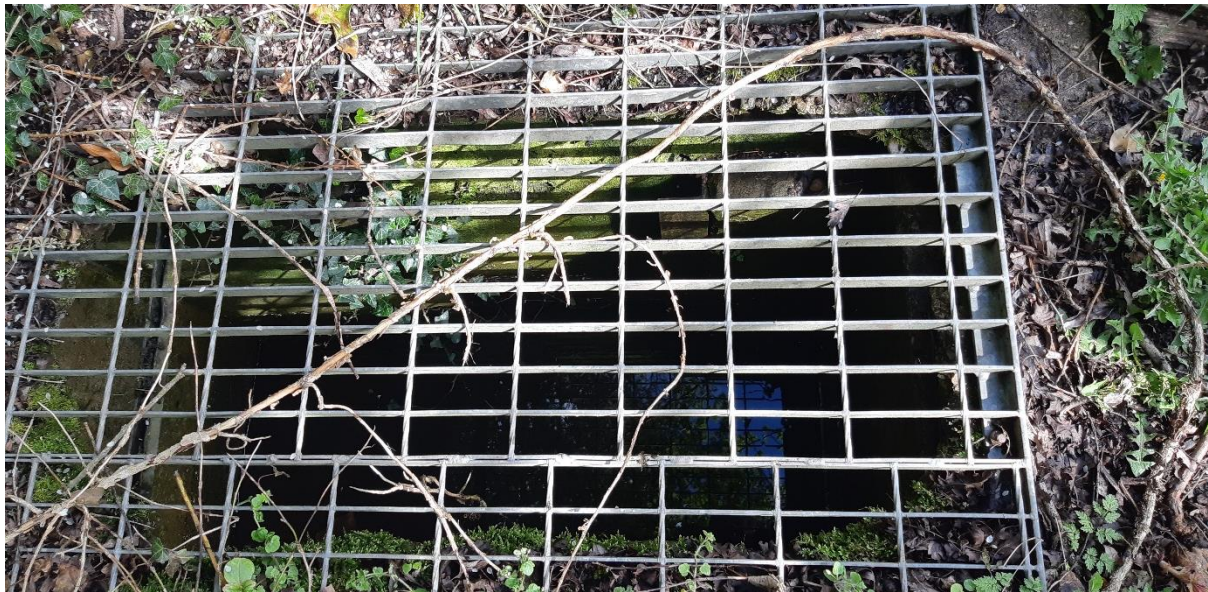
Looking down into the structure of the weir, it seemed as if a previous connecting duct/goyt has been blocked off (Fig. 14); though formal confirmation of that would be required.

Figure 14: Looking down into chamber fed by the weir – with an apparently sealed connecting goyt – suggesting the weir may be redundant in terms of water diversion.

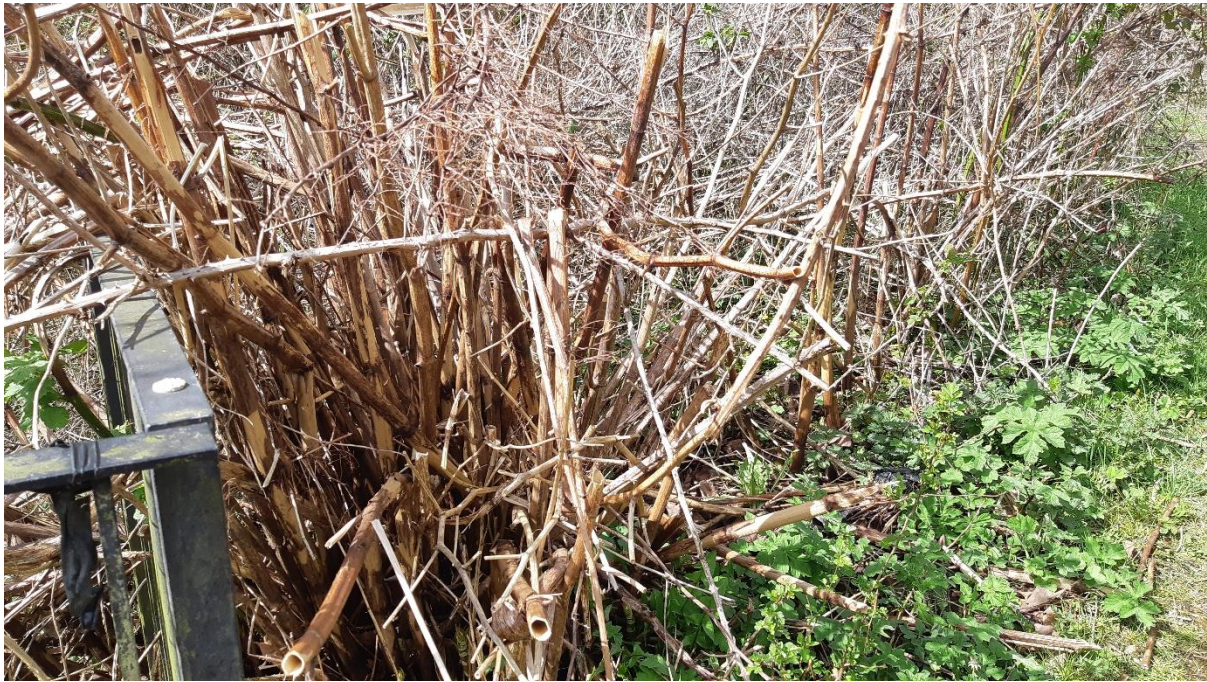
Both directly adjacent to the bridge at SP0725379197 (Fig. 15) and also around seven to ten metres away from the watercourse on the LB (Fig. 16), dead canes from a stand of Japanese knotweed (*Fallopia japonica*) were noted. This invasive, non-native plant tends to spend quite a long time as a relatively small patch – while it establishes an extensive underground rhizome (root) mass. After reaching a certain tipping point, the increase in coverage quickly overwhelms native plant species and has a strongly negative impact on biodiversity.

Figure 15: Dried Japanese knotweed canes left behind following winter die-back. The rhizomatous mass remains alive underground and will produce vigorous re-growth of new canes through the warmer months of the year.

Consequently, treating stands of knotweed while in that initial, relatively controllable, lag-phase of growth can significantly reduce both the costs of dealing with it and the damage associated with exponential growth. Unlike Himalayan balsam (*Impatiens glandulifera*), Japanese knotweed cannot be easily controlled via hand-pulling, strimming or other mechanical methods. In fact, attempting that will accelerate the spread of an infestation – and would constitute an offence under the Wildlife and Countryside Act 1981. Instead, it requires specialist herbicide treatment by accredited personnel.

Since control, would be an acceptable ecological outcome (compared to construction sites where total elimination is the only option), stem injection with glyphosate-based herbicide is likely to provide the most cost-effective control. This also carries the lowest risk of impacting surrounding, native flora. For dedicated groups of local custodians, it may be possible to undertake appropriate training and accreditation (City and Guilds/NPTC PA1 and PA6 including PA6 stem injection) in the use of herbicides adjacent to

watercourses (and also purchase the appropriate stem-injection, pesticide storage and personal protection equipment). However, the simplest approach may be to employ suitable contractors to inject any stands of knotweed identified.

- Instigate visual (and if possible optical-brightener) monitoring of the main outfall at the upstream end of the visited reach (Fig. 23)
- Fund and carry out control of Japanese knotweed on the site by accredited personnel via stem injection (repeated as and when necessary)

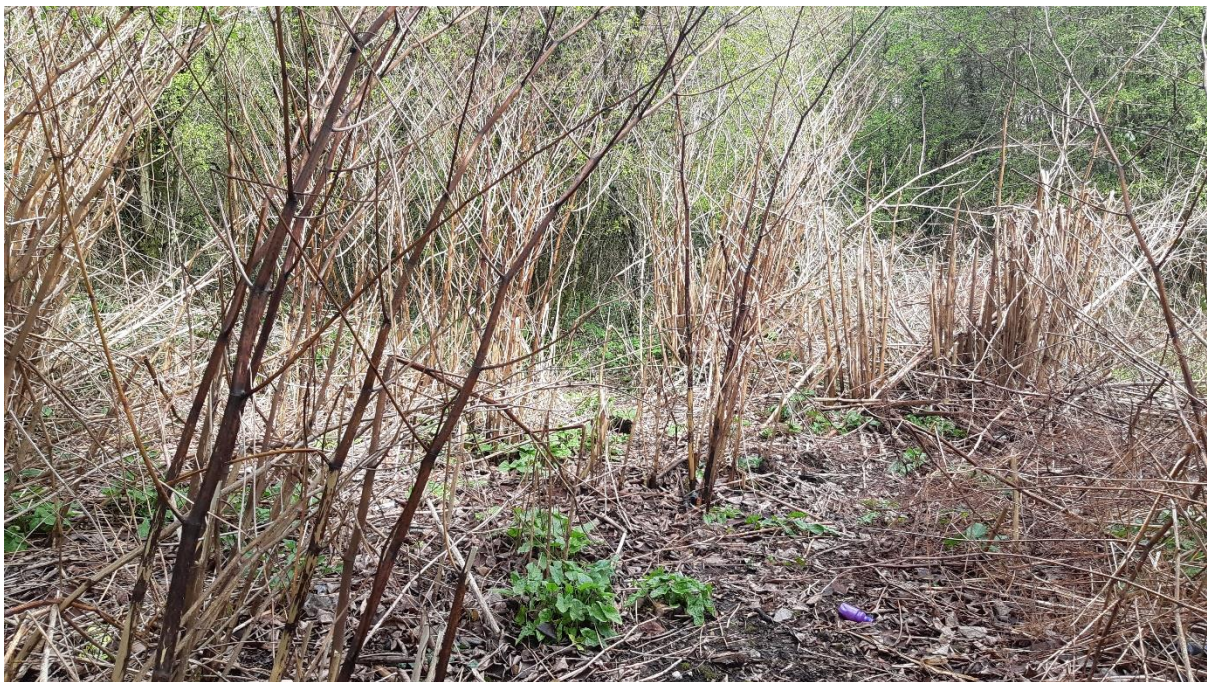
Figure 16: Stand of Japanese knotweed several metres away from the watercourse. It is possible that the rhizome network from this stand is connected to the smaller stand adjacent to the bridge shown in Fig. 15.

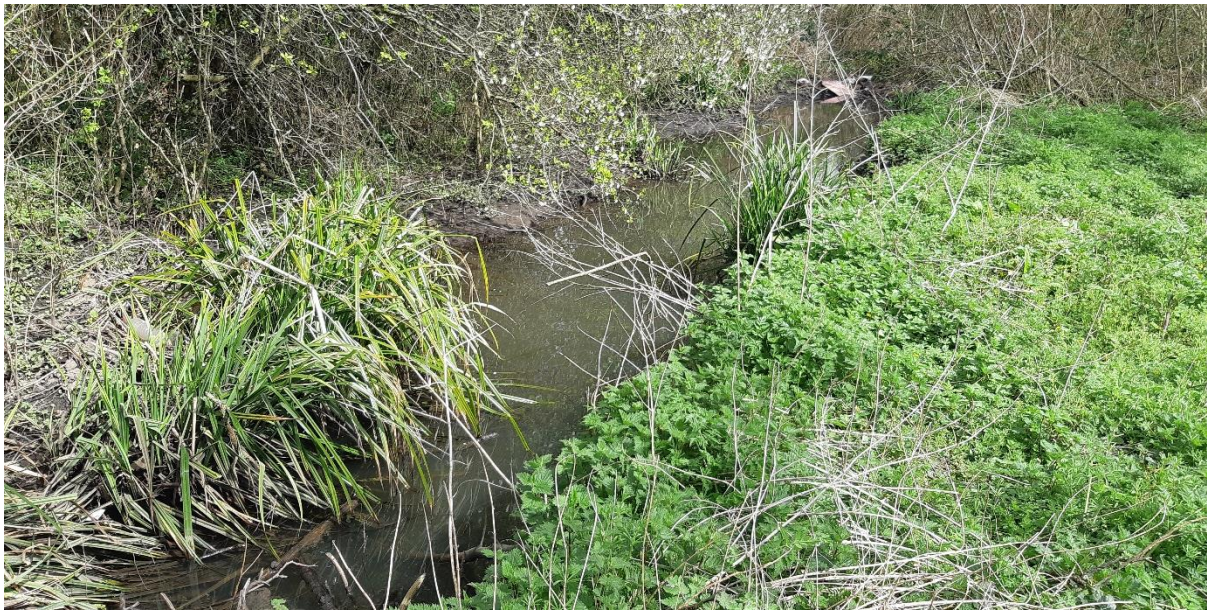
The combined effects of impoundment and straightening of the channel are very obvious for considerable distances upstream. For instance, the brook at SP0718979176 (Fig. 17) shows extremely uniform characteristics of flow velocity and cross-sectional depth profile.

Figure 17: Uniform depth and flow-velocities over the full cross-section in a box-shaped artificial channel. Marginal vegetation provides some structural variation and shelter from predators but cannot mitigate the overall severe habitat degradation.

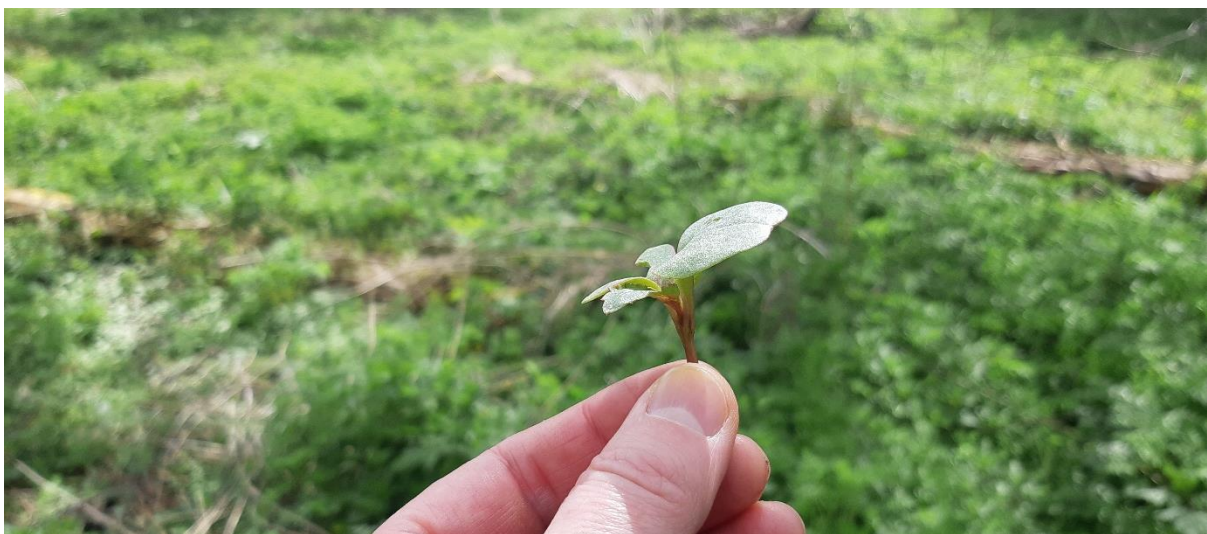
Extensive stands of Himalayan balsam grow on the RB here (Fig. 18).

Figure 18: A significant area of the ground vegetation coverage in the background is made up of Himalayan balsam seedlings in this area.

Fortunately, it is at least possible to control stands of Himalayan balsam by hand-pulling before the plants set seed (and composting the resultant

stems on-site, but well away from any watercourse, to avoid spreading the infestation). With repeated efforts to account for early and late flowering individual plants, it is possible to gain good control over Himalayan balsam within two to three years. Their seeds tend to only remain viable for less than three years in the seedbank. When viewed in the context that many native plant species lay down seed that can remain viable for centuries, then prospects for recovery are good.

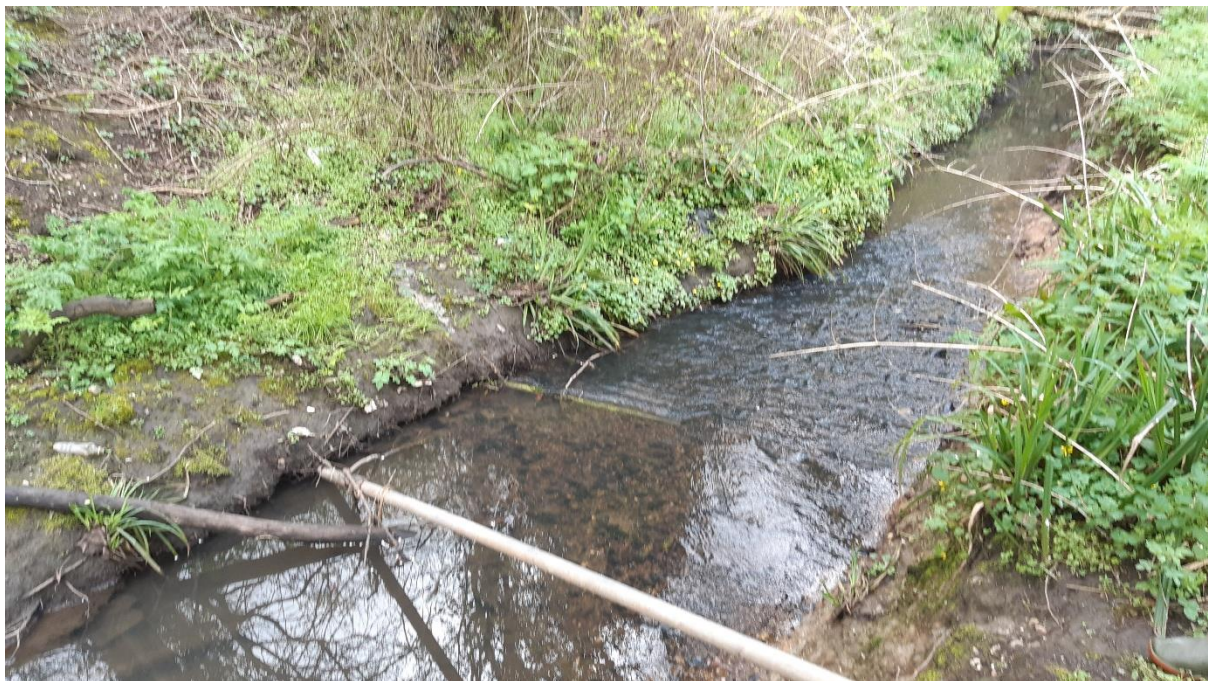
Although the brook shows some very limited signs of recovering a more natural, meandering planform (e.g. Fig.19), the rate of such recovery will be limited by the impounding effect of the weir.

Figure 19: An obvious gradient-break has locally-increased water velocities and a small amount of lateral erosion and deposition has resulted. However, the impounding effect of the weir strongly limits the potential extent of those processes to create significant re-naturalisation of the channel form.

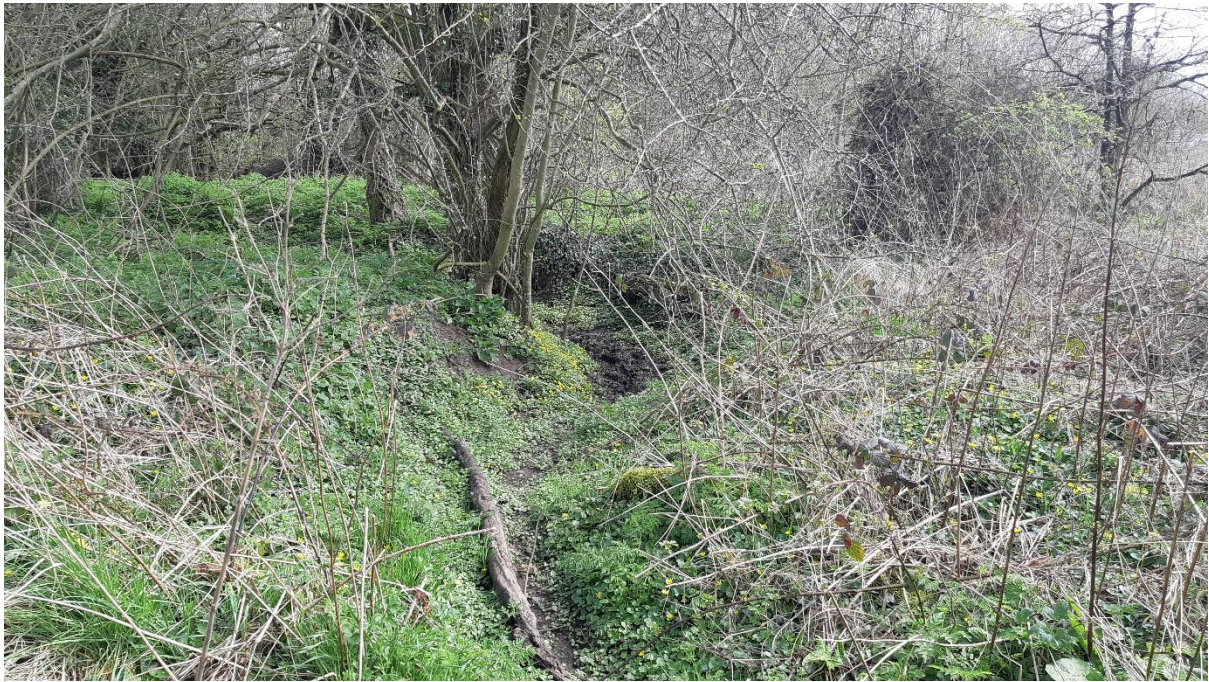
While examining this section, it was possible to back-track and visit part of the flood-plain on the RB-side of the artificial channel. Here, there were clear signs of the paleochannel of the brook (e.g. Fig. 20).

Figure 20: A view along the centre of a section of paleochannel. A small meander winds around the coppice-regrowth towards the centre/left of the frame.

Re-connecting this paleochannel (if necessary, via a designed, nature-like connecting channel) to the current course of the brook would provide a suite of benefits. As well as increasing the potential to incorporate natural

flood-risk management to downstream infrastructure and properties, both ecological quality and the associated community wellbeing benefits would be improved. With interpretive signage, those wellbeing benefits can be maximised by providing visitors to the site with the ability to recognise and appreciate the wildlife associated with a naturalised channel. The common land status of the surrounding floodplain creates an unusually large area around the watercourse in a heavily urbanised setting.

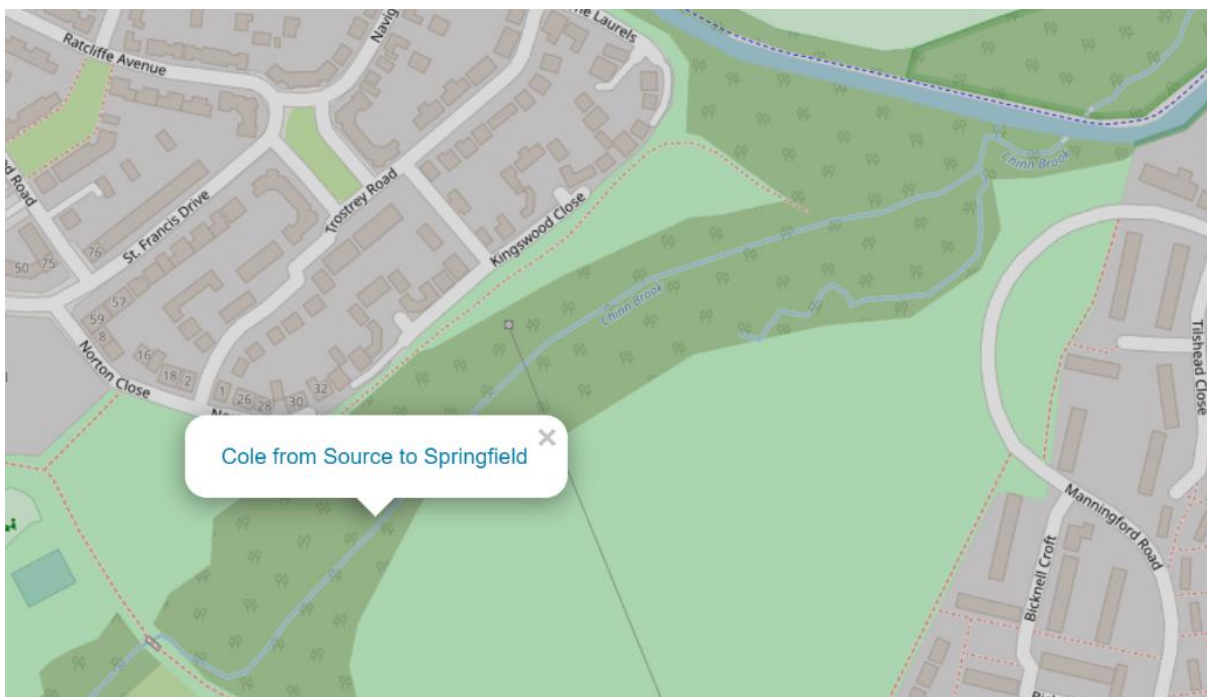
On the EA Catchment Data Explorer map of the waterbody, part of the paleochannel is clearly marked (presumably because it acts as an ephemeral watercourse during heavy rainfall; Fig. 21).

Figure 21: Catchment Data Explorer map with the Chinn Brook annotated as "Cole from Source to Springfield" waterbody. The meandering, cut-off paleochannel can be seen joining the new, straightened, channel just upstream of the canal overspill (upper right corner).

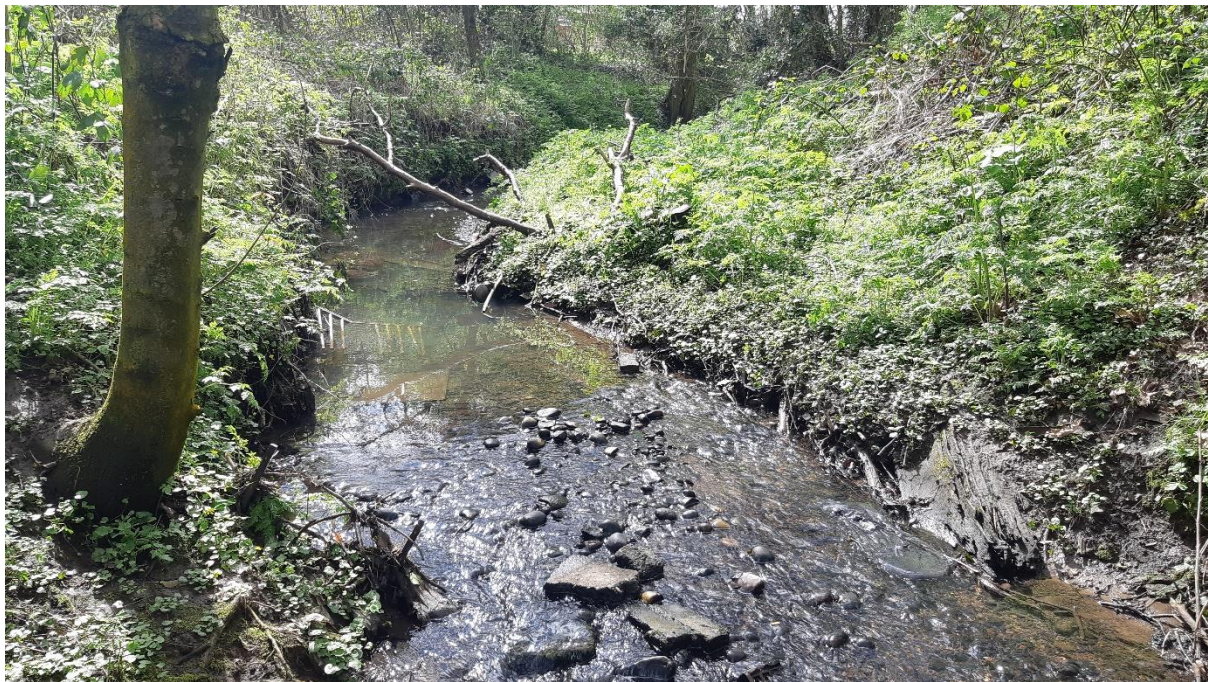
As an indication of what the Chinn brook can (and should) look like, there is a short section of more natural channel towards the upstream limit of the visited reach (Fig. 22).

Figure 22: The brook's characteristics change significantly when allowed to occupy its natural cross-sectional width and depth – providing a far greater range of micro-niche habitat structures.

Consequently, the connection to any re-meandered nature-like channel should aim to join the brook as close to this point as possible (thus minimising any artificially-straightened/deepened channel). Once disconnected from the flow, the current, straightened channel can be retained as wet woodland areas.

Given the extent of the obvious paleochannel, any connection to it should also – easily – bypass the problematic weir towards the lower end of the visited reach. It may also be possible to use further investigative tools (e.g. LIDAR survey data) to identify the complete paleochannel and simplify any channel design work.

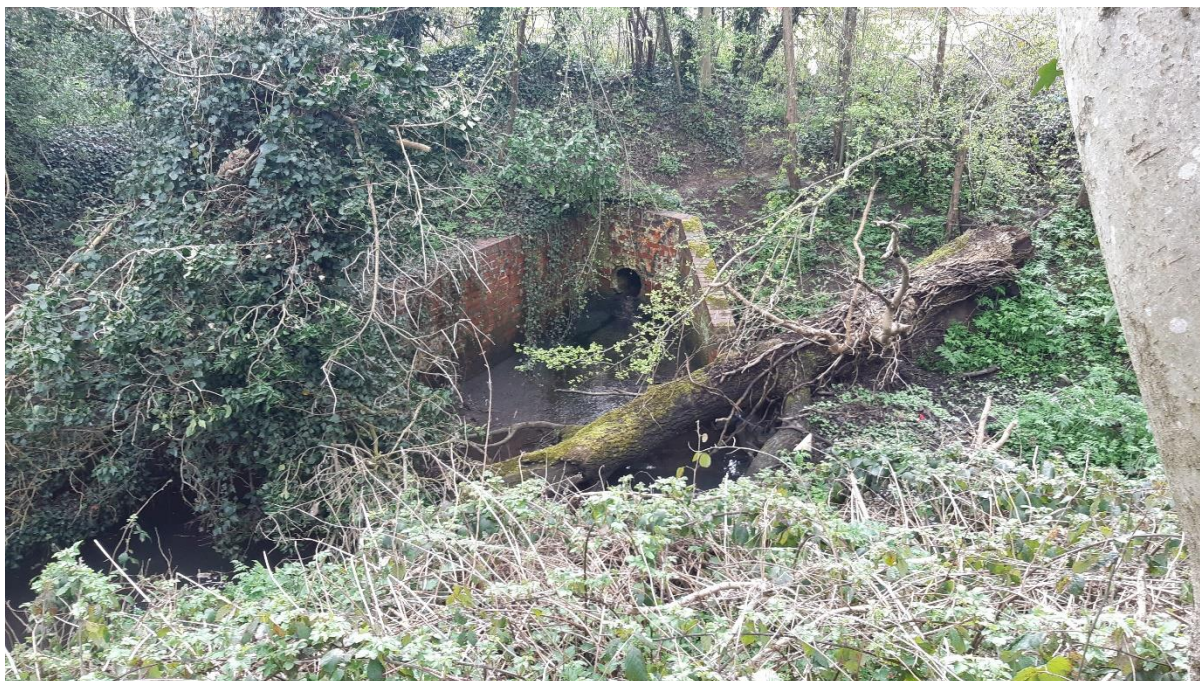
Just upstream from the features shown in Fig. 22, an outfall was noted as a potential source of pollution (Fig. 23).

Figure 23: Simple visual monitoring of this outfall could be augmented by invertebrate monitoring upstream and downstream of the discharge point – and even relatively low-tech tests for misconnections are possible to carry out.

Identifying whether this outfall is creating water quality issues within the brook would be extremely valuable. It should be possible to deploy a suite of investigative techniques to give the best chance of flagging up any problems. Simple visual monitoring to check for the formation of grey “sewage fungus” bacterial biofilm in the area of the discharge is a vital first step. Secondly, the presence of any “optical brighteners” in the discharge itself should indicate whether there are misconnections of residential drains to this outfall point. More details about an unconventional, but cheap, assessment method for testing for optical brighteners (used in many household products, including laundry detergent) can be found here:
