Advisory Visit Chinn Brook, Druids Heath

Advisory Visit by Paul Gaskell (pgaskell@wildtrout.org)

13/04/2022

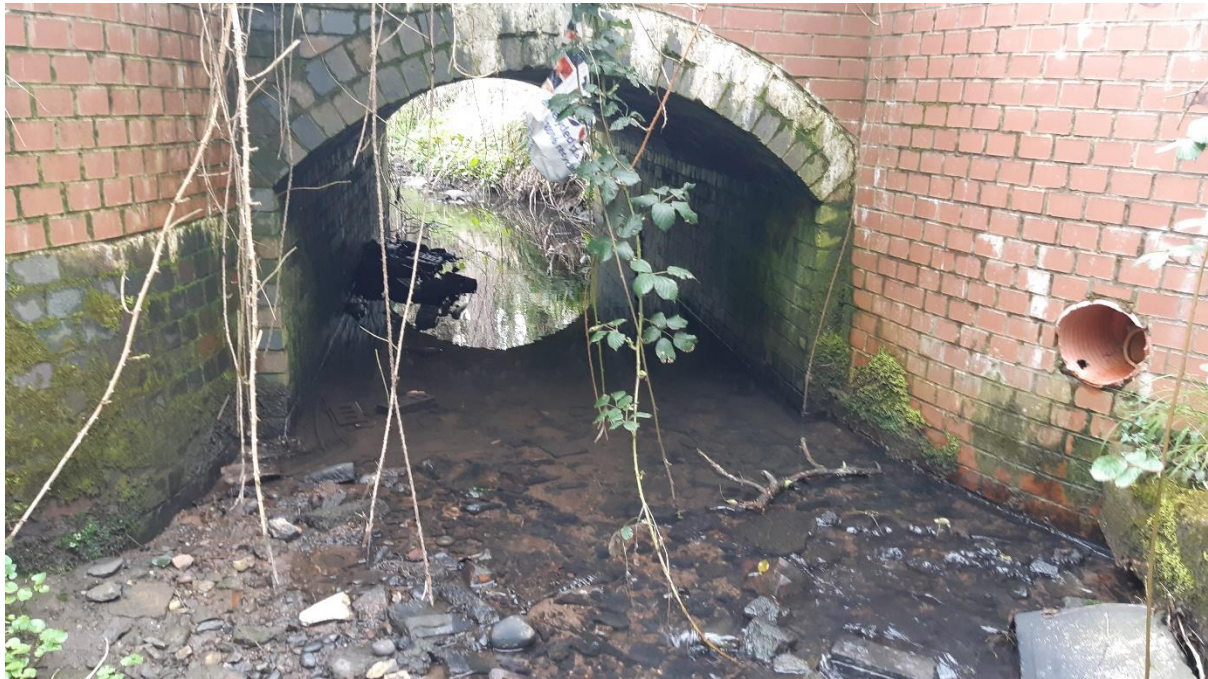
The visit covered in the current report had an upstream limit at SP0688278967 where the brook entered a culvert beneath a road (Fig. 24). The existence of a continuous streambed within that culvert has significant benefits for the general habitat value and also the physical “passability” of that culvert.

Figure 24: Culvert beneath a road at the upstream limit of this visit. Note the continuous streambed consisting of natural substrate.

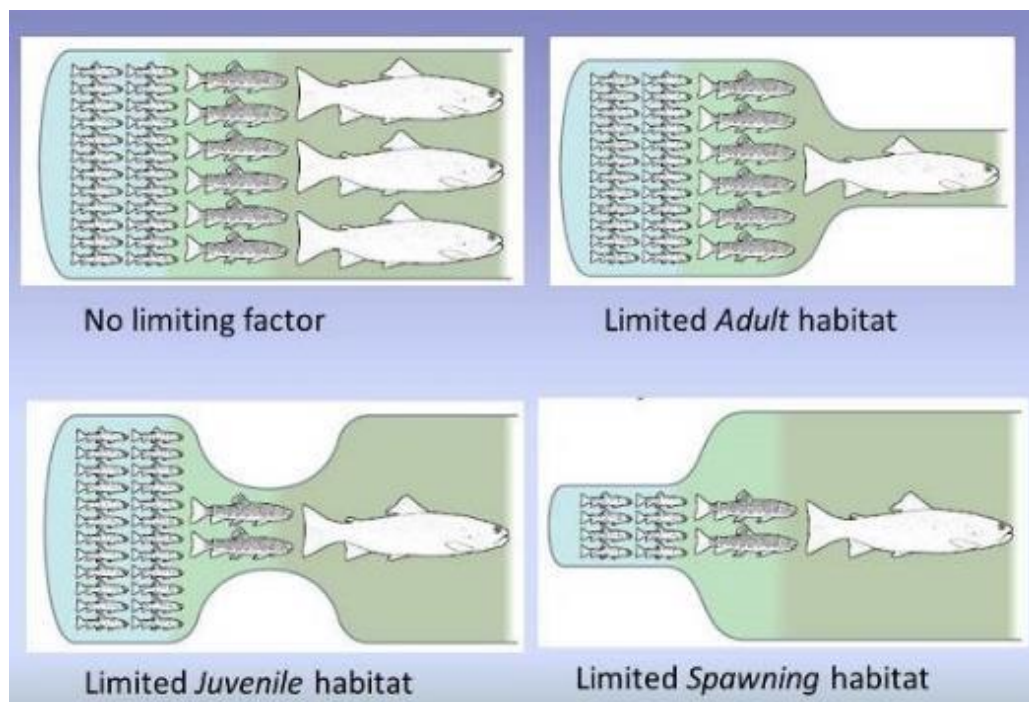
There are three main types of habitat that are needed in order for wild trout to complete each one of three key lifecycle stages (spawning, juvenile and adult; Fig. A1). The consequences to trout populations of a lack of each specific habitat-type are also illustrated in Fig. A1.

Figure A1: The impacts on trout populations lacking adequate habitat for key lifecycle stages. Spawning trout require loose mounds of gravel with a good flow of oxygenated water between gravel grains. Juvenile trout need shallow water with plenty of dense submerged/tangled structure for protection against predators and wash-out during spates. Adult trout need deeper pools (usually > 30cm depth) with nearby structural cover such as undercut boulders, sunken trees/tree limbs and/or low overhanging cover (ideally trailing on, or at least within 30cm of, the water's surface). Excellent quality in one or two out of the three crucial habitats cannot make up for a "weak link" in the remaining critical habitat.

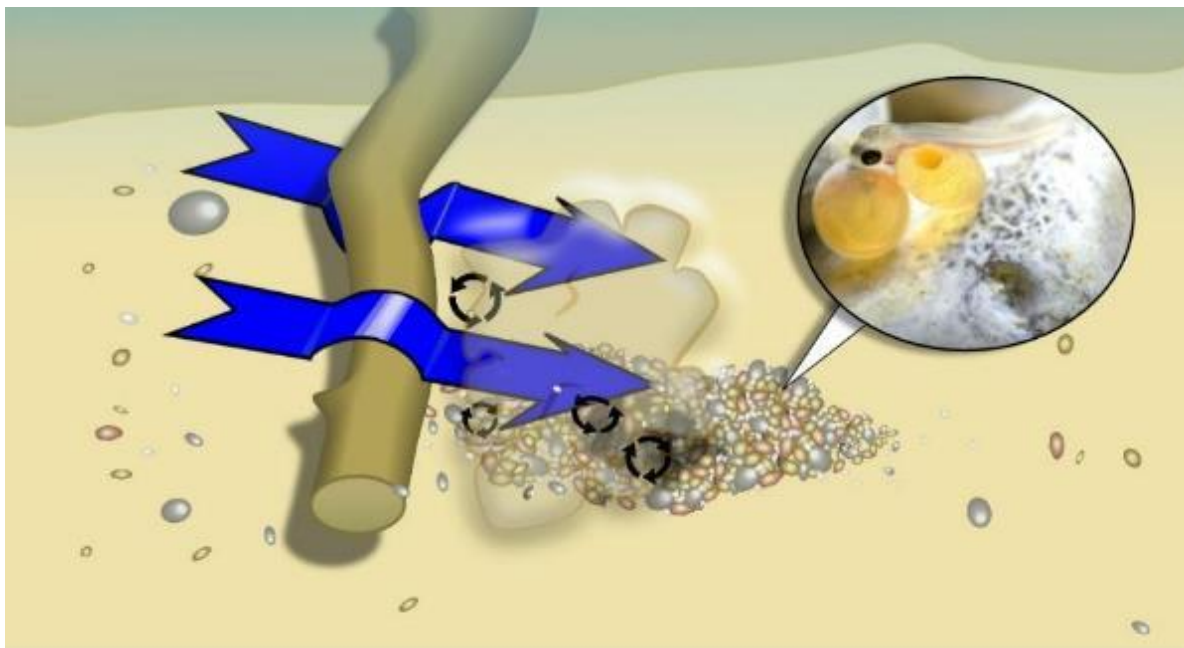
Figure A2: Features associated with successful trout spawning habitat include the presence of silt-free gravels. Here the action of fallen tree limb is focusing the flows (both under and over the limb as indicated by the blue arrows) on a small area of river-bed that results in silt being mobilised from between gravel grains. A small mound of gravel is deposited just downstream of the hollow dug by focused flows. In the resulting silt-free gaps between the grains of gravel it is possible for sufficient oxygen-rich water to flow over the developing eggs and newly-hatched “alevins” to keep them alive within the gravel mound (inset) until emerging in spring.

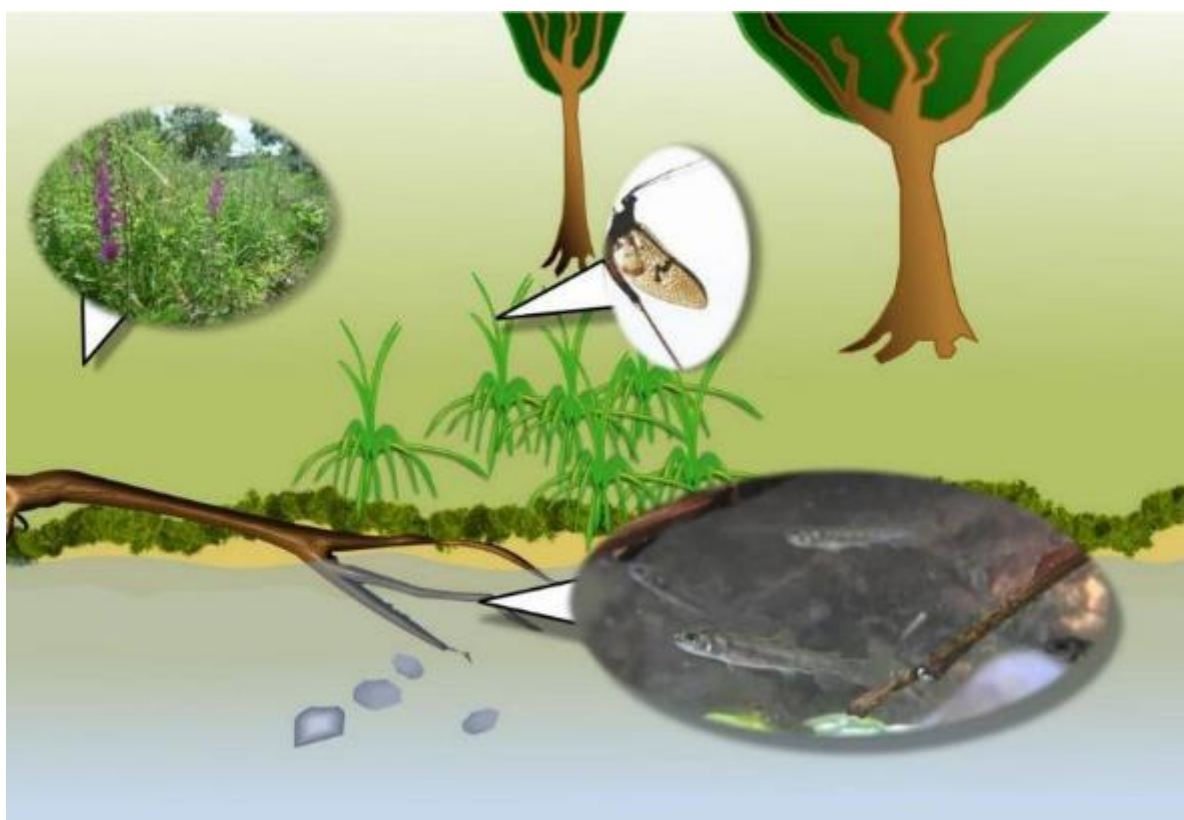
Figure A3: Larger cobbles and submerged “brashy” cover and/or exposed fronds of tree roots provide vital cover from predation and spate flows to tiny juvenile fish in shallower water (<30cm deep). Trailing and overhanging bank-side vegetation also provides a similar function and has many benefits for invertebrate populations (some of which will provide a ready food supply for the juvenile fish).
