WILD TROUT TRUST

Advisory Visit
River Derwent
Darley Dale FFC, Derbyshire

Paul Gaskell (pgaskell@wildtrout.org)

29/09/2025

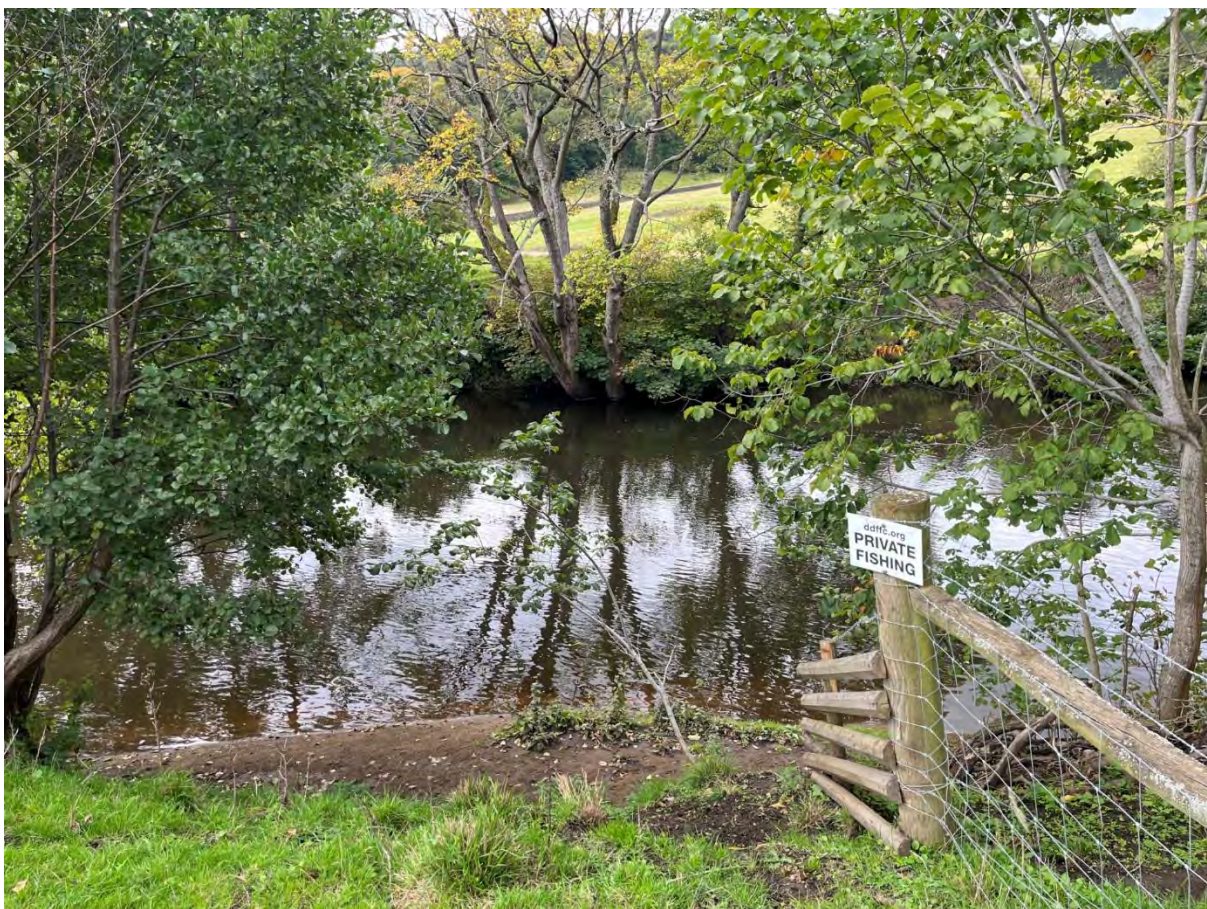
Figure 1: Grazing access **down to the water's edge** reduces the resistance of banks to erosion and also leads to a loss of ground-cover vegetation and tree regeneration.

- Creation of an effective riparian buffer strip of ungrazed, woodland vegetation via
 - Exploration of options with relevant landowner(s) to set back fence-lines to a functional distance from the bank top (recommended 10-12m)
 - Work with landowners in seeking funding designed to support riparian buffer strip/riparian woodland creation via potential routes such as
 - CSHT; <https://www.gov.uk/find-funding-for-land-or-farms/csw25-manage-riparian-and-water-edge-habitats> (12-m buffer strip minimum)
 - WCPG; <https://www.gov.uk/government/publications/woodland-grants-and-incentives-overview-table/woodland-grants-and-incentives-overview-table> (10-m buffer strip minimum)

- Using fencing grant funding to create grazing exclusions a minimum of 5m (ideally 8m or more) from the bank top; <https://www.gov.uk/countryside-stewardship-grants/fencing-fg1>
- Sourcing subsidised tree planting via <https://www.woodlandtrust.org.uk/plant-trees/trees-for-landowners-and-farmers/morewoods/> in support of river woodland creation; <https://www.woodlandtrust.org.uk/plant-trees/river-woodland/>
- Break up and redistribute stone revetments so as to allow some additional, natural meandering to take place
- Continue to allow natural deadfall of trees into the river channel
- Liaise with landowners/tenants in order to ensure adequate livestock watering provisions are available as part of any fencing projects
- Liaise and collaborate with interests on the RB in order to match interventions as far as possible on both banks

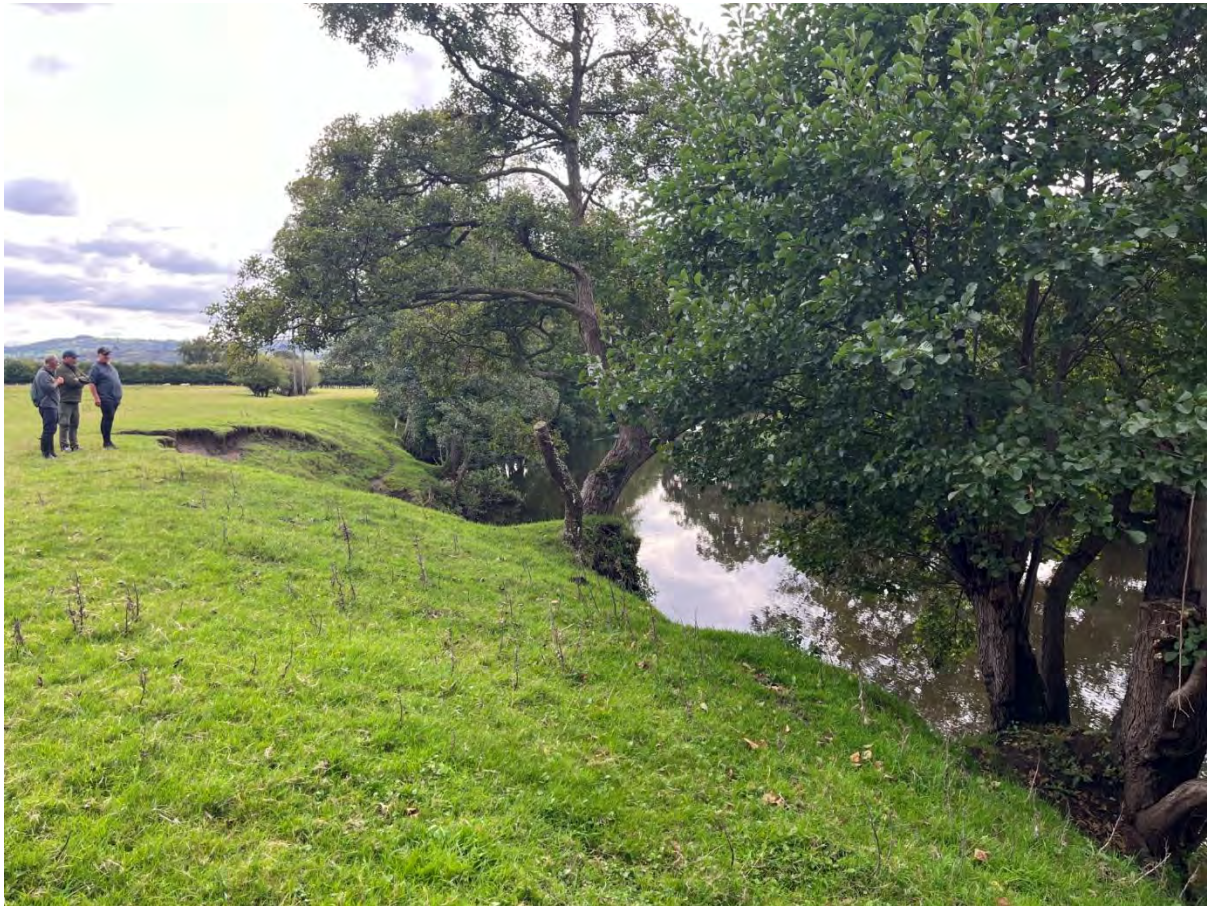
The surveyed reach was walked in a downstream direction. Observations were recorded and are reported following that same downstream, sequential progression. At the upstream limit, two of the main characteristics of the investigated reach were evident. Firstly, the **extensive grazing access down to the water's edge (Fig.1) is a feature throughout** much of the reach. Secondly, the degree to which the river is incised below the level of the surrounding floodplain (Fig.2).

Figure 2: Unrestricted grazing, single line of veteran trees and channel incision.

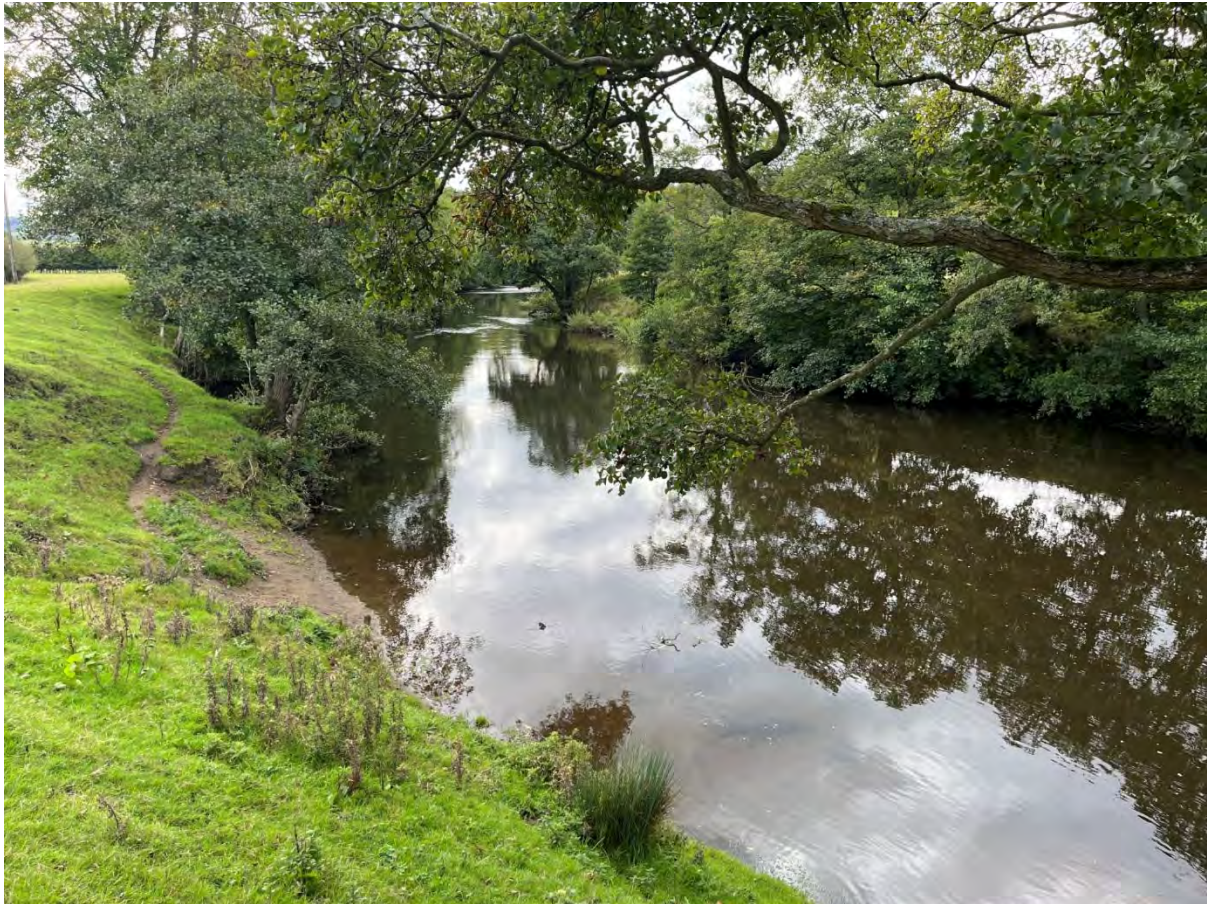
The net result is a lack of robust, vegetated buffer zones between agricultural land and the river. Aside from a single line of veteran trees, there is a low structural diversity in the riparian (riverside) vegetation, and with the current grazing regime, they too will be lost, ultimately. The lack of ground cover and susceptibility to trampling by livestock footfall tends to elevate runoff of fine sand and silt particles into the river. Similarly, the access and egress points for livestock using the river create runoff pathways. The feedback loop between soil erosion occurring during surface water runoff events and ongoing trampling created by livestock consolidate sediment runoff pathways (e.g. Fig.3).

Figure 3: Fine sediment runoff pathway exacerbated by grazing, livestock access and rainfall events.

Surrounding land use is also contributing to elevated fine sediment runoff. Earth compaction by livestock and lack of diverse root structure associated with grazing prevents surface water from soaking into the ground. This effect **isn't easy to visualise without a physical demonstration**. The following short video helps to place the scale of the effect into context:

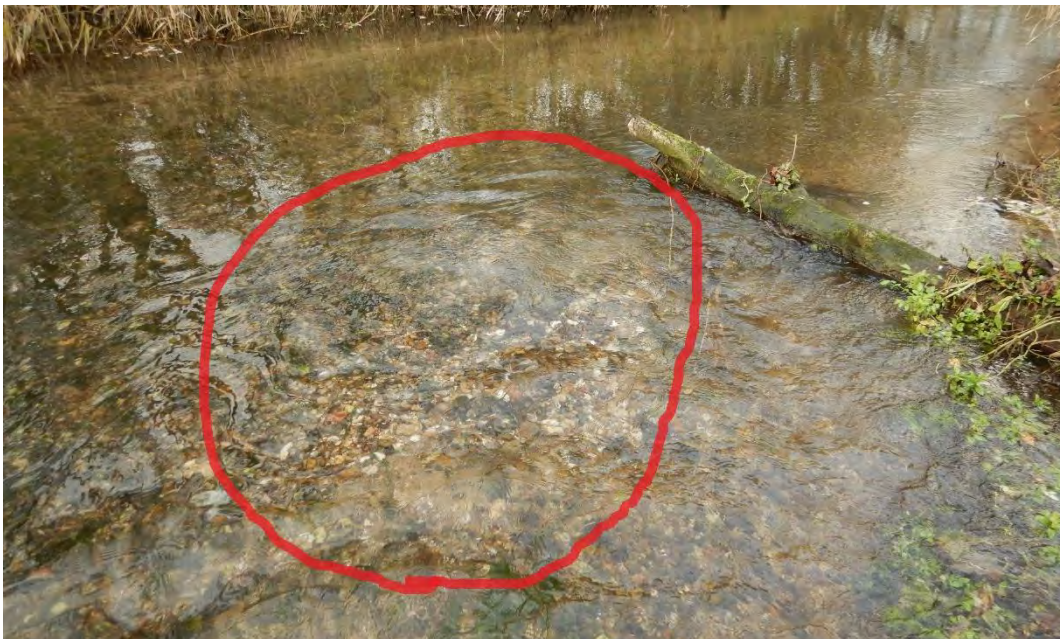
Throughout the visited reach, relatively few high-quality spawning opportunities were noted. With that said, there were certainly areas where it is reasonable to expect trout to attempt to breed. It would be beneficial for club members to walk the reach regularly during November and December to monitor breeding efforts. As a visual aid to what to look for, freshly dug redds consist of an approximately tear-drop shaped bright patch of gravel. The hen fish first cuts a depression into which the eggs are laid and fertilised. This leaves a tailing of clean gravel behind the hole. She then moves upstream of that first depression and cuts a second hollow in order to cover the eggs with a further tailing of gravel (e.g. Fig. 4).

Figure 4: Trout redd (circled) with the upstream hollow located in the centre of the frame, towards the log while the mound of gravel tailings are towards the lower left corner of the frame. Gravel particle diameters tend to be in the 10-50mm range.

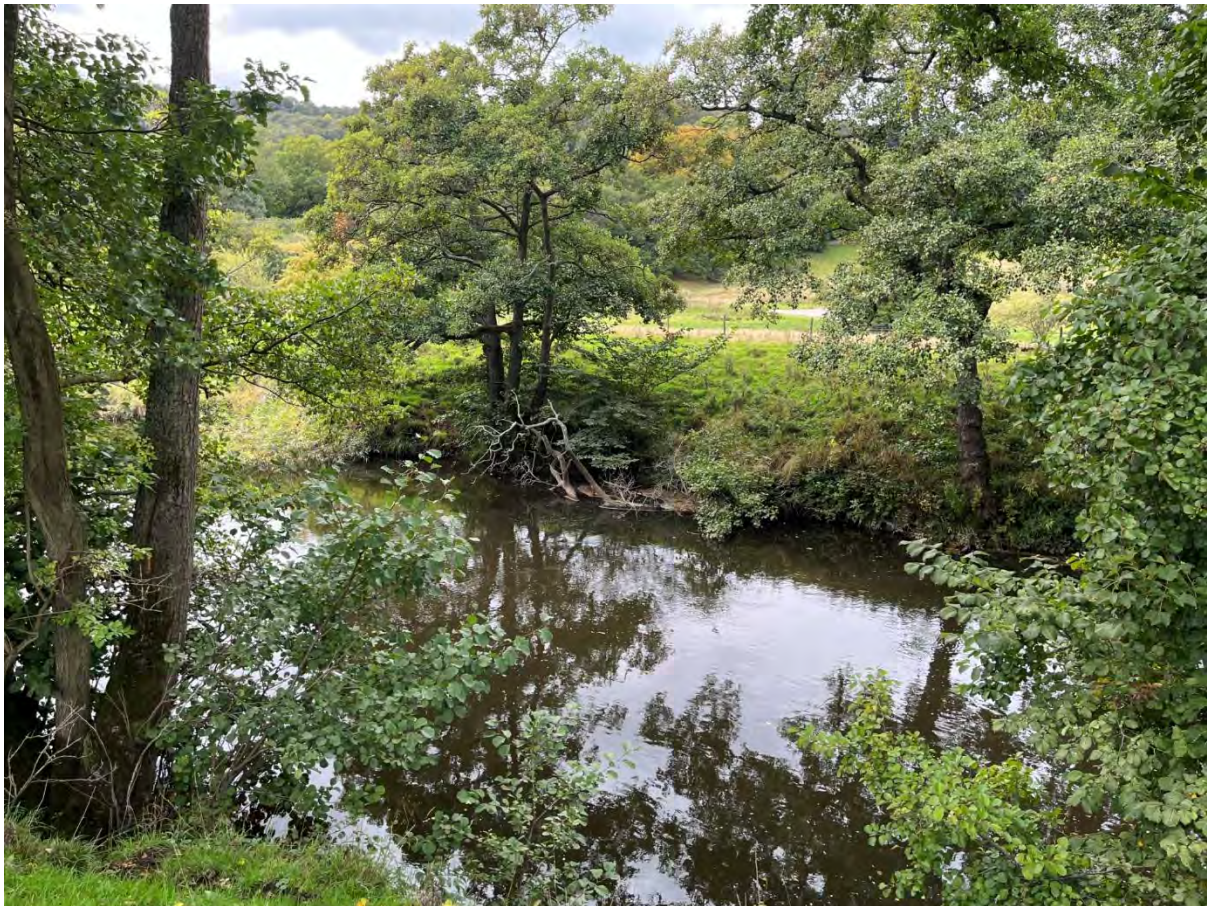
For spawning gravels to be optimally utilised, there needs to be nearby cover available for fish to use between active breeding attempts. In fact, cover from predation is essential for adult and juvenile fish alike, particularly as they emerge from the gravel. A good example of valuable cover on the opposite bank (RB) was noted from the LB at 53.171004, -1.612618 (Fig.5).

Figure 5: Valuable cover habitat on the opposite bank (RB) incorporating both low, overhanging limbs and submerged crown and trunk from deadfall. Note the higher quality riparian habitat within the buffer strip there.

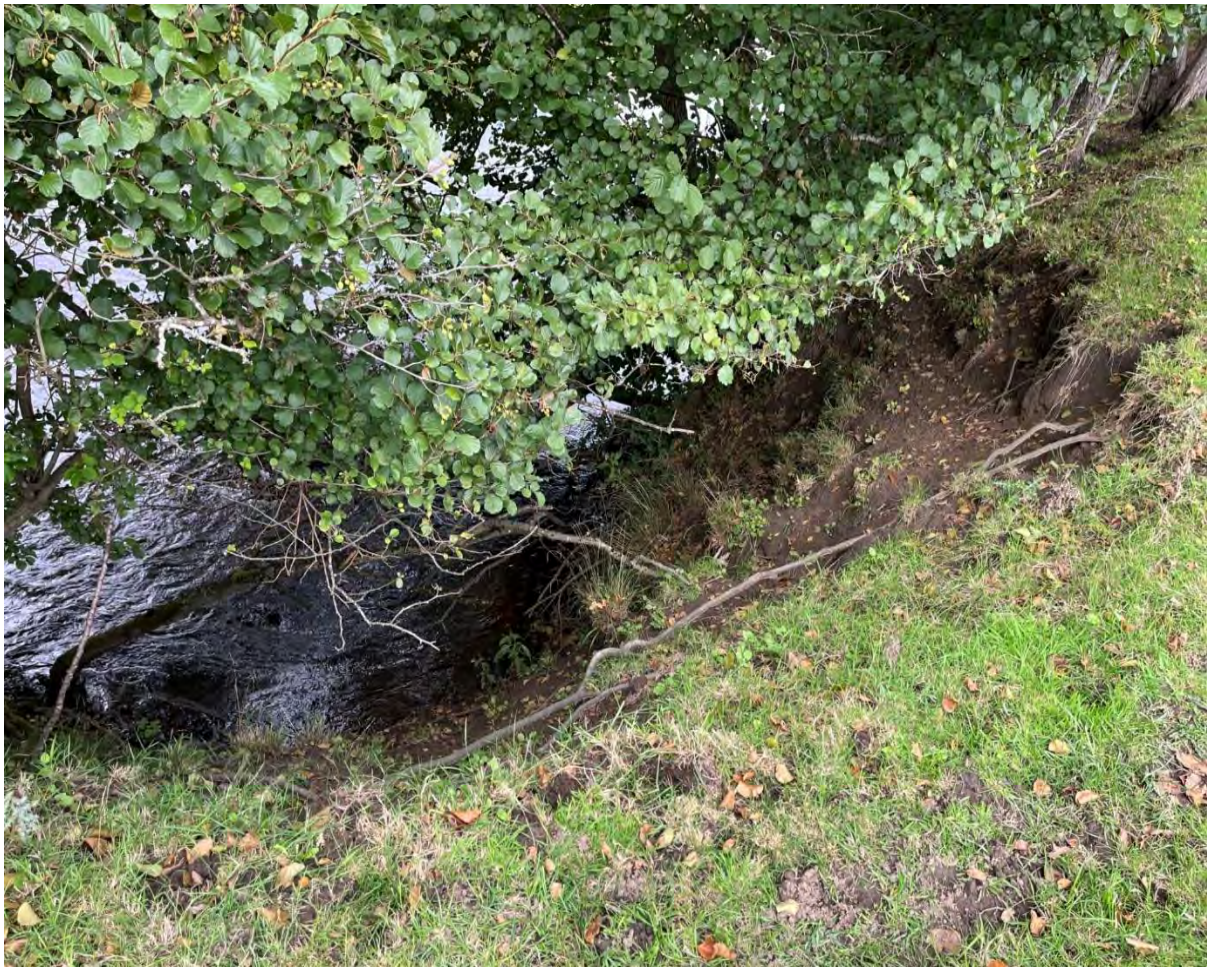
Wherever unrestricted grazing access was available to the riverbank, the combined effects of shallow roots and poaching by livestock footfall were evident (e.g. Figs. 6-8).

Figure 6: Steep, collapsed banking associated with trampling and the loss of deeper root structure created by over-grazing. Grazing intensity that is perfectly suitable for a farmers field is not suitable for a riverbank.

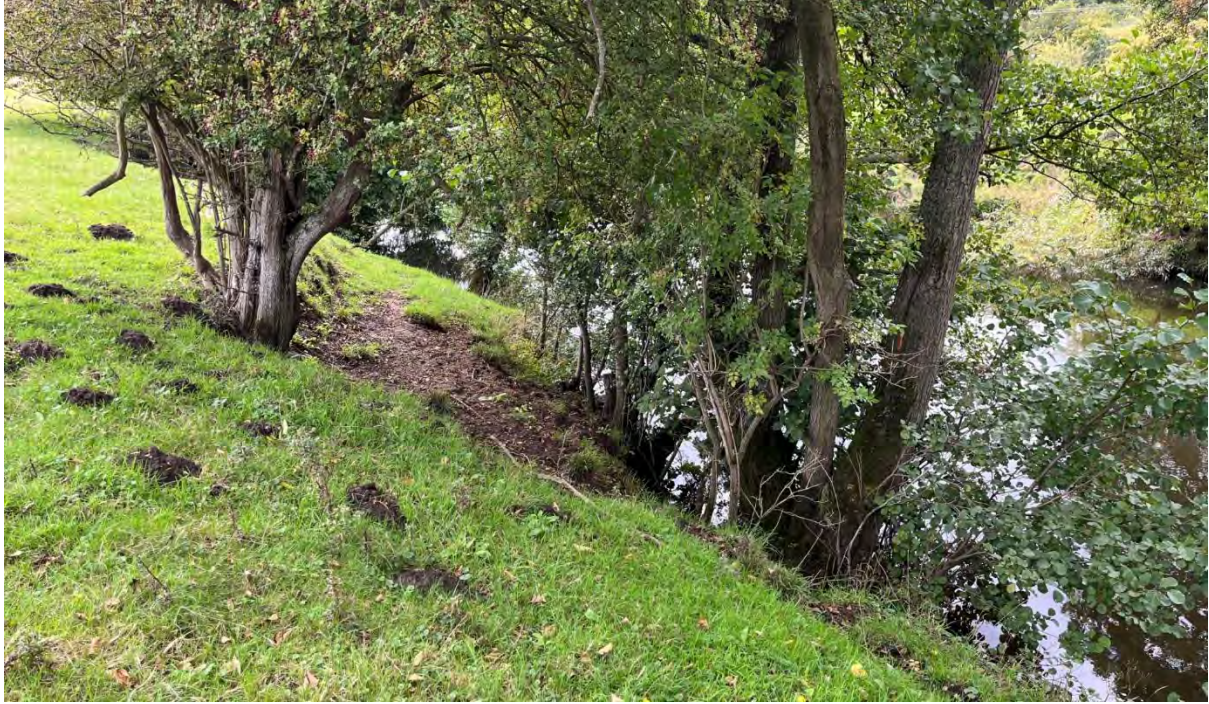
Figure 7: Single line of trees with livestock poaching.

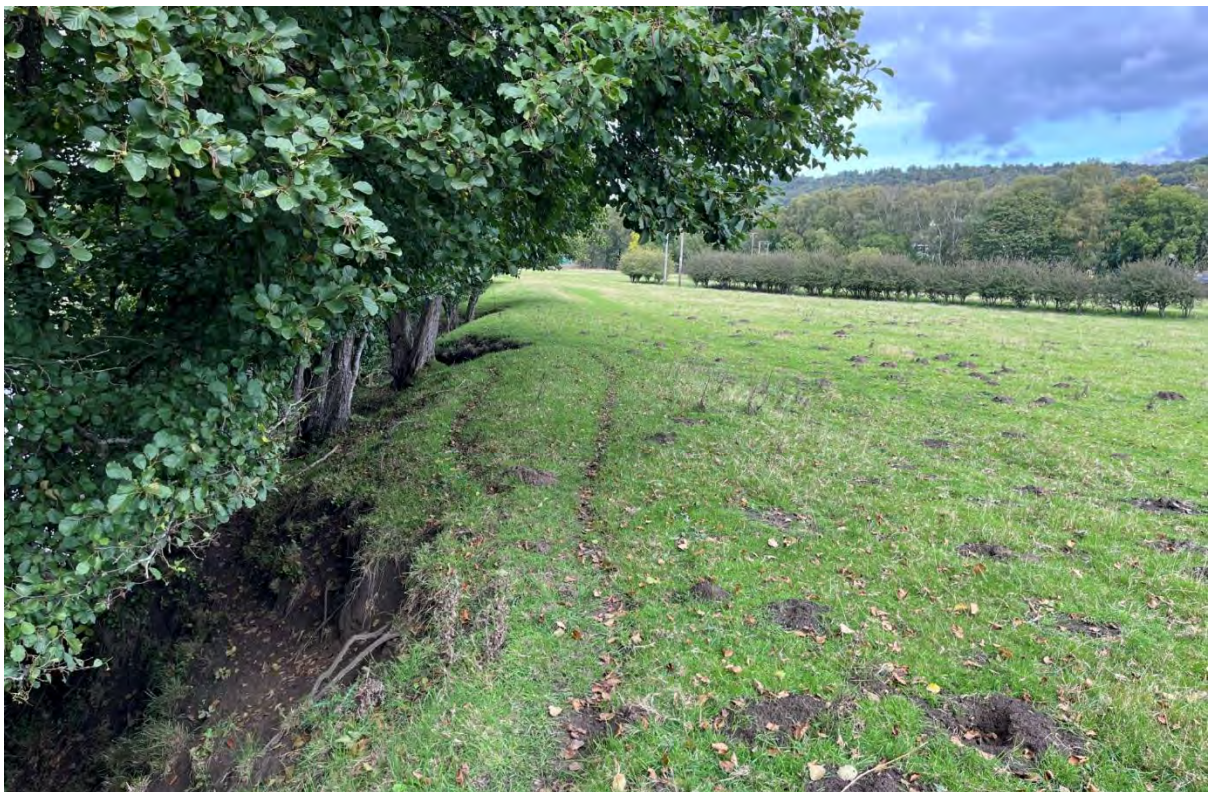
Figure 8: Single line of trees with habitual walking and river channel access routes visible.

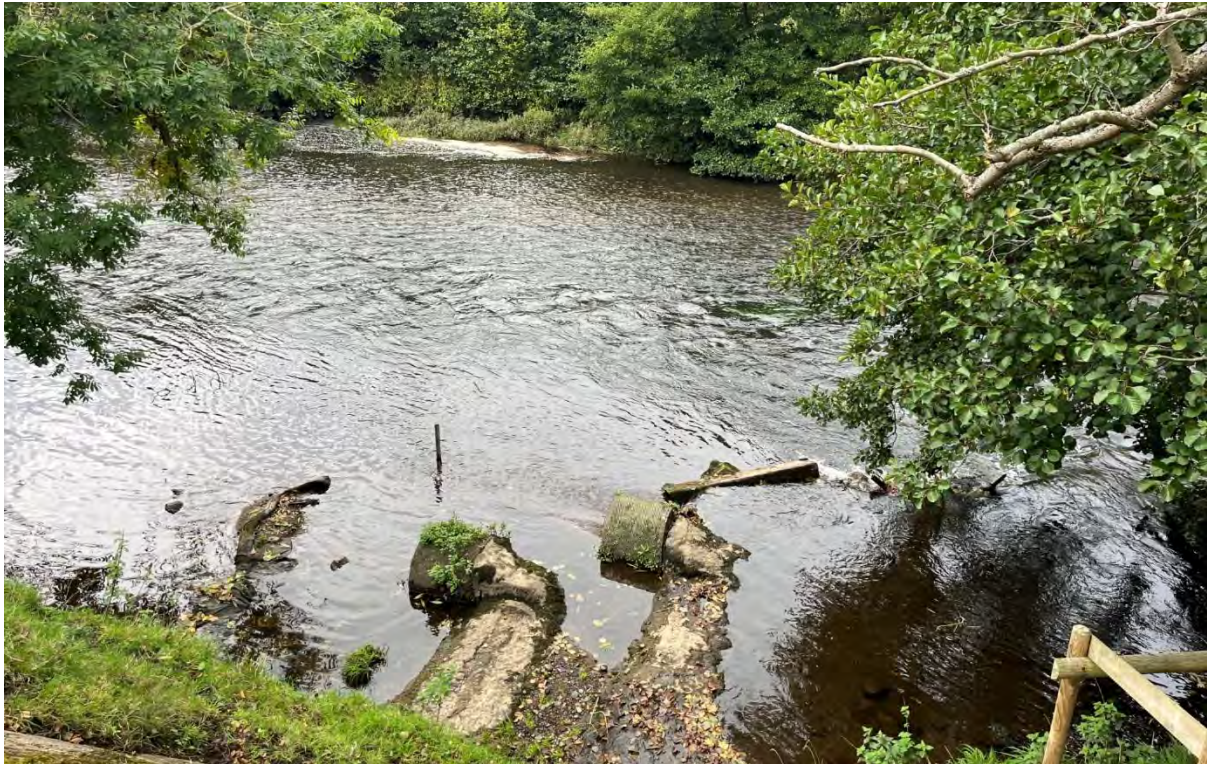
What appears to be an old pumping station and two associated pipe outfalls or intakes were noted at 53.170978, -1.612481 (Fig.9). Finding out if these assets are still live and pose any pollution threat is recommended.

Figure 9: Dual pipes with their open ends facing downstream apparently associated with an old pumping station or other asset building at 53.170978, -1.612481.

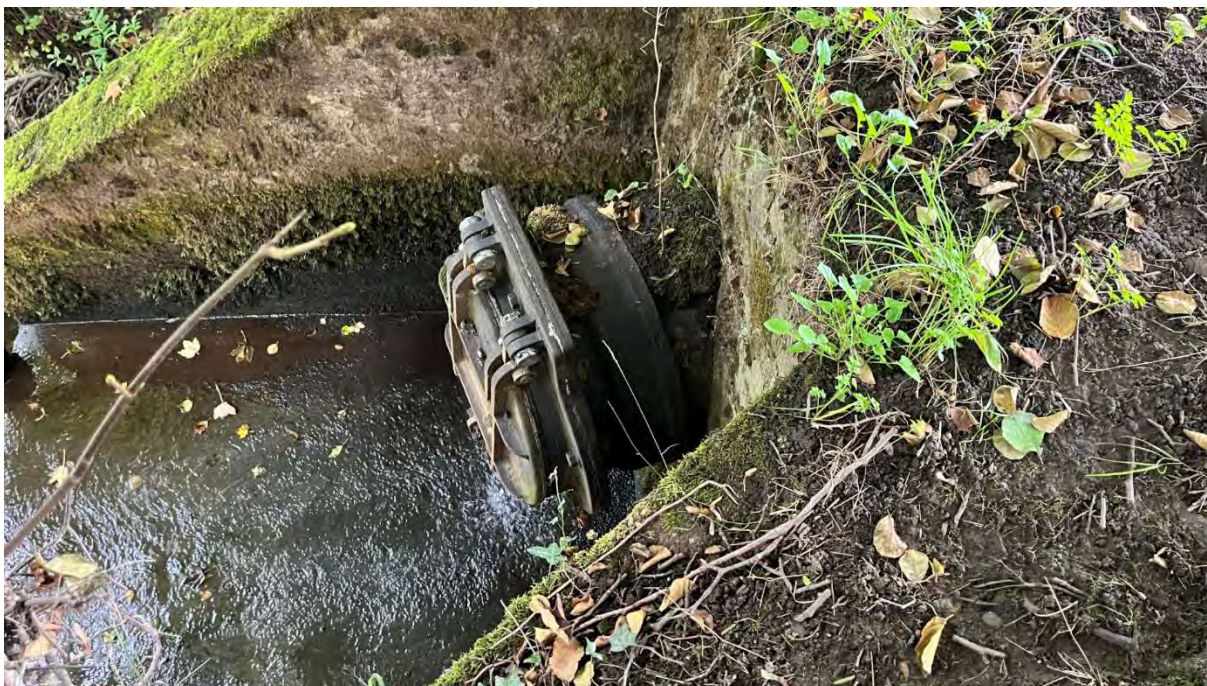
Similarly, it is recommended to investigate what could be a combined sewer overflow in the steep banking adjacent to the location shown in Fig.9 (Fig.10).

Figure 10: Outfall that is apparently in use. At the time of visit this was not showing gross signs of pollution.

- Stem injection of knotweed stands and/or giant hogweed plants by appropriately certified personnel as necessary
- Establish regular Riverfly monitoring at points upstream and downstream of areas of concern (e.g. noted pipe outfalls, ochre-rich outfall point and existing stock drinking areas) to gain an understanding of baseline invertebrate populations and any point-source impacts

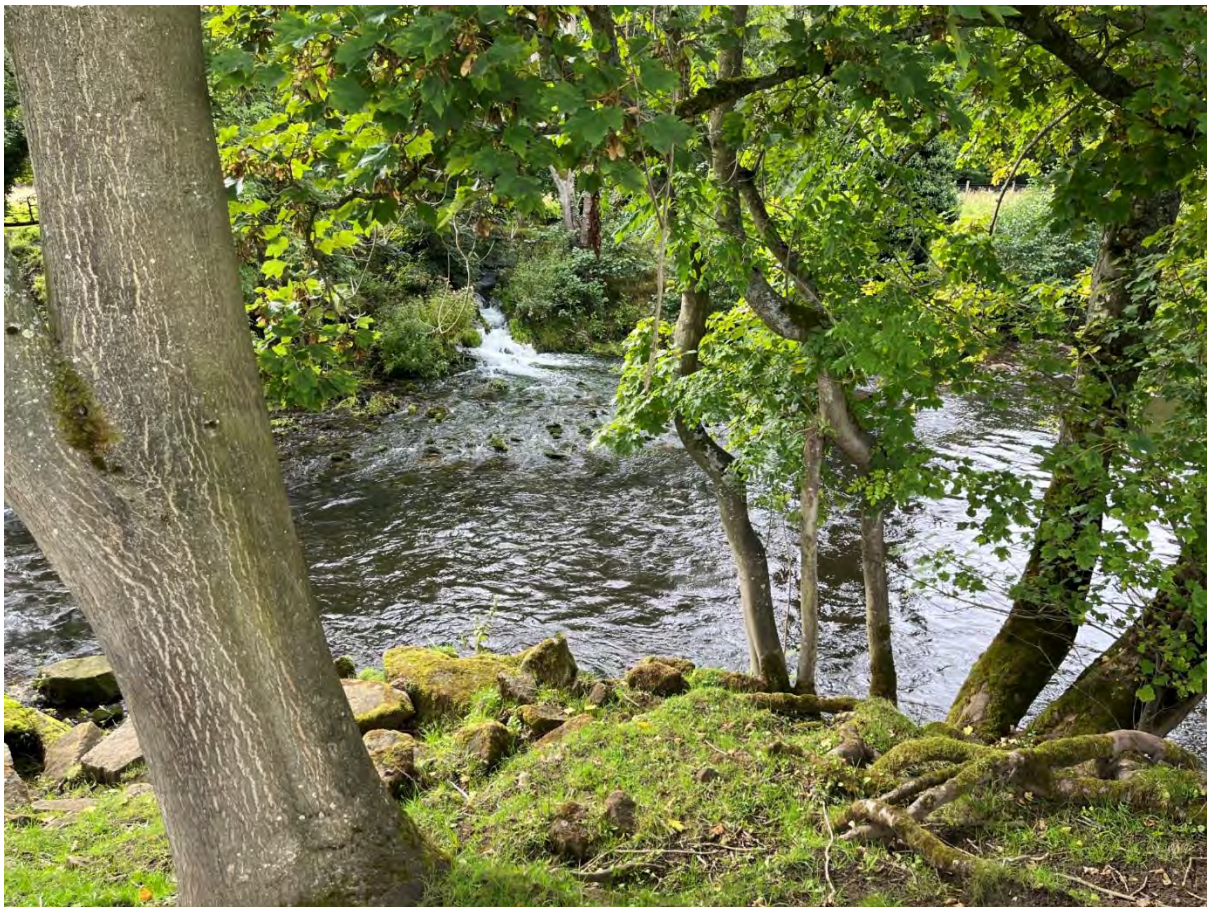
Further downstream of the outfall, the confluence with Hill Carr Sough was visible on the RB (photographed from 53.170062, -1.612190; Fig.11).

Figure 11: Hill Carr Sough confluence with the Derwent visible on the far bank (RB).

Sampling and identification of basic riverfly invertebrate groups around this confluence may help to characterise the water chemistry derived from Hill Carr Sough. In order to achieve useful insights, this would need to be compared to a wider sampling distribution **over the club's reach of** the main River Derwent. Sampling locations upstream and downstream of any noted outfall sites, sediment runoff points or other features of interest would maximise the benefits of invertebrate monitoring.

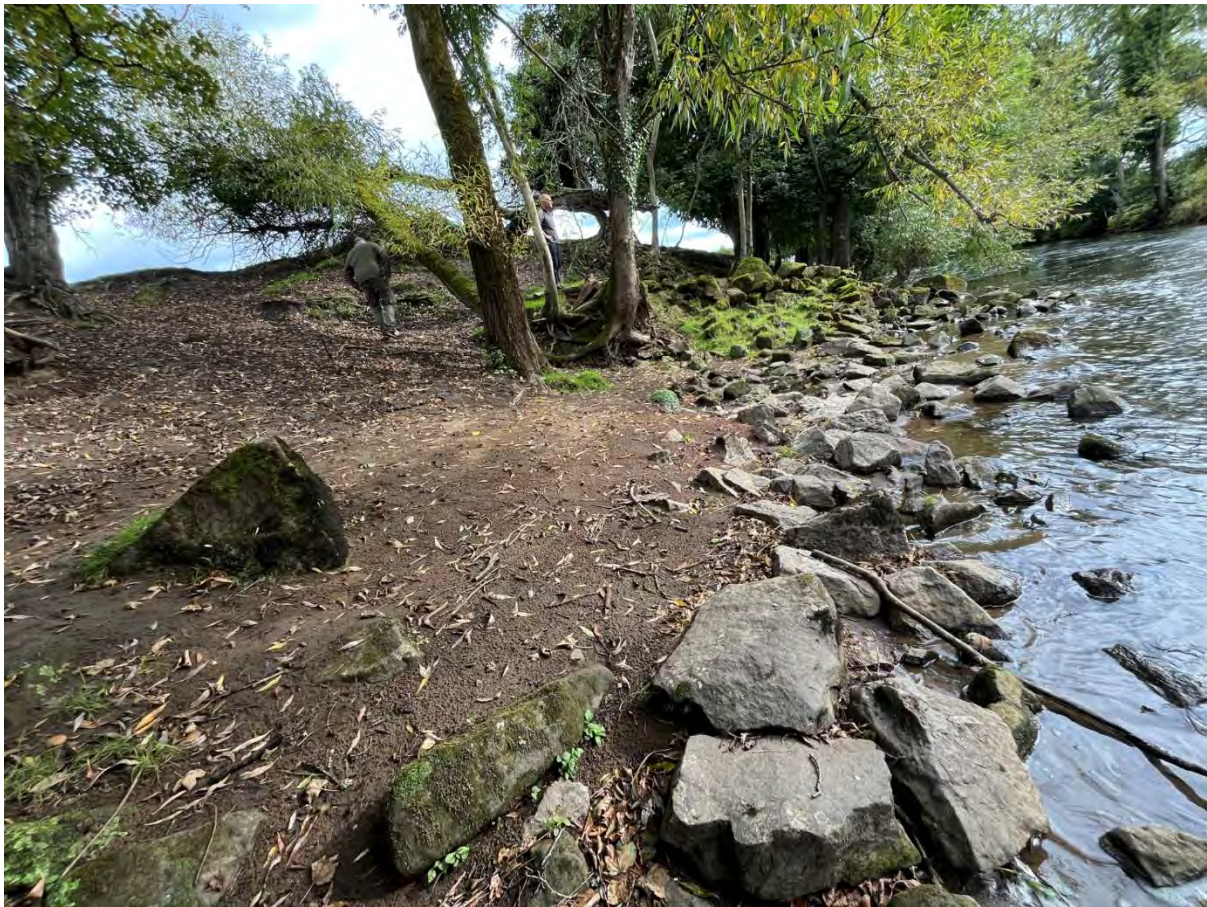
Directly downstream of the point from which Fig. 11 was photographed, an area of scattered stonework appears to have arisen due to collapse of the stone revetment lining the LB. As a minimum, stone has been taken from a nearby structure and positioned in an improvised fashion to limit bank erosion. The resultant flat area has a well-consolidated, firm base and seems to have been adopted as a drinking area by stock. This type of access to the river tends to introduce pollution in the form of nutrient enrichment derived from livestock urine and faeces, along with soil runoff pathways previously highlighted. Consequently, a more river-friendly option would be to create an offline stock watering area by excluding livestock from the channel and providing either pasture pump or mains-water-fed trough drinking facilities well away from the river. Mains-fed troughs have an

Figure 12: Collapsed (or deliberately positioned) stonework that appears to be used by stock as a watering point.

advantage over river-water in the form of reduced rates of waterborne disease infection rates. It may be possible, for instance, to recover the costs of mains supply in the form of reduced veterinary treatment charges.

Creation of a more abundantly-vegetated riparian buffer zone (as previously recommended) would require grazing exclusion from the riverbanks. Alternative stock watering arrangements need to be provided as part of this strategy. Mains-fed troughs appeared (from a distance) to already be present in fields adjacent to the river, raising the possibility that pasture pumps may not be required. Confirming the presence and suitable capacity of mains watering points for desired stock levels with the landowner is certainly advisable. Any strategy for excluding livestock from the river would be a positive development for water quality as well as in-river habitat. For the full benefit to be realised, involving parties responsible for land management on the opposite bank (RB) would be needed. Collaborating to ensure ongoing double-bank exclusion of stock, while allowing angler access, throughout the Darley Dale FFC reach is a great opportunity. Ultimately, the beneficial presence of large woody material in the channel will rely on there being a ready supply of trees within the immediate surroundings. The only reliable way to ensure such a supply over

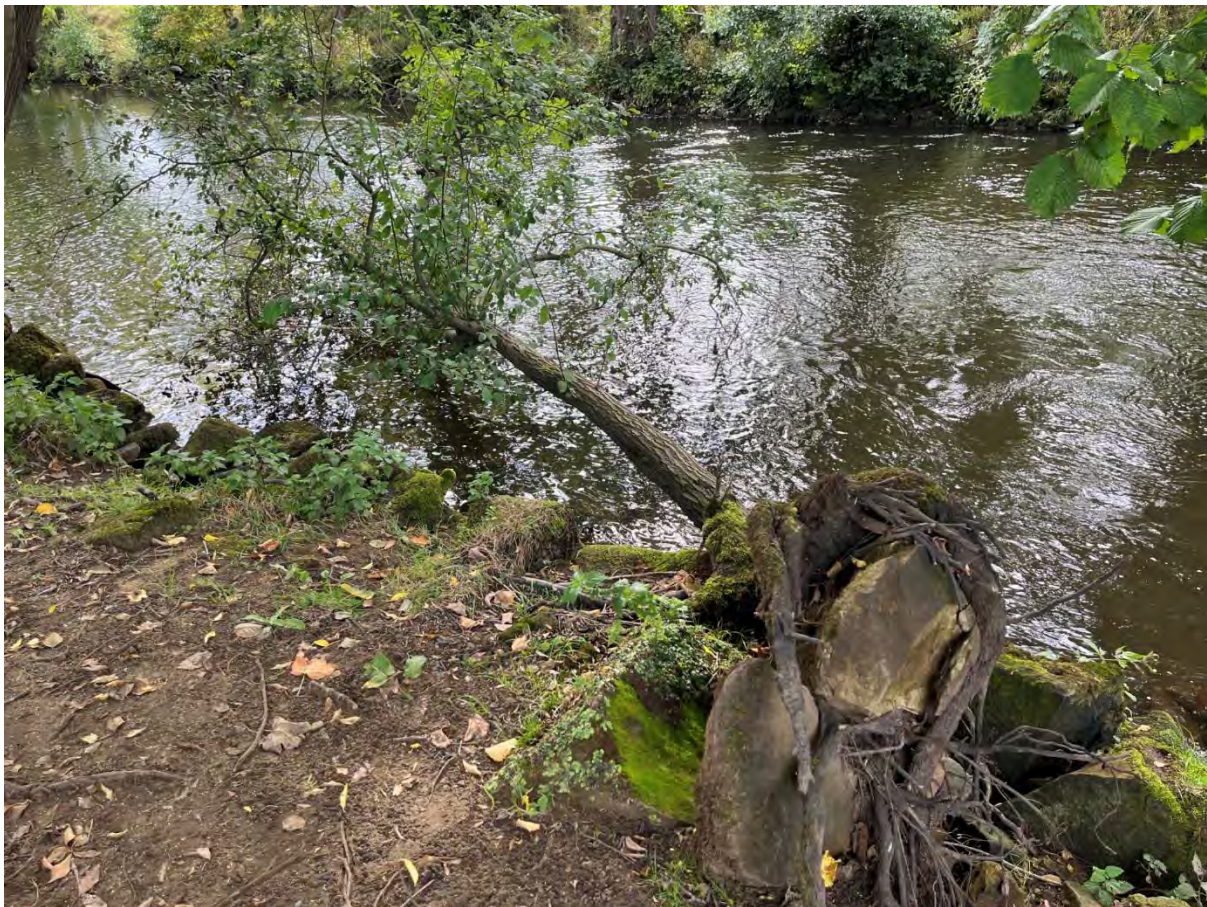
Figure 13: A modestly-sized fallen tree whose crown is providing highly valuable cover against predation and refuge during spate flows. Grazing prevents successional regeneration that would replace such fallen mature trees via sapling growth. It also limits the growth of understory species that would, otherwise, reduce losses of topsoil, silt and sand from the surrounding land into the river, leaving the existing trees at greater susceptibility to washout.

Although scattered (and ecologically valuable) examples of large woody material were noted in the river (e.g. Fig. 13), a more plentiful supply with a greater long-term assurance would be preferable. Restricting the bankside vegetation to a thin covering of grazing-resistant species tends to expose topsoil. Bare soil is highly susceptible to being washed into the river during rainstorms. This is another reason that having very narrow or only a single row of veteran trees provides only limited ecological benefits to the river. The bank reinforcement by the roots of a single line of mature trees tends to enforce a linear path for the channel. Conversely, a wider woody buffer strip with a much more scattered distribution of trees allows for more lateral migration of the channel while still maintaining the course of the river within manageable boundaries. When single lines of mature trees and lack of sapling growth are maintained by grazing, it is inevitable that grazing also excludes the lush understory growth necessary to protect topsoil from being washed away. Clear examples of these dual impacts

- Within existing (and any created) riparian woodland sections, monitor for and retain any large dead-fall trees so as to promote localised bed scour and improve spawning gravel conditions as well as diversifying channel morphology

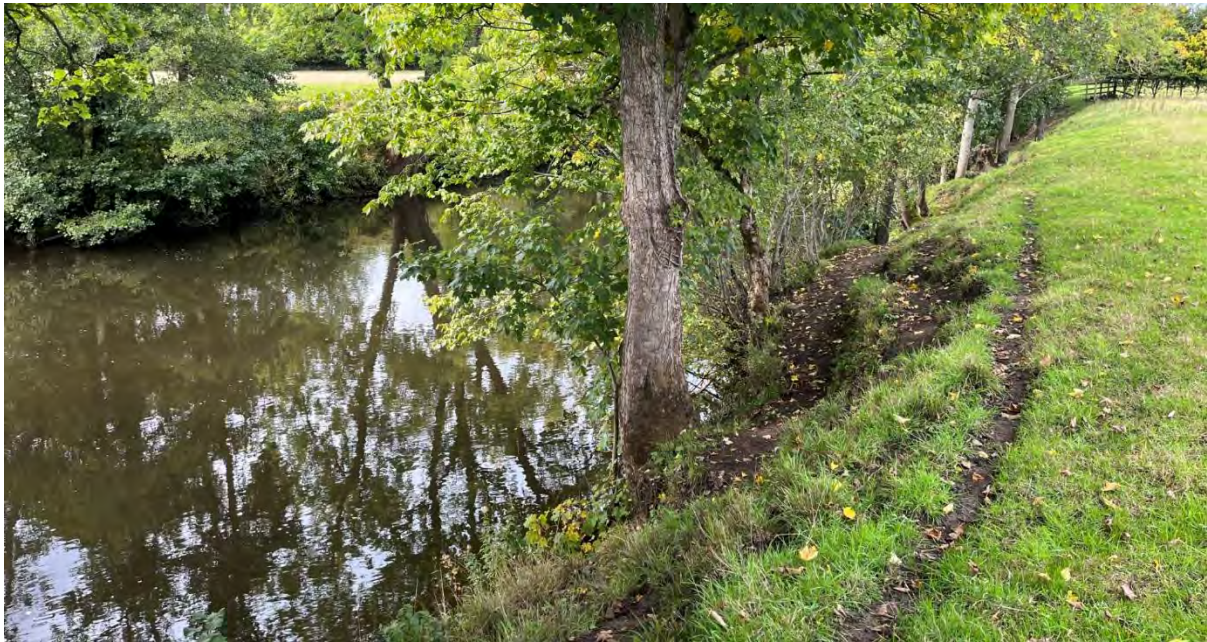
were noted throughout reaches of the Derwent accessed by grazing livestock (e.g. Fig. 14).

Figure 14: Single line of mature trees, lack of understory growth and accompanying bare earth and banking collapse.

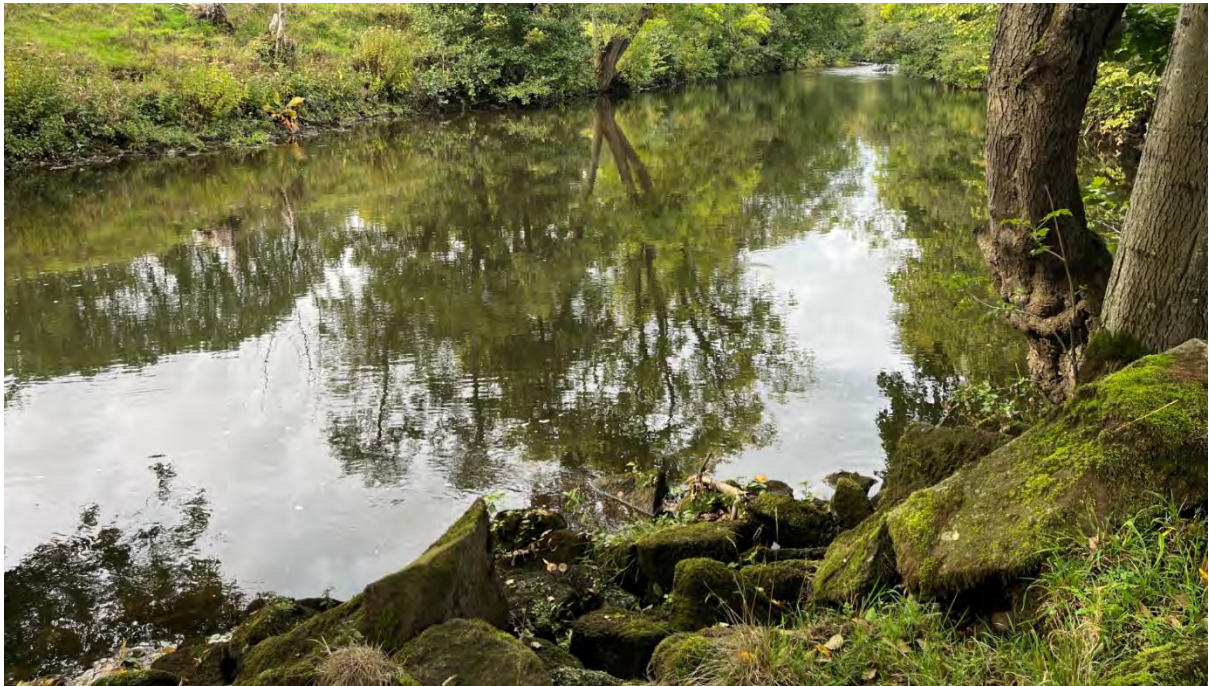
Straightening a watercourse can lead to the channel following along contour lines for greater distances than would otherwise be the case. This reduces the gradient of the channel compared to watercourses that cross contour lines. Conversely, removing meanders often creates a steeper reach which would exacerbate channel incision. In short, channel realignments have the potential to create both increases and decreases in longitudinal gradient. As well as fundamental structural variety lost when meandering channels are straightened, the artificial creation of low gradient reaches particularly limits the potential for erosion and deposition to recreate complex habitat. These canal-like glides tend to have a reduced variation in substrate sizes and cross-sectional profile (Fig.15).

Figure 15: Flat glides are more common when channels are artificially straightened. A common method used by the Victorians was to line banks with rubble and then plant trees (usually alders or sycamore) into that matrix. This is very effective at locking a river channel in place.

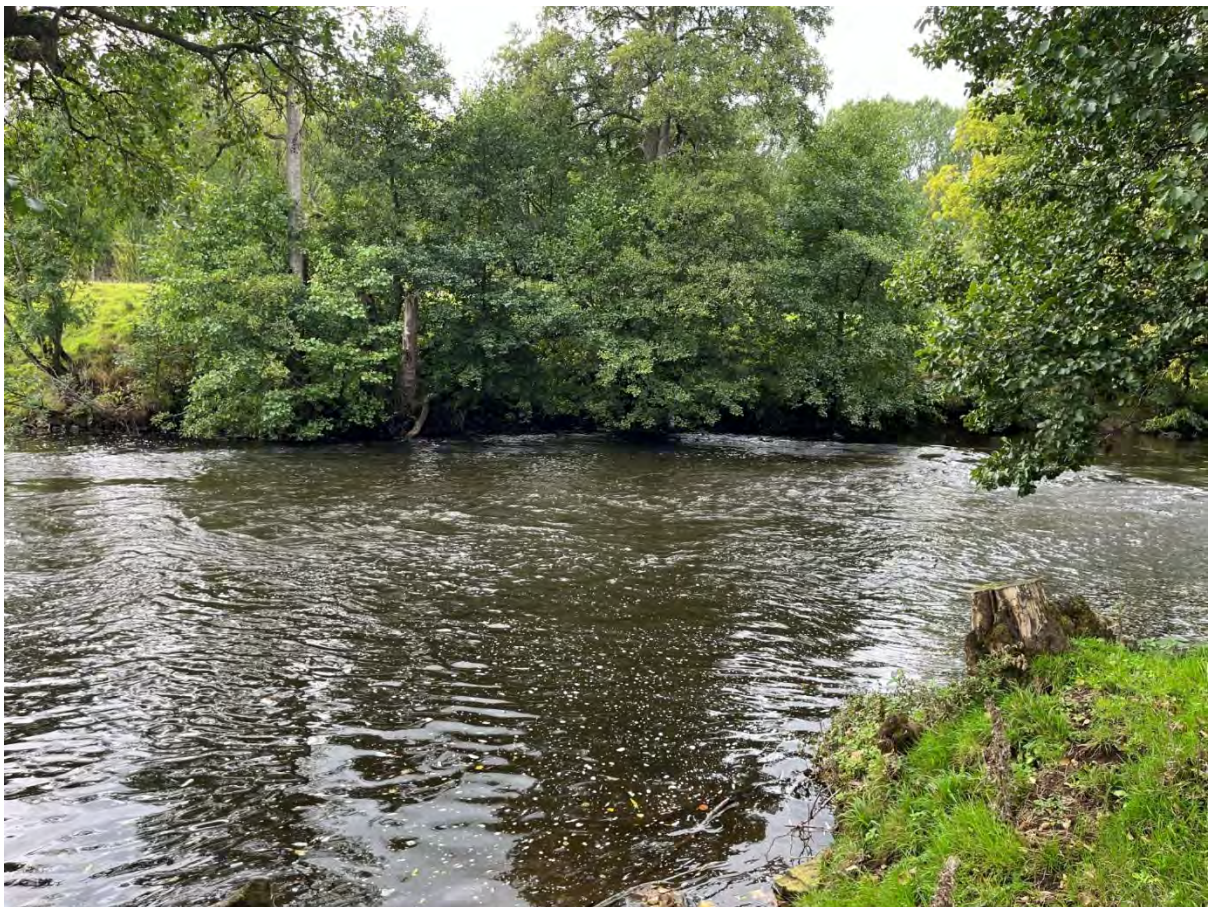
Where variable bank resistance allows more freedom of movement outside prescribed limits of channel width and direction, greater structural diversity may arise. Particularly when regular pools are interspersed with areas of naturally-steep gradient (i.e. riffles), the channel shows much greater structural diversity and habitat quality (e.g. Fig. 16).

Figure 16: The far greater diversity in current pace, depth and direction affords a much wider range of opportunities for fish and invertebrates. In the absence of weirs and the replacement of stone-revetment/single tree-lined banks with diverse, low-lying vegetated riparian flood plain, the frequency of such complex features would significantly increase.

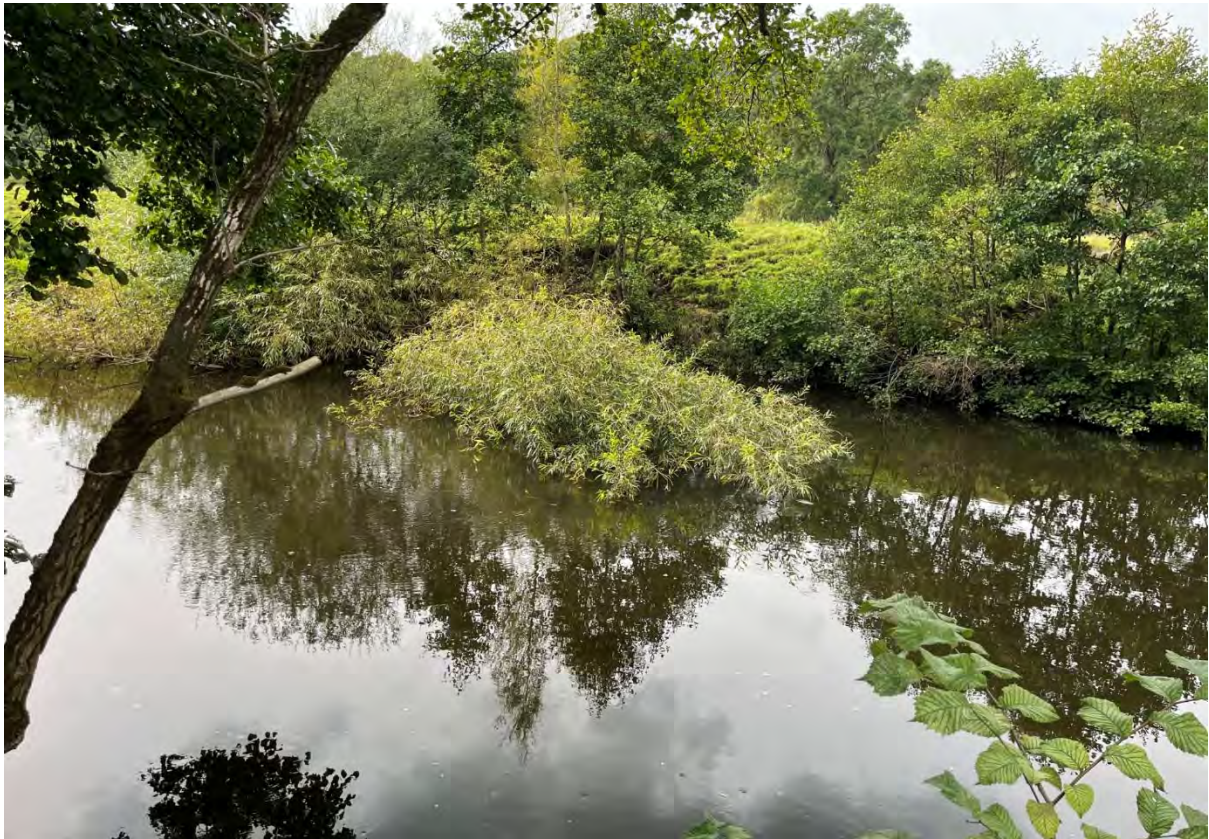
Throughout the visited reach there are consistent patterns of positive features that are tempered by negative impacts. The most widespread of these positive patterns is the welcome tolerance for naturally-arising large woody material in the channel. Conversely, consistently negative impacts are the maintenance of a relatively straight, incised channel via historical revetment and ongoing grazing practices (Figs. 17-20).

Figure 17: Large tree crown providing cover and valuable structural diversity in an otherwise uniform section.

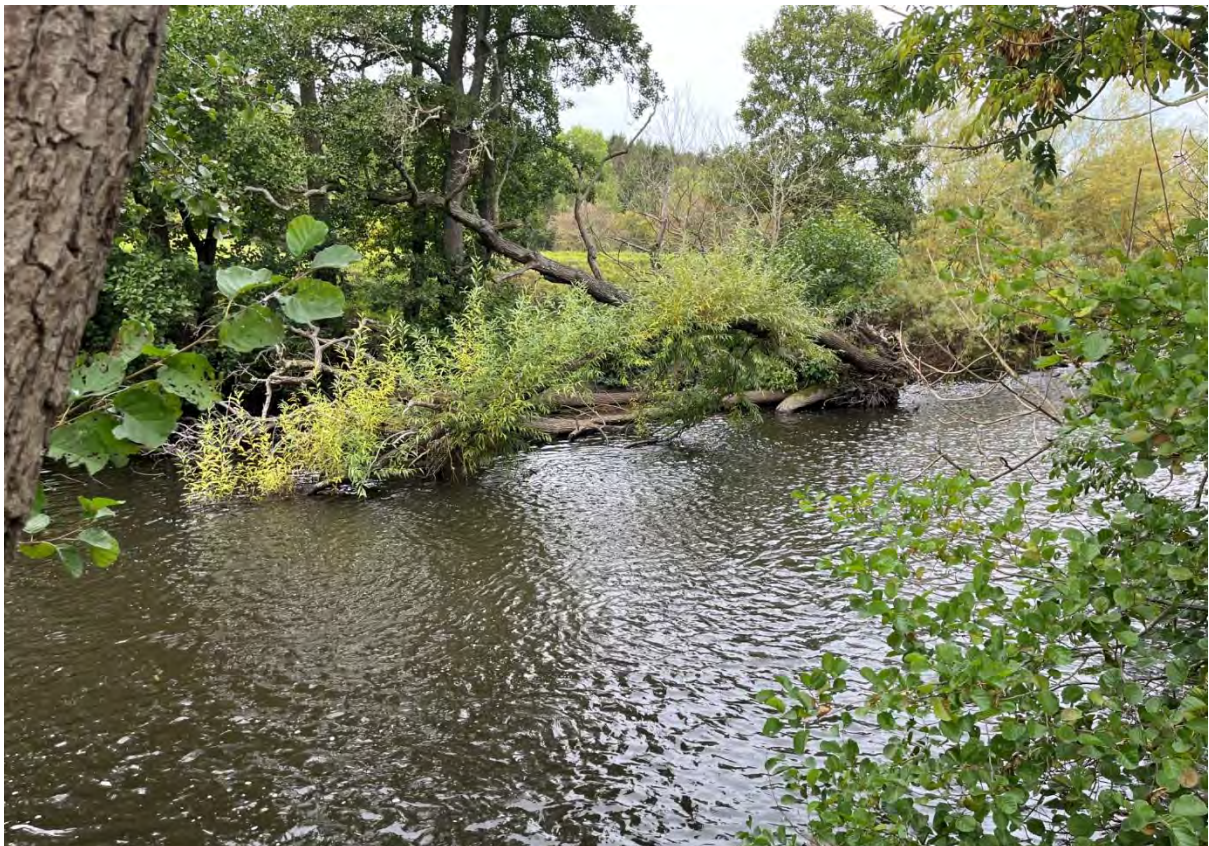
Figure 18: Low, overhanging and submerged cover in shallower water that is likely to boost juvenile salmonid fish survival rates and benefit a range of important invertebrate species.

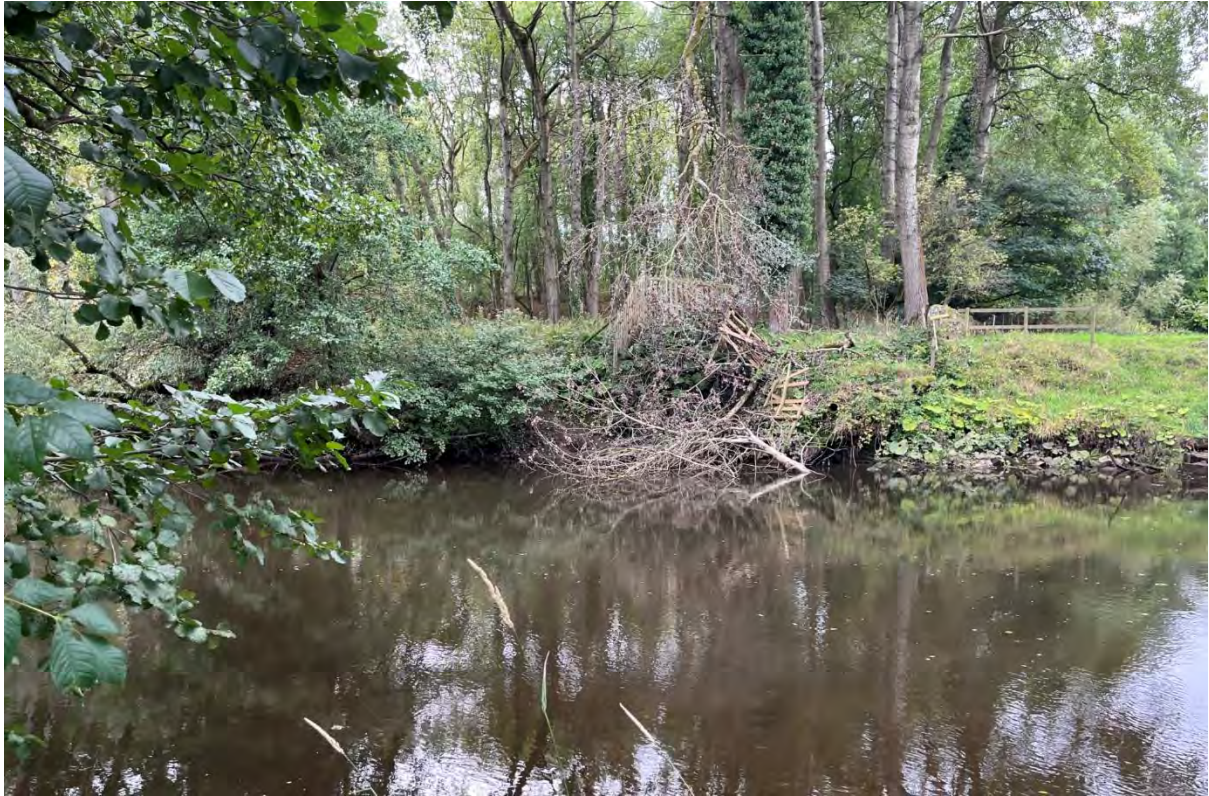
Figure 19: The slightly "messier" brush on the far bank at the downstream limit of the Darley Dale FFC fishing at 53.161352, -1.608835 also provides great cover from predation.
