WILD TROUT TRUST

Advisory Visit
River Derwent
Darley Dale FFC, Derbyshire

Paul Gaskell (pgaskell@wildtrout.org)

29/09/2025

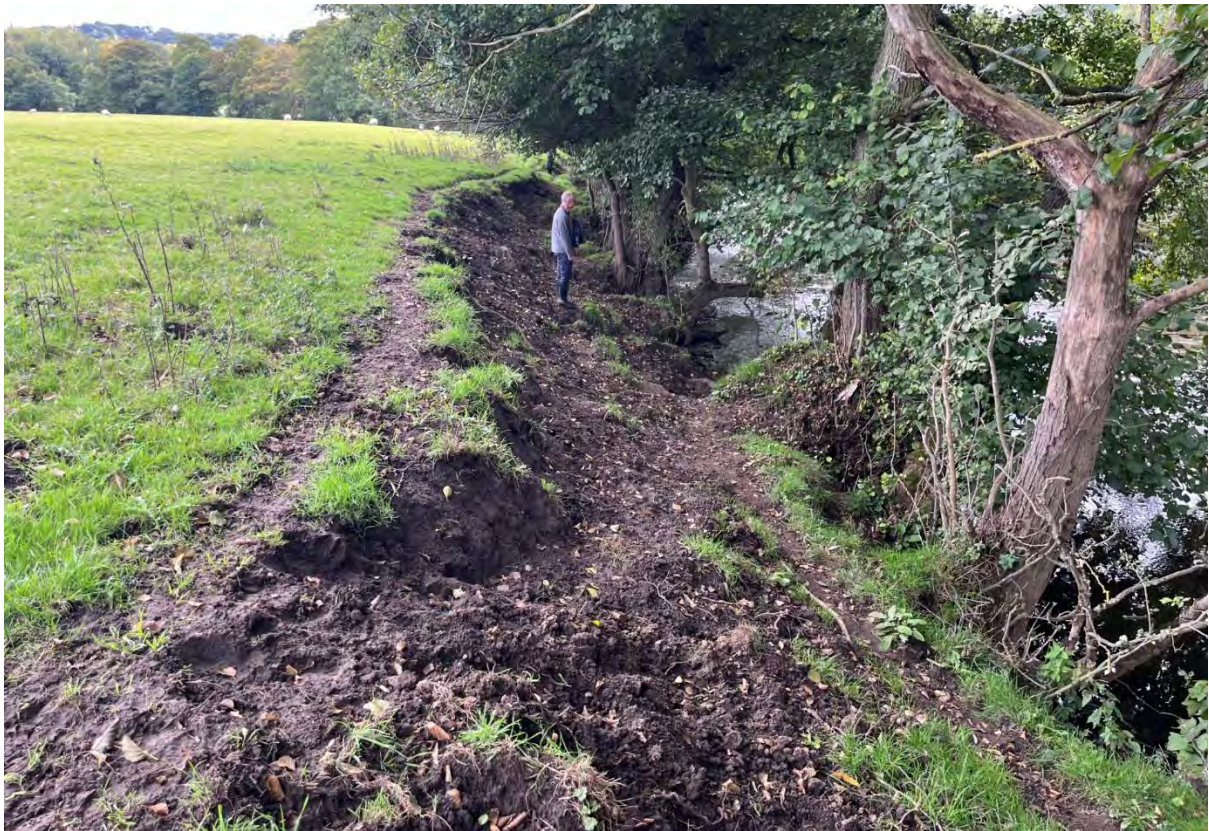
Figure 20: Channel incision, single line of trees, grazing to the water's edge, livestock poaching of banks and obvious sediment runoff pathways. Most of the typical impacts noted throughout the reach are captured here in one image.

It's important to note that whatever trees are present are still valuable. In other words, removal of the remaining single-line of trees is not advised. Instead, it should be viewed as those trees hanging on to provide some benefits, having escaped grazing early in their lifespan. Rather than attempting to tinker with rotational coppicing of such a sparse row of trees, a more valuable intervention would be to extend the width of a diverse, vegetated riparian buffer strip and to incorporate a more scattered distribution of trees within that strip.

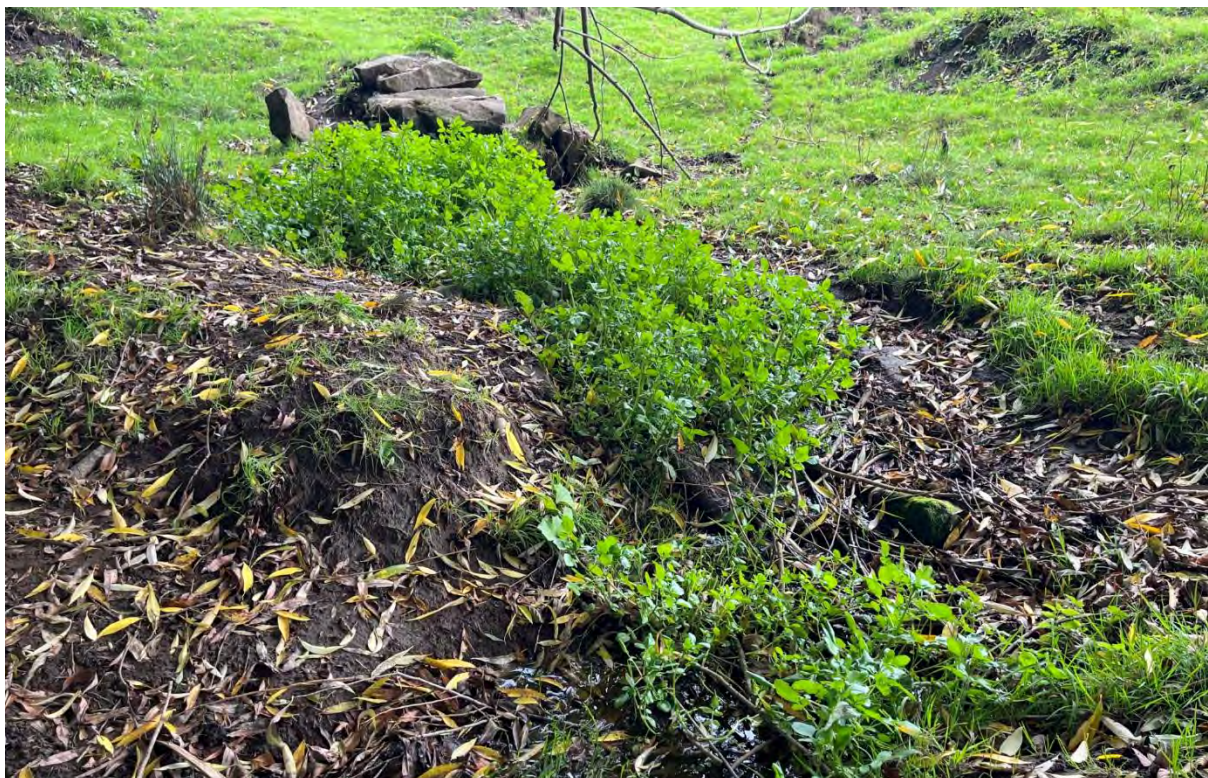
A more specific, individual potential impact was noted at 53.165256, -1.611404 (Fig.21). This was an ochreous discharge presumed to derive from groundwater associated with underlying coal measures.

Figure 21: Emerging at the piled stones in the background, an orange coloured discharge trickles towards the river.

The orange ochre is iron III oxide (essentially rust) and is commonly associated with minewater. When deep underground in anoxic conditions it will be green Iron II oxide which is highly toxic. However, upon contact with atmospheric oxygen, the Iron III oxide becomes much more inert. When discharged in sufficiently high volumes, even the inert and relatively non-toxic substance can create a marked smothering effect on the streambed. There may also be other metallic contaminants within minewater. As such, it would be worth visually monitoring the site for signs of obvious toxicity or significant increases in discharge volume and smothering impacts. However, in comparison to the landscape-scale impacts noted throughout this report, the limited individual discharge shown in Fig. 21 is likely to be having relatively minor or undetectable effects on the ecology of the river, particularly considering the significant dilution factor from the Derwent. Nevertheless, exercising due diligence and making enquiries as to the source of this discharge and any other known characteristics would be worthwhile. If a watching brief on the extent of the discharge and any associated impacts give cause for concern, it may be possible to create a reedbed settling and biotreatment feature as mitigation.

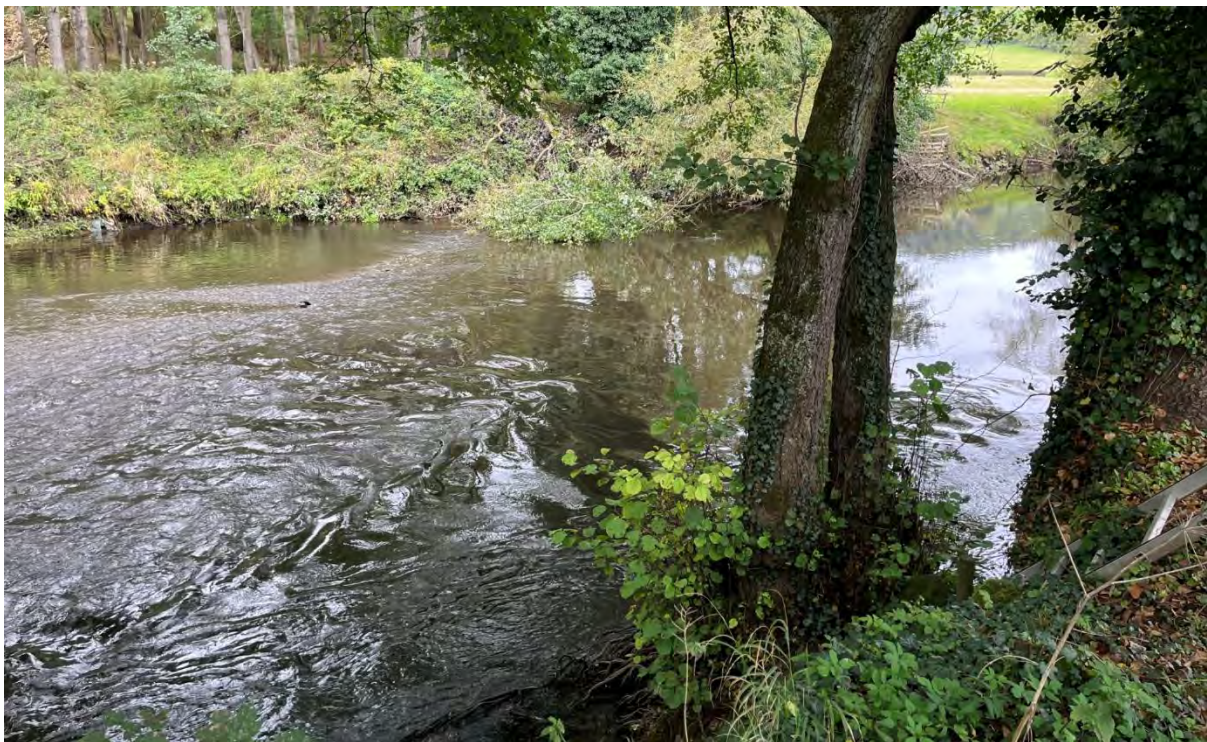
Overall, when assessing in-river habitat structure and diversity, there appeared to be good opportunities for both adult and juvenile salmonid fish. However, at least within the visited sections of river, trout spawning habitat opportunities were relatively limited. The most suitable example noted was just above the downstream limit at the tail end of a glide, as it reached the head of a riffle (Fig. 22).

Figure 22: Although often referred to as "riffle-spawning" species, trout tend to prefer less turbulent flows in which to lay their eggs. The upward ramp of gravel just upstream (i.e. to the right) of the head of this riffle represents potentially suitable spawning habitat.

The ramp of gravel and cobbles just upstream of the broken water of the riffle itself is likely to have water forced between the grains of substrate. That through-flow of water is important to continually replenish oxygen-rich water within those gravel deposits. Without that ongoing irrigation of oxygenated water, eggs laid in such gravel deposits will suffocate before they can hatch. Since the walked route alongside the visited reach resulted in some sections being bypassed, it is recommended that any habitat features similar to those shown in Fig. 22 are identified by club members. If possible those features should be observed each winter between around November to late January to check for signs of trout spawning activity. Patches of brighter gravel that have been turned over and formed into shallow mounds are indicative of spawning activity. Sometimes these may be small test-pits dug prior to genuine spawning. Often, there will be more substantial areas of gravel turned over at the most suitable sites at a later date. An example of what to look for when spotting redds is shown in Fig 4.

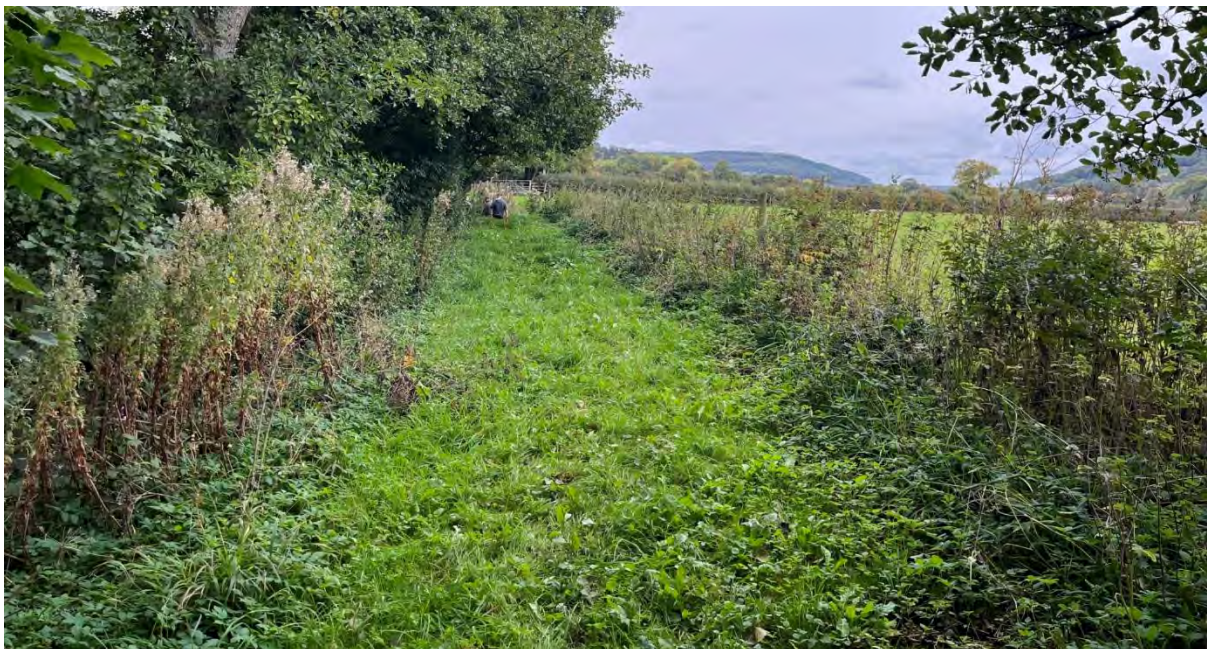
Finally, a very clear example of the effects of grazing exclusion is available adjacent to the angling access path that serves the downstream limit area of the beat. Here, a combination of fenced grazing exclusion and periodic mowing of a ride to allow angler access on foot indicates the potential for vegetated buffer strip development (Figs. 24 and 25). Within the grazing exclusion zone a far more diverse and lush understory vegetation has developed. As well as potential for more scattered tree distribution, the protection against sediment runoff and potential for greater invertebrate diversity are significant benefits of this practice.

Figure 23: Grazing excluded to the right of frame, a mown access ride in the centre and much wider unmown buffer strip to the left. Note the incredible species diversity when compared to the adjacent fields and unfenced bank sections. The ride could be reduced to half its width to create a wider buffer strip and increase terrestrial insect inputs.

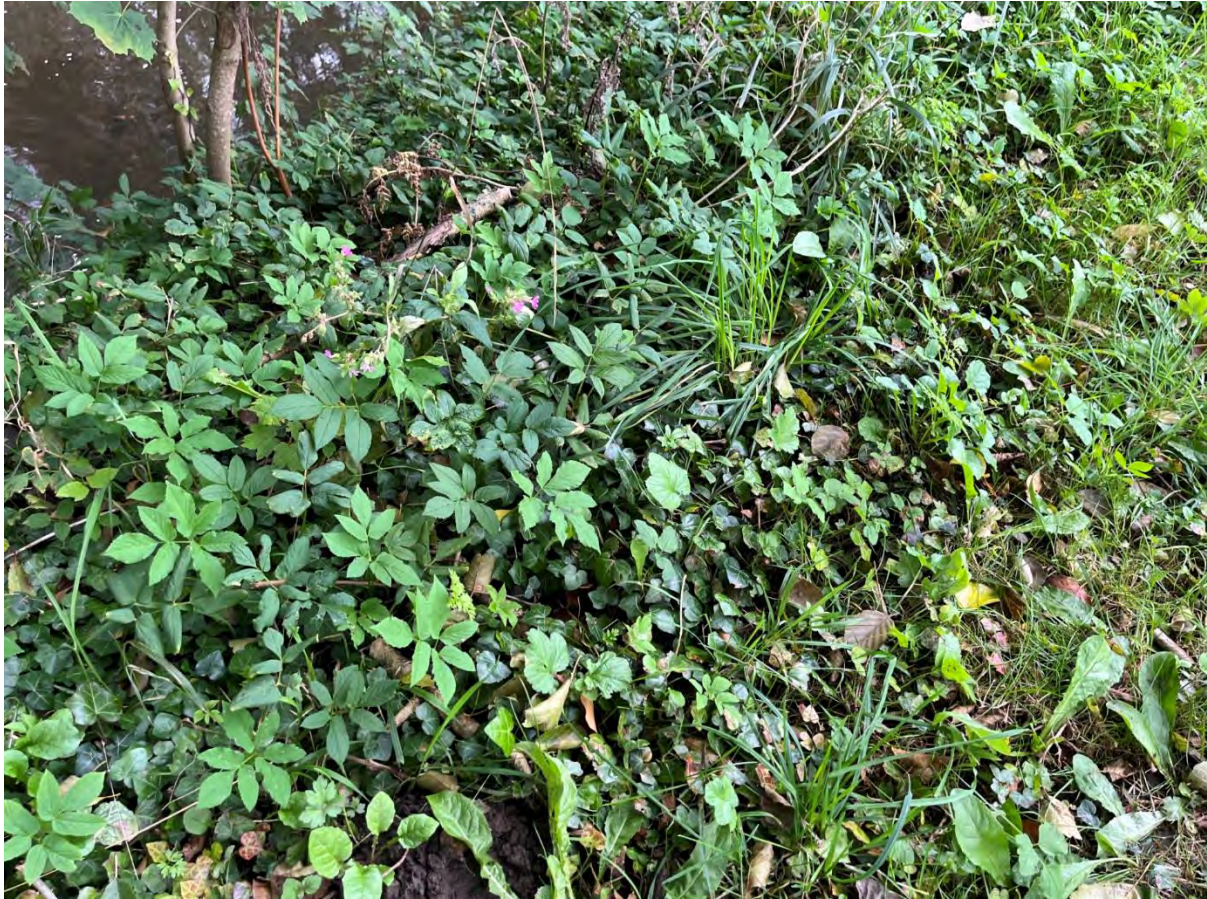
Figure 24: Greater diversity and coverage of understory species beneath the tree canopy is very obvious when compared to images such as Figs. 6, 12 and 20 as examples.
