WILD TROUT TRUST

Project Proposal

River Kent, Kentmere

Prof J Grey (jgrey@wildtrout.org), May 2025

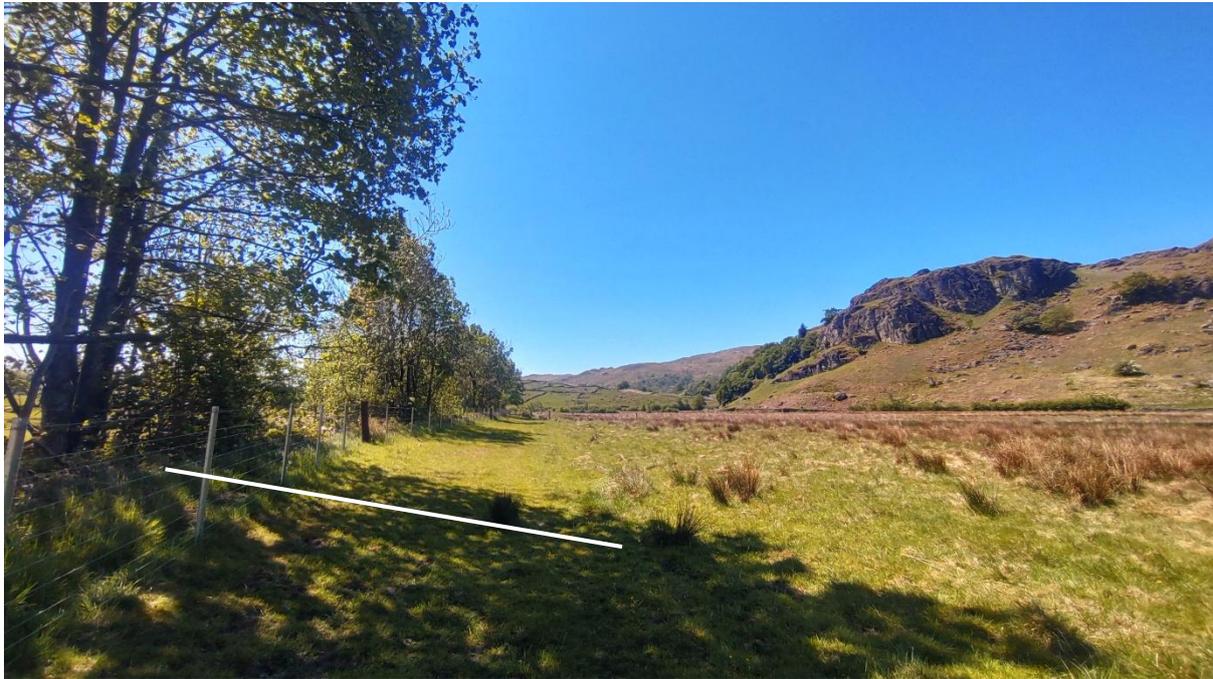
Fig 1. Looking d/s from NY 46152 05348 with the Kent channel obscured by the artificial embankment, fence and trees – the white line accentuates the ramp of soil down from the crest of the modifications to the floodplain. The rushes demarcate the naturally wet part of the floodplain.

At the uppermost site, the Kent had been realigned and straightened, with substantial revetment and walling along the bank top to maintain its artificial course (Fig 1). The field adjacent to the RB was clearly low-lying and exhibited substantial rush growth, and probably accommodated the paleochannels of the Kent. However, the land had been substantially reworked and various smaller tributaries contributing to it coalesced into a straight drain, parallel to the Kent (Fig 2).

Straightened channels are steeper and retain more erosive power, and coupled with the revetment to each bank, there is little opportunity for spate flow to engage with the floodplain where the energy could dissipate. That excessive power reduces the physical habitat diversity within the channel, and hence the potential for biodiversity.

- Boulder revetment and walling stone along with the ramp of soil could be excavated from the RB to a depth of 1-1.2m (ie level with the floodplain adjacent – see Fig 1)
- Ideally this would be conducted for the full length between the orange and grey arrows in Fig 2 to maximise impact.

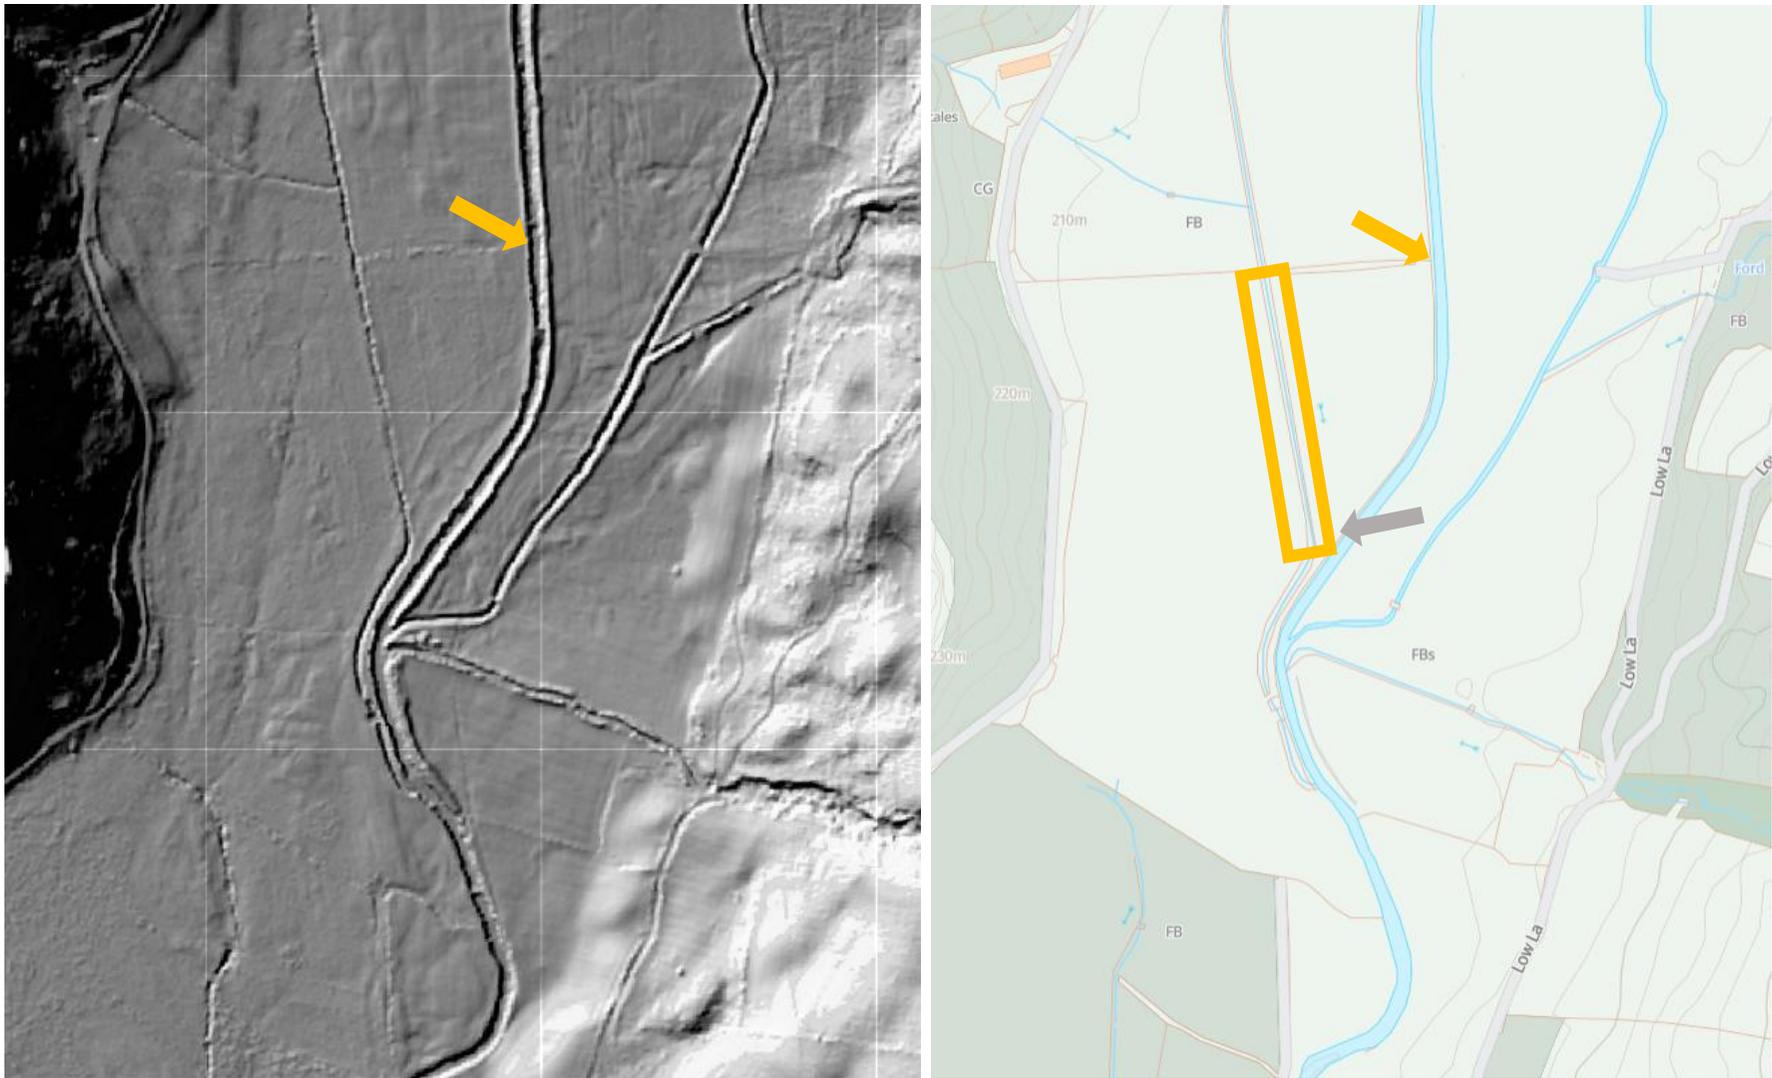
Fig 2. LiDAR & MAGIC views of the heavily incised Kent channel. Orange arrow marks the field boundary below which the embankment could be removed, potentially as far as the grey arrow. Orange rectangle denotes straightened field drain that could be filled / modified for pools & scrapes – NB works should be extended around the bend d/s.

- A lower impact option would be to reduce the height of the embankment by 1-1.2m as before, ie starting at the orange arrow, but for a reduced length, min 30m, to allow spate flow to access the floodplain.

- Spoil arising from the excavations. Boulder and stone probably originally taken from the channel anyway should be returned to the channel as a dispersed matrix to subtly raise the bed level. Soil and smaller stone could be used to infill the drainage channel in the floodplain.

- The drainage channel could be infilled completely using the spoil (as described above) as well as material that was laid along each bank of the drain when it was excavated – this would essentially be a 'stage-zero' approach, letting the water find its own way across the floodplain.

- An alternative might be to excavate the drain sides to form a series of broader, shallow pools and then use the spoil arising to block the extant drain channel in between the pools for short distances.

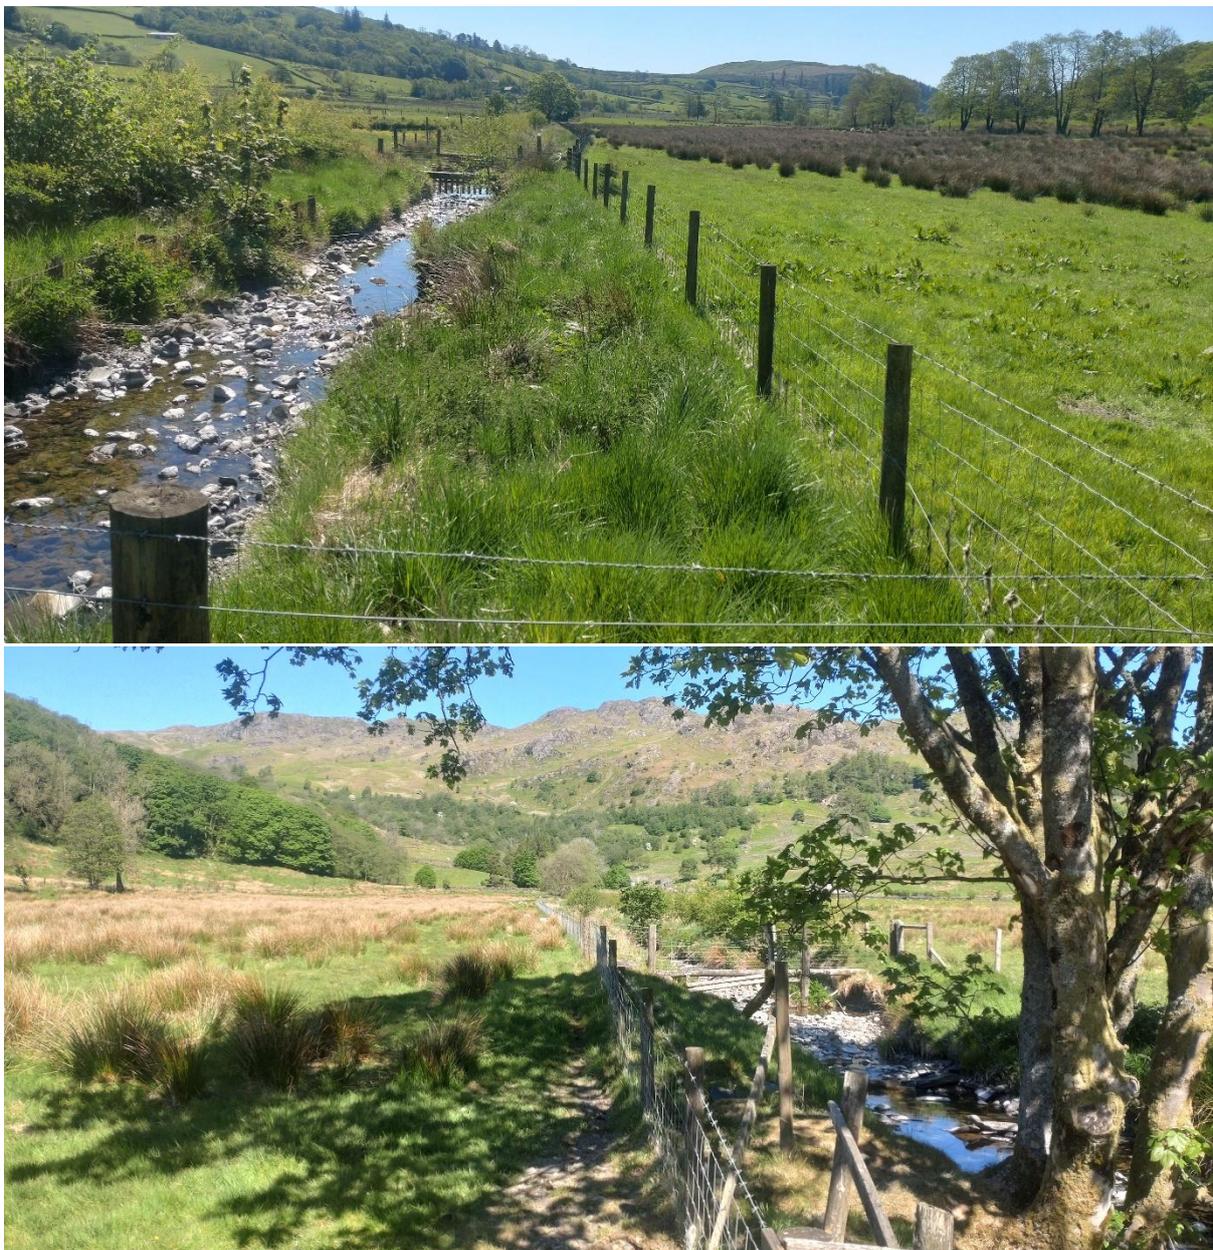
Hall Gill has been historically straightened and embanked to act as a drain for the fields to the LB but in doing so seemingly has impounded flows off the valley side to the RB where rushes now dominate – see Fig 3. The channel has been reduced to a trapezoidal cross-section, effectively a gutter with no physical variability to sort the sediment into different size classes, leaving it homogenously distributed. Coupled with scant tree cover, the channel was extremely susceptible to warming – poor conditions for cold-adapted aquatic invertebrates and fish species.

Fig 3. Views along the straightened Hall Gill. Upper – from a drinking bay at NY 45302 03840 looking d/s. Lower – from NY 45411 03681, the bridge near the confluence looking u/s.

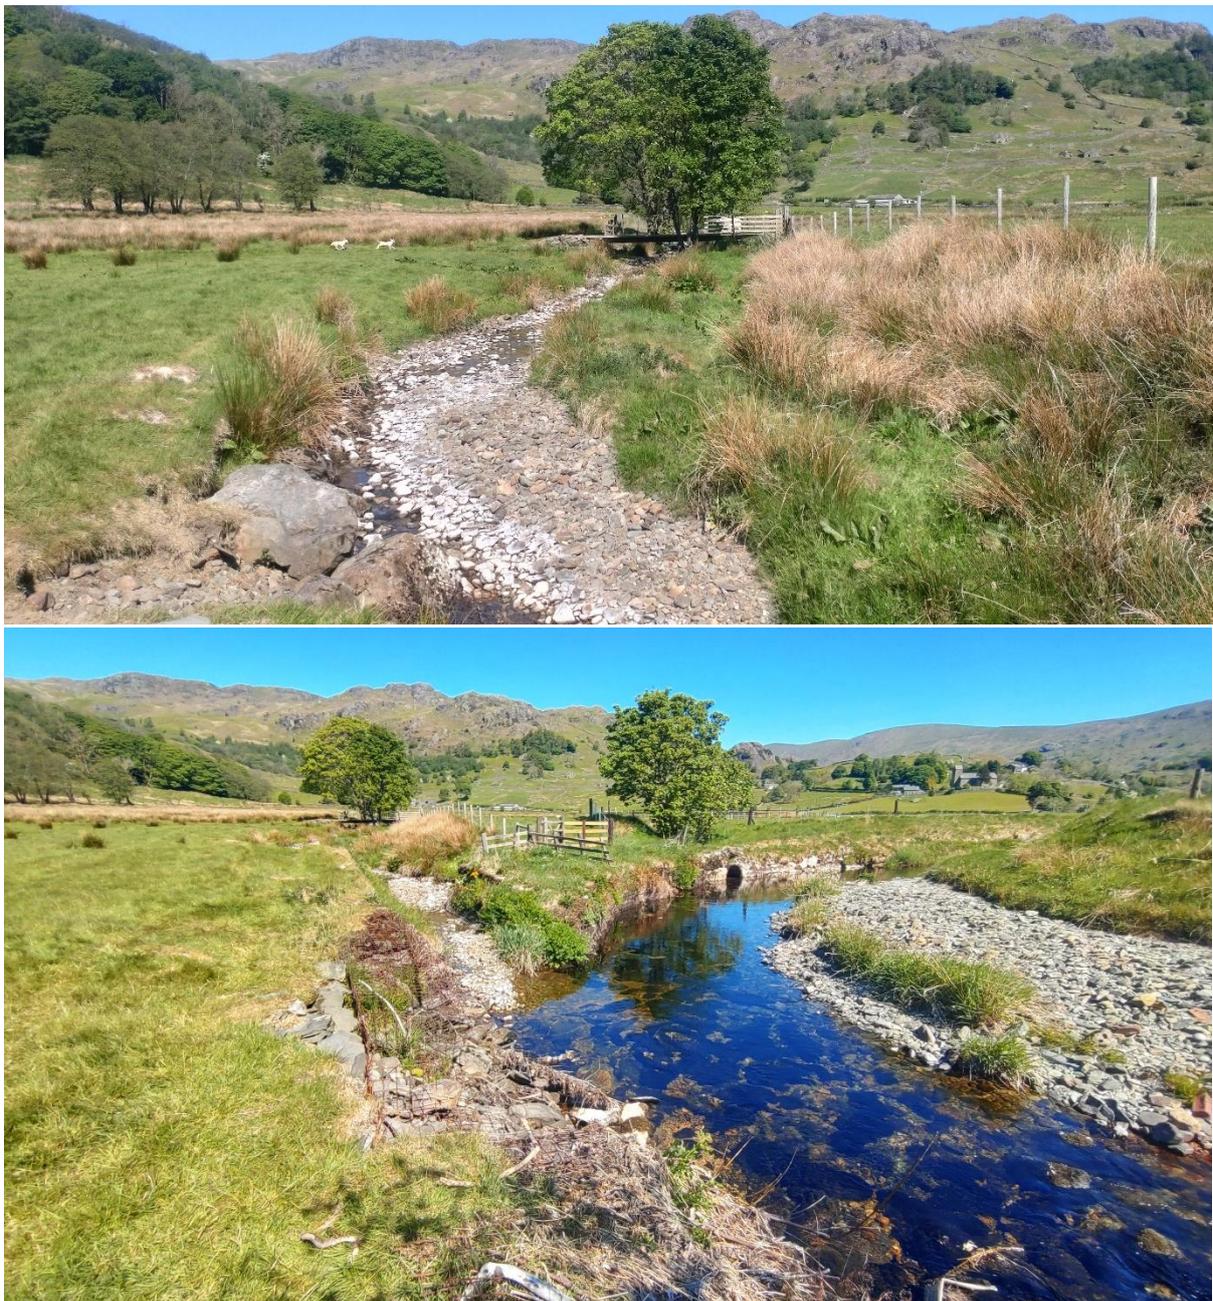
Although the majority of Hall Gill was buffer fenced and recovery of vegetation from livestock grazing was evident, the lowest reach near the confluence was not, and even further exposed to the effects of warming (Fig 4 – upper). The RB of the Kent on either side of the confluence was heavily modified with a mix of concrete, walling, gabion baskets and boulder revetment of various ages and states of repair (Fig 4 – lower). Boulder revetment extended some 50m d/s from the confluence along the RB (Fig 5), preventing floodplain connection and any dynamism and therefore functionality of the channel.

Fig 4. Upper – Hall Gill looking u/s from the confluence. Lower – The R Kent and the confluence of Hall Gill on the outside of the bend amidst all the artificial bank modifications.

- Break-out all artificial RB modifications immediately u/s of the confluence to ~50m d/s – see Figs 4-6. Any boulder material should be dispersed within the channel from whence it originally came.

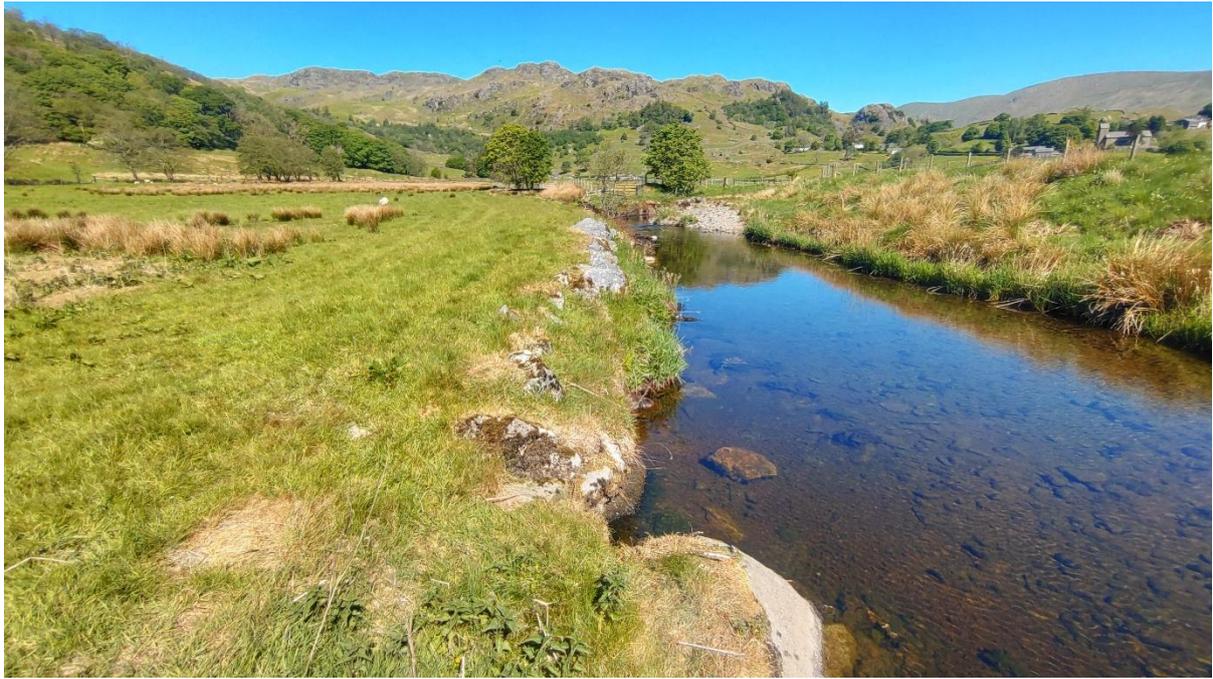
Fig 5. Large boulder revetment extending for ~50m d/s of the confluence on the RB

- Removing the concrete, gabion baskets and boulders would a) renaturalise the confluence with Hall Gill, but crucially b) reinstate connection into a paleochannel depression.

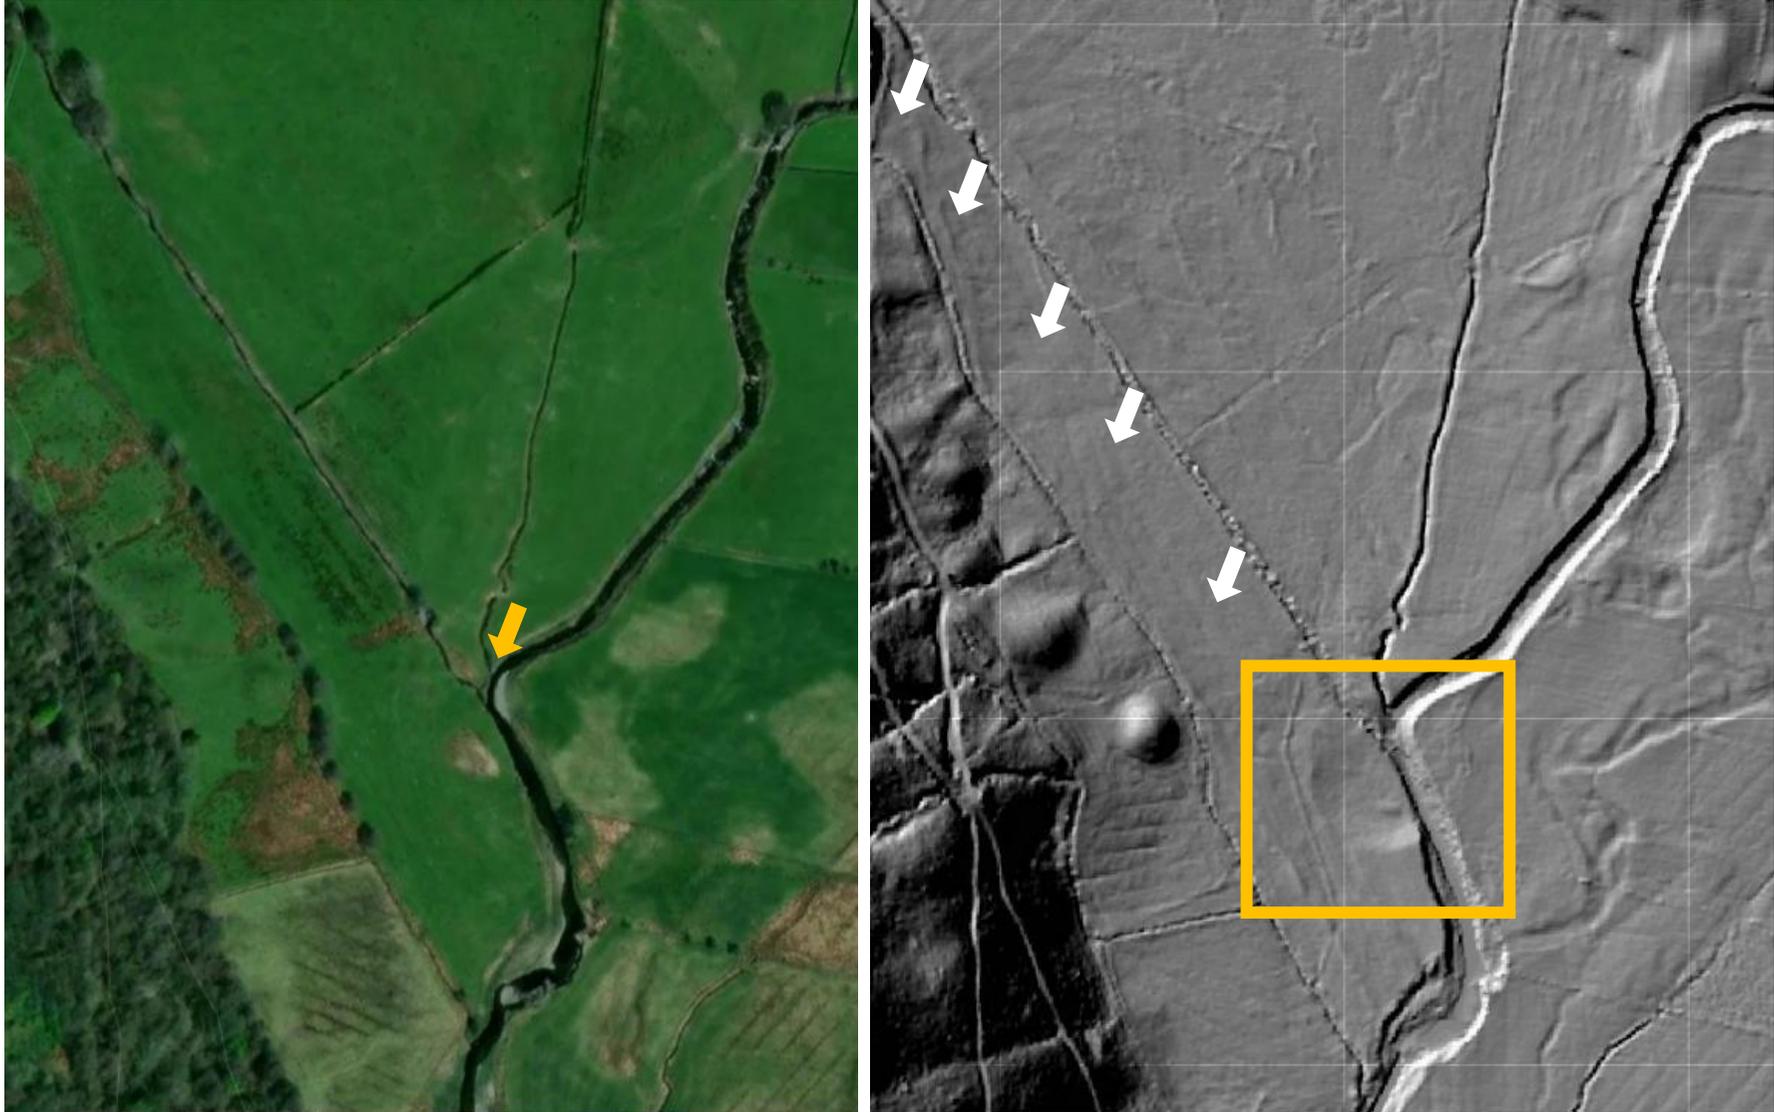
Fig 6. Satellite & LiDAR of Hall Gill & confluence with the R Kent. Orange arrow points to perched control culvert for the field drain running N-S. White arrows indicative of breaking out boulder revetment along the length of the Hall Gill RB. Orange square highlights the confluence area and depression to the south west indicative of a paleochannel of the Kent which could be reinstated.

- Reprofile the entirety of the RB to just u/s of the bridge, removing boulder revetment and lowering the soil embankment – see Fig 6. Boulders should be returned to the channel in clusters to the extant LB to encourage sinuosity and natural erosion into the RB. Any soil arising could be used judiciously as low bunds within the floodplain to accentuate retention of water.

- The perched culvert controlling flow from the N-S field drain (see Fig 6) could be left in situ or even modified further to retain more water within the drainage network.
