River Stour, Littleton Farm at Charlton Marshall

An advisory visit by Nick Lawrence of the Wild Trout Trust, May 2022

Introduction

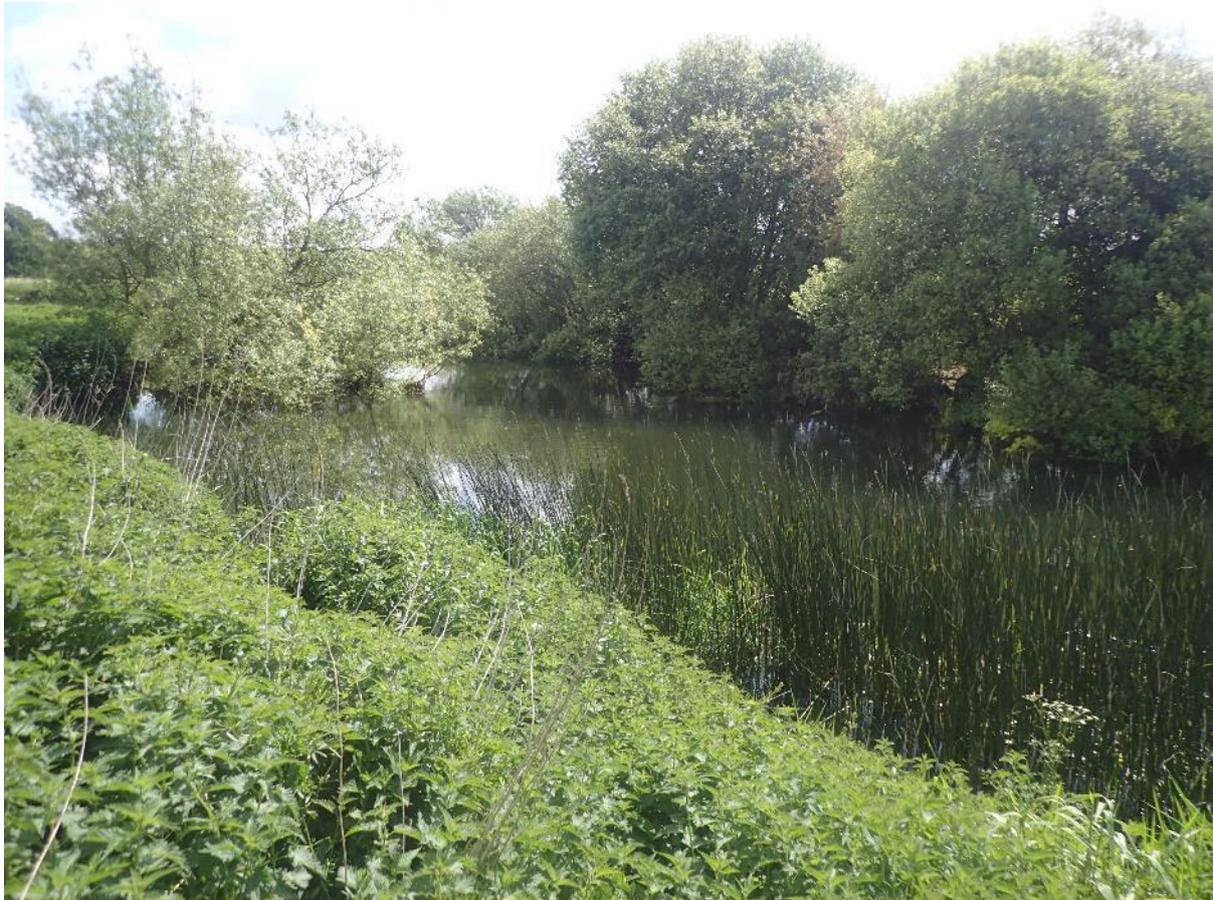
At the downstream end of the fishery, upstream of the island at Charlton Marshall, a large pool (Photo 1) exhibited lots of high quality habitat, including overhanging cover in the form of goat willow and marginal encroachment of club rush (*Scirpus sp.*). The trees and marginal cover provide prime habitats for large adult trout to evade predation from birds or mammals as well as assisting invertebrate populations and helping regulate water temperature.

Photo 1 High quality trout habitats: water crowfoot (out of shot), overhanging willows on the RB and LB and lush emergent vegetation.

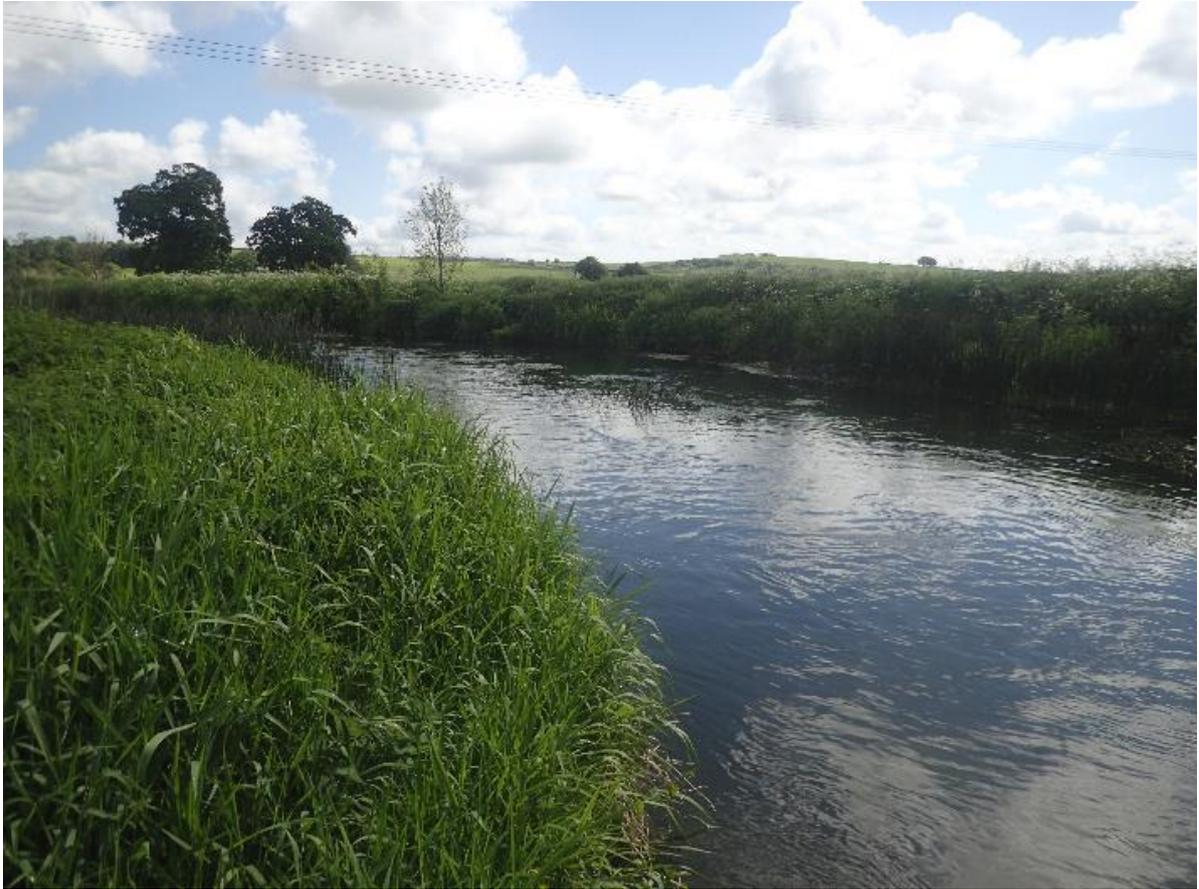
Moving upstream (photo 2) a nice glide had an array of submerged plants which couldn't be photographed due to difficulty of access. The channel here contained water carrot, water crowfoot and water parsnip; a good diversity of submerged plants, providing a mix of habitats for aquatic invertebrates and a good food source for fish.

The buffer fencing here, and within much of the reach visited, is set too close to the edge of the river, merely circa 1-2 metres in some areas. This is an insufficient buffer leading to impeded development of trees and scrub, which if allowed to develop with sufficient space and lack of over-fence grazing pressure would in time diversify river habitats and supply the river

with coarse woody material. As seen in Photo 2 the tree development is poor: although in-river vegetation is beneficial to fish and invertebrates the lack of overhead tree cover and resulting large woody material (LWM) result in sub optimal fish habitats.

Photo 2 Lush emergent sweet grass on the RB (left of shot) providing good habitats for juvenile fish and invertebrates, while the incised LB is impeding marginal development: buffer fencing on both banks is set too close to the bank top, which is suppressing tree regeneration.

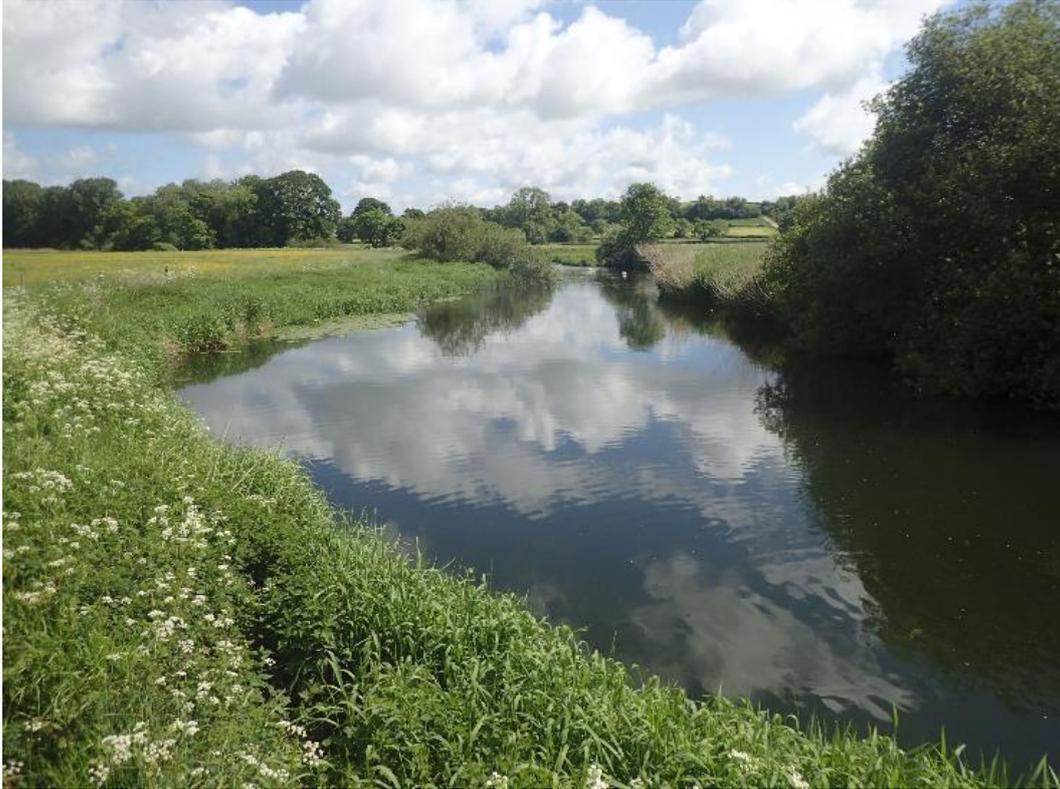
Photo 3 Deep bend with sparse tree cover on the LB: buffer fencing too close to the river is again reducing tree cover on the RB.

Upstream of the glide in photo 2 a deep meander (photo 3) provided good variation of habitat, and a number of chub were sighted. Some overhanging tree cover had developed on the LB, but both banks in general were suffering a lack of trees and diversity form, reducing the potential for improved fish habitats.

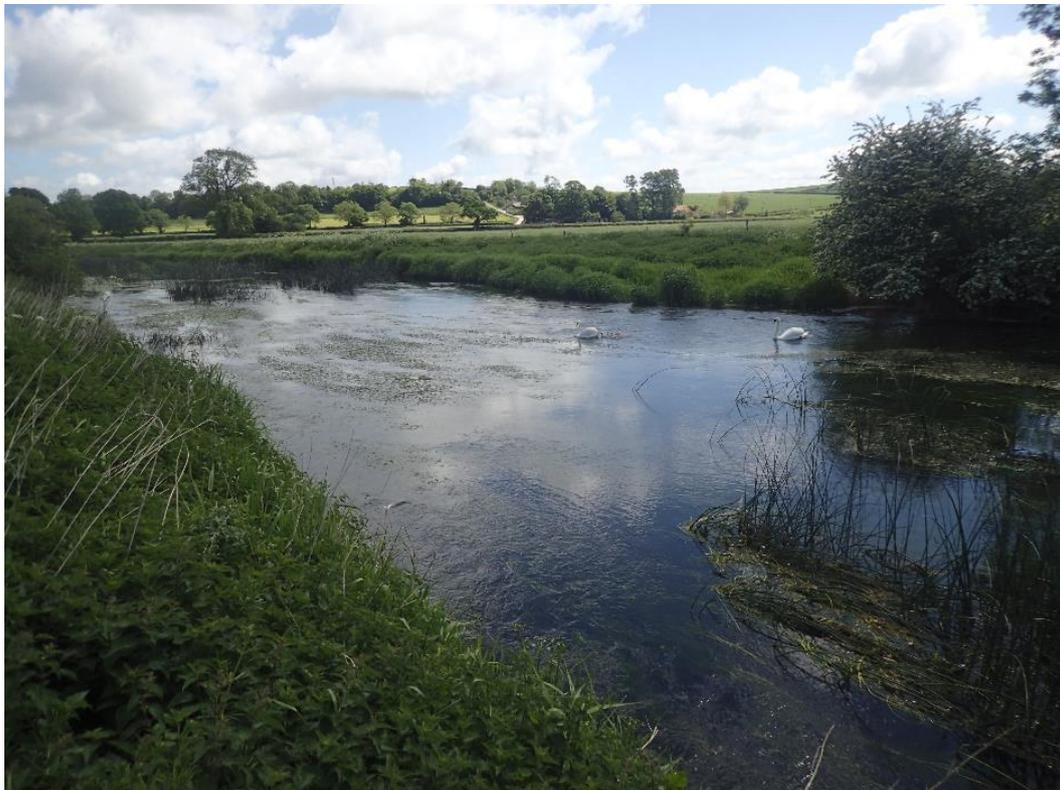
Photo 4 Wide shallow riffle with thick water crowfoot growth: prime habitats for juvenile trout and salmon parr.

Upstream of the deep meander the river shallowed, and a wide riffle was covered in thick water crowfoot (photo 4) -the type of habitat where juvenile trout and salmon parr would thrive. The channel here has been modified in the past, with tell-tale signs of very steep incised banks, circa 2m from bank top to water level. The steep banks impede marginal plant development and are vulnerable to erosion in high flows. Without tree or marginal growth to stabilise them, such banks can become particularly unstable and a source of increased sediment loads.

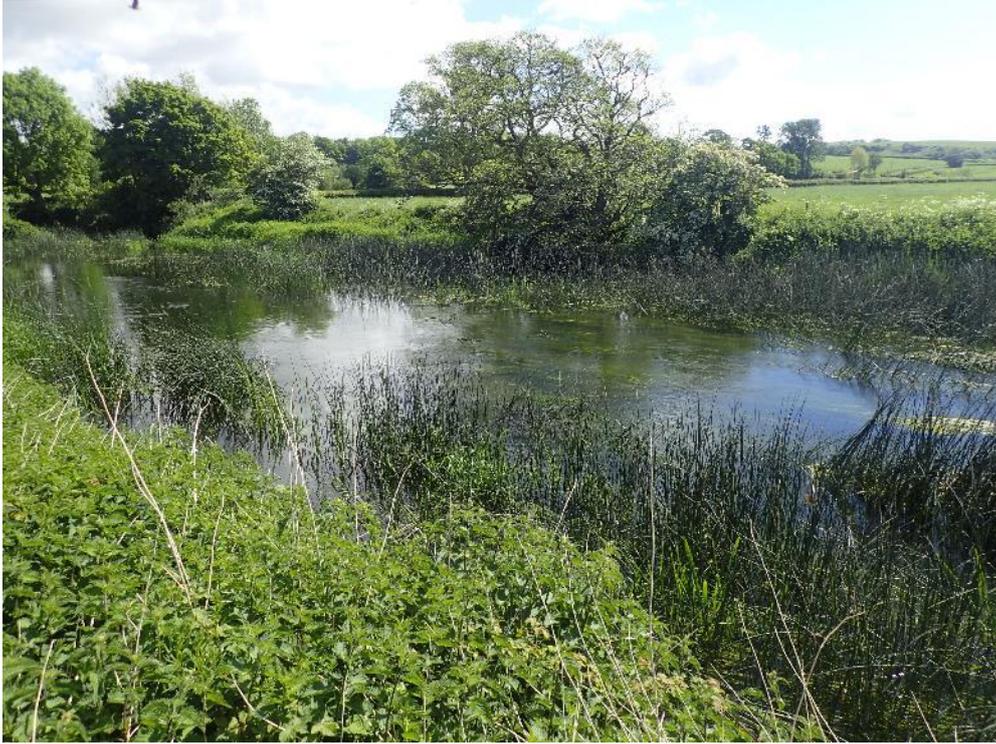
Photo 5 The *Scirpus* encroachment leaves clues to what was once a much narrower and more sinuous channel, before historical modifications were made.

The river in some areas (photos 5 & 7) is attempting to re-narrow itself by sedimentation and marginal encroachment, this process has led to a healthier and narrower channel, with increased velocities helping to cleanse the gravels. As noted in photo 5, the encroachment gives clues as to the original size of river channel, which would have once been more diverse and sinuous before the modifications.

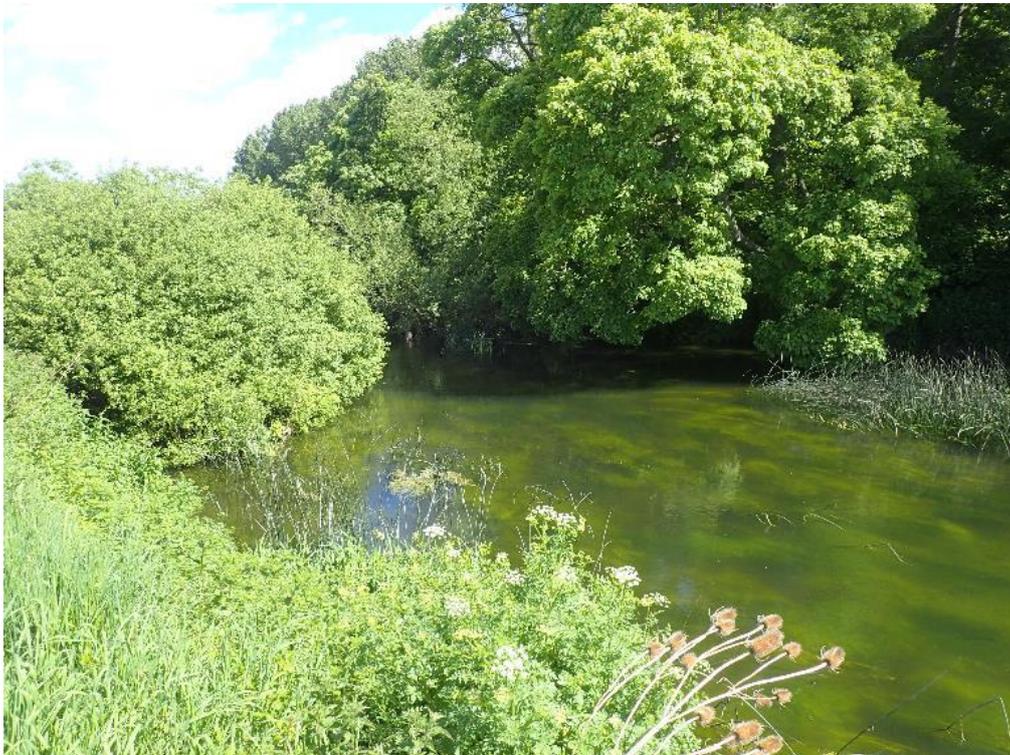
Photo 6 The island on the right of this shot, which has been unmanaged for some time, and has developed mature trees which have diversified the channel as they have fallen and slumped into the river. More areas such as this would be highly beneficial.

One particular aspect that will be important is planting of willows within the marginal fringes, in an attempt to get trees growing in a similar fashion to photos 6 & 8, providing low cover and possibilities for a future supply of woody material.

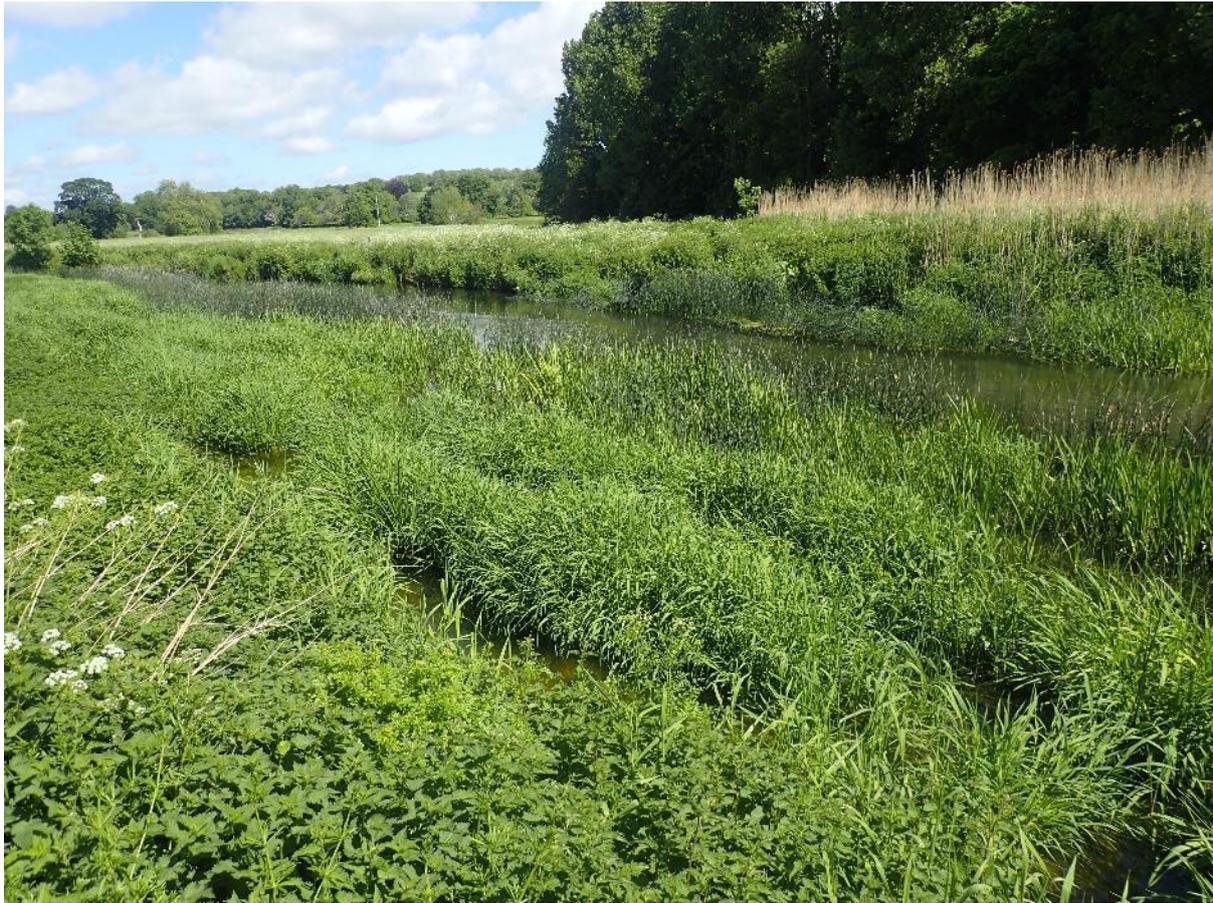
Photo 7 More marginal encroachment from the RB, narrowing the
overwide channel by half: however, note still the lack of trees due to
narrow buffers.

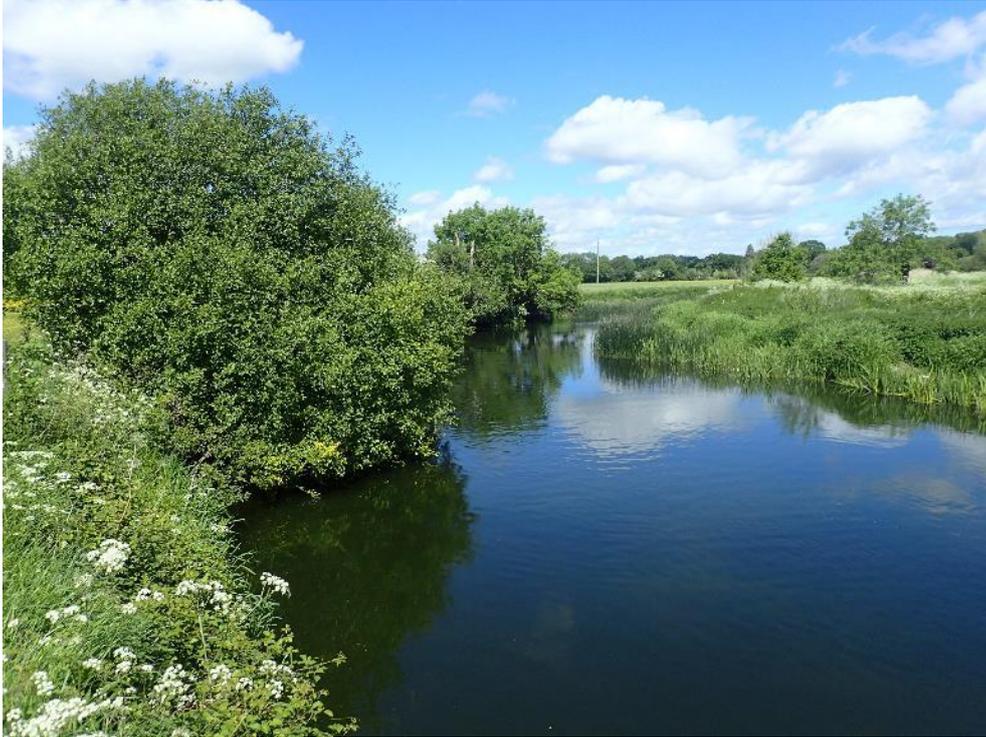
Photo 8 Deep meander with goat willows growing at the toe of the bank providing high quality cover: however other trees are struggling to succeed here due to the small buffer zone, leaving the bank in the foreground vulnerable to erosion.

Moving upstream the river starts to become very heavily impacted from previous modification/ dredging works (Photo 8-10). The river from photo 8 to near the top boundary is similar, characterised by a homogenous glide. Some beneficial habitat features for fish were present with low, overhanging cover and accumulations of sub-emergent vegetation. The RB also has a thick common reed (*Phragmites sp.*) bed (photo 10), which was full of reed warblers, which should also be a haven for insects.

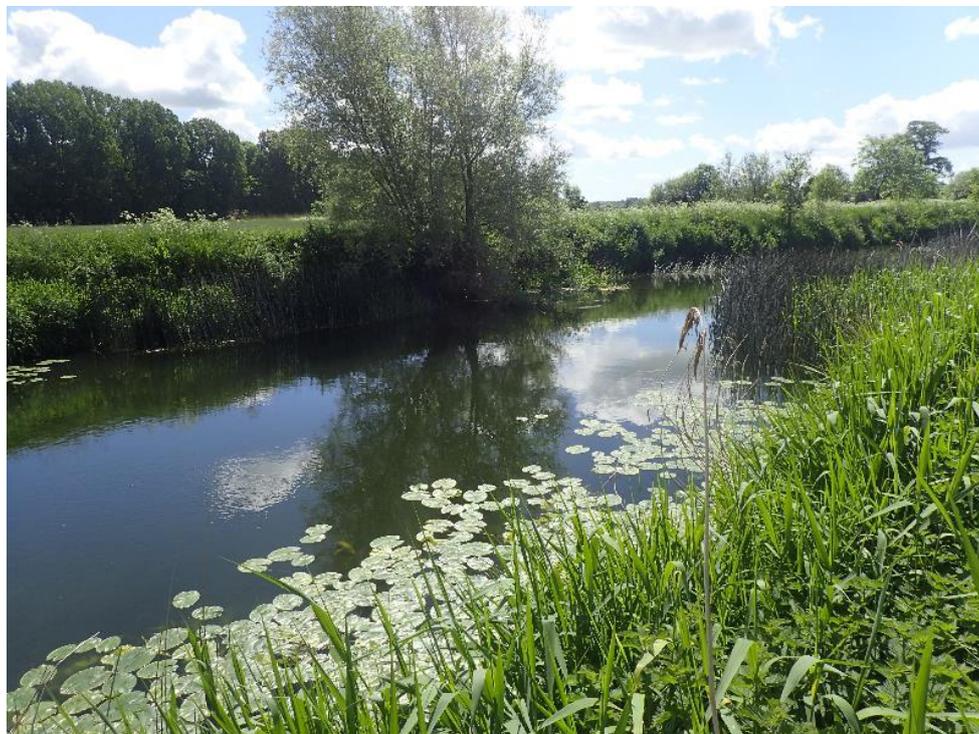
Photo 9 The dredged uniform channel does have pockets of willow cover which will be highly valuable. Otherwise tree cover is sparse within this reach.

Flow diversities were limited, and generally only where willow had managed to succeed, was there a variety of cover. Photo 9 shows a nice example of a willow that has partially collapsed, with some branches growing at water level. More incidences such as this would be highly beneficial to the reach.

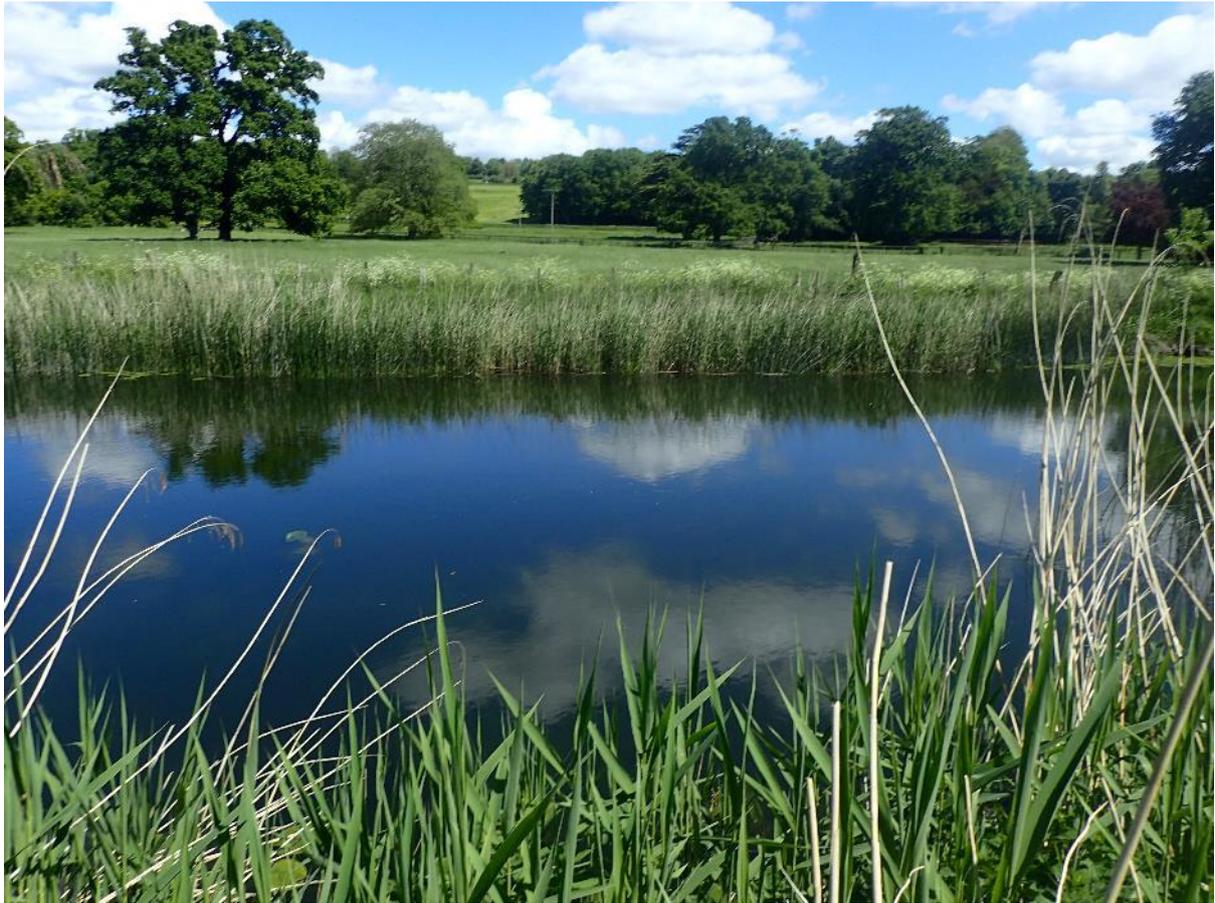
Photo 10 The lack of diversity within the middle reaches is stark: this area, and much of the reach, would benefit from a riparian tree planting scheme.

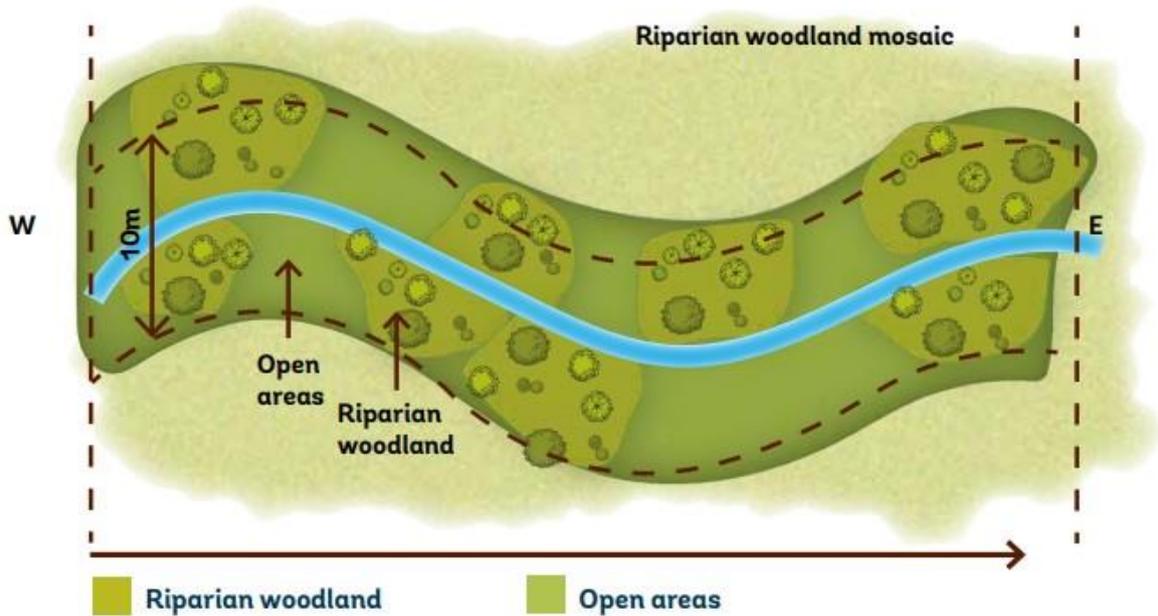
Photo 11 Suggested riparian planting to create a mosaic of tree cover producing dappled shade across the channel.

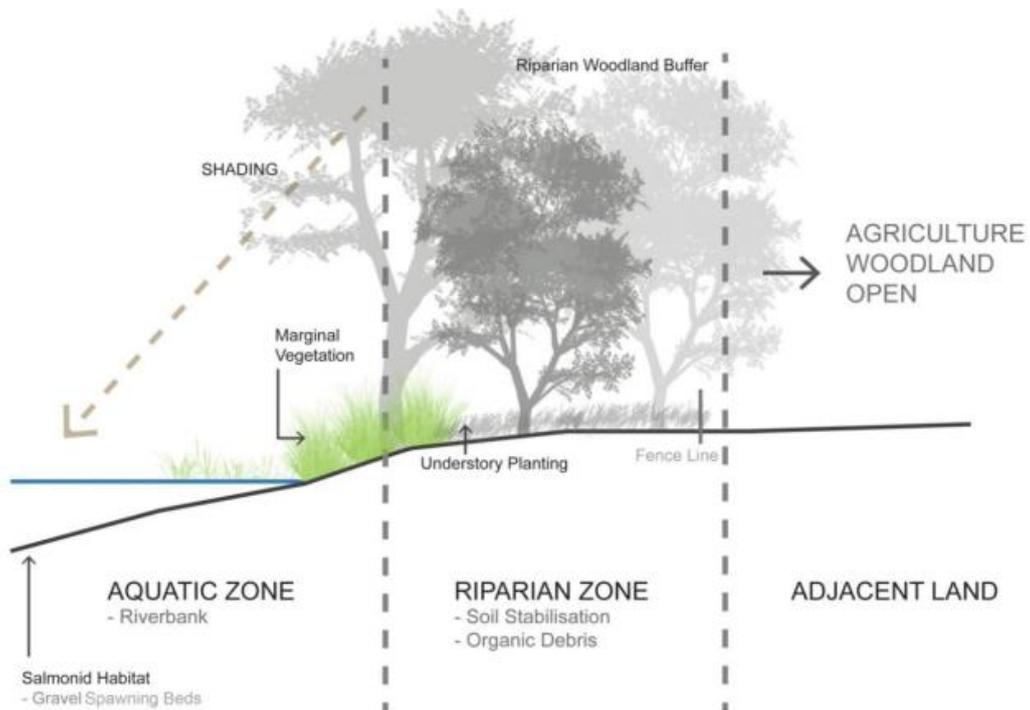
Photo 12 Diagram showing possible ideal scenario for the riparian zone behind a fence line.

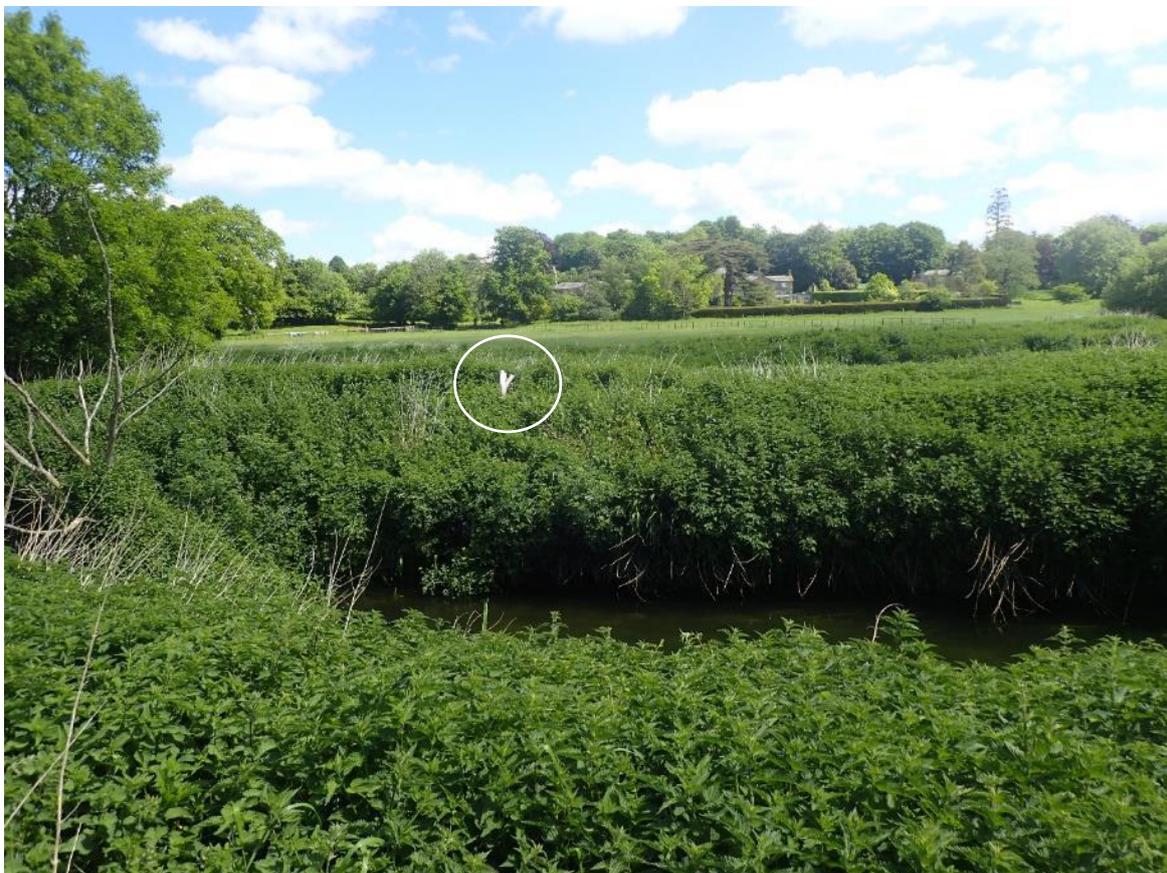
Photo 13 A failed planting scheme on another island near the top of the fishery, a relic tree guard white circle. Re-planting here would be beneficial.

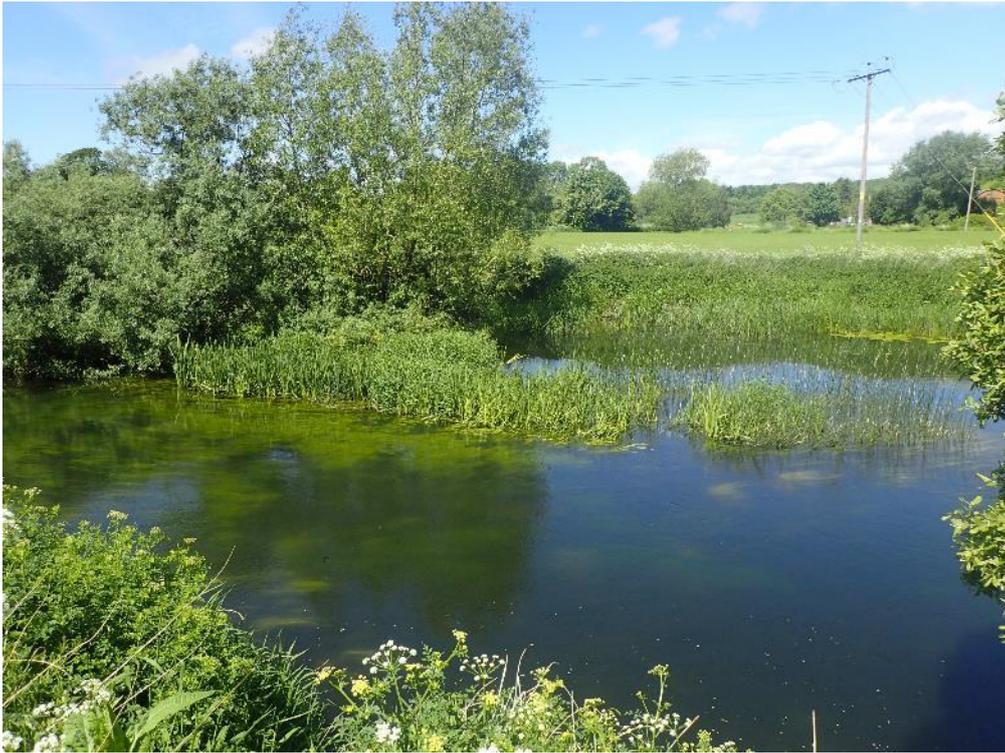
Photo 14 A nice example of how fallen woody material can enhance habitats, note the marginal plant succession behind the fallen willow, creating a small backwater, enhancing habitats for coarse fish and trout.

Within the upper most section (photos 14-16) there is good potential for trout habitats. The riffle shown in photo 15 will be a hugely important area for trout spawning and juvenile fish, especially because areas such as this were very rare throughout the 2km visited. The riffle in photo 15 sits directly upstream of the backwater in photo 14, which provides cover for any juvenile fish spawned from the riffle.

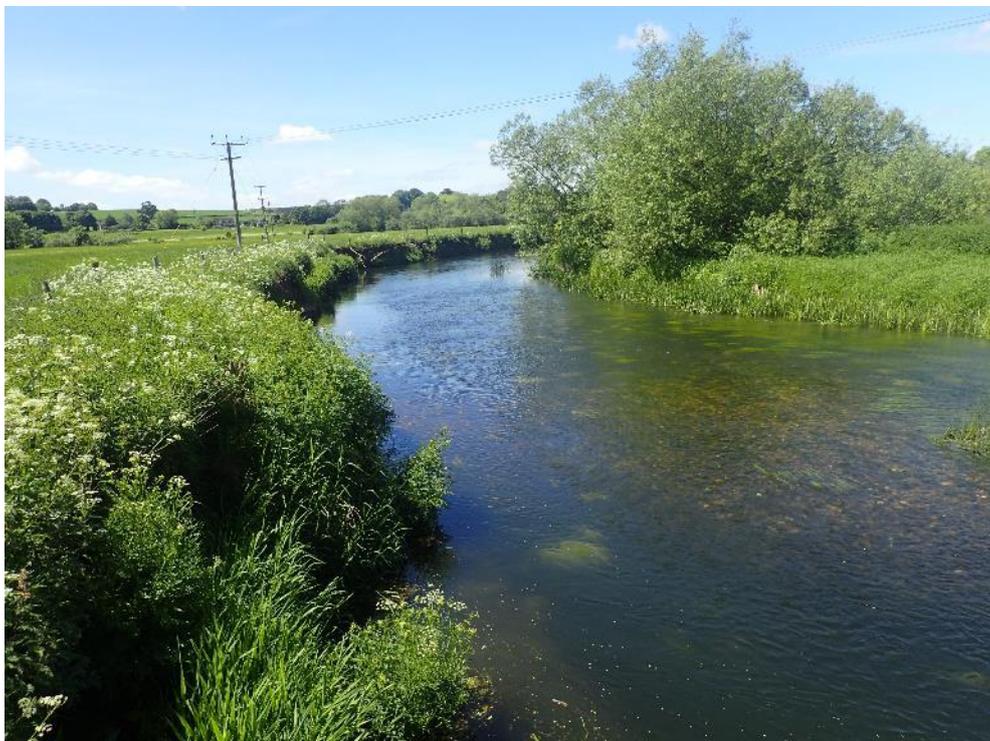
Photo 15 One of the rare riffles within the Littleton reach: this area will be hugely important to spawning trout, but the steep RB is still impeding marginal development.

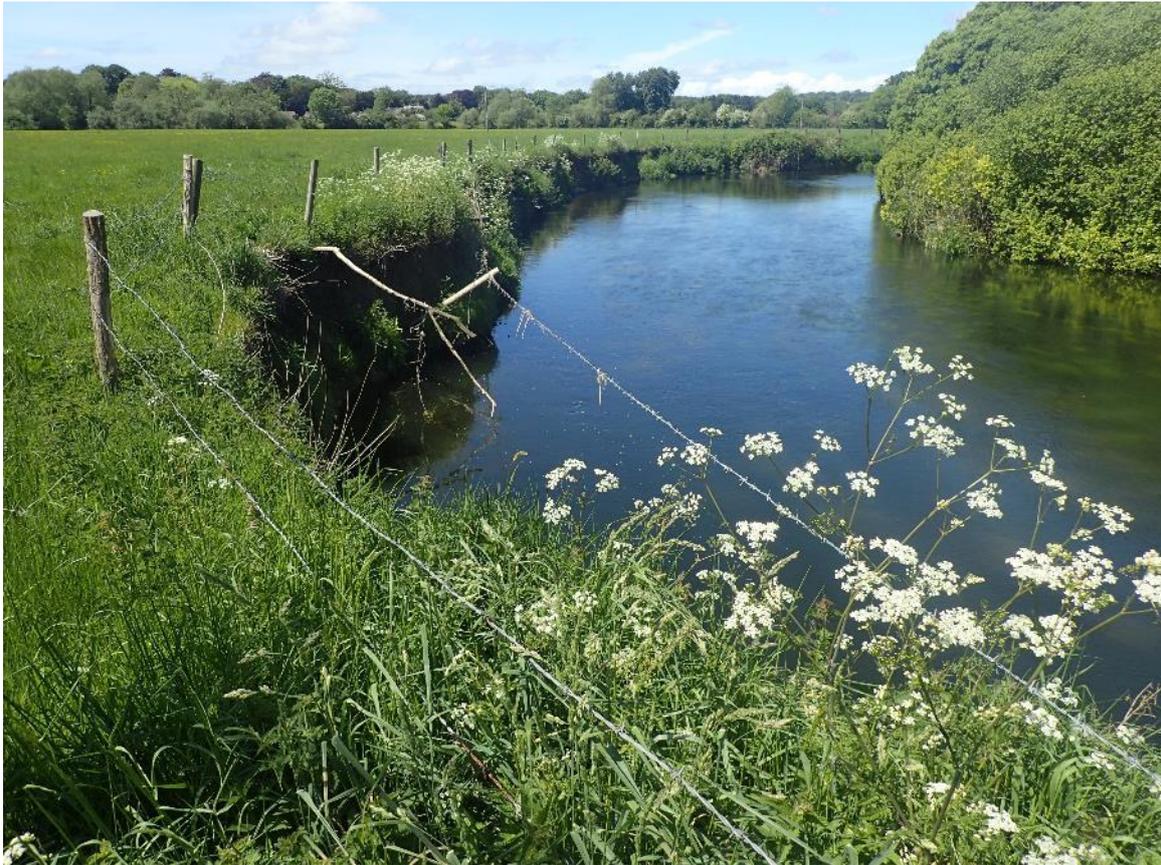
Photo 16 Upstream of the riffle on a bend, multiple fencing attempts keep failing. Tree planting, set back from the bank top, is required to aid bank stability.

Photo 17 shows what can happen when a buffer fence is set too close to the river on a steep incised bend. There have been multiple attempts to re-fence this, but each time the fence is relocated, it has not been moved far enough back to stop browsing of herbage and tree saplings over the fence, thus reducing the succession of trees taking hold and helping to protect, stabilise and slow erosion. Encouraging willows to grow along the toe of the outer meander will be particularly important here in providing improved habitat and diffusing flow, which in turn will reduce erosion.

The recommendation here is to move the fence back a minimum of 10 metres, and establish a riparian tree planting scheme that will stabilise banks, improve habitats and protect the field from further erosion.
