WILD TROUT TRUST

Project Proposal

Malham Beck & Goredale Beck, R Aire

Prof J Grey (jgrey@wildtrout.org), Nov 2022

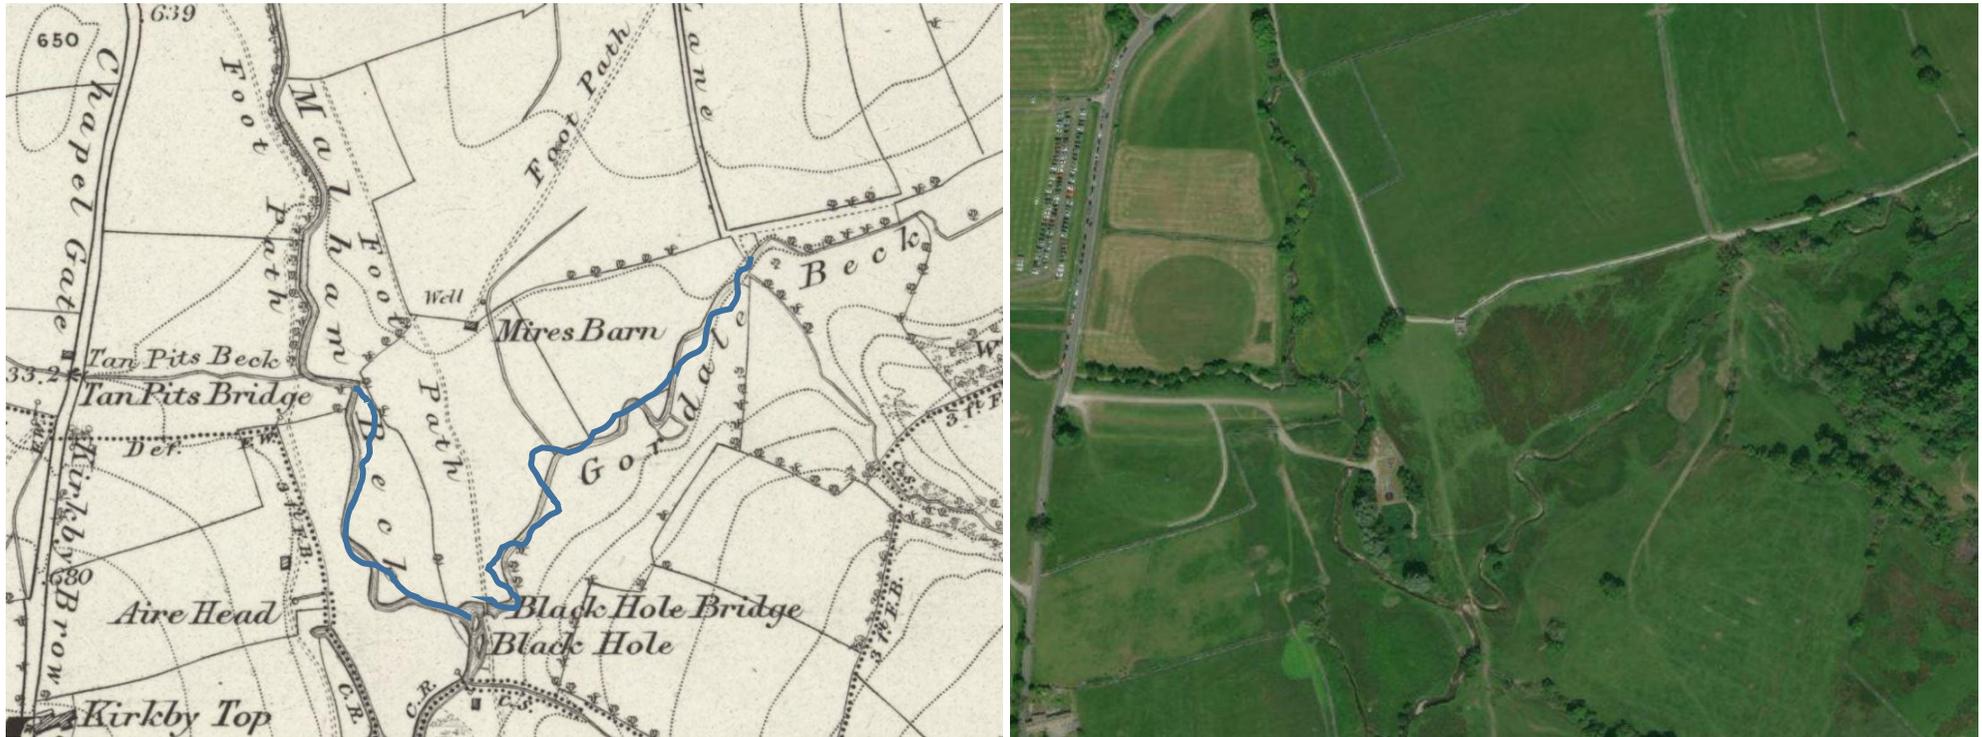
Fig 1. Comparison of the Ordnance Survey map from 1854 to current satellite imagery, and an overlay of the extant course of both Malham & Gordale Becks in blue to highlight change over time. Even 170y ago, Malham Beck had been realigned and pinned against a boundary wall in the upper reaches (of this map extract) with an occasional abrupt turn and long, straightened reaches.

It appears that within the intervening years, parts of both becks have been further straightened by cutting off meanders. However, there has also been some natural re-meandering occurring resulting in increased sinuosity, especially on Gordale Beck just above the confluence.

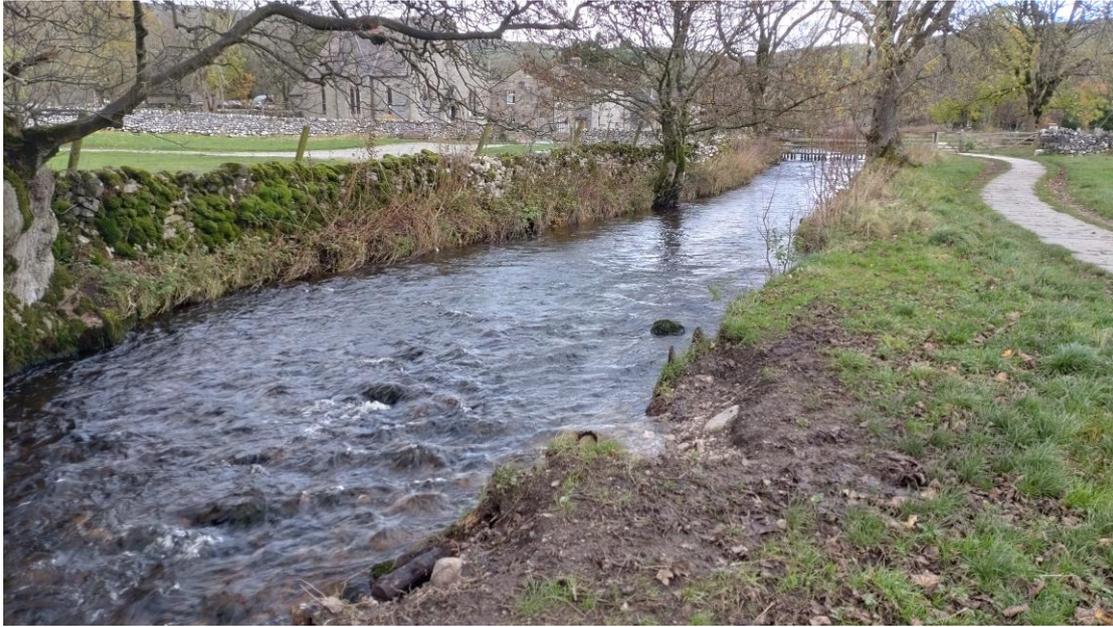
Fig 2. The uppermost reach (u/s boundary at the watergate) where Malham Beck has been straightened and pinned between a wall boundary and the Pennine Way. Wooden stakes can be seen at the erosion point where the LB has been formalised (and recently 'repaired' with wired branch bundles d/s, just out of shot).

Note continual shallow riffle habitat, a function of straightening into a trapezoidal channel of fixed width. The erosion point was likely to have arisen from livestock or dogs accessing the beck and subsequently exacerbated as a desire line developed. It is difficult to prevent such deterioration with the proximity of the Pennine Way and the amount of footfall.

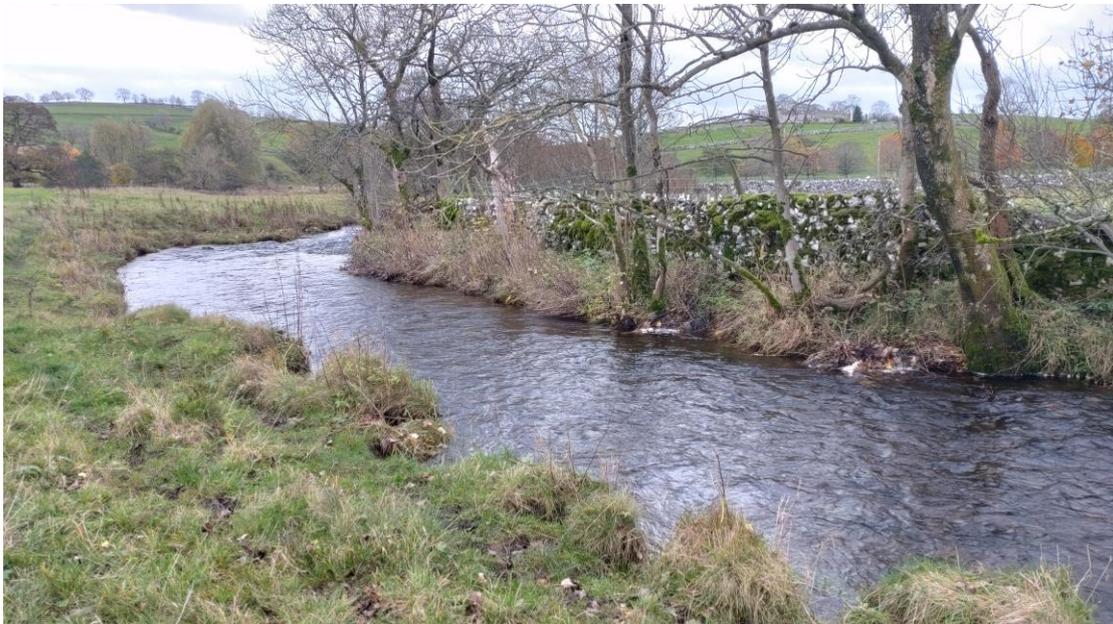
Fig 3. Where the Pennine Way departs from adjacent to the channel, there is more scope for renaturalising the channel. The land to the LB is relatively low lying but has been disconnected from the channel by boulder revetment (each of the 'hummocks' along the LB).

Opportunity to use some of the diseased ash or stems from previously coppiced alder and sycamore on the RB by felling and laying them into the channel to accentuate the inside of the bend in conjunction with removing the boulders to the LB and rewet the meadow.

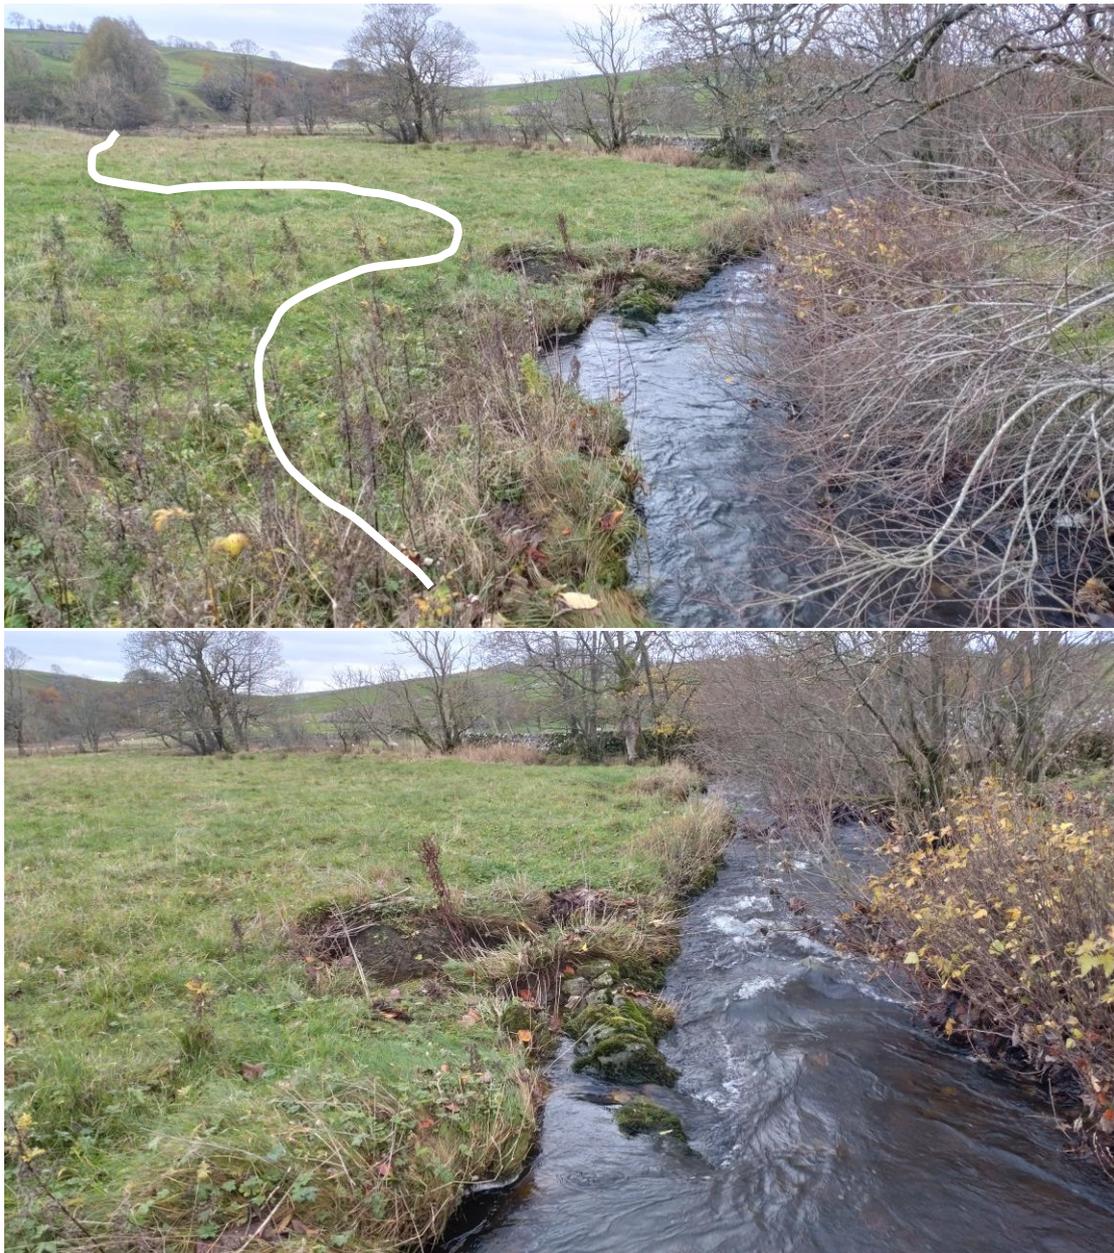
Fig 4. Upper panel, by eye, there appeared to be a palaeochannel evident across the field to the LB (highlighted by the white line) but the beck had been forced right to stay parallel to the boundary by walling.

Lower panel – a close up of the LB walling which the beck has started to erode behind to return to a more natural position within the floodplain and develop a more naturally variable width. Retained by walling, flow energy cannot dissipate laterally onto the floodplain, so it scours downward creating a more incised chute-like channel even further disconnected from the floodplain and stripping out the finer substrate (exemplified by turbulent accelerated flow in this image).

Opportunity to break out the LB walling to reinstate a more natural channel width and use the material *in situ* to raise the eroded section of bed, thus reconnecting the floodplain and rewetting the meadow.

So, the majority of the recommendation for Malham Beck is simply to remove any LB walling. As noted in Fig 4, down-scour caused by the walling has lowered the bed of the beck and increased the gradient. The most cost-effective solution is to use the limestone walling (local) material to infill the scoured sections and lessen the gradient, thereby raising the bed slightly and allowing better reconnection to the floodplain.

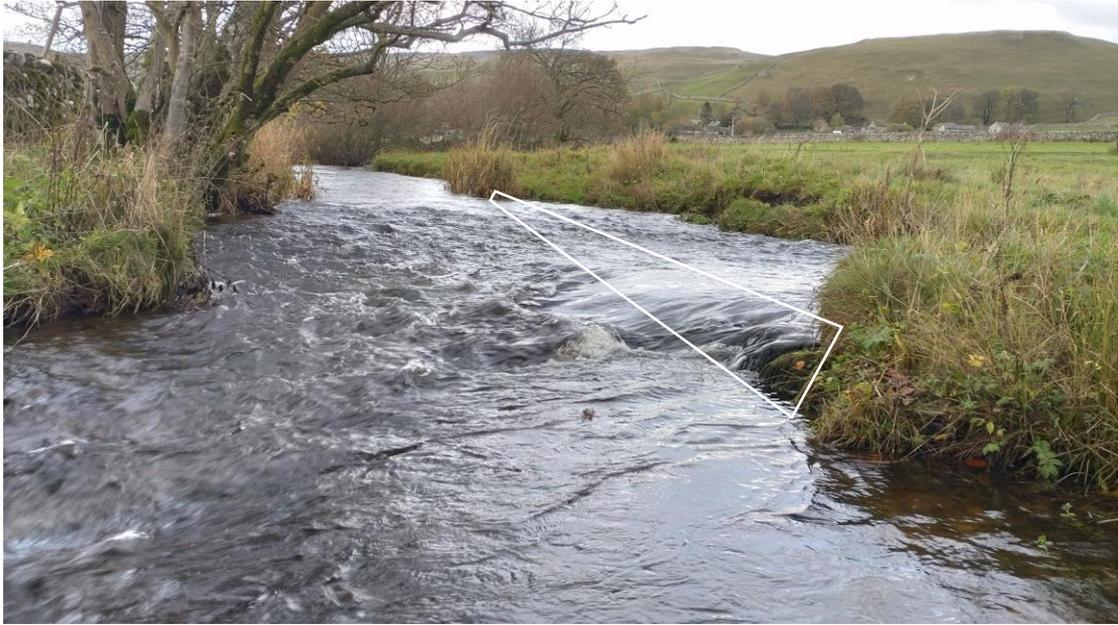
Fig 5. Looking u/s at another section of LB walling that has partially failed. Originally there would have been walling the length of the white trapezoid; there remains a spur at the d/s end. Unshackled from walling, the channel has widened by eroding into the LB, slowly returning to a more natural position within the floodplain. Where it is wider, there has been deposition of gravel, creating a shallow riffle and further diversifying the physical characteristics of the channel. The remaining walling forces flow to be constrained again and creates a chute of much steeper gradient

Opportunity to break out the remaining walling and encourage more sinuous flow, reinstate a more natural gradient, again in conjunction with laying of woody material from the RB.

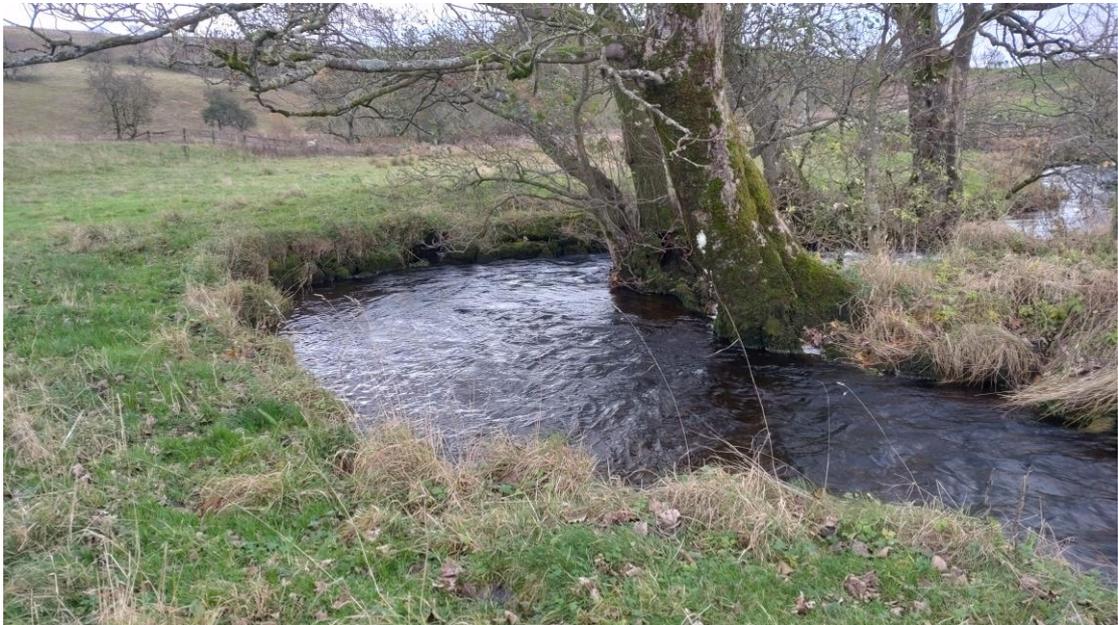
Fig 6. Another example of formalised LB walling (forcing the channel through almost 180°) which could be broken out with material used to raise the bed and reconnect the floodplain.

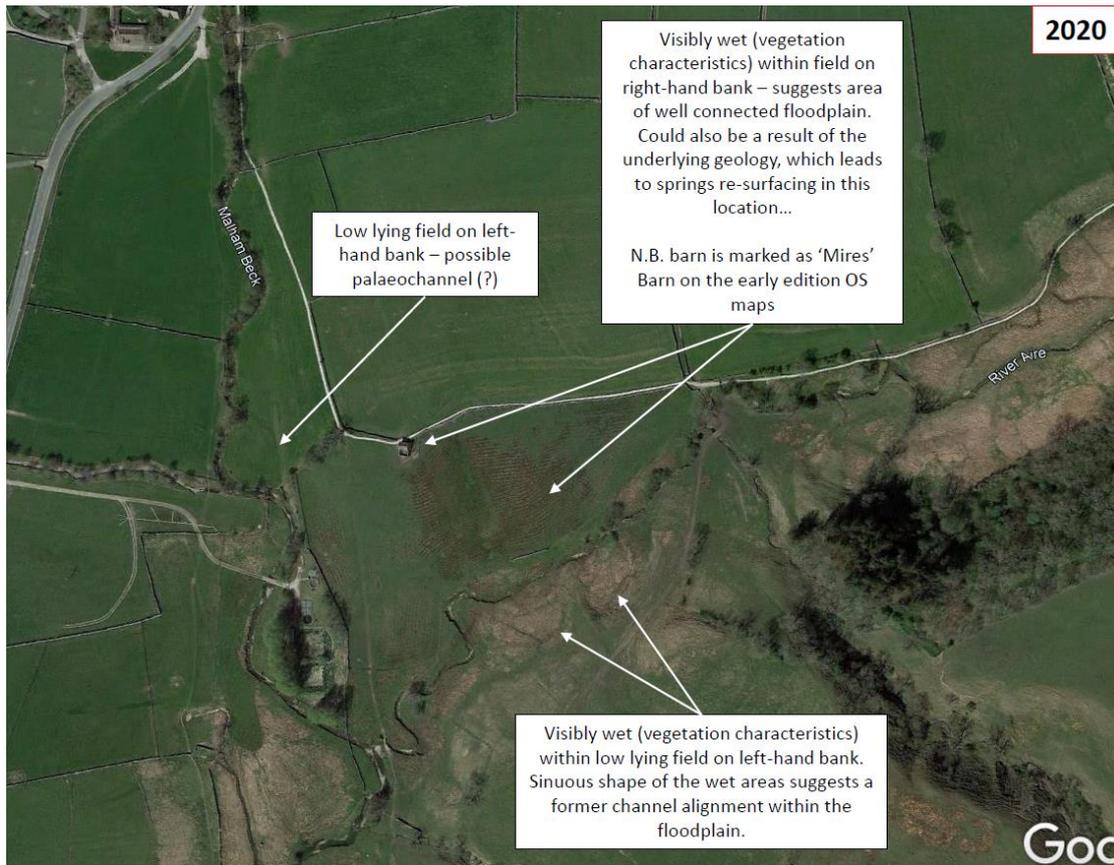
Fig 7. Satellite image from 2020, with accompanying notes provided by Chris Nash (Environment Agency). Lidar coverage is poor for Malham & Goredale Becks, but the wet nature of the floodplain and evidence of palaeochannels are visible to the naked eye in places.

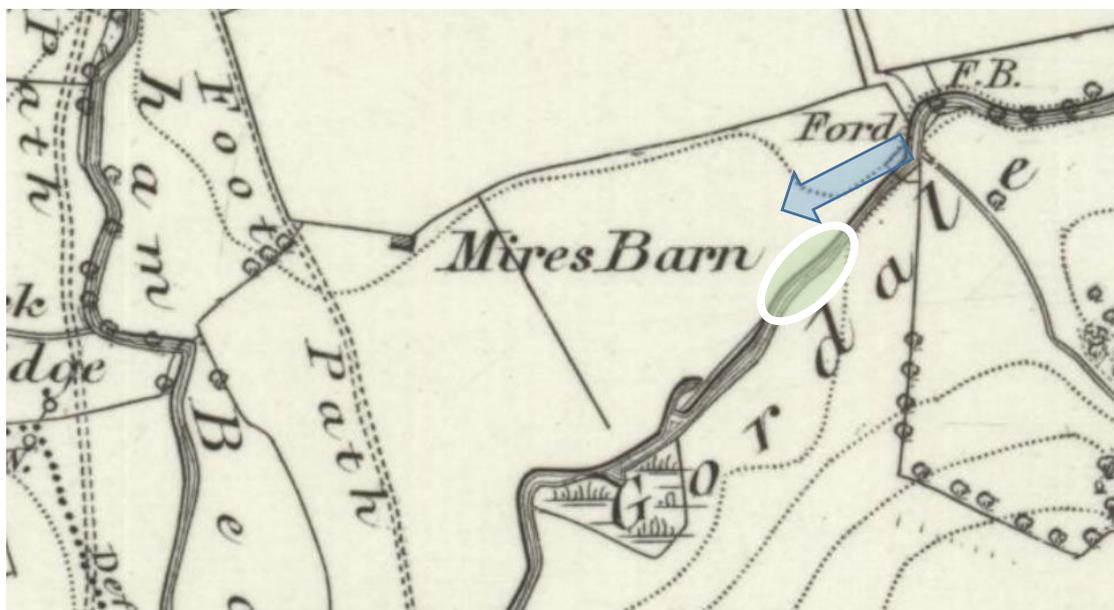
Fig 8. Extract from the 1896 Ordnance Survey map highlighting a formalised ford crossing of the beck (now bridged) and revetment of the RB preventing the most likely route of former channel (highlighted by blue arrow).

Opportunity to remove revetment and hinge / lay scrubby goat willow into the channel within the white oval.

Allowing better floodplain connection at the u/s boundary (the ford area in Fig 8) will reduce spate flow energy within the extant channel and encourage more deposition, especially if the scrubby willow beside the channel can be hinged in to form a permeable matrix. Hence, the solution to channel restoration on the Goredale Beck reach is to encourage more out of bank flow, and let the beck do the work. Whips cut from the stand of goat willow could be pushed into the toe of the bank on the inside of any nascent bends to encourage flow in a more sinuous path, and provide further low cover and shade in a currently exposed reach.
