WILD TROUT TRUST

River Lugg
Midland Flyfishers

Herefordshire

2025

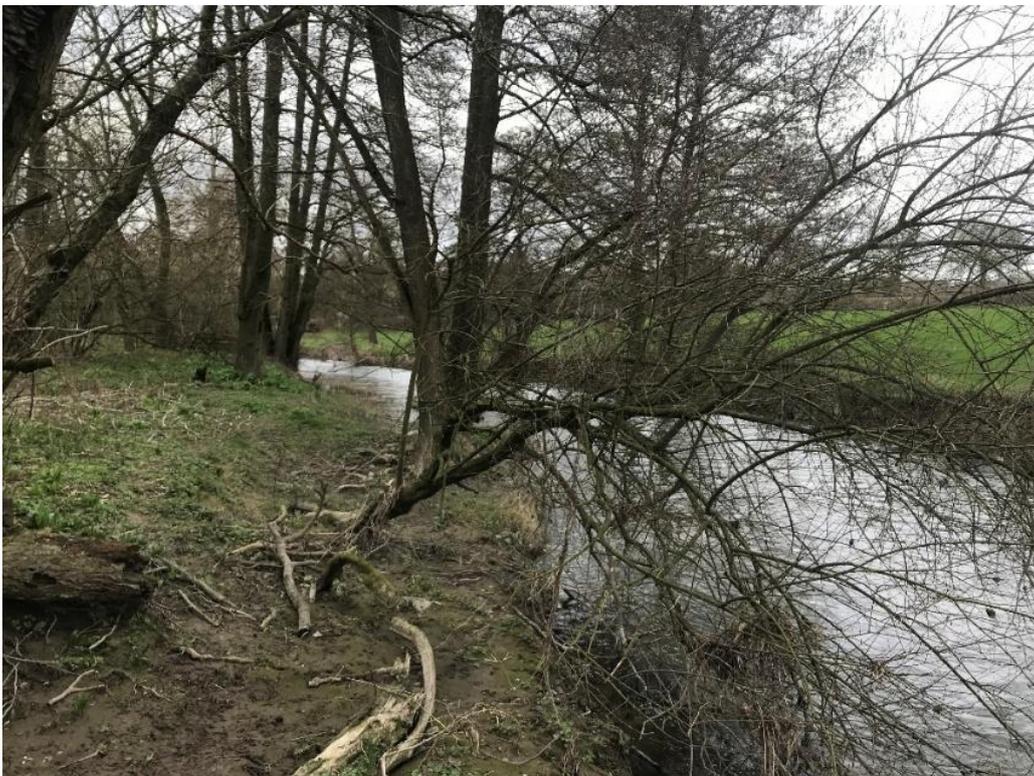
Photo 1. The top of the Meadow Beat (52.268209 , -2.8399465). The channel here is modified, but beneficial trailing branches in the channel will help provide some important habitat structure for the trout population.

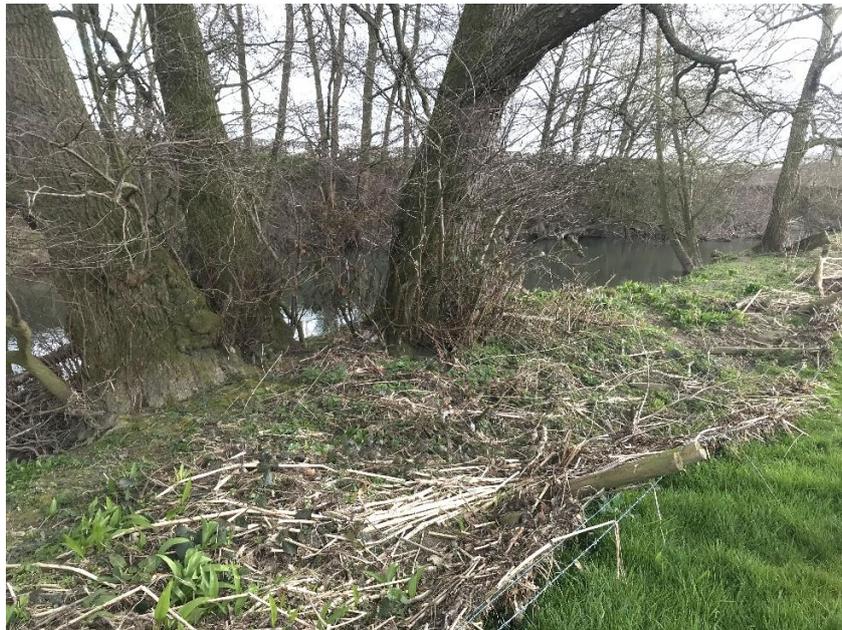
Photo 2. An elevated bank top from dredging spoil, which further disconnects the river from the floodplain. The fencing that was installed here is perfect for allowing natural bankside vegetation to develop, both defending against erosion and providing beneficial riparian habitats. Importantly it allows regeneration and perpetuity of bankside trees. The fence here has clearly suffered from flood damage, highlighting one of the challenges for developing and protecting buffer areas on flashy rivers like the Lugg. If possible, moving the fence back into the field will increase the volume and complexity of beneficial riparian habitat.

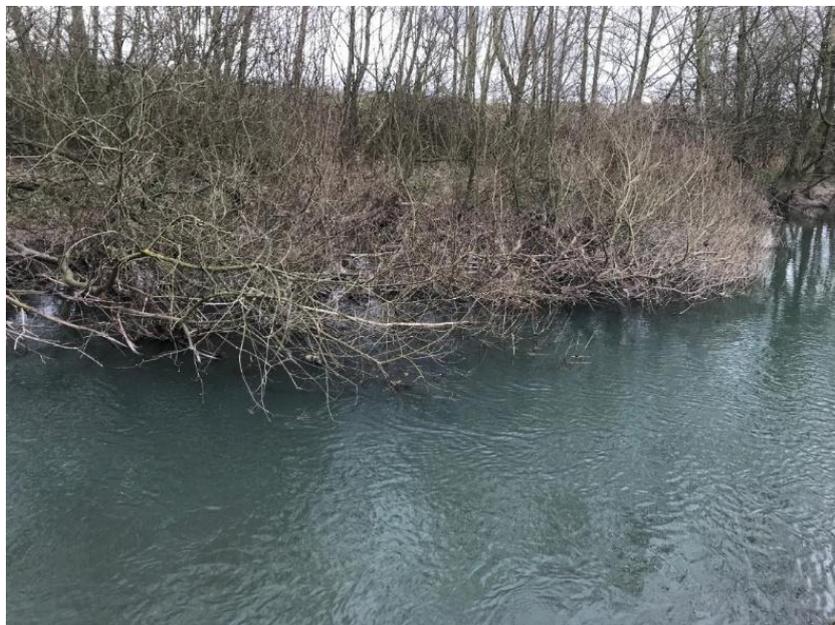
Photo 3. Low overhanging vegetation and branches creates excellent cover for holding trout, and critical for providing refugia from avian fish predators and otters. It also provides refugia for fish as river levels rise during floods by dissipating flood water energy. This effect can be replicated elsewhere along this section by introducing large woody material from bankside trees to the channel (see recommendations).

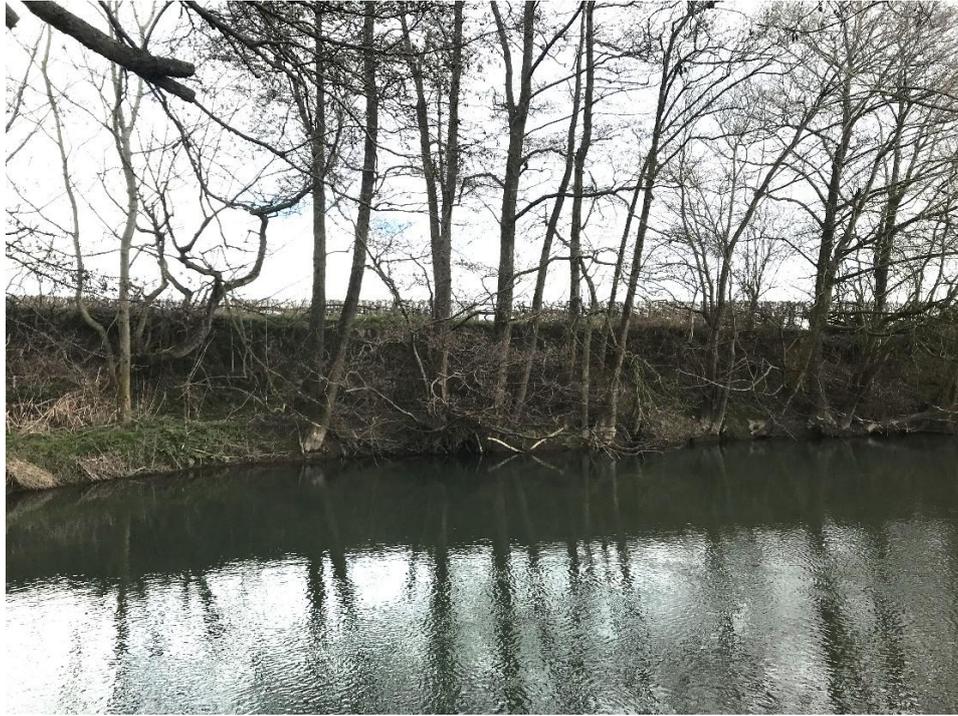
Photo 4. The alders at (52.267920 , -2.8386397) provide important protection to this elevated bank-face through their root systems. However, where stands of similarly aged trees exist, some coppicing work will help diversify the age of growth and allow light through for regeneration, aiding longevity of the protection. Material generated by this work can be used at other locations for habitat and bank protection interventions.

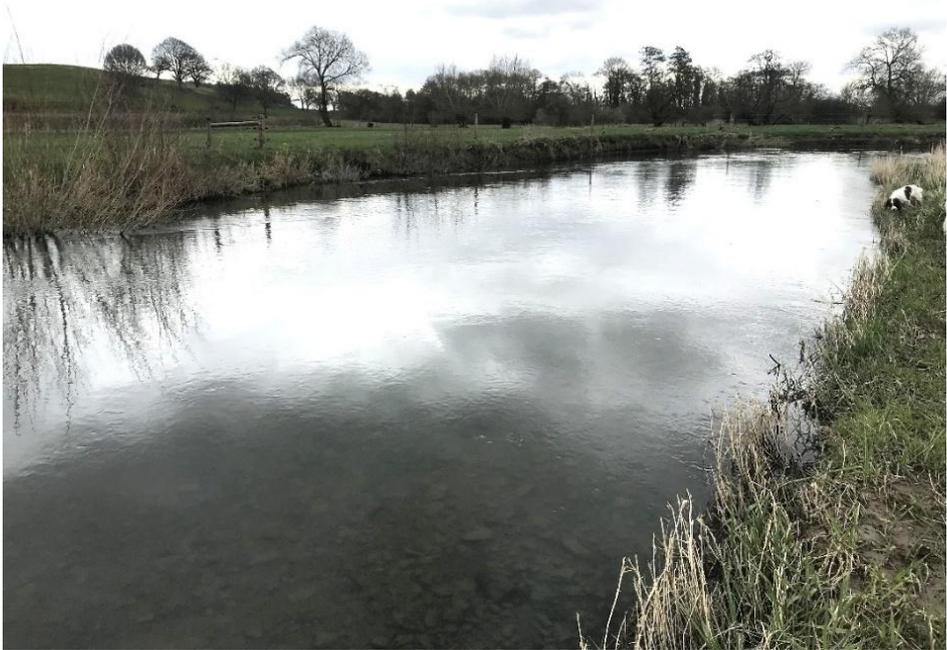
The initial upstream section at (52.266907 , -2.8370991) is still overly deep and flows directly into the apex of a very acute meander bend (Photo 5). While this sinuous channel planform creates some very beneficial in-channel habitat features, it also provides an example of a classic challenge that occurs between balancing river processes and farming in this region. Where the surrounding floodplain is very closely grazed by sheep, and very close to the edge of the river, there is little significant vegetation to consolidate the riverbanks and regulate the rate at which the river erodes the banks. The floodplain material of rivers in the Marches region is generally unconsolidated alluvial and glacial depositional material and highly erodible when exposed. As a result, the river erodes into the outside of meanders at a far greater – (accelerated) rate compared to if established, vegetated, riparian buffer strips existed along the bank, especially containing mature trees. This can be a difficult scenario to rectify, evidenced where fencing has been previously installed and is now at the edge of the riverbanks or

Photo 5. Coming out of the straightened, but lightly wooded upper section of the beat, the surroundings open out to grazed floodplain. The channel in this initial open section is still overly deep due to modification.

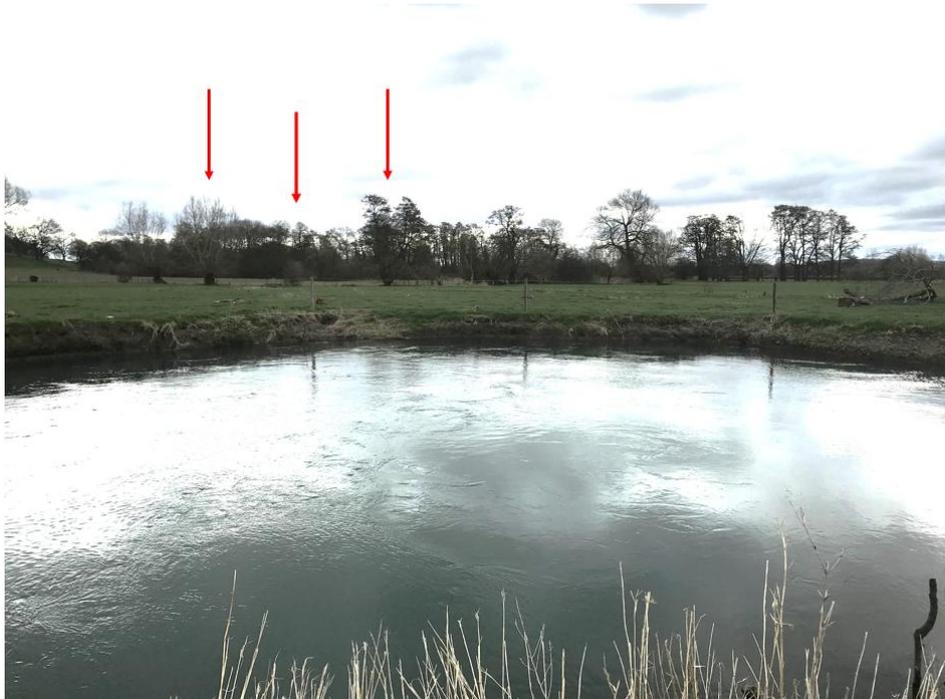
Photo 6. The outside of the acute first meander bend (52.266304 , -2.8368802). The rate of erosion here is clearly too rapid to allow riparian vegetation to develop properly – especially trees, where root systems are by far the best thing for binding riverbanks together throughout the year. The arrows indicate the proximity of standing wood that could potentially be used to protect this bank, while the fence is reinstated and bankside tree growth established. Without this, this meander will continue to march into the field at an accelerated rate.

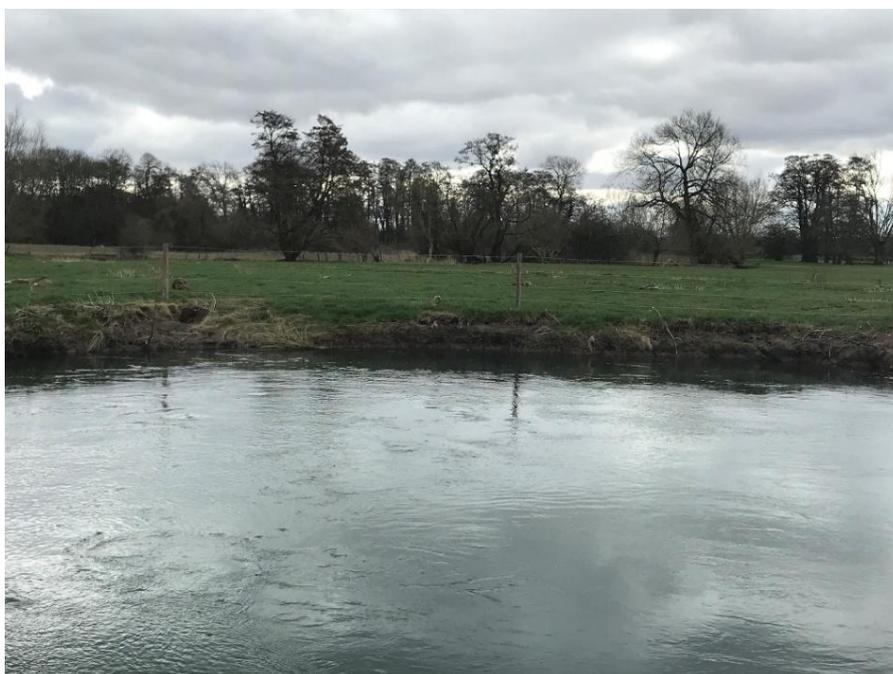
Photo 7. Fenceposts perched right on the top of the bank, which has slumped due to erosion pressure over the winter. Clearly there is little space for vegetation to develop here that will slow the erosion down and limiting the initial purpose of the fence.

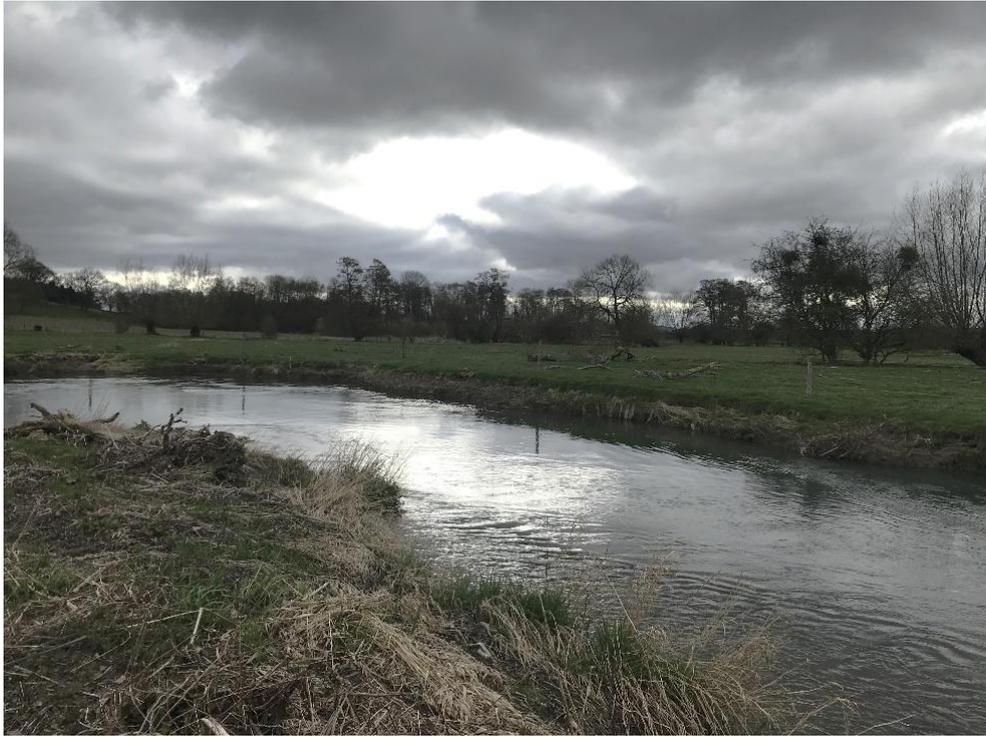
Photo 8. Although devoid of critical bankside cover, the deposition from the erosion in the first meander creates a change in bed level and flow through the downstream glide; in combination with the deep pool, this provides both feeding and refugia opportunities for trout and other fish species at different life-cycle stages (52.266357 , -2.8372664).

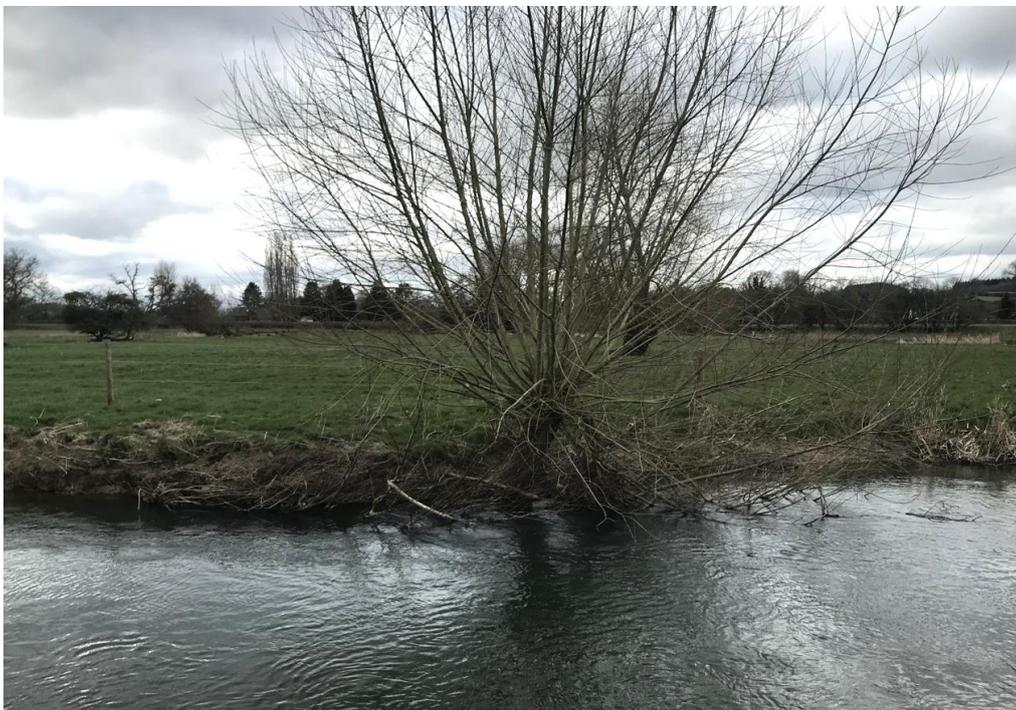
Photo 9. A lone bankside willow at NGR provides an example of how useful tree roots are for binding the bank throughout the Meadow beat. Re-pollarding this would generate material to use for bank protection measures in the adjacent area.

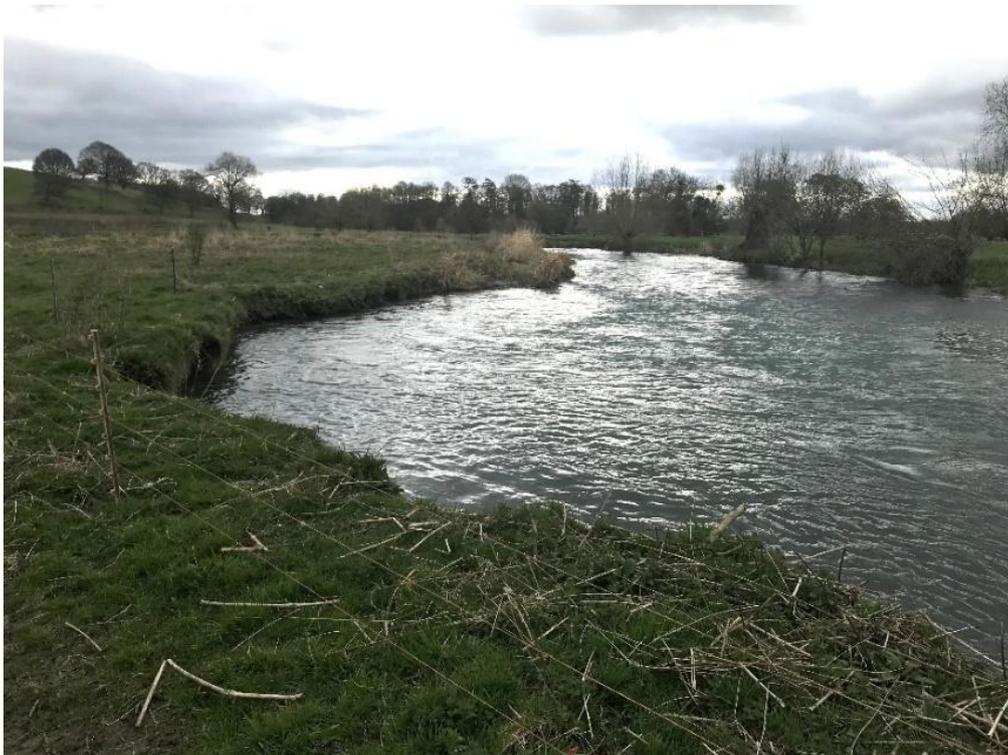
Photo 10. (52.266836 , -2.8377385) The rapid erosion in this meander resulting from a lack of bankside trees and other vegetation. Erosion will continue to eat away at the grazing land if left as it is, and the river may split behind the stand of trees immediately downstream. Additionally, a lack of defined low flow channel in an over-widened section left from high erosion rates is unlikely to form habitat trout and grayling can utilise much once river levels drop to low 'summer' levels due to lack of complexity and cover (high percentage chance of being predated).

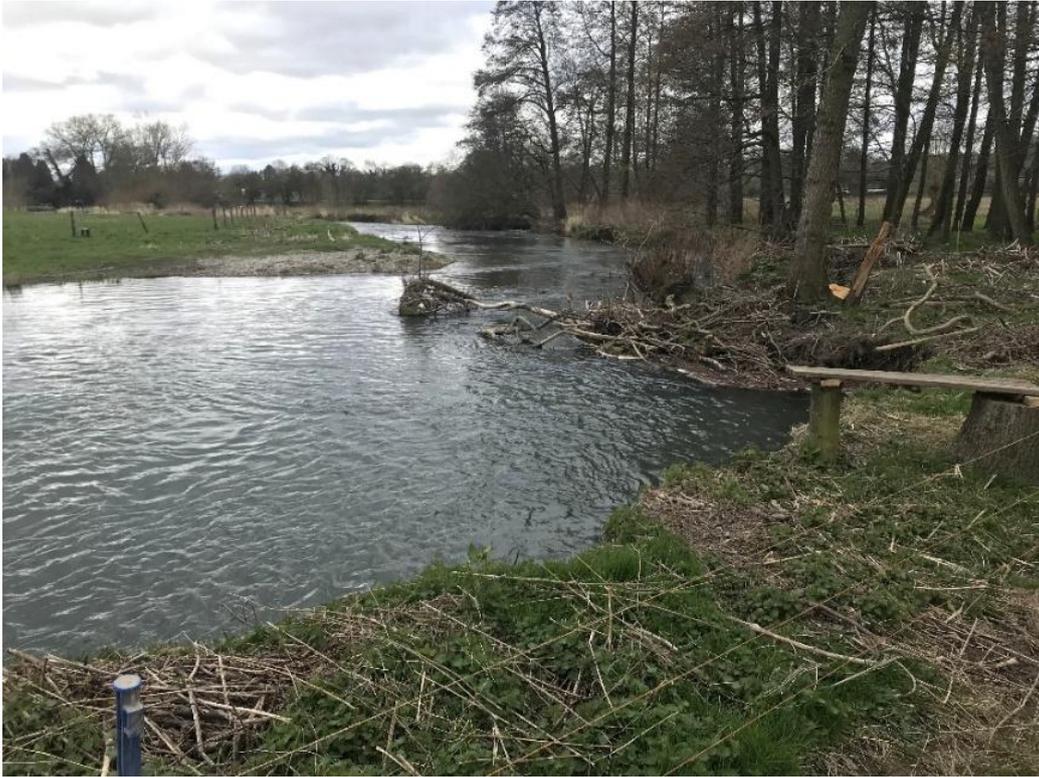
Photo 11. On the downstream end of the bend, some large woody material has got caught up on standing timber at 52.266889 , -2.8379745 as the river erodes into the small block of woodland. This is excellent in-channel cover for fish and provides an important resource for aquatic invertebrate diversity, while immediately driving channel and flow diversity downstream. Some large stems have been removed from the trees here, which could have been put to good use in the eroding bay just upstream. If some of these trees can be used, they provide very useful material for bank protection, adjacent to the erosion in photo 10, making moving of material to where it is needed easier.

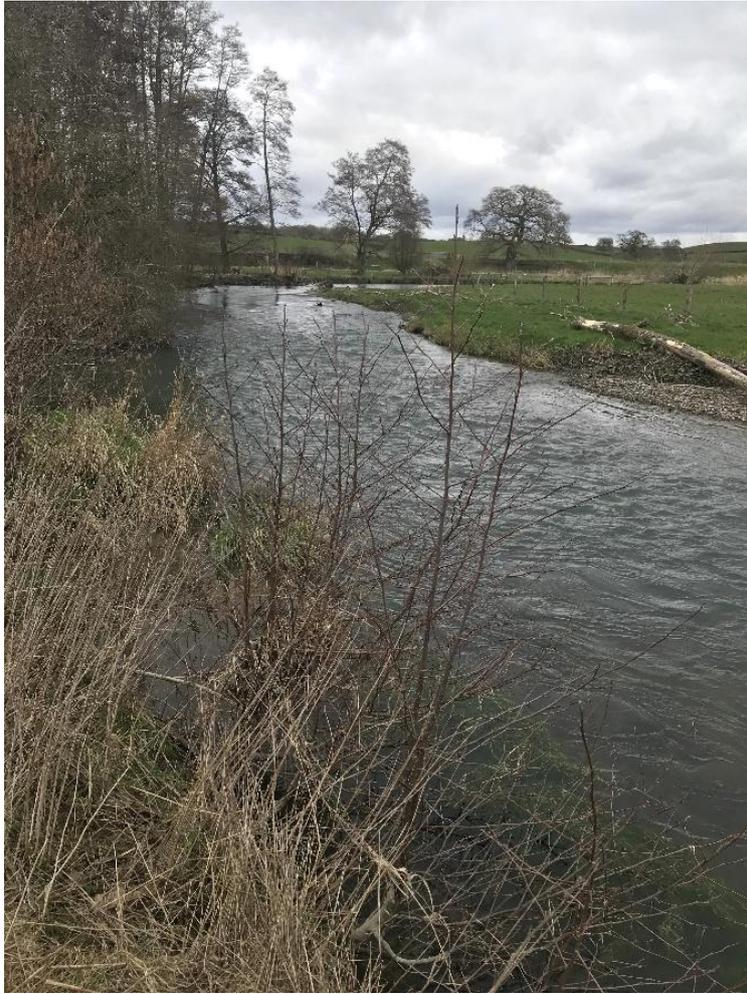
Photo 12. The vegetation on the RHB (near distance) is a great example of what can be achieved by allowing space for bankside vegetation to regenerate (52.266383 , -2.8387792). The tree growth is particularly beneficial. An excellent cross-sectional form to the channel here allows connectivity to the flood plain, with a deeper outside to the slight bend, tapering up to the start of a side bar on the inside of the bend. Over-hanging vegetation on the bank on the outside of the bend will certainly encourage trout to take up residency here.

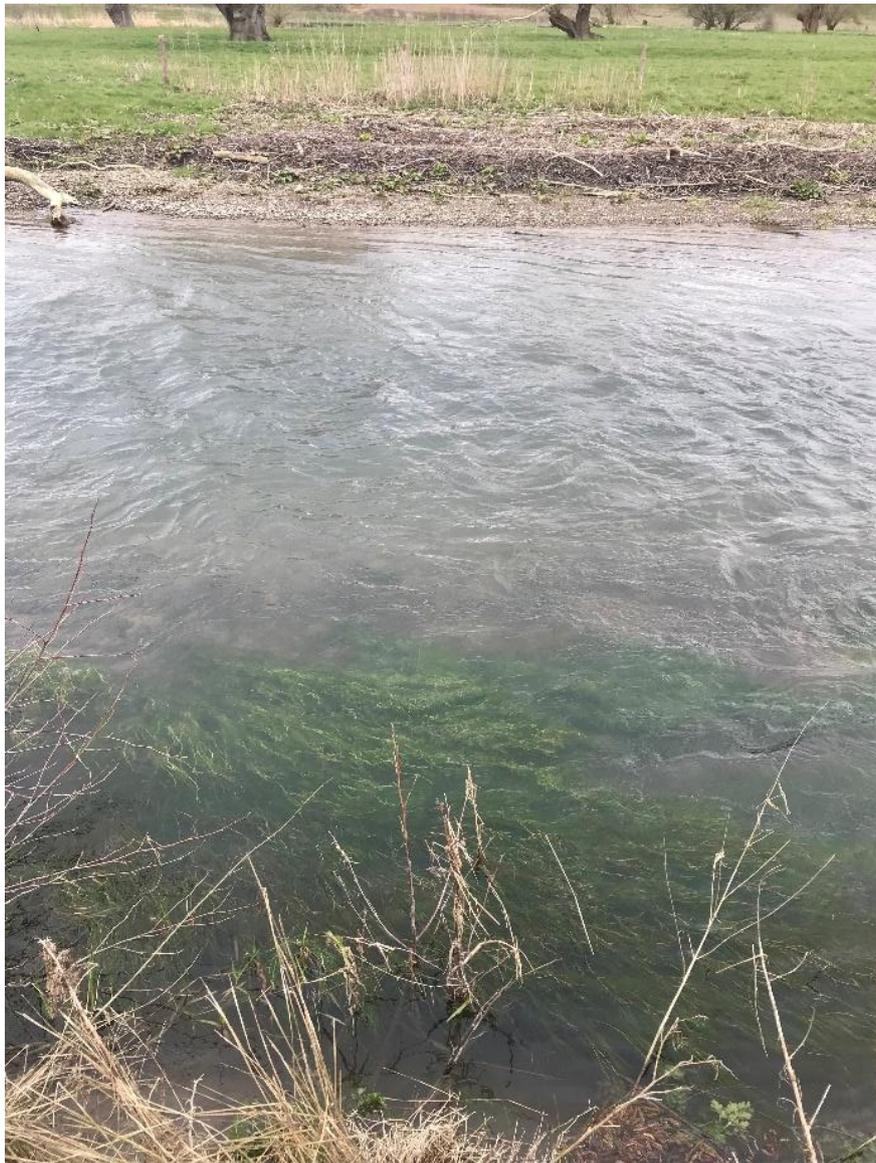
The *Ranunculus* seen at 52.266548 , -2.8386859 is an excellent river plant indicator species, which should be abundant in the Lugg if given the conditions for it to thrive (Photo 13). Reasonable water quality, steady flow velocity and locations where flood waters can dissipate to the flood plain quickly due to low bank heights, will allow it to continue to proliferate here. High energy flows and mechanical removal by large movements of bed material during floods creates too hostile an environment for it (such as in modified, deepened channels). The structure of the leaves and configuration on the stem gives a high surface area for invertebrate habitat and feeding (especially blue-winged olives, gammarus and black-fly larvae), protected from high flows. The same structure and gaps underneath the fronds are a magnet for all river fish species, especially juvenile salmon, trout and bullhead. In low flows, the in-channel vegetation helps constrain flows, keeping them energised, gravels clean in channels between the plants and specific feeding lies for trout along their edges.

Photo 13. Lush fronds of Ranunculus will provide high quality physical habitat that is very attractive to fish species and a range of invertebrates. Indicative of good river process at this location. The far bank (LHB) is currently unprotected from stock with no mature riparian buffer.

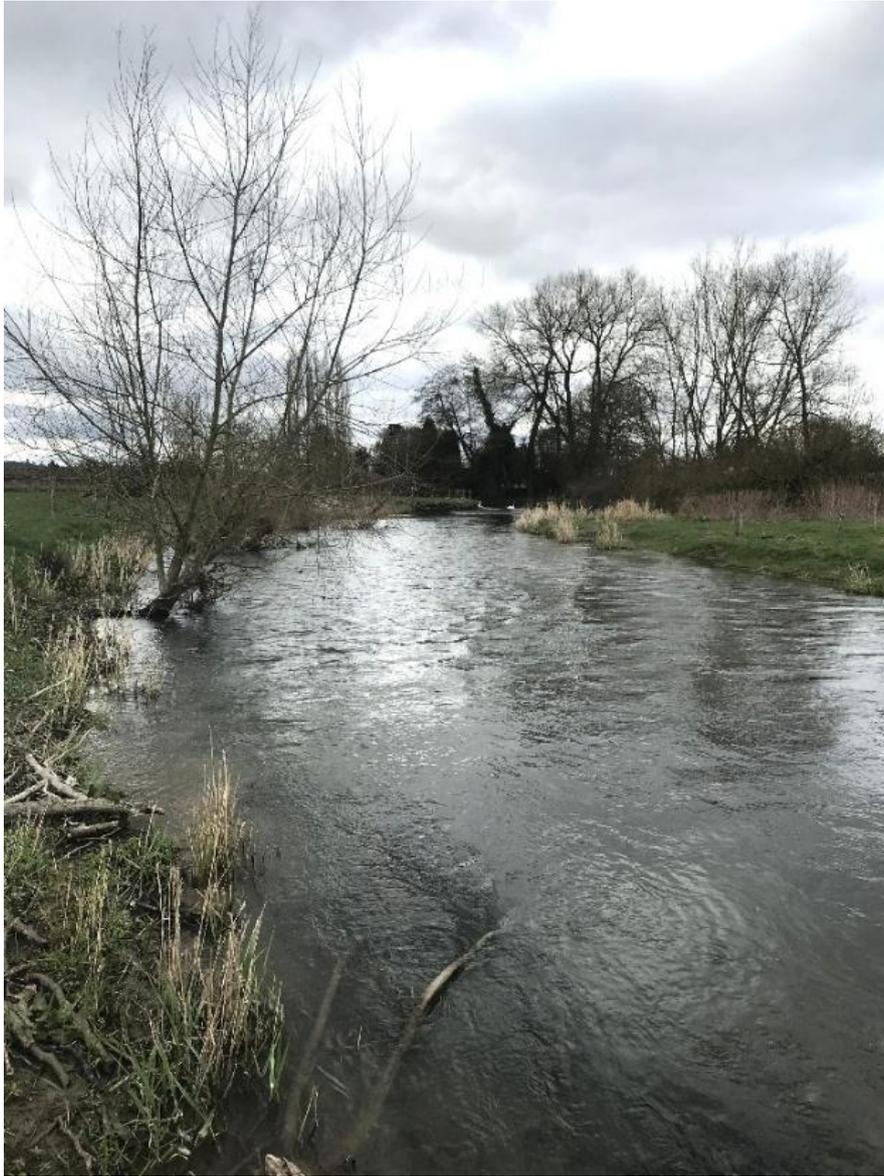
Photo 14. More regeneration of tree growth where a buffer has been able to develop (52.265727 , -2.8389187). Emergent reed provides further bank protection and diverse habitat structure along the water's edge. Note the two swans in the distance; they can graze heavily on ranunculus growth so an eye should be kept on whether they are causing excessive damage to this.

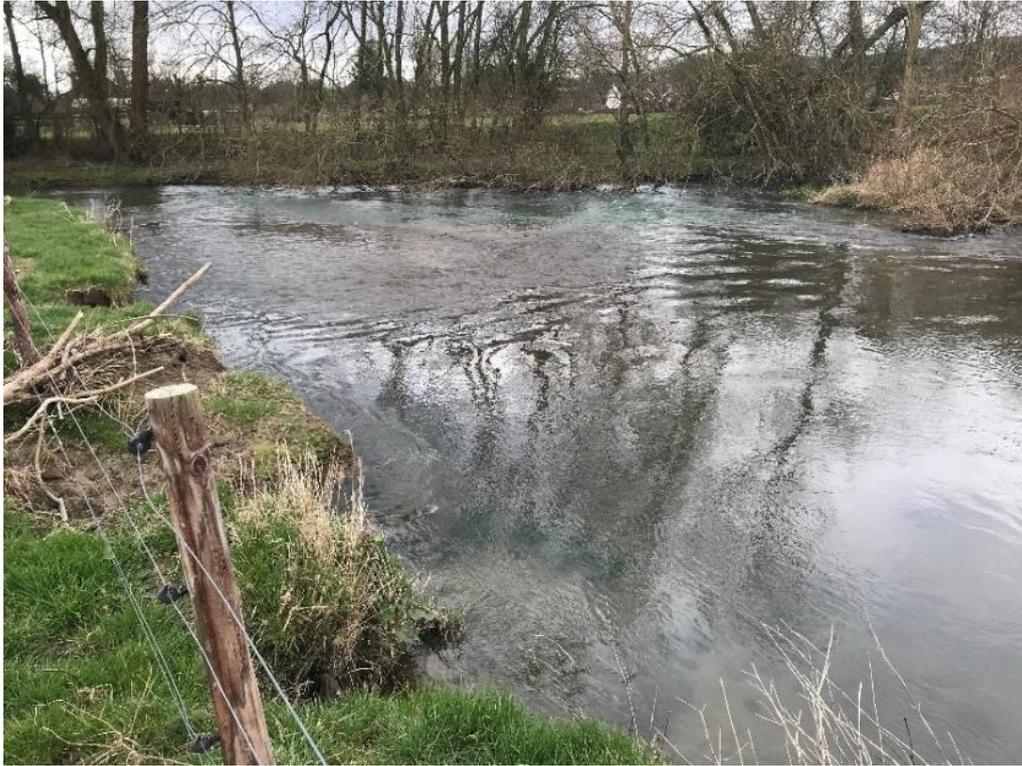
Photo 15. The pool at the downstream extent of this picture creates a prime location for adult salmon to lie up in prior to spawning on the tail-out of the glide as it lifts into the short riffle in the middle of the photo (52.265247 , - 2.8392942). Large trout may utilise this too. Updating fish surveys in the fishery, either through arrangement with the EA or through bespoke sampling with WUF or WTT, will help inform which fish species are spawning and recruiting to the wild fish population, and where in the fishery. This could also be conducted to record fish response to any future habitat works carried out (before/after).

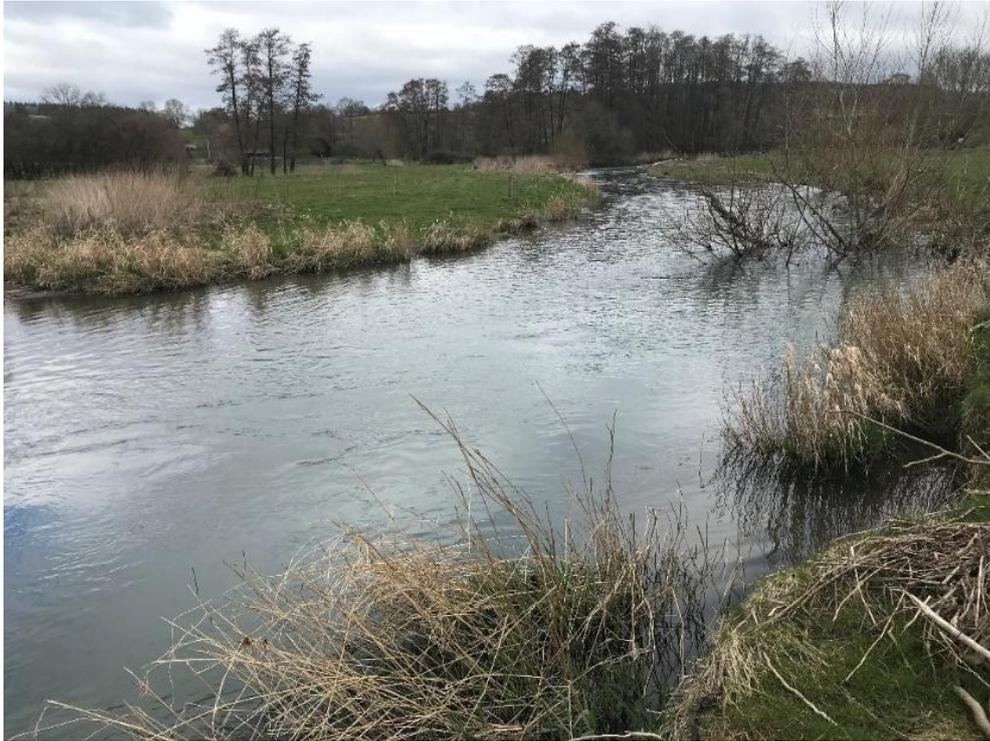
Photo 16. (SO 42831 63362) Open, but good habitat features for trout around this pool approaching the meander in photo 15, with in-channel and overhanging tree growth and marginal emergent reed cover. Additional bankside trees to increase shading will help regulate temperatures in the river here and provide additional cover and invertebrate food resources.

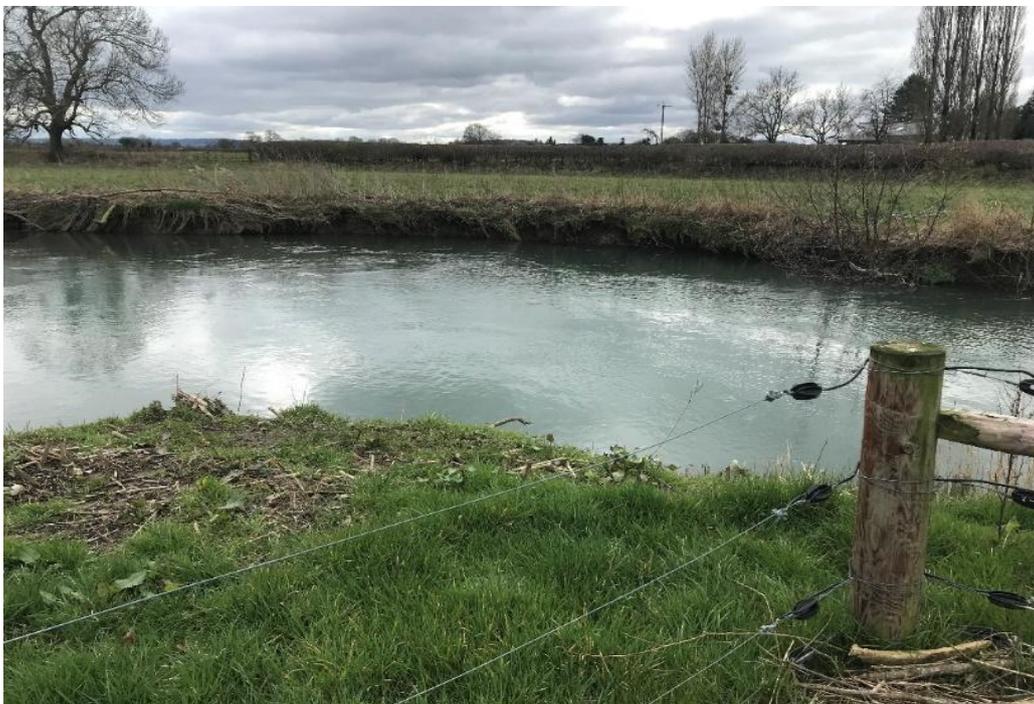
Photo 17. The thin strip of beneficial marginal vegetation on the far (RHB) may disappear in the next few floods as this undercutting bank collapses at (52.264965 , -2.8389401). The young tree at the top end needs to be retained and protected so it can grow into something substantial for future river habitat.

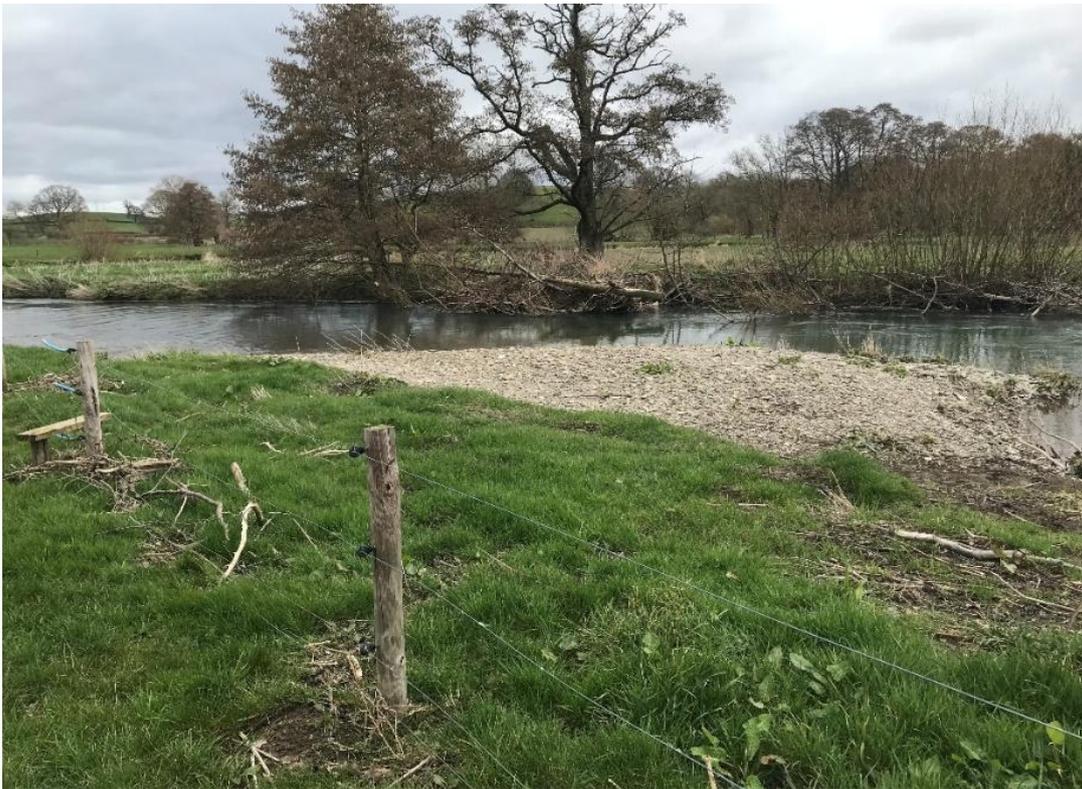
Photo 18. Immediately downstream of the location in photo 17, is a complete contrast in habitat along the far bank (52.264991 , -2.8385539). The network of willow provides solid bank protection and erosion regulation. The tangle of stems pushing out into the channel provides critical refuge and cover for fish species present. The large woody debris caught up in this further enhances the feature. The large alder at the downstream end provides some shade to the channel, its location on the margins of the river means roots will be exposed in the channel providing superb habitat for trout. Again, this is likely a valuable location for spawning salmon and large trout in the main river, with the amount of cover available in the pool immediately adjacent to an uplift into a riffle downstream.

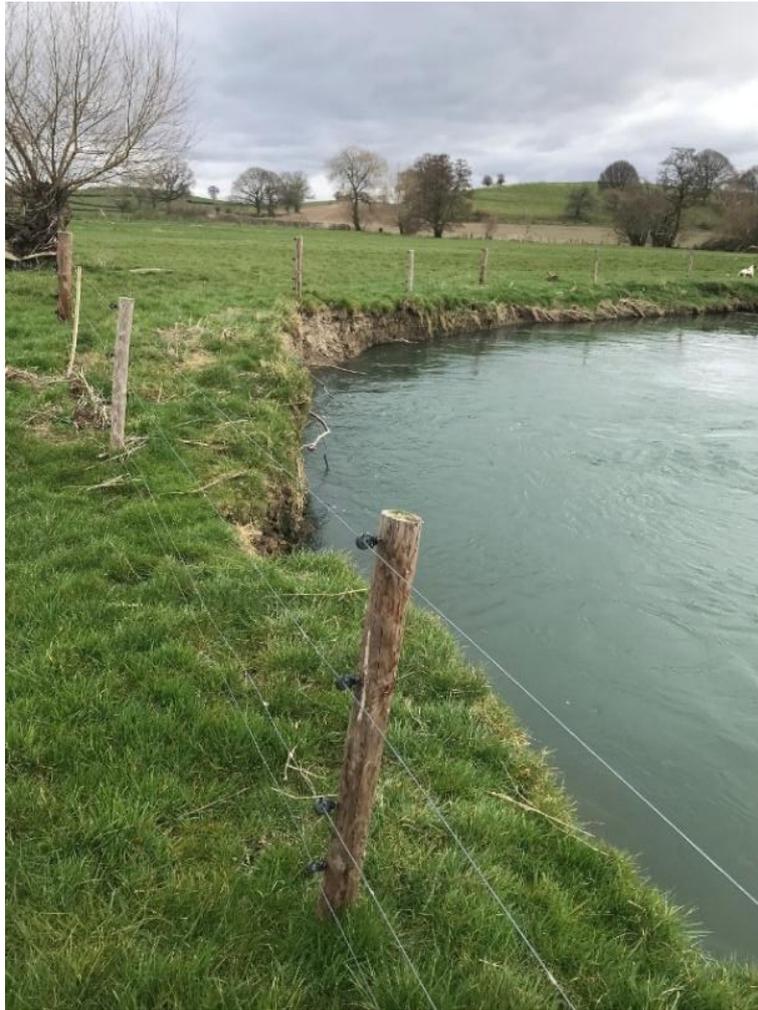
Photo 19. Pressure from accelerated erosion persists throughout the reach downstream. It won't take many floods for this bank to erode under the fence in this section and collapse it (52.265457 , -2.8380497). There may be enough material available from pollards in the flood plain to contribute to a revetment structure here. There are options to consider, such as using root wads or stakes and other material to form a revetment to slow the rate of erosion down, discussed in the recommendations section. Then, whether to plant a line of trees back from the bank top near the existing willow, so they have time to mature before the river erodes through to them, or move the fence back and attempt to establish trees nearer the existing bank top.

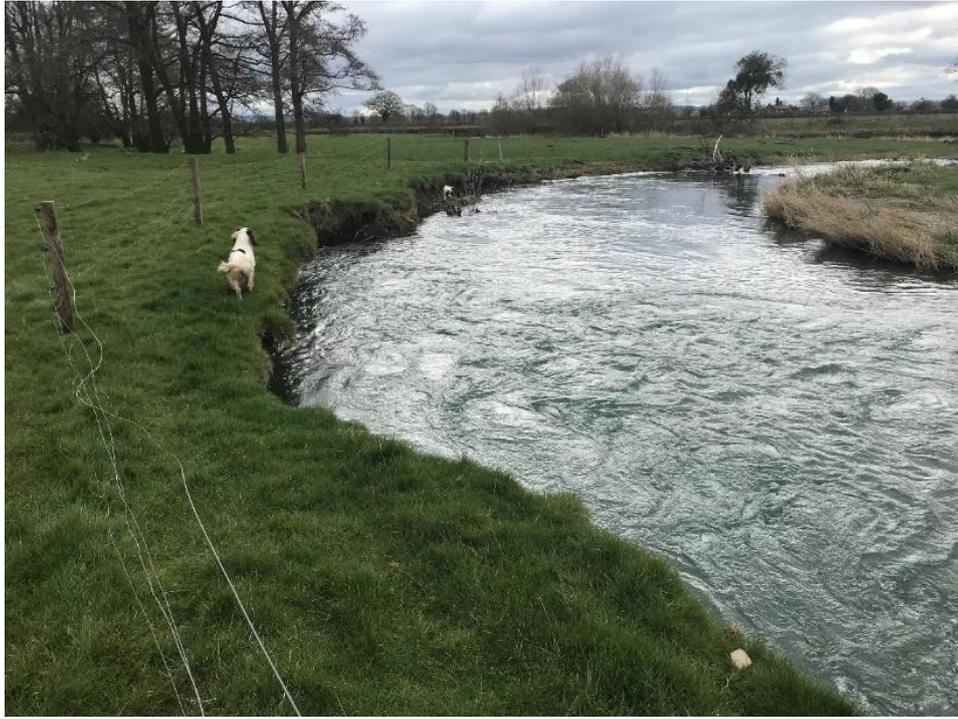
Photo 20. An exposed bank rapidly eroding on the outside of the next meander down (52.264853 , -2.8373630). The alder stand in the middle distance may provide some potential material for an intervention to slow erosion rates here.

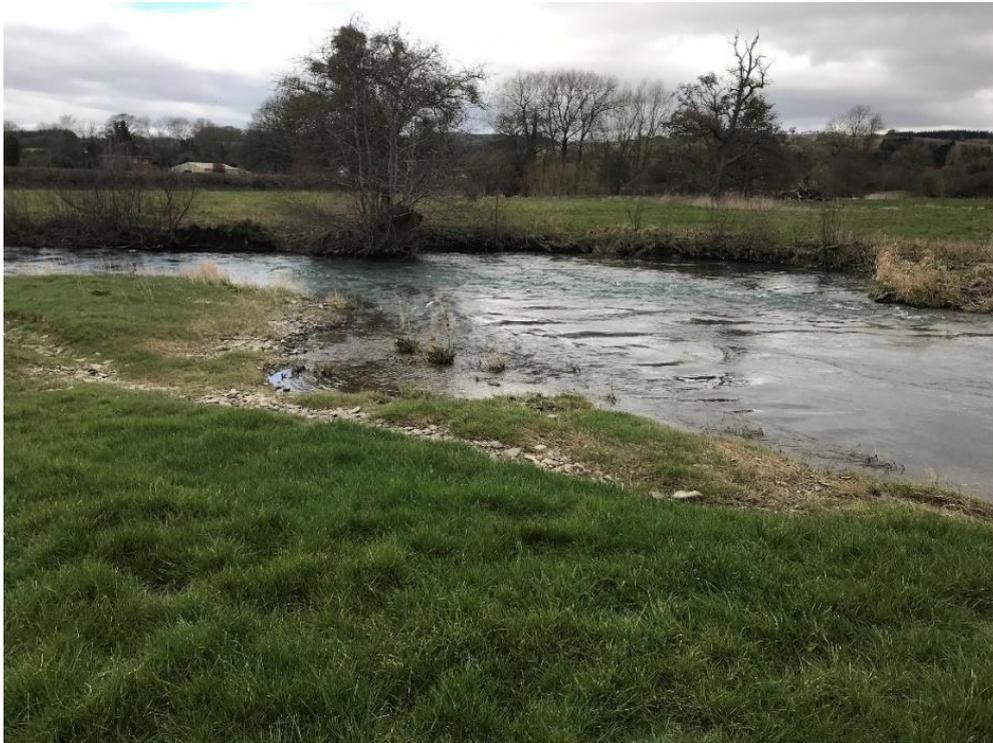
Photo 21. Regeneration of riparian trees is evident at 52.264643, -2.8377492, where erosion is regulated by existing young tree growth and emergent reed at the upstream end. Good spawning opportunities for salmon on the tail-out of the glide on the right of the picture.

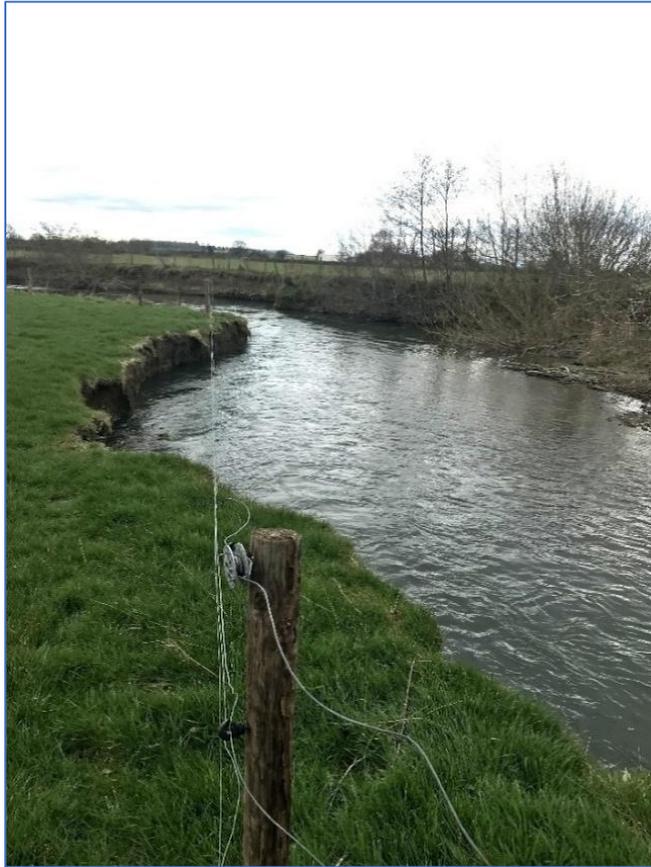
suspended over the outside of bends in the river (Photo 22). The magnitude of floods (especially through the winter) and subsequent rate of erosion on exposed banks is too rapid for vegetation to mature in buffer areas and important tree root systems to develop to a level where they protect the bank before the next flood happens and erodes further bank material away. The buffer zones are relatively narrow along parts of the beat due to proximity of grazing, so the physical area isn't available to absorb erosion before it reaches the fenceline. This is where using locally available woody material to form a protective barrier as a temporary measure to slow erosion while bank top interventions establish can be extremely useful. All through the open grazed area of meadow beat there were some excellent sources of material that could be used to create revetment with natural materials (and additional channel habitat), and generate a suitable buffer zone, discussed in the recommendations section of this report.

Photo 22. A fence line now overhanging the water at 52.263704, -2.8371377, where the rate of channel movement has out-paced vegetation development.

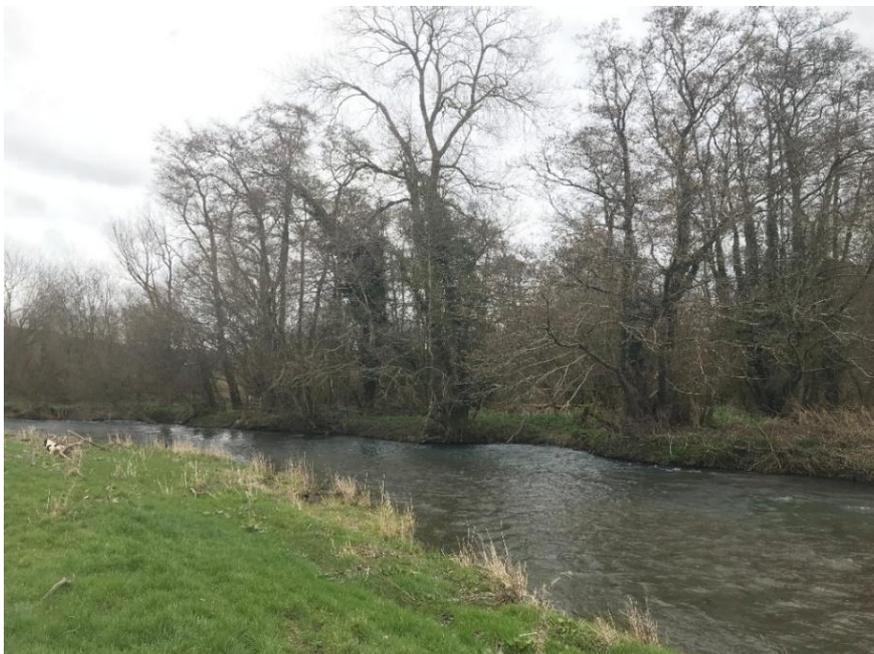
Photo 23. The end of Meadow beat, where it meets mature woodland (52.263751, -2.8361753). The river will retain its course here for a very long time due the wooded bank side regulating channel movements during floods. This section could be enhanced in-channel with introduction of some large timber out of the bankside woodland, along the margins of the watercourse.

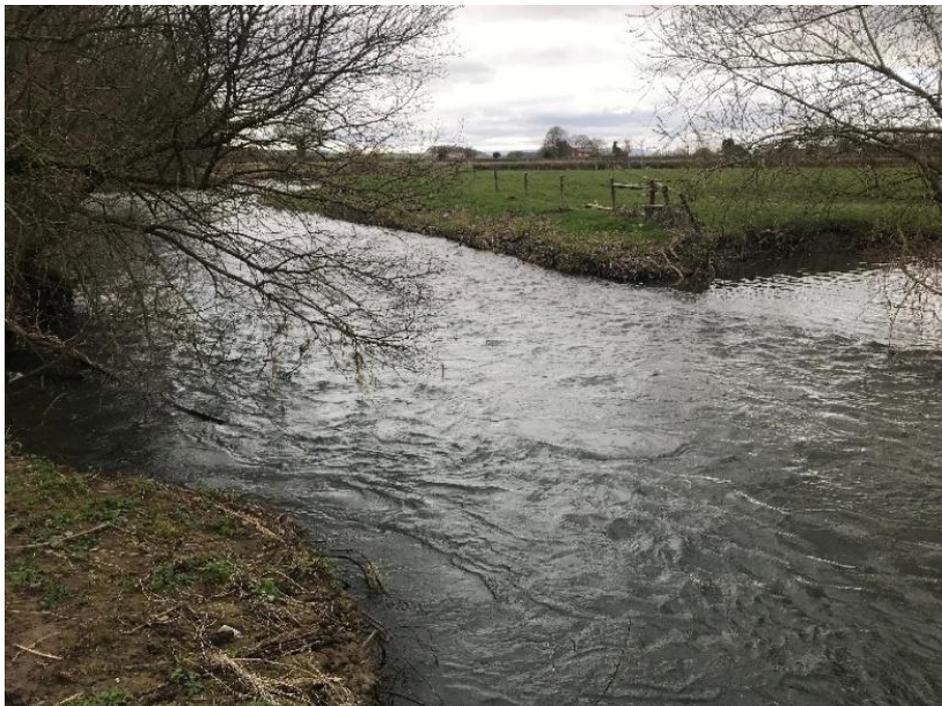
Photo 24. A small field drain enters the Lugg on the LHB at 52.264283 , - 2.8361002, where the two beats meet. The erosional bay that has formed will provide good high flow refugia for all fish species present by creating a back-water feature.

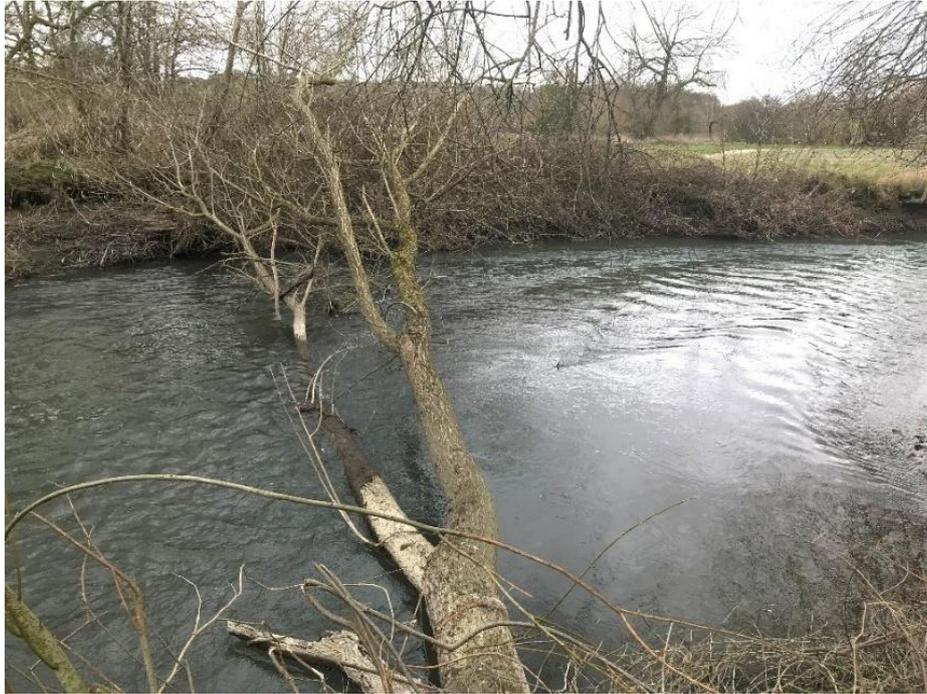
Photo 25. The first example of inspired river management in Upper Kingsfield (52.264335 , -2.8357462); leaving large trees that have come down where they are. The resulting habitat is excellent; undershot flows have scoured a deep hole under the tree, providing first class fish holding cover, the deposition from the scour immediately downstream creates excellent riffle habitat for spawning, fry and invertebrates, coupled with the trailing marginal vegetation. Large cross channel trunks will also help regulate flood flow energy, by 'slowing the flow' as river levels rise and interact with the structure.
