WILD TROUT TRUST

River Lugg
Midland Flyfishers

Herefordshire

2025

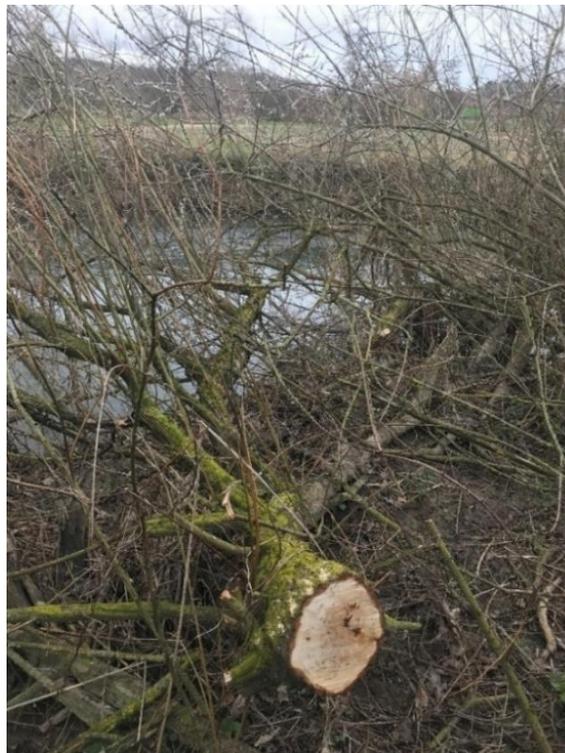
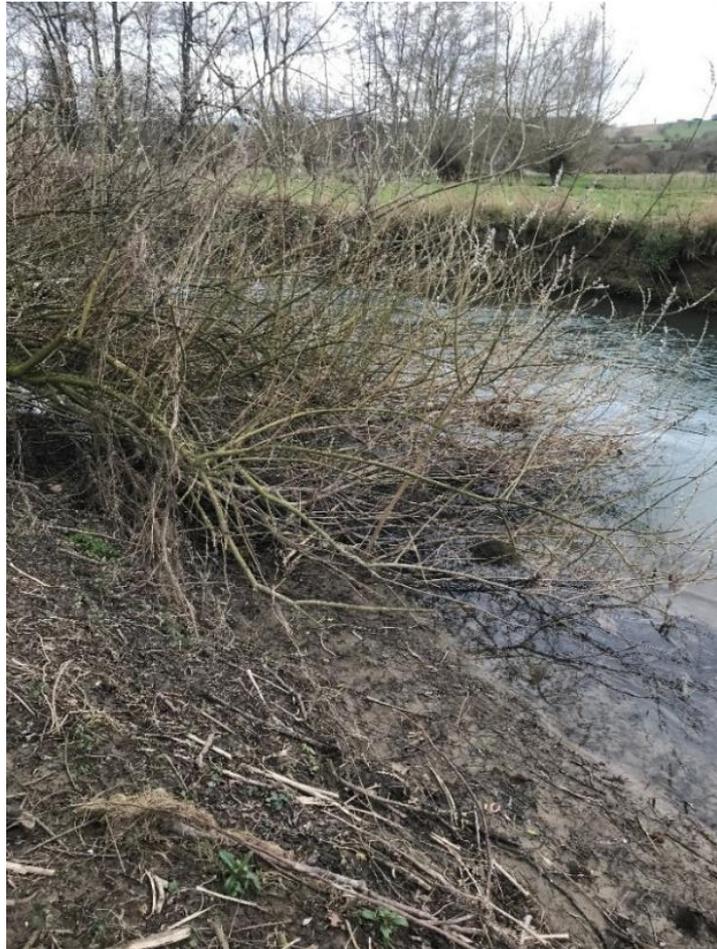
Photo 26 and photo 27. (52.264348 , -2.8356603) A very good example of exactly how felled material can be used to enhance river habitats. Keeping the main trunk on the bank will help keep the feature in place. The mass of smaller branches in the channel will provide key habitat for both juvenile and adult trout along marginal areas, and important resources for aquatic invertebrates. The benefit of willow, shown in photo 27, is that it will 'take' when submerged, regenerating further growth and root systems along the river margins. The main stem of this tree can be secured from being washed away in floods by using cable or rope (see recommendations). This helps alleviate flood risk concerns.

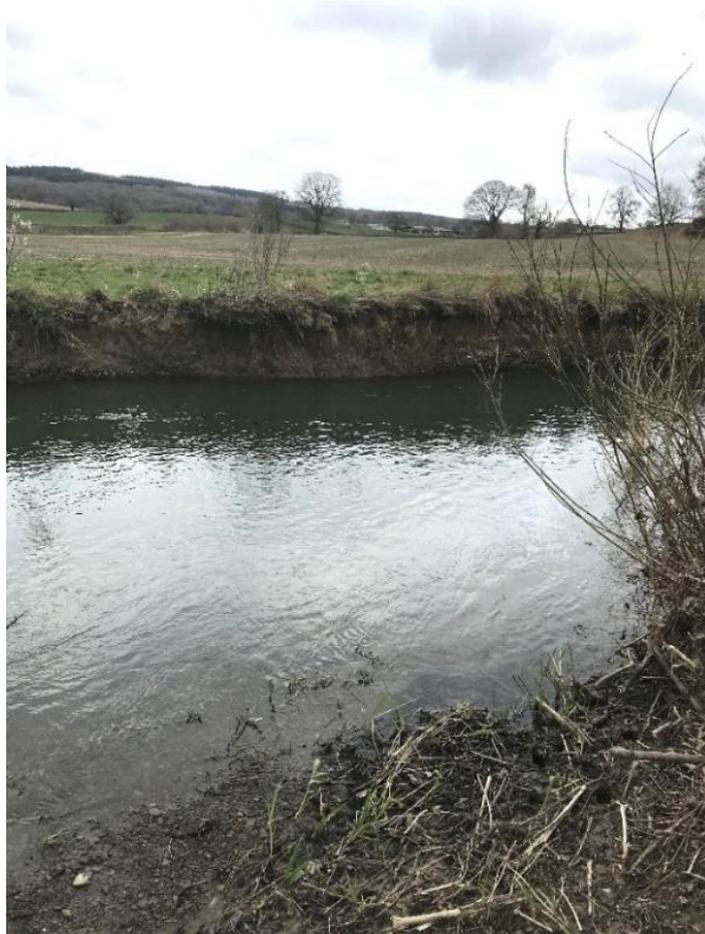
Photo 28. The left-hand bank becomes bare and exposed a little further around the bend (52.264329 , -2.8354887). Given the arable land use and absence of stock, a line of trees could be planted back from the bank top, to establish root systems before future erosion reaches them.

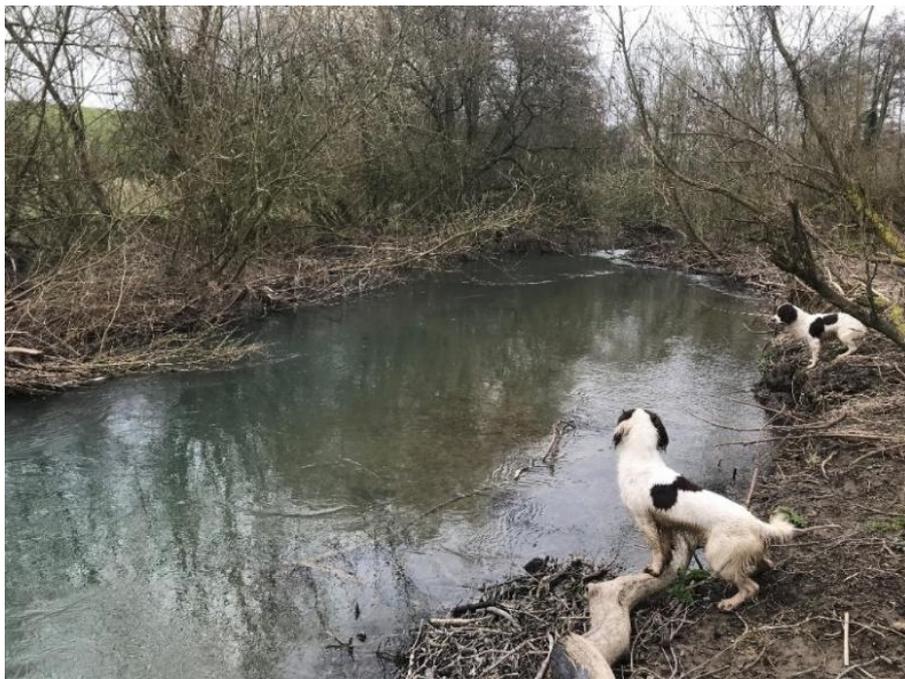
Photo 29. Potentially difficult to fish, this section of river at 52.264168, -2.8351185 provides good habitat complexity through bed level change and

woody structure. The overhead and trailing branches are primary habitat features selected by adult trout. The blend of some open water still provides opportunities to cast at feeding fish, once they leave the denser cover used for resting up. Having areas of complete refugia in thick cover for fish from angling will certainly help retain numbers of fish and larger specimen individuals in the fishery. It will also provide a superb buffer for fish populations against avian predation.

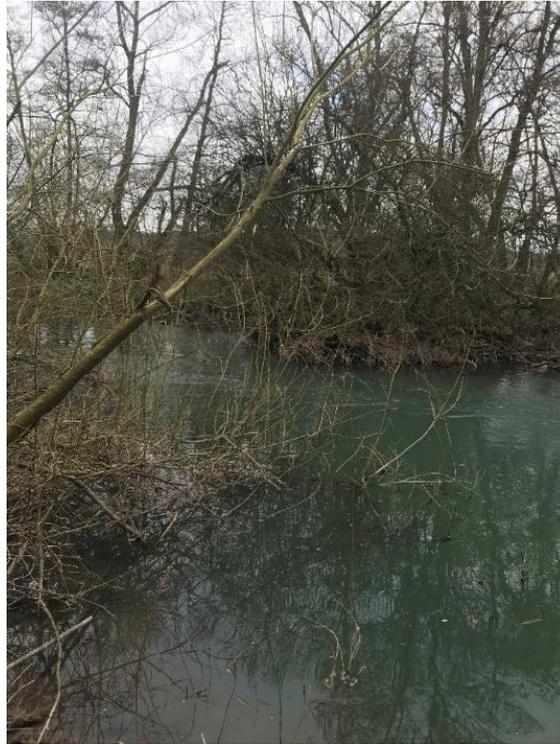
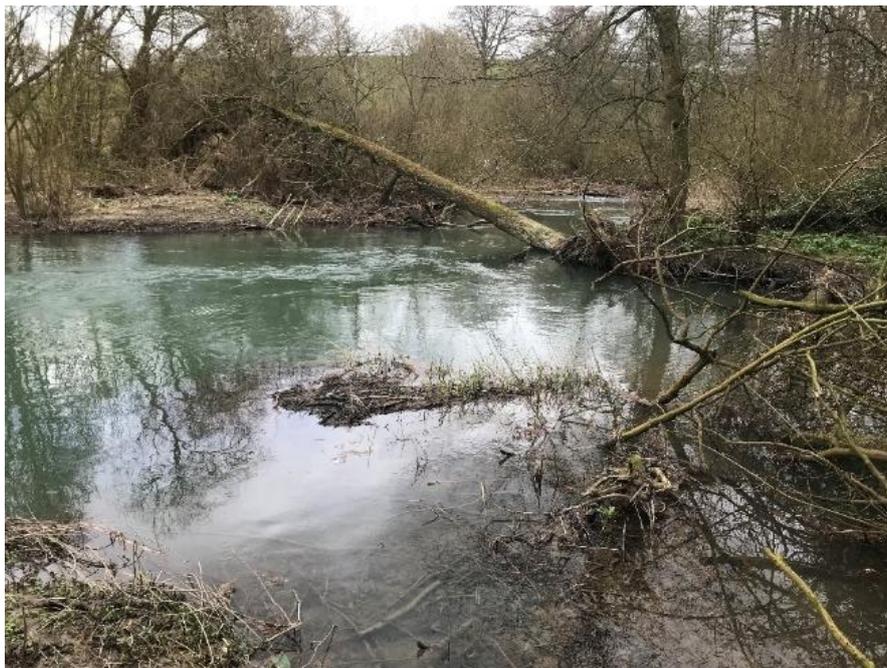
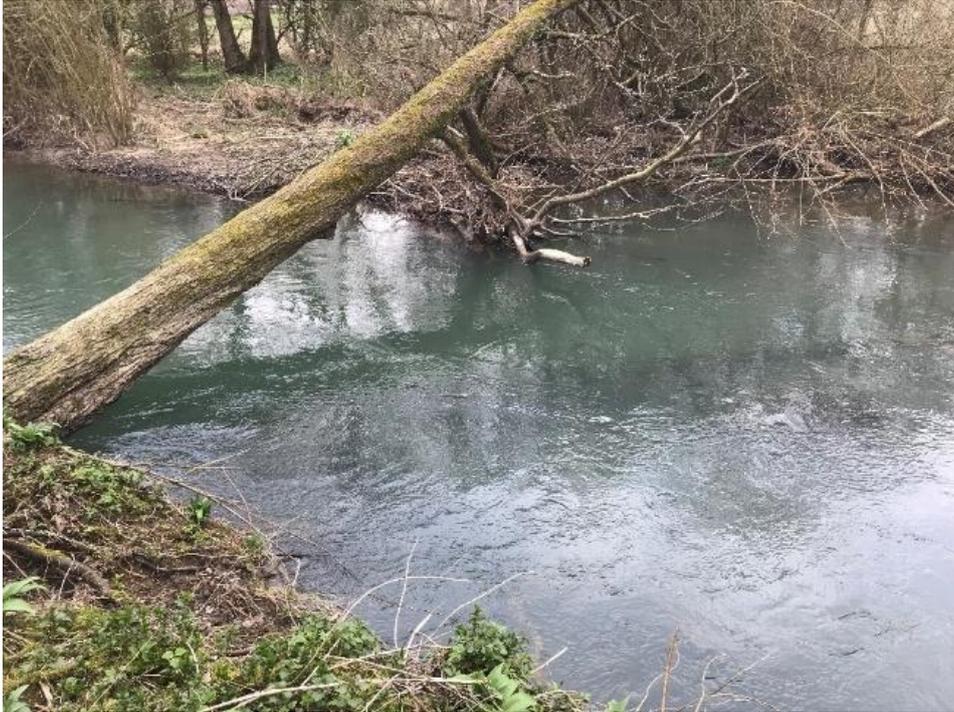
Photos 30, 31 and 32. Another quality combination of habitat diversity and features, driven by interaction between bed morphology and large woody material around this pool. The tree that has leant into the river here provides key overhead structure for adult trout; the submerged limbs enhance the quality of this feature even further. Positioned adjacent to a deep pool, and coupled with back eddies, slacks and other trailing branches, this area is valuable to a range of fish species present at various sizes and ages.

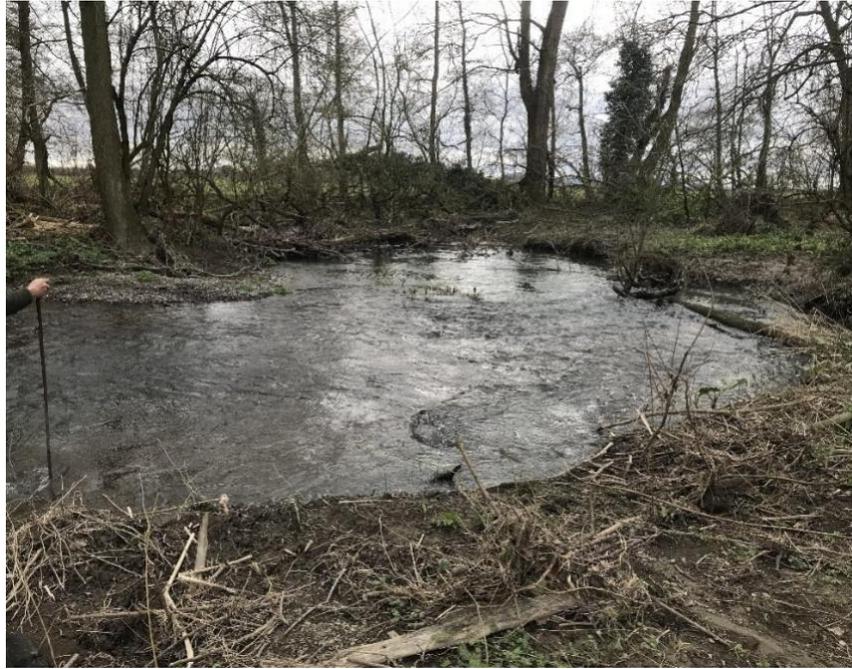
Photo 33. (52.263895 , -2.8340156) The coarse substrates deposited here provide opportunities for spawning. The complex woody 'trash dam' at the downstream end will slow flows, assist the deposition of spawning material, regulate winter flow energy over spawning locations and provide holding cover for pre-spawning adult fish. Anywhere a large amount of woody material accumulates, care should be taken that it doesn't evolve into an impenetrable barrier for fish as more material accumulates. Generally winter floods should create flow pathways through the dam and remove old material as other fresh material gets caught up. The river bifurcates and splits at this point, the additional channel is discussed in section 3.2.1.

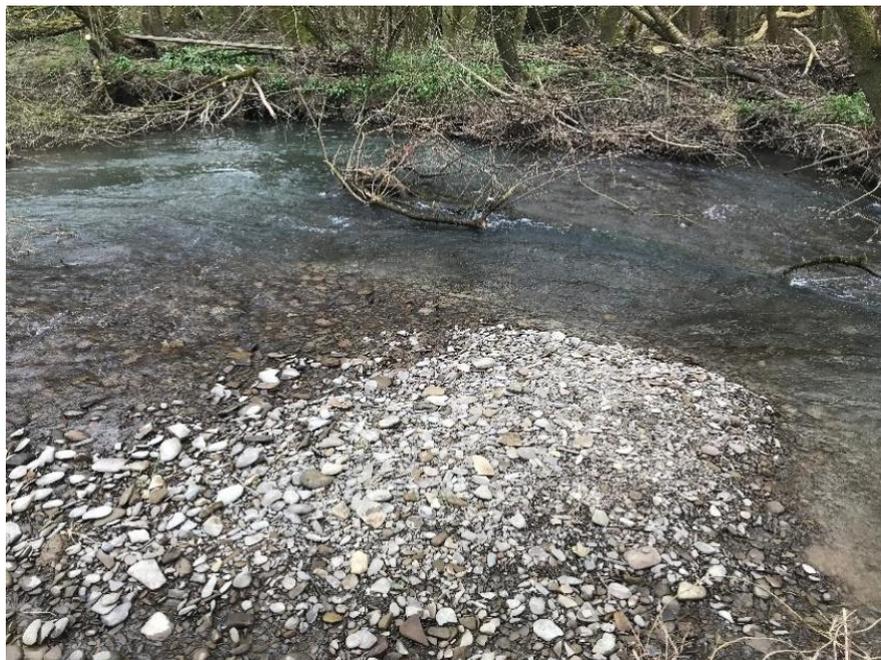
Photo 34. Exposed areas of coarse sediment highlight the range of material sizes available for salmon, trout and grayling to spawn in at this point in the Lugg.

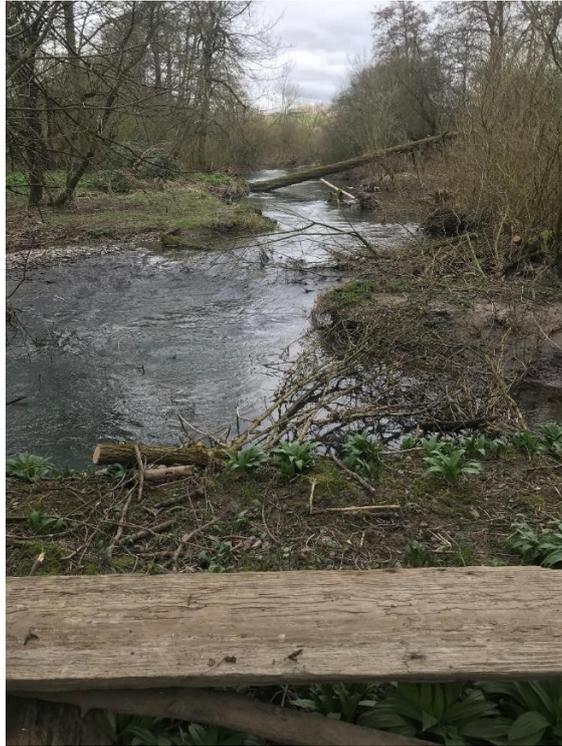
Photo 35. Sensitive habitat management was evident in Upper Kingsfield, adjacent to where a side channel splits from the main flow at (52.263941 , - 2.8337581). Essential cover for juvenile trout has been created here by placing a complex and fine mesh of branches over shallow riffles and marginal areas in the channel, using a couple of small trees. These extremely beneficial habitat features can be retained through a selection of options (staked, secured etc), explained in the recommendations section.

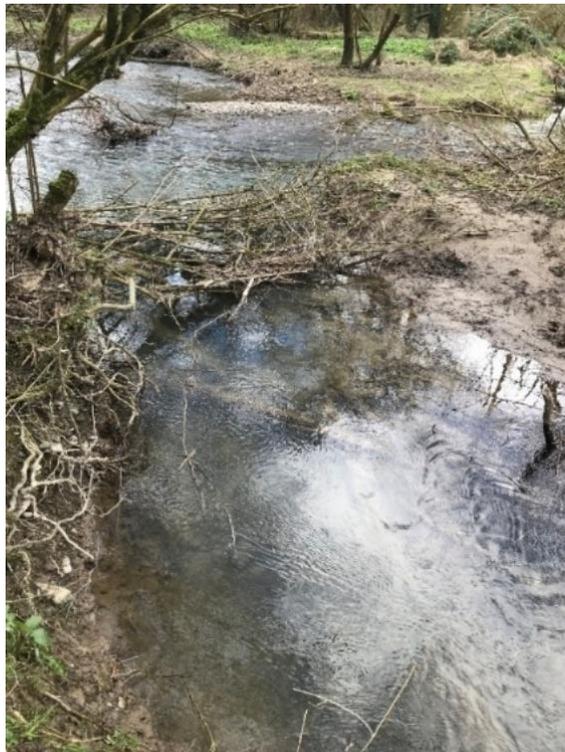
Photo 36. (52.263862 , -2.8333719) Another side channel feature. The overhead structure formed by smaller branches, the larger underwater limbs, shallow

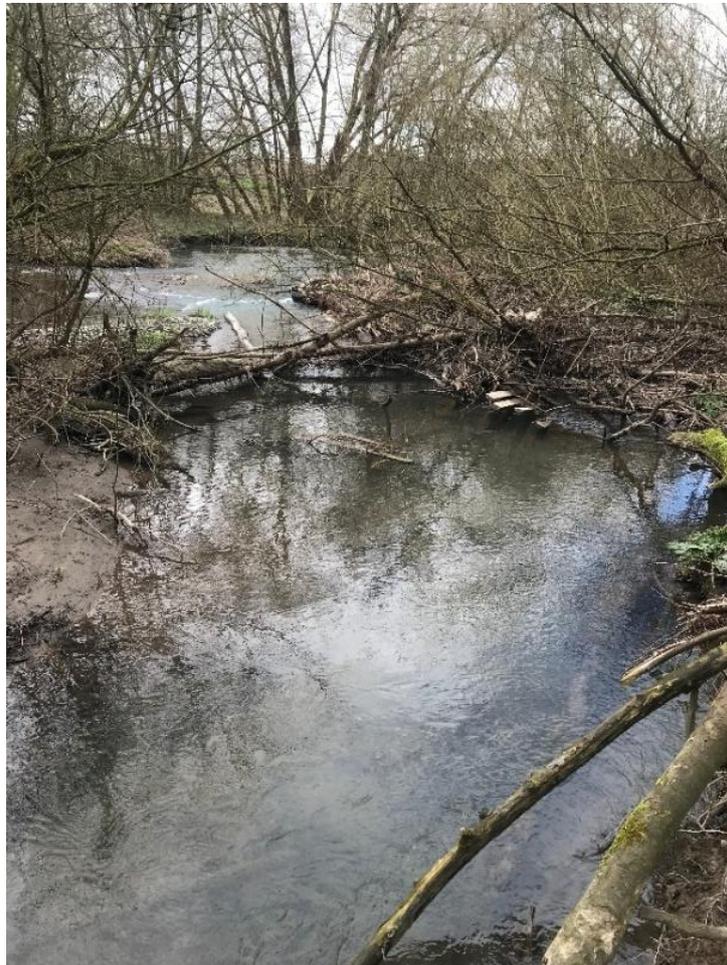
Photo 37. Again, addition of further 'bushy' material from the crown of small trees or shrubs pinned along the marginal edge on the far side (LHB) of this channel will further enhance this area for both trout fry and parr.

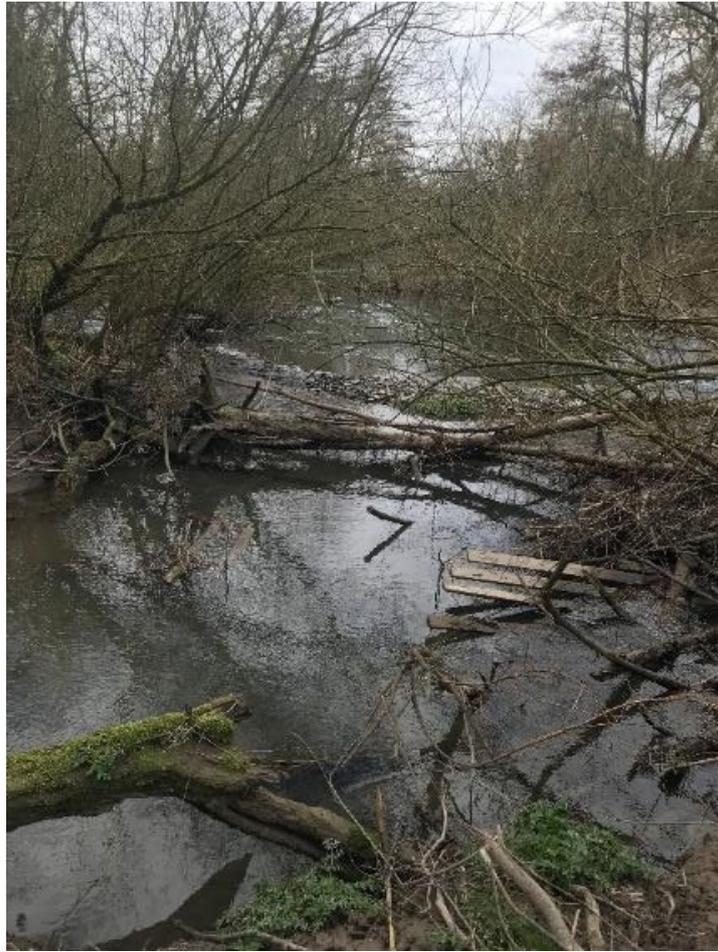
Photo 38. Habitat diversity for all life stages of fish...

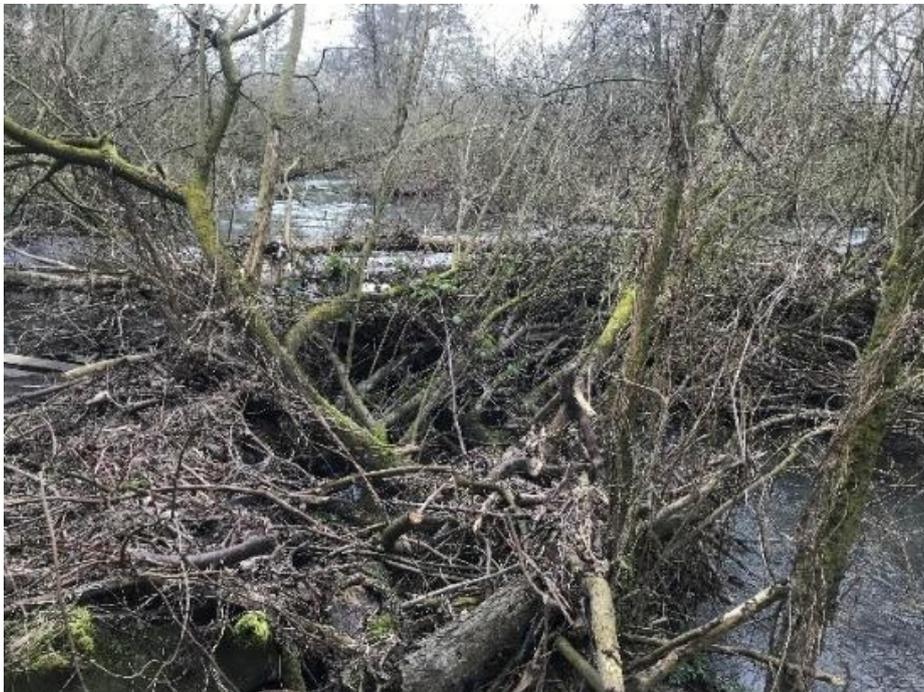
Photo 39....driven by interplay with woody material and trash dams...

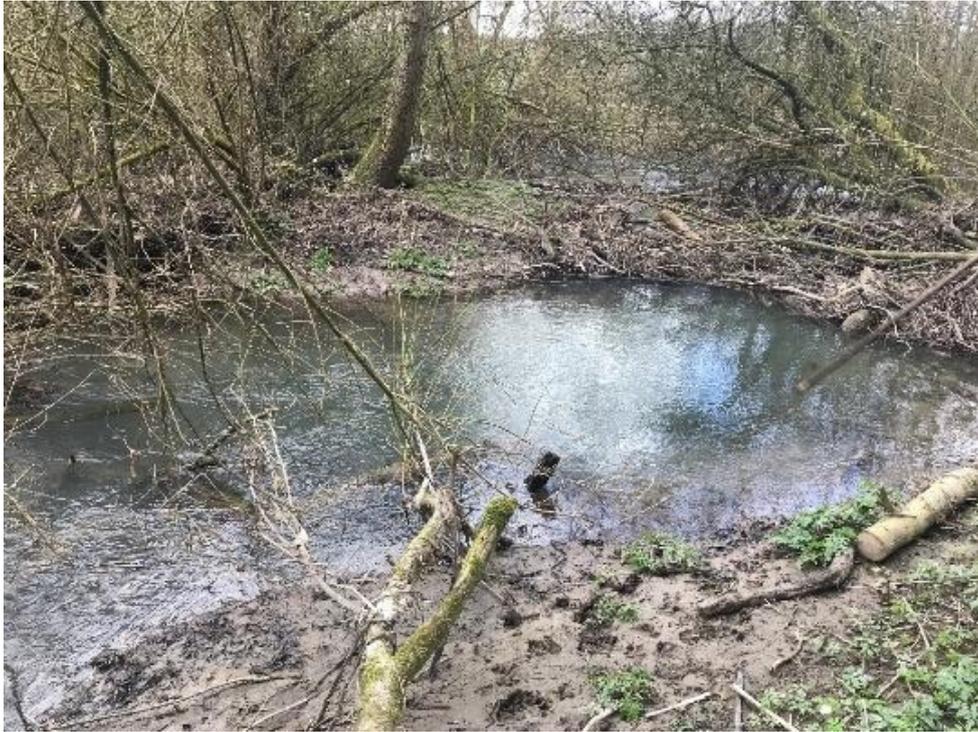
Photo 40....and more trash dams....

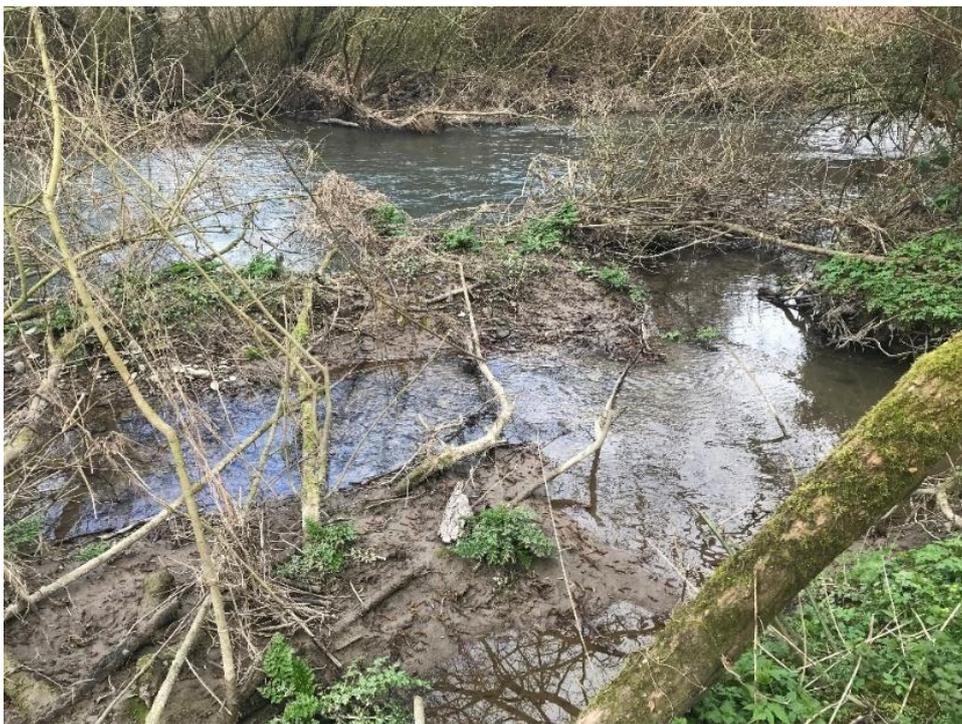
Photo 41....Driving channel braiding (anatomisation) as the river finds its way through this natural and dynamic situation in the woodland.

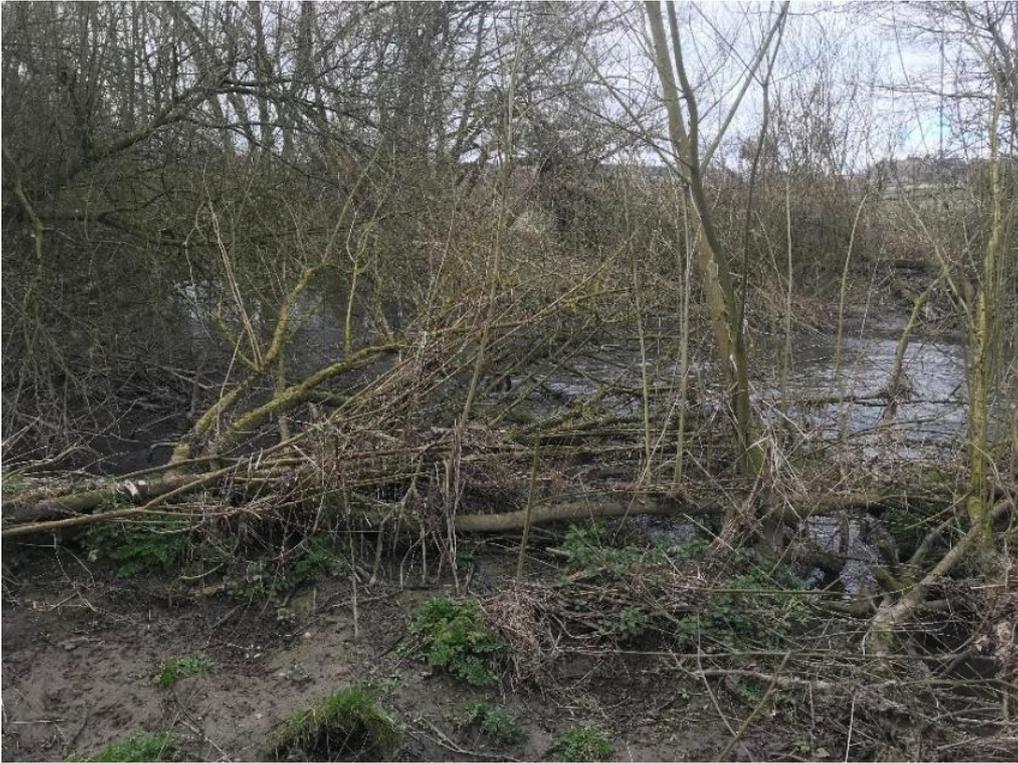
Photo 42. This fallen tree creates an impressive piece of bank protection, prime marginal habitat and maintains geomorphic process and further channel habitat formation in the main channel.

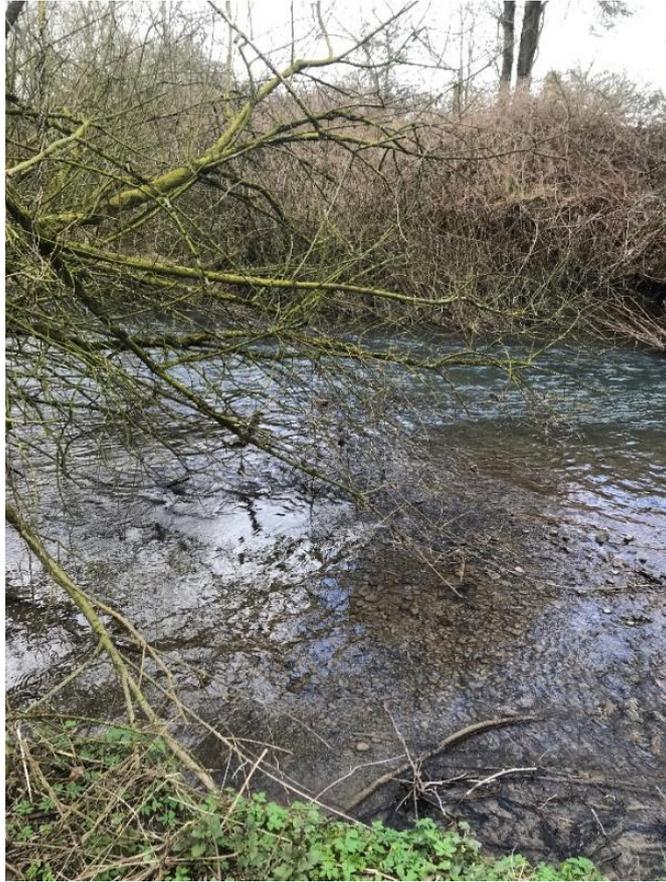
Photo 43. Once 'greened up' with leaves in the late spring, this draping and trailing branch network, coupled with the trailing vegetation along the far bank will provide essential habitat for trout fry and parr at (52.263945 , -2.8329545).

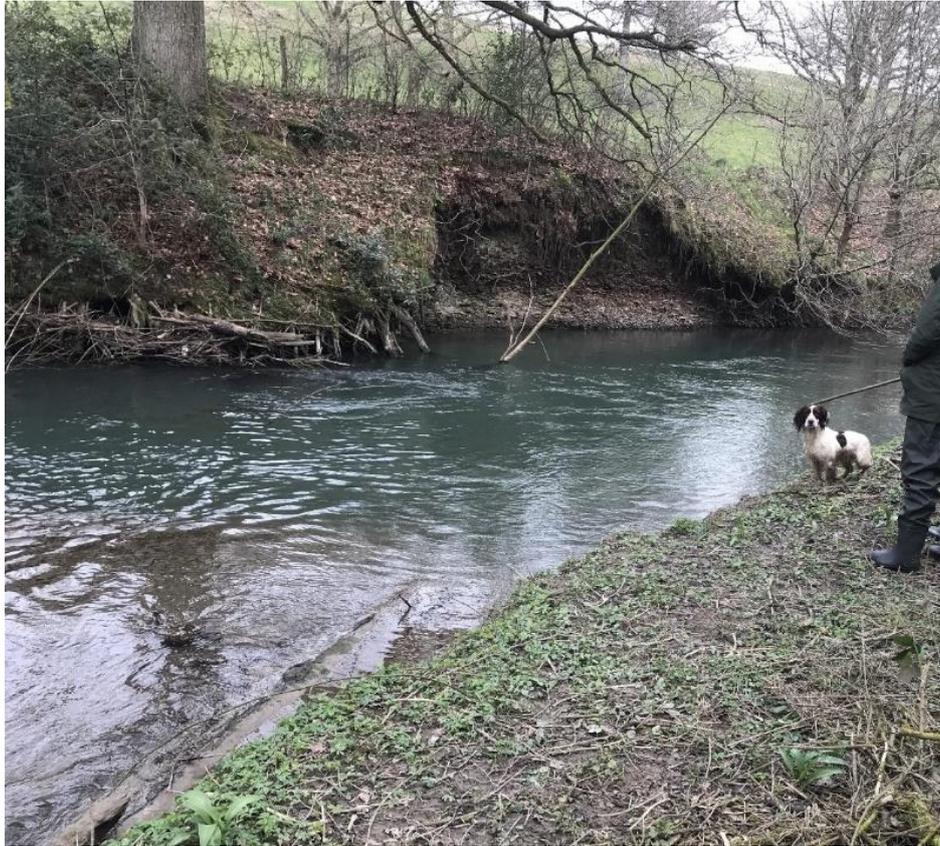
Photo 44. (52.264020 , -2.8327587) As the valley sides steepen off the LHB, this elevated and exposed bank face has started to erode due to a back eddy formed during floods. A thick seam of river 'gravels' can be seen clearly, which the river will be eroding and depositing as part of natural processes to form channel habitats downstream . The network of roots adjacent to the deep pool provides valuable adult trout habitat. Folding and pinning some of the available standing wood adjacent to the erosion feature will help regulate the rate of erosion.

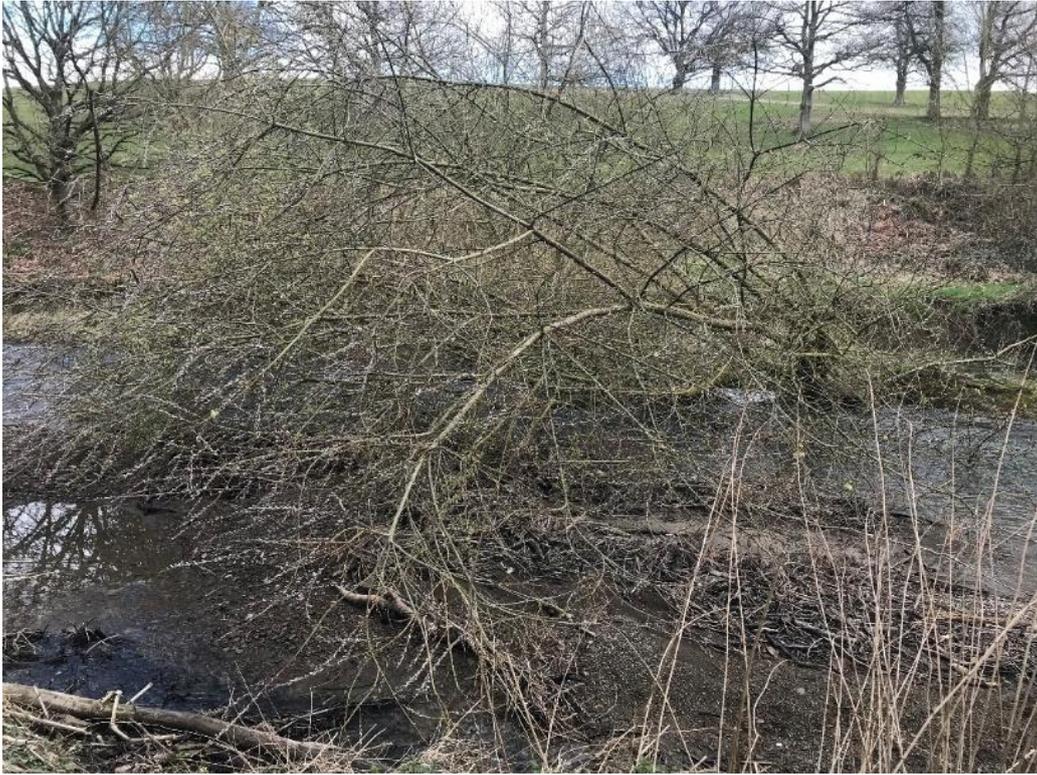
Photo 45. (52.263810 , -2.8328311) While beneficial to have overhanging cover, this fallen willow could also be used to provide bank protection and additional habitat benefits in conjunction with Photo 47, below.

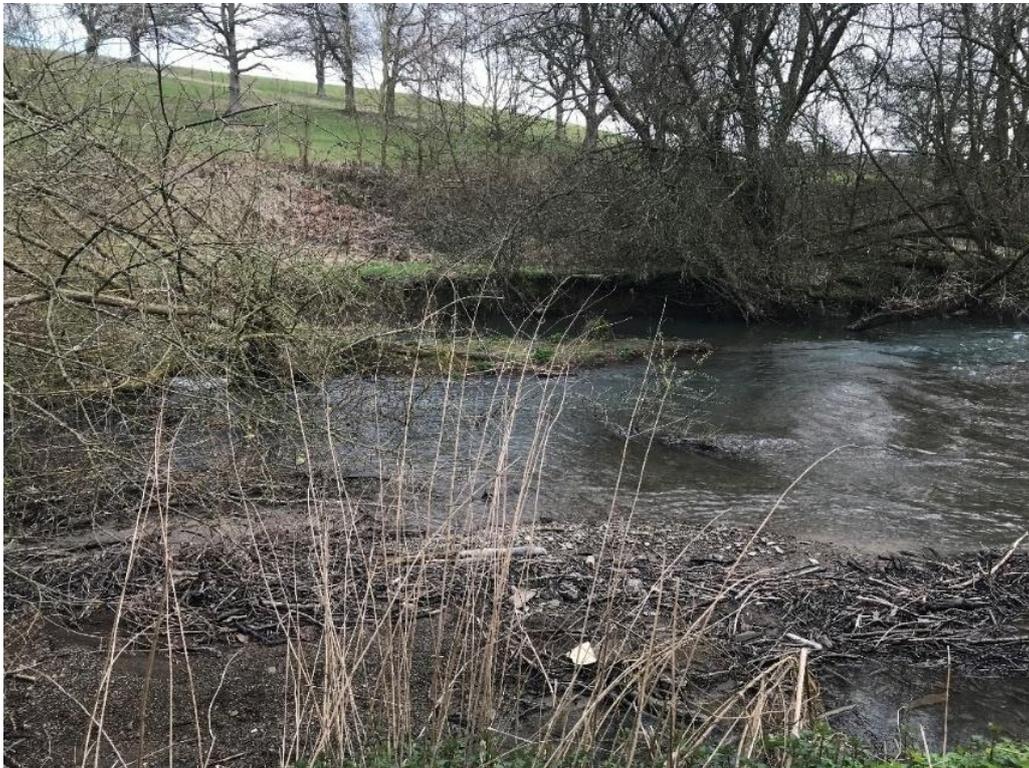
Photo 46. The back eddy eroding into the far LHB could be filled by pulling the fallen willow around and pinning it in the hole (see recommendations for potential techniques).

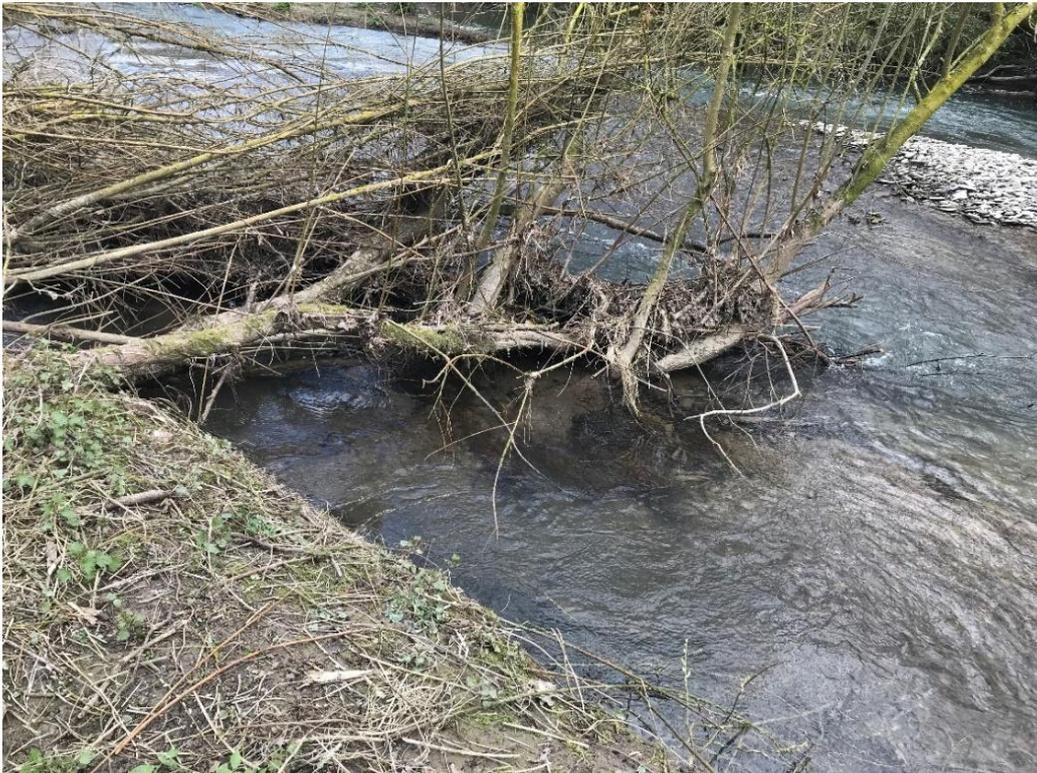
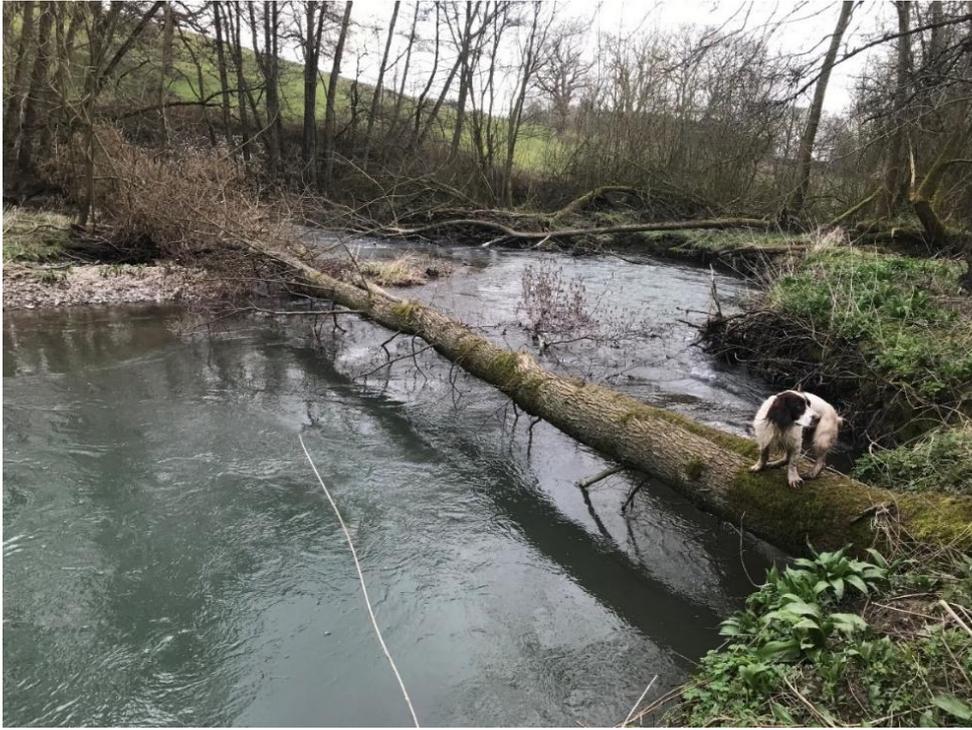
Photos 48 and 49. A mid channel bar formation, coupled with large and brashy woody material adjacent is providing excellent flow diversity and a wide range of habitat opportunities for fish and aquatic invertebrate life.

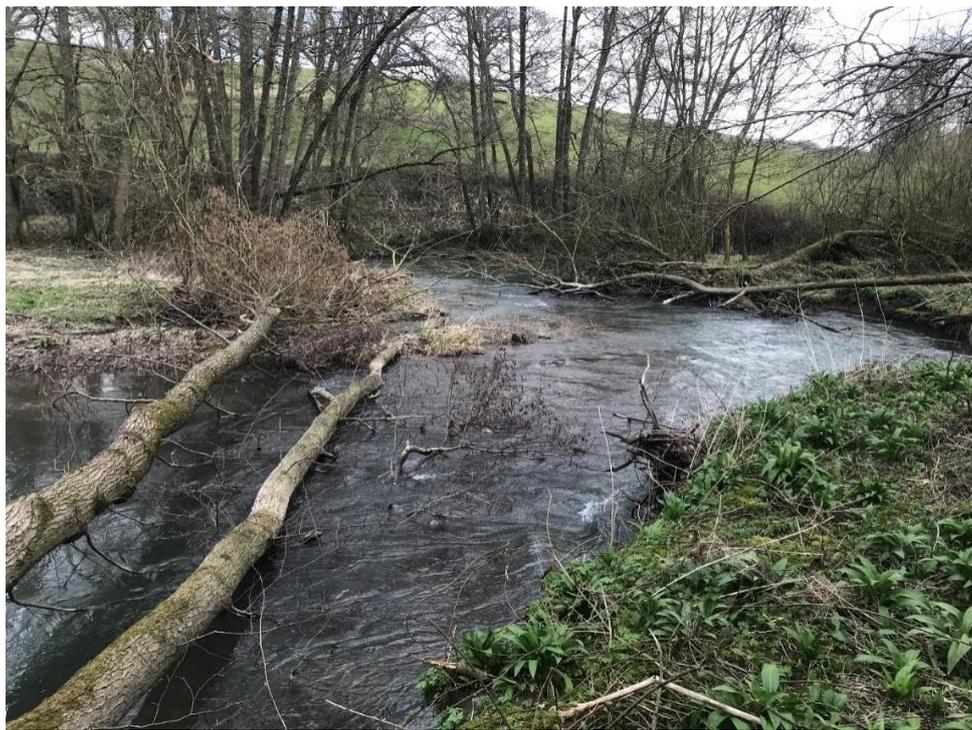
Photo 50

Photos 50 and 51. (52.263515 , -2.8328902) A great example of natural interaction between river and woodland, creating quality, dynamic, river habitat. Also, how natural river habitats can regulate increasingly intense floods; the cross channel trunk will slow down elevated flows, the downstream marginal trunks will further dissipate flood energy, reducing both rates of erosion and how quickly water heads to downstream locations. Moderating flood flows is critical for maintaining aquatic biodiversity, especially as flood intensity and frequency has increased in recent decades.

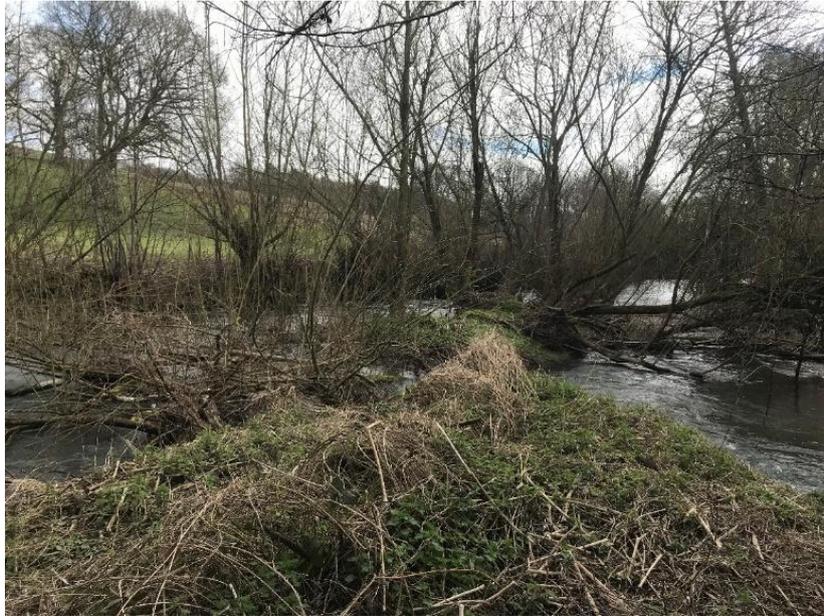
Photo 51. The bifurcated channel discussed in 3.1.1 rejoins the main channel of the Lugg; still lots of dynamic river habitat and large woody material interaction in both channels (52.262831 , -2.8321767).

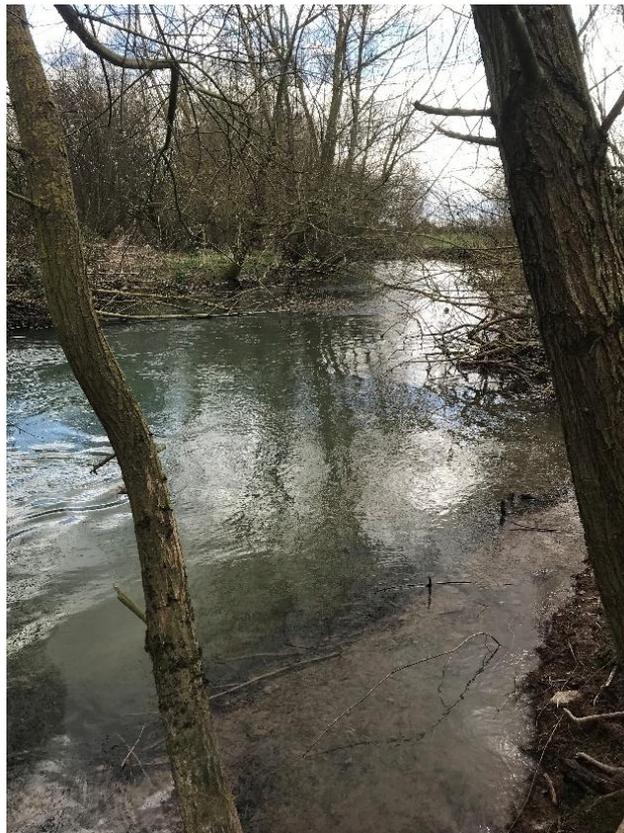
Photo 52. The channel becomes much larger in the downstream half of the beat, once all the anastomosed and bifurcated river channels have converged. Trailing tree limbs and brash add some habitat diversity to a now far more uniform channel. It is likely the woodland and excellent habitat upstream provides some moderating effect on flood water energy by slowing flows, allowing features such as this in the larger downstream channel to stay in place, when flows increase.

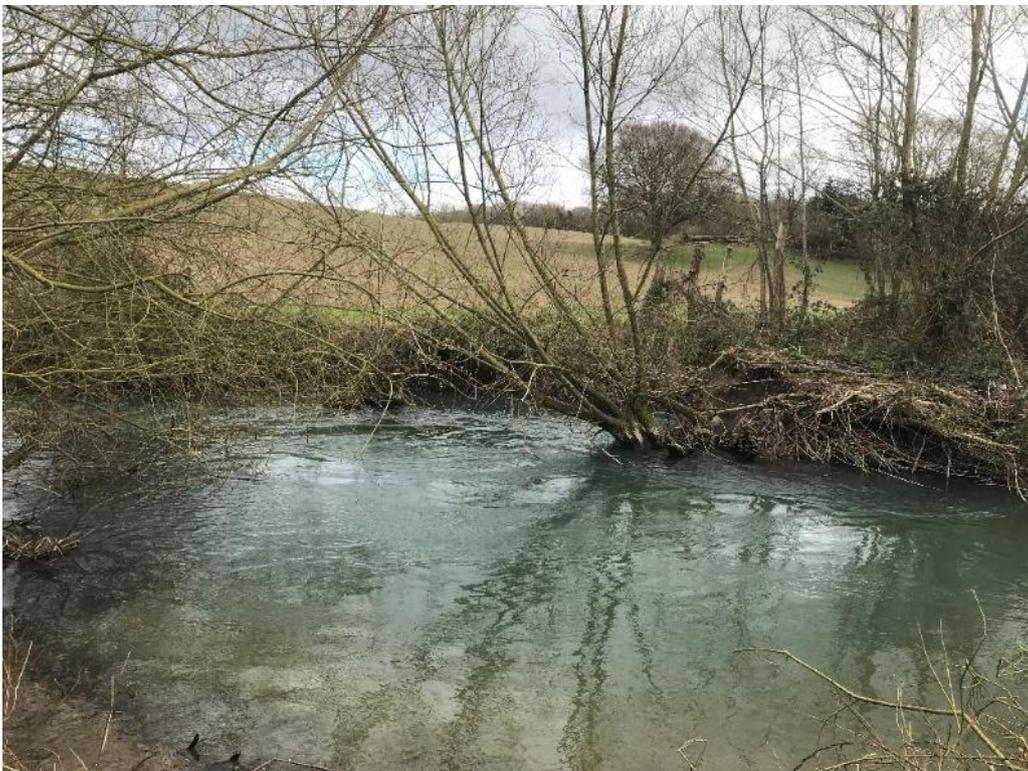
Photo 53. (52.261917 , -2.8312969) Beneficial pool habitat with root systems but only a thin buffer strip between the cultivated field and river here.

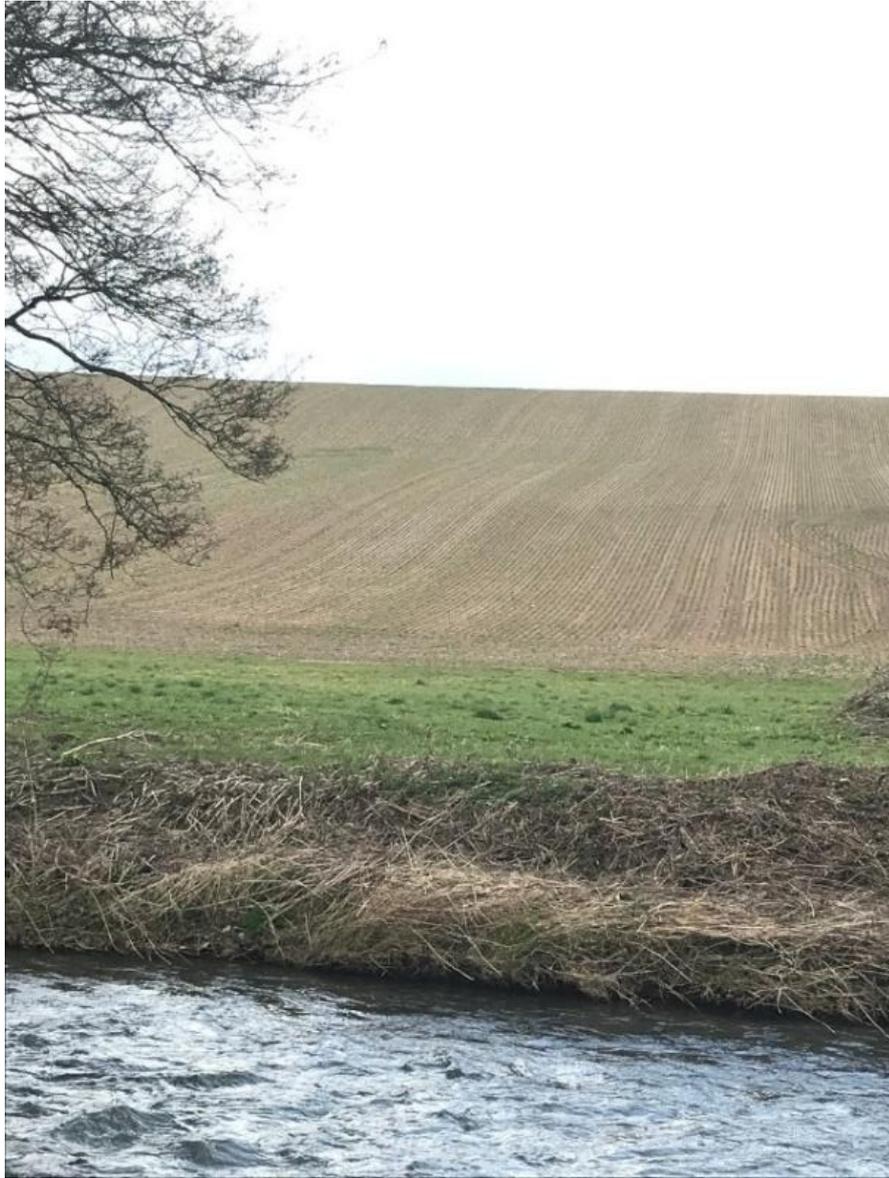
Photo 54. (52.261116 , -2.8304386) Cultivation down the hill slope and exposed soil pose a direct impact to the river during usually wet spring periods. The wide buffer strip will afford some protection but is still likely to allow silt through if a period of continuous rain is experienced.

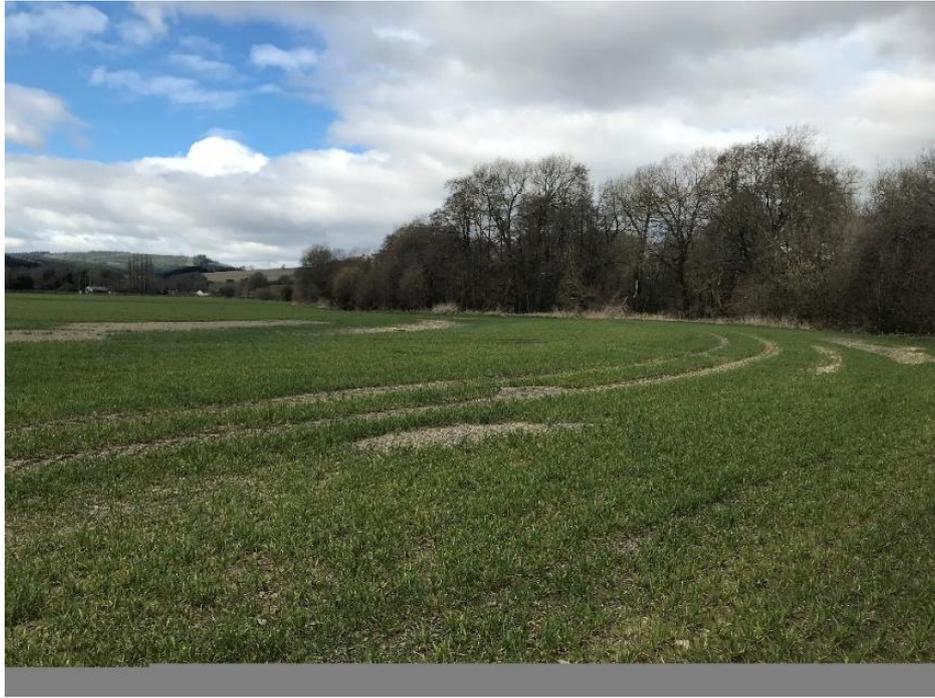
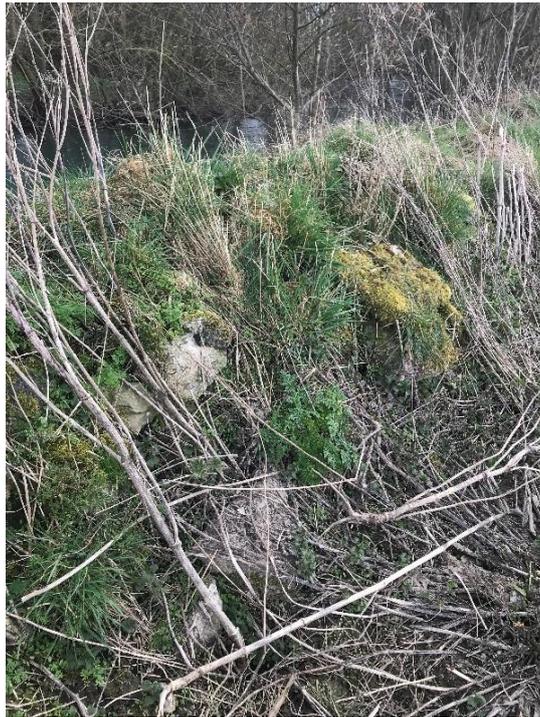
Photos 55 and 56. (52.261418 , -2.8307819) Paleochannels exist in the large cultivated field across the floodplain on the right-hand bank. Flood waters break out across the field and into the old channels left by the river migrating across the floodplain. A wall has been constructed on the bank top at the downstream end of this process to try and stop flood water heading to this point, which increases the height of the bank and disconnects the section of river below from the floodplain.

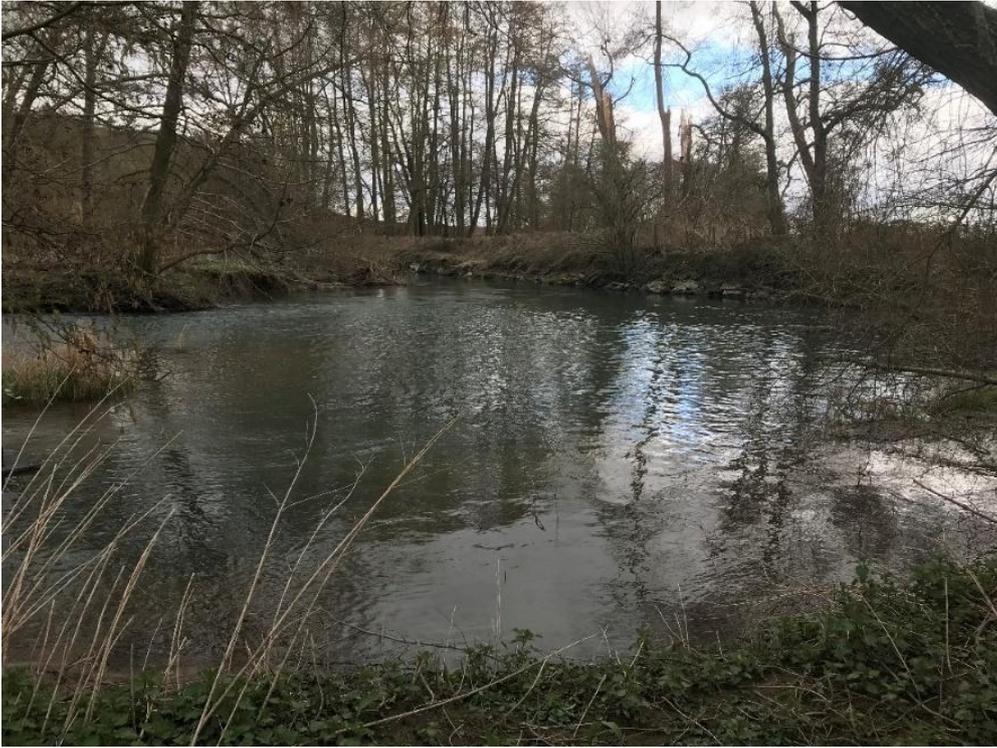
Photo 57. A large pool on a sweeping bend at 52.260682 , -2.8301167 marks the return of some diversity in the now larger river channel. Rip-rap boulders, tree roots and trailing branches provide cover and make this a valuable feeding habitat that could hold a number adult trout. Excellent features to be retained.
