WILD TROUT TRUST

River Lugg
Midland Flyfishers

Herefordshire

2025

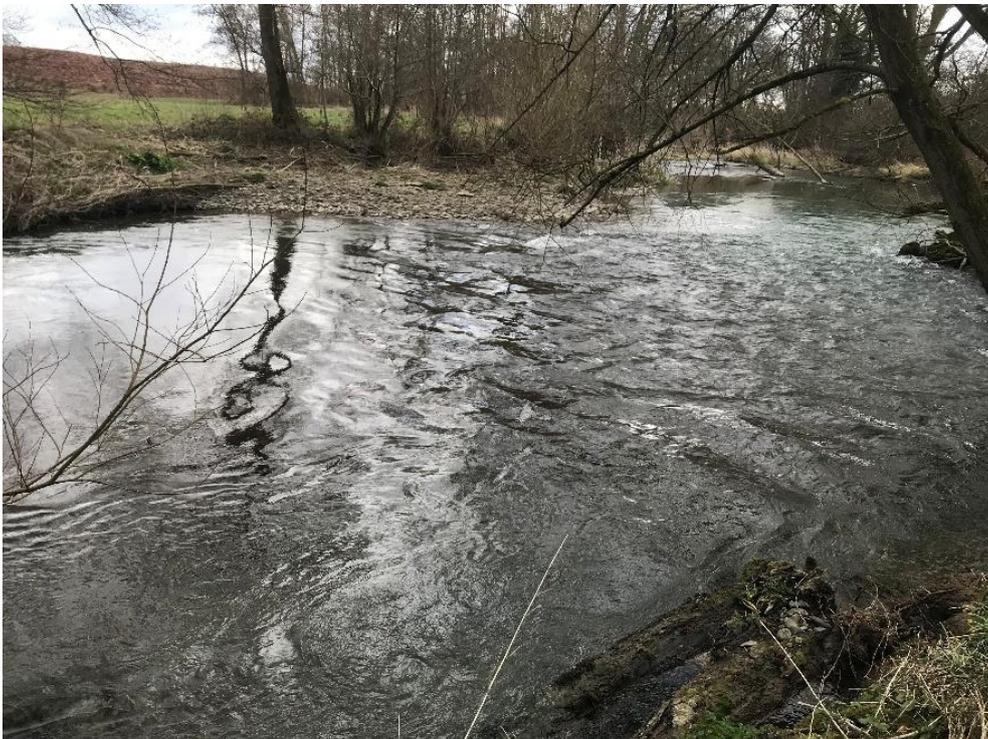
Photo 58. In conjunction with sinuosity returning to the channel planform, glide and riffle channel habitats are formed as the river erodes and deposits bed material again. Salmon may spawn at this location in the right conditions.

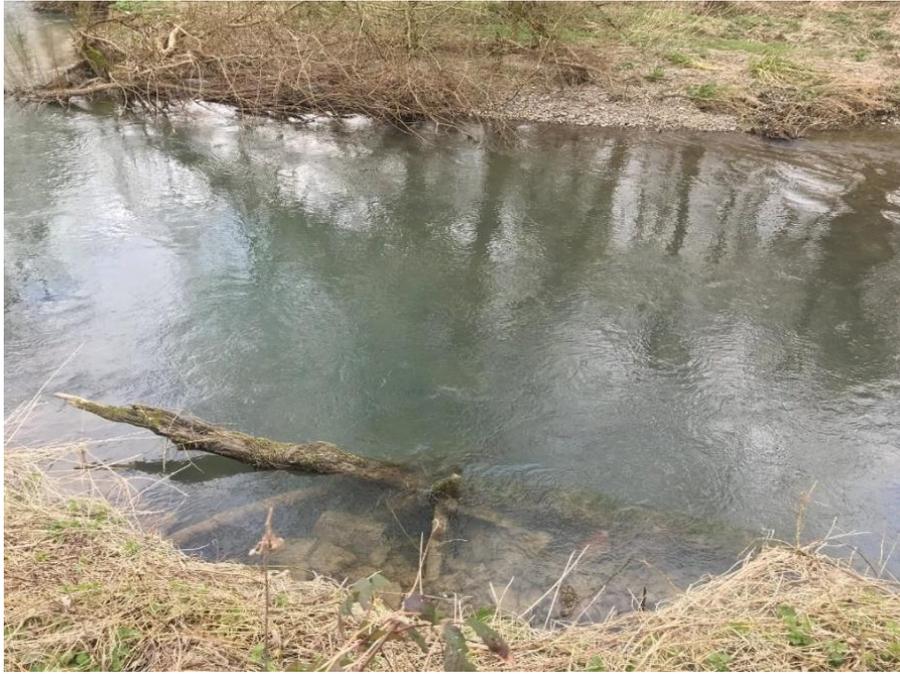
Photo 59. Submerged logs and tree trunks provide perfect holding habitat for trout and grayling. This is located very beneficially on the outside of a bend at 52.260737 , -2.8295159. Additional woody material could be folded in over the high bank face and pinned to help moderate erosion.

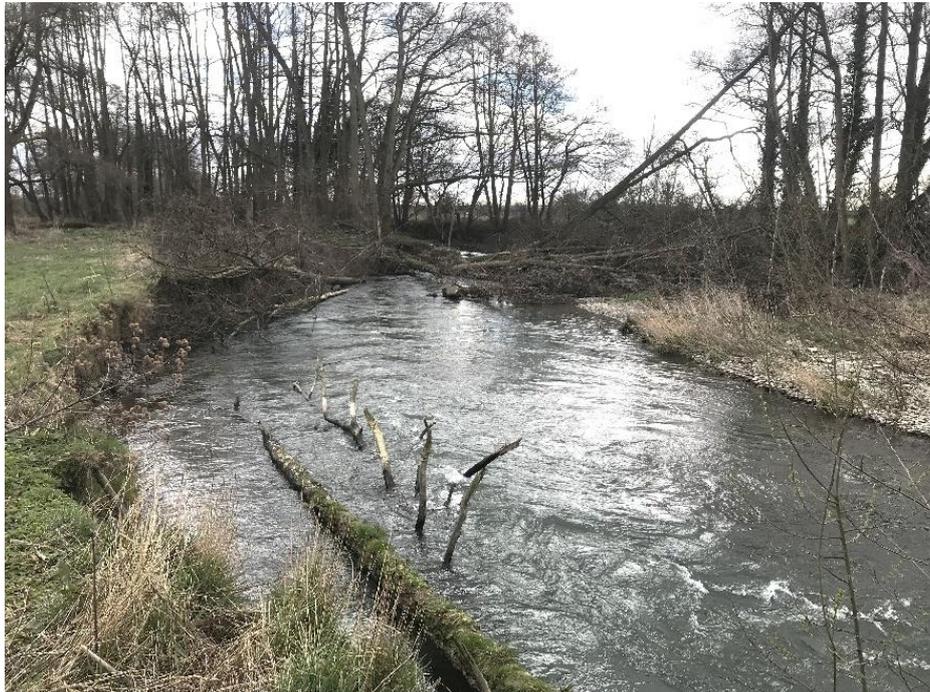
Photo 60. (52.260409 , -2.8287756) A fantastic combination a very large timber interacting with the channel. The lodged and submerged trunk against the eroding left-hand bank will provide excellent structure for trout to lie under, while feeding on invertebrates brought down by the flow. An additional trunk could be imported and installed in the eroding bay, perhaps packed with brashy material to slow the erosion here. Coupled with bank top planting of suitable tree species to future proof bank stability.

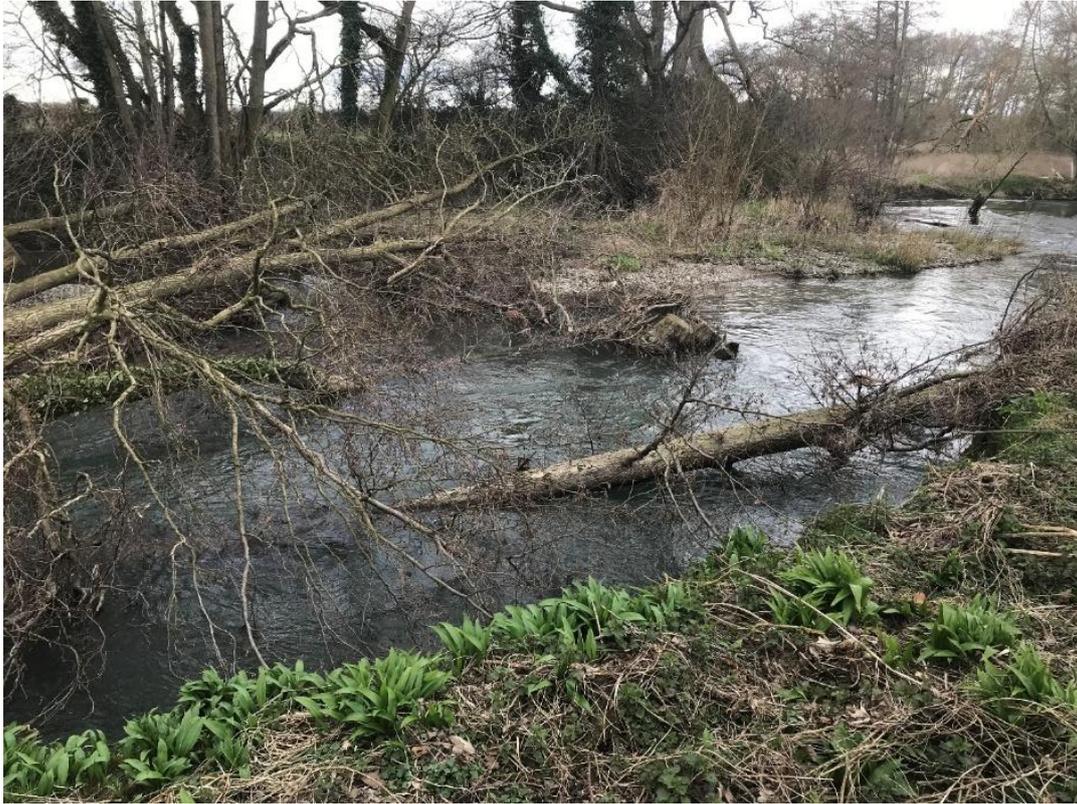
Photo 61. The suspended log jam of fallen trees highlights how quickly flow energy gets dissipated by large woody material in the channel, and will continue to do the same when river levels rise during floods. The structure provides superb cover and will attract trout at all river levels; refugia from flood flow, predation and intense sunshine.

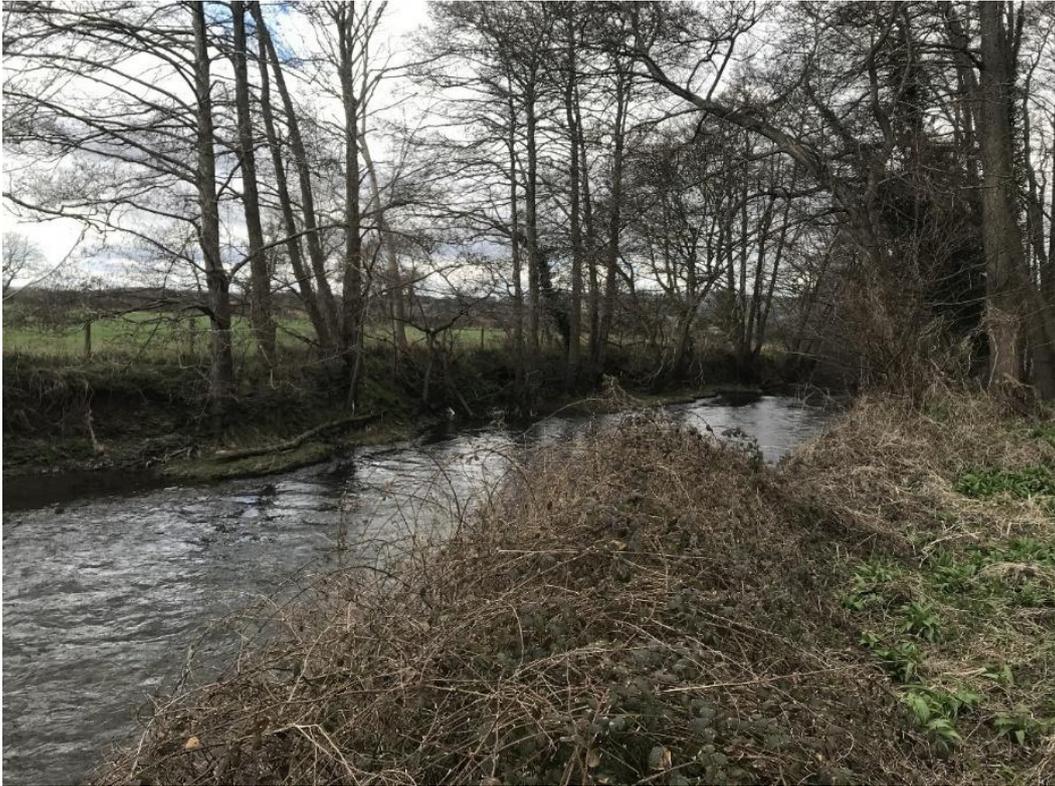
Photo 62. Straightened channel at the bottom of the beat.

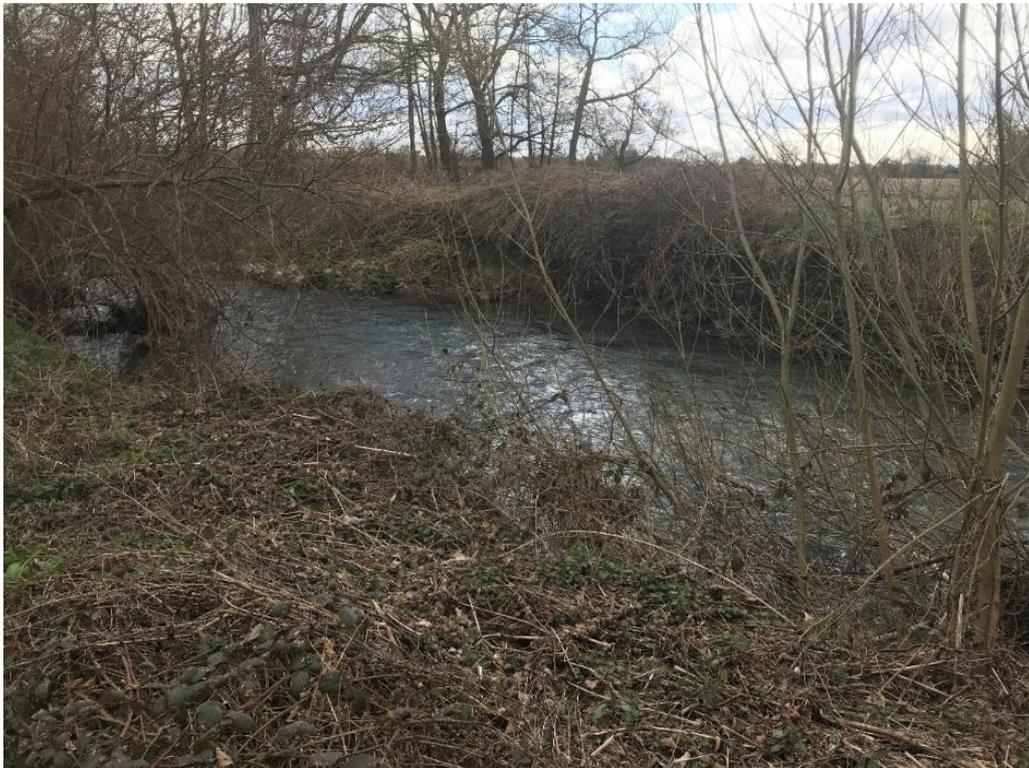
Photo 63. (52.259278 , -2.8272200). Bankside material could be cut and heeled into the channel to create some marginal cover here. More ambitiously, some root wads could be pushed into the bank to create some sinuosity in the straightened channel.

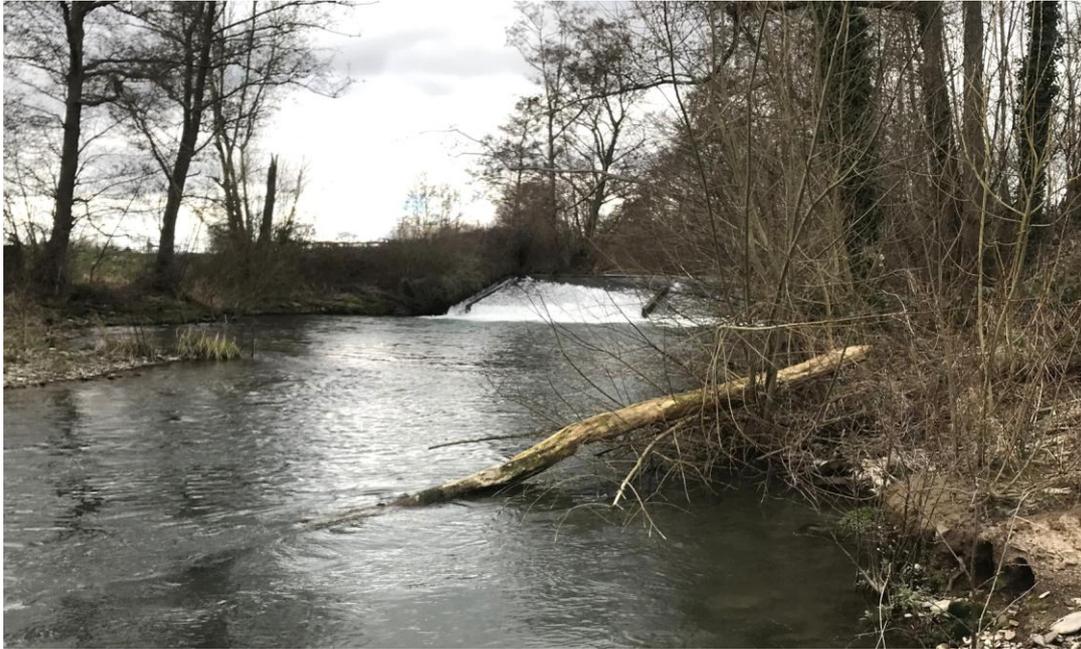
Photo 64. (52.258423 , -2.8245807) The weir below Upper Kingsfield beat. Despite the low-cost baffle system installed on the face of the weir to ease salmonid fish passage, this is a significant barrier to river process and fish migration in the Lugg (Figure 5). Salmon and trout life cycles will be strongly disrupted by this feature as they cannot move freely up or downstream, and river habitat impoverished downstream as replenishing bed material gets stuck behind the weir. The vertical toe at the bottom of the sloping weir face means fish will find it very difficult to get into the baffle system at lower flows. A revisit to look at options for remediating issues caused by this weir (ideally partial or full removal as a first option) would be hugely beneficial to the Lugg generally, and fishery upstream.

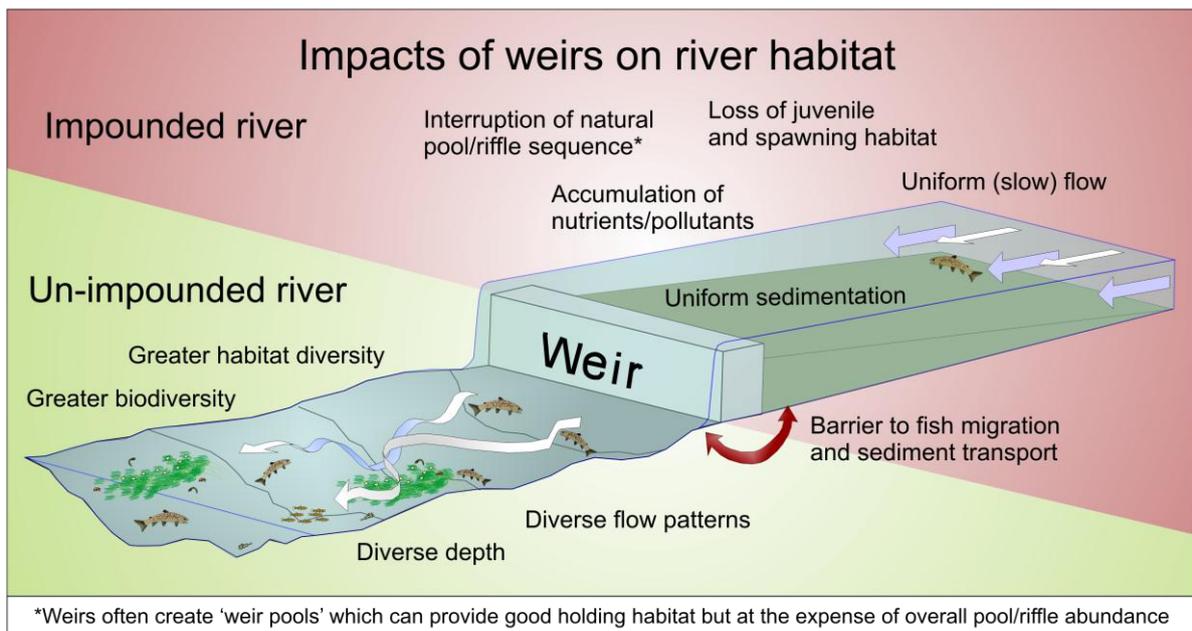
Figure 5. This diagram highlights the impacts weirs – or river barriers – have on river habitat development and fish populations.

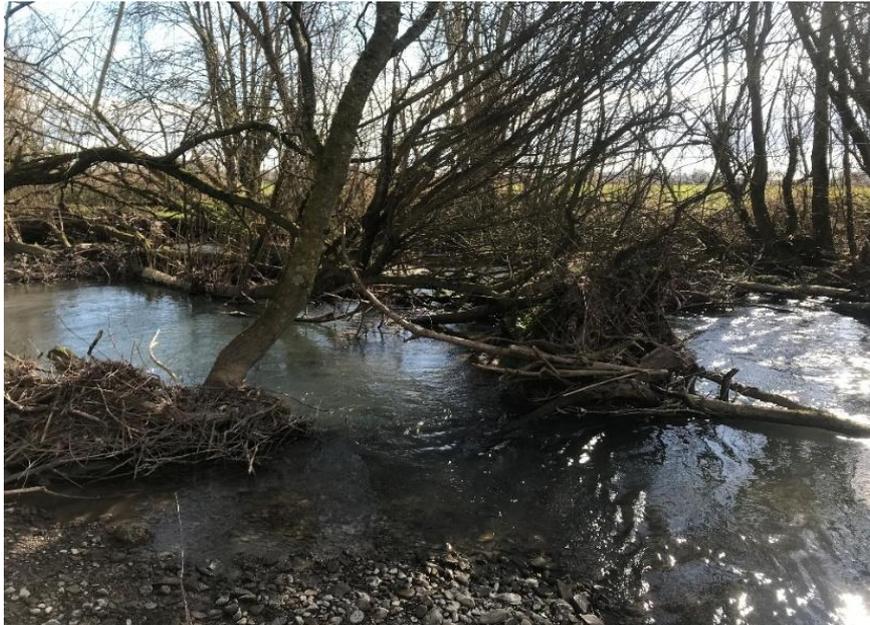
Photo 65. Complex habitat through shallower water will provide excellent trout parr habitat, along with a huge range of habitats for aquatic invertebrates in this section (52.262769 , -2.8332464).

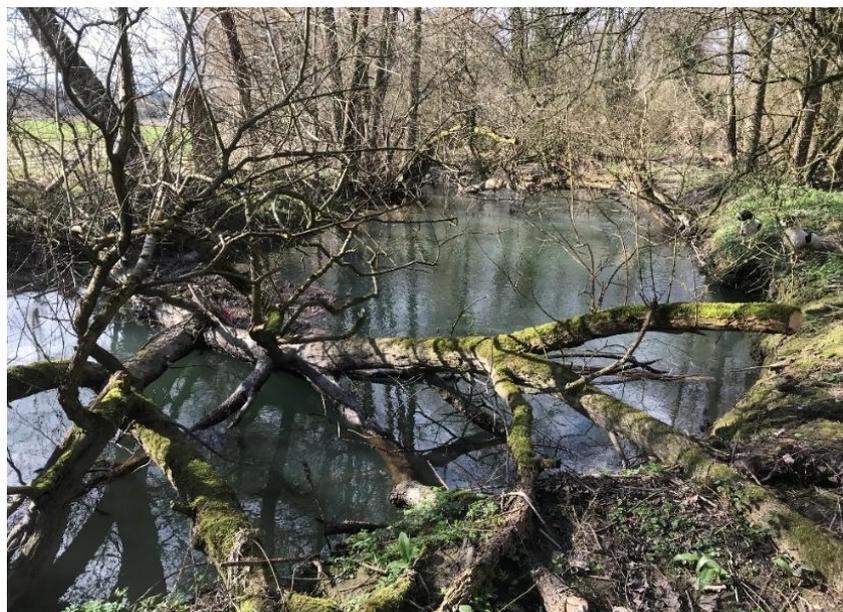
Photo 66. (52.263409 , -2.8337989) A heavily protected pool; ideal habitat that will hold large adult trout and salmon. Ensuring this fallen wood is retained will

benefit the wider fishery. Having some truly difficult places for predators and anglers to exploit should mean some great fish make it through to spawning, benefiting the fishery by increased numbers of progeny in the future.

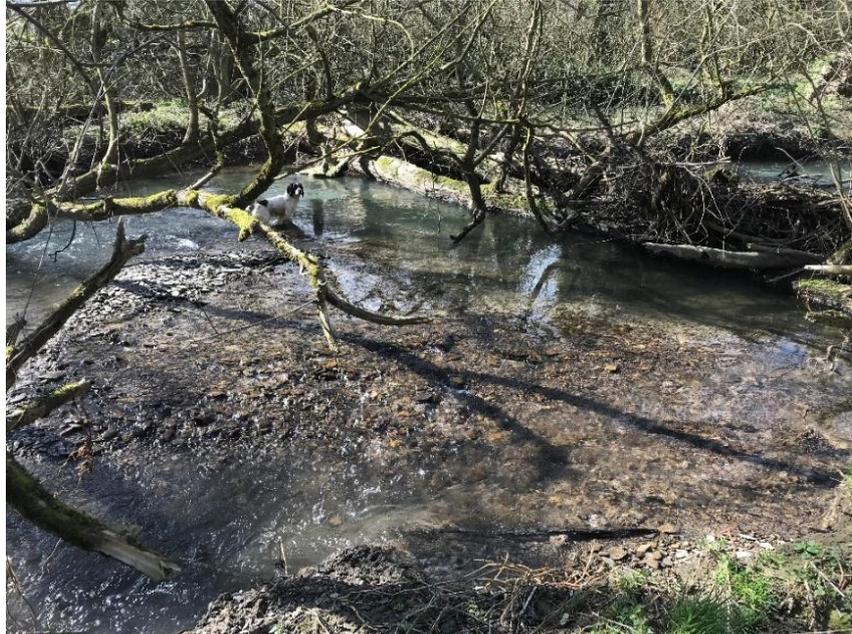
Photo 67. (52.263531 , -2.8343890) A large trunk has forced the flow underneath it, blowing gravel and pebble substrate up into a riffle. This could offer a potential spawning location, with a secure pool for pre-spawning fish to lie up in.

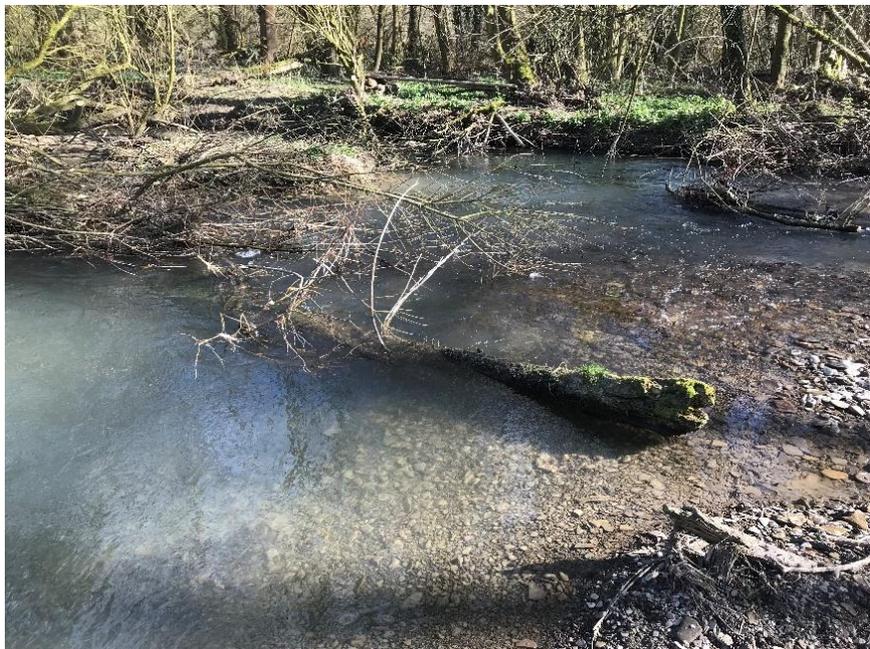
Photo 68. Further fallen limbs creating scour and gravel deposits in short riffles at (NGR). Spawning opportunities for larger fish exist in front of the trunk in this picture.

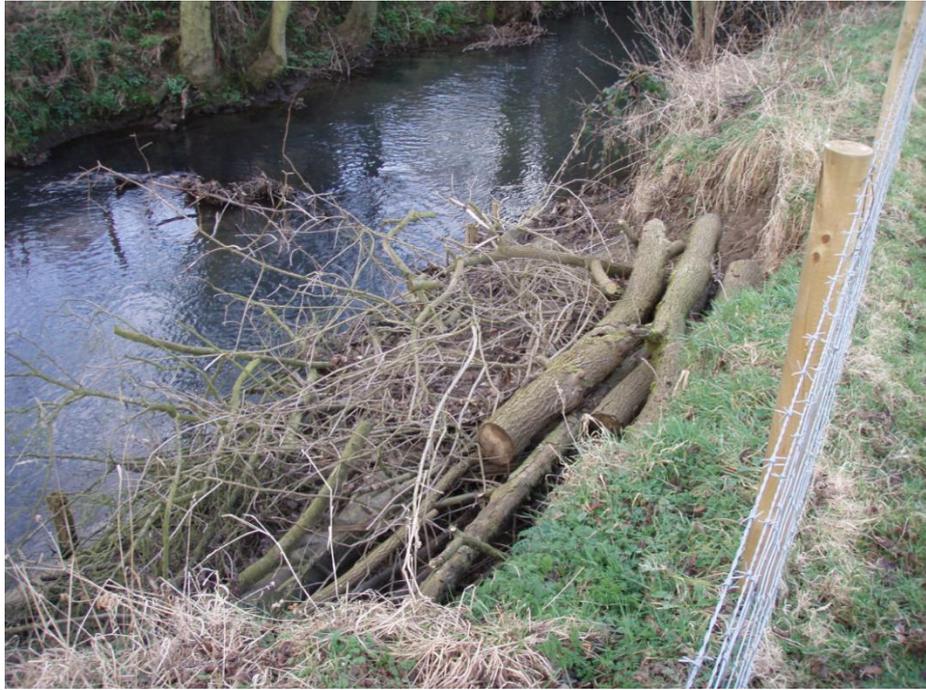
Figure 6. Installation of large timber, packed with brush and possible planted with willow whips will slow erosion rates down. This provides time for vegetation to develop on the bank which will naturally regulate erosion. Moving the fence away from the bank top and tree planting back from the edge of the bank will develop very beneficial root systems to bind the bank in the future.

- Install large woody material and brash interventions to defend areas against accelerated erosion in Meadow beat. These will need to use substantial material at their foundation, pinned and wired to stop them washing out. Root-plates may work in places too. Willow material can be used to create growth through structures and bind banks together, but care should be taken not to encourage it to become overly dominant along the beat. A selection of approaches for defending against rapid erosion are available (Figure 6) and more

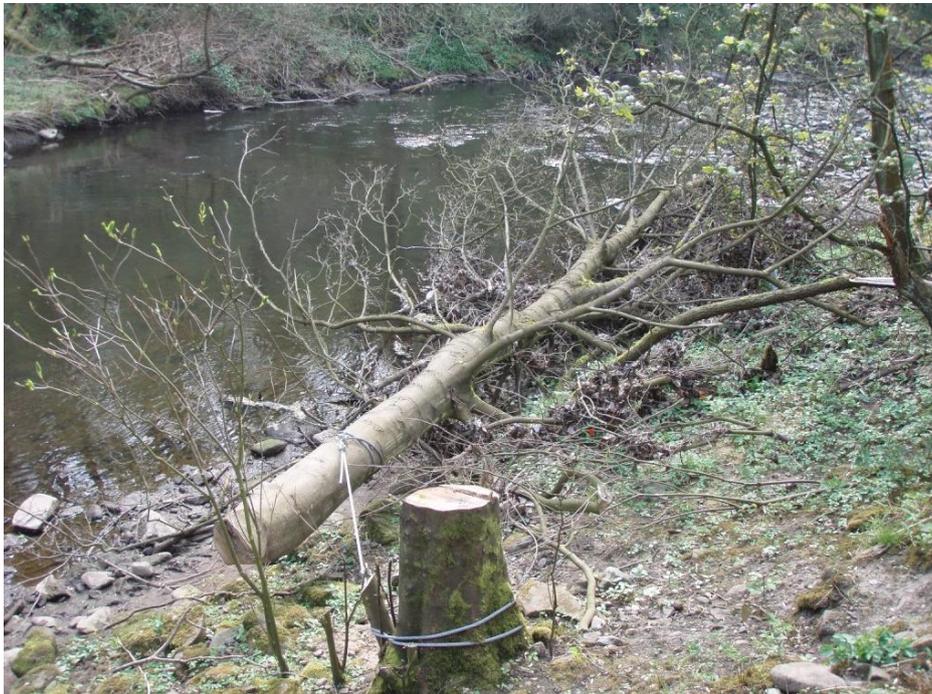
Figure 7. One example of how steel cable can be used to secure large timber in the river, such as this tree kicker (more information: [Habitat-Sheet-Kicker.pdf](#)). Combinations of cable, wire and anchors will ensure features are flood resilient.

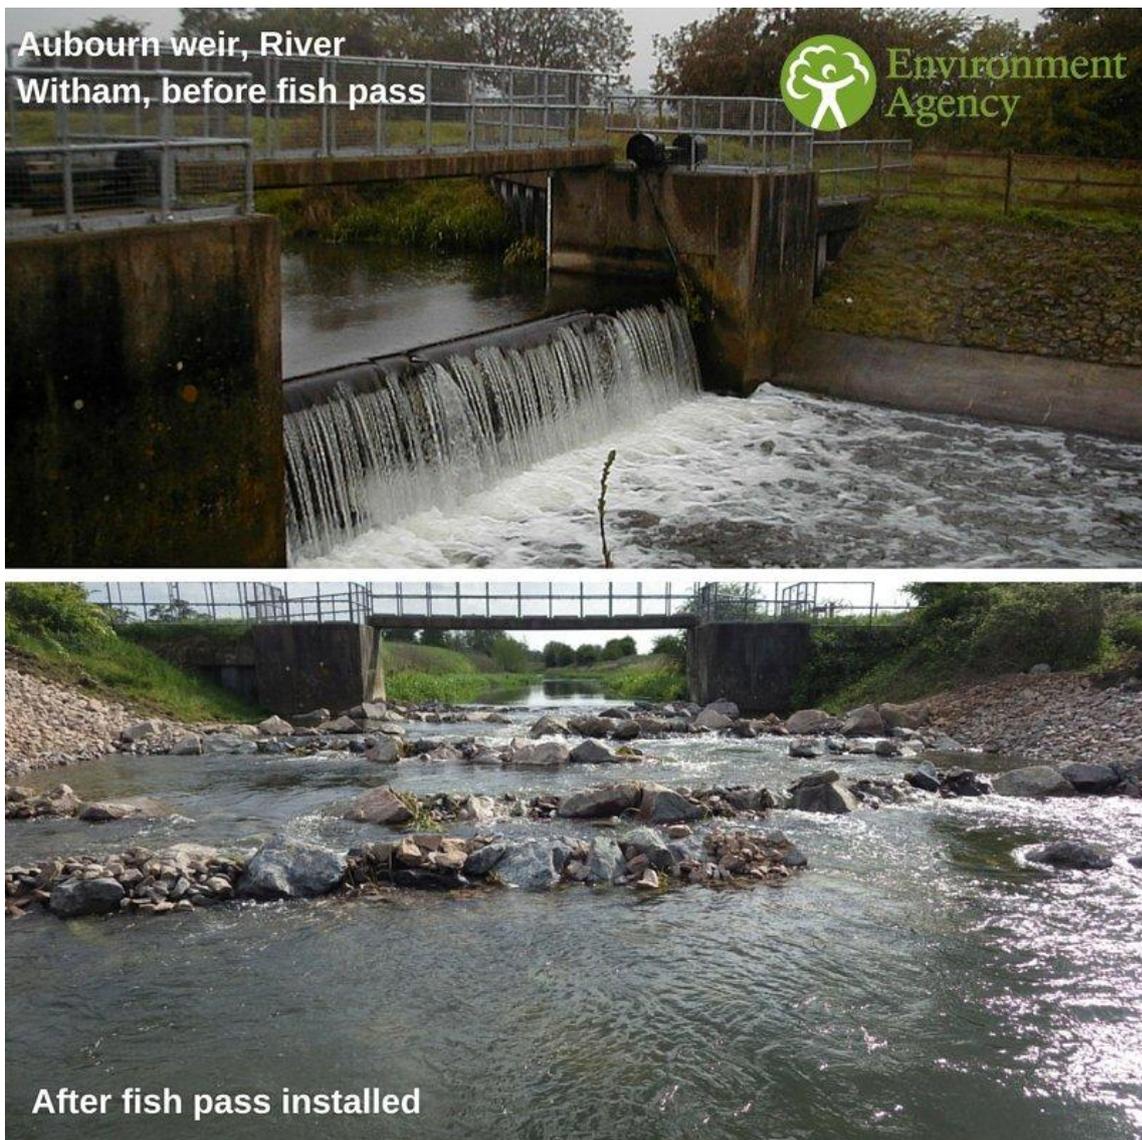
Figure 8. An example of weir alteration and rock ramp being used to remediate a river barrier and reconnect the watercourse. On the Lugg, given the incised and modified channel upstream of the weir below the fishery, removing the weir would be the best option, but retaining a bed check would ensure channel stability following the work.

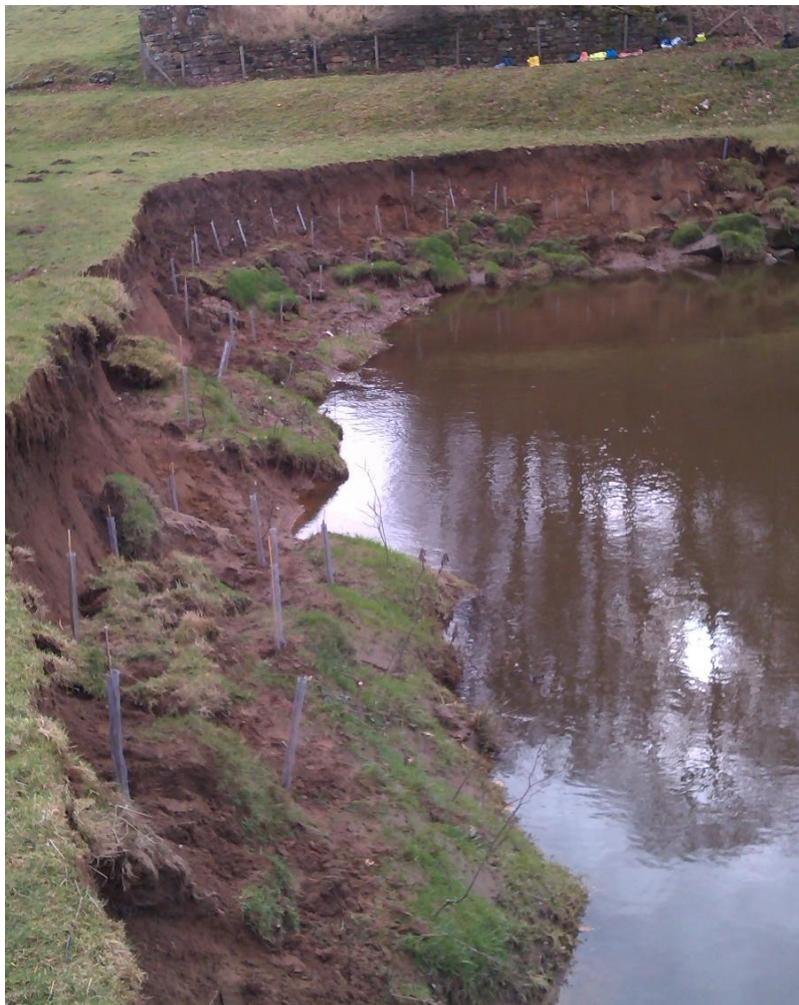
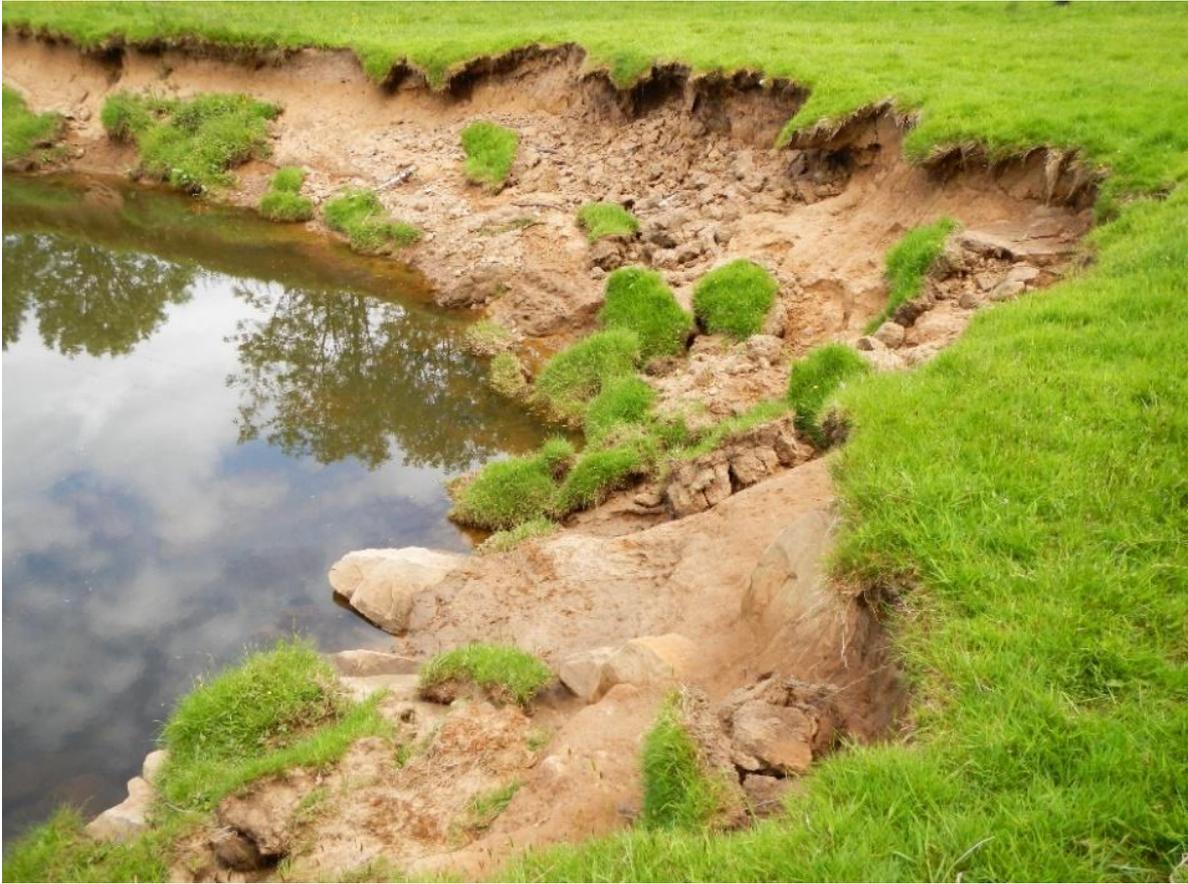
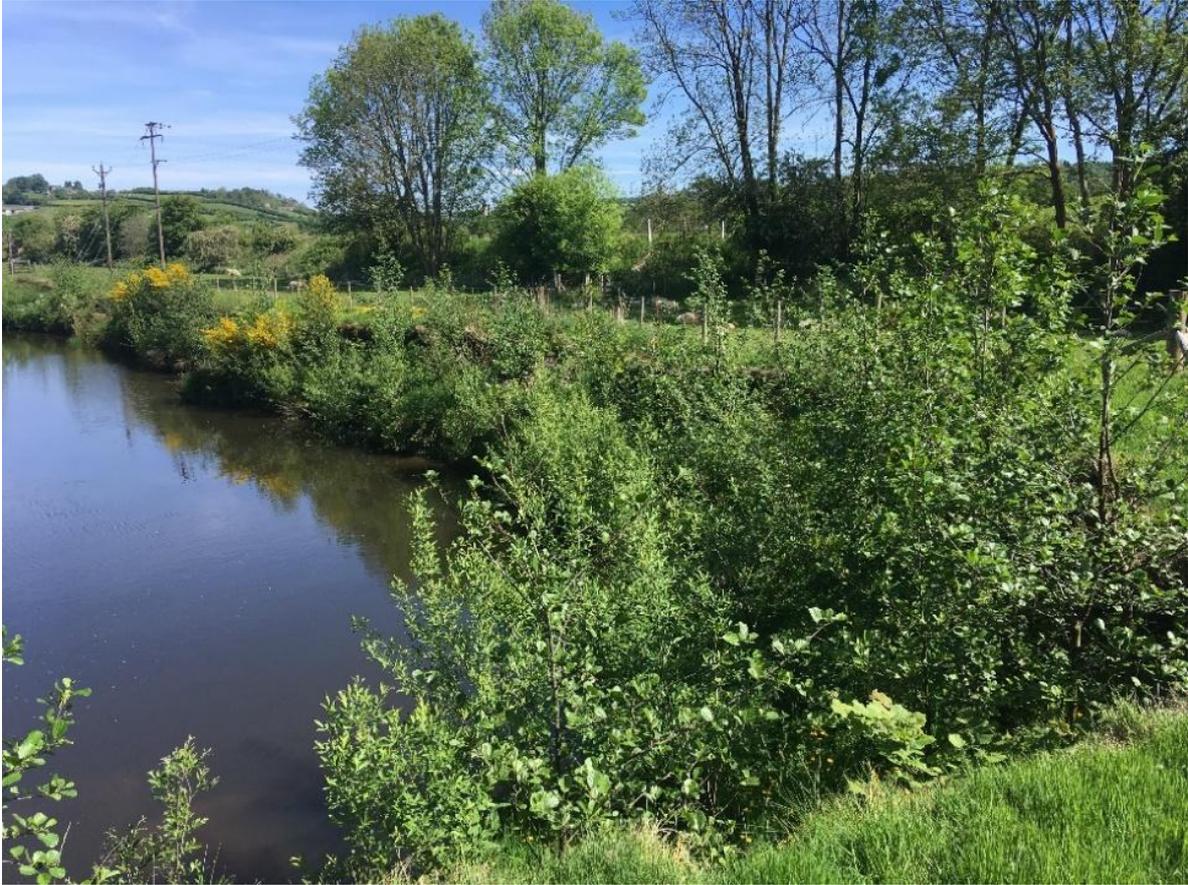
In the following example, fencing to exclude livestock, tree planting and light regrading by hand with spades is all that was required to restore bank stability. The work was undertaken by the Glaisdale Angling Club as a work party, following and advisory visit and recommendations from WTT. The first picture is taken looking downstream, with the following before and after photos looking upstream.

Bank erosion is a natural process that is important in supplying a river with sediment, such as the gravels used by fish for spawning. However, erosion often becomes a problem when it is accelerated by grazing and/or trampling, through the associated reduction of vegetation and vital root structure, and physical damage to the bank. Past channel alterations (dredging and straightening) and hard bank revetments can also exacerbate erosion by deflecting and focussing flows onto adjacent areas of bed or bank, as can in-channel structures which interrupt sediment transport. Somewhat counterintuitively, the simplest bank protection measures are often the most effective, like excluding livestock or using soft, diffuse structure to turn the high flow-energy area into a lower energy area.

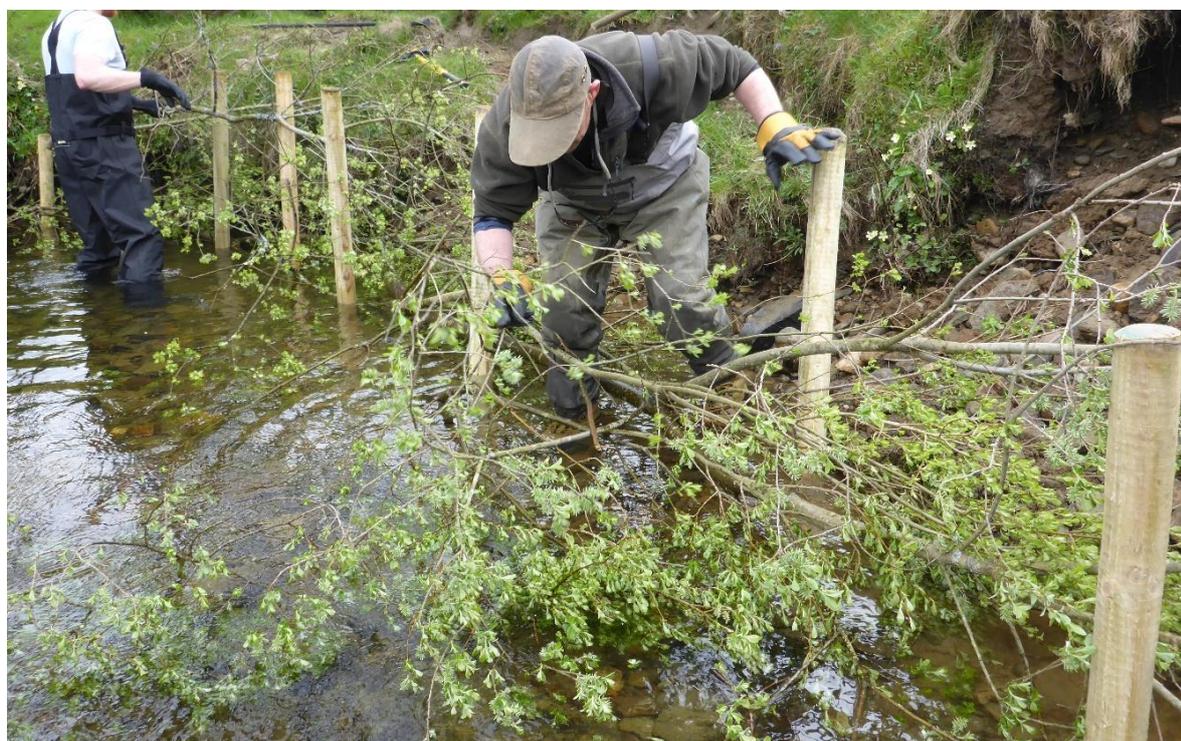
Above - Live willow being very loosely woven between the posts of the bank protection. Unlike the hard lines of traditional willow spiling (or hard revetment), this provides diffuse protection from day 1, and is unlikely to create erosion elsewhere. Note the valuable in-channel structure for fish and invertebrates.

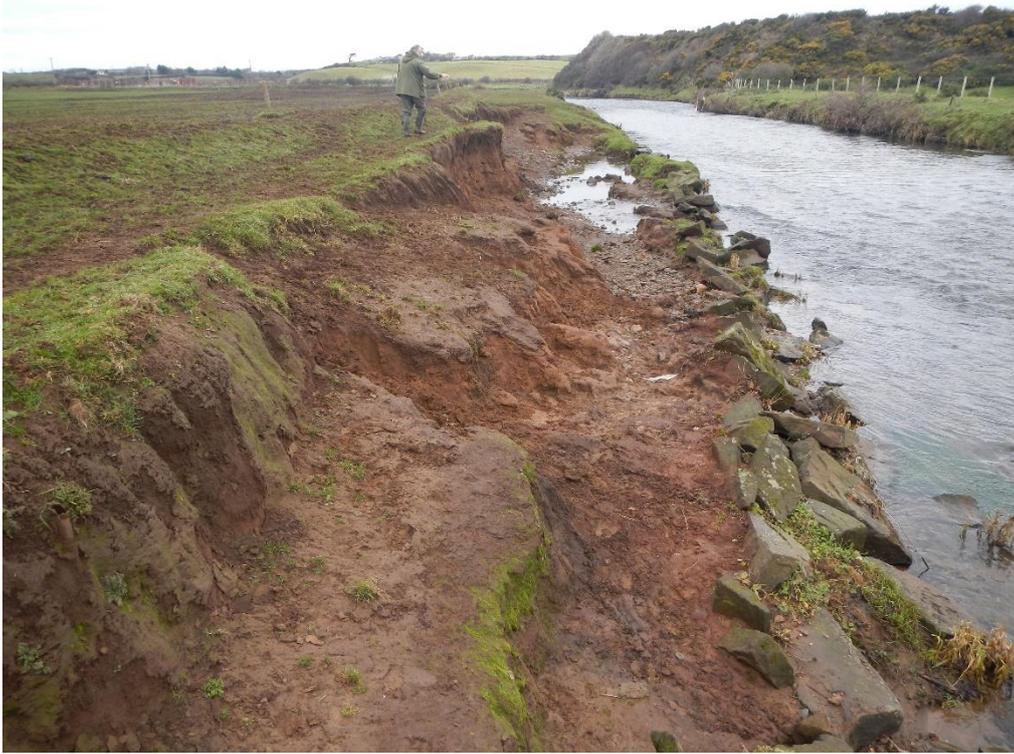
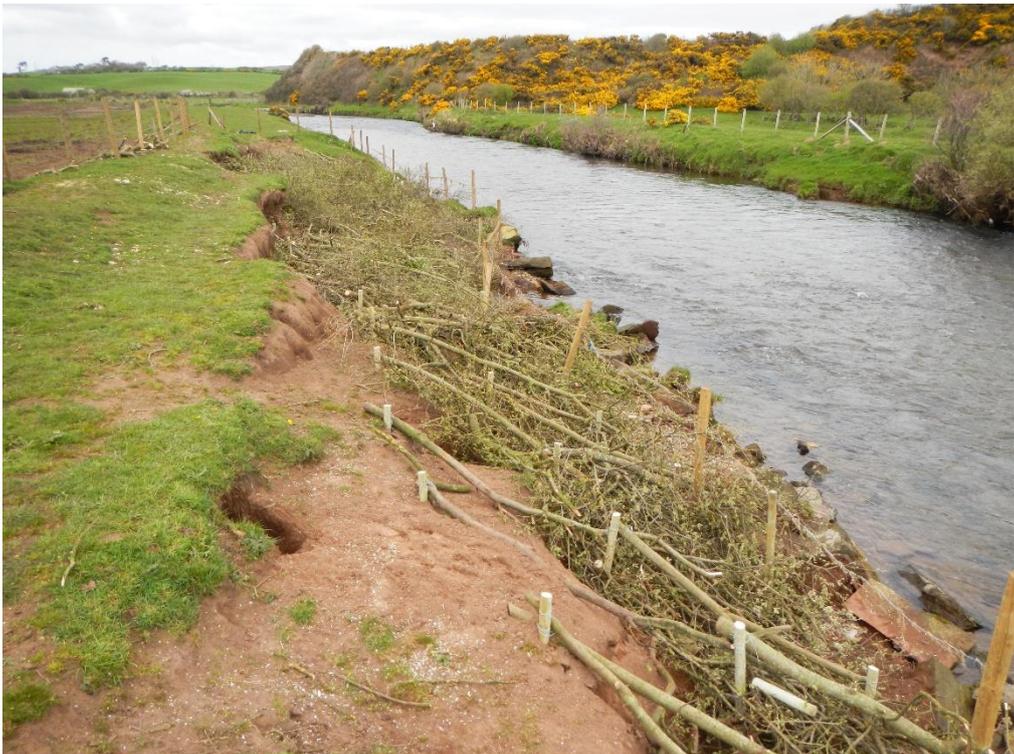
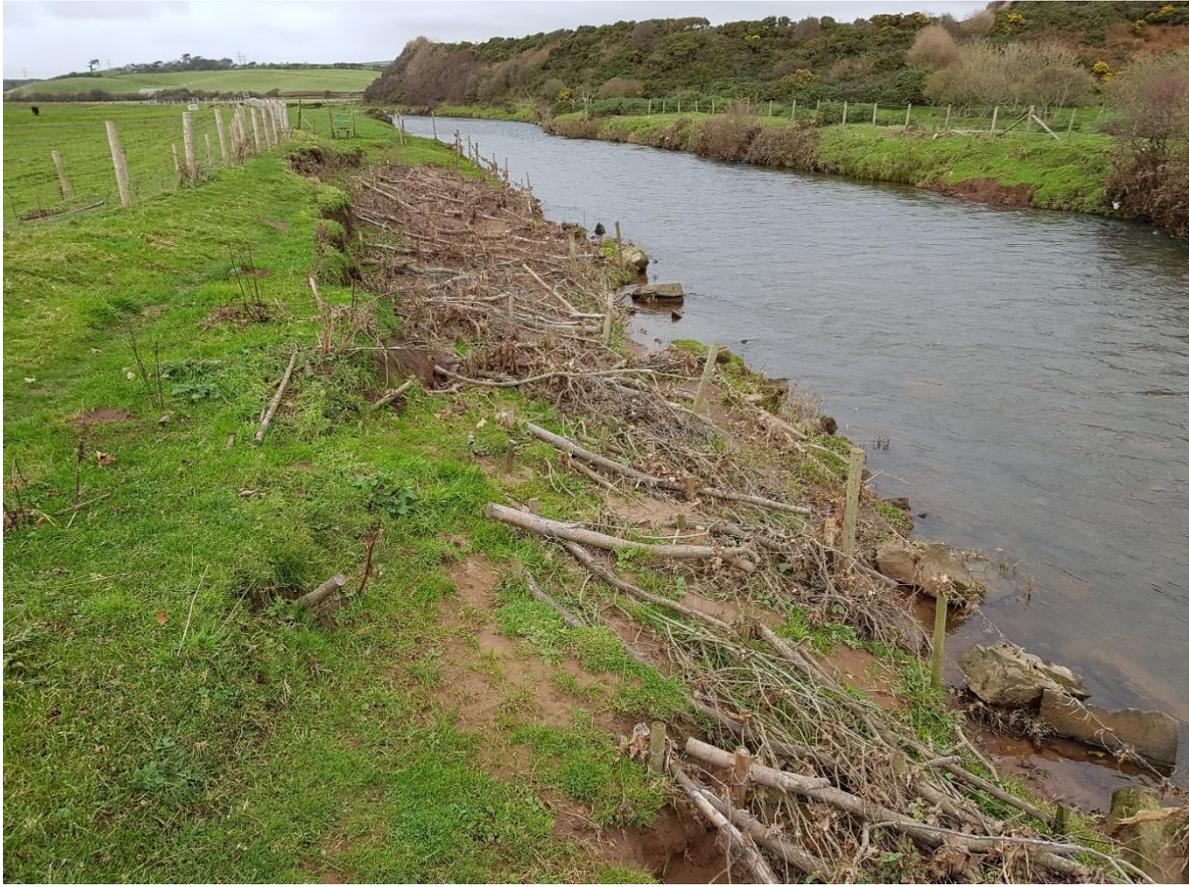
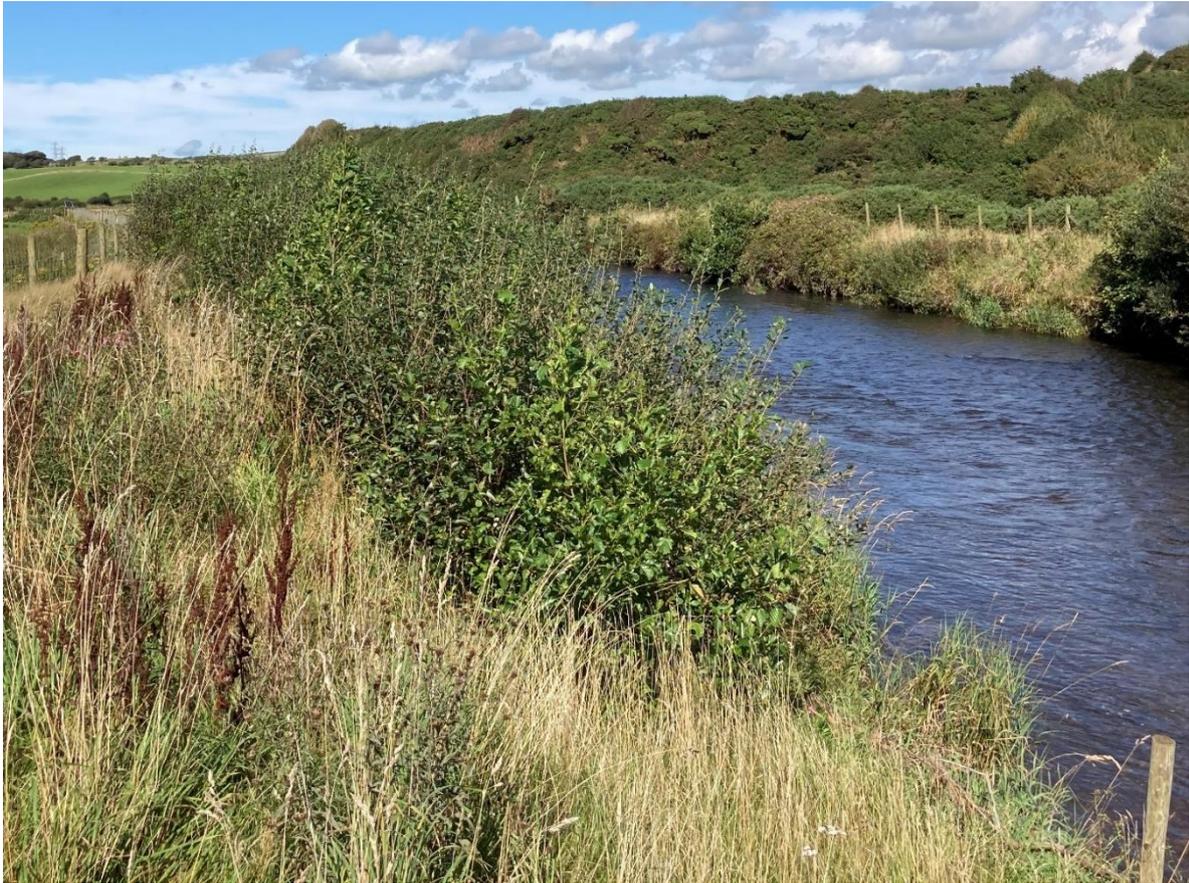
The following sequence shows how installation of a brush mattress not only halted major erosion but dissipated flow energy sufficiently to facilitate deposition of river sediment, infilling the erosion void in less than one winter. Several years down the line, the area is now a stand of willow and regenerated alder. The contribution fencing made should not be underestimated, as although the brush fixed the erosion scar, the fencing prevented livestock from perpetuating the erosion issue.

Brash bank protection entails installation of brushwood/branches to protect the bank face, prevent undercutting, and retain any slumped material long enough for vegetation to establish. Brash is installed with the butt ends upstream, working in a downstream direction, so the butt of each branch is fed amongst the branches upstream to create an interlocking matrix. Stakes are then driven into the matrix to secure it in place, with longer branches fastened over the top with low-tensile wire to preventing lifting in high flow. It can be beneficial to use live willow within the matrix as it will usually take root and grow in damp sediment. Grass seeding and tree planting can help too, but are often unnecessary. Green bank protection methods still require livestock exclusion to treat the issue as well as the symptoms.

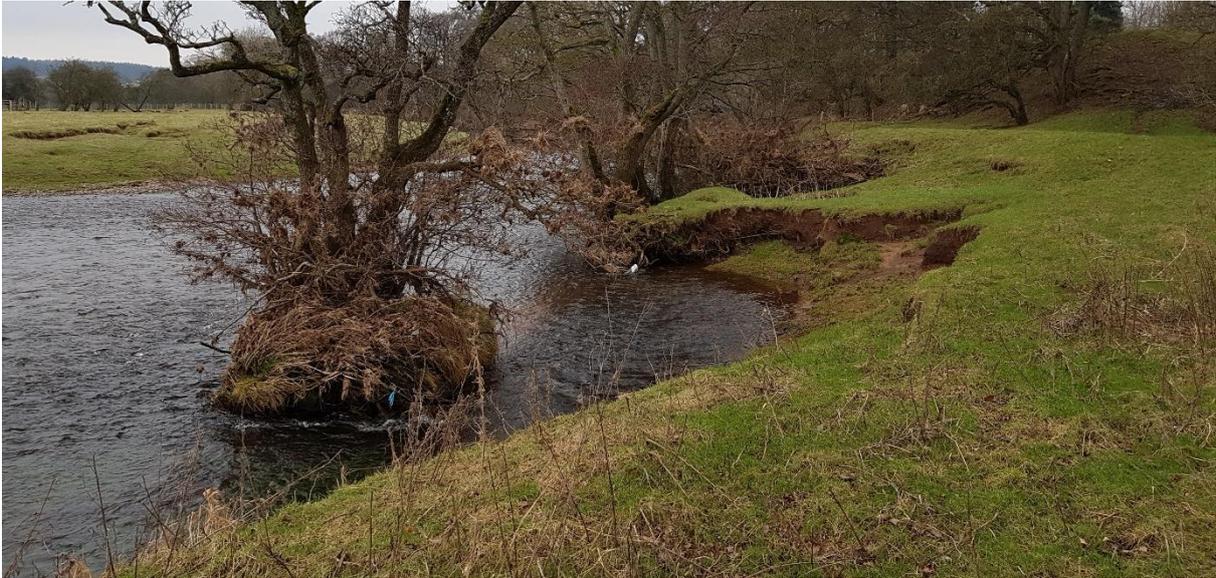
As grazing intensity increases, regeneration of other tree species is lost, often leaving only single lines of mature trees along a watercourse, with no smaller sapling regeneration to replace losses through old age or erosion – the latter often completely outflanking trees in a heavily grazed scenario. In the most extreme cases, trees are lost completely from the watercourse.

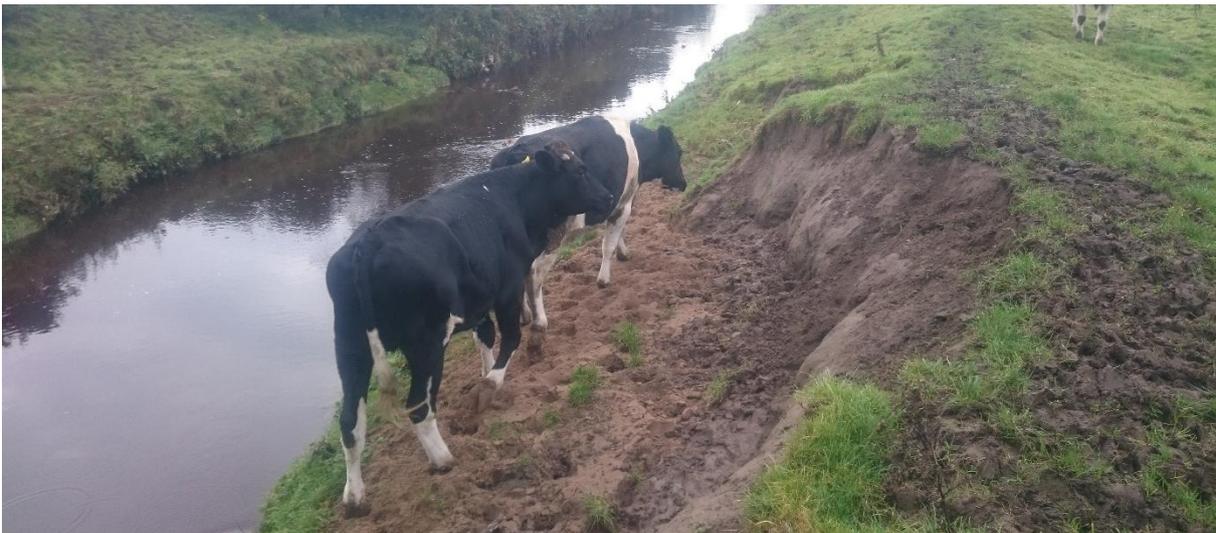
When grazing is by cattle, the negative impact upon foliage and root structure is generally less marked, as the grass is not so tightly cropped as by sheep, but they create greater physical damage to a bank, which can be significant, particularly so if they are grazed at high densities and/or alongside sheep.
