WILD TROUT TRUST

River Kennet

Northcroft Meadow Nature Reserve and Northcroft Recreation Ground

Newbury

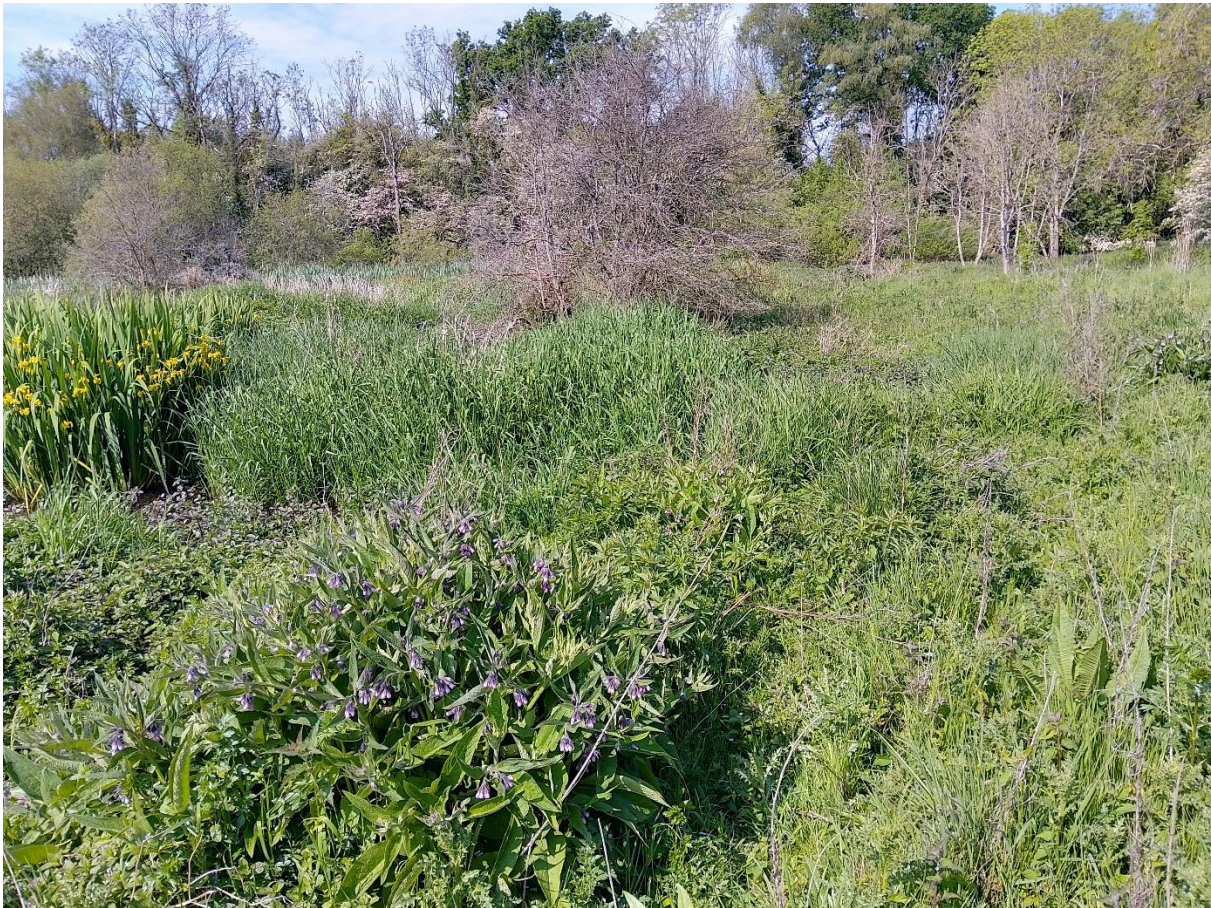
Photo 1 From elevated, wooded ground down through marginal emergent wetland plants – excellent habitat diversity....

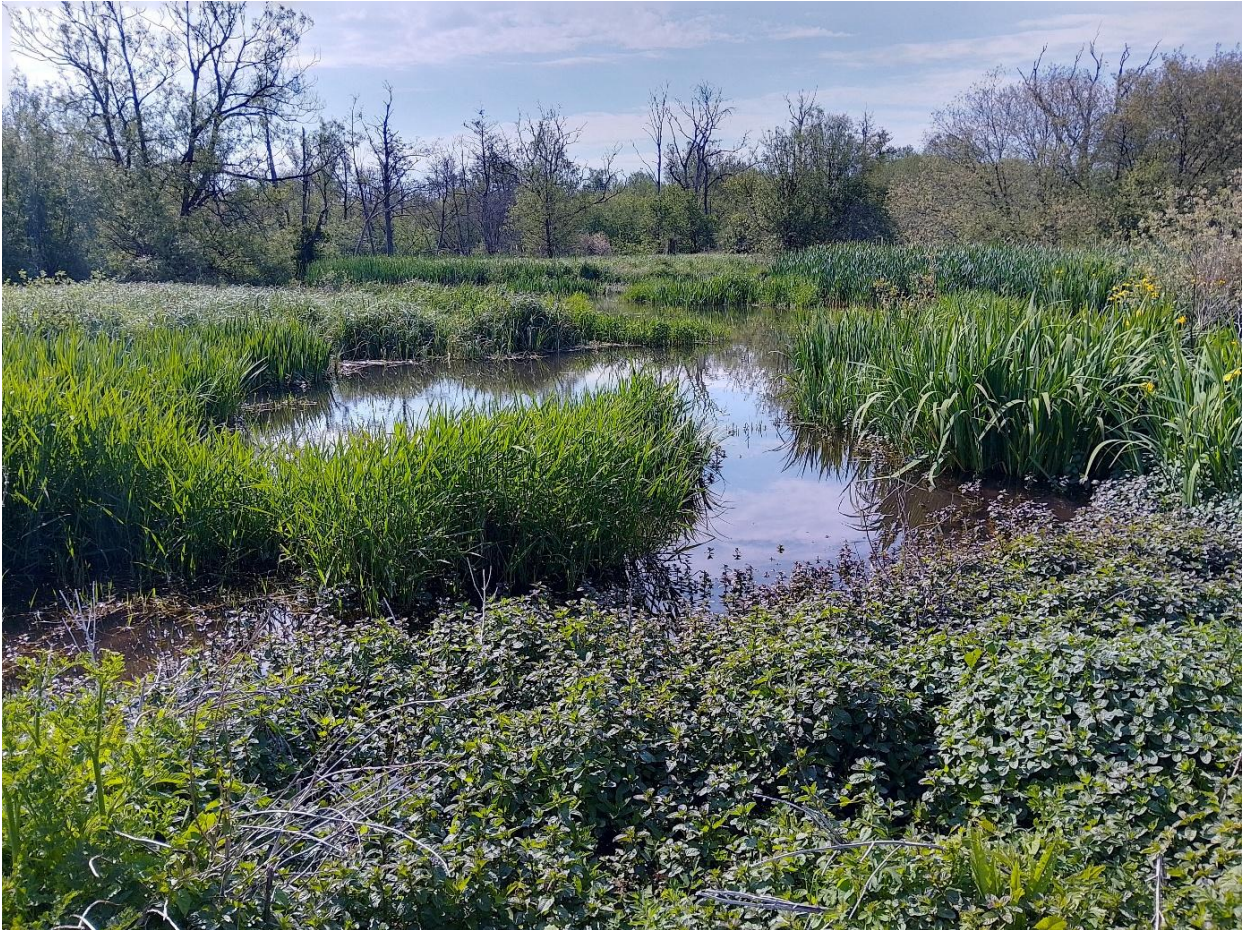
Photo 2Into diverse wetland habitats adjacent to the river; open water, submerged, emergent and floating plant structure for invertebrates, amphibians, fish and bird life to thrive in (51.403473, -1.3401572).

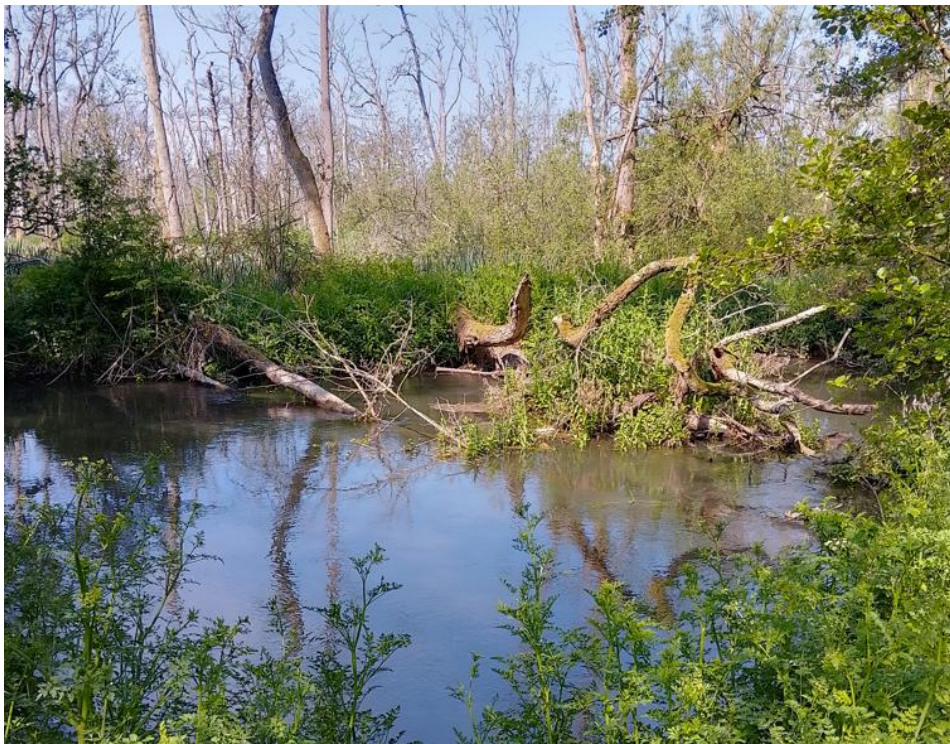
Photo 5 Some large woody material has lodged in the channel here, giving some beneficial structural habitat for fish and invertebrates in an otherwise featureless channel. Note the amount of standing dead wood on the far bank, supporting the observation of increasingly wet conditions in the surrounding floodplains.

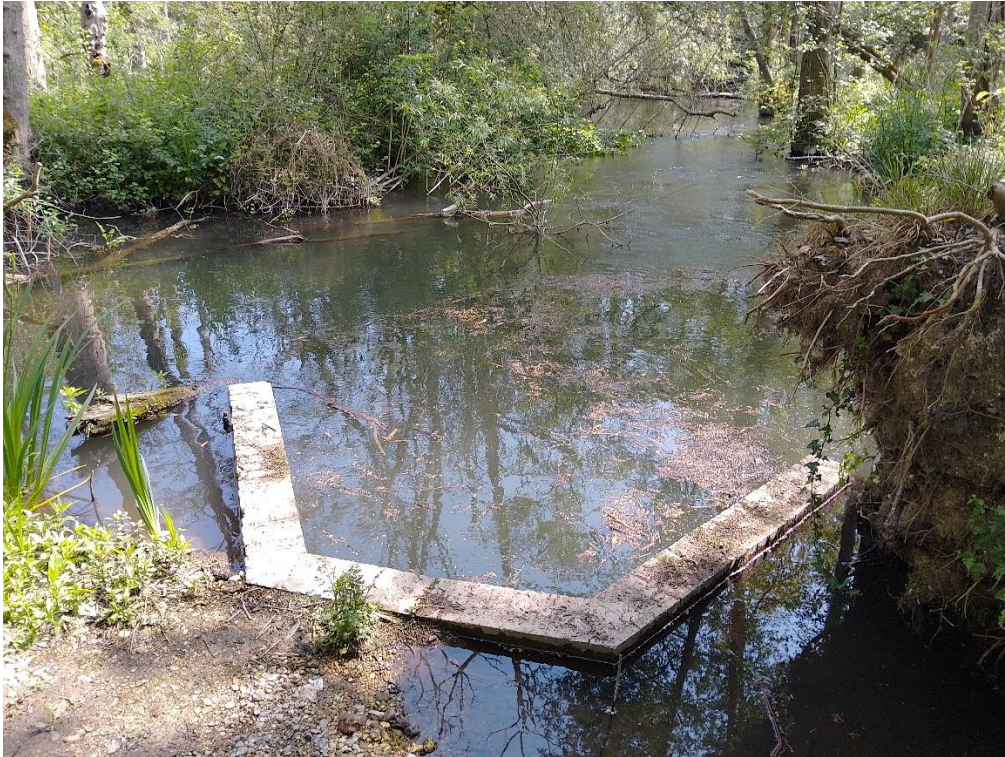
Photo 6 The channel running between the northern arm of the Kennet and the railway embankment, then on to the wetland (51.402883, -1.3421193). This is one possible location to formalise fish passage to allow fish to enter to and from the wetland at the upstream end.

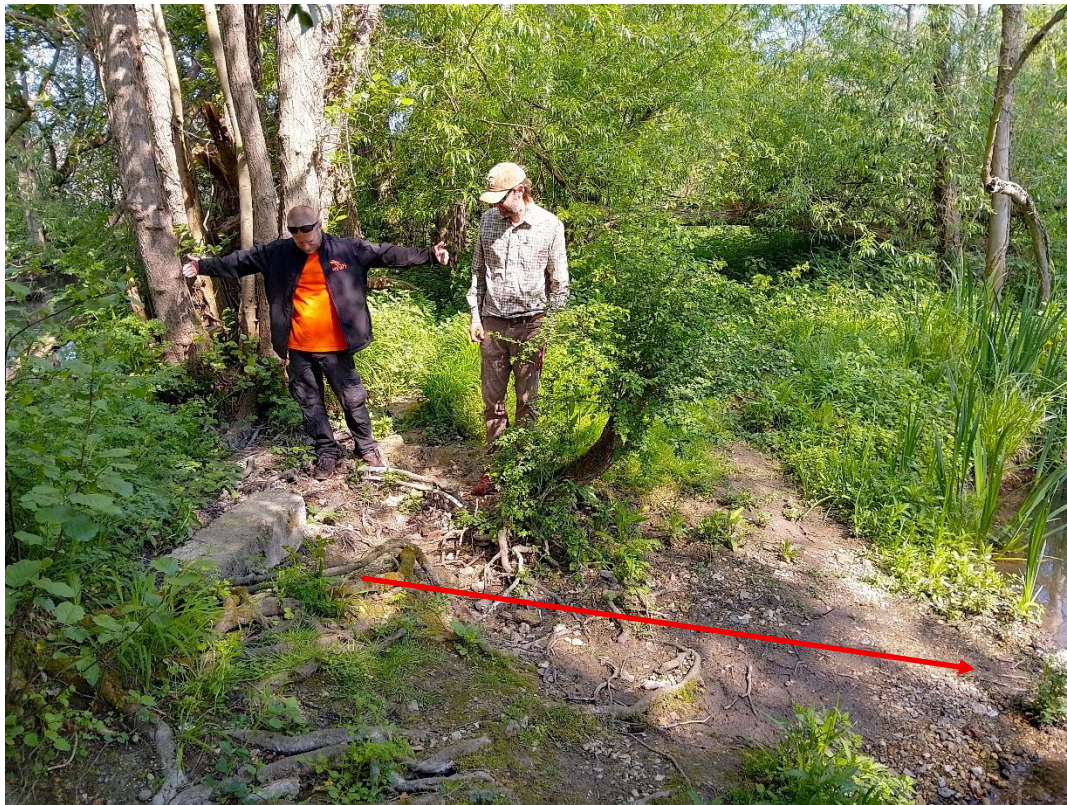
Photo 8 The site of a large breach that is reported to be flowing more regularly and with more water than in previous years. This picture was, however, taken during one of the driest springs on record (51.403242, -1.3421142).

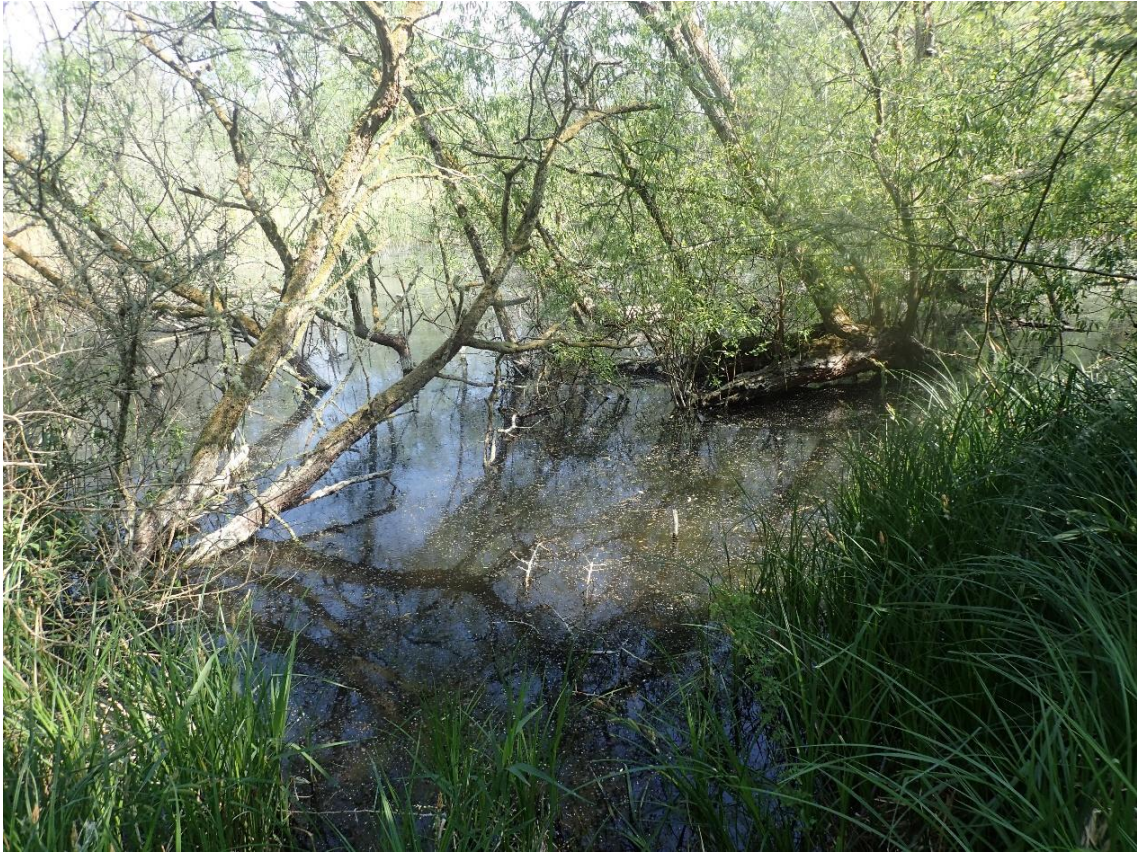
Photo 9 The additional wetland area between the Kennet and the Northcroft Meadows wetland pools.

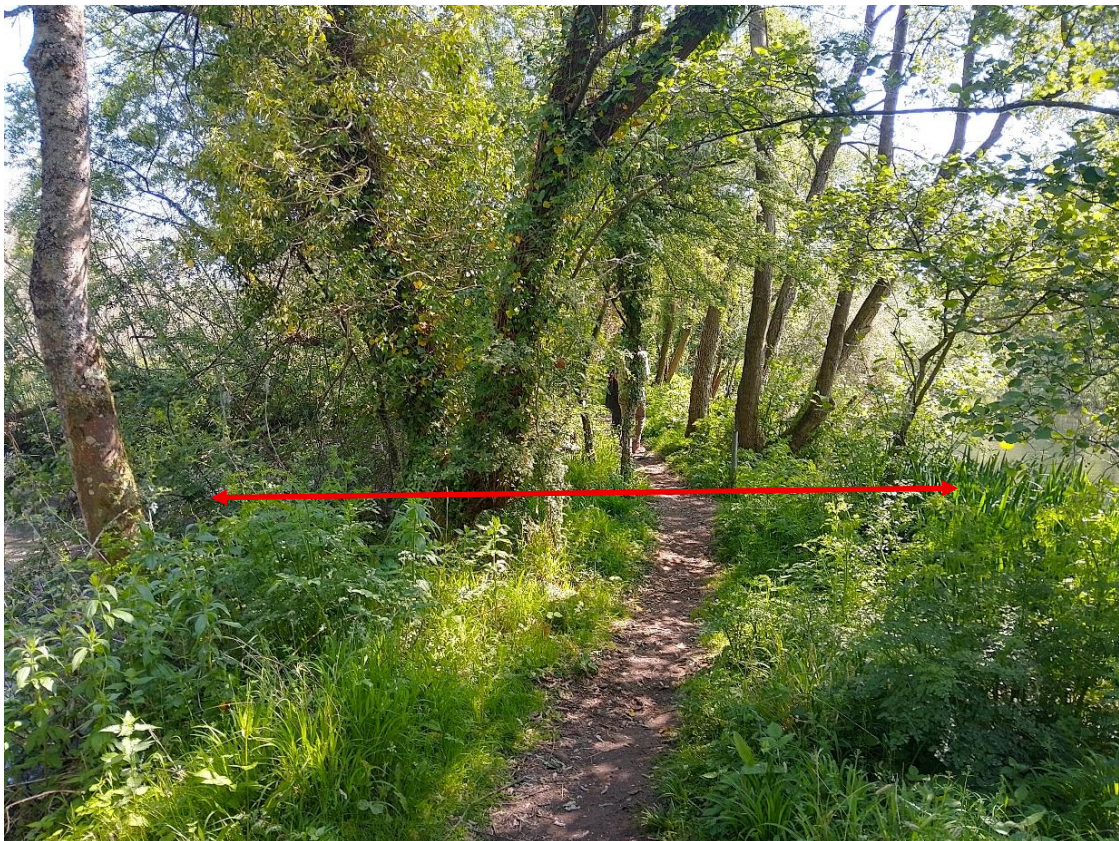
Photo 10 Highlights the hydrological and ecological connectivity between the river and the wetland system at 51.401783, -1.3388375 (wetland to the left, river to the right in the picture). Water levels are very similar between the two and will

readily connect to allow exchanges of fish, invertebrates and plant material when the river over-tops the bank during floods.

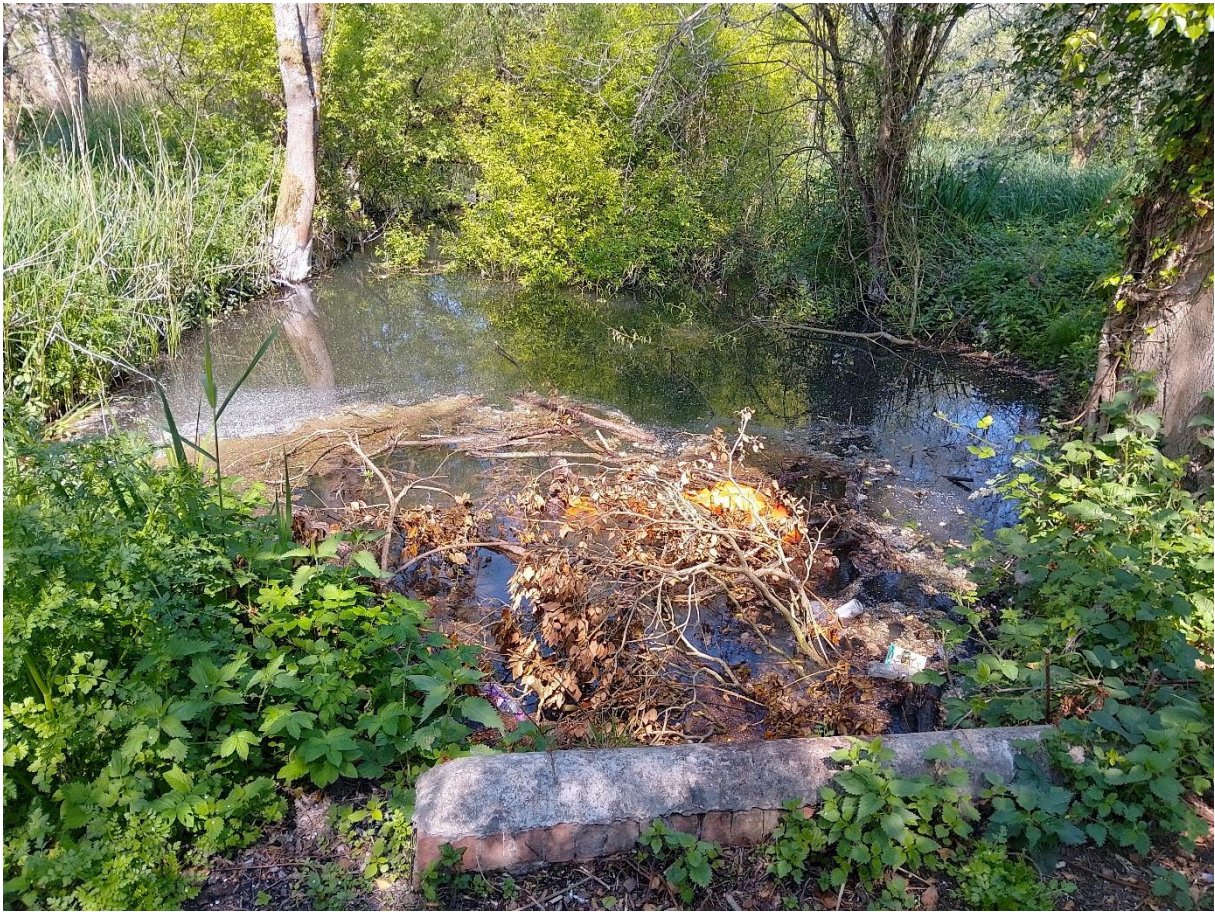
Following the Kennet downstream, past the confluence where it becomes a single channel, and toward where it heads into the K&A Canal, the river channel remains the same: a featureless and modified 'U' shaped channel, but with plenty of beneficial over hanging tree cover and inputs of trailing branches and woody material (Photo 10). From a fish perspective, the 'shaggy' effect from the inputs of wood structure will provide cover from predators for all species and encourage residency from adult chub and wild brown trout. While difficult to restore physical channel features (i.e. diversity in riverbed levels) due to size and situation, developing a plan to add and fix woody material to diversify flow could be considered here. Woody material and leaf litter also provide excellent resource for aquatic invertebrates. Extensive additional wetland pools are present immediately adjacent to the LHB of the Kennet here, and between the Kennet and the drainage channel that runs between the wetlands (Photo 9). A high level of connectivity between all waterbodies present is evident here, allowing flood waters to enter the wetland as they come down the river, assisting movement of species between the wetland and river. Before exiting this wooded section and heading into the amenity grassland and playing field where the Kennet meets the canal, the end of the drainage channel that runs from the northern arm of the Kennet and between the wetlands was viewed. The flow in this channel is controlled by a brick clad structure, impounding the movement of water, assuming there is some sort of sluice system underneath it or it is blocked with organic material (Photo 11).

Photo 11 The structure where the drainage channel that comes through the northern arm of the Kennet, and then runs between the Kennet and the wetlands, is controlled at 51.402048 , -1.3376749 (see the location of X in Figure 2). This impounds water and helps keep the levels in the wetlands. Downstream of this structure, it then becomes the Northcroft Ditch on the maps, pushed up between the wetlands and playing field, to re-enter the Old Kennet channel on the other side of the greenspace (discussed below). The structure pictured here prevents fish passage from the Northcroft Ditch into the wetlands currently, something NEWT are looking to help resolve. The organisation responsible for the structure will need to be identified and engaged with, to ensure all stakeholders agree with proposed actions (e.g. WBC, Thames Water) once the structure has been investigated.

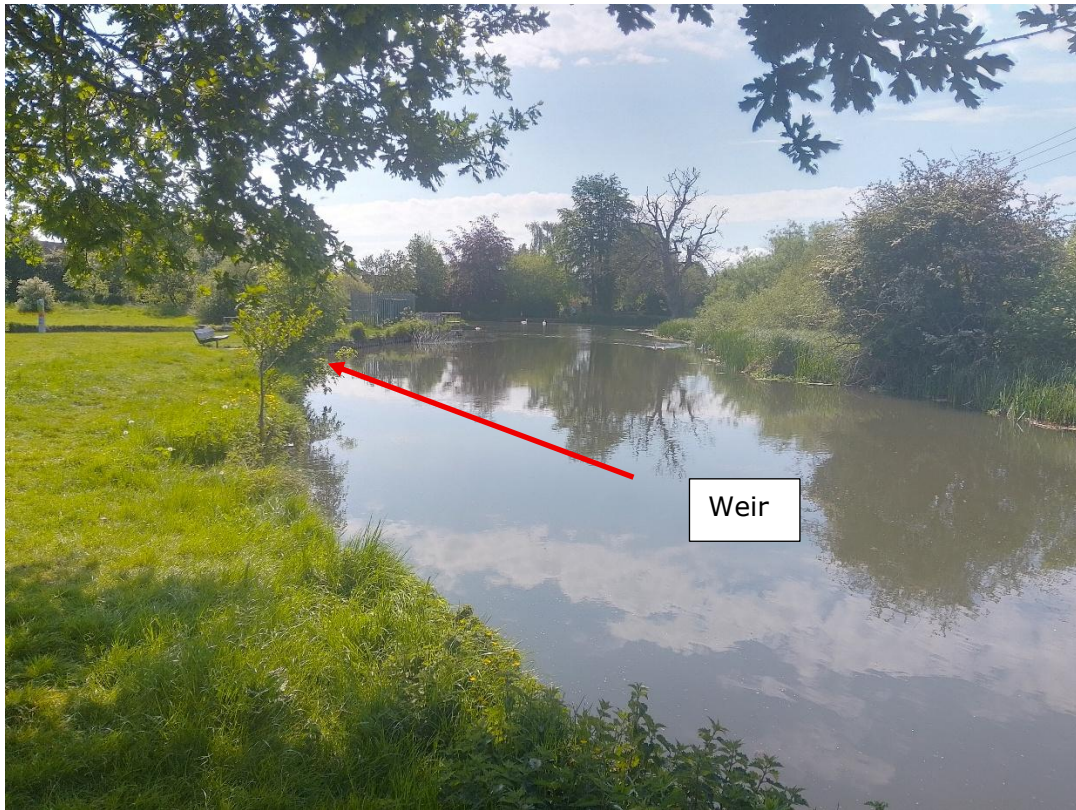
Photo 12 The Kennet as it enters the K&A by the swans in the distance (51.401006, -1.3367829). The channel of the Old Kennet, after it exits the weir, can be seen on the middle left of the picture.

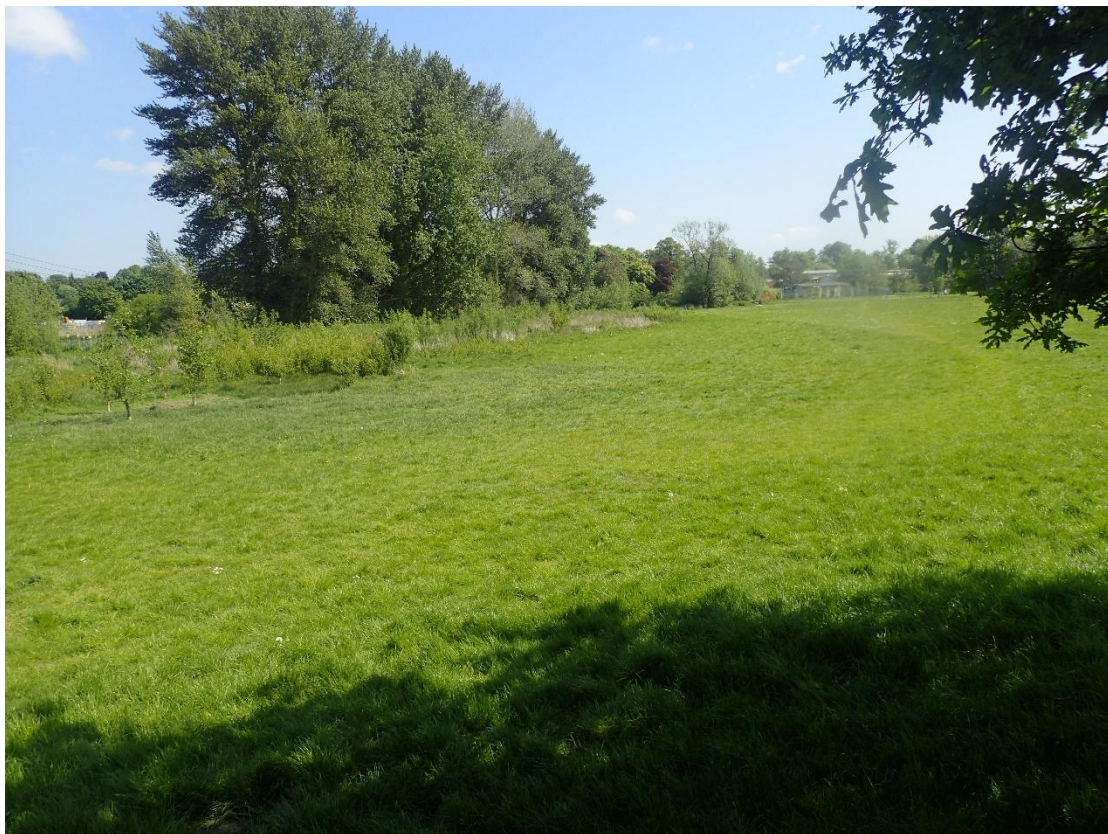
Photo 13 The Northcroft Ditch runs along the line of alder and willow, then makes a right turn back to the Old Kennet, before the buildings in the distance.

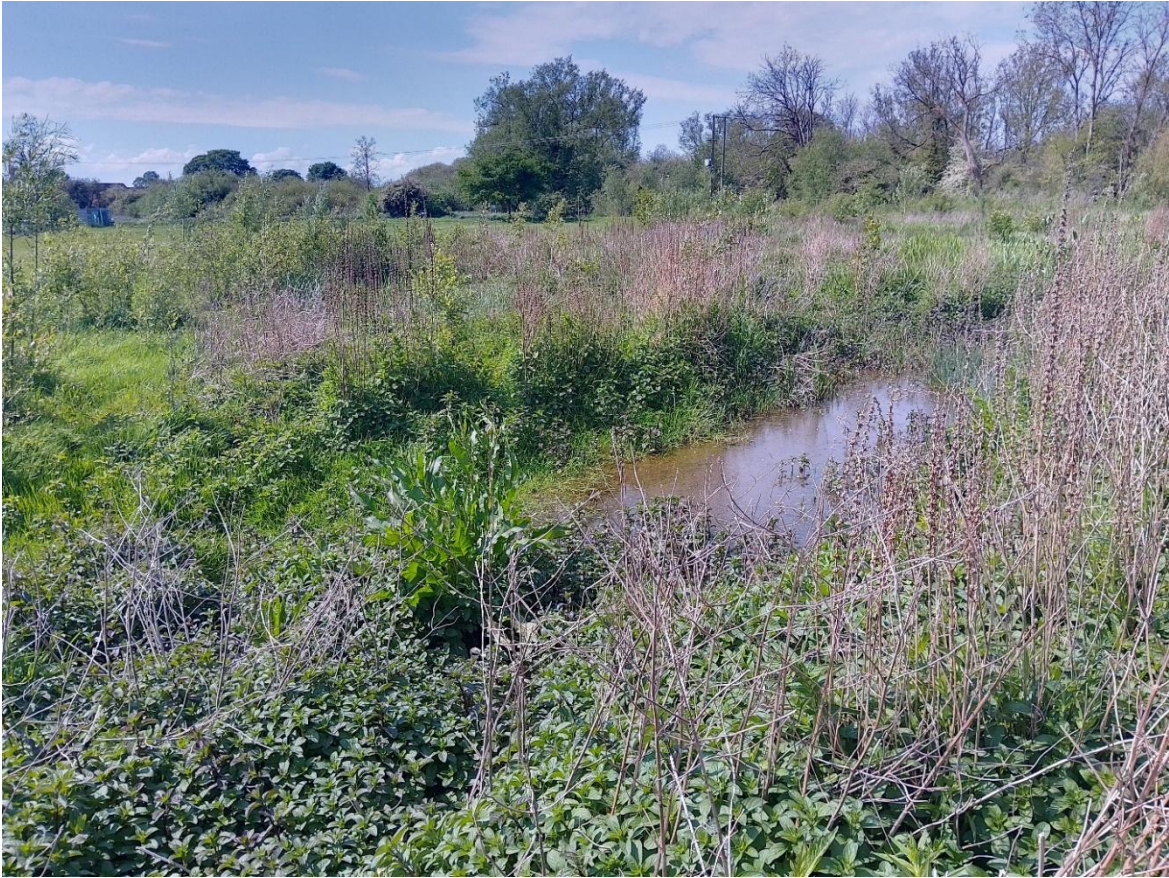
Photo 14 Wet ground below the level of the Northcroft Ditch, in the paleochannel.

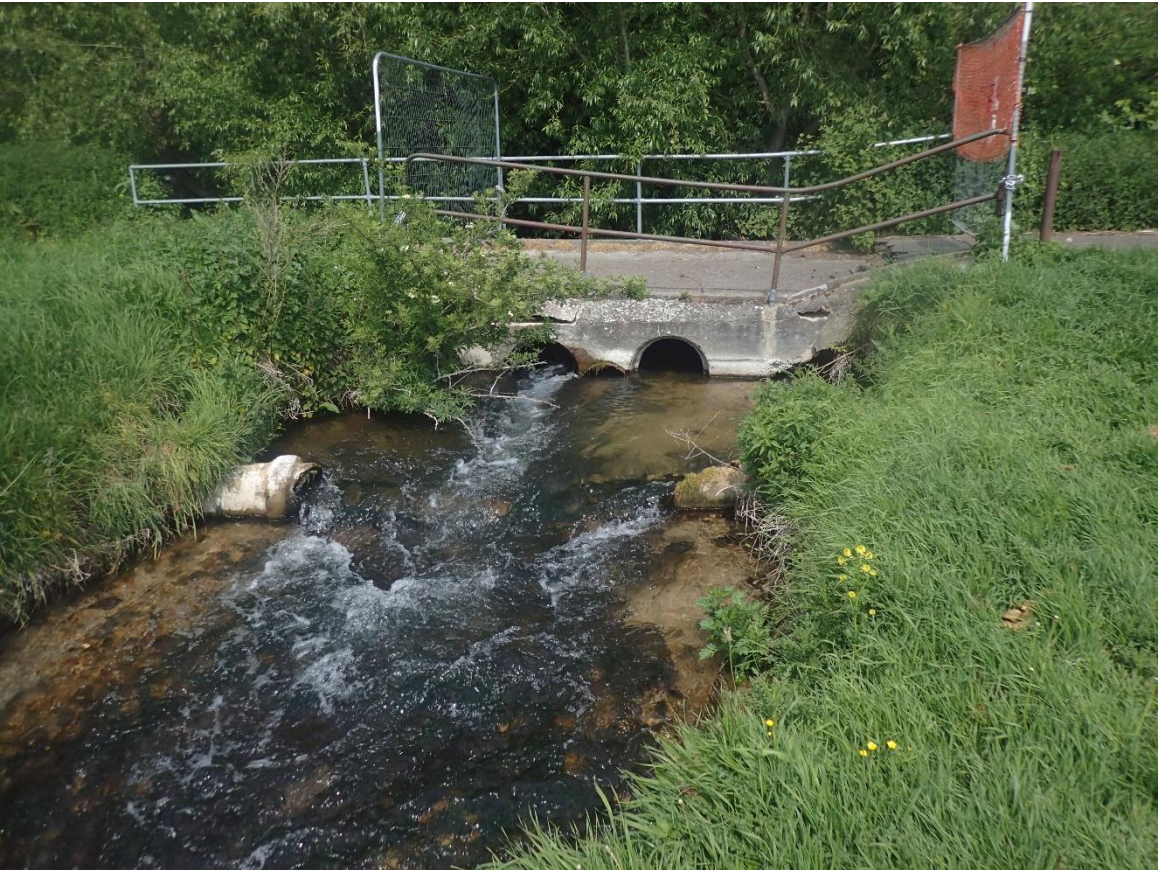
Photo 15 The collapsed culverted bridge as the watercourse turns back toward the old Kennet. This becomes a fast, high gradient section of watercourse down to the Kennet confluence, with space to regrade banks and re-meander the stream.

- Plan and develop a restoration project for the Northcroft Ditch and central drainage channel, to create a channel with high quality habitat and connectivity for fish, connected to the floodplain.

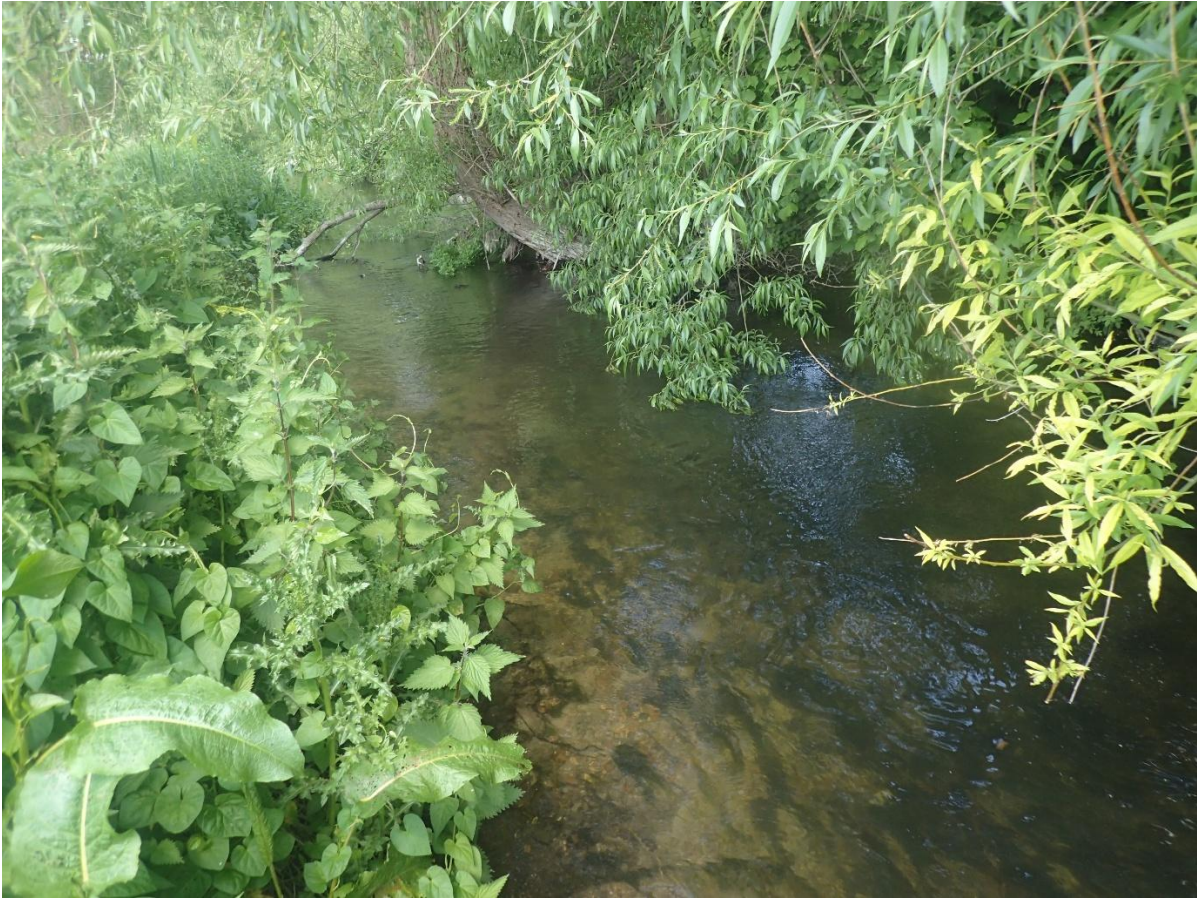
NEWT report the channel is now carrying far more water than in the previous years, creating both a physically larger channel and an increase in stream energy. Where this stream takes a right-hand bend back to the old Kennet, the gradient and volume of water creates a very energetic section of watercourse. This has increased erosion around an access bridge that used to cross the stream and contributed to its collapse (Photo 15) at 51.402696, -1.3344813. Further back up in the perched section of channel, the flow energy is still positive and has driven some areas of clean gravel and larger bed material. With this, coupled with bankside vegetation and overhanging trees creating favourable habitat features, wild trout were seen here (Photo 16).

Photo 16 Natural habitats forming in the perched channel of the Northcroft Ditch, along the tree line. Wild trout were seen here, due to the cover provided by the trees, woody material and emergent plant life helping to drive good flow velocity. Spawning may be possible in this side stream due to the development of clean, coarse riverbed material (gravels and pebbles). Small sections where trout can successfully spawn and recruit juveniles to the population may disproportionately support the trout population in a more widely degraded river catchment. Restoring the paleochannel and developing the section of stream downstream of the bridge (and allowing space for marginal habitat to develop) could therefore reinstate an important section of watercourse for all gravel spawning fish in the immediate catchment area.

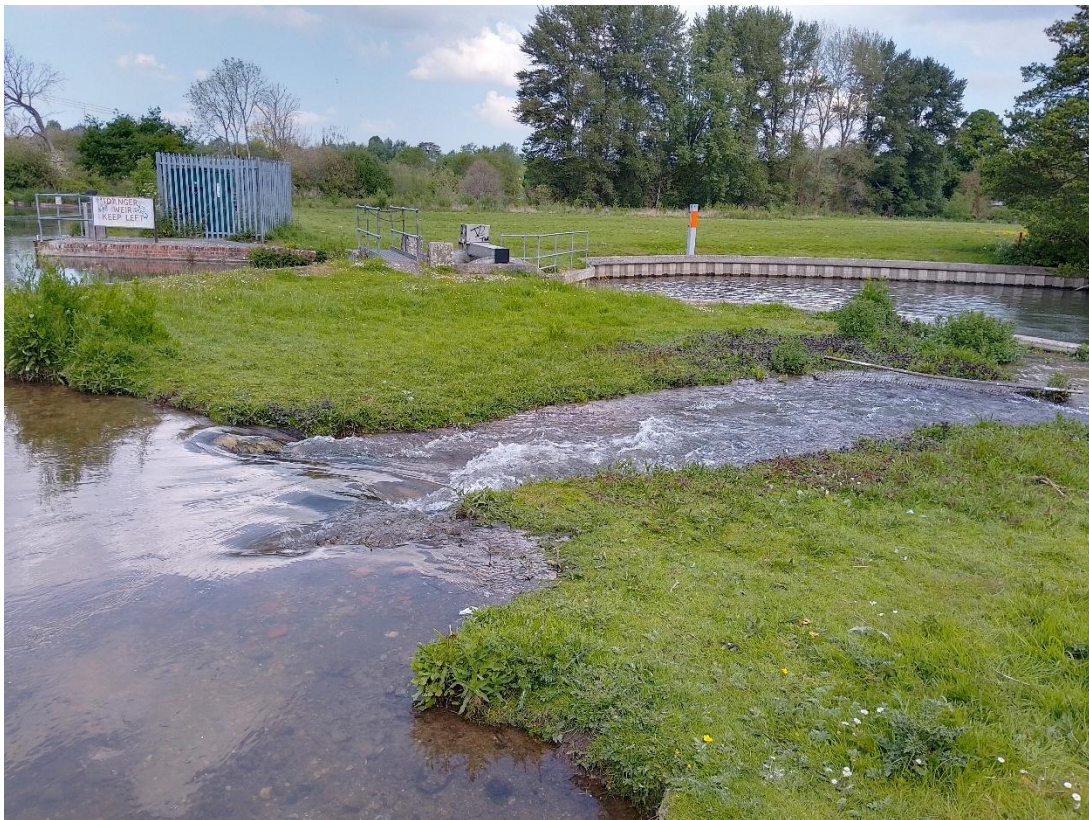
Photo 18 The breach takes a significant volume of water and is increasing in size. This either needs repairing to protect against bank failure near the canal, or could be reviewed for installing a fish passage solution.

- Review the breach adjacent to the weir at the top of the Old Kennet channel. This either needs resolving or formalising into a fish pass to further improve alternative fish passage around the weir structure.

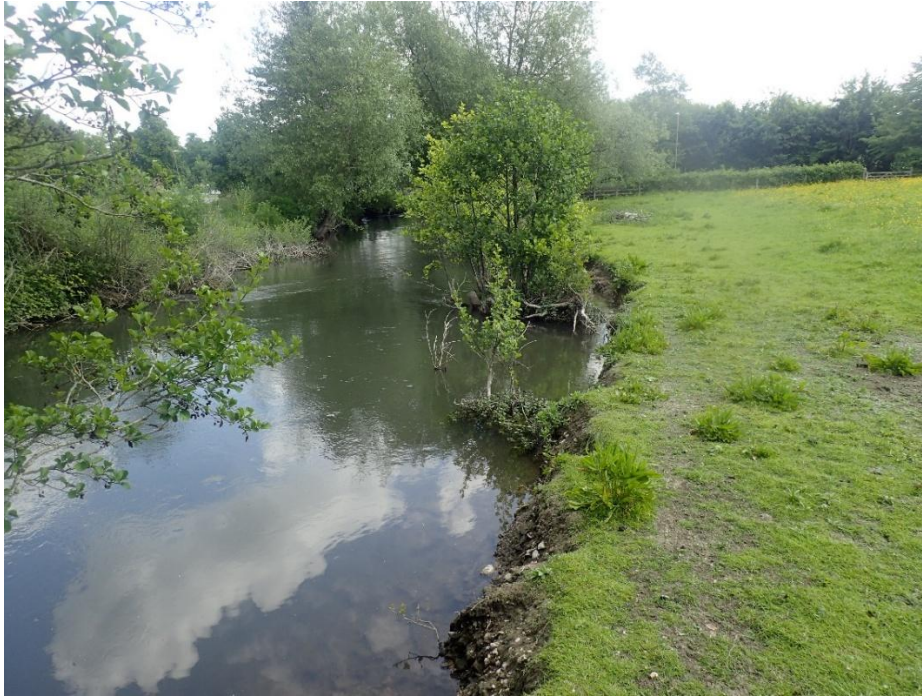
Photo 20 The area of ground between the Old Kennet and the K&A Canal is grazed by cows. The right-hand bank of the river needs fencing to prevent the suppression of vegetation, damage and excessive erosion to the banks caused by the grazing – seen here around 51.401803, -1.3351253. This will allow good quality riparian habitat to regenerate and help the river.

- Protect the riverbank with fencing on the field where cows graze and develop a healthy riparian buffer strip 5m-10m width). Access to water for stock can be provided through a formal drinking point in any fencing, or via solar powered pumps into troughs.

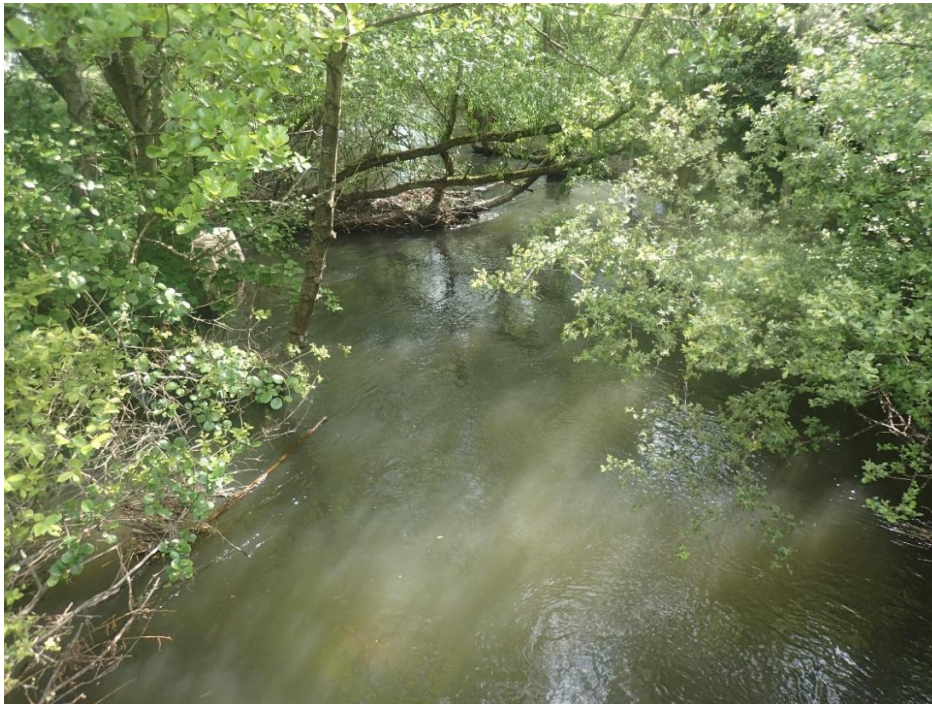
Photo 21 At the downstream of the section of Old Kennet inspected (51.401937, -1.3333229), marginal and riparian tree growth had developed, encroaching on the channel and narrowing it down, maintaining energised flows and meandering flow between the woody material (which drives changes in bed levels). It also provides superb physical habitat structure for aquatic biodiversity.

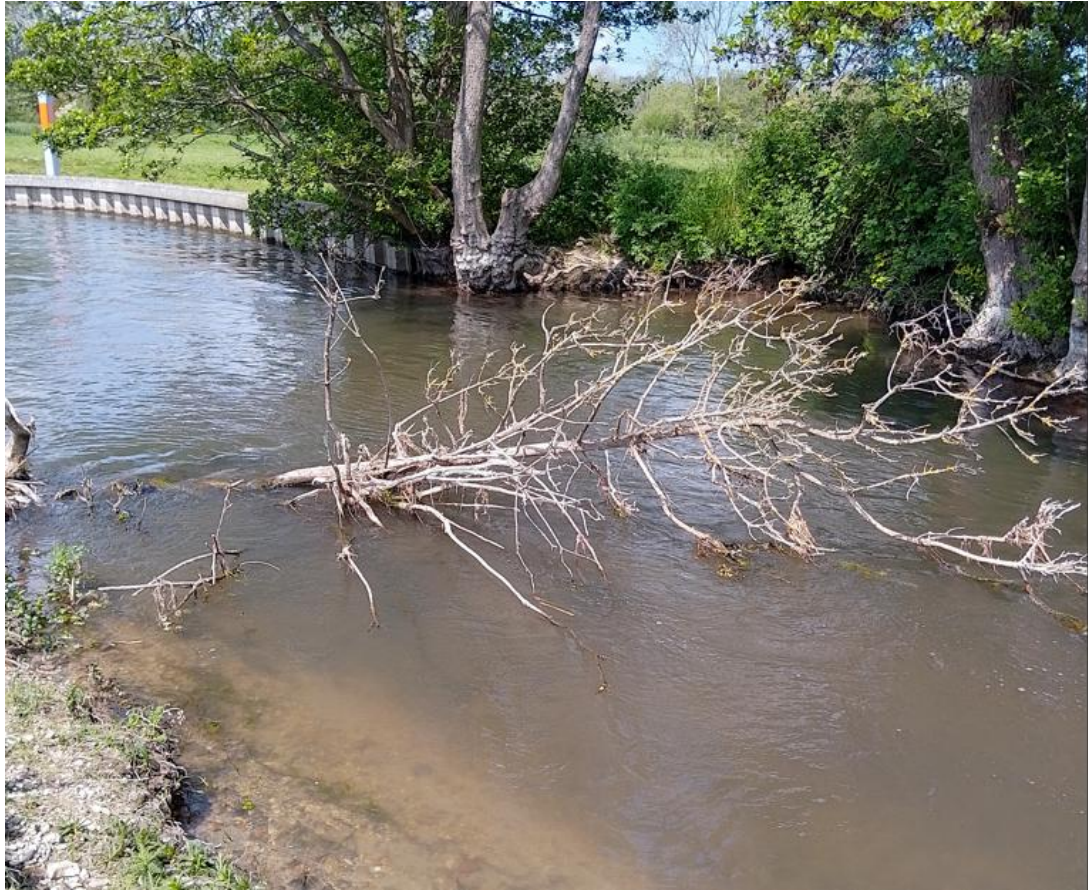
Photo 22 Useful woody material left in the channel, driving dynamic flows, providing cover for fish and habitat for invertebrates (51.401431, -1.3359611). Considering introducing more substantial wood from the bankside trees in a targeted way will allow winter floods to scour out the riverbed, deposit material downstream to create some shallows and kick-start some dynamic river processes through this section.

- Consider adding further large woody material to the Old Kennet channel to drive flow diversity and development of diverse channel forms, which all aquatic species in the river will benefit from.
