Northend Stream – Sussex Ouse

Advisory Visit December 2025

By A. Thomas, athomas@wildtrout.org

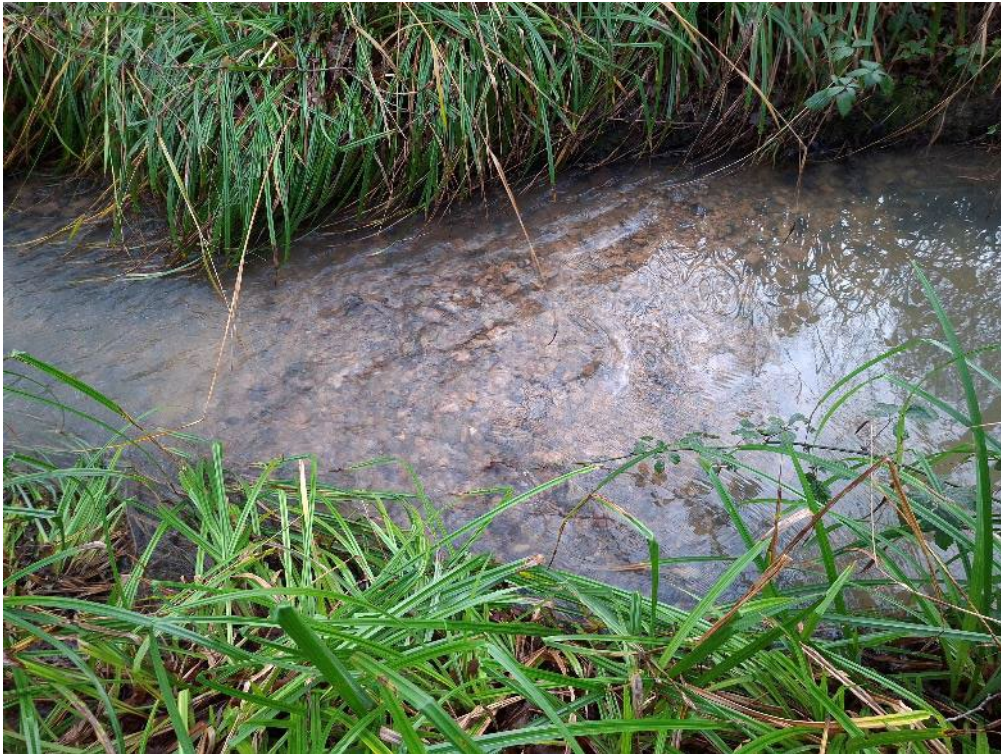
Opportunities for trout spawning are available via occasional outcrops of eroding flint and chert gravels (photo 1), providing opportunities for productive spawning for any fish that can penetrate up, especially into the headwater reaches adjacent to Warningore Farm. Flow and hence readily available access for migrating fish will vary both seasonally and annually, with the perennial source of the stream likely to migrate up and down the headwater valley, depending on autumn/winter rainfall and the critically important groundwater recharge.

Photo 1. A nest of trout eggs (redd) located right near the very top end of the Northend Stream at Warningore. Evidence that sea trout can currently access virtually all of the catchment.

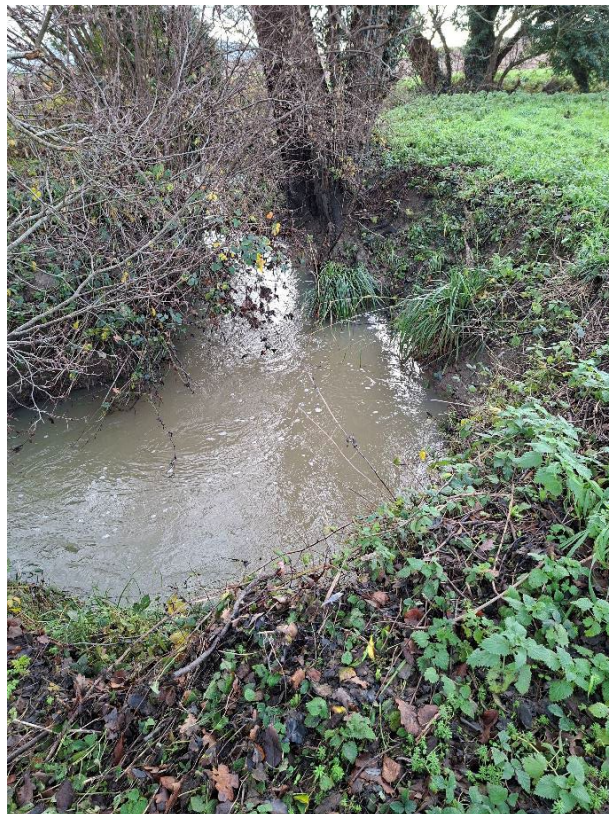
evident providing opportunities for trout of all life stages. Mature bank-top trees offer additional cover via complex submerged root systems (photo 5).

Photo 5. A good example of high-quality stream habitat with complex roots systems provided by the riparian tree and natural bend and pool. Great habitat for adult brown migration trout to hold up and feed, or a resting zone for a large sea trout on spawning migration.

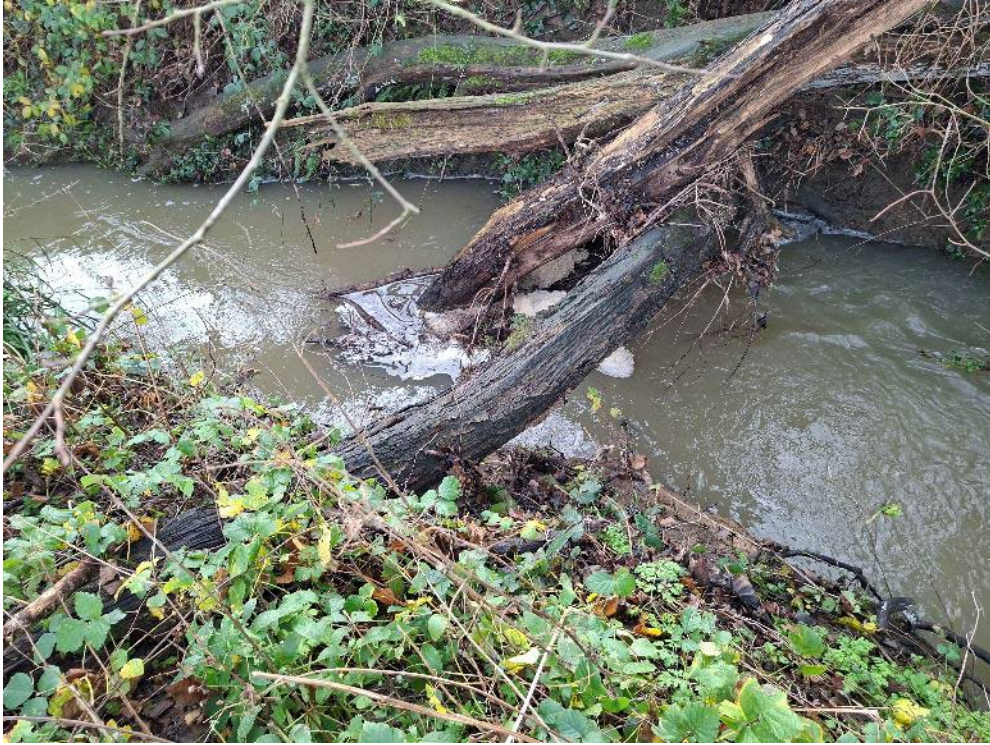
Naturally fallen woody material (photo 6) was also present within the stream channel. This valuable material also provides opportunities for promoting essential bed and bank-toe scour, helping to clean and free-up fresh gravels for spawning, as well as providing cover and a critically important food source for aquatic invertebrates, thus helping to build the natural food-web.

Photo 6. Large chunks of fallen woody material help to drive valuable natural process and should always be retained when possible. Move it, don't remove it is the key message if it causes a full-channel width debris dam to form. Only redistribute the wood if the dam becomes completely blocked with fine brush and leaves and the upstream bed and water levels begin to rise.

When woody debris dams naturally form, they can occasionally become occluded with fine brash and leaf material and subsequently upstream water levels will rise. This is when some intervention is recommended. However, the woody material must not be completely removed from the stream but moved or repositioned to allow free flow and lower upstream levels.

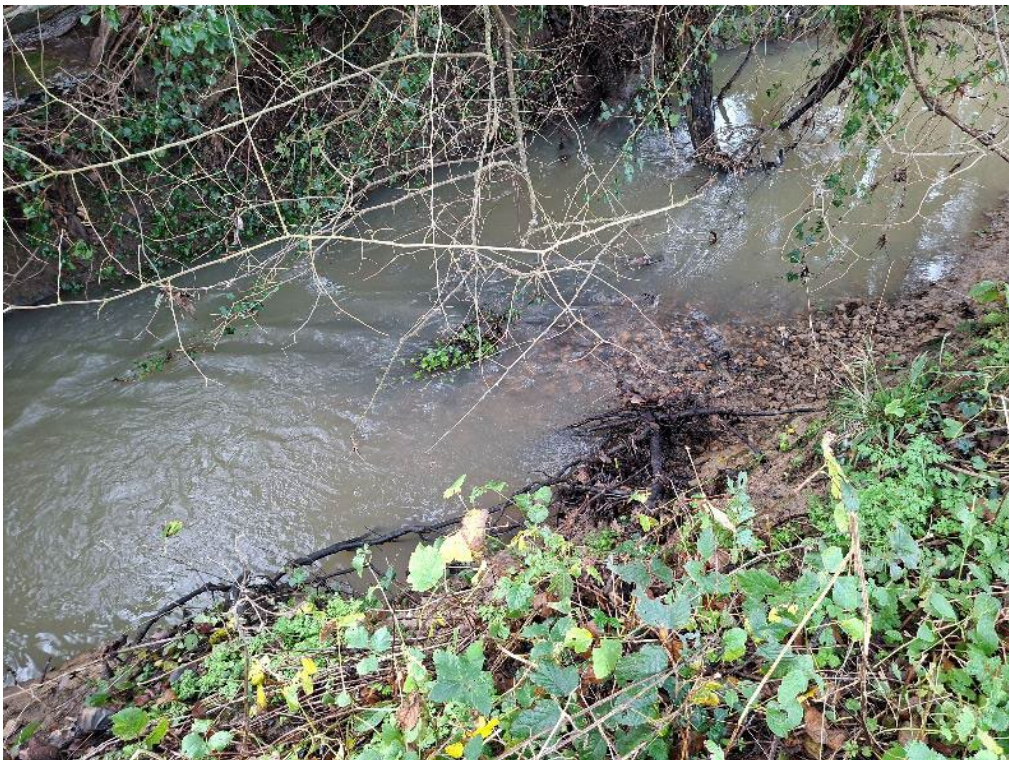
In addition to the examples of large woody material, there were also good examples of marginal zones benefiting from trailing riparian vegetation (photo 7 & 8). This is particularly valuable winter cover, especially when it coincides with small outcrops of bed gravels. The combination of a spawning site adjacent to a well-covered shallow margin provides emerging trout fry with essential and extremely valuable cover from predators.

Photo 7. A great example of high-quality trout habitat, with a seam of clean bed gravels adjacent to a light matrix of trailing riparian brushwood cover.

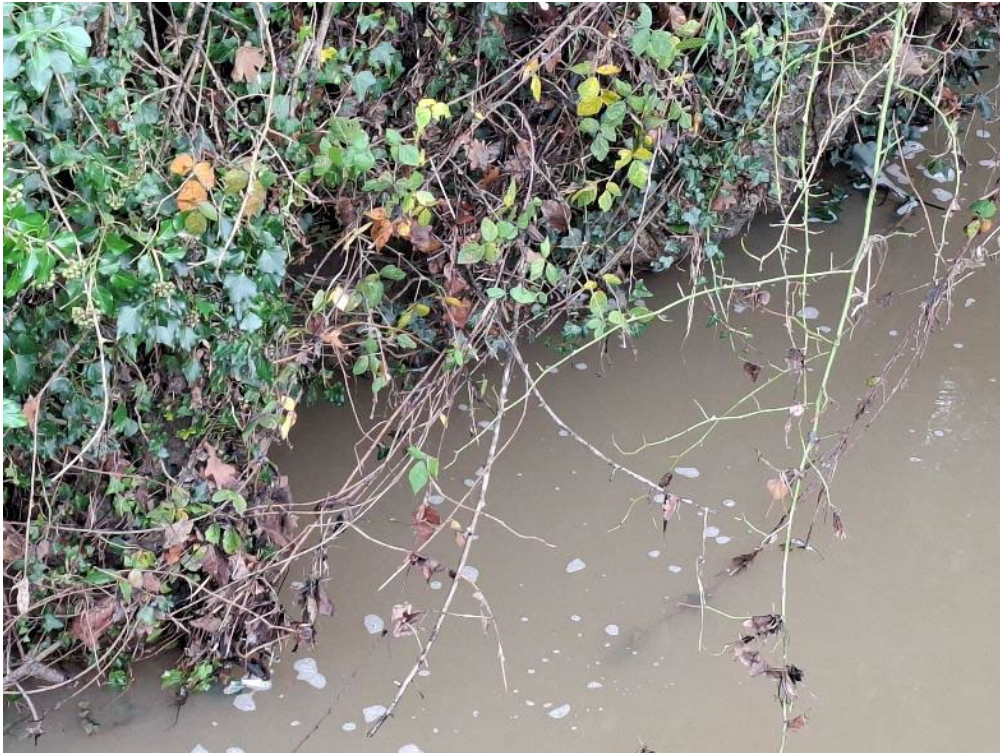
Photo 8. Marginal cover provided by terrestrial plants, including bramble and ivy should never be cleaned out of the channel as it provides valuable winter cover for fish of all life stages.

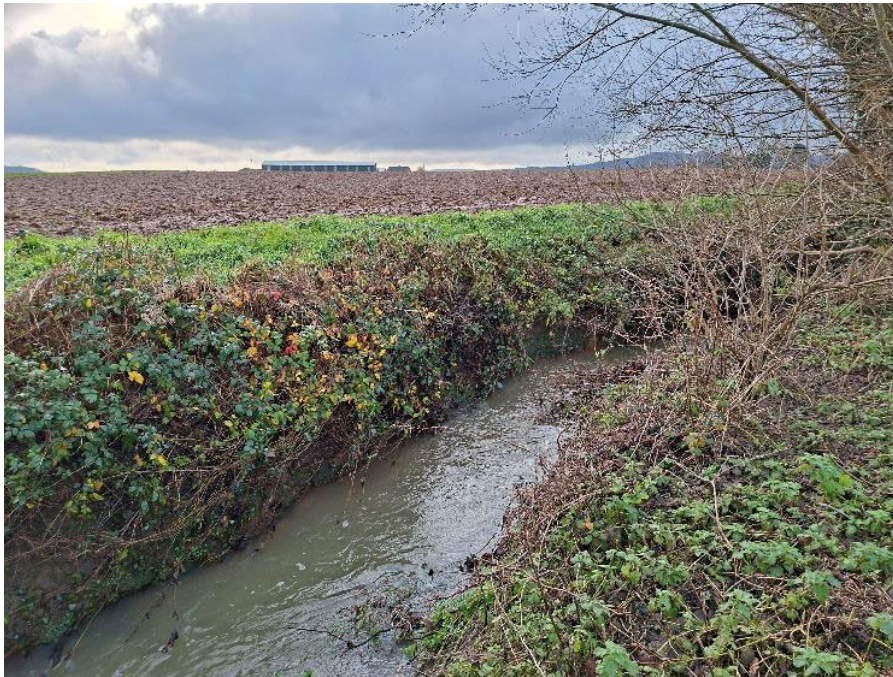
In several areas, but particularly in the reach just downstream of Cooksbridge, the stream is under pressure from various riparian farming practises, ranging from cattle poaching pressures on unfenced stream banks adjacent to parcels of permanent pasture, through to intensively worked arable fields (photo 9). Uncultivated buffer zones between the field margins and the bank top were very narrow and lacked the complex vegetation and root systems necessary to fully protect the river from pollution by nutrient rich, fine sediment-laden run-off. The sloping topography of some of the adjacent meadows potentially increases the risk of large quantities of nutrient rich soil being picked up during intensive rain-fall event and deposited into the stream.

Photo 9. A large sloping arable meadow under recent cultivation with only a tiny buffer zone that is too narrow to potentially intercept over-land run-off.

The Northend Stream has been very heavily modified, but despite long sections having been dredged and straightened, it still supports some extremely valuable spawning and nursery habitat for trout and other important fish species of conservation concern. The reach downstream of Cooksbridge needs much wider, planted buffer zones to mitigate for agricultural diffuse pollution pressures. Areas that are currently grazed require stock fencing to eliminate bank poaching and again would benefit from thick, complex buffer zones.

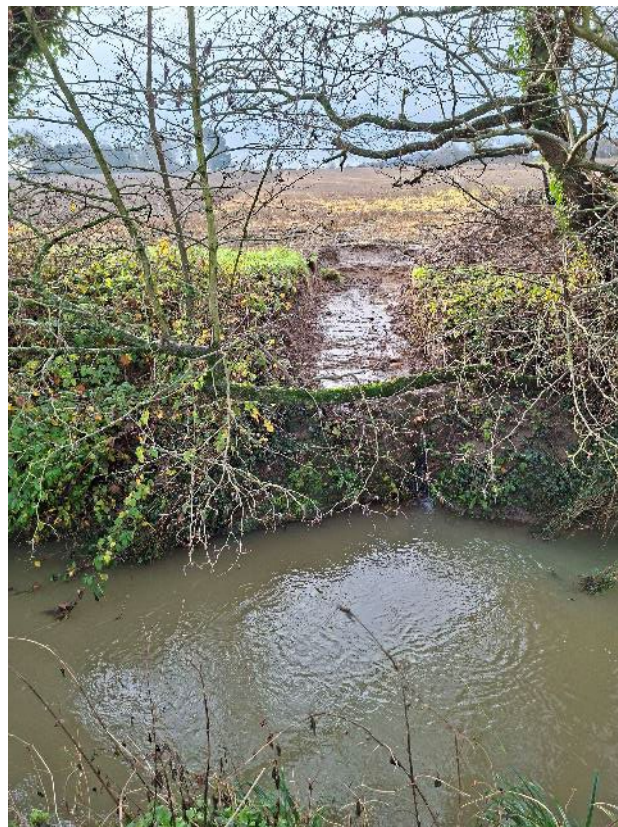
In one area (photo 10), it looks as though a drainage channel has been deliberately cut into the top of the bankside buffer to assist field drainage. This is very poor land care and soil conservation practice. The topography of this large arable field, and possibly even the direction of tillage, coupled with thin and sometimes non-existent buffer zones means that it's likely to be a particularly challenging reach for viable trout production. Even the farm track and bridge provide a pathway for diffuse pollution (photo 11) threatening the health of the stream below. All of these issues can be easily mitigated via the installation of wide (20m plus) planted buffer zones.

Photo 10. Sloping arable field with buffer zone drainage slot. A direct pathway for nutrient rich sediment.

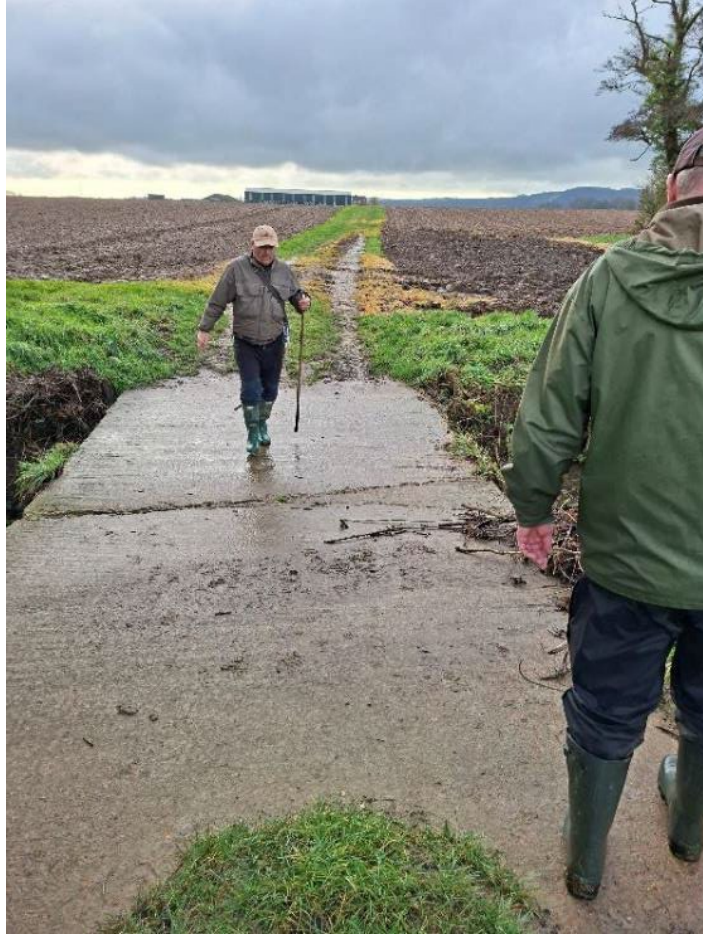
Photo 11. If arable production is to continue here then the buffer zones should ideally be 20 to 30m wide and planted with trees to help intercept sediment (and nutrient) rich run-off.

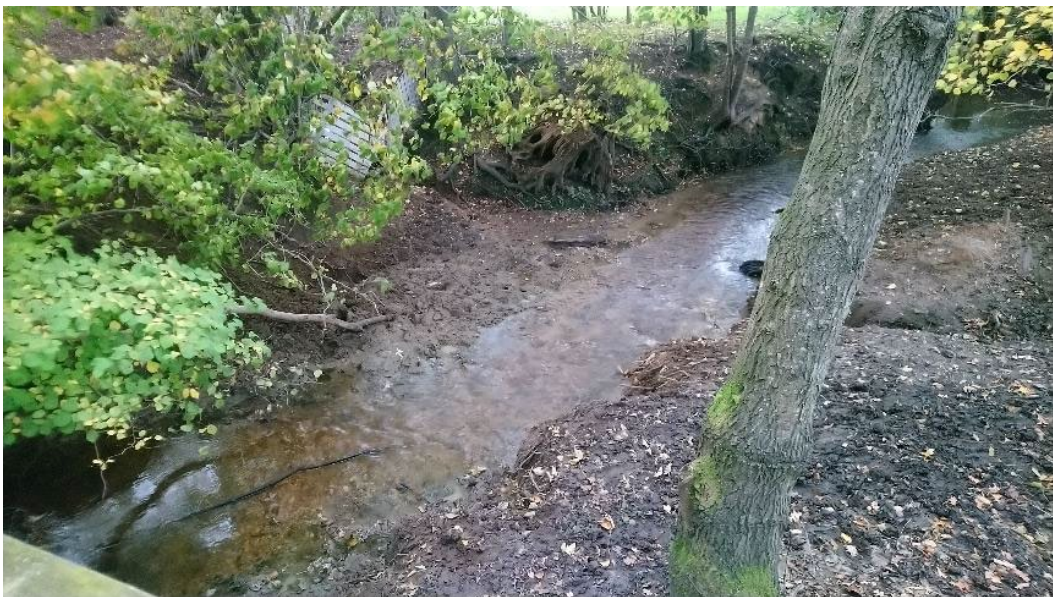
Photo 12. Cattle poaching site at the footbridge at the bottom of the first field downstream from main A275.

Significant damage to the streams ecology is being cause by serious livestock bank poaching (photo12). Ideally the bank should have stock fencing set back from the top of the bank and a pasture pump and drinker installed on the top of the bank to reduce pollution pressures in fields where livestock grazing is carried out.

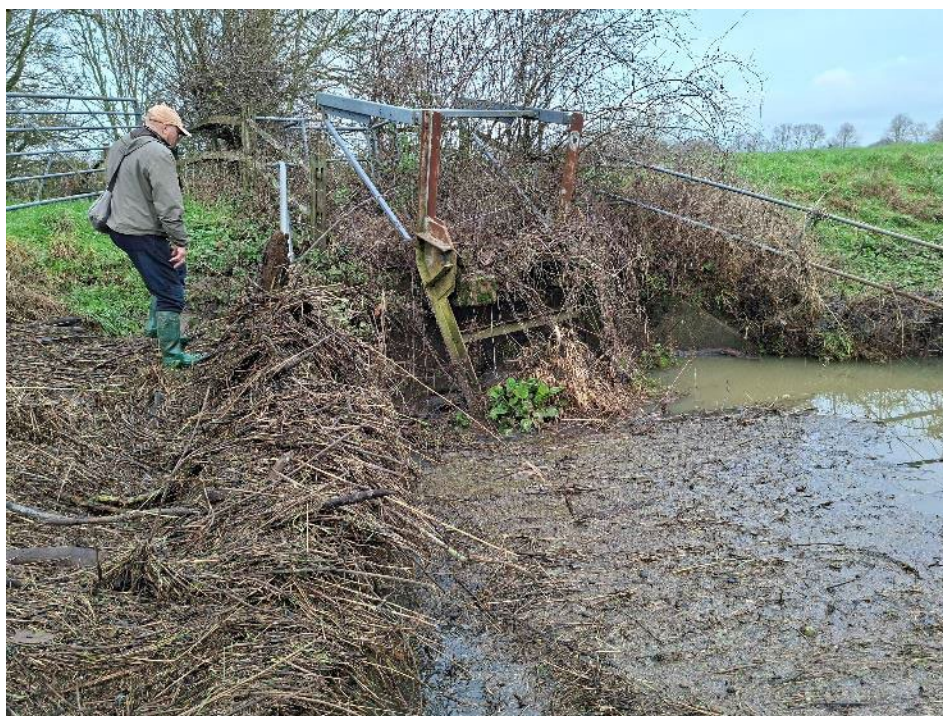
At the confluence of the stream with the main river Ouse, a flap gate (photo 13) has been installed to reduce the risk of tidal flooding into the lower reaches of the stream and adjacent meadows. It was not possible to fully inspect the design of the structure, due to a lack of maintenance of vegetation and for safety reasons.

Tidal gates like this are known to be a huge issue for migrating trout and eel, depending on design criteria. The duration when sea trout can successfully navigate through tidal gates very much depends on their function, design and nature of the tidal cycle and freshwater flow patterns.

These gates appear to be “top hung” gates and if operational will potentially have a much shorter duration of when they are fully passable, unless of course they are partially wedged open by debris, which is entirely possible. If these gates are deemed not worthy of maintenance and in effect redundant, then they should be completely removed to allow a natural flow regime to exist between the stream and the tidal river. If there is a plan to facilitate fish migration through this semi derelict structure, then it certainly isn’t obvious.

Photo 13. Top-hung tidal gate at the confluence with the Ouse. Functional or derelict? These gates will have a profound impact on the ecology of the lower section of the stream and the species that need to navigate in and out of the system.

In the context of River Ouse tributaries, the Northend Stream is of critical importance, discharging as it does into the lower, tidally influenced reaches. The tidal flap gate, located at its confluence with the Ouse, is a truly awful structure. This should be removed, or if the flood defence function is deemed essential, then replaced with a modern side hung, or float operated gate designed to facilitate improved access for migrating fish over a wider time-period within the tidal cycle.

Removing the gate and installing a narrow (300mm) deep slot could potentially create an attractive flume of fresh water exiting the stream and is likely to attract interest from migrating fish. Fish passes only ever work well if fish can easily detect the entrance and a modification to this structure could significantly improve access into the system and crucially the behaviour of fish that might be looking for suitable spawning tributaries to run into. Despite the difficulties this semi derelict gate poses to the Northend Stream, it still manages to function as a high-quality spawning and nursery habitat. We know the stream currently supports spawning sea trout, clearly corroborated by the signs of recent spawning activity recorded on the day of the site visit.
