WILD TROUT TRUST

Oxfolds Beck

23/11/2020

River	Oxfolds Beck
Waterbody Name	Costa Beck (Source to Pickering Beck)
Waterbody ID	GB104027068480
Management Catchment	Derwent Humber
River Basin District	Humber
Current Ecological Quality	Moderate
U/S Grid Ref inspected	SE7802583855
D/S Grid Ref inspected	SE7704582767
Length of river inspected	1.8 km

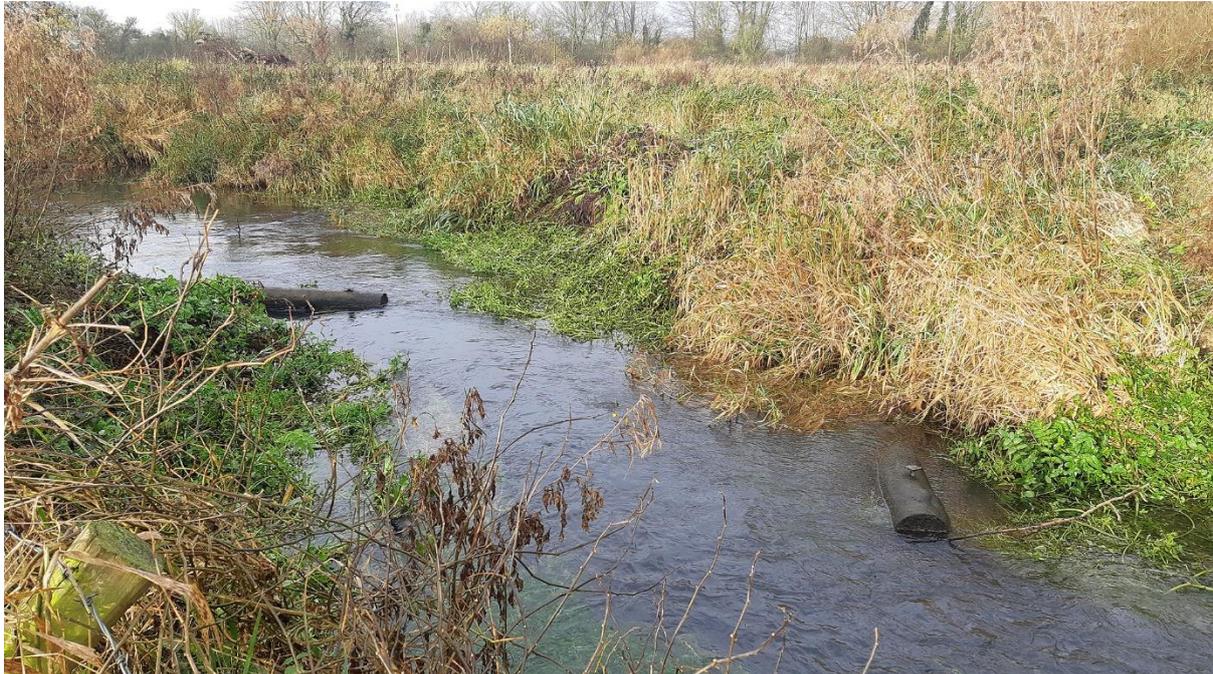
Previous attempts to introduce structural variation to channel habitat have been restricted to relatively small-scale actions (e.g. small flow deflecting structures; Fig. 1). Beneficial effects of such structures are also likely to be hampered by larger catchment-scale processes creating excess fine sediment supply, modifications that locally reduce longitudinal bed-slope and channel sinuosity (and therefore flow diversity) and increases to channel cross-sectional area. The combined effect of these processes is to promote extensive accumulation of fine, nutrient-rich, sediment. As well as

Figure 1: Small woody structures can provide some extra structural diversity. The small scale of this particular intervention is not sufficient to overcome the scale of ecological degradation currently impacting the Oxfolds and Costa Becks

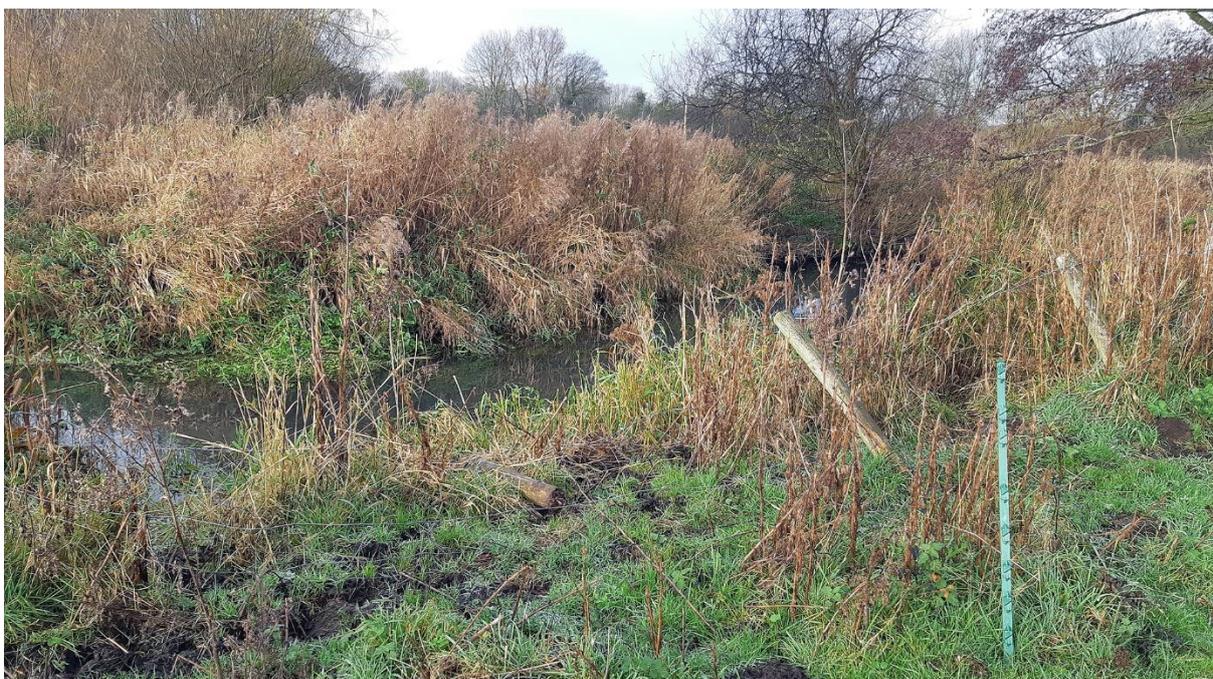
The fencing, although creating a relatively narrow buffer strip, has had significantly more impact on structural diversity. To this end, the repair of some crushed sections of fencing (e.g. Fig. 2) should be prioritised.

Figure 2: Allowing uncontrolled access for grazing animals to the buffer strip risks undoing positive impacts of a more structurally-diverse riparian zone and ultimately leading to bank destabilisation and accelerated erosion

It appears that livestock use this area for drinking – so the repair of fencing should be combined with an alternative provision of water. Although mains water troughs can offset installation and running costs by reducing waterborne disease rates, other options also exist. These include pasture pumps, small ram pumps or even drinking troughs supplied by solar-powered pumps.

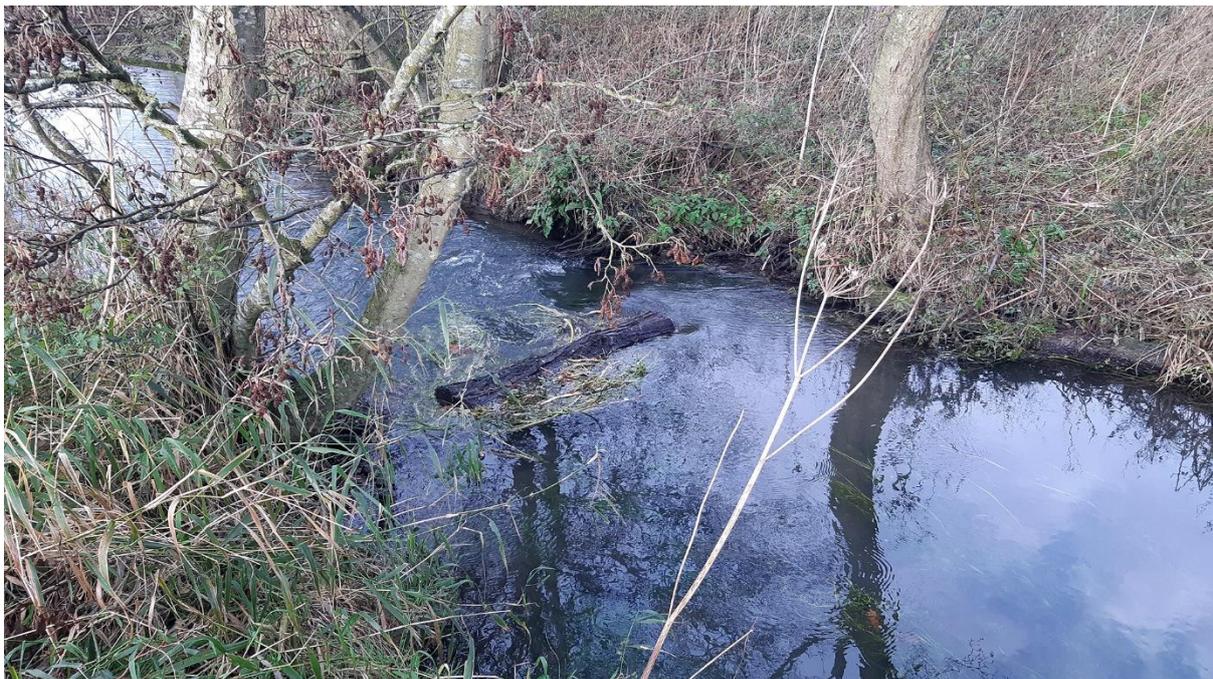
A low impoundment at SE 77898 83822 (Fig. 3) is reducing the potential for the river to redistribute bed material and create greater structural diversity.

Figure 3: Log sitting on what appears to be a low, artificial impoundment structure. It would create ecological benefits to remove the impoundment at this location. Note how the structure also splits the flow down either bank side. It is generally far more beneficial to maximise the sinuosity of flow (from one bank to the other) and capitalise upon the depth-maintaining scour that produces

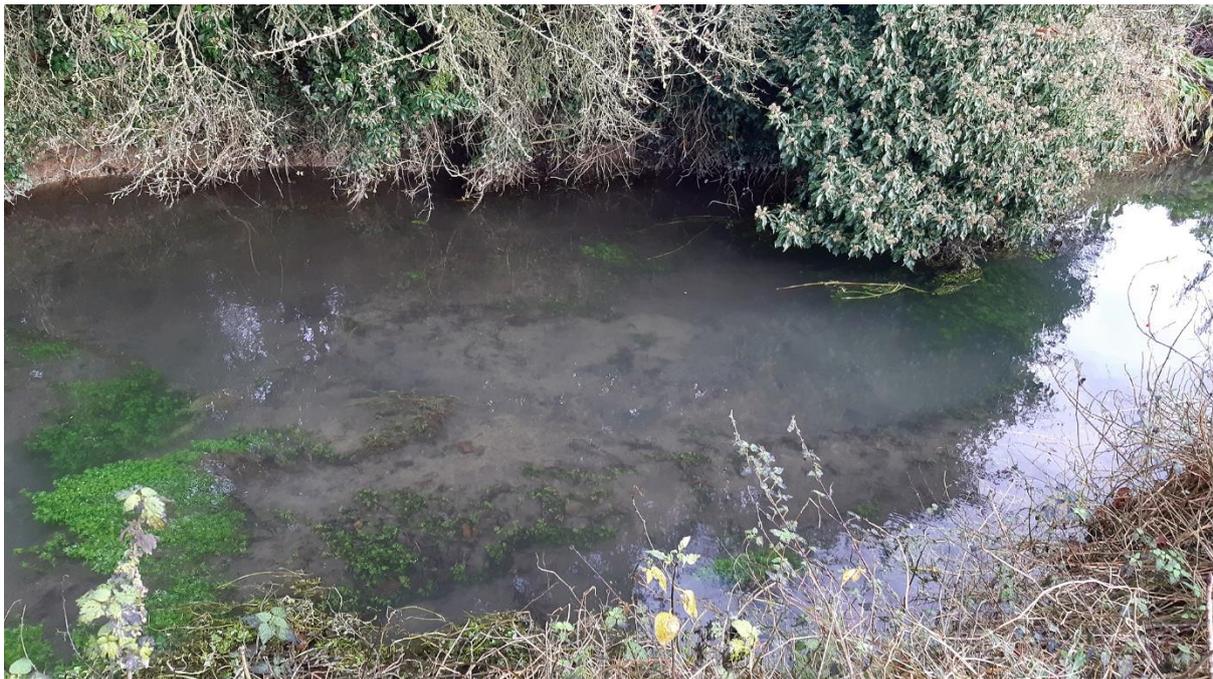
However, the presence of deep, fine silt from bank to bank (and to a considerable depth) has created particularly uniform habitat that will suit only a limited subset of aquatic species.

Figure 4: Extensive, deep, soft silt deposition - only a short distance *downstream* of the low impoundment pictured in Fig. 3

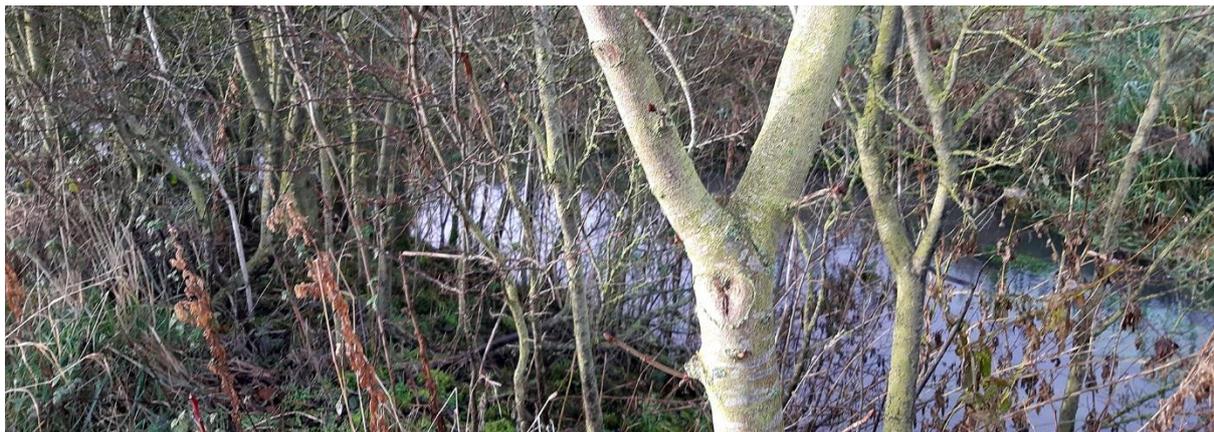
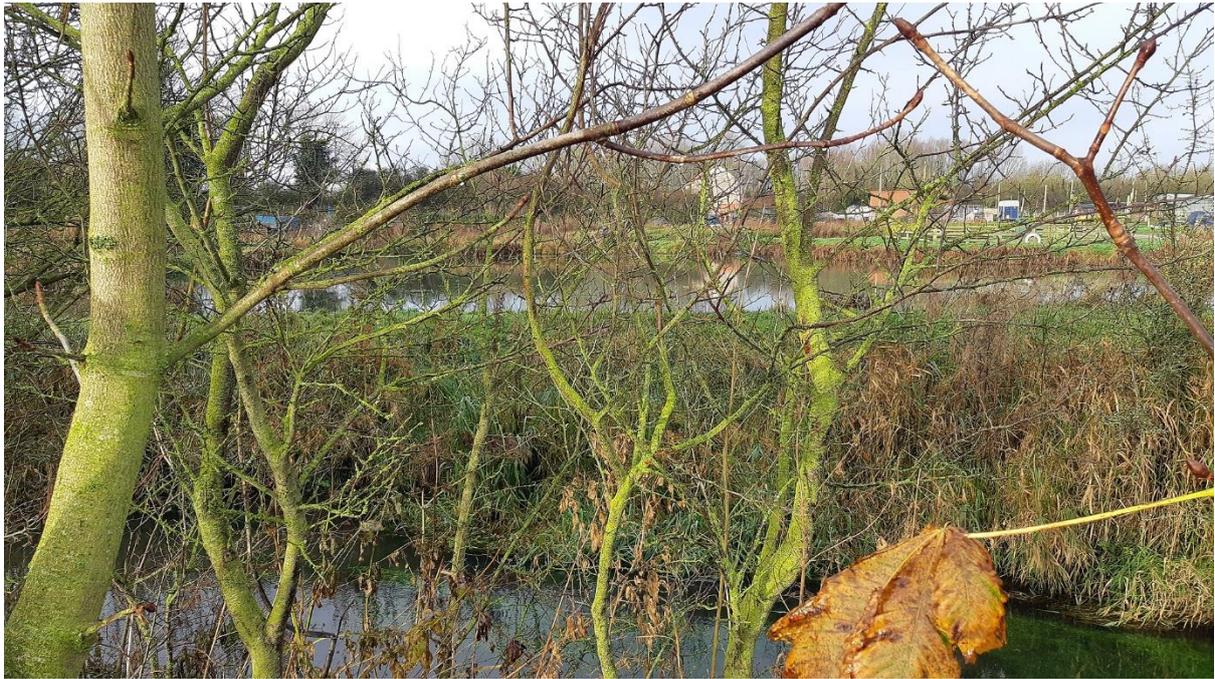
Another, slightly unusual, potential source of fish toxicity could be the "saponin" content of horse chestnut fruits and twigs. Native Americans traditionally used crushed bark or fruits containing this substance to poison fish and collect them. Although more often associated with crushed fallen horse chestnut fruits on roads (and rainfall washing this into streams), those kinds of inputs have been observed to cause fish kills over 1km reaches of stream (Andy Thomas, Pers. Comm.). There is the relatively famous case in Kolding, East Jutland where unexplained periodic fish kills each autumn were eventually tracked down to an avenue of Horse Chestnut trees along the watercourse. The buffer strip (e.g. Figs. 5-7 inclusive) contains a quite unusually high proportion of horse chestnut trees. There is a case, therefore, for removing most/all of these and replacing with specimens of a locally-appropriate species.

Figure 5: Riparian strip containing young horse chestnut trees (1 of 3 examples)

Figure 6: Riparian strip containing young horse chestnut trees (2 of 3 examples)

Figure 7: Riparian strip containing young horse chestnut trees (3 of 3 examples); part of the fish-farming facility is also visible in the background

- Undertake targeted removal of horse chestnut trees from riparian buffer strips (and replace with locally-appropriate native trees)
- Explore opportunities to extend the width of the buffer strip where possible

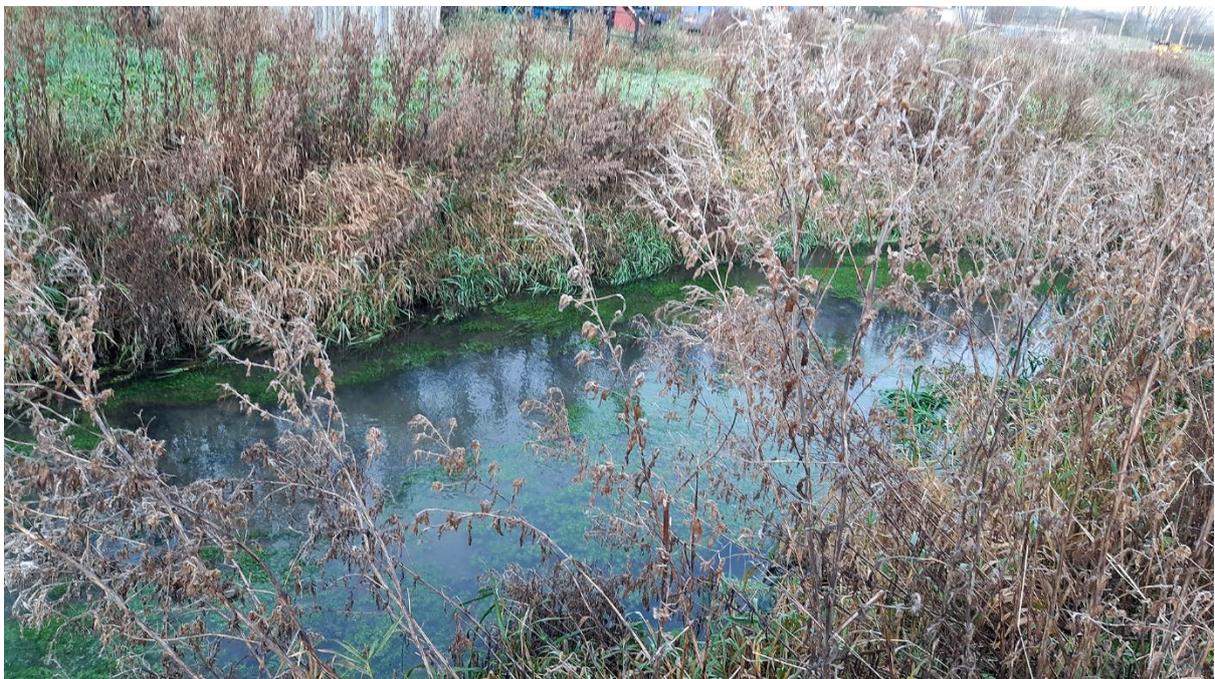
Silt deposits and a corresponding increase of starwort (*Callitriche* sp.) – plus extensive realignment of the channel - continue to dominate the section of river adjacent to the fish farming ponds (Fig. 8).

Figure 8: Silt and starwort predominate in the artificial, uniform channel. The riverbed in the upper reaches visited during this assessment are dominated by this characteristic set of conditions – which are consistent with over-dredging and resultant bed-lowering

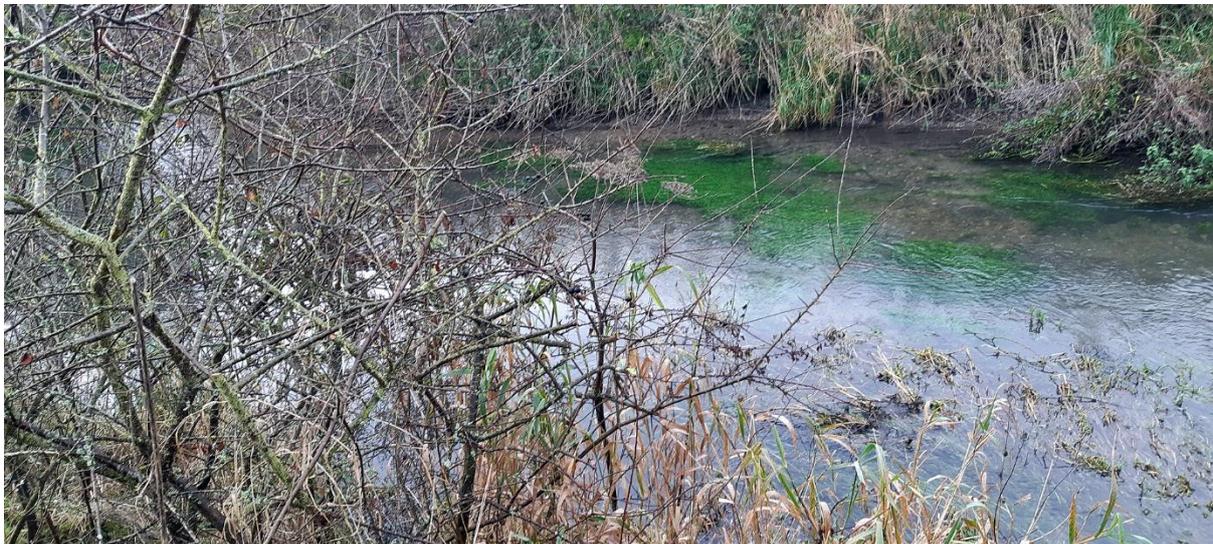
During the visit, the first gravel deposit was noted around SE 77736 83819 (in the channel adjacent to historic cress beds; Fig. 9).

Figure 9: Gravel deposits and *Ranunculus* sp. as well as fine silt/sand, emergent and marginal vegetation; a little more in-channel habitat diversity via more natural capacity

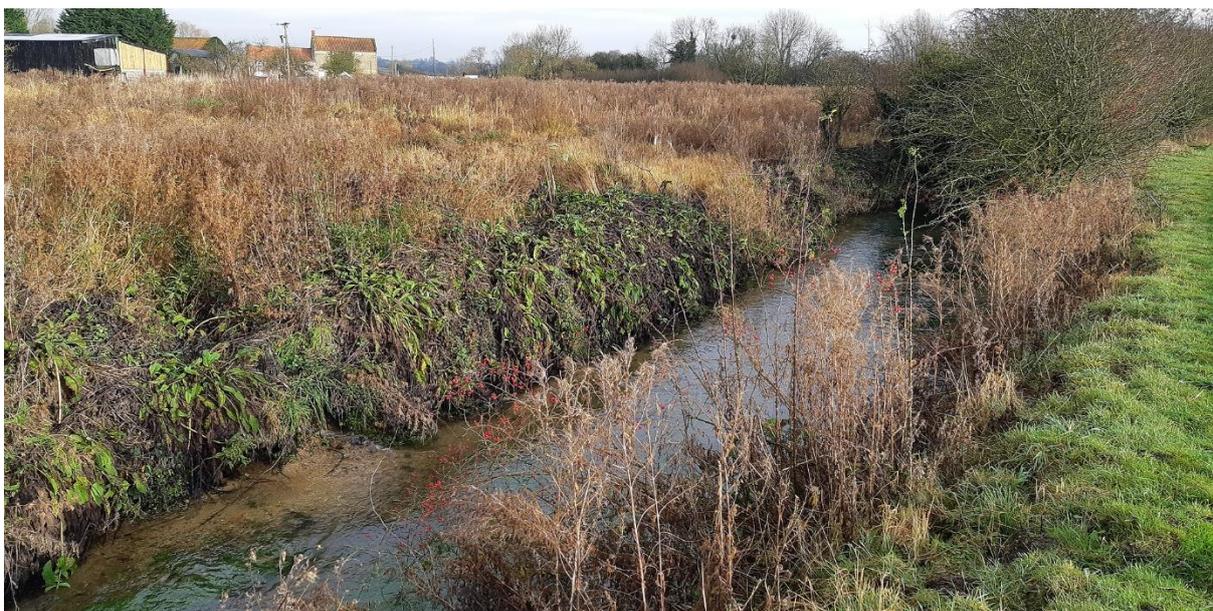
Figure 10: Sandy deposits (lower right of frame) indicate water flowing from the cress beds into the Oxfolds Beck channel

The evidence of water returning to the Beck channel from the site of old cress beds (Fig. 10) may indicate an opportunity to incorporate wetland treatment of fish farm effluent (if not already doing so). Utilising the cress beds in this way could significantly reduce any inputs of organic and nitrogenous compounds – even when current consent levels are being met.

- Continue to look for ways to eliminate polluting conditions arising from water treatment facilities and activities
- Explore whether old cress bed infrastructure could be used to create wetland water treatment for fish farm effluent

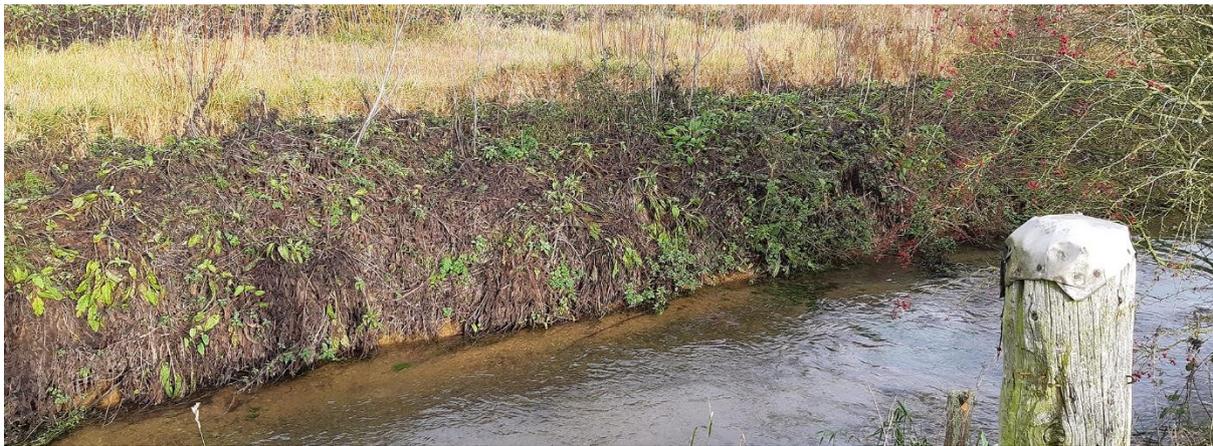
As is visible in Figs. 10 and 11, there appears to be evidence of herbicide treatment of riparian vegetation. Avoiding overspray onto the watercourse would be essentially impossible in this situation – so it is important to understand if this is what is happening, whether this activity is properly consented and certificated, and what is the actual purpose.

Figure 11: Apparent spray-treatment of riparian vegetation right down to the waterside

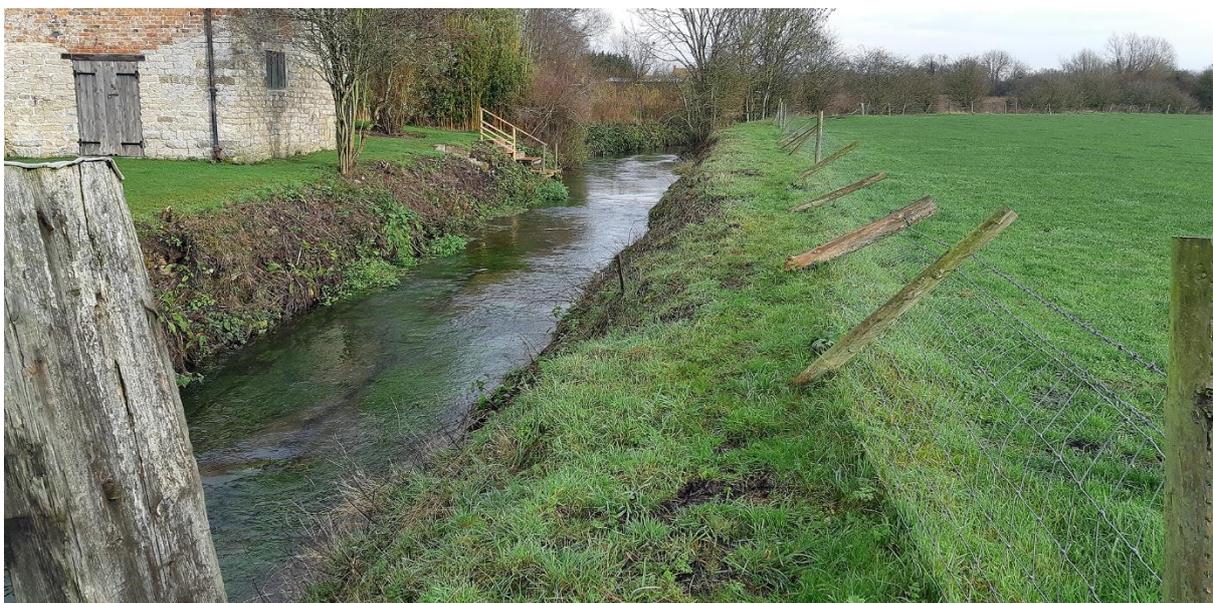
The two branches of channel join at the downstream limit of the cress beds - though the watercourse continues to be called Oxfolds Beck apparently as far as the gauging weir shown subsequently in Fig.16. After combining into a single channel, the historic realignment (downstream of this point) has created much longer reaches of completely straight channel. The channel running past the mill cottage is a prime example of this (Fig. 12).

Figure 12: Straightened channel by mill cottage

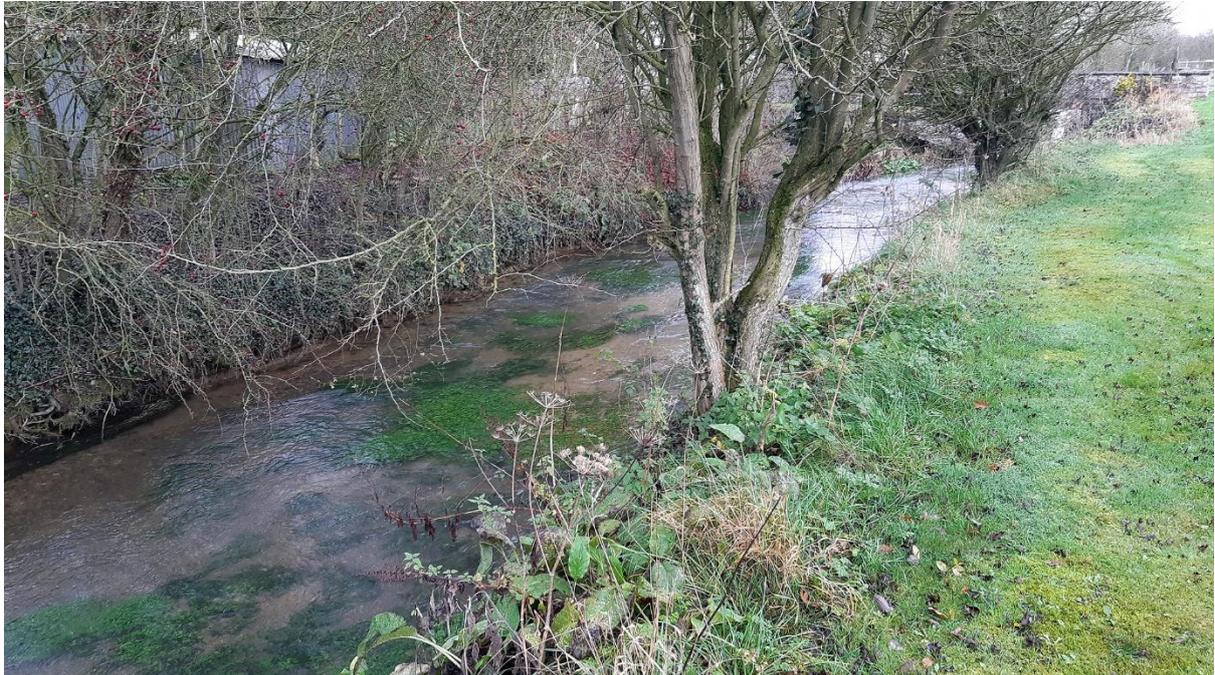
Although some scattered tree growth and the presence of a wider range of substrate particle-sizes has created slightly more diverse habitat in some areas (e.g. Fig. 13), extensive straightening is still constraining biological diversity.

Figure 13: The more diverse light/shade regime created by riparian trees has created some structural diversity by producing a patchwork of aquatic weed and bare substrate. However, the severe straightening of the channel means that there is little potential for cross-sectional variation in water depth and flow velocity

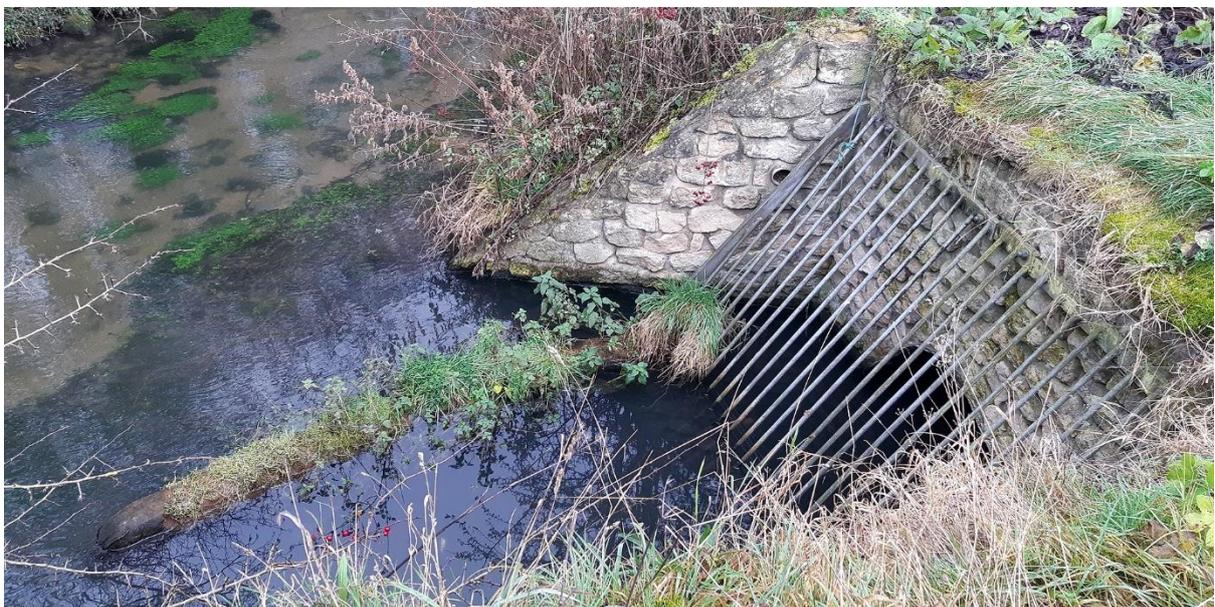
Just downstream from Fig. 13, there is an outfall at SE 77449 83659 that is cited to be "final effluent" from the sewage treatment works but which was not flowing at the time of the visit. Additionally, the colour and appearance of the sediment below this outfall looks to be of poorer quality than would be expected from final effluent (Fig. 14).

Figure 14: Outfall cited as "final effluent" at SE 77449 83659

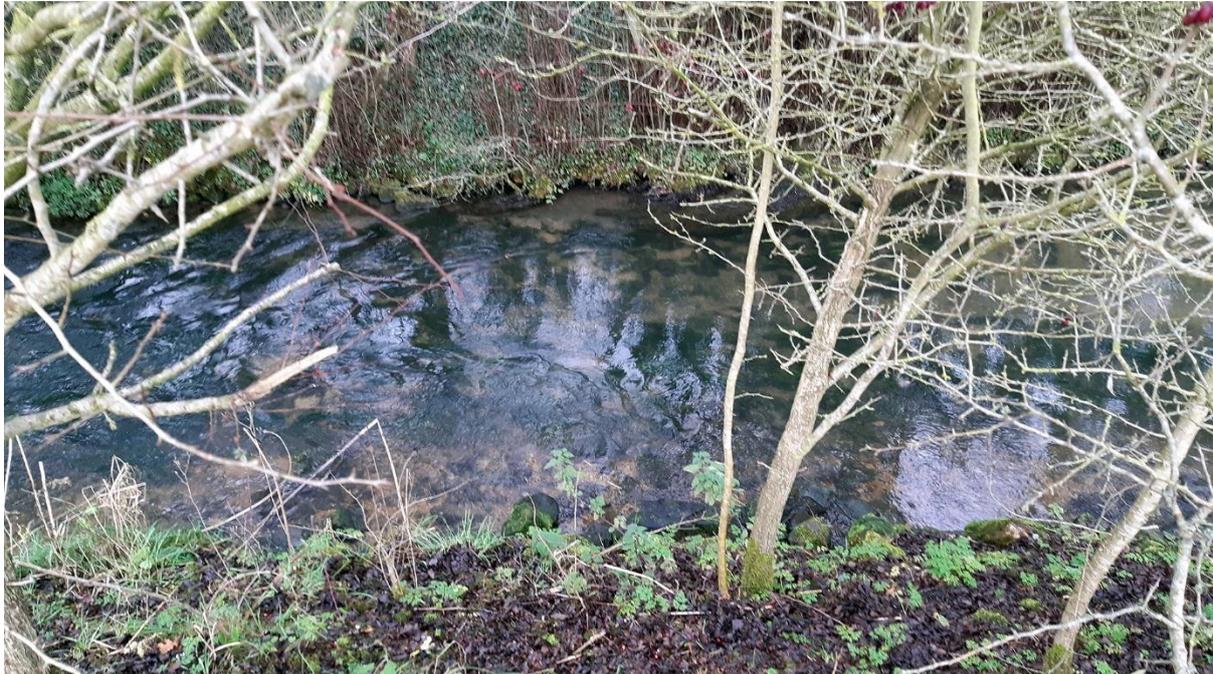
Silk weed (filamentous algae, indicative of nutrient enrichment and increased Biochemical Oxygen Demand) was prolific below this outfall (Fig. 15) – while all but absent in the upstream reach.

Figure 15: Silk weed (filamentous algae thriving in elevated nutrient levels) visible as all the dark green growth on the riverbed below the outfall. Note that this growth spreads across the full channel width, indicating that the nutrient enrichment appears to be cross-sectionally well-mixed at this point – and of (chronically) sufficiently high volumes to maintain “bank-to-bank” silk weed growth throughout the channel.

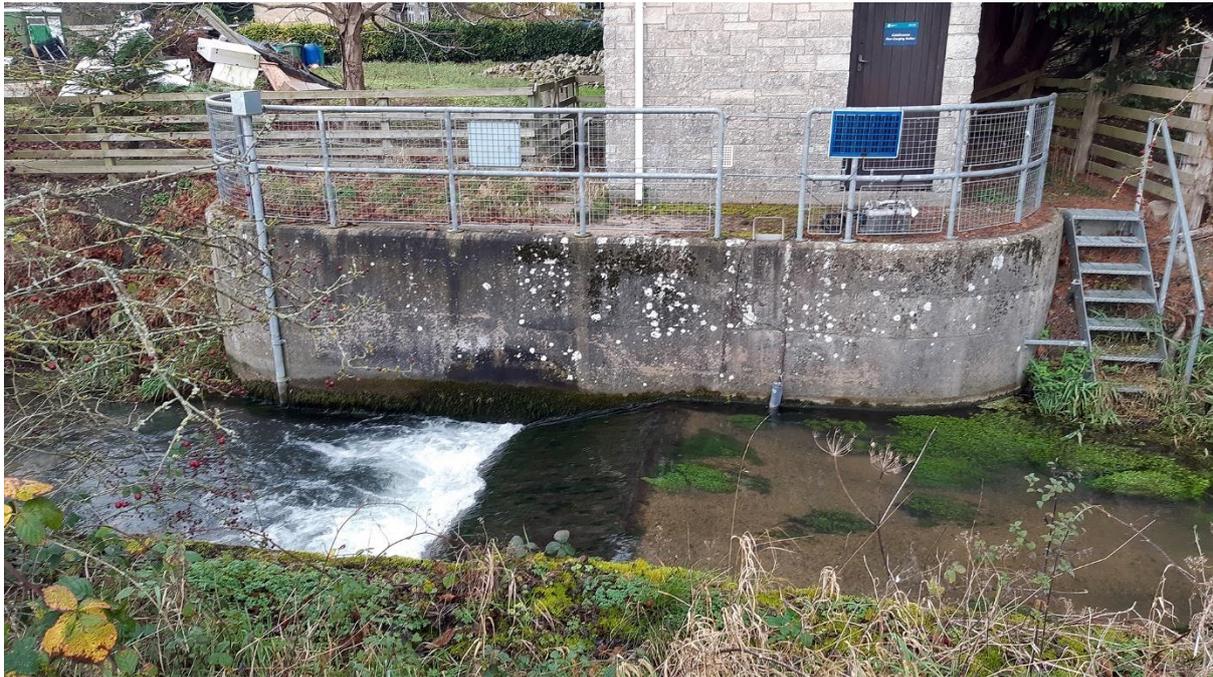
In conjunction with the “chemical barrier” effect, the ease and speed of recovery via recolonisation will be hampered by the physical barrier of the gauging weir at SE 77413 83628 (Fig. 16). As with all physical impoundments, the impact of this weir is not restricted to the impedance or prevention of upstream/downstream migration of pelagic species. Of equal or greater significance is the interruption of geomorphological processes of riverbed material transport. The “step” created in the riverbed

harms habitat diversity upstream and intercepts bed material that would otherwise form habitat downstream of the barrier.

Figure 16: Weir and associated monitoring instrumentation at SE 77413 83628

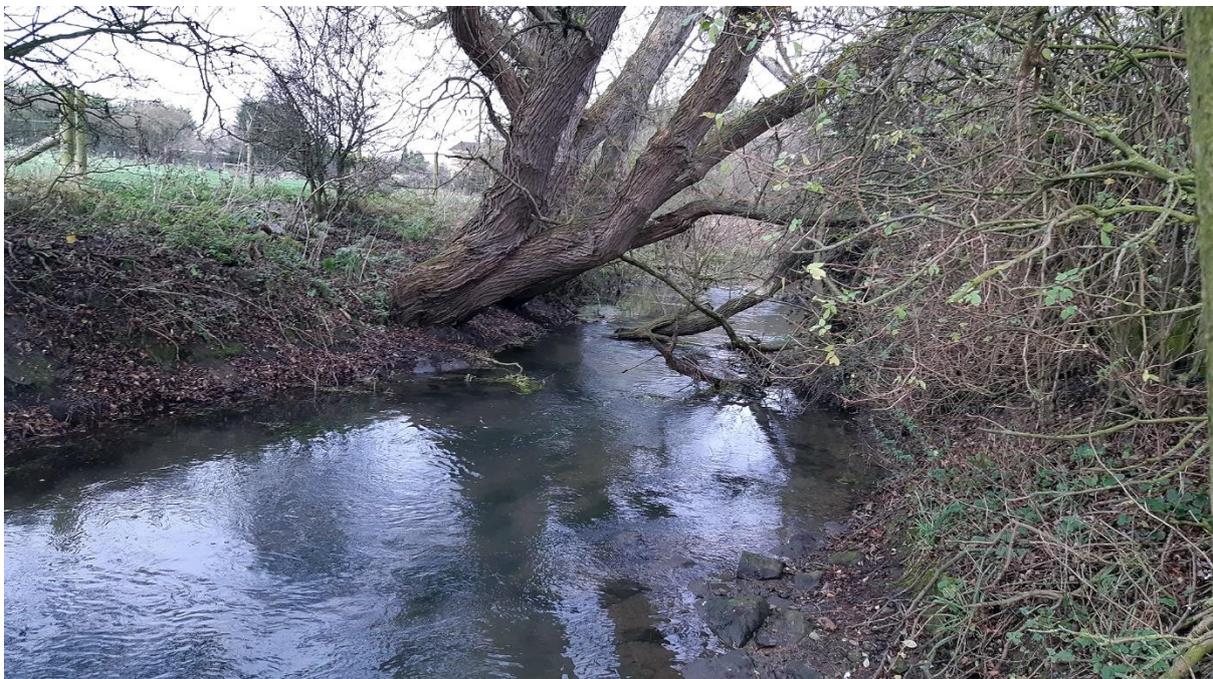
Downstream of the weir, examples of more structurally-diverse habitat were found (e.g. Fig. 17).

Figure 17: Biologically valuable habitat created by in-channel woody material. Note, however, the relative lack of gravel compared to upstream of the weir pictured in Fig. 16

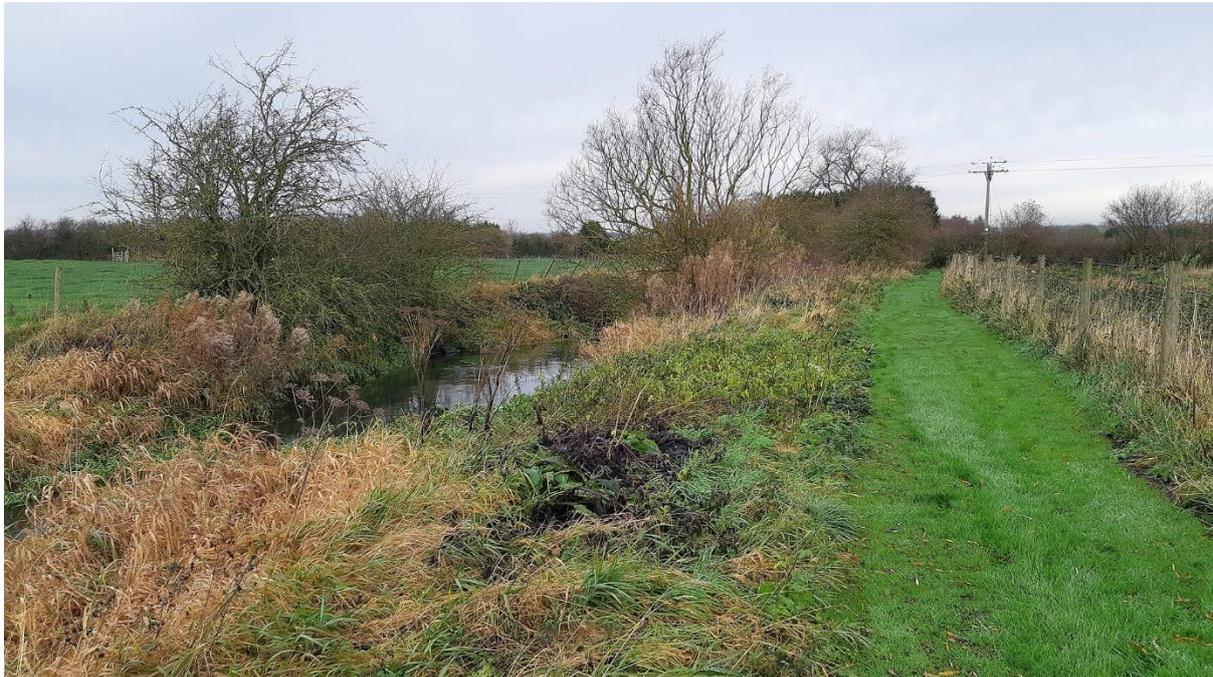
There are also examples of wider (vegetated) riparian buffer strips downstream of the gauging weir (e.g. Fig. 18). These are especially important given that many aquatic invertebrates complete their lifecycle in

Figure 18: Although a mown "ride" is maintained along this section of river, there is a wider unmanaged strip of riparian vegetation compared to other reaches. Many additional ecological benefits are accrued in the river channel from this slightly wider and structurally-varied buffer strip

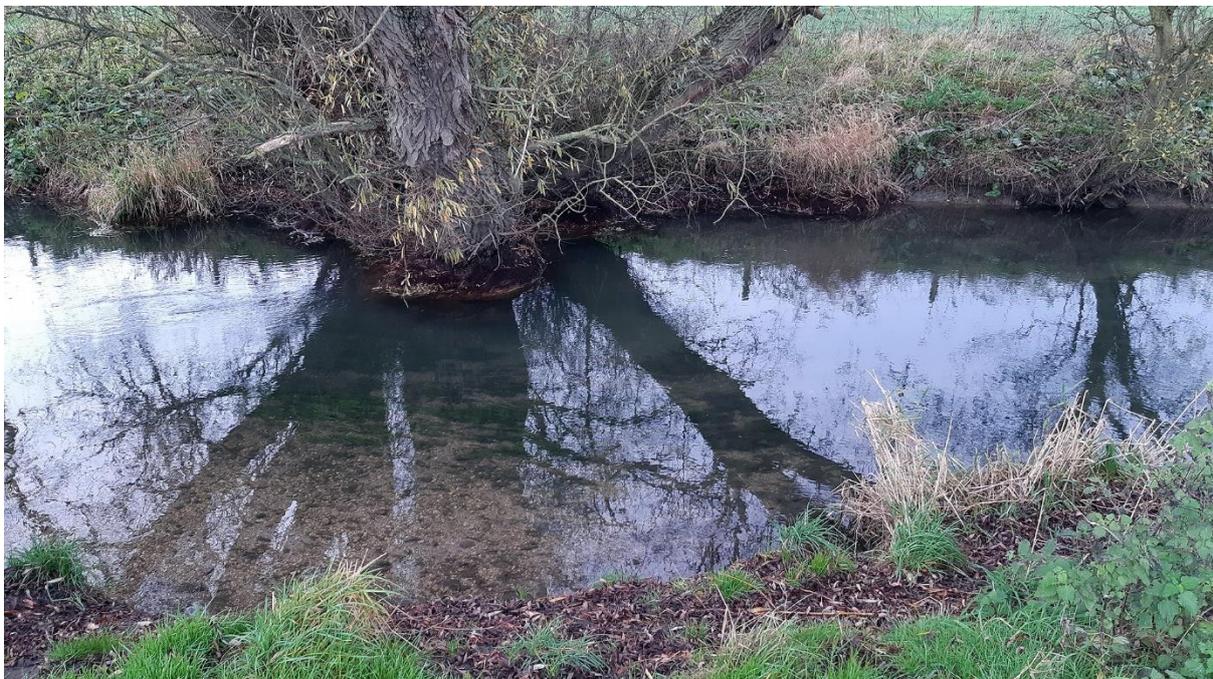
Some localised bed-scour and a degree of meandering course result from larger bankside tree-roots and trunks (e.g. Fig. 19).

Figure 19: A large bankside willow has created some much-needed lateral redistribution of bed material in this historically-straightened channel

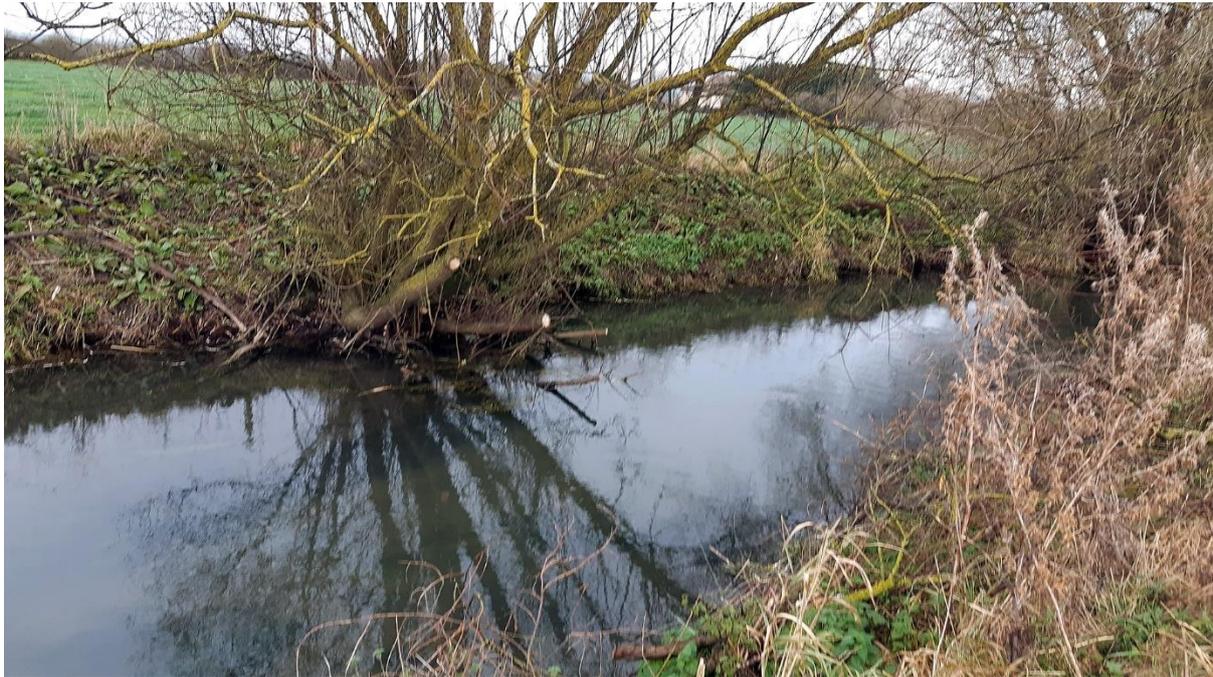
in simplified habitat). Figure 20 shows limbs cut off a bankside tree – reducing the value of this as a potential lie for fish.

Figure 20: For aquatic fauna, the most valuable overhanging limbs are those which trail in the water - and/or hang within about 12"/30cm of the normal water-level

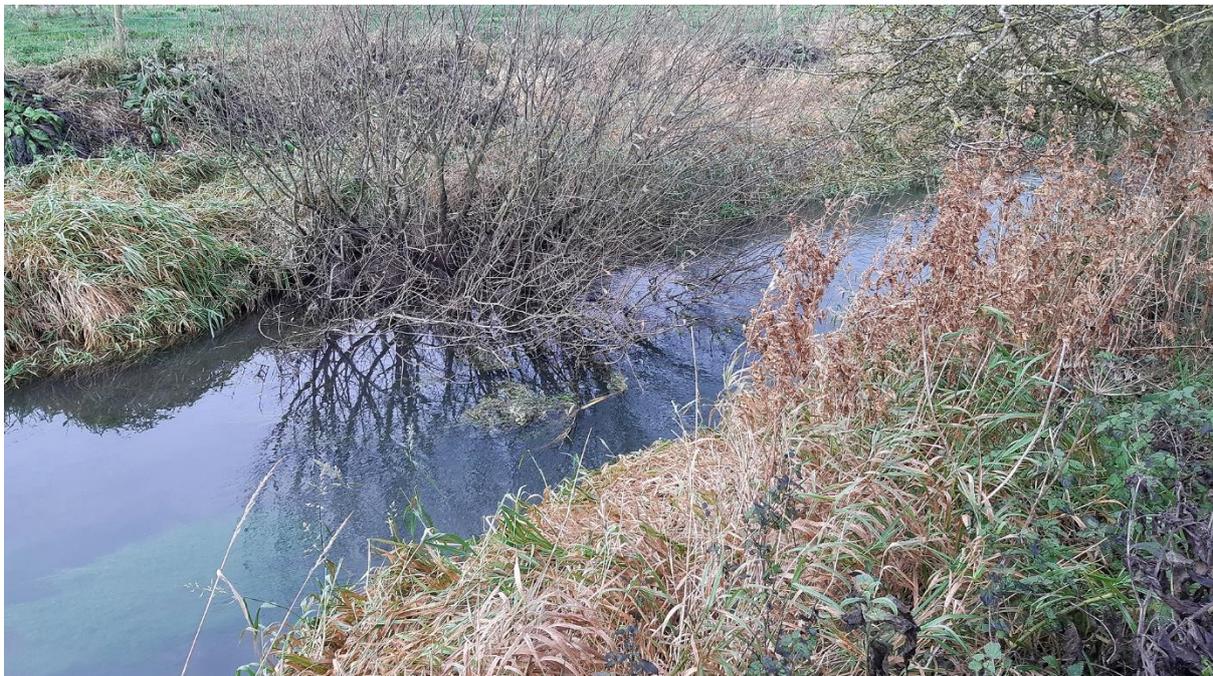
As well as retaining the tree growing within the channel (Fig. 21; resulting in dense submerged cover – essential for overwinter survival of fish), the effect of trailing branches on riverbed substrate “sorting” is also evident (Fig. 22).

Figure 21: A dense matrix of submerged branches not only protects against predation but also creates a haven of low flow velocities during spates

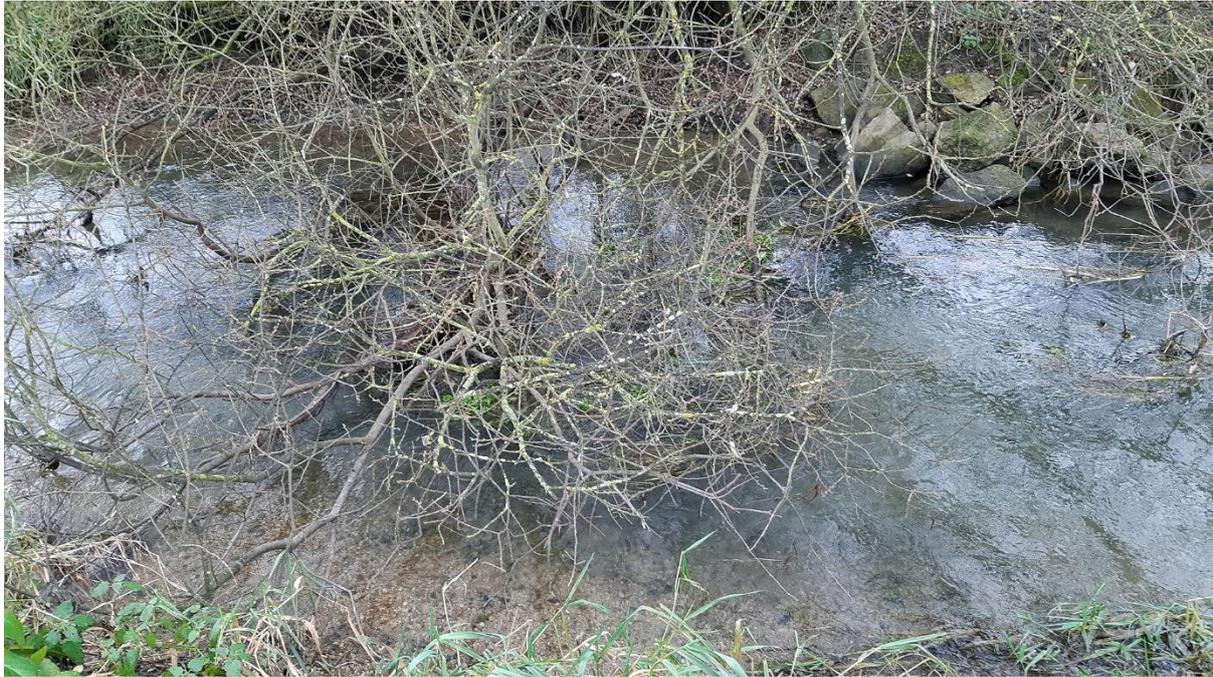
Figure 22: Separation (i.e. sorting) of gravel particles (lower edge of frame) from fine sand/silt particles is created by the effect of localised scour resulting from deflection around submerged and trailing branches in higher flows

- **Extensively hinge and secure a scattered selection of existing bank-side trees to create similar conditions to Fig. 22) throughout all “simplified” (i.e. historically over-dredged and straightened) sections**

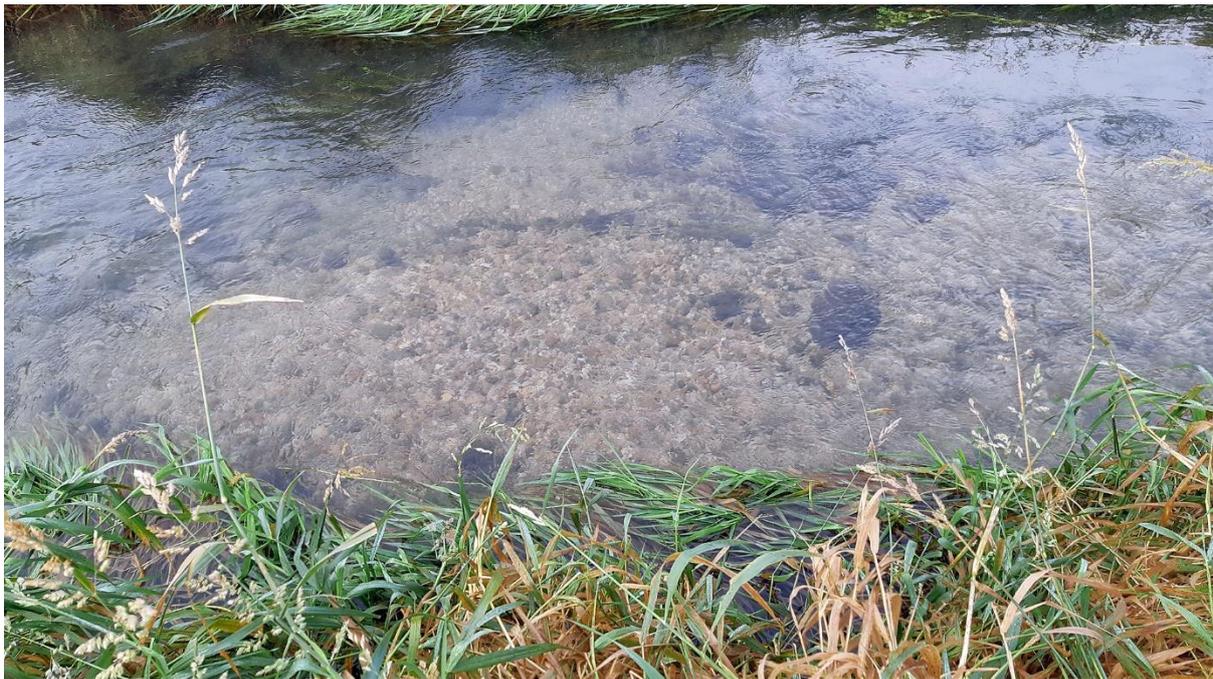
There was also evidence of in-channel breeding attempts at the time of the visit (e.g. Fig. 24):

Figure 24: Freshly turned-over gravels. In this location this probably results from multiple breeding attempts. Previous redds can be over-cut by subsequent mating pairs (blurring the boundaries of each individual redd-site)
