WILD TROUT TRUST

Oxfolds Beck

23/11/2020

River	Oxfolds Beck
Waterbody Name	Costa Beck (Source to Pickering Beck)
Waterbody ID	GB104027068480
Management Catchment	Derwent Humber
River Basin District	Humber
Current Ecological Quality	Moderate
U/S Grid Ref inspected	SE7802583855
D/S Grid Ref inspected	SE7704582767
Length of river inspected	1.8 km

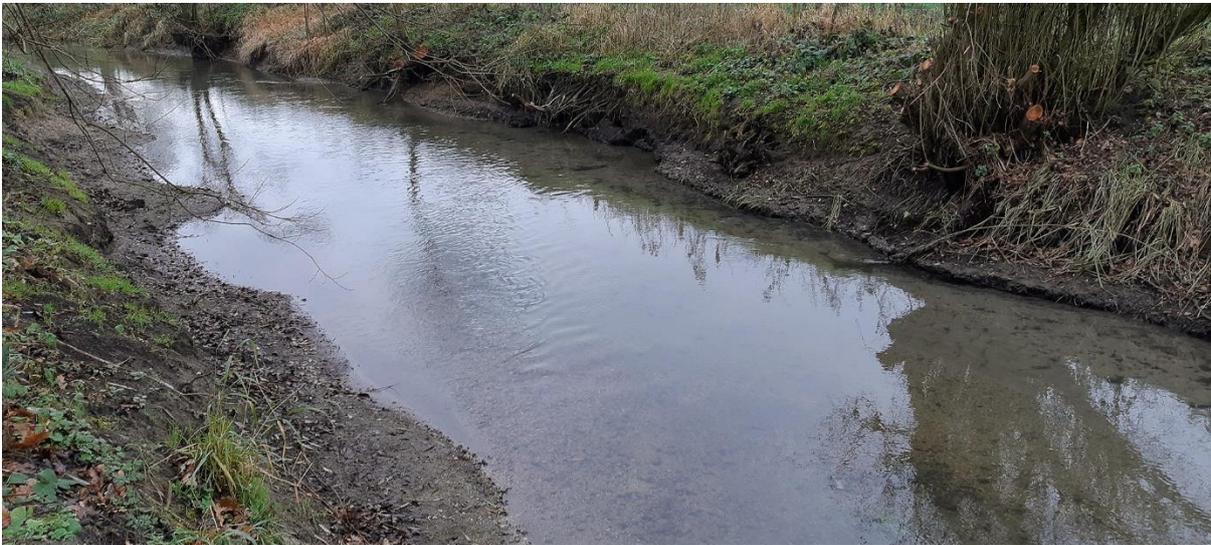
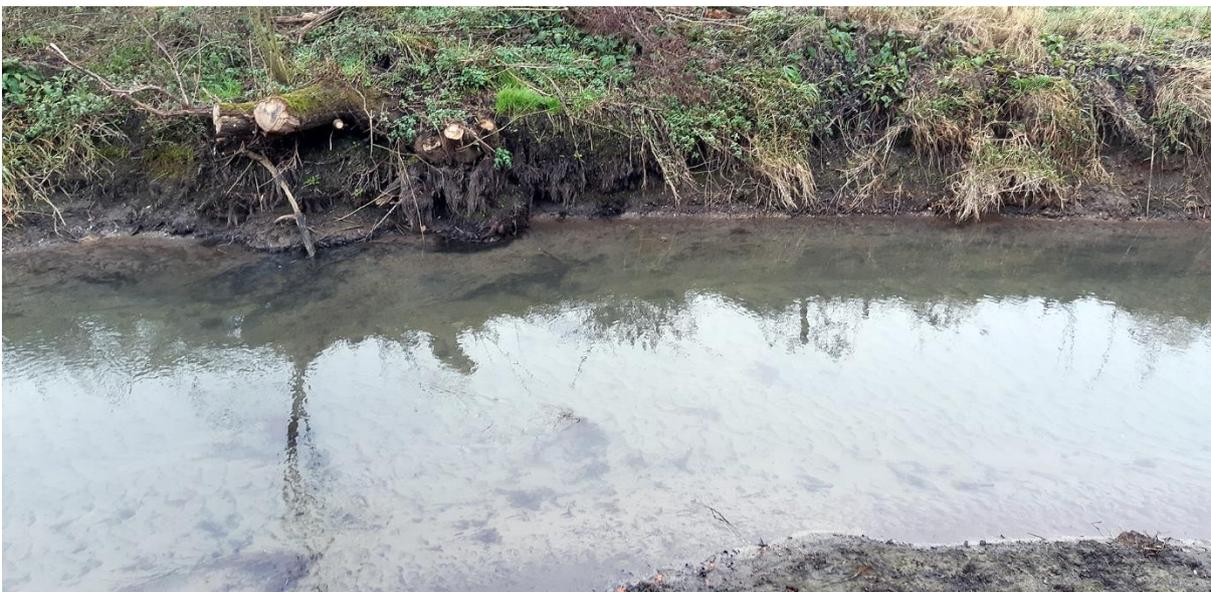
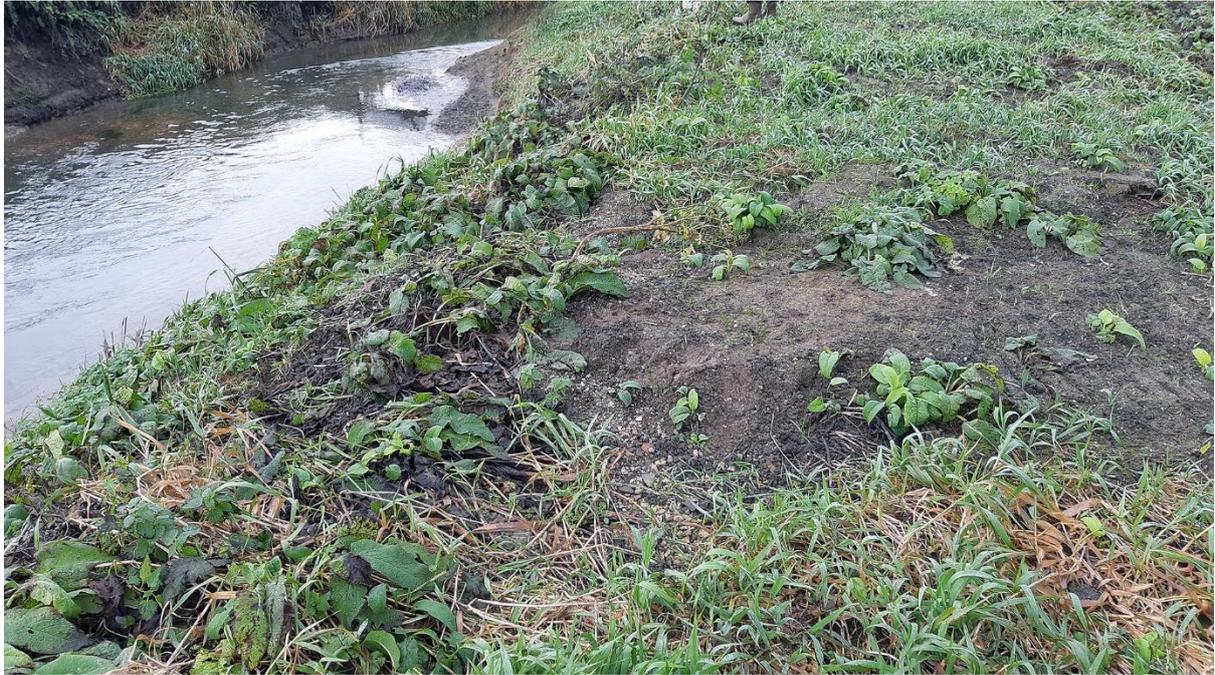
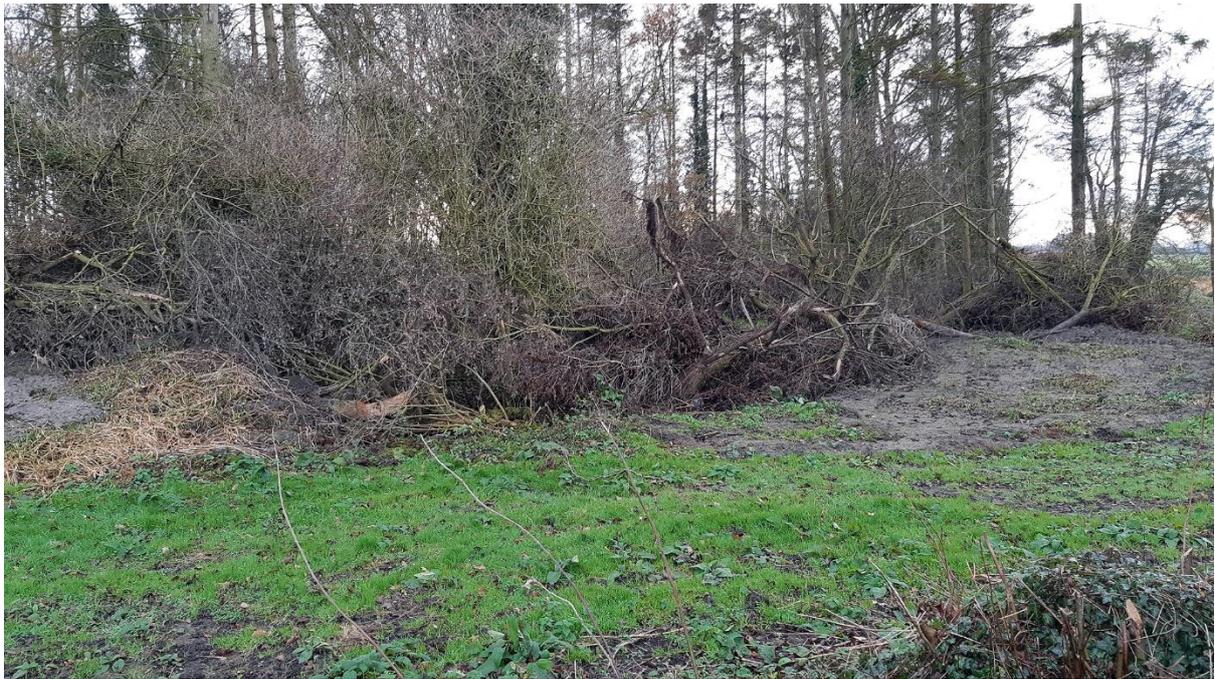
In the reaches immediately adjoining the downstream limit of the angling club water there was evidence of recent extensive habitat destruction via dredging and riparian vegetation removal (e.g. Figs.25 – 28 inclusive).

Figure 25: Riparian structure removed and channel dredged

Figure 26: Cross-sectional variation removed via dredging – leaving only sand/silt. Note also the loss of vital bankside tree cover

Figure 27: Spoil dredged from river applied to bank tops

Figure 28: Discarded woody material on opposite bank to cut tree limbs

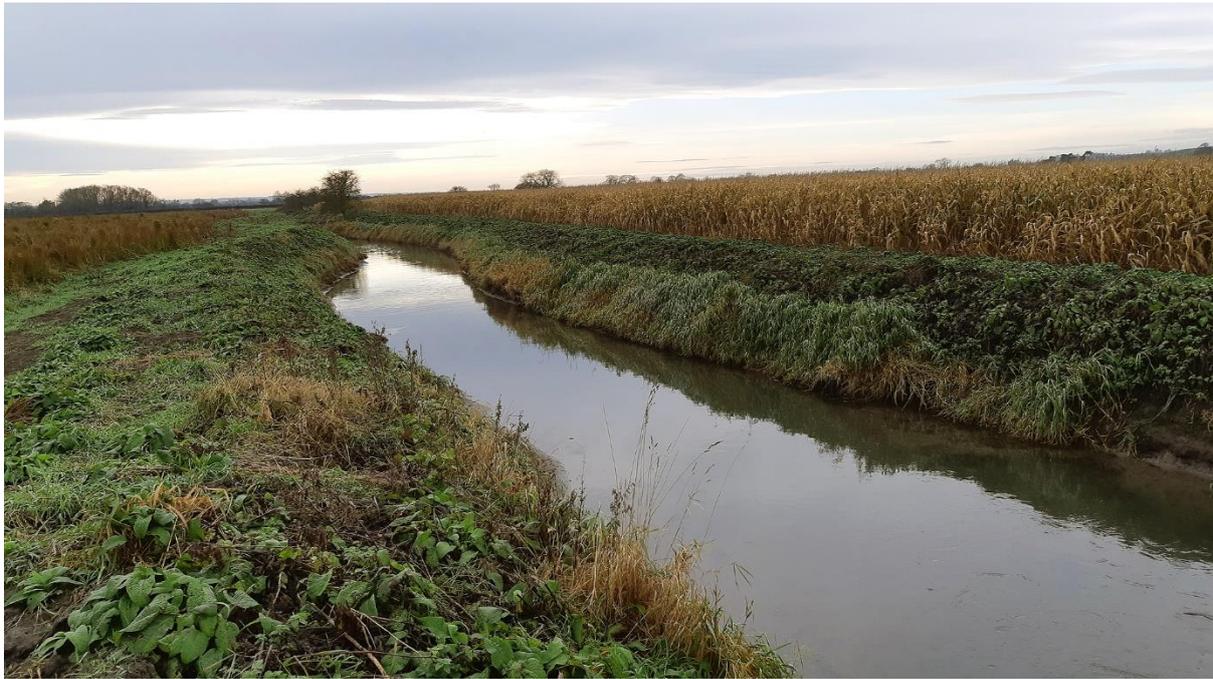
Downstream of these recent works, it seems that there has been a longer-term/ongoing programme of dredging and vegetation removal. This has left long reaches of sterile, trapezoidal channel devoid of its original rich ecological habitats (Fig. 29).

Figure 29: The sterile, dredged drain of what was previously the Costa Beck

Assuming this condition continues throughout the visible landscape in Figure 29, then this massively degraded habitat also represents another barrier to recolonisation. Straying into this long, uniform, clear-water reach without cover carries an extremely high risk of predation for fish. Consequently, the proportion of fish willing to continue exploring upstream for the distance required to reach the next available refuge will be extremely small. The combinations of chemical, degraded habitat and artificial impoundment barriers mean that any recovery from pollution incidents is most likely to rely on immigration from upstream. By reducing the opportunities for re-colonisation, the duration of impacts resulting from poor water quality incidents may be significantly extended.

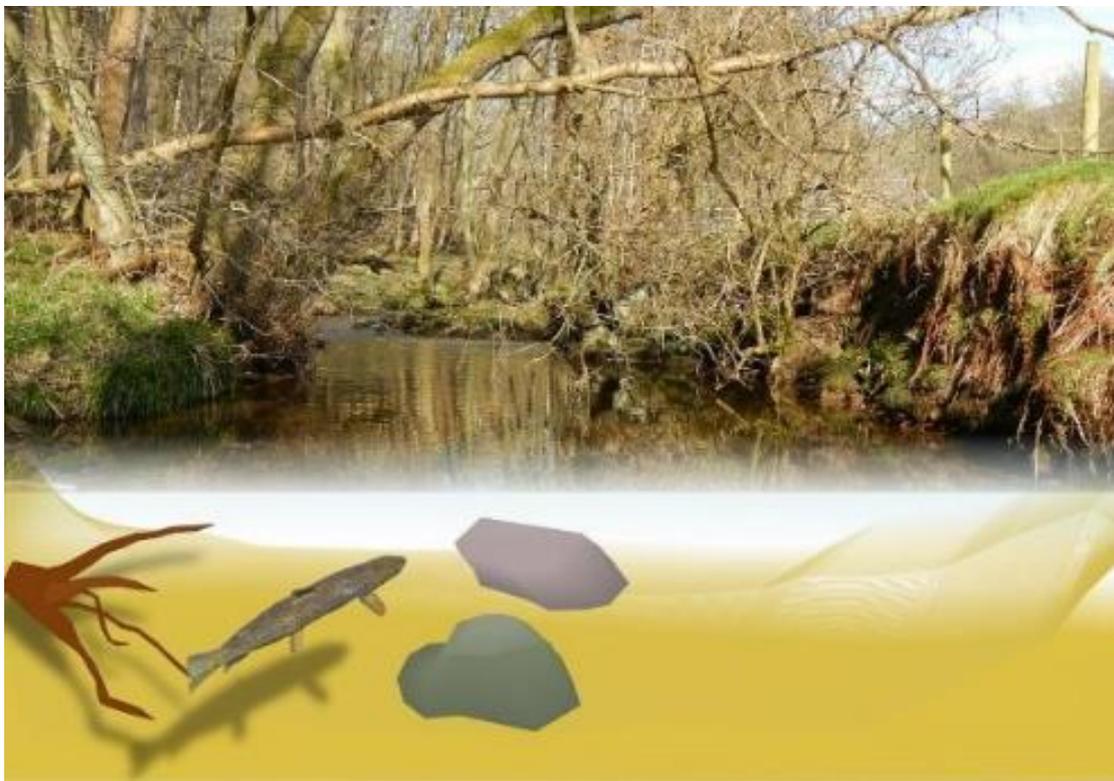
Figure 33: The availability of deeper water bolt holes (>30cm to several metres), low overhanging cover and/or larger submerged structures such as boulders, fallen trees, large root-wads etc. close to a good food supply (e.g. below a riffle and with prey likely to fall from overhanging tree canopy in this case) are all strong components of adult trout habitat requirements
