Advisory Visit

Pix Brook, Bedfordshire

July 2020

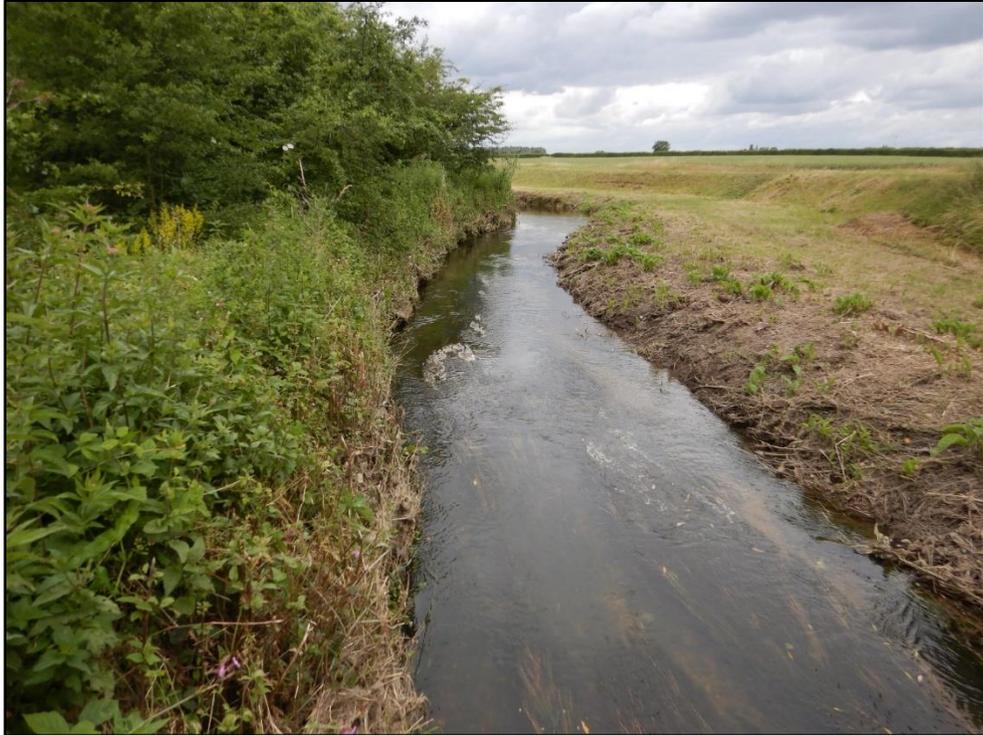
The channel of the brook is overly uniform, with an average width $\sim 2\text{m}$ and a depth $\sim 0.4\text{m}$. The banks are generally vertical, and past re-engineering has created a 2-stage channel providing a maintenance berm $\sim 1\text{m}$ above the current water level (pic 1). Recent rainstorms have left a water mark which showed the berm not to have been inundated (pic 2).

Pic 1 – The brook showing the 2-stage channel to the RB.

- Better floodplain connection should be sought. The current maintenance berm could be lowered to allow inundation at a lower flood level. That would bring flood risk management benefits to the downstream community, and possibly justify less maintenance of the brook allowing natural processes to prevail.

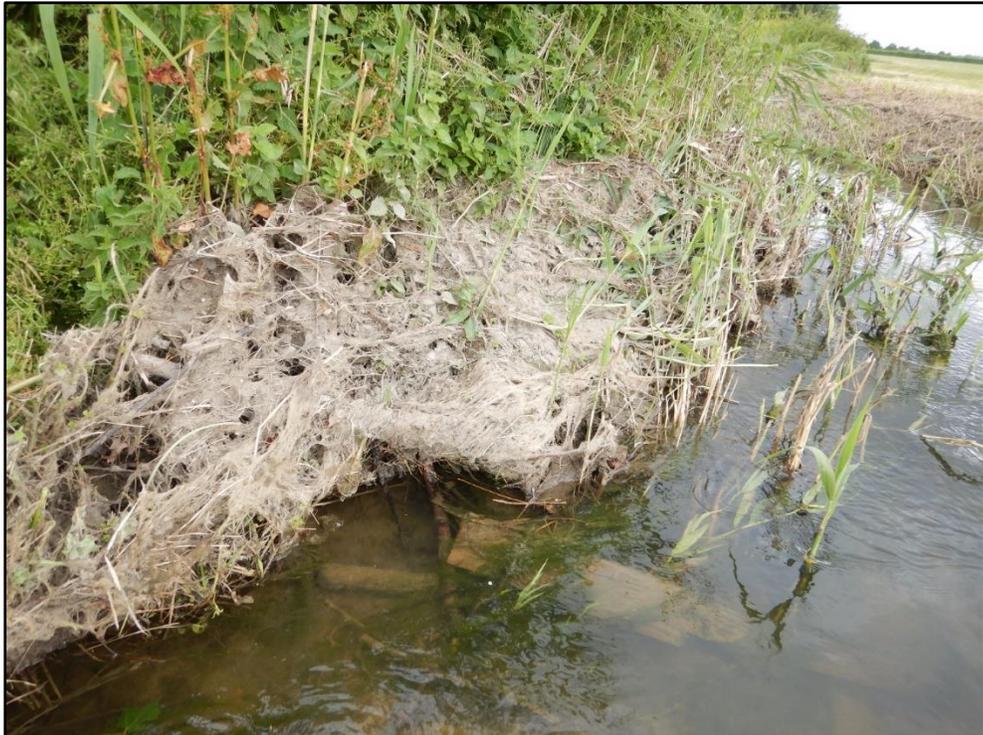
Pic 2 – The brook has risen in rainstorms.

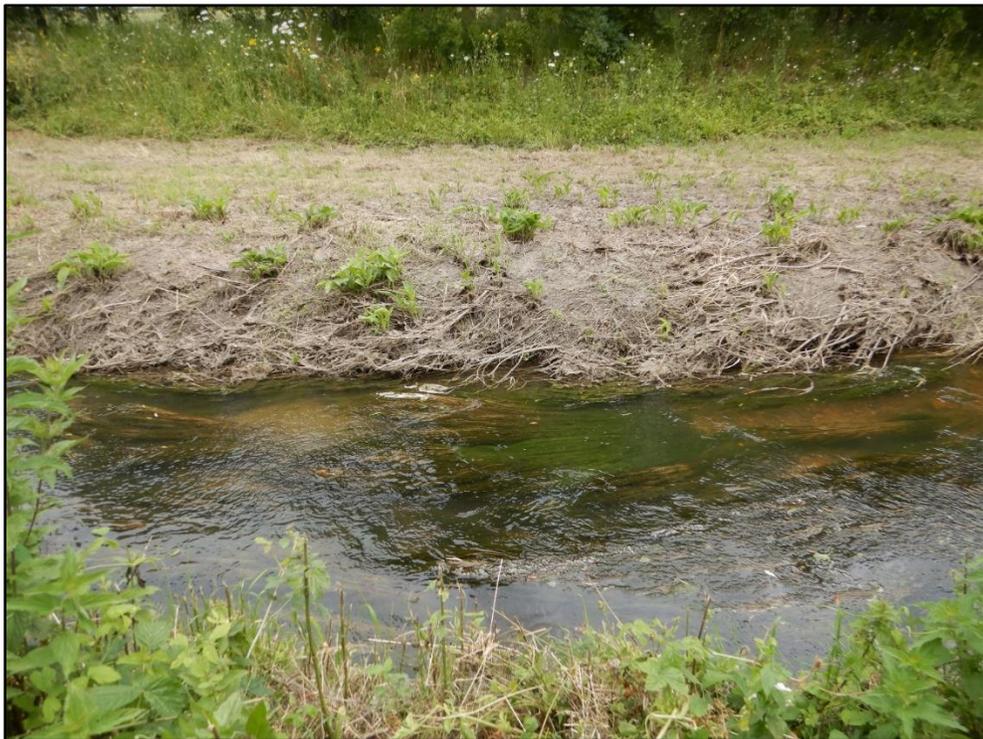
pendulous sedge were present. The bed of the brook was covered by aquatic plants dominated by watermilfoil, *Potamogeton* Sp, algae (pic 3) and very occasional lesser water parsnip. These aquatic plants provide cover for occasional silver fish (guessed to be roach or small chub). The occurrence of aquatic plants is important as they naturally retain a head of water, increase in-channel cover for fish, increase the extent of aquatic habitat available for invertebrates and provide shade. Shade is crucial in regulating water temperature (an issue likely to become increasingly important in hot dry summers) and for suppressing the growth of in-channel and marginal plants. The recent flail cutting has removed the shade provided by tall vegetation and has enabled flow to move down the brook, as opposed to being held back and spilling on to its floodplain (or in this case, the berm of the 2-stage channel).

Pic 3 – The brook’s aquatic flora is dominated by water milfoil and algae, suggesting nutrient enrichment,

- The lower brook does not contain the excessive aquatic plant growth that the upper brook has. Causes of this may be removal by high flows or disturbance by dogs and people, or simply the effect of partial shade. One would expect chalkstream plants of water crowfoot, lesser water parsnip and starwort to be prevalent. Observations of the brook upstream and downstream should be made to see if the plants are present and to identify causes as to their absence. If the underlying reasons can be understood, and addressed, it may be possible to translocate the plants into the reach from elsewhere in the brook (do not bring in plants from other watercourses).

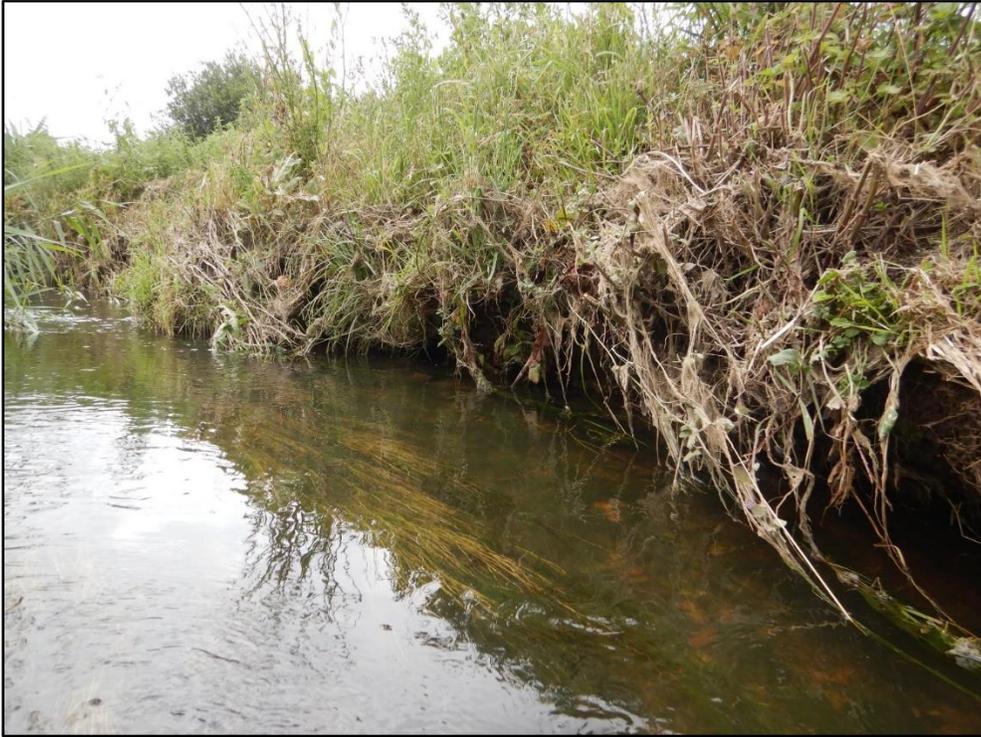
strength allowing undercutting to develop (pic 4). The undercut bank provides cover for fish and is a source of gravel input to the reach (pic 5).

Pic 4 – An undercutting bank provides valuable habitat for a range of fish species and biodiversity.

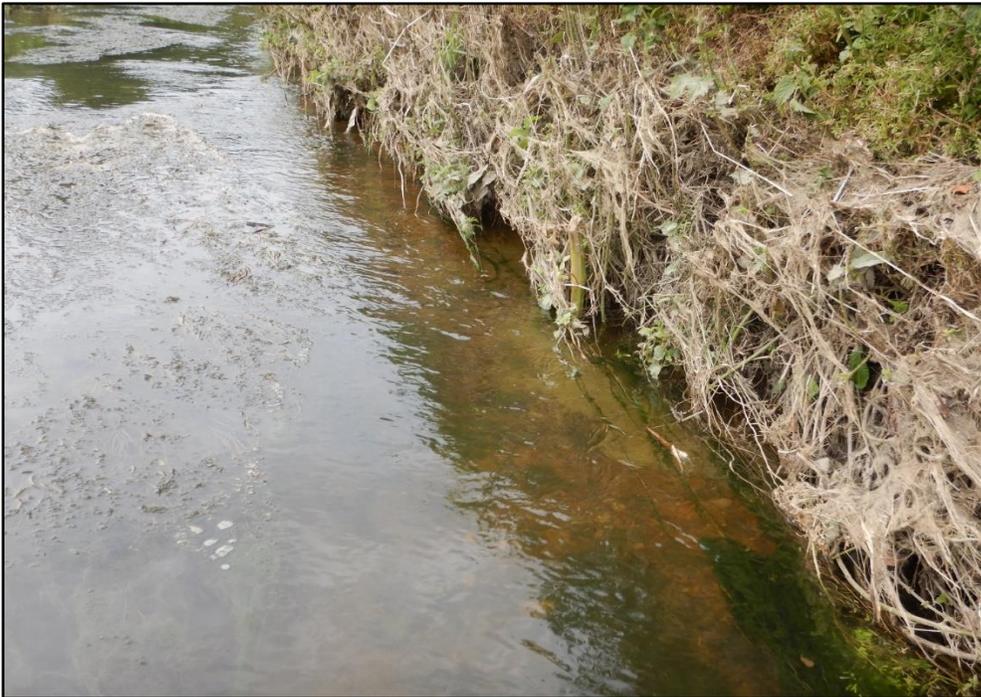
Pic 5 – Gravel covers areas of the bed, with small patches of clay marl exposed (grey colour). in others.

- The upper brook lacks the gravel bed present lower down. Reasons for this disparity should be investigated. Causes may be past dredging combined with a lack of supply from upstream and from the banks. If no natural supply is available, then gravel placement to restore the brook's bed form should be considered.

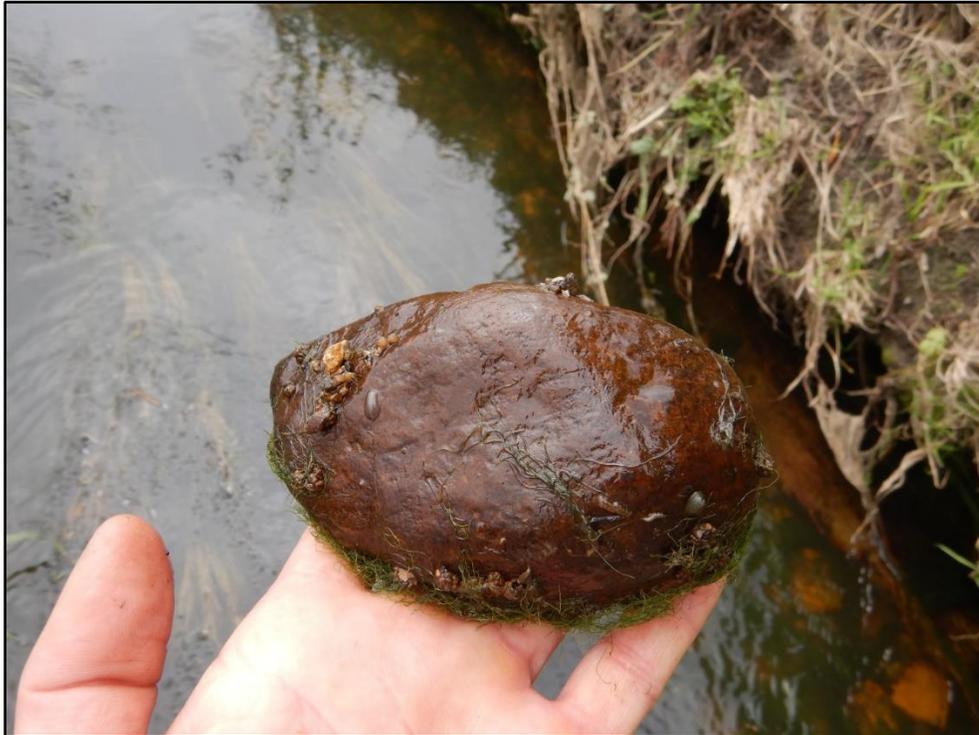
Stone turning revealed an encouraging array of aquatic invertebrates including mayfly larvae (*Baetis* sp.), cased and caseless caddisfly larvae, freshwater shrimp, freshwater limpets, snail eggs and flatworms. This supports the WFD classification of 'good' for the brook's invertebrates. In turn, aquatic invertebrates will support fish communities as they are consumed.

Pic 6 – A diverse array of aquatic invertebrates are present.

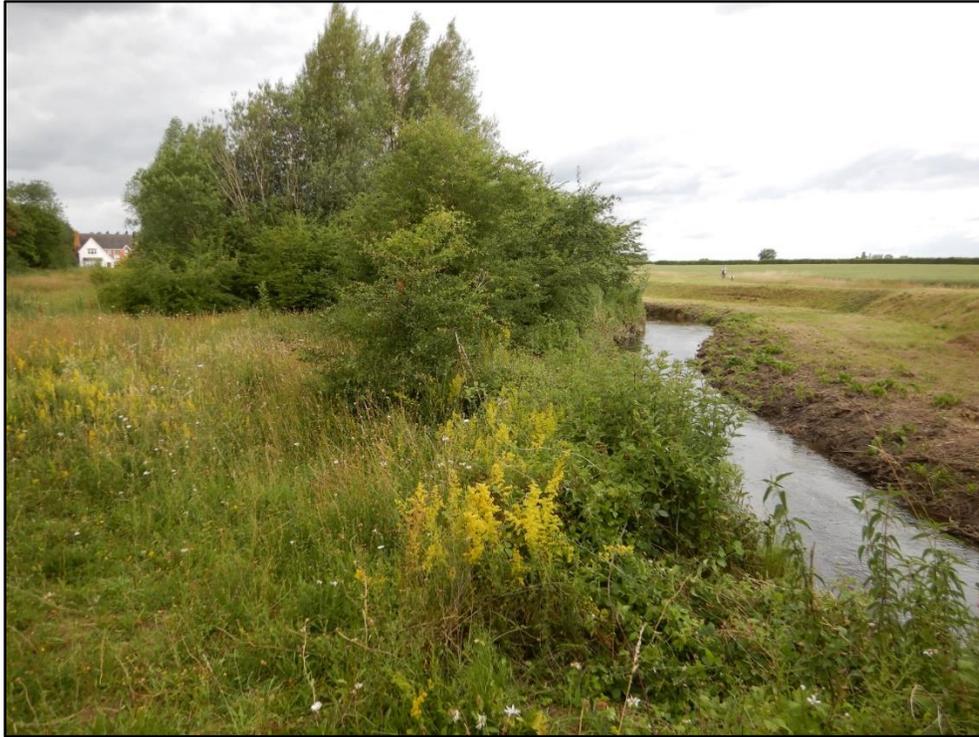
The adjacent land use of the LB is a flood attenuation area with a balancing pond receiving water from the nearby housing estate. The land has been successfully planted with wildflower seed mixes (pic 7). A small body of open water is present which is dominated by reedmace, together with lower growing emergent plants such as flowering rush and water plantain.

Pic 7 – The brook runs alongside a flood attention area which also doubles as an informal nature reserve.

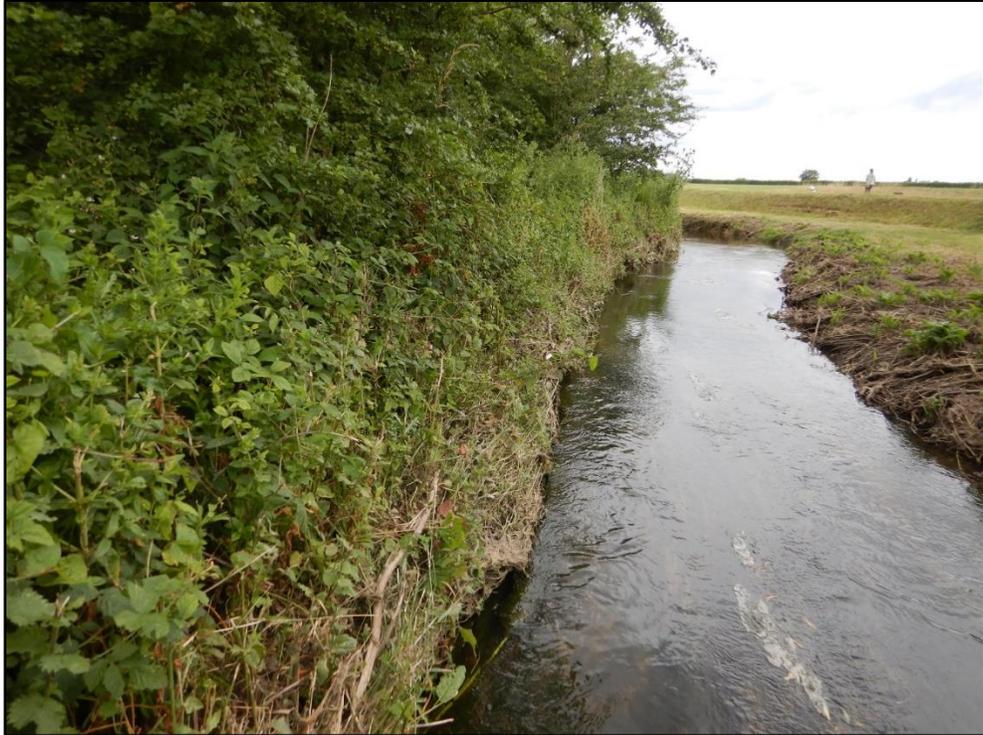
The quantity of flow in the brook was surprisingly good considering the dry spring. The brook's velocity was reasonable with flow diversity present as a result of the aquatic plants (pic 8). Flow diversity is important for supporting a range of aquatic invertebrates and potential spawning habitat for brown trout. In contrast, some slow flowing areas are accumulating fine sediment (pic 9) with the bed becoming smothered by fine silt, thus reducing the range of niches for aquatic flora and fauna. The depositional areas tended to be deeper and illustrate how the brook is trying to revert to its true, shallower, form.

Pic 8 – The brook's gradient combined with aquatic plants created flow diversity.

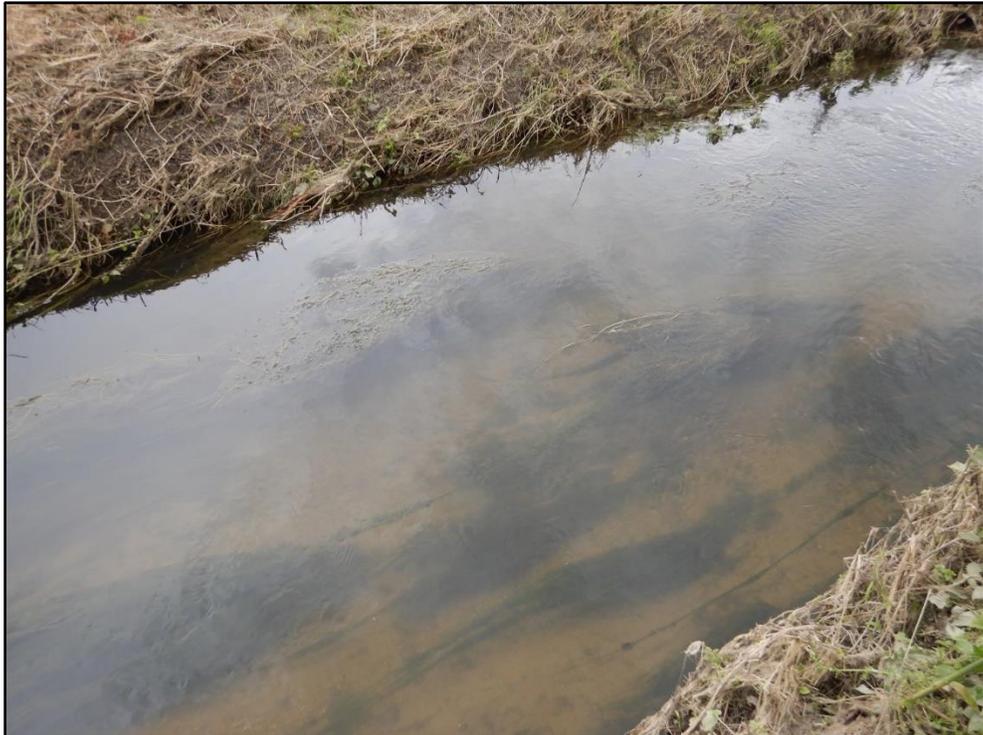
Pic 9 – Silt smothers the bed in deeper-water areas.

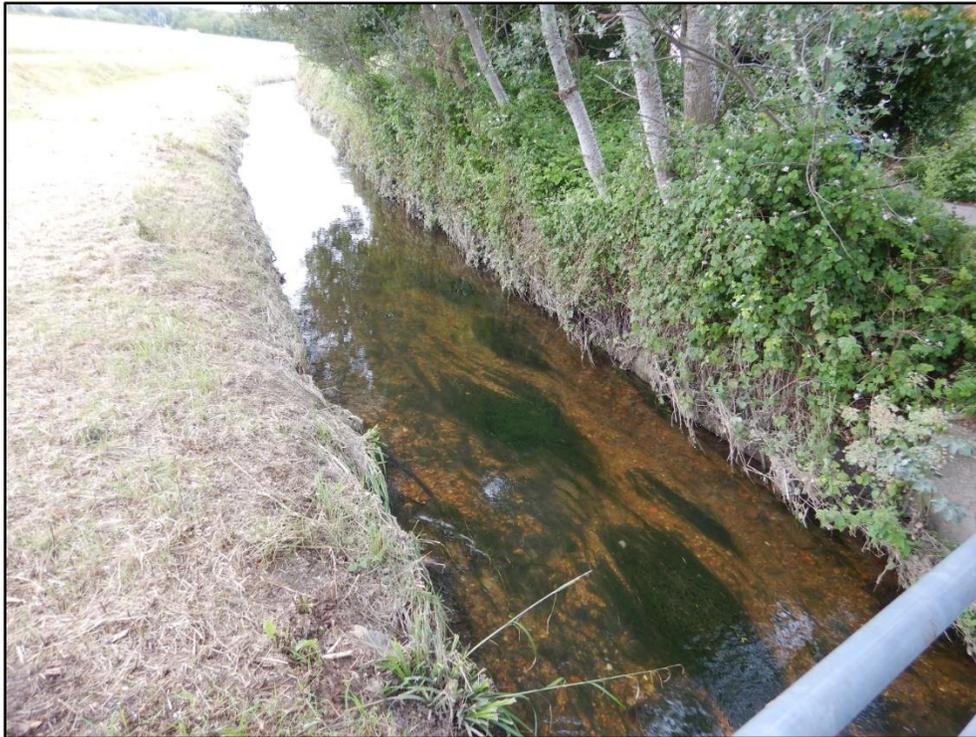
within the control of the recipient of the AV). The nature of the brook became markedly different with a much greater accumulation of gravel (pic 10).

Pic 10 – The downstream end of the upper part of the brook, note the gravel bed.

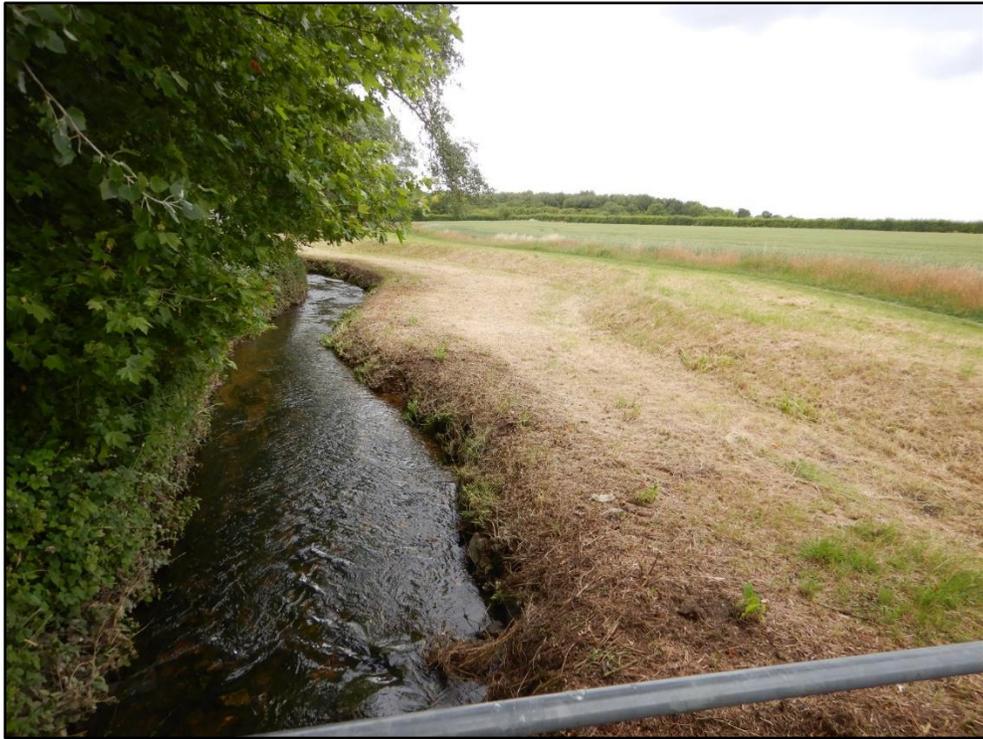
The lower brook retains its artificially uniform width of ~2m but the bed becomes dominated by deep deposits of relatively well-sorted gravel, supporting shallow riffles (pic 11). In places bank scour is occurring due to a lack of tree roots to maintain stability. The scour has also produced small pockets of deeper water (pic 12), in which small chub were seen (sometimes 10+, up to ~20cm). Deeper 'pool' habitat is present as a result of trees roots and bank protection work deflecting flow off a meander leading to increased bed scour. This habitat is important to the chub and could be utilised by brown trout, particularly when in combination with trailing vegetation (pic 13). Trailing vegetation and branches are particularly important as overhead cover for a wide range of fish, especially brown trout; they create small areas of shelter and increase the available number of lies within a river. Branches also present opportunities for invertebrates to fall into the channel where they become food for fish; those that extend into the water may also provide a

Pic 11 – Riffle habitat is present where the gravel bed bars have formed.

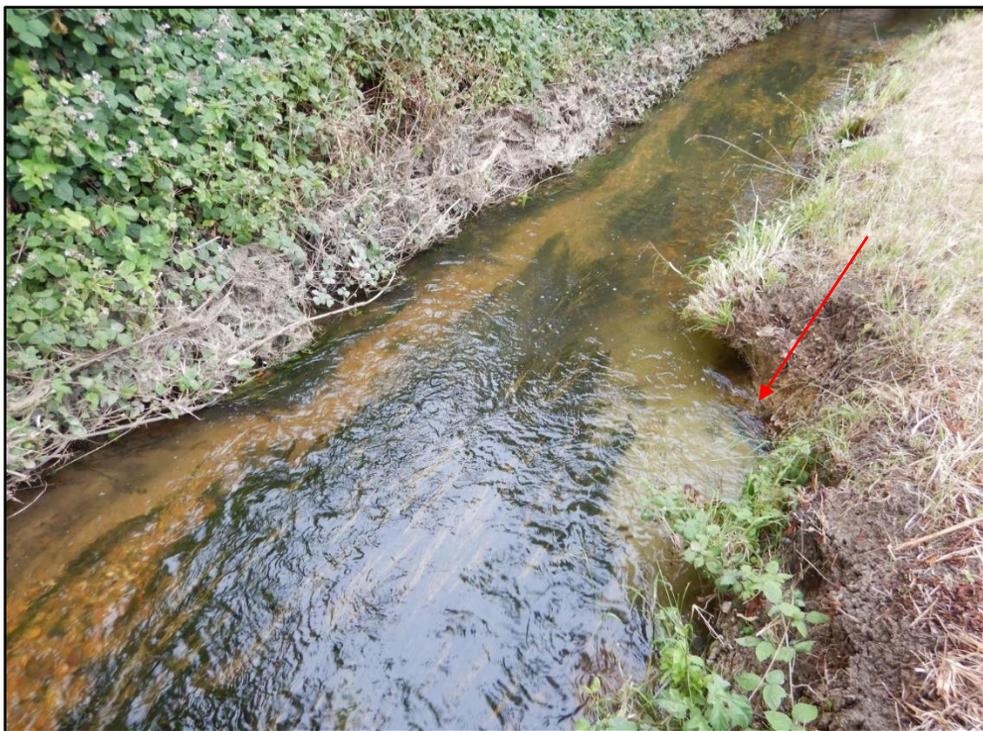
Pic 12 – Bed and bank scour produces pockets of deeper water which provide refuge for fish (red arrow).

- The RB margins are poorly vegetated and friable for much of the length. The bank could be re-graded and sown with a suitable wet grassland seed mix to establish a stronger sward. Allowing some shrub and tree species to grow will further strengthen the bank. Ultimately, the close flail cutting is removing marginal plants and leading to bank collapse. The collapsing bank results in a detrimental input of silt to the brook. The LB illustrates that stability can be achieved.

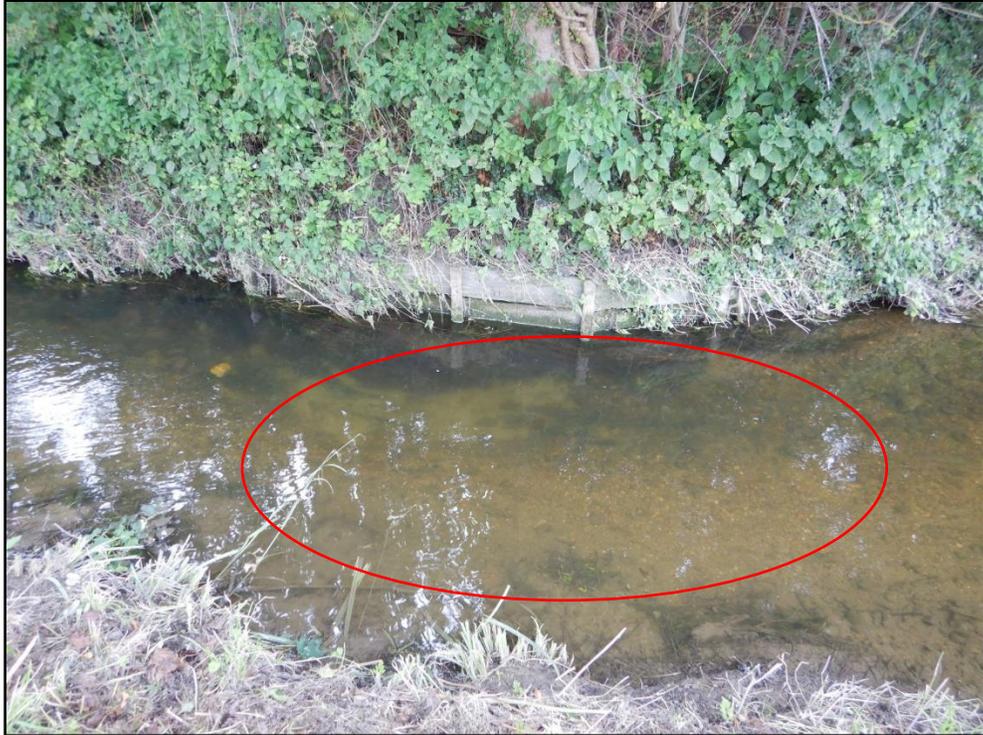
Pic 13 – Deeper 'pool' habitat (red oval) provides refuge for many small chub.

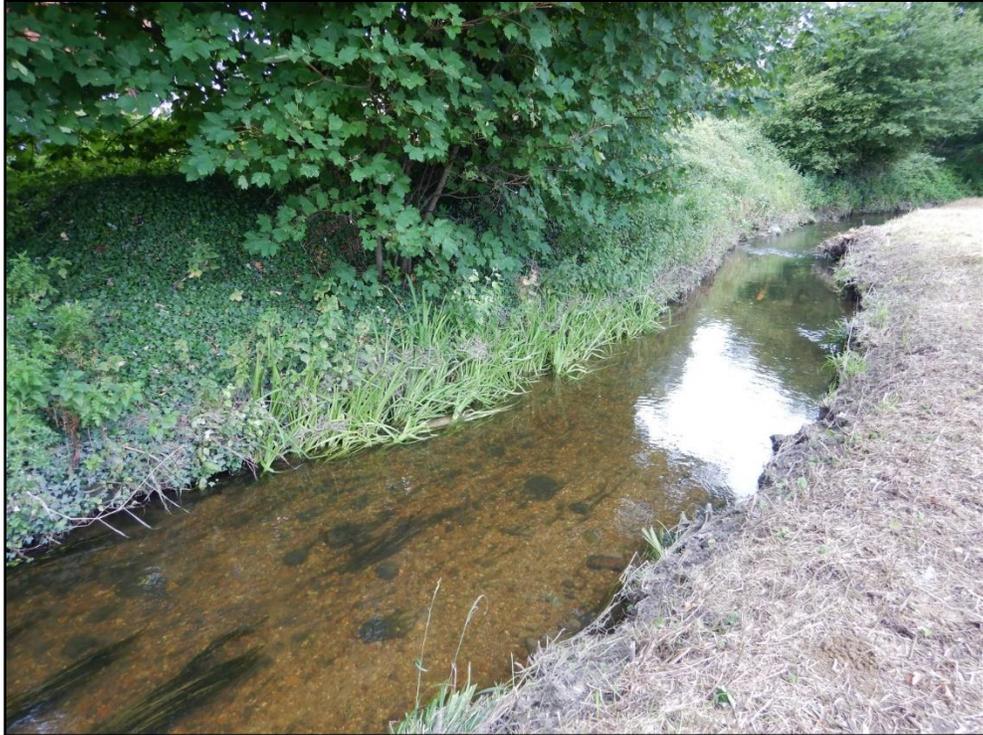
The shallow glides contain poorly sorted gravel with small stands of marginal branched bur reed. Bur reed can often choke the channel of small brooks and it was encouraging to see it retained as a marginal plant where flow and bedform prevent its ingress to mid-channel (pic 14).

Pic 14 – Branched bur reed occurs on the LB and (encouragingly) did not dominate brook.

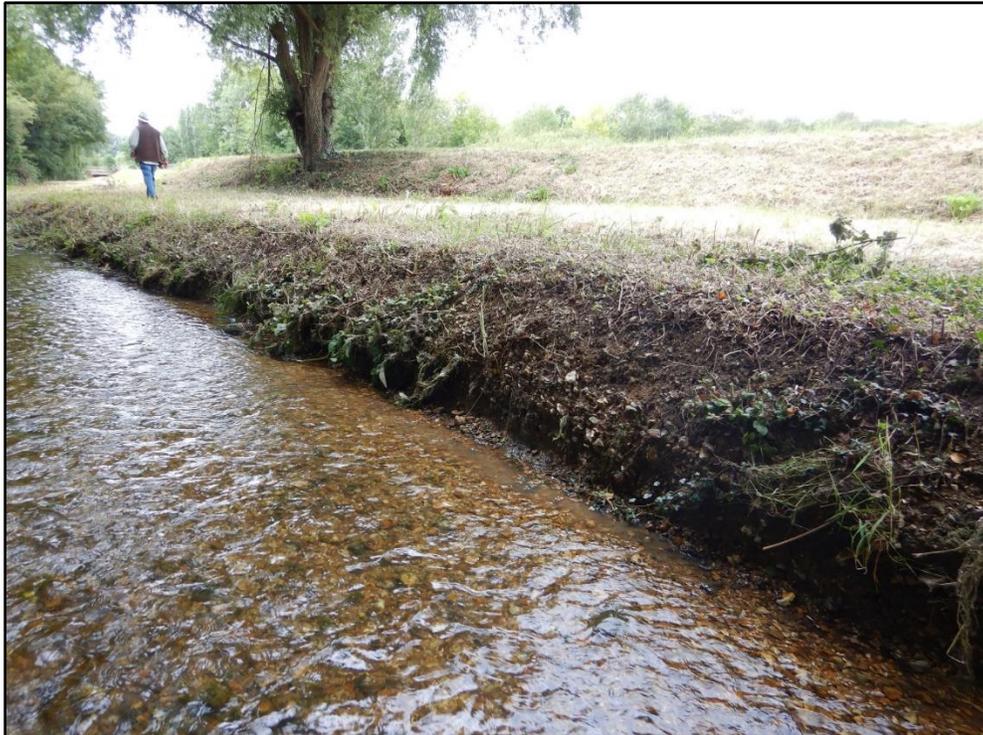
The eroding right bank provides a source of gravel to the brook (pic 15). In time, with better sorting and cleansing by flow, it may become suitable for trout to spawn upon. Dredging of the channel will disrupt and set-back the process. The body responsible for the current flail cutting may have intentions to dredge the channel and dialogue should be initiated to see how the reach can be better maintained for flood risk management and biodiversity.

Pic 15 – The gravel bed could provide spawning opportunities for brown trout if cover could be increased.

- The lower brook is relatively devoid of habitat but possibly has the best potential for brown trout due to its more rapid flow and gravel bed. There is a pressing need for LWM to be added (in various forms) to initiate bed scour together with sediment transport and sorting. LWM will increase underwater cover and aquatic invertebrate production. LWM could be added to the brook by the following means:

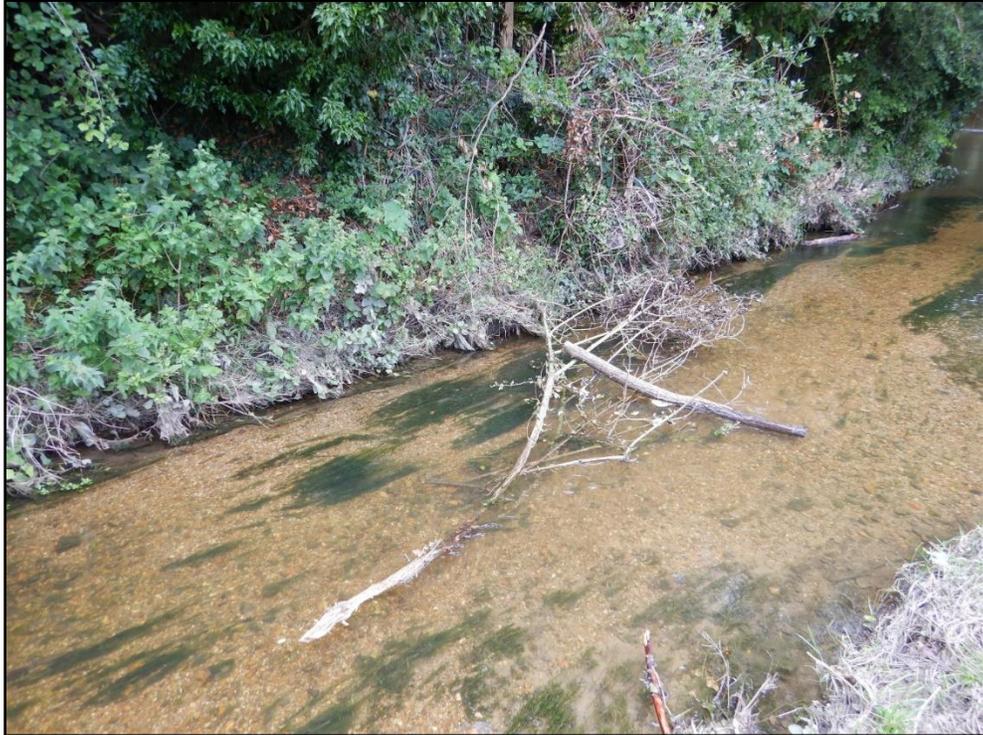
Pic 16 – The only piece of LWM seen in the brook. This kind of feature could be replicated in other gravel-rich areas to encourage bed scour, sorting and deposition, to diversify the bed profile.

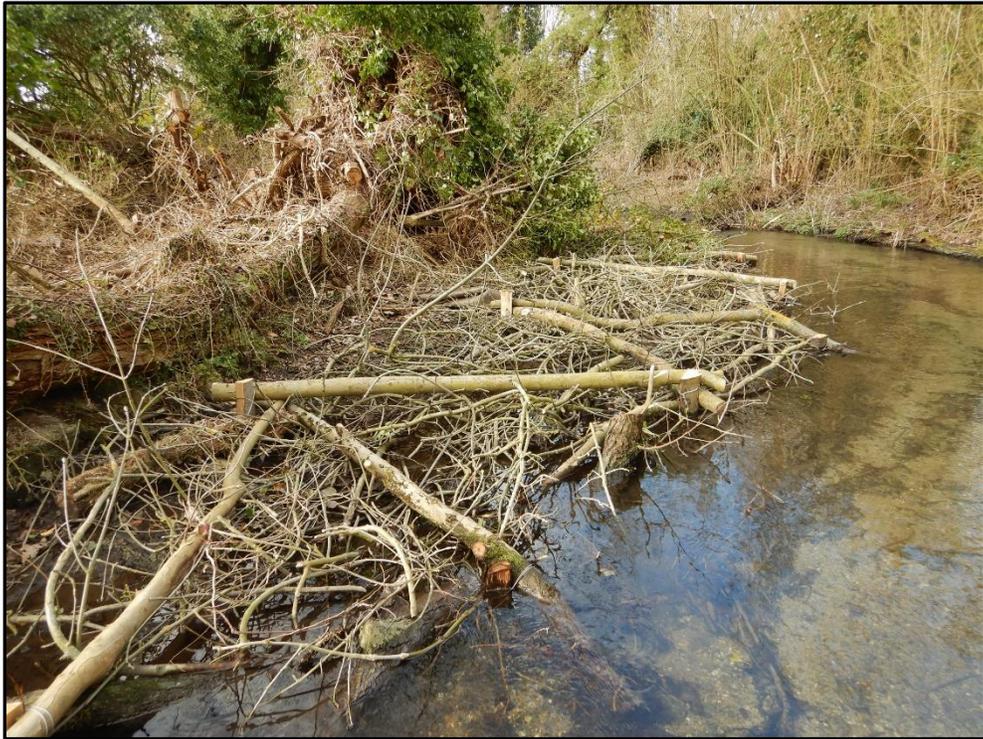
Pic 17 – A low-level brushwood ledge.

- Brushwood ledges (pic 17): provide complex cover at and below water level. Brash from tree thinning is pinned against the bank and is securely wired down or held with battens. The brushwood lattice provides niches for invertebrates and small fish, aids silt entrainment and provides a rooting substrate for plants to establish. In time (~3yrs), a brushwood ledge will become a vegetated berm if exposed to full sunlight. Vegetated ledges can also help to address bank erosion.

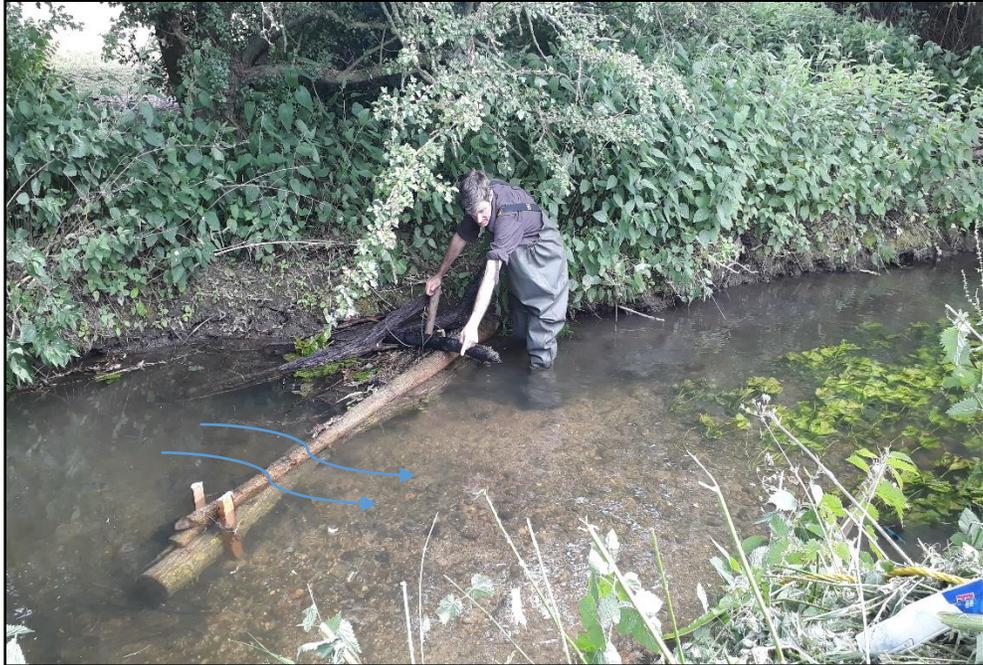
Pic 18 - A flow deflector used to focus flow and scour into the centre of the channel.

- Flow deflectors (pic 18): can be used to increase flow diversity and bed scour. They can be simple log deflectors or tethered tree stems. The complex flow they create results in bed scour, depth cover, sediment sorting and sediment transport.

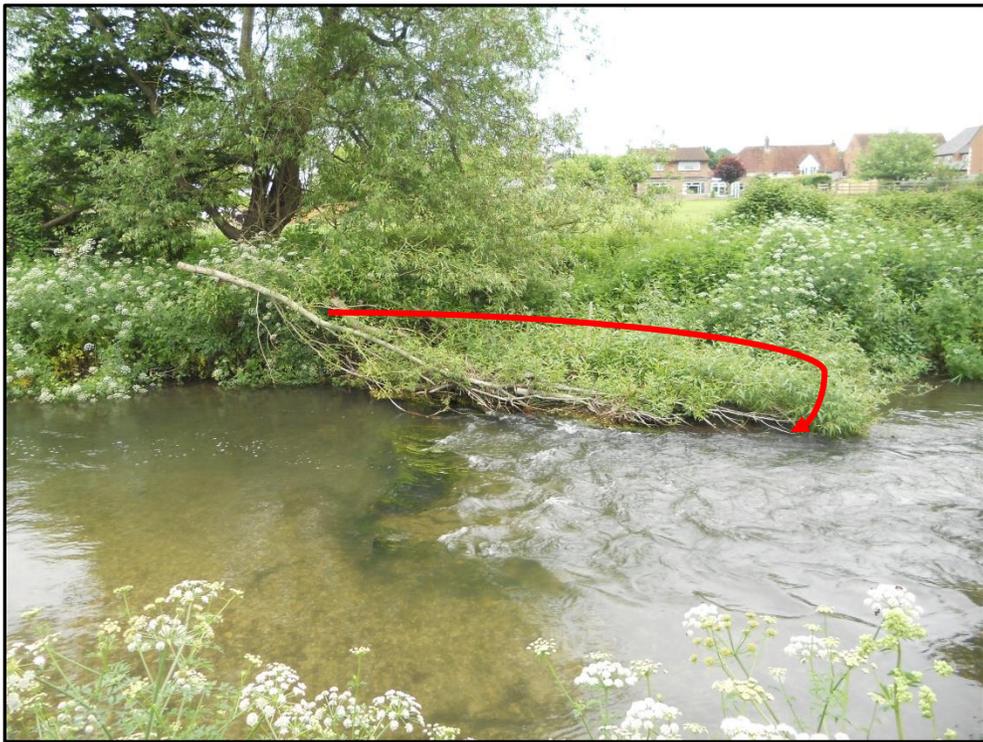
Pic 19 -This willow limb has been hinge-cut to lay at water level.

Tree hinging (pic 19): is a simple approach to managing the tree stock whilst providing cover at water level. Trees (large or small) are cut to produce an effect similar to hedge laying. Species such as willow and hazel respond particularly well. Laying retains a living hinge that secures the cut stem to the tree stump. With the tree-top laid at water level, it provides excellent over-head cover, flow deflection and, if beneath the surface, increased habitat for aquatic invertebrates and cover for fish against predators.
