WILD TROUT TRUST

Advisory Visit
Pendle Water
Reedley, Lancashire

10/09/2025

River	Pendle Water
Waterbody Name	Calder - Pendle Water to conf Ribble
Waterbody ID	<u>GB112071065490</u>
Management Catchment	Ribble
River Basin District	North West
Current Ecological Status	Moderate
U/S Grid Ref inspected	SD8345834841 (53.809620, -2.252538)
D/S Grid Ref inspected	SD8273634897 (53.810038, -2.263624)
Length of river inspected	1.1 km

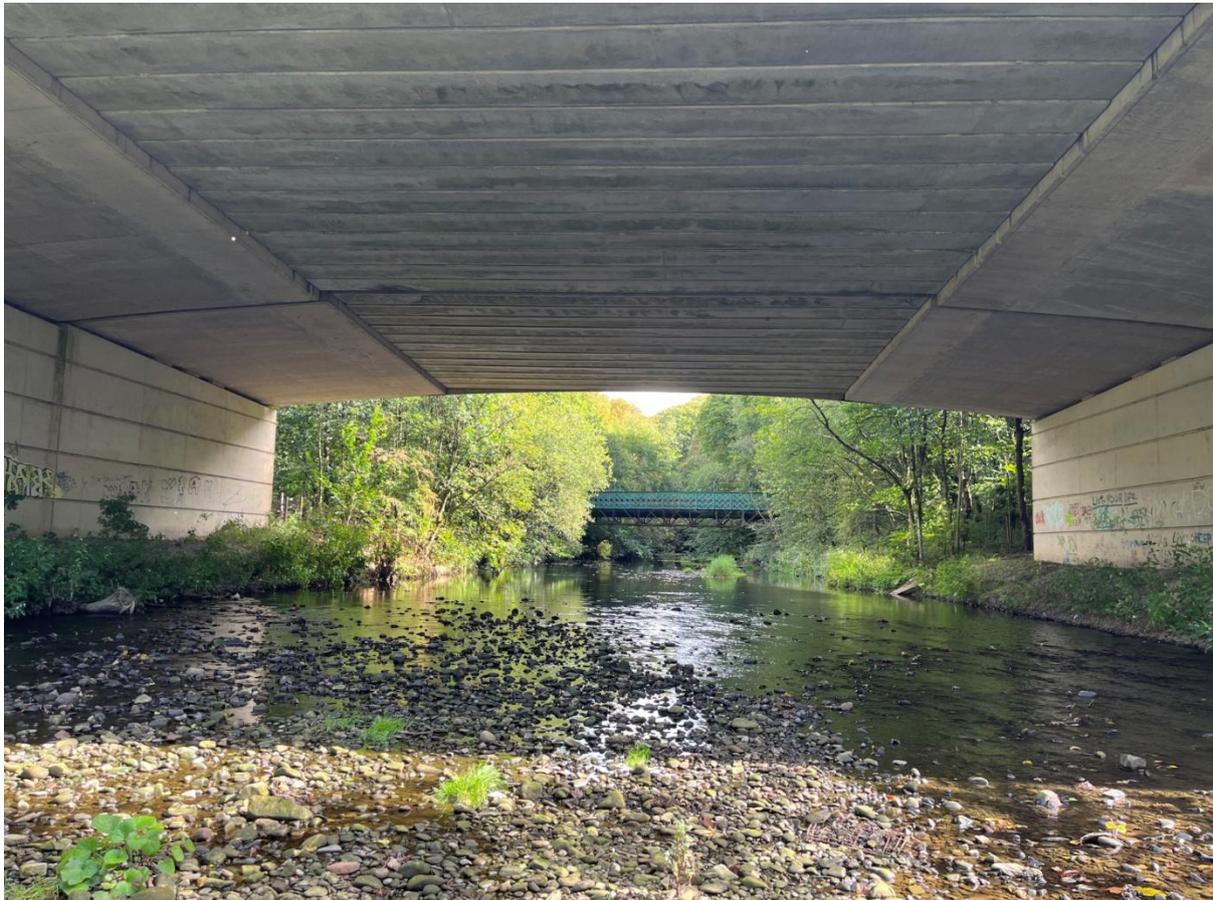
The surveyed reach was walked in a downstream direction. Observations were recorded and are reported following that same downstream, sequential progression. At the upstream limit the M65 bridge crosses the river at 53.809620, -2.252538 and, upon entering the water, an abundance of cobble and gravel substrate is apparent (Fig.1).

Figure 1: Partially vegetated cobble and gravel bar indicating an abundant supply of relatively mobile substrate.

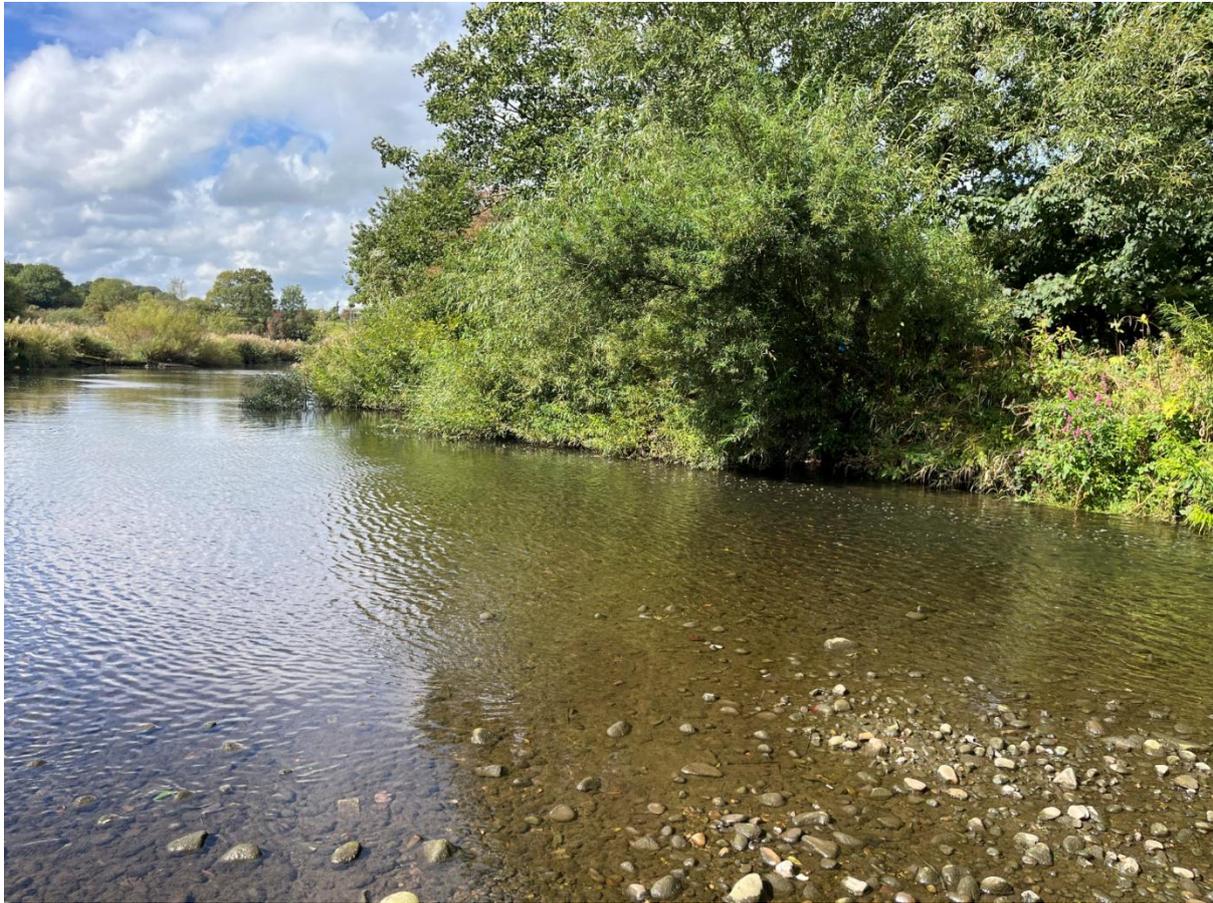
In this reach some shaggy, trailing marginal vegetation provides valuable cover for fish of all sizes while the presence of Himalayan balsam (*Impatiens glandulifera*) is also notable (Fig.2). Invasive, annual plants such as balsam tend to dominate native vegetation and, upon dying back in winter, leave banks susceptible to widespread elevated rates of erosion.

Figure 2: Himalayan balsam (right of frame) competes with the surrounding native vegetation. Note the low-hanging vegetation cover on the RB (centre frame) and overhanging tree canopy. This type of cover is essential in balancing predator/prey interactions.

- Hand pulling using volunteer parties (potentially drawing on local wildlife groups and wider volunteering networks)
- Strimming below the first node while plants are in flower
- Eradicate known stands of Japanese knotweed while still relatively small
 - Stem injection of knotweed stands by appropriately certified personnel
- Establish regular Riverfly monitoring at points upstream and downstream of areas of concern (e.g. outfall from wastewater treatment works, ochre-rich outfall point) to gain an understanding of baseline invertebrate populations and any point-source impacts
- Within existing (and any created) riparian woodland sections, monitor for and retain any large dead-fall trees so as to promote localised bed scour and improve spawning gravel conditions as well as diversifying channel morphology

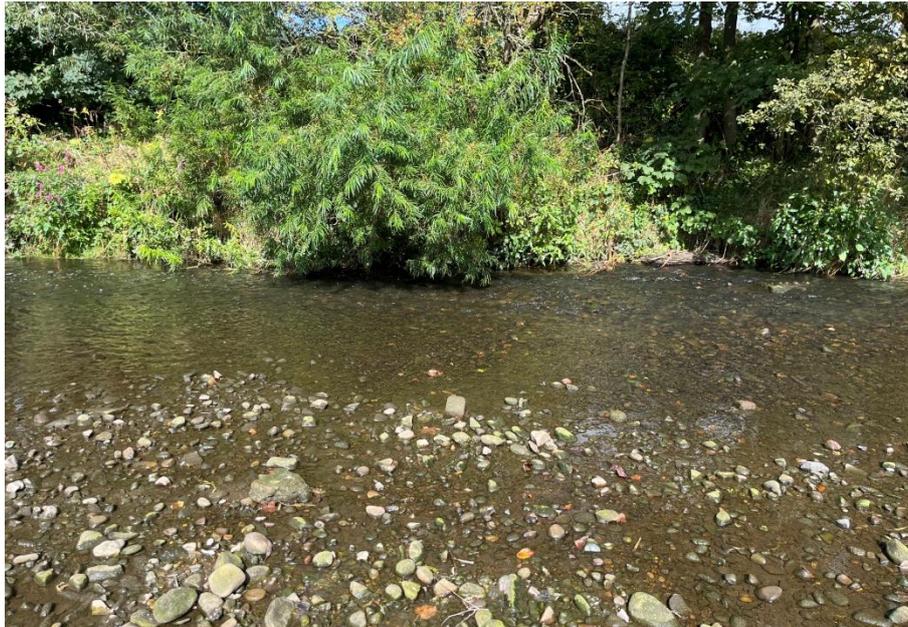
Figure 3: Low, trailing branch cover on this riffle will provide some year-round cover from predation. During hot weather, vital cooling is also created by the shade it provides.

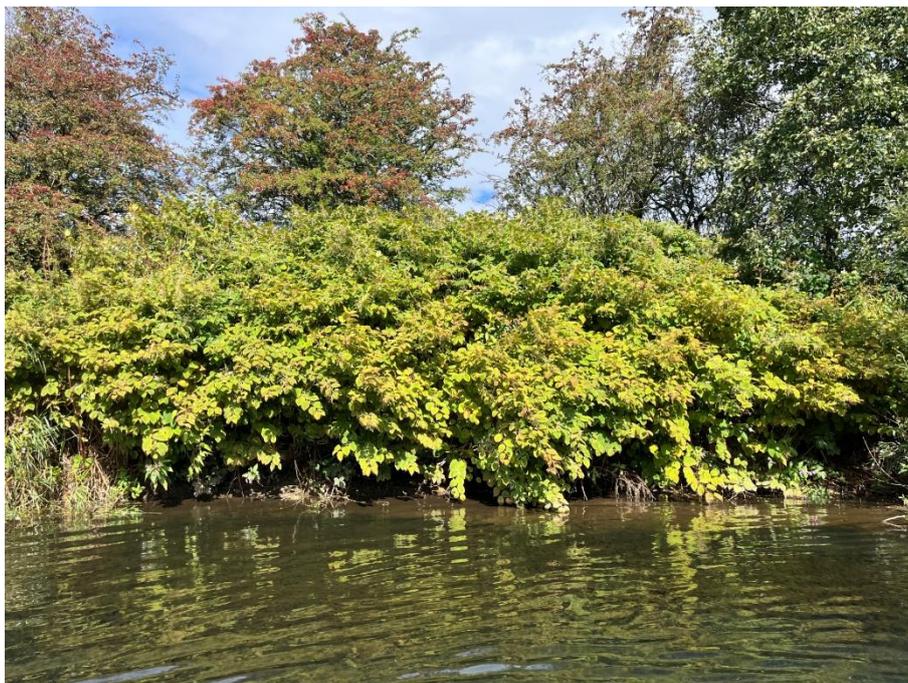
Figure 4: This Japanese knotweed stand at 53.809469, -2.253403 will die back to leave bare earth in winter.

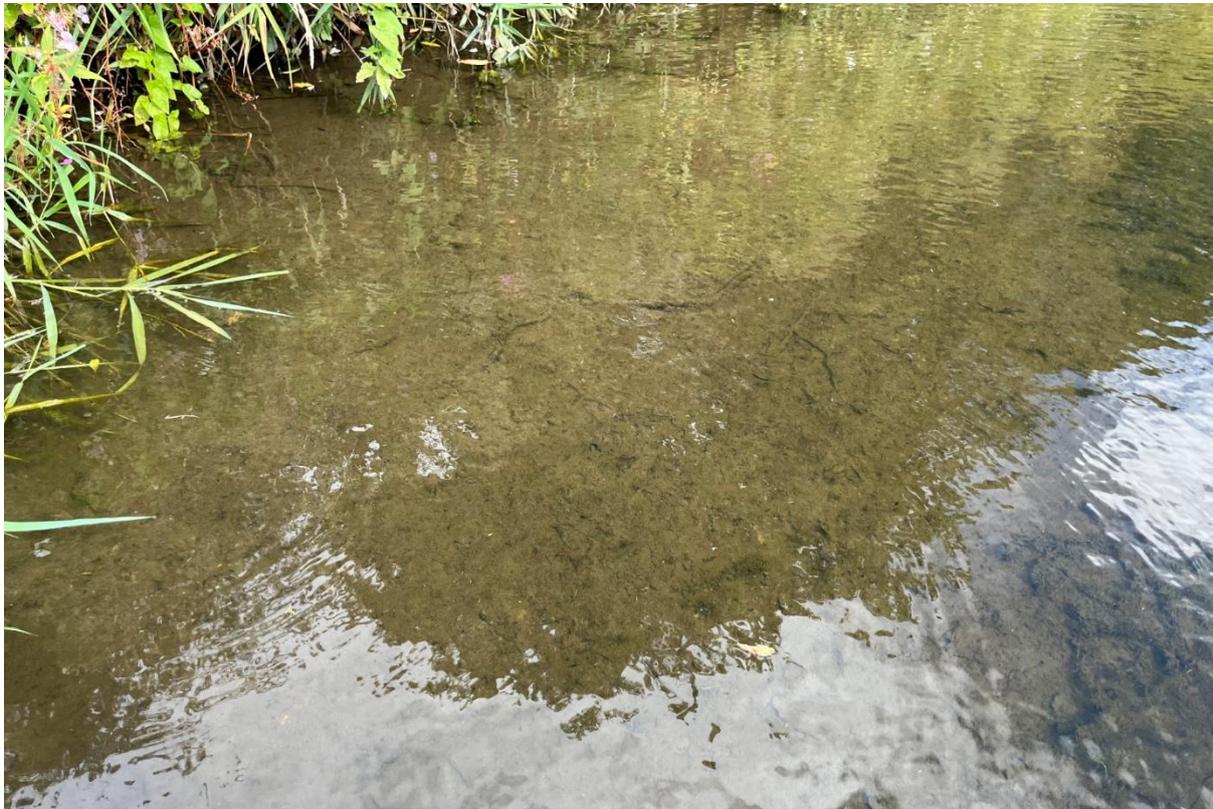
When wading the channel, the high bed-loading of fine silt and sand is very apparent (Fig. 5). Consequently, even though gravel and cobble substrate is in plentiful supply, much of it is either choked or entirely buried by fine sediment.

Figure 5: Thick deposits of silt and sand completely burying the abundant cobble and gravel substrate below.

Complete burying, or simply the choking of gaps between larger substrate particles with fine sediment, both create simpler habitat with less structural variation. This effect is comparable to the loss of trailing and submerged complex cover provided by vegetation. Essentially, the fewer complex nooks and crannies present within a river reach, the fewer different species can find their ideal microhabitats in which to thrive. To compound habitat homogenisation impacts, fine sediment often also carries elevated nutrient levels from surrounding land into the watercourse. Associated algal blooms and increases in microbial respiration will suck dissolved oxygen out of the water – particularly during warm weather. Nutrients and fine silt may also favour in-channel weed growth of submerged macrophytes that favour organic enrichment and/or soft riverbed substrate. For instance, in glide reaches of Pendle Water, large stands of invasive, submerged macrophytes were noted. These were thought, on preliminary observation, to be either *Elodea* or *Lagarosiphon* species (e.g. Fig.6).

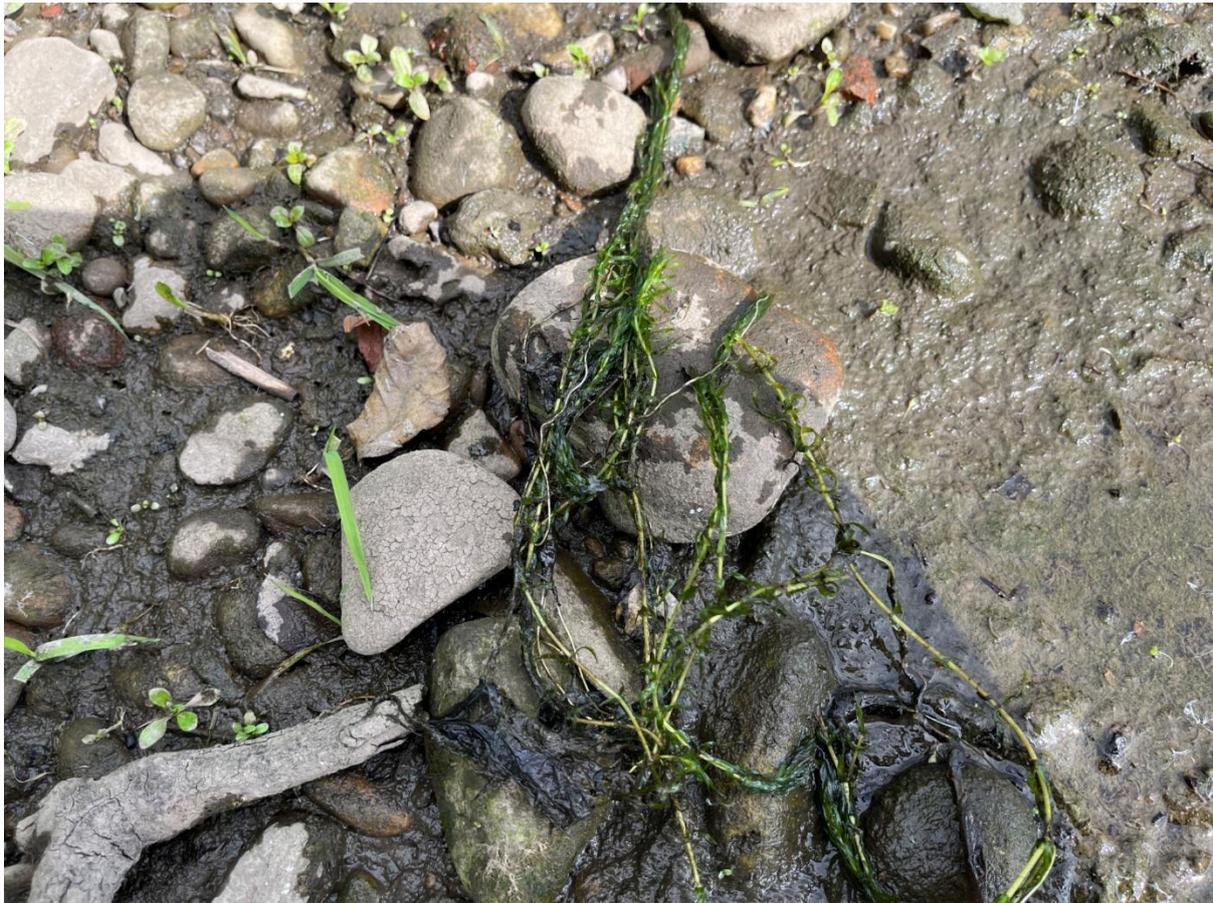
Figure 6: Sample of submerged macrophyte (probably *Elodea nutallii* or *Lagarosiphon sp.*) present as substantial stands in steadily flowing areas of the surveyed reach.

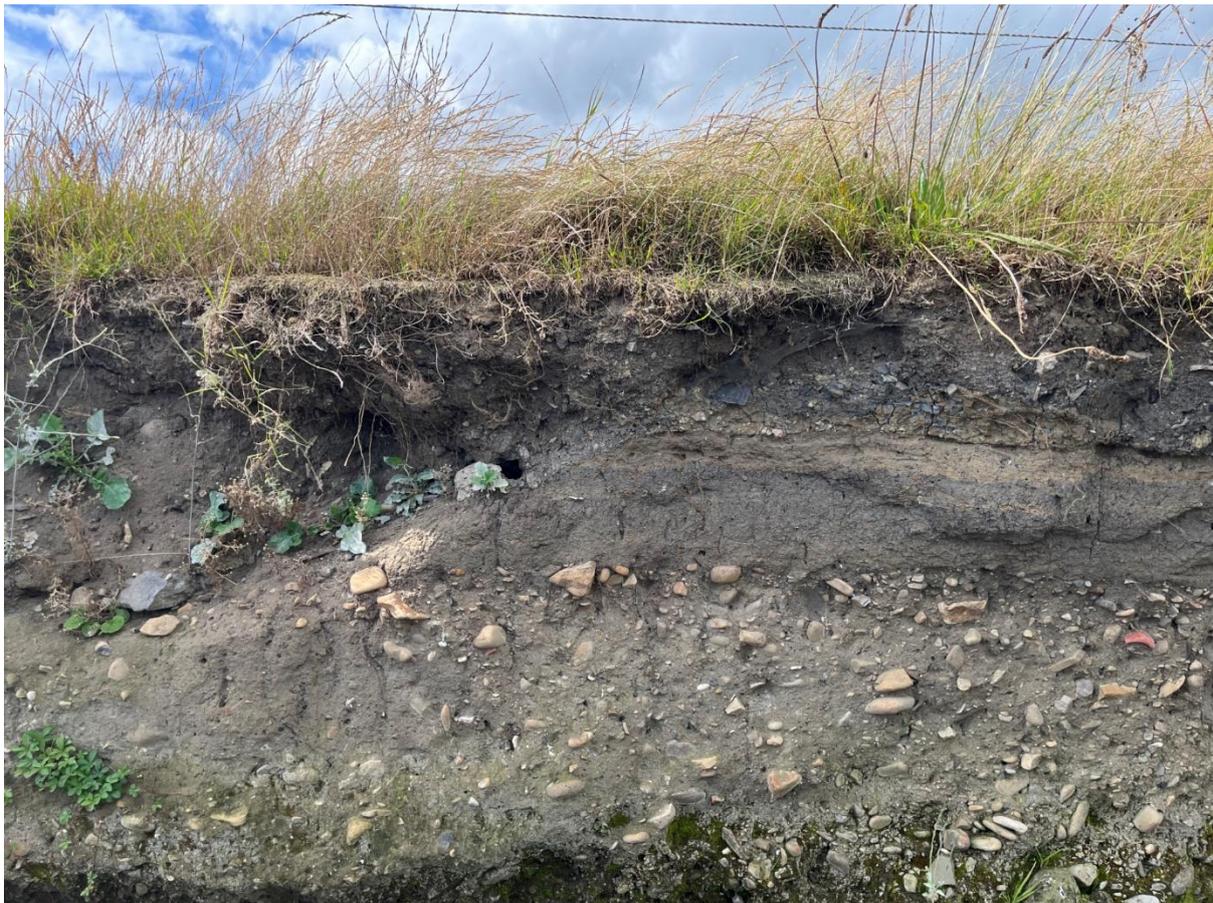
Within the surveyed reach, there are long sections of shallow root-horizon banking with little to no resistance to erosion. Looking at the exposed cross sections of eroded cliff features is a perfect illustration of the mechanisms at play. The shallow root horizon associated with grazed land is clearly visible (e.g. Fig. 7).

Figure 7: Shallow root horizon associated with grazed grassland. Little resistance to erosion and a source of large tonnage sand/silt inputs along with gravels.

- Creation of an effective riparian buffer strip of ungrazed, woodland vegetation via
 - Exploring options with relevant landowner(s) to set back fence-lines to a functional distance from the bank top (recommended 10-12m)

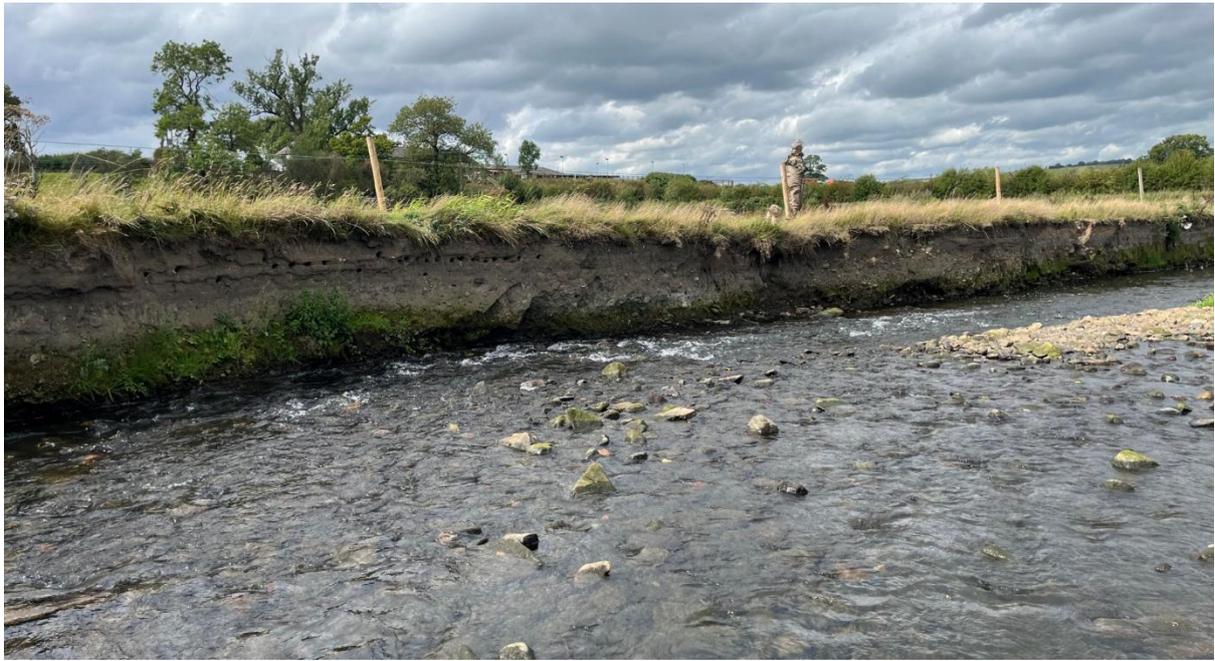
The rate of erosion appears to be causing problematic land loss to the landowner due to the river's movement under and through the fence-line bordering the surrounding fields (e.g Fig. 8). However, what is also easy to see is how the lateral migration of the channel creates valuable erosion as it meanders, and provides an important source of cobble and gravel. Eroded cliffs clearly show the layers of alluvial deposits of cobble and gravel at the bank-toe throughout the reach (e.g. Fig.9). Consequently, it is the rate and extent of erosion that is currently causing a relative oversupply of fine sediment and loss of surrounding land on the LB for a significant proportion of the surveyed reach.

Figure 8: Some posts in this fence-line were suspended over a clear drop by a thin surface crust of topsoil. Note also the lines of oval burrows well above the winter high water mark which may be sand martin nest sites. Other, scattered burrows close to the summer water level may belong to signal crayfish.

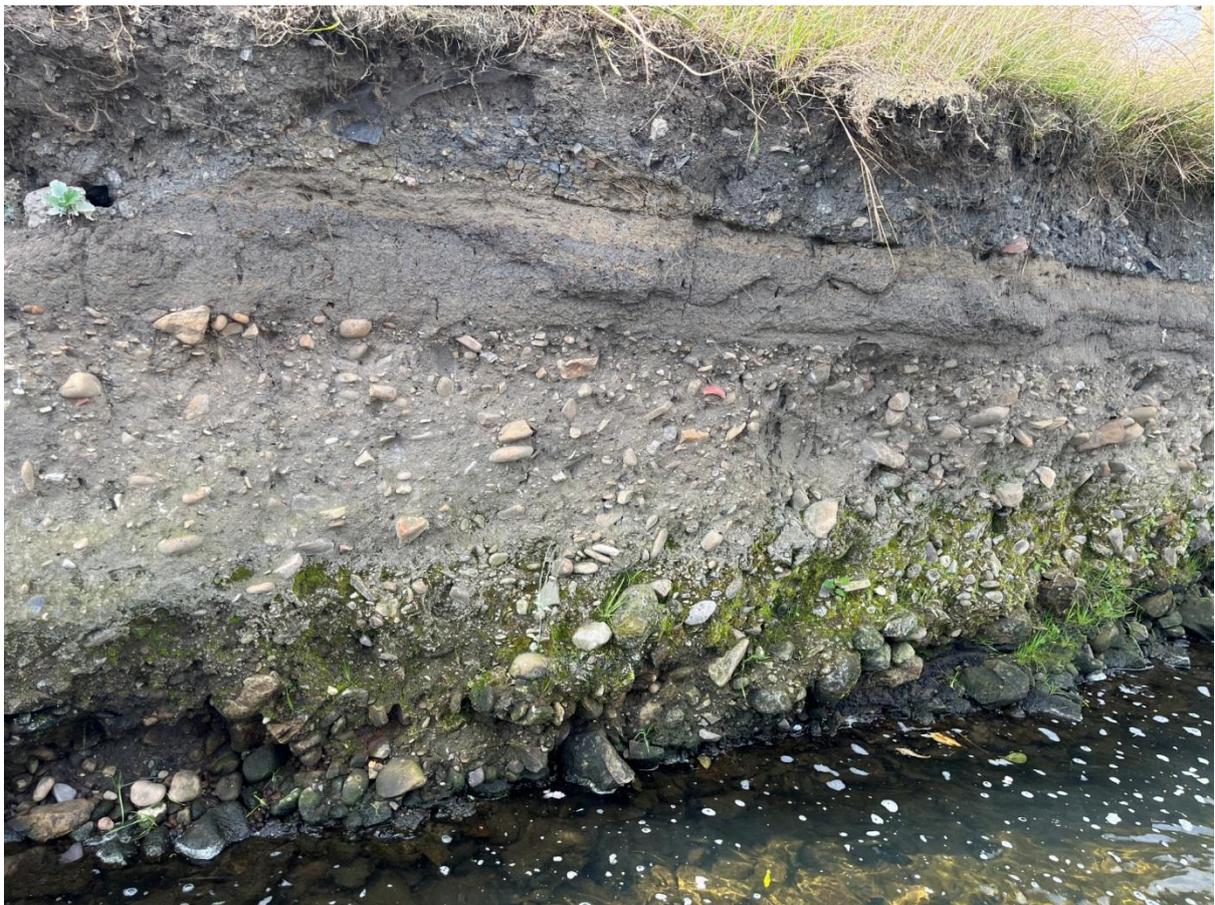
Figure 9: Gravel and cobble at the bank-toe (where the vertical bank joins the riverbed). This is a major source of spawning gravels via erosion during spate events.

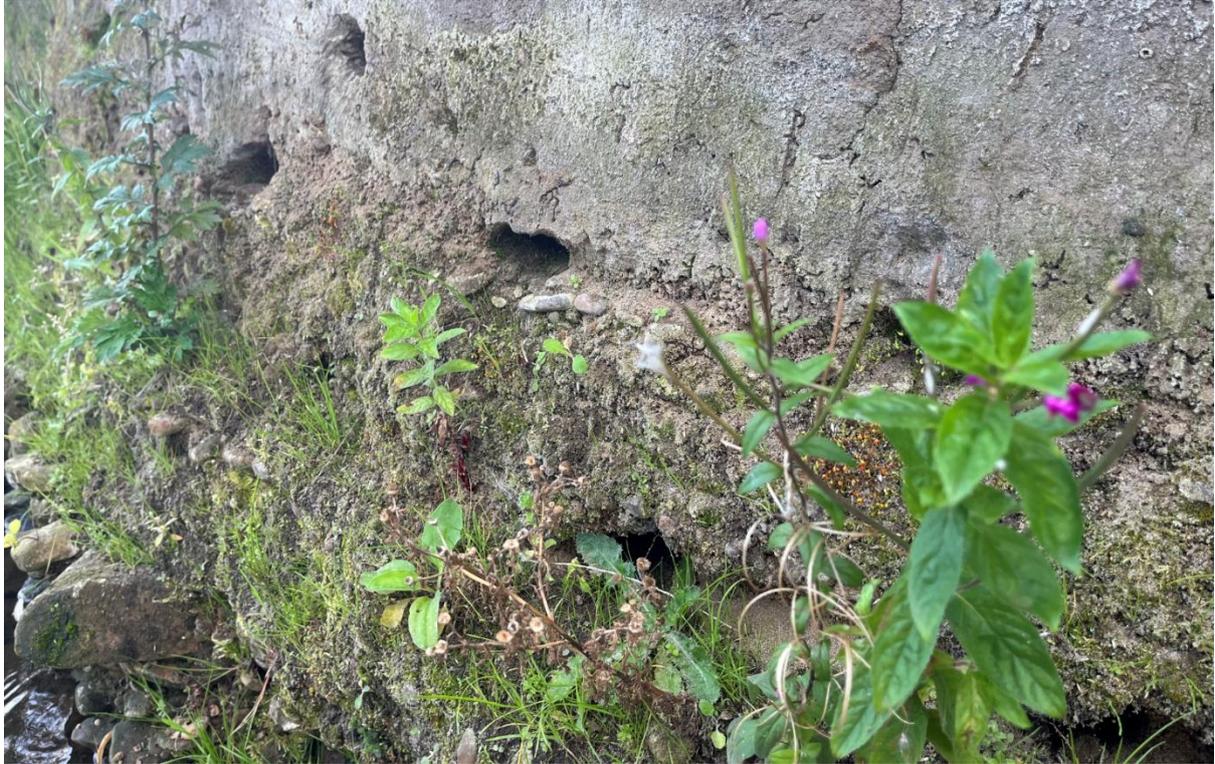
Along with multiple flat, oval-shaped burrows at or below the winter high-water level in the bank (Fig.10), a discarded claw (Fig.11) suggests that

Figure 10: Probable invasive crayfish burrows.

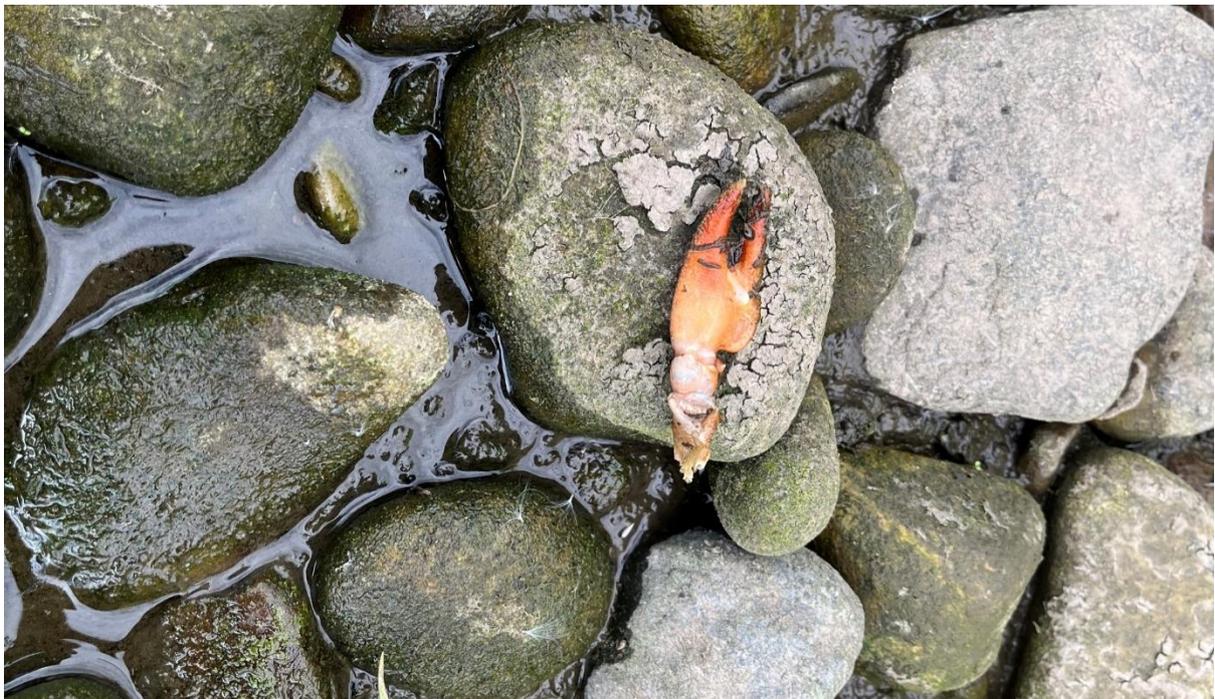
the river has a high population density of invasive crayfish species. As well as displacing native crayfish, the invasive species tend to achieve such high population densities that their omnivorous feeding will substantially impact invertebrate communities. No reliable means of control have yet been identified with variable results reported from "sterilised male" release trials.

Figure 11: Discarded claw from invasive signal crayfish.

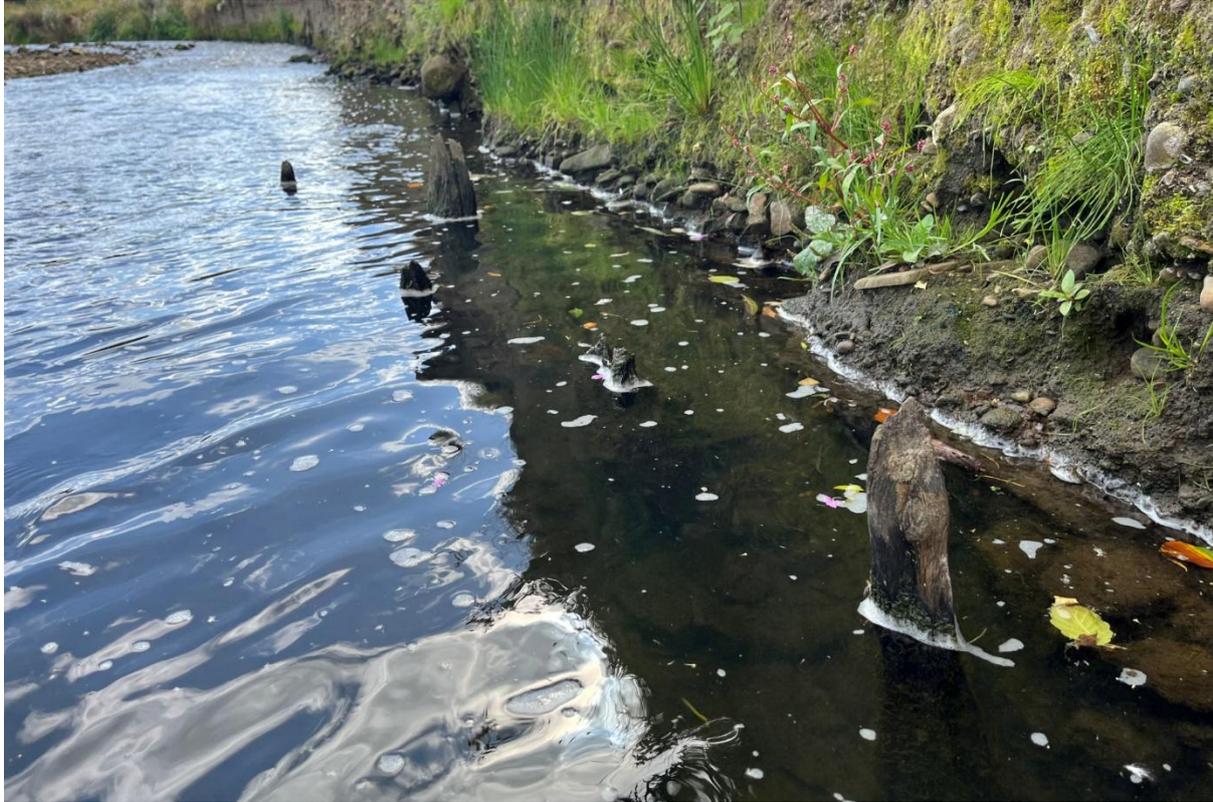
What appears to be the remains of previous attempts to reduce the rate of bank erosion were noted on the LB around 53.809246, -2.254396 (Fig.12). While it isn't possible to be certain of the intended aim of the wooden stakes driven into the riverbed, that approach is consistent with reinforcement of the bank toe.

Figure 12: Remains of old wooden stakes driven into the riverbed, presumably as part of an effort to stabilise the bank toe.

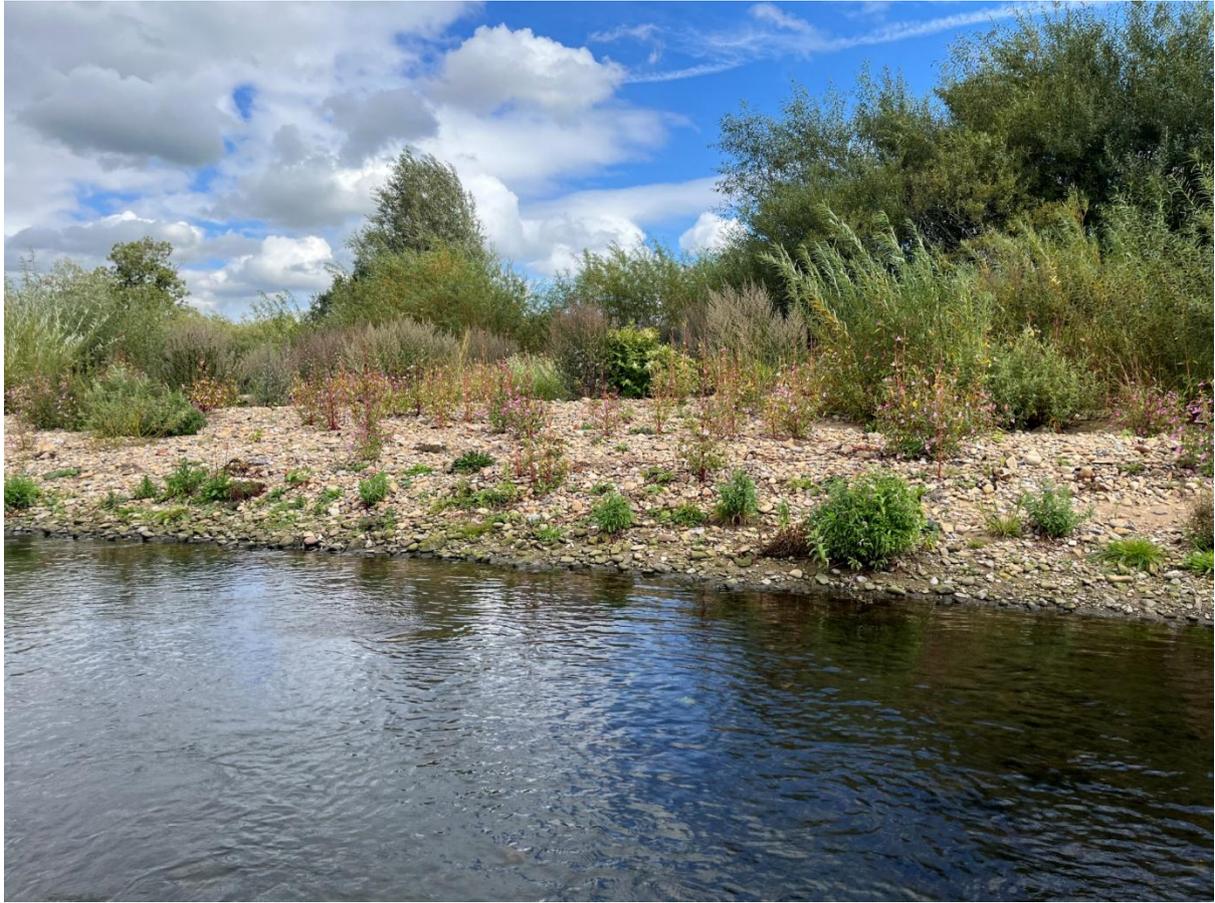
Contrasting the extensive eroded cliff-face of the LB with deposition of substrate towards the RB (Fig.13) gives an important perspective on dynamic river processes. Both the volume of deposited material (cobble, gravel and sand) and the presence of early successional plant colonisation give clues to the power and dynamism of this system. Most obviously, there are large quantities of substrate being supplied to and moved through the system. This is easy to see from the extent of depositional features such as point bars (deposition on the inside of bends) and also mid-channel island formation. However, relatively high frequency significant disturbances due to supply and redistribution of substrate is evident in the pattern of plant colonisation. Figures 13 and 14 show large expanses of exposed substrate along with young, early colonist plant specimens. Longer-standing areas of substrate have been consolidated by greater establishment of vegetation in terms of ground coverage and age of plants. The stage of plant colonisation provides an estimate of the frequency with which that habitat is disturbed and substrate is turned over in response to spate flows.

Figure 13: Point bar/mid-channel island on the RB that appears to have an ephemerally wetted channel adjacent to the junction with the surrounding floodplain land. Note the spectrum of vegetation coverage and age spanning from newest in the foreground (most frequently disturbed) to most established in the background (less frequently disturbed).

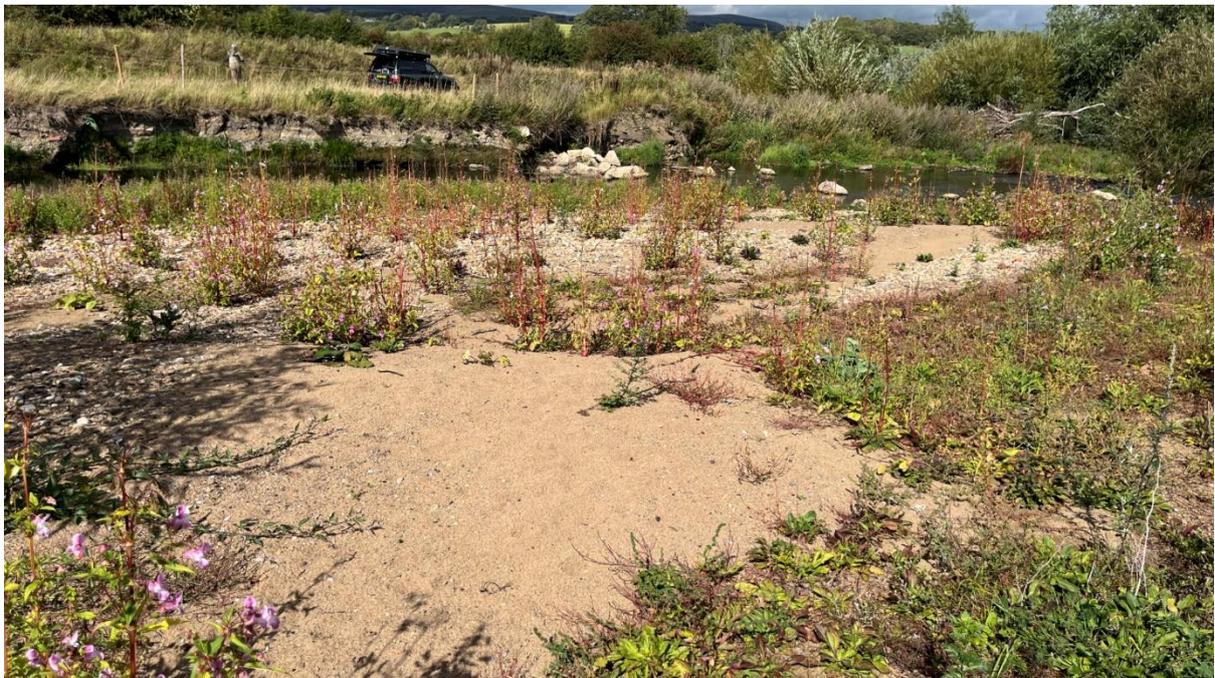
Figure 14: Indication of the proportion of sand deposited as part of substrate matrix in the point bar/ephemeral island. Himalayan balsam and other ruderal/rapid colonising species in evidence.

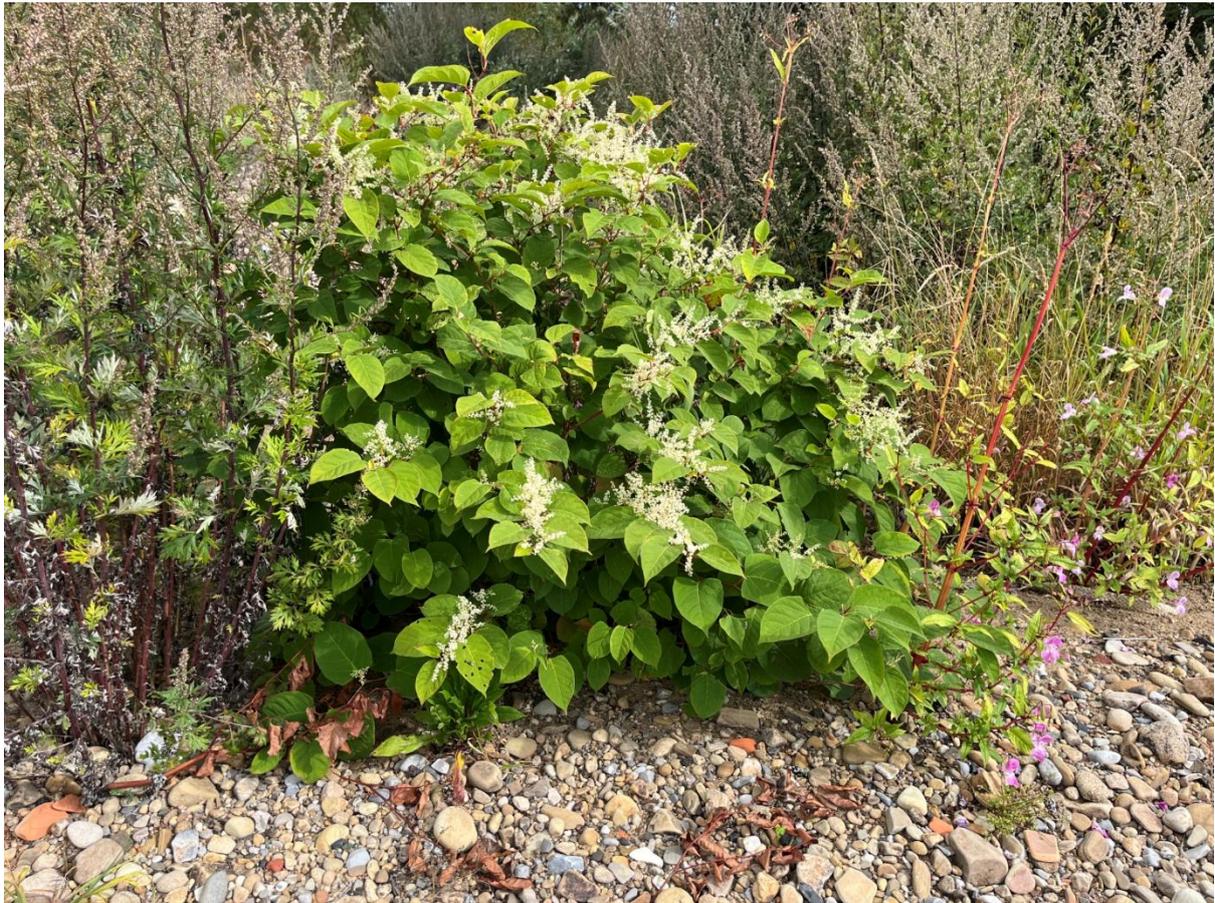
Japanese knotweed was noted at 53.809574, -2.254185 (Fig.15) and adjacent to the high-flow channel at 53.809656, -2.253790 (Fig. 16).

Figure 15: Recently-established stand of Japanese knotweed at 53.809574, -2.254185

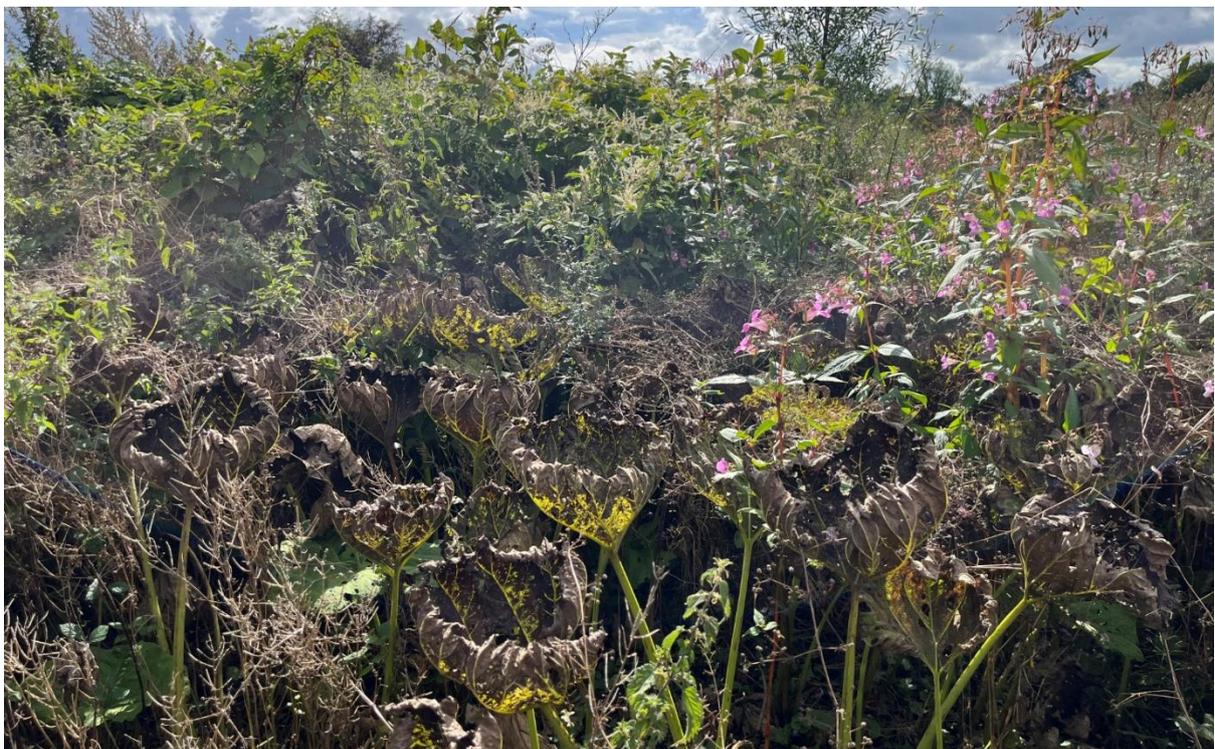
Figure 16: Older knotweed stand in flower (centre frame, background) bordering on the (well vegetated) high flow channel at 53.809656, -2.253790.

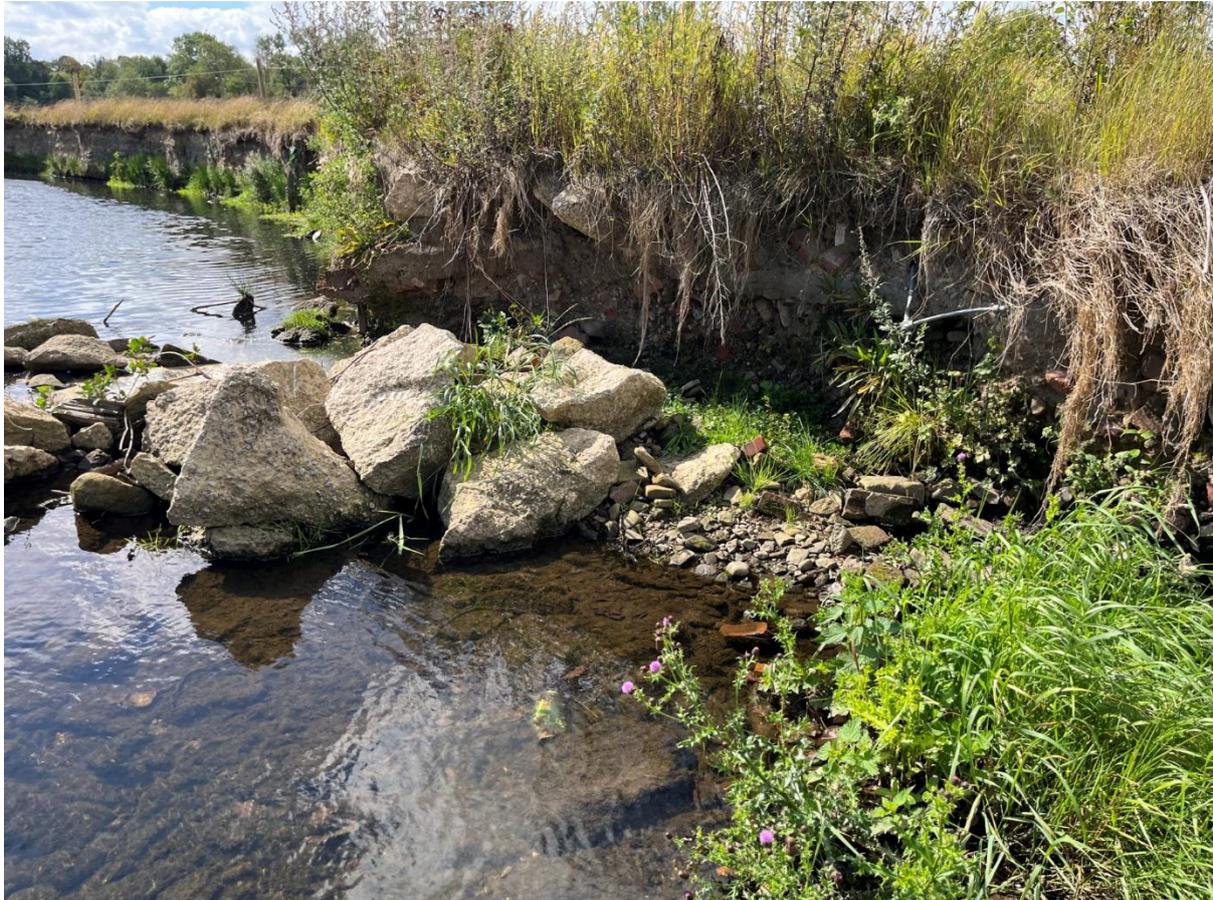
Re-crossing the river to return to the LB and progress downstream, what appeared to be a failed rock revetment structure was noted at 53.810139, -2.255786 (Fig. 17).

Figure 17: Accelerated erosion behind rocks that appear to originally have been placed with the intention of bank protection.

Although it is not certain that these rock placements were intended to protect against bank-loss, it provides a good example of accelerated bank erosion due to eddy creation by hard, angular surfaces. This process is described more fully, along with the counter example of complex brush and root matrices, in the following video: <https://youtu.be/q7zq1yxaPEA>. Scanning the following QR code will also take you to the video explanation:

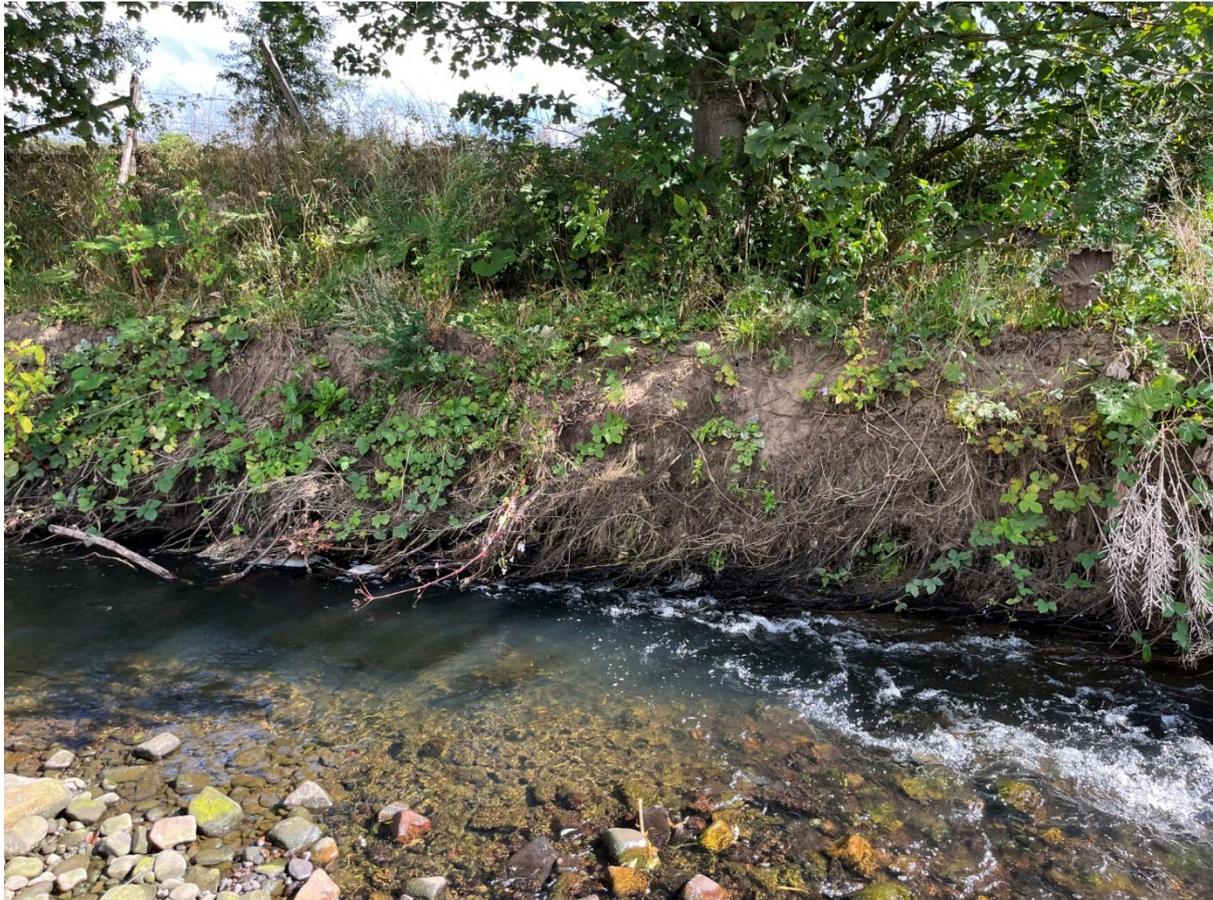
island and surrounding main riverbanks support woodland vegetation. On the outside of the meander within this section (RB) is an excellent illustration of the effects of deeper and more varied root systems on bank erosion (Figs. 18 and 19). Although this is still an eroding bank, the rate at which the river is spreading laterally is significantly slowed. The reduced rate of bank loss results from the reinforcement and flow-dissipation created by deeper and more robust root systems. Instead of being allowed to chew easily into the sandy bank, the exposed roots and trailing stems force the river to dig downwards and create a deeper scour pool.

Figure 18: Bankside trees and a more varied understory vegetation has created a much more erosion-resistant bank. Here the river is forced to dig downwards and create a deeper scour pool instead of rapidly eroding sideways and eating away at the RB.

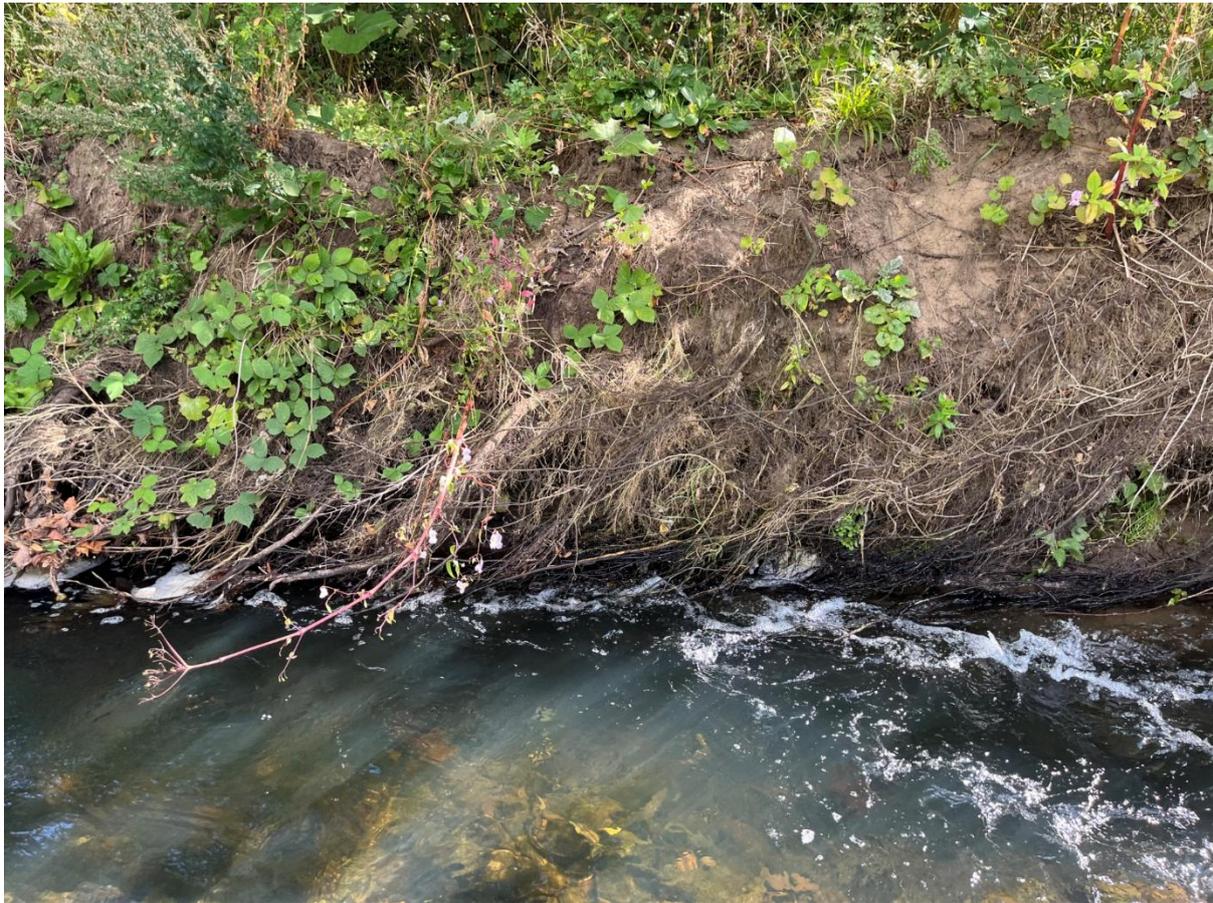
Figure 19: Details of the bank reinforcement as well as cover habitat created by tree and shrub root systems. Contrast this with the shallow root system of grazed land shown in Fig.9. The reinforcement also helps to create stable undercut refuge areas which are important shelters for adult and juvenile trout.

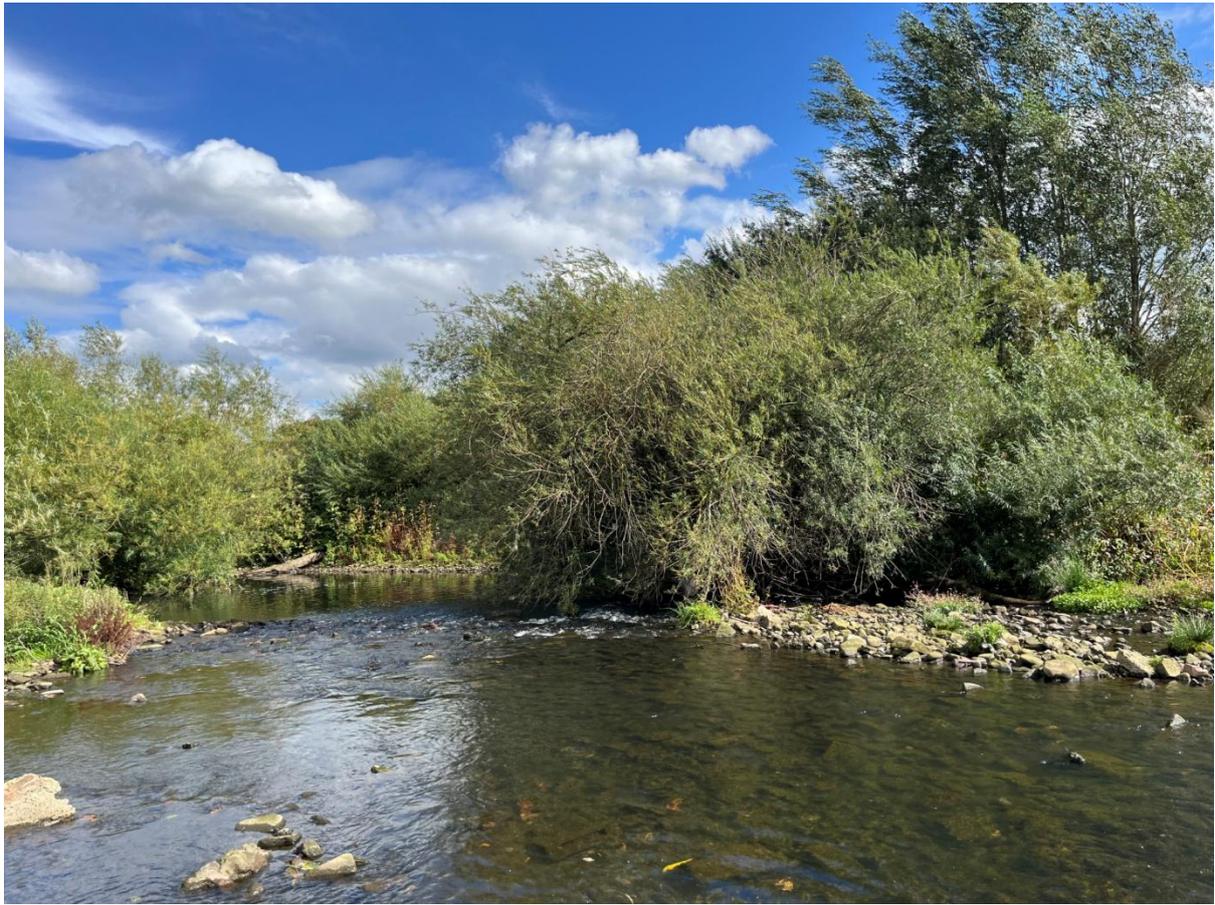
Figure 20: Mid channel island and surrounding banks colonised by mature vegetation.
