WILD TROUT TRUST

Advisory Visit
Pendle Water
Reedley, Lancashire

10/09/2025

River	Pendle Water
Waterbody Name	Calder - Pendle Water to conf Ribble
Waterbody ID	<u>GB112071065490</u>
Management Catchment	Ribble
River Basin District	North West
Current Ecological Status	Moderate
U/S Grid Ref inspected	SD8345834841 (53.809620, -2.252538)
D/S Grid Ref inspected	SD8273634897 (53.810038, -2.263624)
Length of river inspected	1.1 km

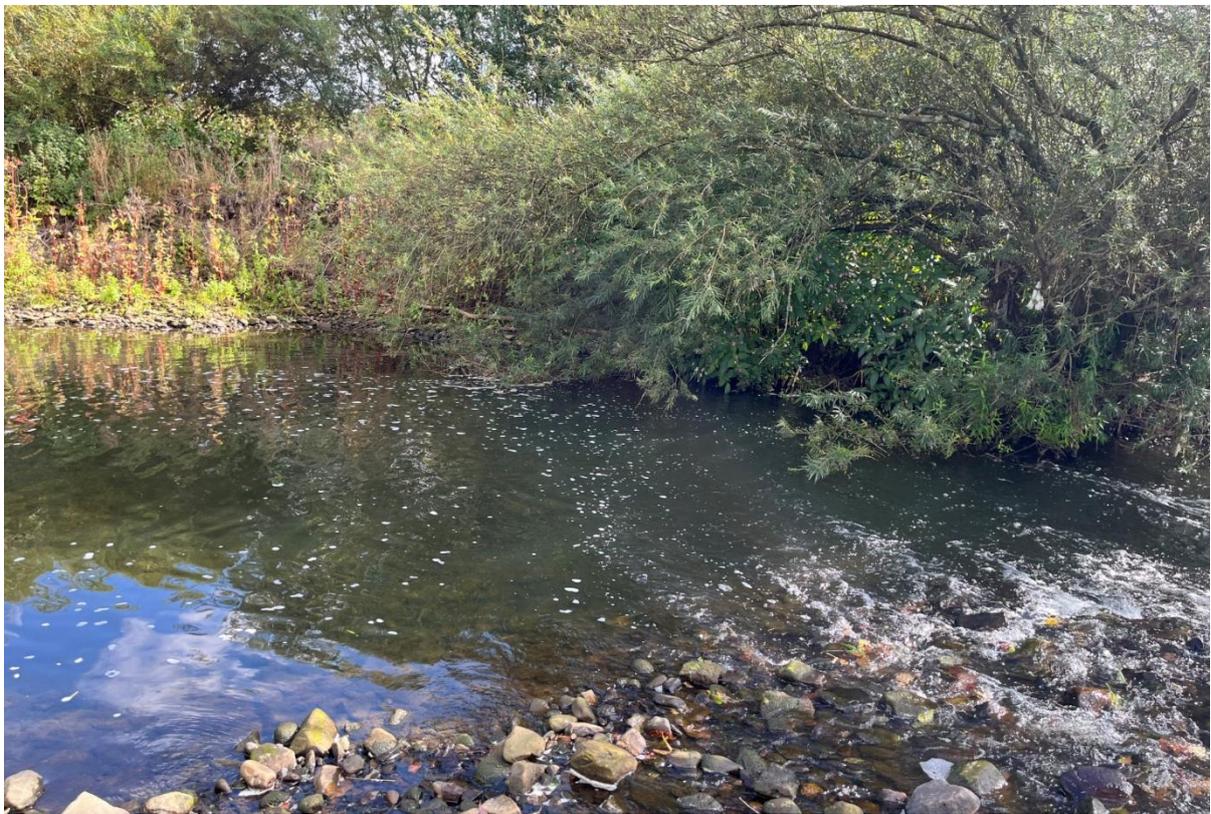
Figure 21: Cobble riffle running into a scoured bend-pool under the protection of low, overhanging willow branches. Excellent trout habitat for a range of life-stage.

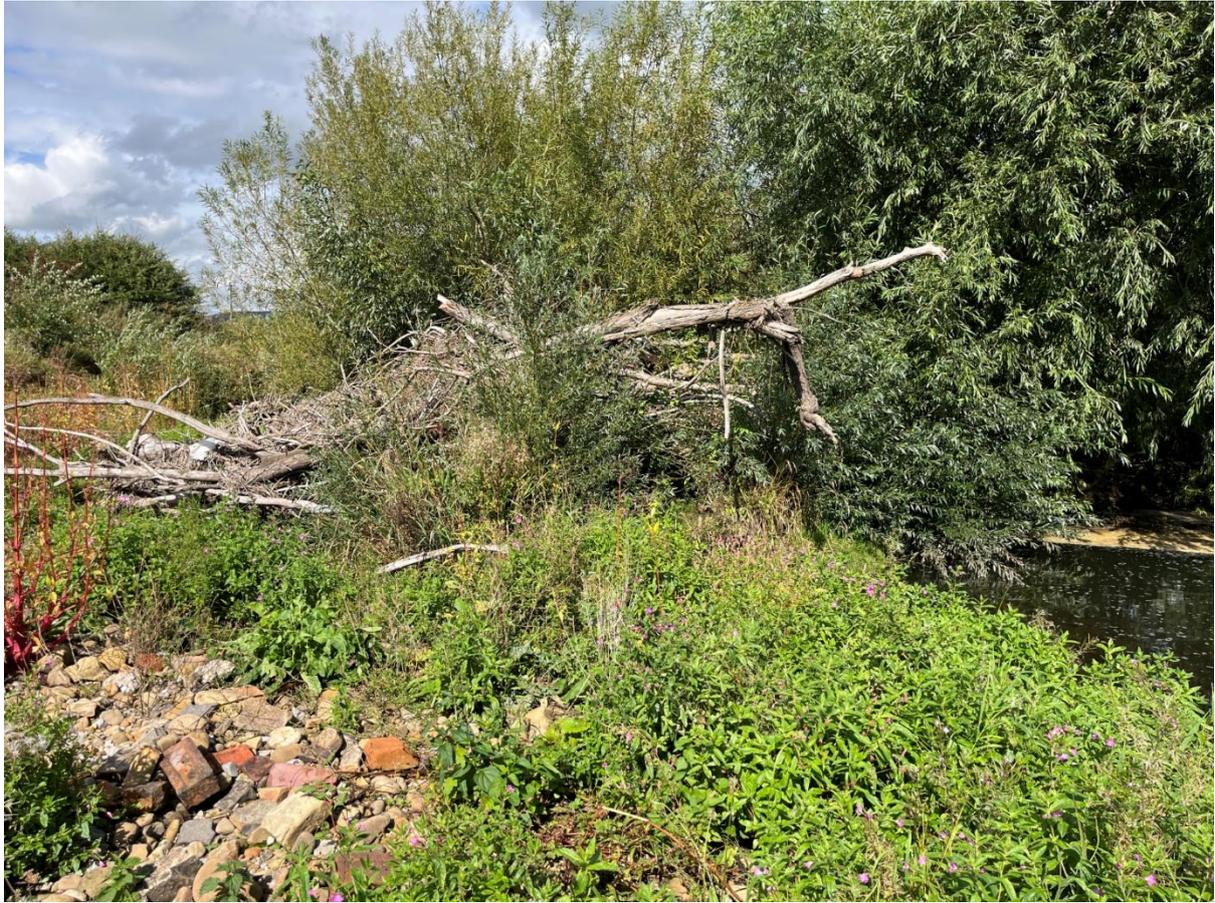
Deadfall of large woody material is an extremely valuable component of healthy river systems. With the island apparently being in place for a long time, a dense stand of mature woodland has arisen. This provides a source of woody material as well as a high probability that fallen trees will lodge securely against remaining trees and bends in the channel (e.g. Figs. 22 and 23).

Figure 22: Natural deadfall lodged securely by spateflows between the LB and island.

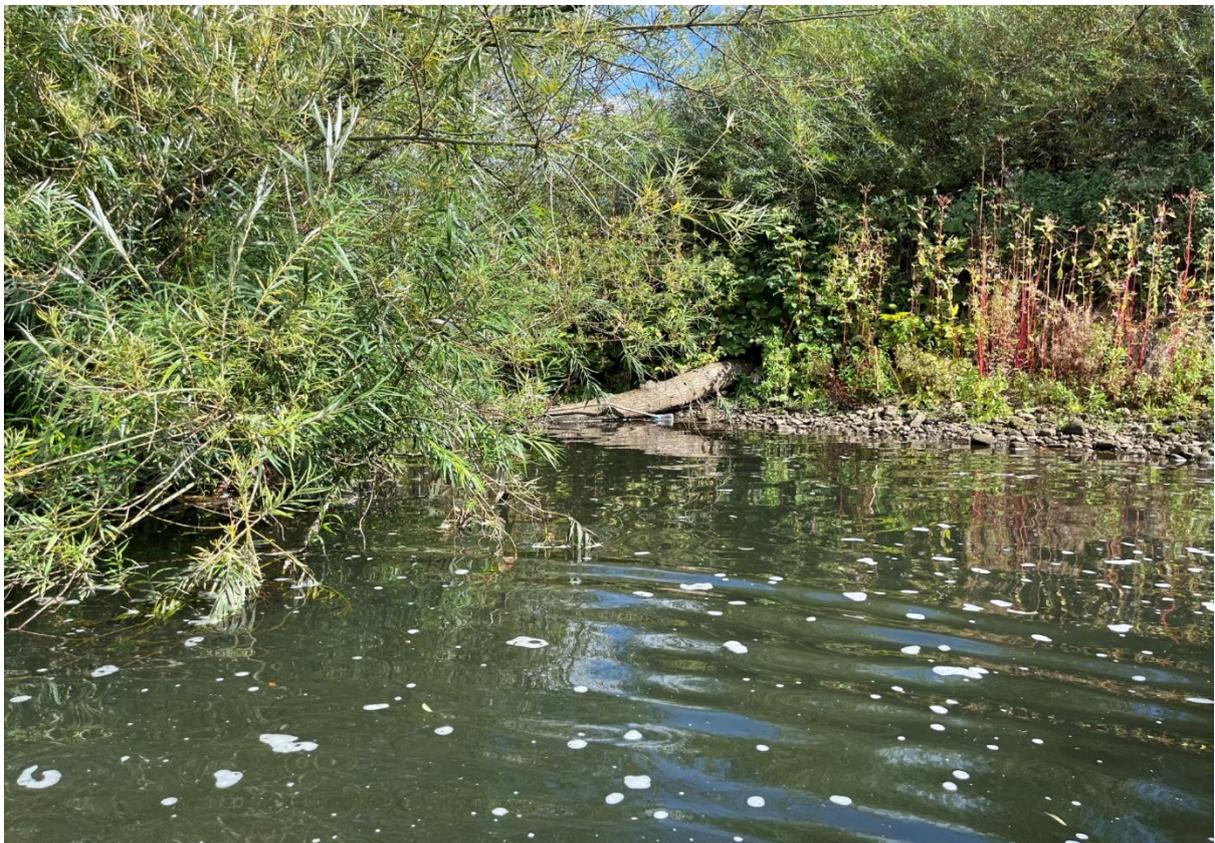
Figure 23: Lodged, fallen tree projecting down into the water in a way that is likely to promote undershot flow (beneath the log) creating beneficial localised bed scour.

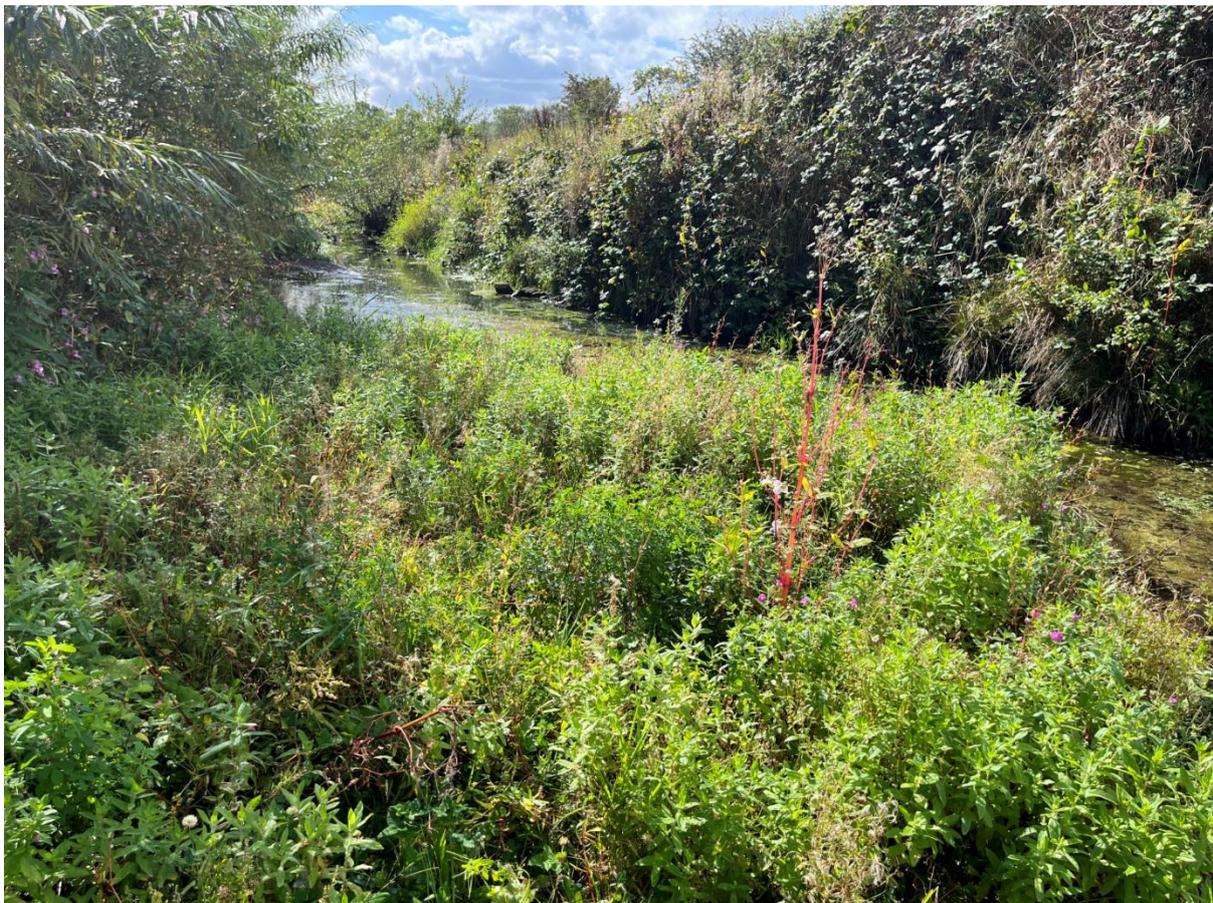
With sufficient room for the river to wander within an ungrazed, riparian buffer strip, it has developed into a braided channel with good variation in depth, flow velocity and meandering planform. While the control or removal of invasive plant species would further improve biodiversity, the structural variety of habitat in this section is supporting a range of native plant species. It may be the case that the much higher physical complexity of habitat has afforded a greater opportunity for those native plants to maintain a foothold. The presence on both banks of ungrazed, well-vegetated buffer strips is central to the river's ability to generate this higher quality, more biodiverse habitat that includes backwater areas (e.g. Fig. 24)

Figure 24: Facing upstream into a backwater channel along the LB (right of frame). Note the vegetated bank face bordering the channel and compare to areas with unrestricted grazing along the bank top.

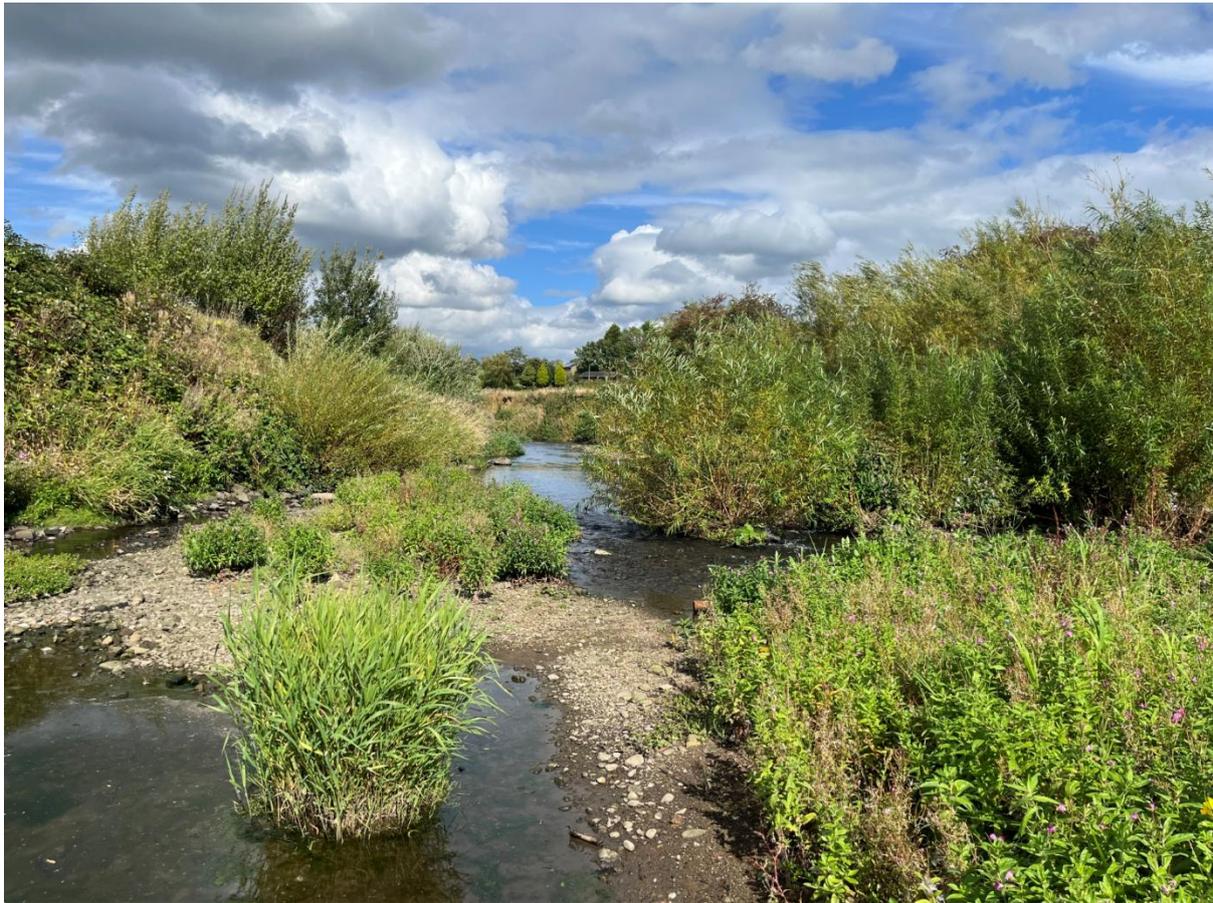
In order for most species of fish to complete their lifecycles, there is a requirement for access to a range different habitat types. The complexity of habitat found in this section with greater riparian buffering and more room for the channel provides a full range of habitats required by, for instance, wild trout. As well as deep scour pool habitat with plentiful overhead and submerged cover, some cleaner gravel glides were noted along with suitably-protected shallow nursery habitat (e.g. Fig. 25).

Figure 25: A range of current depths and speeds suitable for juvenile stages of fish development. The flow of water here is allied to increased cover provided by partially submerged and overhanging vegetation. This type of nursery habitat is often an overlooked necessity for resilient wild fisheries and is one of the features arising from channel braiding via the formation of mid-channel islands.

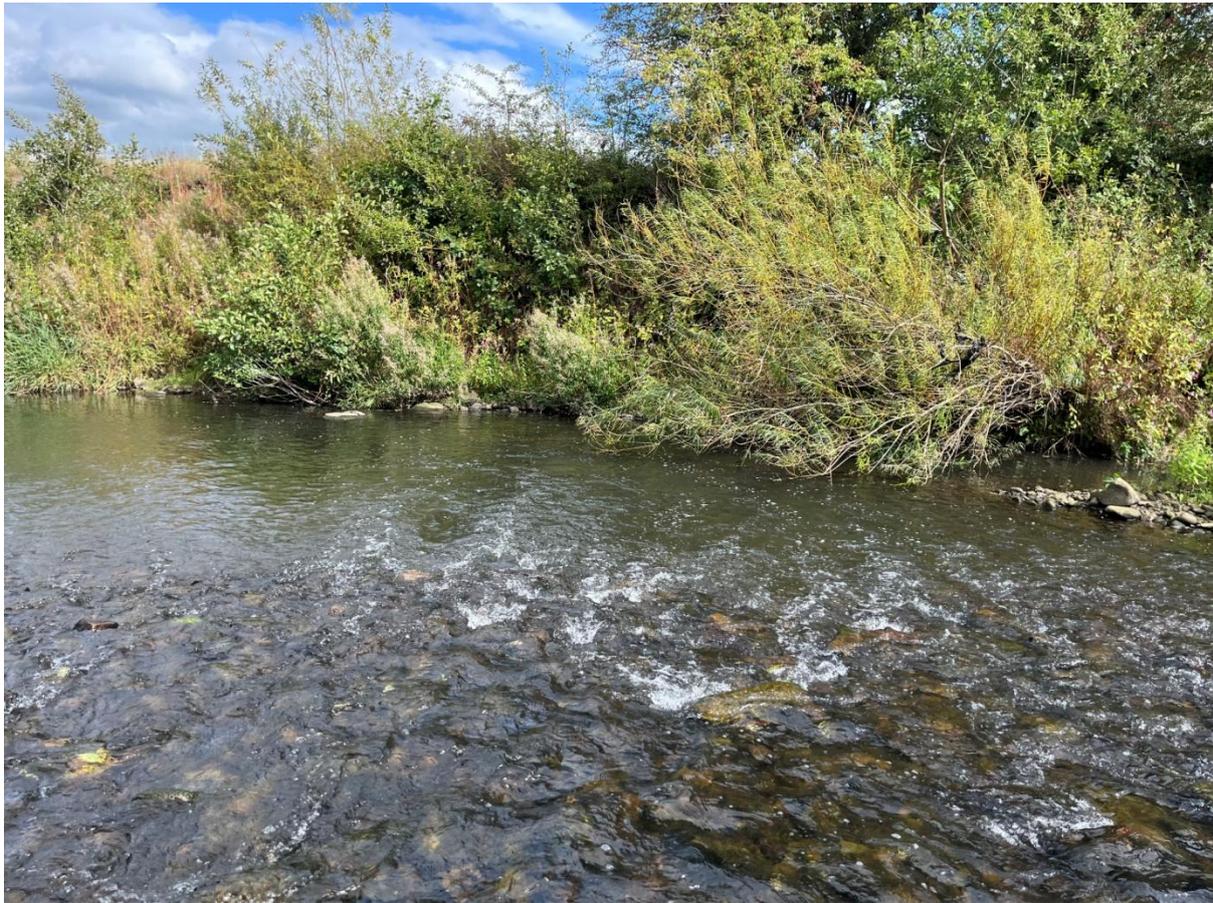
Figure 26: Tail end of a riffle with flow running towards the outside of a bend to meet a bank reinforced by deeper root structure and with overhanging/trailing cover and localised shade.

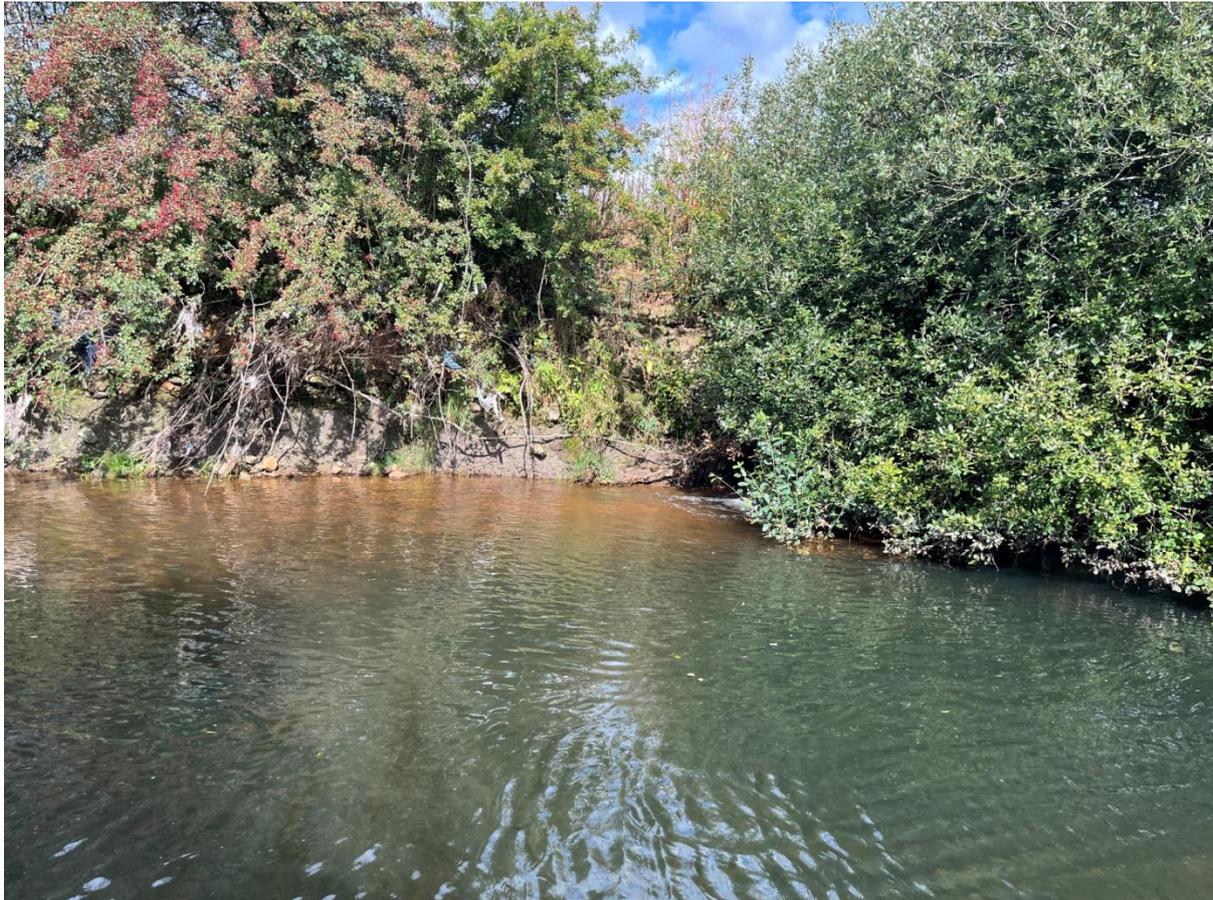
An ochreous discharge was noted at 53.812222, -2.257111 creating a band of orange precipitate that lines the RB margin for several tens of metres downstream (Fig. 27). Typically associated with underlying coal seams and abandoned mine-workings, these iron-rich discharges can well up at unpredictable points due to groundwater inputs following networks of cracks and fissures to the surface. However, they can also be associated

with surficial soils and also mining-waste spoil heaps. The orange substance is essentially rust (iron III oxide) which is relatively chemically inert but can create a physical smothering effect from its fine, sludge consistency. However, when present deep below ground in the absence of oxygen it exists as the green iron II oxide and is much more toxic. Contact with atmospheric oxygen is what reduces that reactivity. The scale of the riverbed smothering in this case is relatively limited though it may be worth exploring potential sources of this outfall in case additional treatment and interception could be implemented via reedbed creation.

Figure 27: Ochreous discharge point with iron oxide precipitate along the RB margin.

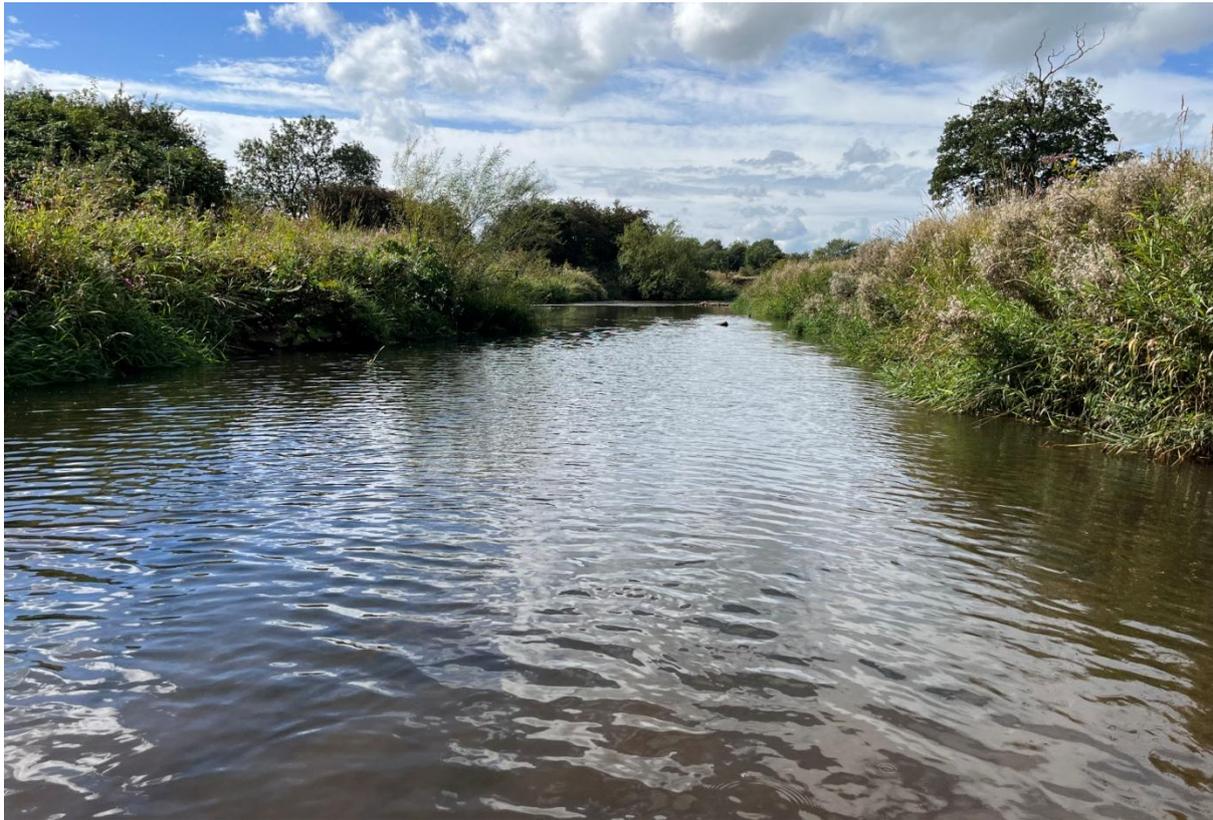
A relatively straight section with a lower gradient (Fig.28) leads downstream from the ochre discharge to a ford and then, after a very gentle right hand curve, into another straight section. The latter reach is dominated by an eroding cliff face running along the LB in response to grazing access being allowed up to the bank top (e.g. Fig. 29). With the same mechanisms of shallow root horizon and low resistance to erosion evident, previous discussion of those principles in this report are equally applicable to this section. At the end of the straight, eroded cliff-face section a ninety-degree left hand bend guides the channel along the perimeter of a wastewater treatment works site. The RB in this section is more extensively revetted using a combination of stone walling and sections of sheet piling (e.g. Figs. 30-32). Apparently, the engineered realignment and

Figure 28: Straight section of slower glide habitat which retains ungrazed riparian zones on both banks. A fording point is just visible in the far background.

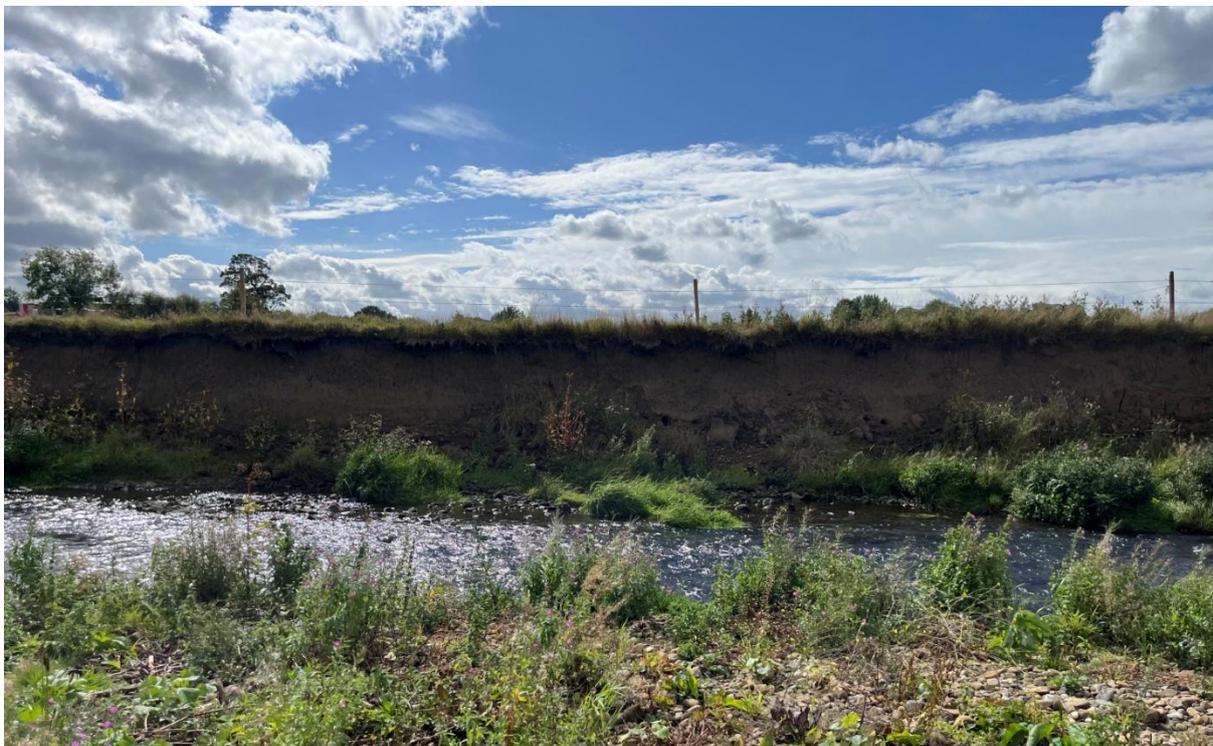
Figure 29: Eroding cliff forming the LB (background) with deposited gravel bar running along the RB (foreground). Note the placement of fence posts allowing grazing access to the bank top and the associated loss of land on the fenced side.

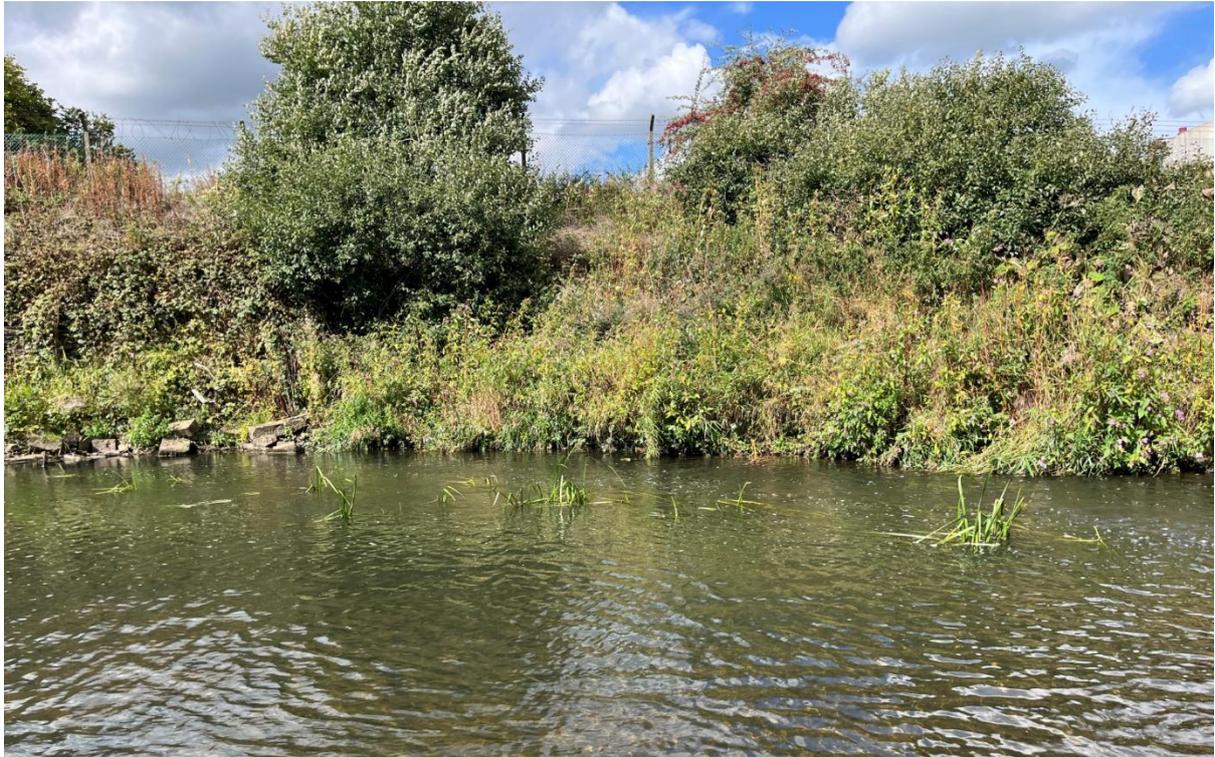
Those slower flows in the modified, widened channel are reflected in the colonisation of emergent macrophyte beds favouring still or slow water (Fig.30).

Figure 30: Mid-channel beds of what appears from distance to be branched burr reed (*Sparganium erectum*), typically associated with slow flows. Note stone bank revetment towards the left of frame.

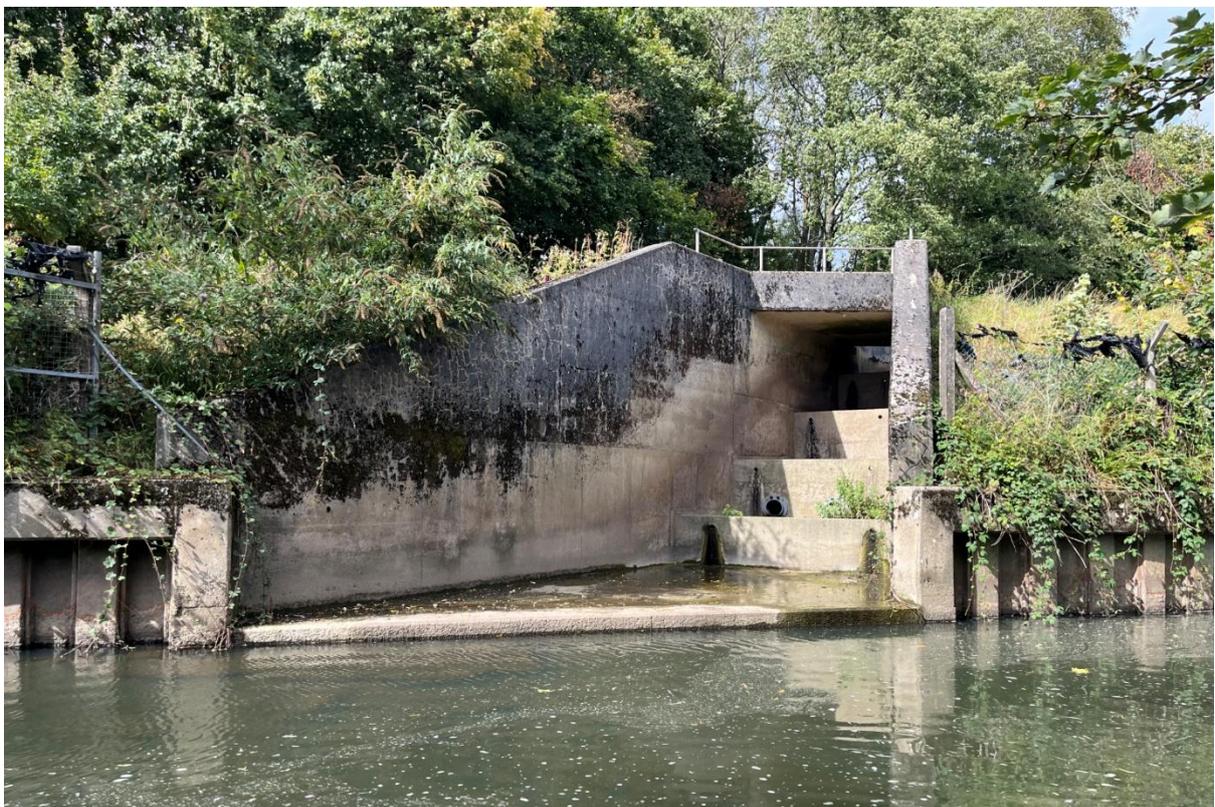
Figure 31: Outfall from wastewater treatment works protected by sheet piling bank revetment.

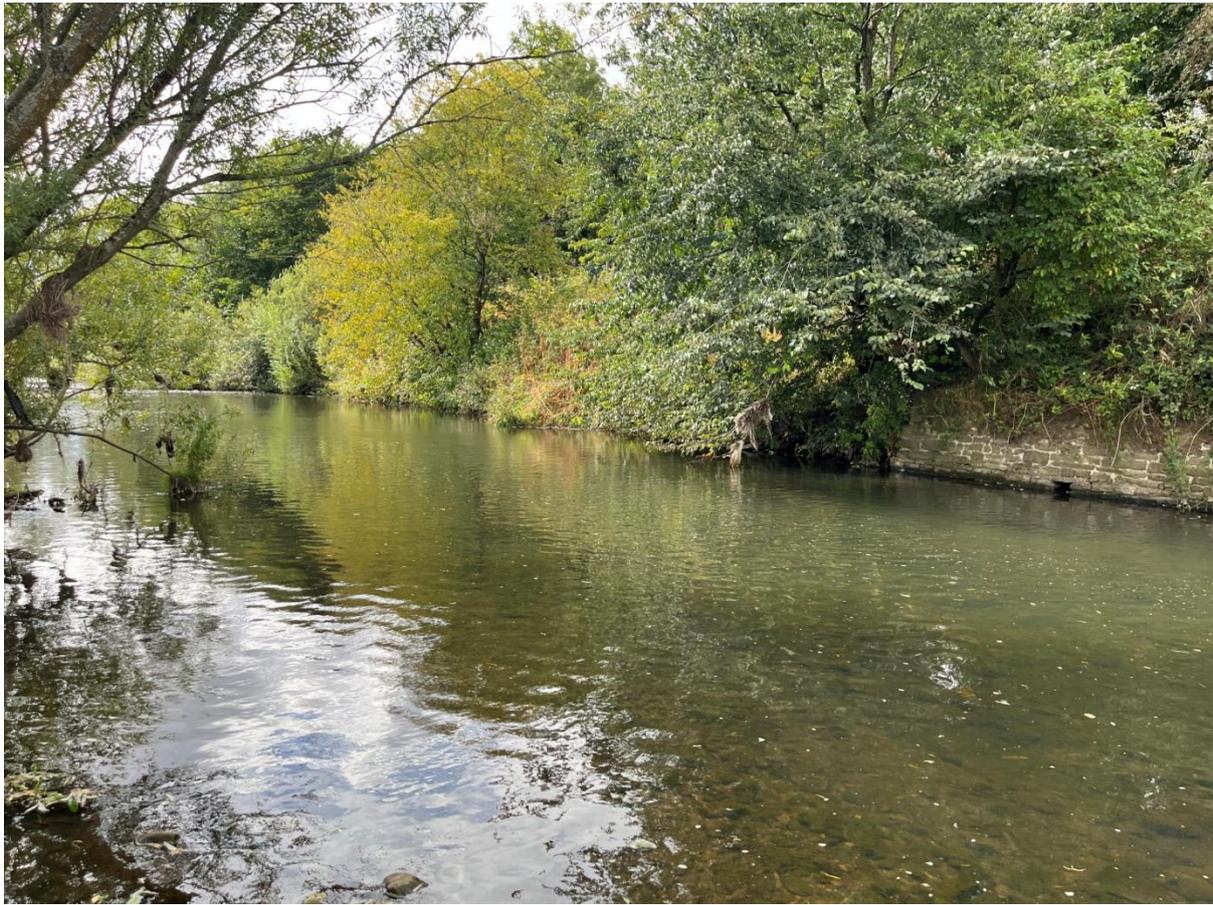
Figure 32: Stonework revetment of the RB downstream of the wastewater treatment works outfall. Note also the mature woodland lining the RB.

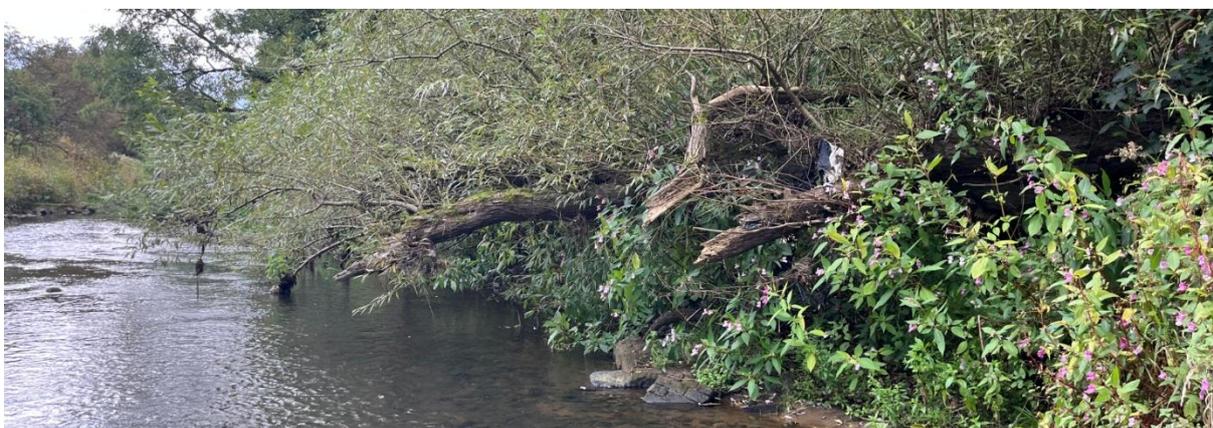
It seems that, in response to historical modifications of the channel, a straight path and relatively uniformly-shallow cross-sectional profile is maintained in this section (e.g. Fig. 32). However, the greater age and size of riparian trees in the woodland lining the RB is a very obvious feature compared to most trees growing in the upstream sections. As well as influencing the supply of leaf litter and foodweb subsidies from invertebrates living in the tree canopy, veteran trees will also tend to supply larger-scale woody material via deadfall. A good example of this was noted just upstream of the confluence with the Calder (Fig.33).

Figure 33: Large fallen willow with just the remnants of the branched crown reaching over the margins. Most of the massive trunk remains on the bank (consequently very stable).

While the multiple stems of the tree crown remained, they would have created structural variation through localised, undershot flow and bed scour. The massive size of the trunk (the main part of which remains on the bank) provided great stability as evidenced by it remaining after the ends of the crown have been torn off.

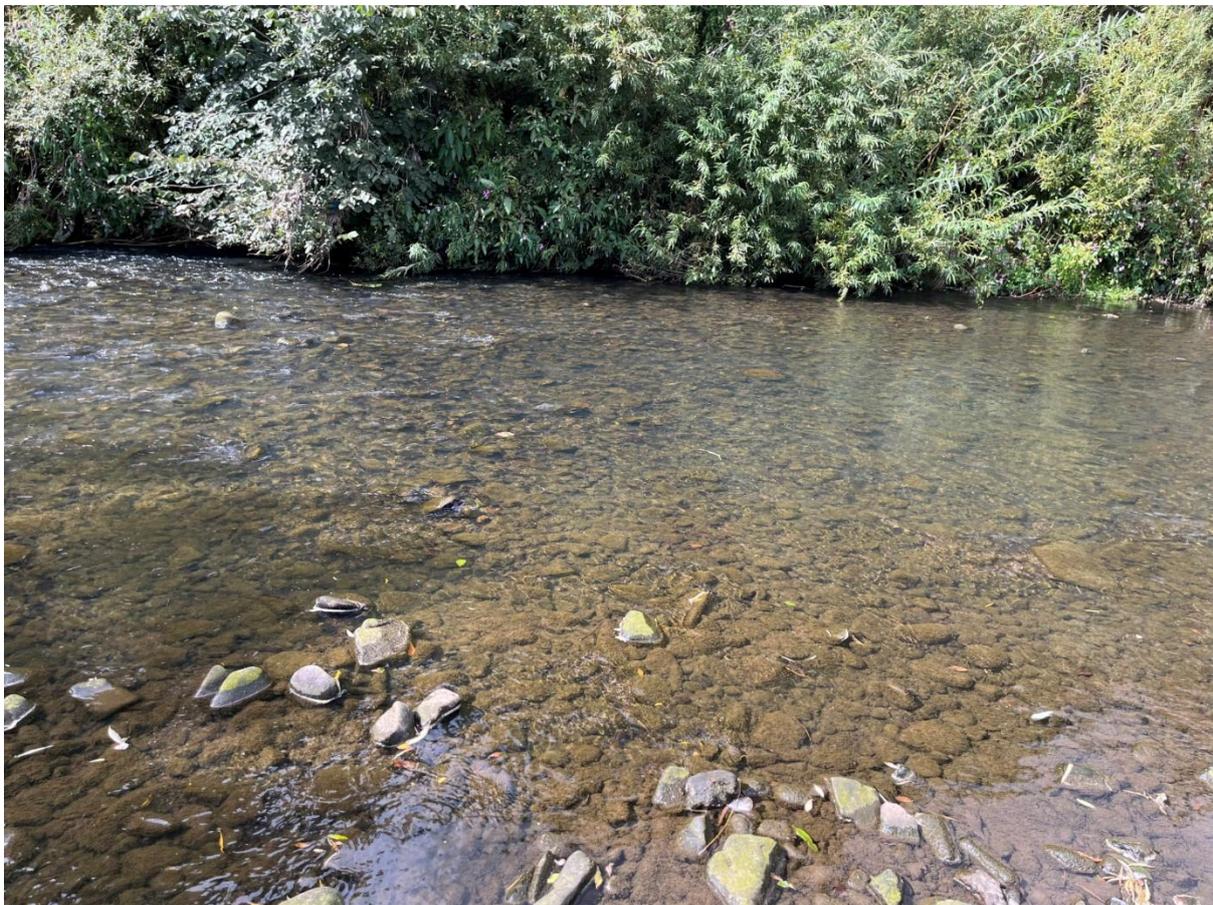
Despite the large supply of gravel to this section of Pendle Water, there is a general lack of high quality spawning material for trout and other gravel-spawning species. In areas where the channel gradient and dimensions would otherwise be suitable, gravels were mostly smothered by fine sediment. In straightened sections with more gradient, the retention of gravel tends to be poorer and substrate is dominated by coarser cobble and larger rock fragments (e.g. Fig. 34).

Figure 34: Cobble-dominated reach where gradient increases within the straightened section below the wastewater treatment outfall.

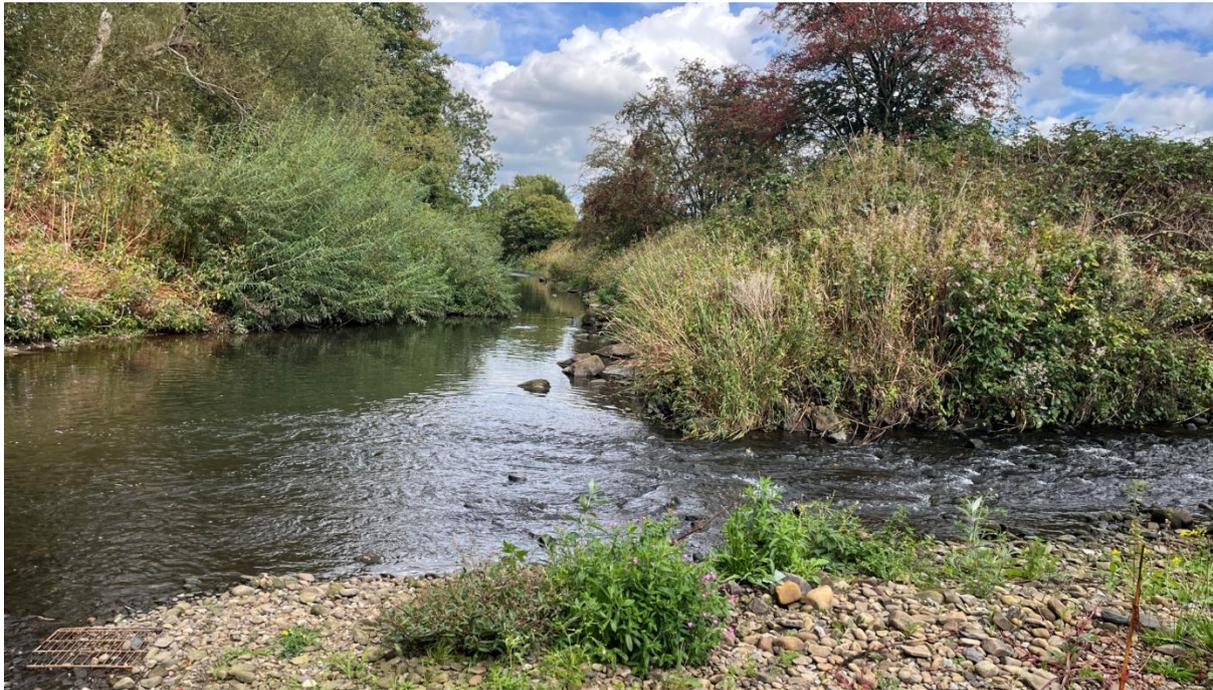
Figure 35: Confluence between the Calder joining on the LB (right of frame) and Pendle Water (centre/left of frame). This was the downstream limit of the visit at 53.810038, -2.263624.

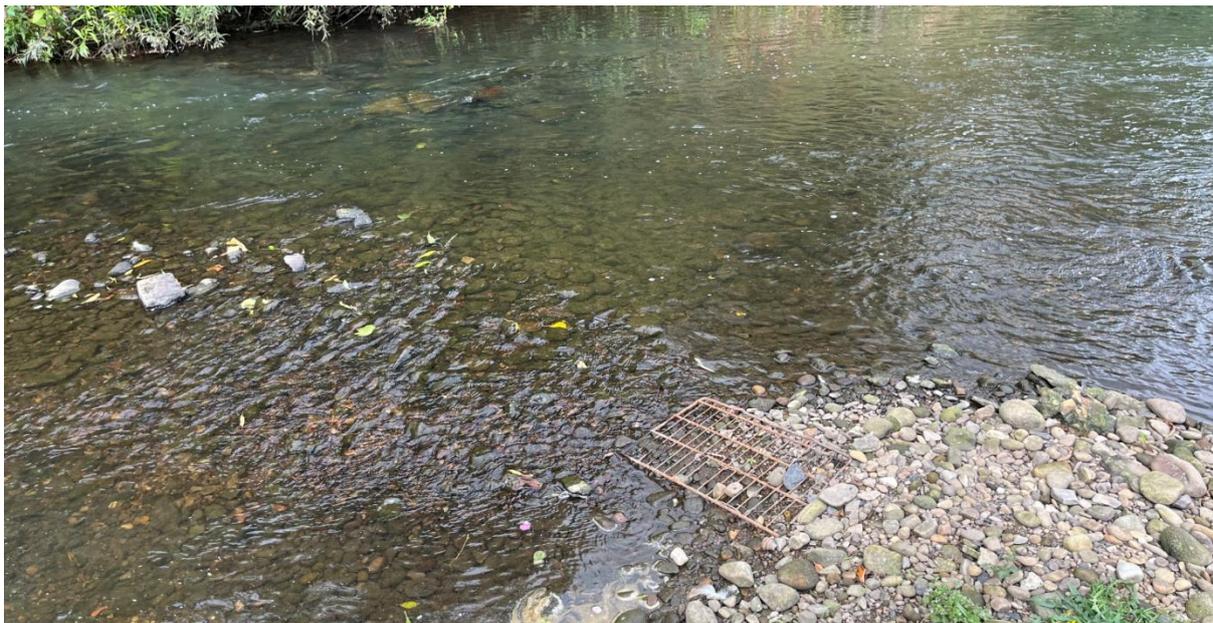
Figure 36: Main river just below the confluence showing some potential spawning gravel. This would be an area to monitor for trout redds during late autumn to mid-winter. However, this is a small and relatively poor quality area of spawning habitat.
