**Advisory Visit undertaken on behalf of Milnthorpe Angling
Association and Dallam Tower Estate**

River Bela

16/17th May 2013

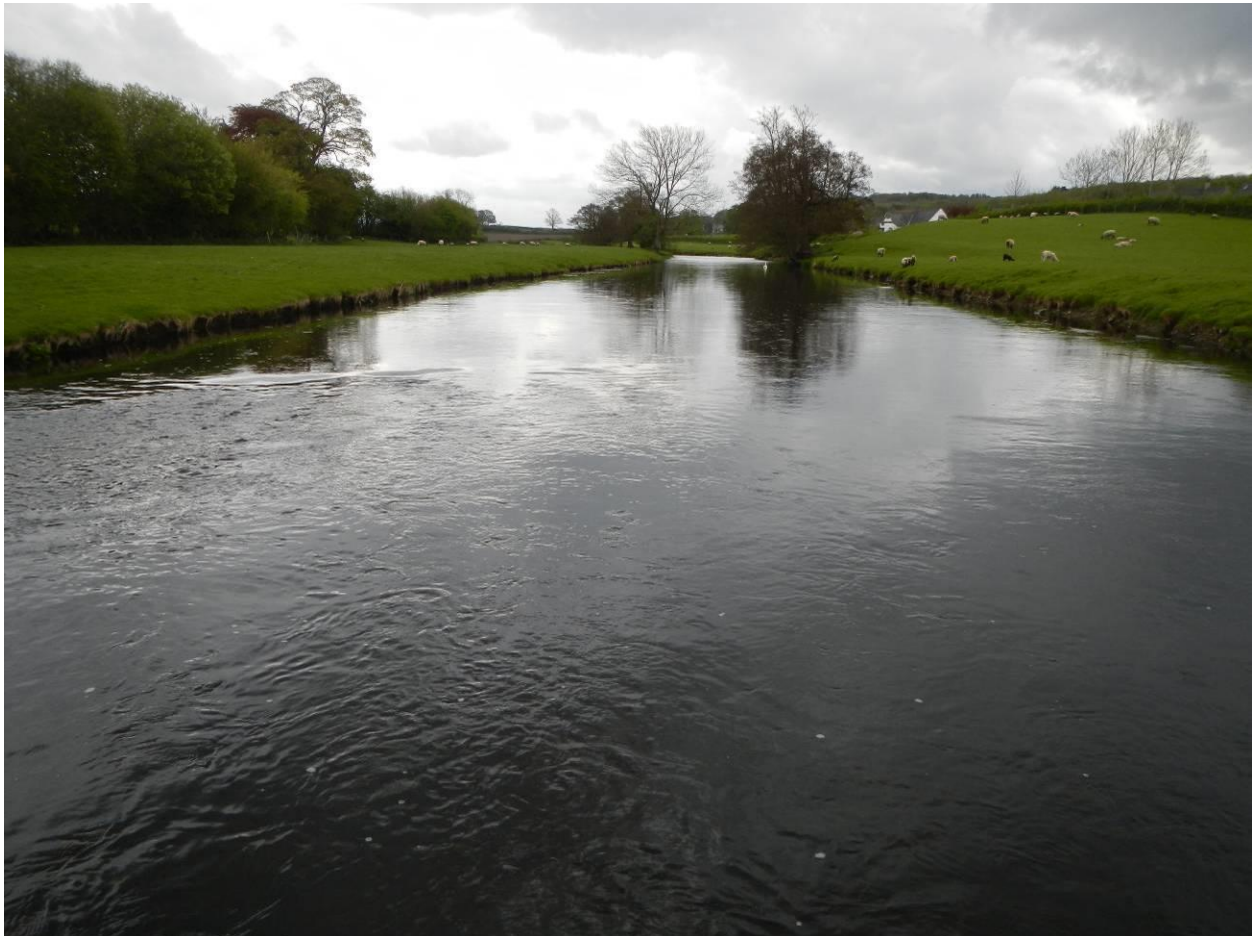
Evidence of the past channel maintenance and dredging activity is very obvious along the river, with several overly straight sections and elongated pools (Figure 1). These actions have created a lack of channel sinuosity and inhibit the natural erosion and depositional processes that would ordinarily scour deeper pool areas, on the outside of bends, and facilitate natural channel narrowing through sediment deposition on the inside. The removal

Interestingly, the riffle in the foreground of Figure 1 (SD4973379632) is believed to be one of the primary spawning sites on the main River Bela. Being directly adjacent to Beetham Bridge, the area may historically have been subject to less dredging activity and so retains a more natural substrate than most other areas. However, assessment of the site suggests the habitat is far below optimal, as the overly wide channel leaves gravels that are significantly impacted with sediment due to a lack of scouring, and increased sediment deposition. This will greatly reduce the survival of any eggs deposited within the gravel, and as such, its use is likely due to a lack of other suitable locations.

Figure 1. Low diversity trout habitat resulting from straightening and dredging which, in combination with over-grazing, has resulted in an over-wide channel significantly lacking in flow diversity and unable to maintain clean gravels. The lack of marginal vegetation and trees also provides a paucity of aerial cover.

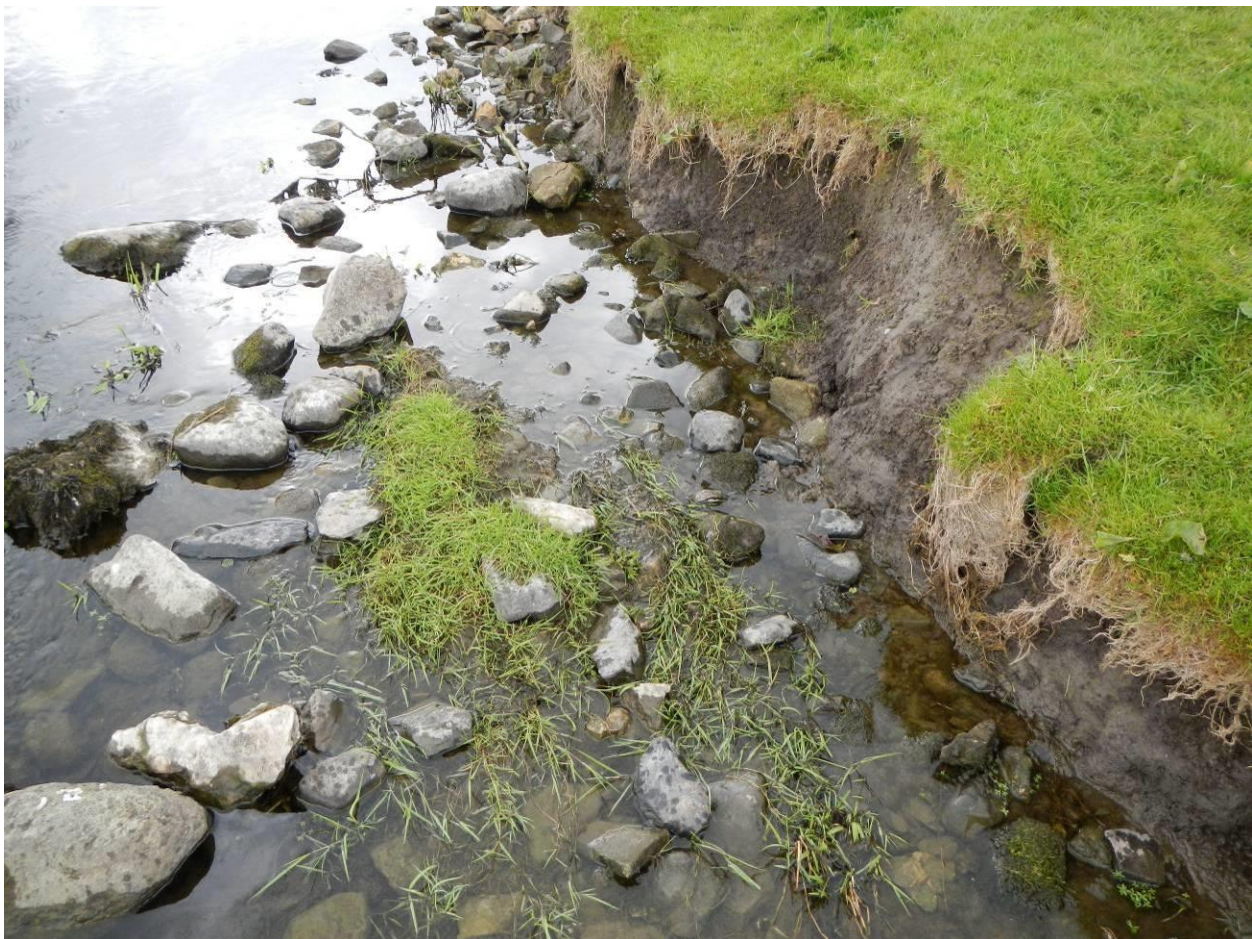
Over time, this can be greatly damaging to a river, leaving over-wide channels that are unable to narrow naturally as the riparian vegetation that would ordinarily encroach into the channel (particularly in low flows) to form new bank is eaten before it consolidates the new bank line (Figures 2 & 3).

Figure 2. Slumped material resulting from bank erosion. If left un-grazed it is likely that this material would consolidate to form a new toe to the bank. It is also likely that over time, the bare bank face and areas between would become vegetated to form a shallower bank line that would encroach into the river, providing valuable channel narrowing.

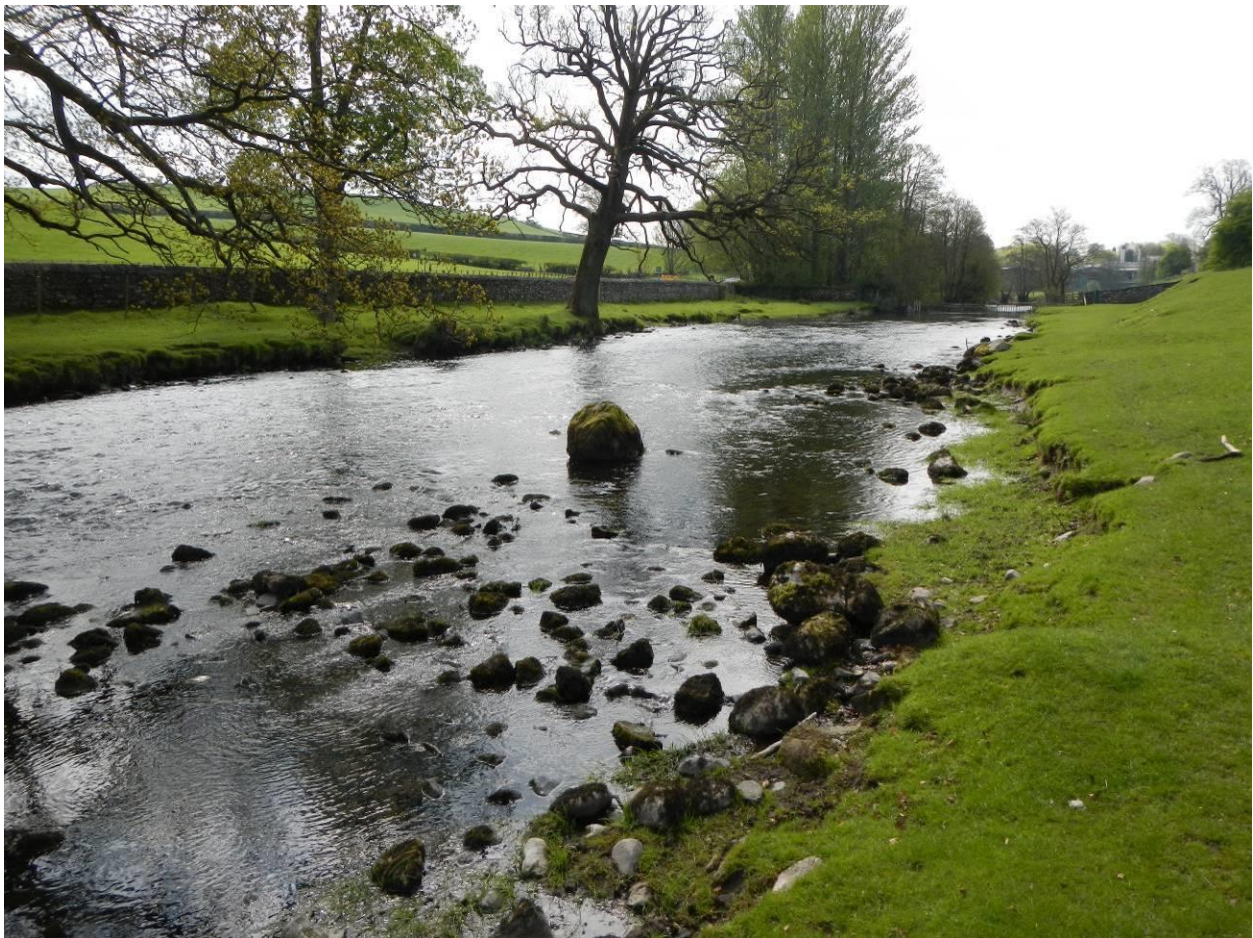
Figure 3. Over-wide channel, prevented from naturally narrowing by continual grazing pressure, which has also left the banks devoid of trees and vegetation and lacking low aerial cover for trout.

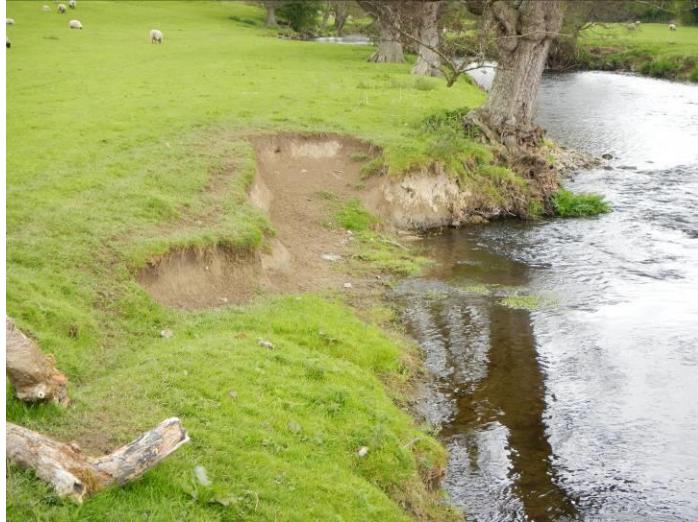
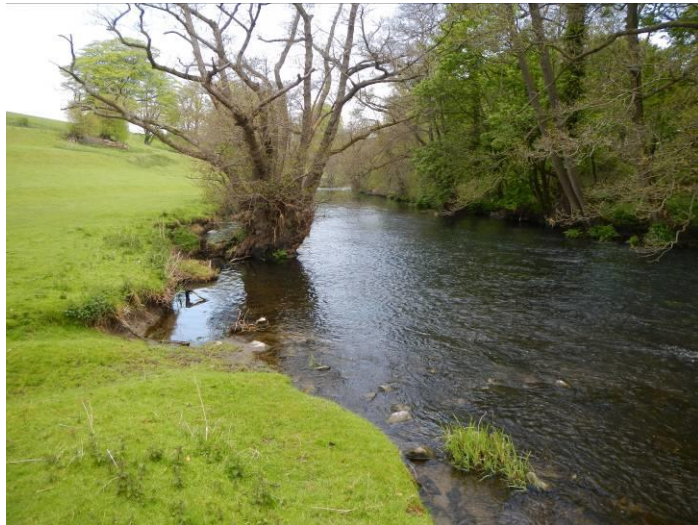
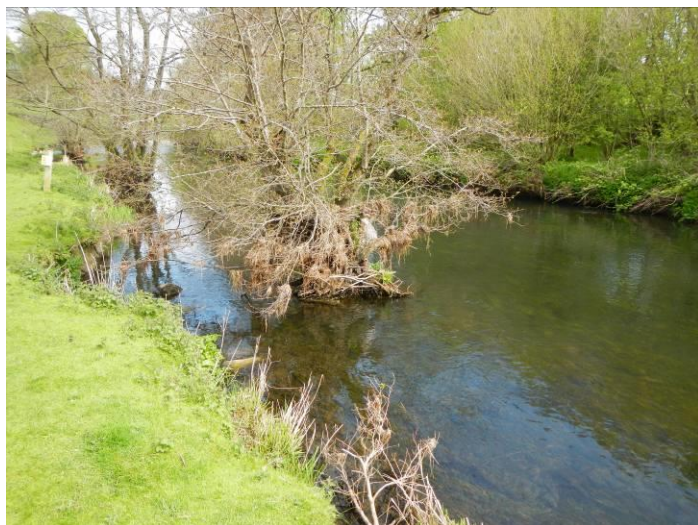
Similarly, over-grazing can actually result in the loss of trees over time, with the scour occurring around trees along un-vegetated bank-lines eventually eroding round them (Figure 4, 5 & 6), creating a tree island and eventually leading to wash out of the tree in high flows. To compound this issue, grazing of any self-set trees and propagules prevents any natural regeneration. The issue of intensive stock grazing, and resultant over widening of the river channel, is very evident throughout unfenced areas of the river, and in particular, through the estate parkland. It is likely that this is actually the primary reason behind the lack of bank side trees along many bank lines where grazing occurs, rather than any historical, conscious effort to maintain river banks to be clear of trees.

Figures 4, 5 & 6. These figures demonstrate progressive erosion around mature trees, and how over time, over-grazing with sheep often leads to a loss of trees and significant river-widening.

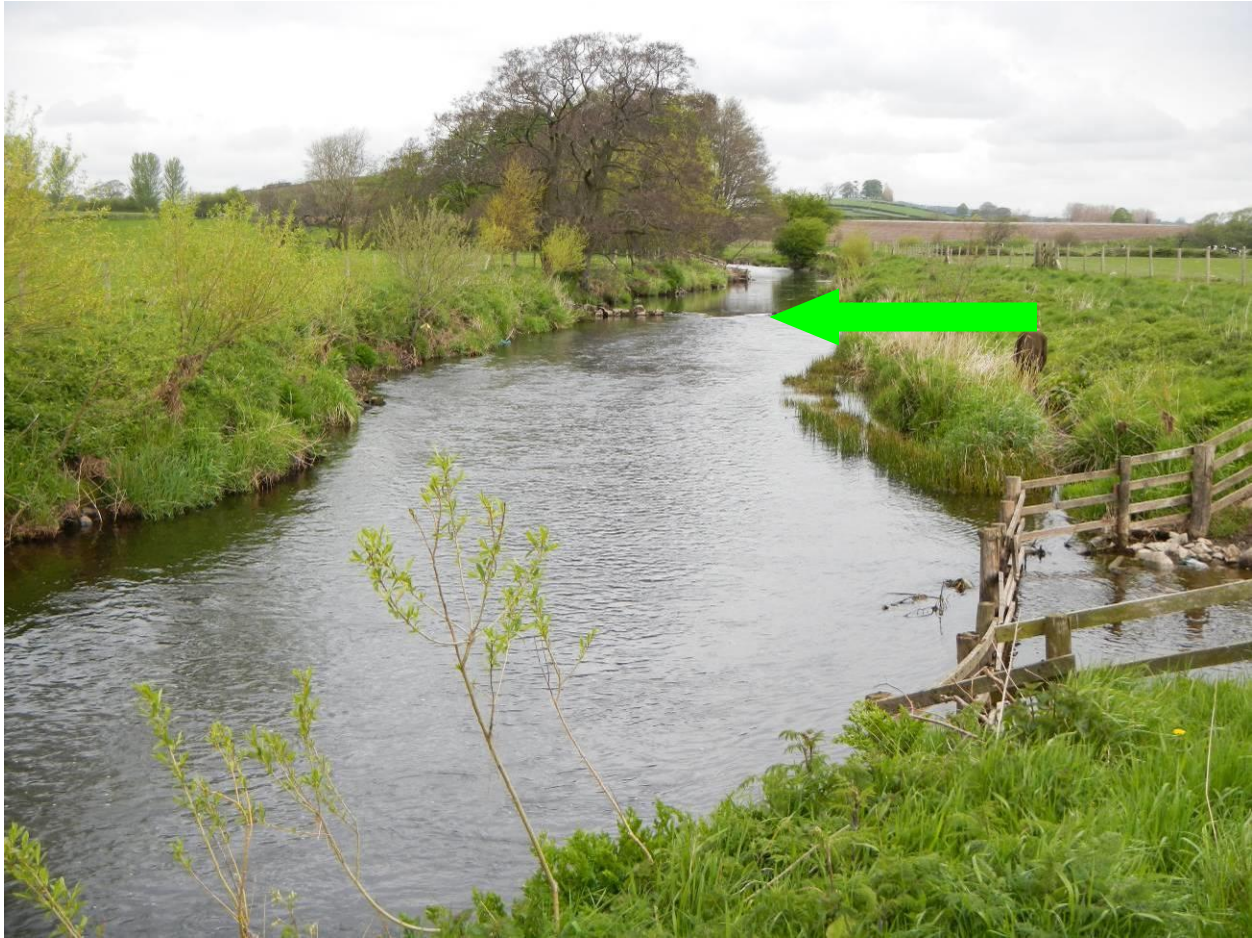
In areas where livestock have been excluded from the river bank, the transformation to a naturally recovering river margin can be quite astonishing; marginal and emergent vegetation will encroach into the river, naturally narrowing the channel to a width that is naturally maintained by the flows it carries (Figure 7: SD5019579354).

Figure 7. An excellent example of a fenced river section that is already narrowing naturally. Note how the slumped material from previous bank slippage has consolidated in the absence of grazing pressure, and the emergent vegetation is encroaching (left to right – green arrow). This is increasing flow velocities within the channel and providing and valuable cover and protection of the new river margin. This is also excellent fry cover.

Preventing livestock access to the riverbank is vital for many of the required improvements to be initiated on both Milnthorpe AA's and Bela Anglers' waters. Stock exclusion will prevent the physical damage currently occurring to the banks, while allowing more natural diverse marginal vegetation to establish. The additional vegetation will then protect and consolidate the banks, reducing erosion and helping to trap and store sediments that are entering the river through surface runoff. For fencing to be effective, and to provide suitable conditions for trees and shrubs to be planted, it will be vital to ensure that any fencing not only excludes cattle, but also prevents sheep access. The benefits of this treatment are clearly evident in Figure 7, where the river banks and channel are naturally recovering well.

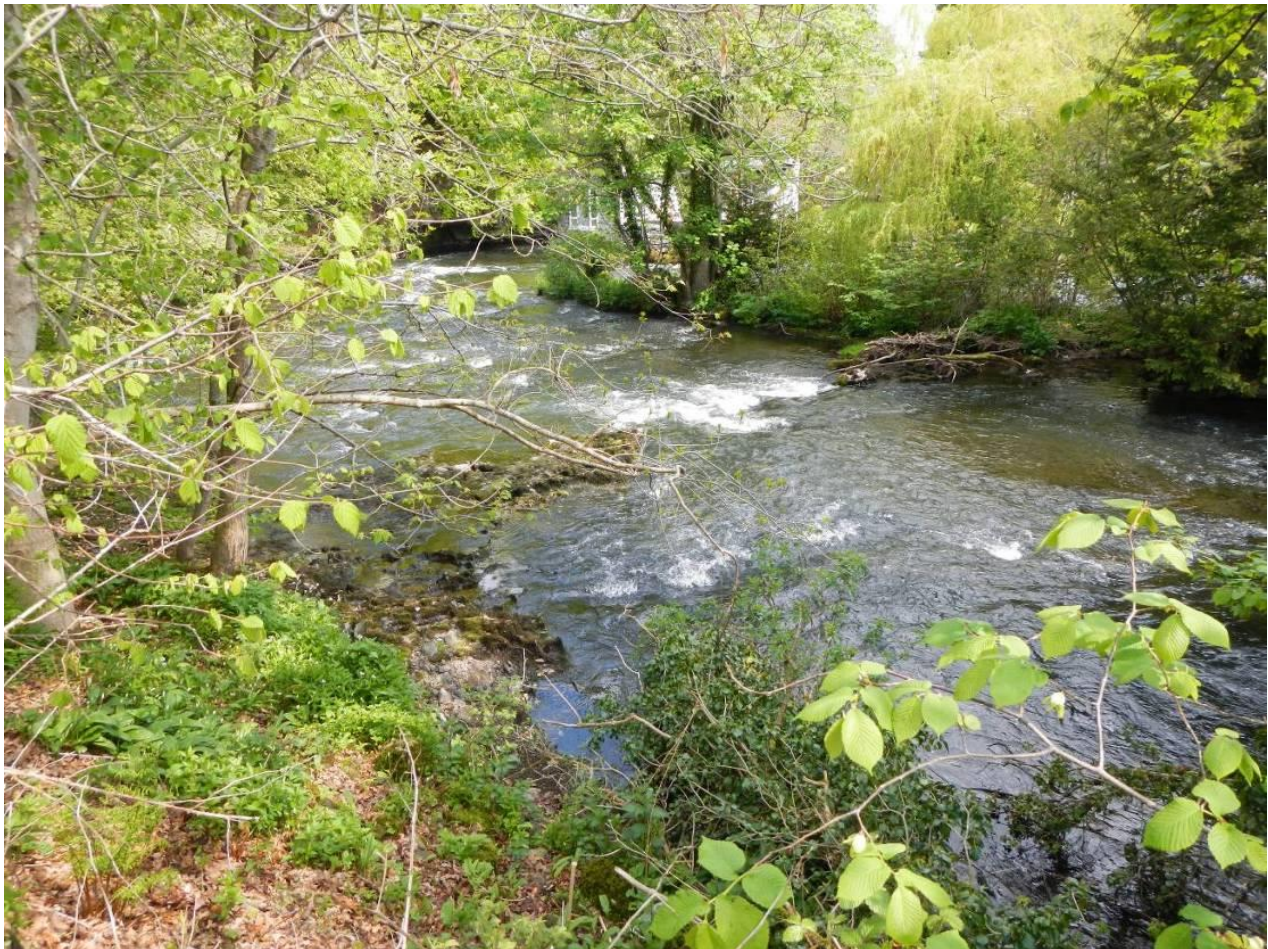
Deer fenced areas within the parkland on Bela Anglers' water, where sheep and cattle access is prevented, were also of much higher habitat quality. The untouched habitat within those areas is close to optimal, with overhanging trees and marginal cover, and significantly increased flow diversity through a natural gravel, cobble, and boulder and bedrock substrate. These provide high quality habitat for all stages of the trout and salmon lifecycle, particularly juveniles, which will find refuge within the numerous shallow riffles (Figure 8). The wooded upstream limit of Bela Anglers waters (between Beetham Bridge and the Paper Mill Weir) was also of high quality, with living trees providing branch and root cover, and fallen trees providing beneficial large woody debris (LWD), which create valuable cover and flow diversity. Towards the weir, habitat becomes degraded by the impoundment, but the good levels of marginal cover will hold fish.

Figure 8. Excellent juvenile trout and salmon habitat, with increased flow diversity, and a good balance of marginal and aerial vegetation to provide varied light and shade.

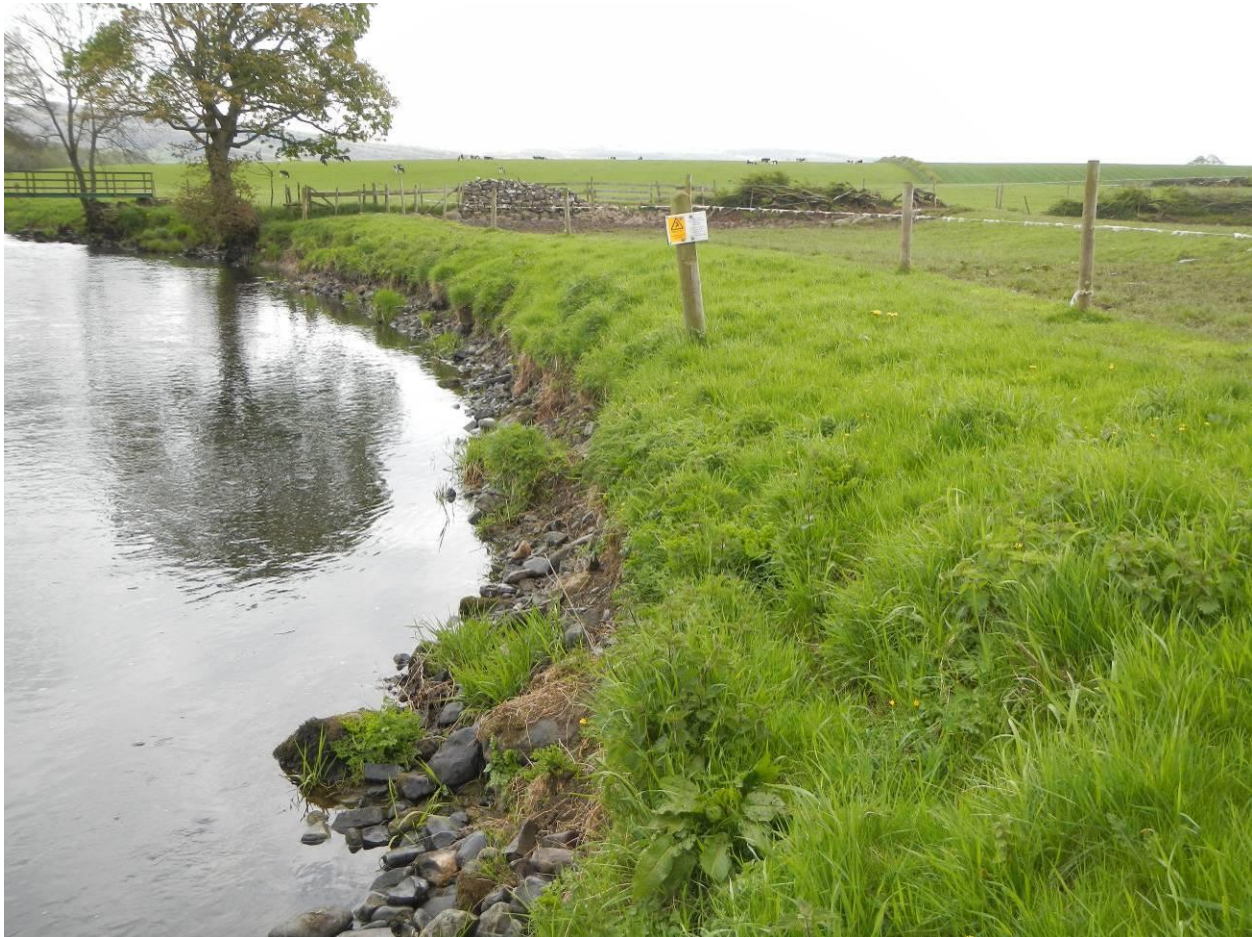
For the above reasons, simply excluding cattle is insufficient, and planting in areas where sheep have access is likely to be futile, as they will target any new growth. Figure 8 shows a perfect example of a bank line that left completely un-grazed is likely to fully vegetate, including the currently sparsely vegetated bank face and toe. However, as can be seen to the right of shot, the fencing only excludes cattle, with sheep allowed underneath, to

graze the riverbank. Aside from significantly degrading the habitat along this margin, the lack of vegetation and roots is likely to lead to more rapid erosion of the bank.

Figure 8. Bank with sheep access (under the bottom wire), where increased vegetation would enhance habitat and reduce erosion.

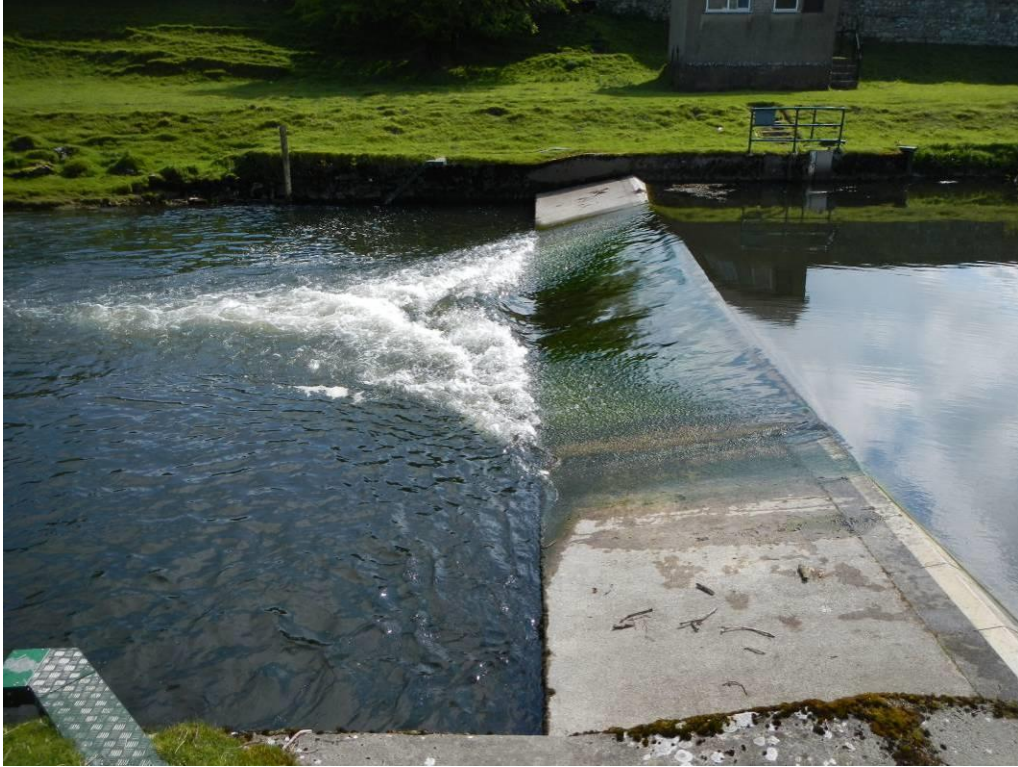
The next obstacle downstream is Bela Sit, a typical flat-V type EA gauging weir, which are inherently poor for fish passage, due to the steep gradient, high velocities, shallow water, and standing wave downstream that disorientates approaching fish (Figure 10). Larger migratory salmonids are likely to pass under medium and high flows, but at low flows it will form a major obstacle. Similarly, smaller species, including resident trout, eels and lampreys, all of which migrate to utilise different habitats, are likely to find it impassable at most flows. Eel passes are installed at either side of the structure; however, neither pass is in operation and the upstream ends fail to meet the upstream water level, reducing their functionality (Figure 11). There may also be issues with power supply to the passes (J. Oston, pers. comm., 17th May).

Figure 10. Bela Sit, flat-V gauging weir, posing a significant obstacle to fish movement in most flows.

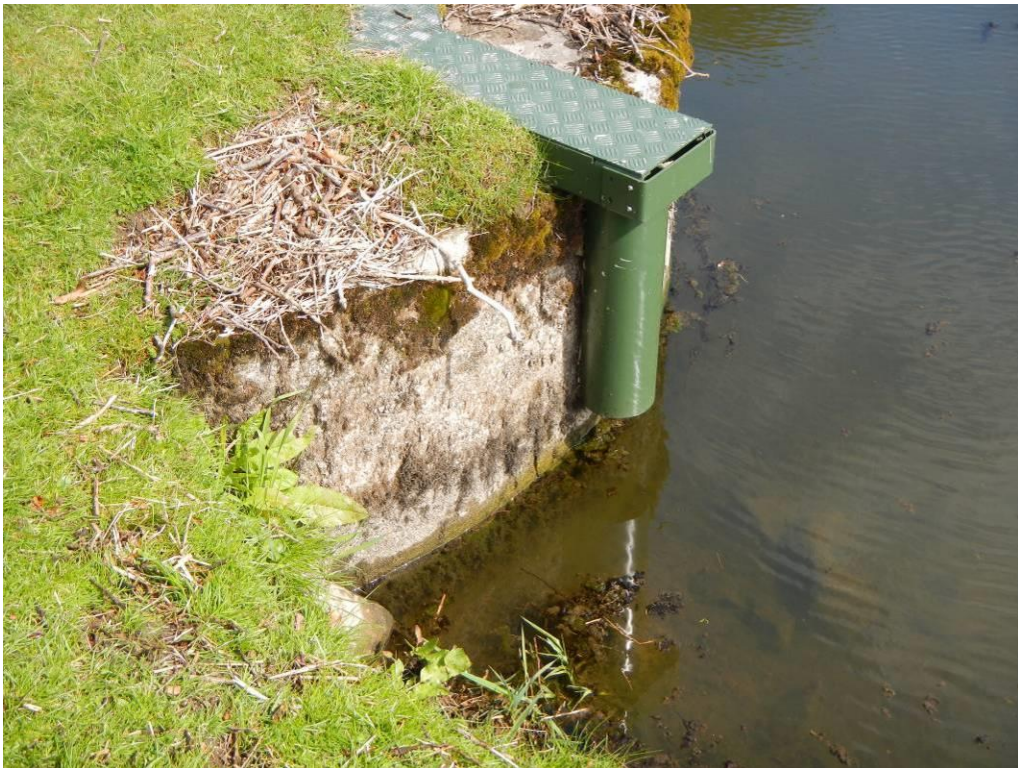
Figure 11. Upstream exit to eel pass, which is perched well above the water level and should be submerged.

Initially, the two eel passes on the gauging weir should be reinstated to operational condition, as although not the most enigmatic of creatures, eels are a valuable part of the river's ecosystem and are also seriously endangered. Once functioning, providing enough water is supplied, the pass may also assist other smaller species like lamprey.

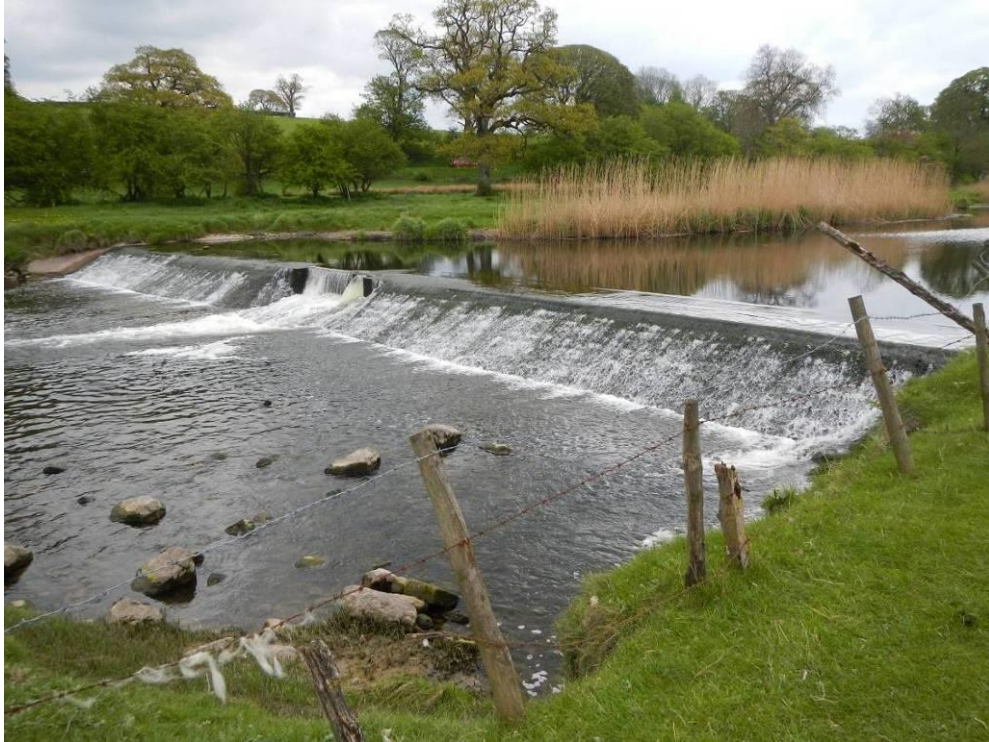
The final and farthest downstream obstruction on the river is Tidal Weir, which currently forms the tidal limit of the river (Figure 12). This again forms a significant barrier to fish migration at low water, although the obstacle will be reduced on higher tides. Discussions with Pete Evoy (South Cumbria Rivers Trust) revealed that the weir does drown out on high spring tides, but on a normal tidal cycle, in low/medium river levels the weir is likely to remain an obstacle. A gap has been left in the centre of the weir that may assist fish passage to an extent, by concentrating flows to a central notch and providing a greater plume of water; however, the raised area at the downstream side of the weir reduces the depth of water from which fish can jump to ascend the weir. A large metal bar, presumably for reinforcement of the structure provides an additional obstruction to fish, restricting the depth of the gap through which fish can pass (Figure 13).

Figure 12. Tidal Weir, which will provide an obstacle to fish in low water, until it is drowned out by high spring tides, with a potential to significantly delay fish ascending the river.

evidence suggests that this weir may only be a more recent addition to the estate, built around the same time as the old viaduct (P Evoy, pers. comm., 22nd May), so its removal would not be detracting from the long-term history of the estate. Further evidence to support this theory can also be observed at www.oldmaps.co.uk, with the weir not appearing on the 1862 map, but present on the 1898 map.

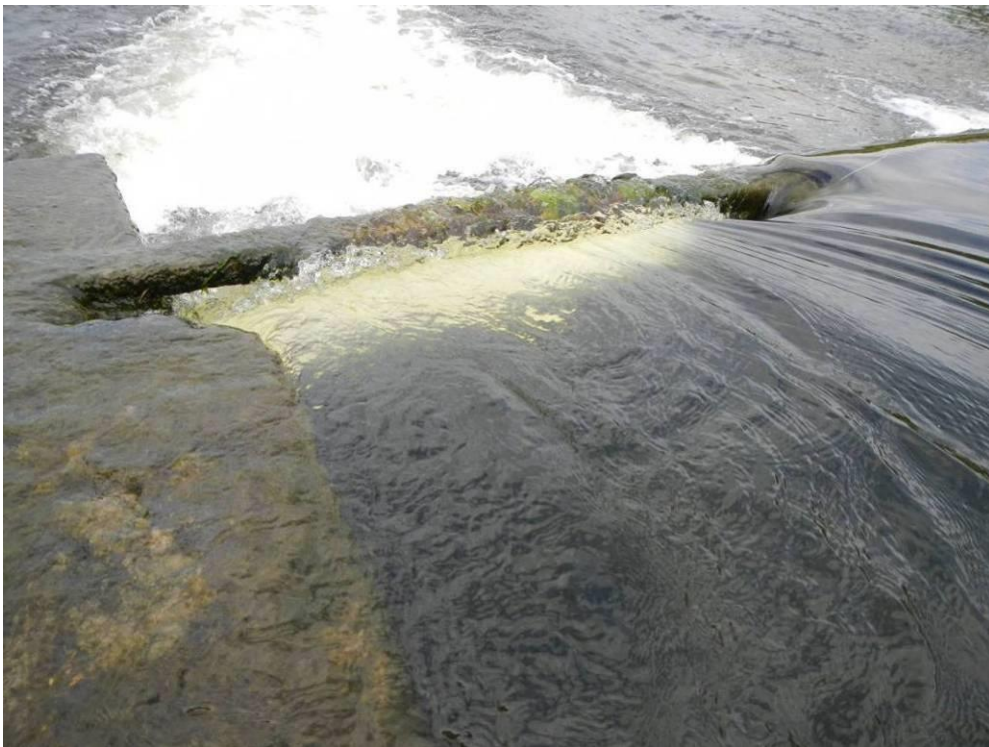
Figure 13. Slot through which fish passing the weir will have to travel in normal flows. The bar across the top of the gap further reduces the passability of the weir.

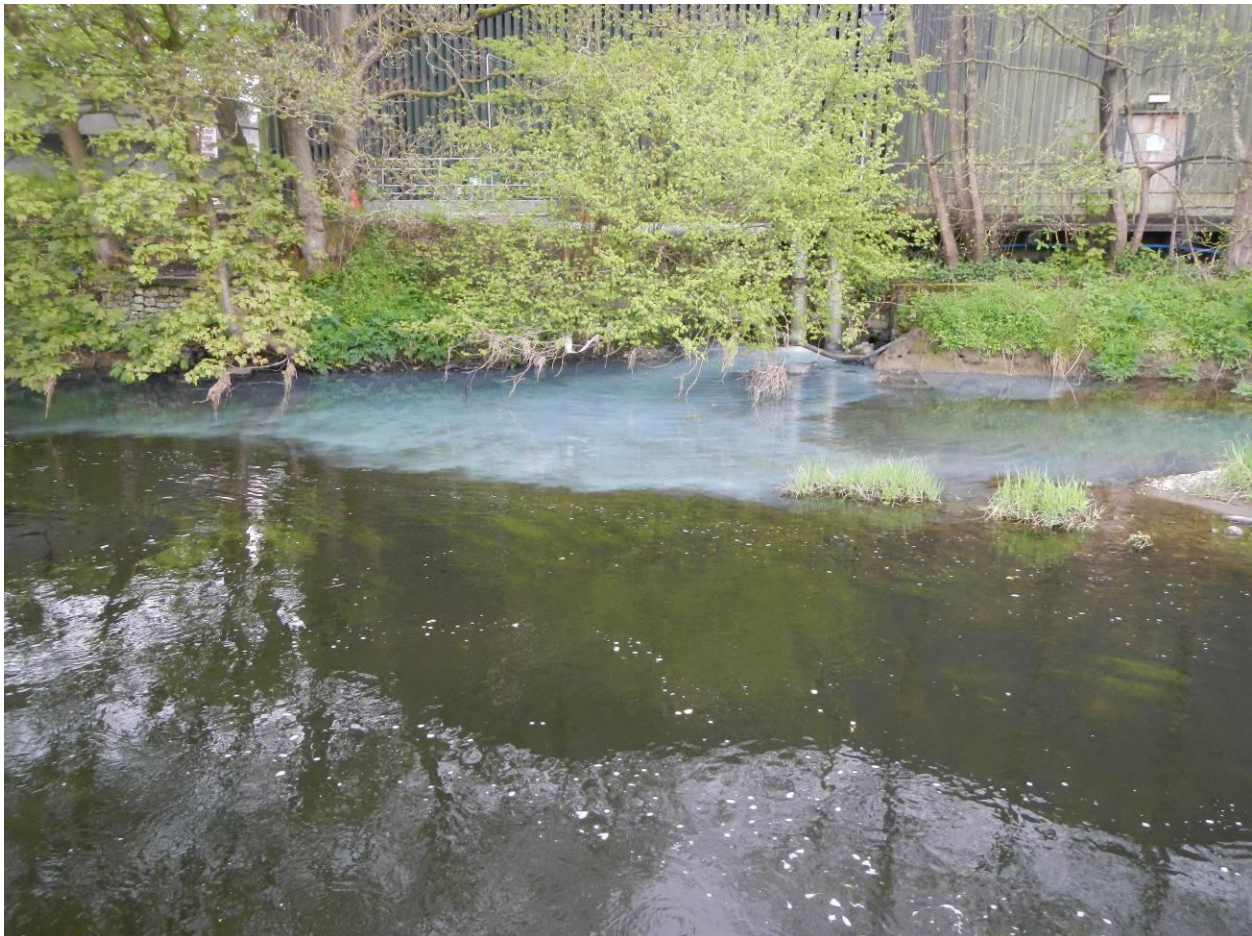
A pollution incident was also observed during the AV on the Bela Anglers water (Figure 14: SD4972980031), and it was suggested that this is a recurring event (I. McMurdo, pers. comm., 16th May). It is likely that the severity of this incident will depend largely upon the toxicity of the dye that the mill is using; however, even if the dye is non toxic there may also be issues of pH, if the discharge contains bleaches that are used in the paper making process, or nutrient enrichment if the whiteness of the discharge is caused by paper pulp. Either way, this is a pollution and should be reported to the Environment Agency whenever it occurs and prevented from happening in the future.

Figure 14. Pollution occurring via the outflow from the Paper Mill. The milky-blue plume was visible for some distance downstream.

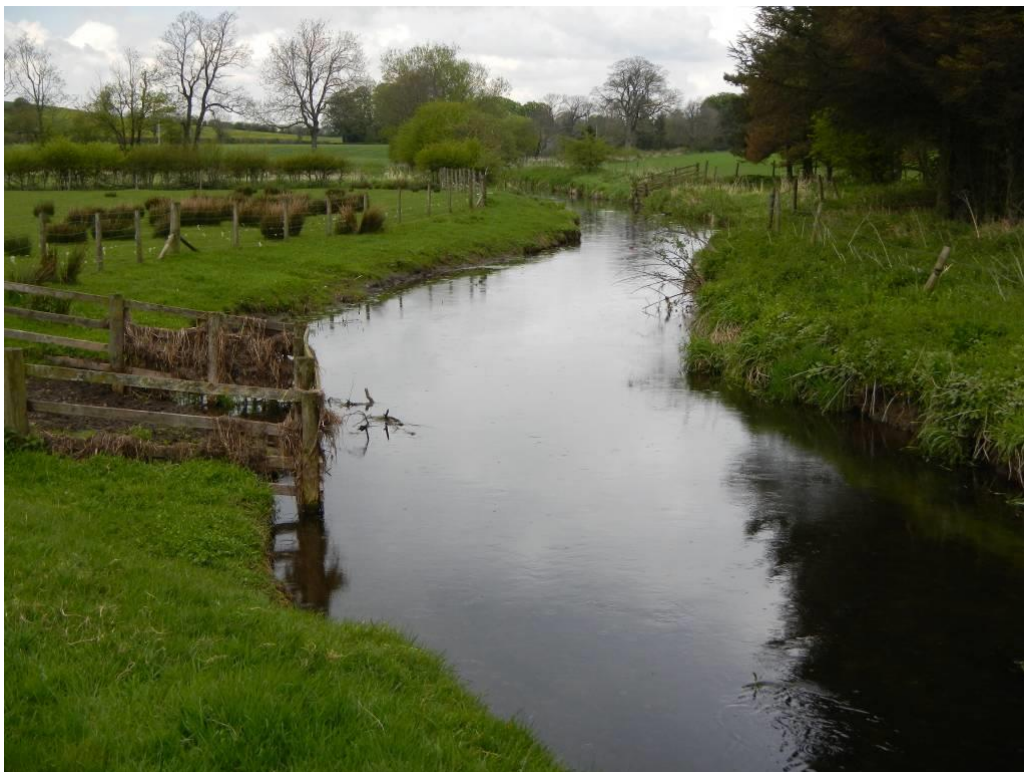
Figure 15. Poorly maintained stock fence allowing sheep access to the riverbank, as evident by the monoculture of grazed grass within the buffer strip.

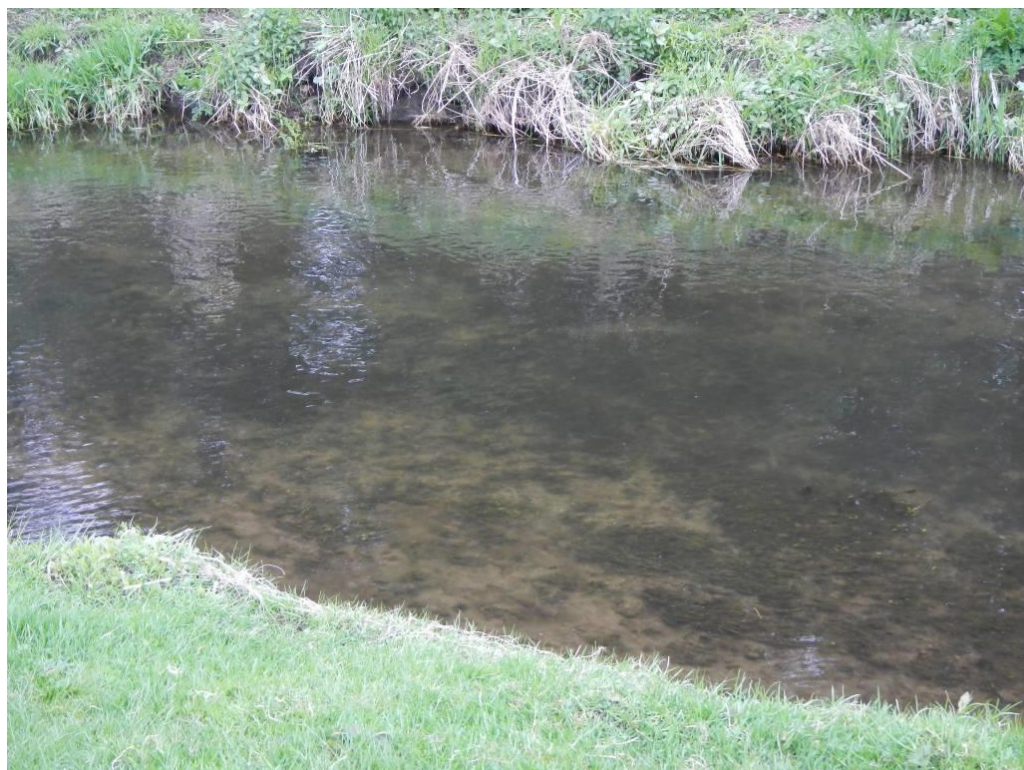
Figure 16. Over-wide channel with significant smothering of the bed through sediment deposition.

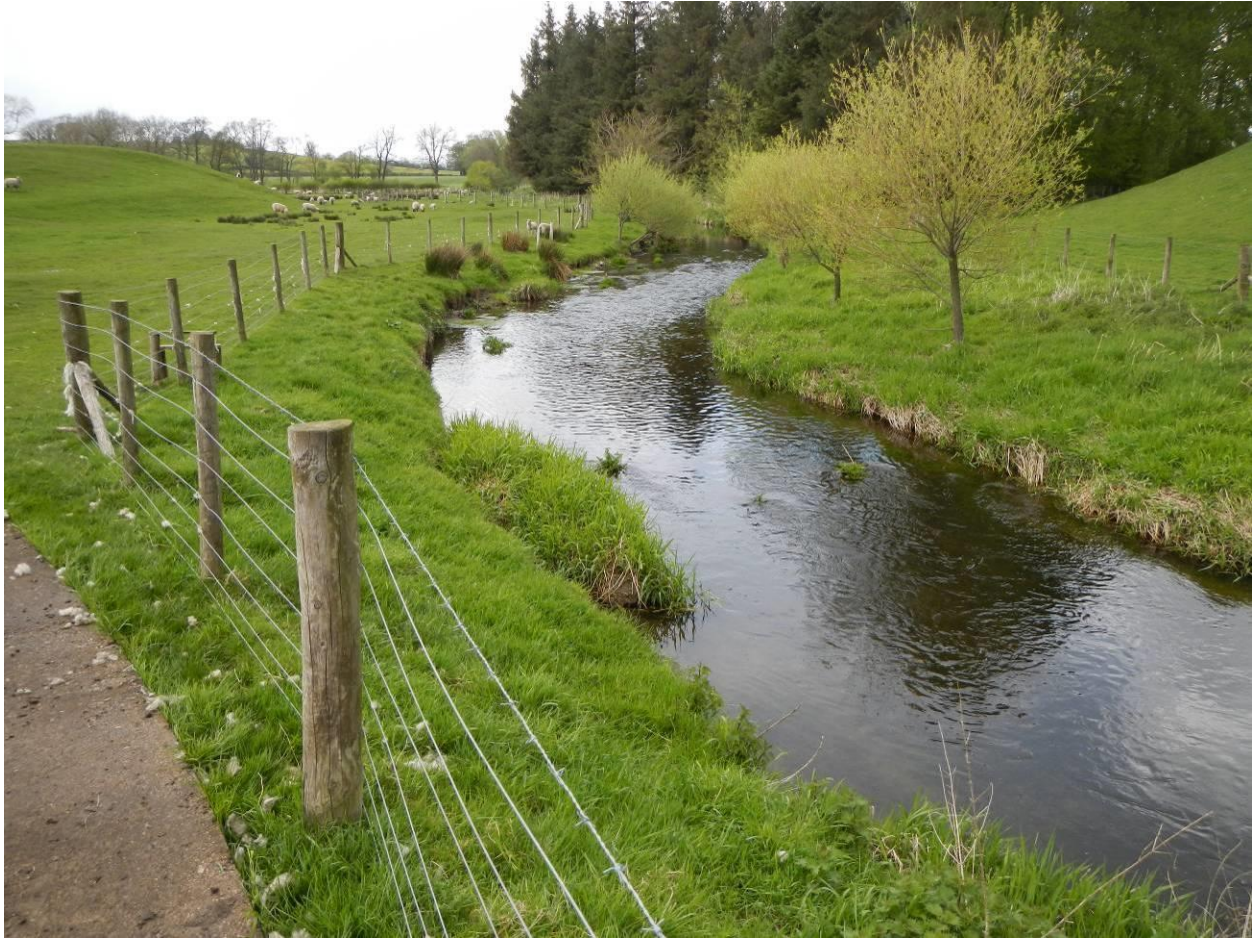
Figure 17. Slightly higher quality habitat, although livestock access through the fence remains a problem.

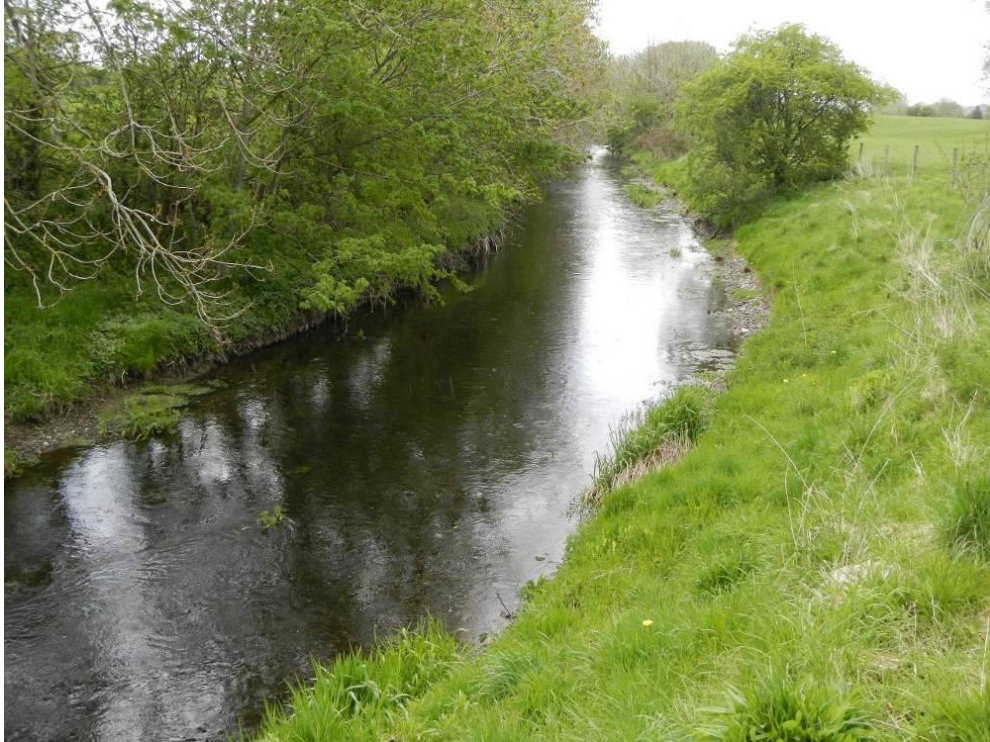
Stainton Beck, upstream of the Fire Fighter Experience, is subject to even greater human modification. Removing much of the natural substrate, in conjunction with the over widening, has left the channel resembling a trapezoidal drainage ditch (Figure 18: SD5200282699), designed to convey water as quickly as possible with no regard to habitat within the watercourse. The result is a channel where high flows wash out any natural substrate, while deposition is increased in low flows. This has resulted in significant sediment deposits, severely compromising the reach for salmonid spawning and invertebrates. In places, some degraded gravel and cobble riffles remain (Figure 19), but for the majority of the reach inspected, the channel was incredibly straight and featureless.

Figure 18. Significantly modified channel, now devoid of features, which extends for several hundred metres upstream. This was also, historically the site of significant salmon spawning, but current high levels of sediment deposition are likely to significantly compromise this.

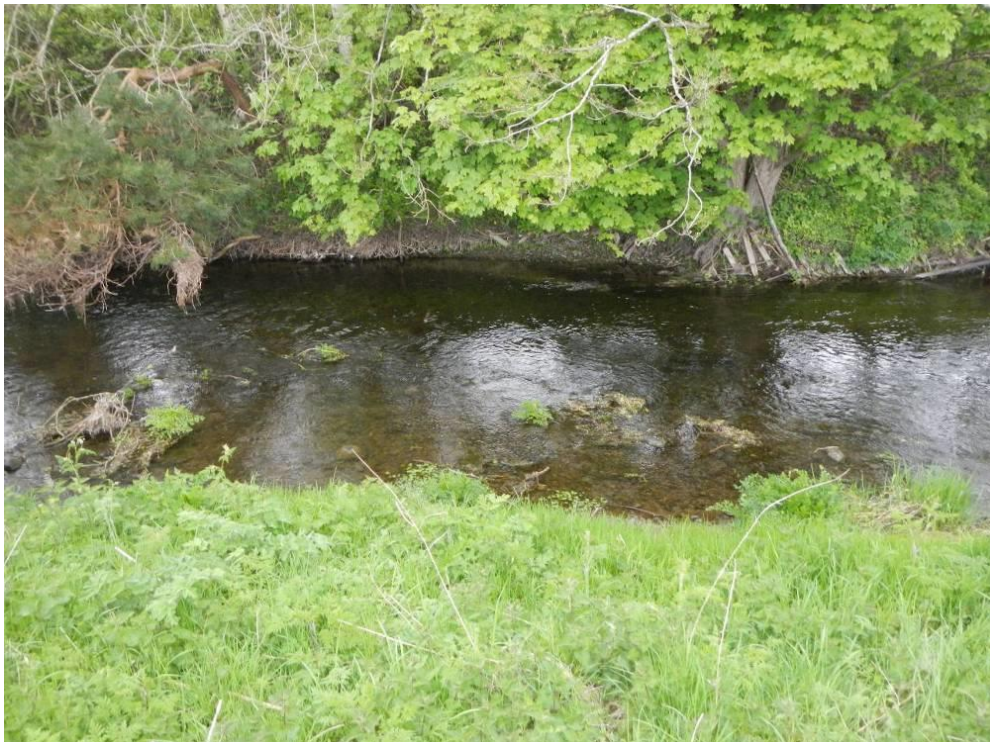
Figure 19. Some remnants of in-channel features, but significantly lacking natural substrate and channel diversity.

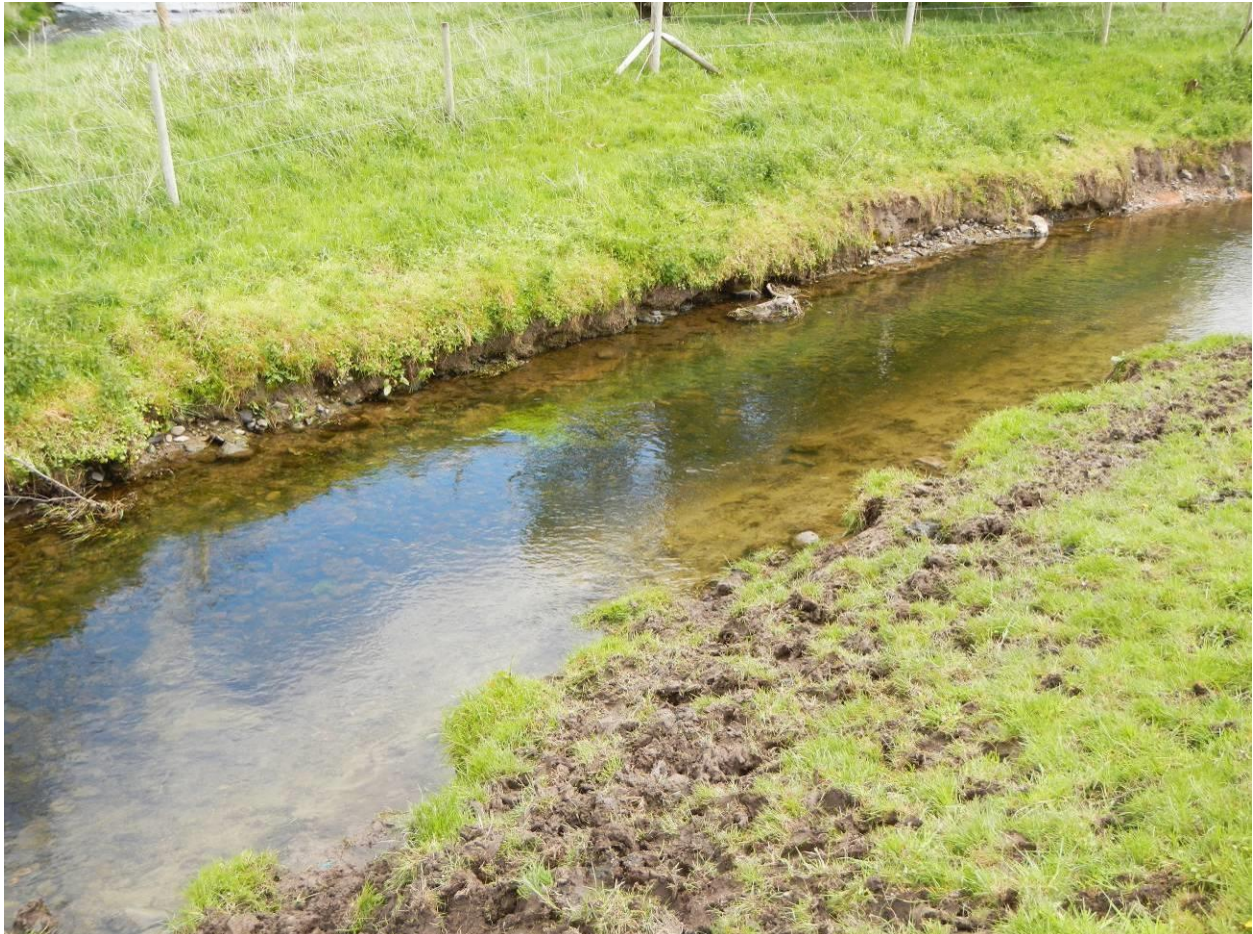
Only a short section of the Holme Beck was walked, but it became immediately apparent that there were issues with excess sediment input from livestock damage to the banks (Figure 20). This is likely to significantly reduce the habitat quality for salmonid spawning and invertebrates, and is likely to be contributing to the low fish numbers observed by anglers in comparison to the main river. A significant section of the lower Beck appeared to be man made, with a fixed width channel having been carved into the actual bedrock (Figure 21). There was also a notable lack of in-channel features (LWD etc.), and low-level or trailing cover, leading to a lack of fish holding features and refuge from high flows (Figures 20 & 21).

Figure 20. A major lack of cover and poor riparian vegetation, coupled with physical damage to the river banks by livestock. Also note the significant accumulations of fine sediment along the near side bank.

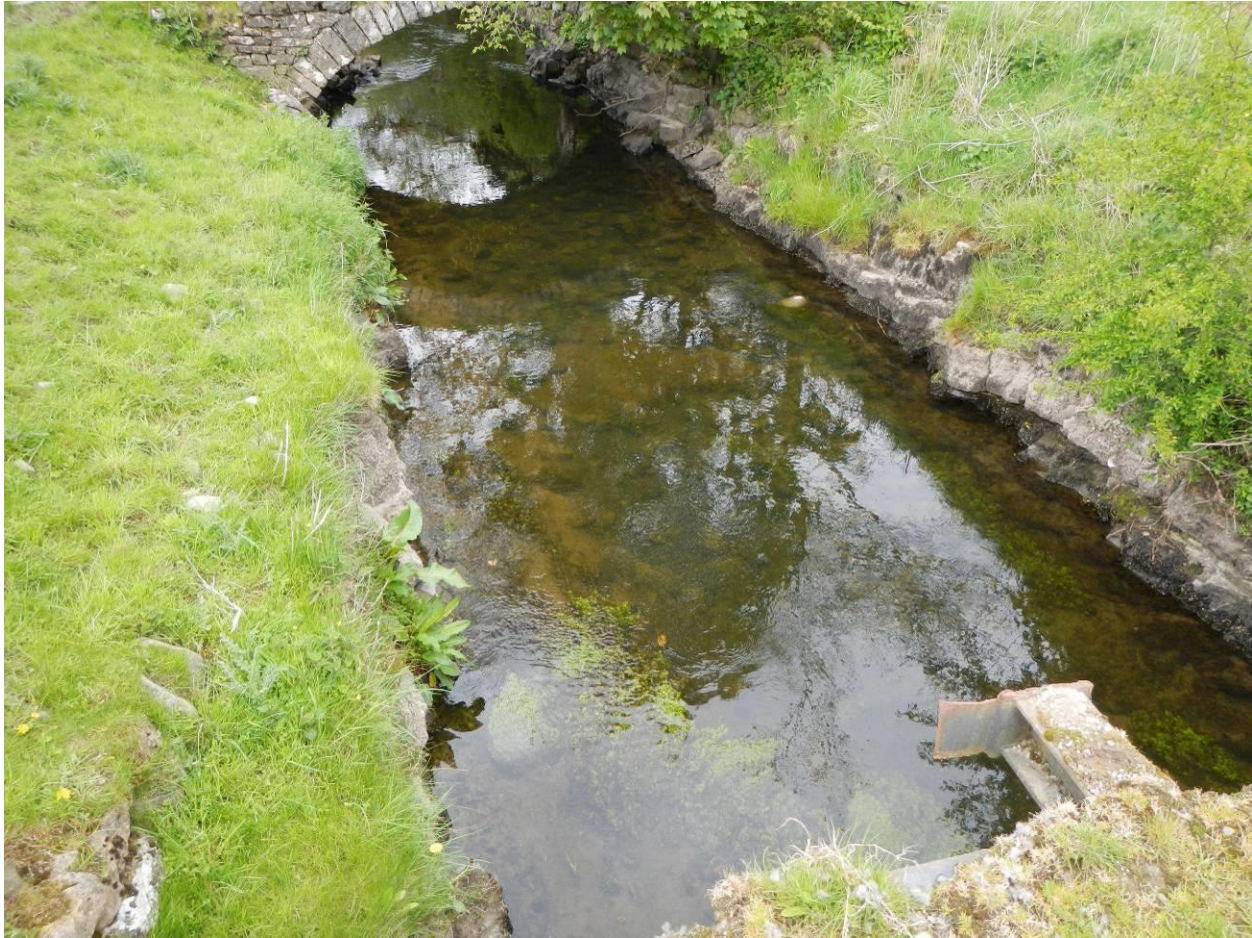
Figure 21. Section of the Holme Beck where the channel appears to have been carved out of the bedrock, leaving a featureless fixed cross section. Again, note sedimentation of the bed.
