**Advisory Visit undertaken on behalf of Milnthorpe Angling
Association and Dallam Tower Estate**

River Bela

16/17th May 2013

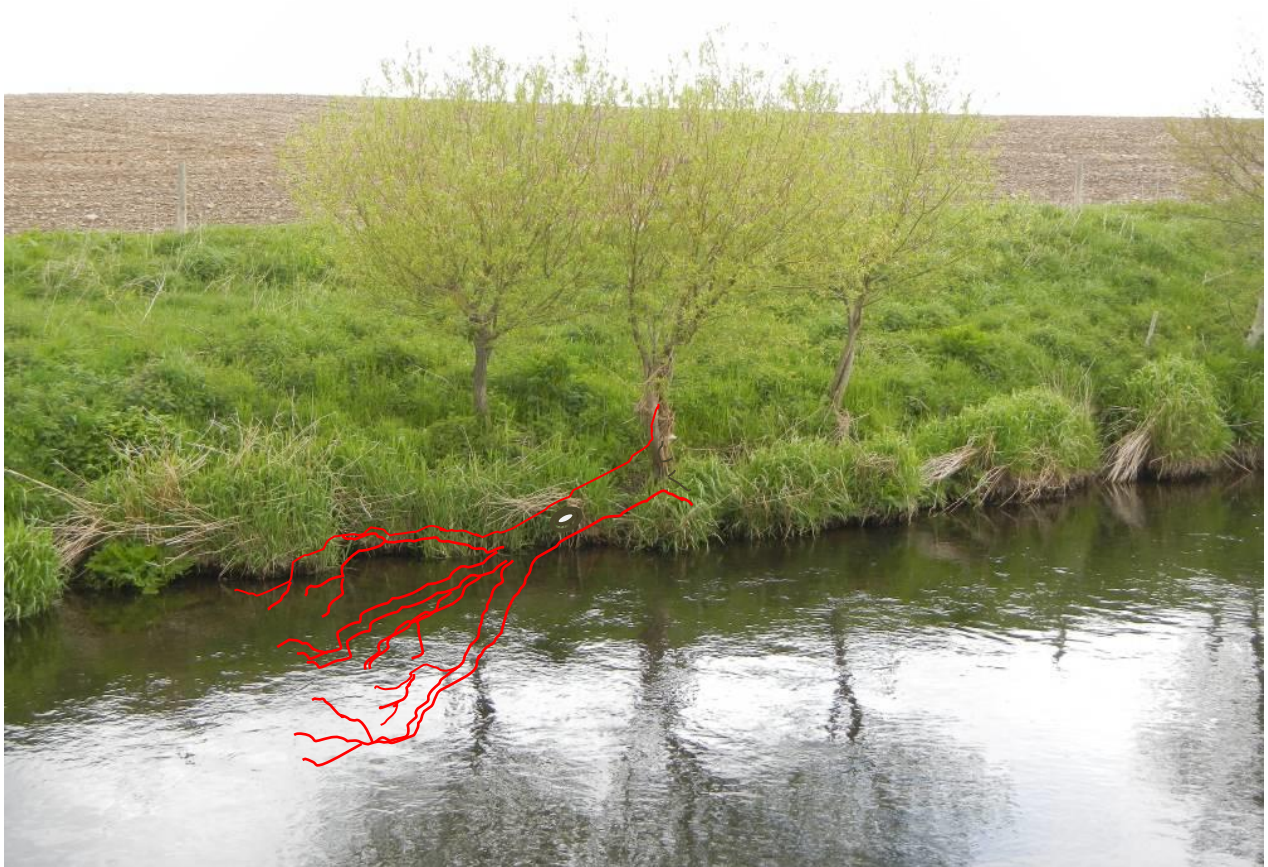
Figure 22. A prime example of one of the many locations where willow could be laid into the channel to increase cover and flow diversity (as demonstrated in red, also see Appendix A).

Laying trees, as you would a hawthorn hedge, is an excellent way of instantly increasing in-channel structure and cover. Many of the willow trees/whips planted by Milnthorpe AA are now at a stage where they can be effectively laid into the channel (Figure 22). A good example of willow and hazel laying can be seen in Appendix A. It is not recommended that this is done with all trees, but this would be greatly beneficial to selected trees in areas currently lacking flow diversity and cover. Supporting laid trees with posts and wire may be beneficial to aid their retention; however, this may require Flood Defence consent from the EA.

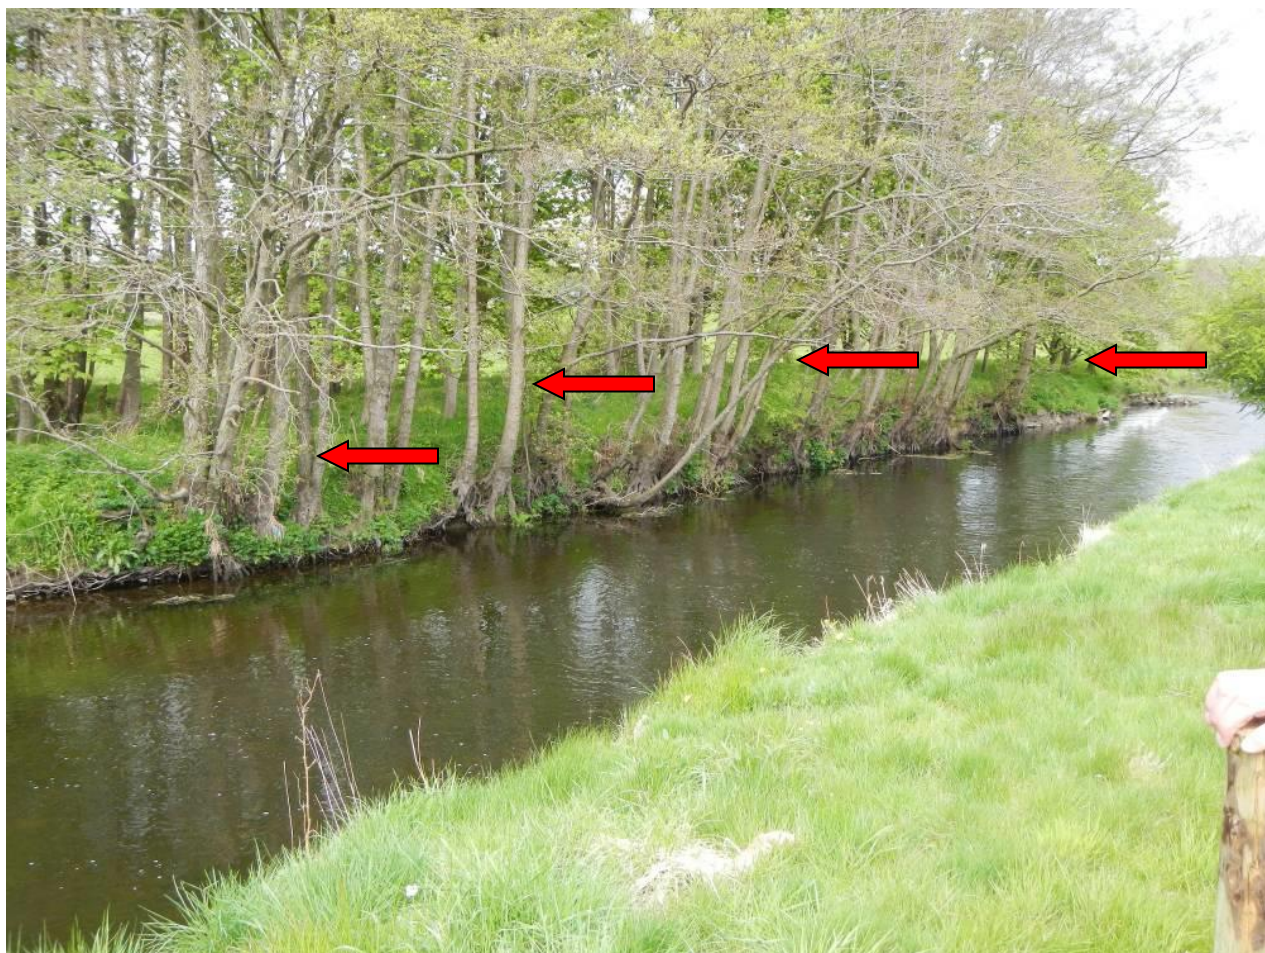
Figure 23. Alder canopy lifted well above the river and no-longer providing optimal low-level cover. One of the few areas where selective coppicing would be beneficial. Note there are no branches below the red arrows.

Coppicing is another great way of increasing low level re-growth of trees where the canopy has naturally lifted, or been pruned so that it no longer provides low and trailing cover. Fortunately, very little pruning occurs on

either association waters, and it is recommended that none is undertaken, so that optimal cover habitat can be retained. There was, however, two sections on the Milnthorpe AA section (and SD5064179889), where the canopy is raised well above the river and coppicing of every 3rd or 4th alder is recommended to improve the cover provided (Figure 23). A demonstration of the benefits of coppicing can be seen in Appendix B, where a whole run of trees have been coppiced; however, for better results can be achieved by only coppice selected trees, as suggested above, to prevent short term loss of habitat diversity.

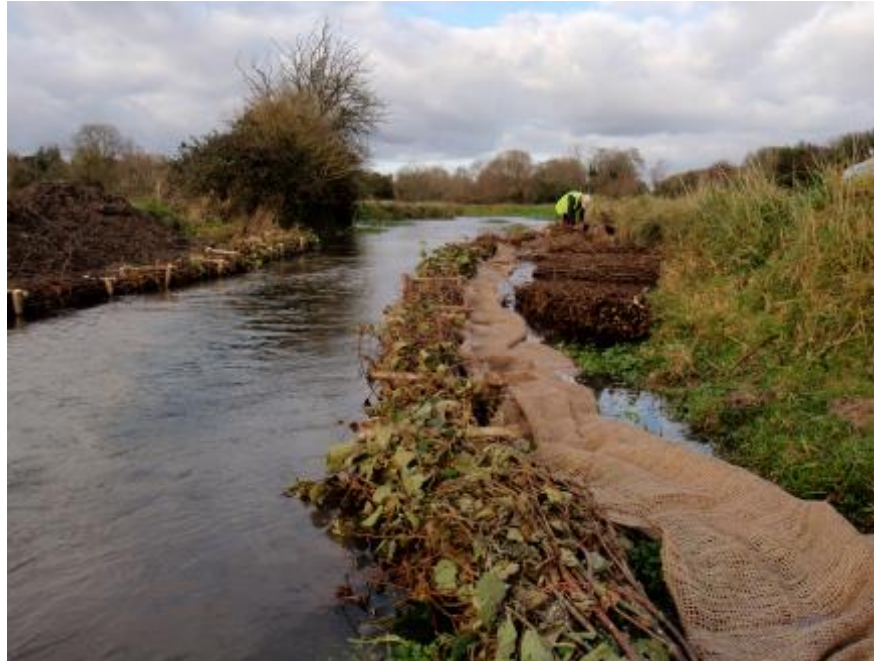
Figure 25. Bank creation using willow faggots and brush backfill. This example also includes the use of hessian or coir.

A further option, particularly on the lower energy, highly degraded sections, such as the trapezoidal channel of Stainton Beck, is creation of a new, low-level bank line using living willow or hazel faggots. These can be staked into the bed to create a new bank line. The area behind the new bank could then be backfilled with brash, to create a mattress, and pinned and wired to the bed with multiple stakes to prevent wash out (Figures 25 & 26).

This method increases sediment deposition within the brash, by baffling and slowing the flow over it. The example in Figure 25 also employs geotextiles to encourage deposition and protect the backfilled area until it is colonised by vegetation; however, the use of geotextile may not be necessary in this particular case. Alternatively, the area could be partially filled with material sourced from the river banks, thereby not actually reducing channel capacity, just relocating materials within it, or the area could simply be left open to accumulate sediment transported from upstream.

The faggots used for this should be relatively small diameter (c.300-400mm) and brash backfill kept to a low level, particularly towards the centre of the channel to lower the amount of drag in high flows, and reduce chances of washout. The height of the brash backfill can be graded, being higher at the bank than at the faggot toe, but it is recommended that none of the brash stands more than 400mm above the bed, to maintain the channel capacity.

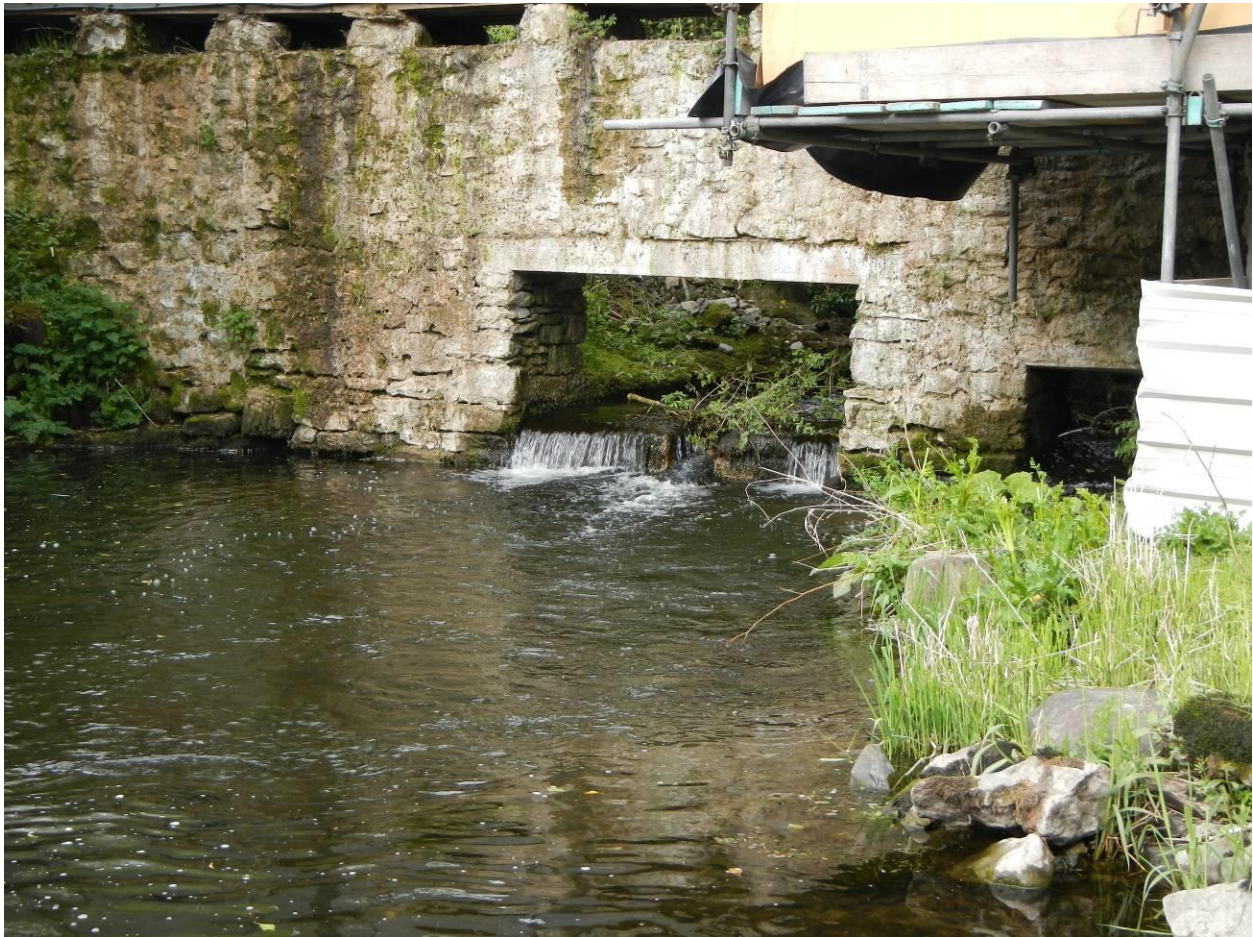
Figure 27. Poor attraction flow to the fish pass, exacerbated by debris blockage in the pass.

More flow could be directed through the fish pass to increase its attraction, providing that it is not supercharged (over filled). The capacity/size of the pass could even be increased, so that it can take more water without becoming super charged. Both of these methods would hopefully draw more fish to the pass, and any remaining flow of water spilling over the weir (RB) could also be distributed more evenly to reduce attraction to other areas. Finally, adequate maintenance of the pass should be ensured at all times, and any materials blocking the pass, as in Figure 27, should be removed immediately.

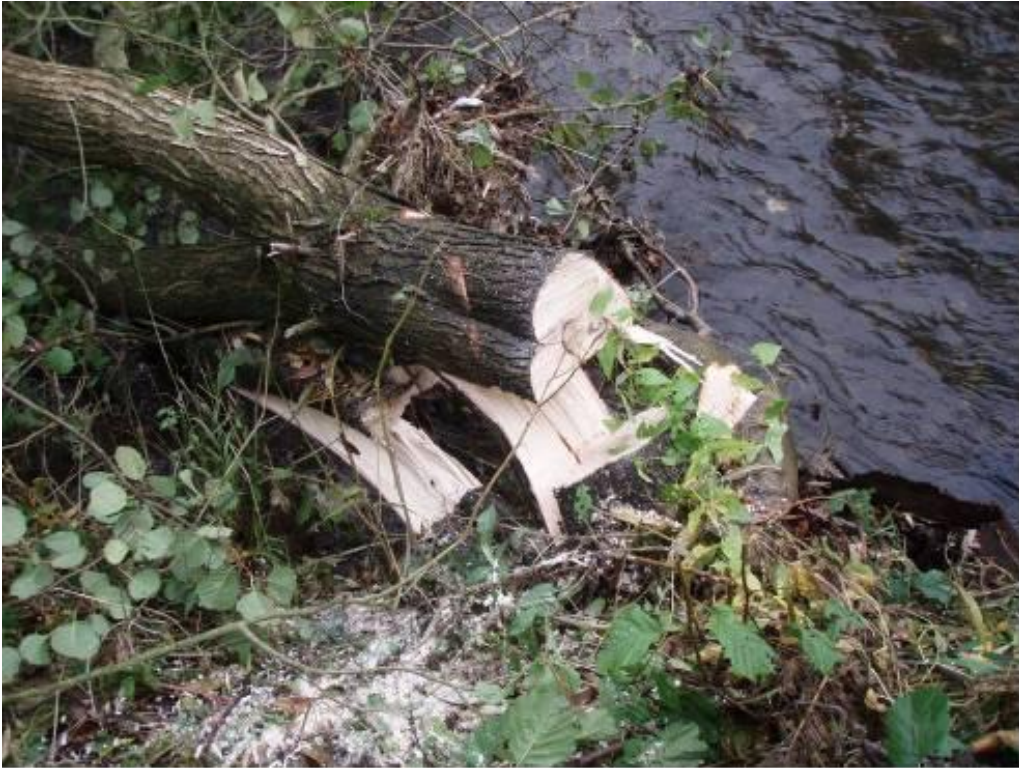
Willow after laying.

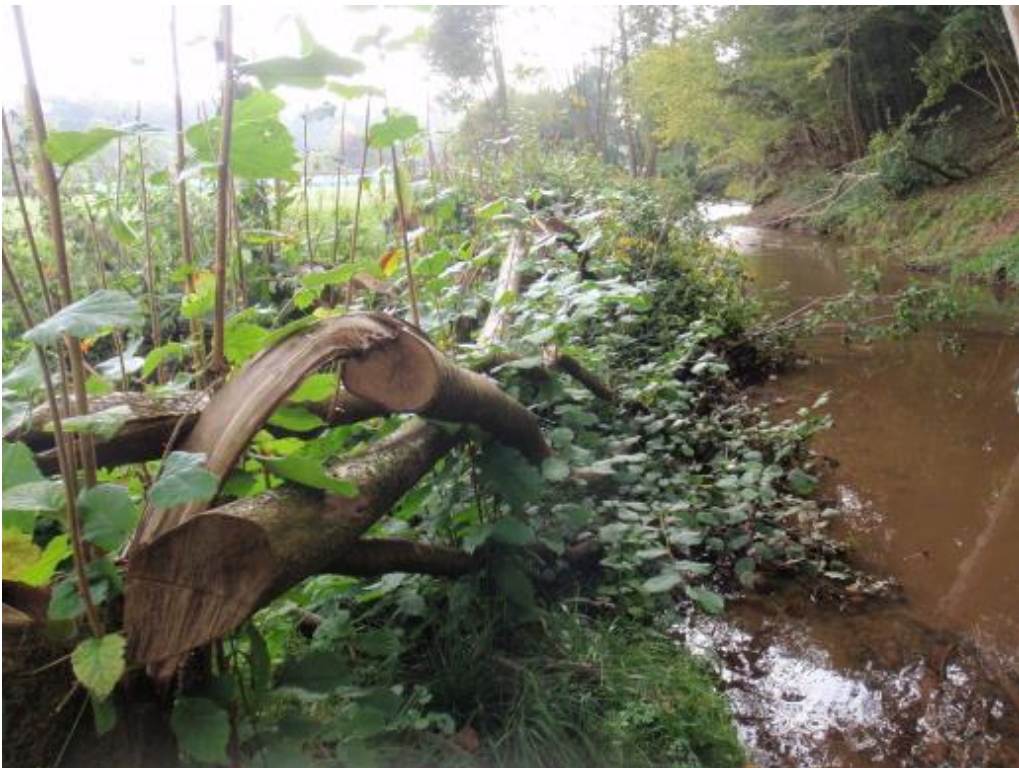
Hazel after laying into the channel margin.

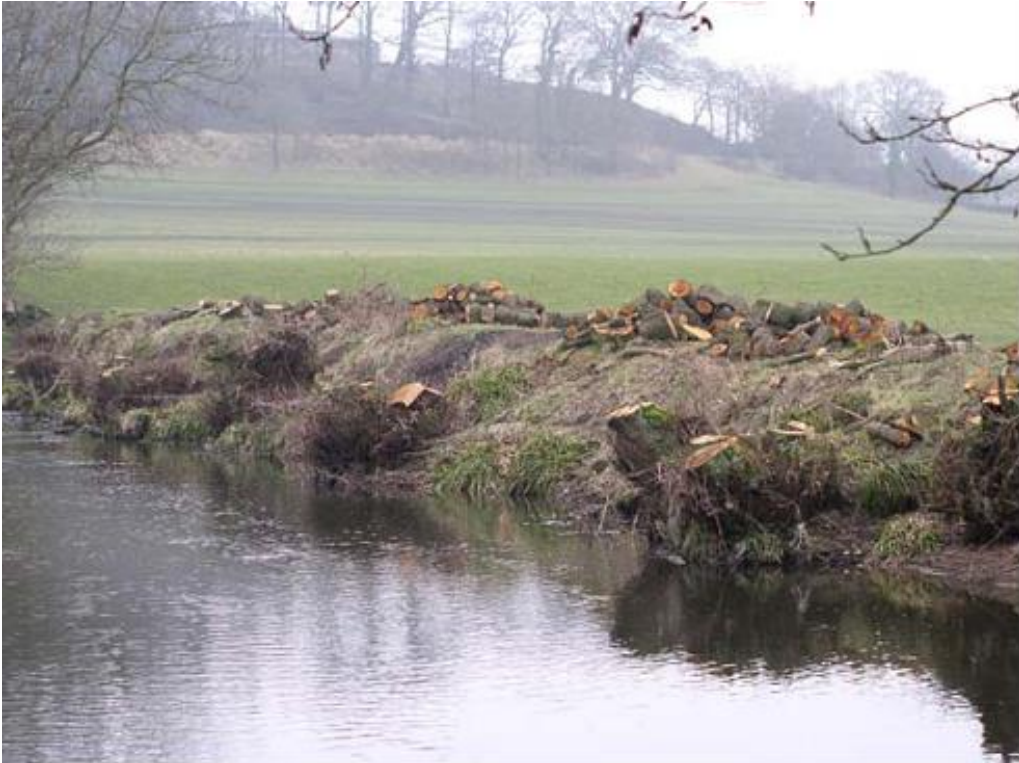
Alder shortly after coppicing

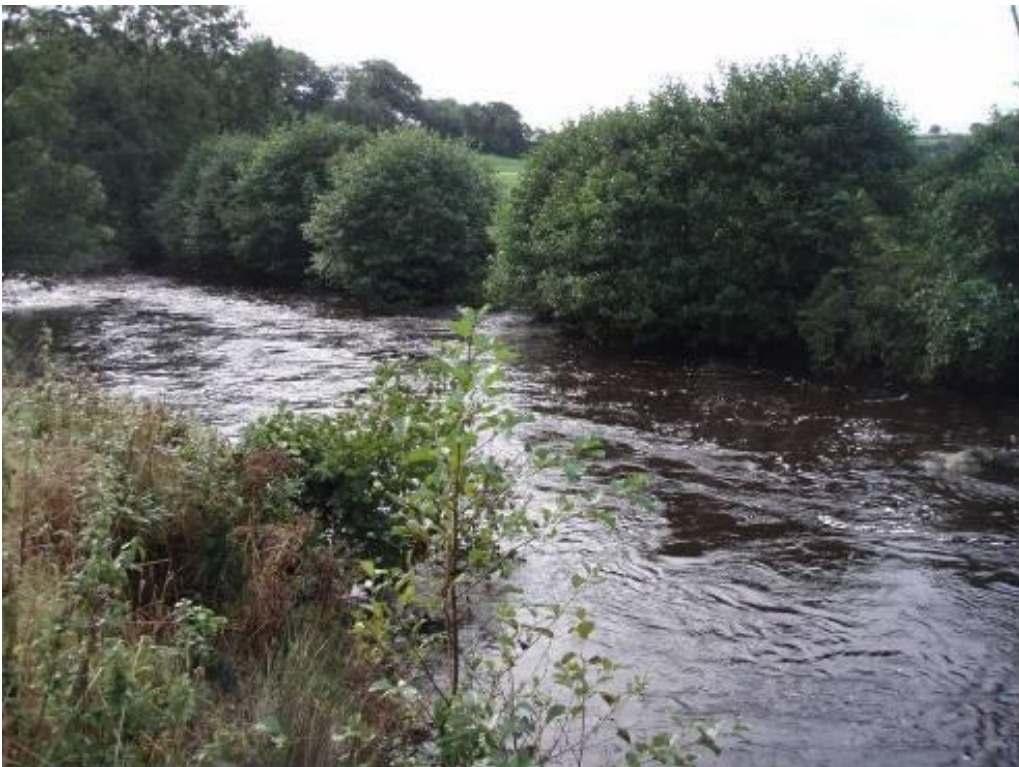
Alder 5 years after coppicing
