WILD TROUT TRUST

## **River Bradford, Haddon Estate**

12/05/2021

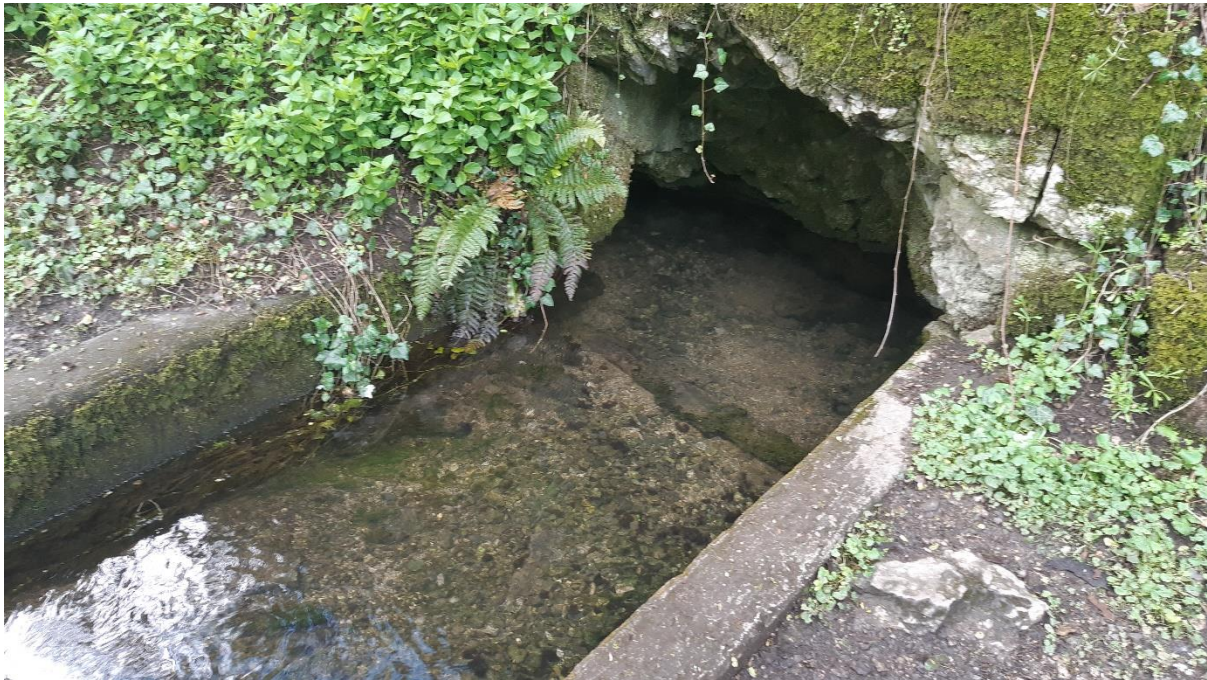
Figure 1: The formalised outflow of the underground spring marking the source of the Bradford.

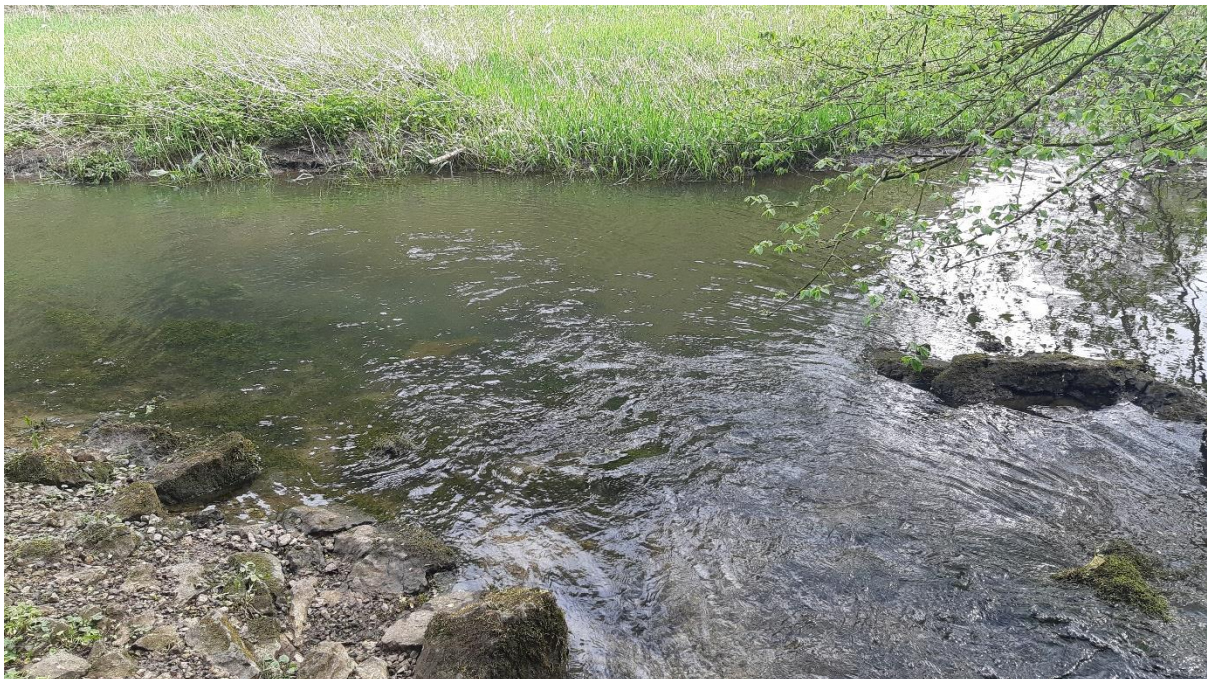
Figure 2: The outflow from the spring into the Rowlow Brook (an ephemeral stream) - to form the Bradford.

Because the spring is physically separated from the river (rather than issuing into the bed of the river), it would be possible to sample its physico-chemical properties. Basic measurements such as temperature, dissolved oxygen, pH and electrical conductivity (a measure of dissolved salts/ions – and so related to the mineral content) are possible to monitor with

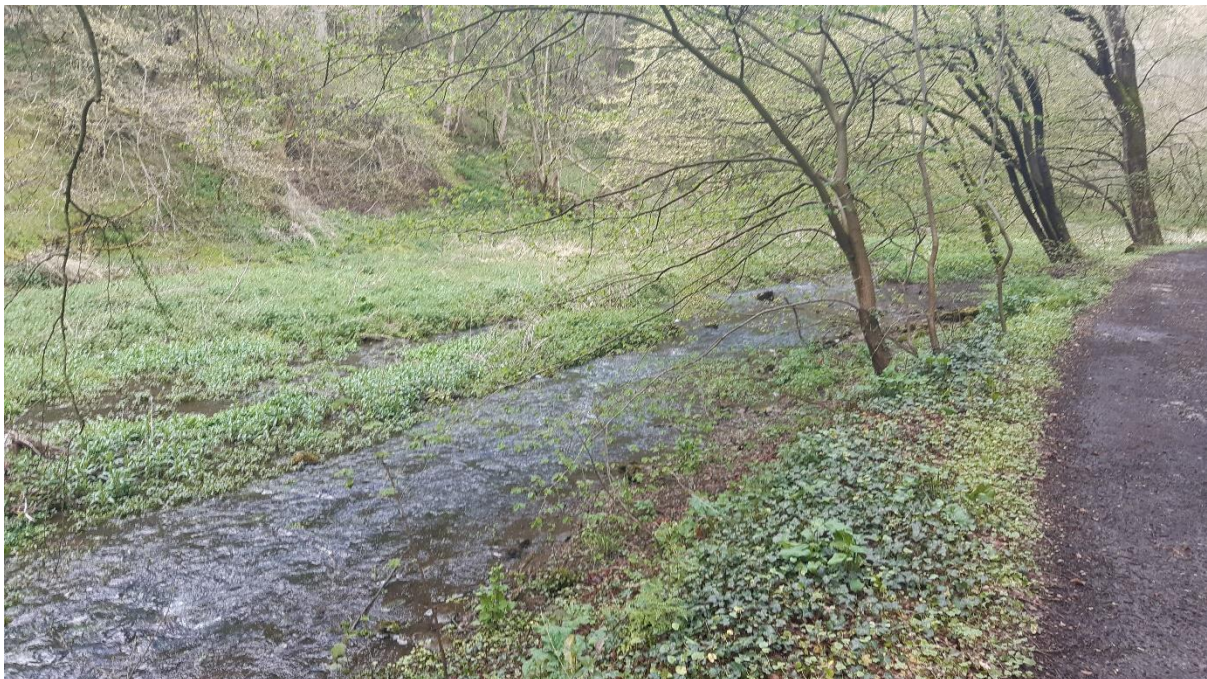
Figure 3: The dam furthest upstream on the Bradford - showing the condition with the sluice raised (and hence the “pond” is drained).

While locally contentious, raising the sluice-gate (bypassing the overflow channel; Fig. 4) at the downstream end of the dam shows the potential for river-channels to re-form in the absence of impoundment. Allied to this, there are successional processes of flora/fauna re-colonising what was previously the pond-bed; reclaiming it as a vegetated flood-plain. Given sufficient time, the initially-dominant flora (thriving on the nutrient-rich sediments) will diversify as those nutrients become sequestered in longer-living plant tissues and create more complex competitive interactions. Already, as observed on the walkover, there are a variety of insects and birds benefiting from the re-vegetation of exposed substrate.

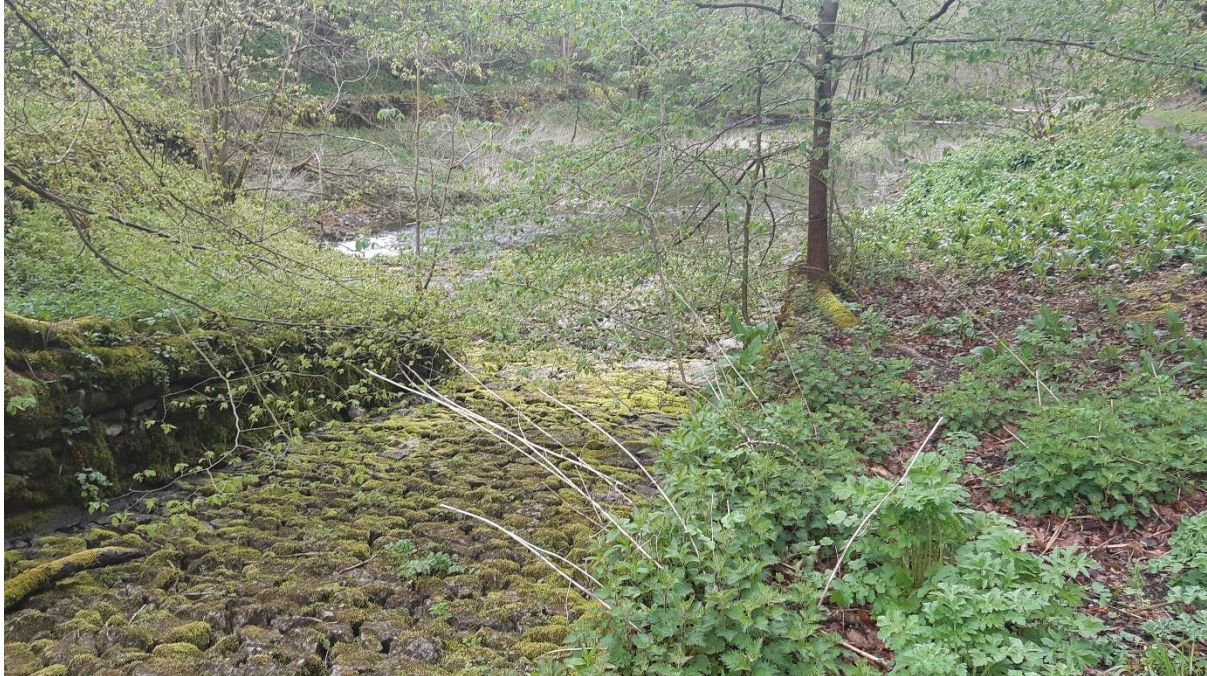
Figure 4: Cobbled overflow channel at the downstream end of the dam #5. Currently dry since the sluice gate bypasses this structure.

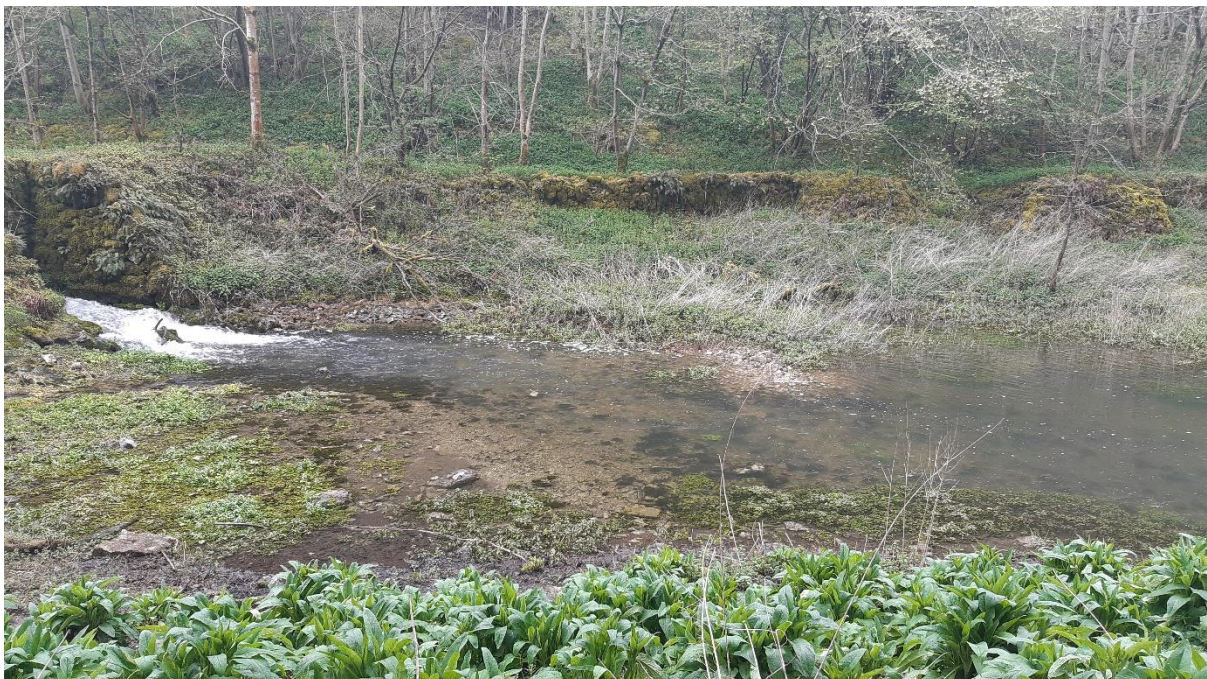
For instance, cobble material deposited downstream of the sluice shows the potential for ramps of spawning gravel to form – but has insufficient depth of suitable particle-sizes (Fig. 5).

Figure 5: A shallow fan of gravel and cobble below the raised sluice draining dam #5.

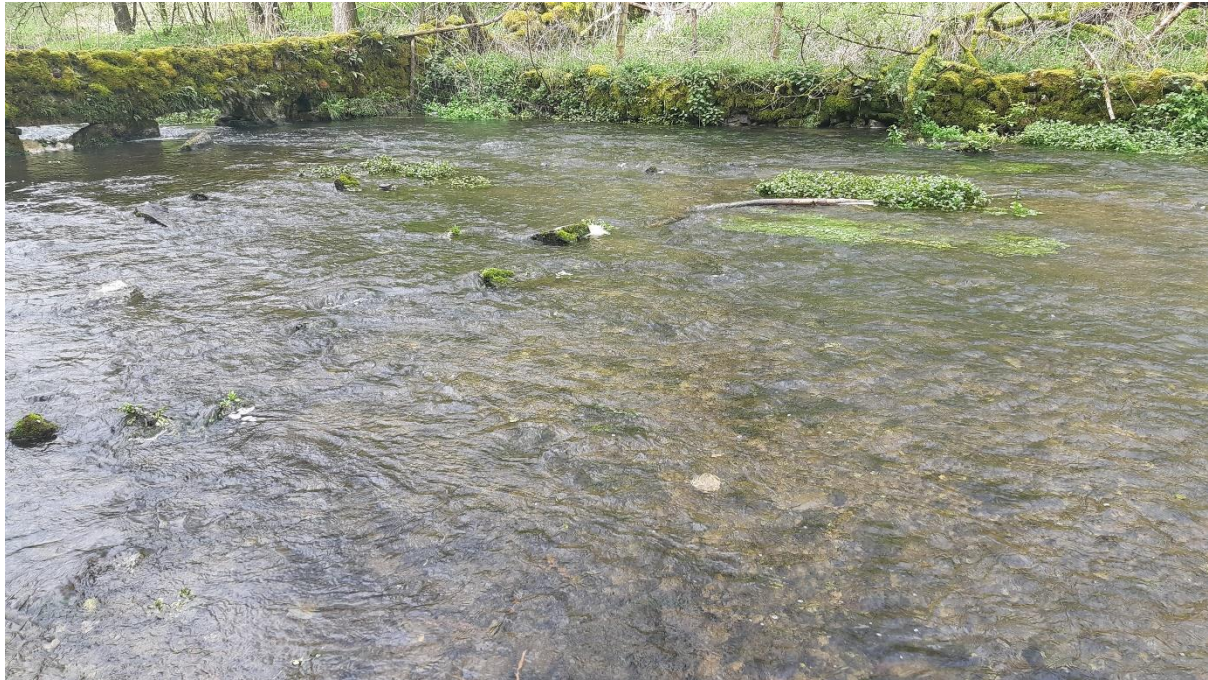
Just below the undershot wall/boundary structure (background in Figs. 7 and 8), there is some potential spawning habitat (Fig. 8).

Figure 8: Gravels in the 20-50mm particle diameter range could potentially support some trout spawning. There is scope for improvement of this habitat for that purpose.

Creation of cover is central to spawning success – since the threat of predation (as well as *actual* predation) both greatly reduce the actual utilisation of available gravel beds. Cover and bed scour could both be kick-started via the deliberate introduction of stable, large woody material in this section.

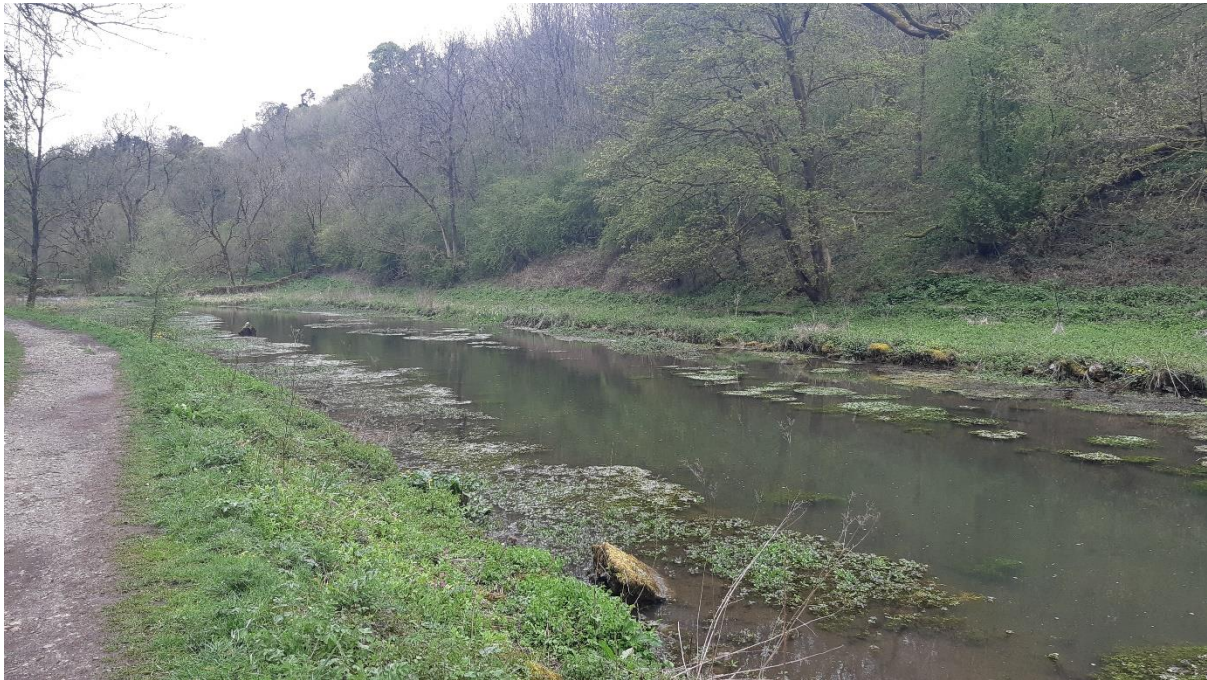
The contrasting situation of sluice gates remaining closed can be seen in the typical, impounded habitat evident in dam #4 during the visit (Figs. 9 and 10). Although creating deeper water (and consequently the potential to hold adult trout), the uniform habitat, interception of bed material,

restriction of up/down-stream fish movement and relative lack of cover are all limiting its value to wild trout populations.

Figure 9: Central section of dam #4 facing upstream.

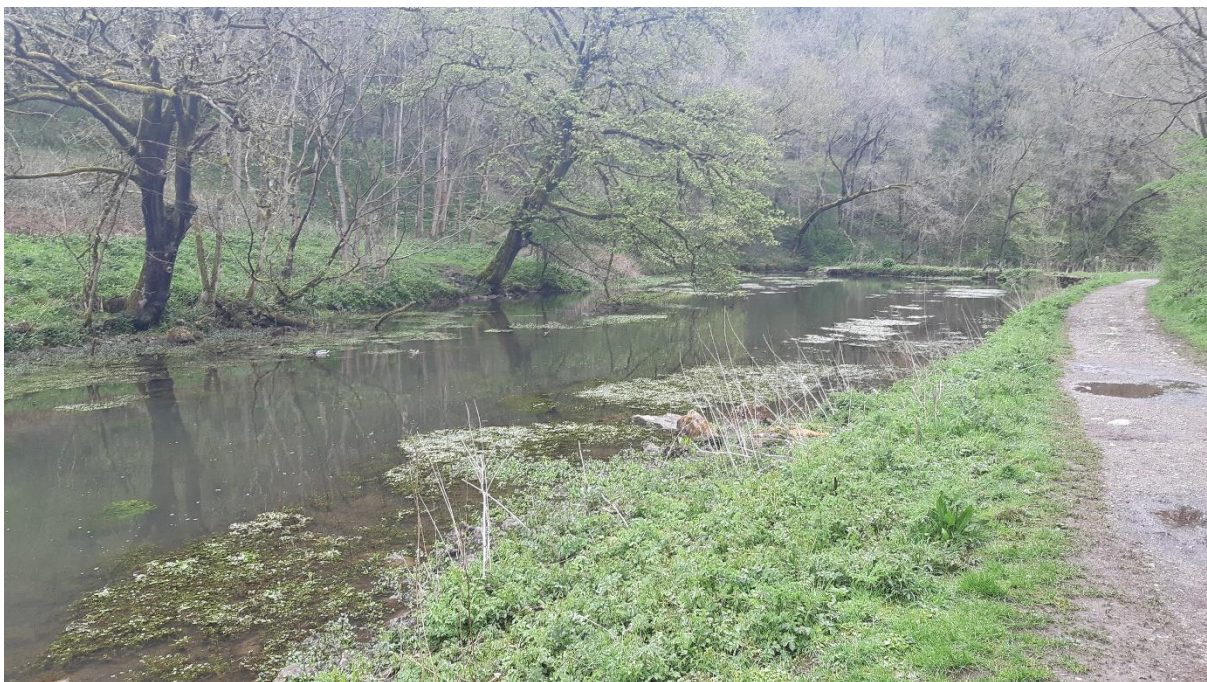
Figure 10: Dam #4 facing downstream.

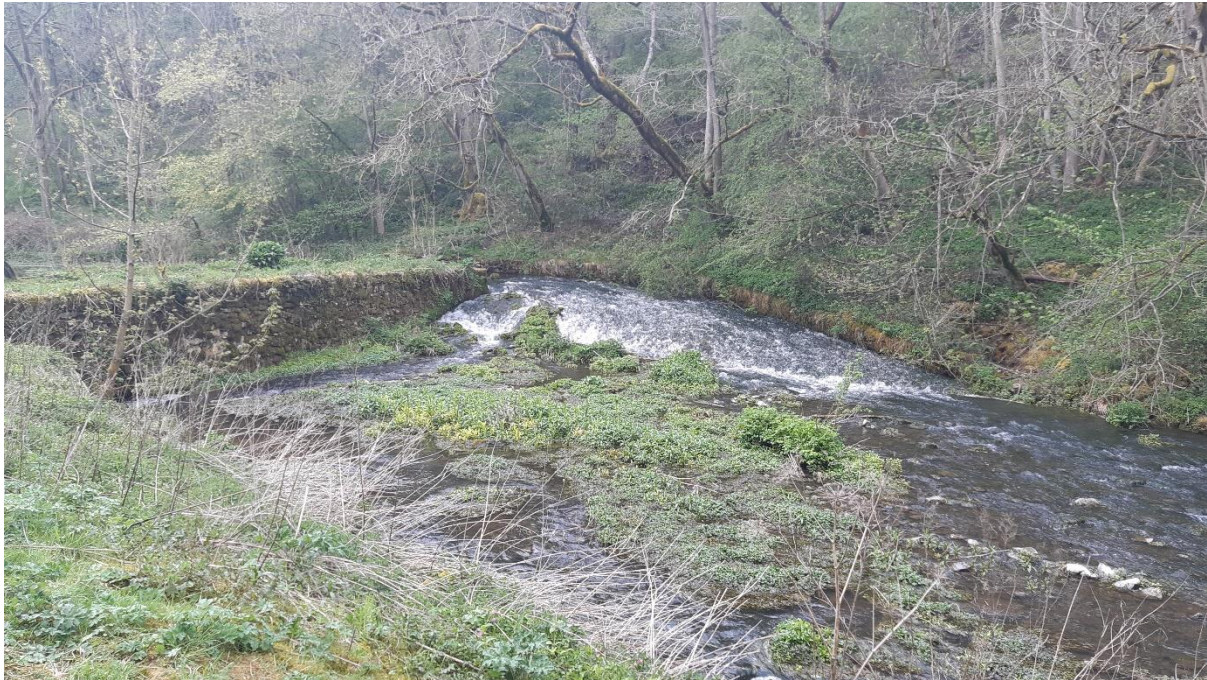
As part of various possible future scenarios, the overspill at the downstream end of dam #4 may be a potential site of a fish passage easement (Fig. 11). However, installation of fish easements and/or formal fish passes do not contribute to habitat quality. Instead, they may at least allow some fish to bypass the most degraded habitat (which is at least better than a complete barrier). At the other end of the scale would be genuine reconnection of geomorphological process throughout the Bradford (via

Figure 11: Overspill (in action) at the downstream end of dam #4 – there is potential for a baulk or other improvised baffle easement to be constructed on the sloping face.

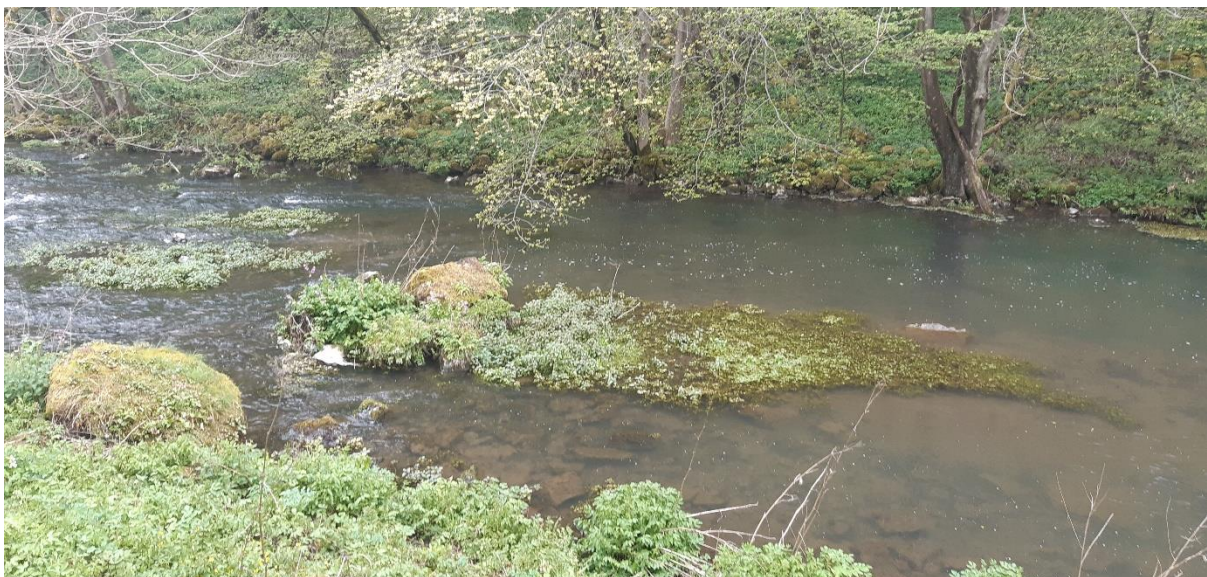
Figure 12: Depending on the options adopted by the Estate, seeding this area with locally-appropriate gravel could provide some mitigation for interruptions to the natural supply.

Figure 12 also shows the presence of more cross-sectional variation in depth and flow velocity – along with low overhanging cover. There is also a mixture of dappled light, shade and full sunlight – with patches of in-channel weed growth responding to that variable light regime. This is creating many more microhabitat niches for a variety of species. Allowing any natural deadfall of large wood to remain in the channel – or deliberately introducing some – would further enhance the diversity of this habitat.

Directly below the overspill (Fig.12) it should be possible to augment the existing substrate with additional spawning gravel (to offset impacts resulting from past channel engineering).

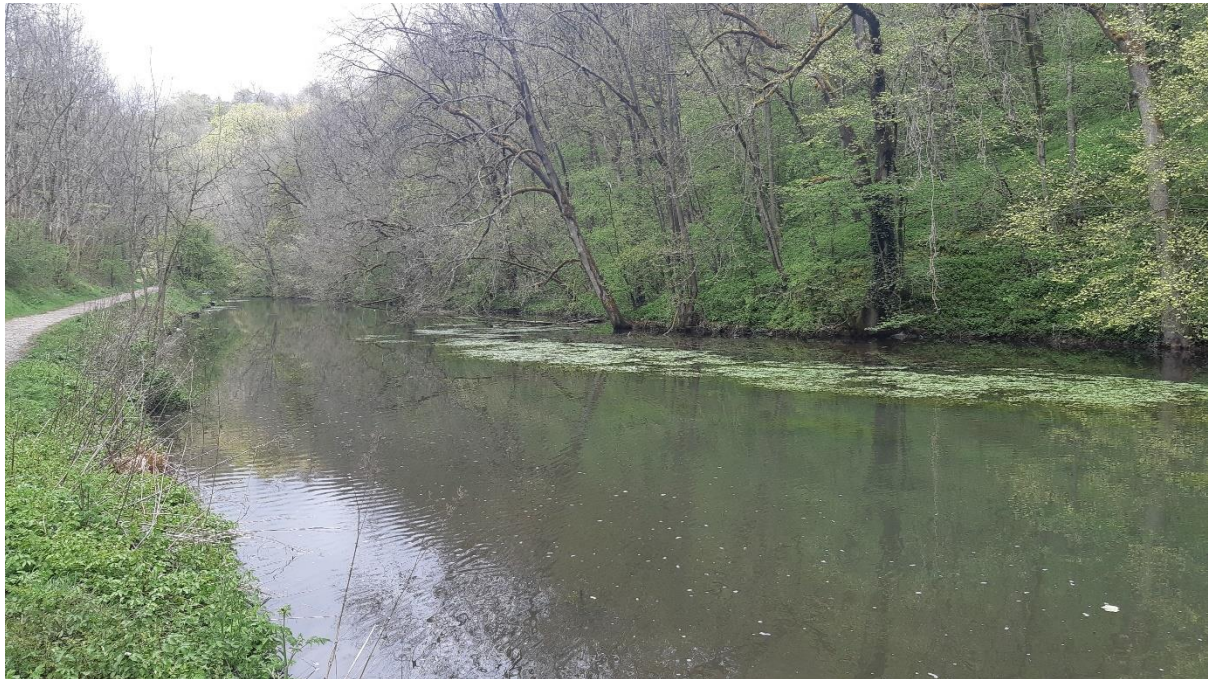
Figure 13: Some overhanging and emergent tree cover coupled with deep water and uniform silty bed in dam #3.

Again, while one or two adult trout were spotted, the ideal situation (ecologically-speaking) would be the removal or bypassing of the weir. The resultant connectivity for both bed-material-transport and free fish passage – coupled with the ability of the river to create pool, riffle, glide habitat of its own – would be of great benefit to fish and other aquatic populations.

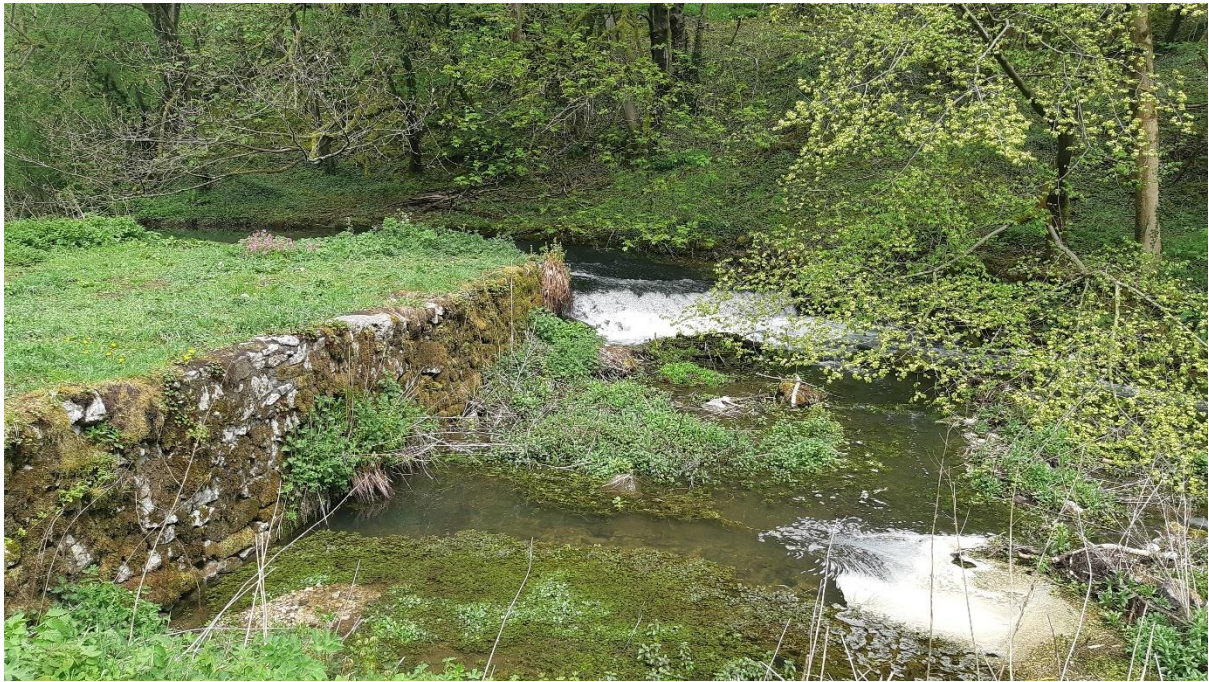
The overspill at the downstream end of dam #3 is a steep drop (Fig.14). This would create a different challenge for the creation of fish passage easements or formal fish pass structures. With sufficient material and the ability to transport it to site, it would be possible to build out a rock ramp (with retaining side-walls to contain the flow). Doing this should make some upstream and downstream migration more feasible for strongly-swimming species. Again, though, this solution leaves the impacts of impounded flows in place – which also include a greater vulnerability to avian predation.

Figure 14: Overspill at the downstream end of dam #3.

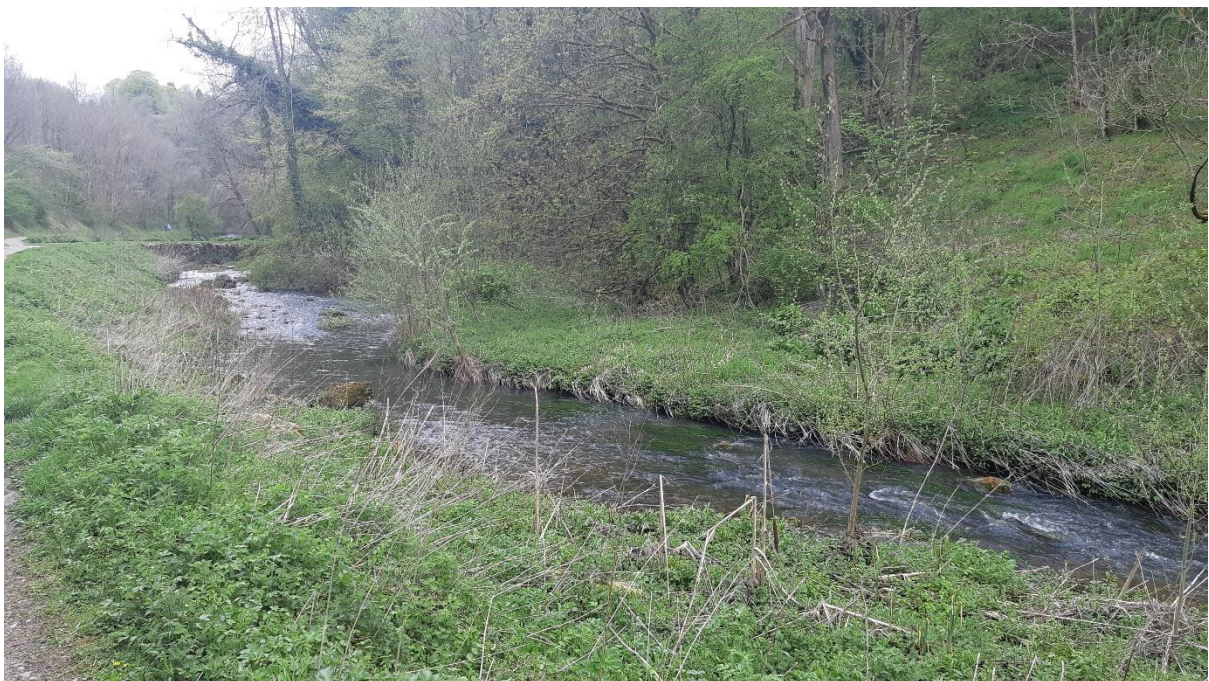
At dam #2 there are efforts being made to maintain a permanently low level by lifting the controlling sluice (Figs. 15, 16 and 17). This section is immediately adjoining the overspill shown in Fig.14).

Figure 15: Significant benefits to habitat from lifting the sluice of dam #2 the encroachment of vegetation and recovery of some meandering planform add to the benefits of varied flow velocity and depth that emerge when impoundment is removed.

Throughout that flowing section of watercourse within the perimeter of dam #2, the introduction of large woody material would be of great benefit. As well as natural cover, structural diversity would be generated via localised scour and deposition.

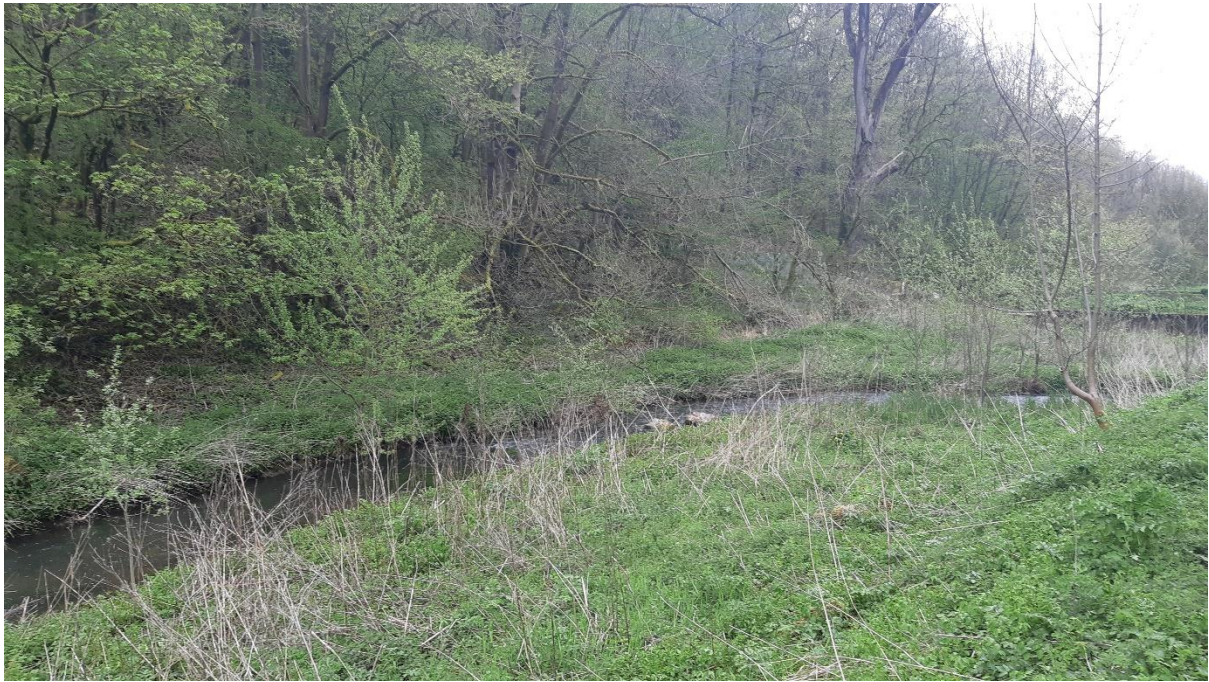
Figure 16: Further downstream in the perimeter of dam #2.

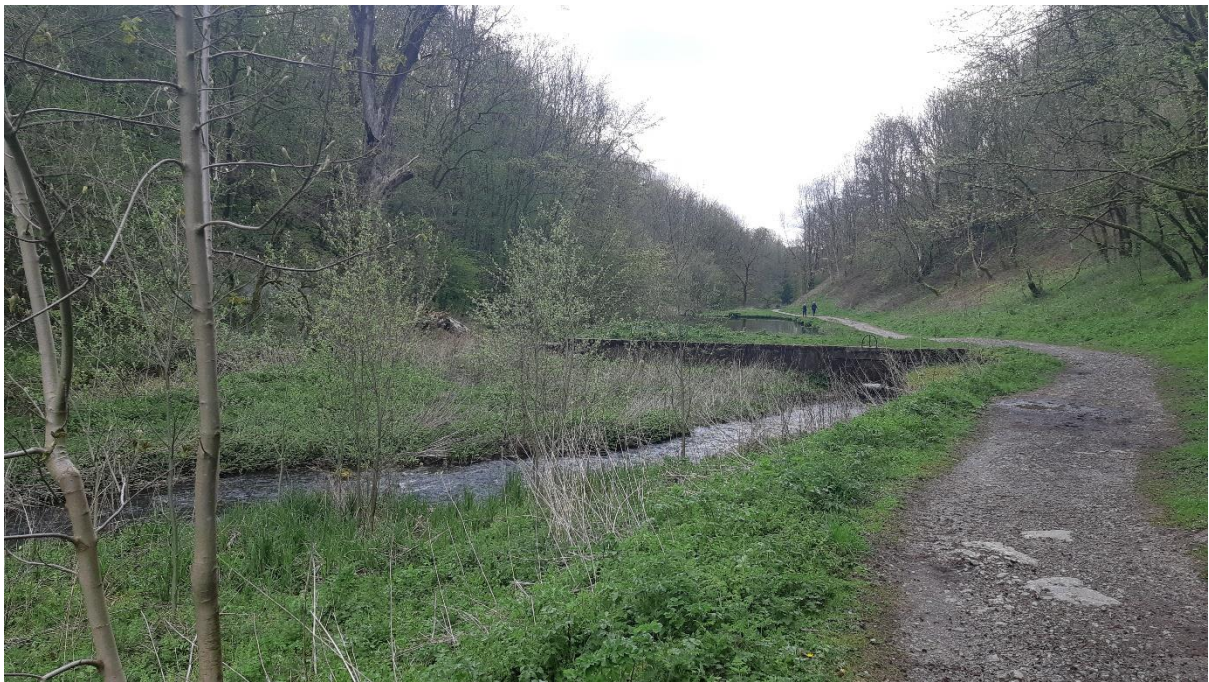
Figure 17: The dam wall for dam #2 – showing the former level of impoundment when the sluice was closed.

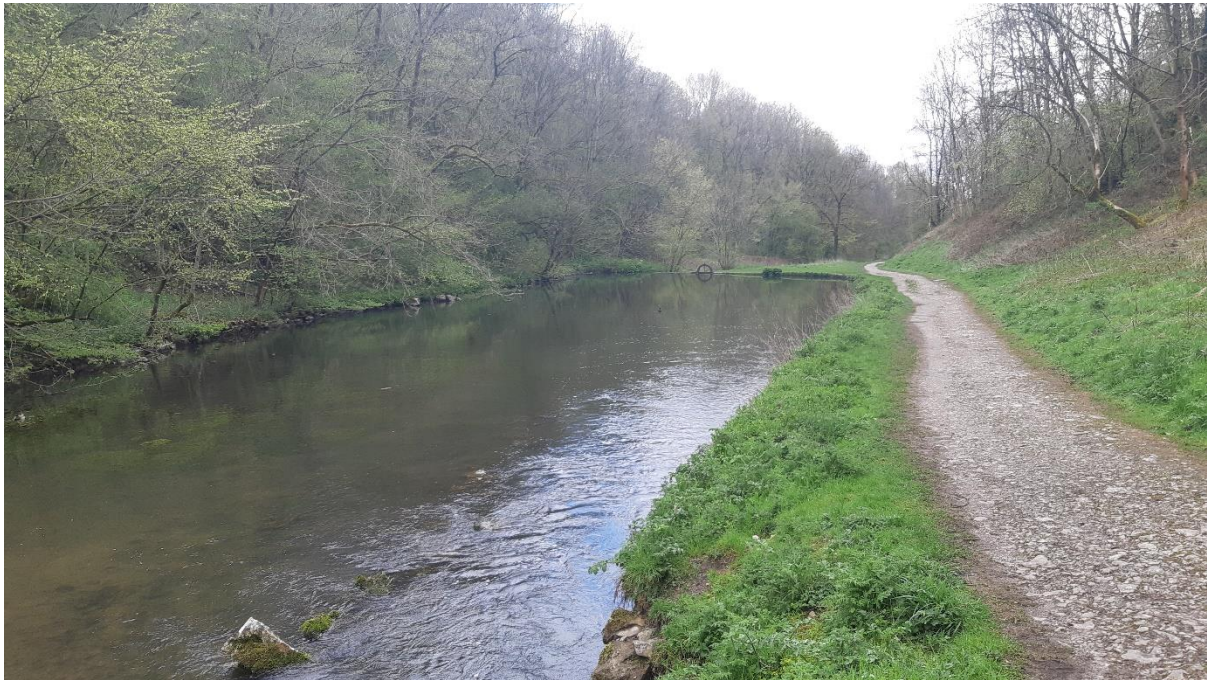
As would be expected, the free-flowing watercourse of dam #2 is a very marked contrast to the uniform habitat found in dam #1 which is maintained at full capacity (Fig. 18). Again, all the previous comments on the impacts of holding flowing water back and the interruption of bed-material transport, habitat simplification (risking over-exploitation by avian

predators) and prevention of free movement between good quality habitat apply here.

Figure 18: Dam #1 impounded reach with simplified/silty habitat.

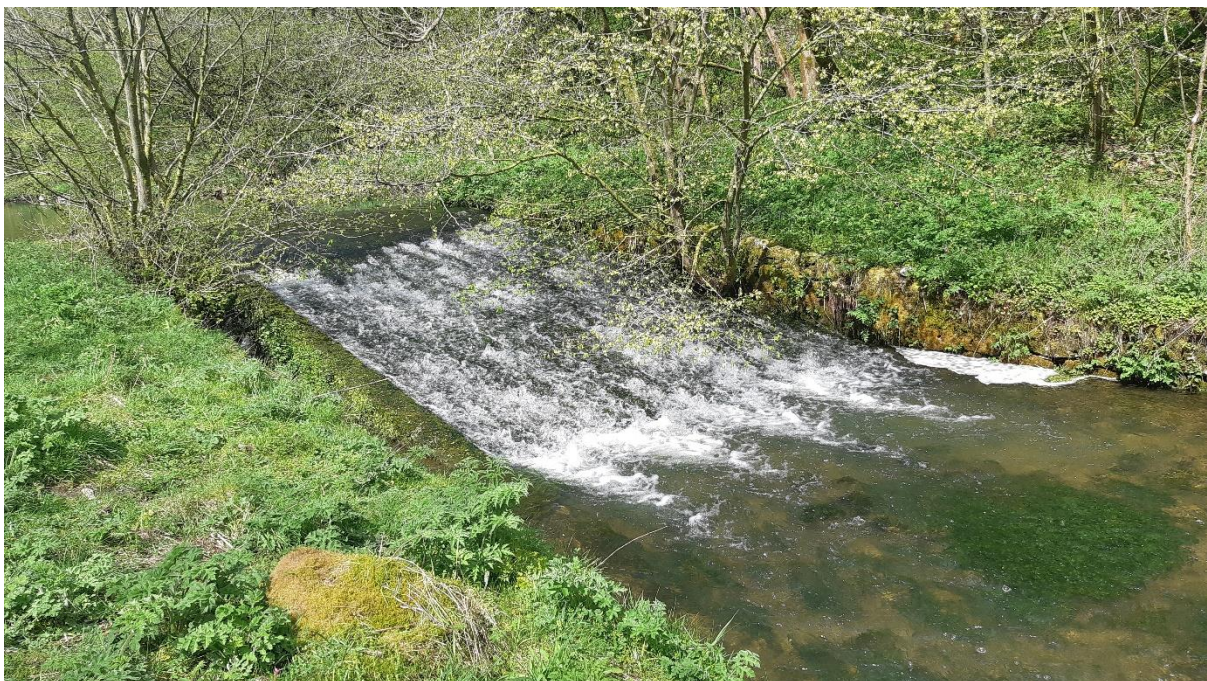
The overspill at the downstream end of dam #1 (Fig. 19) may be amendable to low-tech easement installation – though implicitly that carries no habitat benefits.

Figure 19: It may be possible to facilitate some upstream migration by installing batons to produce a series of resting pools and baffled flow on the face of the weir (arranged so that access to each resting pool is as easy as possible for fish ascending the structure).

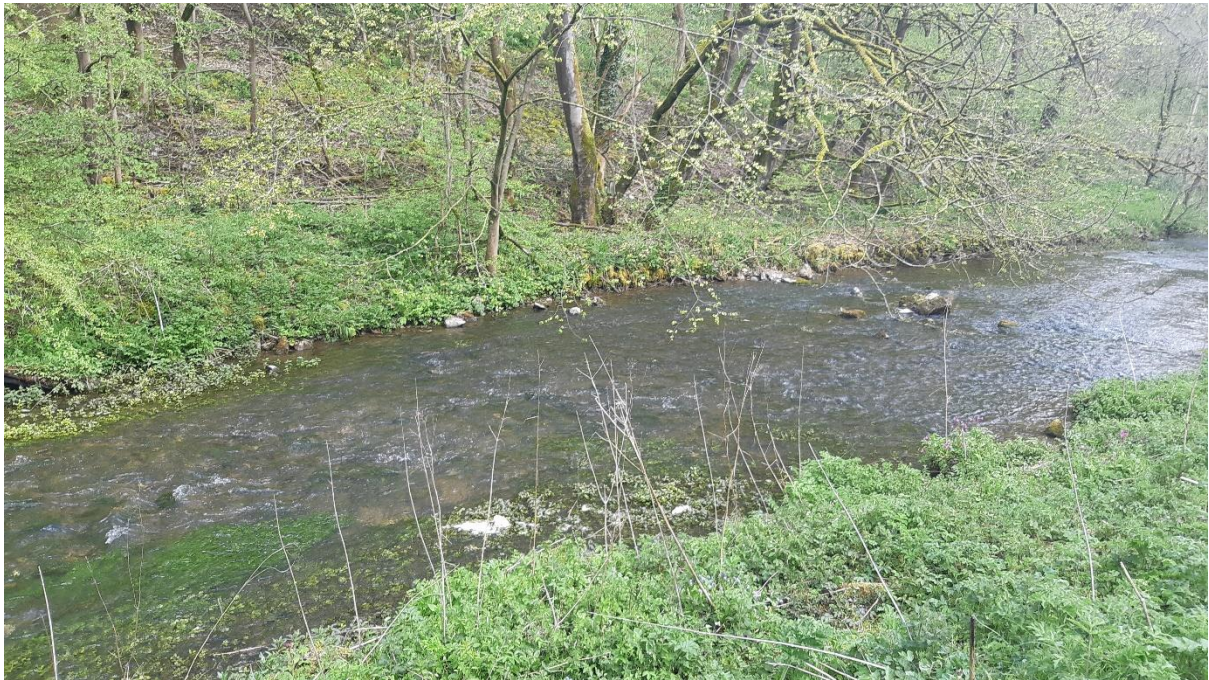
Figure 20: Riparian cover is generally quite high above the water - and relatively sparse. Laying down some riparian trees into the channel at a variety of angles to the flow would improve this situation.

The free-flowing channel below dam #1 (Figs. 20 and 21) would benefit from the introduction of “lay-down” style woody material cover (by avoiding

removal when trees fall in naturally and/or kick-starting with some targeted felling).

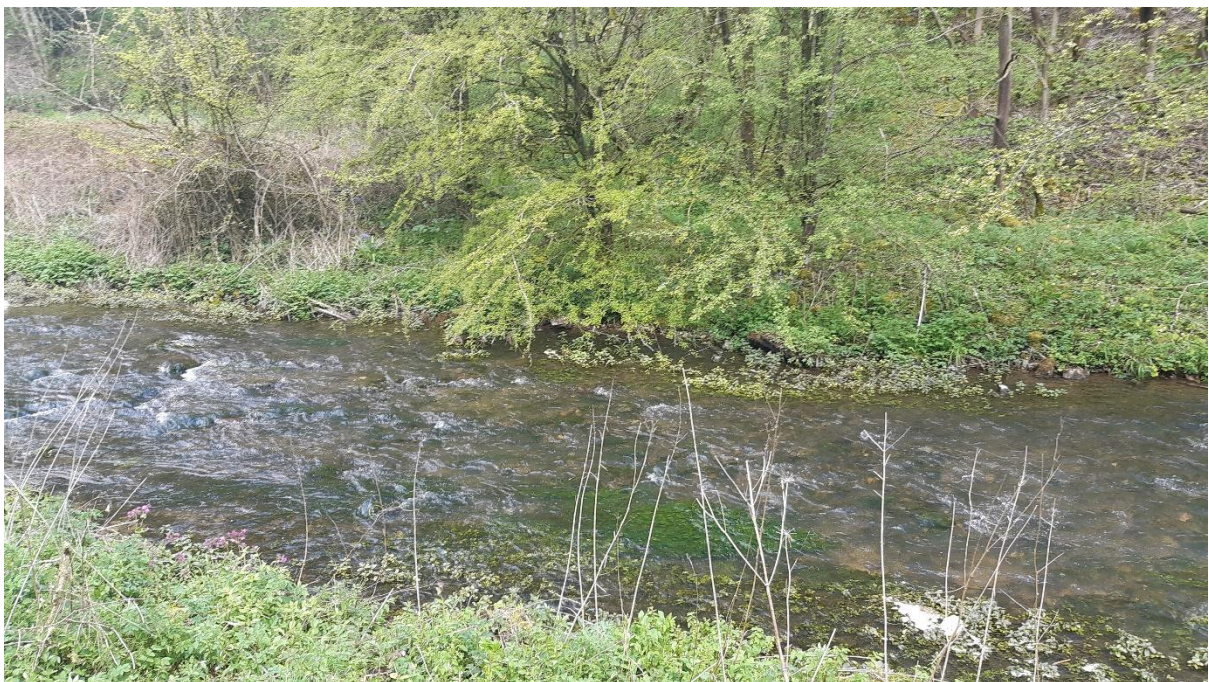
Figure 21: Examples of low, overhanging cover such as this are relatively rare within the free-flowing reach below dam #1.

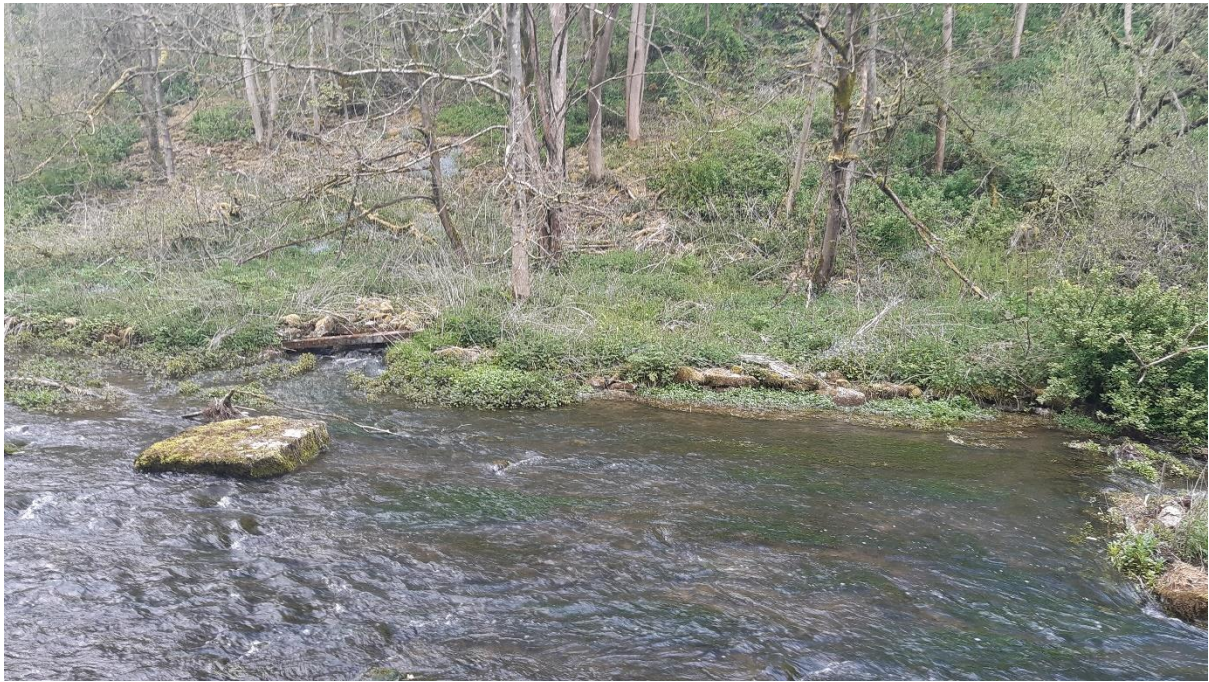
Another spring input (Fig. 22) was photographed from SK2068963945 and this may provide another opportunity for comparative water physicochemical sampling of upstream, downstream and spring-water conditions.

Figure 22: Spring issuing into the River Bradford mid/left of frame.

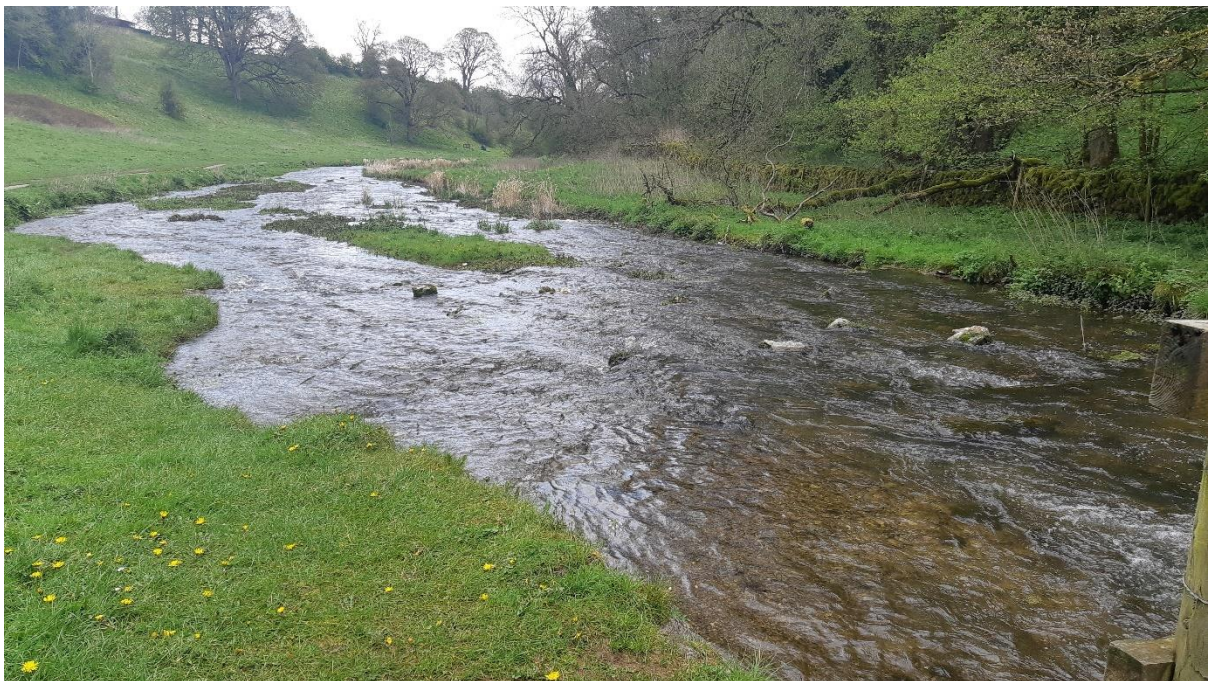
The reach below the spring runs into the public swimming area – though upstream of that impoundment is free-flowing and contains potential spawning substrate (Fig. 23).

Figure 23: Unimpounded flow and potential spawning gravels. A cessation of grazing would benefit riparian habitat.

The RB of this reach has more vegetation cover – although an apparent recent change in land-use may mean that neither bank is grazed in future. Maintaining an unmown/ungrazed buffer along the LB would be of great benefit to aquatic and terrestrial communities. For instance, such cover would increase the likelihood of fish attempting to use available spawning substrate (and avoid predation in the process).

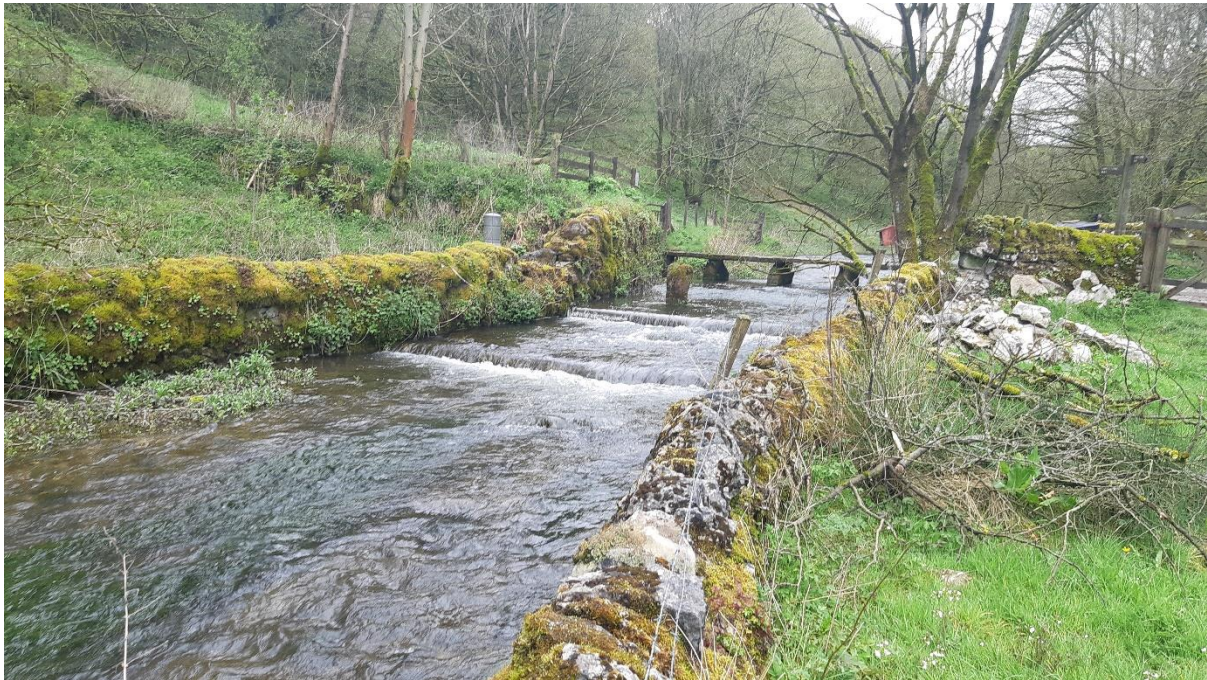
Figure 24: Notching these low barriers would be surprisingly beneficial.

The low barriers (Fig. 24) within this reach would be relatively easy to notch and this would provide great connectivity and geomorphological benefits.

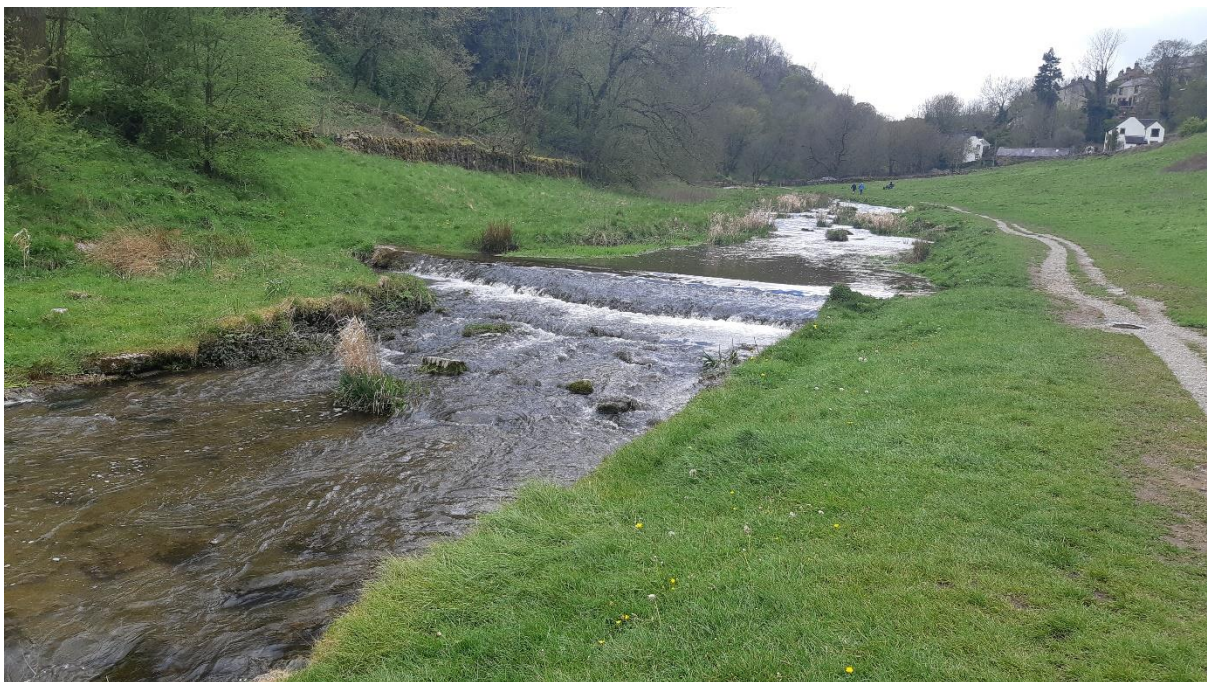
Figure 25: Apparent service pipe buried beneath a smooth, sloping weir-face.

The next barrier downstream (Fig. 25) appears to contain a service pipe that -if live – would obviously make removal, bypass or notching extremely problematic. Constructing a “pre-barrage” a few metres downstream (with a notch to allow fish passage) would effectively drown-out this barrier.

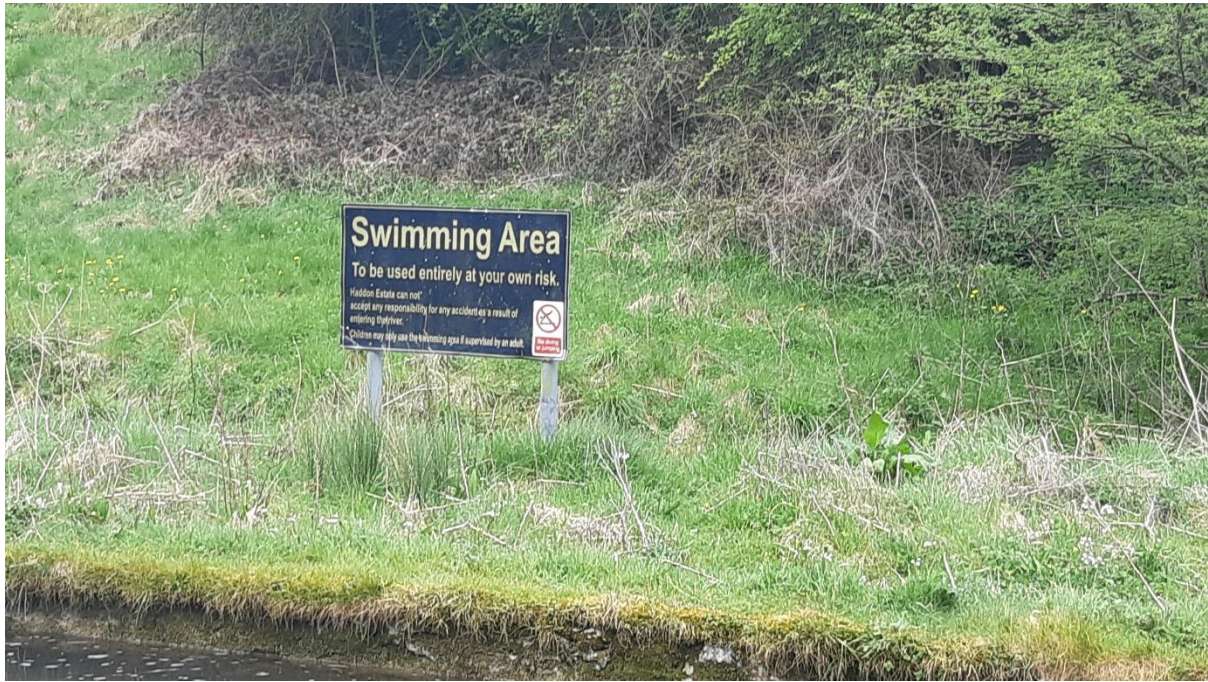
The designated swimming area (Figs. 26 and 27) is formed by a substantial weir (Fig. 28) which – because of the degree of public use – would face strong resistance to removal.

Figure 26: Swimming area sign (indicative of local attachment to this amenity).
