WILD TROUT TRUST

## **River Bradford, Haddon Estate**

12/05/2021

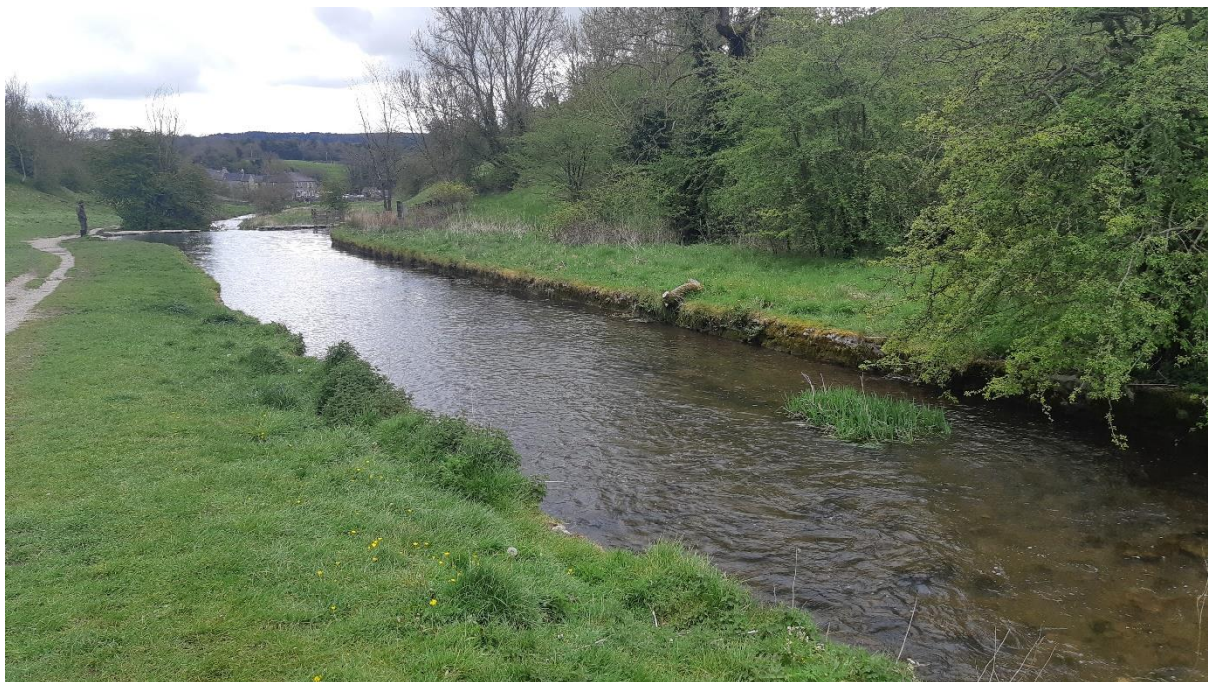
Figure 27: The shallow head of the swimming area - dropping off into deeper more impounded water.

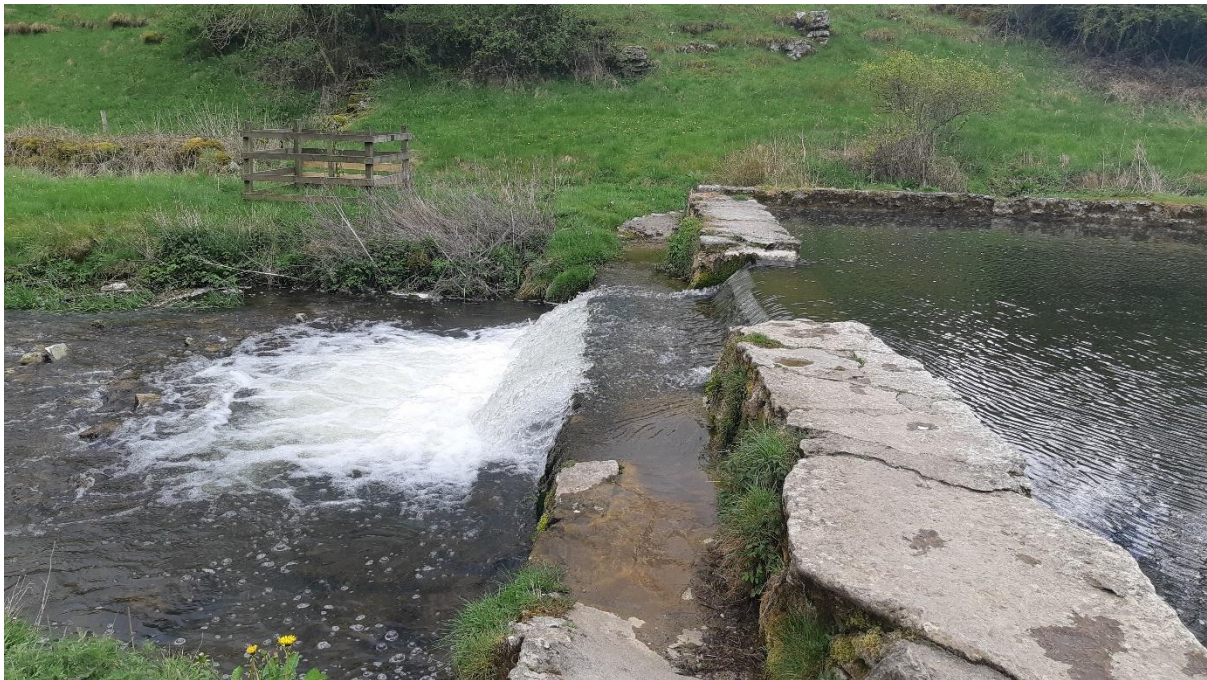
The designated swimming area (Figs. 26 and 27) is formed by a substantial weir (Fig. 28) which – because of the degree of public use – would face strong resistance to removal.

Figure 28: The weir that forms the swimming pool.

The size and design of this weir suggests that a formal fish pass may be merited as a compromise in this situation. The great value of a well-executed fish pass at this location is that, with the previously-mentioned efforts to improve connectivity upstream, the potential exists to reconnect around 3km of river habitat. As well as possibly increasing fish numbers – the degree of resilience of those populations would be significantly improved by the ability for immigration and emigration throughout Bradford Dale. It would also increase the opportunities for gene-flow, preventing in-breeding within the currently segregated smaller breeding populations. The

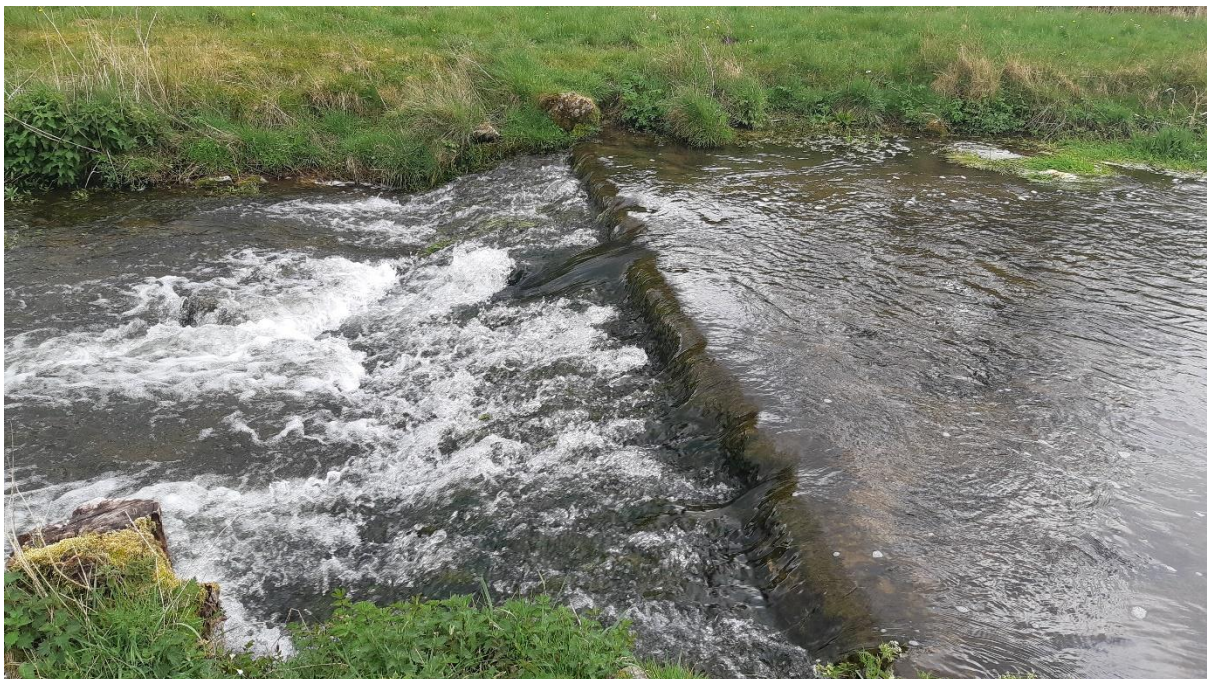
Figure 29: A low stone weir just downstream of the swimming pool weir – the small existing notch needs to be enlarged to enable free fish passage.

Low-key notching of stone (Fig. 29) and informal boulder (Fig. 30) weirs just below the swimming pool weir would help to complete that 3km of connected habitat.

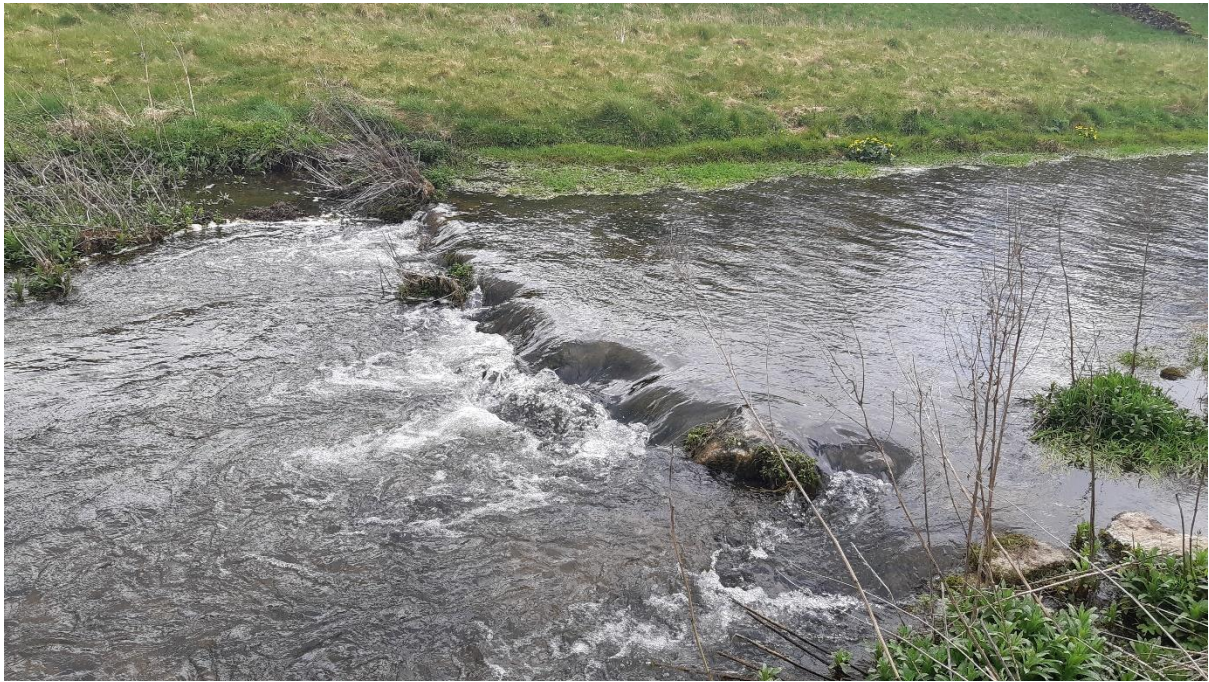
Figure 30: Boulder weir - amenable to simple block removal.

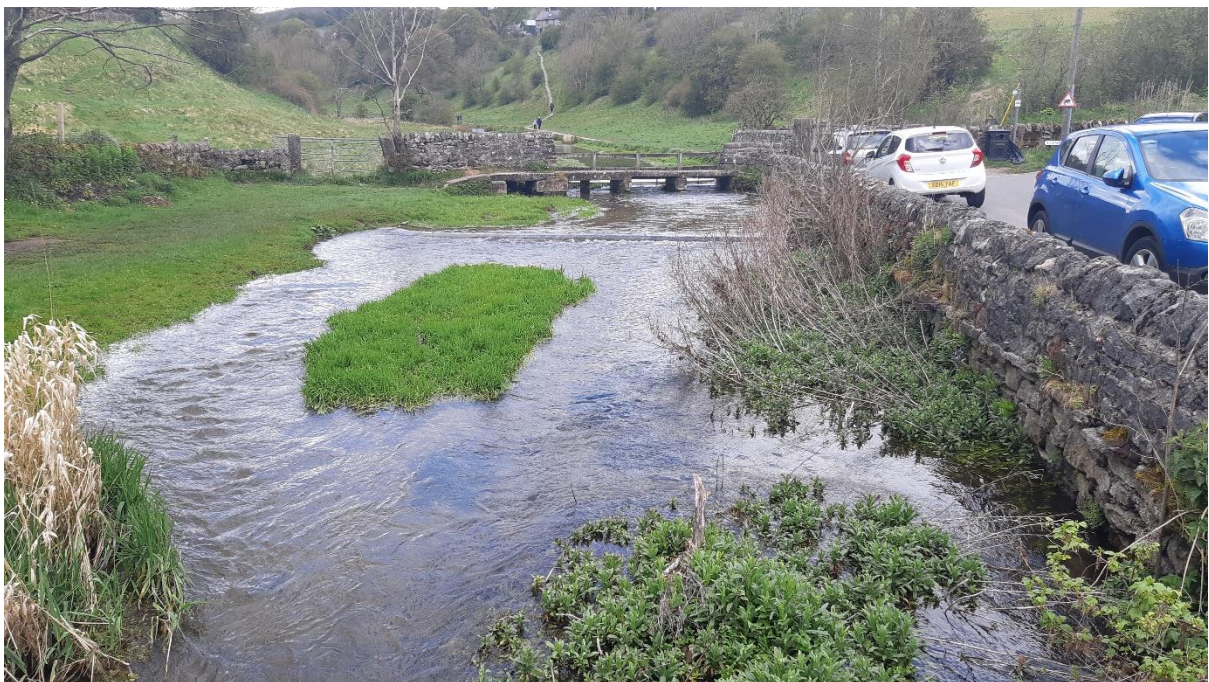
Figure 31: Small stone barriers can have a surprising (negative) impact on free fish movement. In these cases, notching is recommended.

Finally, either side of a small footbridge at Mawston lane, two very small barriers (Fig. 31) should be notched in order to ensure connectivity.
