WILD TROUT TRUST

River Dane, Cheshire/Staffordshire

River Weaver Catchment, North West River Basin District

June 2025

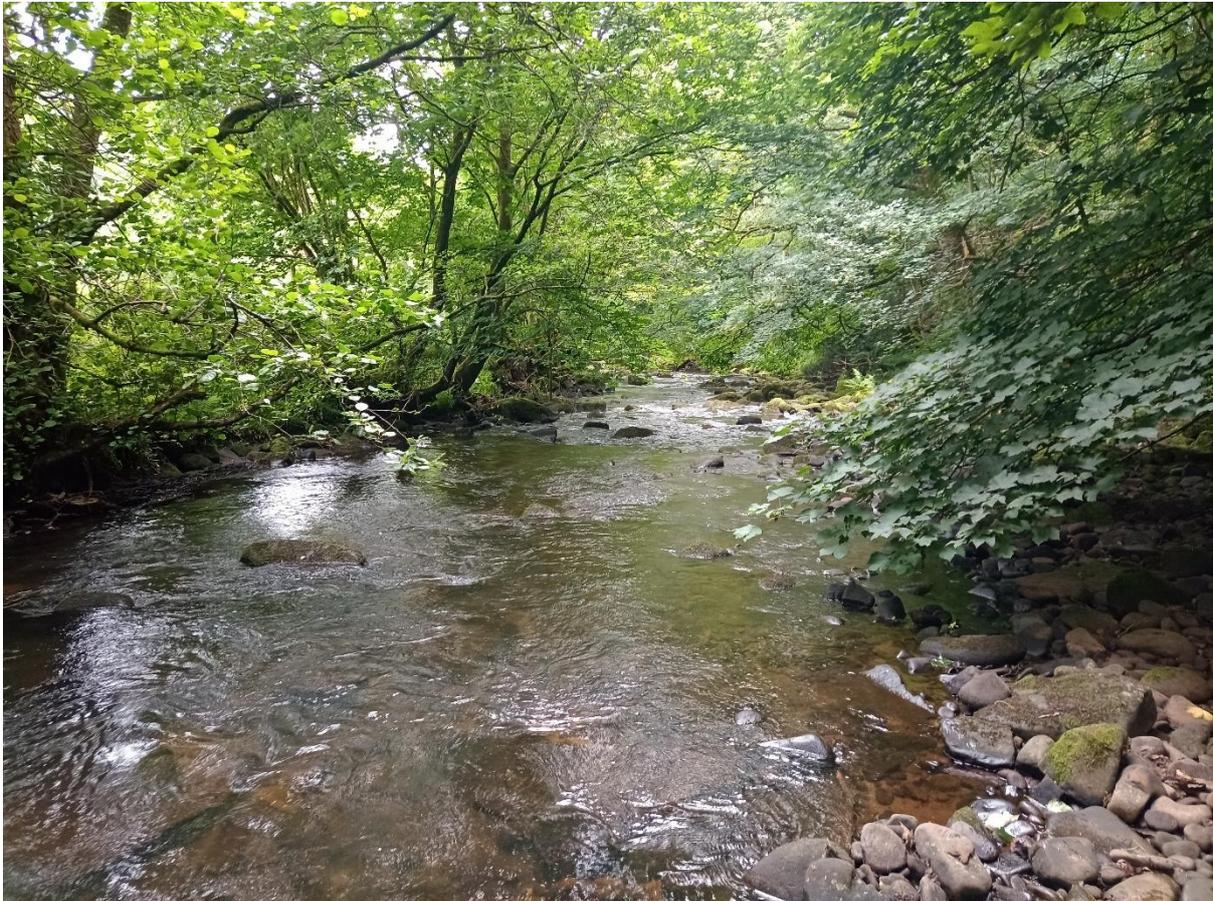
Figure 1 Typical section of Bartomley Bottoms beat. Tree shading such as this is very valuable for maintaining cool water temperatures during hot weather, particularly on stony-bedded rivers like the upper Dane.

This part of the Dane has an upland character, flowing off the sandstones and gritstones of the south-western Peak District's moors and falling c.150m in c.6.5km between Three Shires Head and Danebridge. The river flows through a steep-sided valley (and in places rock gorges – cover picture), a fair proportion of which is wooded (Figure 1).

The presence of woodland on the valley sides provides multiple benefits for the river including:

- Shading, which moderates water temperatures during hot weather. More exposed streams, particularly those with a surface-water hydrology and a stony bed like the Dane, can reach lethal temperatures for trout without adequate tree cover.
- Input of leaf litter which supports a range of aquatic invertebrates preyed upon by trout and other species; also, inputs of terrestrial invertebrates eaten by trout.
- A dynamic source of large woody material (LWM) to the river channel in the form of fallen trees and branches.
- Moderates the hydrology of the river – trees greatly increase infiltration of rainwater to the soil which can help reduce flood peaks and support flows during dry weather.

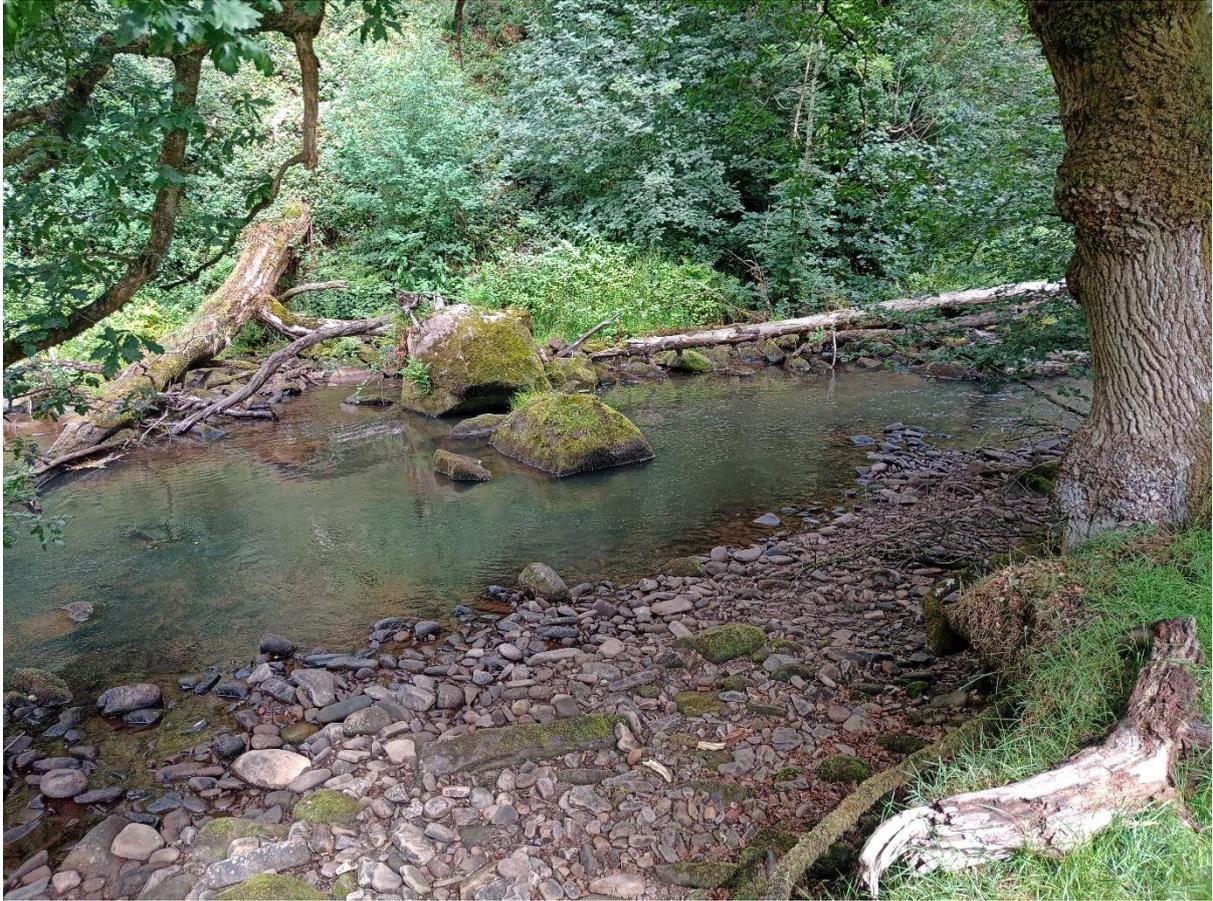
Large woody material (Figure 2) is very valuable habitat within the river. It provides refuge areas for fish from predators, for example fish-eating birds such as goosander which are frequently observed here. LWM also traps leaf litter, making it available to aquatic invertebrates (trout food). Larger pieces of wood influence the shape of the channel by causing localised scour and deposition of sediments; this creates habitat niches, for example well-sorted gravels for fish spawning.

The occurrence of LWM was less frequent than might be expected given the extent of woodland along the river. MFC do not remove LWM which is a wise policy given the above benefits, so the relative lack may be down to the size and frequency of flood flows washing LWM away. The 'flashiness' of flows may be influenced by the moorland catchment upstream; moor restoration projects like [Moors for the Future](#) are working to restore bog and clough habitats which help to moderate flows, but do not appear to have worked in the upper Dane catchment.

Figure 2 Fallen wood in the channel is extremely valuable habitat and provides multiple benefits. Note also the variety of sediment sizes present.

- Retain fallen trees and branches within the channel.
- Control Himalayan balsam by hand-pulling plants before they flower and set seed.
- If undertaking works to improve angling access, retain as much fish cover as possible by using techniques like hinging (Figure 10).

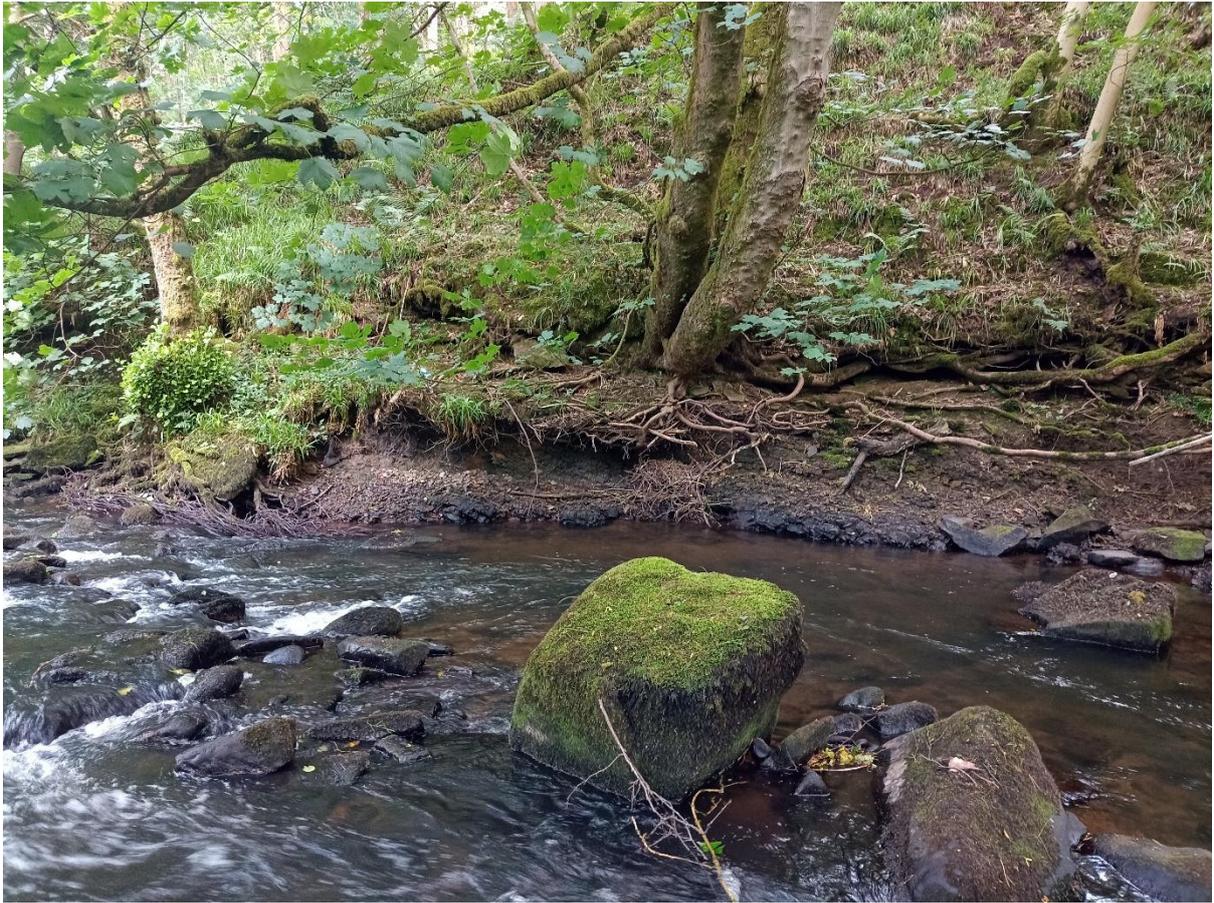
The geology and hydrology of the upper catchment is reflected in the composition of the river bed, with sediment sizes ranging from large boulders down to sand, with a large proportion of cobble and large gravel deposited in side bars. There is evidently a dynamic sediment supply and regular flows sufficient to transport particles up to cobble size. The larger and more stable boulders provide good habitat niches for trout, particularly for juveniles in the shallower reaches.

Figure 3 A seam of gravel in an eroding bank provides a good source of material of a suitable size for trout spawning.

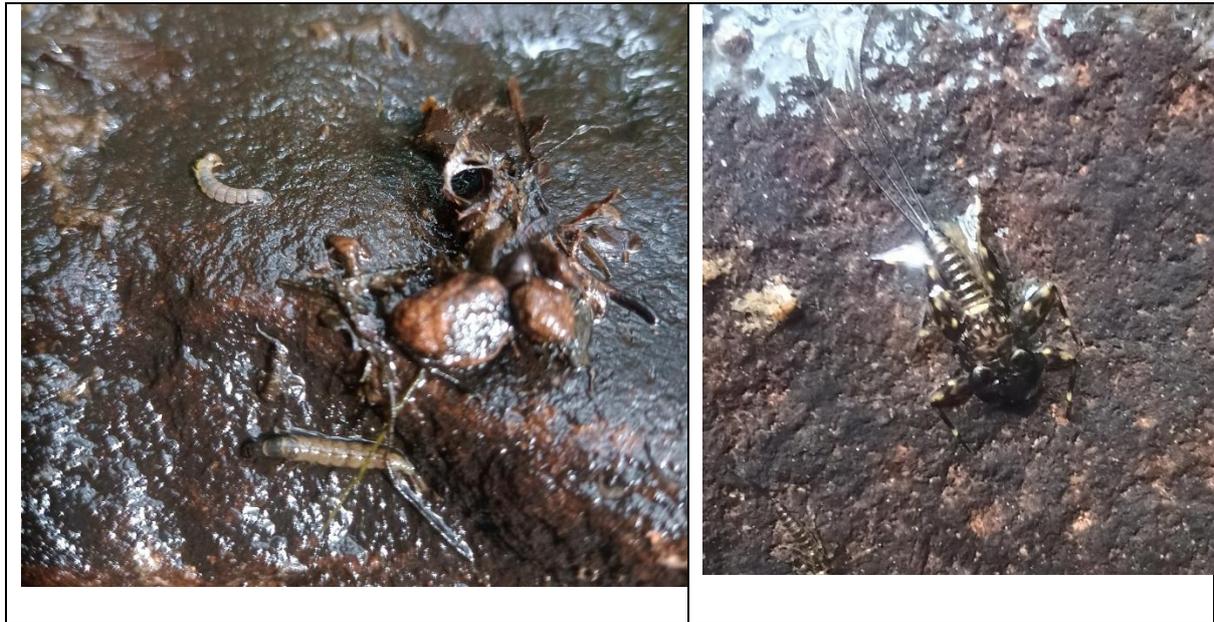
Figure 4 Caseless caddis (Hydropsyche sp.), left, and flat-bodied mayfly nymph, right.

Stone-turning revealed some pollution-sensitive invertebrates which is a

positive sign of good water quality. The taxa observed included flat-bodied mayfly nymphs, stoneflies and caseless caddis (Figure 4).

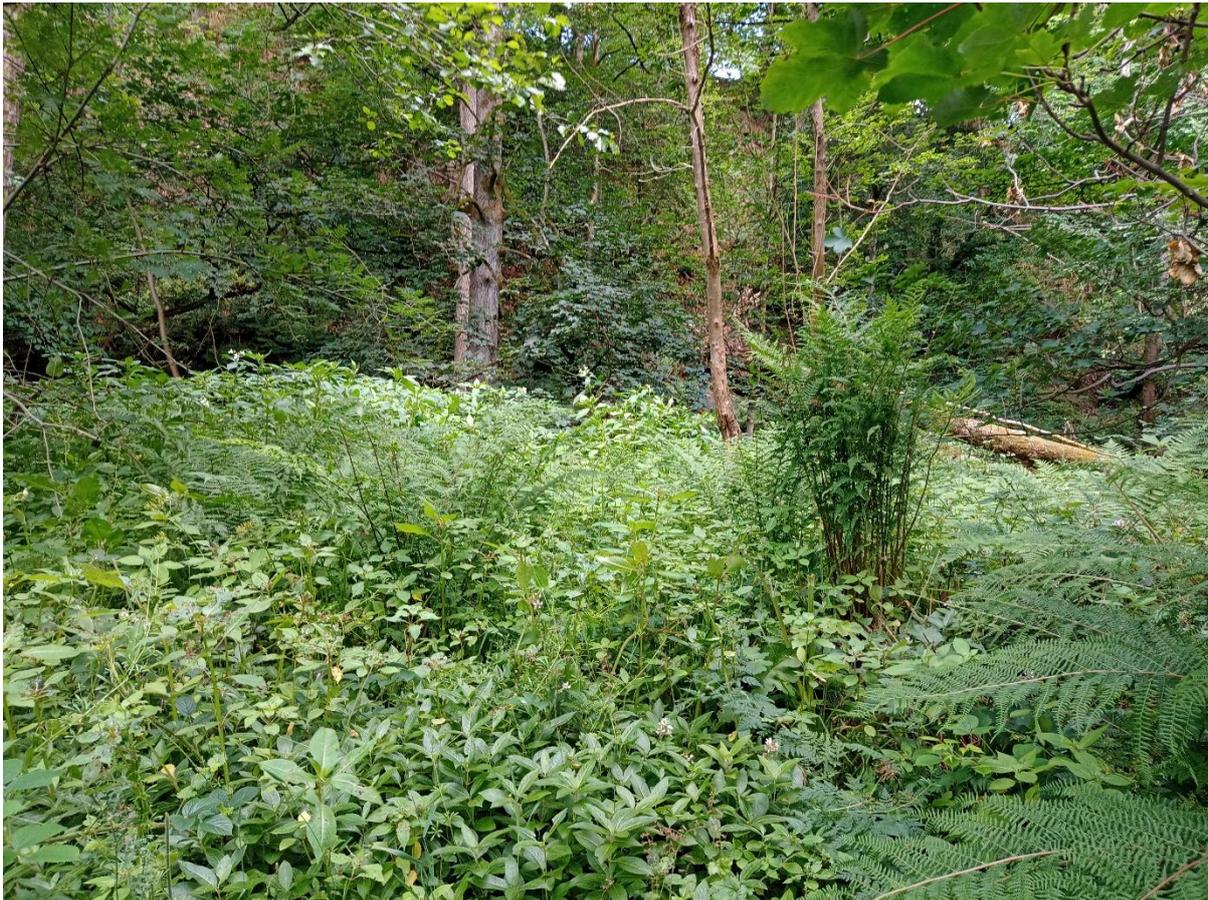
Himalayan balsam was noted throughout the reaches inspected. This non-native invasive annual plant species out-competes native vegetation to the detriment of plant diversity, bank stability and invertebrate diversity and abundance. MFC are aware of the issues and undertake working parties to control balsam by hand-pulling prior to it seeding. This appears to be having a positive effect in that the number of plants observed was relatively low alongside the river; however, there were some denser stands seen in some locations which should be tackled to limit their spread (Figure 5).

Figure 5 (53.186909,-2.054488) A dense stand of Himalayan balsam in the woods alongside the river.

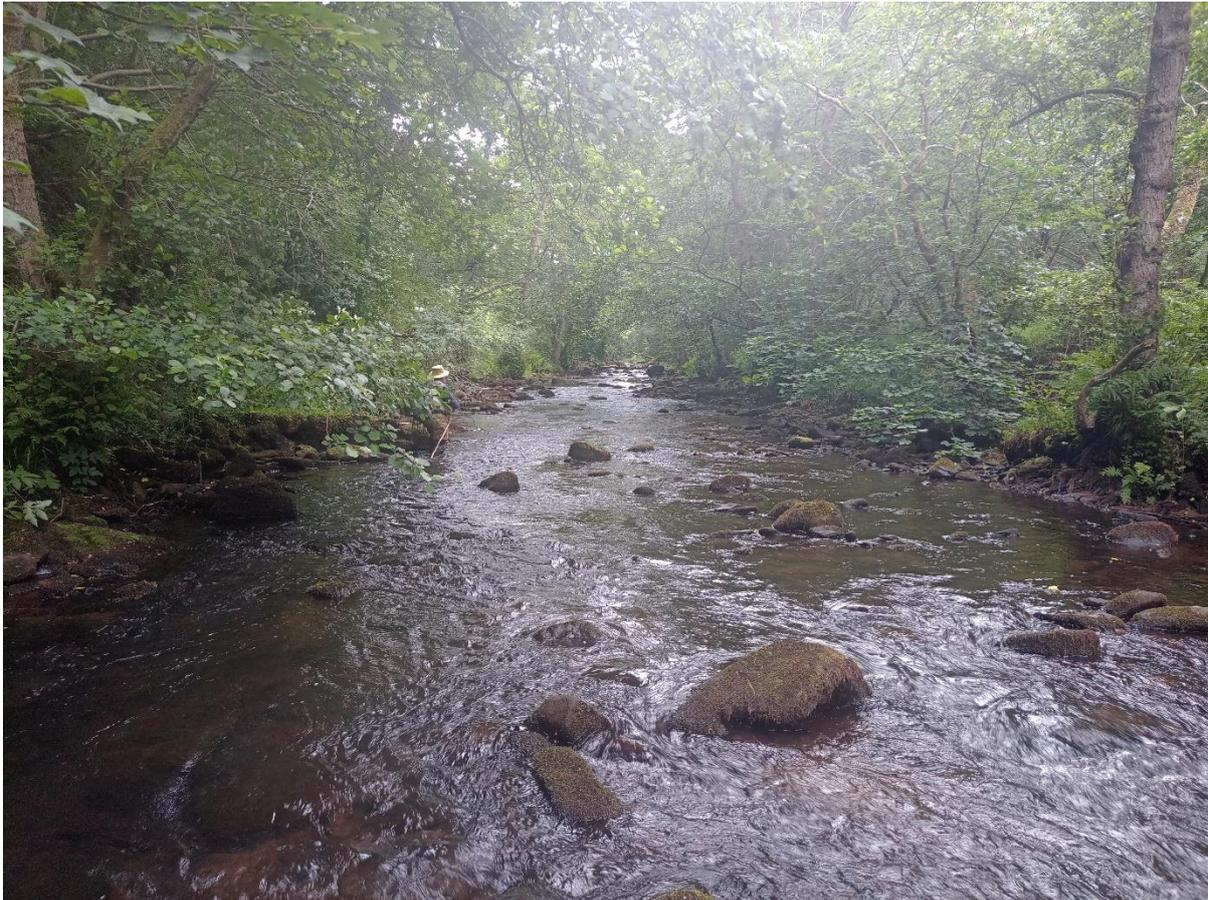
Some long sections of the river channel were very straight (Figure 6), quite uniform in width and lacking deeper pools. Whilst this habitat is good for juvenile trout, it is limiting for larger adult fish. The straightness may be a natural phenomenon in this upland, steep-sided valley but could possibly be a legacy of channel modification. The deeper pool areas observed were on bends in the channel or associated with bedrock/boulder cascades.

Figure 6 (53.188557,-2.05181) Some sections of the river channel are very straight, which limits the potential for the formation of deeper pools (which occur on bends) more suited to larger adult trout. The straightness may be a natural phenomenon in such an upland, steep-sided valley but a large proportion of UK rivers have a history of channel modification (for example for agricultural improvement, milling, etc.) with little remaining evidence other than the homogenous channel form.

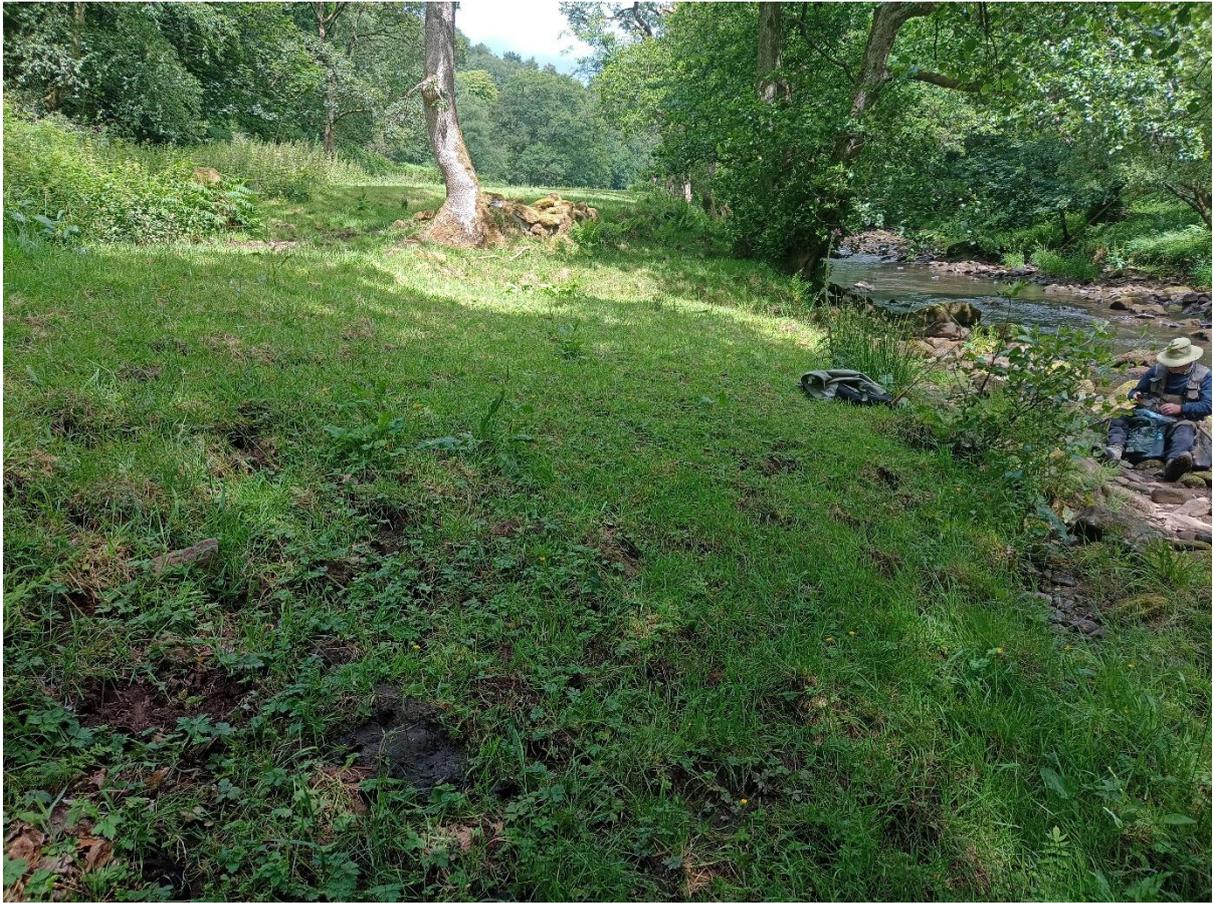
Where the valley sides were not wooded, land use alongside the river was generally low-intensity grazing on valley-bottom meadows (Figure 7). Livestock was largely fenced out of the river with occasional access points for watering. Inevitably these areas were a focus for trampling and faecal inputs, but the observed impact was very minor. One area would benefit from the reinstatement of a barbed wire barrier to prevent cattle accessing the far bank (Figure 8). The weather had been very dry at the time of the visit and observation during wet weather is recommended to assess the impacts of these and other areas for fine sediment, etc. inputs (Figure 9).

Figure 7 In less wooded areas, land use alongside the river was low intensity grazing, with access to the river for livestock watering restricted to short sections.

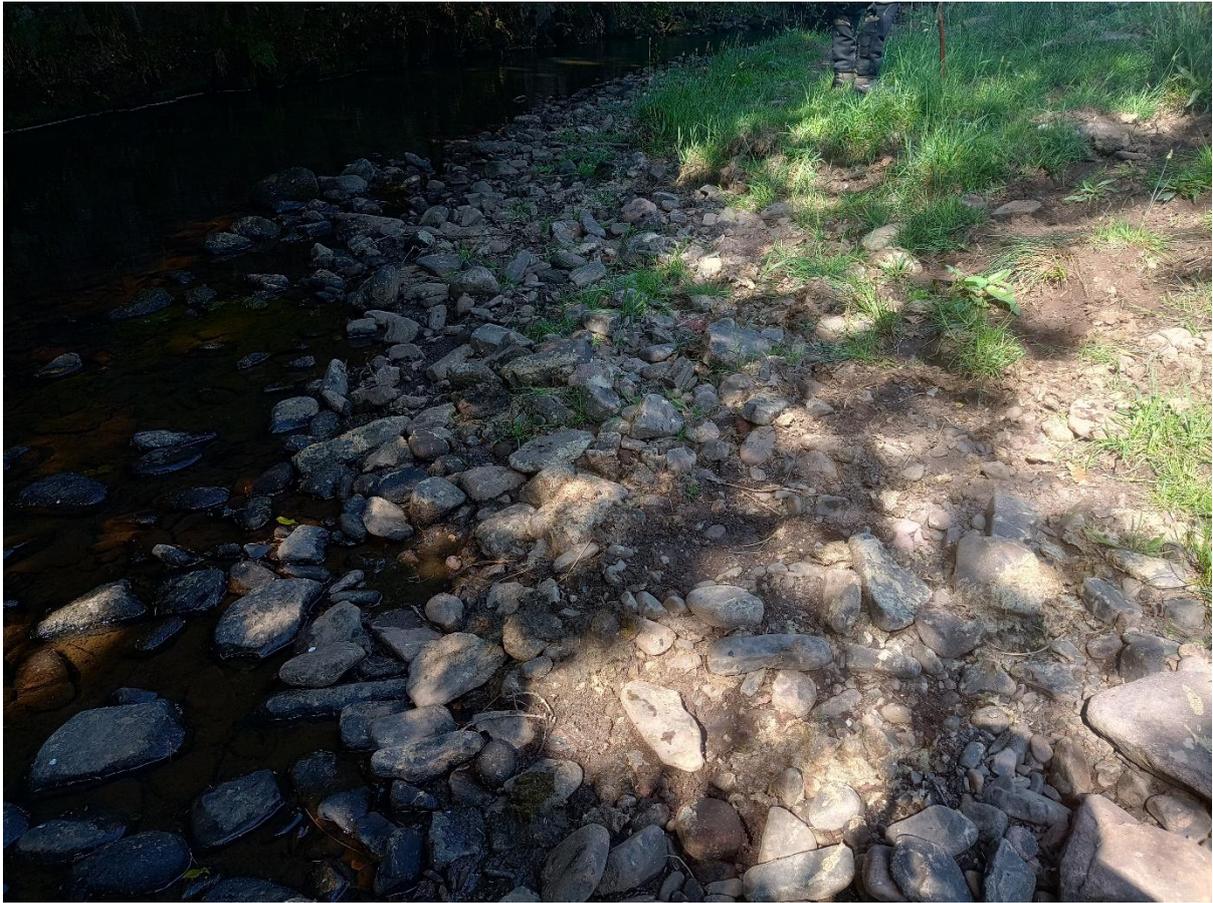
Figure 8 (53.194015,-2.033997) A point bar ("beach") used by cattle for drinking. This area had previously been corralled by barbed wire to limit livestock access, but the barrier has been partially washed out and cattle were accessing the far bank. The barbed wire should be reinstated.

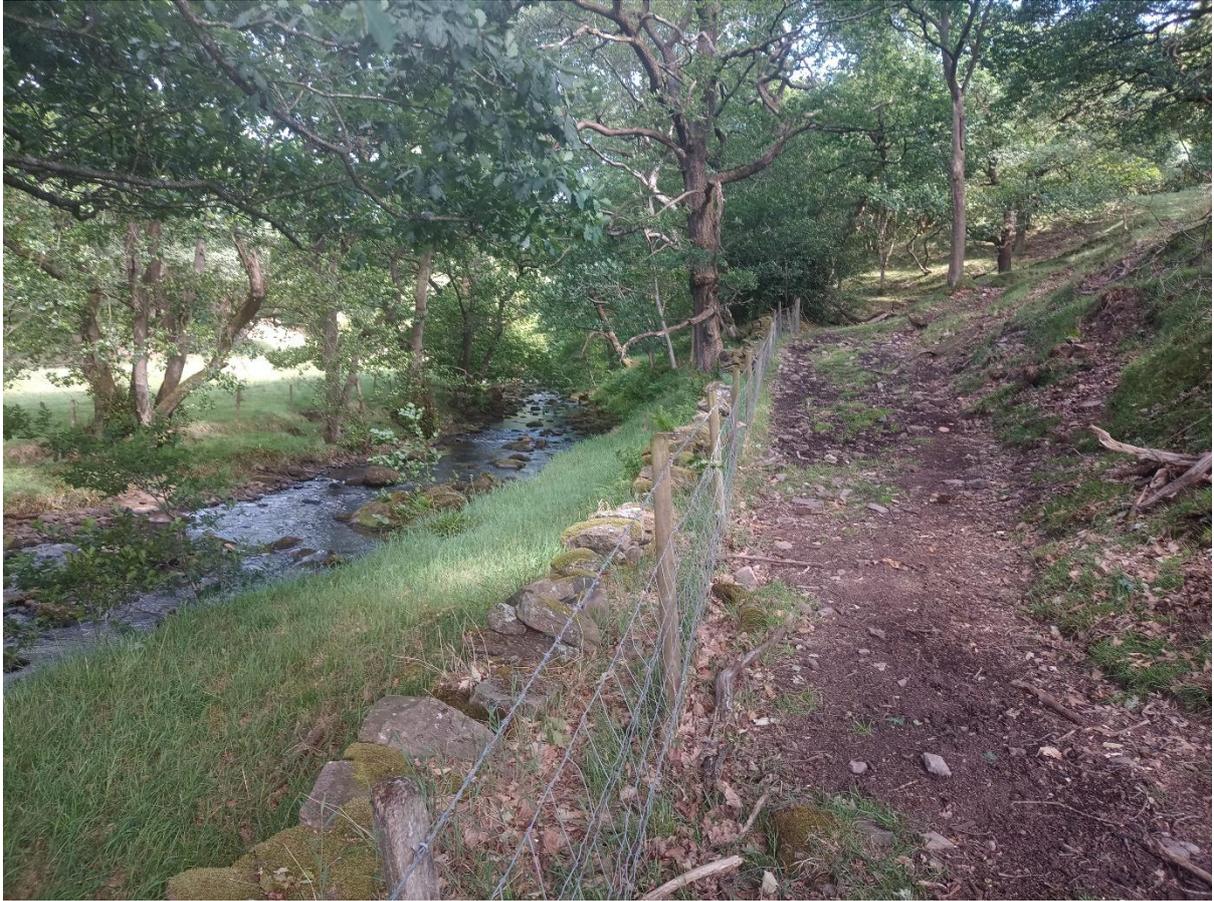
Figure 9 In some areas, livestock desire lines and/or footpath traffic create a potential source of fine sediment, but in general there was a reasonable buffer alongside the river. Observation during wet weather is recommended to find potential preferential runoff pathways.

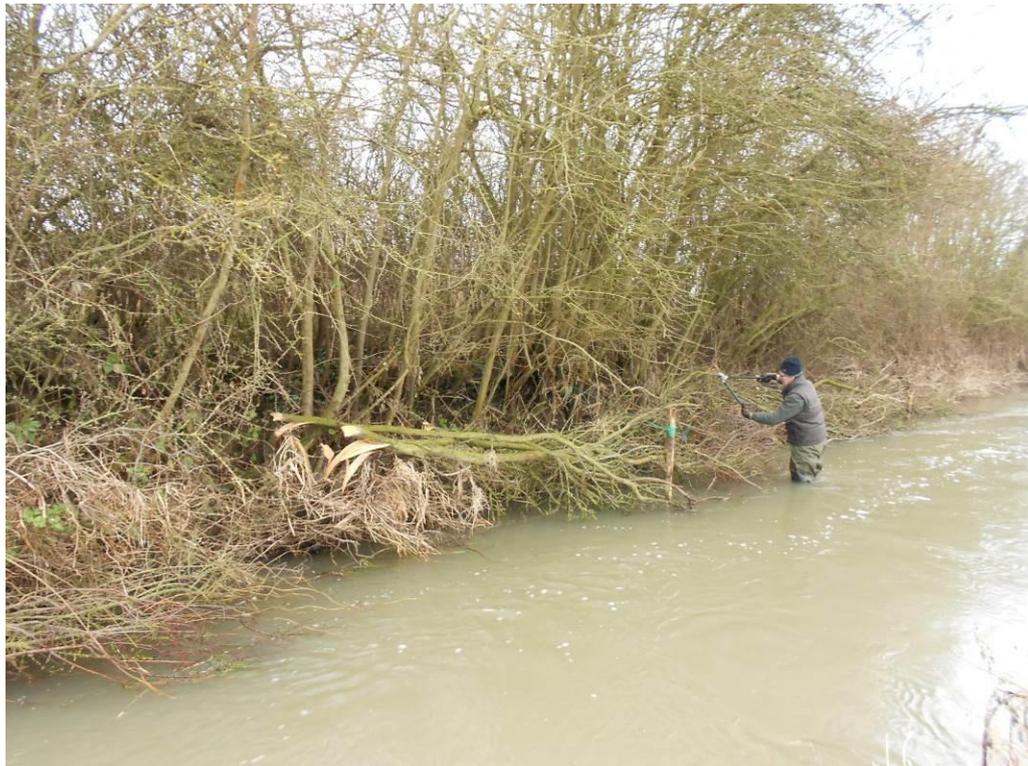
Closer to the upstream access point at Gradbach, MFC has undertaken some vegetation clearance to facilitate angling access. It is important to strike a balance between access and habitat when undertaking such works. Hinging of trees/branches into the river is often a good way to achieve both objectives.

Figure 10 Hinging marginal trees
