WILD TROUT TRUST
wildtrout.org

Advisory Visit River Don, Salmon Pastures

Advisory Visit by Paul Gaskell (pgaskell@wildtrout.org)

11/05/2022

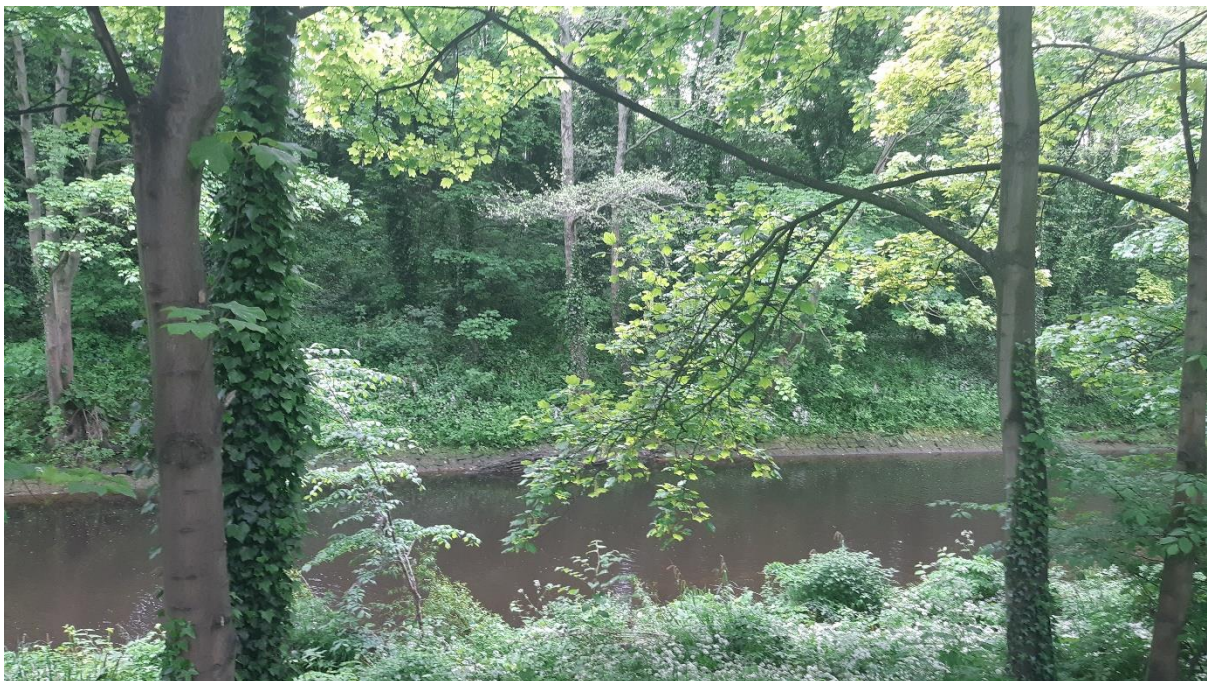
As well as favouring uniform bed characteristics, the block-stone revetment also significantly reduces the amount of trailing/partially-submerged vegetation cover in the margins (as well as reducing the supply of gravel and cobble material). Note the lack of understorey vegetation between the widely-spaced mature trees – and the resultant separation of riparian vegetation from the river by exposed block stone surfaces (Fig.2).

Figure 2: Note the "sterile strip" of block stone separating the woodland understorey vegetation from the water at SK37141 88140.

Dense matrices of complex, brashy cover are vital resources for juvenile fish to shelter from predators and also from powerful spate flows. Due to the reduced opportunity for such material to arise in the margins of the watercourse, introductions of stable woody material to the margins confer significant potential ecological benefits (see Appendix 1 for the importance of particular habitat features across wild trout lifecycles).

During the walkover survey, several opportunities on the RB were noted for cabled tree installation (e.g. Figs. 1, 2, 5 and 6).

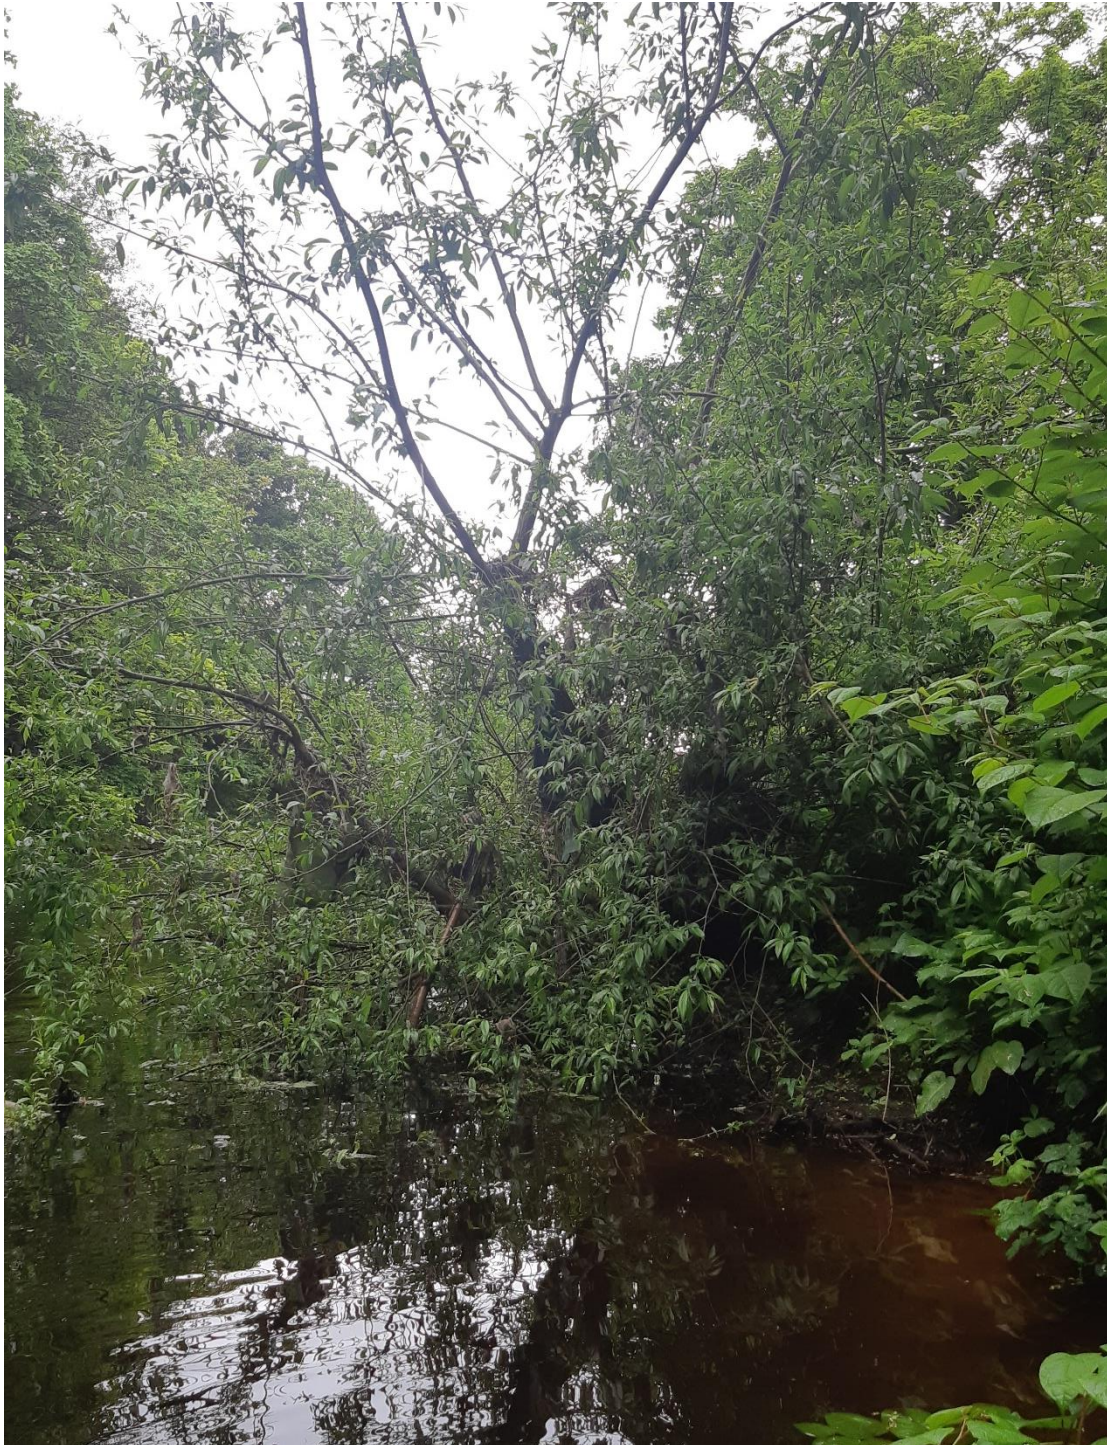
Cabling (or lodging) selected, suitable riverside trees securely to their stumps is a good way to provide that marginal cover. Leaving the crown end free allows the trunk to line up with spate flows – offering the least resistance. This enhances the stability of anchored structures and actually promotes deposition of sediment (consolidating banks, rather than accelerating erosion). A similar effect can be achieved by hinging smaller sapling growth into the margins in a comparable manner to hedge laying techniques. An opportunity for this was noted on the LB close to the upstream limit visited for this report (Fig.3).

Figure 3: Young willow growth on the margins of the LB at SK37123 88123 – suitable for laying brashy material into the water while retaining live growth.

- Undertake some hinging of bankside sapling growth to increase marginal cover
- Pursue the secure introduction of marginal tree-crown/large woody material via felling and cabling or lodging suitable mature trees to their own stumps (see below and Figs. 8 & 9)

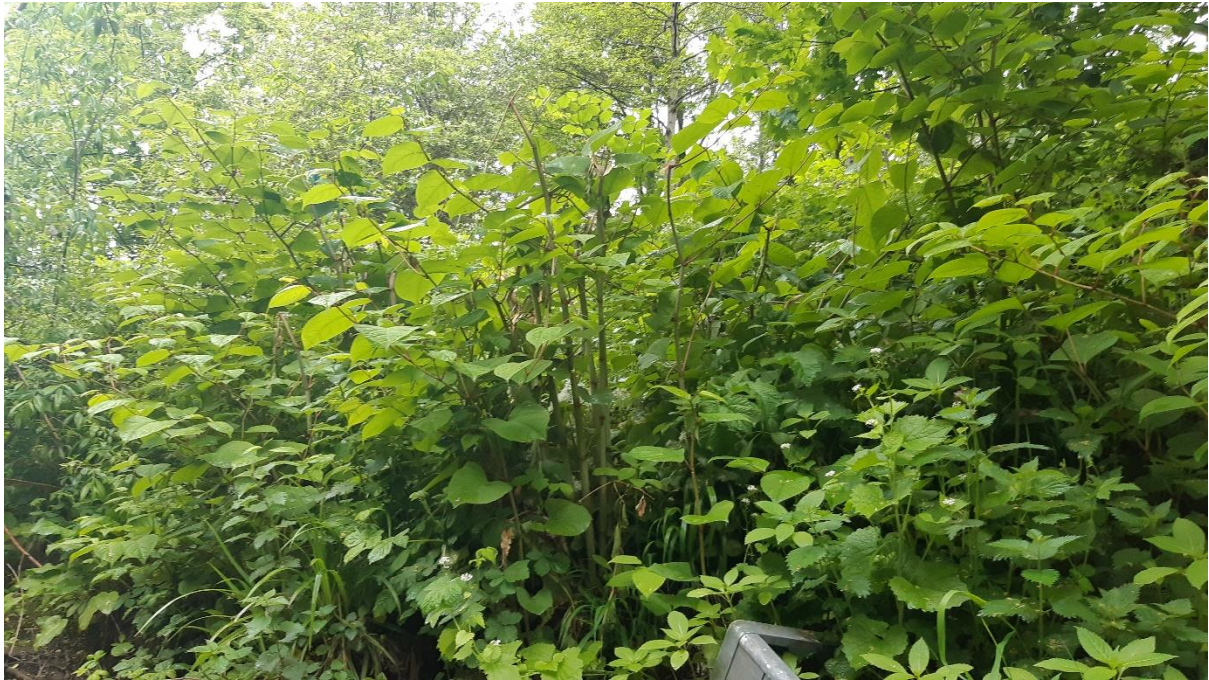
It may be possible to identify other, similar, opportunities in nearby locations also. However, it is important to also undertake control of Japanese knotweed (Fig.4) and Himalayan balsam wherever possible in order to remove their suppression of native flora and fauna.

Figure 4: Japanese knotweed and Himalayan balsam photographed adjacent to the willow growth shown in Figure 3.

As with previously-noted stands of Japanese knotweed, this would require intervention from appropriately certified personnel. Stem injection towards the end of the growing season – just before winter dieback – would be the preferred option. This minimises poisoning of non-target species as well as being highly effective and cost-effective for ecological gains.

For stands of Himalayan balsam, hand pulling by volunteers can be extremely effective when carried out with sufficient regularity. Composting the pulled plants on site helps to avoid spreading infestation around, while also being effective in preventing pulled plants from re-rooting and/or dispersing seed.

- Undertake and support regular “balsam bashing” to hand-pull and compost Himalayan balsam on-site prior to plants setting seed

- Undertake Japanese knotweed control using appropriately-certified personnel – if a fishery benefit can be identified, potential funding is available via <https://anglingtrust.net/funding/aif/>

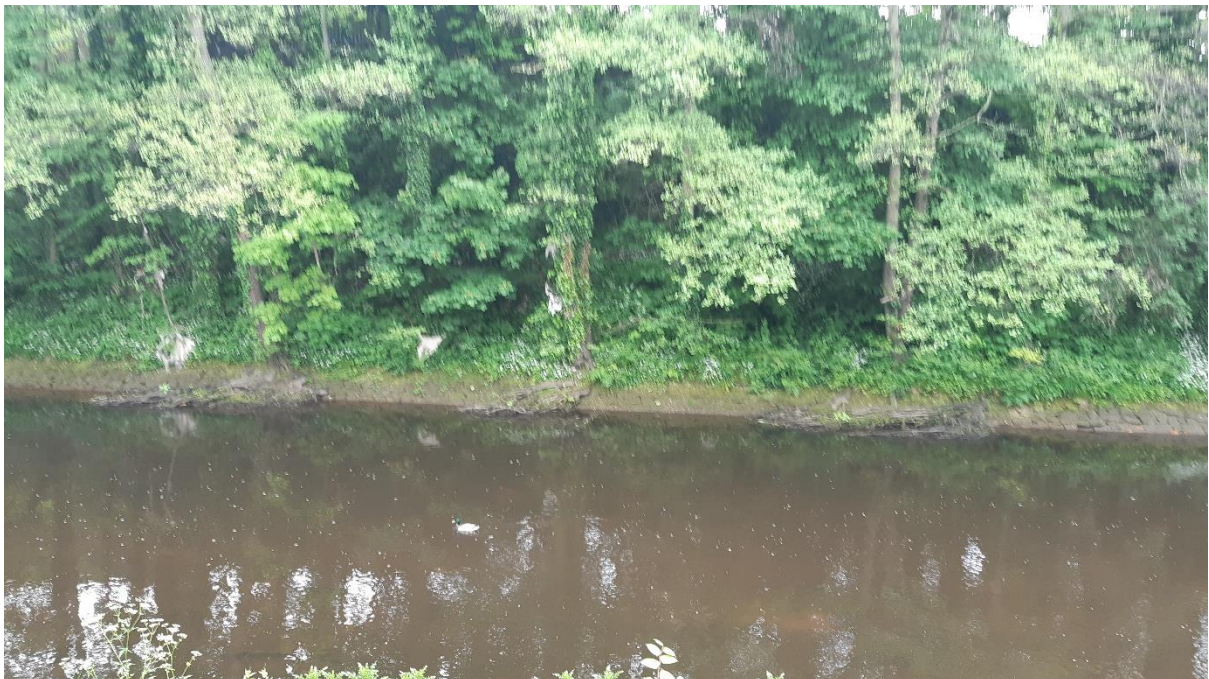
Figure 5: Three bankside trees at SK37240 88218 whose root plates could be protected by coppicing the main stem and cabling to the stump (or lodging the "v" of a felled tree around a standing tree where possible). Coppice regrowth from stumps would also generate low, bushy cover.

This would act to protect the root plate of these trees and prevent it being ripped out from the stonework as the tree ages (along with the stonework). Bankside trees often have shallow roots due to easy availability of water close to the soil surface. Being at the base of the embankment supporting the canal and other infrastructure, there are win:win opportunities for the ecology of the river and surrounding structural stability. Felling a mature tree and cabling to its stump allows the water to support the weight of the tree – and creates much less leverage compared to high winds acting on a standing tree. At the same time, this creates the range of habitat benefits described already in connection to marginal brash and refuge habitat from spate flows and/or predation. Additional benefits are derived from the cover and tree-canopy diversification created by low, bushy coppice regrowth.

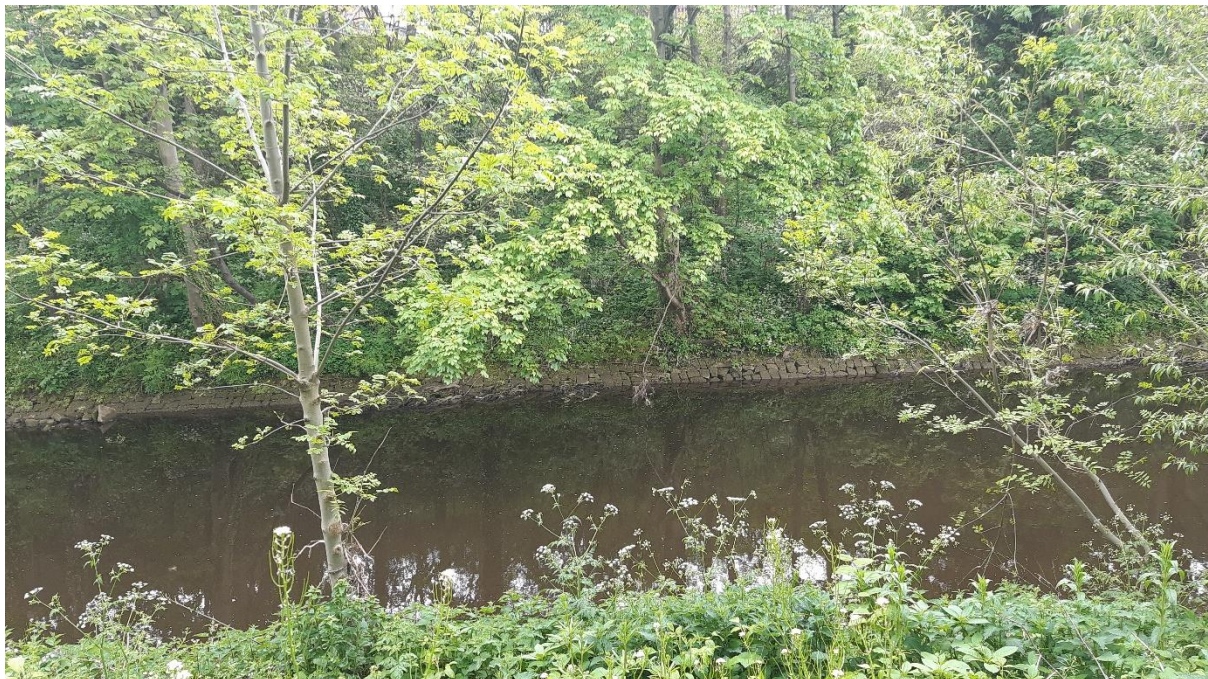
Figure 6: Additional "cabled tree" opportunities at SK37265 88267 on the far bank. Care must be taken to avoid interference with the canal overspill (just out of frame to the left)

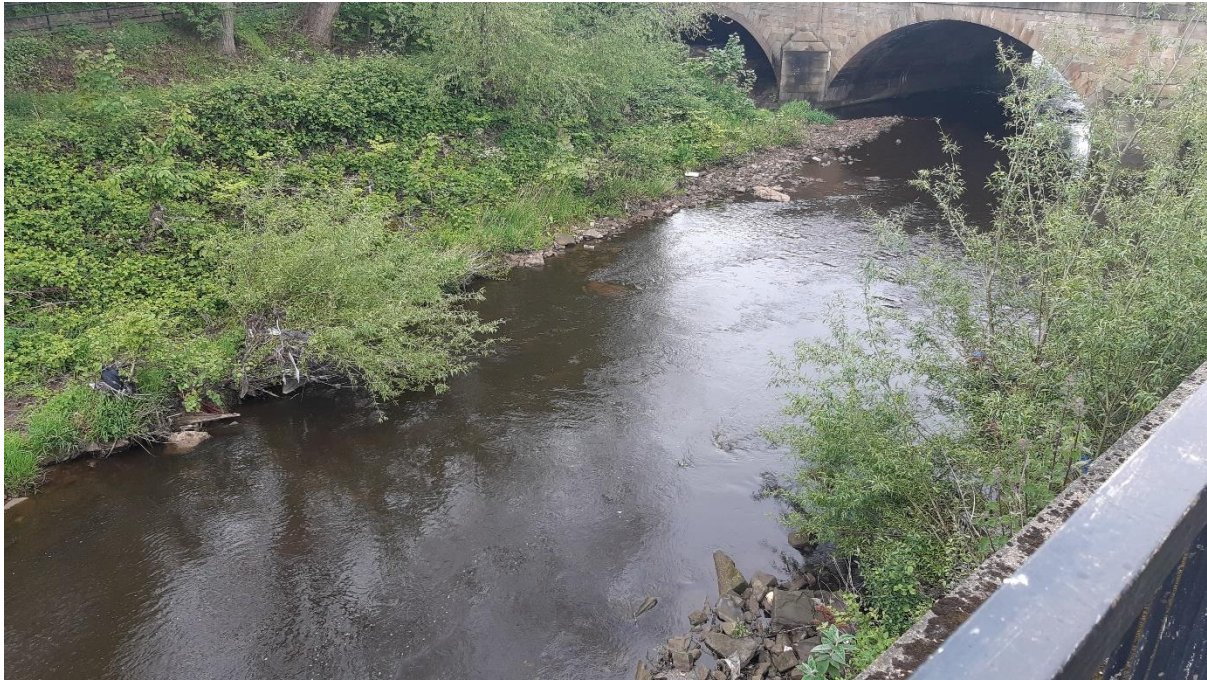
The downstream limit of this visit featured generally more varied habitat (Fig.7). While some opportunities for hinging sapling growth exist, probably the most significant action here would be an ongoing programme of invasive plant control.

Compared to rest of the visited reach, the spatial variation in substrate deposition and erosion, flow depth and velocity over the channel's cross-section was probably greatest in this section. Consequently, little structural intervention is proposed for this location.

Figure 7: Downstream limit of the reach visited for this report. Lateral variation in scour and deposition is apparent – along with trailing marginal vegetation and invasive, non-native plants.

Instead, wider campaigns to protect and improve water quality have much greater potential to achieve ecological improvements. While greatly improved compared to the decades of the 1970s and 1980s, intermittent pollution is still evident. Evidence of combined sewer outfall discharges are noted in the presence of rag-waste in the lower limbs of trees. Surface-water drainage also appears to be contributing excess fine sediment to the reach.

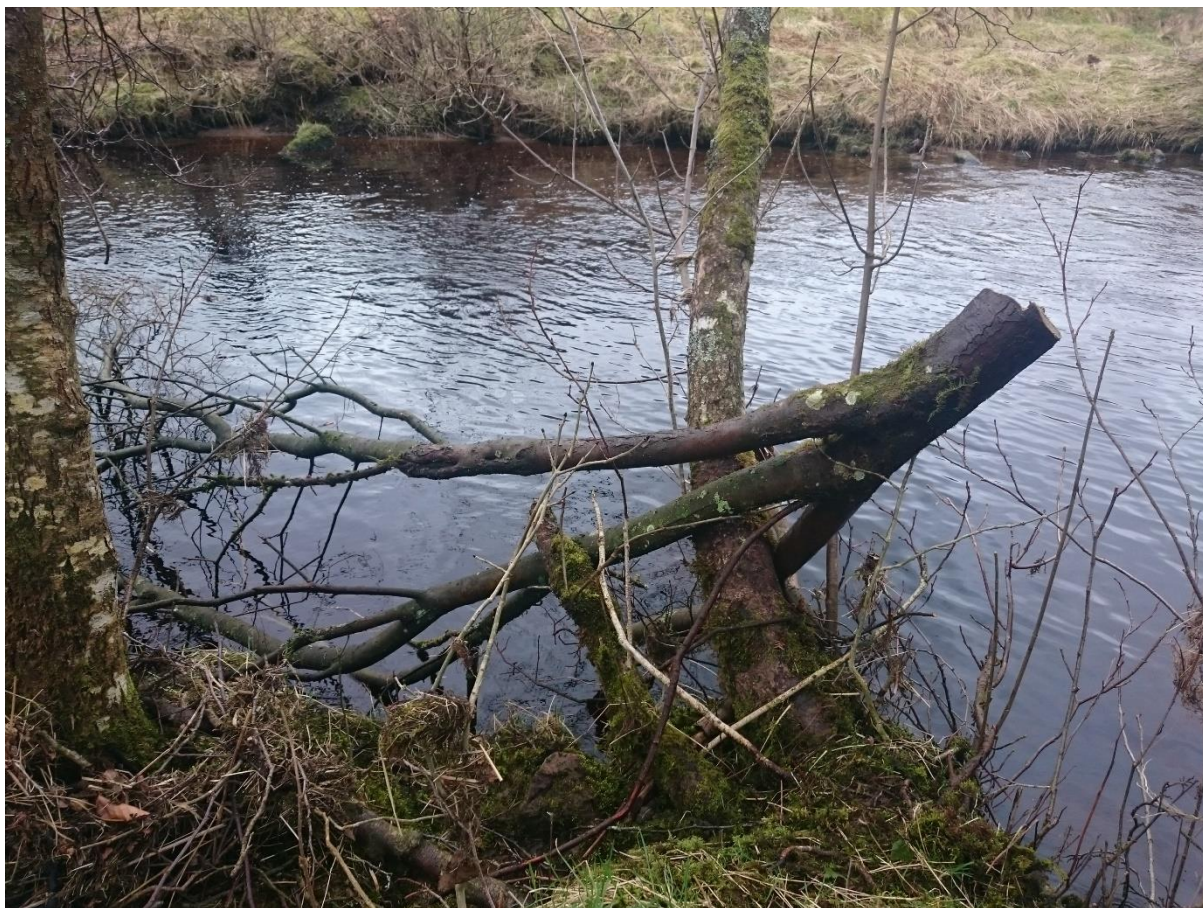
For the creation of marginal/submerged cover using tree crowns, the ideal situation is to avoid the use of extraneous materials (such as cables and cable crimps). Instead, lodging a felled tree by slotting the "V" shape formed by the main stem and a significant limb around a stable, standing tree is the ideal way to mimic naturally-arising woody material. As long as the point of the "V" is facing upstream, it will always be pressed into the standing-tree anchor point by strong currents.

Figure 8: One example of securely-lodged tree crown material – the same principle is scaled up for larger trees.

It is important to note that a standing "anchor" tree needs to be tall enough to avoid the lodged tree floating over the top during spate flows. A potential risk, given the extreme height of spate flows at this site, is that trees may need to be pollarded (rather than coppiced) in order to provide a suitable anchor.

Lodging the arising crown around the standing trunk should be successful in the short term. However, the response to pollarding is likely be accelerated growth in the canopy – at the expense of the roots. For shallow-rooted trees growing through stonework, this could increase the risk of the tree blowing over in high winds. Consequently, subject to a case-by-case assessment, it may be necessary to deploy cables for at least some of the installations suggested in this report.

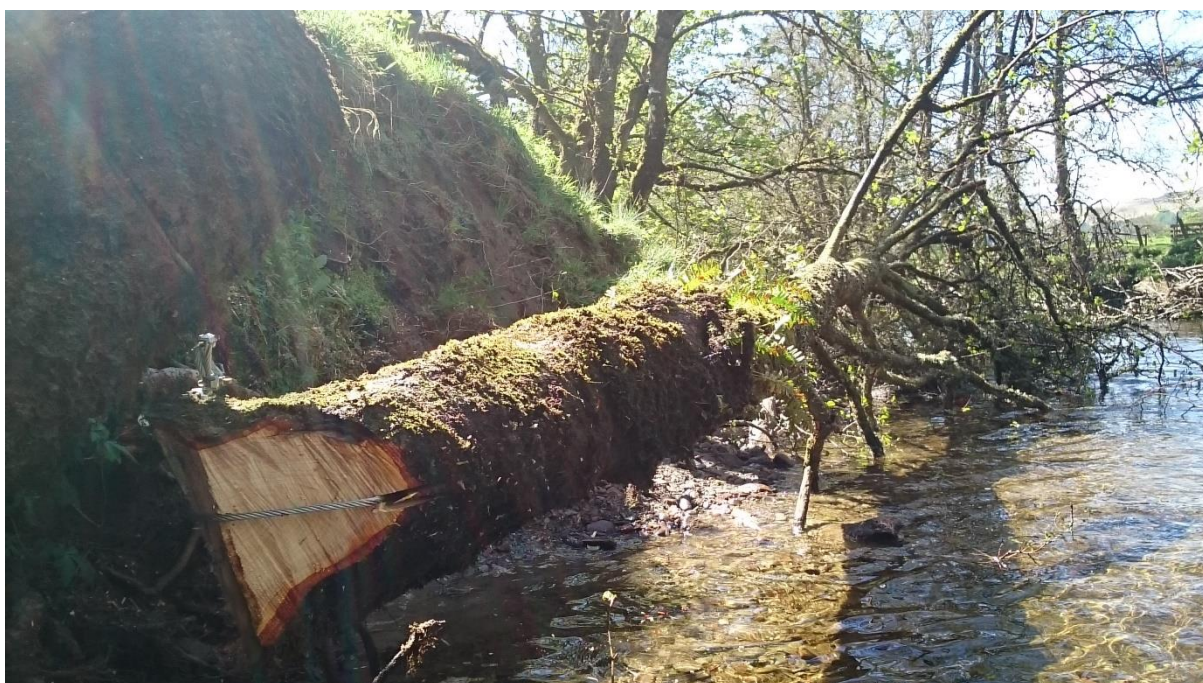
Figure 9: Cabled tree creating cover habitat as well as providing bank protection as a side-effect.

There is more guidance on using cables (where they are necessary) to anchor trees in the "Secure Tree Kicker Installation" video on this link: <https://www.wildtrout.org/content/how-videos#:~:text=This%20video%20illustrates>

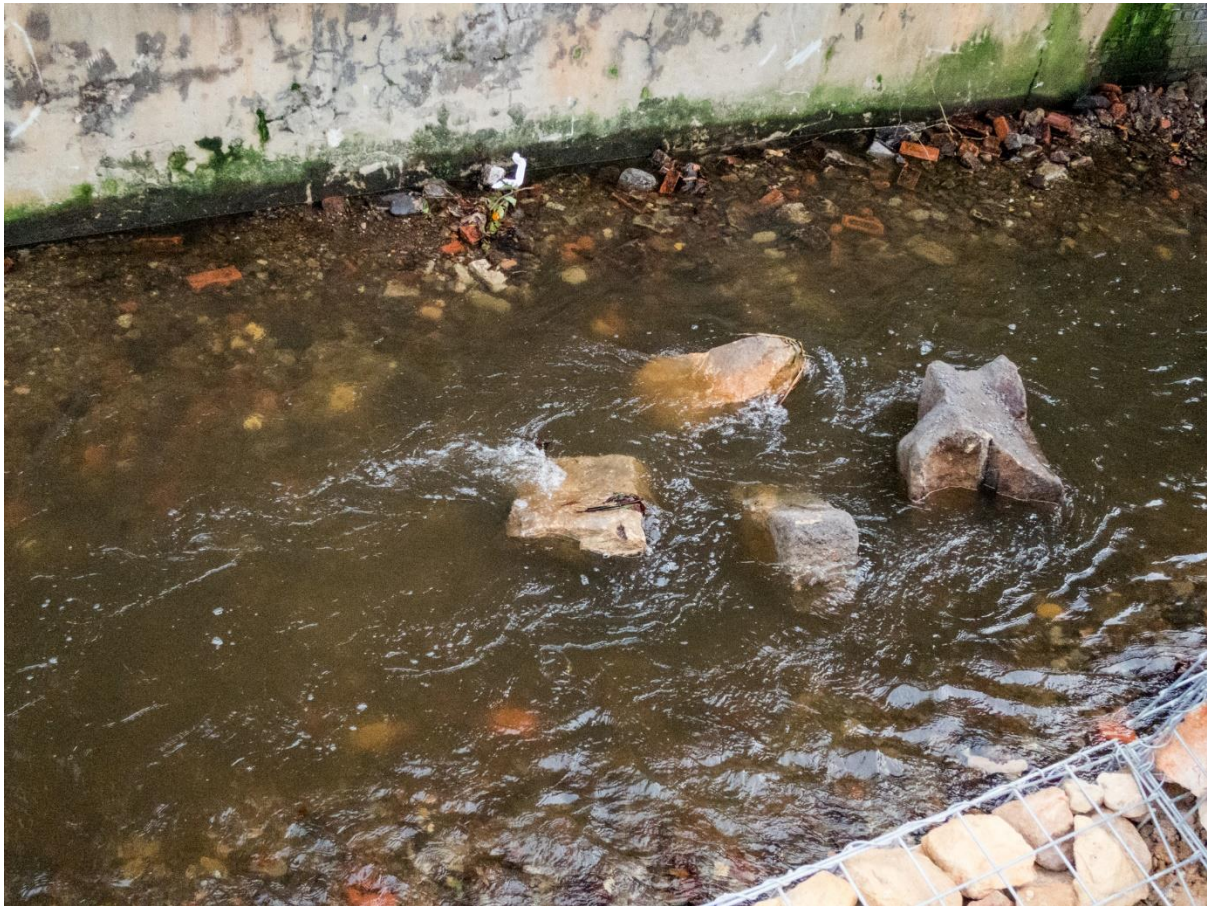
For the installation of boulders, there obviously needs to be a feasible route and method to getting the stone into the channel. Assuming that this challenge can be overcome, a common way to arrange clusters of boulders is in a diamond formation (e.g. Fig.10).

Figure 10: An example of one placement pattern of introduced boulders - where each rock represents a point making up a "diamond" shape. One of the corners of the diamond is pointing into the flow. The stream is flowing from the top right to bottom left corner of this picture.

- Consider introduction of mid-channel boulder clusters in the most uniform reaches to promote greater structural variety in substrate deposition (Fig.10)

Grouping rocks in this way aims to create some diversity in the patterns of localised scour and accumulation of cobbles and gravel. Introducing a rough gridwork pattern of such clusters throughout an area of channel will increase the hydraulic roughness within that "grid".

Assuming sufficient cobble and gravel materials are transported into that reach during spate flows, there should be an increase in accumulation of that material around the boulders. Over time, the boulders shown in Fig.10 have been almost completely buried by accumulated cobble material.

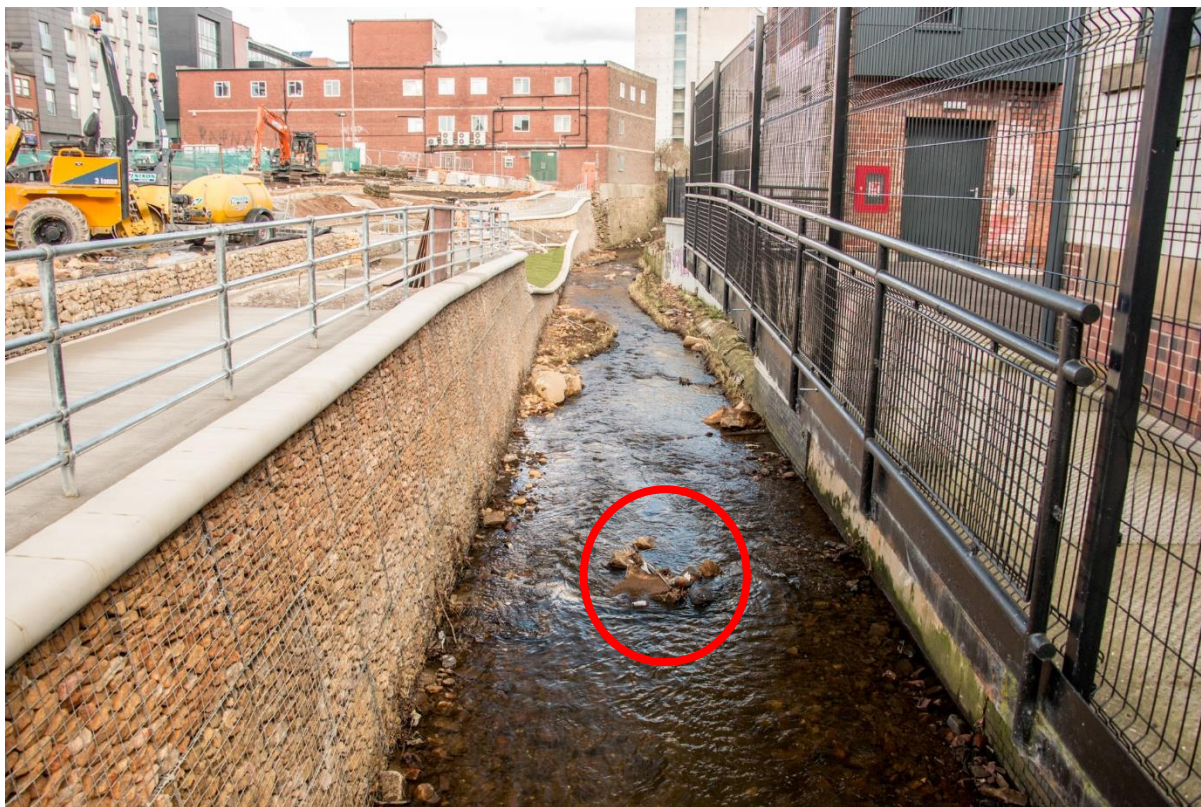
This has formed a riffle in a steep section of stream, subjected to strong spate flows (Fig.11) and shows the potential changes that are possible as a result of increased roughness within the channel.

Figure 11: The same cluster of boulders shown in Fig.10 (circled) have caused a cobble and gravel riffle to deposit around and among that cluster in a walled section of steep, fast-flowing spate river.
