River Dour: Technical notes from preliminary Trout in the Town (TINTT) visit on 26/08/09

Lower Road (Temple Ewell; TR 28747 44280 to TR 28819 43857)

Kearnsey Manor Park (below confluence of Lower Road arm and Alkham arm of the Dour in Kearnsey Abbey lake) to Crabble Mill TR 28917 143662 to TR 29750 43192

Buckland Mill Area to Bridge Street (TR 30587 42695 to TR 31417 42181)

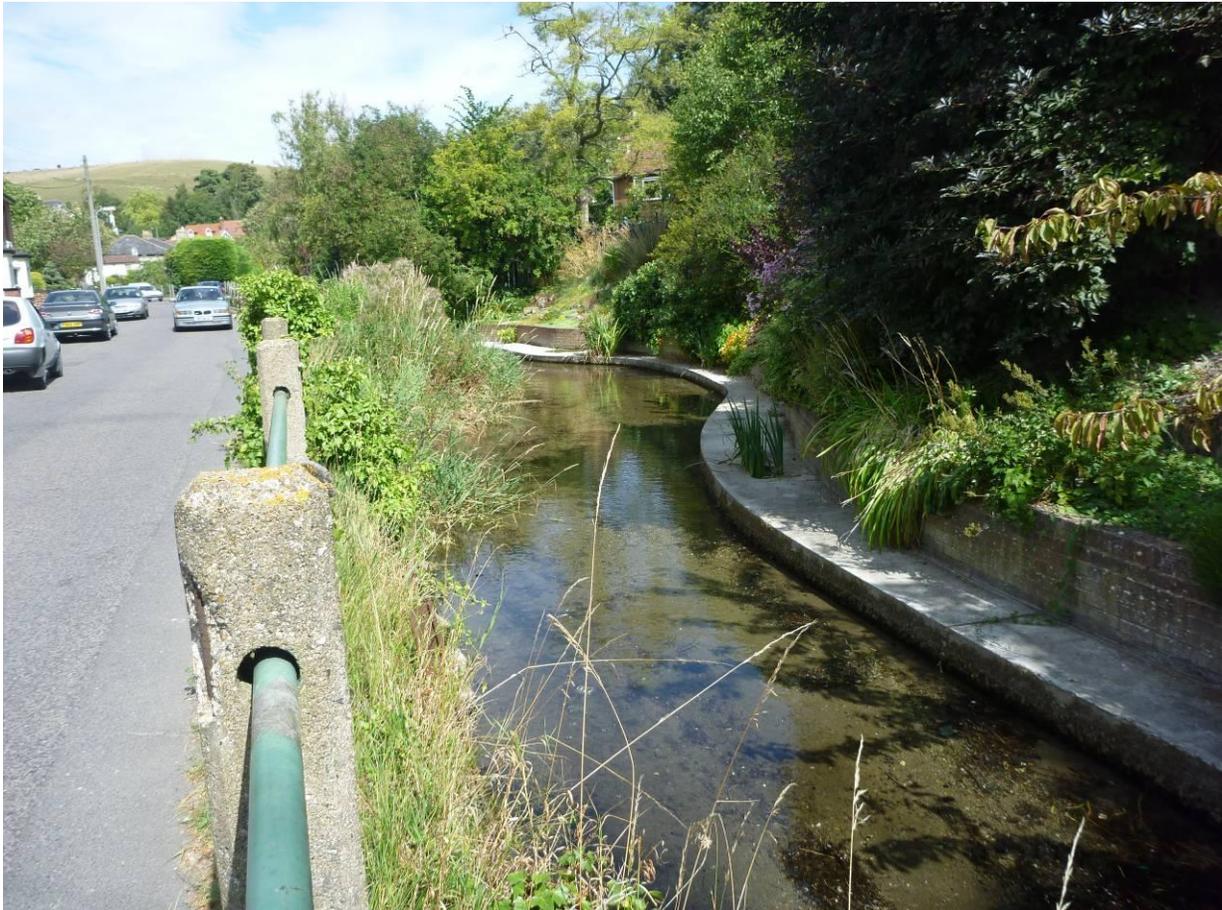
Lower Road, Temple Ewell

This section of the upper River Dour is reported to have previously supported *S. trutta* populations. However, these are believed to have been lost when the upper watercourse dried up during severe drought conditions. The generally sandy substrate (lacking spawning opportunities), susceptibility to drought and an impassable barrier (extremely difficult to circumvent) make this upper section a low priority for any putative trout re-introduction programme. A pre-requisite to any such attempt would be to make the barrier at TR 28819 43857 passable to fish, so that re-colonisation could take place following recurrent drought conditions. The complexity of any engineering solution that could account for the existing road and lake architecture is likely to be prohibitively expensive.

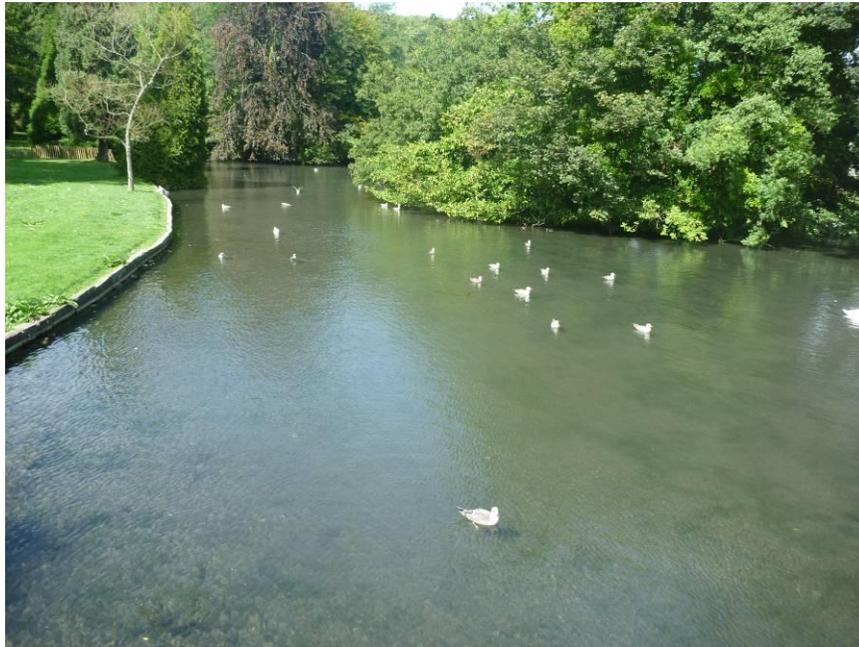
Although the Abbey lake would not typically be valued as wild chalkstream trout habitat – the adjacent bypass channel was observed to support sizeable adult *S. trutta* individuals.

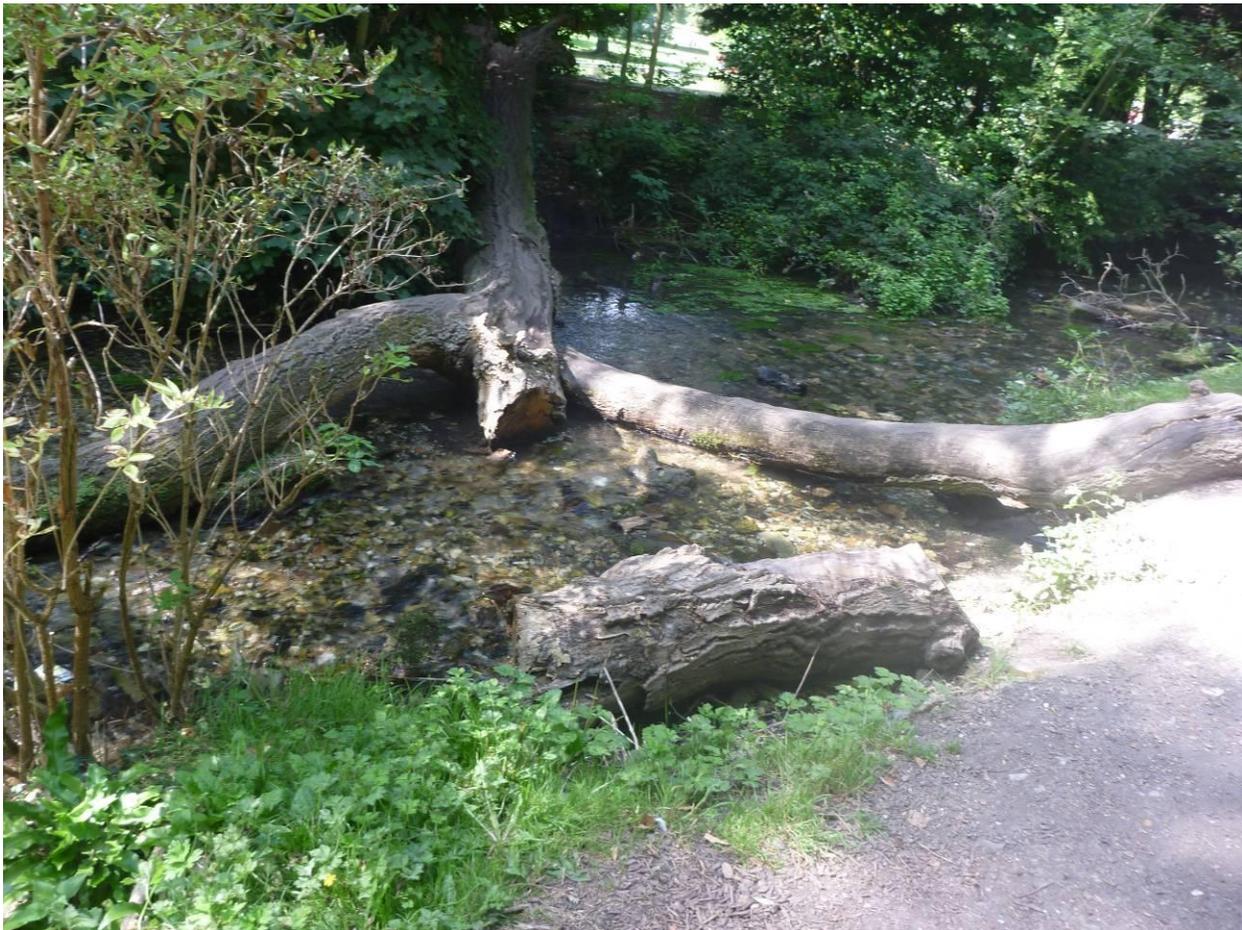
Continuing downstream from the on-stream lake, the main river Dour channel exhibited some high quality habitat, including evidence of a good and relaxed attitude to Large Woody Debris (LWD) within the channel. Such LWD can be vital in generating well sorted gravel particles suitable for trout spawning. Unsorted (i.e. an evenly-mixed aggregate of fine and coarse particles and cobbles) does not provide the well-irrigated interstitial spaces within gravel beds that are required to successfully incubate trout eggs. Some excellent examples of sorted gravels in the 20 to 40mm diameter range were observed to have been thrown up via currents acting on fallen tree boughs (ideal trout spawning habitat). The stream bed throughout the park sections tends to be dominated by flints and gravels – although some silty areas of slower flow also exist.

Clean “ramp” of well sorted and irrigated gravel downstream of fallen tree boughs: Good spawning habitat and a superb example of the value of retaining LWD within river channels

- Encourage naturally occurring LWD to be left in place unless specifically blocking a bridge/culvert
- Investigate potential for sensitive weed cutting **performed by suitably experienced personnel**

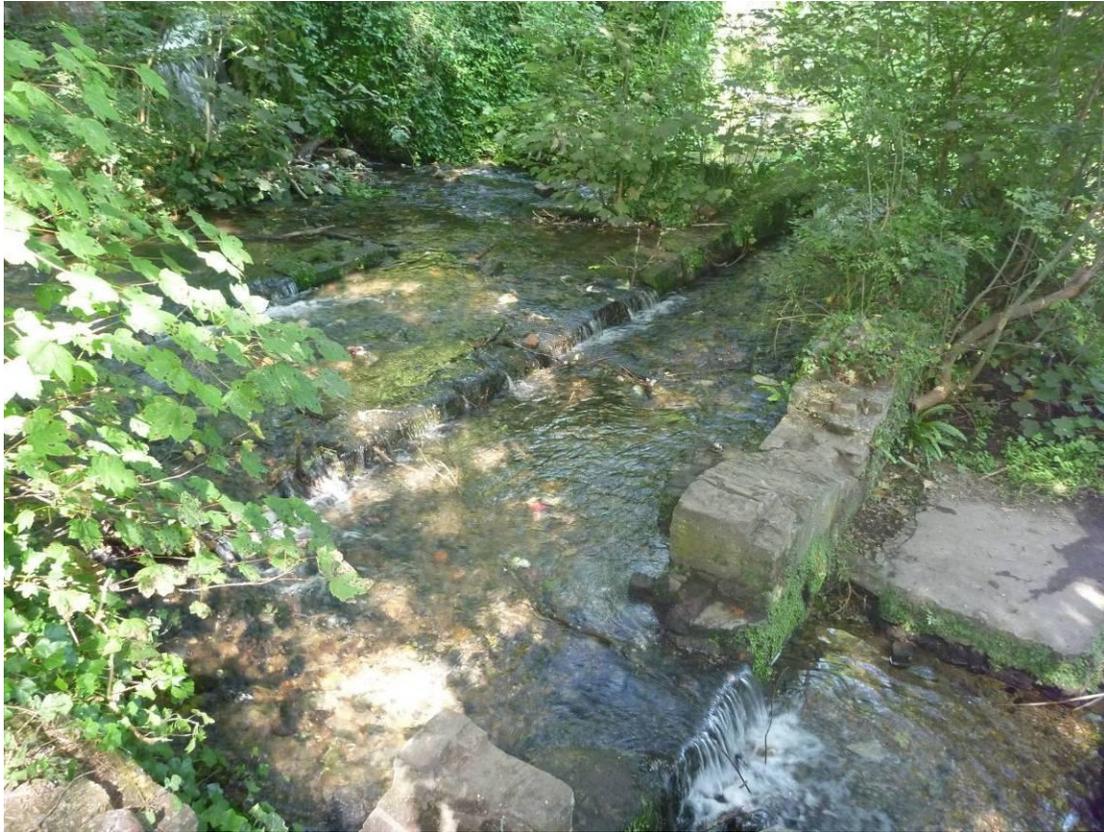
LWD within the channel). A high vertical weir within the park appeared to be bypassed by a series of adjacent, stepped water chutes that ought to be passable to adult trout in most flows of water.

Channel network bypassing large vertical weir (outside the upper right corner of the frame). Pictured during low flow conditions

If this weir can be bypassed by fish, then the section within the park boundaries and on down to Crabble Mill is likely to be one of the longer continuously connected sections of river habitat on the Dour. A greater length of connected habitat confers greater “insurance” against localised fish mortalities (e.g. from pollution) and also improves the capacity for fish to access required habitats according to their specific life stages.

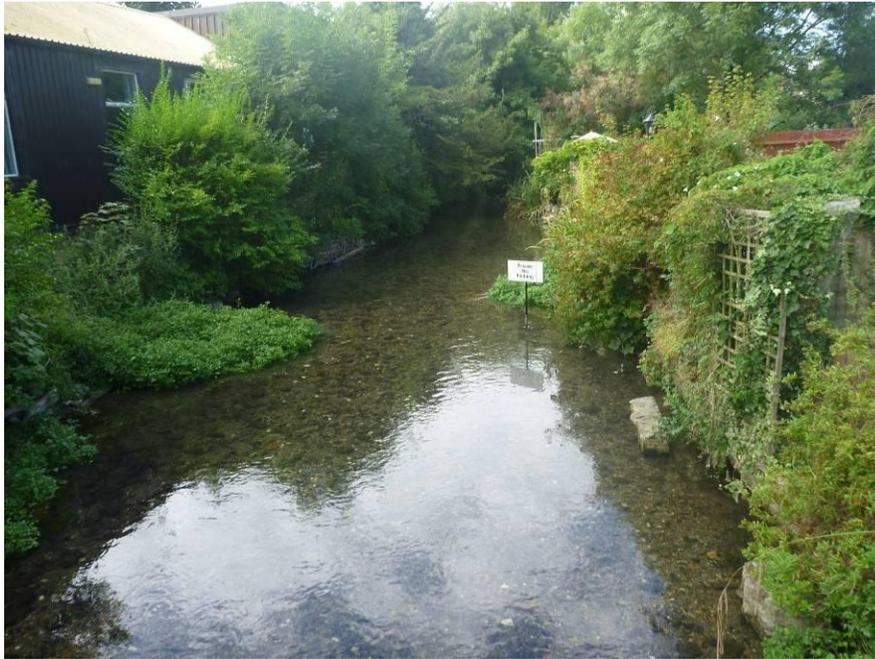
A short distance downstream from the Park (bridge over river at Common Lane) – the channel continues to have a bed dominated by flints and gravels. Although it is relatively uniform in terms of depth, being a little overwide and shallow, large numbers of adult trout were observed upstream of the bridge (in excess of a dozen fish clearly visible). This habitat, therefore, is a highly valuable stronghold of the native brown trout of the Dour and should be recognised as of great ecological importance in the preservation of this UK BAP species. Again, for further insurance against the loss of this population, the secure introduction of some LWD would promote additional structural diversity and cover for adult trout (and aid gravel sorting for spawning). However, extensive consultation with residents whose properties back onto this section would be required in order to obtain suitable permissions to perform in-channel works.

Relatively uniform, generally shallow – but full of large adult wild trout!

- Investigate local land ownership and householder opinions around the Common Lane area (e.g. by leaflet drops) with respect to “light touch” installation of pinned LWD (using steel rebar pins driven into stream bed through logs)

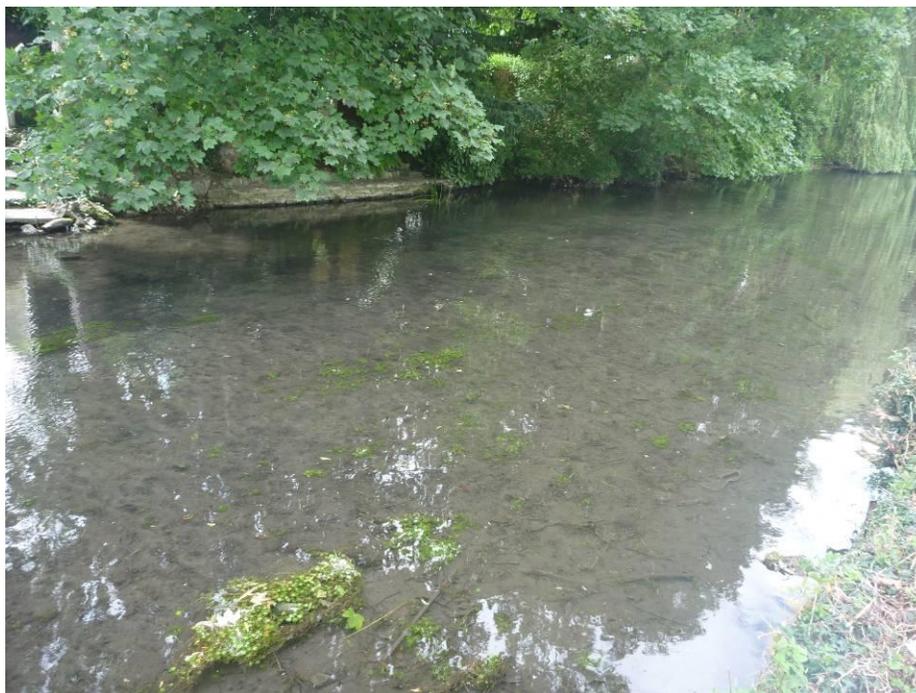
Downstream of this section, the influence of the weir at Crabble mill becomes apparent in the slower and deeper flow. Accordingly, siltation is more evident along with an increased abundance of starwort (*Callitriche spp.*) which favours slow silted areas.

Slow silty conditions – adequate but sub-optimal habitat for adult or juvenile trout

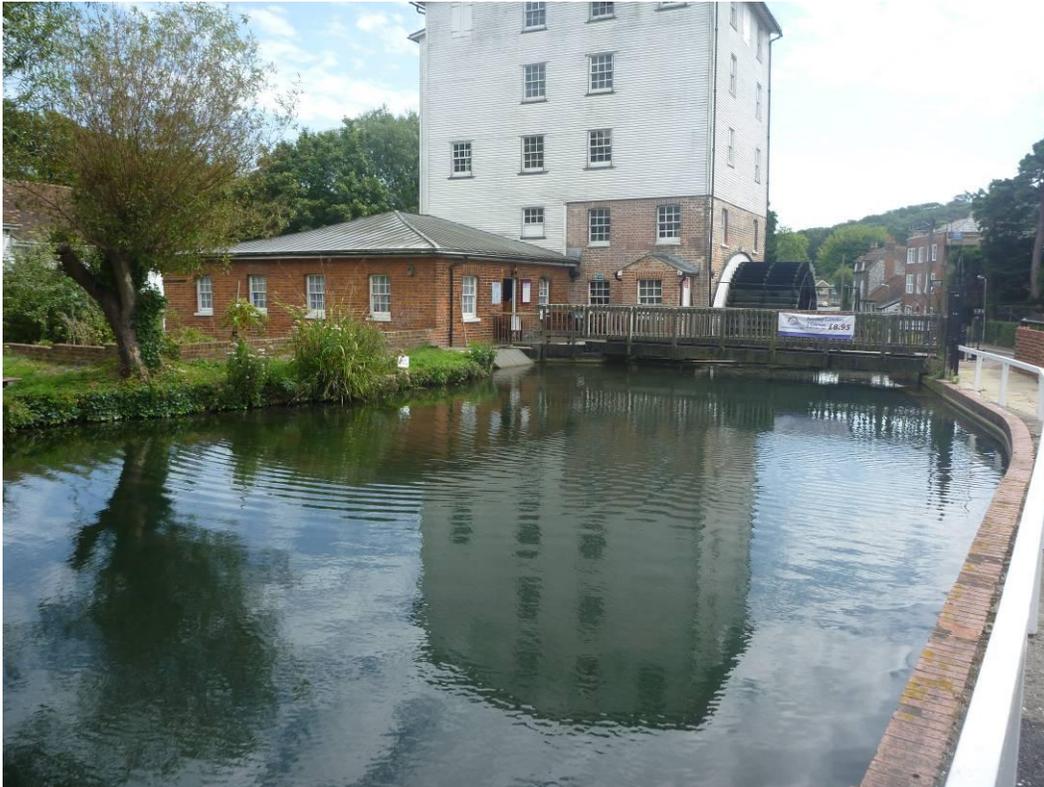
Weir and wheel at Crabble Corn Mill - home to huge trout and an important heritage feature but an impassable barrier to migration (causing fragmentation of usable habitat)

- Invite press photographers to signage installation and clean up parties
- Flag up the potential for easing fish passage on the significant barriers on the Dour

- Identify which single barrier would link up the greatest length of river if bypassed
 - Balance against cost/difficulty of engineering solution
 - Produce a prioritised list of the order in which to tackle barriers and task the local E.A. fisheries, recreation and biodiversity team to deliver E.U. requirement for fish passage

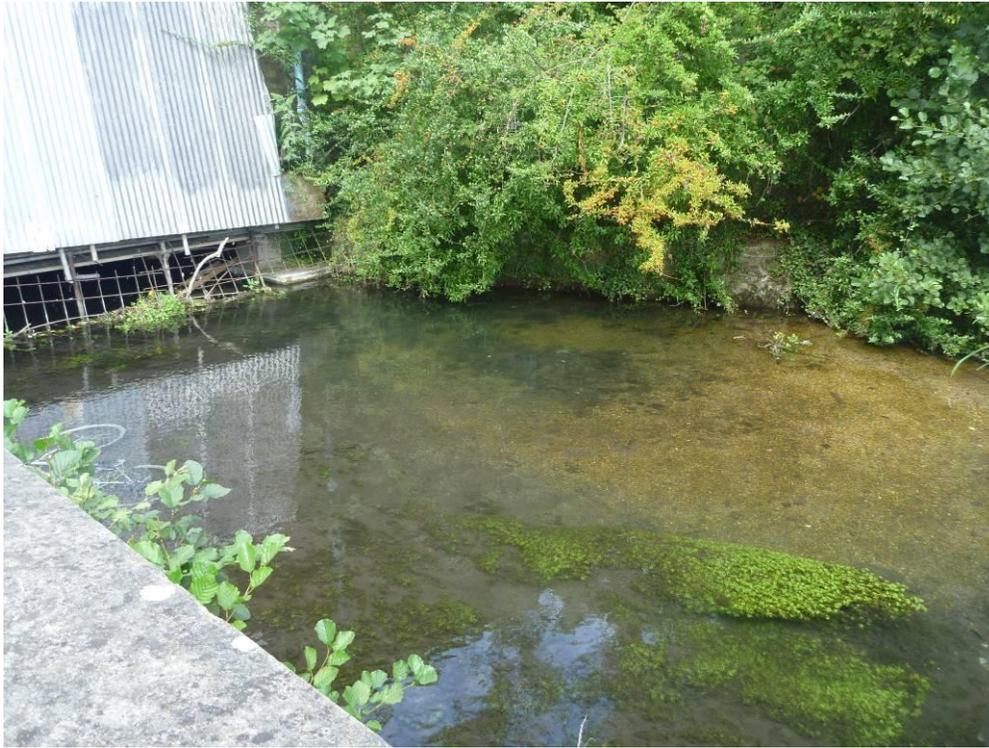
The habitat from the Buckland Mill area and downstream flows through much more heavily urbanised land. Again, fragmentation by weirs (notably at Buckland Mill, Chitty's Mill and at Bridge Street) heightens the importance of the continued survival of upstream trout populations. In the event of fish being wiped out between pairs of weirs – the only mechanism for recolonisation comes from the downstream drift of fish from further upstream. There are relatively extensive silted, slow flowing areas that result from the backwater effect of these weirs. However, good quality habitat does exist in patches and adult trout can be readily observed. The plans for redevelopment of the riverside at (and upstream of) the Buckland Mill site offer an opportunity for local wildlife interests to be represented. The great value of making barriers passable (and reduction of vertical head loss/increase in upstream current flow) would be important to communicate and incorporate in such development plans.

Directly downstream of Buckland's Mill; earmarked for redevelopment

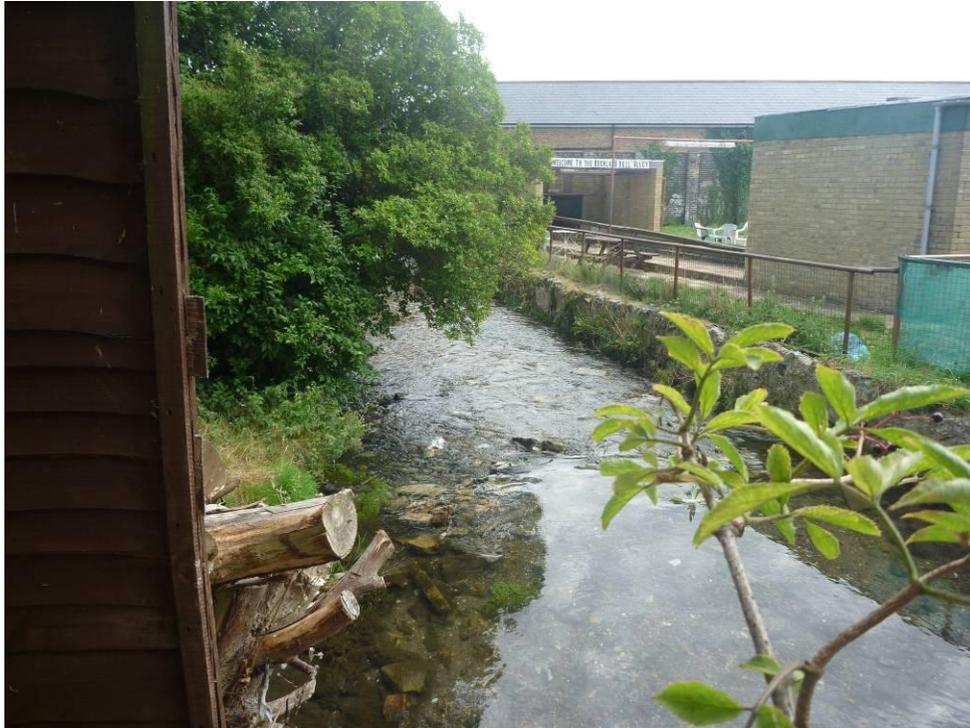
Straightened river but with good pool and riffle habitat behind Buckland Bull pub

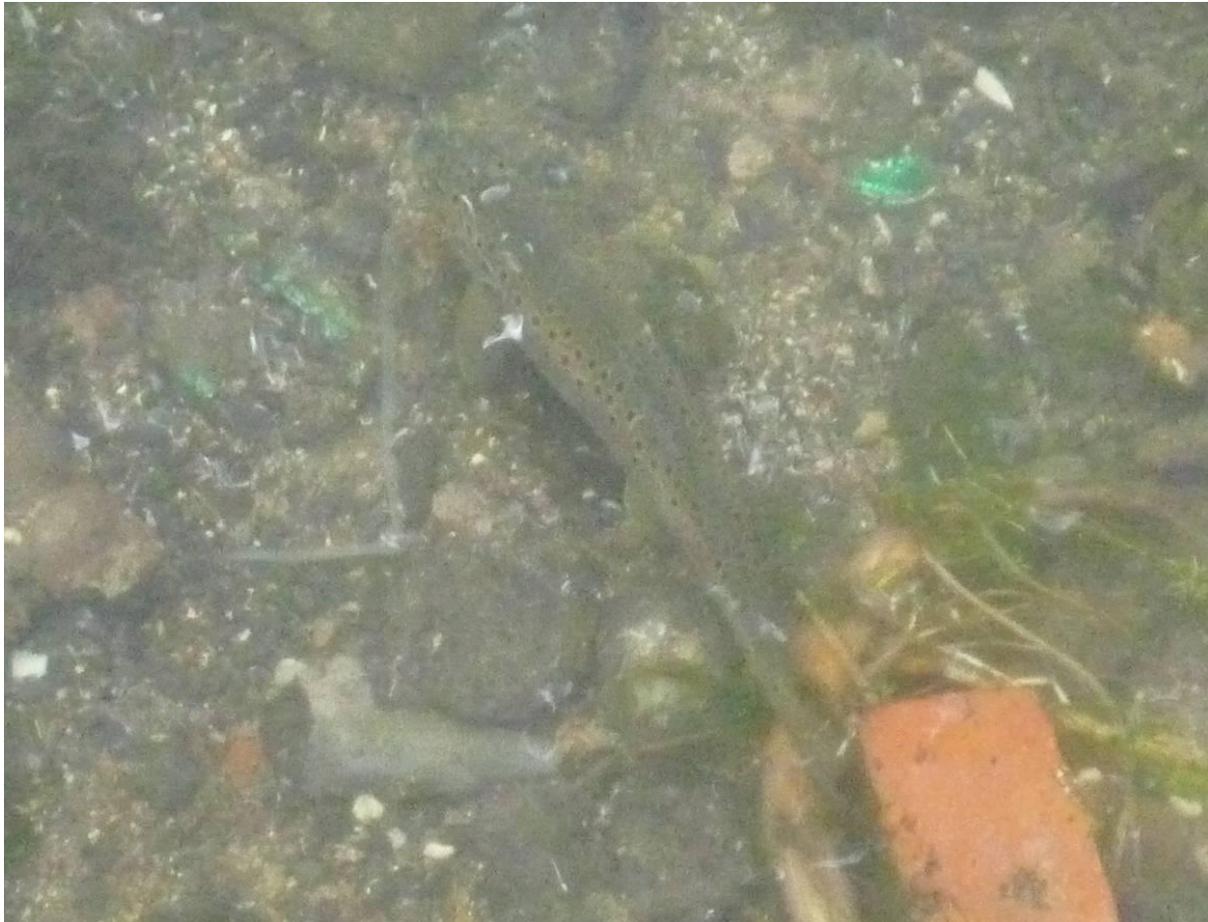
Trout below Buckland Mill

Similarly, the current (and future potential) condition of the weir at Chitty's Mill should be investigated for feasibility with respect to enabling fish passage.

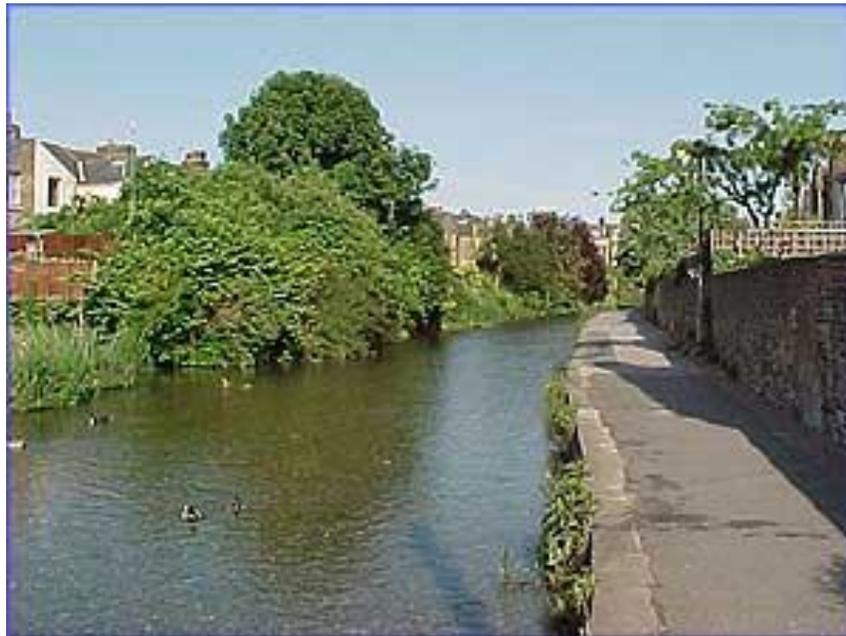
Special mention must be made of the habitat adjacent to Barton Path (in common with all of the urbanised reaches, the channel here is constrained within hard engineered surfaces). The Environment Agency has undertaken a planting initiative along this reach in order to enhance both aesthetic and ecological diversity amenities. Comparison can be made between the reach as it appeared in June 2001 and this site visit of August 2009 (over page):

Barton Path in summer 2001 (image from dover-kent.co.uk)

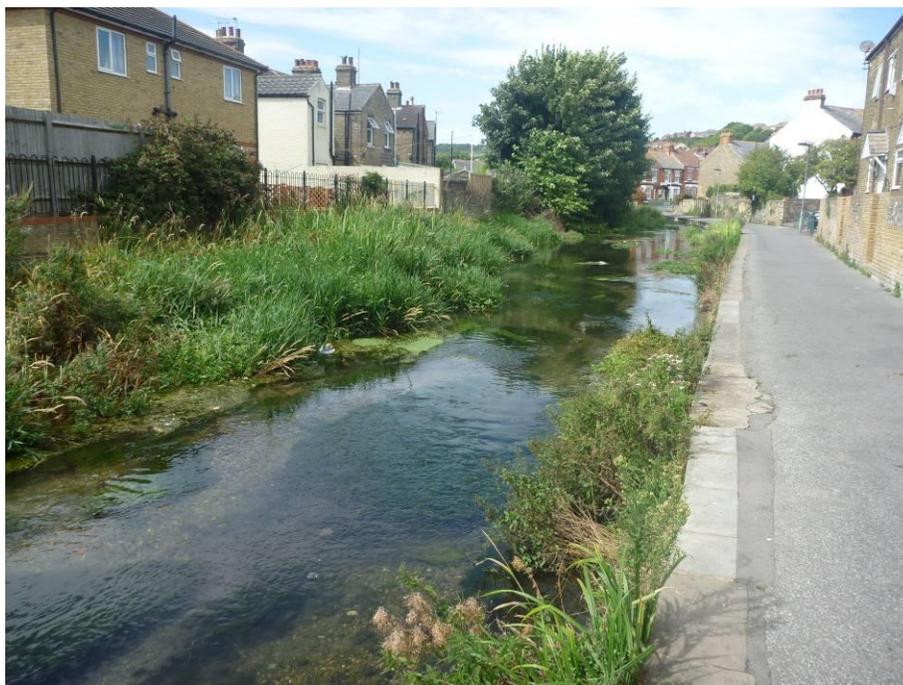
Barton Path 2009 – note *Ranunculus* growth and resultant substrate depth variation

The value of the submerged and emergent vegetation in the 2009 photograph above (as well as the very first photograph in this report from the same reach) is immediately apparent. It is a great illustration of how the vertical concreted edges have been softened by the development of marginal vegetation and

also how stream bed topography has become much more varied in response to both emergent and submerged flora. The presence of mid-channel vegetation islands greatly concentrates flow (enhancing silt removal from exposed gravels). In particular the water crowfoot (*Ranunculus spp.*) growing within the channel has huge benefits in supporting a range and great abundance of clean water-loving invertebrate species (e.g. a variety of Ephemeroptera, Trichoptera and gammarid crustaceans). At the same time, the shelter provided by weed fronds provides an abundance of great habitat for juvenile and adult trout. It can also help to promote the structurally diverse “patchwork” of differing depth profiles and current speeds within the channel. Such variety of physical structure maps very well onto the variety of different creatures that are specially adapted to each particular “microhabitat” – producing greater biodiversity.

It should be noted that, for the optimal benefits to biodiversity to be maintained, some considered and controlled management (cutting) of *Ranunculus* can be beneficial. **This should be performed with the intent to preserve a varied patchwork of exposed gravel channels** – where flow is concentrated and silt is washed away. Exposed gravel should be approximately matched at peak growth by an equal (or slightly dominant) coverage of healthy weed fronds that filter out and accumulate some fine material around the root/stem system. In this way, a nicely varied “egg-carton” undulating character of the stream bed can be promoted. Naturally, the presence of short logs or root boles within the channel can also further promote this pattern of localised scour and localised deposition. Habitat and vegetation of this nature is highly prized for aesthetic, ecological and, in some cases, fishery recreational values. It is precisely this type of habitat that exists on the most exclusive beats of classic chalkstream fisheries – costing many thousands of pounds to be granted access to (see River Test photo below).

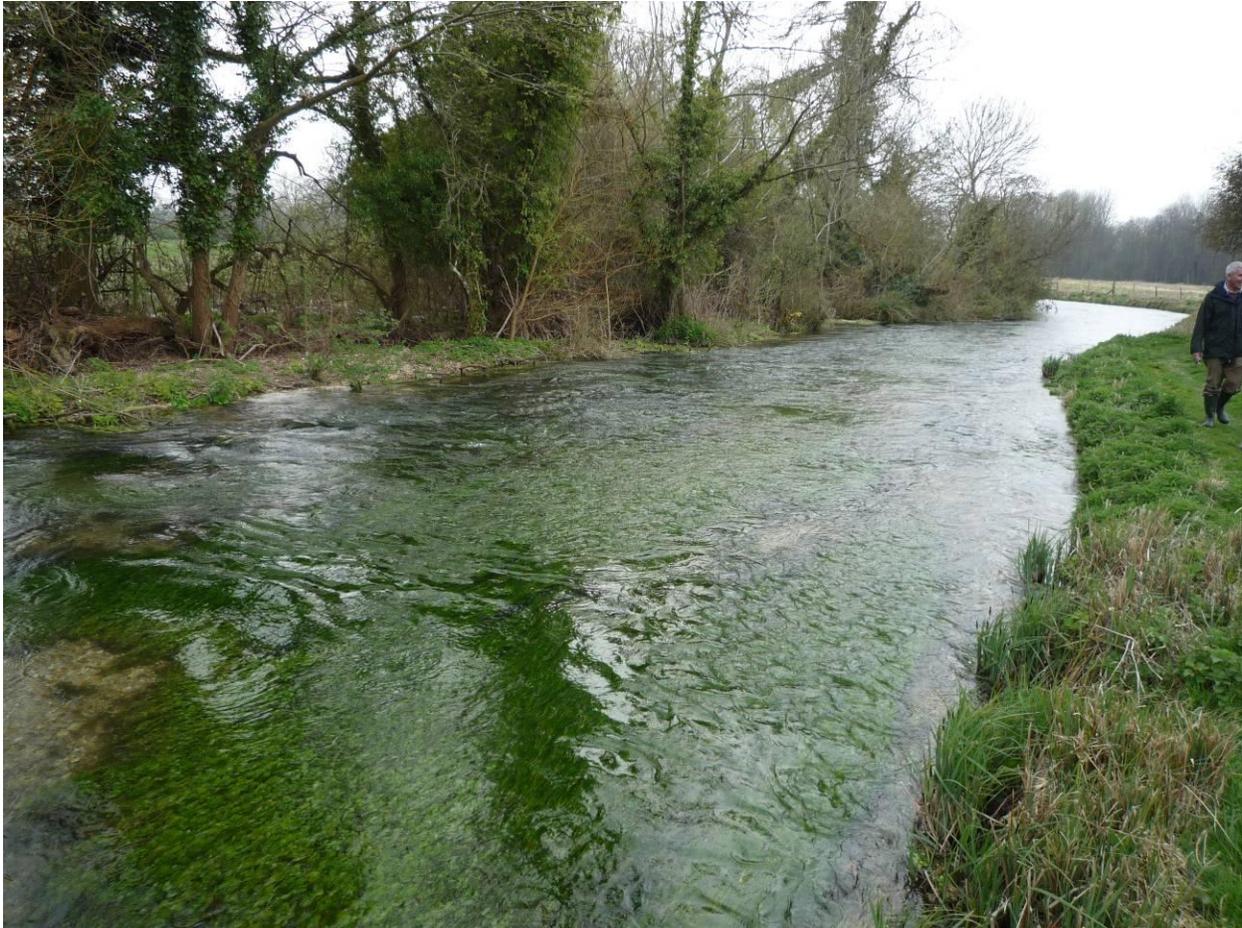
***Ranunculus* growth in The River Test at Tufton: This chalkstream, its *Ranunculus* and fly hatches are world famous in fly fishing circles**

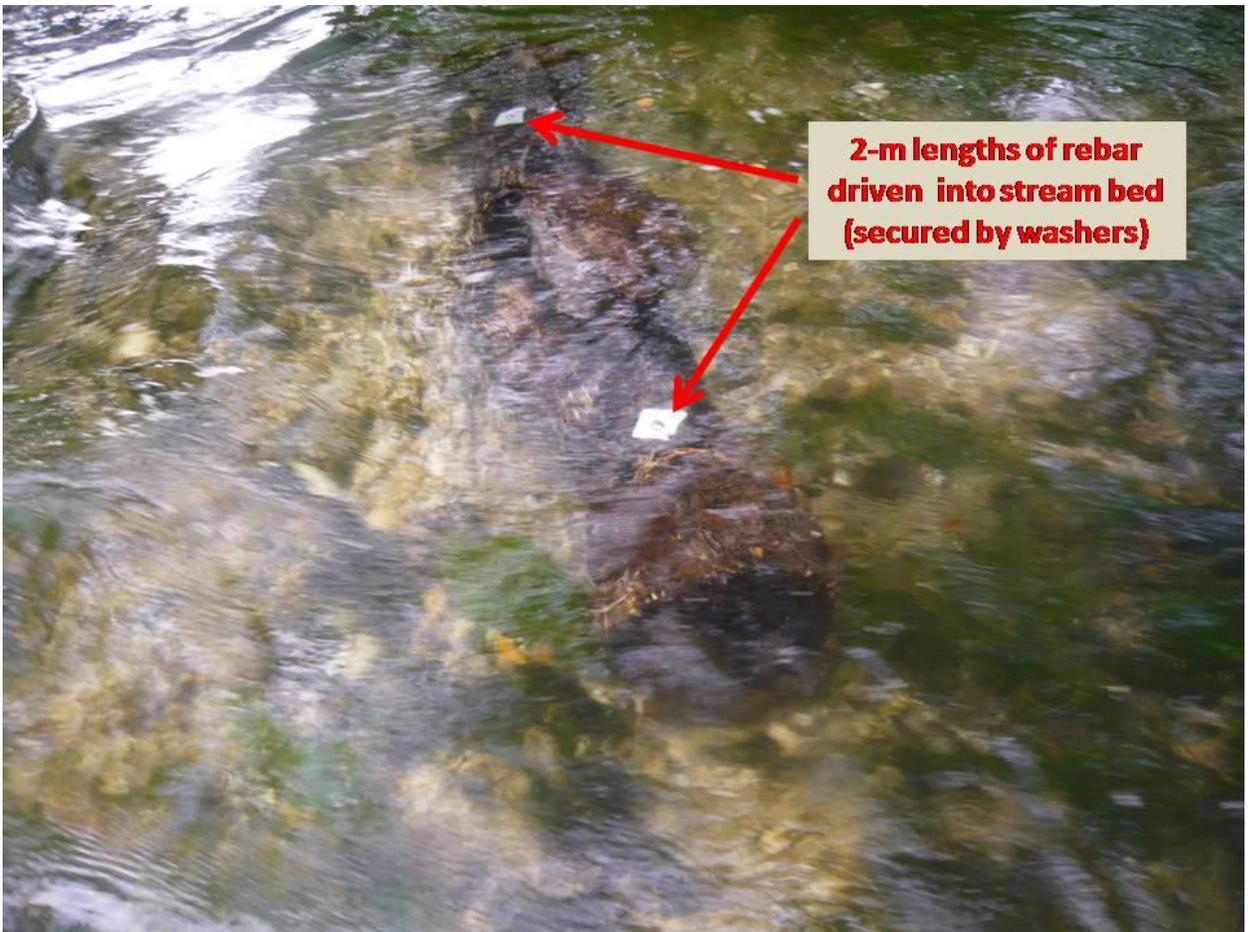
Short (1.5-m long) log pinned to the bed of the River Test at Mottisfont in order to generate localised scour pool and sort spawning gravels

- Ideal installations would typically consist of “Y-shaped” sections of tree stem/bough with each “limb” approximately 1-m in length (and a diameter of 12 to 18 inches)

- The pointed end of such a section would be fixed in an upstream orientation – to focus scour between the splayed limbs
 - Similarly, small scale “upstream facing V” log deflectors could be constructed from 1-m long logs (to produce an angle of between approximately 45 and 90 degrees)

- Two or three such “Y” logs or small scale “upstream V” logs could be spaced at varying points across and down the channel within a 50-m reach of river in a haphazard arrangement
