# WILD TROUT TRUST

**An Advisory Visit by Nick Lawrence of the Wild Trout Trust, December 2020**  
[nlawrence@wildtrout.org](mailto:nlawrence@wildtrout.org)

## 1. Introduction

This report is the output of a Wild Trout Trust advisory visit undertaken on the River Ebble at Coombe Bissett in Wiltshire. The visit was carried out at the request for Paul Welling (Property Industry Fly Fishers) who has just secured a lease for the fishery. He is interested in enhancing the river's potential for Brown Trout.

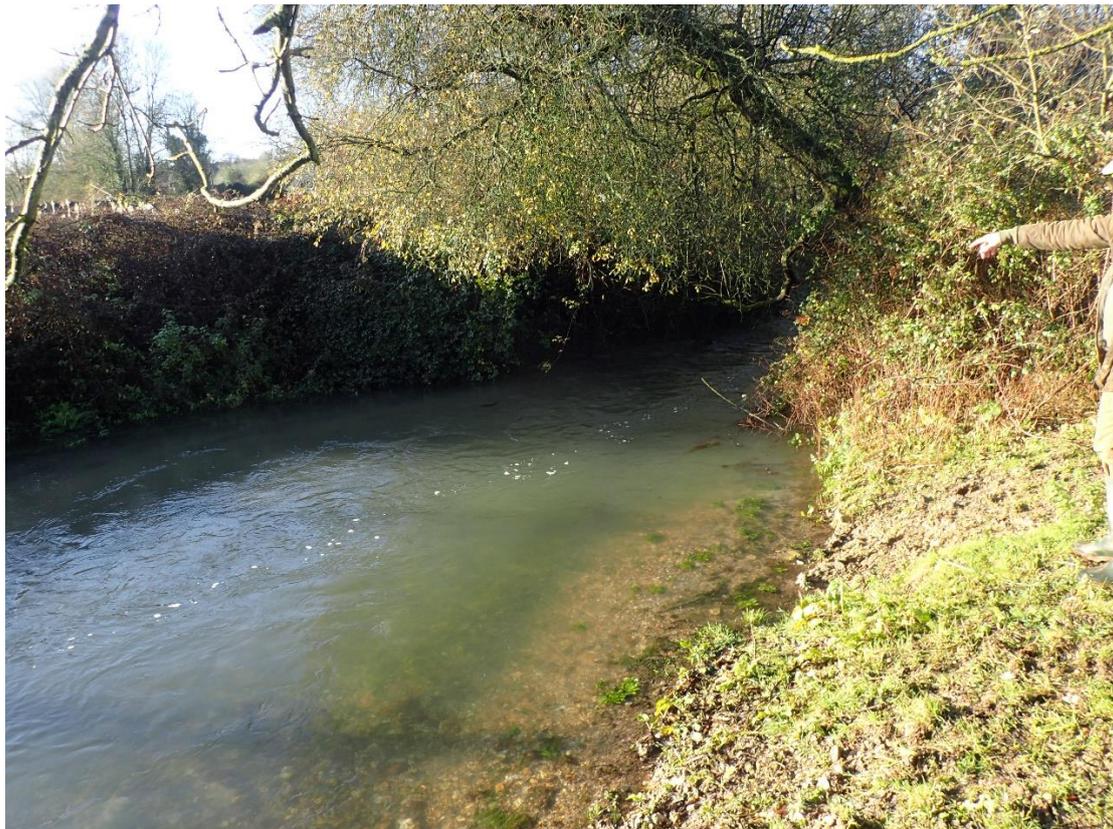
The visit started at the most downstream section which appeared to be a livestock drinking area (photo 2) due to the heavy poaching and lack of marginal vegetation. The RB bordered the main road with some hard engineering, while the LB had open access to the field which was well trodden by horses.

Photo 2 Most downstream section near the Salisbury to Blandford road. This area is unprotected from grazing, but the leaning willow has created good overhead cover at a natural pinch point.

The lack of maintenance upstream of photo 2 has allowed some of the most varied habitat within the reach to develop; with some fantastic 'gifts from nature'. Firstly, the heavily leaning willow (photo 2) which provides important low cover over a likely looking run for a trout. Secondly, scrub has started to dominate due to the lack of horse grazing. Photo 3 has a variety of trunks of willow that have entered the channel by natural means, diversifying flow regimes and providing refuge from predators.

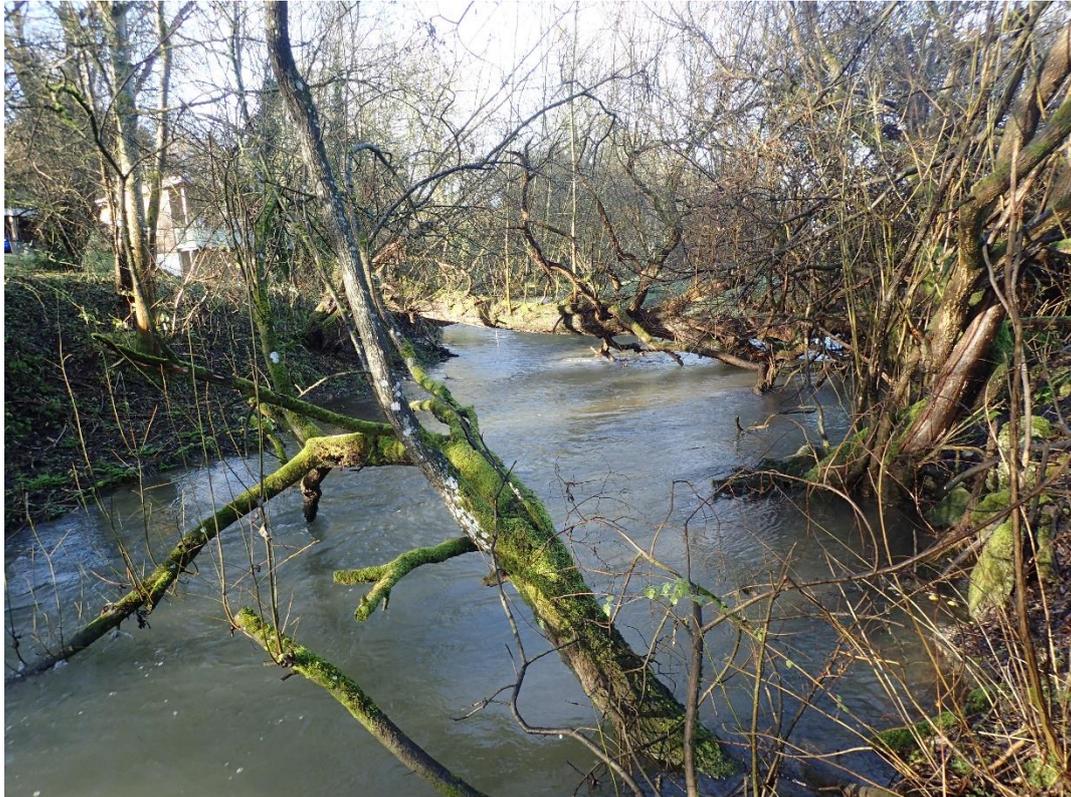
Photo 3 A huge variety of beneficial, naturally accumulating woody material.

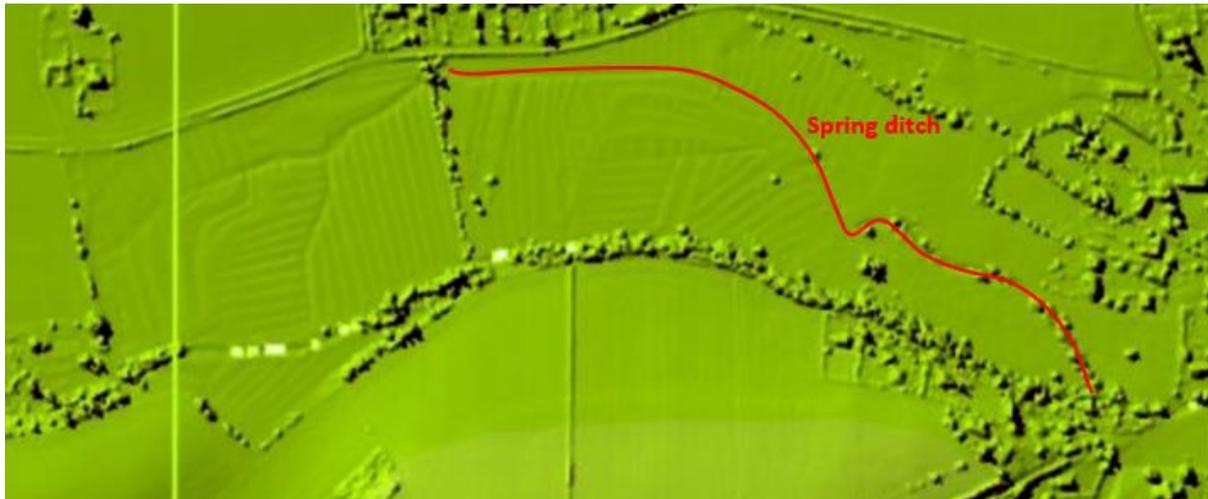
Upstream from this heavily wooded section, the spring ditch joins the main river. The spring rises from hills on the north side of the valley and had a very good flow, suggesting that the aquifer beneath is well charged. Given that a spring rises at this low point of the valley, and that the ditch conveys a steady flow of clear water, it is possible that the origins of the ditch are in fact the original course of the river. The river and its ditches will have been altered over time for human needs, straightened and furrowed for historic water meadow use, which can be seen in photo 4.

Photo 4 Screenshot from National Library of Scotland showing the furrows on the LB used for wetting of water meadows.

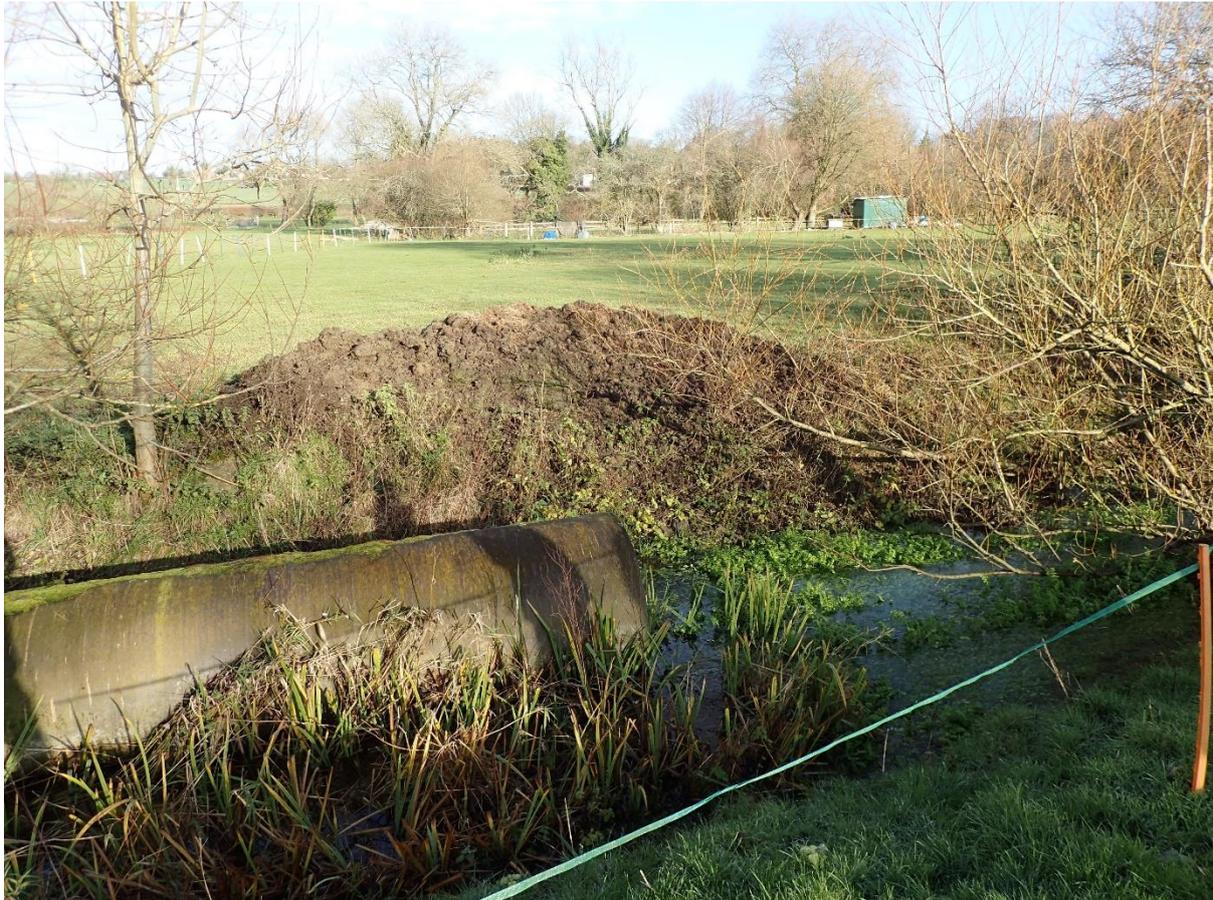
Photo 5 Horse manure piled up adjacent to the spring ditch, a pollution incident.

As shown in photo 5, this should be brought to the attention of the tenant and removed, it is classed as a pollution event and could result in a fish kill, which may well carry a fine. It will already be leaching into the watercourse, polluting it, leading to a decline in the aquatic invertebrate diversity and abundance within the spring-fed ditch and possibly beyond.

diverse vegetated sward to grow, buffering the river from sediment and associated pollutants, and providing important food and cover for invertebrates. Horse manure heaps were located adjacent to the spring ditch and will undoubtedly affect its water quality. The manure heaps should be moved away from water sources. Farming Rules for water are clear on this – no storage within 10m of a watercourse or within 50m of a spring. (<https://www.gov.uk/guidance/rules-for-farmers-and-land-managers-to-prevent-water-pollution#storing-manure>)

- Engage with the farmer/ tenant firstly with regard to manure deposits adjacent to the river to see if these can be stored in a more appropriate place i.e., At least 10 meters away from a watercourse. Secondly, discuss the possibilities of livestock exclusion from the river bank, ideally a 5-10 metre buffer strip. This needs to be strategic as it may increase maintenance in time.

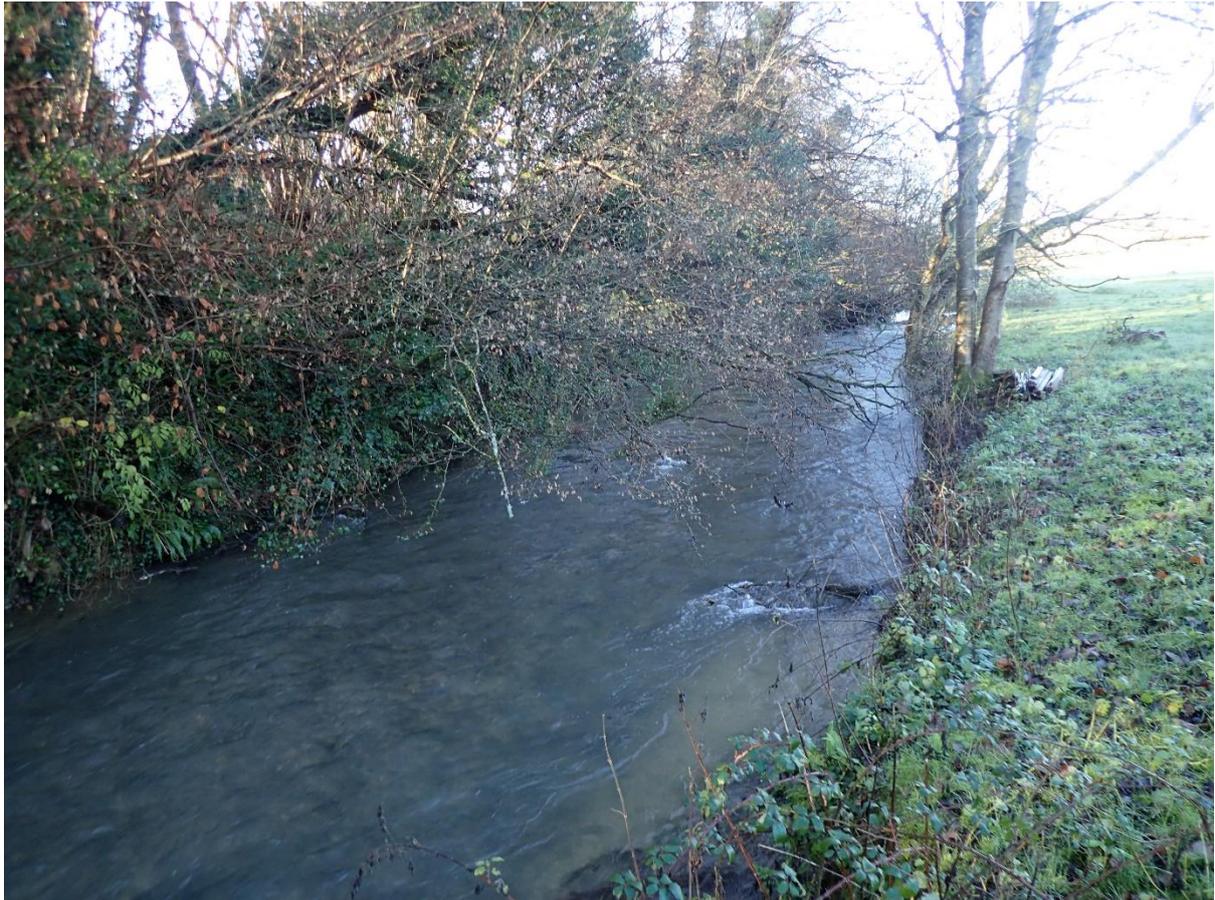
Moving upstream, it was noticeable how the reach was straightened and realigned to the southern edge of the floodplain, and the floodplain itself was relatively dry. There is now overshadowing of the lower reaches, compounded by the RB being on the southern side of the valley which is heavily wooded with a hazel coppice (photo 7) further reducing light to the river. The shade, straightening and steep gradient has led to the development of uniform river habitats, essentially the simplified habitat is continuous shallow riffle, lacking flow/depth diversity and reducing sorting of gravels. This reach of river is considered sub-optimal for trout and grayling.

Photo 7 Shading on the southern bank, a typical view in the lower section.

The hazel coppice can be managed on a rotational basis and some of the arisings could be used to build brushwood mattresses (appendix photo 16) while living stems could be hinged into the channel to provide more instream habitat and increase the available holding lies for fish. The woody material will also act to catch marginal plants drifting downstream and aid their colonisation of the reach. If the brushwood mattress is used to narrow the channel and increase flow then it will bring benefits to aquatic plants, especially *Ranunculus*.

Another quick and easy way of creating fish holding areas by diversifying the river bed are woody flow deflectors seen in appendix 15 & 16. These can blow holes into the river bed which will provide deeper pots for larger fish to colonise. This will assist in undoing some of the uniformity of the reach.

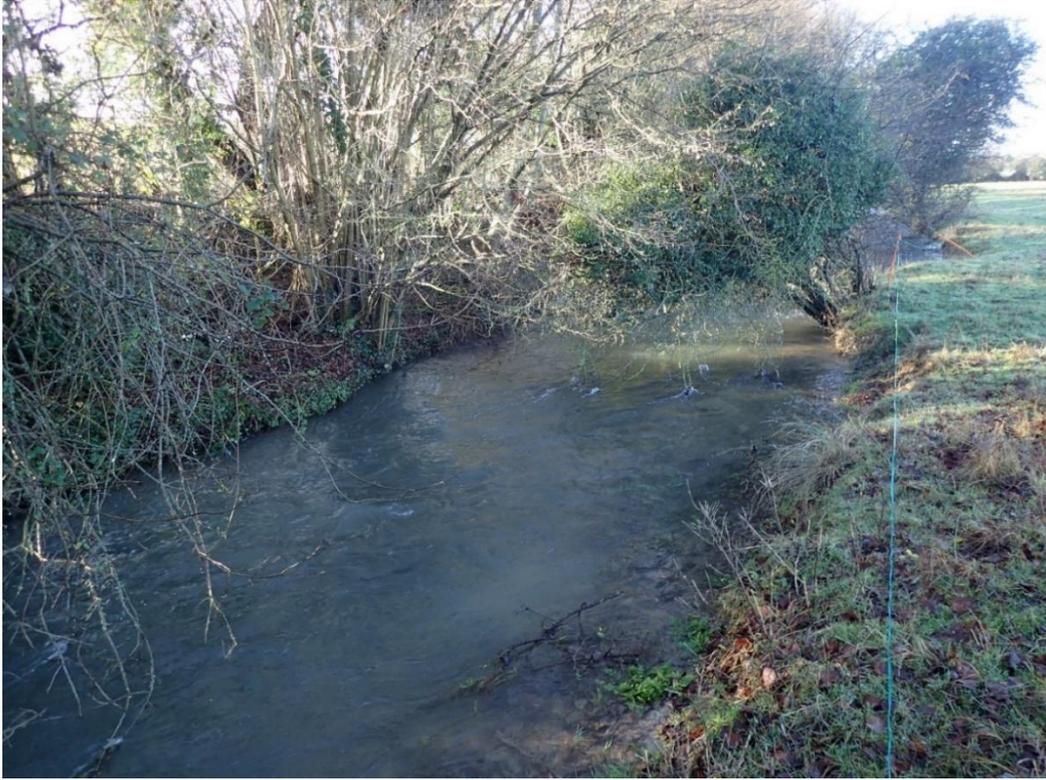
Photo 8 Excessive shading again southern bank (RB), hazels middle of shot are prime candidates for hinging. Note the woefully inadequate fencing which does nothing to protect the denuded marginal fringe.

The LB is fully exposed to grazing animals; photo 8 provides an example of how the fence is wholly inadequate. It should be replaced to exclude animals from the riparian fringe, but it may increase the fishery maintenance for fishing access and scrub control.

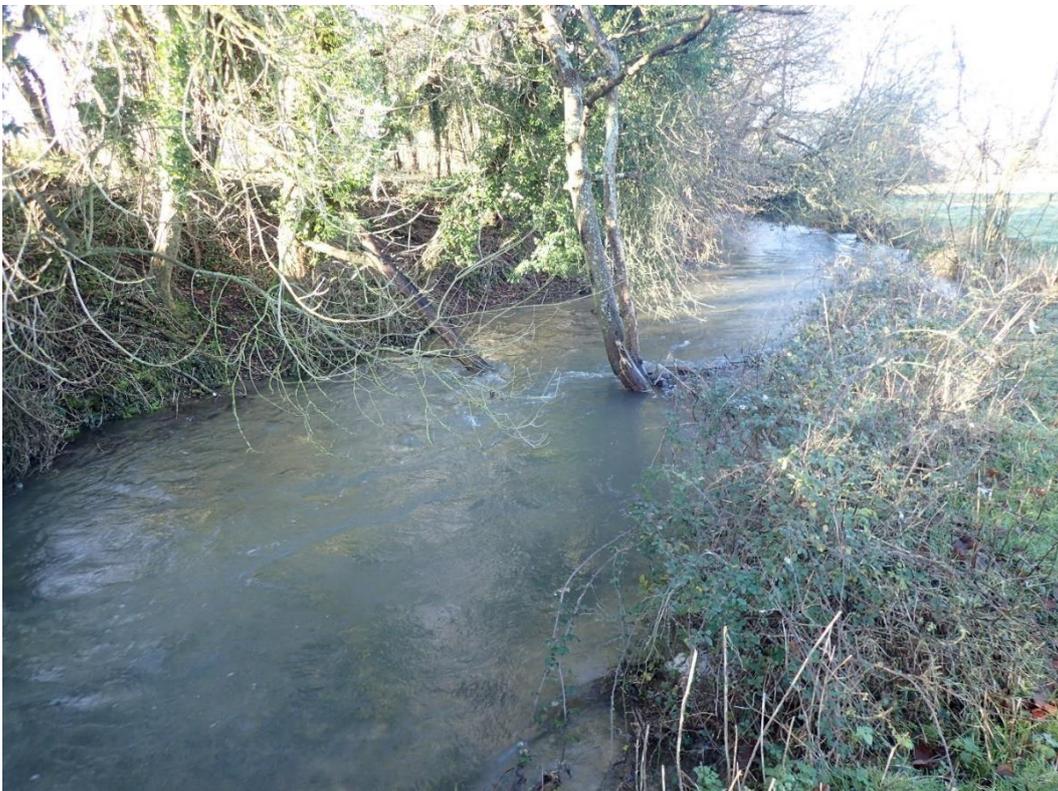
Photo 9 A rarity, woody material naturally accumulating and providing structure for fish populations.

Incidences of naturally occurring, fallen woody material were rare within the reach due to the shrubs being hazel being managed historically. The LB's grazing pressure has reduced both scrub and tree regeneration. But where trees and shrubs are falling into the channel (photo 9), they will provide diversity to the river flow and variable habitat structure for fish populations. Fallen woody material is an important component within rivers and should never be removed without consideration of the major benefits that it provides.

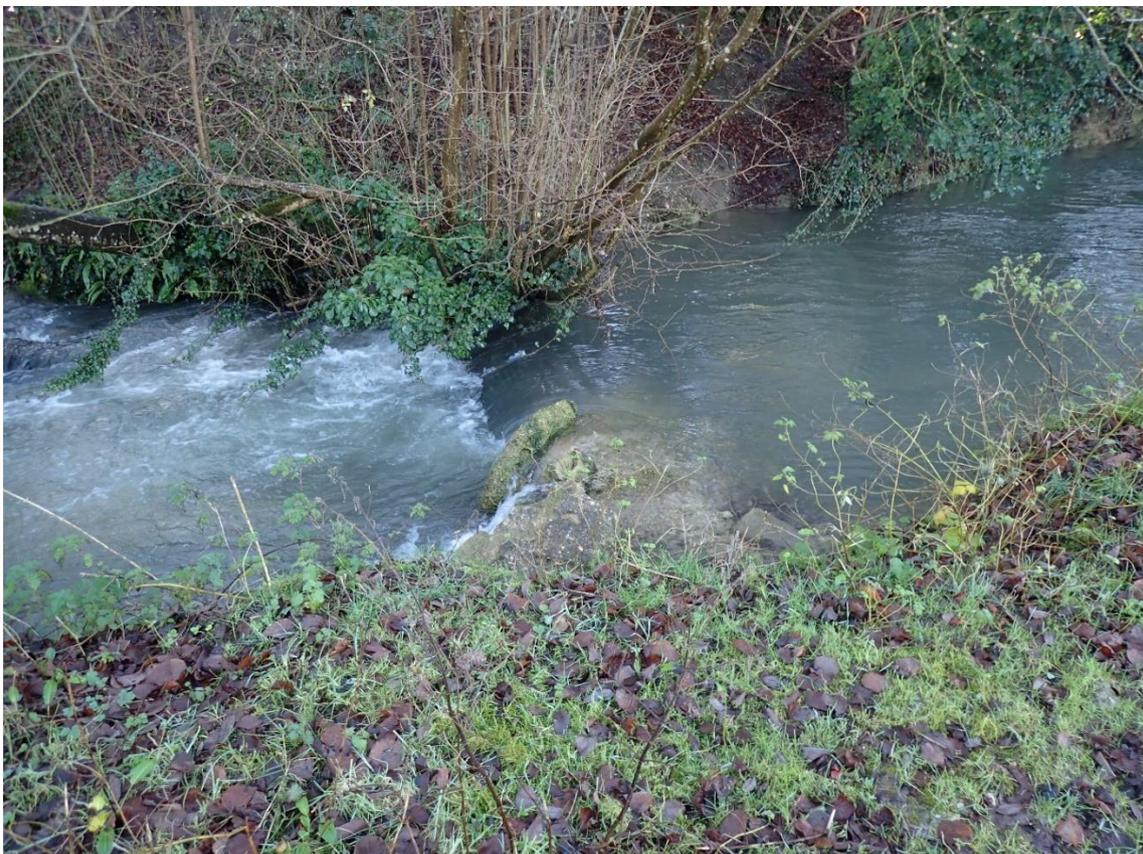
Photo 10 Concrete boulder weir which serves no current purpose and creates a negative impact upon habitat locally.

Towards the upstream section within the first field there was a concrete boulder weir (photo 10) which would have been used historically to retain water level upstream. This structure will interrupt sediment and gravel transport thus degrading the channel for some distance upstream. As it is no longer required, the redundant structure should be removed. The pool that it has created may provide refuge for fish, so a woody deflector may serve as a useful replacement to maintain scour through the pool once the boulder weir is removed.

- Remove redundant weirs. Use woody material to maintain scour through the pools.
- Invite the EA for a meeting to assess the options for a restoration project. WTT would be happy to act as a broker to help this meeting happen. This could be exploring the possibilities of channel realignment which would solve many of the localised habitat issues especially with regard to the straightened, overly uniform and shaded channel.

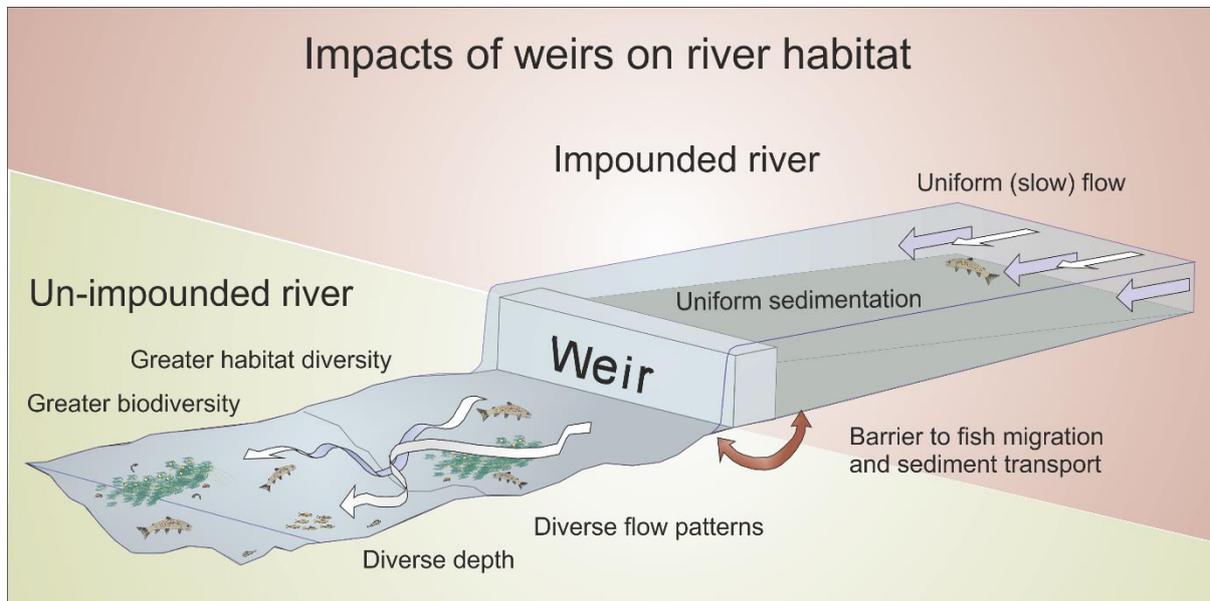
Photo 11 shows how weirs impact riverine ecology. The scour pool that a weir creates can be mimicked with carefully placed woody material (such as flow deflectors or hinged trees). This has far greater benefits to the environment as woody structures retain a partially open channel which should not impound the upstream flow nor interrupt sediment transport down the river corridor.

Photo 11 Diagram explaining how weirs degrade habitats.

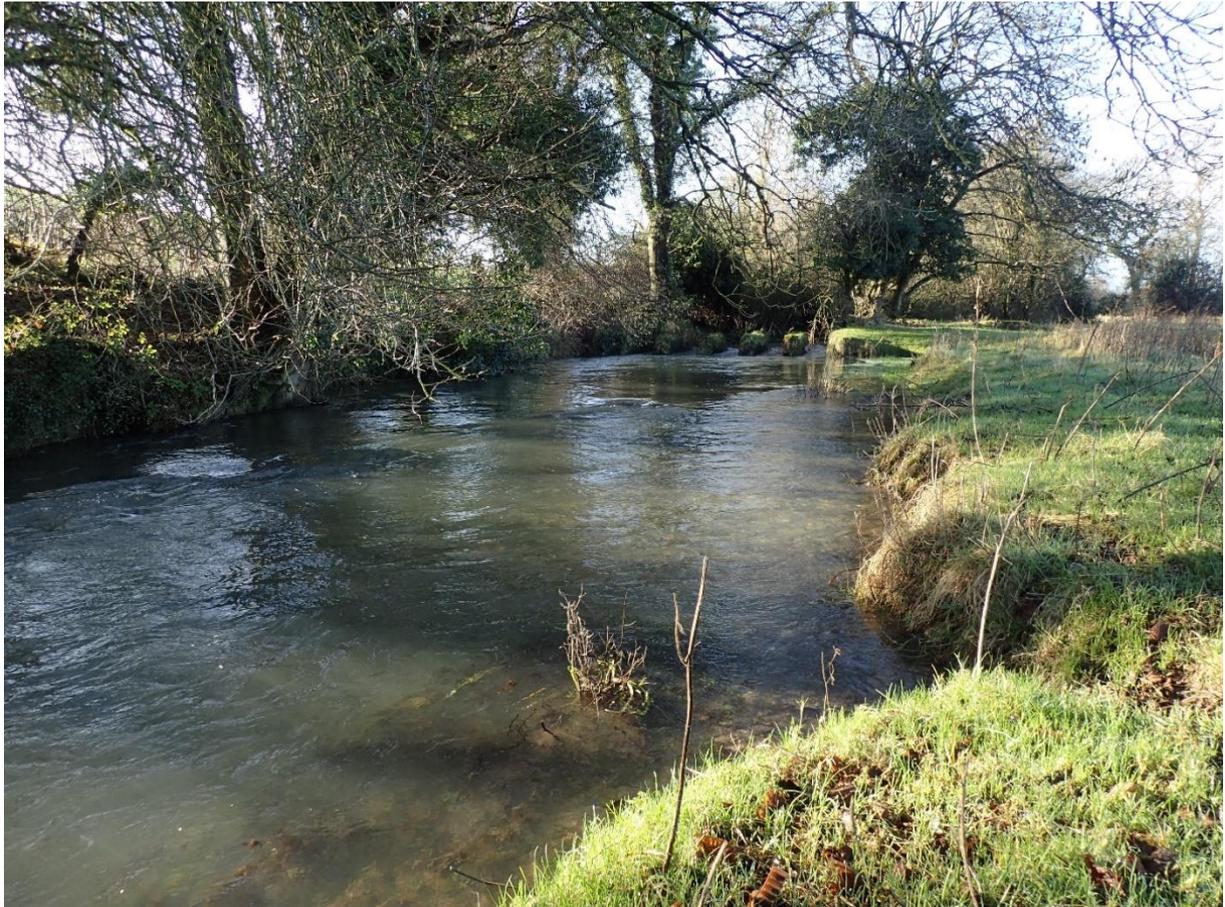
Photo 12 Old hatch pool providing a good quality holding pool, note lack of marginal plants and erosion on LB due to grazing.

At the top of the first field, the old cut-stone hatches were still in place. These were put in hundreds of years ago (photo 12). Closing of the hatches would have been used to flood the meadows. It is probable that the hatches were installed when the river was straightened to layout a water meadows system. Grazing animals were still impacting on the LB with erosion evident. This area would be a likely spot for some strategically placed woody material to allow sediment to settle and encourage a seed bank for marginal plants, but will still be impacted by grazing animals if left unfenced.

The area around the hatches is the most suitable place for channel realignment and reconnection to the paleochannels. Adjustment could be made to the spring-fed ditch to allow the river to connect with the floodplain, providing better flood storage and a more diverse (meandering sequence) river channel.

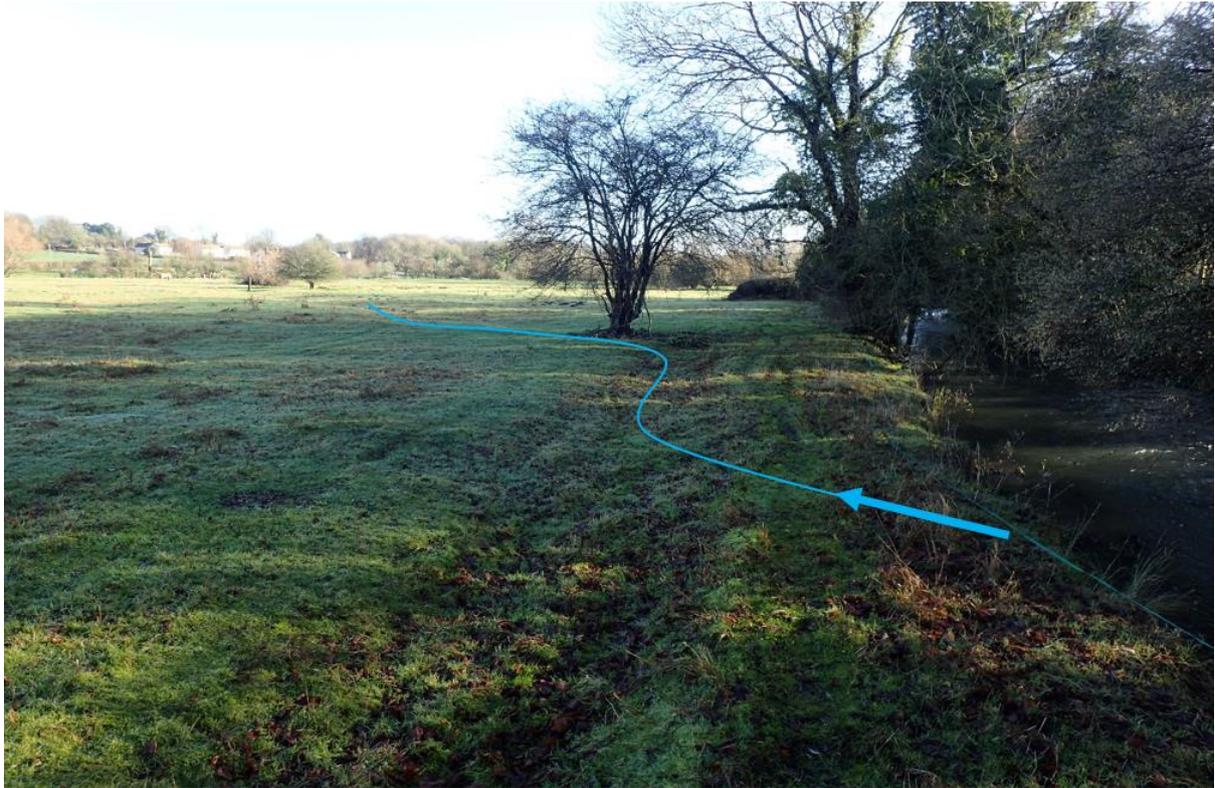
Photo 13 Blue line highlights possible path of channel realignment and floodplain reconnection.

This realignment should be seen as a long-term aspiration for the reach, as many of the local habitat issues can be solved by having a fully functioning and naturalised channel within the floodplain. This realignment would also increase the length of the fishery, create more sinuosity, greater width variability to support spawning riffles, and an increased occurrence of pool features which are all highly desirable for the fishery asset.

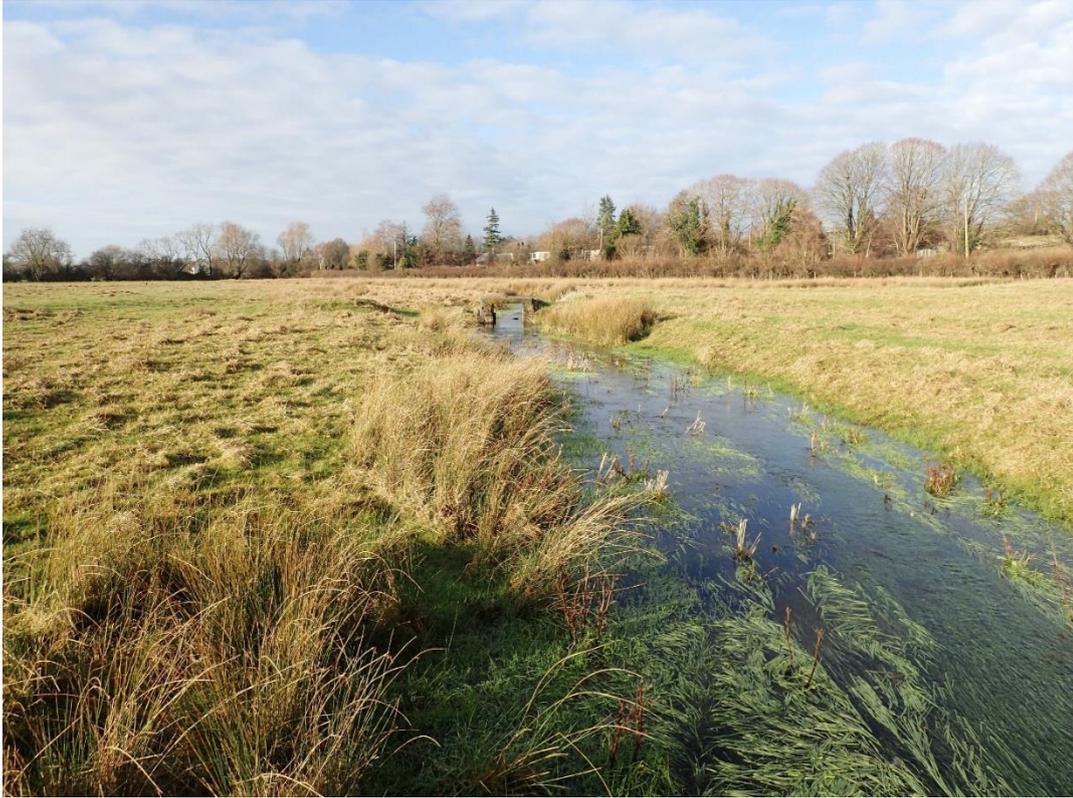
Photo 14 The spring ditch within the middle of the floodplain. Could the main river be reconnected to this lowest point?

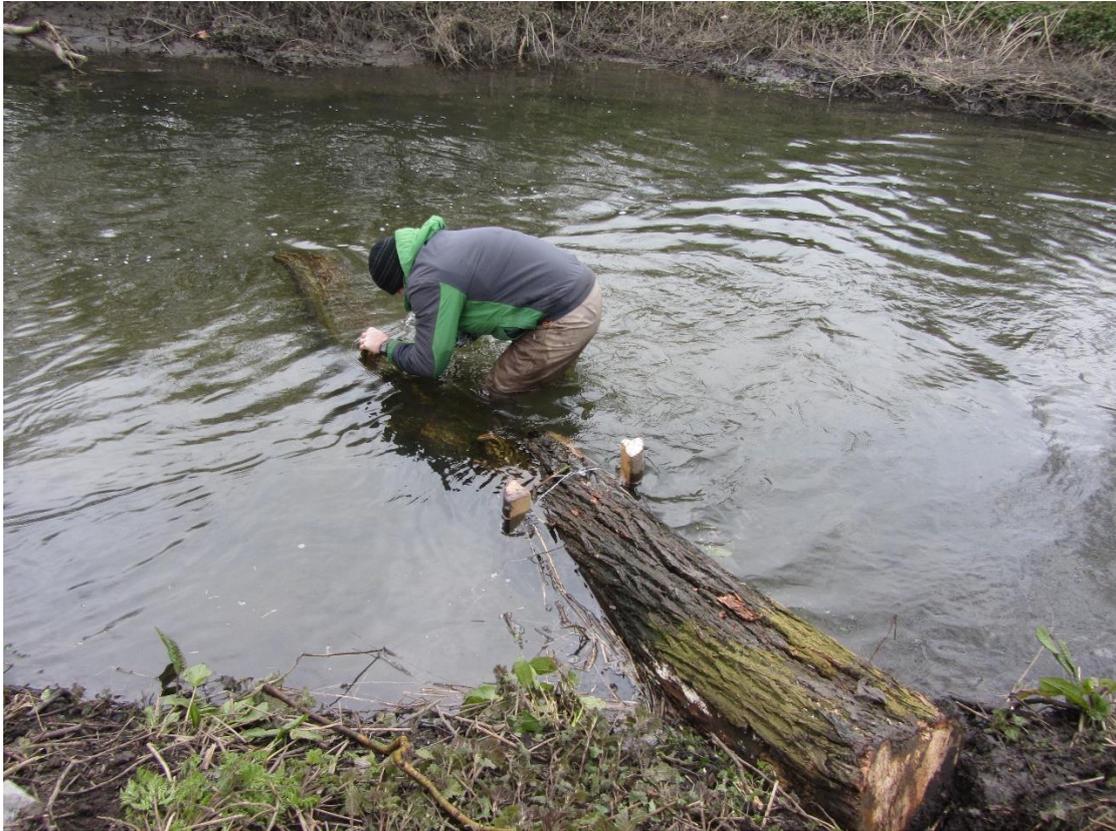
Photo 15 A simple log deflector, good at creating scour within the river bed to create structure for trout.

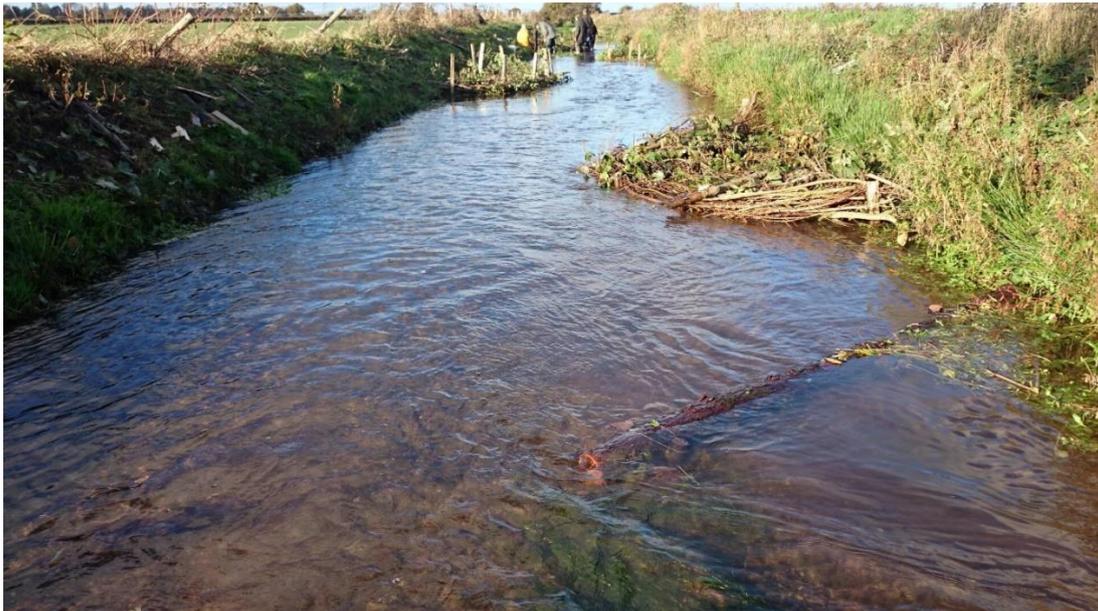
Photo 16 Small brushwood structures and a woody deflector to improve sinuosity and scour of a straight channel and allow marginal plants to develop.

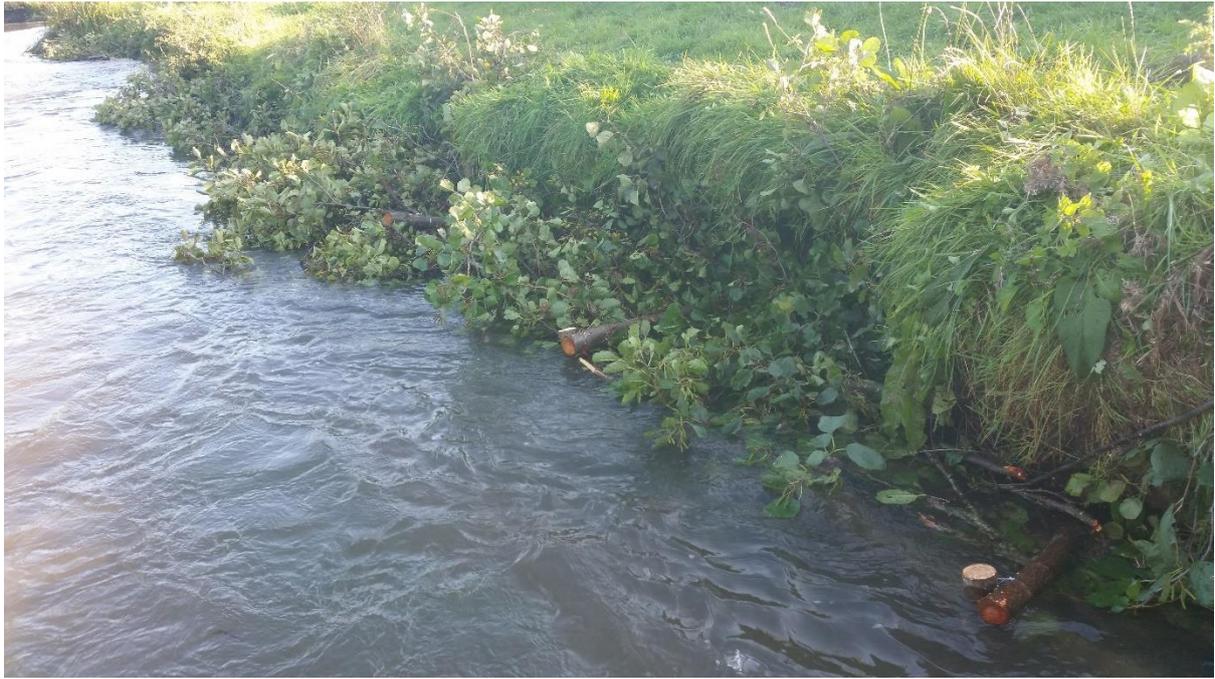
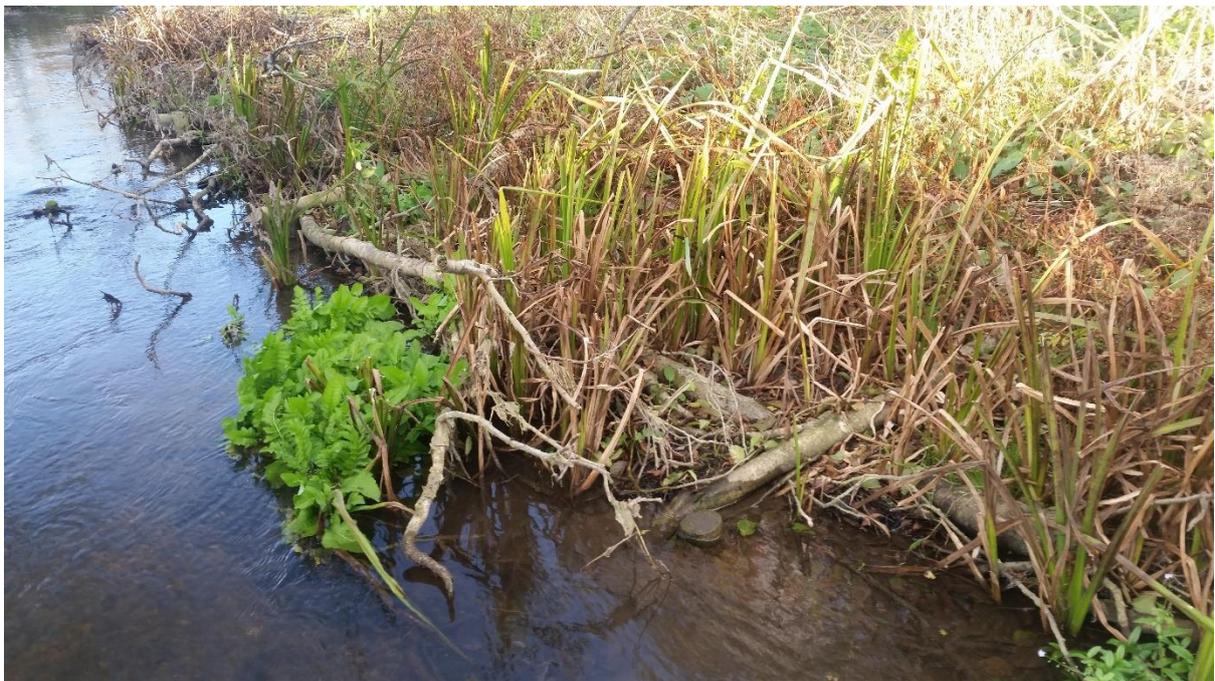
Photo 17 & 18 Before and after, note how the rough structure has trapped fine sediment and allowed marginal plants encroach into the channel.

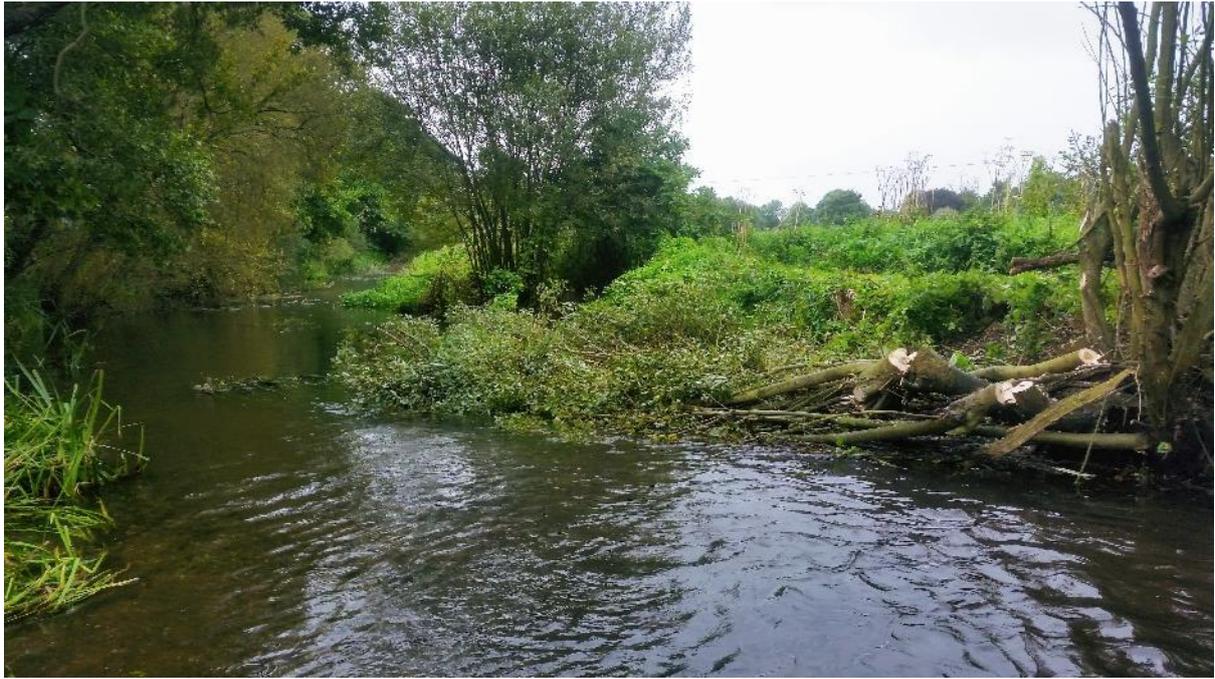
Photo 19 Hinged willow on the Bourne in Wiltshire. Hazel, willows and small alders can be hinged into a river, creating diversity of flow and in-stream cover for fish. The trees are hinged in a similar manner to hedge laying, where the tree is partially cut through at the base and laid into the river margin. Chestnut stakes and fencing wire can be used to secure the trees in place. Willow will survive perfectly well even with 70% of the branches submerged; however, hazel and alder should be laid to retain much of the structure above water level.

- In conjunction with some skylighting works encompassing coppicing (mostly hazel), habitat instream could be improved by hinging some of the material from the stool into the edge of the channel, in a downstream direction (examples in appendix photo 19). Such hazel stools should be carefully selected for optimal benefit, in consultation with WTT to select the best opportunities.
