**WILD TROUT TRUST**  
wildtrout.org

**Advisory Visit**  
**River Perry, Shropshire**  
**July 2026**

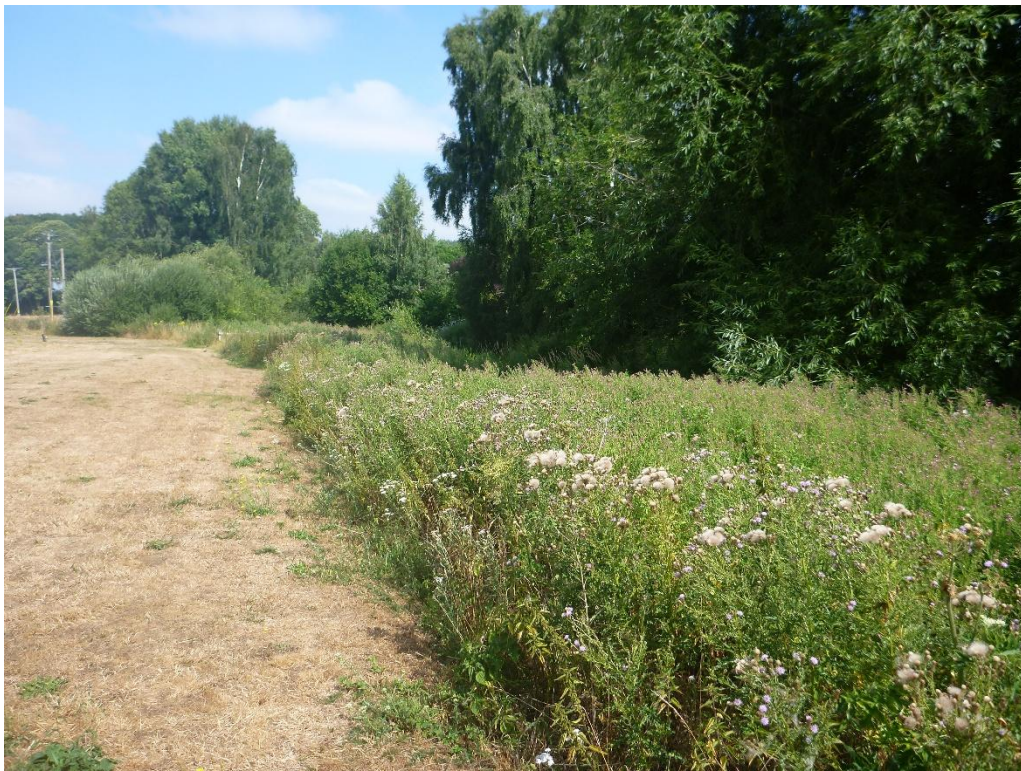
Upstream of Platt Bridge, the west bank is a public open space of mown grass with a wide unmown margin alongside the river; this is beneficial for riverside habitat, providing bank stability and cover from trailing vegetation ([Photo 1](#)). Planting some native trees along this bank would increase vegetation diversity and provide increased shade for the river channel. Shading of rivers is increasingly important in the warming climate and benefits cool-water species such as trout.

**Photo 1 Upstream of Platt Bridge in the public open space the river is bordered by a beneficial wide margin of vegetation. Tree planting in this area would provide some diversity and shade for the river.**

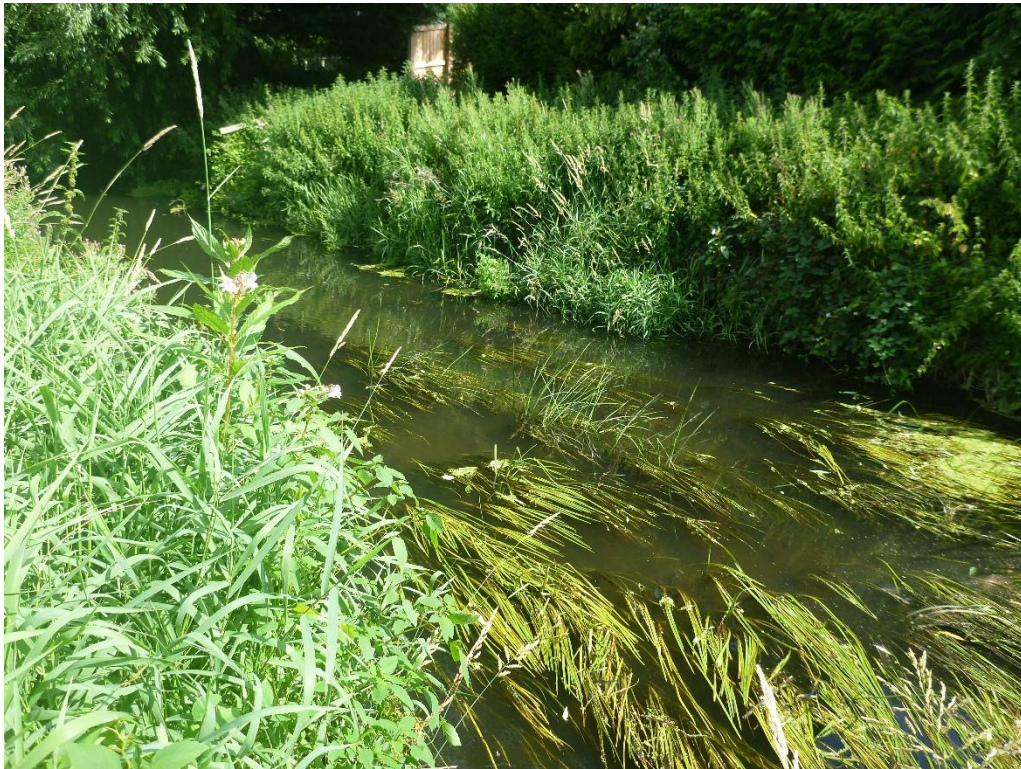
The river channel is slow-flowing with a bed of fine sediment colonised with aquatic plants typical of these conditions ([Photo 2](#)). The invasive non-native plant species Himalayan balsam is present and FORP have made sterling efforts to control it by hand-pulling. Parts of the east bank of the river are within private gardens and there are some stands of balsam there; FORP are engaging with residents to control it.

**Photo 2 River channel u/s Platt Bridge – uniform width and depth, steep banks, slow flow and prolific aquatic vegetation, reflecting past drainage schemes’ impact on river habitat.**

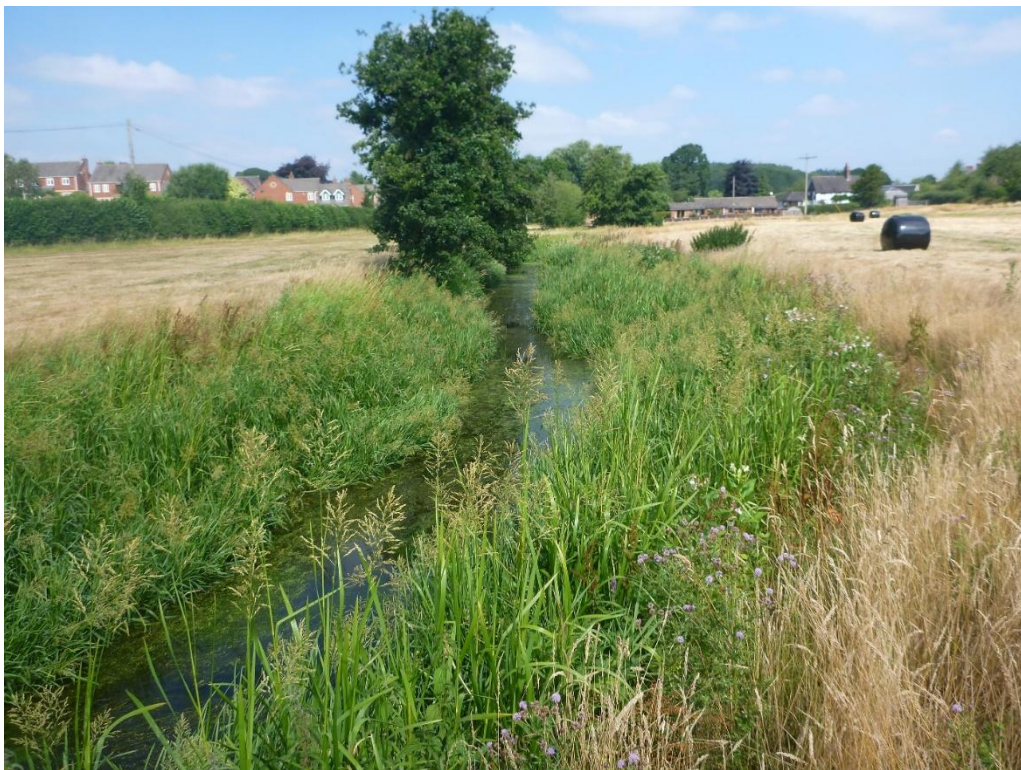
**Photo 3 Downstream of Platt Bridge**

Downstream of Platt Bridge, the river runs through farmland (mowing grass) and has a more meandering planform than other reaches, although the channel remains deeply incised ([Photo 3](#)). There is an open aspect and just the occasional alder trees on the bank, which provide valuable shade and cover within their submerged root systems ([Photo 4](#)). This section would benefit from bank reprofiling on the inside of bends and tree planting to increase channel shading and provide material for future large woody structure within the channel. If bank reprofiling is carried out here, gravel could also be introduced to improve habitat for fish spawning and invertebrates; gravel augmentation in the absence of bank reprofiling would be liable to washout during high flows (see [Appendices](#)).

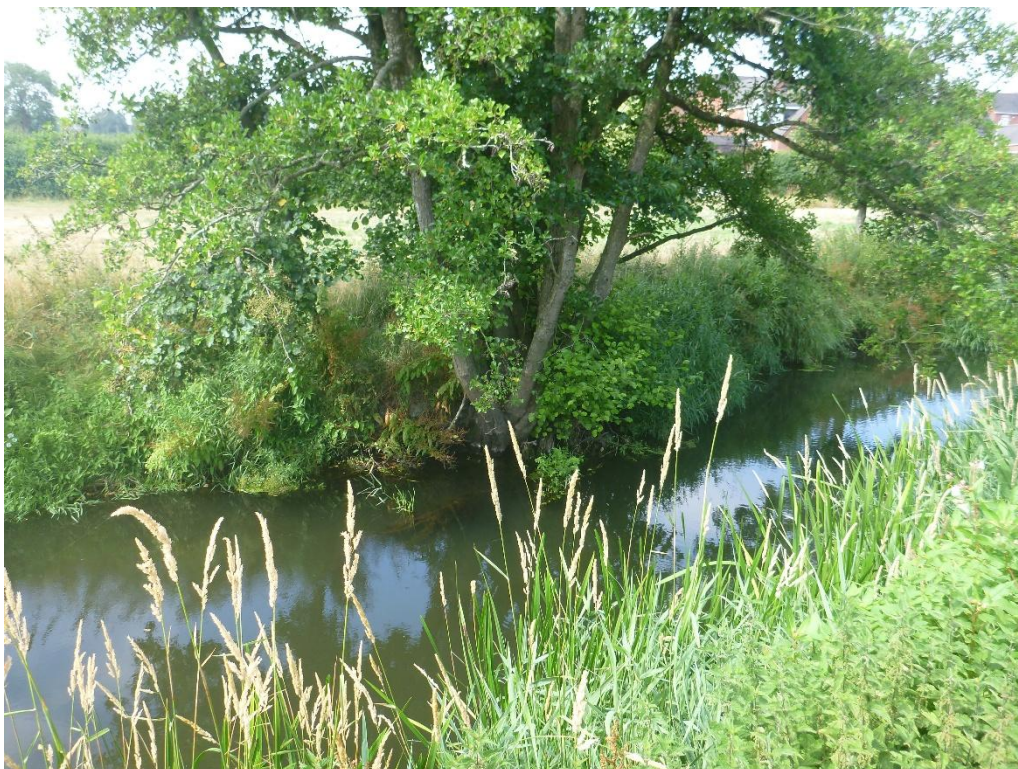
**Photo 4 Alder tree providing shade and cover.**

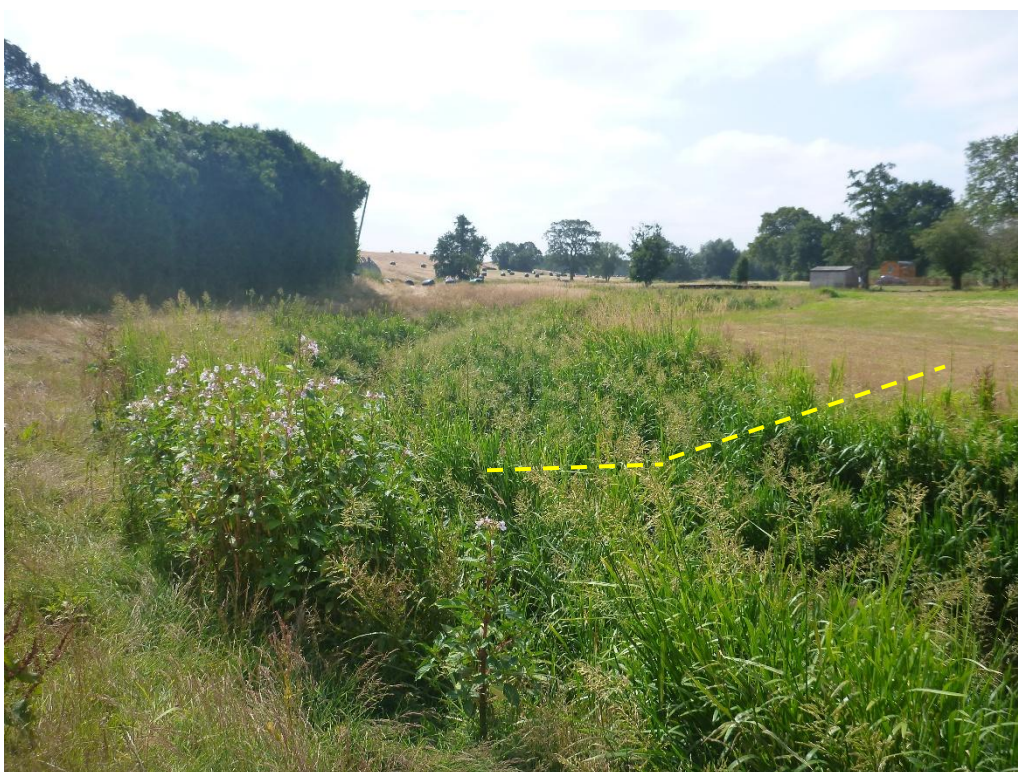
**Photo 5 Reprofiling the banks to a shallower angle on the inside of bends will promote the formation of gravel side bars (“beaches”) and improve the riparian habitat of the river.**

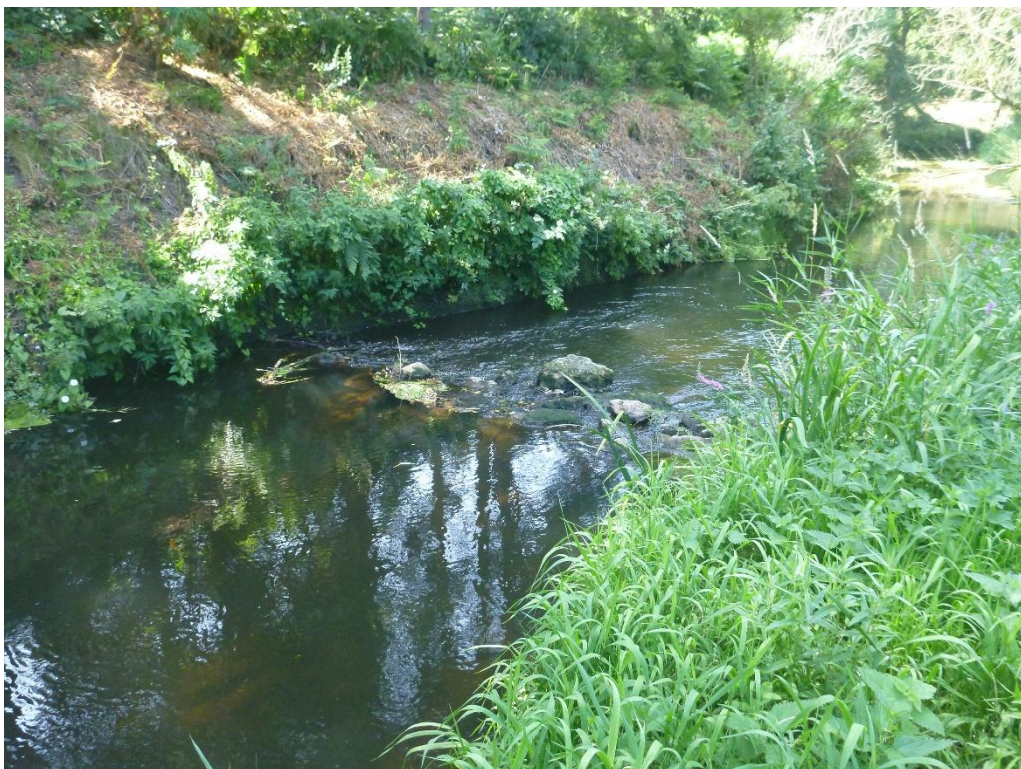
This section of river is located within the Riverside Cabins holiday park and there are various access points (decks) alongside the river on the TRB to facilitate swimming and canoeing. The river channel is deeply incised with sandstone bedrock evident at the toe of the bank (Photo 8), and a uniform slow glide flow pattern interrupted by two low, rubble weirs (Photo 7 and Photo 8).

**Photo 7 One of two low rubble weirs in this section, the only features seen during the visit that interrupted the otherwise ubiquitous slow glide flow habitat.**

Whilst such weirs are generally considered undesirable ([www.wildtrout.org/content/weirs-culverts-and-barriers](http://www.wildtrout.org/content/weirs-culverts-and-barriers)), in the context of this heavily modified channel they do at least provide some diversity. A better way of introducing diversity would be with large woody material (LWM) – the retention of fallen trees, branches, etc. which naturally coalesce into stable structures which can persist for weeks – years. These provide multiple benefits including localised scour leading to a diversity of flow pattern, depths and substrate sorting which creates various habitat niches for invertebrates, fish spawning, etc. LWM also traps leaf litter, a vital component of the aquatic food chain. The retention or introduction of LWM may conflict with the use of the river here for canoeing.

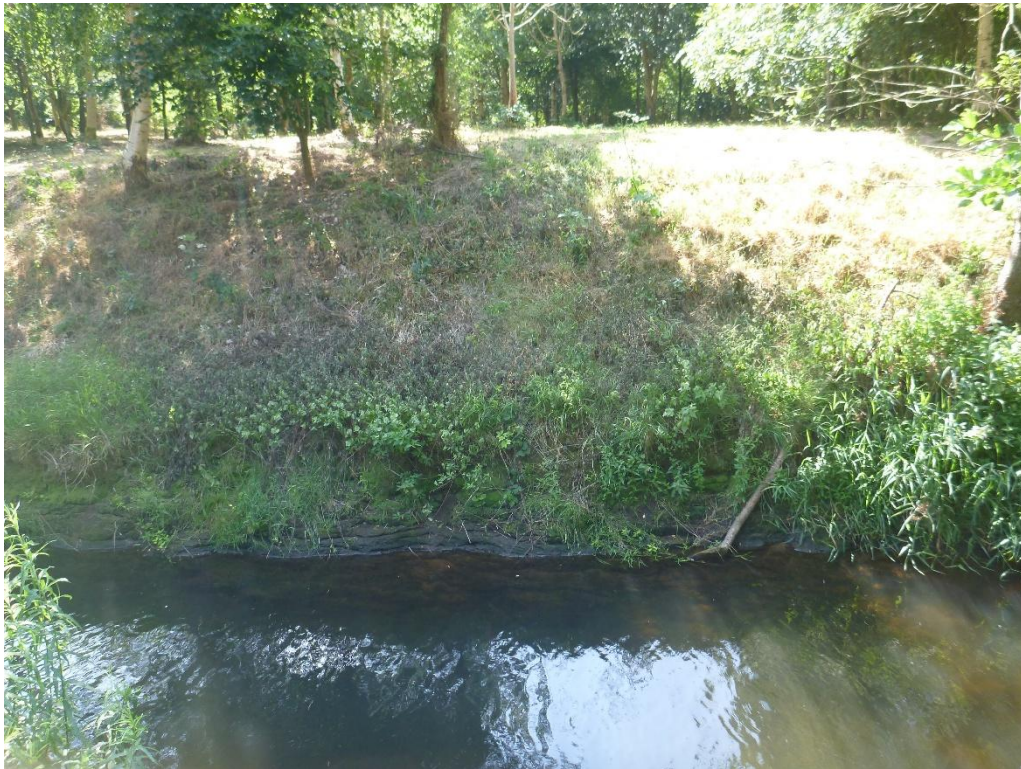
**Photo 8** The steep LHB with exposed sandstone bedrock at the toe indicates the extent of channel incision throughout the reaches inspected. Despite the steepness, it appears here that the banks have been mown, possibly to facilitate canoe access.

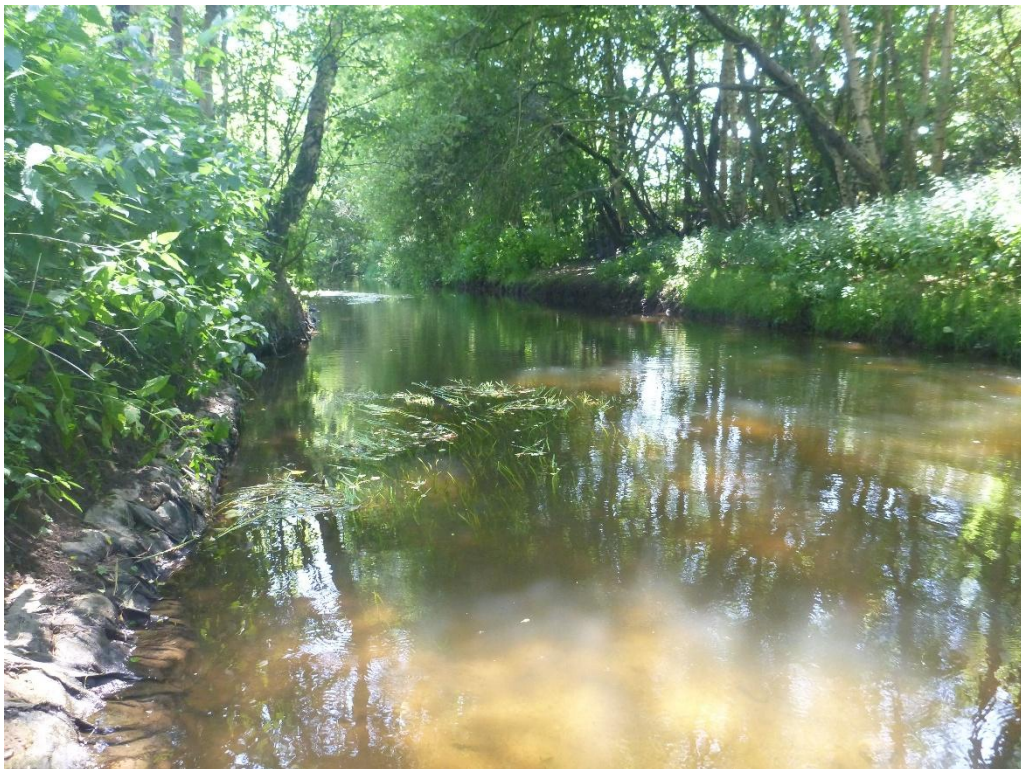
The river habitat here is similar to the site upstream, being a continuation of incised channel and slow glide (Photo 10), bordered by woodland with access points for canoeing (Photo 11) and open grassy areas for other activities. The shallow bays at the canoe access points provide some contrast to the otherwise sheer-sided banks, and shoals of juvenile fish (minnows, dace, chub) were observed here. These areas provide favourable feeding habitat for young fish and refuge areas from predation and high flows.

**Photo 10 Typical view along the channel, PGL site.**

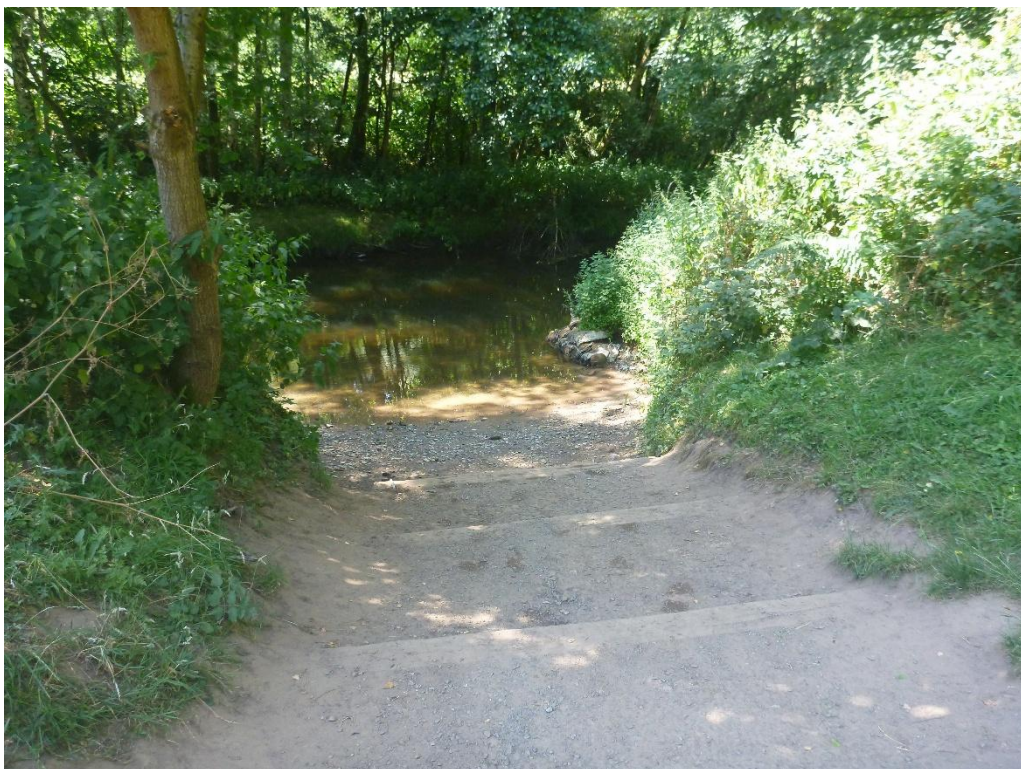
**Photo 11 Canoe access point.**

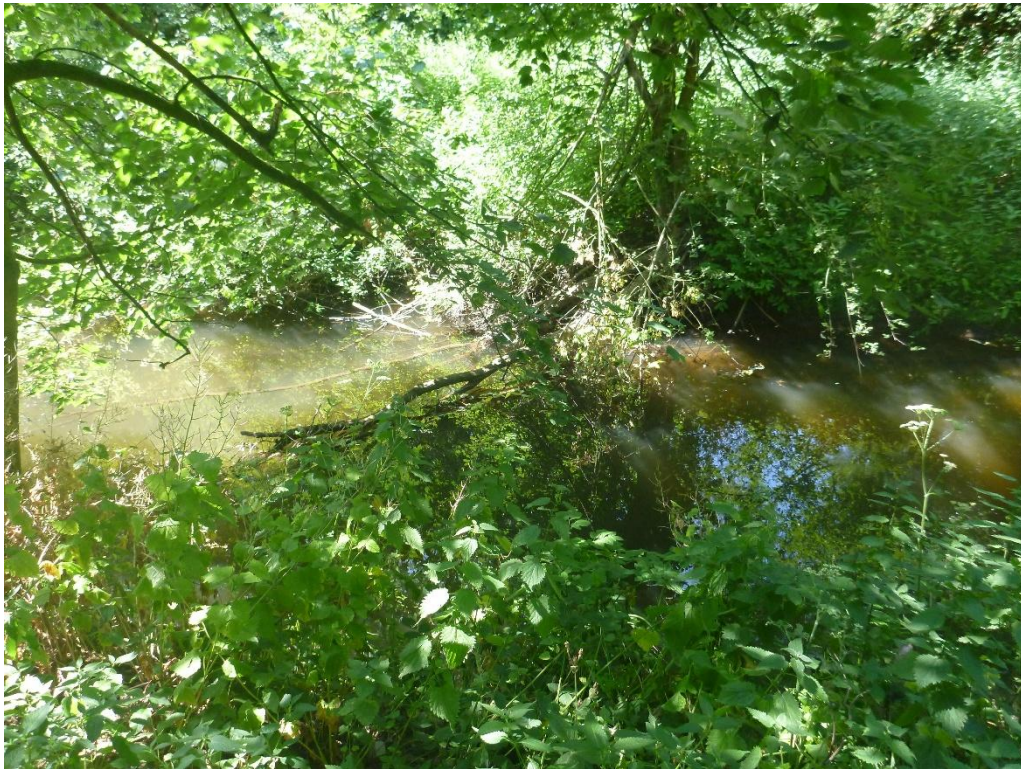
Downstream of the PGL boundary, several natural examples of LWM were observed (Photo 12), providing some much-needed habitat variety within the channel. The lack of LWM upstream suggests it may be actively removed to facilitate canoeing.

**Photo 12** Beyond the d/s PGL boundary large woody material (LWM) is present in the channel, providing some valuable habitat.

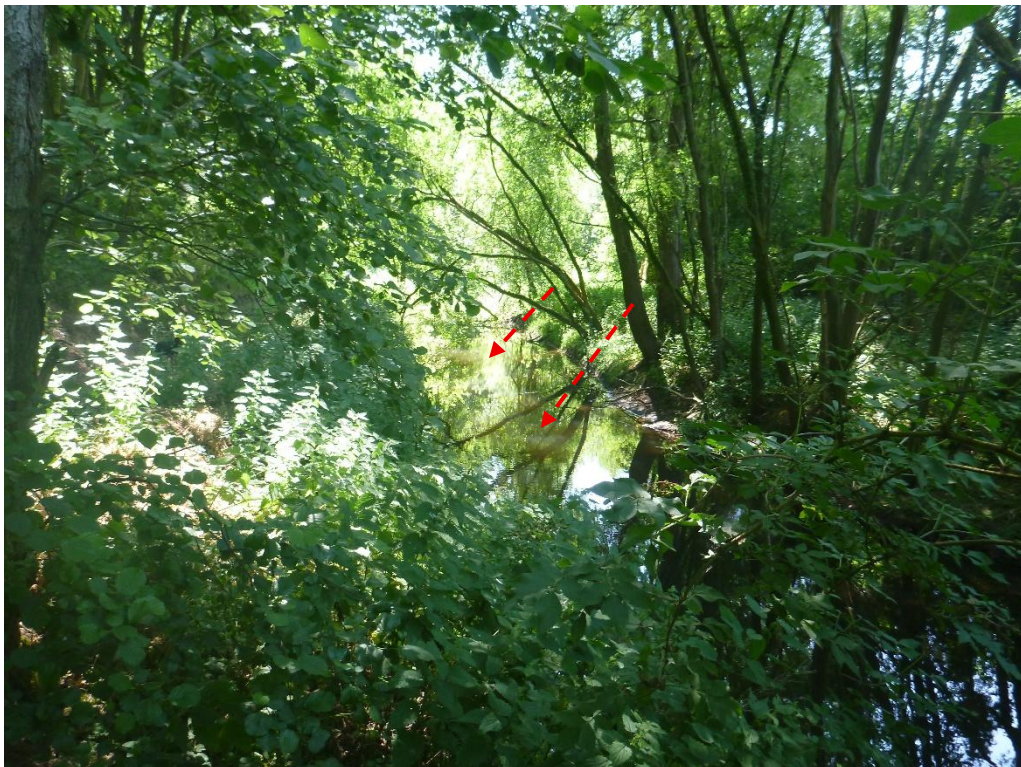
The wooded banks provide valuable shade for keeping water temperatures down and an input of leaf litter which supports the aquatic food chain. The plentiful trees also provide opportunities for introducing large woody structures (Photo 13) to the channel by the various techniques described in the Appendices.

**Photo 13** The woodland alongside the river provides plentiful opportunities for introducing LWM.

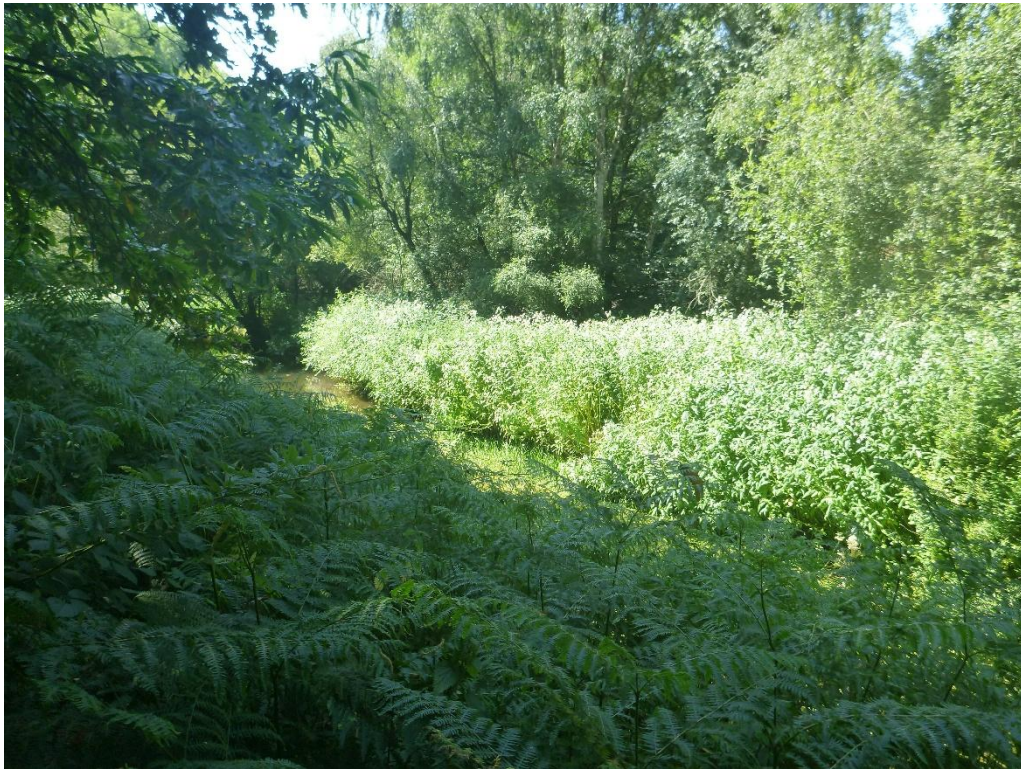
At the downstream extent of the reach, large stands of Himalayan balsam were discovered (Photo 14), which will be supplying seeds affecting downstream areas including the first reach inspected at Ruyton. Balsam control is most effective if tackled from upstream to downstream to reduce the supply of seeds deposited by the river.

**Photo 14** Large stands of Himalayan balsam at the d/s end of the reach.

- Continue to control Himalayan balsam, working in a downstream direction and targeting 'hotspots' prior to flowering to minimise seed production.
- Retain fallen trees and branches within the channel wherever possible.
- In the wooded sections, introduce wood to the channel using the techniques in the [Appendices](#).
- In the open section downstream of Ruyton, reprofile the river banks on the inside of bends to a shallow angle ([Photo 15](#)) and introduce gravel to improve fish spawning habitat ([Photo 16](#)).
- In the open section downstream of Ruyton, carry out tree planting with native species alongside the river.

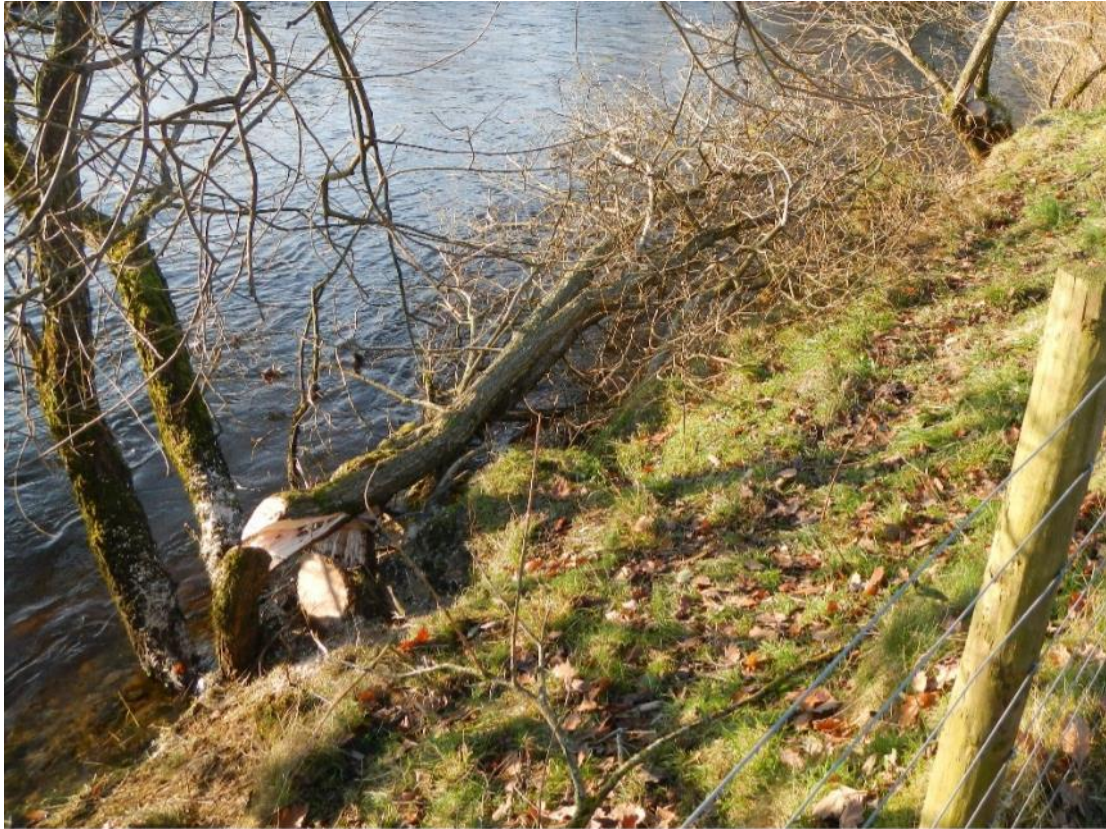
Hinging (also called laying, folding or pleaching) trees into a watercourse is an excellent way of adding flow diversity and roughness to a channel. Hinging replicates the natural process of trees falling into the channel, with the added benefit that the hinged section of tree should continue to grow, developing even more habitat complexity over time.

In its simplest form, hinging involves a single quick cut through the first two-thirds of the trunk/branch, then continuing to cut a little at a time until the trunk/branch collapses down over the river or along the bank (depending upon species). The cut should be made from the exact opposite side of the tree to the desired felling direction. This is similar to conventional tree felling, however the face cut should be omitted. As a result the retained material forms the necessary hinge.

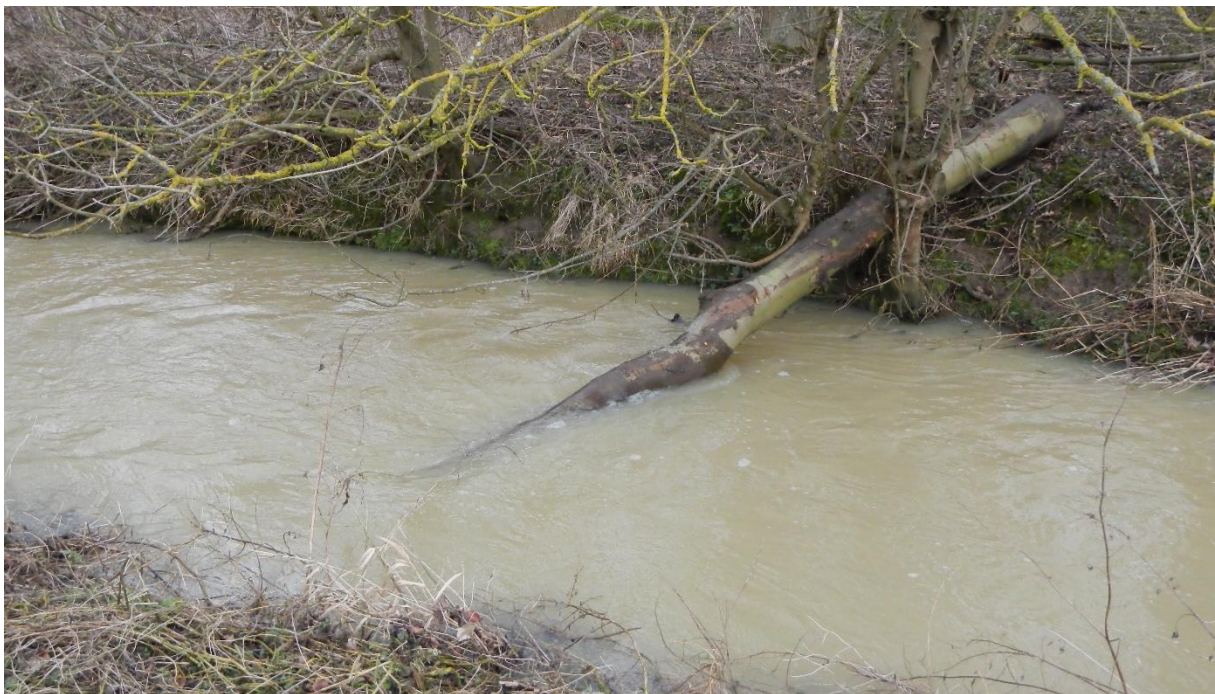
Where there are overriding flood risk considerations or other reasons for retaining wood where it is installed, lodged woody material offers a simple, quick and effective way of securing woody material, without man-made fixings. Choosing the right trunk or branch, and optimal location to install it, requires an understanding of river processes, but installation is relatively straightforward. Lodged woody material simply replicates the natural occurrence of trees and limbs lodged between or against other standing trees or stumps. The structure is secured by its own weight and the force that high flow exerts against it, pinning it even more securely to the anchor point - usually one or more vertical trees (ideally at least two). The picture below shows a simplified form of the technique for illustrative purposes, as a flow deflector that has been lodged between two vertical trunks.

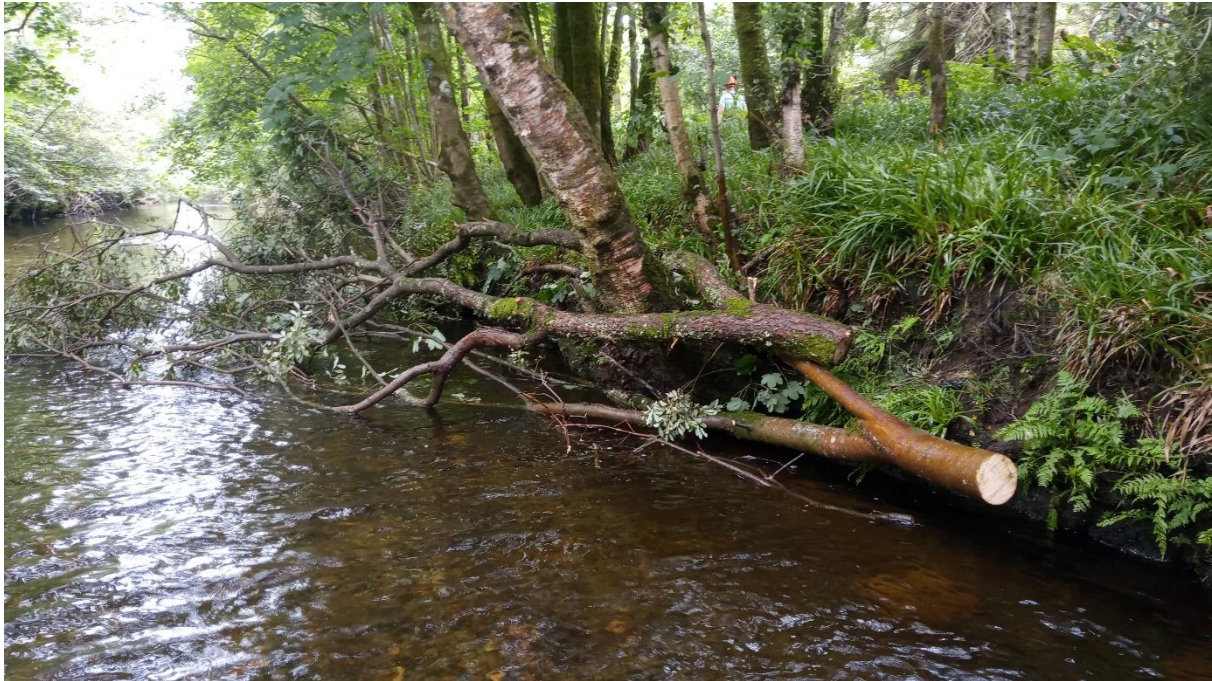
Another simple method for installing lodged woody material is as a hanger, where a forked branch is hooked over a vertical trunk, with the butt end facing upstream and the canopy end downstream. Again, this completely secures the material, with no requirement for wire, rope or posts.

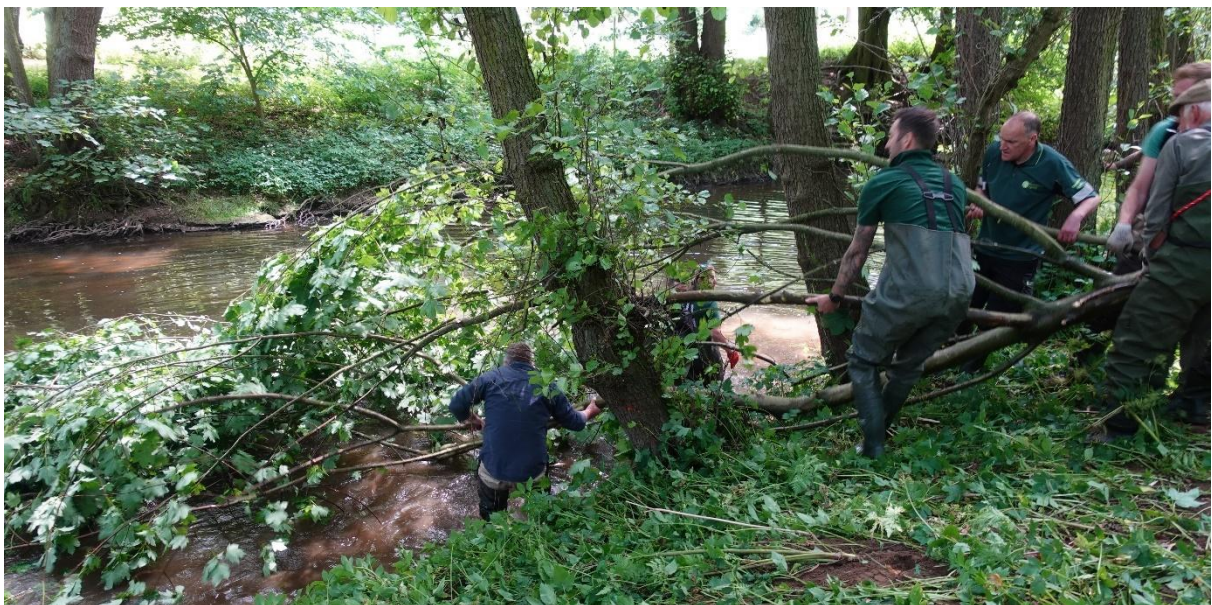
A hybrid of the two techniques can be used, being demonstrated below in a habitat workshop on the River Leven in north Yorkshire. Note the canopy of a sycamore tree being dragged butt end first between two bankside alders, lodging and hanging it in place to leave the bushy, diffuse canopy in the channel. Depending upon the porosity of the material used, this technique can create flow diversity, encourage sediment deposition or scour, and provide cover for fish and invertebrates.

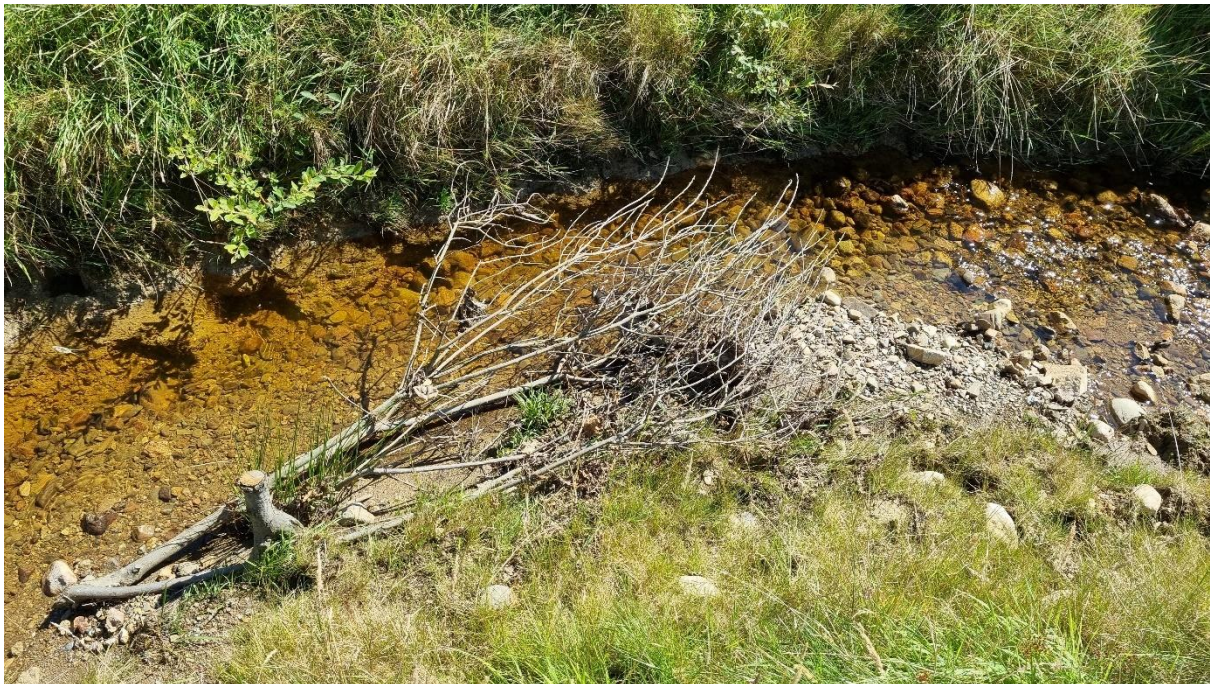
Above, live willow posts were used to secure a branch into a recently restored channel to assist the retention of coarse sediment during high flows. The following two pictures show a piece of live willow pinned into the channel (still healthy and growing) and large ash tree pinned into a stream, both providing much-needed cover and refuge for fish, along with flow deflection that will aid in scouring and sorting of the substrate, diversifying the otherwise uniform bed profile.

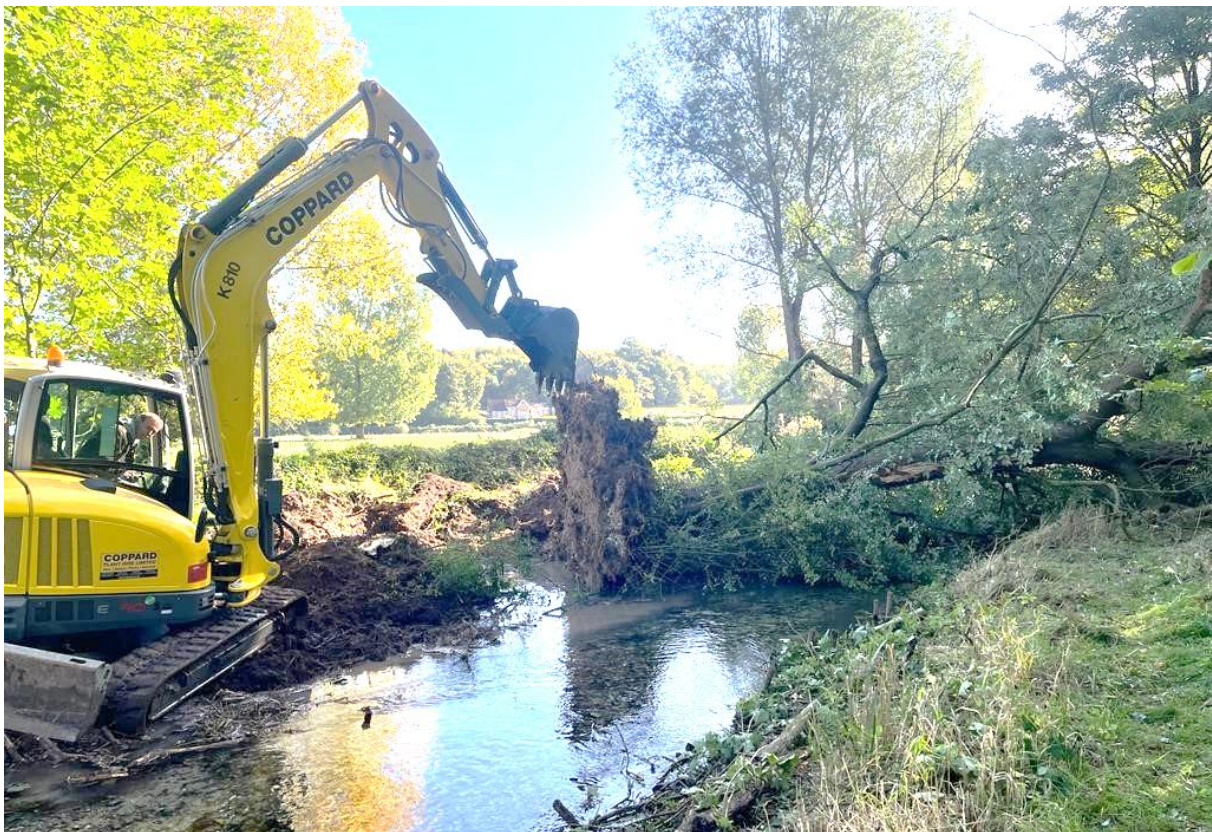
The technique is usually initiated with the use of an excavator, which is used to dig out the back side of the roots (the opposite side to which the tree is intended to fall) and then push the tree over to the desired position. A similar effect can be achieved by winching a tree over, but loosening of the root-plate is still generally beneficial first. Alternatively, the entire root-plate of a tree can be exhumed and the tree transported from any location to be installed to the channel.

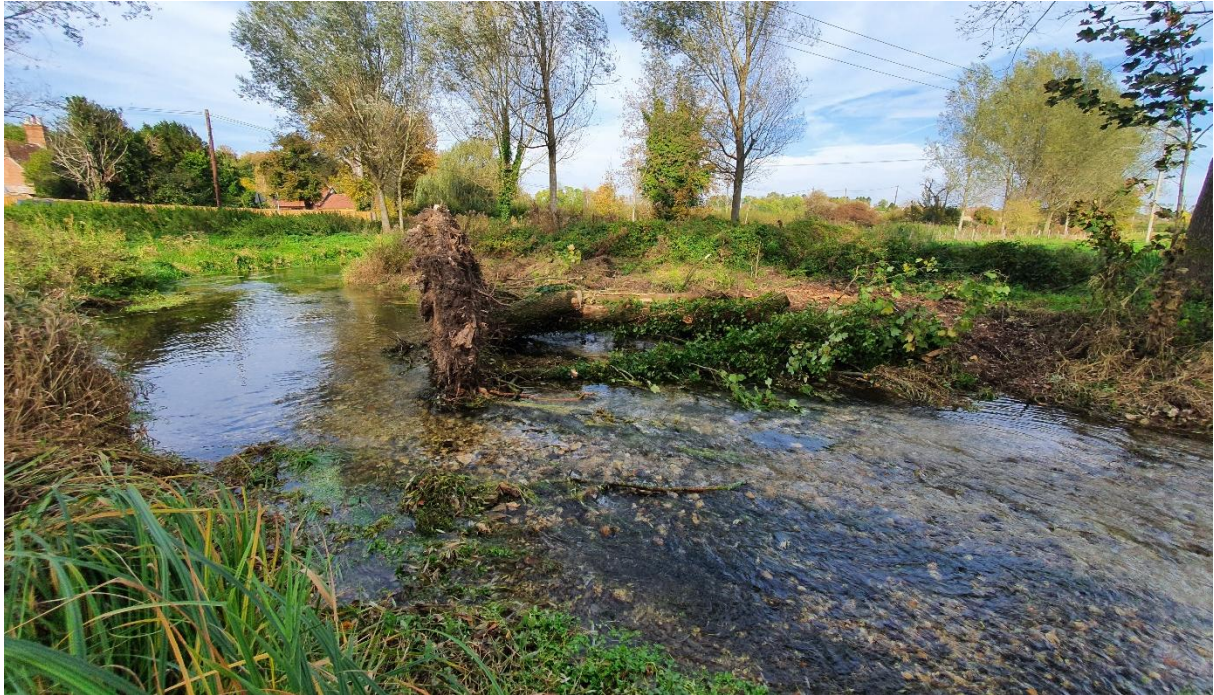
The structure provided within the channel can create valuable pinch-points, which increase flow diversity, focussing scour into the bed locally around the rootball and larger stems/trunk and encouraging deposition in other areas, usually among or downstream of the canopy.

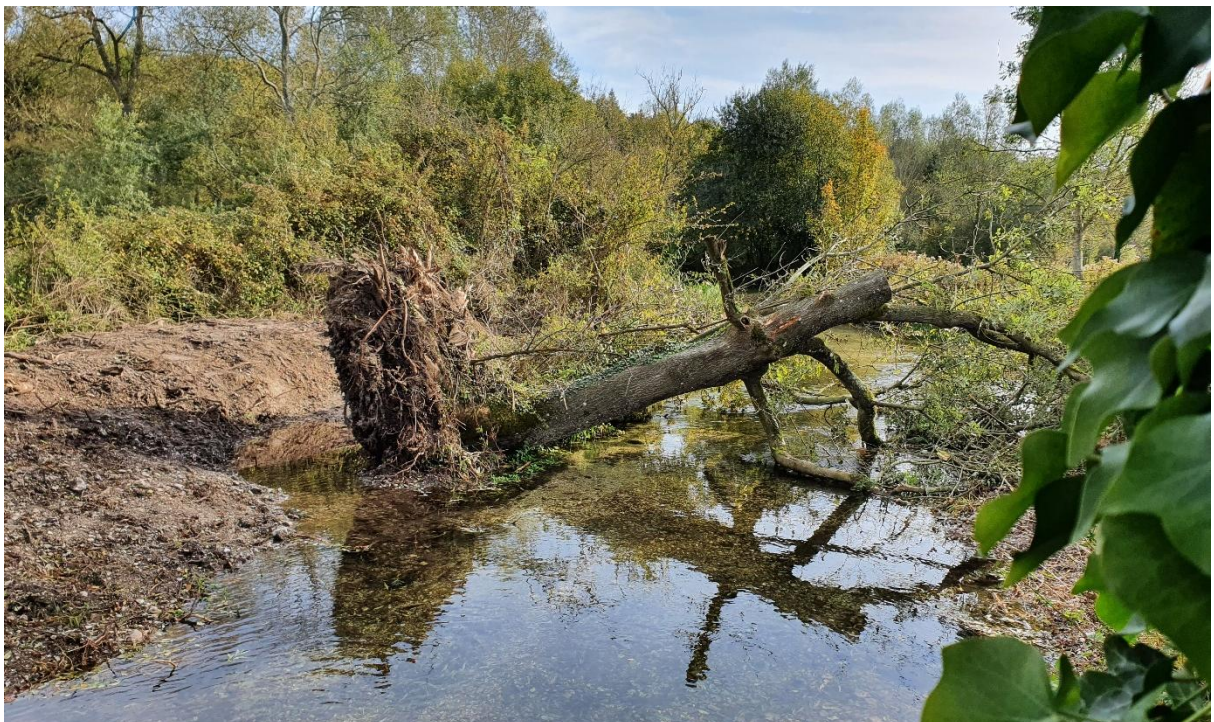
Because of the sheer size and mass of the structure, it can be used to initiate large and quite rapid changes within a channel, which can be great to use where past channel modifications have left an overly straight channel or unform bed profile and significant scouring/reshaping of the bed or banks are required.

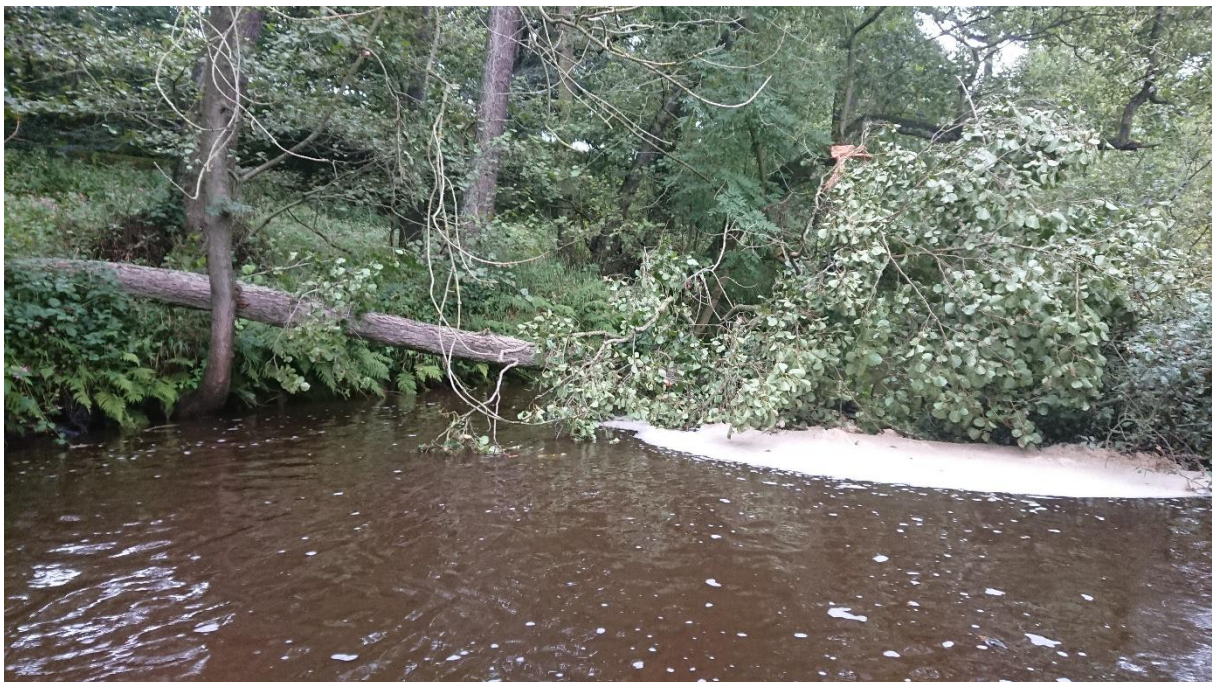
In the example below the tree was felled just downstream of a bankside tree, but with sufficient length of trunk retained on the bank that it cannot be carried away downstream. An alternative option is to fell the tree to the upstream side of the tree or between multiple tree trunks, thereby creating an even more secure Large Lodged Woody Material feature (LLWM). Note how even within a few minutes of initiating the technique, a natural foam raft had accumulated on the upstream side of the structure, creating valuable in-channel cover, a source of shade, and accumulation of invertebrates for fish to eat.

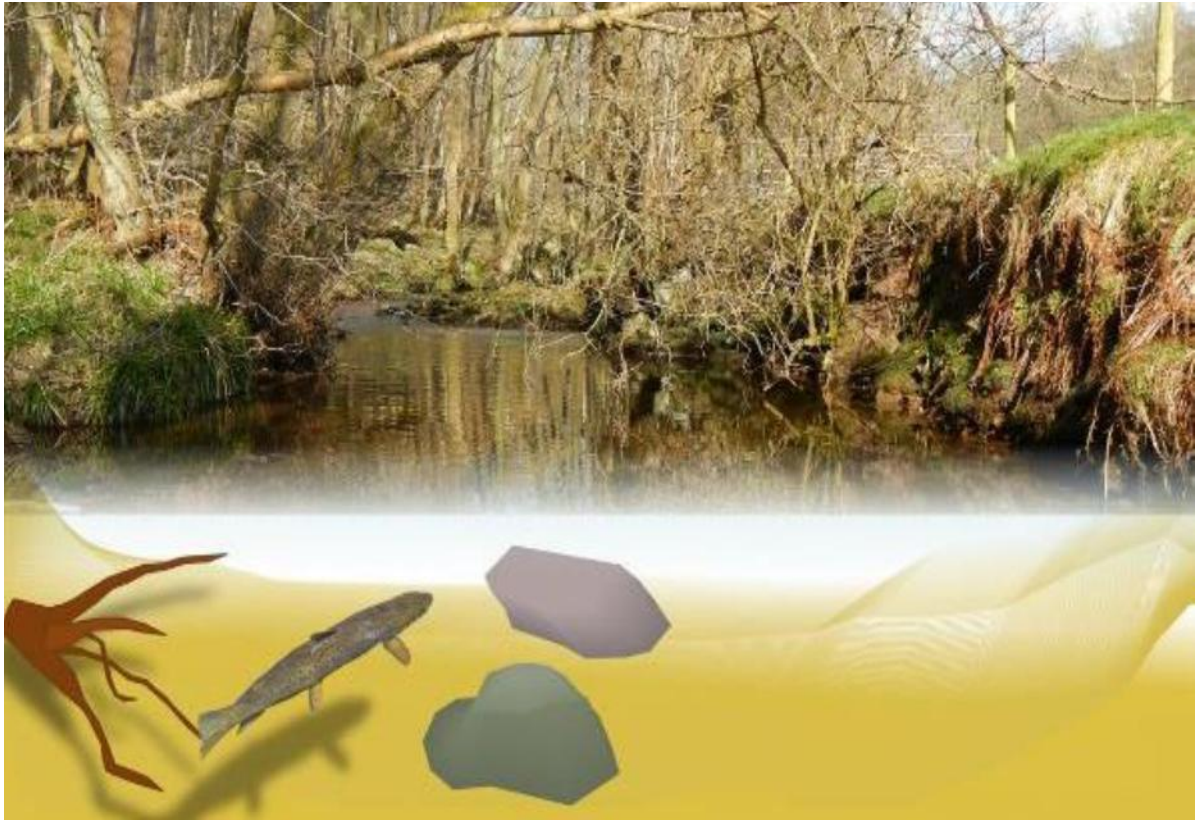
*Figure 4: The availability of deeper water bolt holes (>30cm), low overhanging cover and/or larger submerged structures such as boulders, fallen trees, large root-wads etc. close to a good food supply (e.g. below a riffle in this case) are all strong components of adult trout habitat requirements.*
